**CONSENT ORDER
ISSUED UNDER THE
WATER POLLUTION CONTROL ACT
WEST VIRGINIA CODE, CHAPTER 22, ARTICLE 11**

TO: Columbia Gas Transmission, LLC
Attn: Troy Tally, Vice President
1700 MacCorkle Ave
Charleston, WV 25314

DATE: October 1, 2020
ORDER NO.: 9061

1. Columbia Gas Transmission, LLC is conducting land disturbance activity associated with construction of the Mountaineer Xpress Project in Marshall, Wetzel, Tyler, Doddridge, Ritchie, Calhoun, Wirt, Roane, Jackson, Mason, Putnam, and Cabell Counties, West Virginia. On January 31, 2018, Columbia Gas Transmission, LLC was issued Water Pollution Control Permit No. WV0116815, Registration No. WVR310872, for Stormwater Associated With Oil and Gas Related Construction Activities.

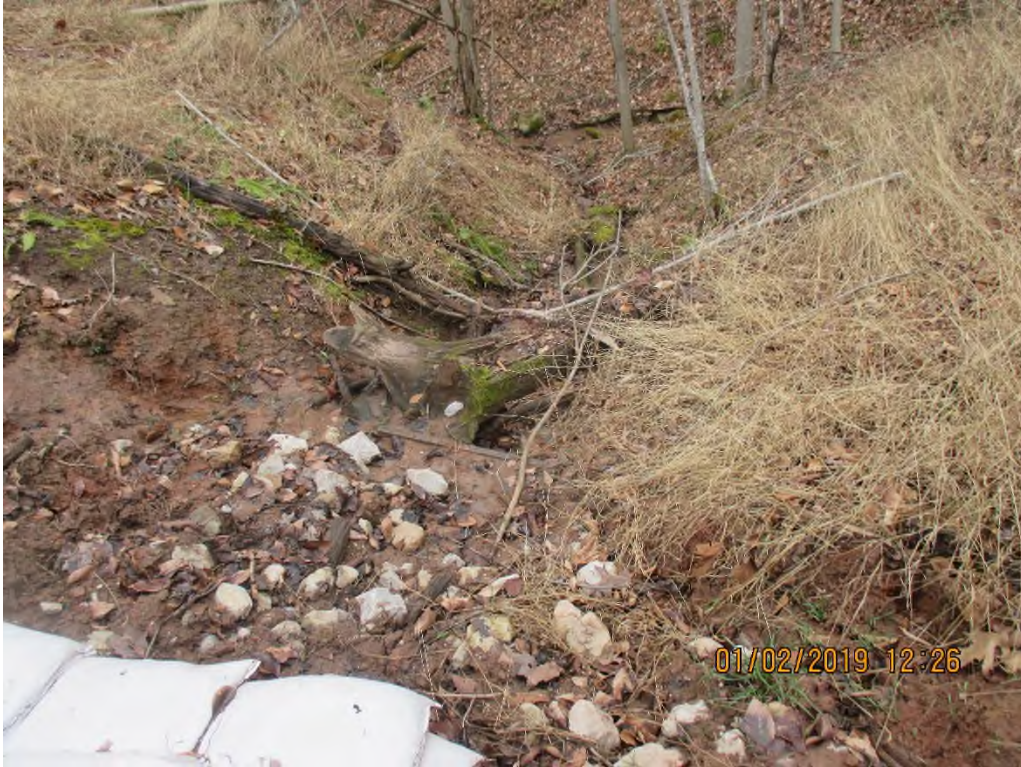
Discharge point at Silt Fence labeled as 24 on North slope that flows into UNT of Grasslick Creek.

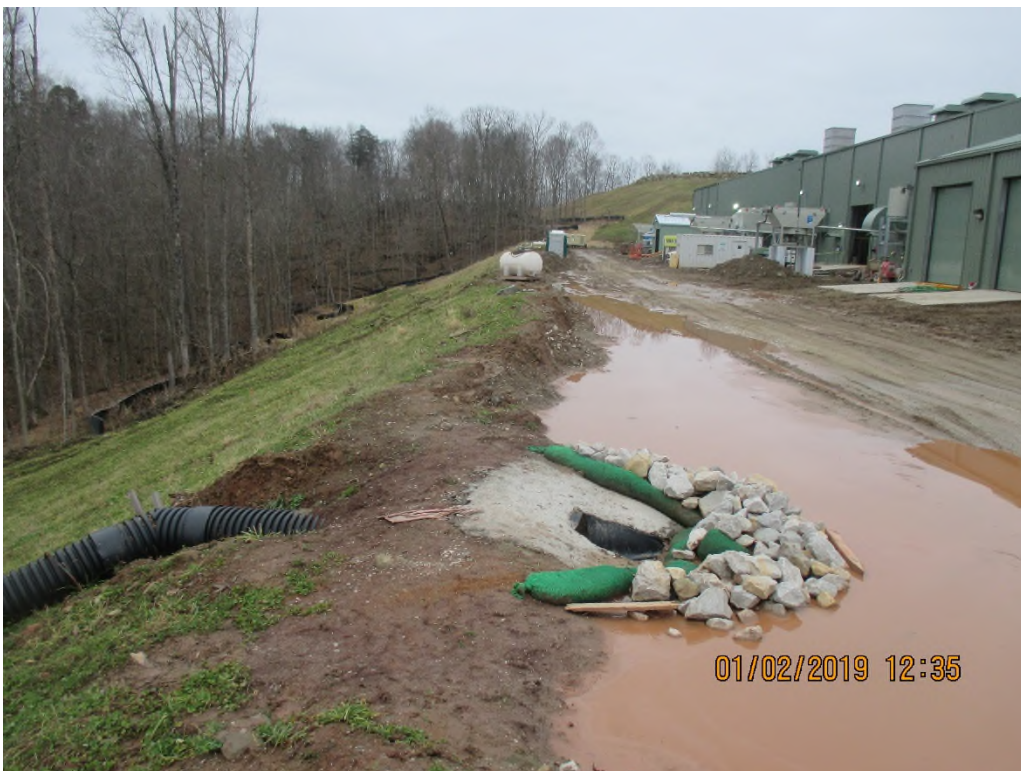
Pipe slope drain on north side of project.

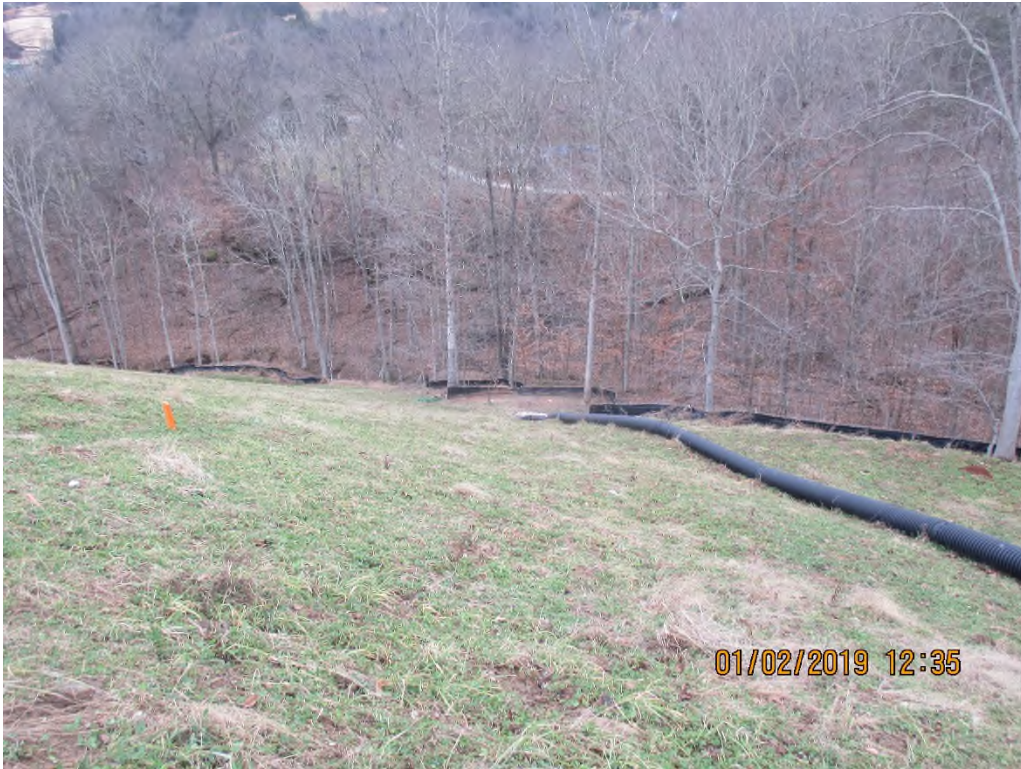
Slope drain terminus at silt fence labeled as 30.

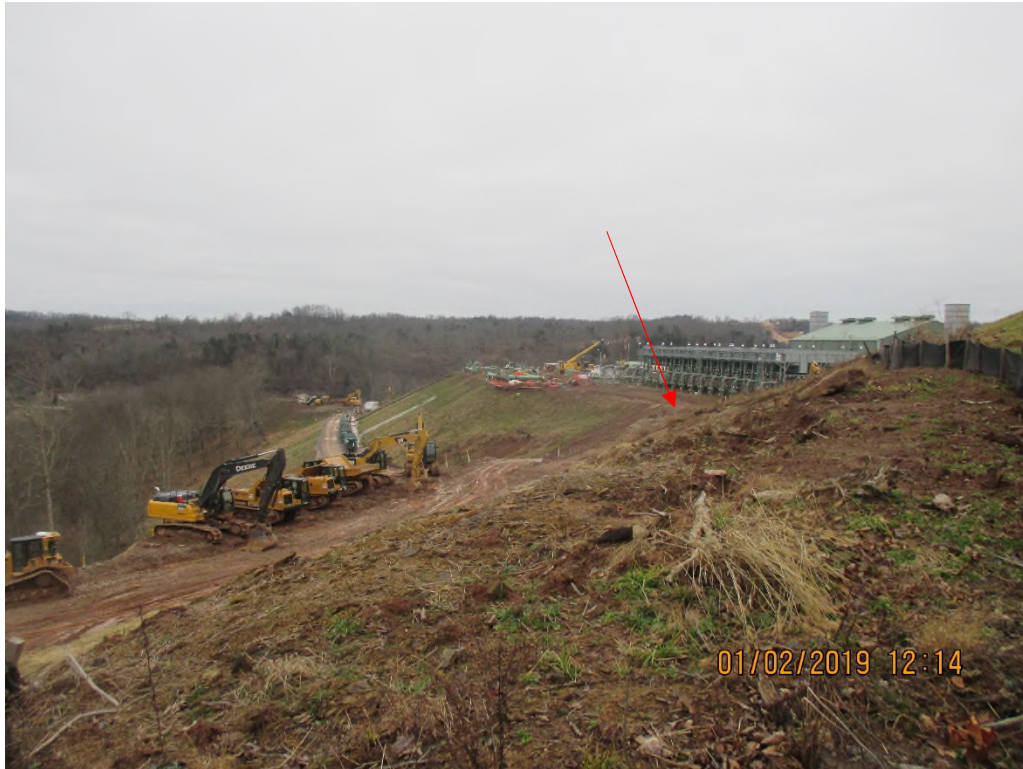
View of South side of project. Slope not protected near compressor station.

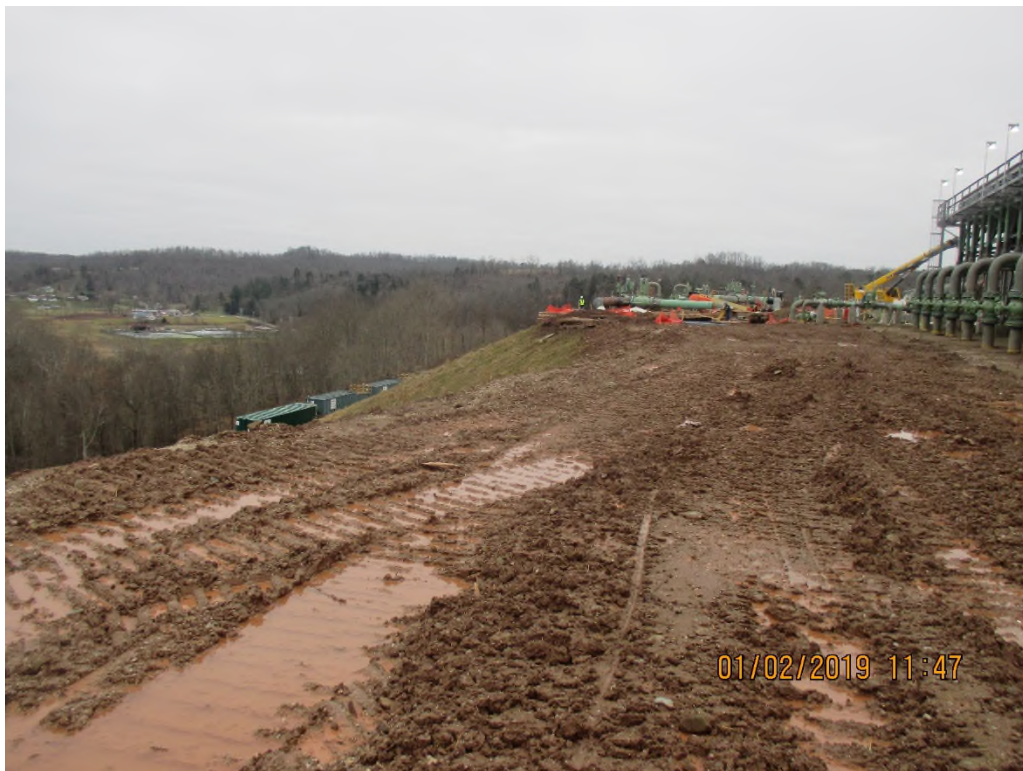
Top of slope facing section of slope not stabilized.

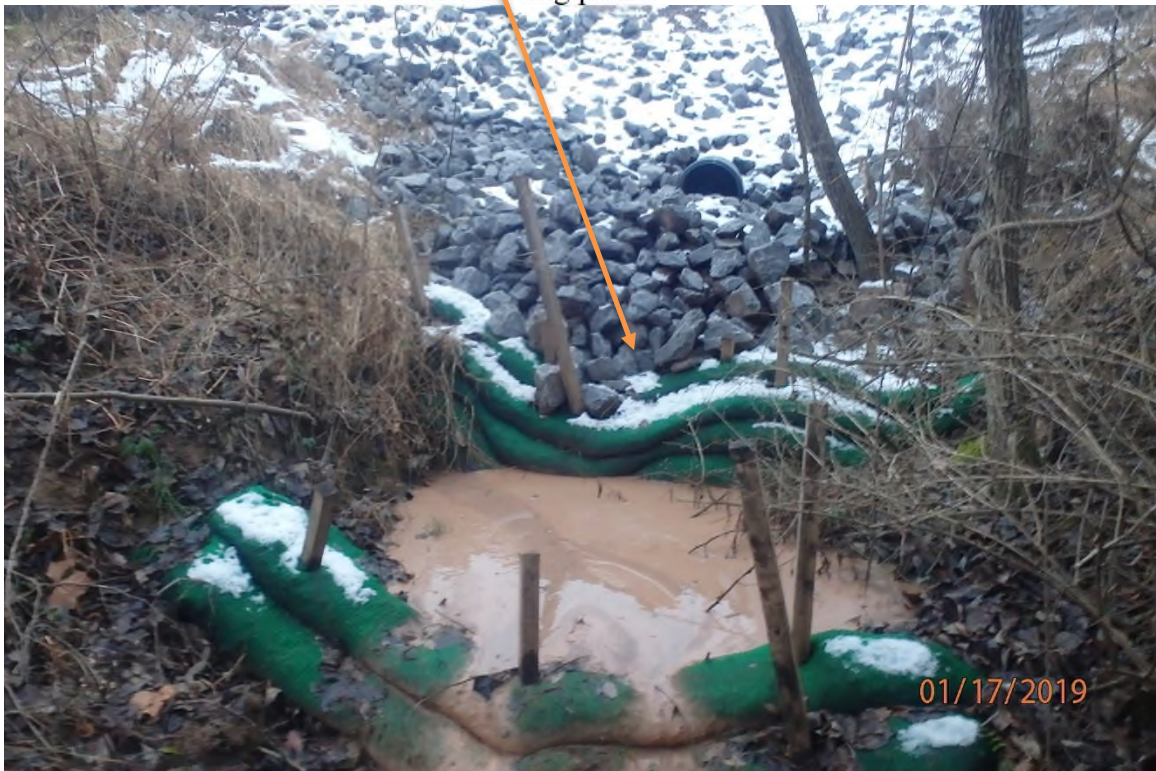
Installed BMPs downslope of truck wash.

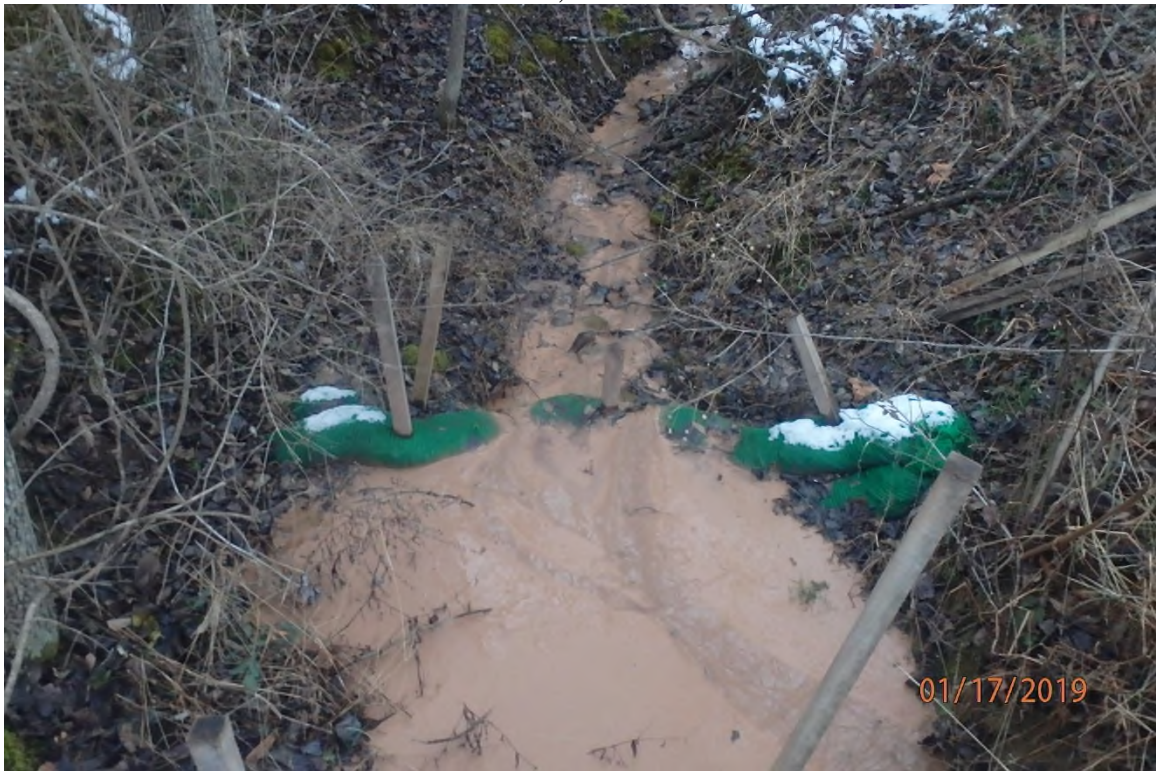
Installed BMPs showing the need for maintenance.

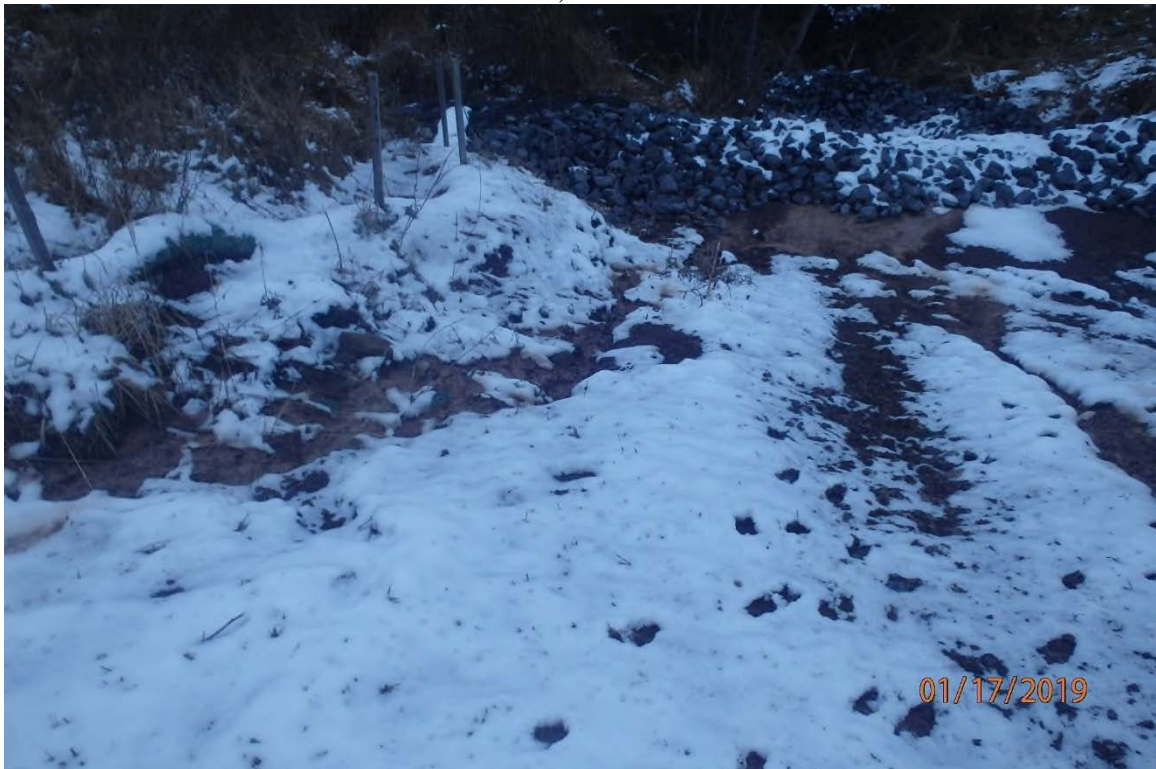
Concentrated flow from the installed truck wash being directed over an unprotected fill slope.

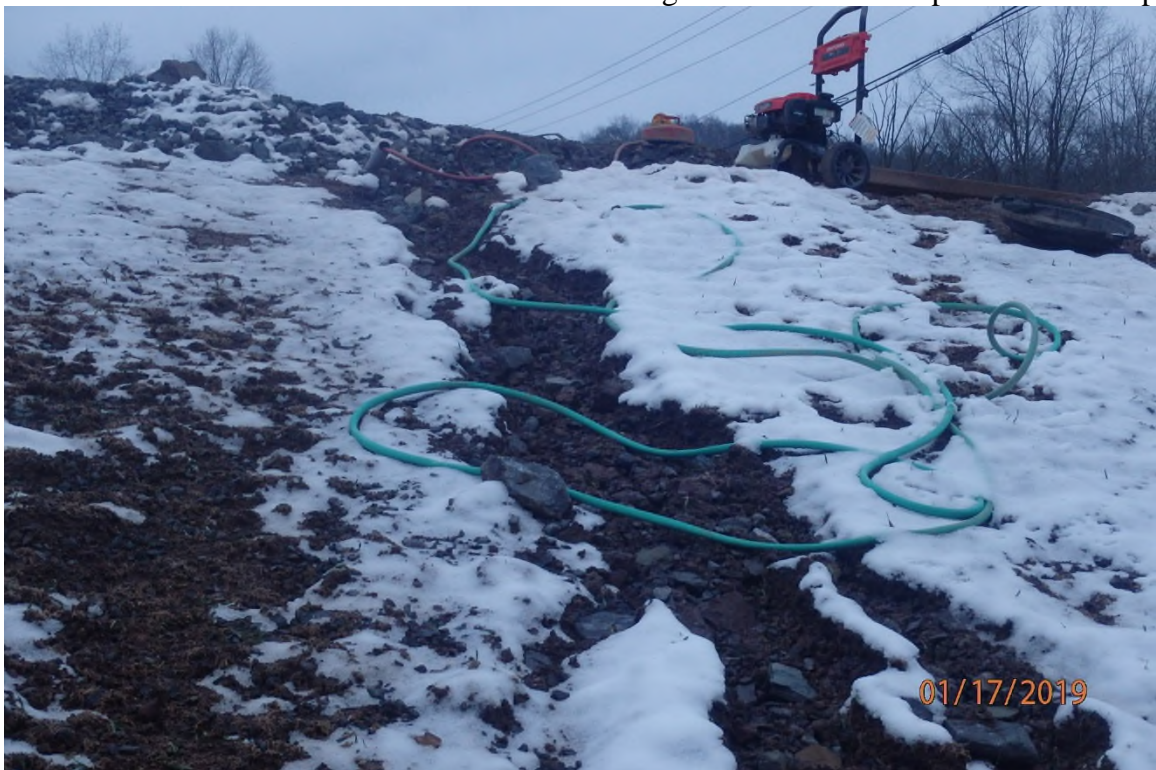
Erosion gullies in the fill slope as a result of concentrated flow originating from the truck wash.

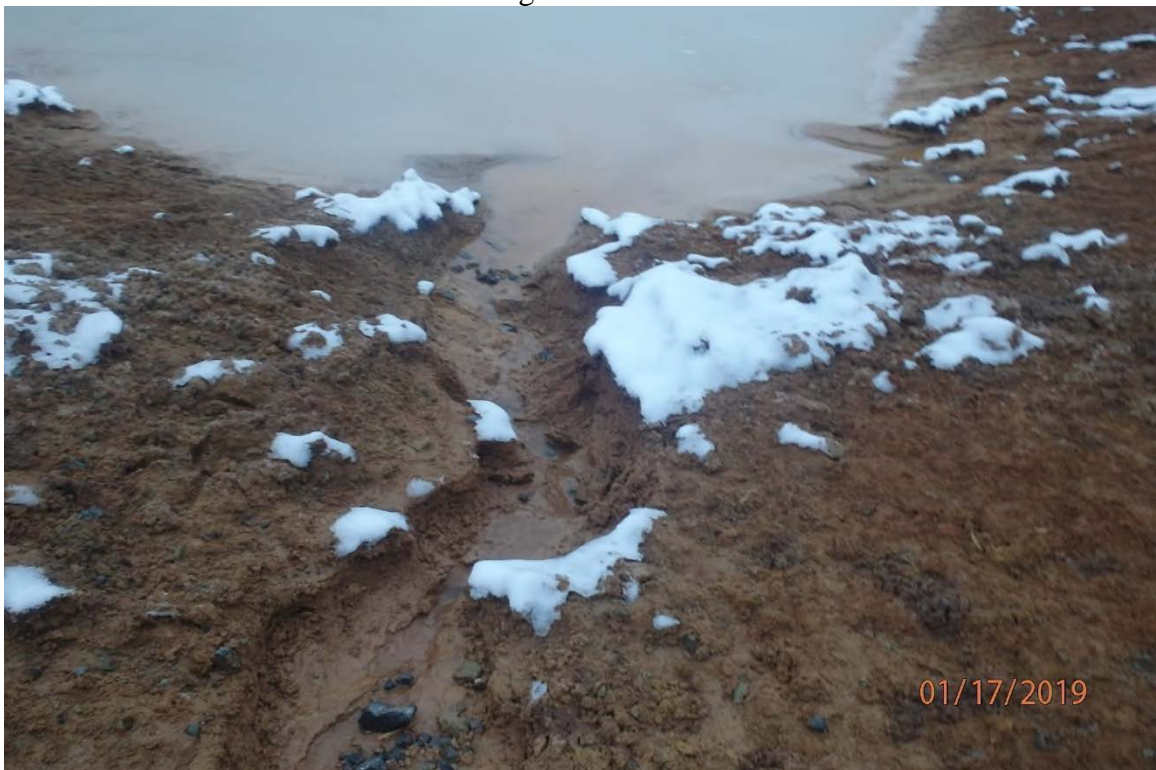
Basin 1 inlet showing the lack of a stabilized inlet.

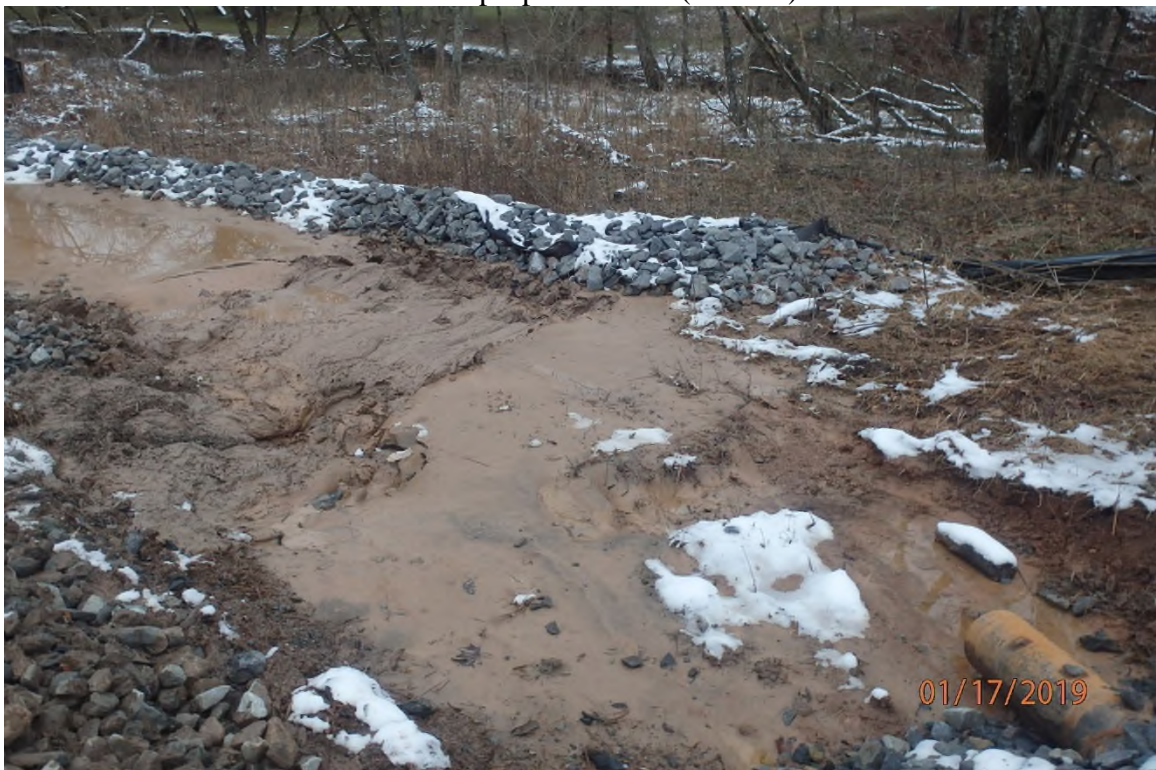
Rock filtration device that is in place. The proposed sediment basin in the approved SWPPP is not in place as designed.

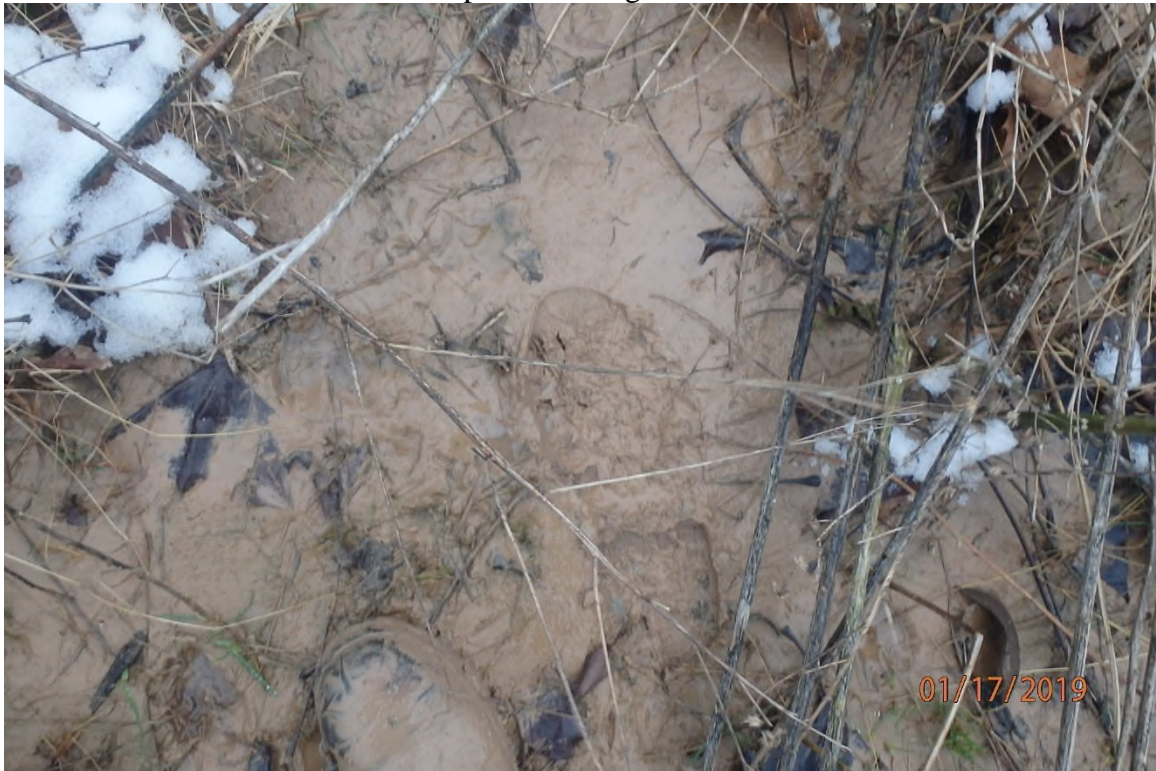
Sediment deposits located outside of the original project area that originate from the rock filtration device due to the lack of an installed sediment basin as indicated in the approved SWPPP.

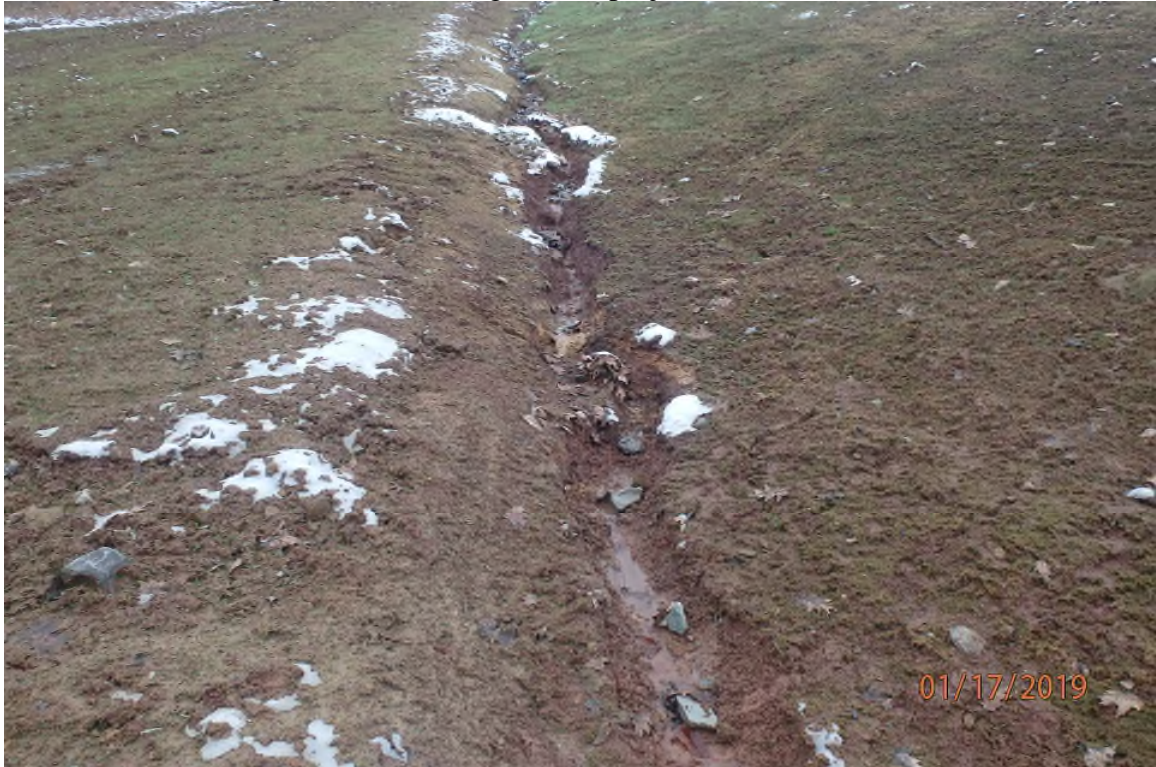
The installed diversion along the southern edge of the project that is eroded and in need of maintenance.

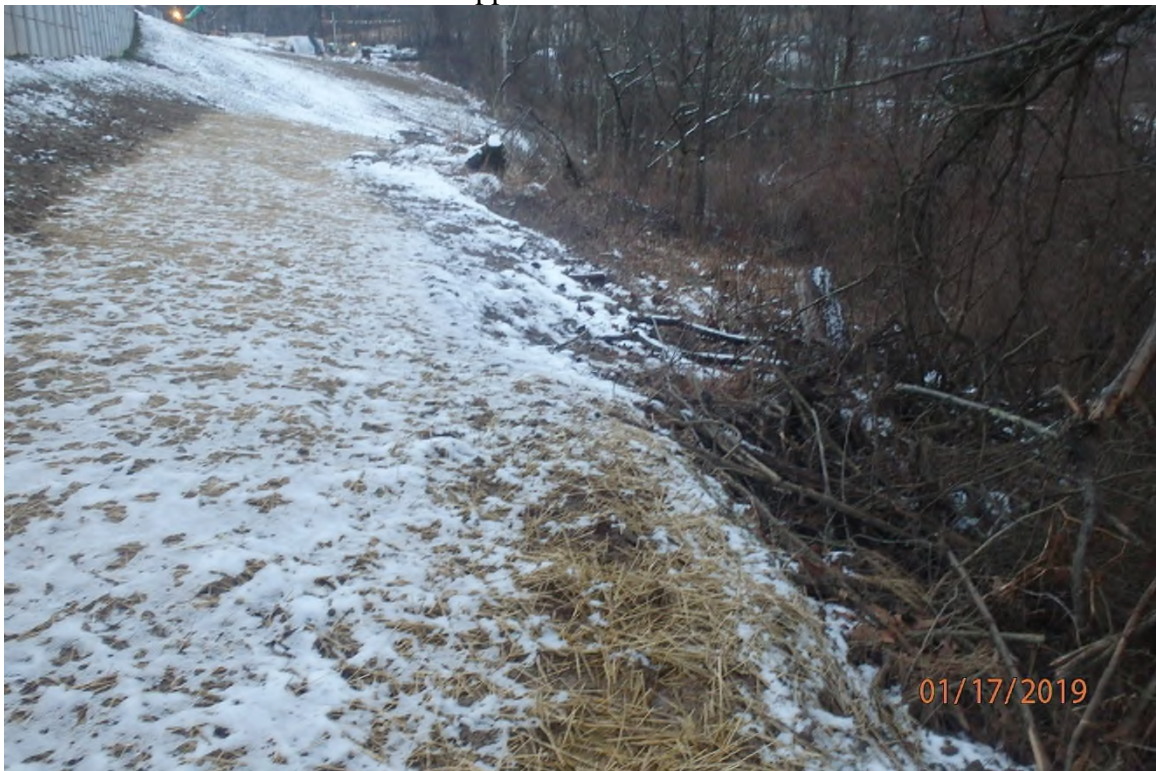
Northwestern perimeter of the project showing the lack of perimeter silt fence that is indicated in the approved SWPPP.

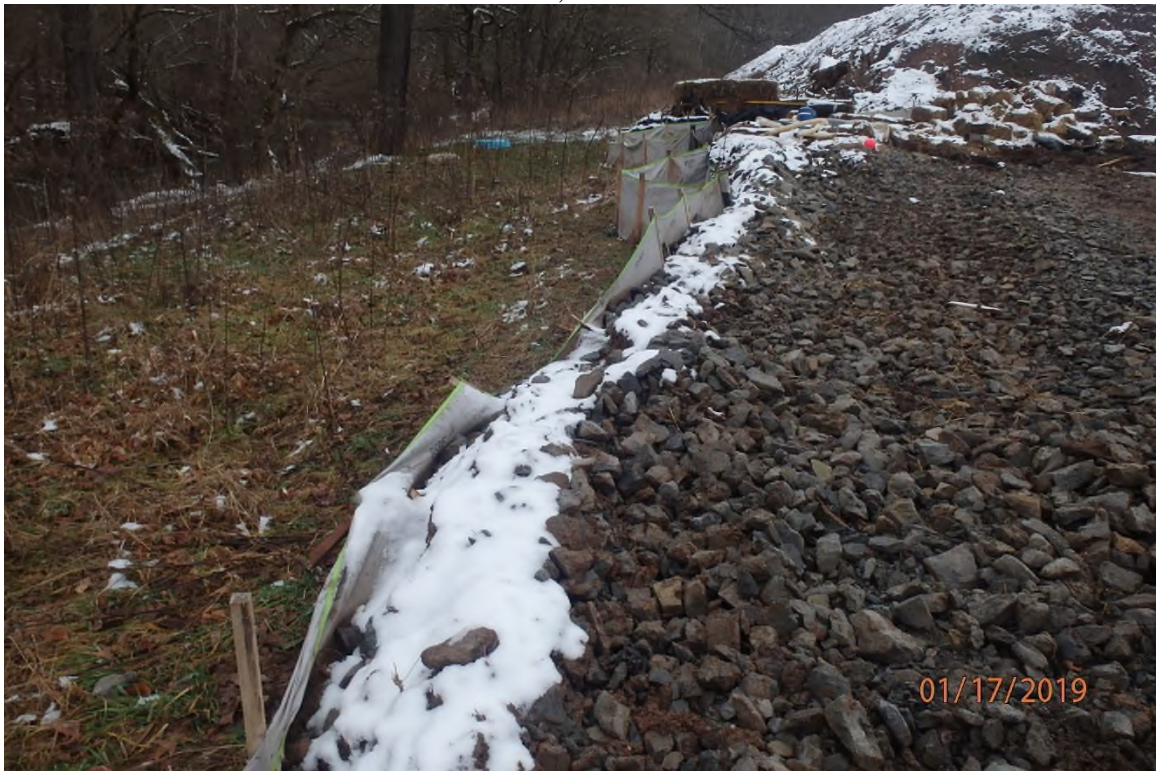
Perimeter silt fence in need of maintenance.

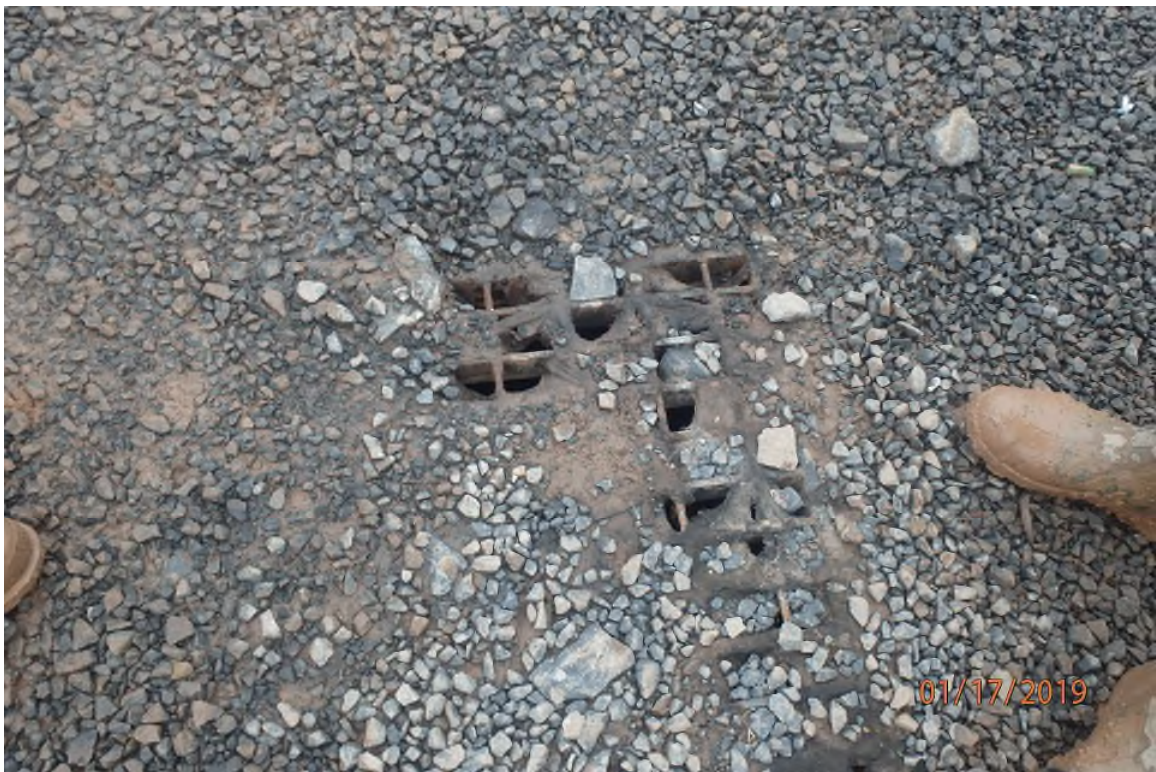
Drop inlet protection in need of maintenance.

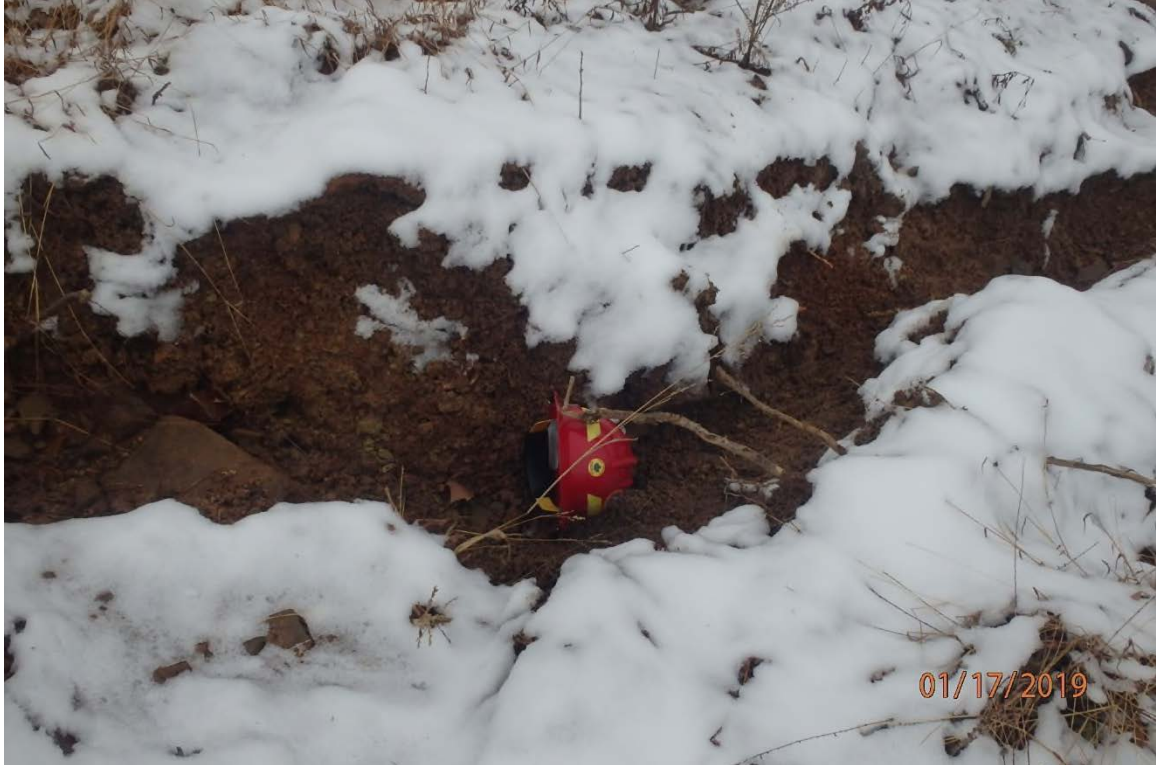
Slope that lacks adequate temporary stabilization in the northwestern portion of the project.

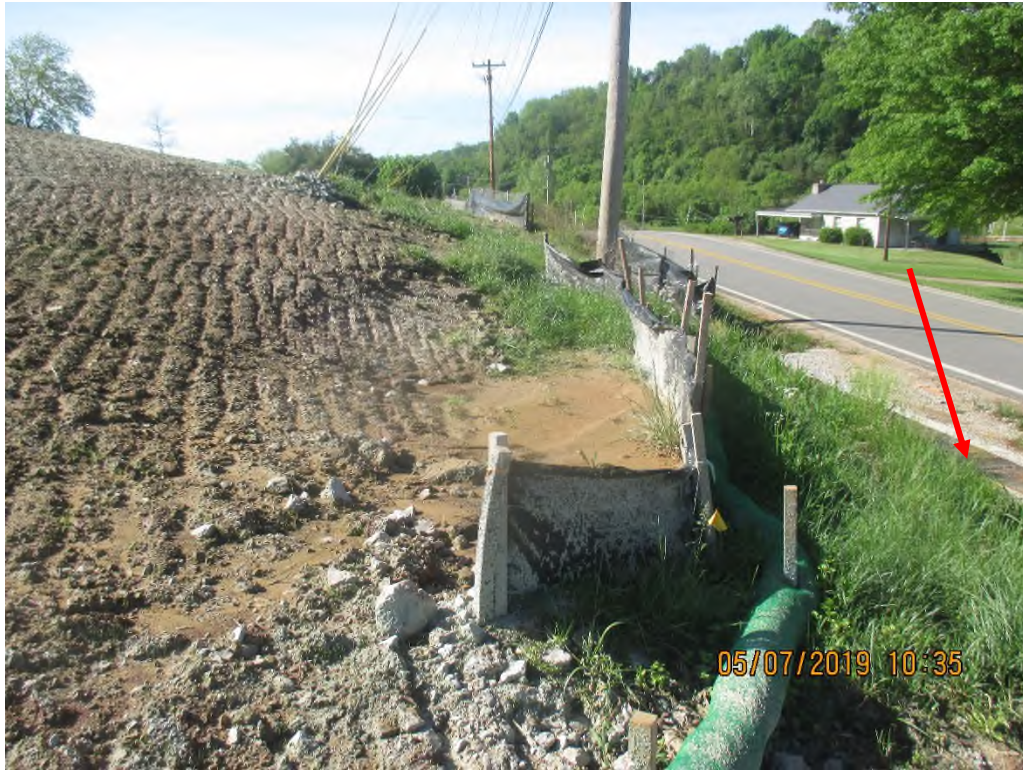
Controls above roadside drain. Sediment being deposited behind controls at base of slope. Arrow depicts roadside drain.

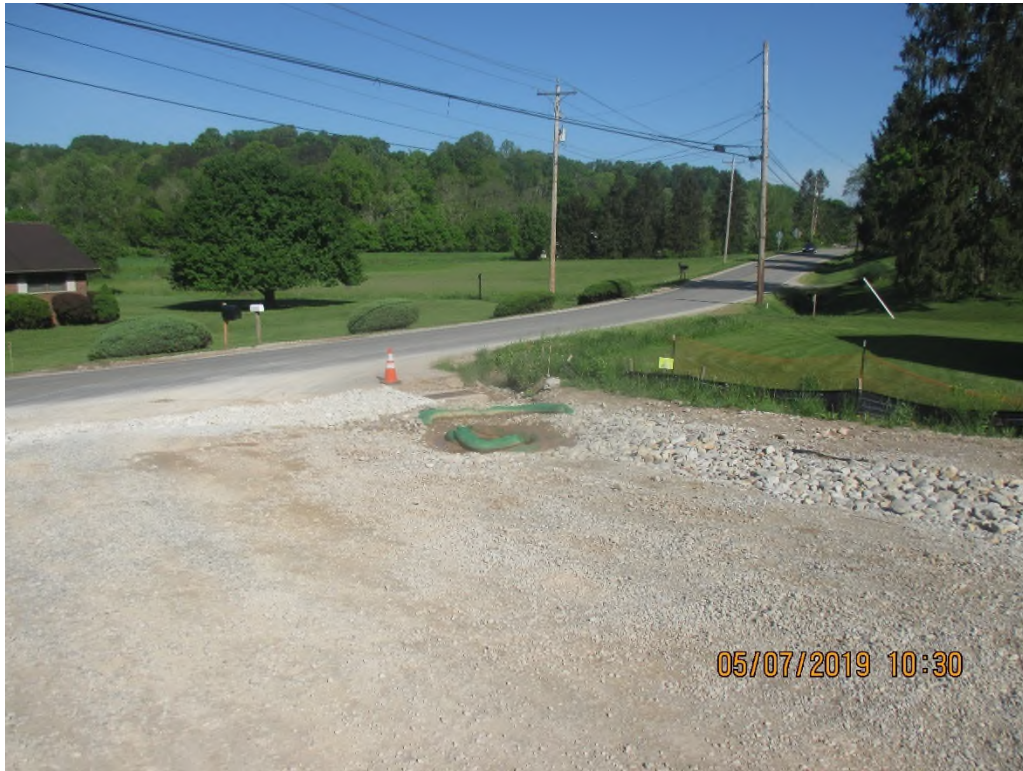
Facing downslope at construction entrance toward outlets for roadside drain and drop inlet. These outlets convey into UNT of Grasslick Run.

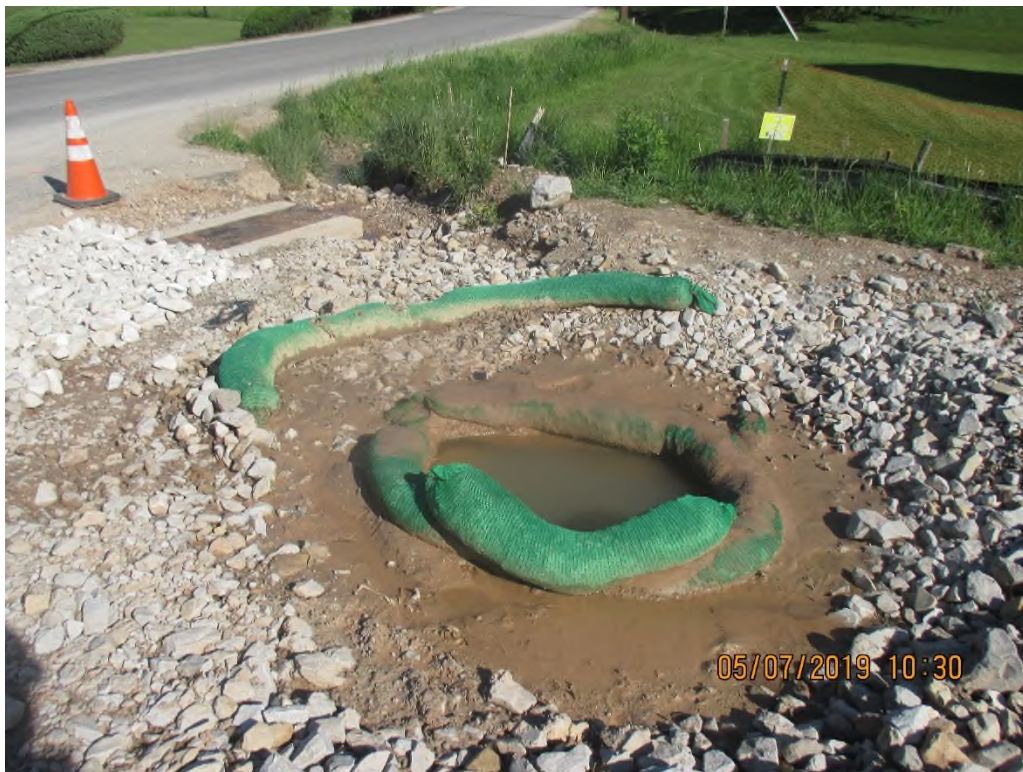
Drop inlet outlet and roadside drain outlets facing toward Route 21 and roadside ditch.

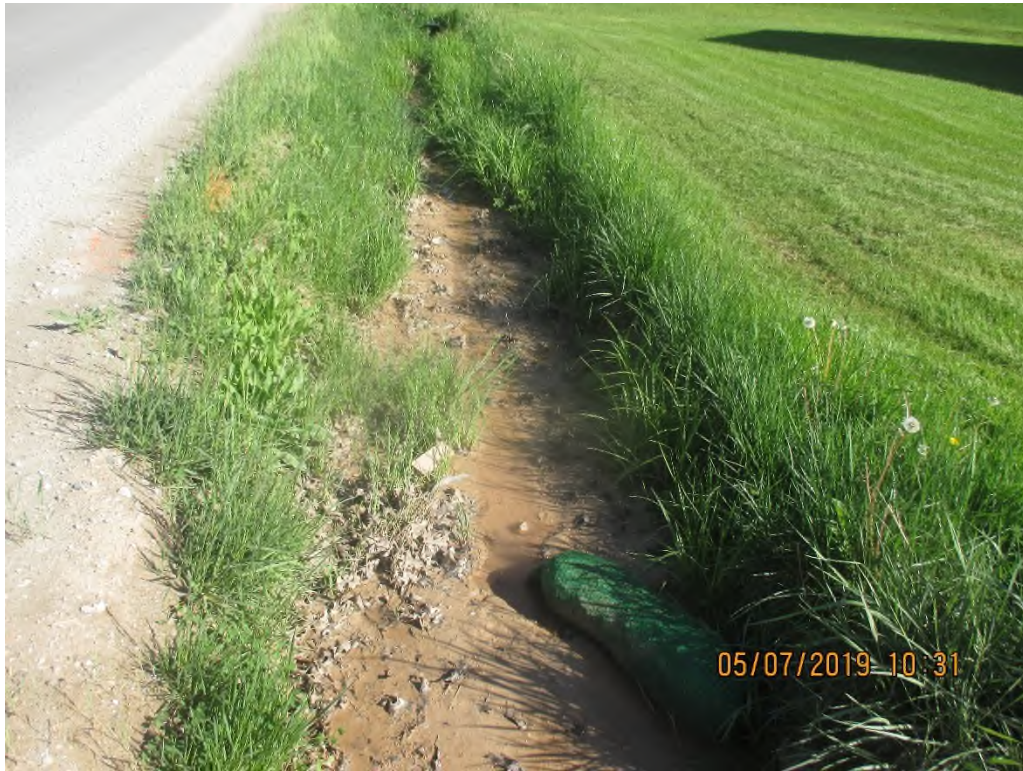
Roadside ditch below roadside drain and drop inlet outlets. Sediment present in ditch that conveys to UNT of Grasslick Run.

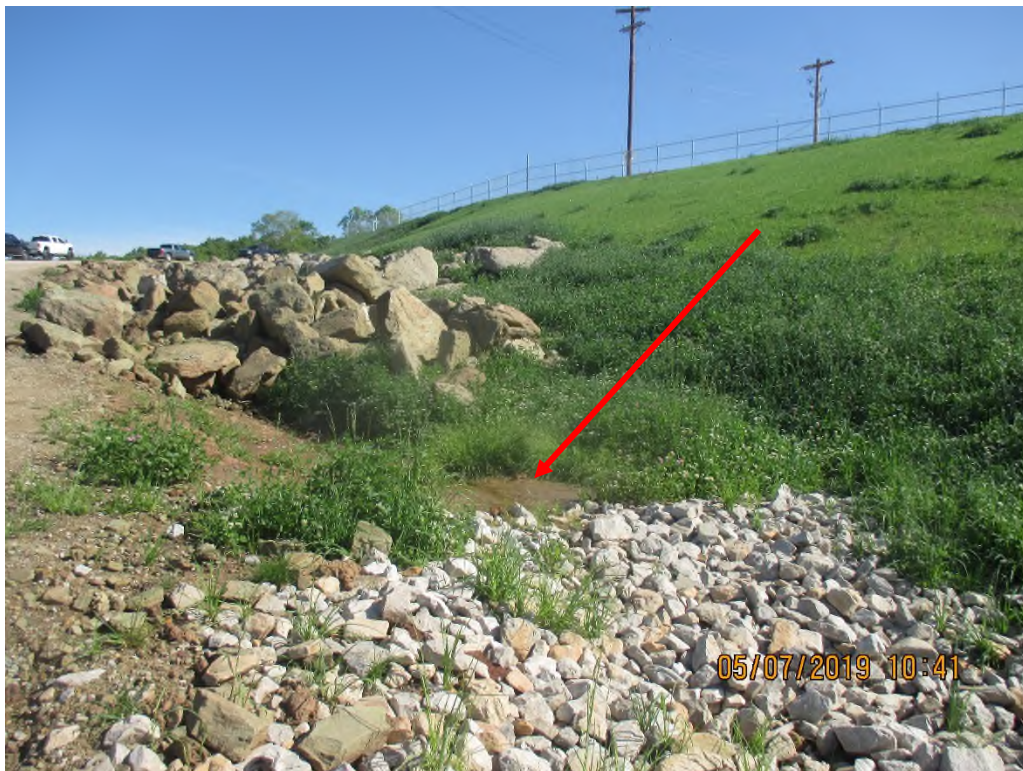
Rock placed in depression at base of West slope. Sediment present above smaller rock lined diversion.

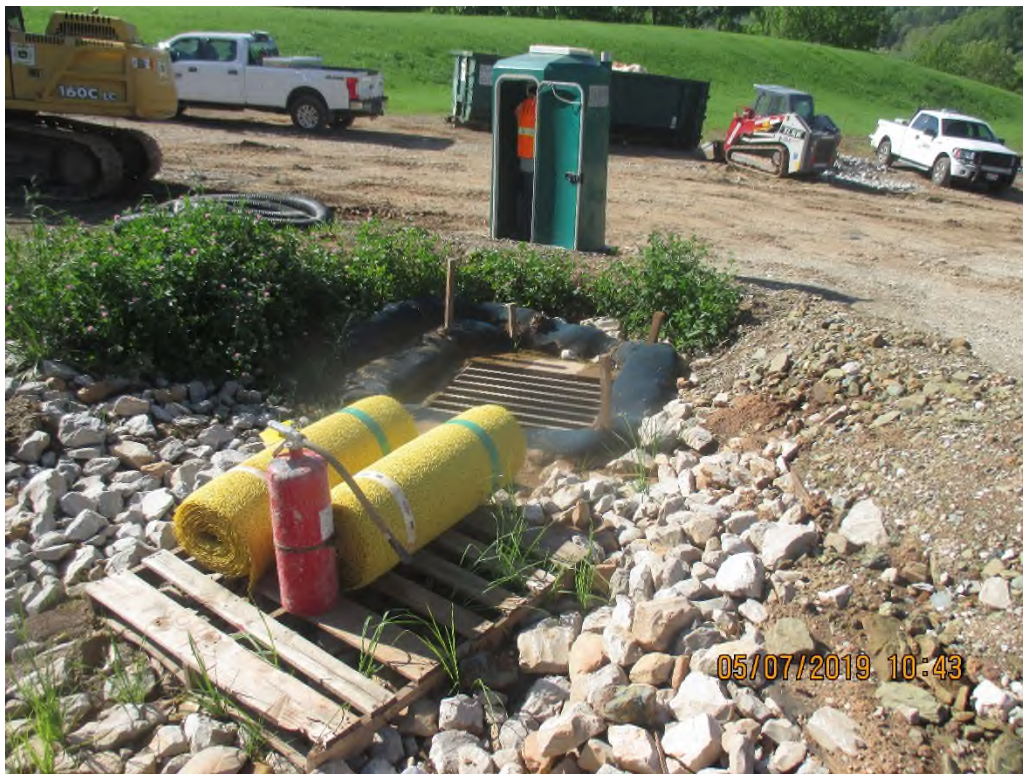
Drop inlet below sediment ponding. Sediment laden water was entering this drop inlet.

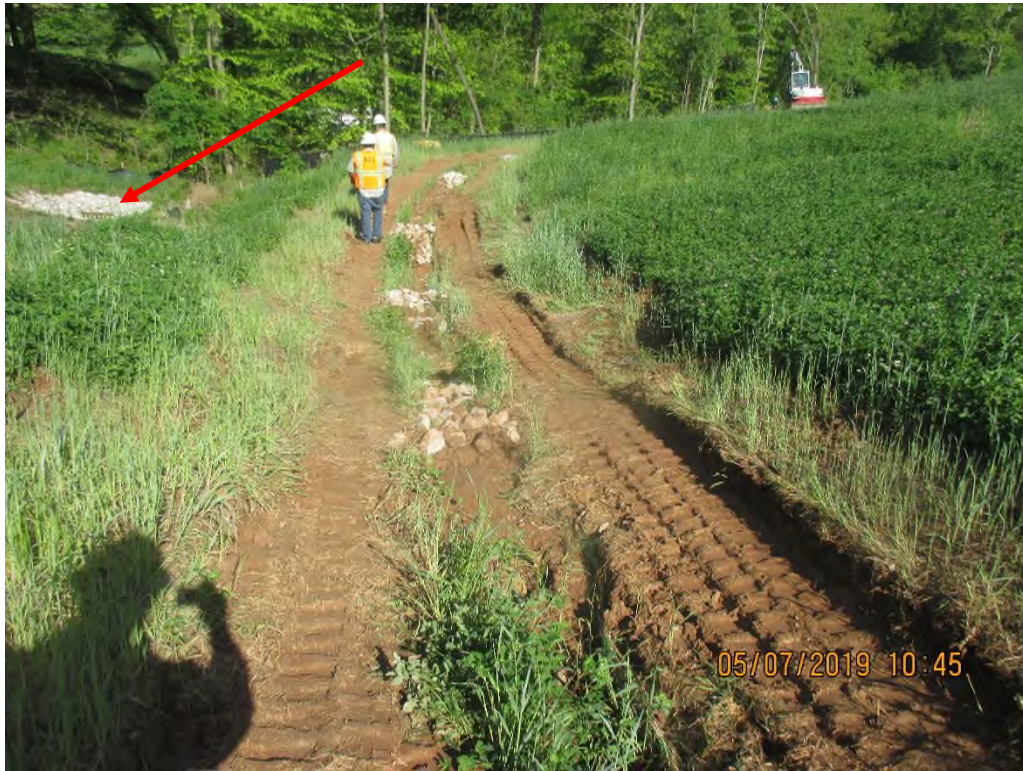
Access road to bottom of West side slope. Rock checks present in middle of road. Drop inlet in place downslope of this road. Sediment was being conveyed into this inlet and was present in the ephemeral stream within the LOD. Arrow depicts drop inlet below this road.

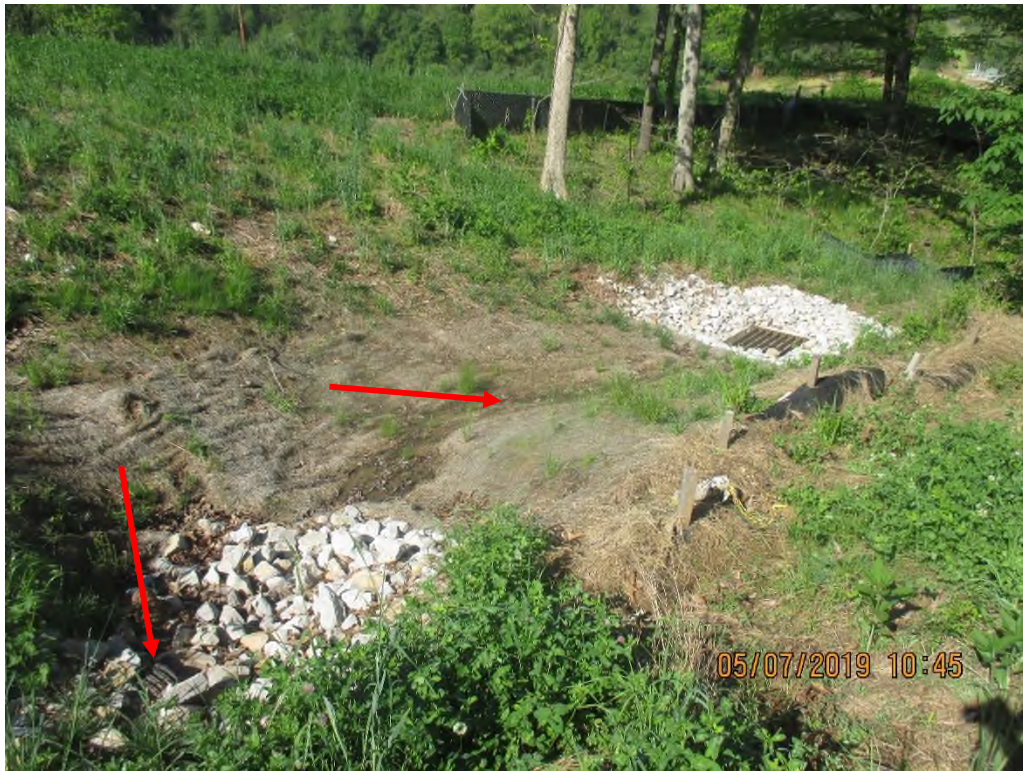
Rock check at drop inlet's outlet, upslope of drop inlet above ephemeral stream. Arrow depicts outlet pipe and erosion between rock checks and inlet.

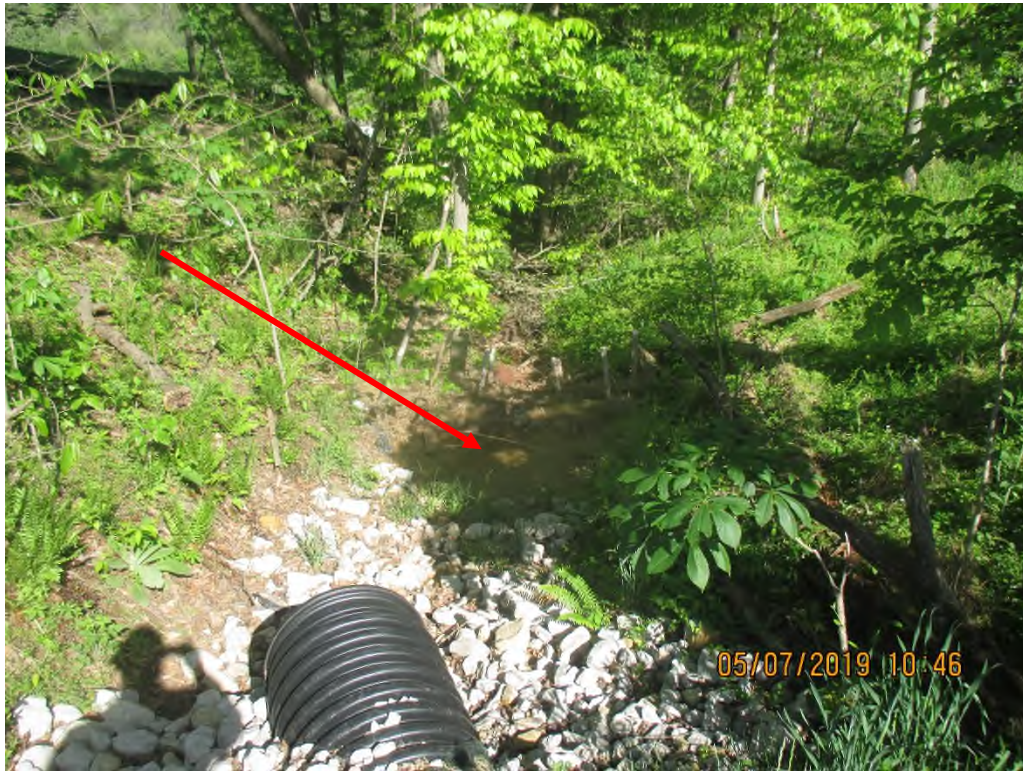
Drop inlet's outlet facing downslope at ephemeral stream leading to UNT of Grasslick Run. Arrow depicts sediment deposits past controls.
