**CONSENT ORDER
ISSUED UNDER THE
WATER POLLUTION CONTROL ACT
WEST VIRGINIA CODE, CHAPTER 22, ARTICLE 11**

TO: Columbia Gas Transmission, LLC
Attn: Troy Tally, Vice President
1700 MacCorkle Ave
Charleston, WV 25314

DATE: October 1, 2020
ORDER NO.: 9061

1. Columbia Gas Transmission, LLC is conducting land disturbance activity associated with construction of the Mountaineer Xpress Project in Marshall, Wetzel, Tyler, Doddridge, Ritchie, Calhoun, Wirt, Roane, Jackson, Mason, Putnam, and Cabell Counties, West Virginia. On January 31, 2018, Columbia Gas Transmission, LLC was issued Water Pollution Control Permit No. WV0116815, Registration No. WVR310872, for Stormwater Associated With Oil and Gas Related Construction Activities.

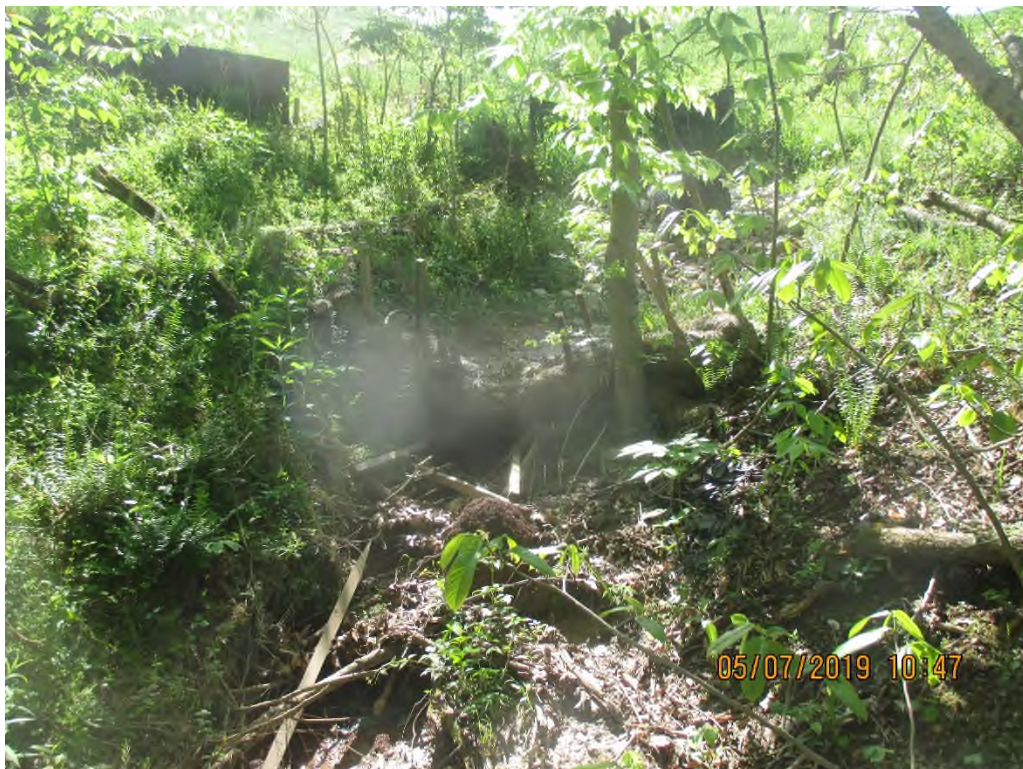
Downslope of controls in ephemeral stream. Controls in need of maintenance and enhancement upslope.

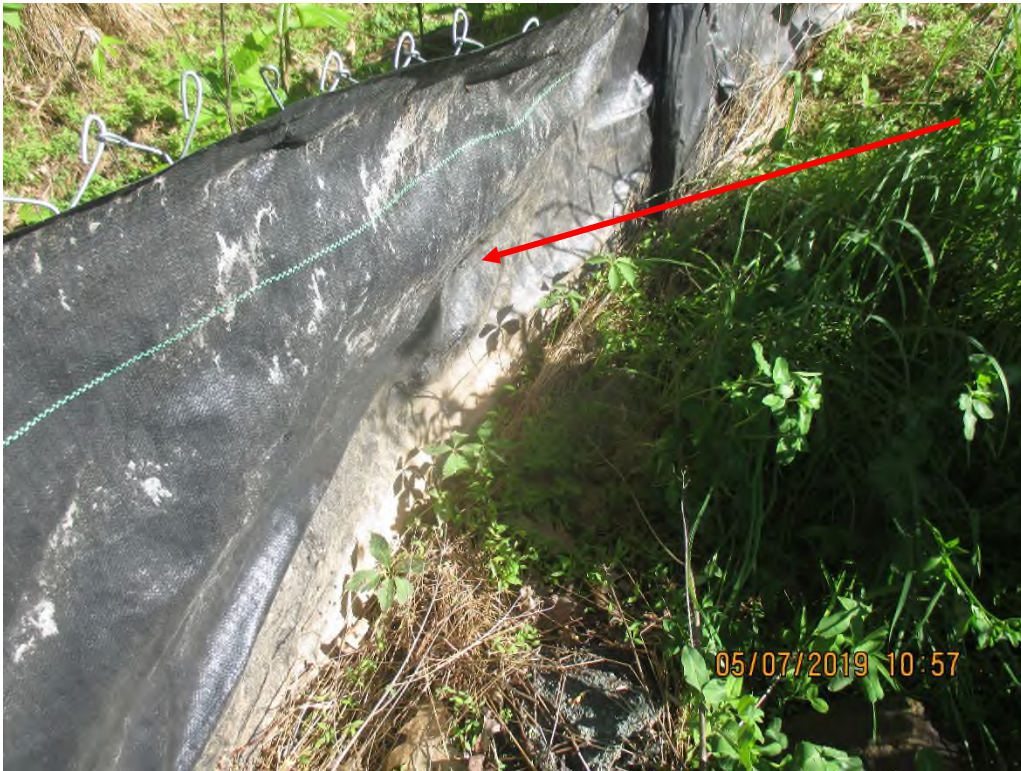
Super silt fence installed at base of North slope below compressor station pad. Arrow depicts hole in fence.

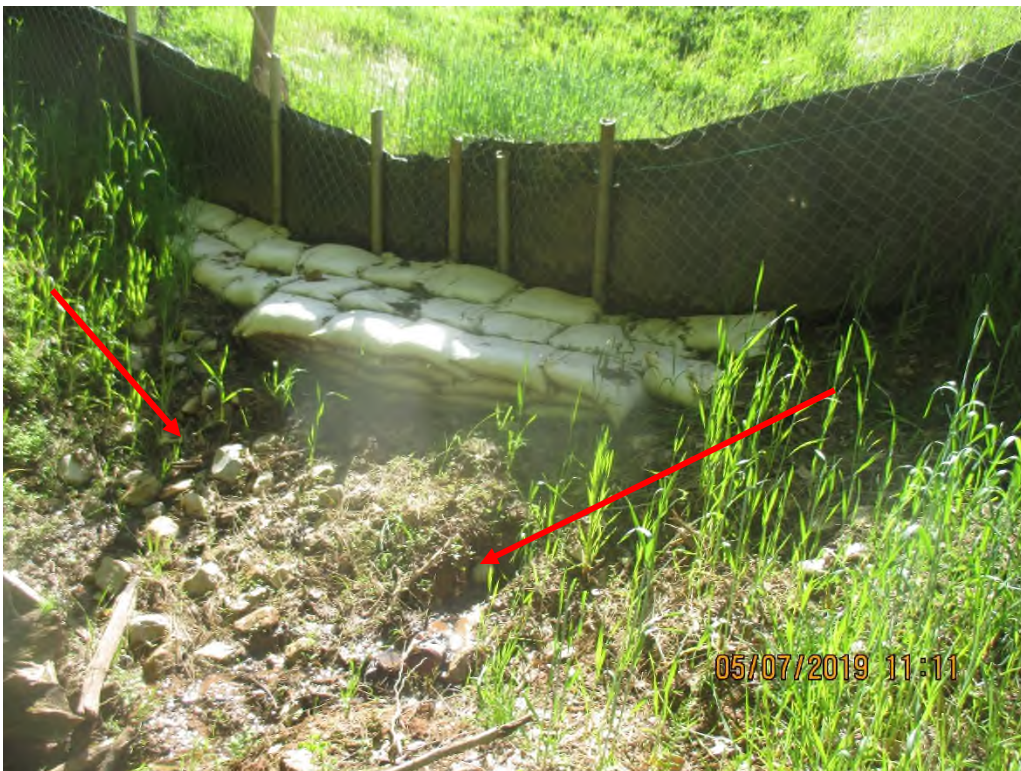
Controls at base of NE slope facing upslope. Controls in need of maintenance due to undermining, causing erosion below controls. Arrow depicts erosion below controls.

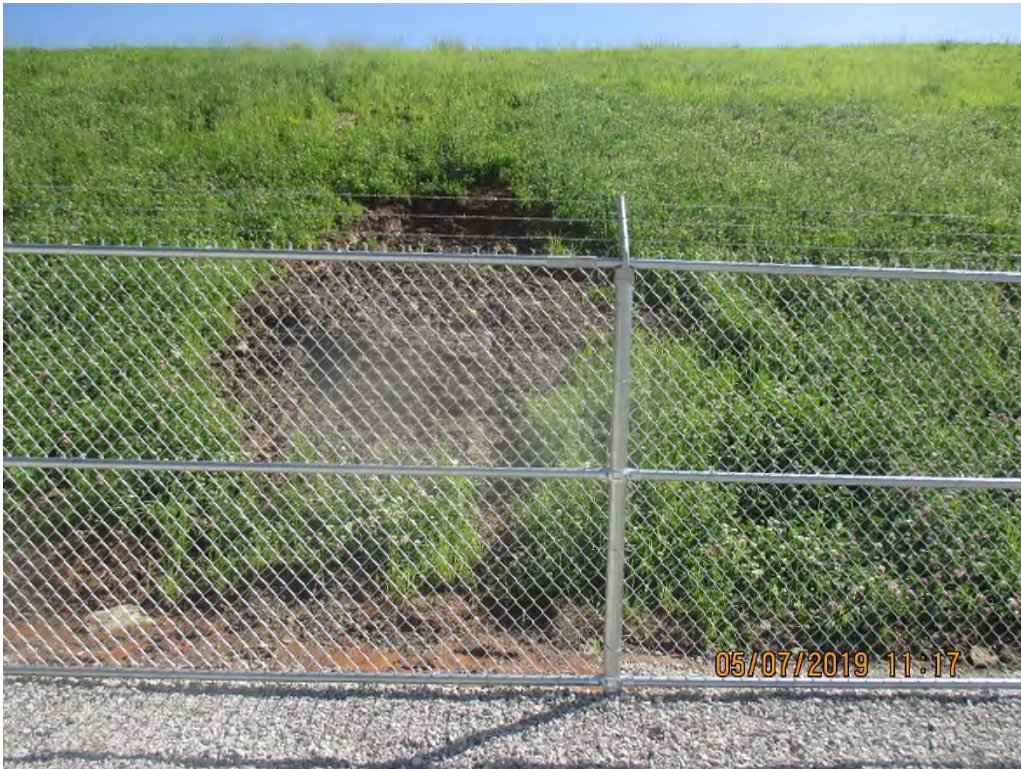
Slip occurring on East side of compressor station above pad.

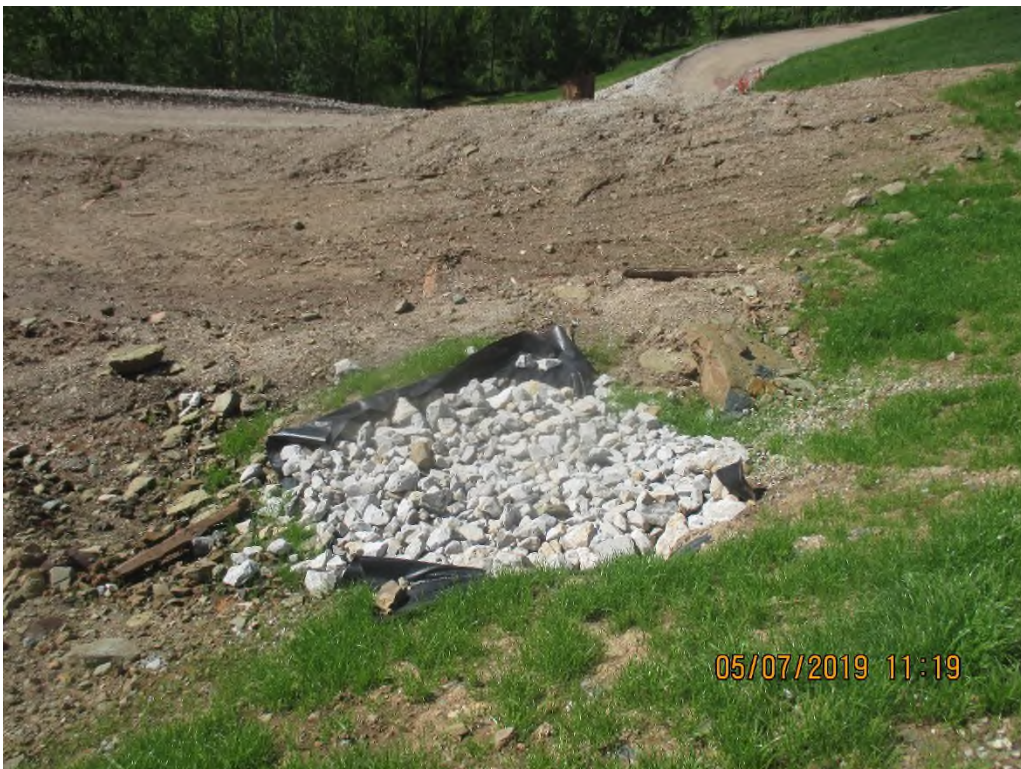
Diversion swale outlet terminating on rock armored pad. However, no controls to protect fill slope below this to the access road were in place.

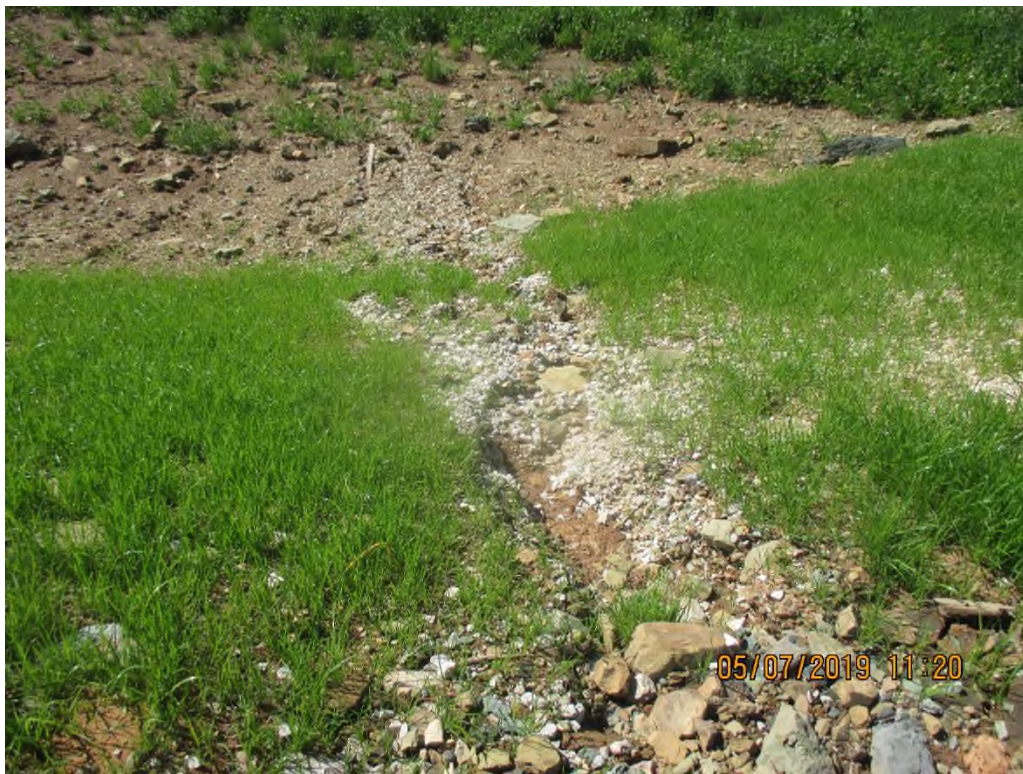
Erosion occurring adjacent to diversion swale outlet. Run-off from pad eroding fill slope on south side of pad.

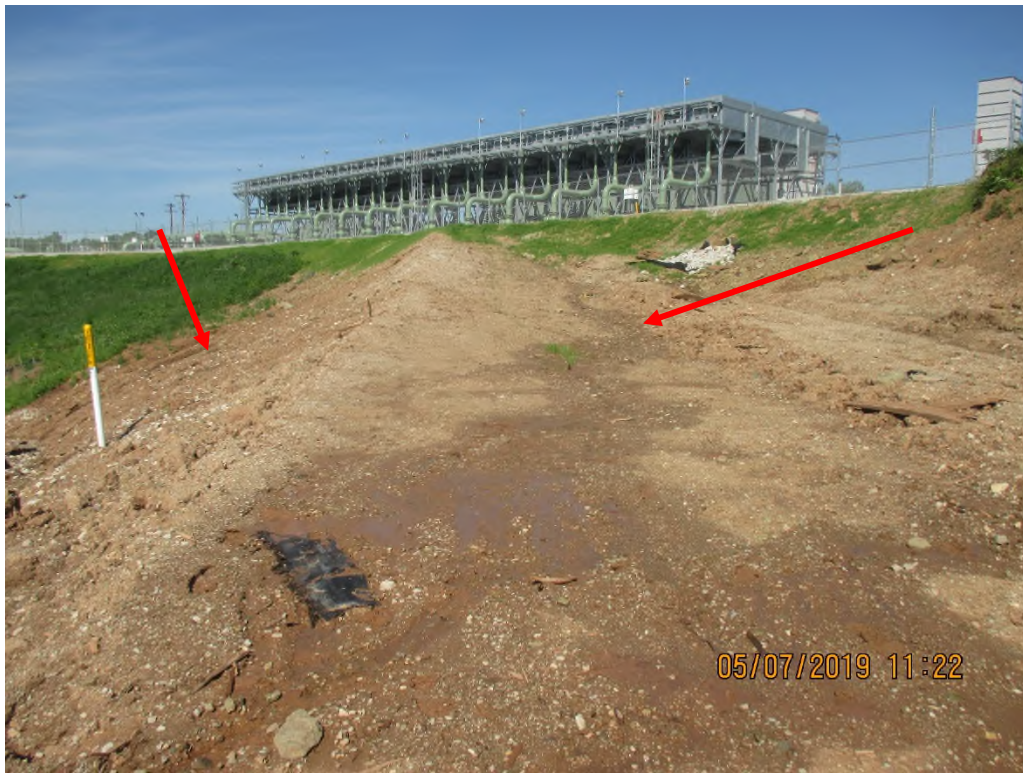
View facing upslope at South slope. Arrows depict swale outlet and erosion occurring from run-off from pad.

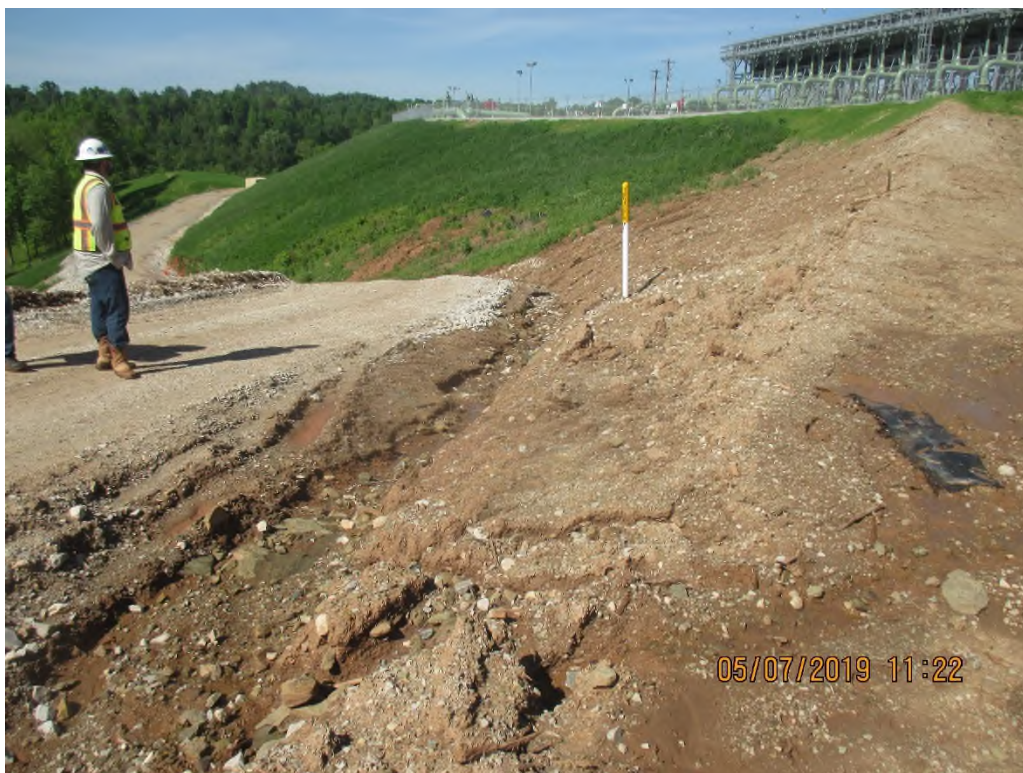
Erosion occurring below swale outlet on South slope.

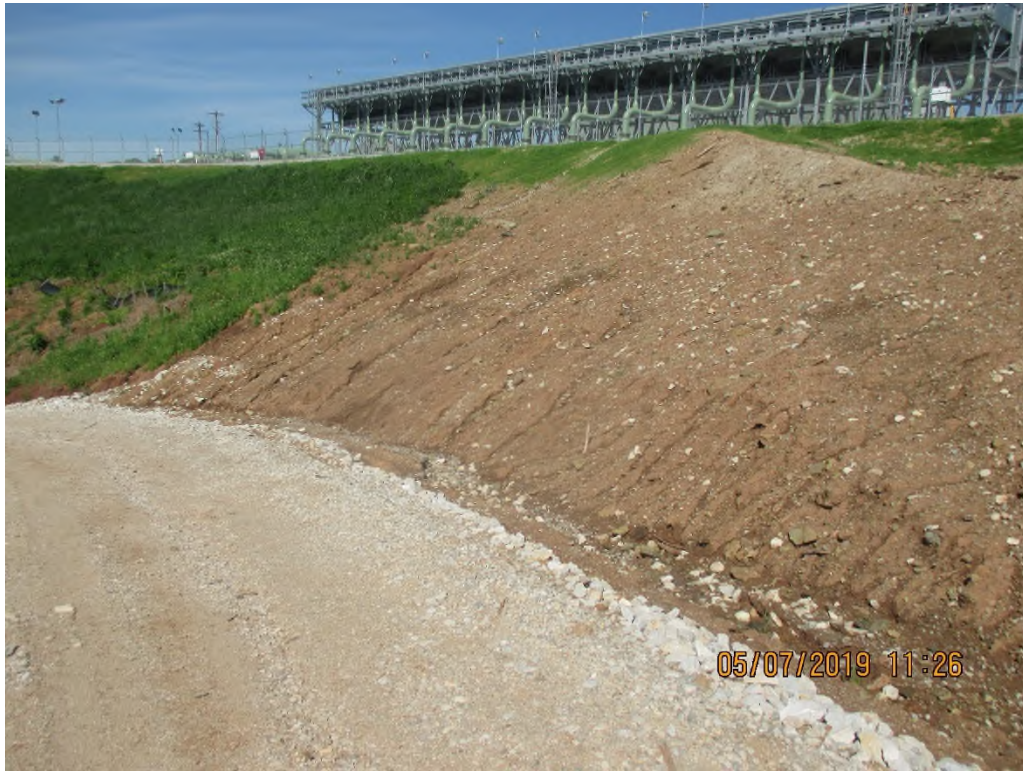
Erosion rills occurring on unprotected south slope above ditch that conveys under access road and toward perimeter of project.

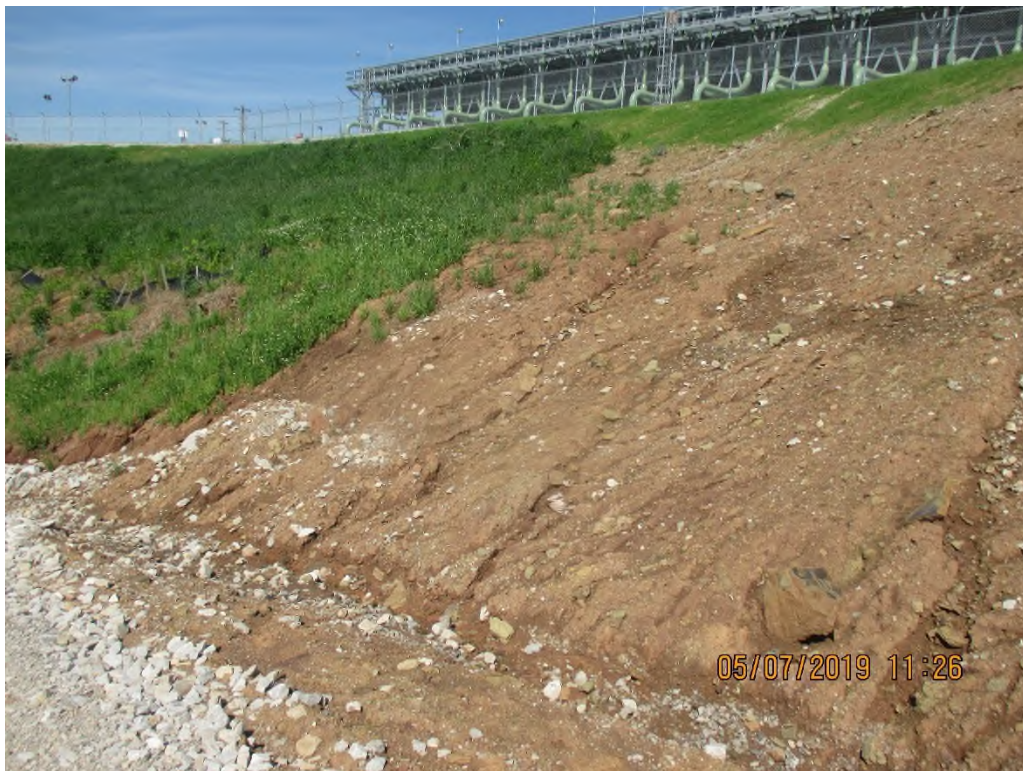
Erosion on south slope above ditch that conveys toward perimeter of project.

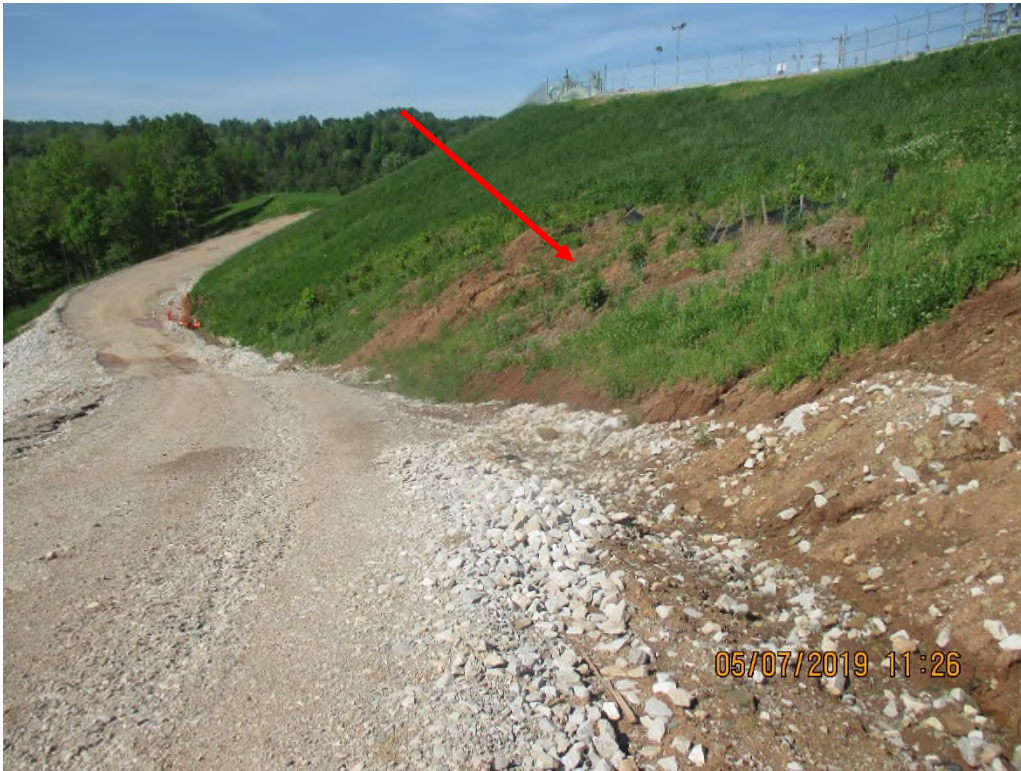
Ditch line along access road below erosion that was taking place along south slope of compressor station pad.
Arrow depicts unstabilized portion of slope above ditch and culvert inlet.

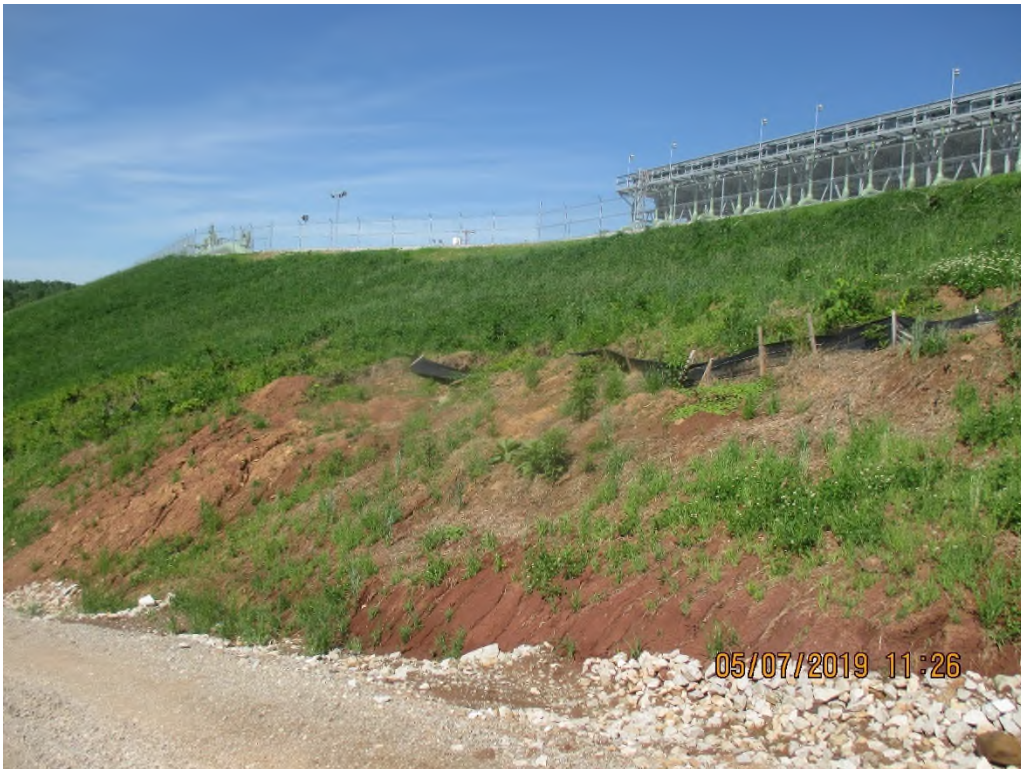
Ditch line along access road below erosion that was taking place along south slope of compressor station pad.
Unstabilized portion of slope above ditch and culvert inlet.

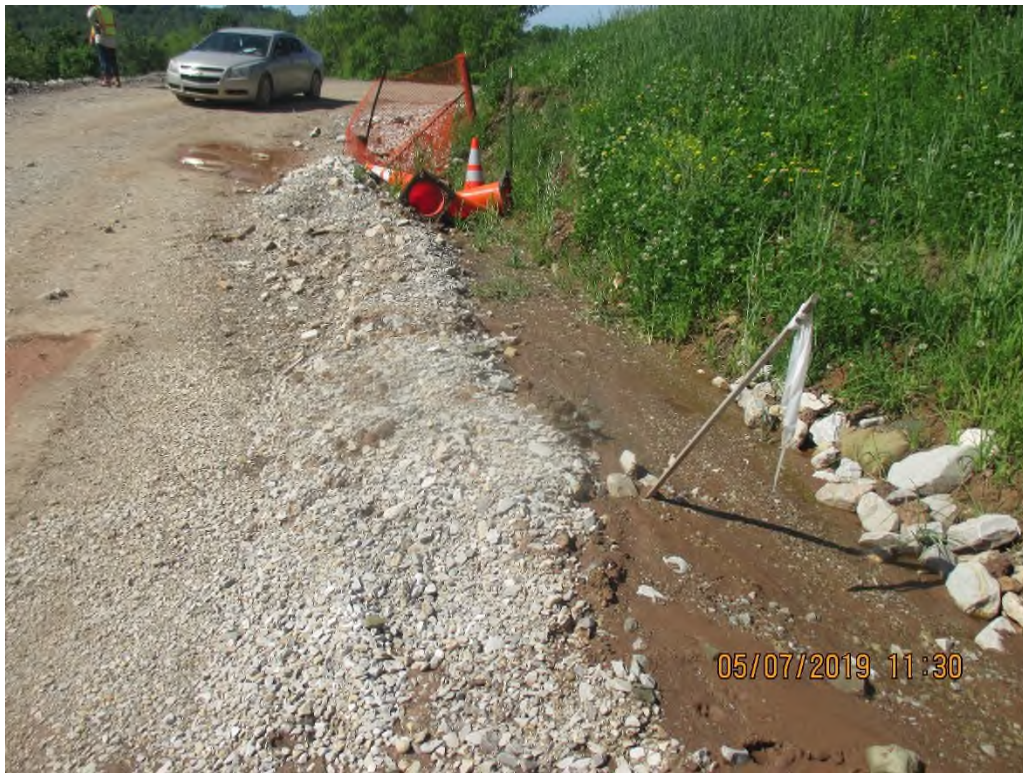
Sediment deposited in ditch downslope of erosion observed on South slope of compressor station pad.

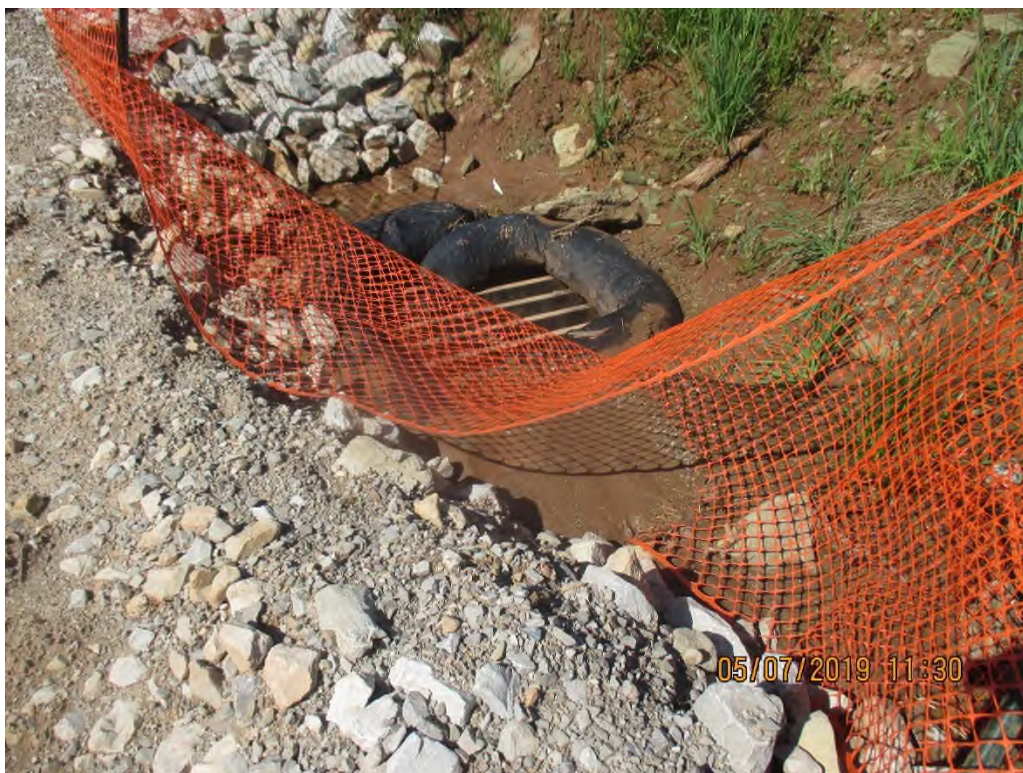
Culvert inlet on South side of compressor station slope conveying under access road. Sediment deposits present in drop inlet.

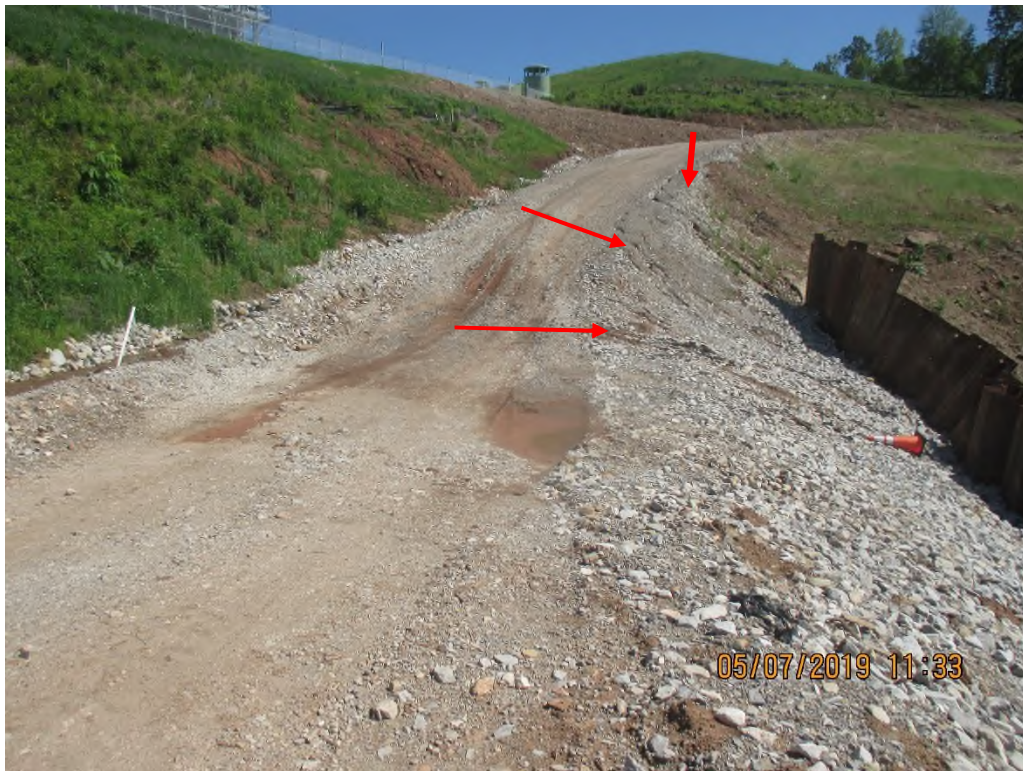
Facing east toward South slope where erosion was observed. Arrow depicts erosion occurring on road.

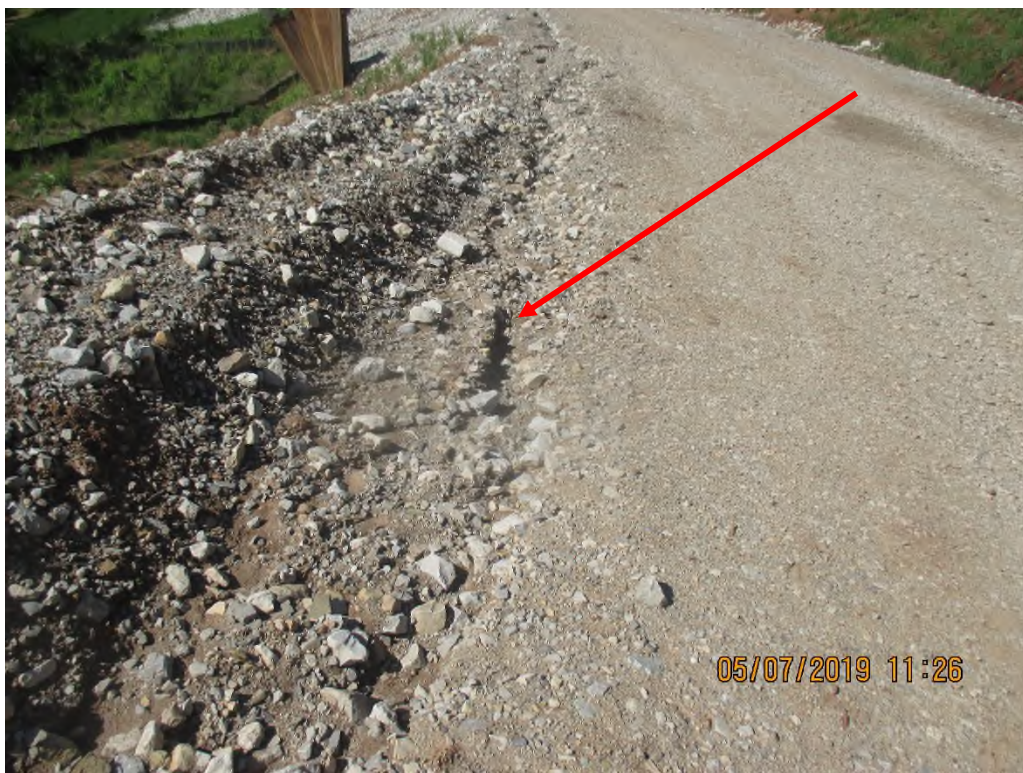
Erosion present on access road above culvert crossing.

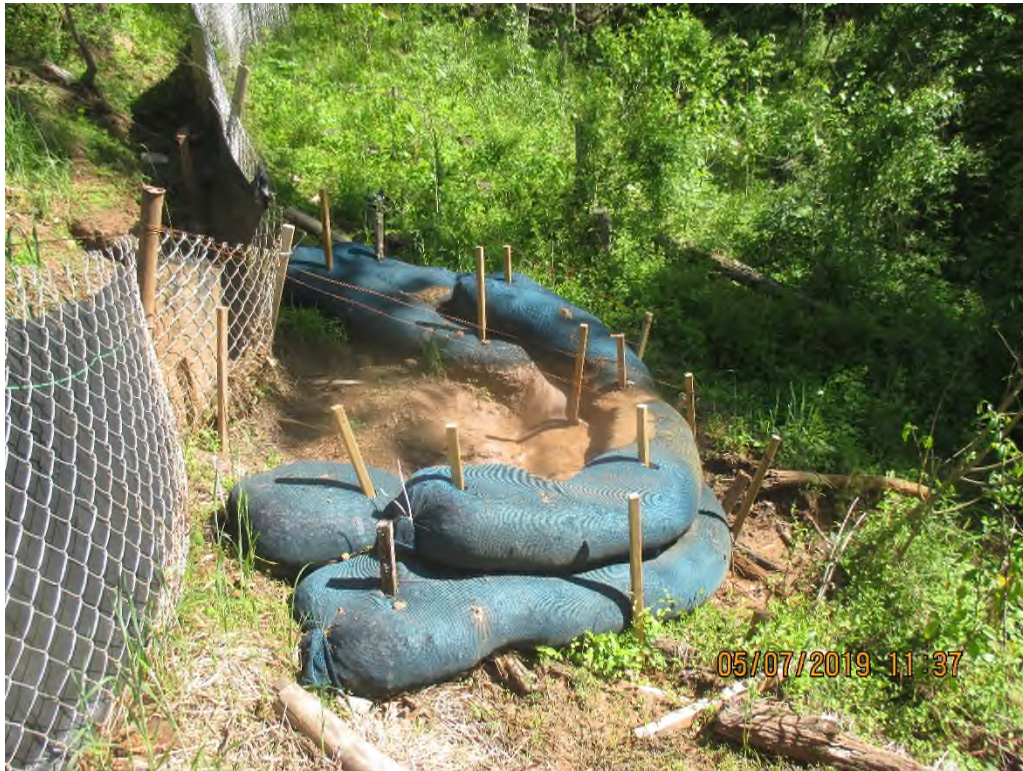
Perimeter outlet controls below armored channel at the base of the South slope.

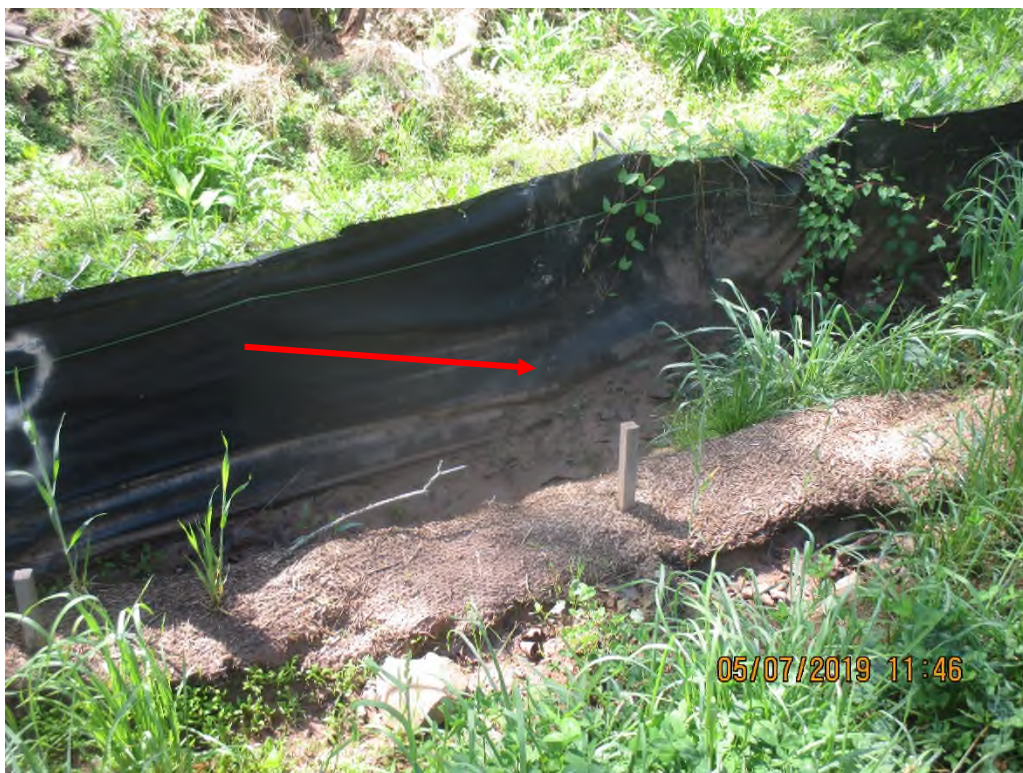
Silt fence on Southwest slope of project perimeter with small hole at stain line on fence.

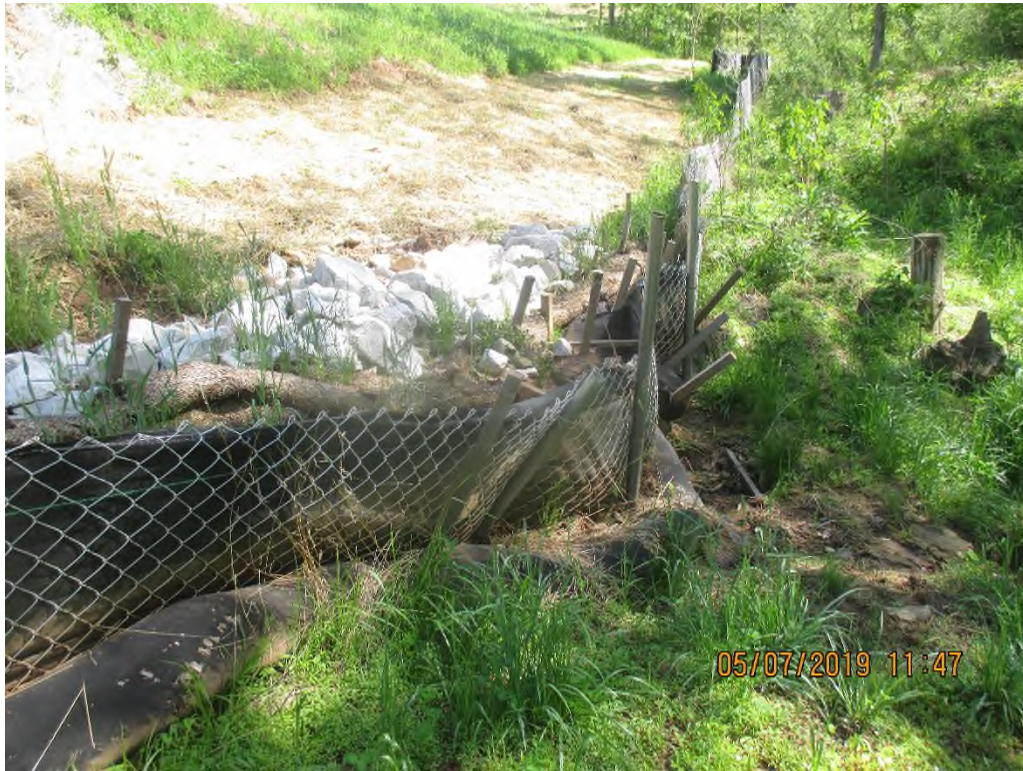
Perimeter controls on southwest slope of project LOD.

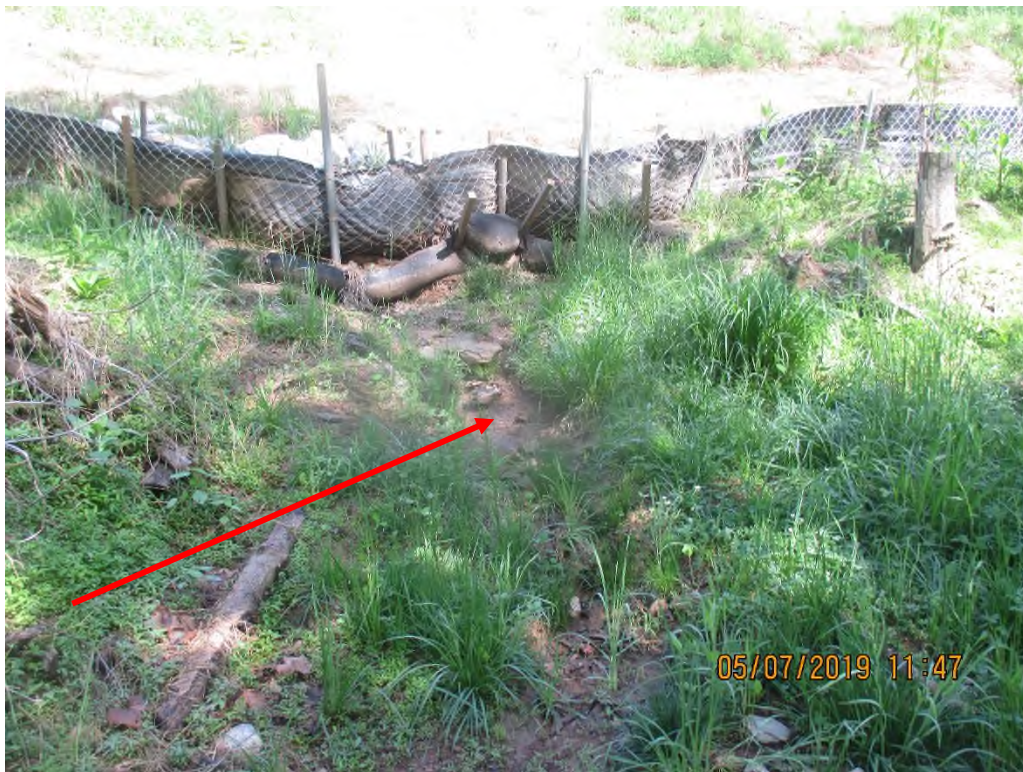
Downslope of perimeter controls on south west slope of project LOD. Arrow depicts evidence that sediment laden water had flowed past controls.

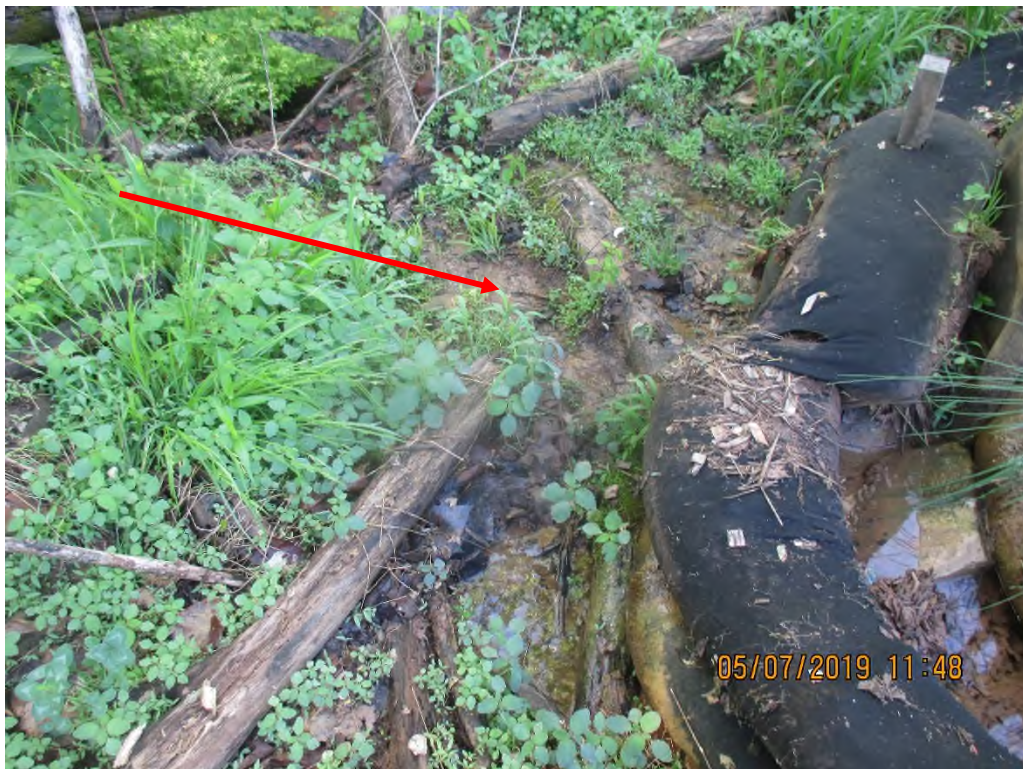
Perimeter controls on south west slope of project LOD. Arrow depicts evidence that sediment laden water had flowed past controls.

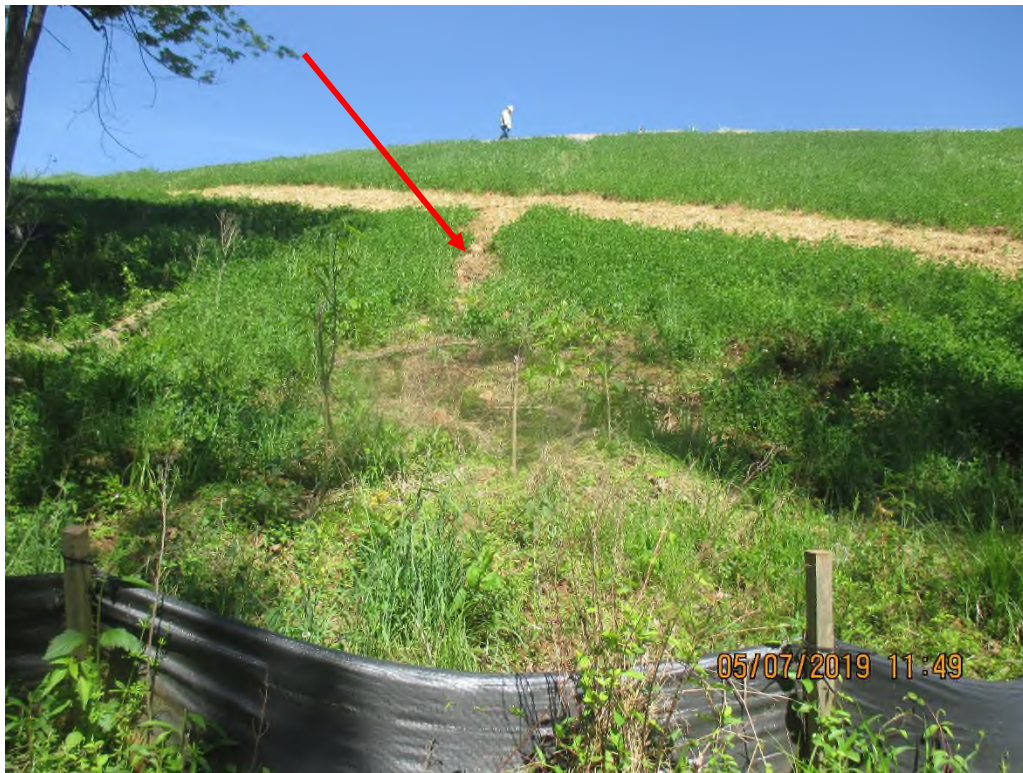
Southwest slope above LOD facing perimeter controls. Scouring present on slope above controls.

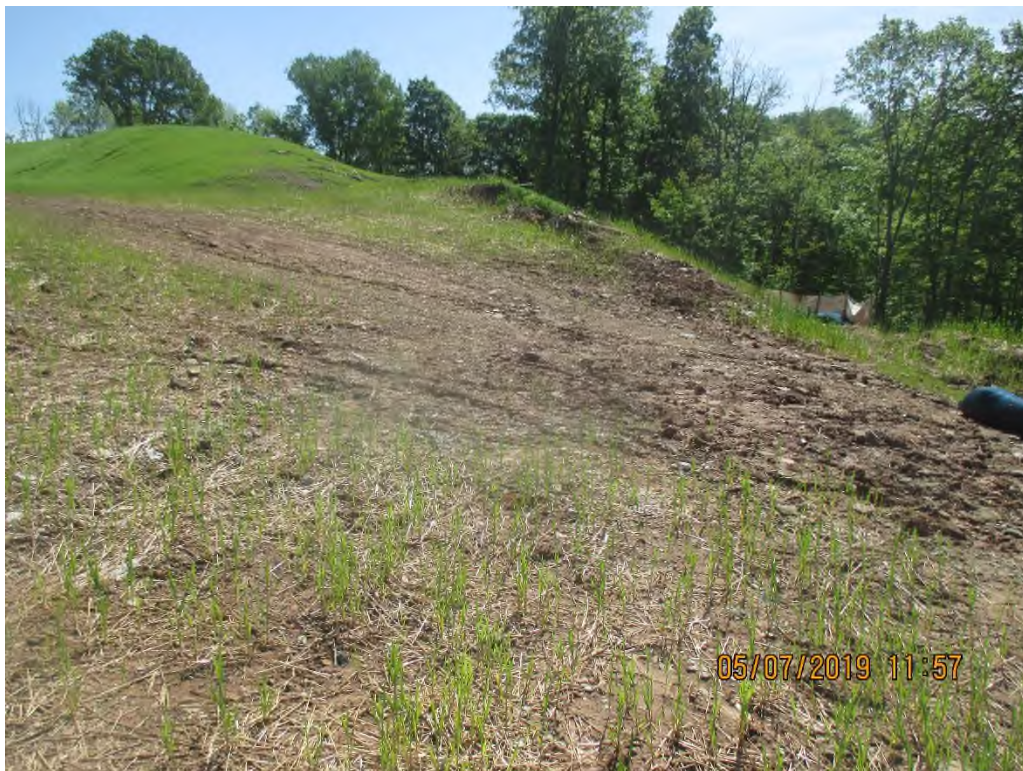
Area of unstabilized slope with erosion occurring on western side of project.

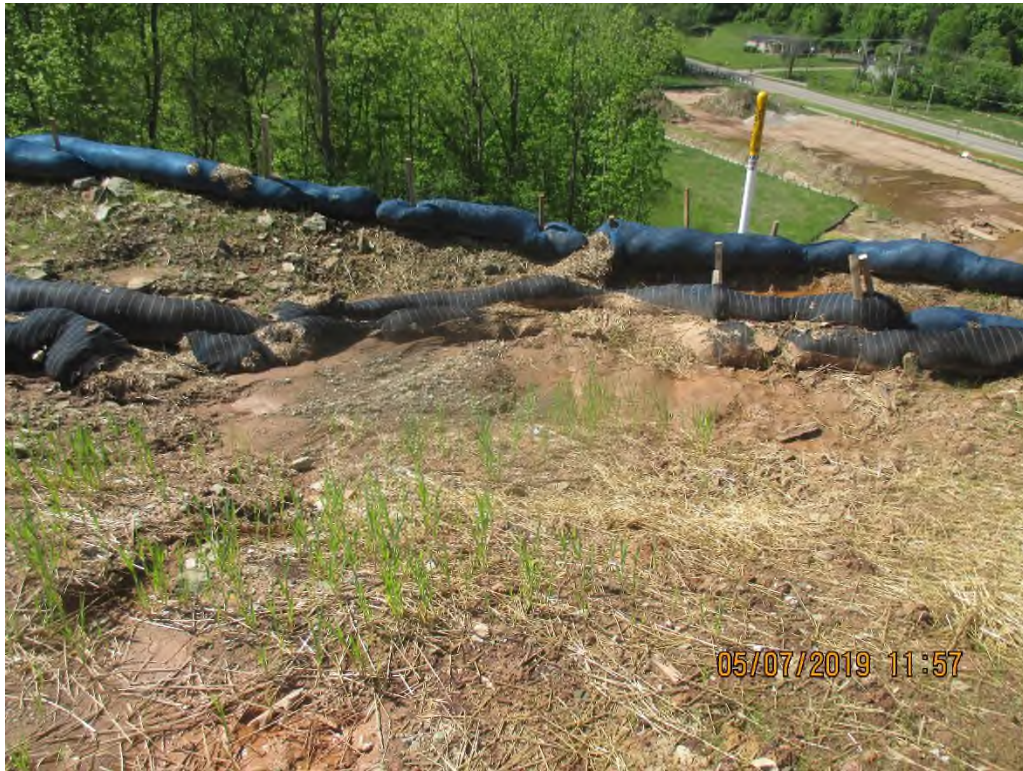
Controls on West side of unstabilized slope facing MXP Spread 7 and Route 21.

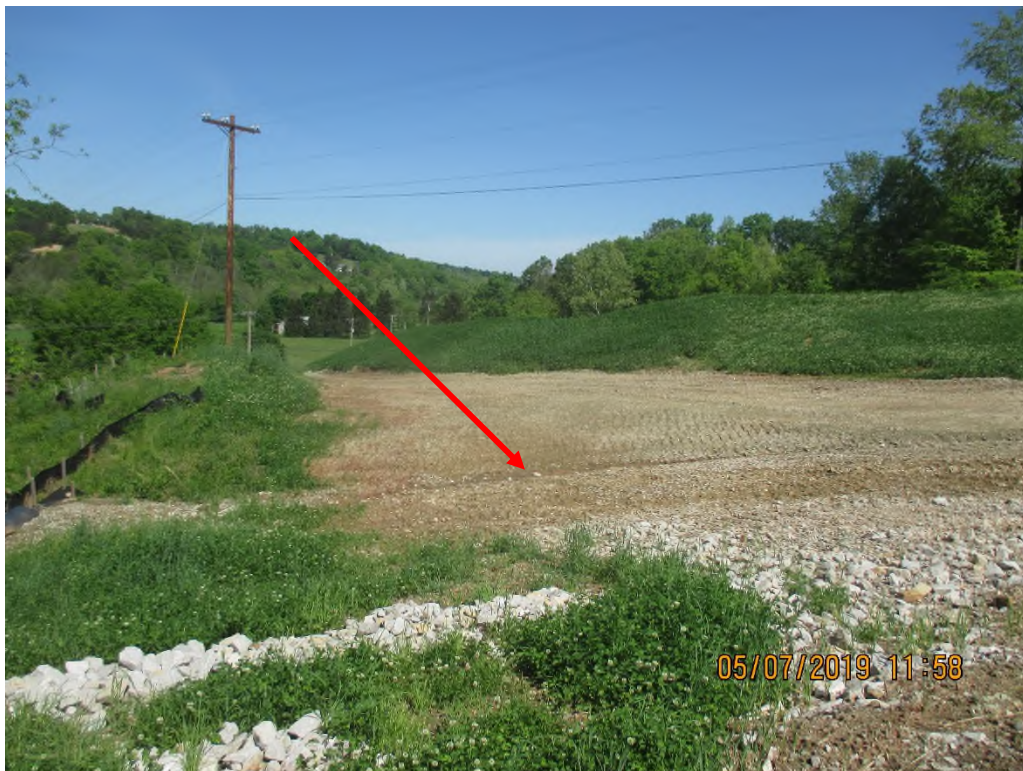
Facing North towards old reggraded construction entrance on West side of project. Arrow depicts erosion occurring on slope.

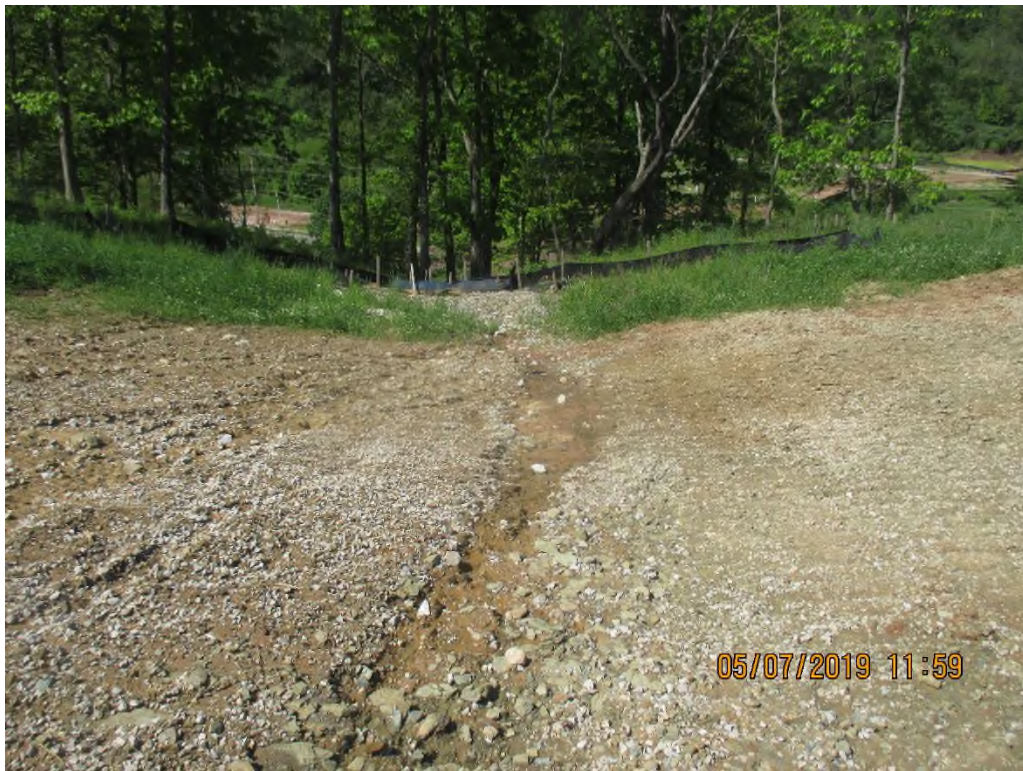
Erosion occurring on slope above perimeter controls on West slope.

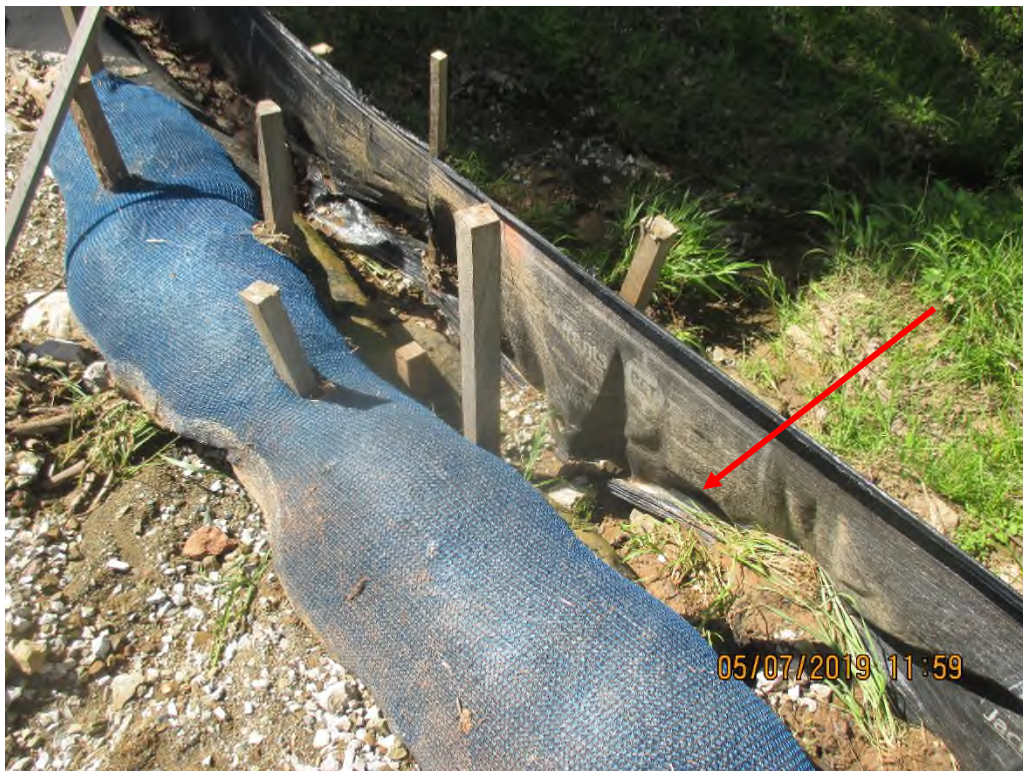
Perimeter controls below erosion on former access road. Arrow depicts silt fence is not trenched-in.

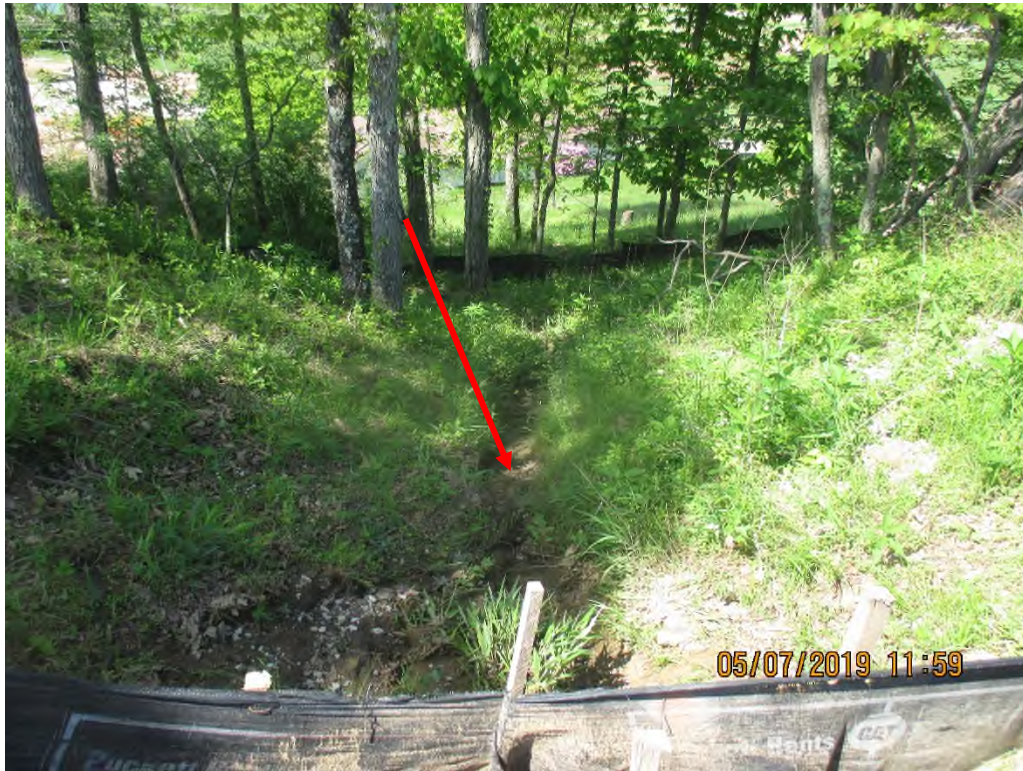
Below perimeter controls and silt fence that is not trenched-in on West Slope. Erosion gully forming downslope of controls.
