**CONSENT ORDER
ISSUED UNDER THE
WATER POLLUTION CONTROL ACT
WEST VIRGINIA CODE, CHAPTER 22, ARTICLE 11**

TO: Columbia Gas Transmission, LLC
Attn: Troy Tally, Vice President
1700 MacCorkle Ave
Charleston, WV 25314

DATE: October 1, 2020
ORDER NO.: 9061

1. Columbia Gas Transmission, LLC is conducting land disturbance activity associated with construction of the Mountaineer Xpress Project in Marshall, Wetzel, Tyler, Doddridge, Ritchie, Calhoun, Wirt, Roane, Jackson, Mason, Putnam, and Cabell Counties, West Virginia. On January 31, 2018, Columbia Gas Transmission, LLC was issued Water Pollution Control Permit No. WV0116815, Registration No. WVR310872, for Stormwater Associated With Oil and Gas Related Construction Activities.

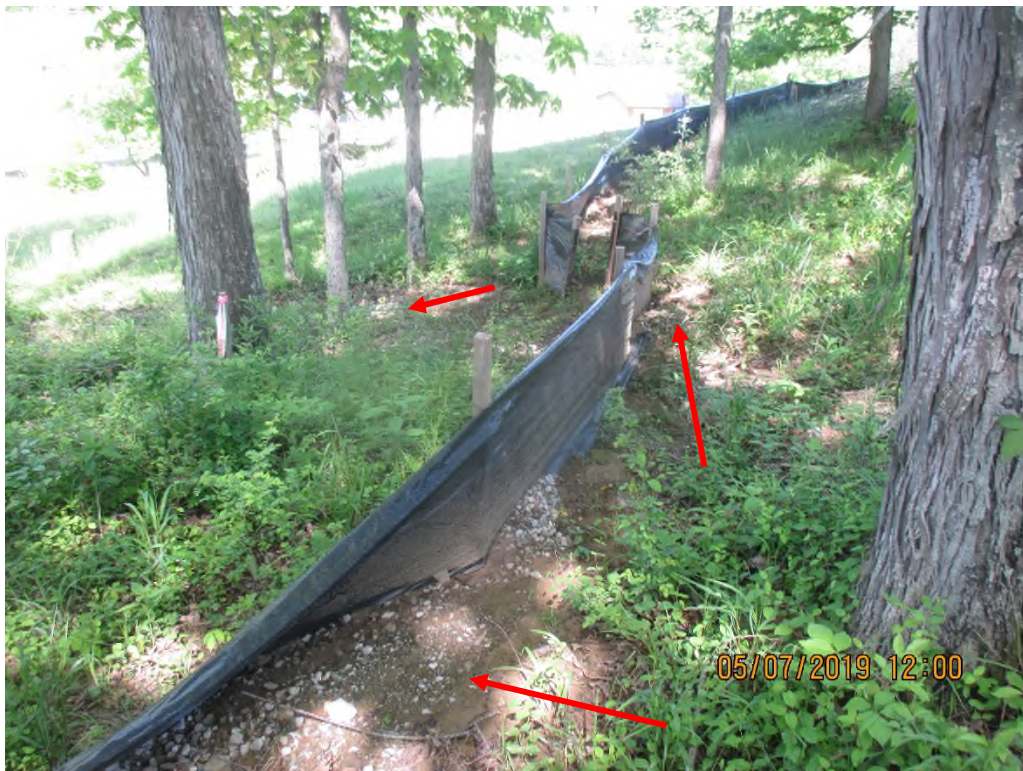
Downslope of erosion gully. Sediment deposited behind controls and being transported along perimeter controls and past LOD.

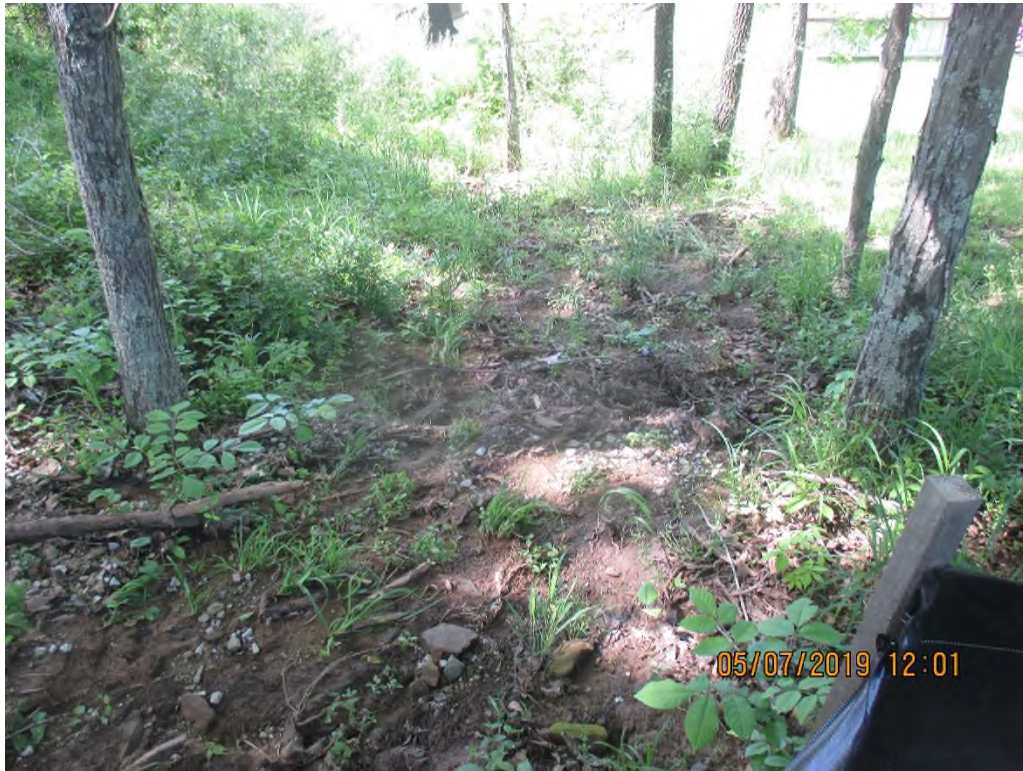
Downslope of perimeter controls below West slope perimeter.

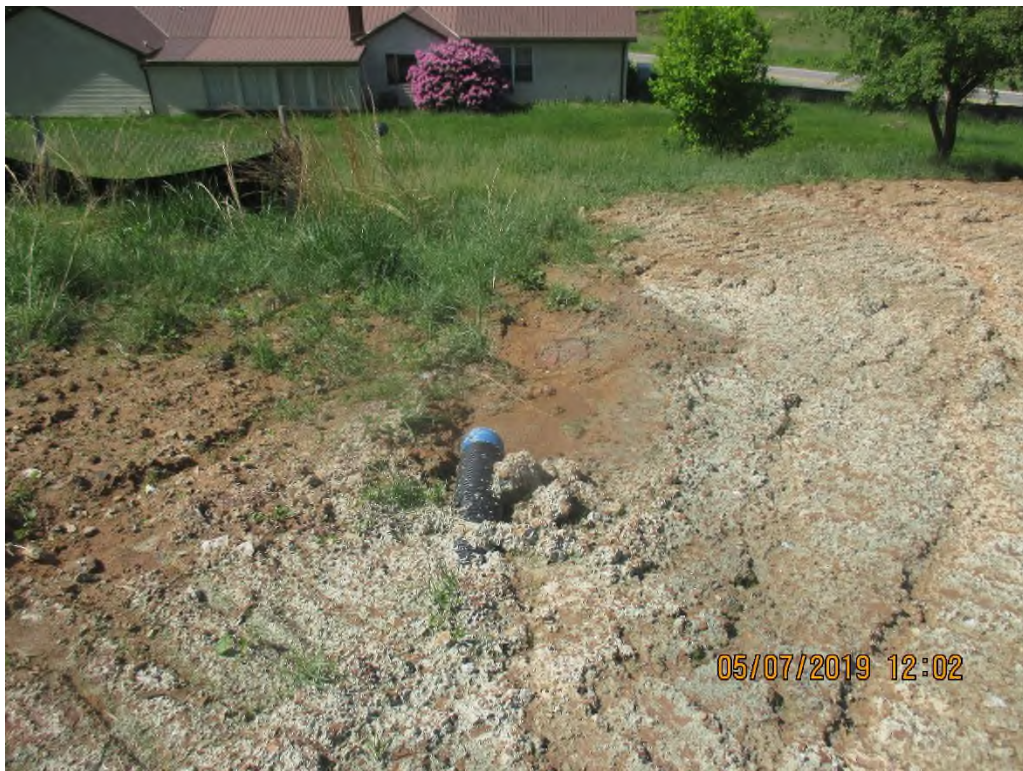
Slope drain outlet terminating onto slope above vegetated buffer.

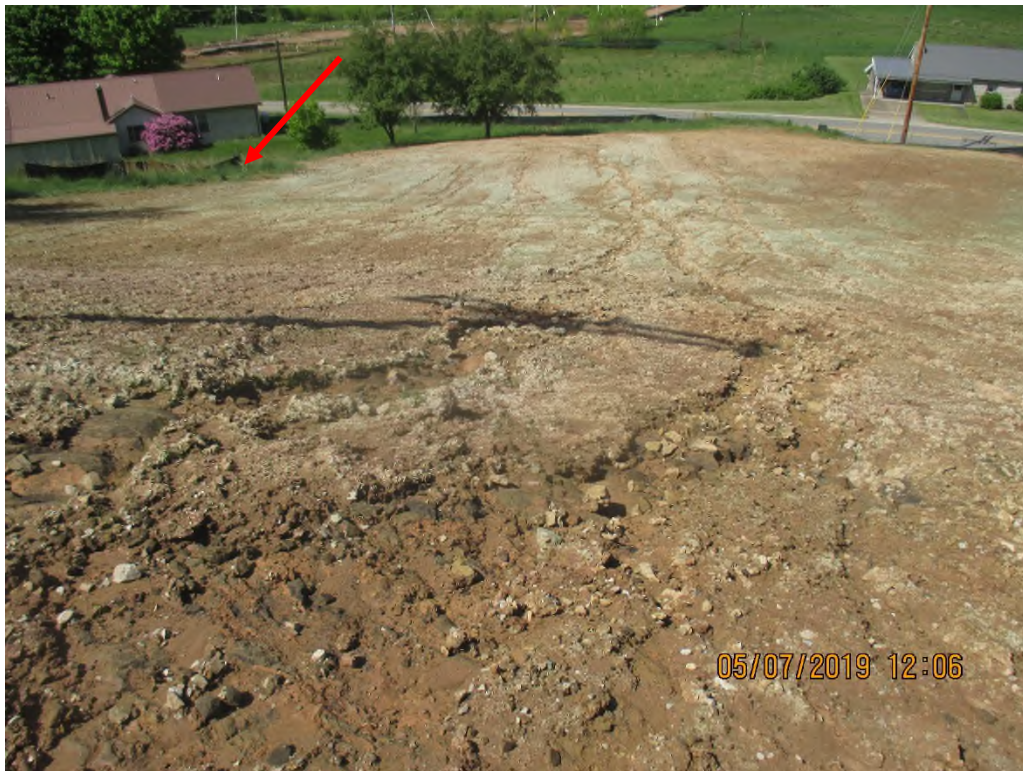
West slope facing perimeter controls and route 21 above slope drain outlet. Erosion present on slope. Arrow depicts slope drain outlet.

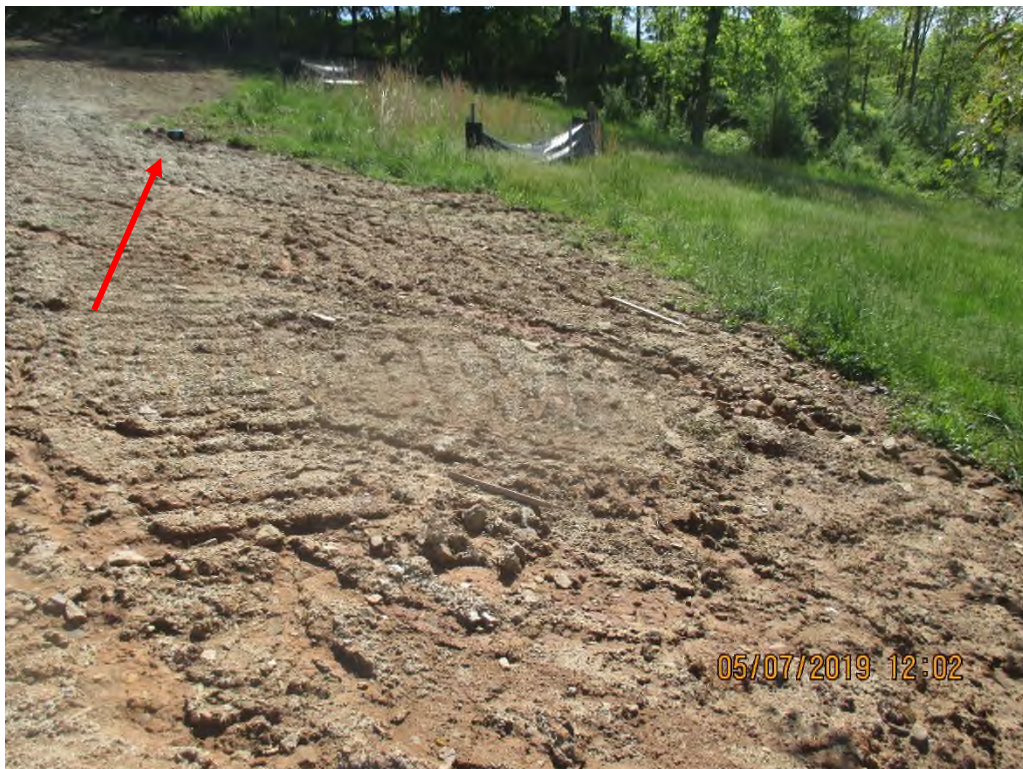
Downslope of slope drain outlet on west slope above LOD. Arrow depicts slope drain. Erosion present on slope, depositing sediment into and through perimeter controls.

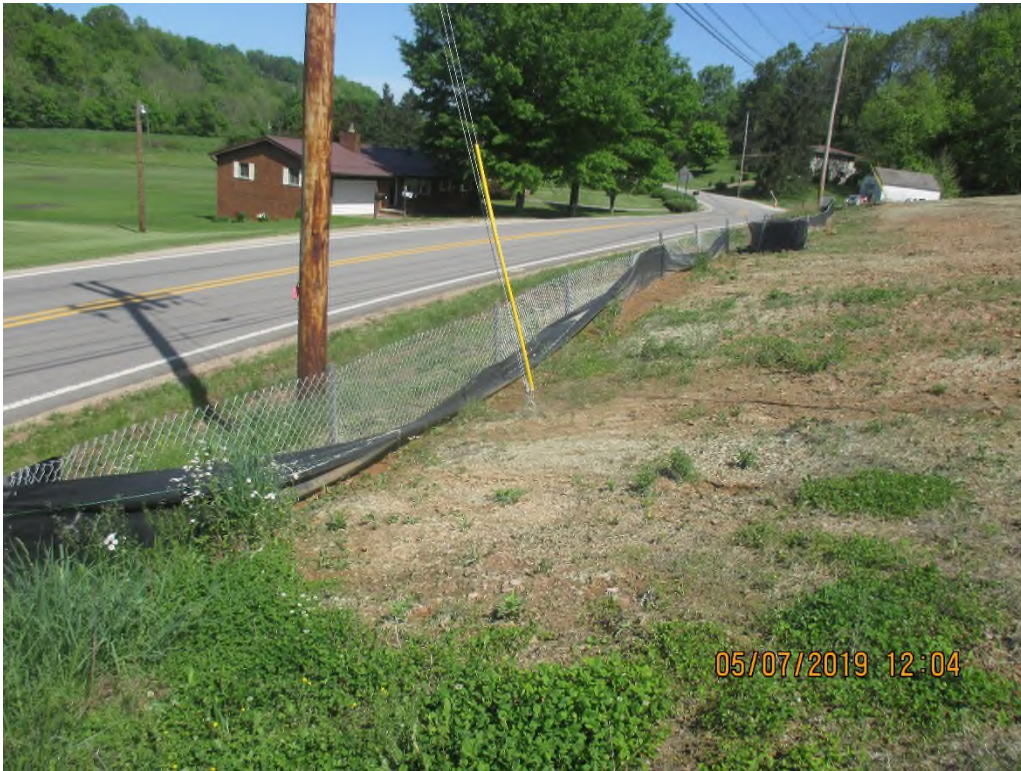
Downslope of slope drain outlet on west slope above LOD. Erosion present on slope, depositing sediment into and through perimeter controls. Super silt fence not maintained.

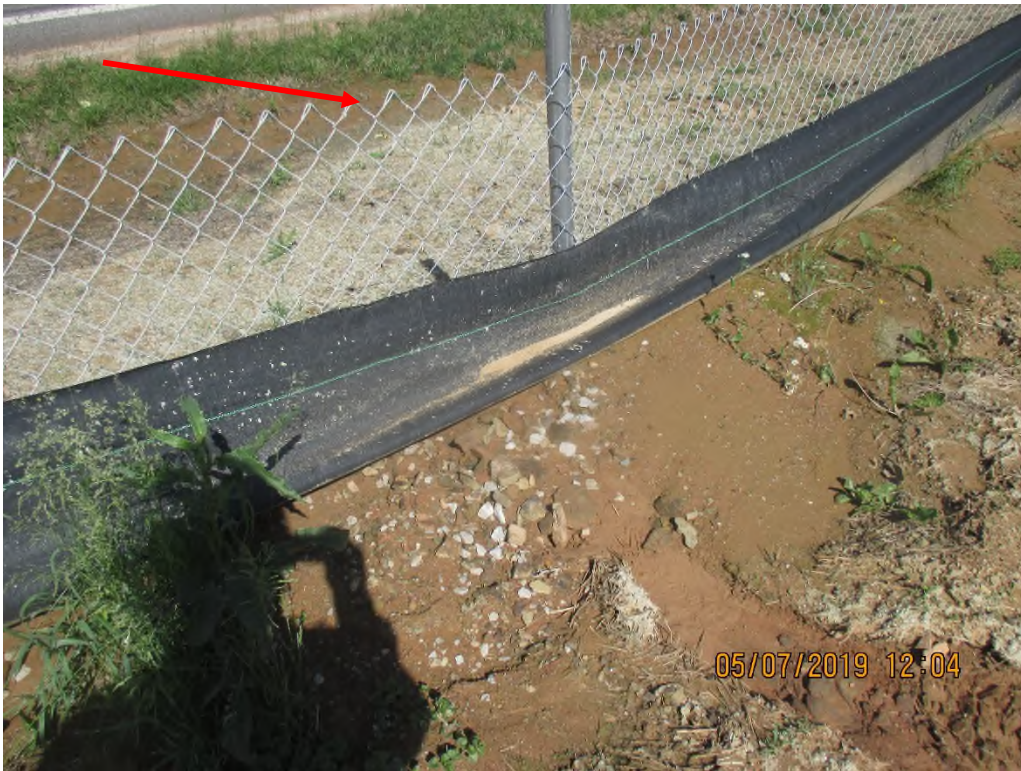
Super silt fence with sediment deposited above, below, and into roadside ditch. Arrow depicts off-site sediment deposits.

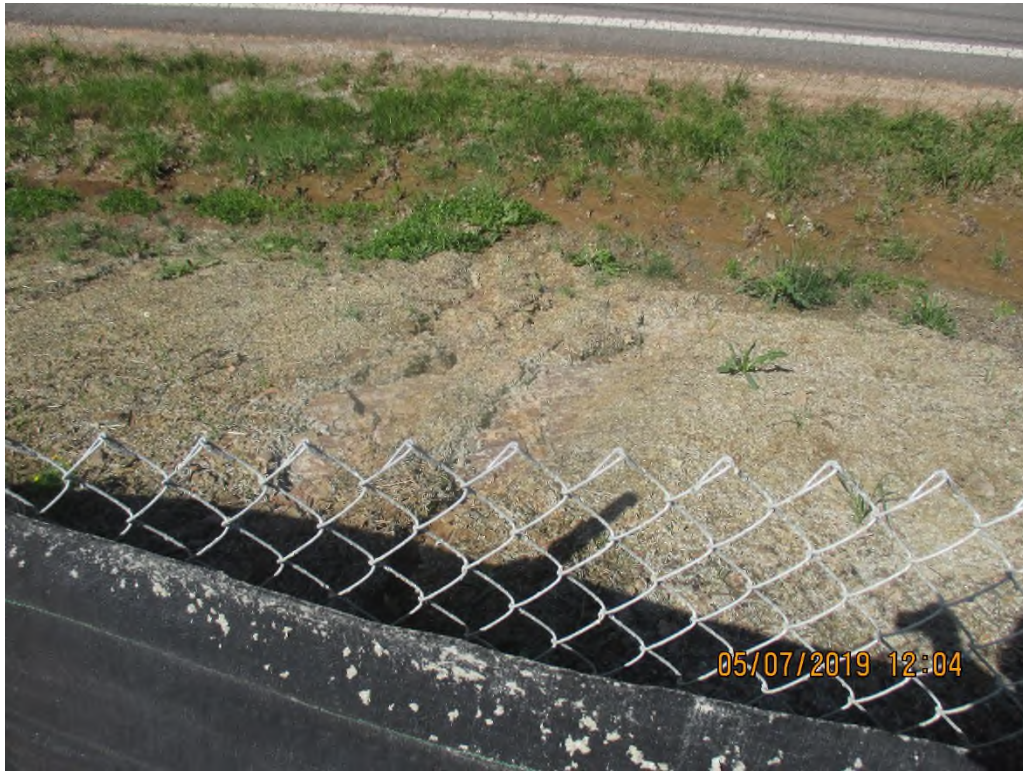
Erosion occurring below unmaintained controls and sediment deposits in Roadside ditch that parallels Route 21.

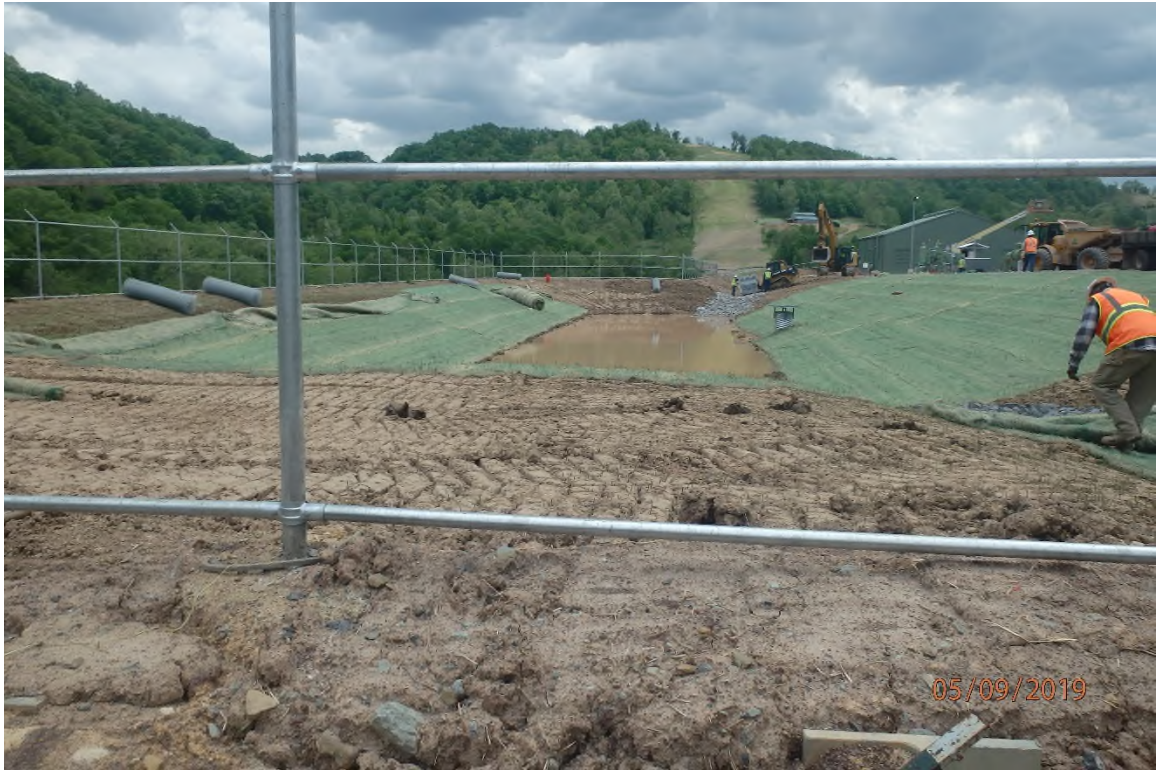
Crews working on stabilization of the area around the sediment basin, even though the site is in Phase 3.

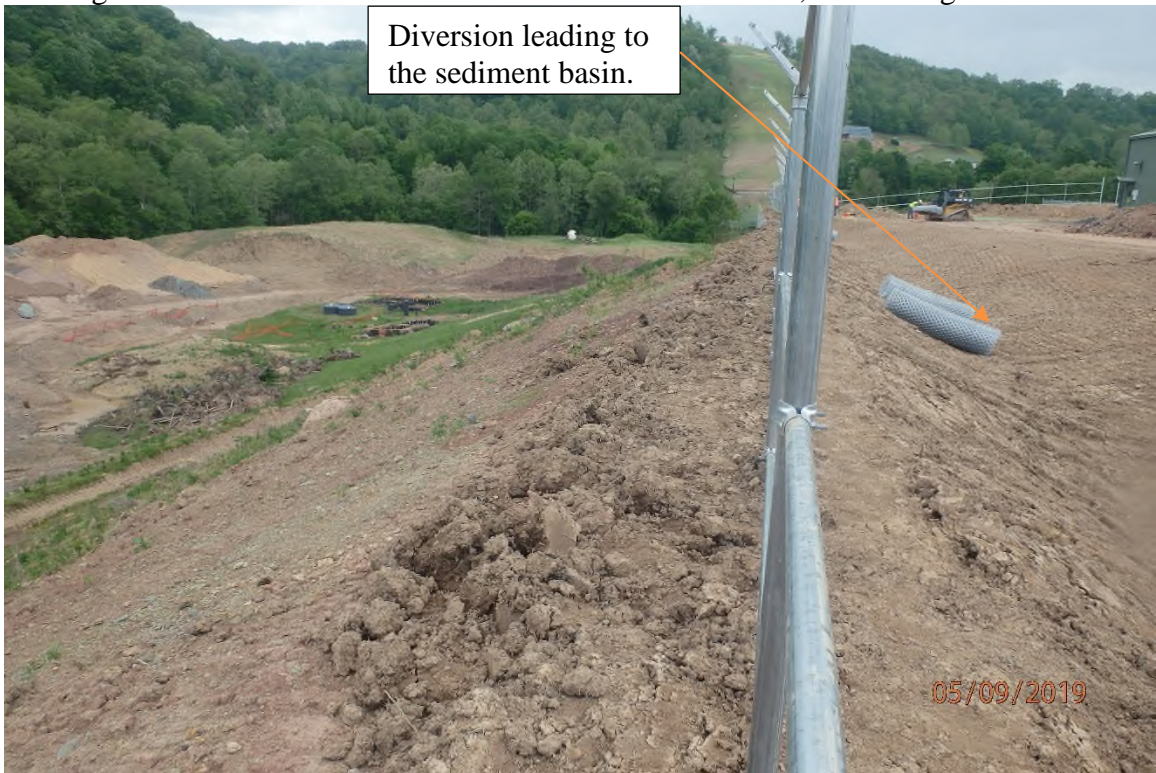
Diversion leading to the sediment basin that has not been stabilized, even though the site is in Phase 3.

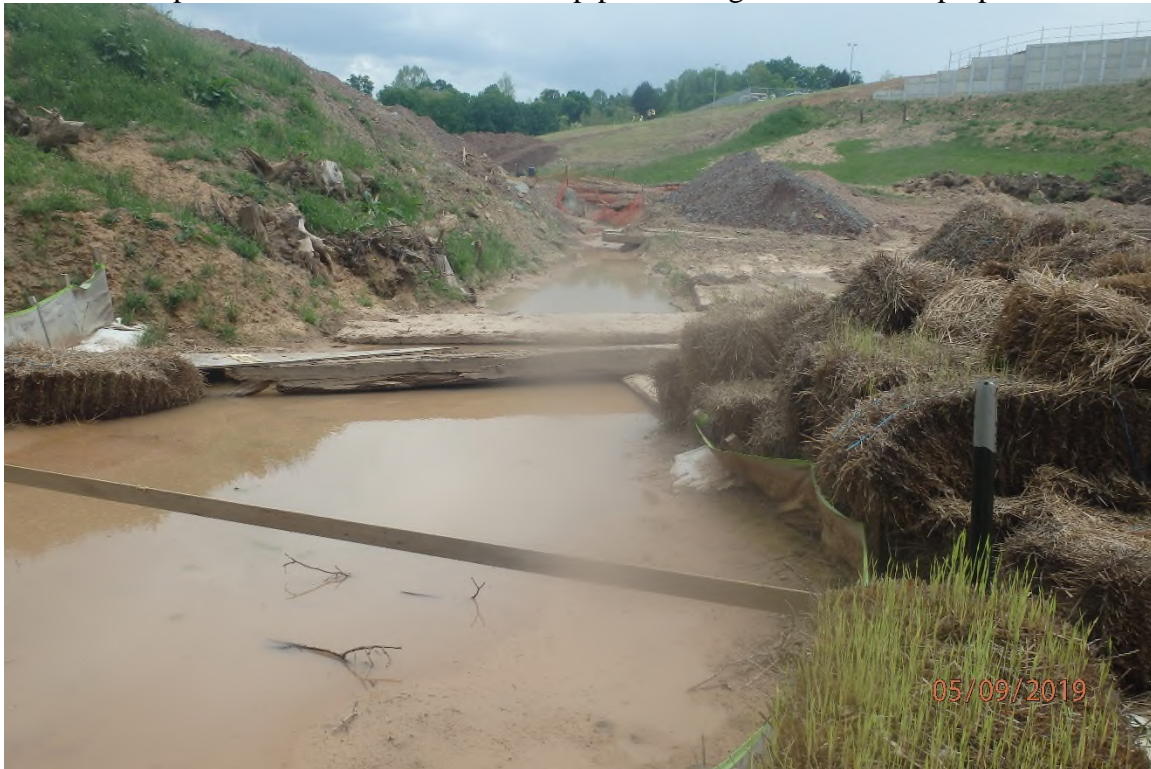
Diversion carrying stormwater from the basin outlet to the makeshift treatment structure.

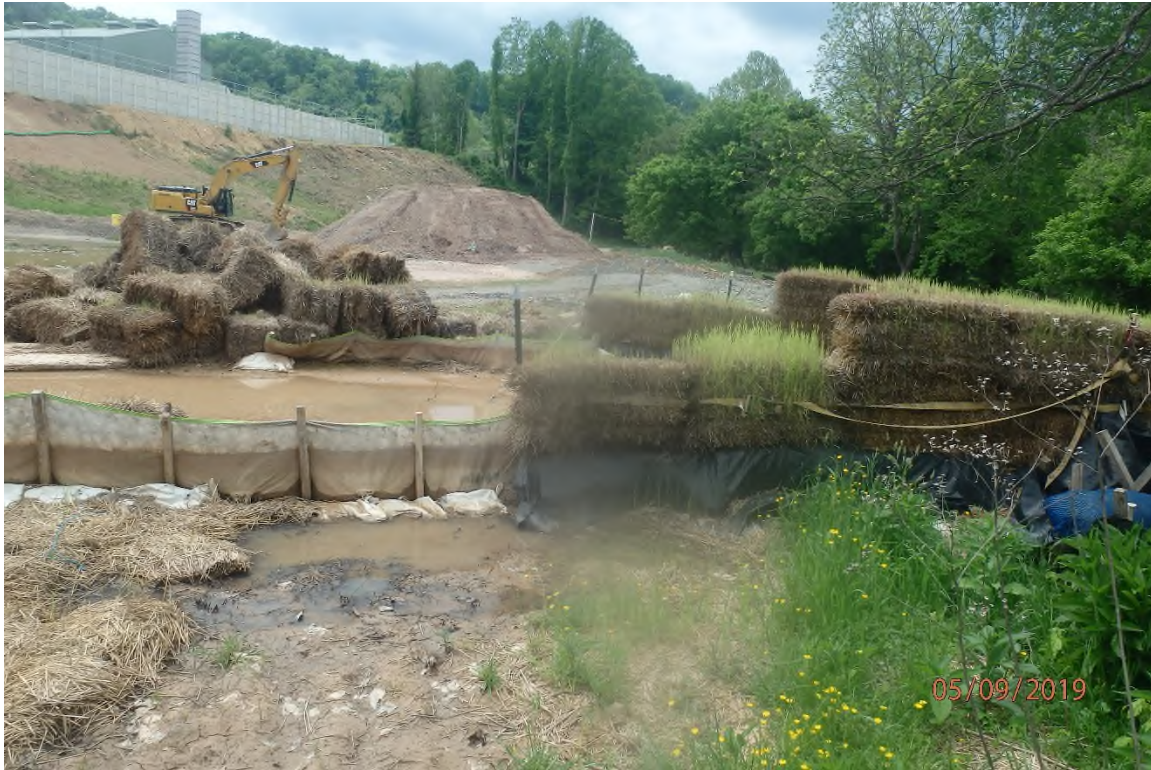
Makeshift treatment structure being utilized to treat stormwater from the sediment basin that is being discharged into an unstable diversion.

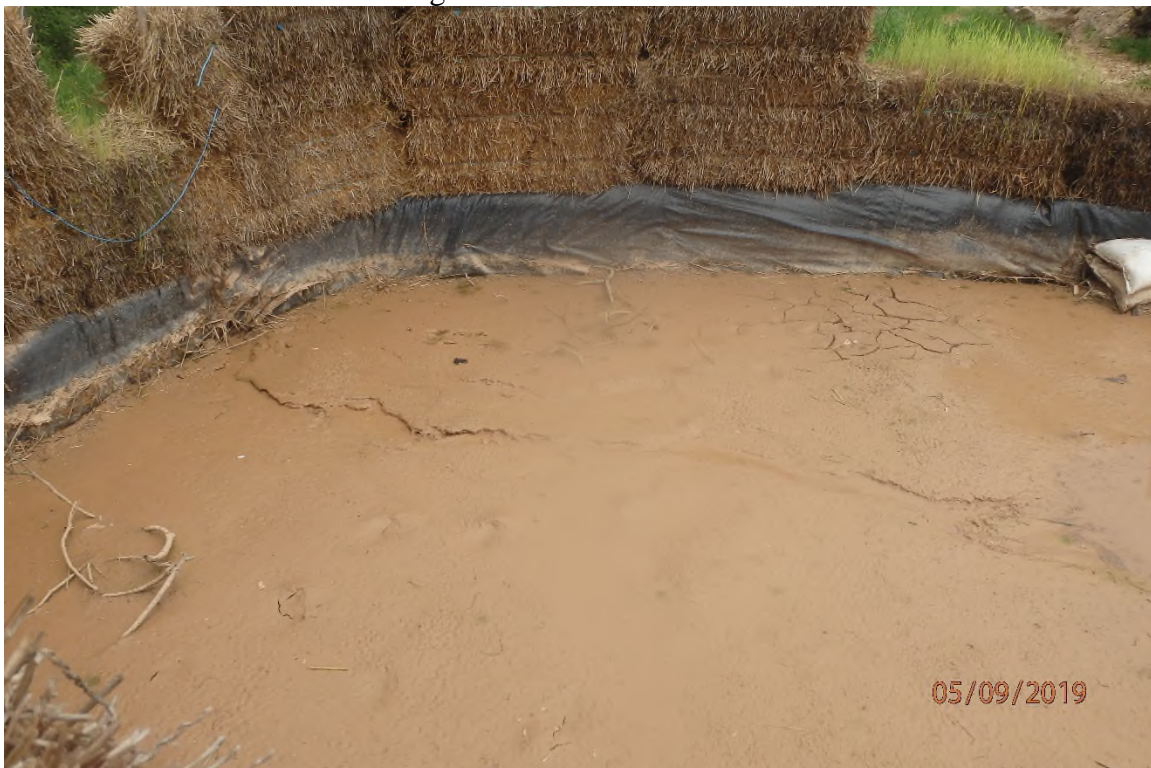
Makeshift treatment structure being utilized to treat stormwater from the sediment basin that is being discharged into an unstable diversion. Structure is inundated with sediment and in need of maintenance.

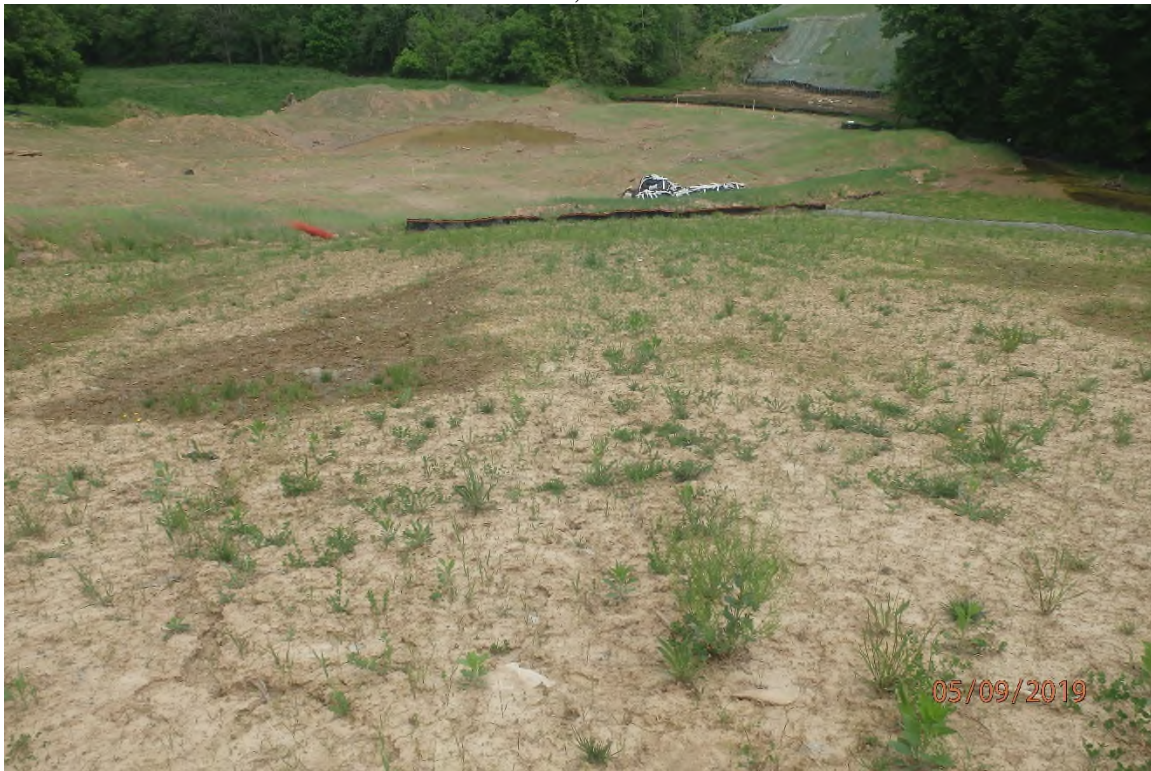
Slope adjacent to the fill pad showing the lack of installed slope interceptors. Area in need of reseeding.

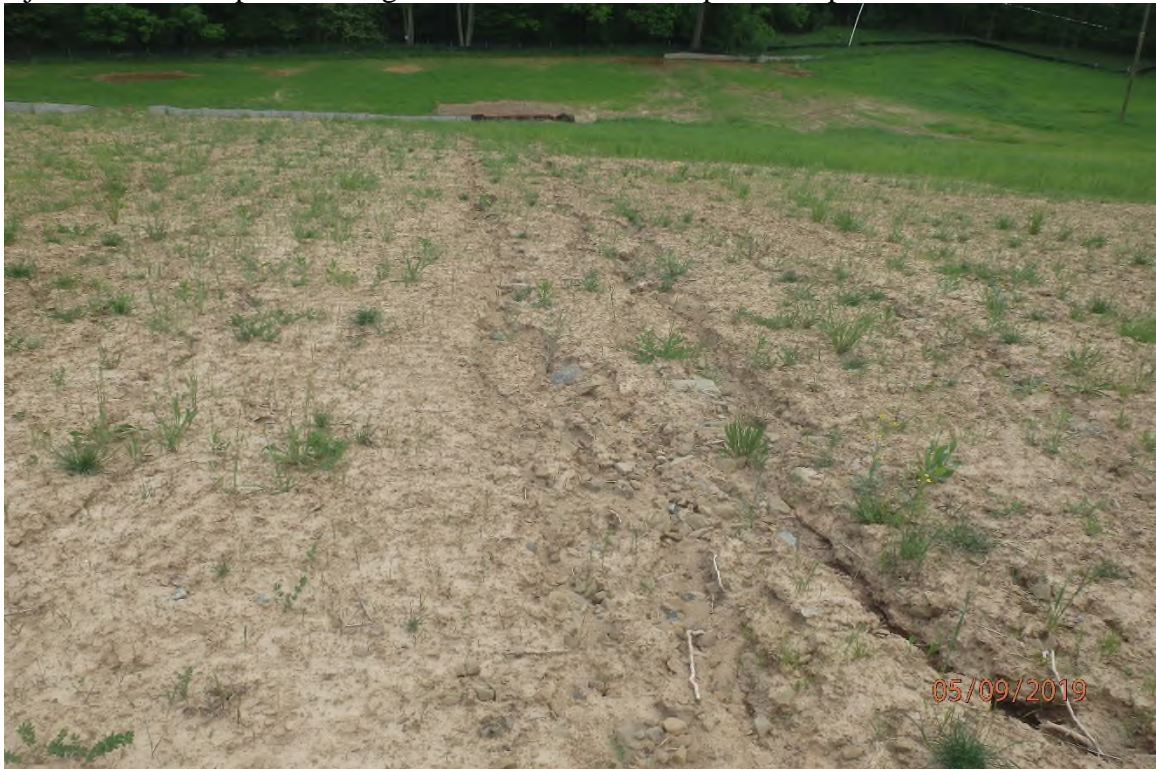
Slope adjacent to the fill pad showing the lack of installed slope interceptors. Fill slope erosion as a result of concentrated flow being directed over an unprotected fill slope. Area in need of reseeding.

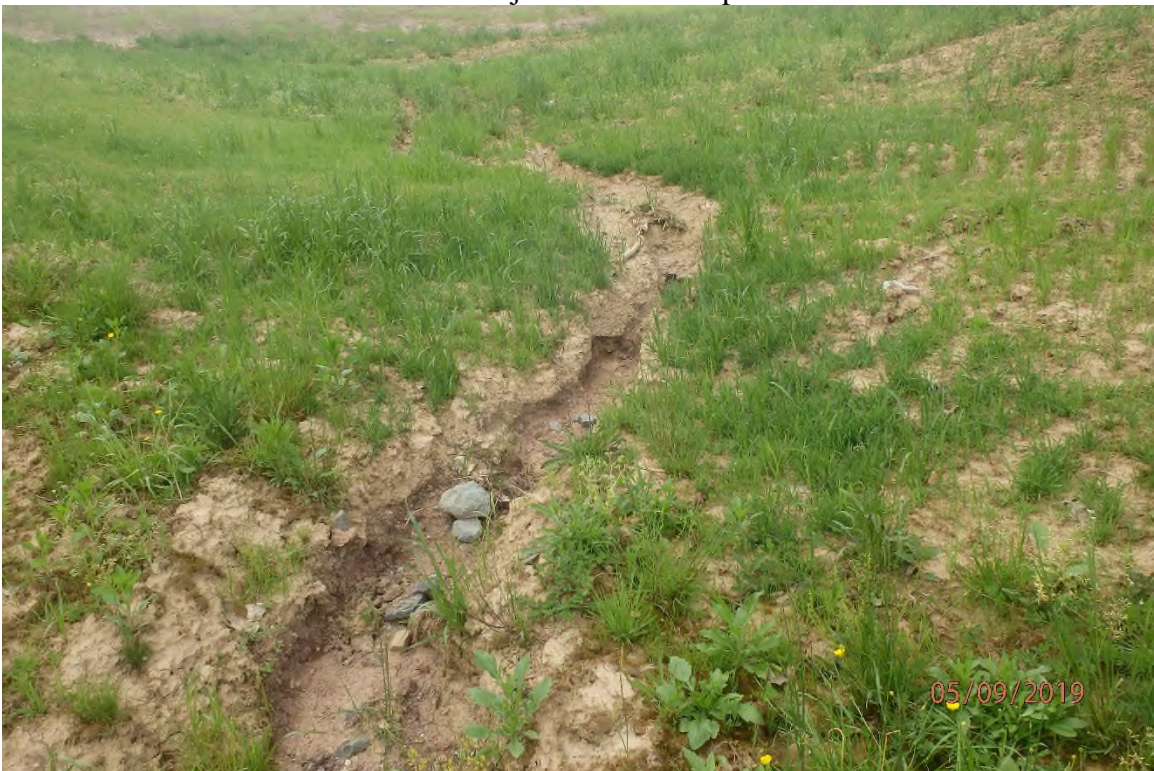
Concentrated flow stormwater being directed over an unprotected fill slope and associated fill slope erosion adjacent to the fill pad.

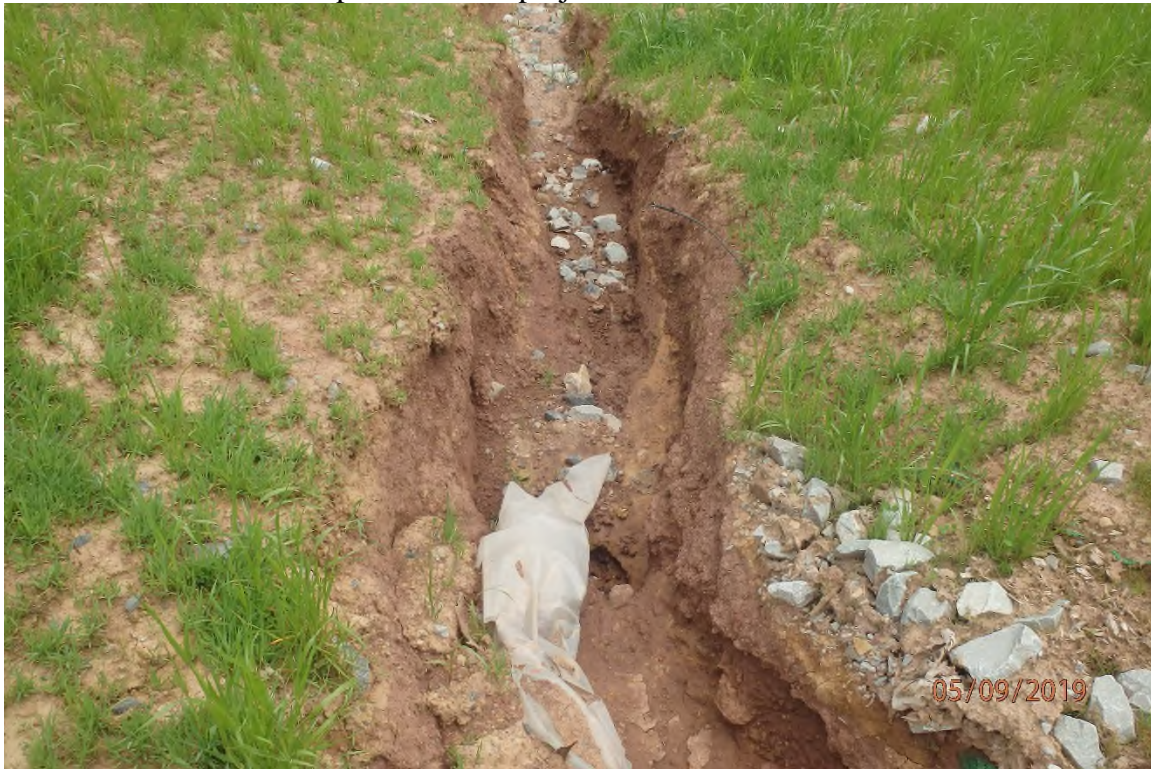
Diversion in the southern portion of the project that is eroded and in need of maintenance.

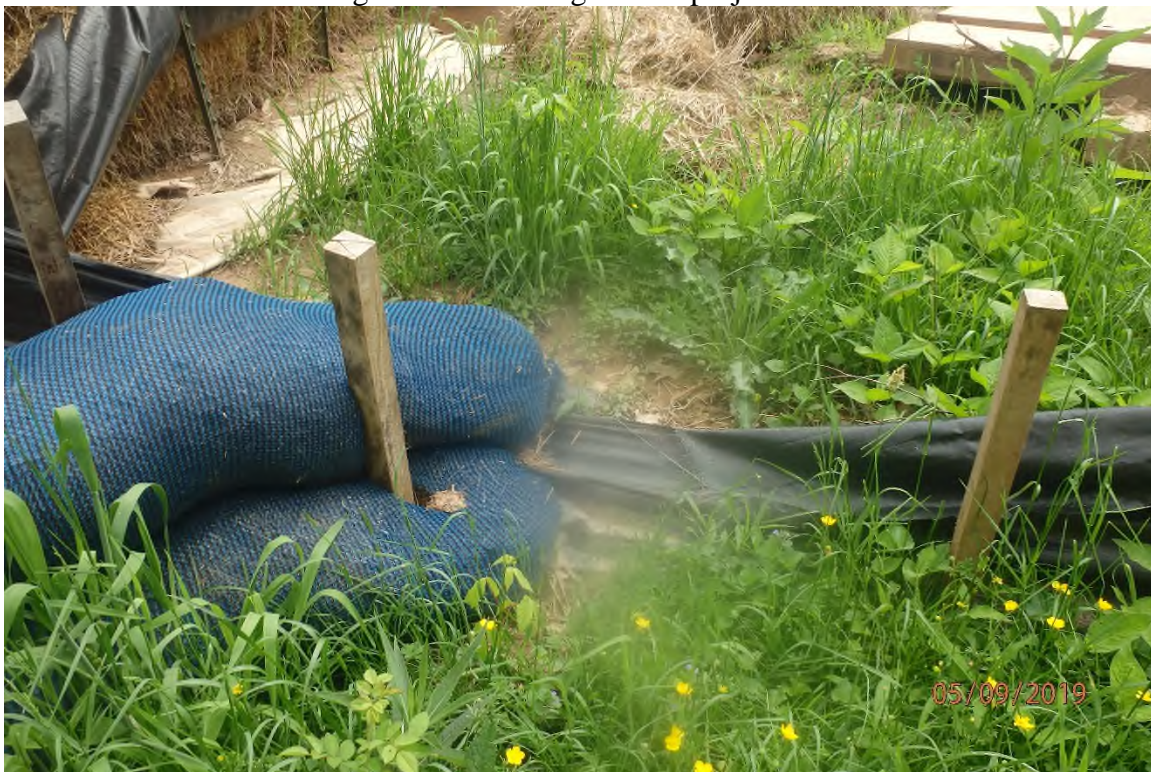
Perimeter control along the northern edge of the project in need of maintenance.

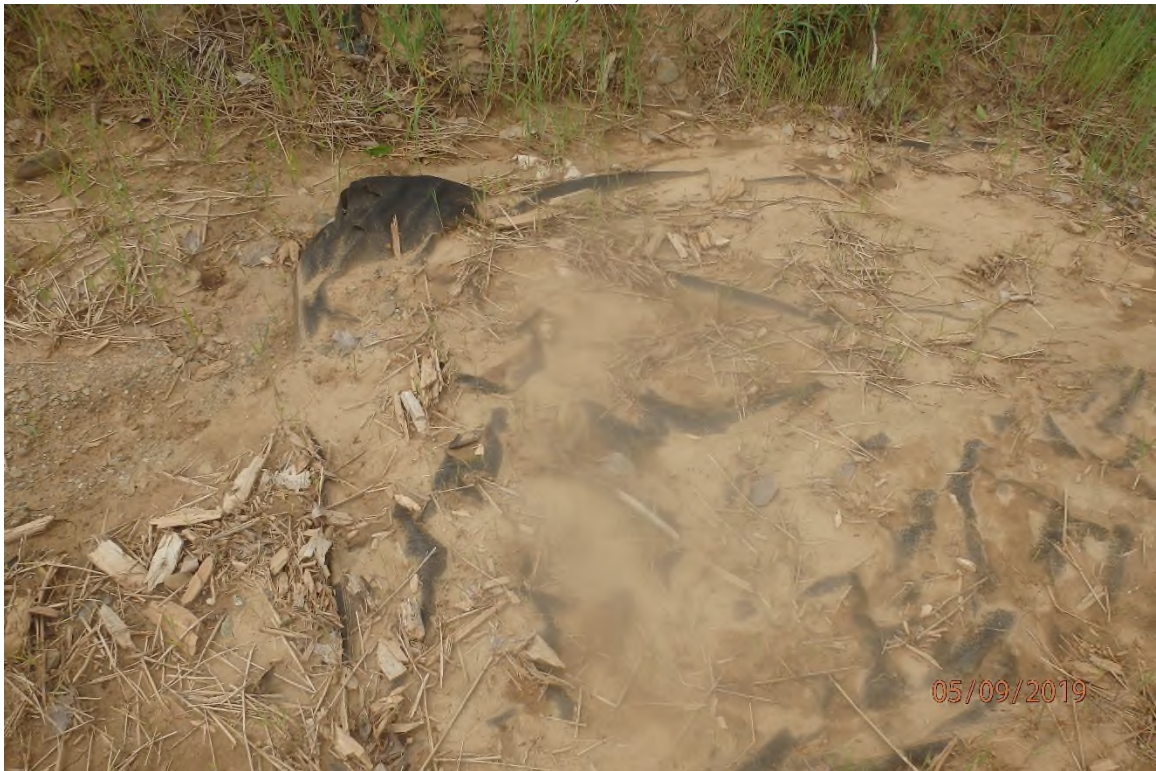
Discarded dewatering bag on the project.

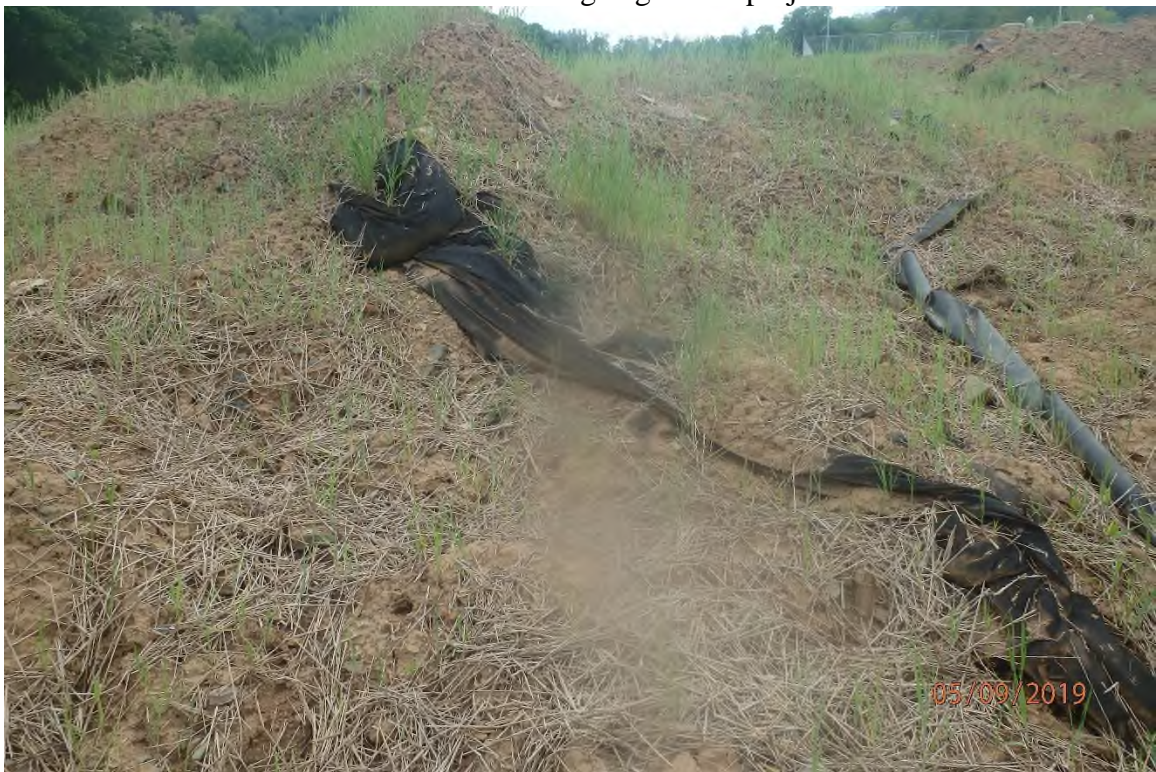
Solid waste in the soil stockpile.

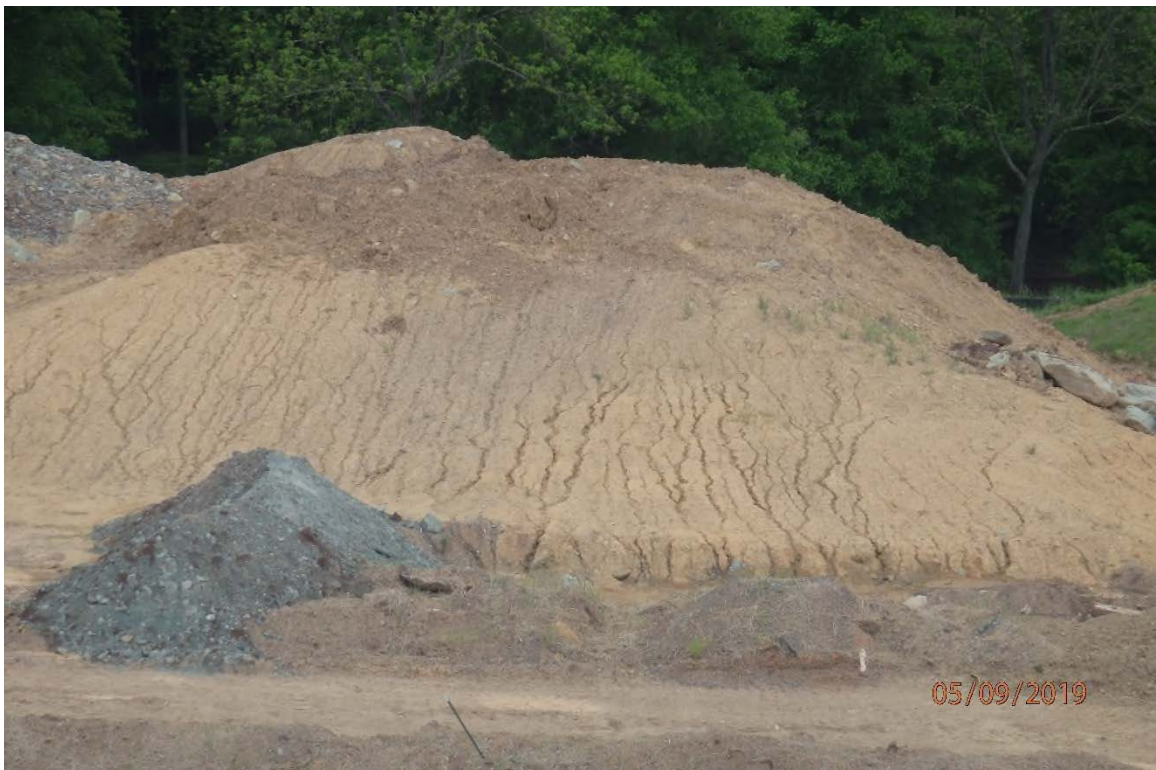
Soil stockpiles have been idle for greater than 21 days and have not been temporarily stabilized.
