# Rapid Geomorphic Assessment Picture Key

# EVIDENCE OF AGGRADATION

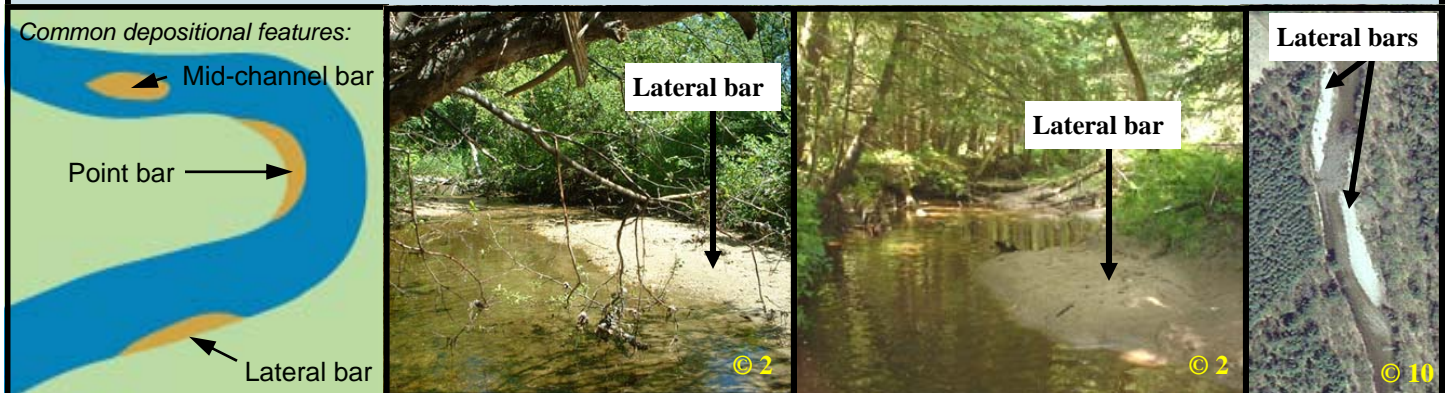
**1. Lateral bars**—Sediment bars located on the side of a river channel. (Do not confuse lateral bars with point bars or mid-channel bars [see diagram].)

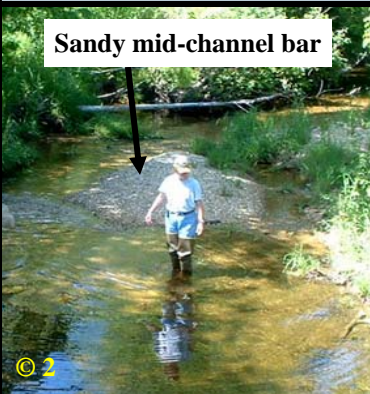
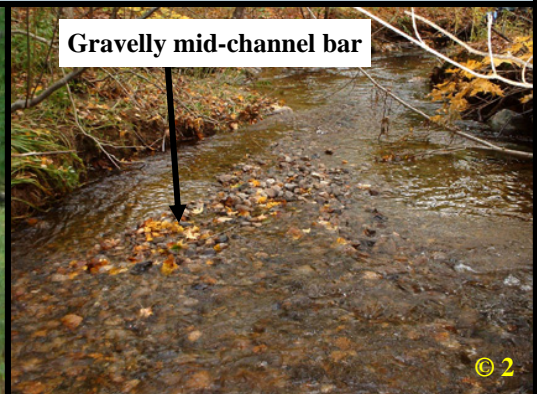
**4. Mid-channel bars**—Bars formed in the mid-channel zone, not extending completely across the channel, and lacking mature vegetation (trees, etc.).

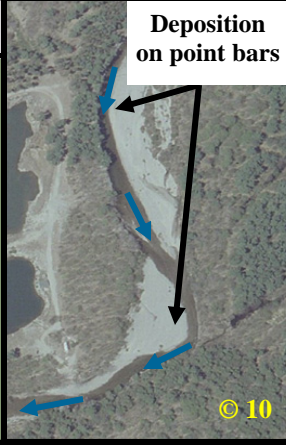
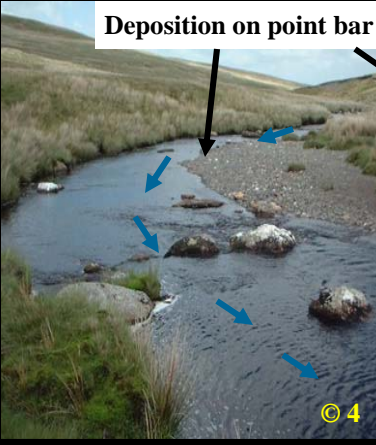
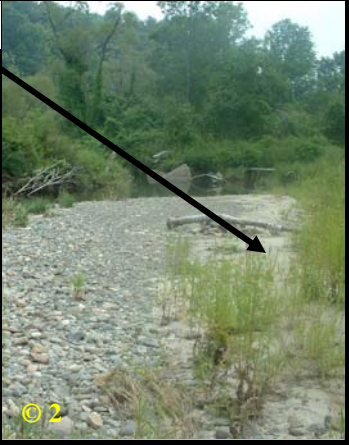
**5. Deposition on point bars**—Is new, fresh material being deposited on the inside of meander bends?

**CAUTION:** Point bars are natural features. You are not looking for the existence of point bars, but rather, evidence of fresh deposition on the point bar. This will appear as fine- to coarse- grained sediment, and is often unconsolidated (it has not had time to compact).

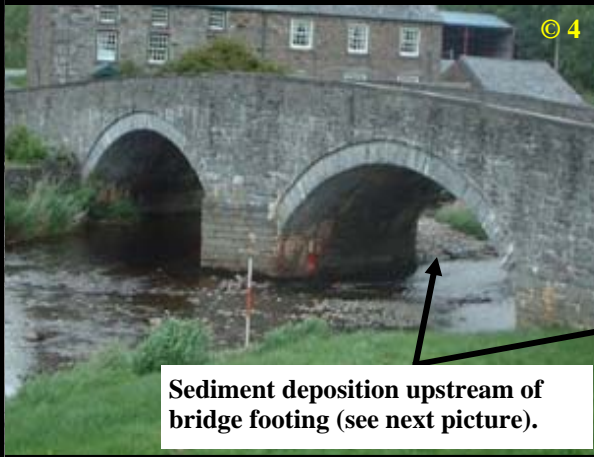
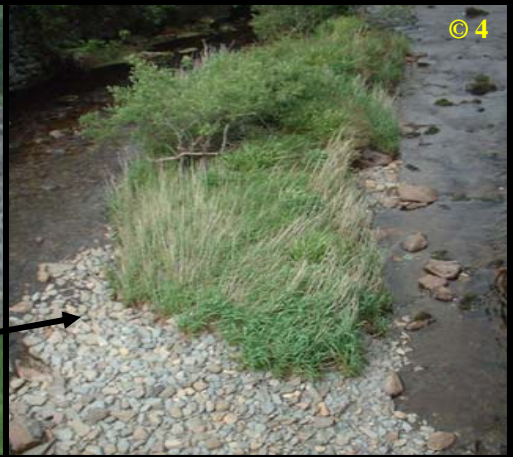
**8. Evidence of deposition in/around structures**—Are sediments being deposited around or in conjunction with larger, more sedentary features such as boulders, culverts, bridge abutments, or in-stream woody debris?

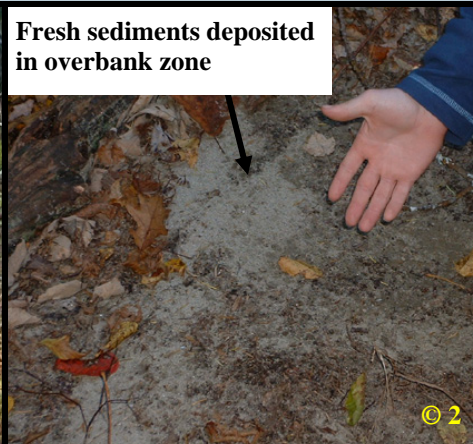
**9. Deposition in the overbank zone**—Evidence of stream deposited materials above the banks (i.e. on the floodplain, where the permanent vegetation starts).

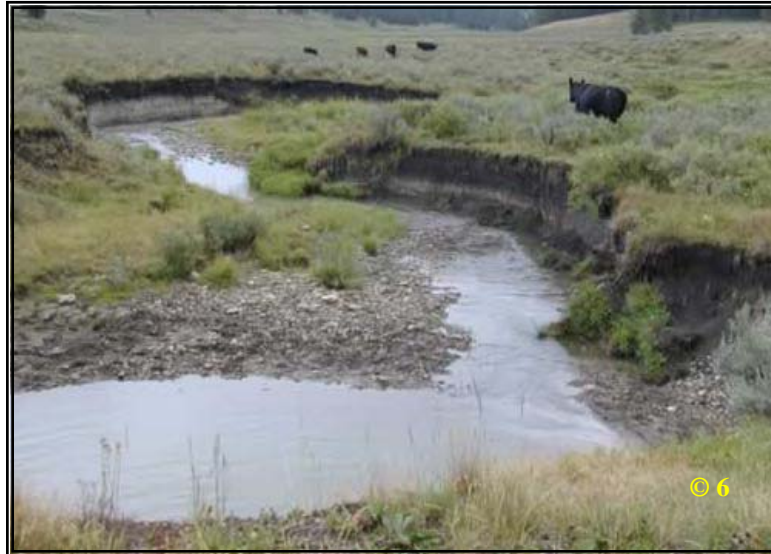
The river cuts deeper into the land. One result is that bridge footings are undermined and exposed. Degradation can sometimes be caused by straightening and shortening a channel, which increases the slope of the river. The water flows faster down this steeper slope and has extra energy to move sediment, causing the river channel to cut deeper or degrade. Other causes of degradation include increases in peak flows and frequency due to activities such as poorly-planned urbanization, agriculture, and forest practices.

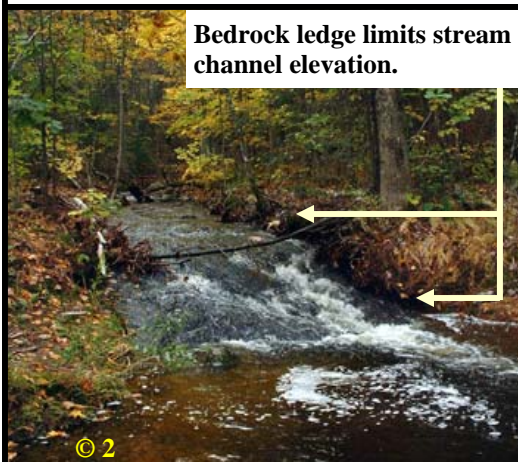
**Bedrock ledge limits stream channel elevation.**

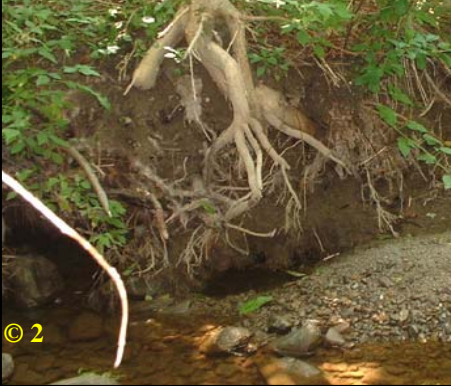
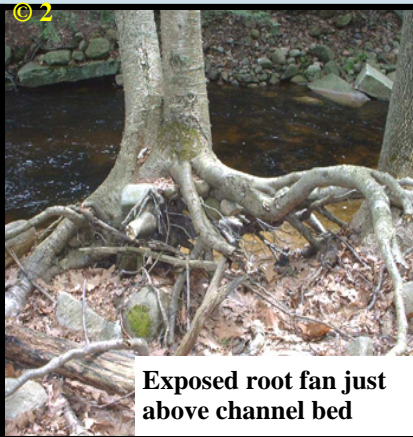
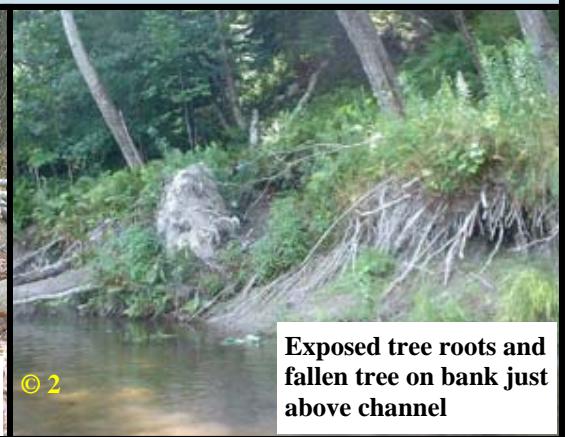
**2. Elevated tree roots/root fan above channel bed**—Are the trees within the channel or just above on the adjacent bank being scoured around their root network?

Exposed tree roots above channel bed

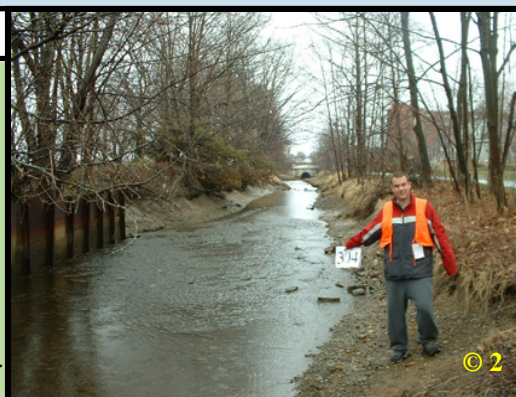
**4. Absence of depositional features**—No bars or other depositional features are present (particularly where you would expect to see depositional features). Should be a reach-wide condition.

Common depositional features:

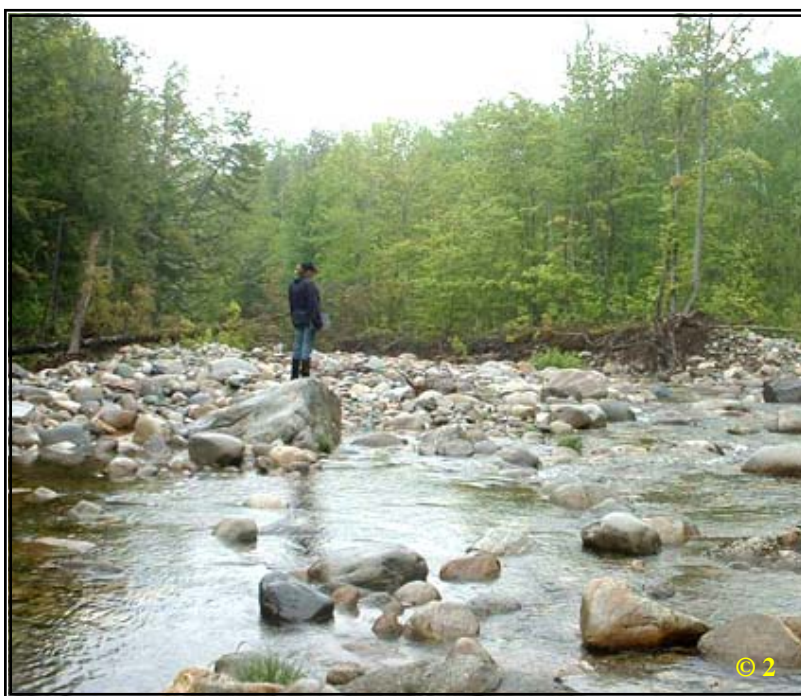
## EVIDENCE OF WIDENING

Banks collapse, and the river becomes wider and shallower. A wider, shallower river does not have the same capacity to transport sediment, so sediment can build up in the channel. ~ ~ ~

Widening is a process that typically follows aggradation or degradation geomorphic phases.

Widening occurs because the stream bottom materials eventually become more resistant to erosion (harder to move) by the flowing waters than the materials in the streambanks.

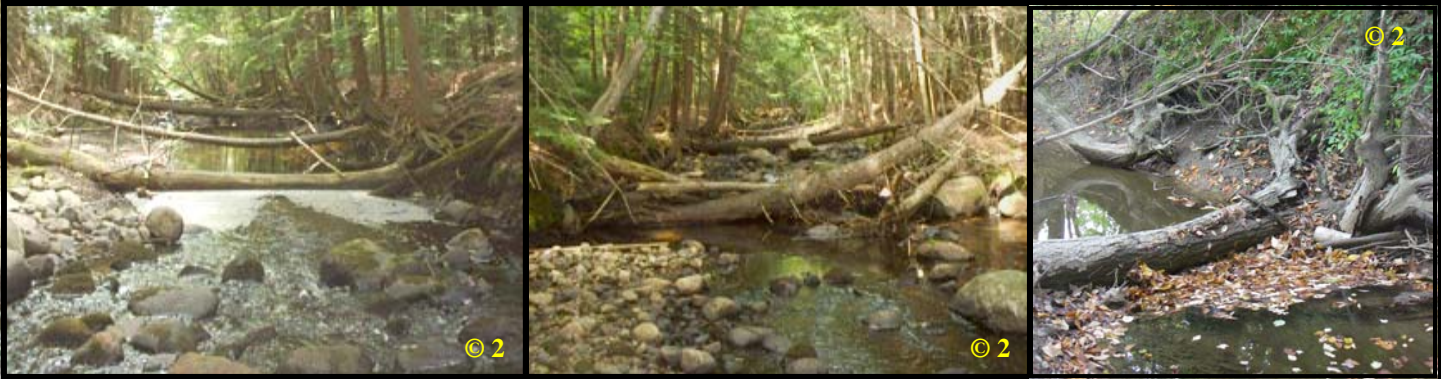
**2. Occurrence of large organic debris**—Are trees or collections of woody debris present in the channel/on bars?

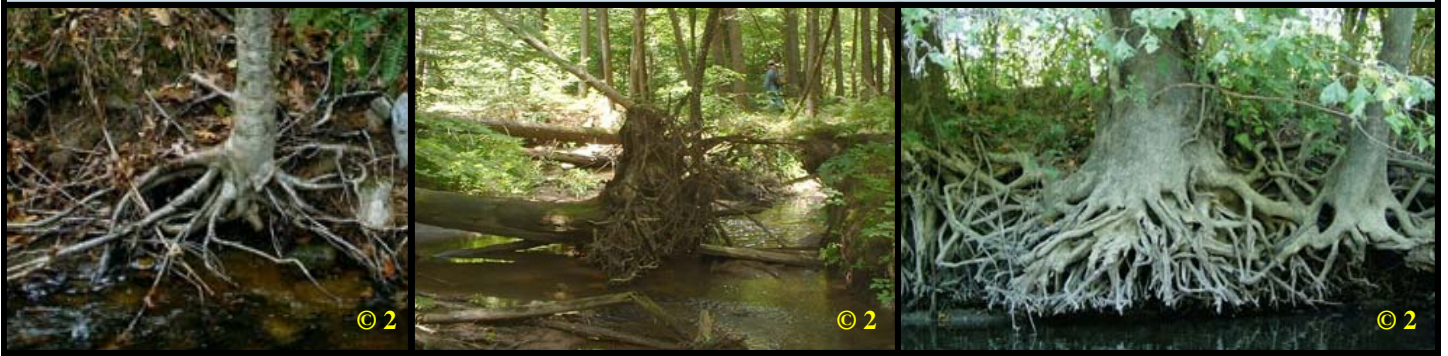
**3. Exposed tree roots**—Are trees on the banks being scoured out with roots exposed?

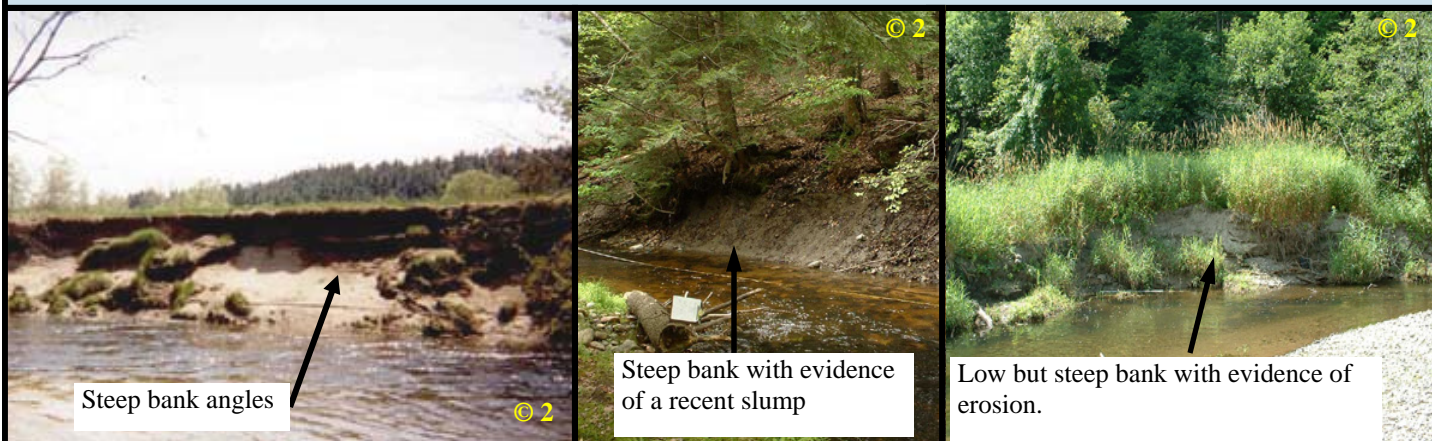
**6. Steep bank angles through most of reach**—Are the stream banks on both sides steep with evidence of recent slumps or erosion? Focus more on straight segments of the stream, where slumping would be less expected. (Banks may be steep due to natural processes, but for this question you're looking for banks steepened by slumping and erosion from river processes.)

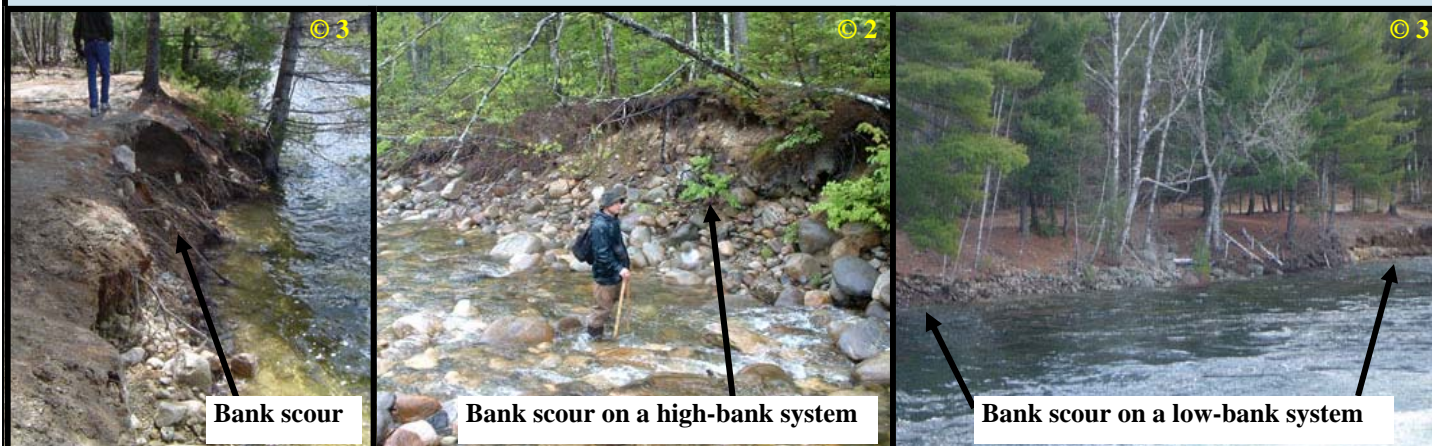
**7. Length of bank scour >50% through subject reach**—Is there evidence of active erosion or bank slumping along more than half of the reach?

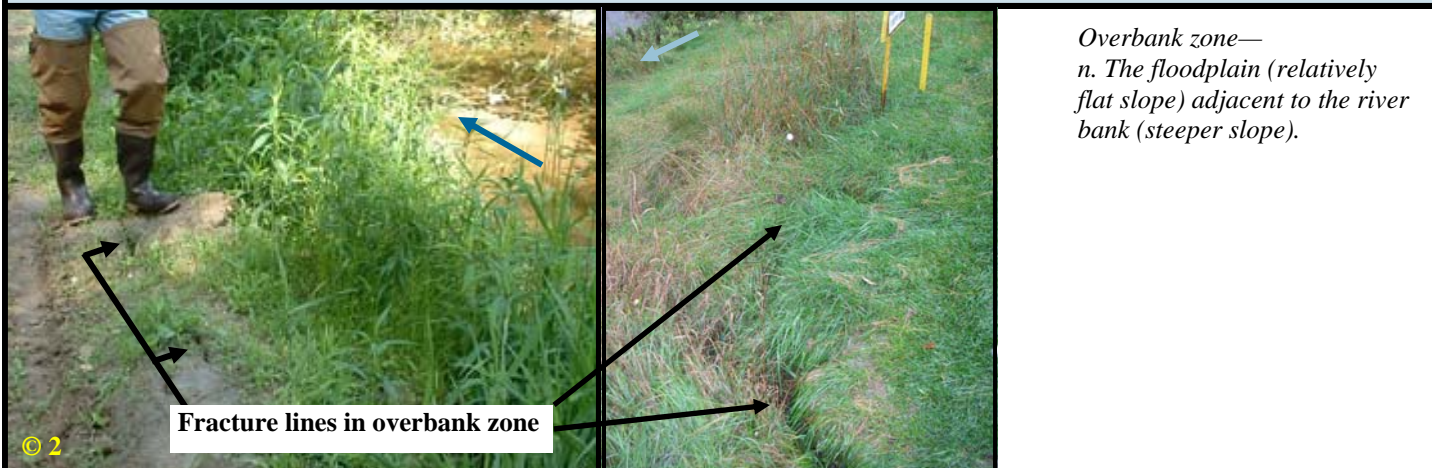
**8. Fracture lines along top of bank**—Are there cracks or visible lines parallel to the channel in the overbank zone?
