## WATERSHED BASED PLAN FOR THE BEAVER CREEK WATERSHED, WEST VIRGINIA

Prepared by:

Friends of Blackwater  
571 Douglas Road || Thomas, WV 26292  
(304) 345-7663 || [info@saveblackwater.org](mailto:info@saveblackwater.org)

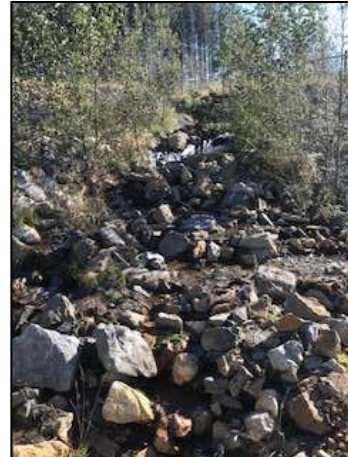
Total Iron = 8.81 mg/L  
 Dissolved Iron = 8.08 mg/L  
 Dissolved Aluminum = 4.32 mg/L  
 pH = 2.90  
 Flow = 105.80 gpm  
 System Components: Open Limestone Channel  
                               Limestone Leachbed  
                               Settling Pond  
 Total Cost: \$106,000

Description: Seep 100-2 receives diffuse AMD along nearly its entire length, is highly acidic, and contains moderate levels of iron and aluminum (and manganese). Project work areas are limited to a small open area located approximately 250 yards south of the highway where an access road crosses the stream channel, and to the channel itself. The envisioned treatment system consists of 1000 feet of open limestone channel constructed upstream of the access road crossing, and a limestone leachbed and settling pond located at the opening.

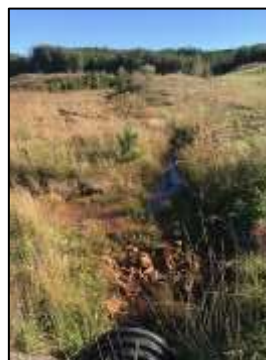
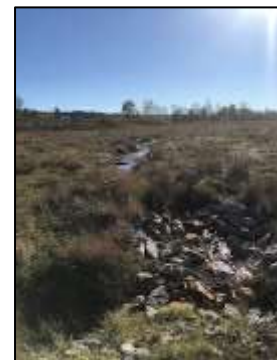
- Seep 100-3 & 100-4

Total Iron = 3.71 mg/L  
 Dissolved Iron = 2.86 gm/L  
 Dissolved Aluminum = 3.41 mg/L  
 pH = 4.21  
 Flow = 196.57 gpm  
 System Components: Limestone Leachbed  
                               Settling Pond  
 Total Cost: \$188,000 – \$234,000

Description: Given that these seeps are within 100 yards of each other at the point where they flow under the railroad grade, it is possible to treat both sources with a single treatment system. Space is highly limited due to the close proximity of Beaver Creek, the abundance of wetlands and the lack of elevation. As a result, a 0.65 acre limestone leachbed system set within the footprint of the existing railroad bed and discharging into a settling pond is proposed. In may be

necessary to discharge into an aerobic wetland rather than settling pond depending on wetland mitigation requirements, which would drive costs up.

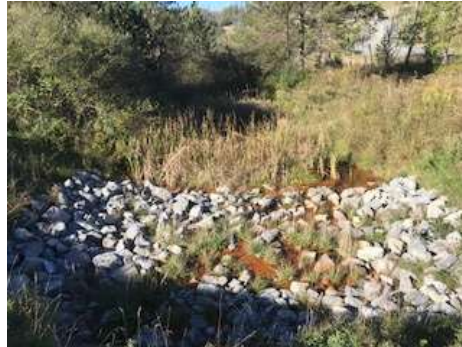
Total Iron = 1.84 mg/L  
Dissolved Iron = 1.44 mg/L  
Dissolved Aluminum = Below Detection Limit  
pH = 6.17  
Flow = 231.83 gpm  
System Components: Aerobic Wetland  
Total Cost: \$68,000

Description: A pair of constructed wetlands are already in place at this seep. An additional aerobic wetland covering 1.19 acres is needed to remove the remaining metals and acidity with sufficient space available between the in-place wetlands and Beaver Creek.

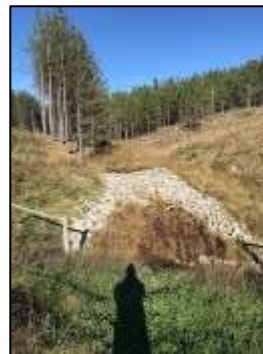
- Seep DOM-1`

Total Iron = 0.80 mg/L  
Dissolved Iron = 0.78 mg/L  
Dissolved Aluminum = 3.52 mg/L  
pH = 3.36  
Flow = 160.71 gpm  
System Components: Anoxic Limestone Drain  
Aerobic Wetland  
Total Cost: \$33,000 - \$72,000

Description: Containing low metals concentrations and moderately acidic, the limiting factor in treatment of this seep is the terrain and available land area with the only space available lying between the highway and an upstream wetland complex. A 0.09 acre RAPS discharging into a 0.33 acre aerobic wetland is proposed, although it may be permissible to discharge from the RAPS directly into the culvert underlying the highway due to the presence of a large constructed wetland on the opposite side which would save roughly \$35,000.
