PENDLETON CREEK STRIP AML PROJECT

Thomas, Tucker County, WV

Introduction

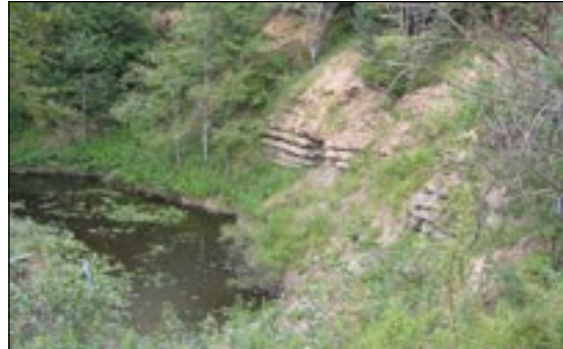
Highwall and dangerous impoundment.

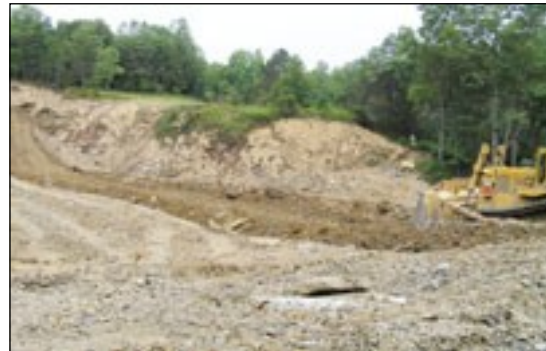
Regrading work.

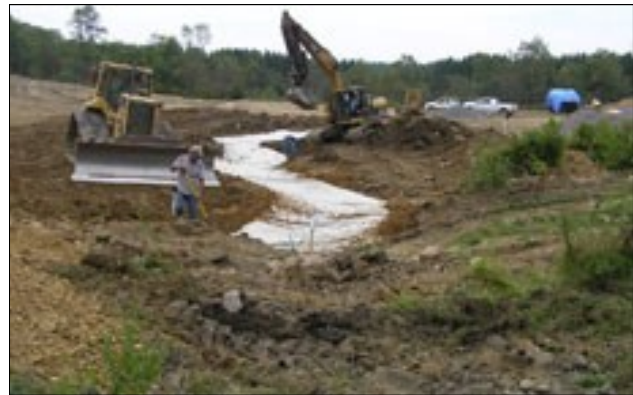
Backfilling anchor trenches for liner.

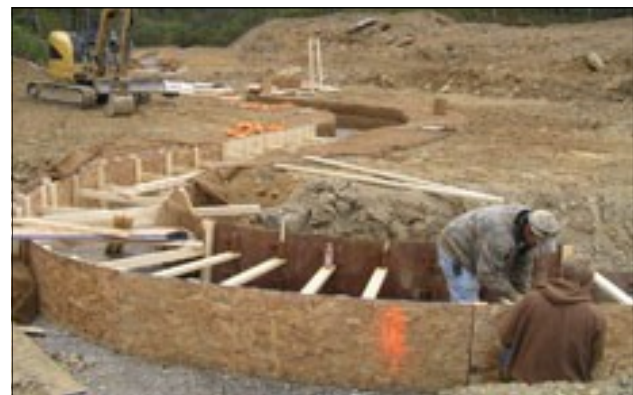
Constructing flexible forms.

custom forms using wood, steel and building foam to better meet their needs. These forms had to be built in place, utilized for the section of stream being worked on, then partially dismantled and rebuilt downstream to match the next section of channel to be constructed. In addition to the large amount of hand labor required, the numerous bends necessitated some smaller equipment for material placement and compaction.

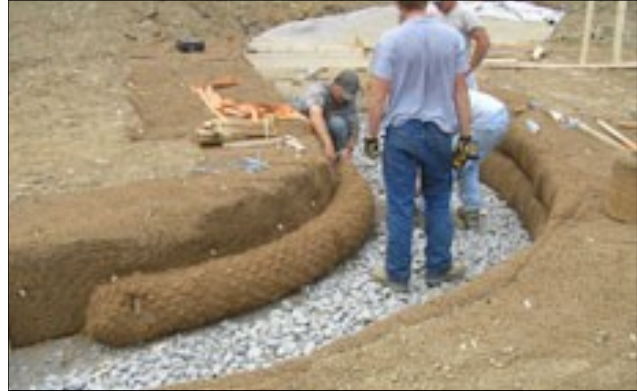
Installing coir logs for point bars on inside bends.

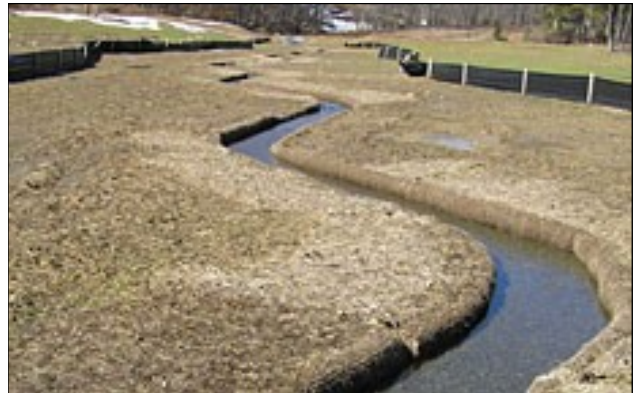
Relocated stream No. 2 in winter after completion.

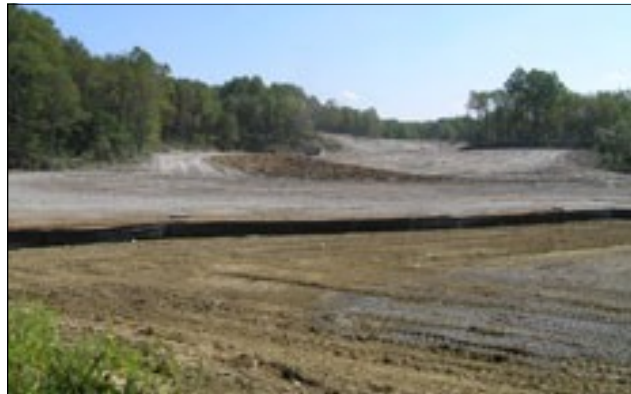
Regrading and liming complete.

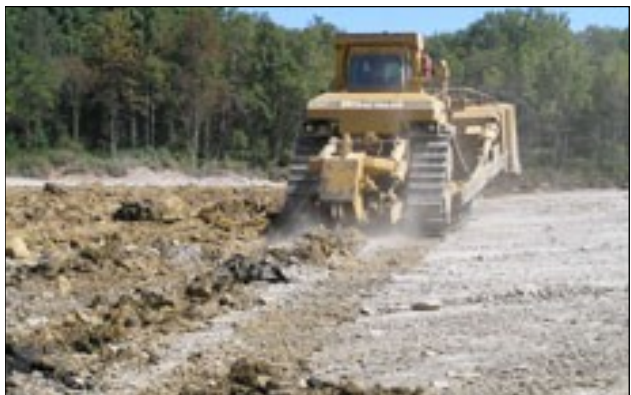
Dozer dragging ripper tooth to loosen soil.

Due to the length of time that had elapsed since the surface mining operation took place, the spoil ridges had reforested naturally. Because disturbing these ridges was necessary to properly backfill the capture areas and regrade the site to provide for positive drainage, 10 acres of reforestation was included in this project. The landowner for this project site is Western Pocahontas Properties. The company maintain a full time forester to manage the thousands of acres of land holdings in West Virginia. This individual is very tree-oriented and partnered with the West Virginia DEP for the inclusion of the Forestry Reclamation Approach in the revegetation of this project. The planting plan incorporated the five steps of the Forestry Reclamation Approach: proper growth medium, non-compacted grading, native and non-competitive ground cover, tree species selection, and planting technique. In order to loosen the top 4 or 5 feet of ground for planting the tree seedlings, a bulldozer dragged a ripper tooth through the regraded areas along the contours of the slopes. This bulldozer was careful to overlap its tracks to avoid re-compacting the loosened material. The ground where the tracks ran may have been further loosened during the following winter by the retention of water and the freeze-thaw cycle.

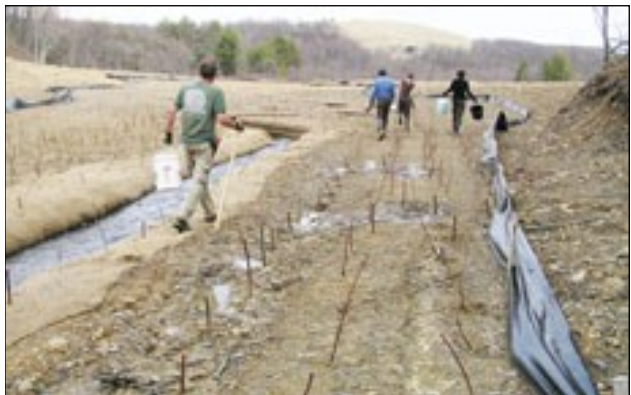
Live branch cuttings planted in stream channel riparian zones.

were planted with 22,400 locally harvested live branch cuttings. Local harvesting of the woody plant material for the riparian zones began at the same time as tree seedling planting. The species placed in the riparian zones were Willow, Dogwood, Arrowwood and Aspen. Although the planting techniques and wet weather in 2011 greatly enhanced root development, heavy deer browsing was detrimental to the trees and branch plantings later in the year.

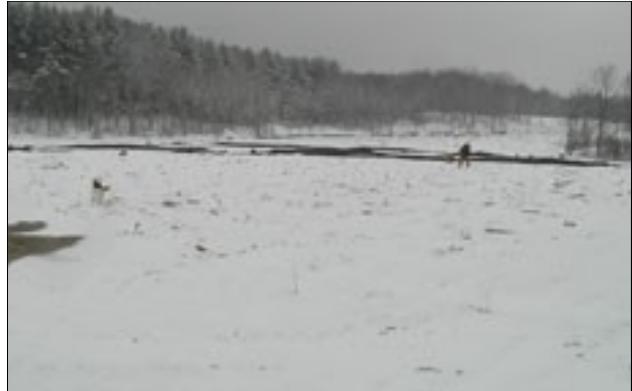
Tree planting in April.

While the regrading and stream channel construction were completed during a dry fall, tree planting had to be scheduled for the following spring. Tree seedling planting began on March 31 in a light rain. A late snowstorm on April 1 kept the seedlings dormant and moist. Tree species included Red Spruce, White Pine, Red Oak, White Oak, Black Cherry, Tulip Poplar, Red Maple, American Chestnut, Common Serviceberry, Speckled Alder, Quaking Aspen, Mountain Holly and Mountain Ash. A total of 11,400 trees were planted on this project. Additionally, the riparian zones along the restored stream channels

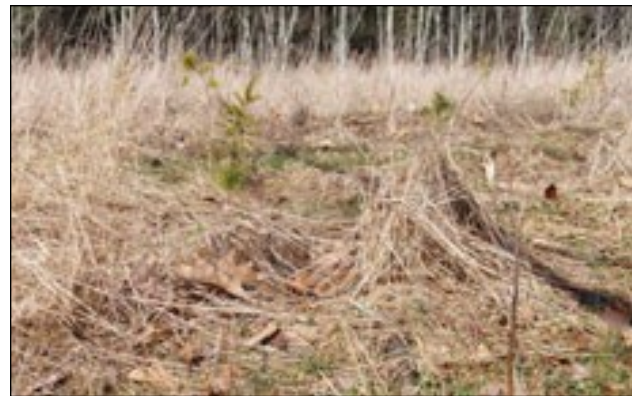
White Pine, Red Spruce and mixed hardwoods.

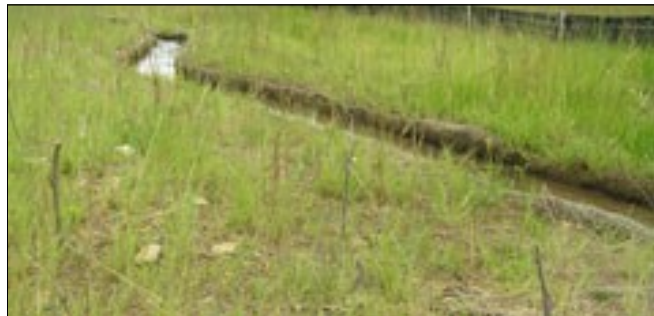
Riparian branch plantings.
