**CONSENT ORDER  
ISSUED UNDER THE  
WATER POLLUTION CONTROL ACT  
WEST VIRGINIA CODE, CHAPTER 22, ARTICLE 11**

TO: Arsenal Resources LLC  
6031 Wallace Rd. Ext Suite 300  
Wexford PA 15090

DATE: October 8, 2020

ORDER NO.: 9923

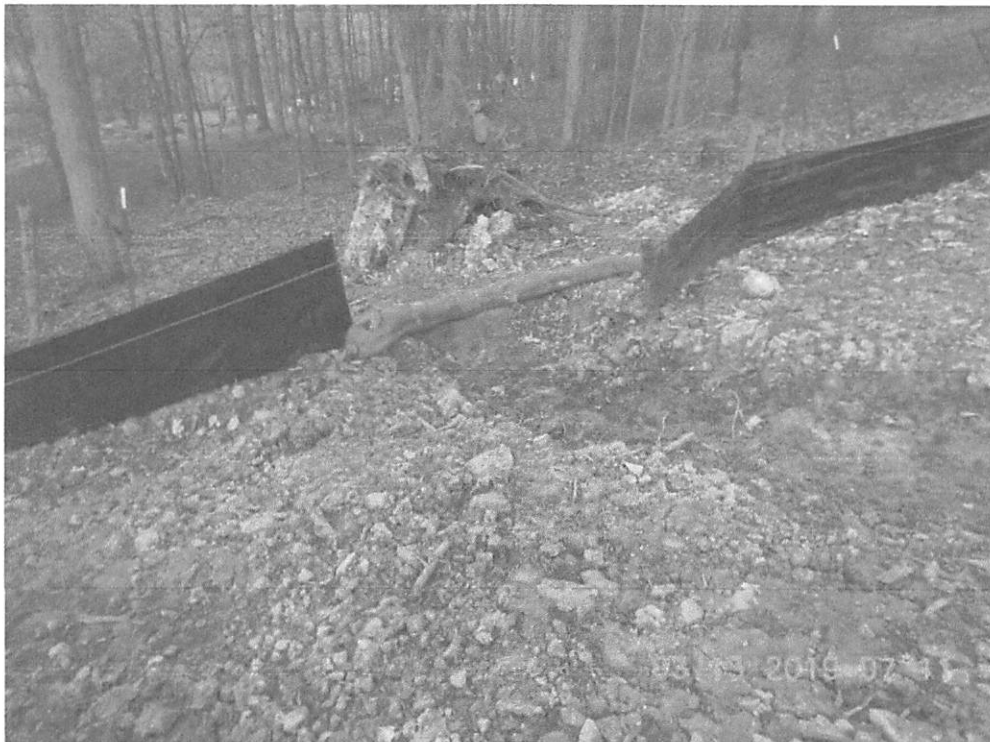
Stat. 218+00, Failure to implement water bar terminus treatment as detailed on page ENV D12 of the SWPPP.

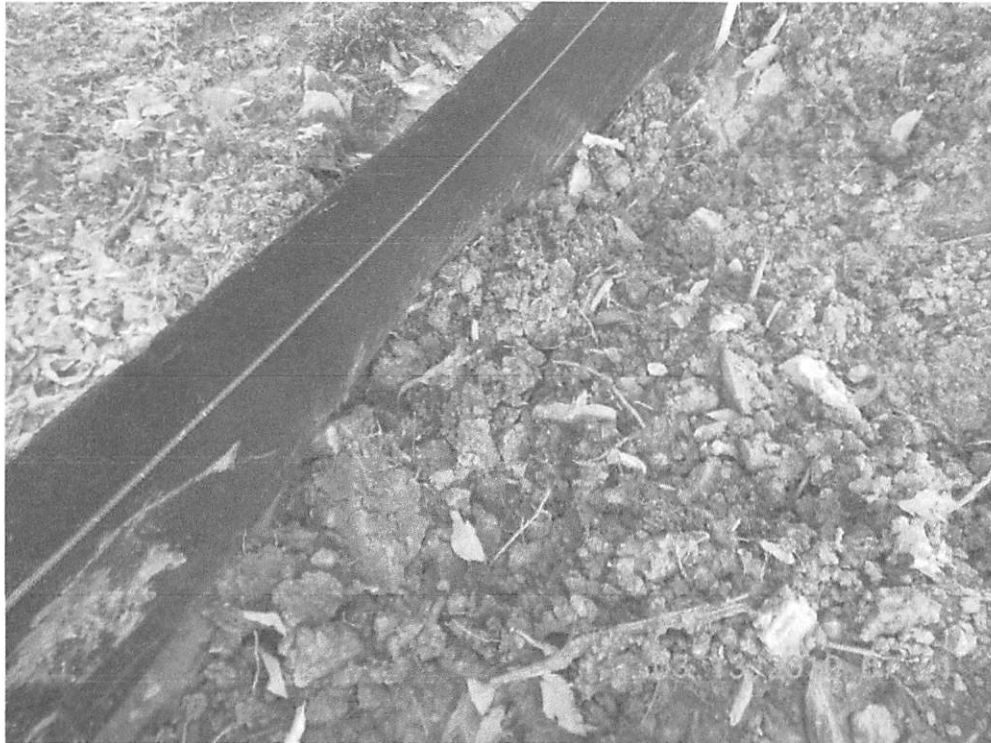
Stat. 213+75, Perimeter controls throughout site were nonfunctional due to bypasses. SSF not tied together with SF, creating a bypass.

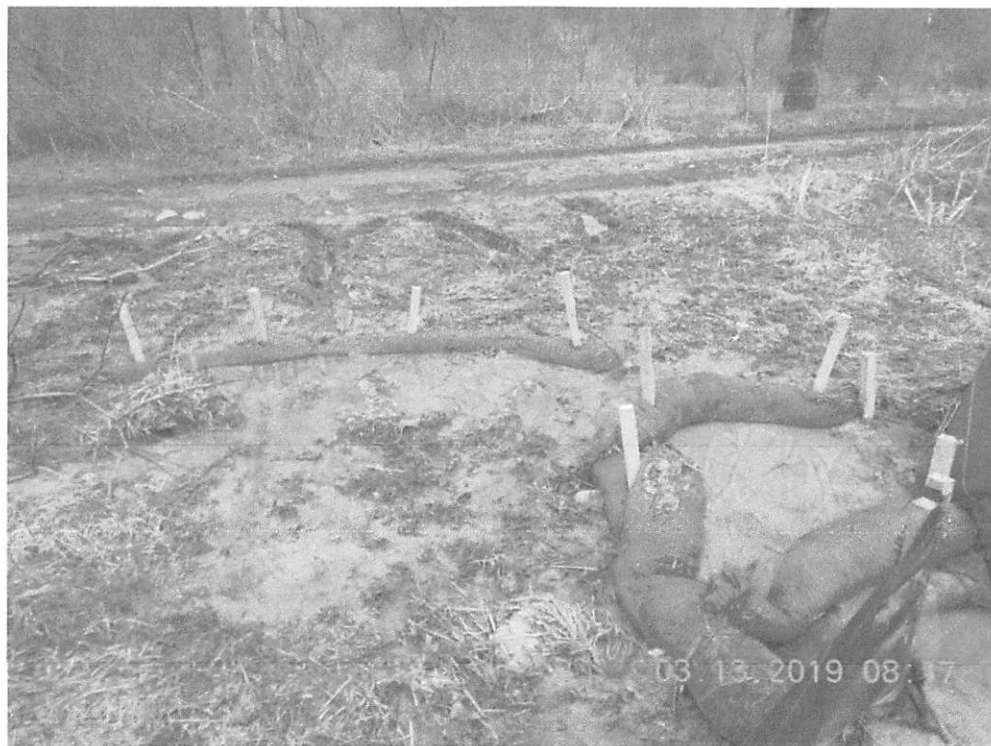
Stat. 175+00, CFS was not conjoined with SF correctly, creating a bypass.

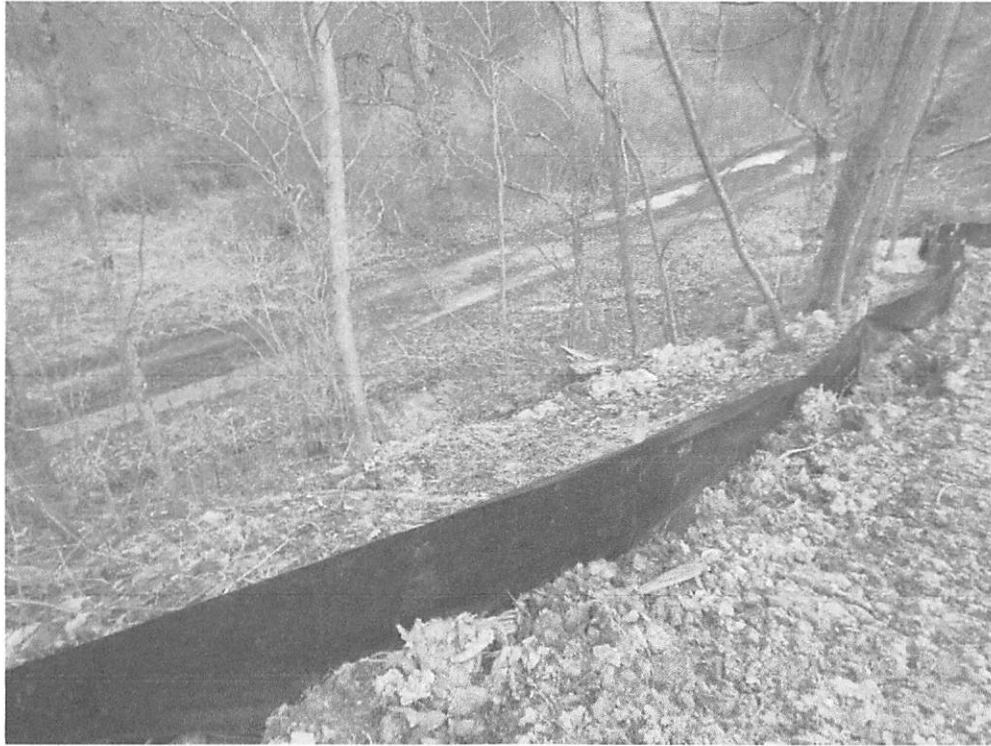
Stat. 175+00, CFS was not conjoined with SF correctly, creating a bypass.

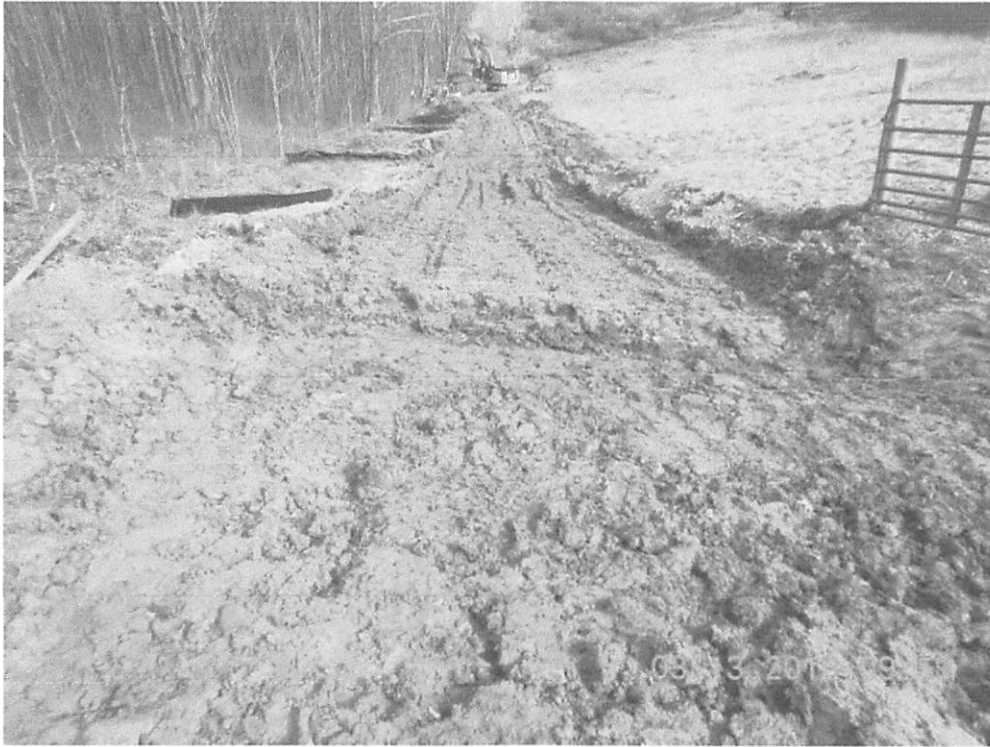
Stat. 147+75, Water bars were not installed as indicated in the SWPPP.

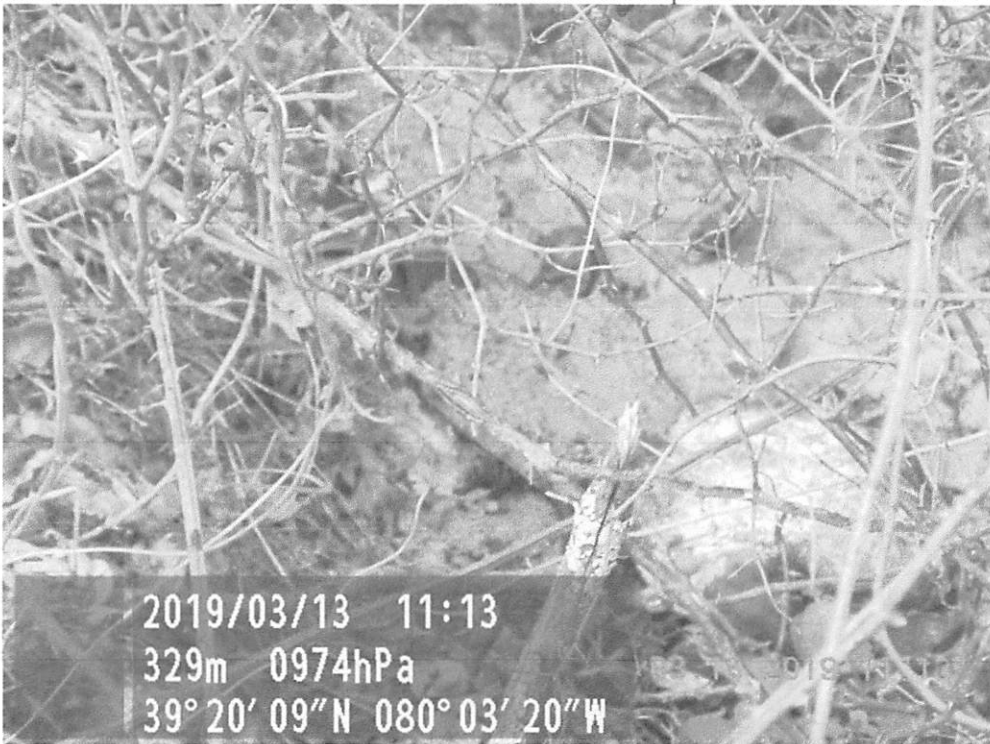
Failed to properly implement geo-wrap and perimeter controls on bridge at UNT 29, UNT of Otter Run, allowing sediment laden water to leave site and create sediment deposits on bottom of UNT of Otter Run.

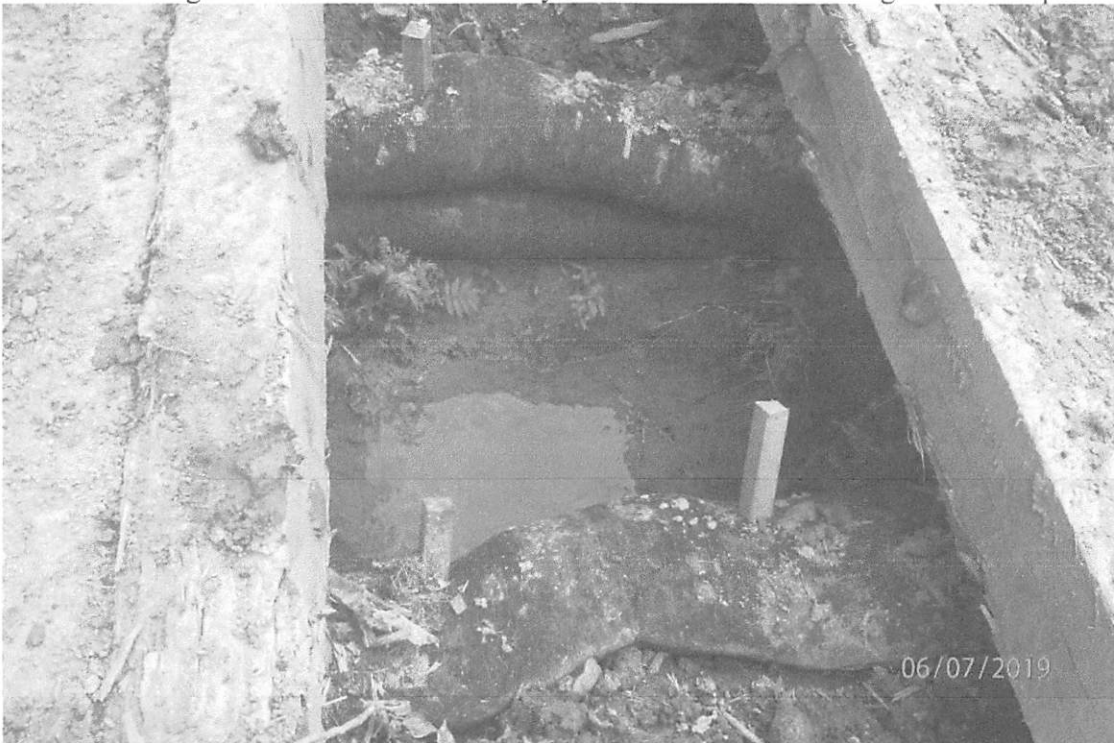
Timber mat crossing of UNT Beards Run conveyance of old CR 17 showing the lack of protection.

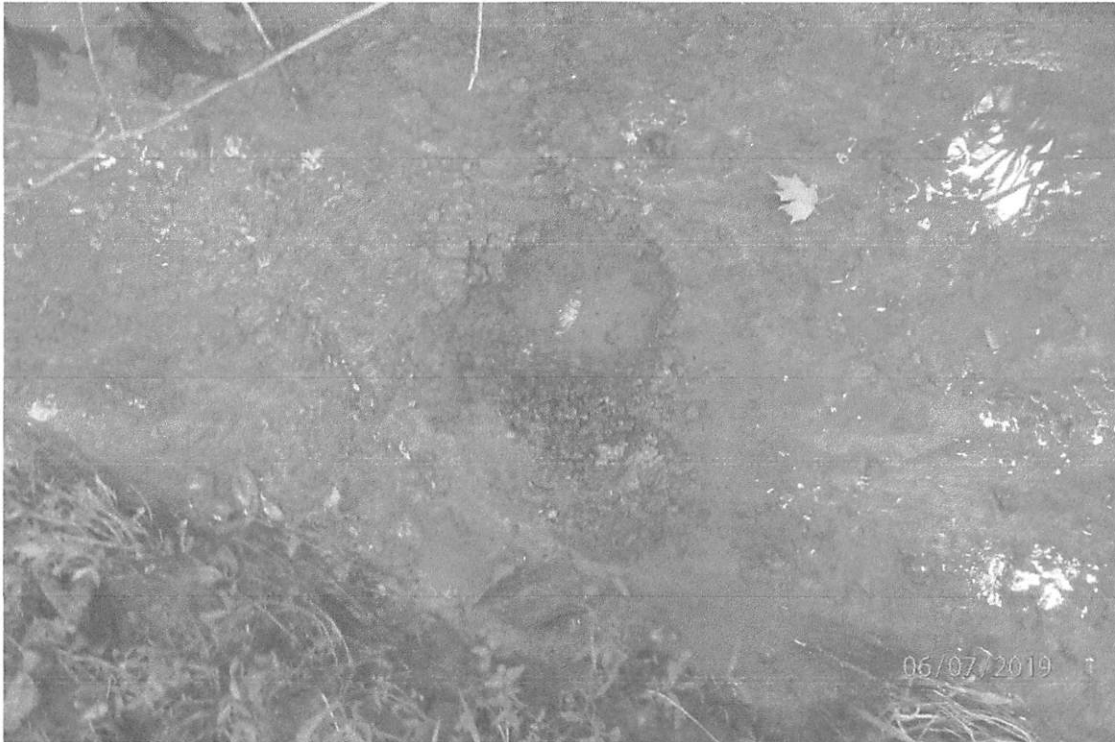
Offsite CNA deposits in UNT Beards Run conveyance (39° 15.023' X 80° 10.561').

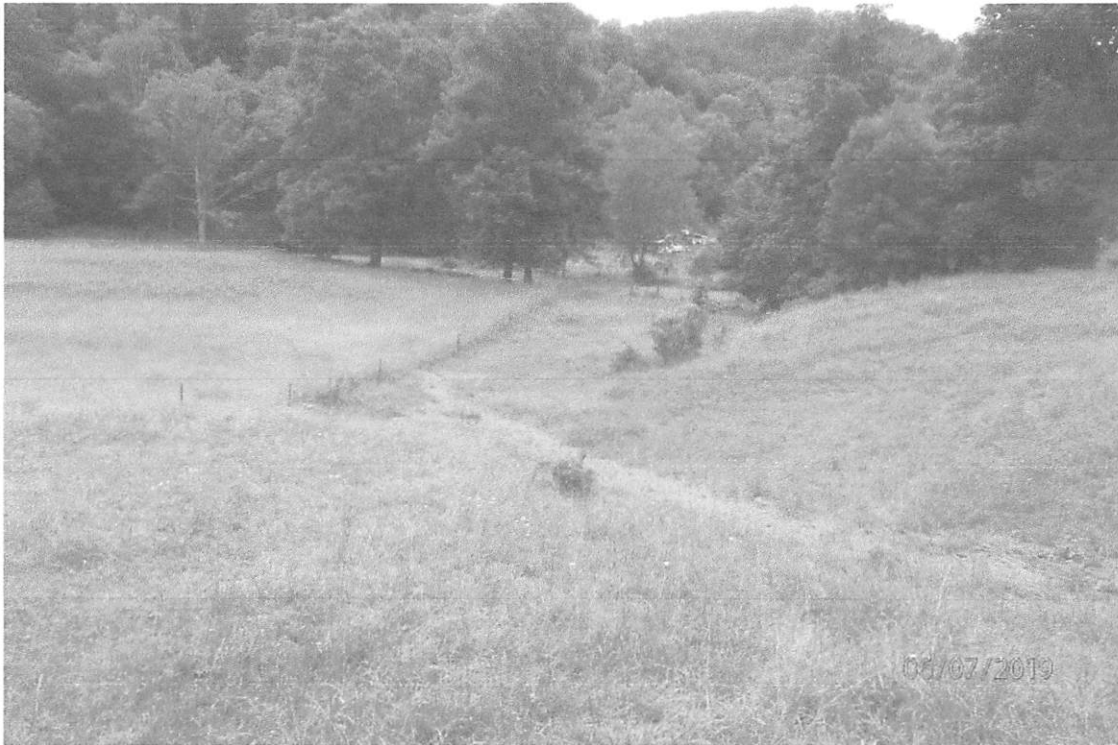
Unmaintained perimeter controls adjacent to 485+50.

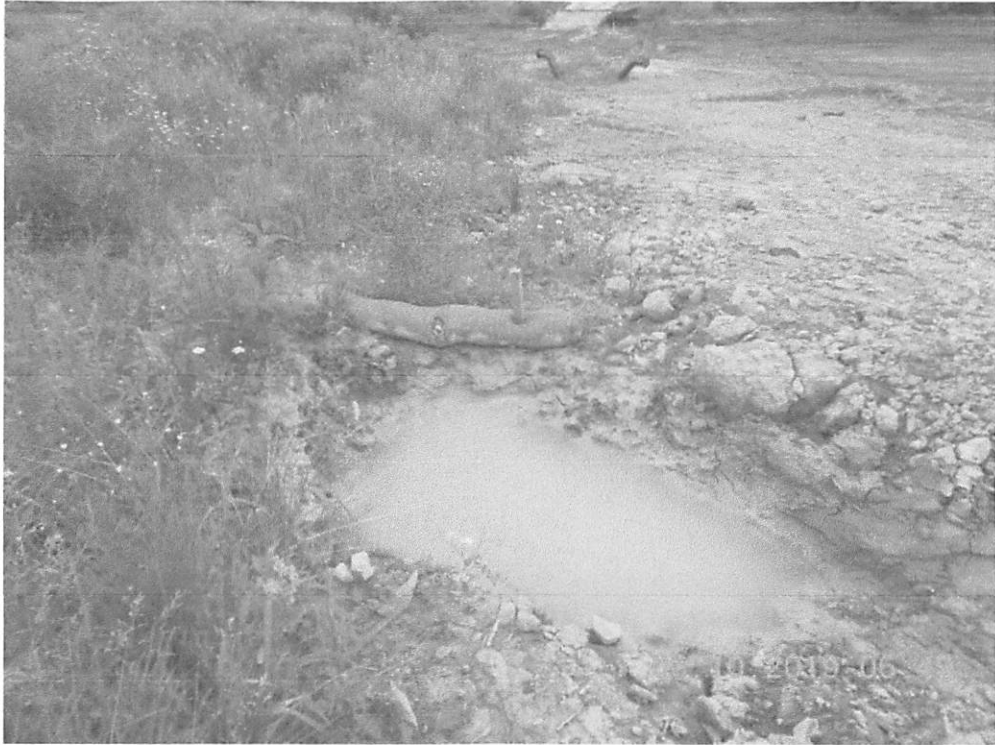
Stone that was placed in the stream by the site operator during the inspection at UNT Beards Run (39° 15.098' X 80° 10.735'). CNA deposits pictured upstream of the crossing.

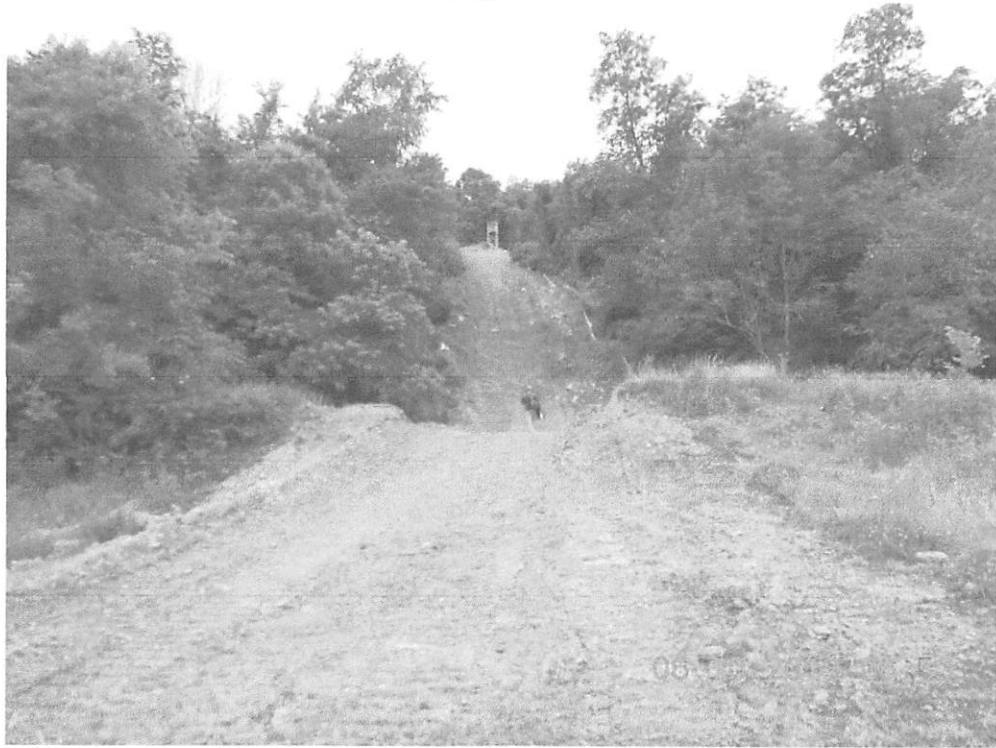
Bypass on water bar terminus treatment.

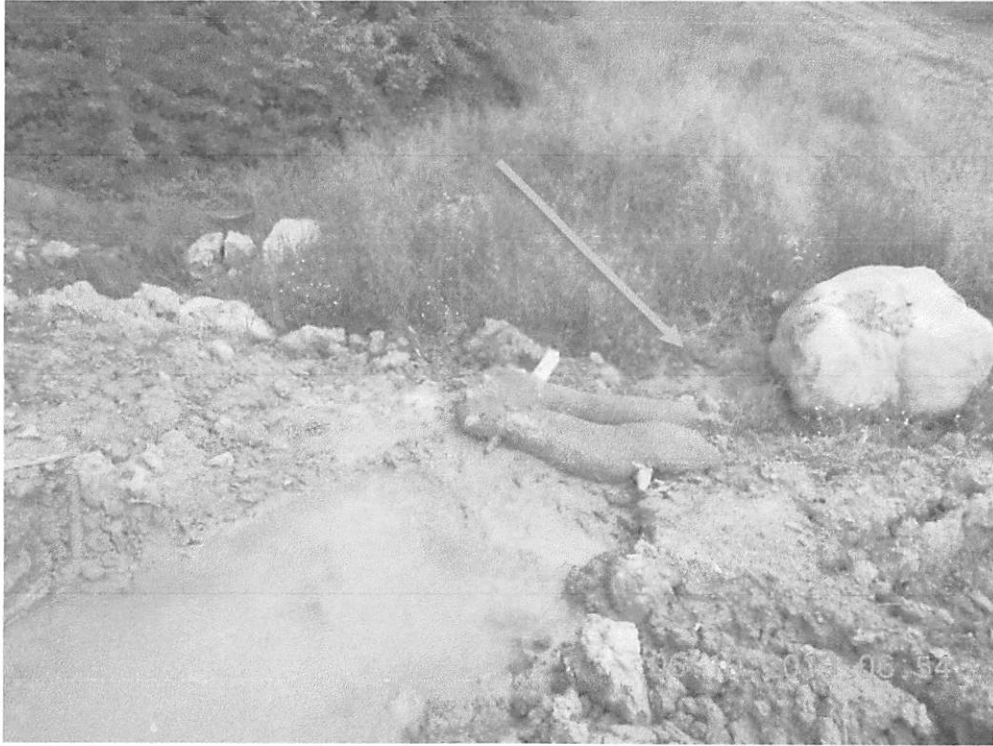
Station 193+00, P2 fence not functional.

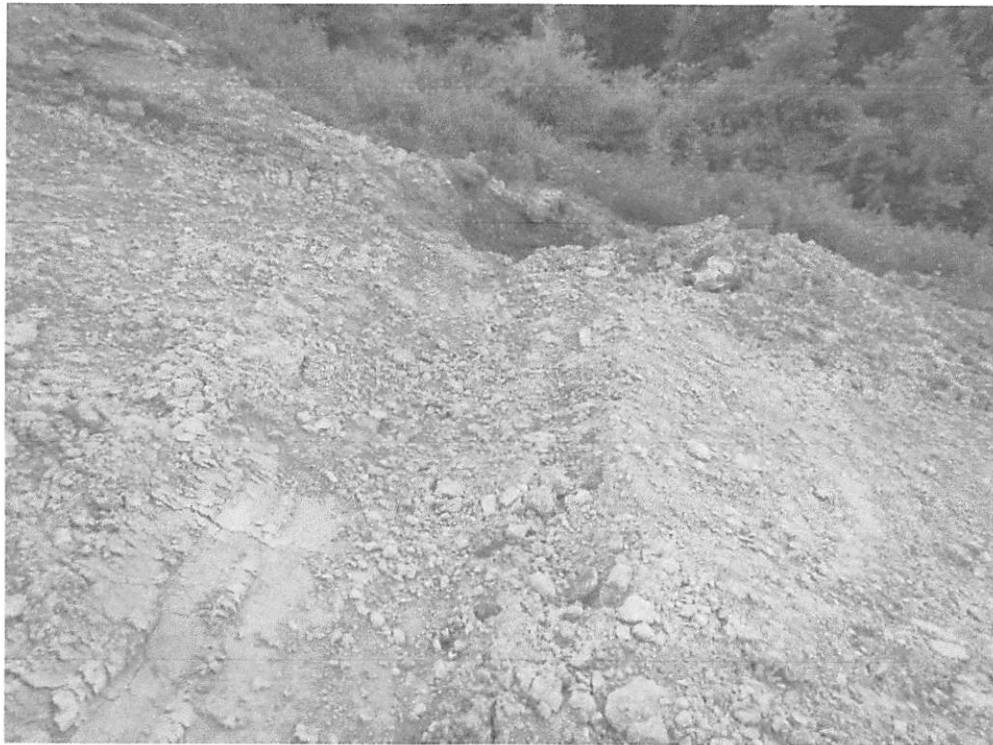
Station 192+00, Water bar terminus BMP not properly implemented, allowing sediment laden water to leave site.

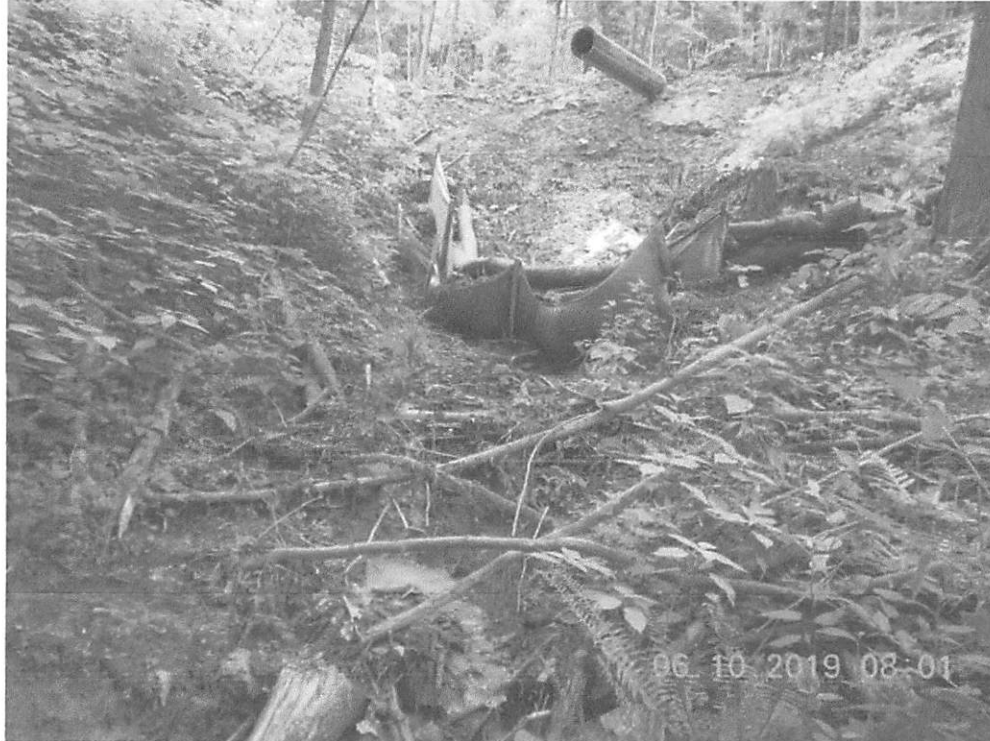
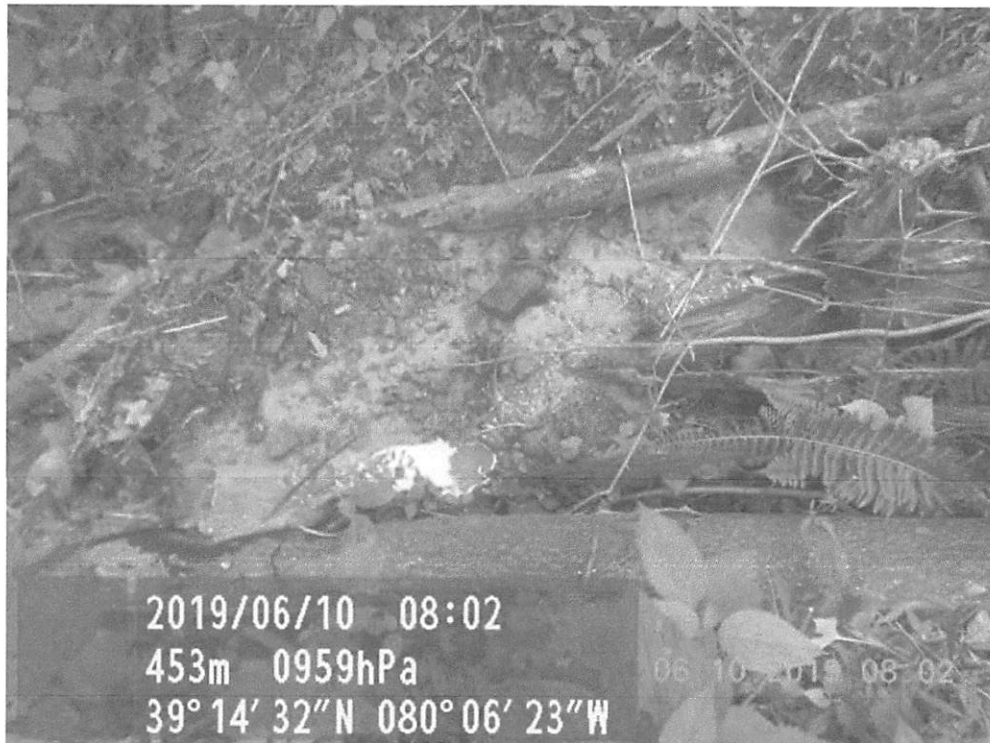
Tail of culvert around Station 211+00. Did not install an energy dissipater as detailed on Page ENV D10. Maintenance needed on perimeter controls.

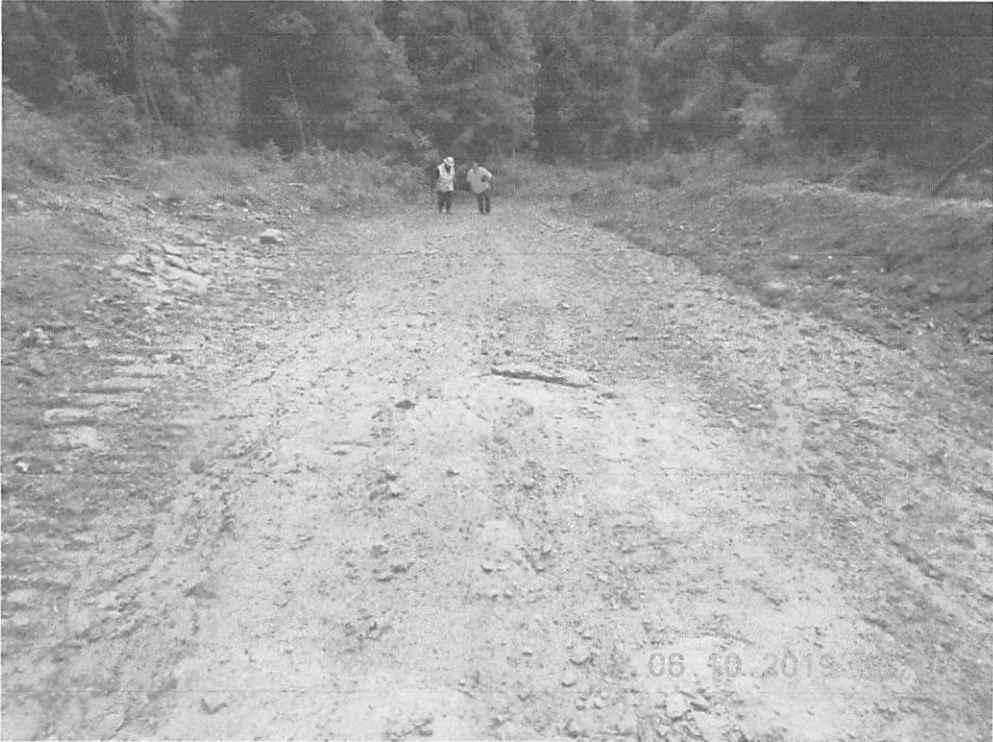
Water bar is ineffective, because water bypasses, resulting in erosion rills at the bottom of the slope.

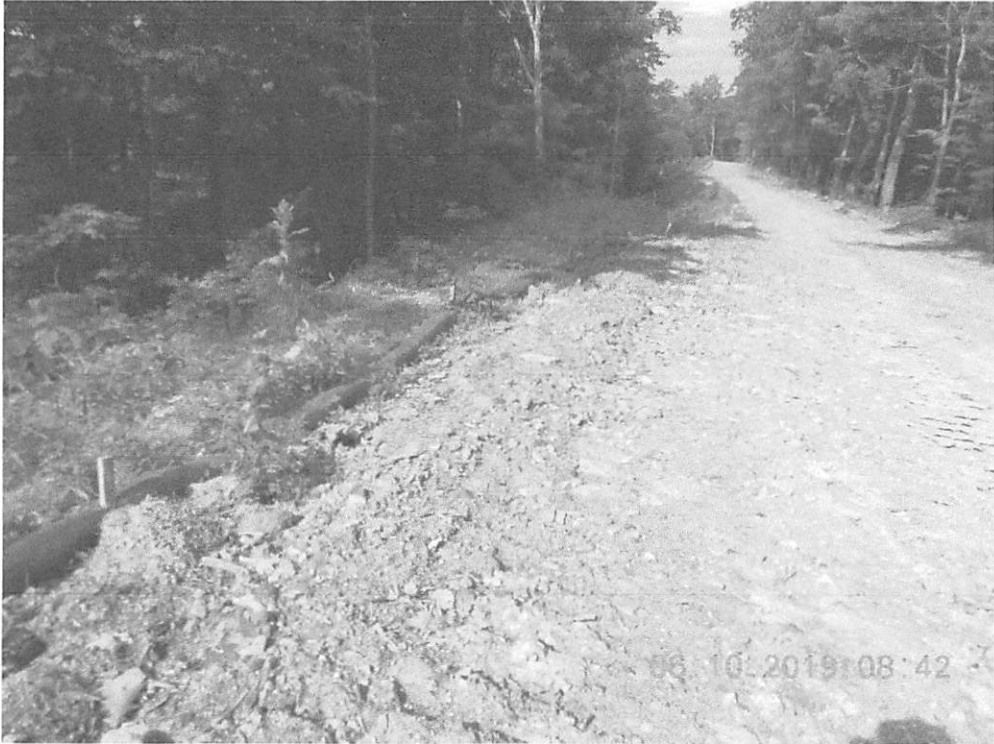
Station 223+00, bypass of terminus treatment. Maintenance needed on sump and perimeter controls.

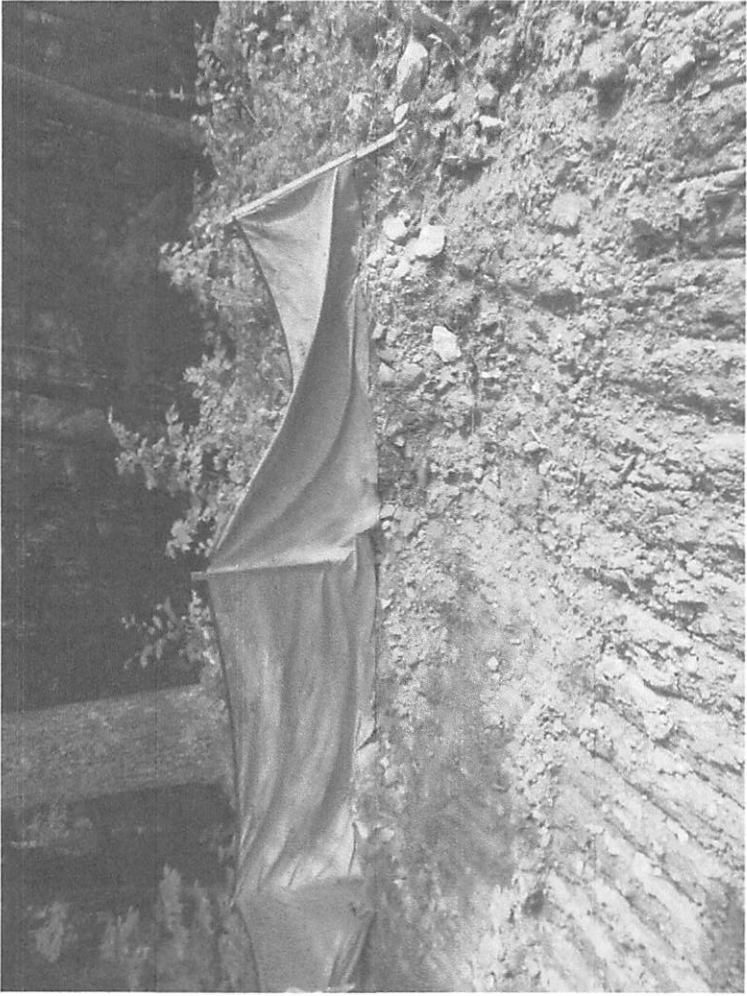
Bypasses in perimeter controls (Station 245+00).

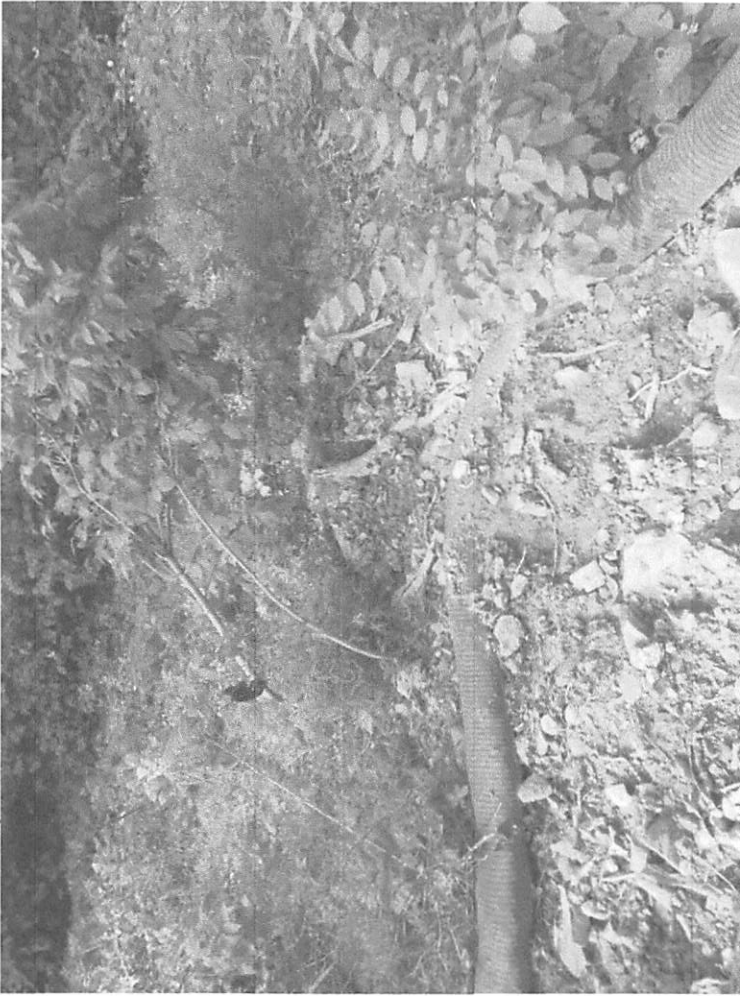
About Station 246+00, perimeter controls in disarray, holes in fabric, and SS2 not toed-in correctly.

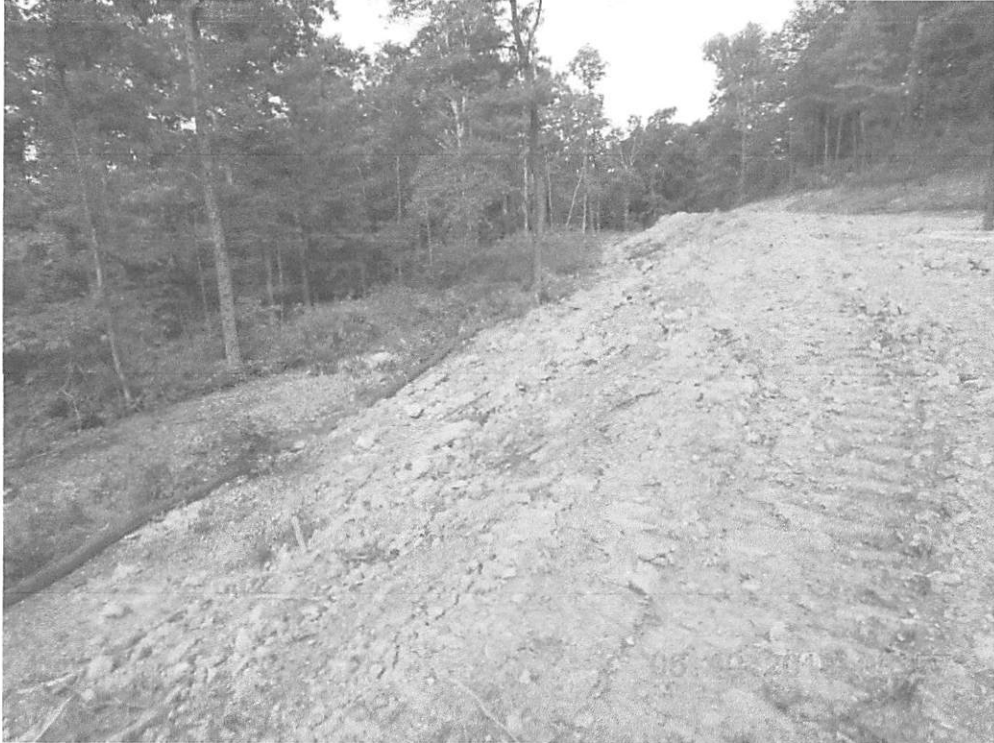
Station 251+00, Sediment laden water left limits of disturbance.

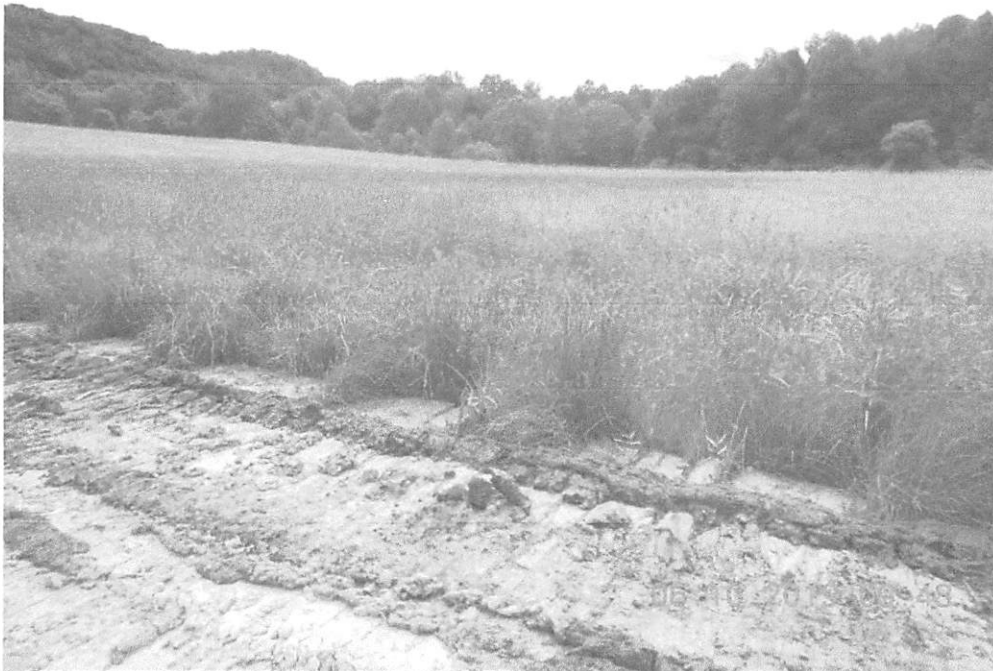
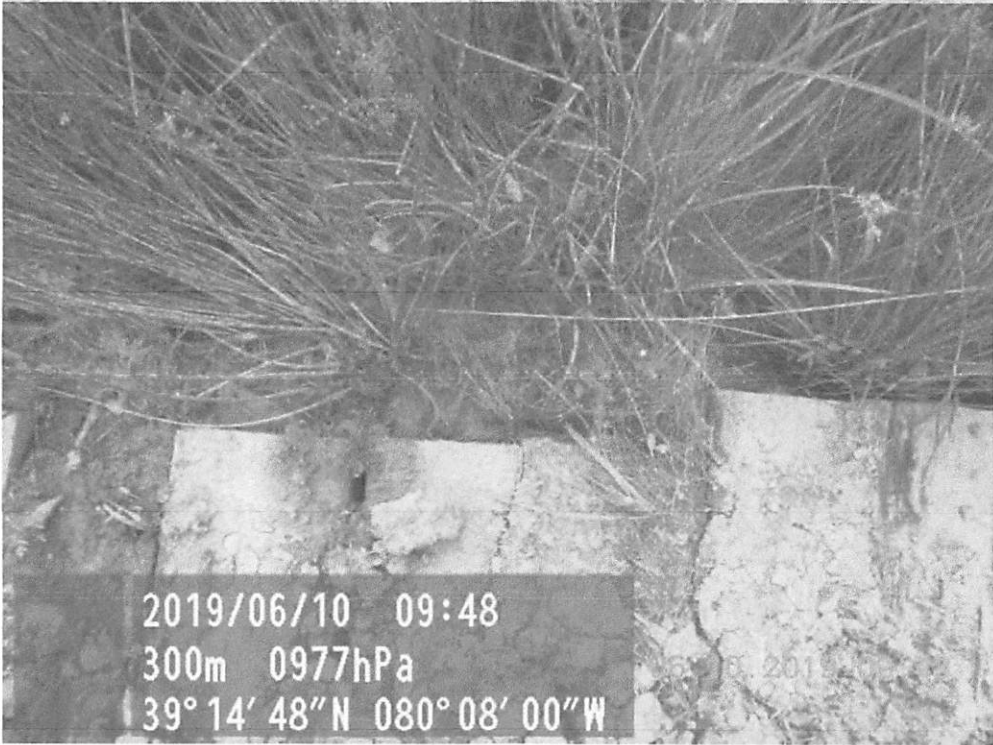
Sediment deposits in WL 9 (39° 14' 48'' N, 80° 08' 00'' W).

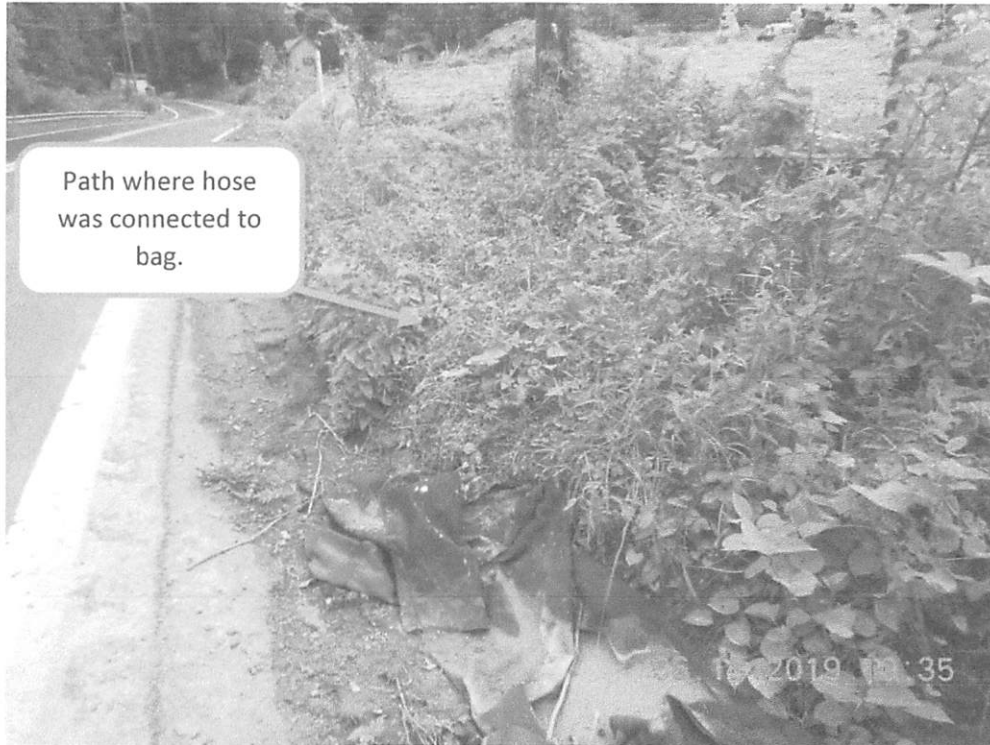
Path where hose was connected to bag.

Dewatering bag in Rt. 76 conveyance.

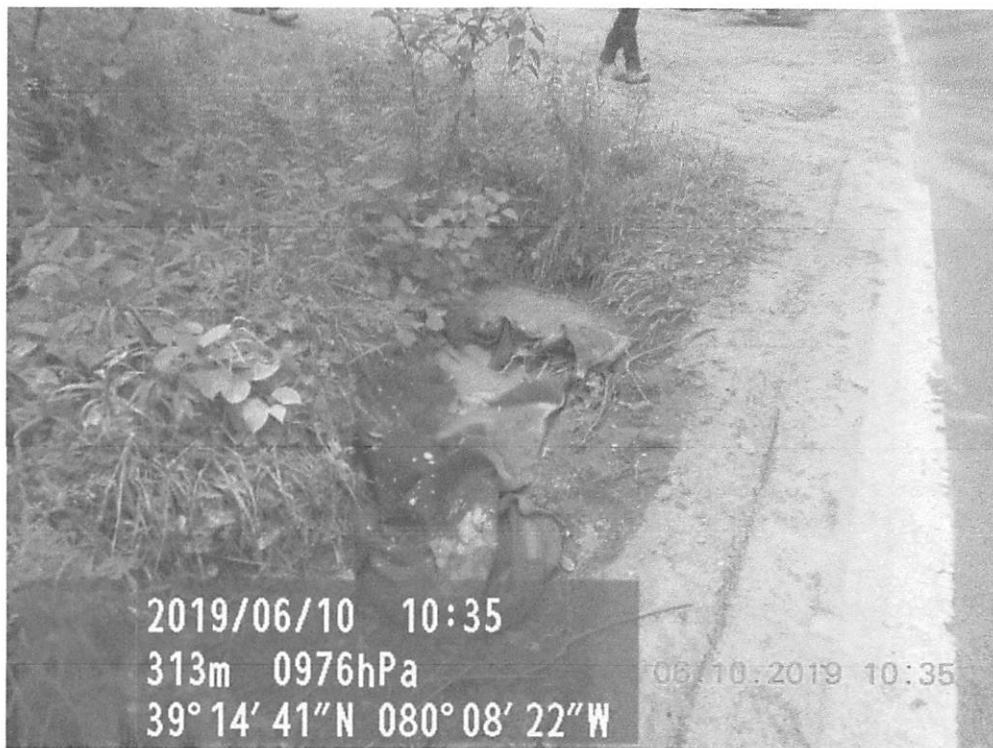
Sediment deposit on bottom of Rt. 76 conveyance.

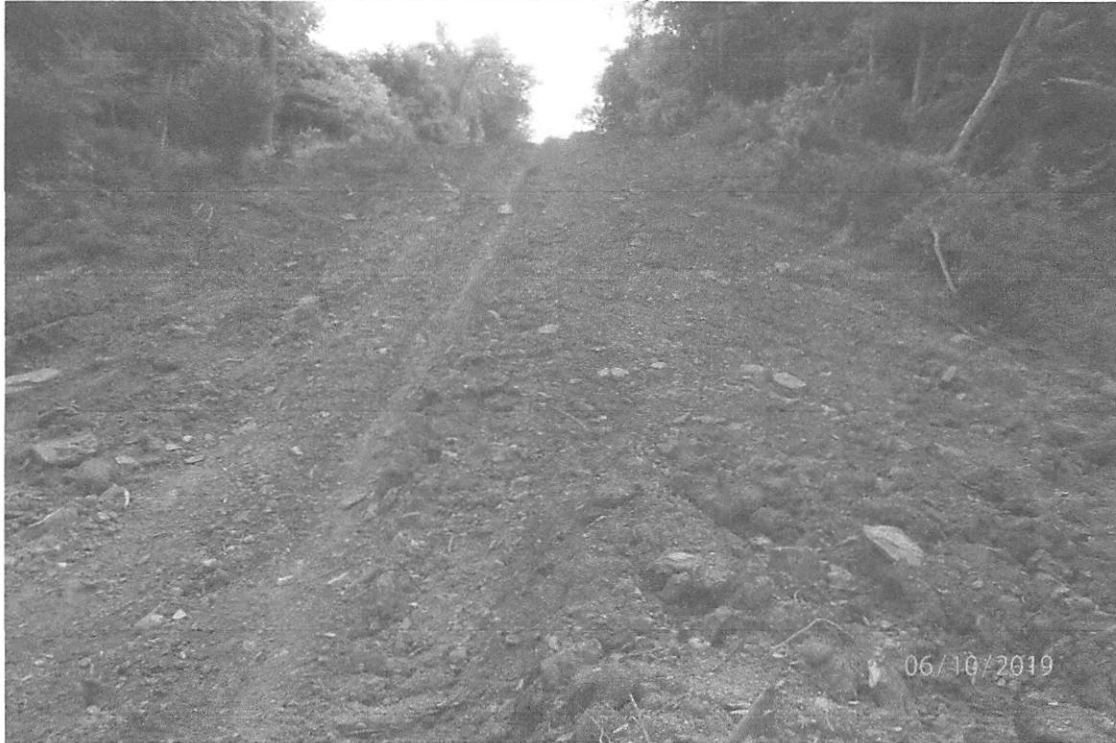
Project area upslope of 447+00 showing the lack of waterbars indicated in the approved SWPPP. The approved SWPPP indicates that 9 waterbars should be installed, but only 3 were in place.

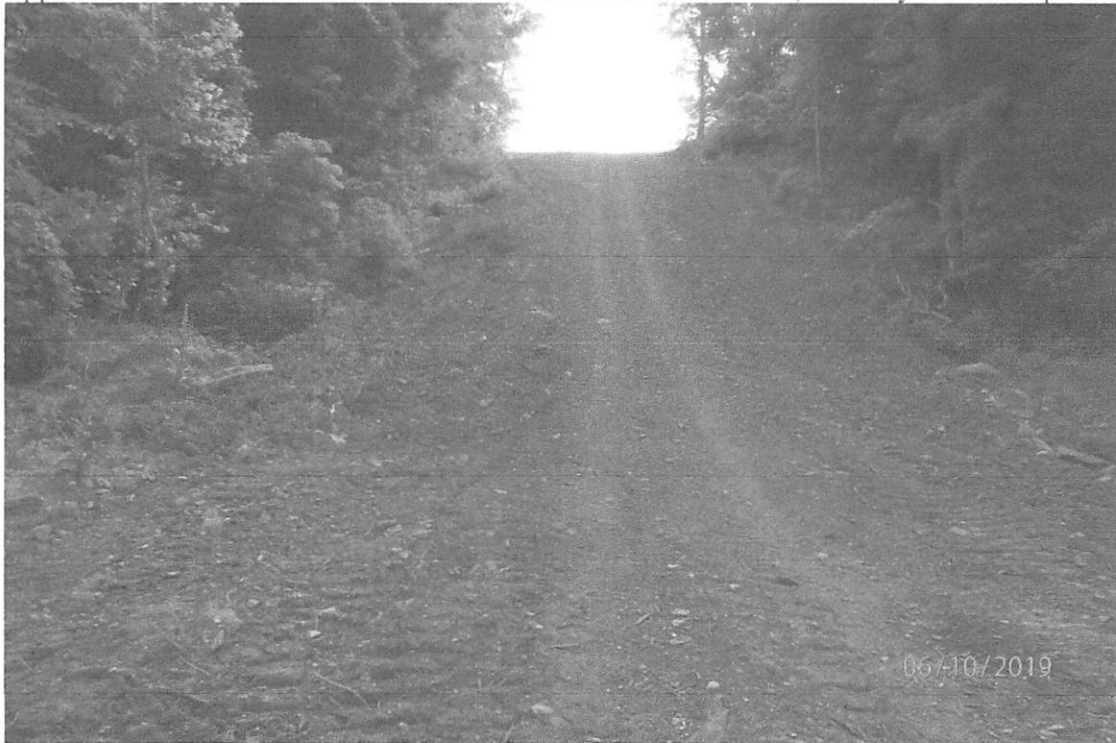
Project area upslope of 447+00 showing the lack of waterbars indicated in the approved SWPPP. The approved SWPPP indicates that 9 waterbars should be installed, but only 3 were in place.

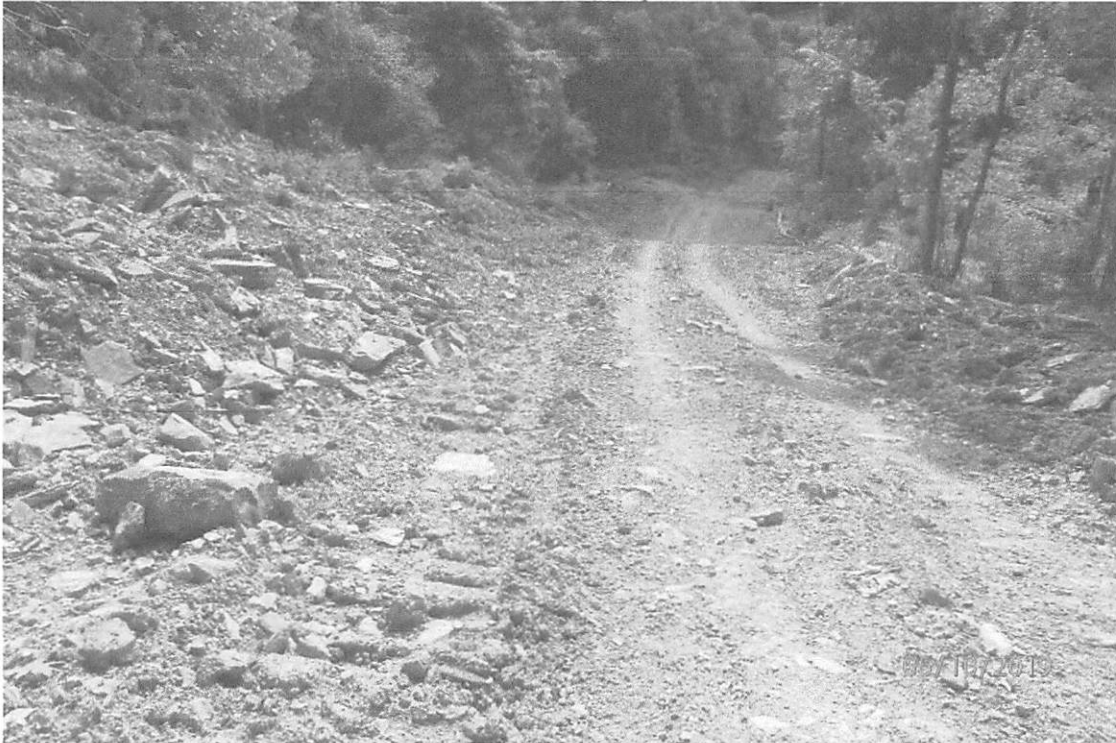
Project area upslope of 433+50 showing the lack of waterbars indicated in the approved SWPPP. The approved SWPPP indicates that 6 waterbars should be installed, but none were in place.

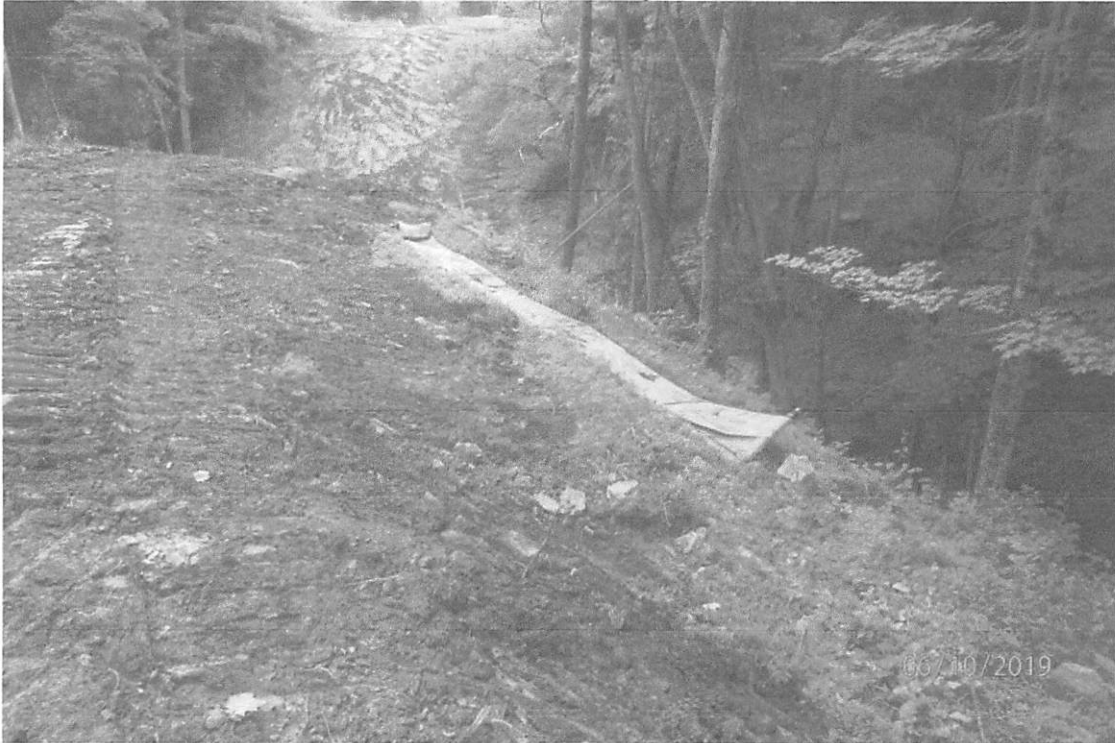
Perimeter control in need of maintenance in the Beards Run watershed.

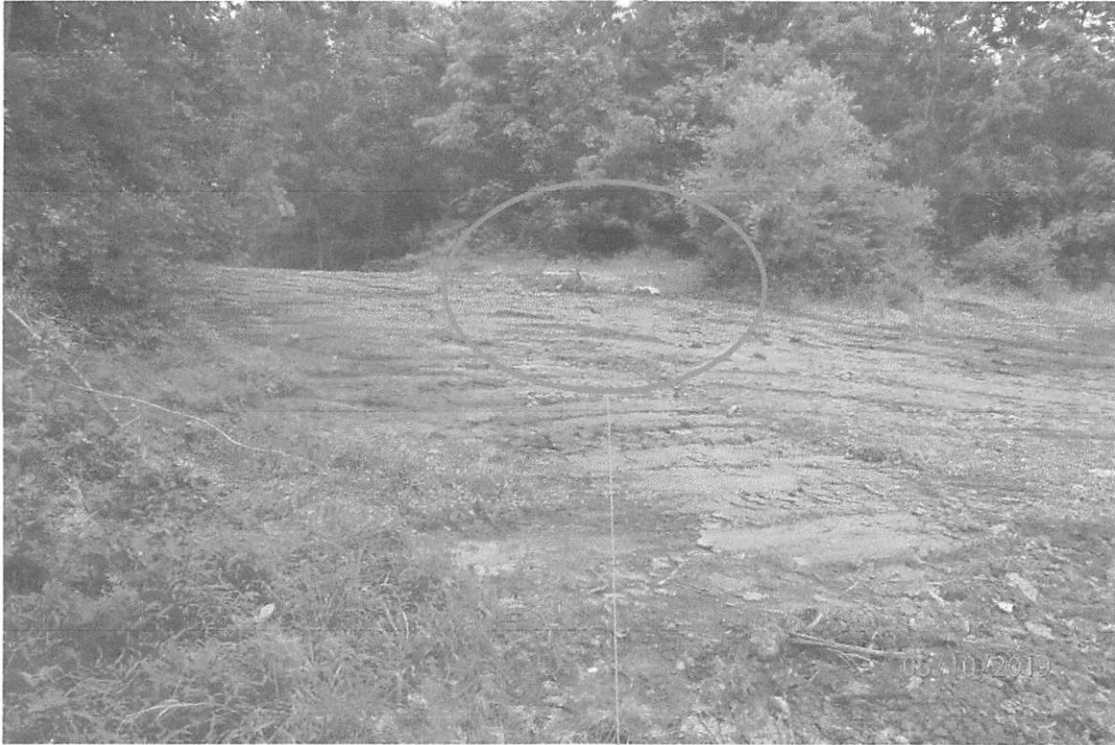
Perimeter control adjacent to WL-27 that is in need of maintenance.
