**CONSENT ORDER  
ISSUED UNDER THE  
WATER POLLUTION CONTROL ACT  
WEST VIRGINIA CODE, CHAPTER 22, ARTICLE 11**

TO: Arsenal Resources LLC  
6031 Wallace Rd. Ext Suite 300  
Wexford PA 15090

DATE: October 8, 2020

ORDER NO.: 9923

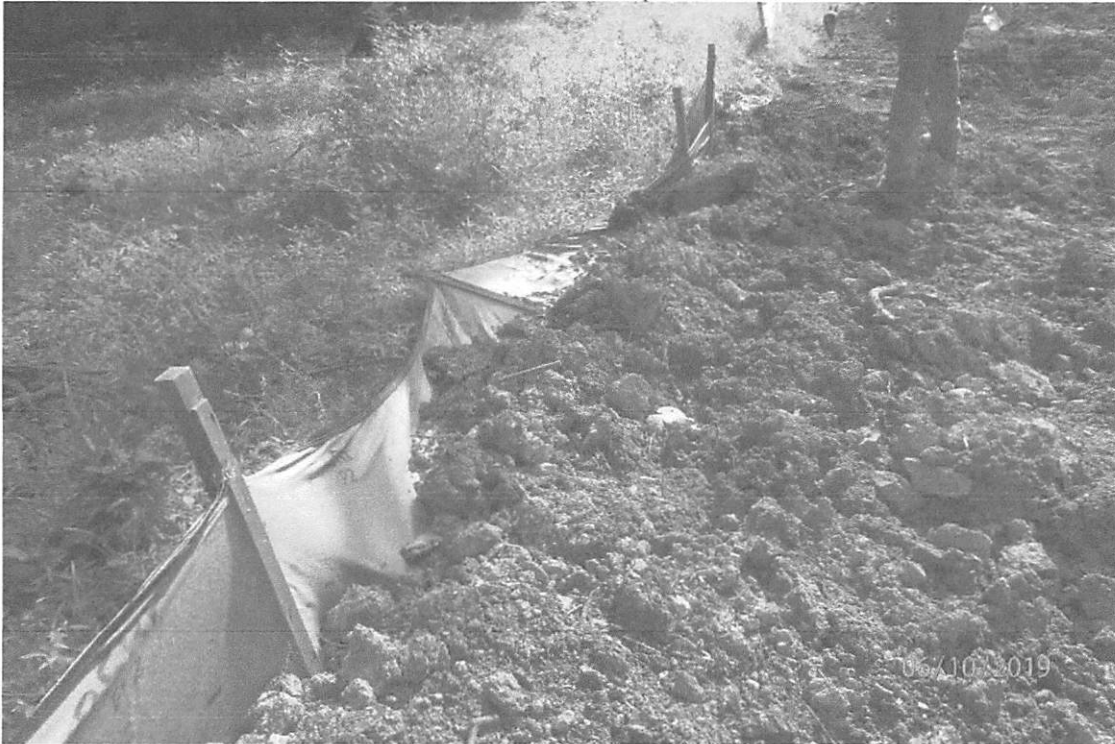
Perimeter control in need of maintenance in the Simpson Creek watershed.

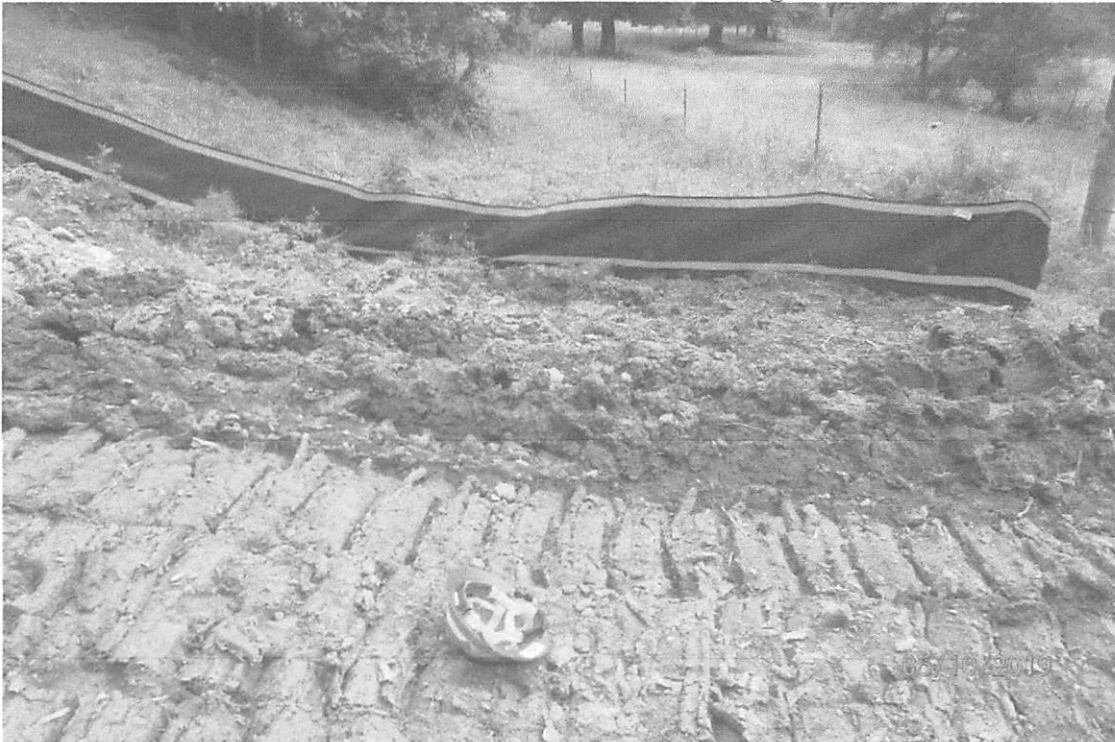
Project area downslope of the above pictured stream showing the installed perimeter controls at the time of inspection. There were no flumes, stabilized channels or temporary crossings indicated in the approved SWPPP in this area.

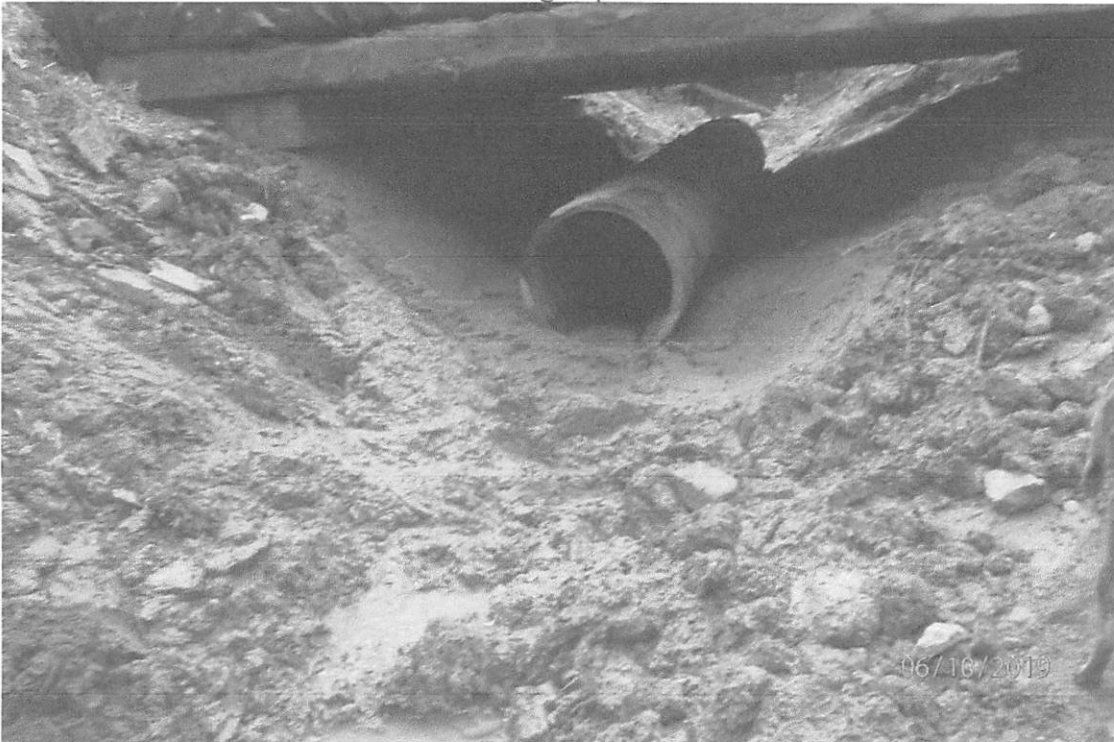
UNT 24 crossing showing the area where a stream crossing took place without the pump-around or flume crossing in place.

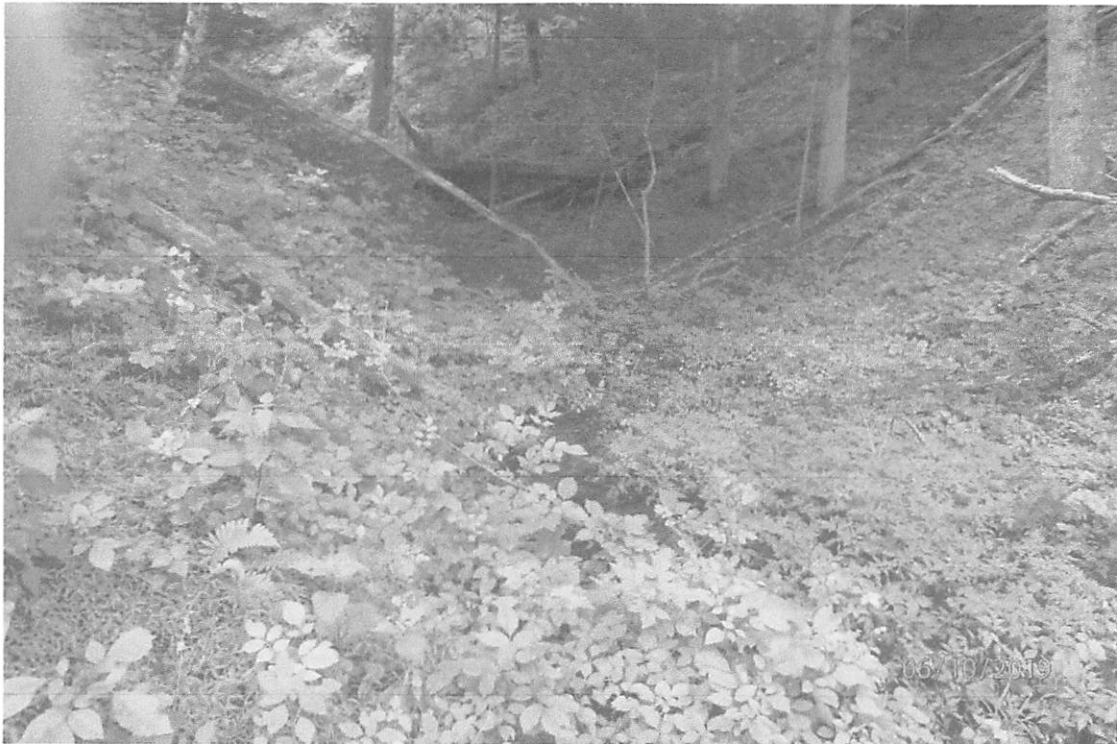
UNT Beards Run quality upstream of the project.

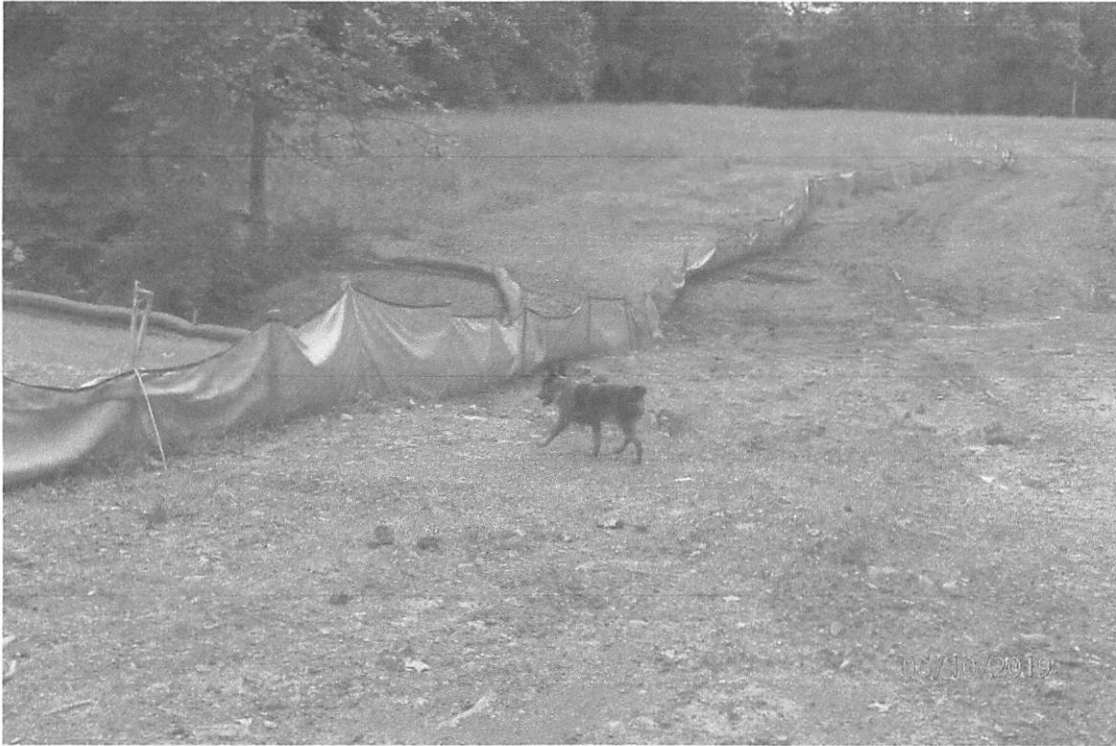
Project area adjacent to UNT – 14.

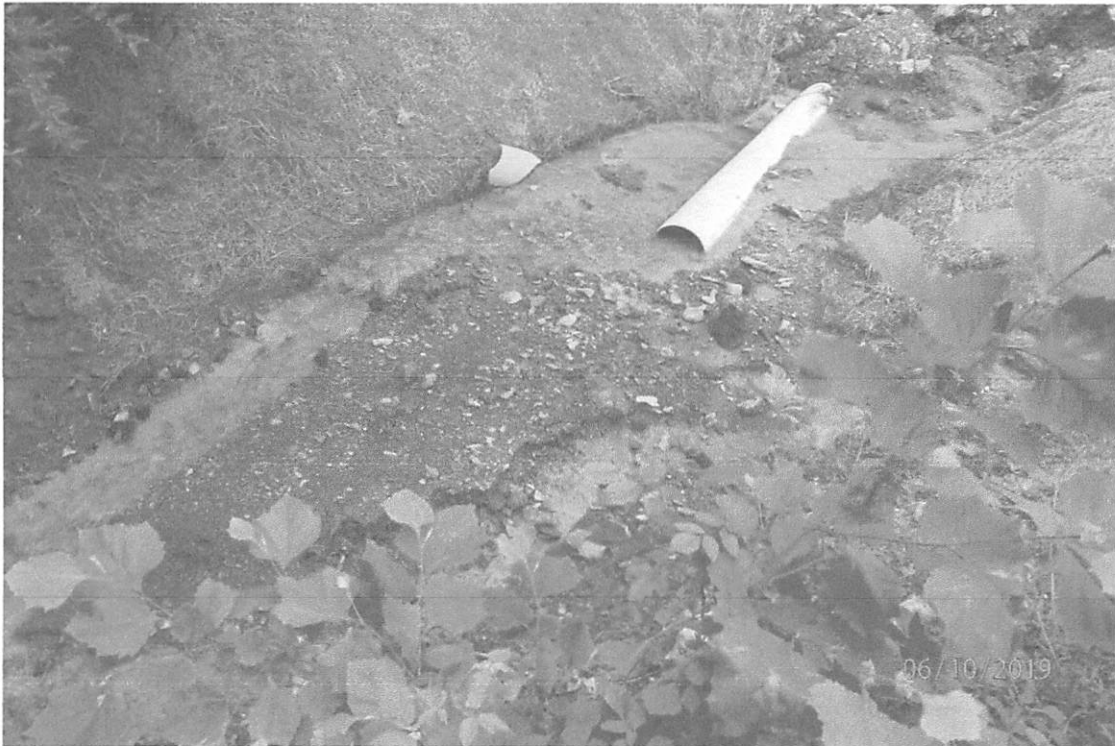
Offsite CNA deposits that originate from site in UNT Simpson Creek (UNT-14) ( $39^{\circ} 14.865' X 80^{\circ} 08.448'$ ).

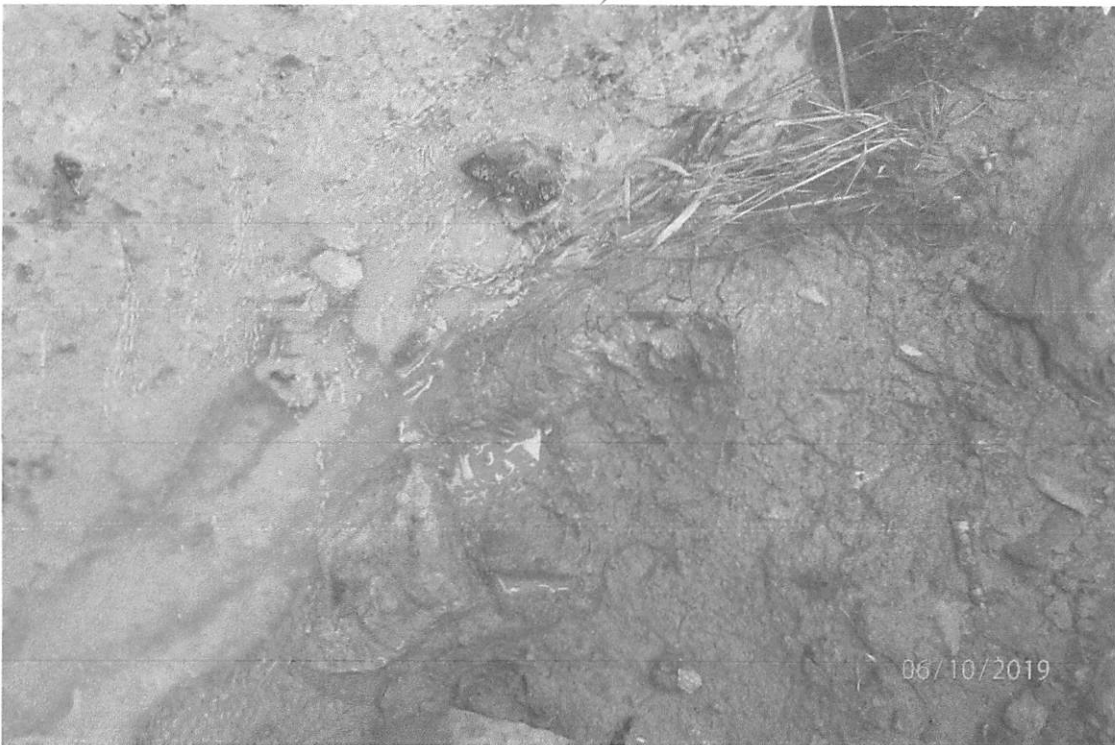
Offsite CNA deposits that originate from site in UNT Simpson Creek (UNT-14) ( $39^{\circ} 14.865' X 80^{\circ} 08.448'$ ).

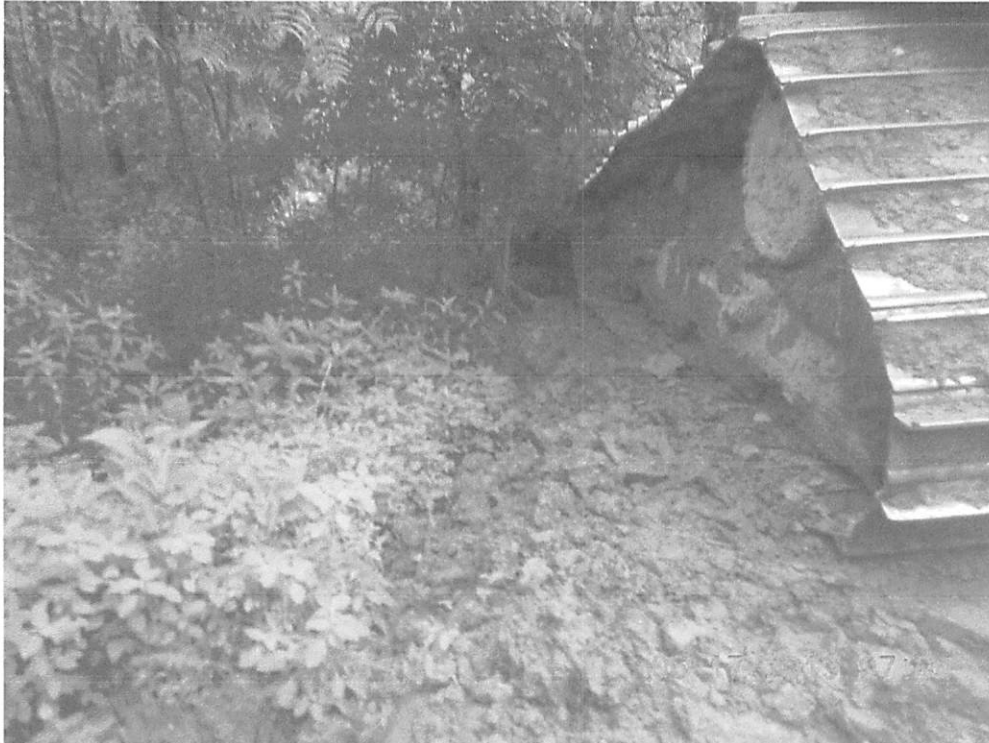
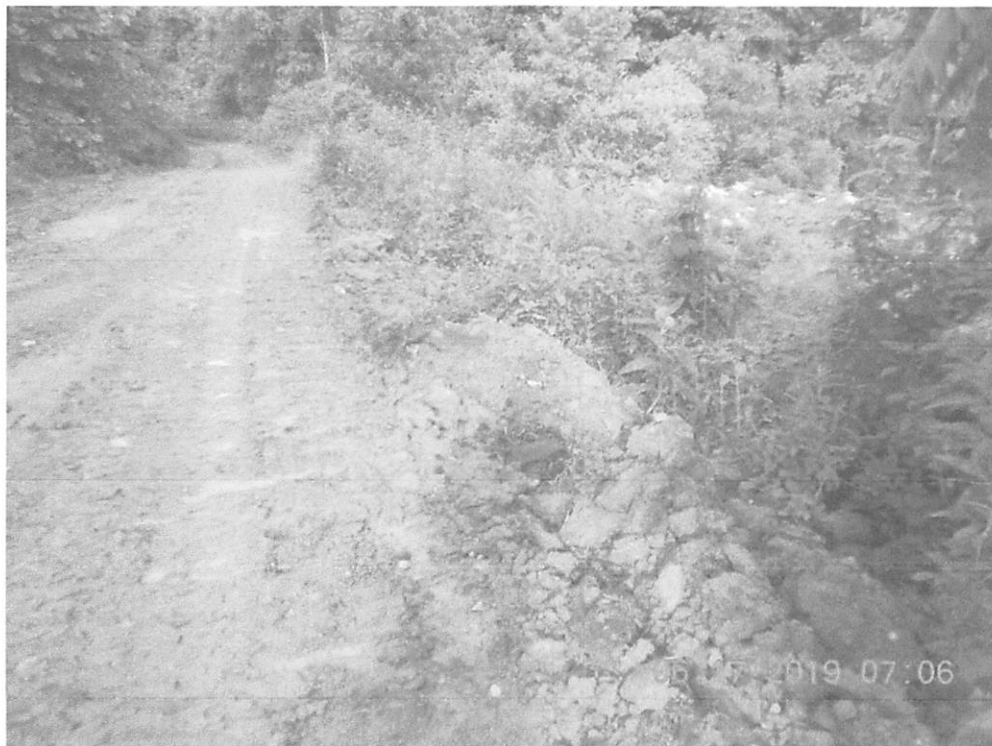
In places along AR 5, the CFS had been overtopped by sediment being pushed out by the equipment, or equipment ran over the CFS, making it ineffective, allowing sediment laden water to leave AR 5 without going through an appropriate device.

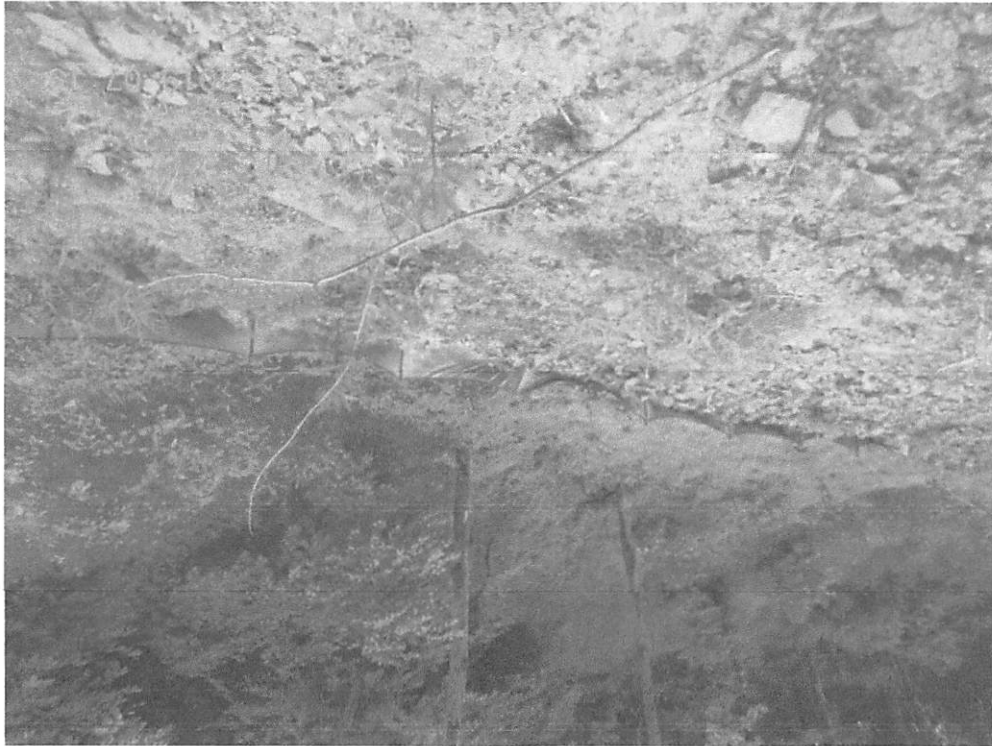
Water bars did not have proper terminus treatment, as indicated in the SWPPP, along with SS2 slope interceptors.

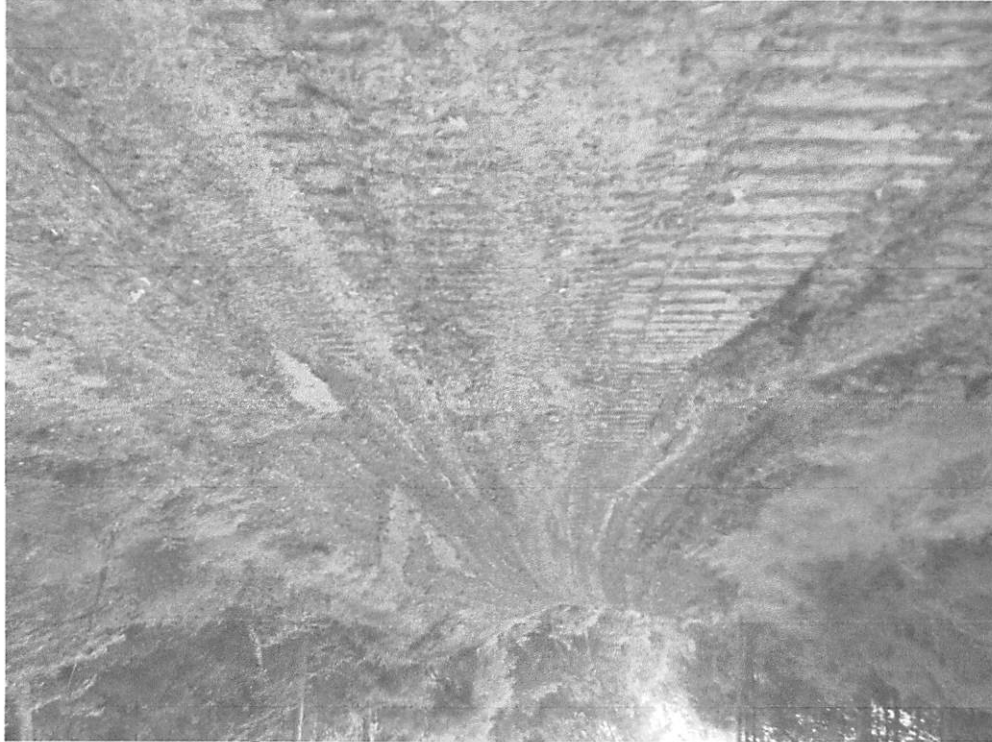
Erosion rills forming at the end of water bars that are lacking terminus treatment.

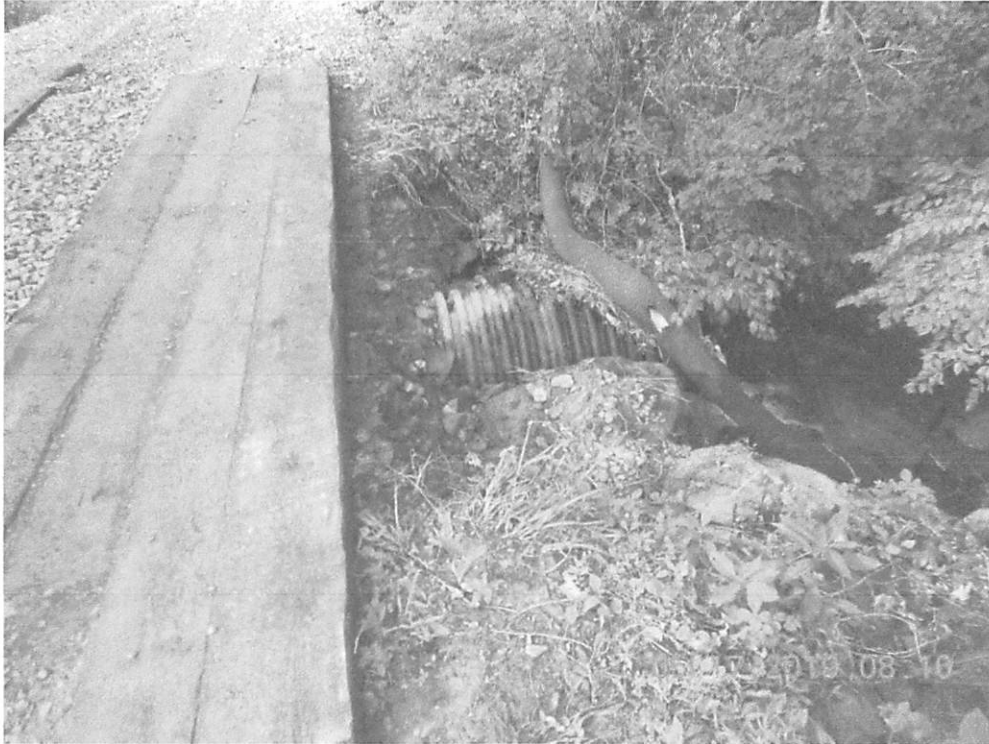
Culvert trail for WL 8 on AR 5.  
Controls were not installed at the culverts.

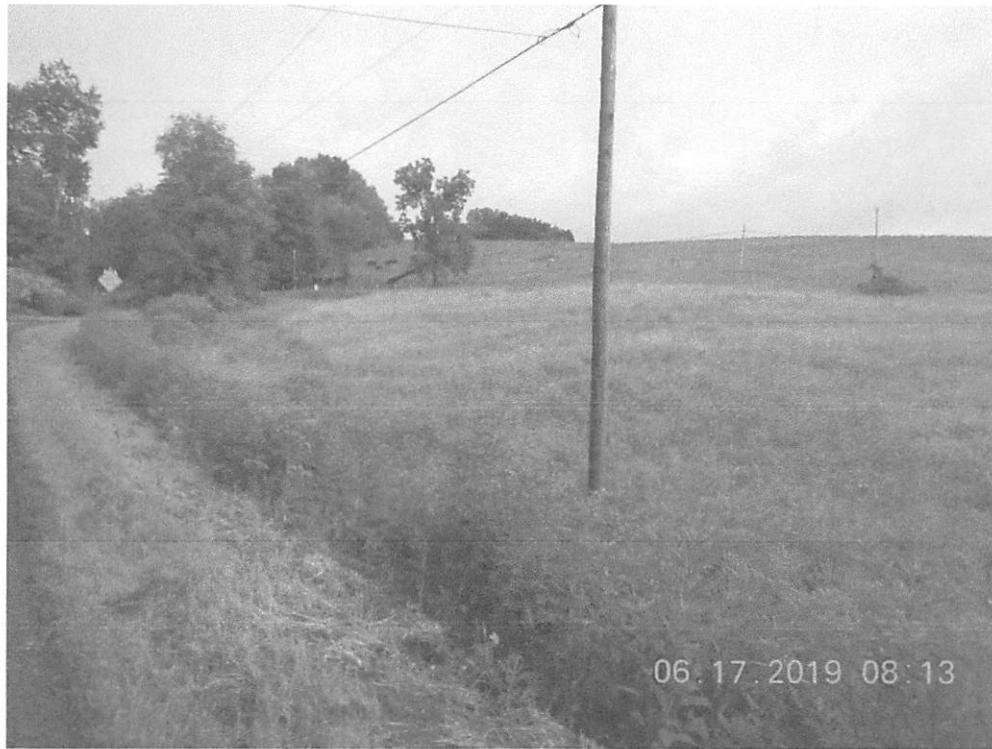
AR 5 construction entrance culvert overwhelmed.

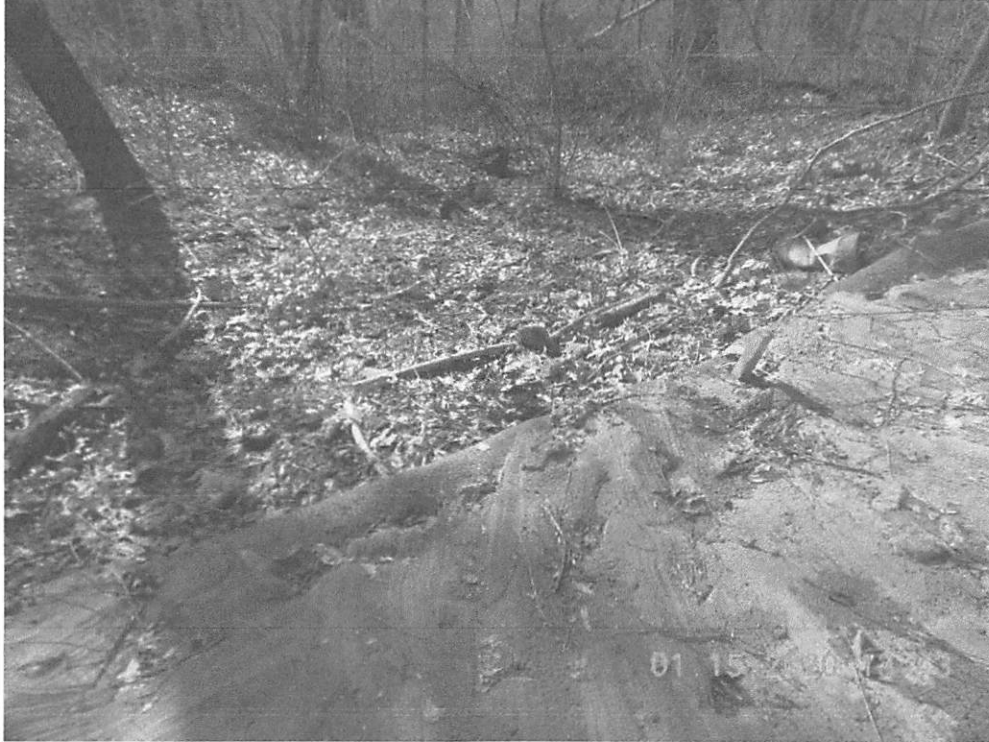
Area that failed to germinate and was not reseeded after 30 days.

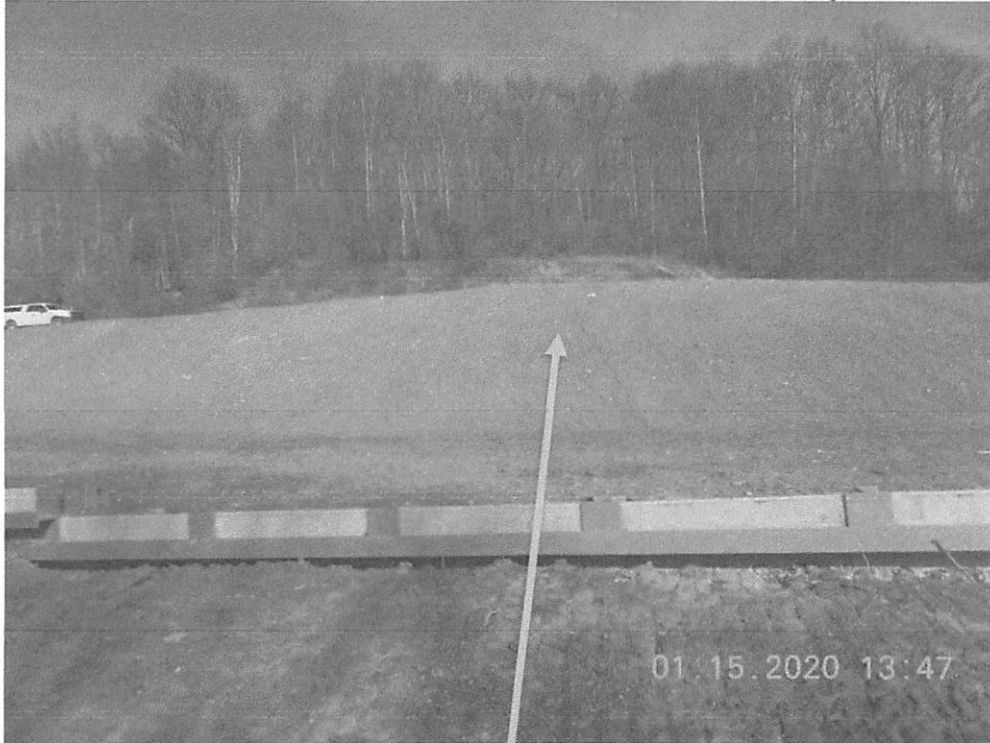
Disturbed area outside of controls.

Bypasses in controls.

Bypasses in perimeter controls with disturbance past the controls.
