**CONSENT ORDER
ISSUED UNDER THE
WATER POLLUTION CONTROL ACT
WEST VIRGINIA CODE CHAPTER 22, ARTICLE 11**

TO: CD DG Wallace, LLC
ATTN: Josh Allen
9461 Kenwood Road
Cincinnati, OH 45242

DATE: April 23, 2024

ORDER NO.: 10227

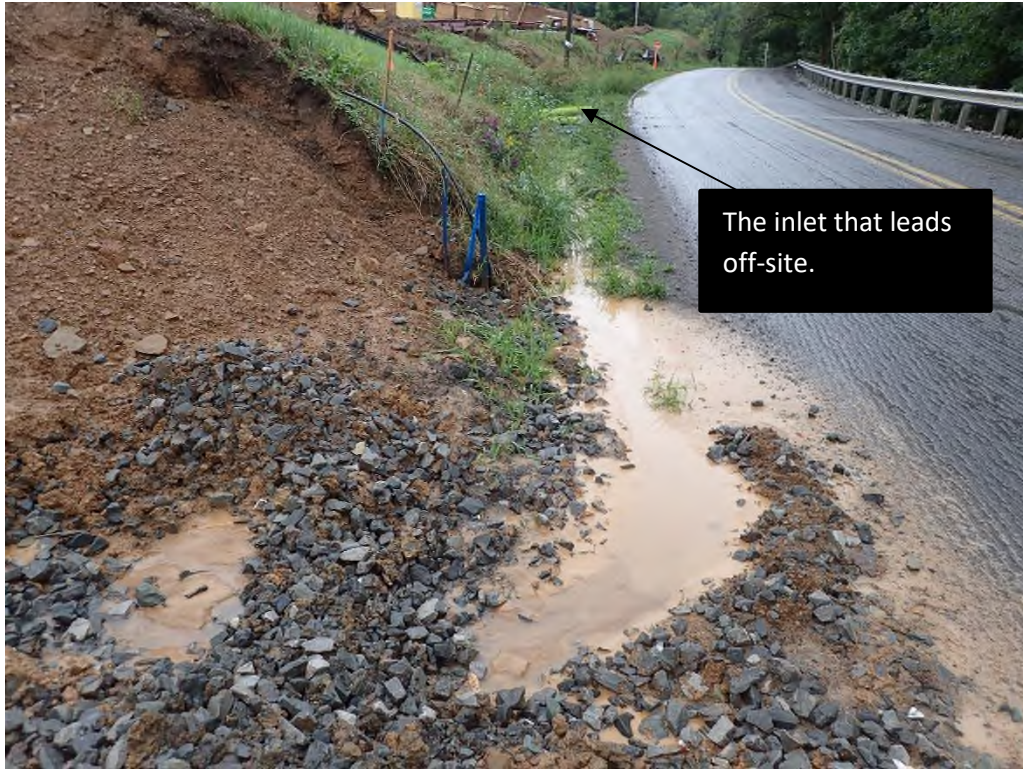
Photo 1: The ditch conveying turbid water toward the inlet.

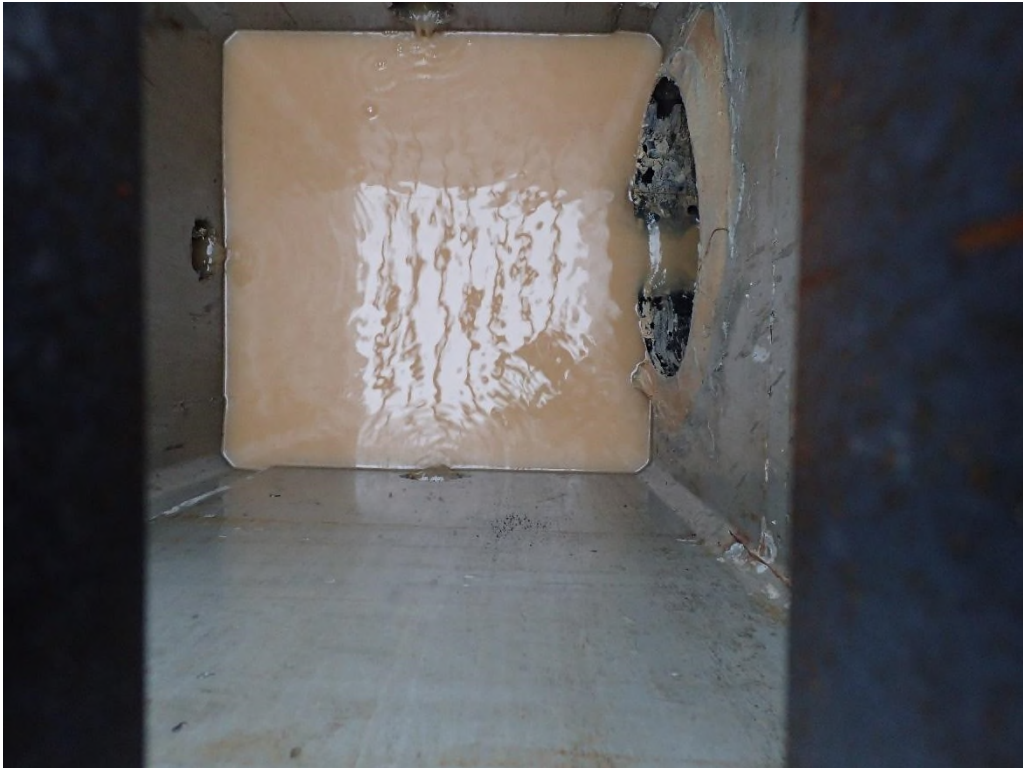
Photo 2: Turbid water inside the inlet that leads underneath Rt. 20 and discharges off-site.

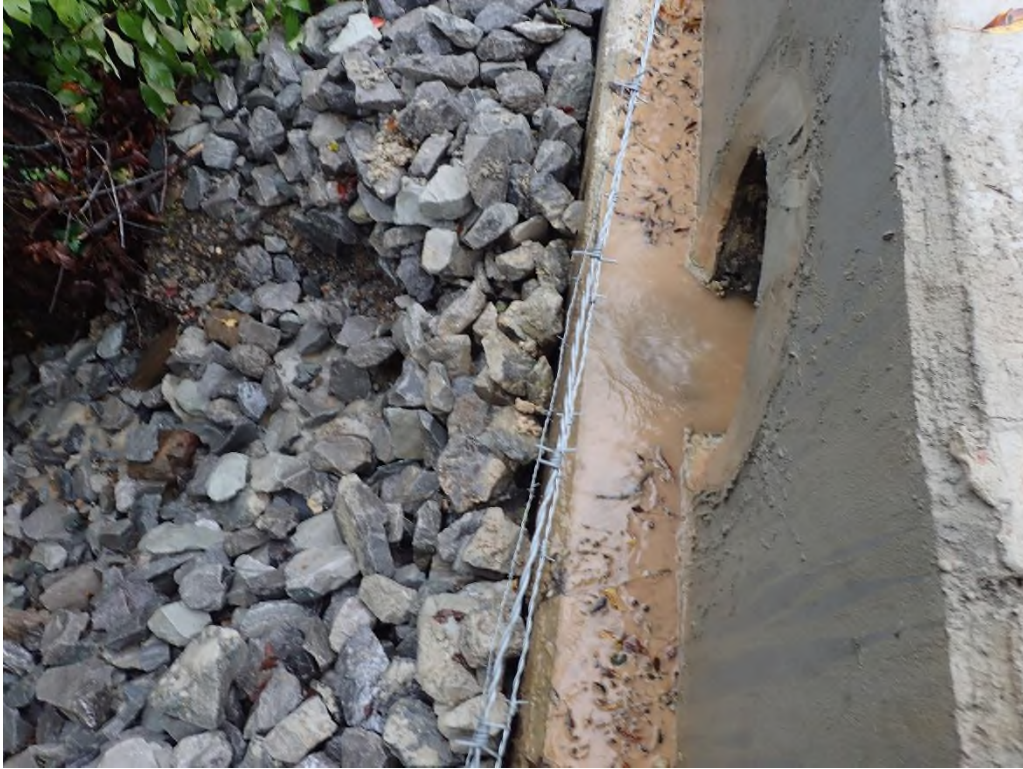
Photo 3: The outlet that discharges to Little Tenmile Creek. Turbid water was being discharged.

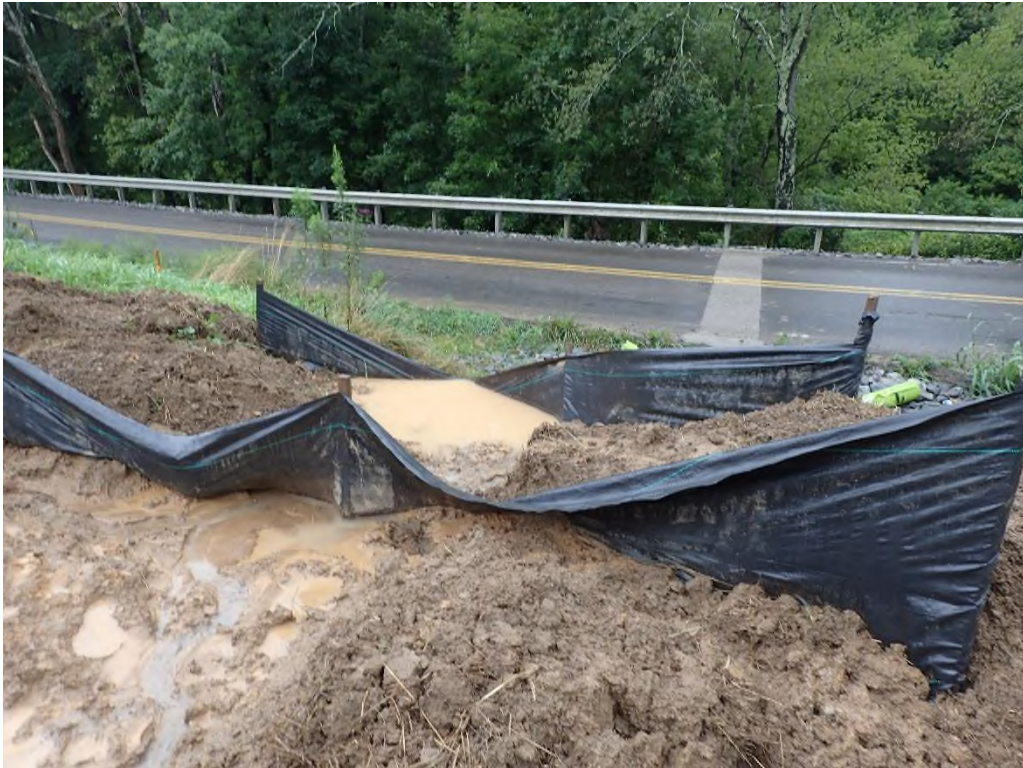
Photo 4: Silt fence overwhelmed with turbid water.

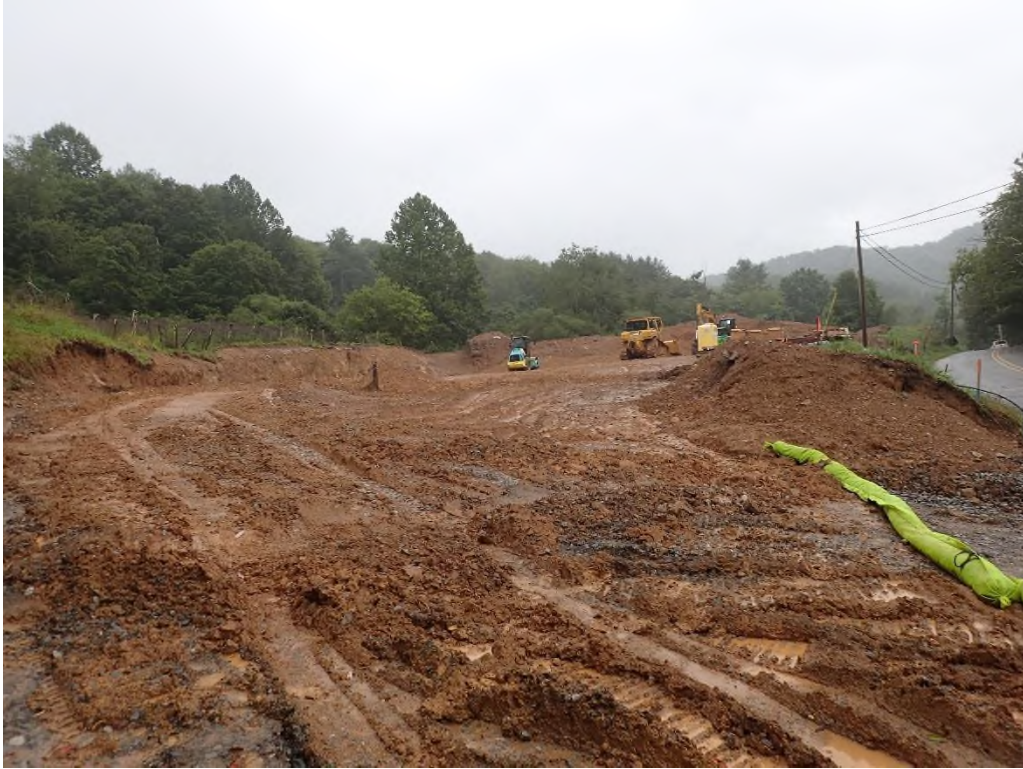
Photo 5: Land disturbance at the site.

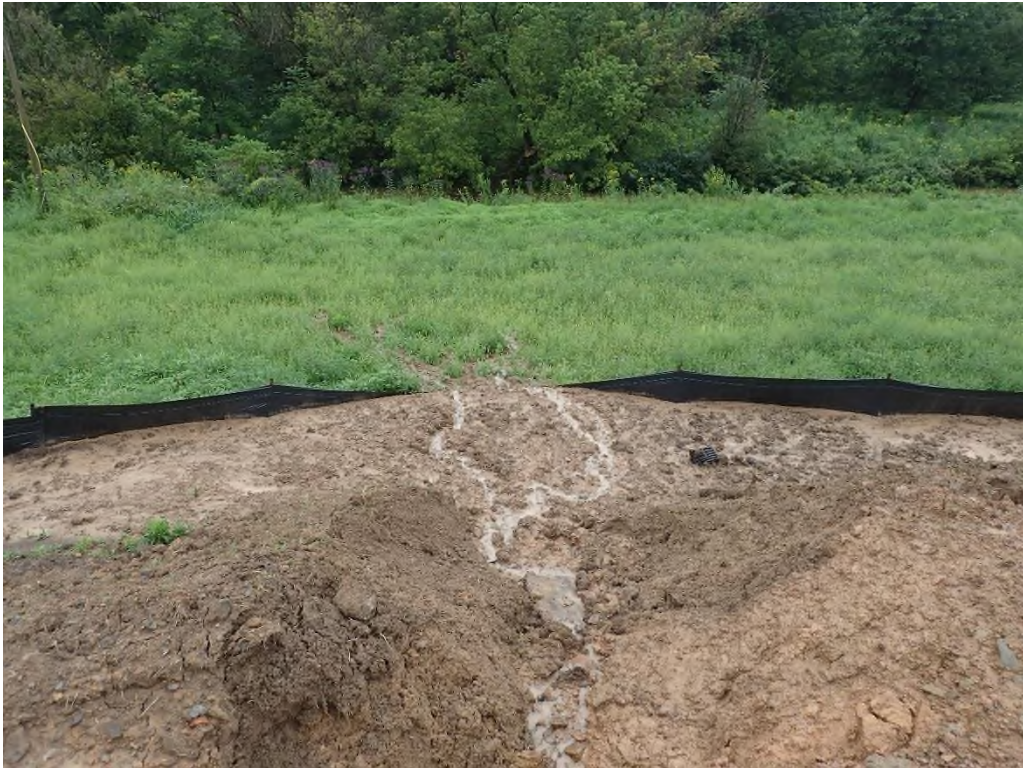
Photo 6: Silt fence overwhelmed at the waste area across the road from the site.

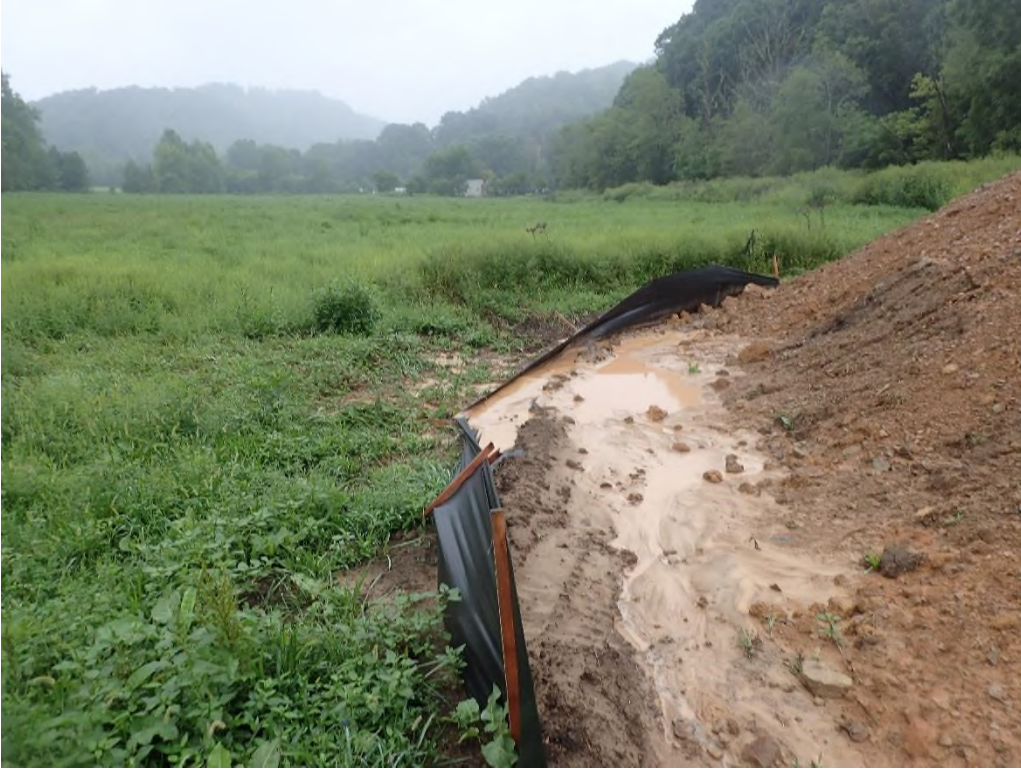
Photo 7: Silt fence is being overwhelmed, and sediment is being discharged into the adjacent field.

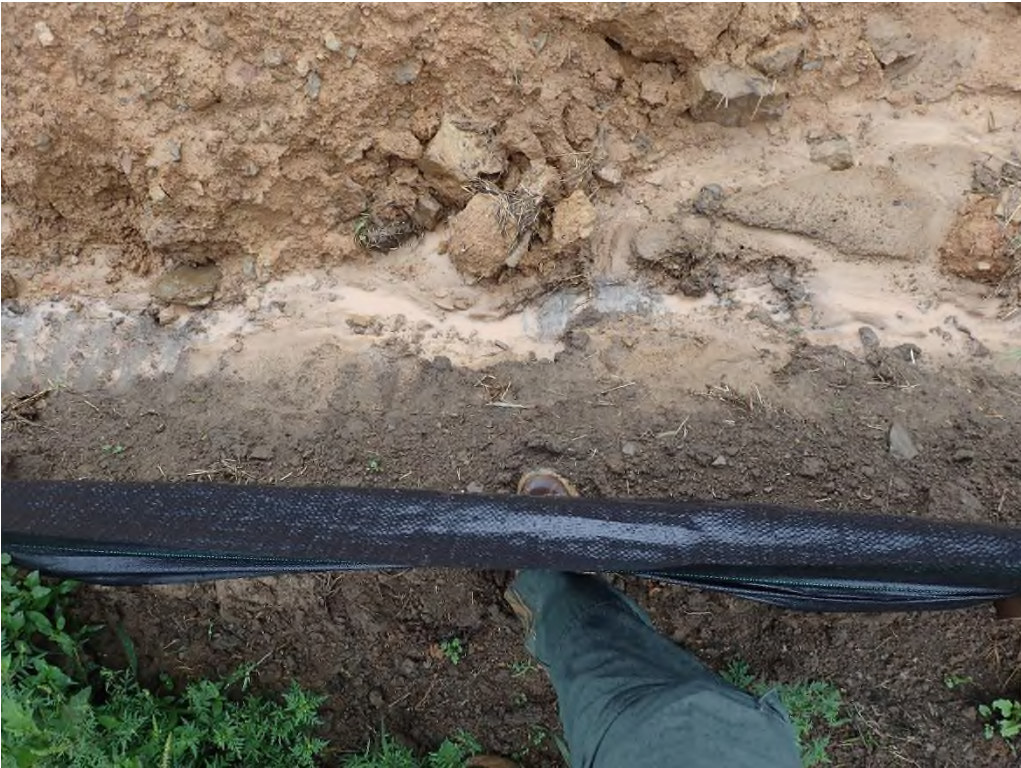
Photo 8: Silt fence not properly implemented around the waste site.

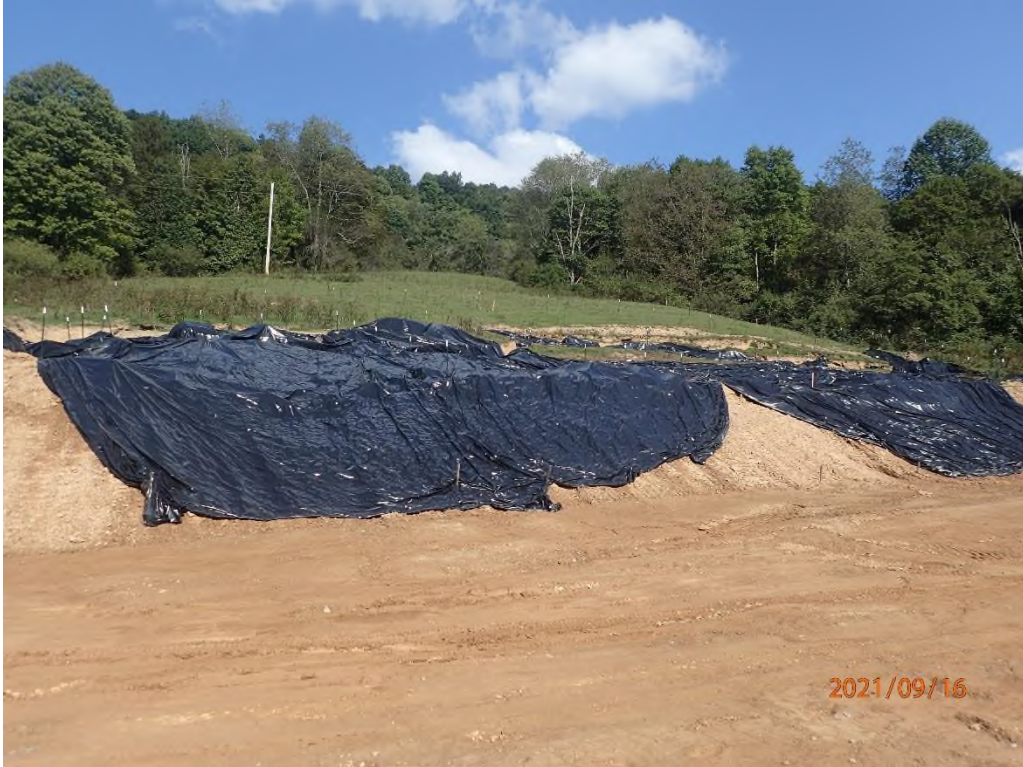
Photo 1: Several slips on the uphill side of the project.

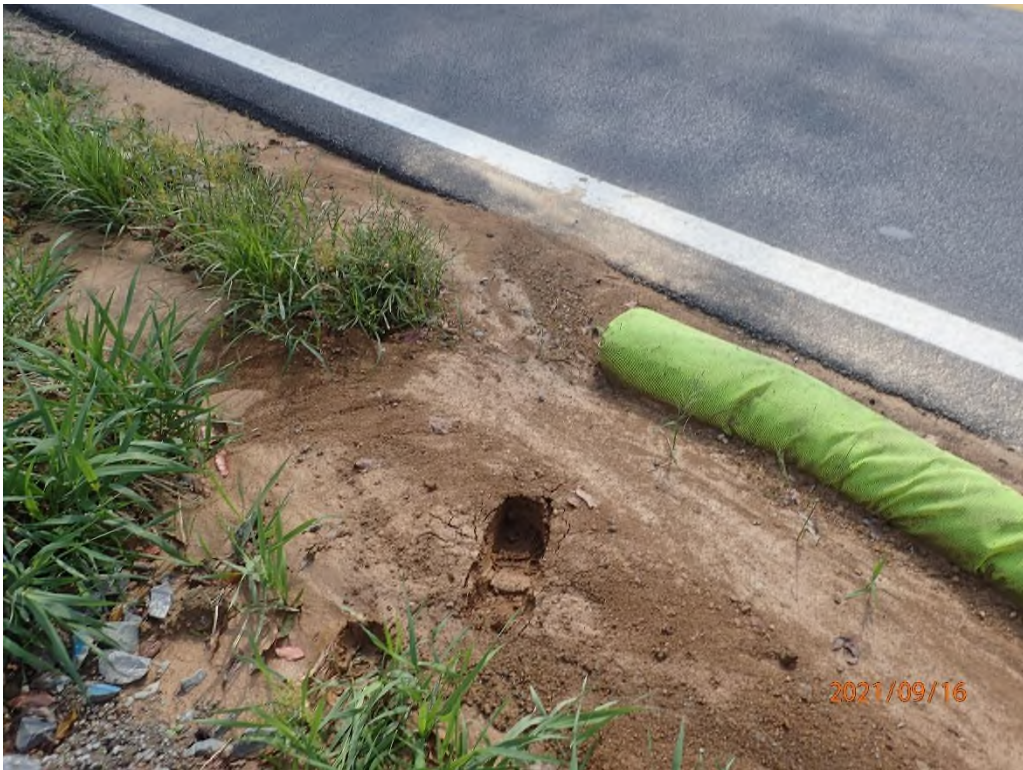
Photo 2: Sediment traveling along the road, toward an inlet that discharges into Little Tenmile Creek.

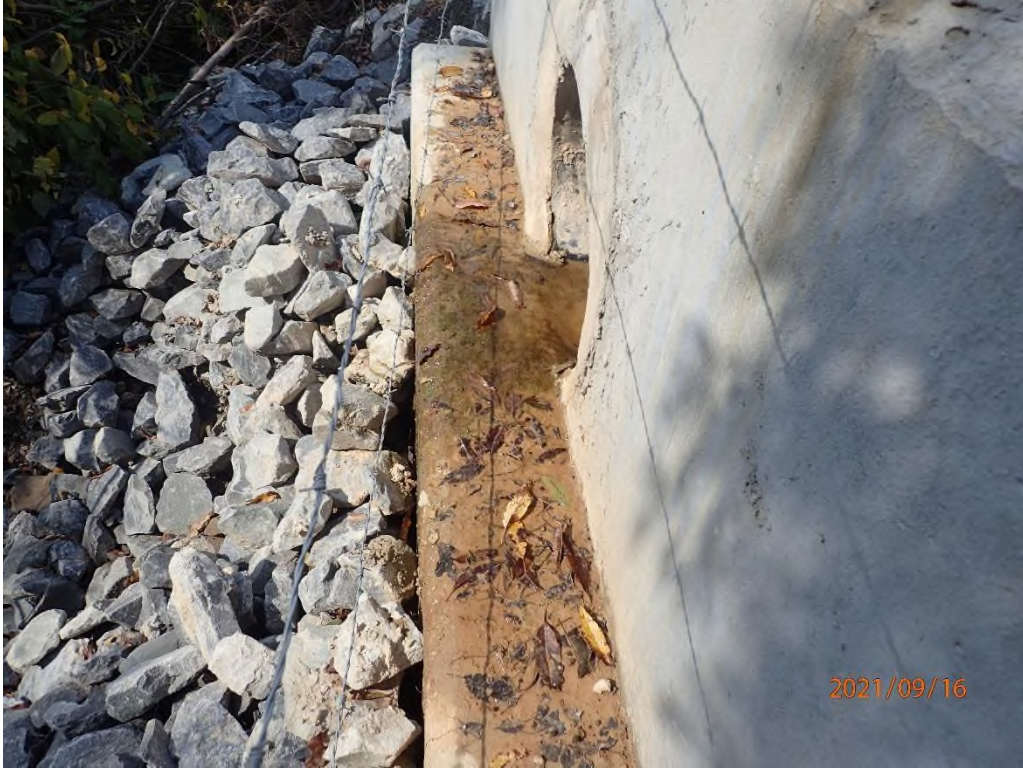
Photo 3: The outlet that discharges to Little Tenmile Creek.

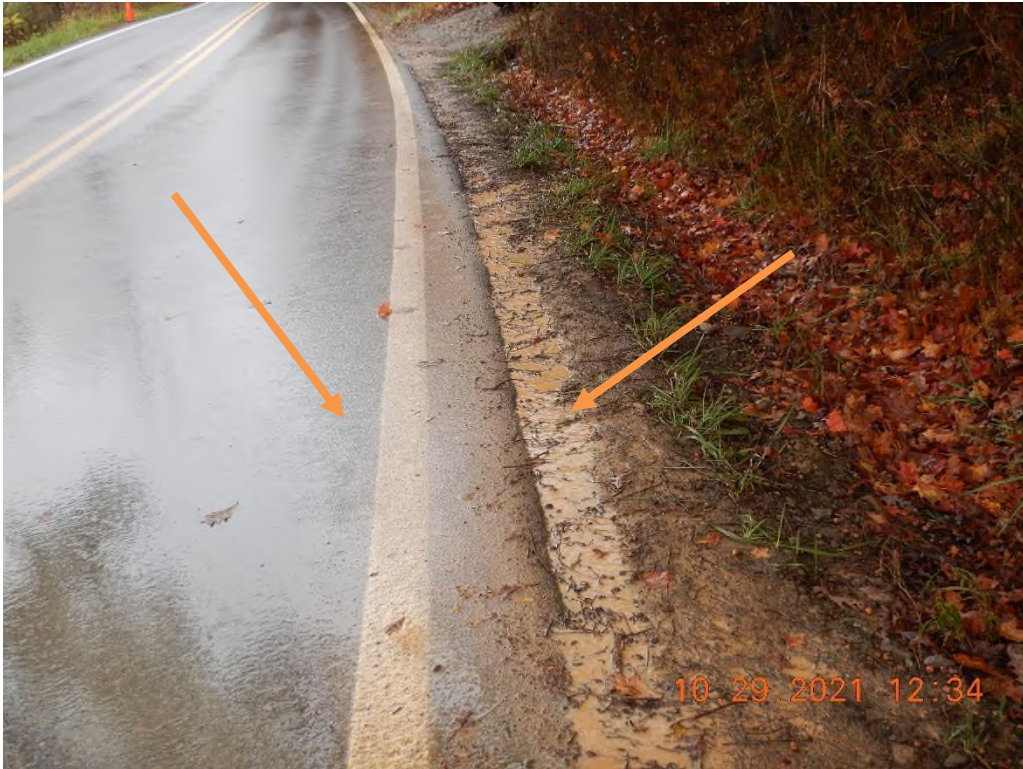
Sediment laden water leaving the project and traveling down the ditch line and across Rt. 20.

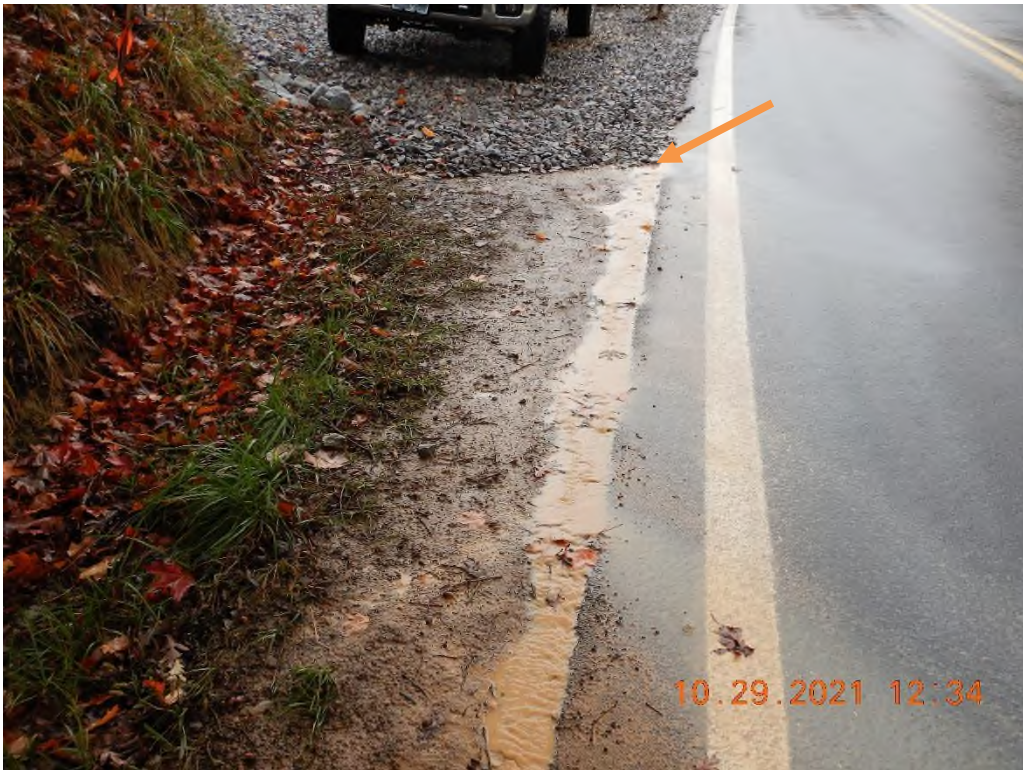
Sediment laden water leaving the site.

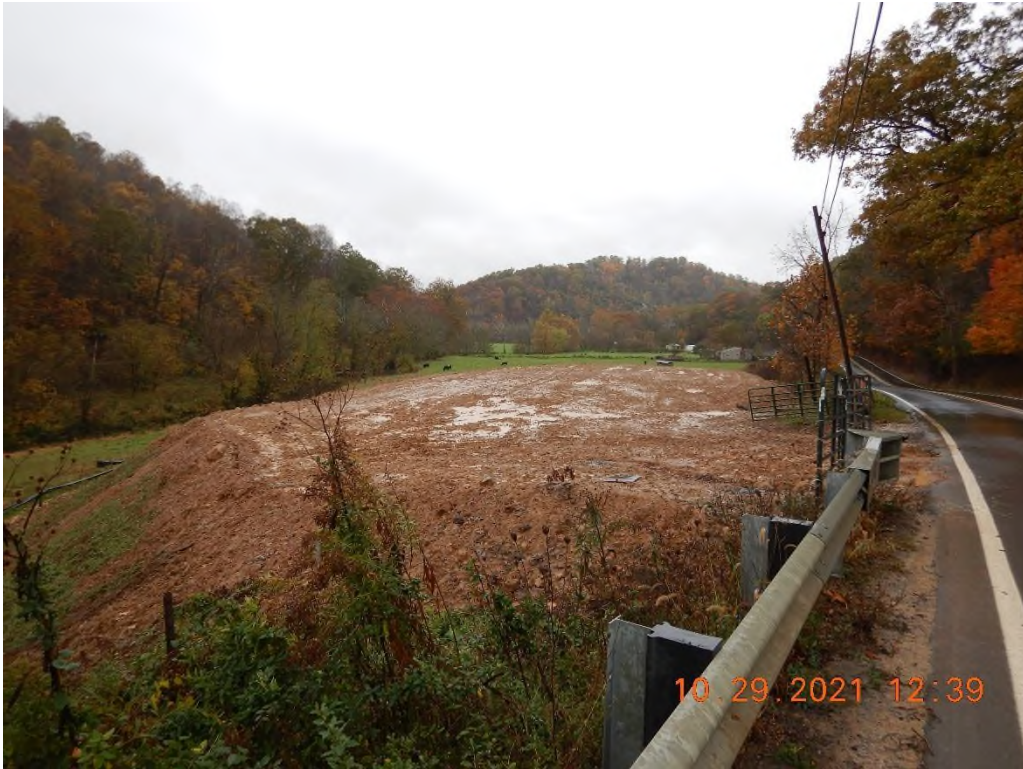
Waste area.

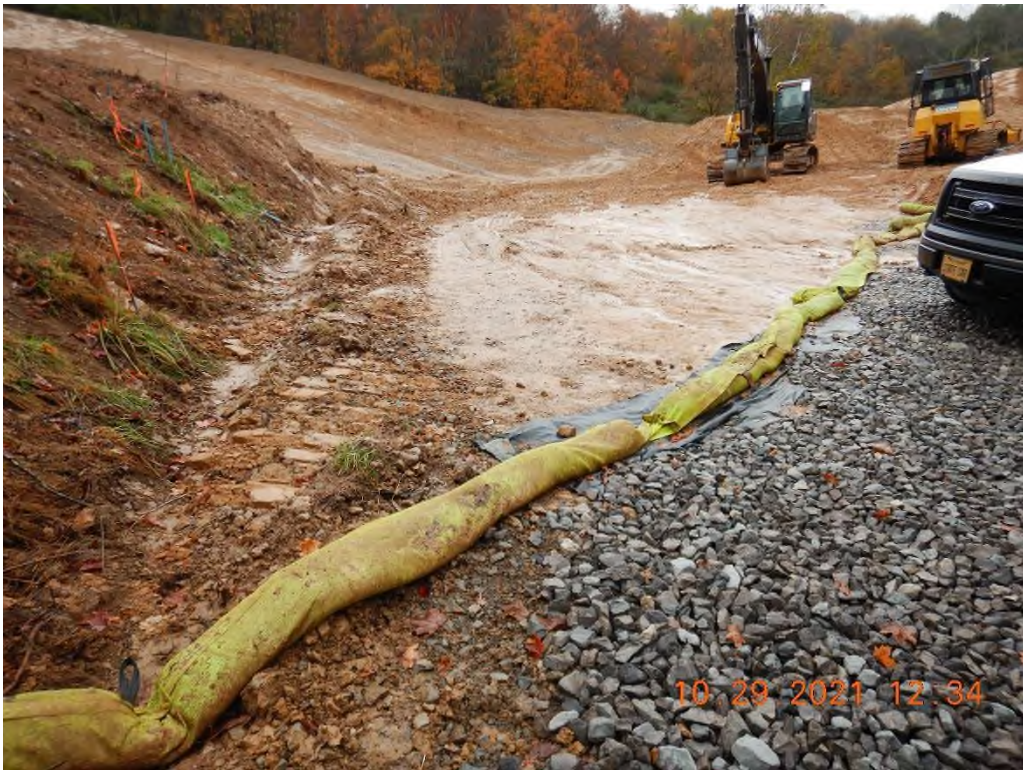
Land disturbance at the site.

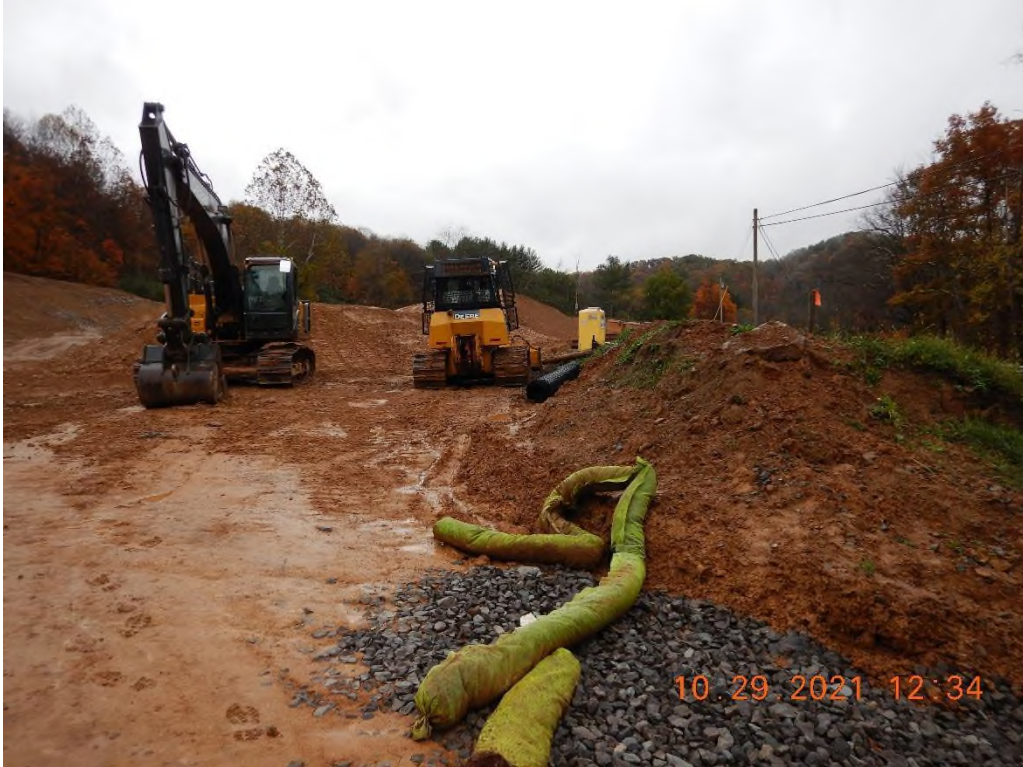
Land disturbance at the site.

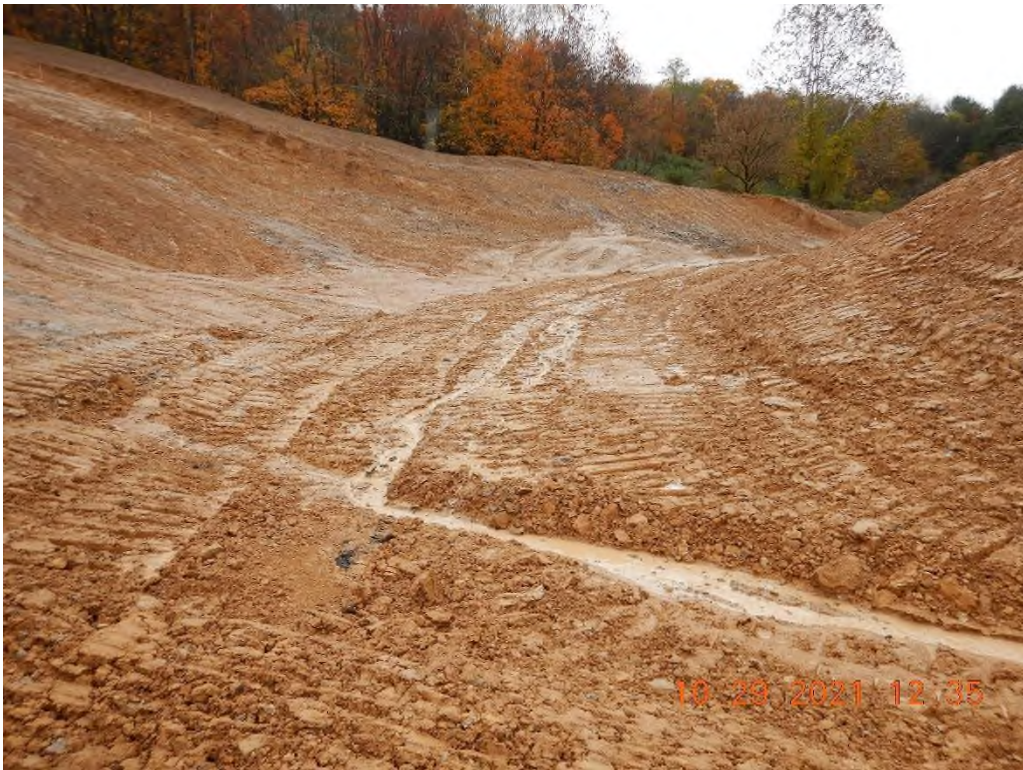
The southern portion of the site.

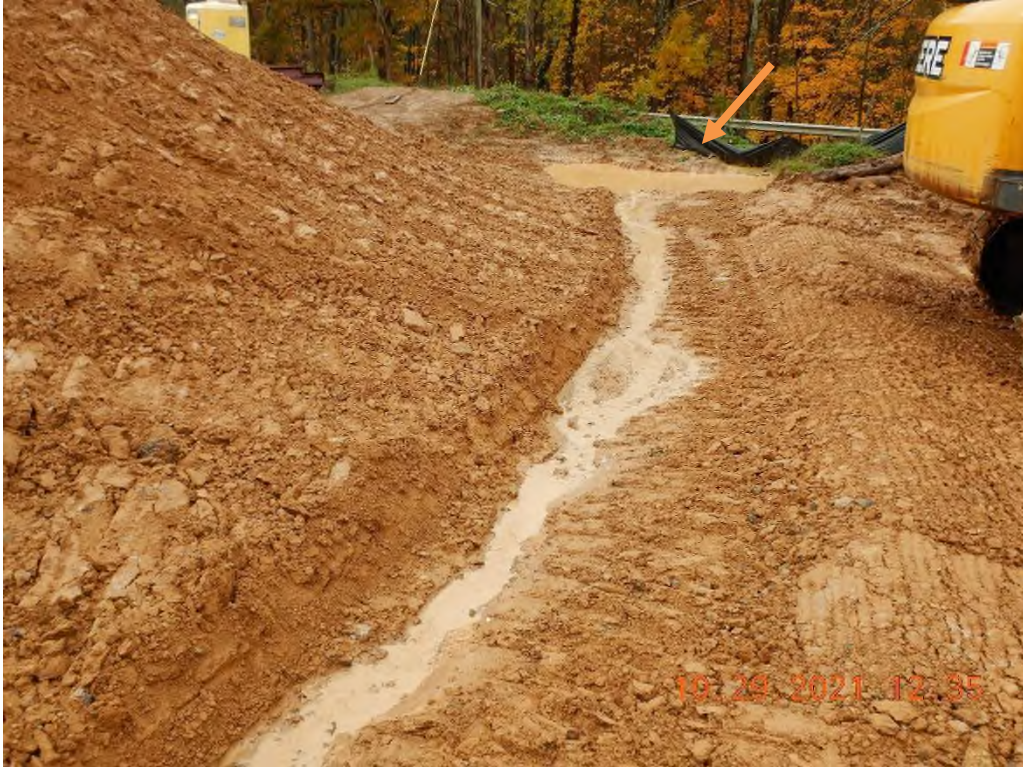
The orange arrow indicates silt fence that is in need of maintenance.

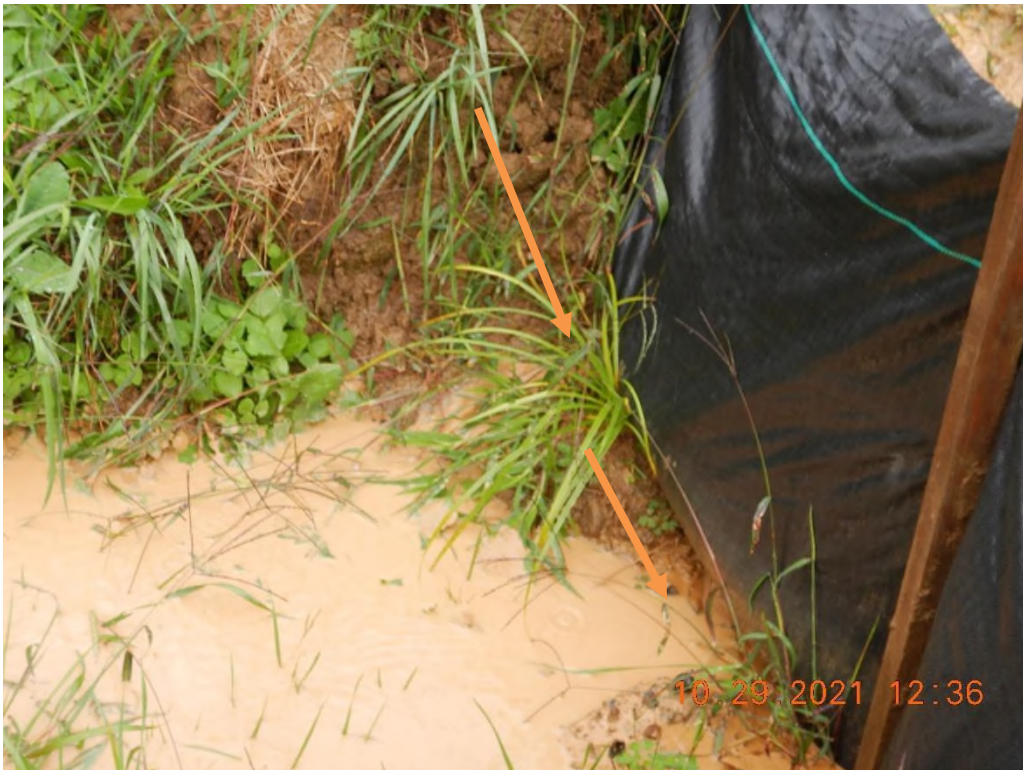
Sediment laden water is bypassing treatment due to a lack of maintenance to the installed silt fence.

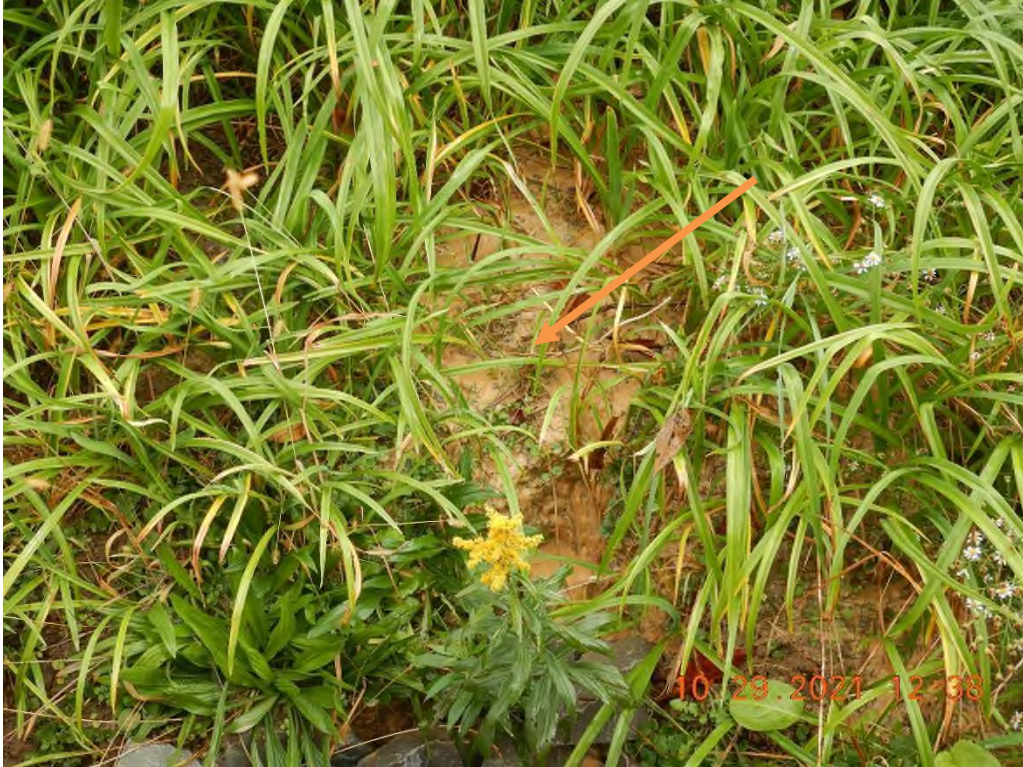
The path of sediment laden water leaving the site.

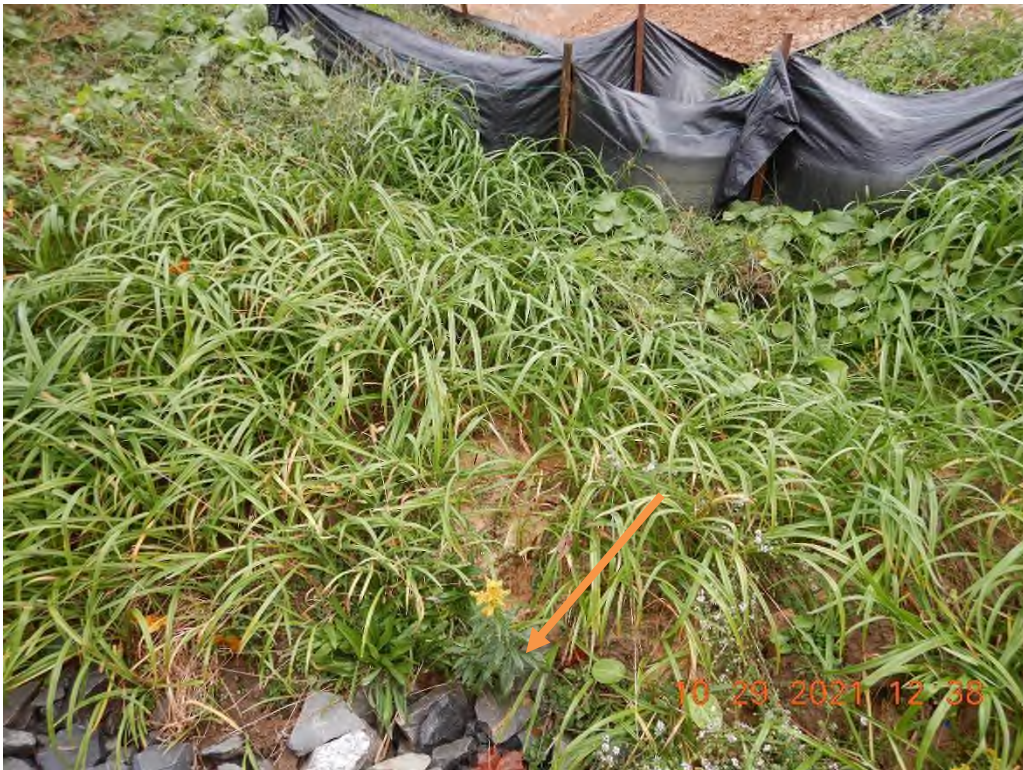
Sediment laden water entering the drain located under the rock rip rap channel.

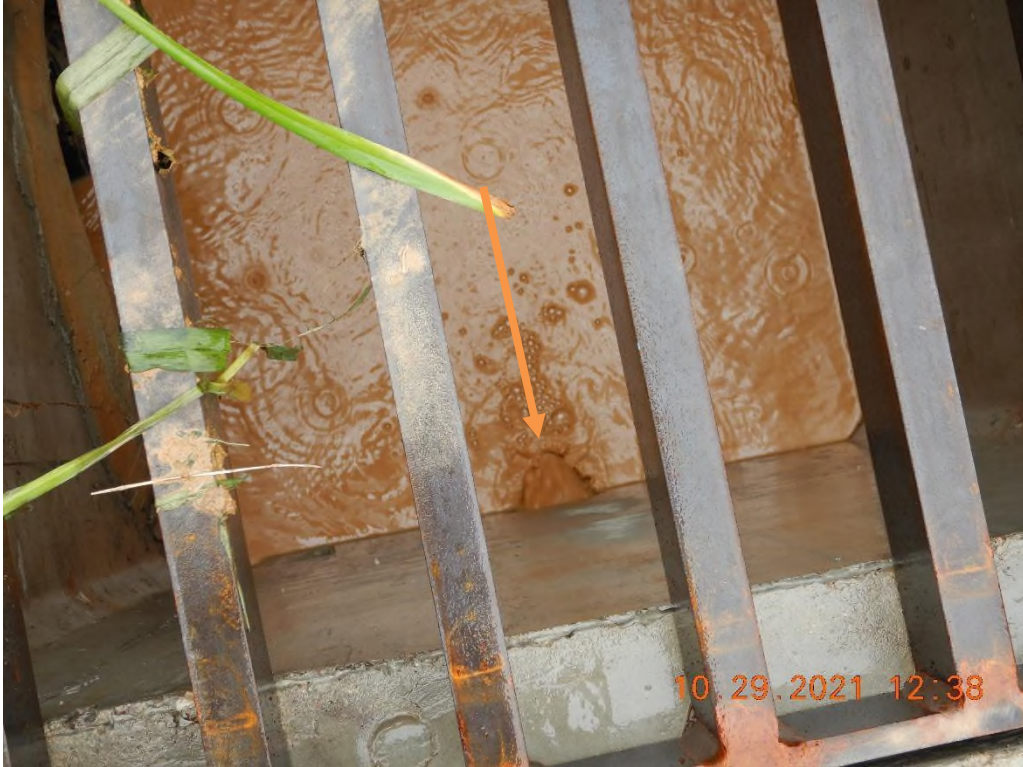
Sediment laden water entering the adjacent drop inlet

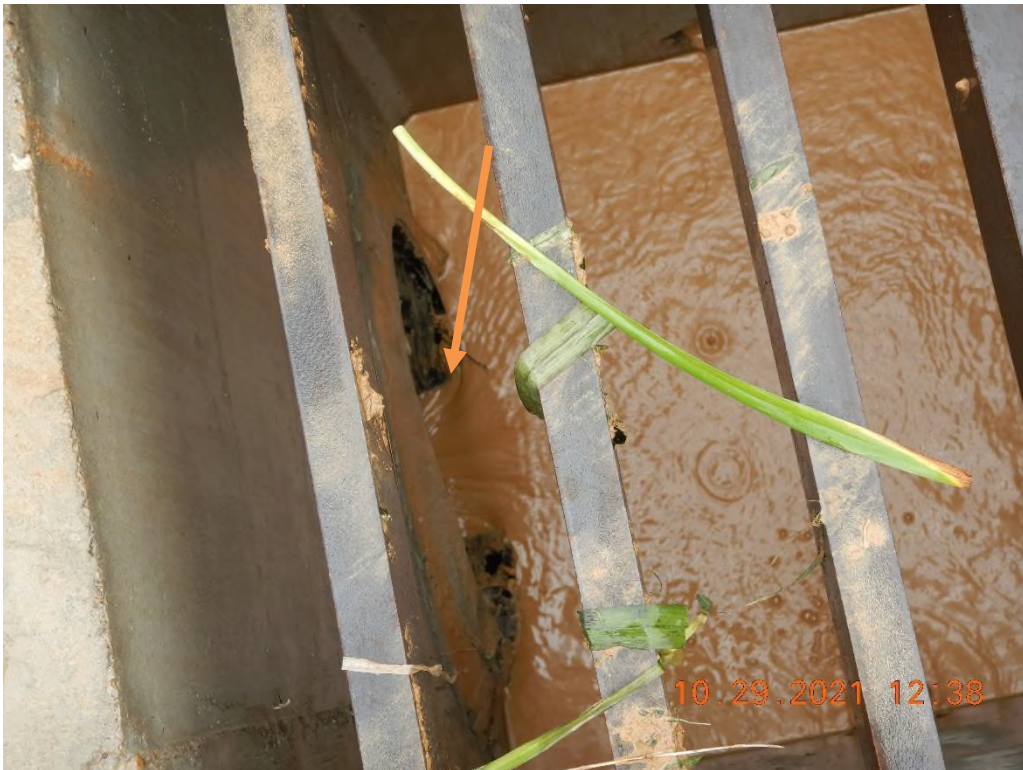
Sediment laden water entering the culvert and discharging toward Little Tenmile.

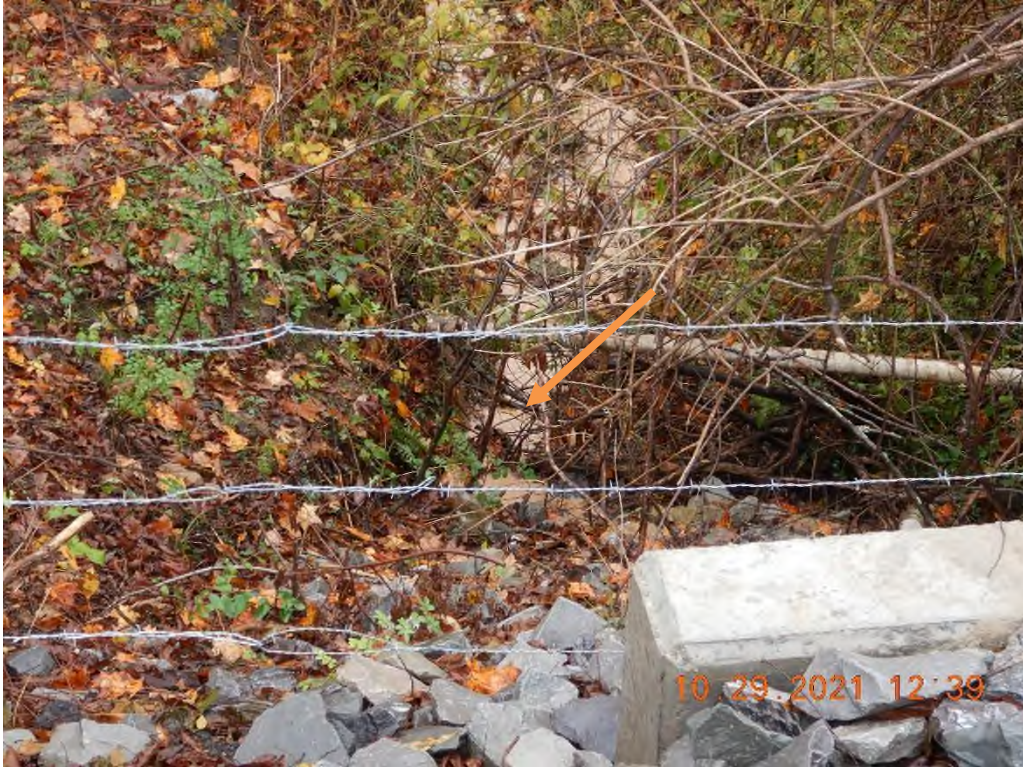
Sediment laden water discharging from the outlet of the culvert.

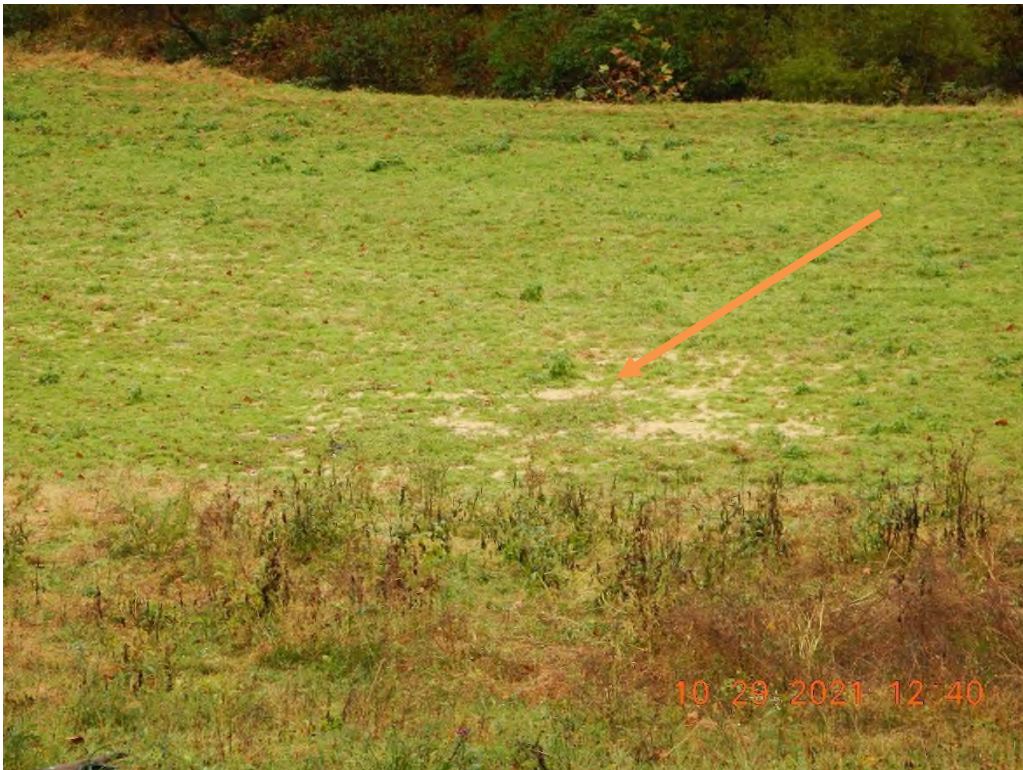
Sediment laden water from the project.

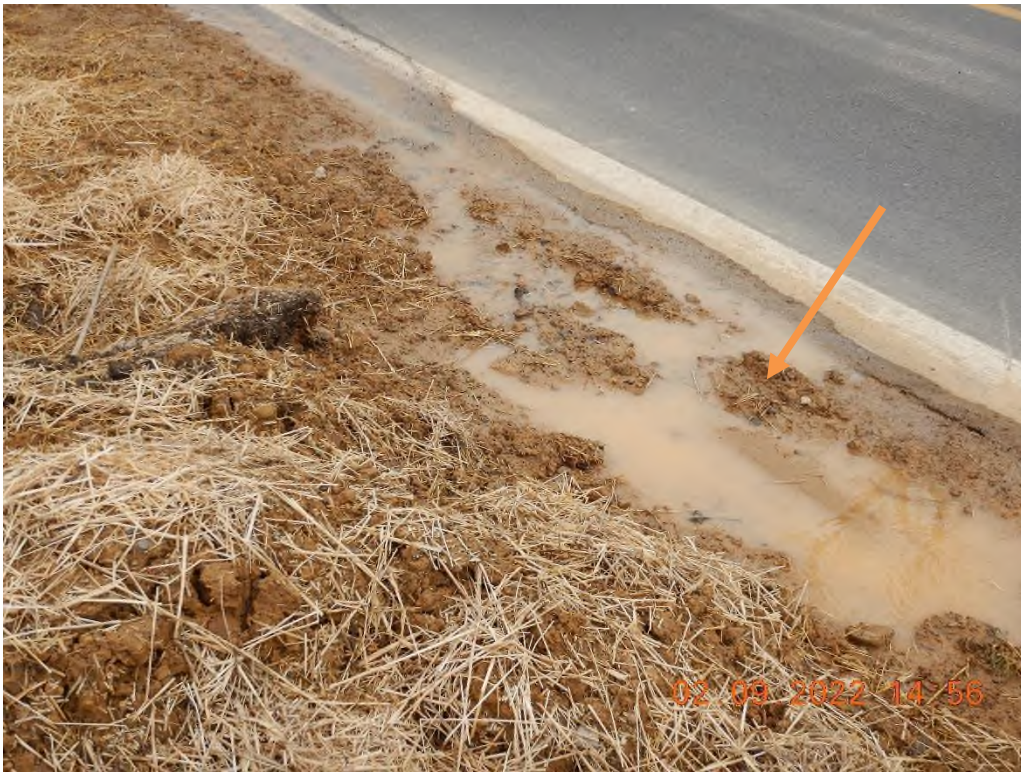
The area on the southern portion where perimeter controls are not required by the SWPPP; however, sediment laden water was leaving the site.

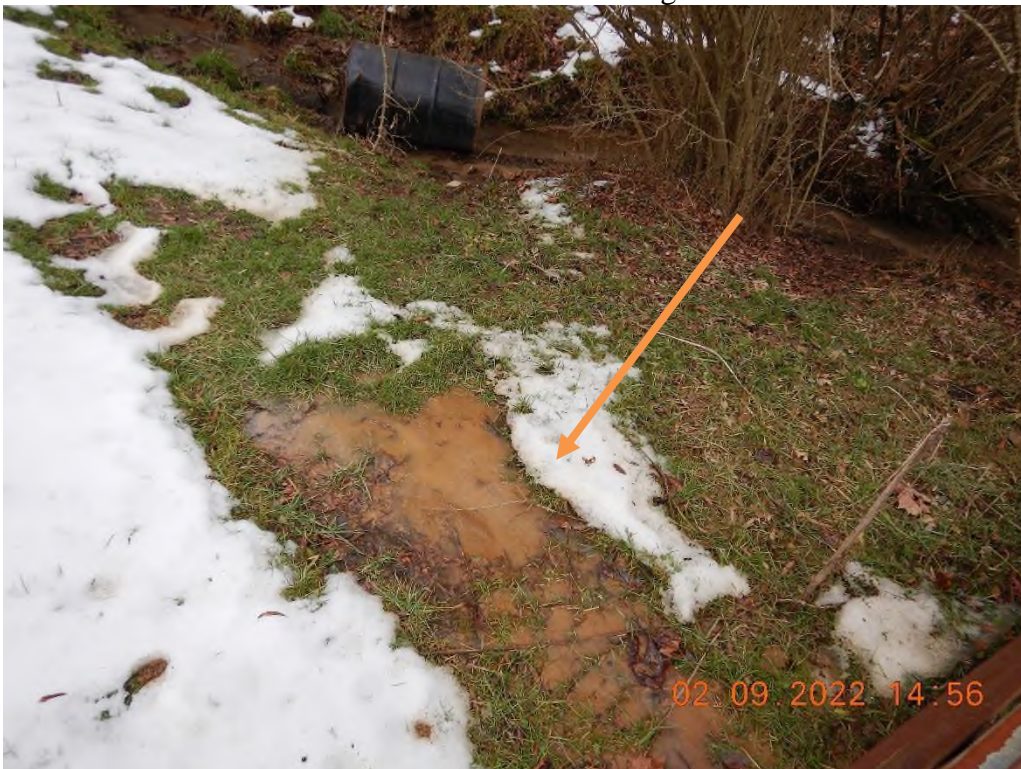
Sediment laden water that has left the site.

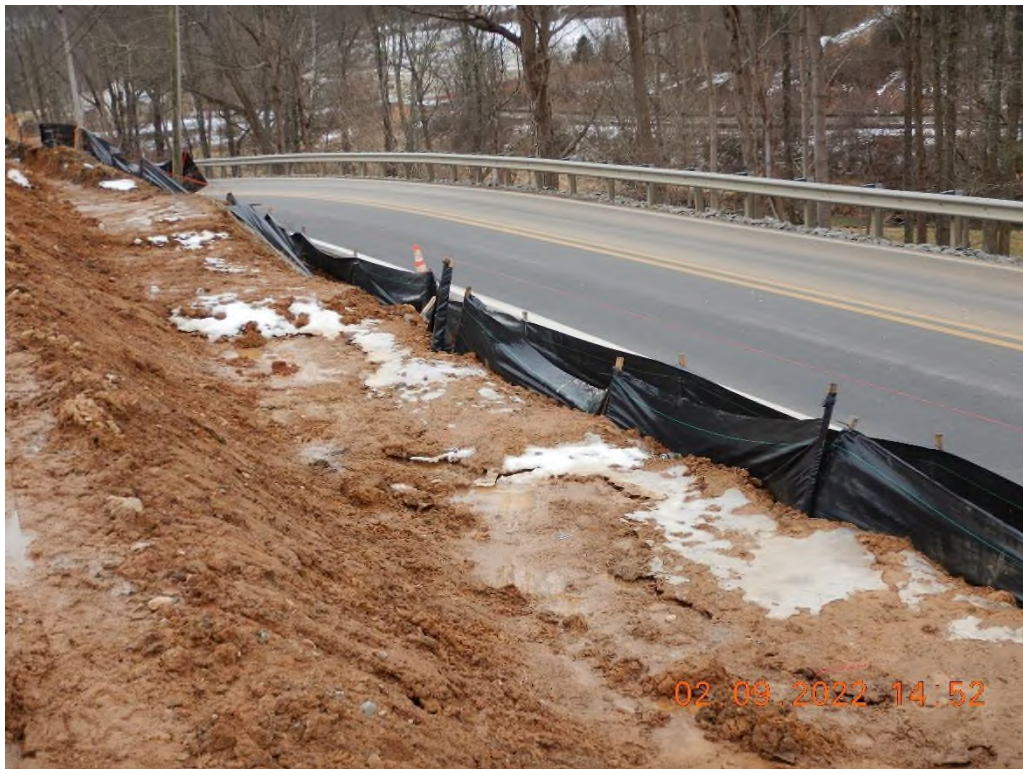
Silt fence in need of maintenance.

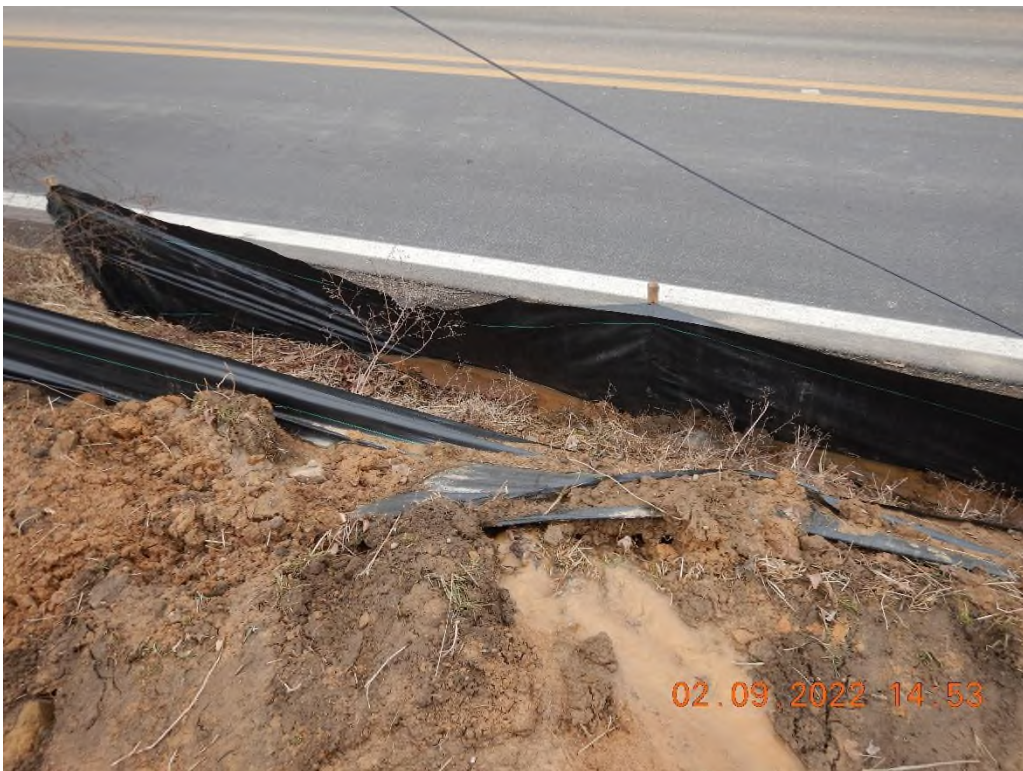
Silt fence needing maintenance.
