**CONSENT ORDER
ISSUED UNDER THE
WATER POLLUTION CONTROL ACT
WEST VIRGINIA CODE CHAPTER 22, ARTICLE 11**

TO: CD DG Wallace, LLC
ATTN: Josh Allen
9461 Kenwood Road
Cincinnati, OH 45242

DATE: April 23, 2024

ORDER NO.: 10227

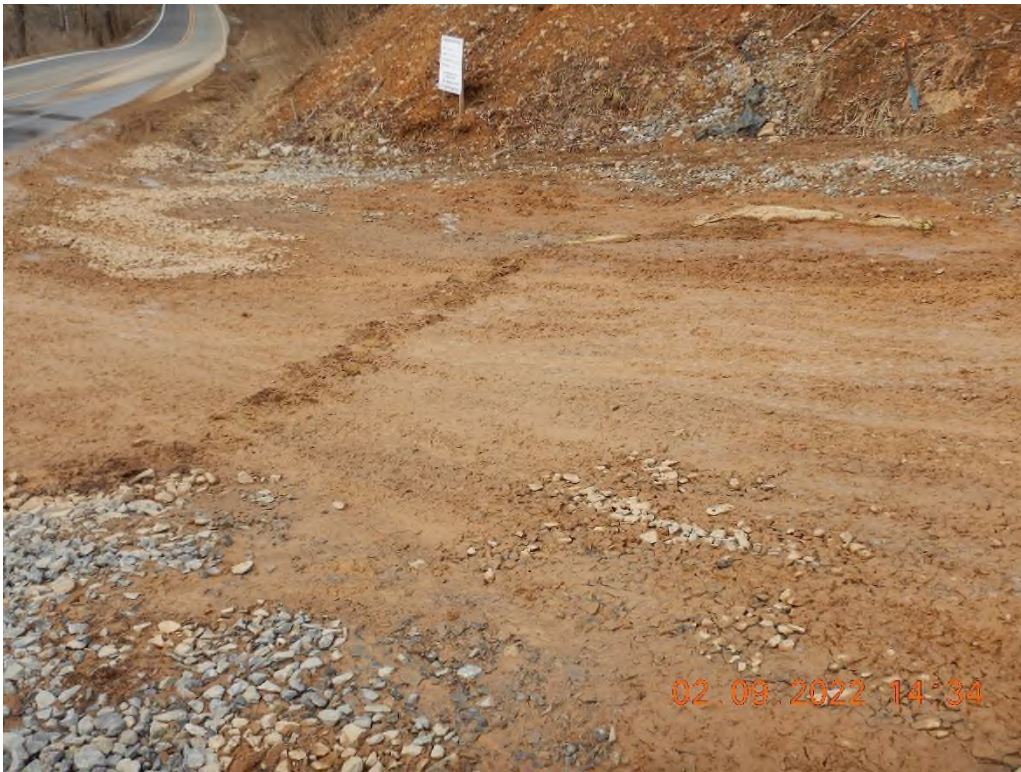
A non-stabilized construction entrance.

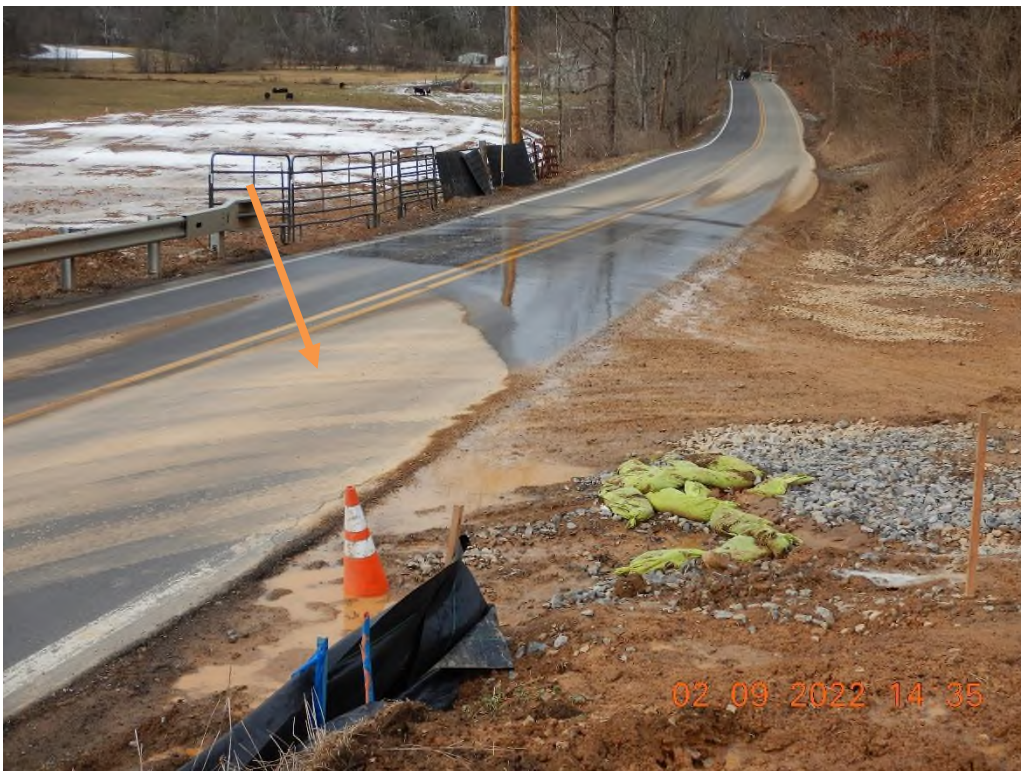
Track-out on WV-20, as a result of a non-stabilized construction entrance.

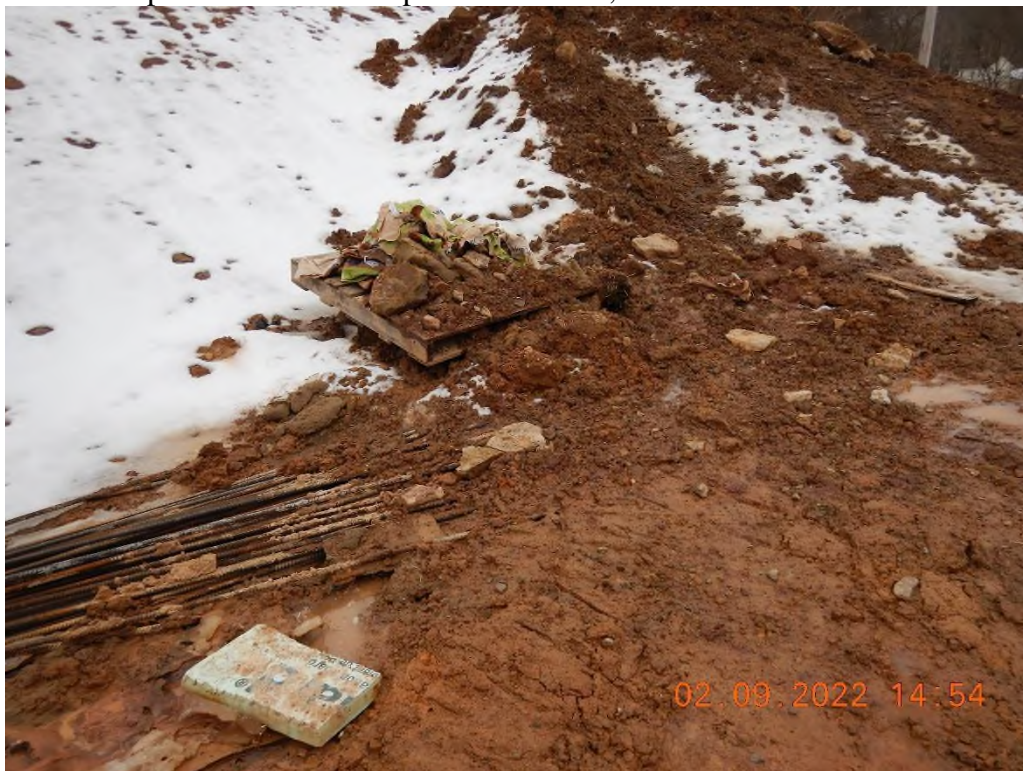
Area where Sediment Trap 2 should have been installed.

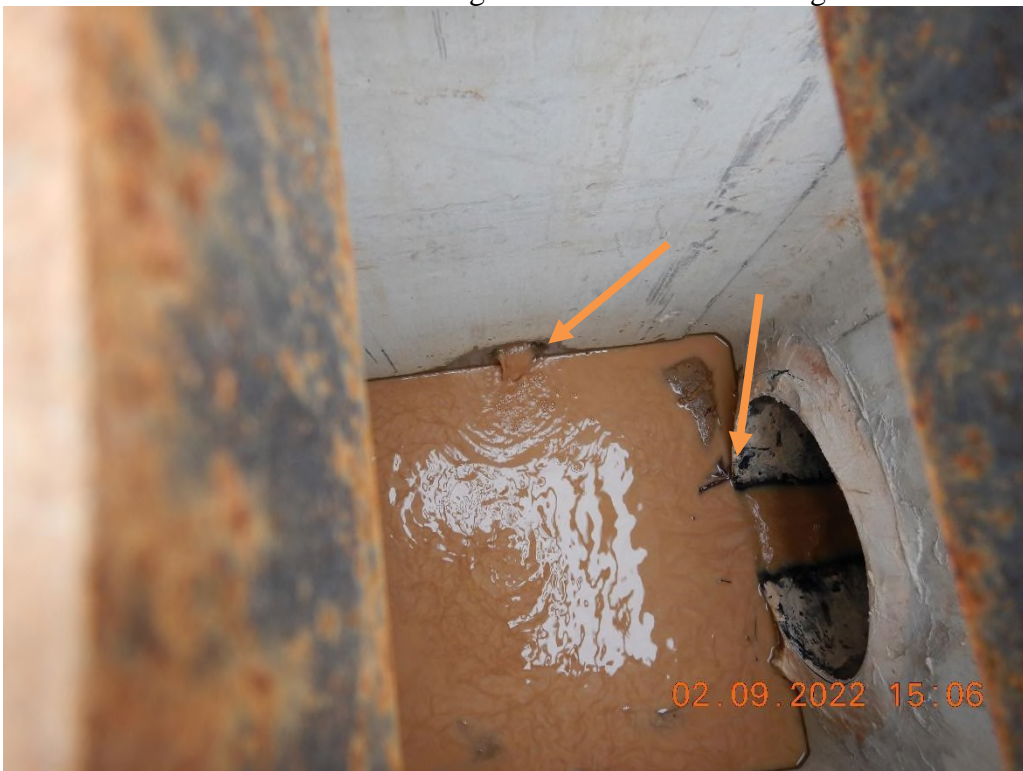
Sediment laden water discharging through the underdrain and leaving the site via culvert. There is no protection for the existing drop inlet.

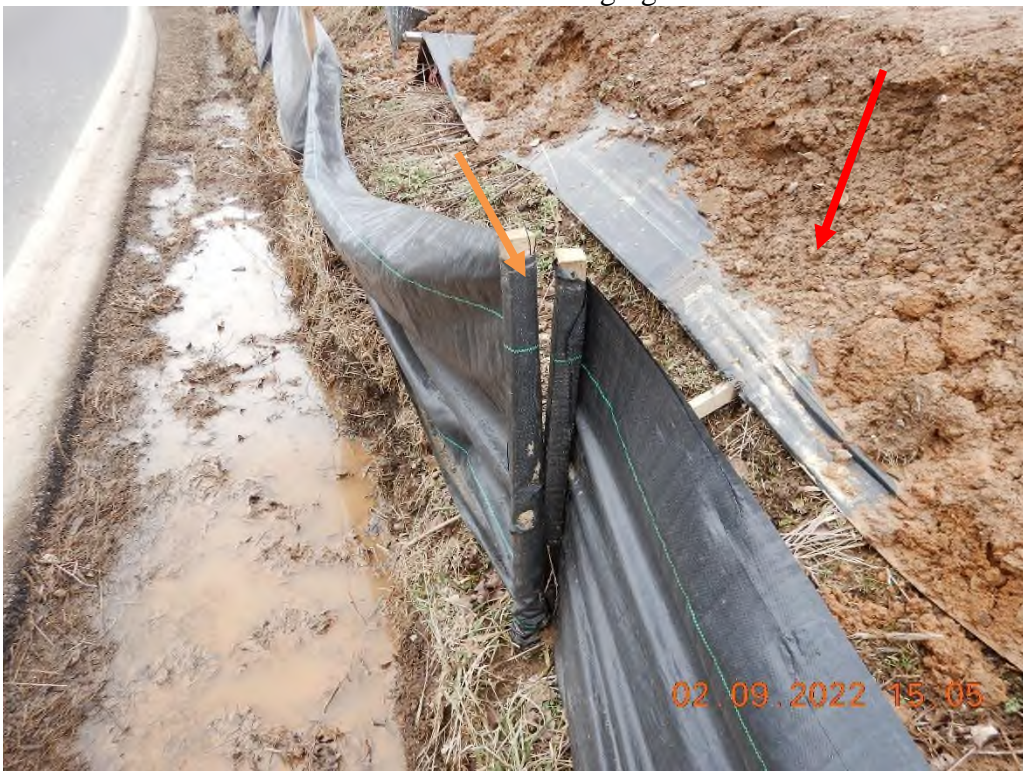
Silt fence was not properly merged (orange arrow) and needed maintenance (red arrow).

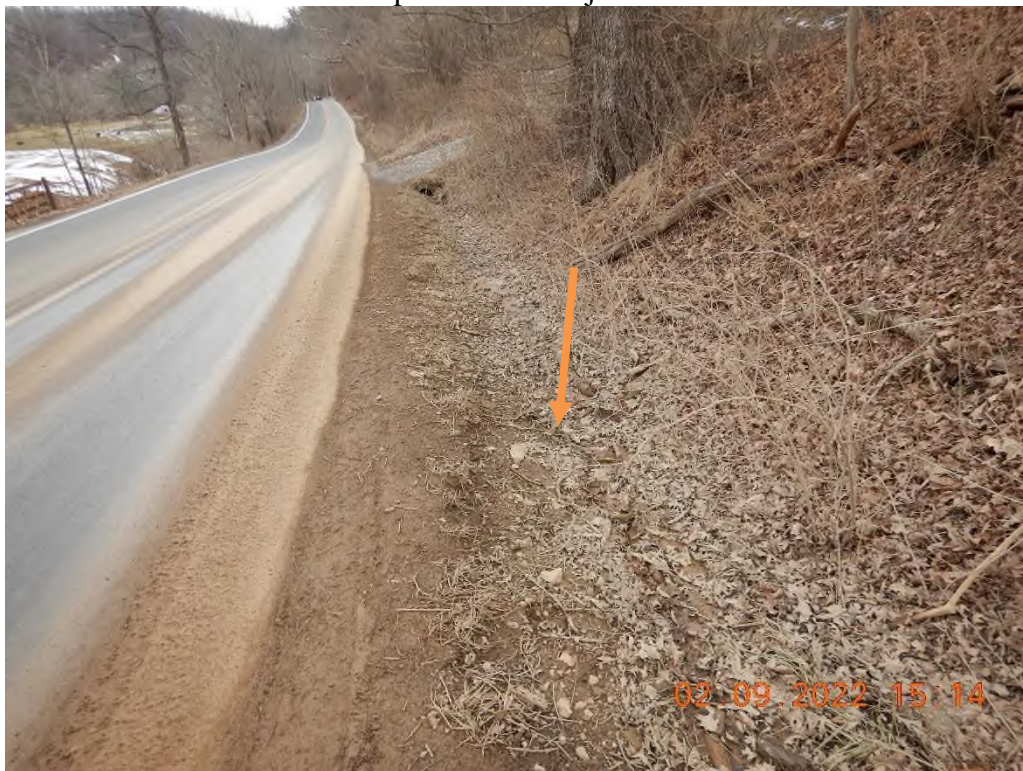
Sediment deposits.

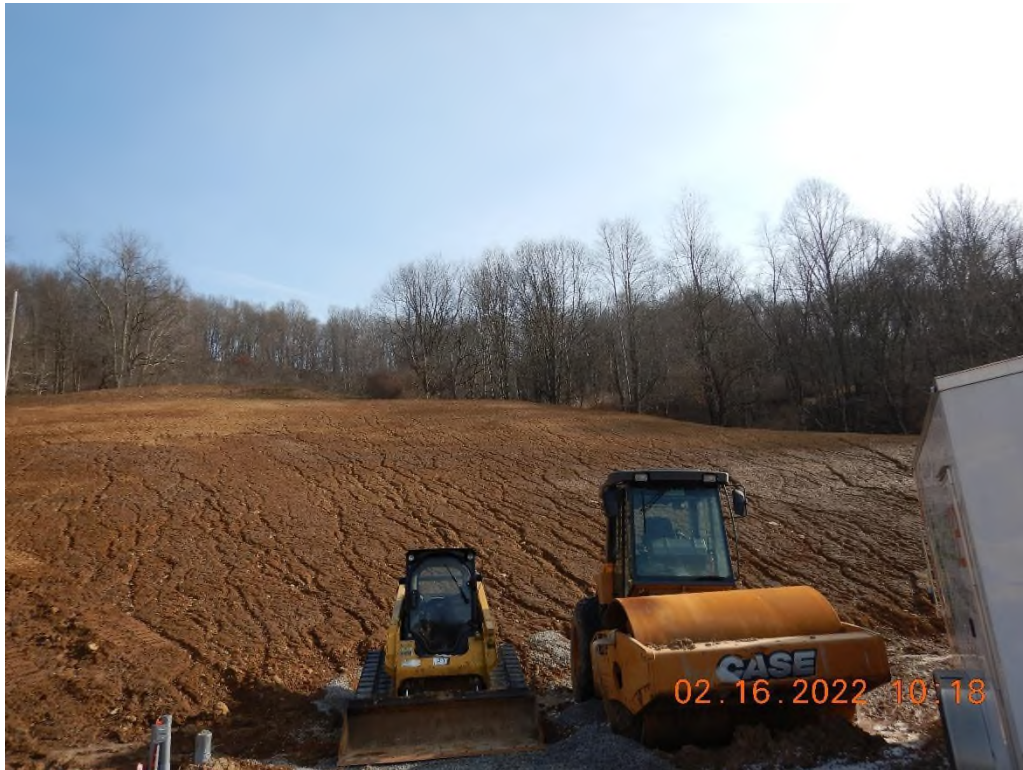
The eastern portion of the site with no temporary stabilization.

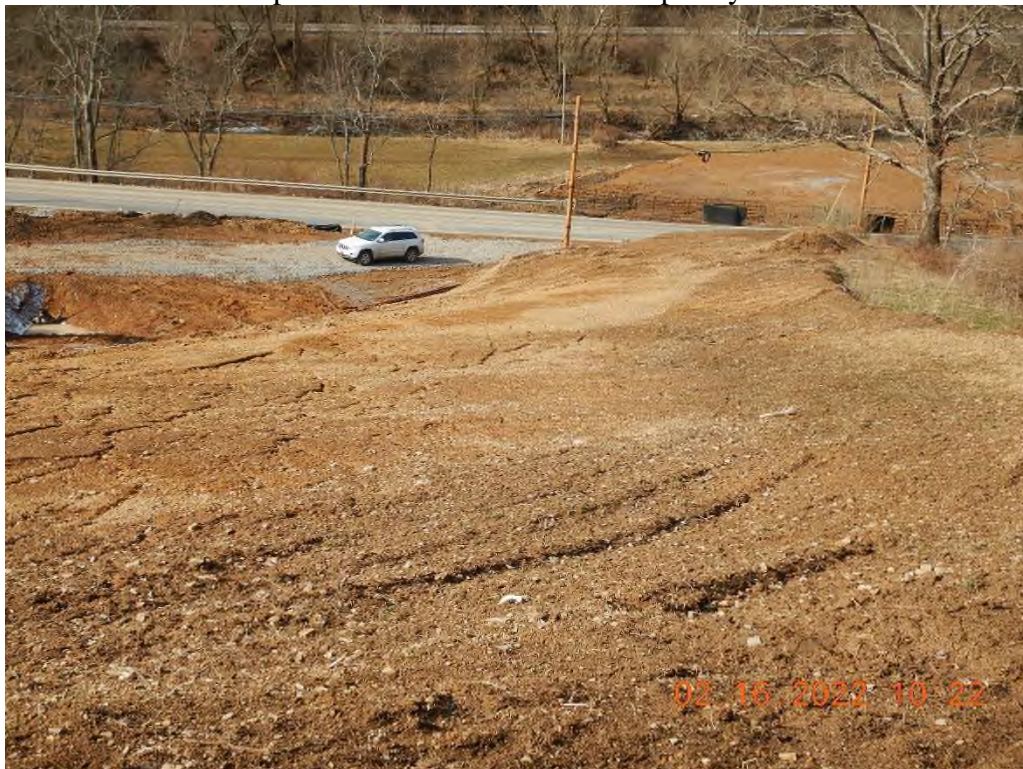
The slip area, showing the lack of temporary stabilization.

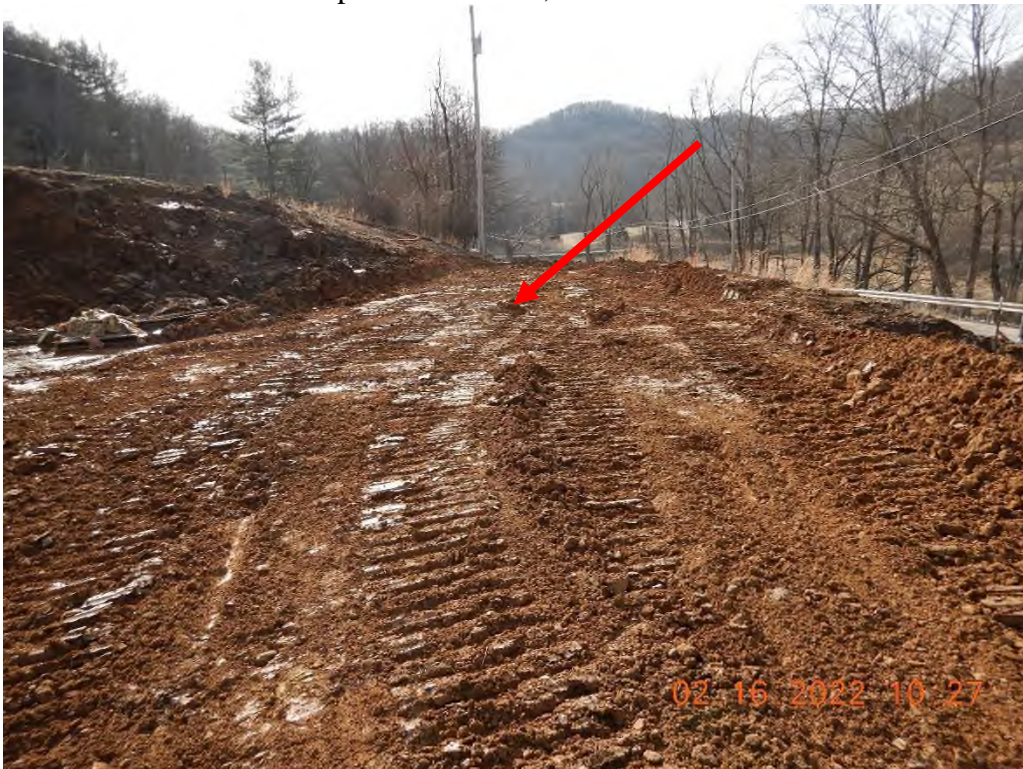
Sediment Trap 2 not installed, as stated in the SWPPP.

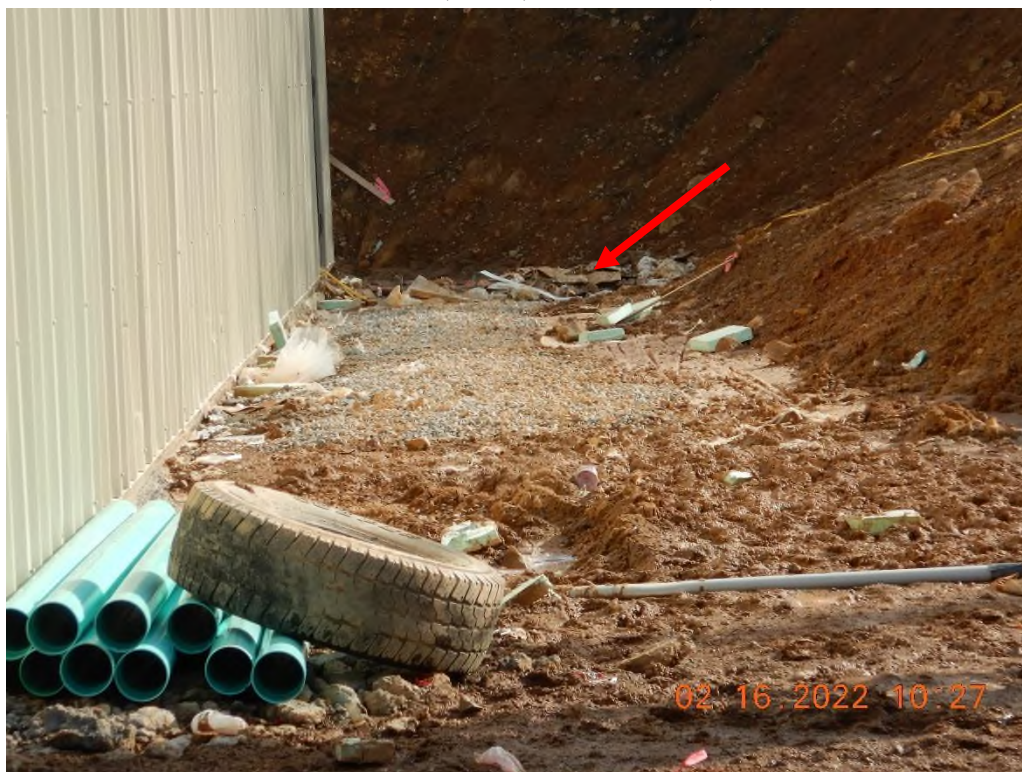
Solid waste.

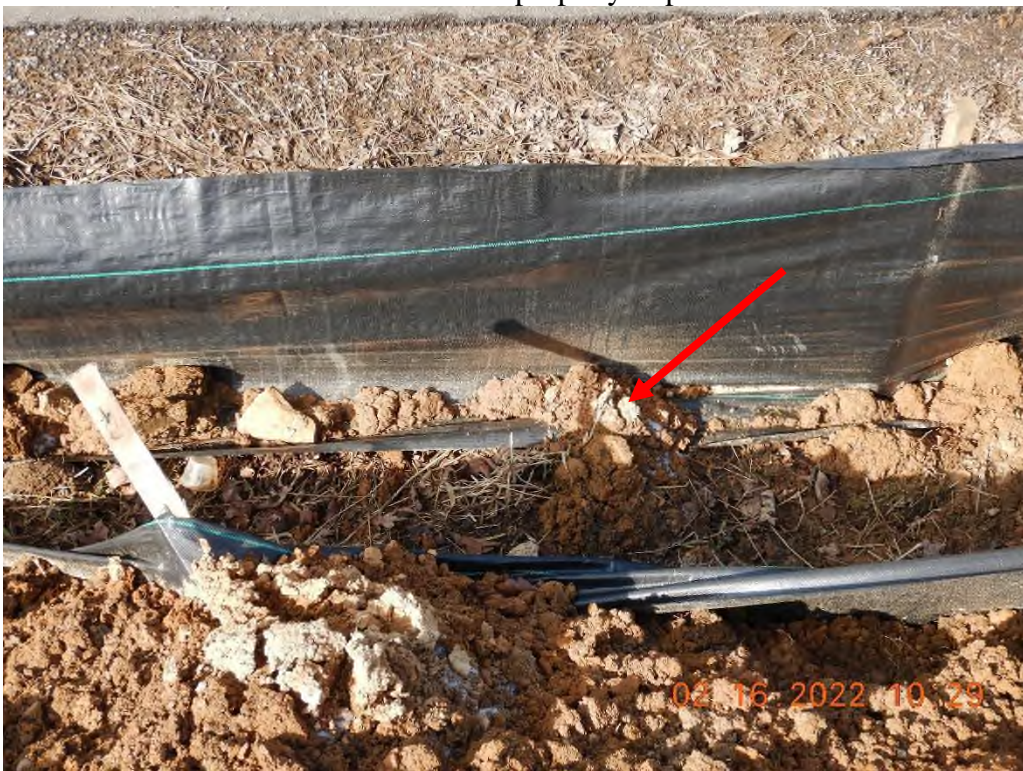
Silt fence not properly toed into the ground.

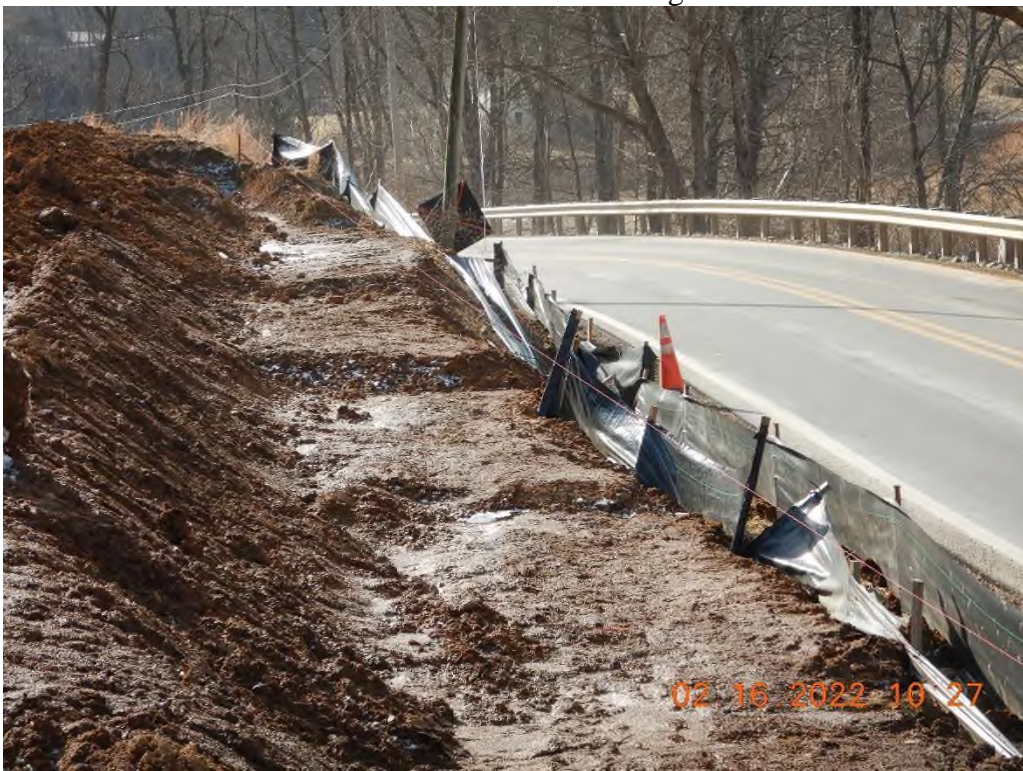
Multiple pieces of silt fence needed maintenance.

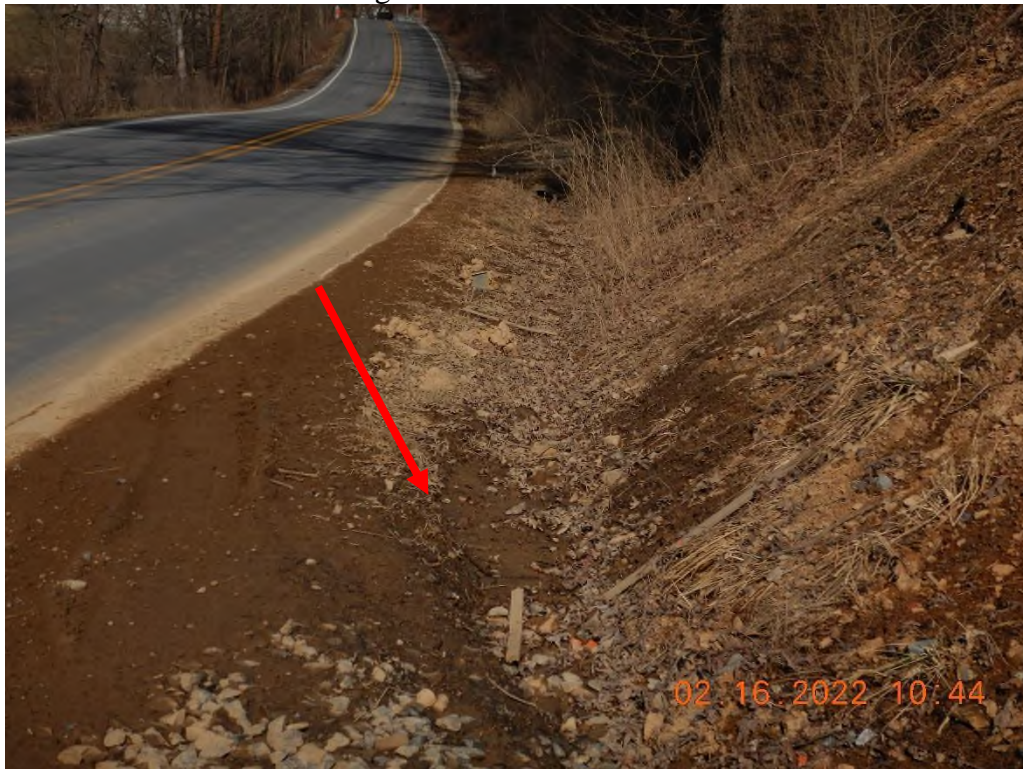
Sediment deposits in the adjacent ditch line.

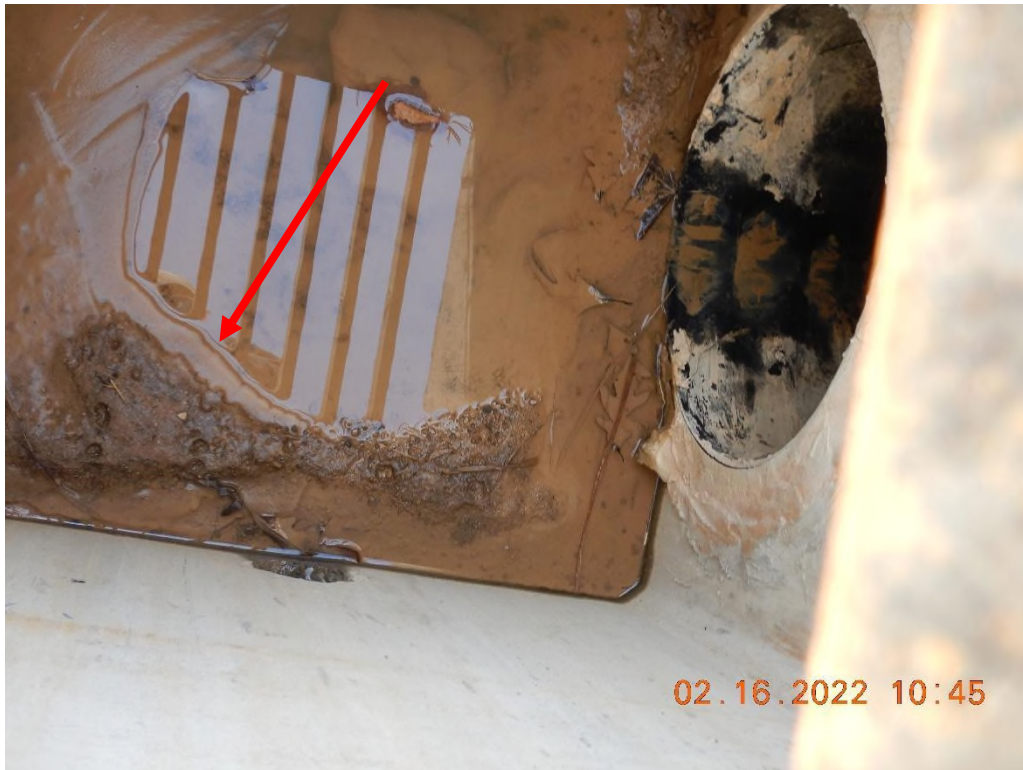
Sediment deposits in the bottom of the drop inlet. There is no drop inlet protection in place.

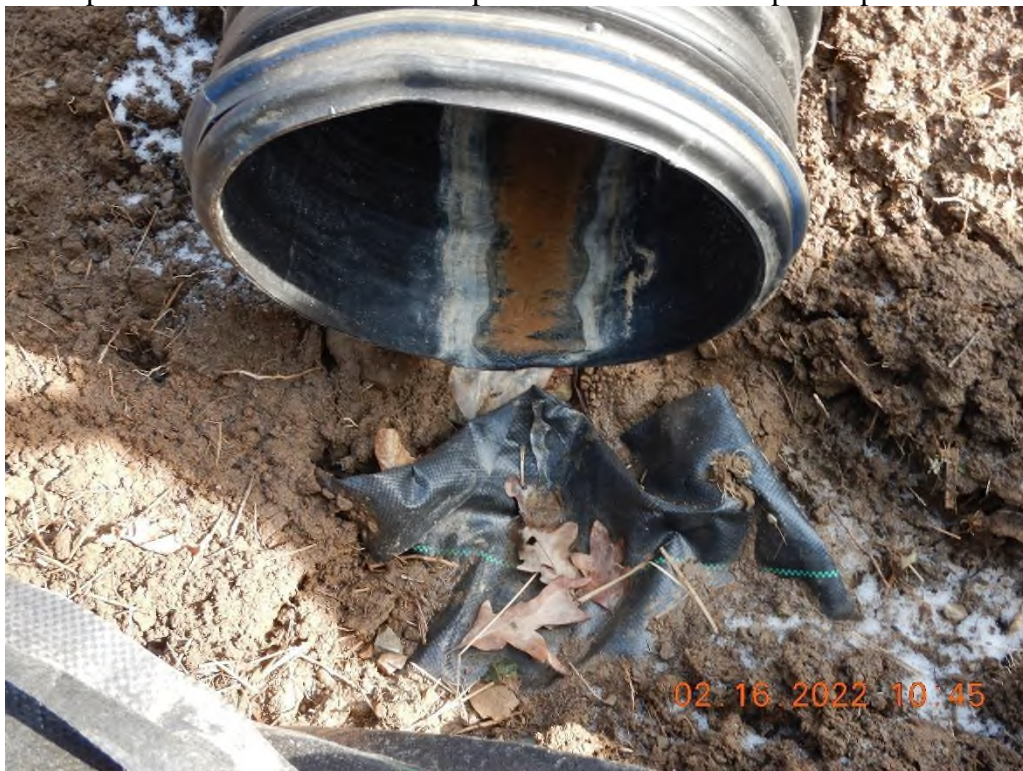
Silt fence installed in a concentrated flow area.

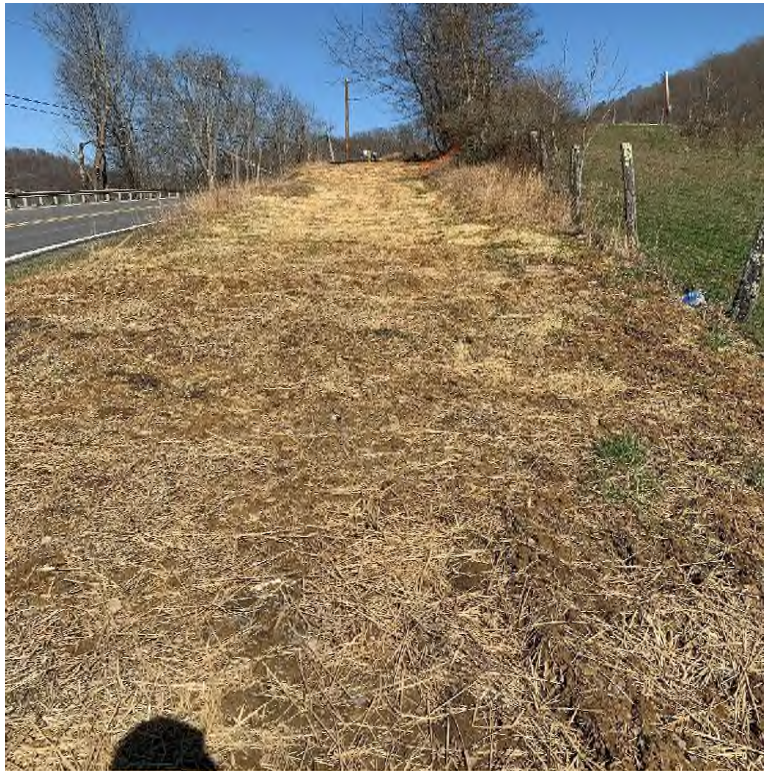
The Southern portion of the site, which was not included in the SWPPP.

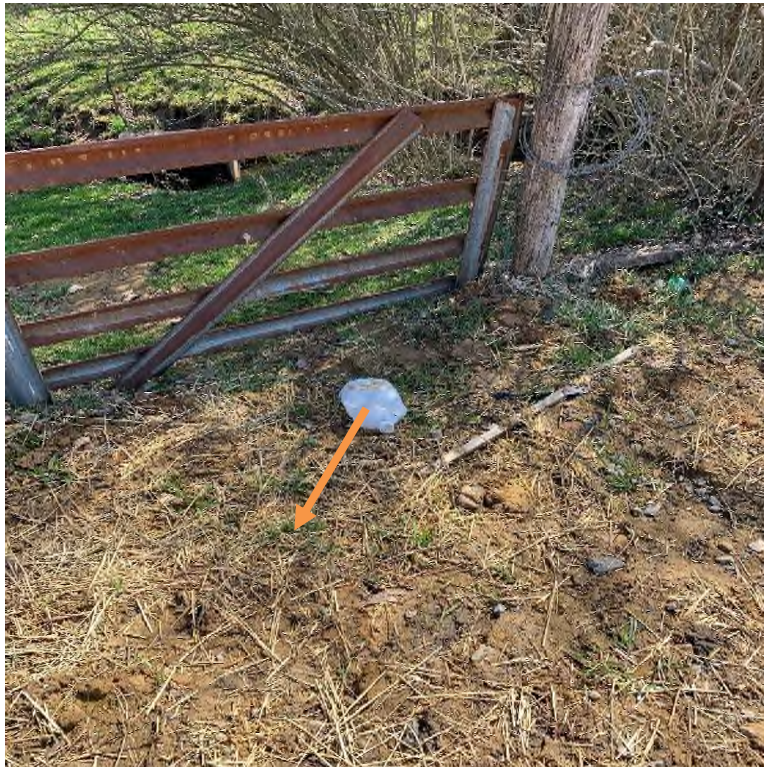
Perimeter controls are not in place, and sediment deposits were present beyond the permitted LOD; however, the SWPPP had not been modified.

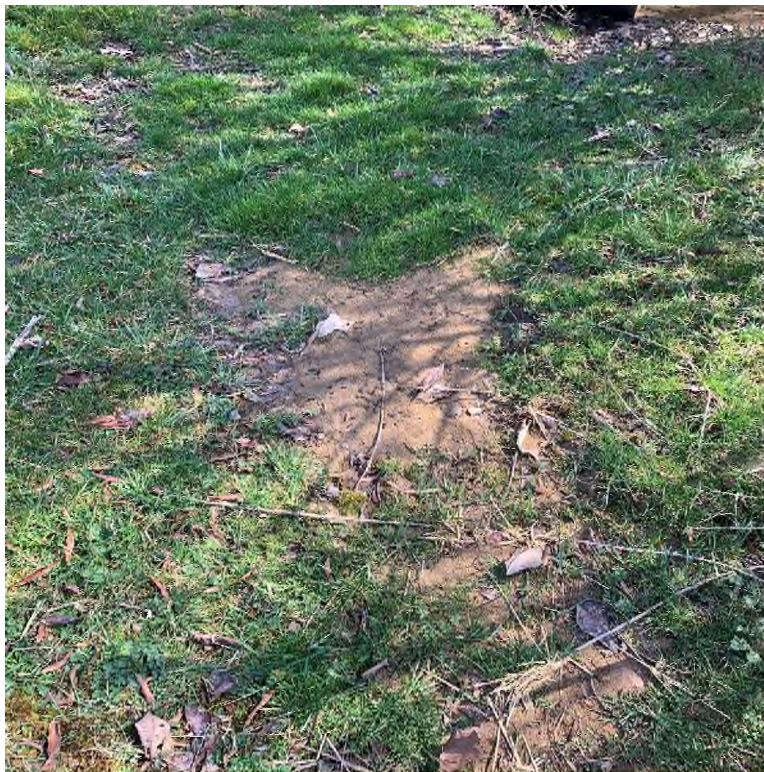
Off-site sediment deposits.

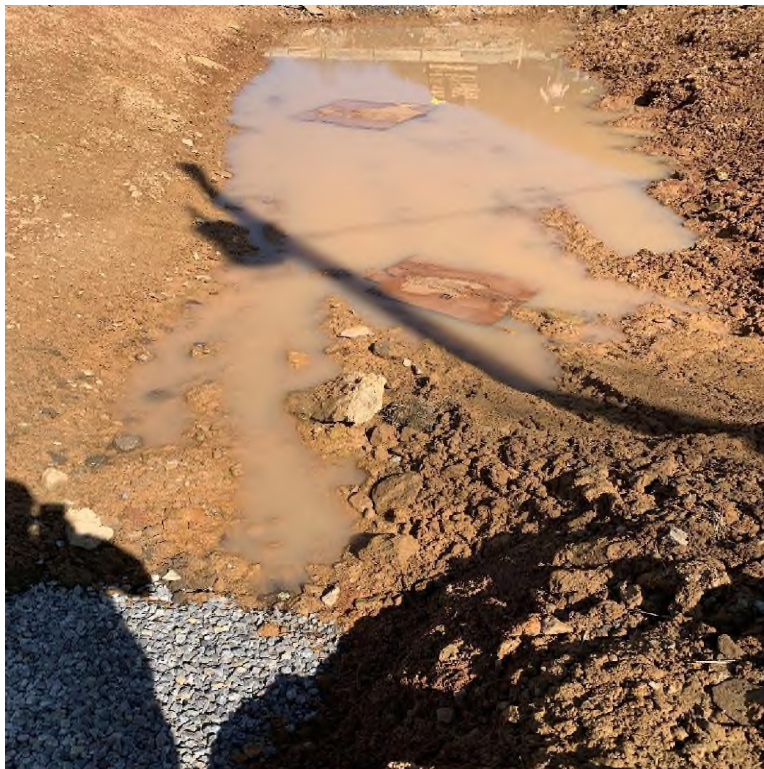
Area where Sediment Trap 2 should have been installed.

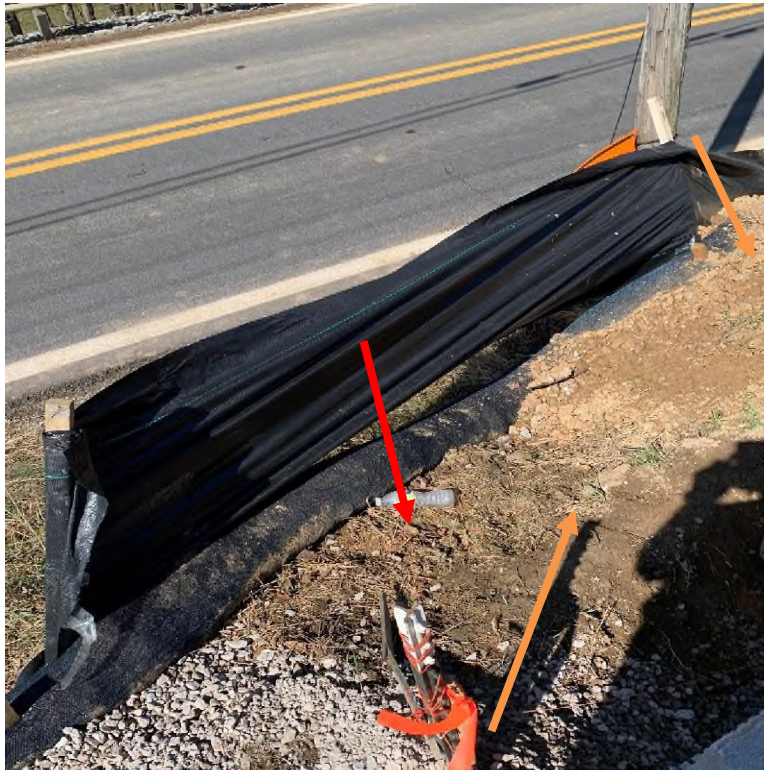
Compost filter sock that is in need of maintenance (orange arrow) and silt fence that was not properly implemented (red arrow).

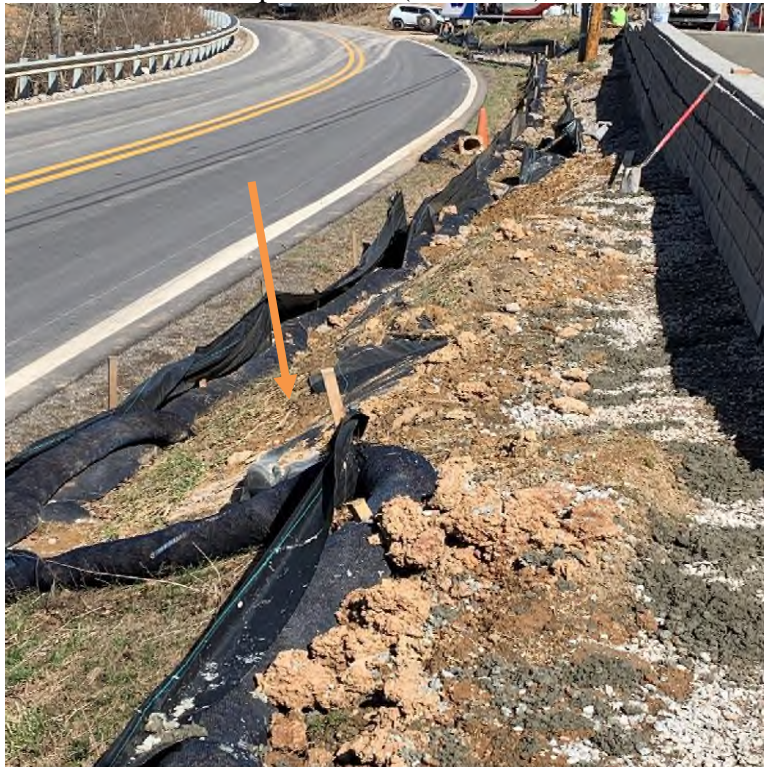
Silt fence that is in need of maintenance.

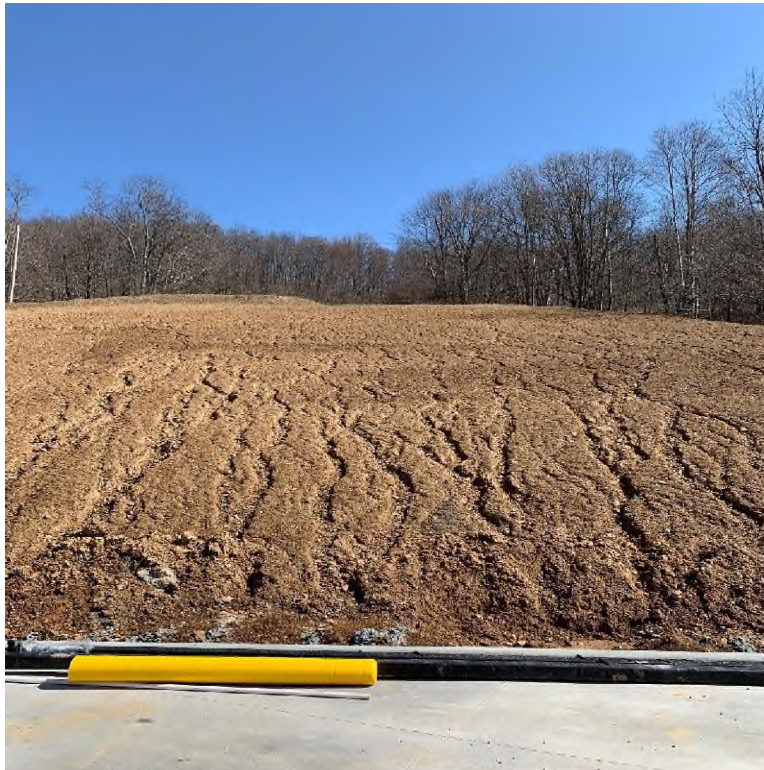
Earthen slip area on the eastern portion of the site, without temporary stabilization.

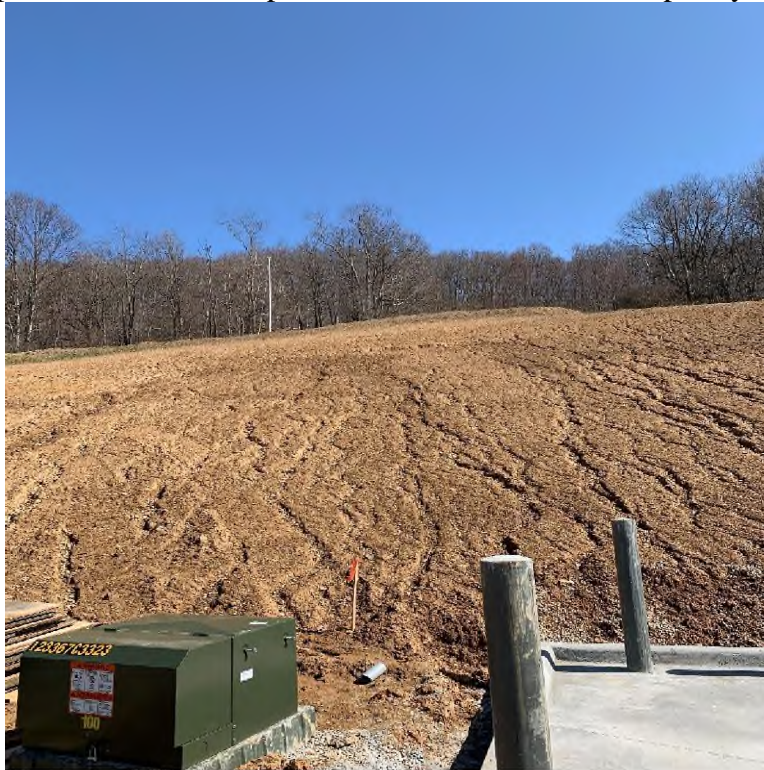
A continuation of the earthen slip area that has not been temporarily stabilized.

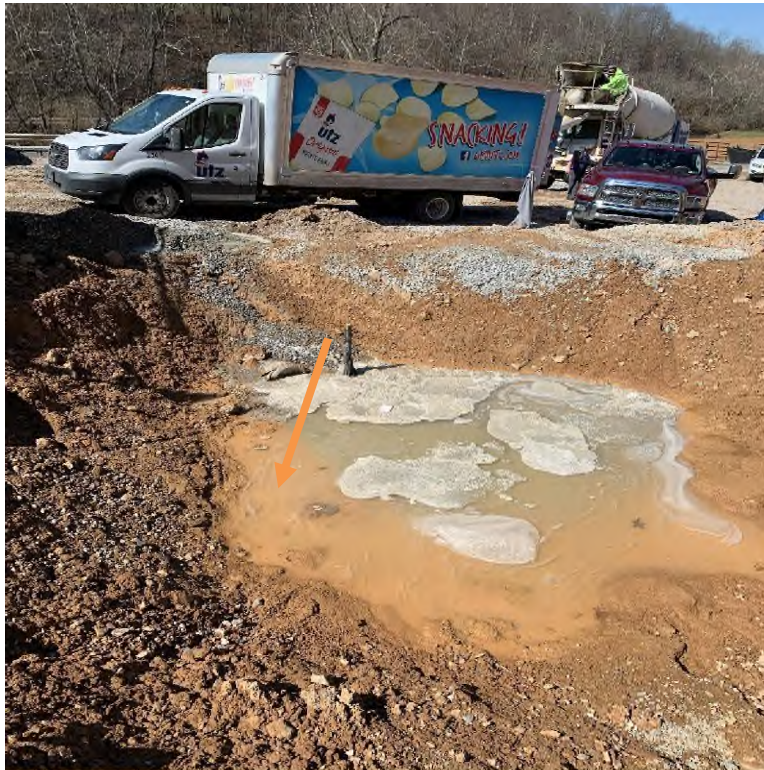
The area where Sediment Trap 1 should have been installed. Concrete is being washed into the proposed Sediment Trap 1 area. The orange arrow indicates the culvert inlet that discharges toward a drop inlet adjacent to the project.

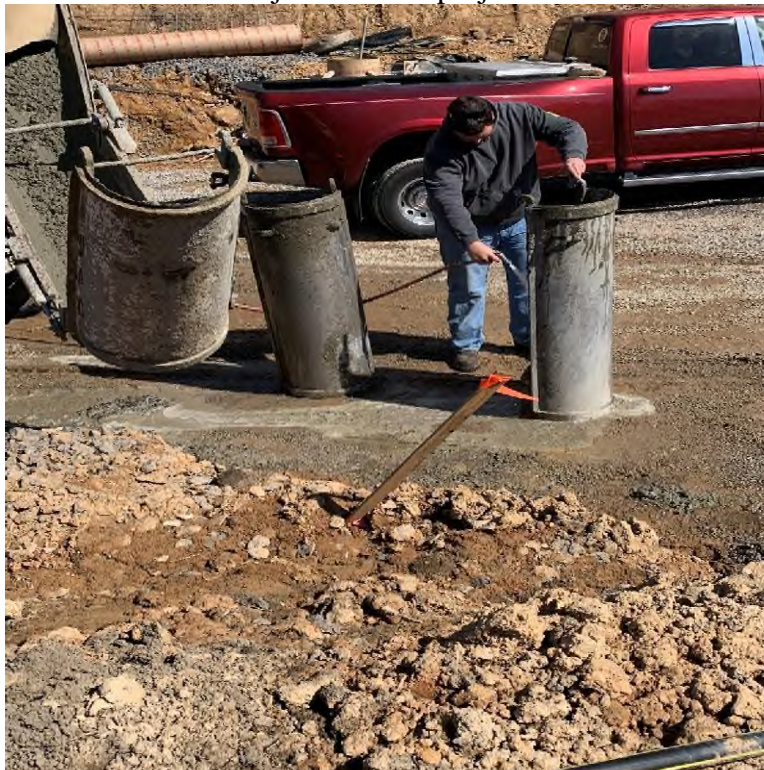
Washing concrete onto the ground, allowing it to integrate with storm water.

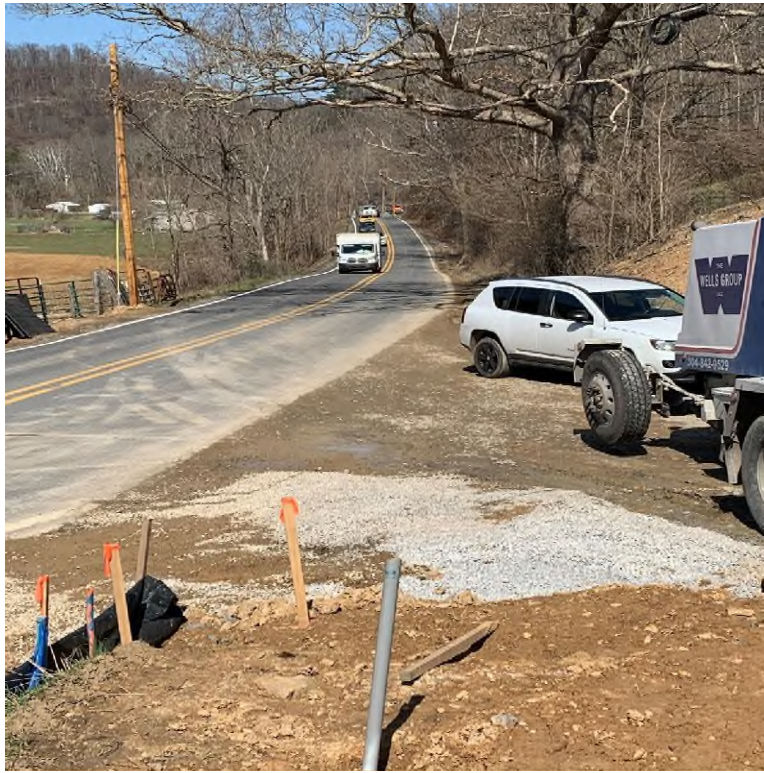
The non-stabilized construction entrance, with track-out onto a public roadway (WV-20).

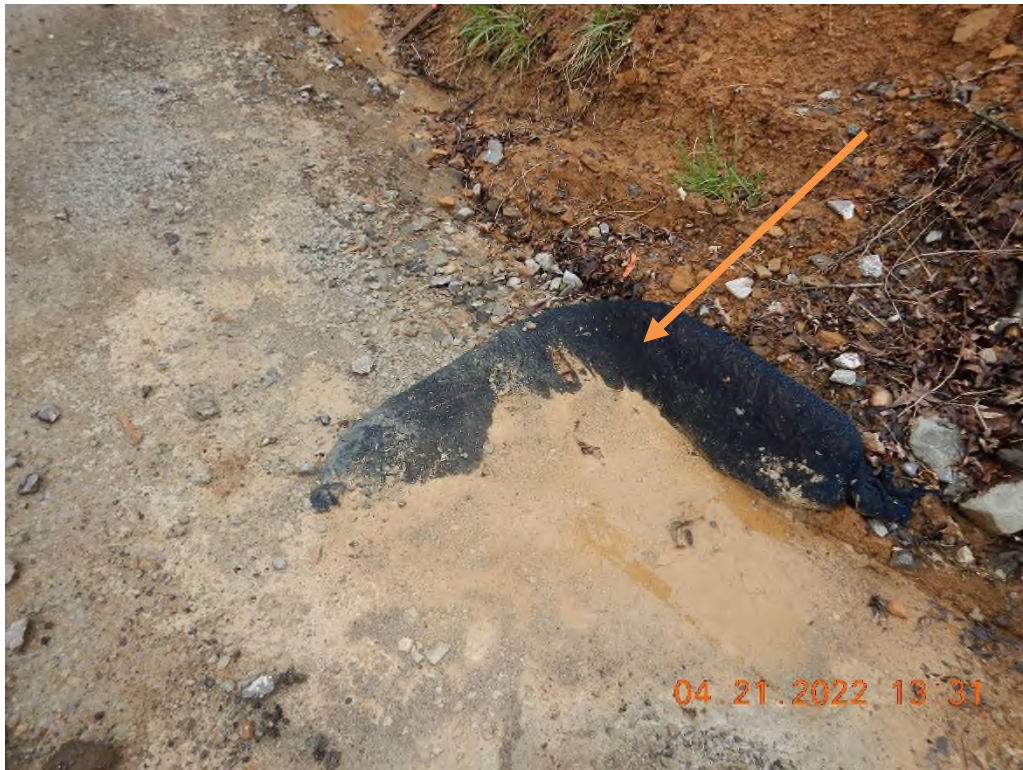
A compost filter sock that was not properly implemented and required staking.

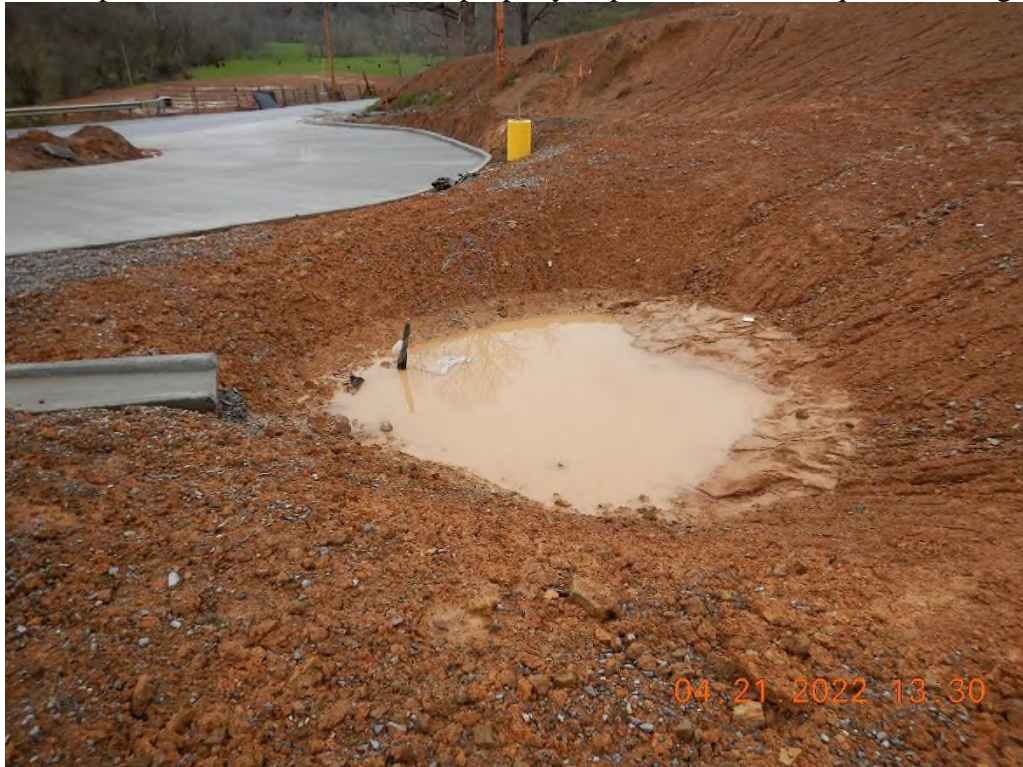
The area where Proposed Sediment Trap 1 should have been installed.

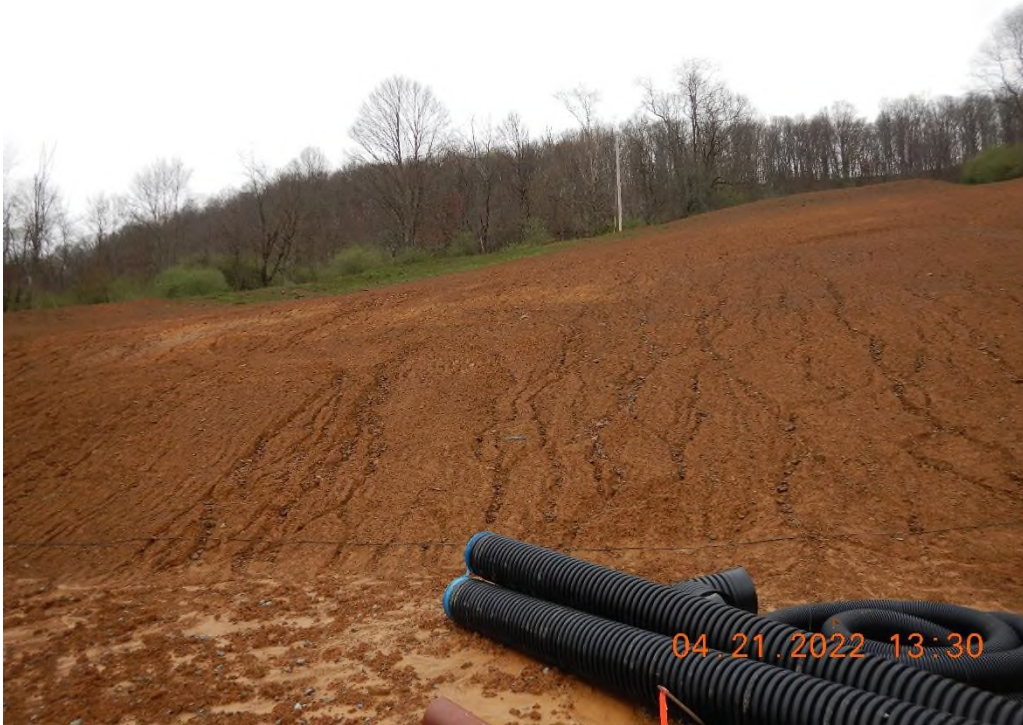
The earthen slip area on the eastern portion of the site, with no temporary stabilization.

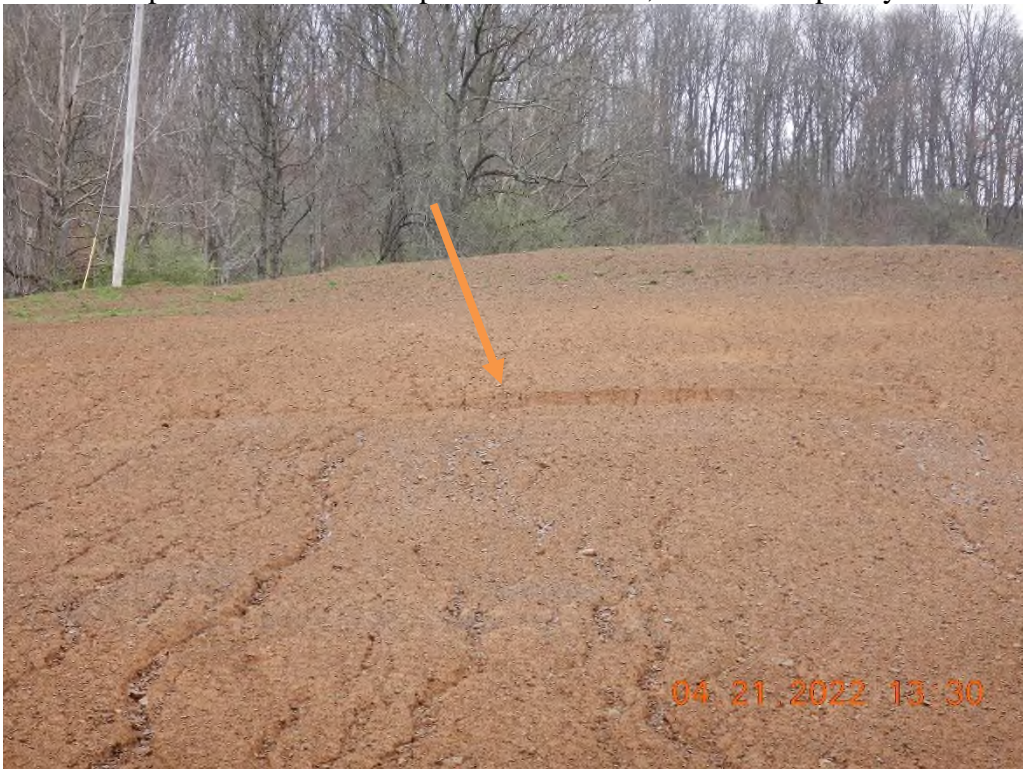
Sloughing on the earthen slip area on the eastern portion of the site.

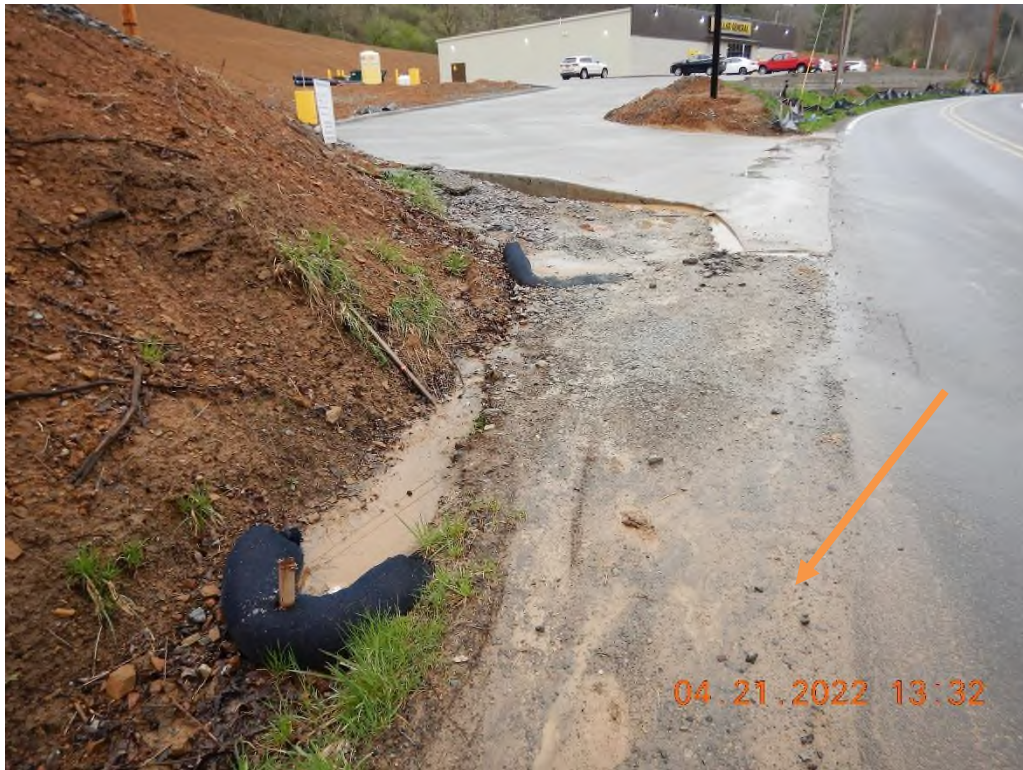
Evidence of sediment laden water leaving the site.
