**CONSENT ORDER
ISSUED UNDER THE
WATER POLLUTION CONTROL ACT
WEST VIRGINIA CODE CHAPTER 22, ARTICLE 11**

TO: CD DG Wallace, LLC
ATTN: Josh Allen
9461 Kenwood Road
Cincinnati, OH 45242

DATE: April 23, 2024

ORDER NO.: 10227

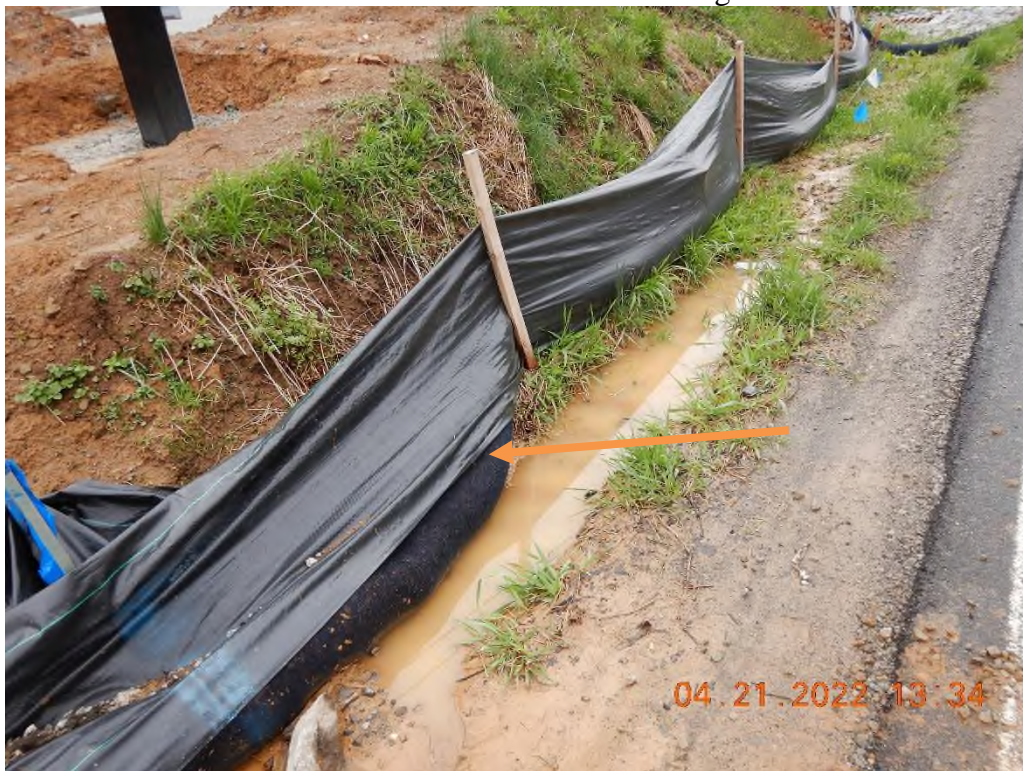
Silt fence was not toed into the ground.

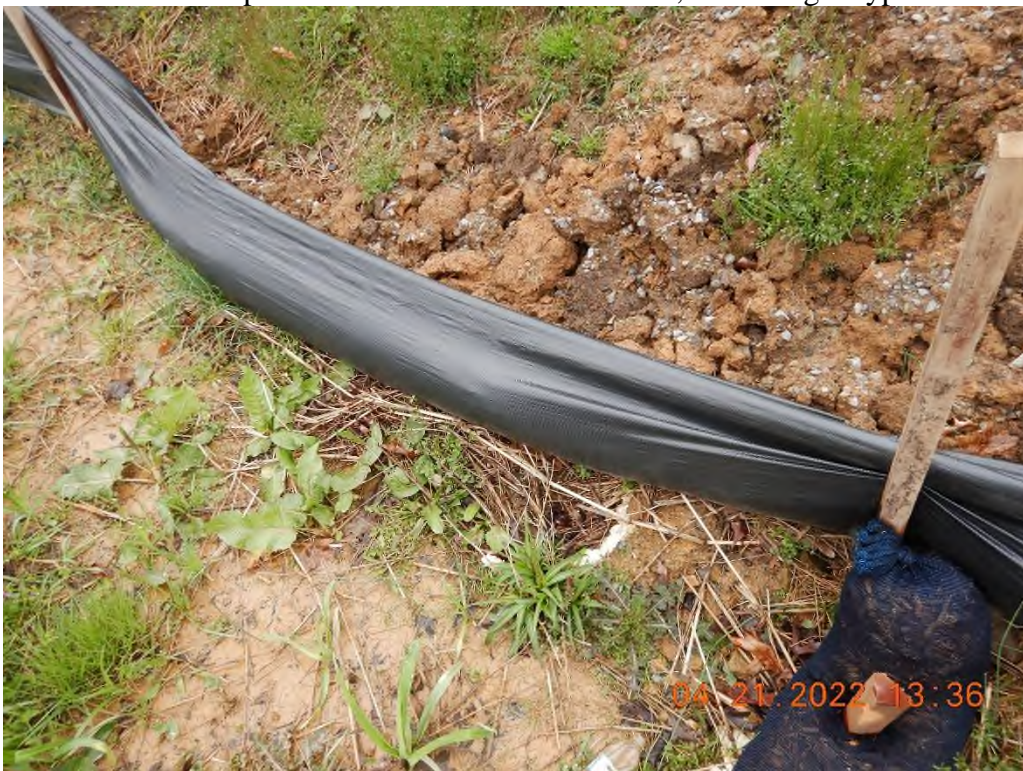
Silt fence needed maintenance.

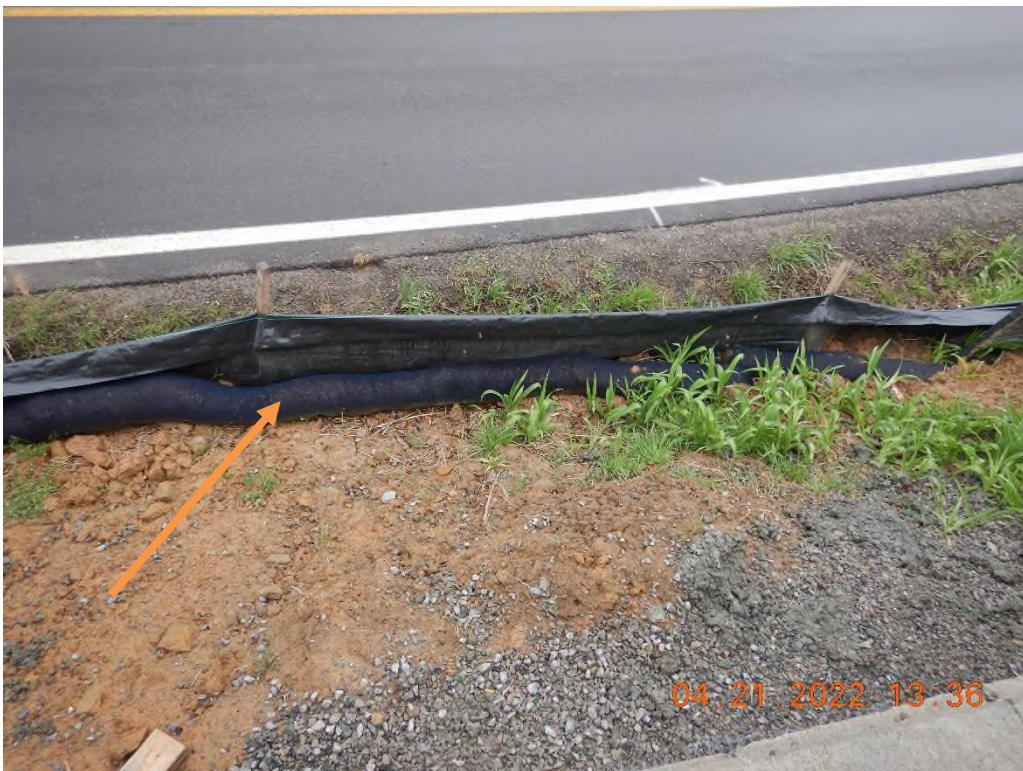
Compost filter sock that lacks the required staking.

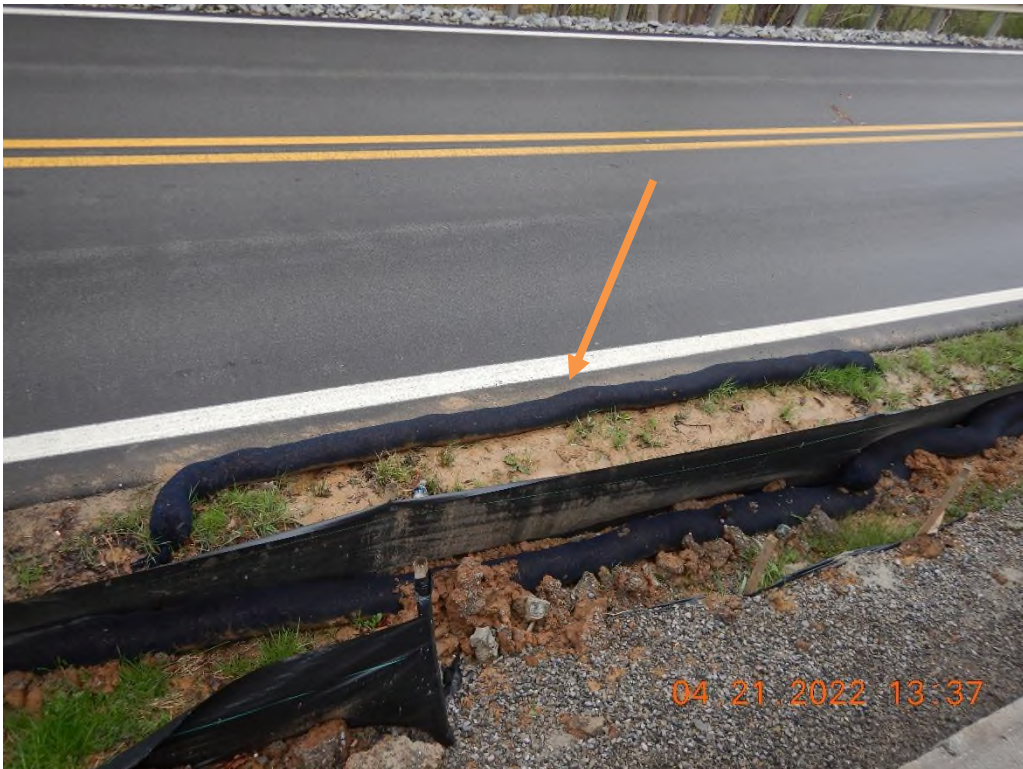
Compost filter sock lacking the required staking.

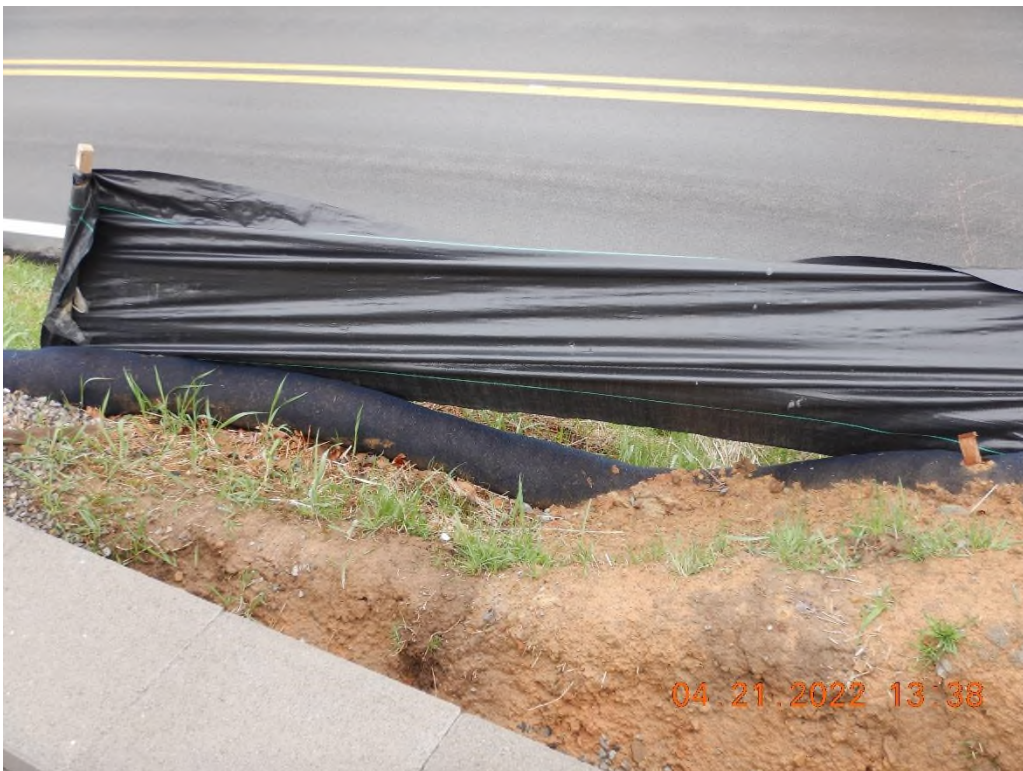
Silt fence was not properly toed into the ground.

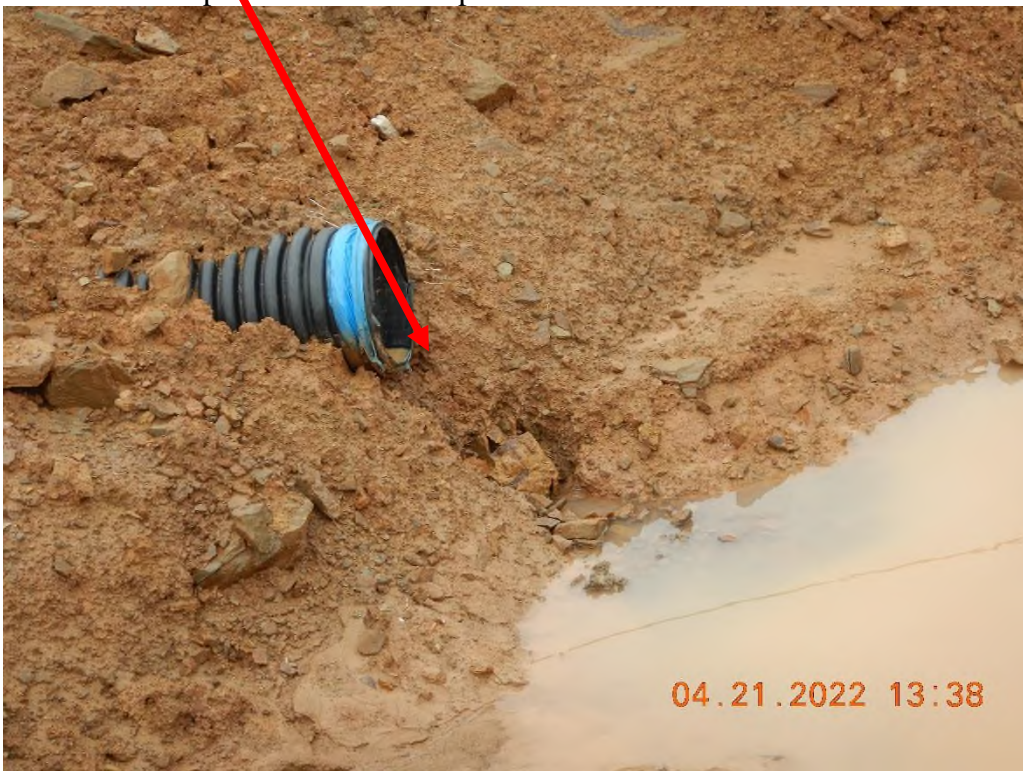
Unstable inlet.

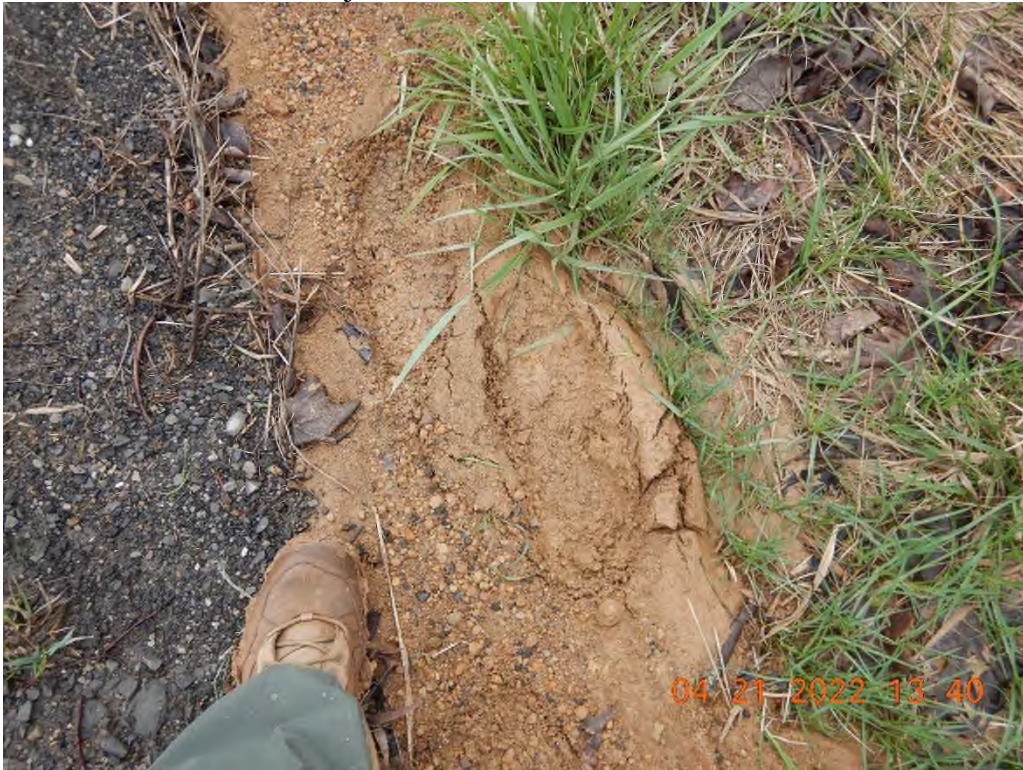
Fresh sediment deposits in the adjacent ditch.

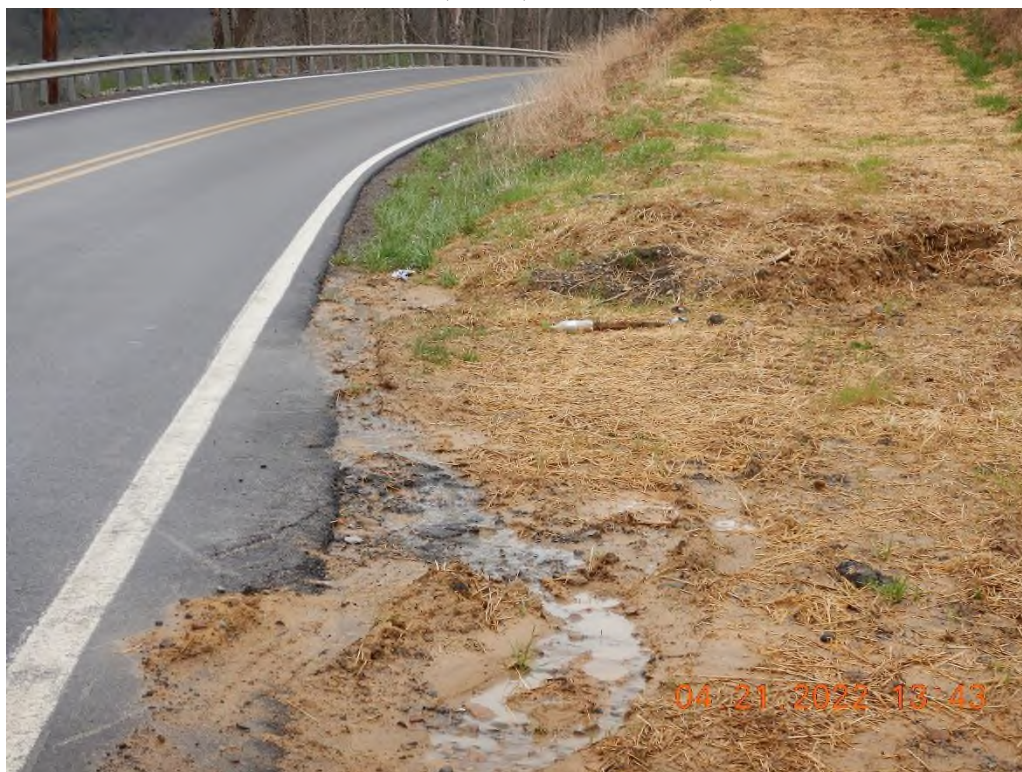
Looking toward the permitted project from the UNT of Little Tenmile Creek.

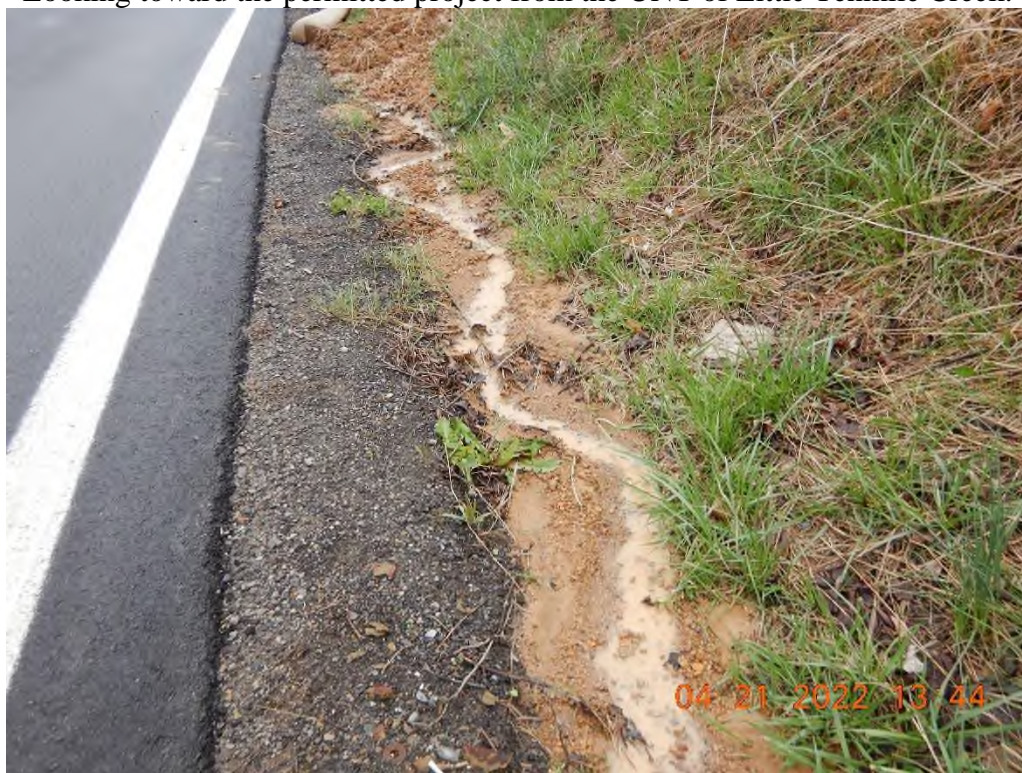
The ditch and the sediment and sediment laden water that has discharged into it.

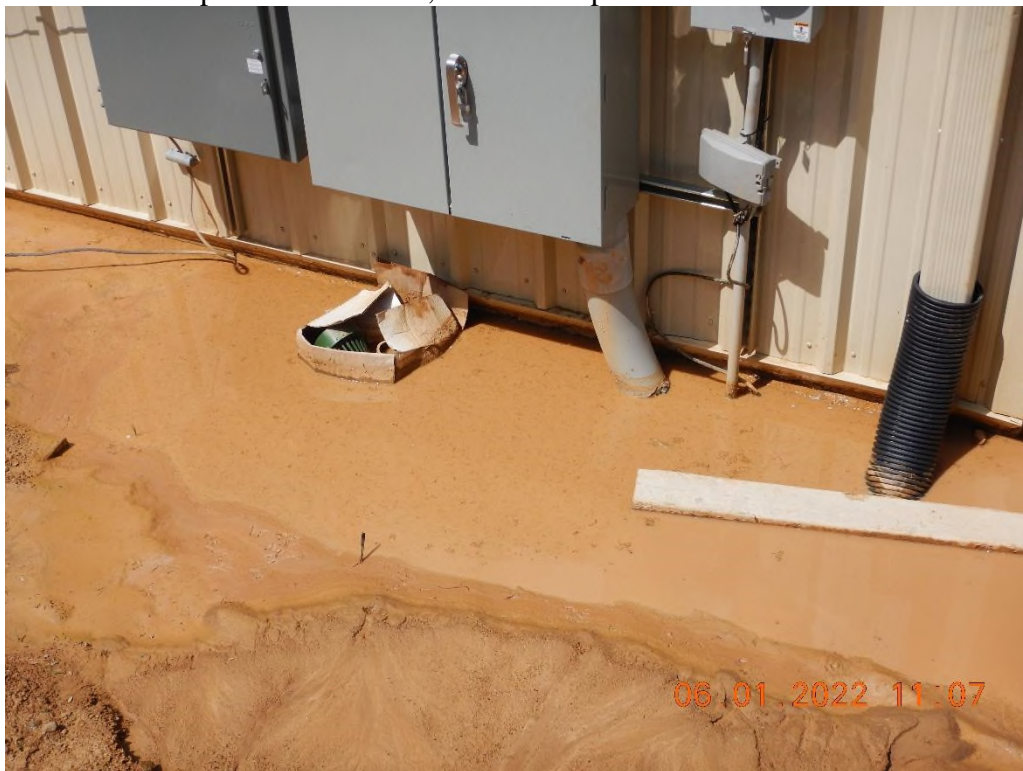
Sediment laden water that has started to pool against the building.

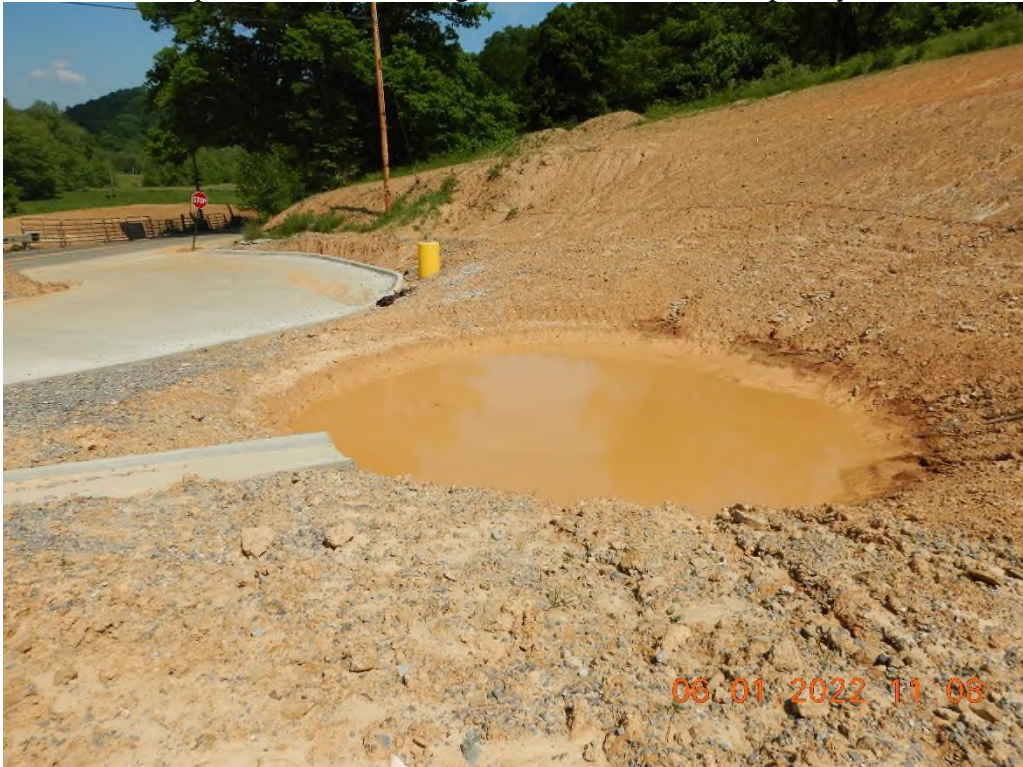
Sediment Trap 1 is not functional or fully installed.

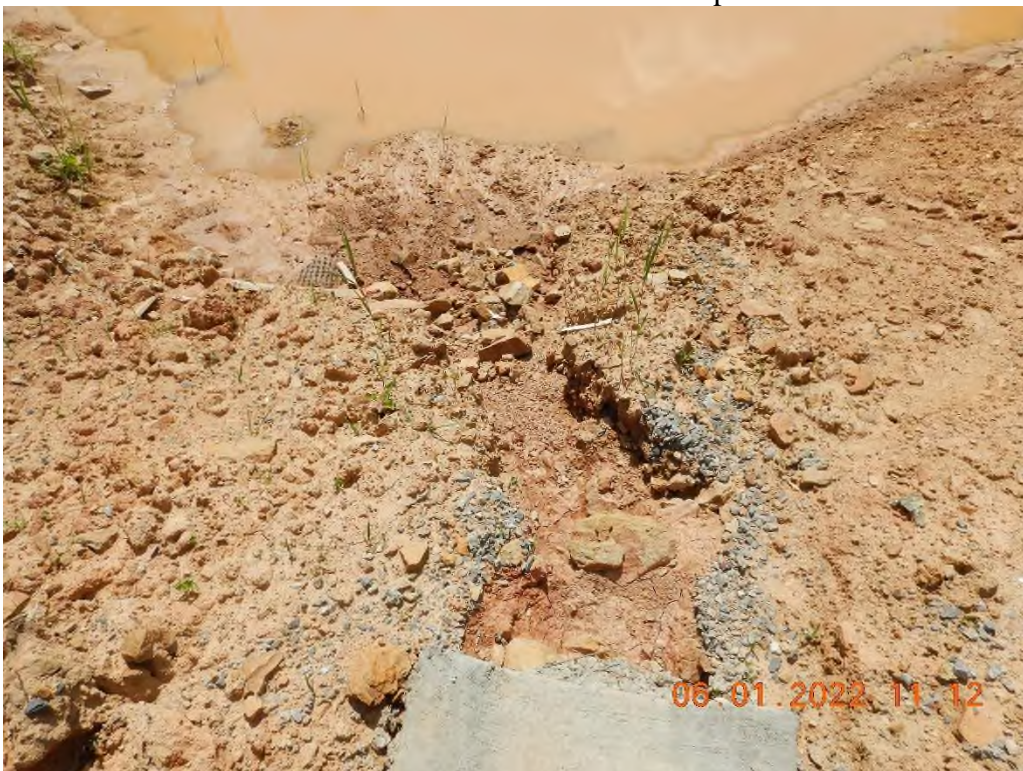
An unstable inlet for Sediment Trap 2.

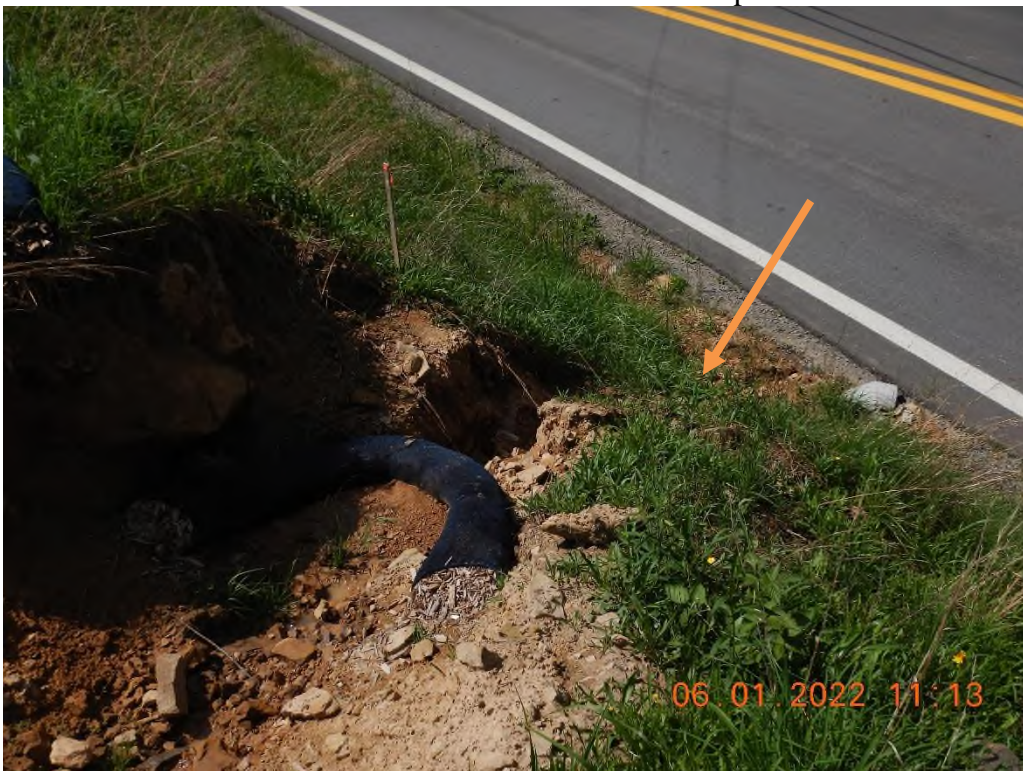
Sediment deposits discharging off the LOD.

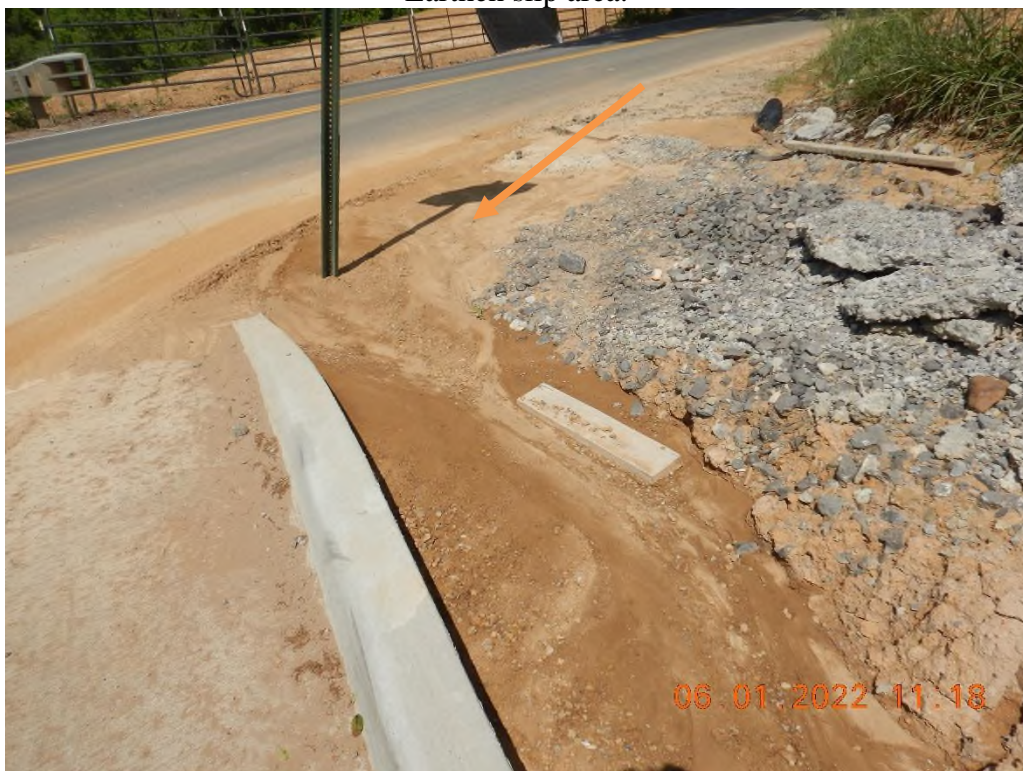
Sediment discharging off the LOD.

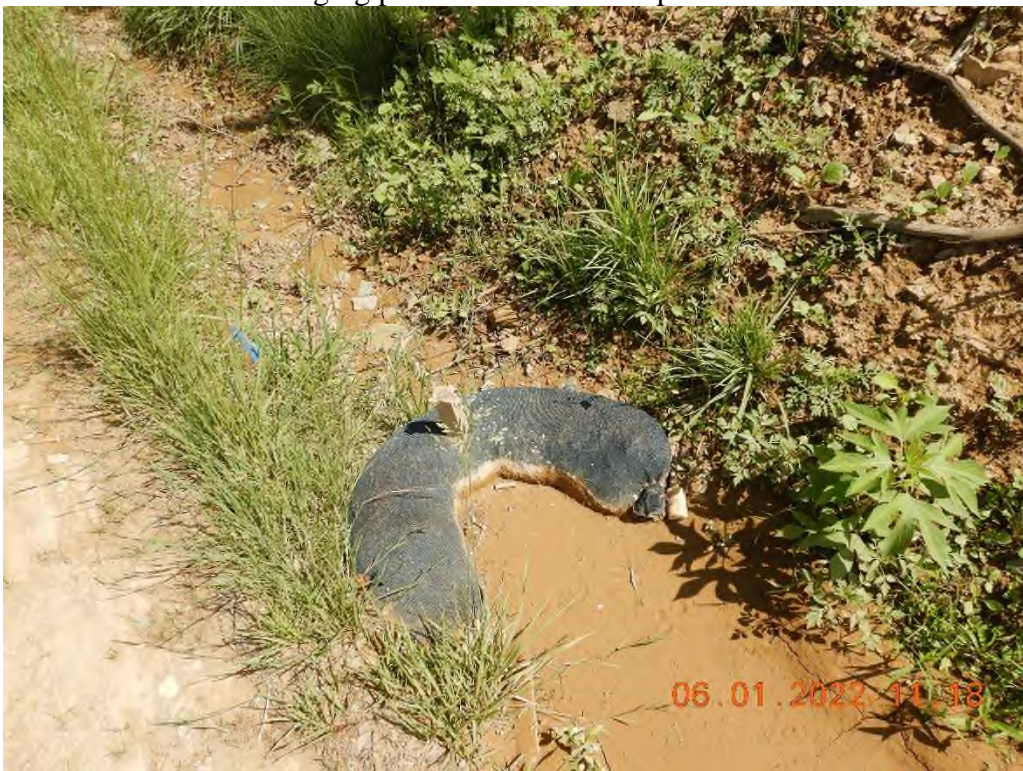
Sediment bypassing the compost filter sock, which needed maintenance.

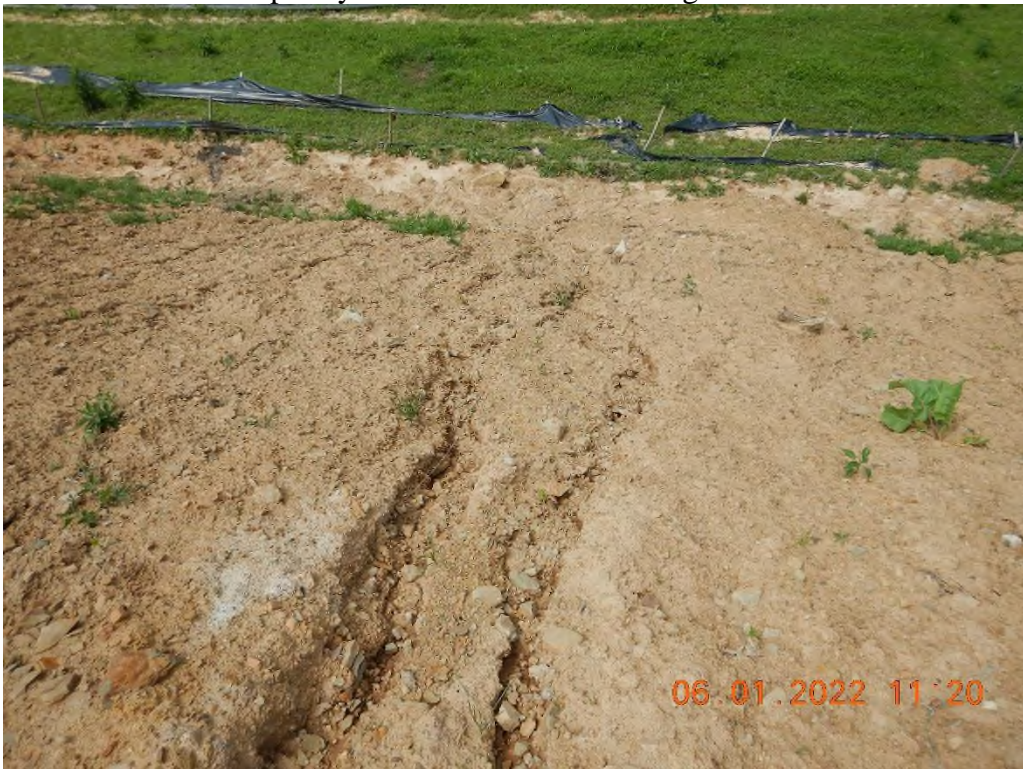
Waste area.

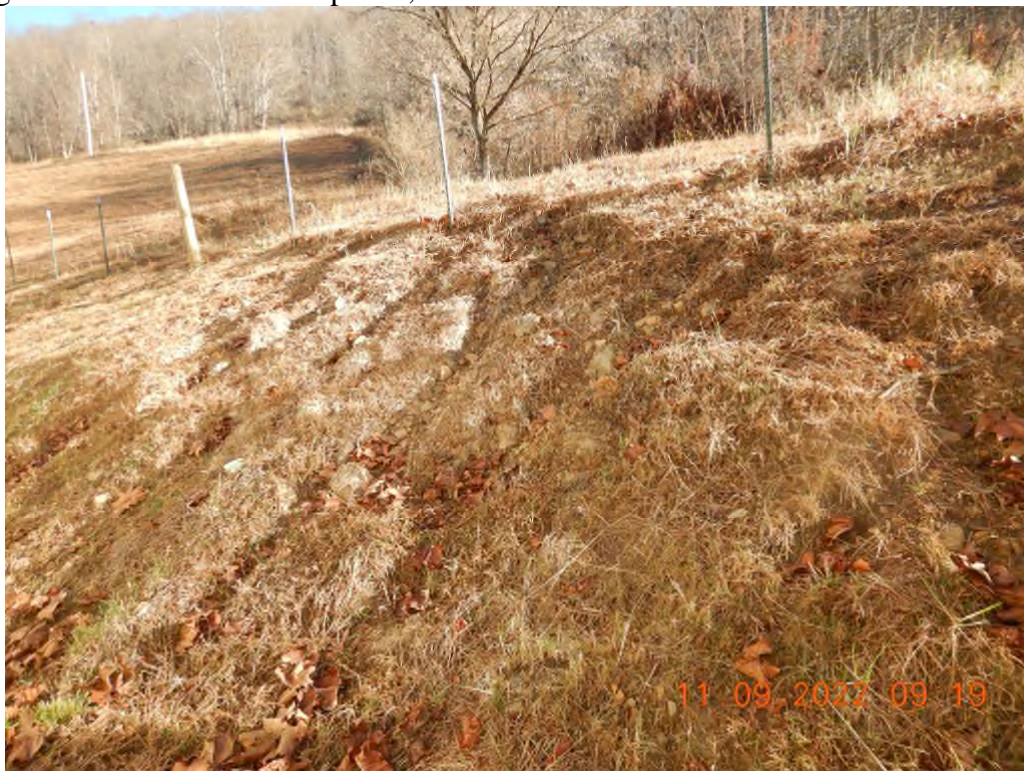
A portion of the hill behind the building, with erosion gullies due to concentrated flow across a non-stabilized area.

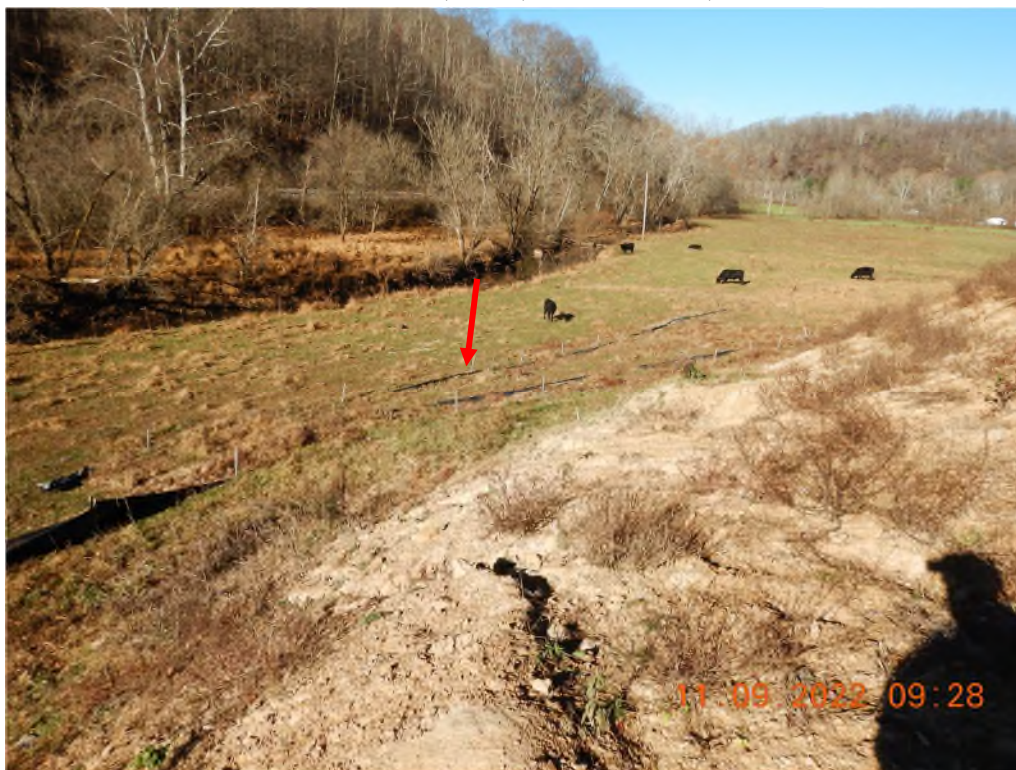
Silt fence needed maintenance at the waste area, allowing sediment laden water to leave the site untreated.

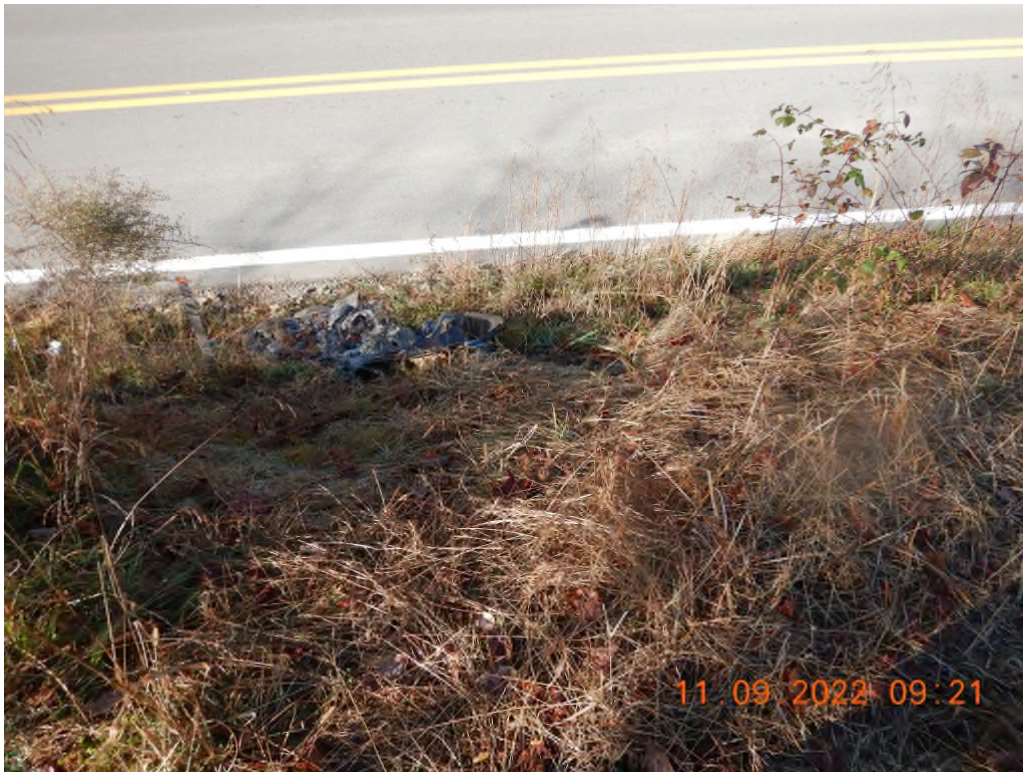
No outlet marker for Sediment Trap 2.

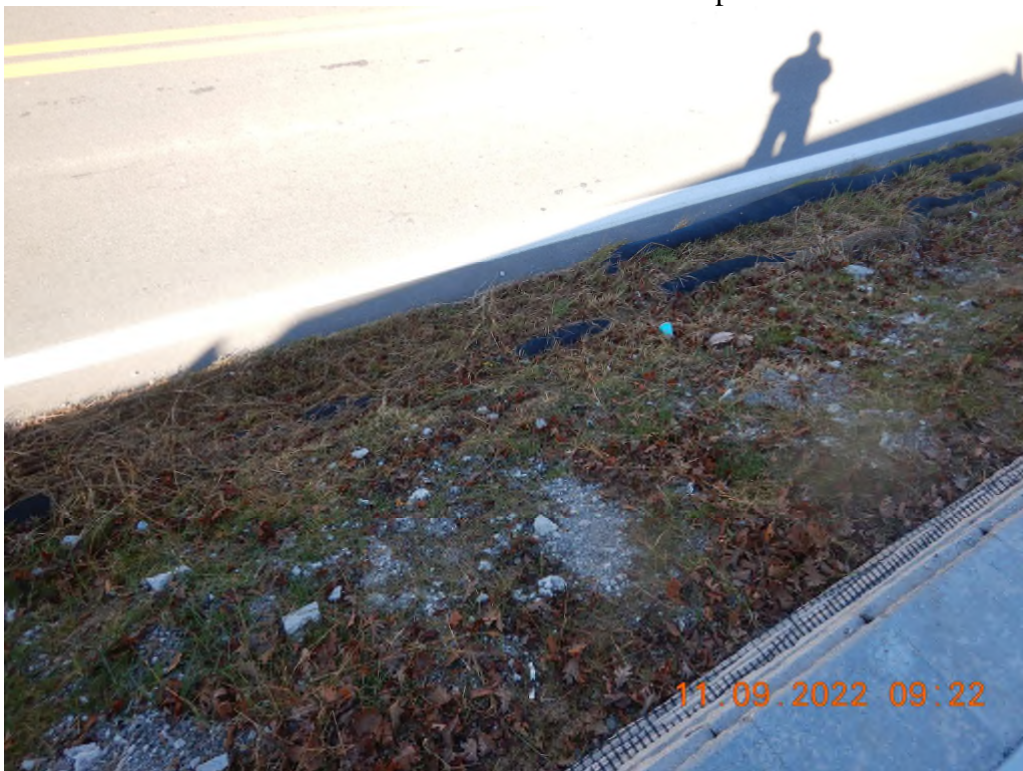
Compost filter sock lacking the required staking.

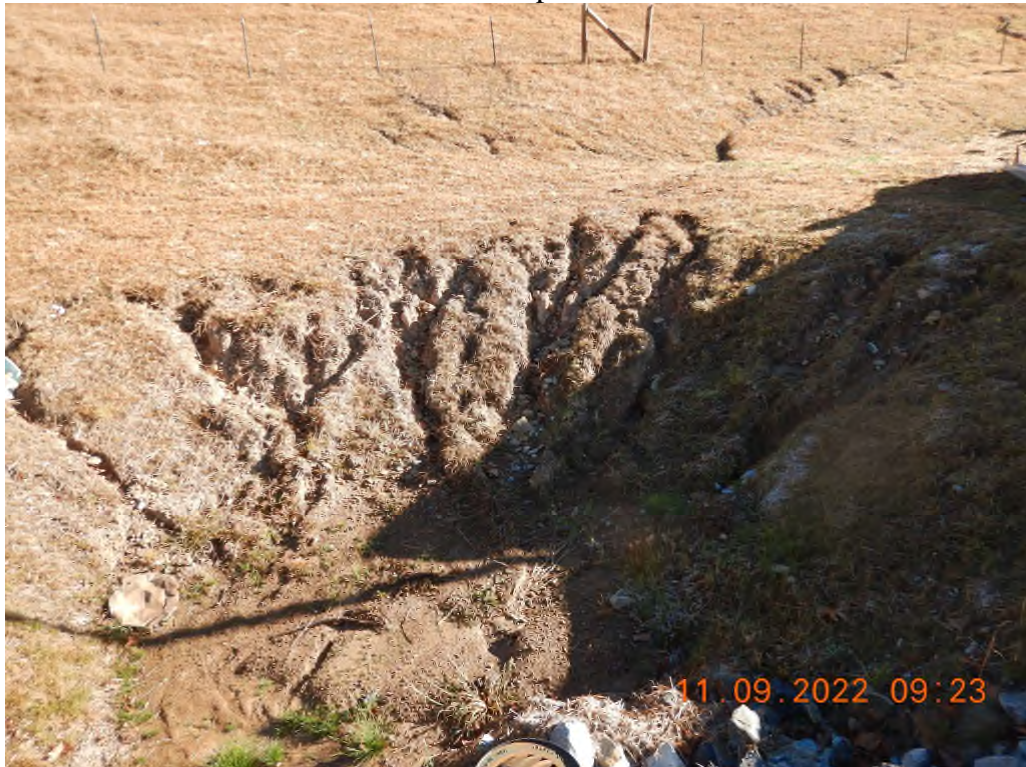
Unstable inlets to Sediment Trap 1.

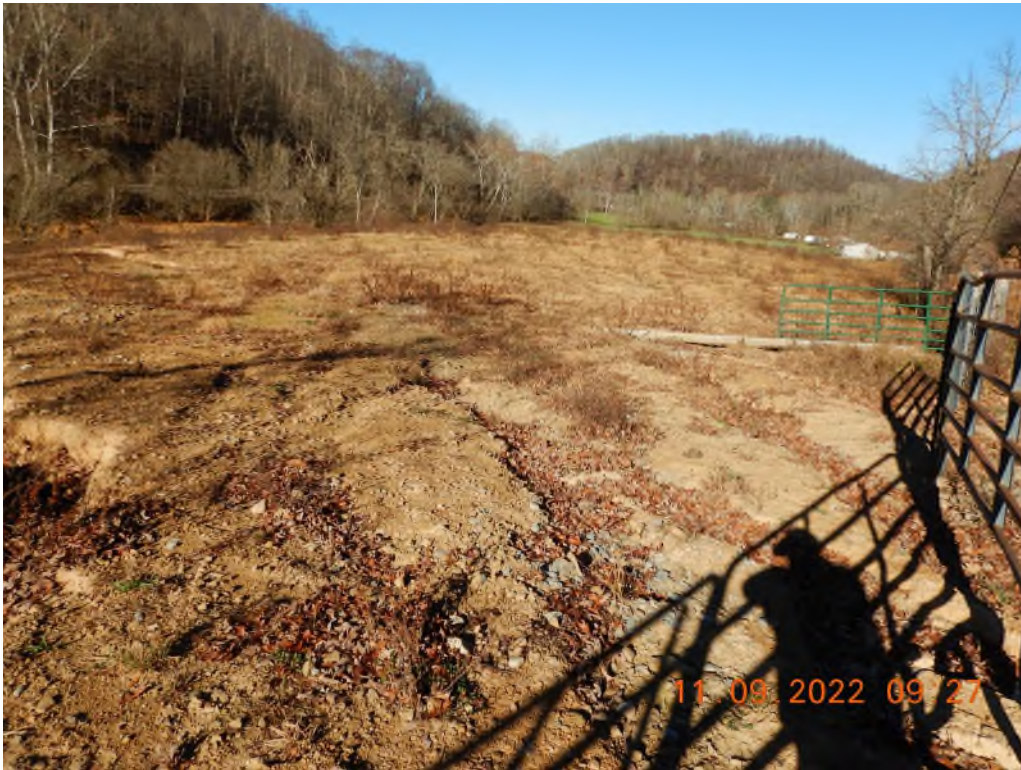
A photo taken from a previous inspection on 11/9/2022. As shown, vegetation had not germinated and there is no evidence of reseeded in the photo. Natural vegetation had started to germinate.

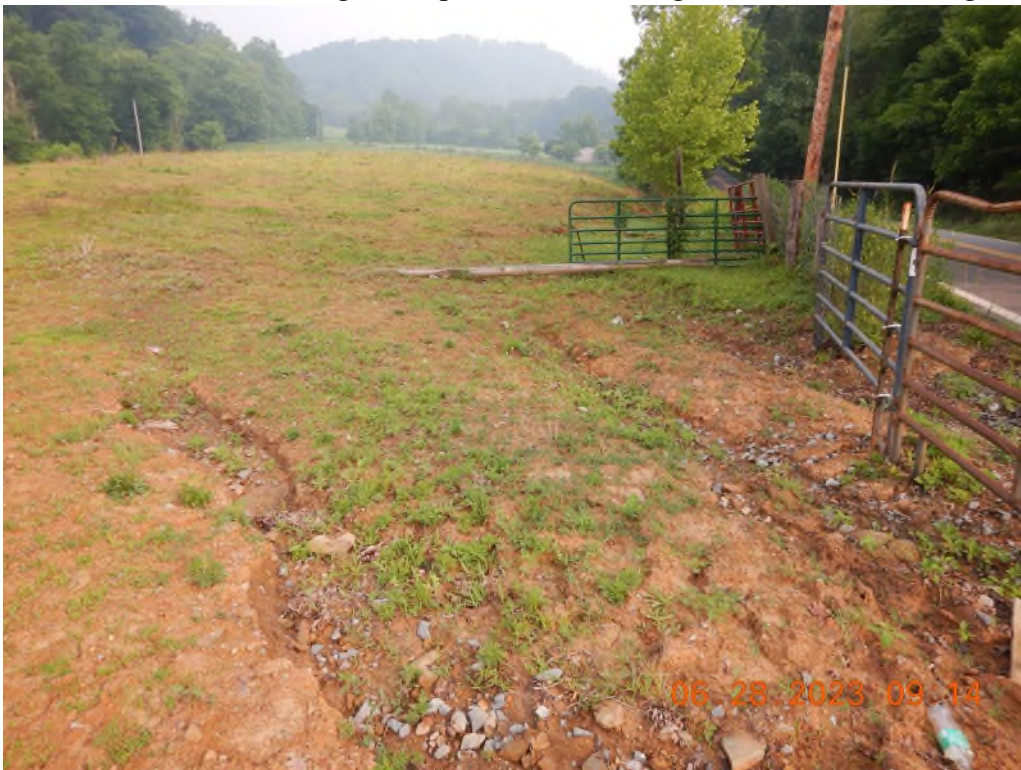
As shown, natural vegetation has started to germinate and there is no evidence of the company reseeding the waste area.

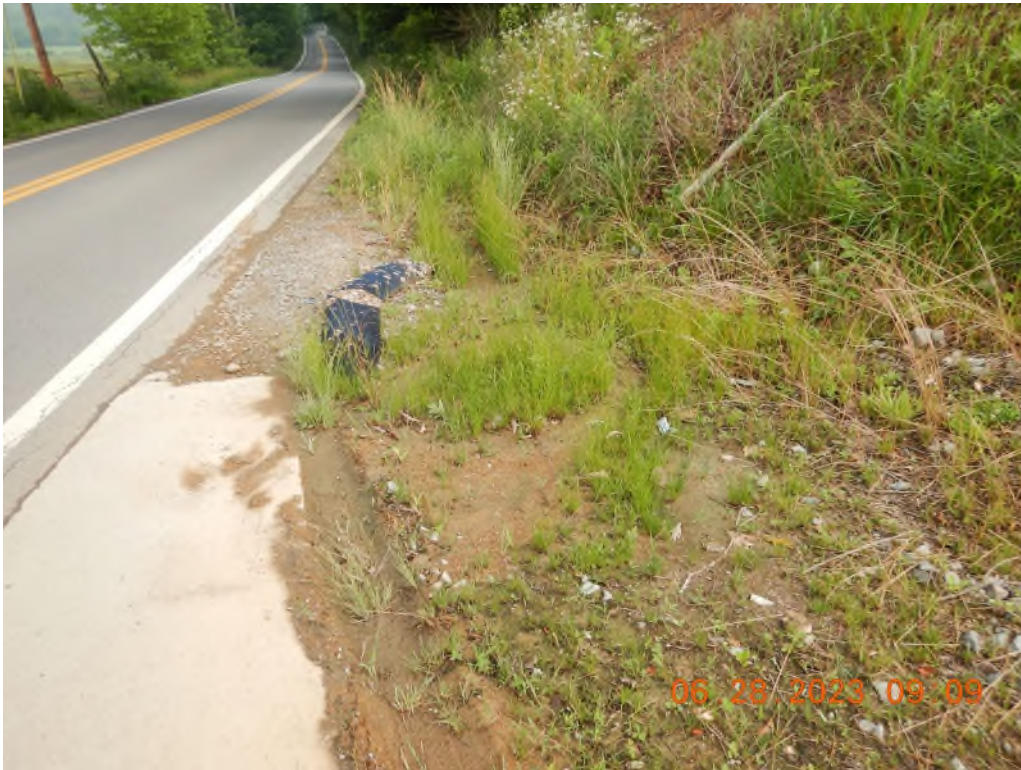
Compost filter sock showing the need for maintenance. As shown, sediment and sediment laden water from the project have bypassed treatment and left the site.

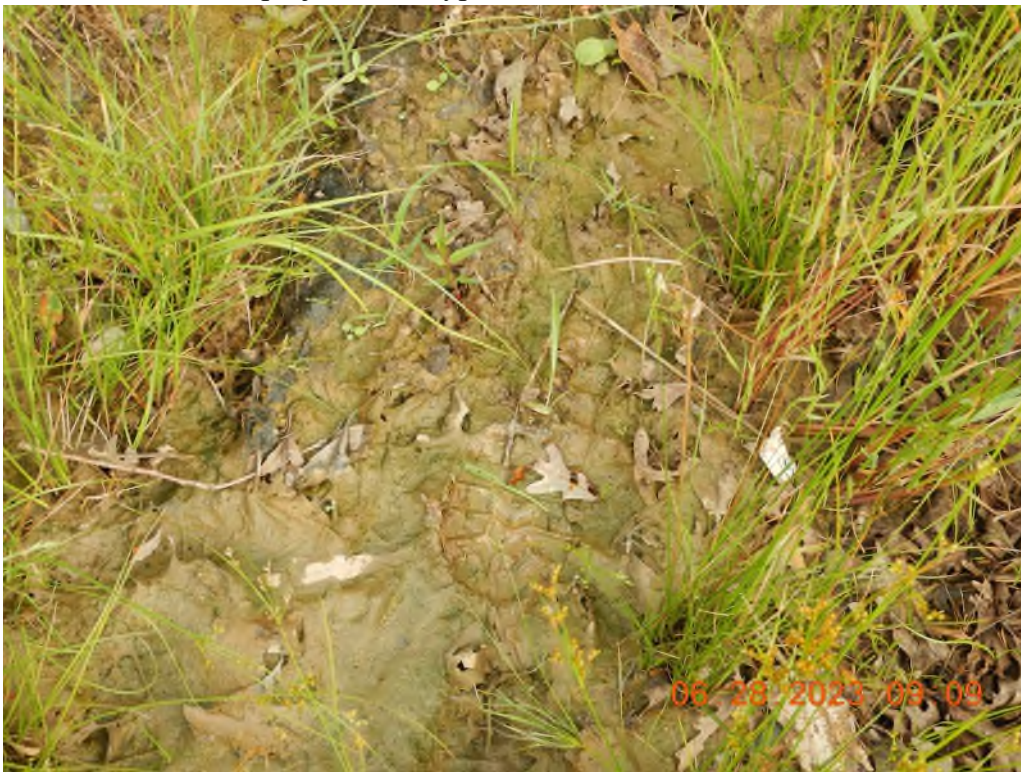
Evidence of sediment deposits off of the company's LOD.

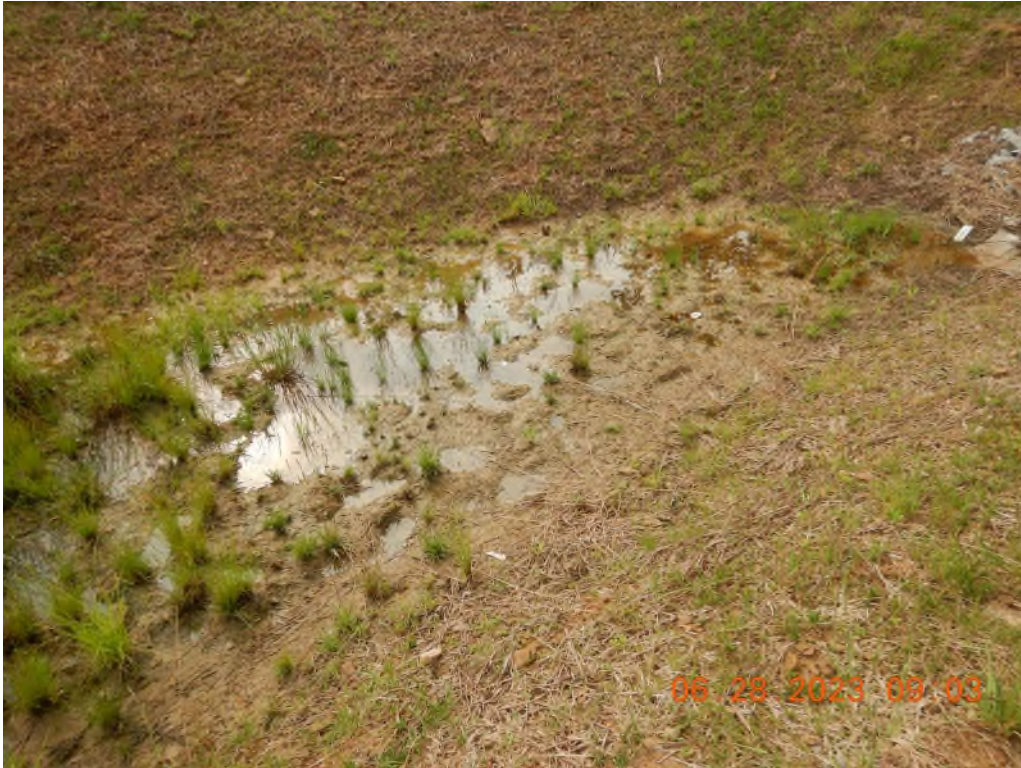
Sediment Trap 2 not holding the required 50% wet storage as required.

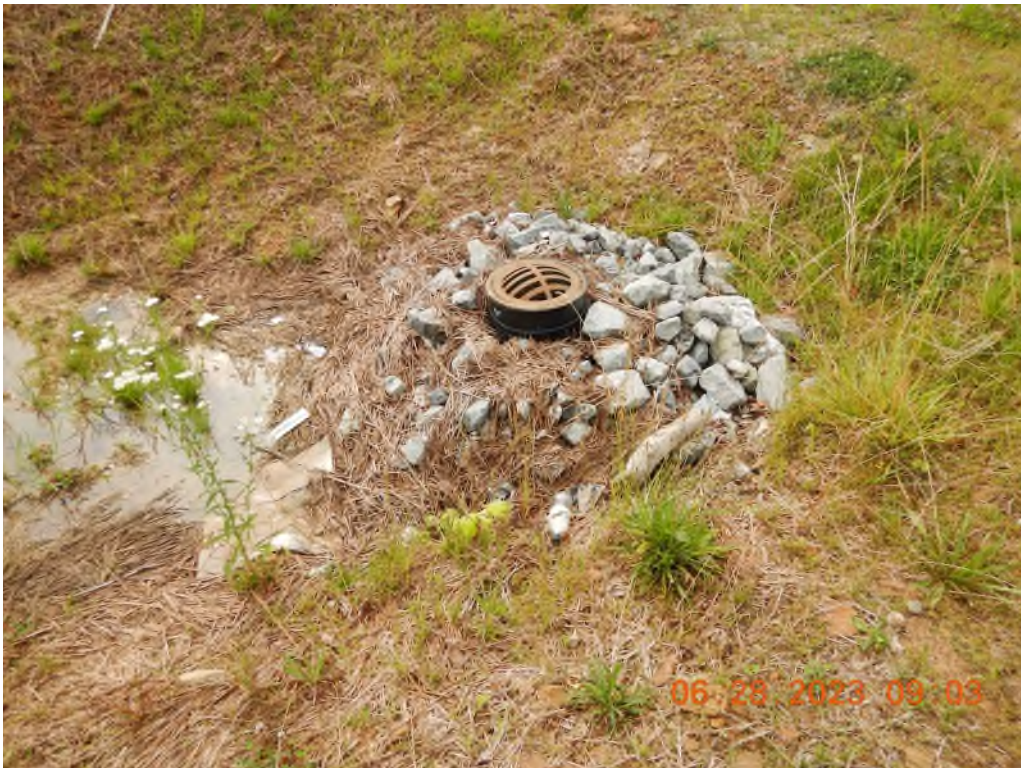
The drainage point of the sediment trap.

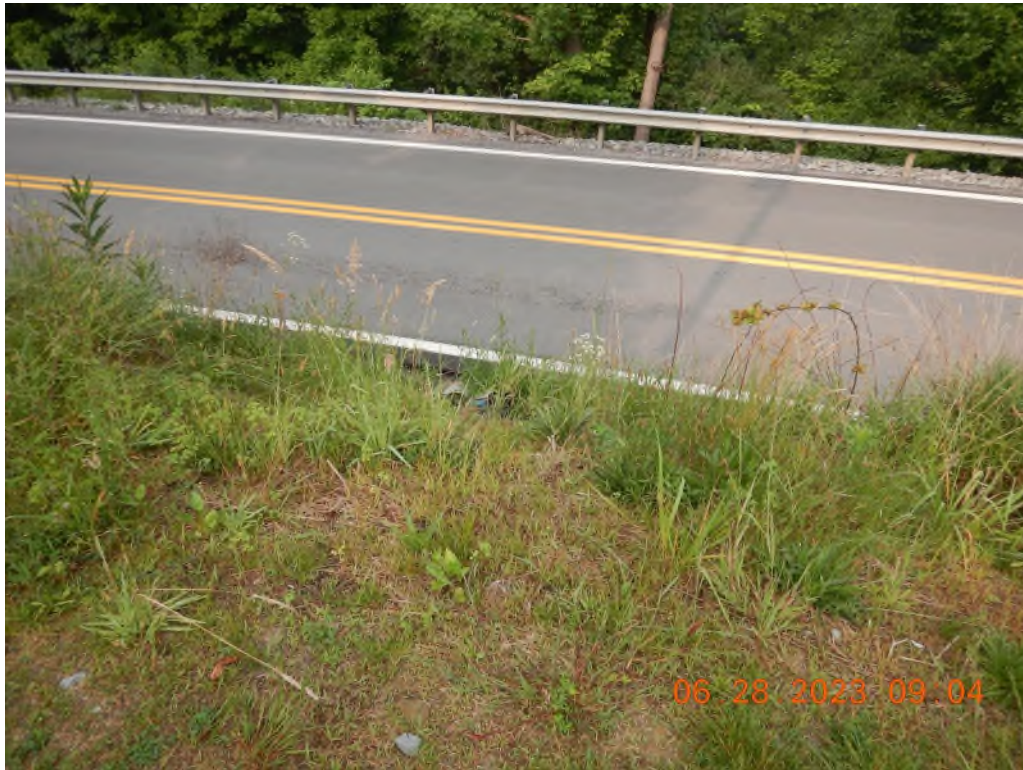
No outlet marker in place at the outlet of Sediment Trap 2.
