**CONSENT ORDER
ISSUED UNDER THE
WATER POLLUTION CONTROL ACT
WEST VIRGINIA CODE CHAPTER 22, ARTICLE 11**

TO: Harrison County Coal Resources, Inc.
Attn: James R. Turner, Jr.
46226 National Road West
St. Clairsville, OH 43950

ORDER NO.: 10302

Rymer I & II Stream Restoration Site – WVR112355

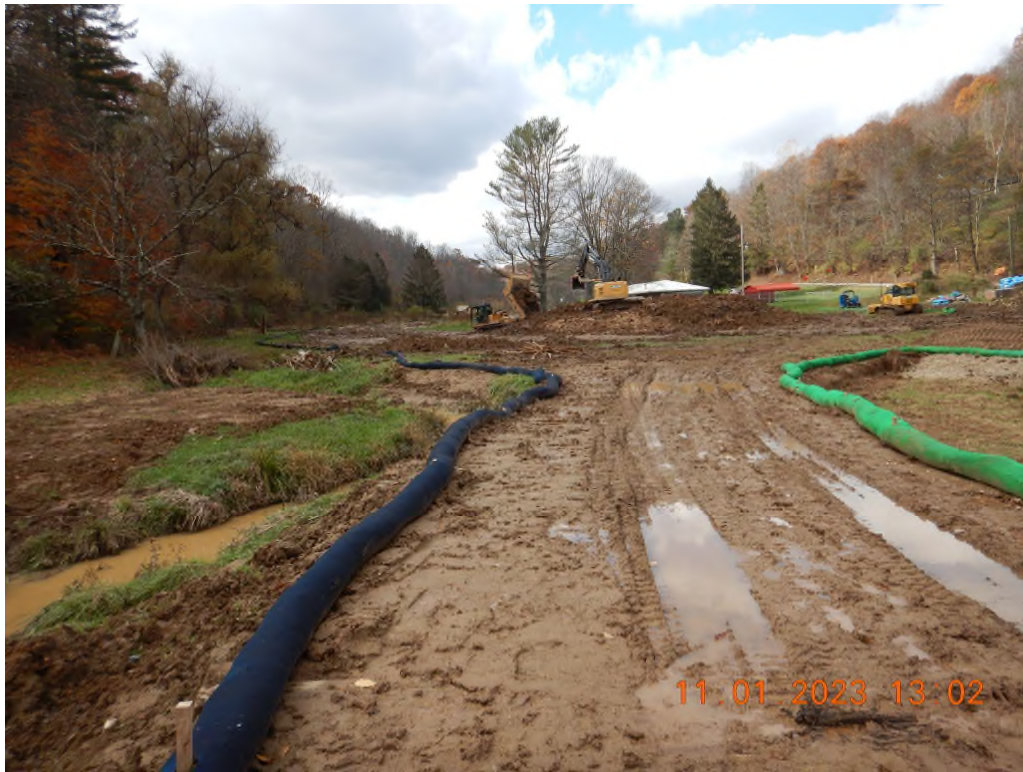
Disturbance on the project.

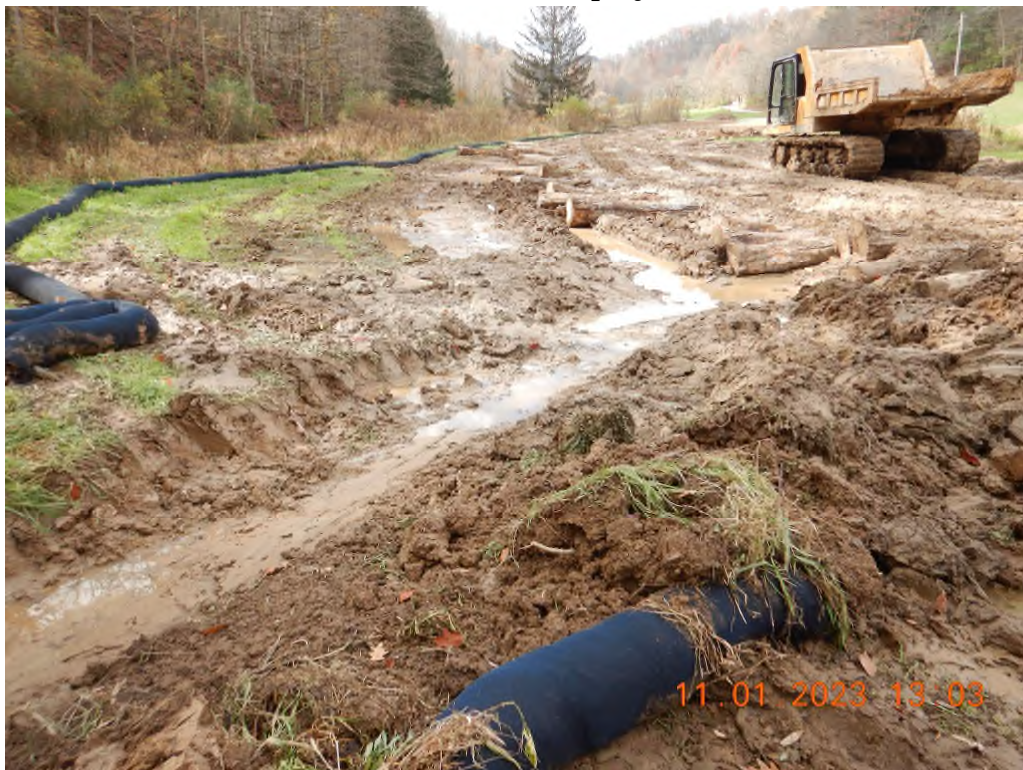
A diversion ditch was cut directly into Buffalo Creek with no erosion sediment controls in place.

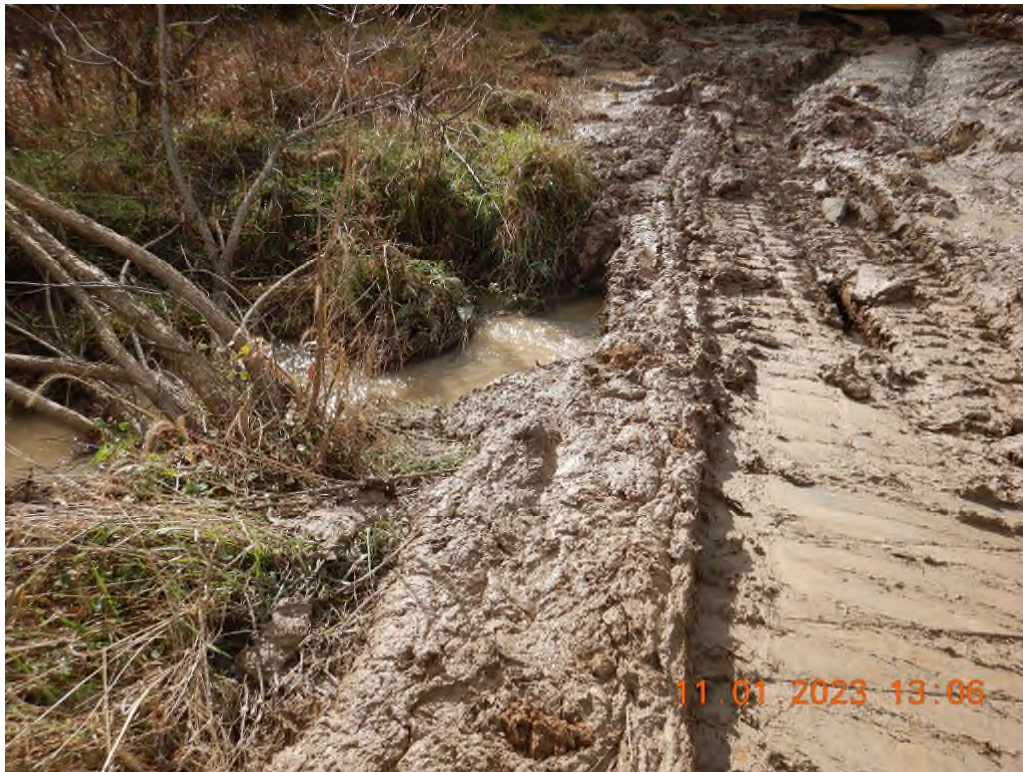
Air bridge over Buffalo Creek in the middle of the project with no controls in place.

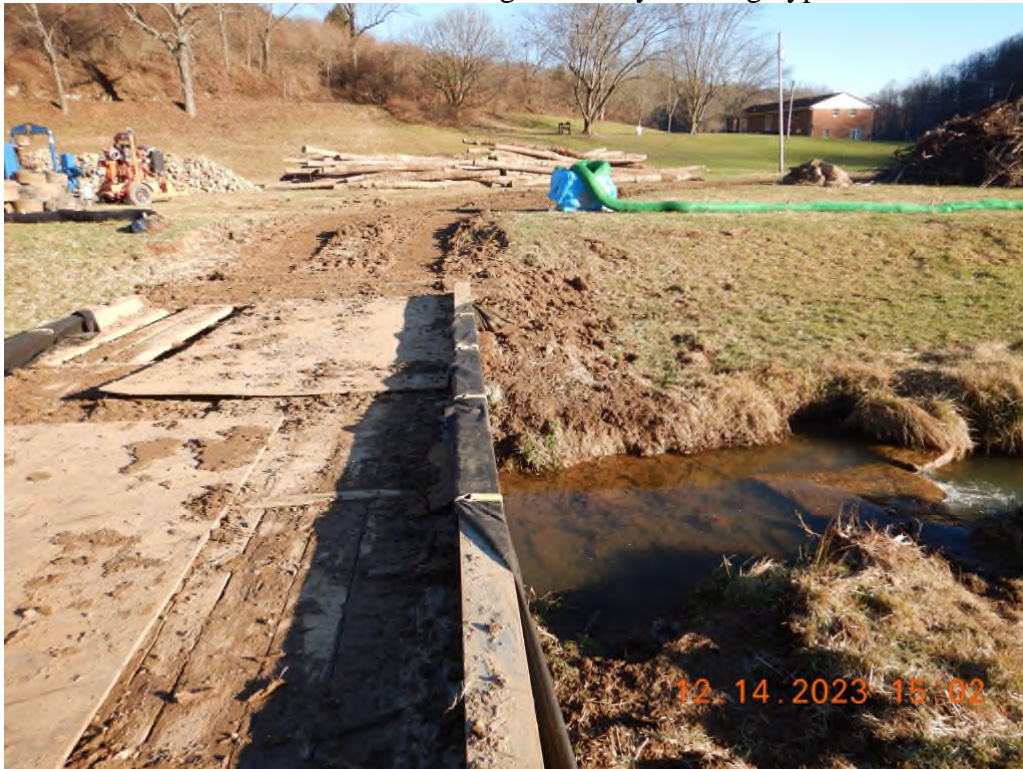
Approximately 30 feet of unprotected area close to Warrior Fork lacked perimeter controls.

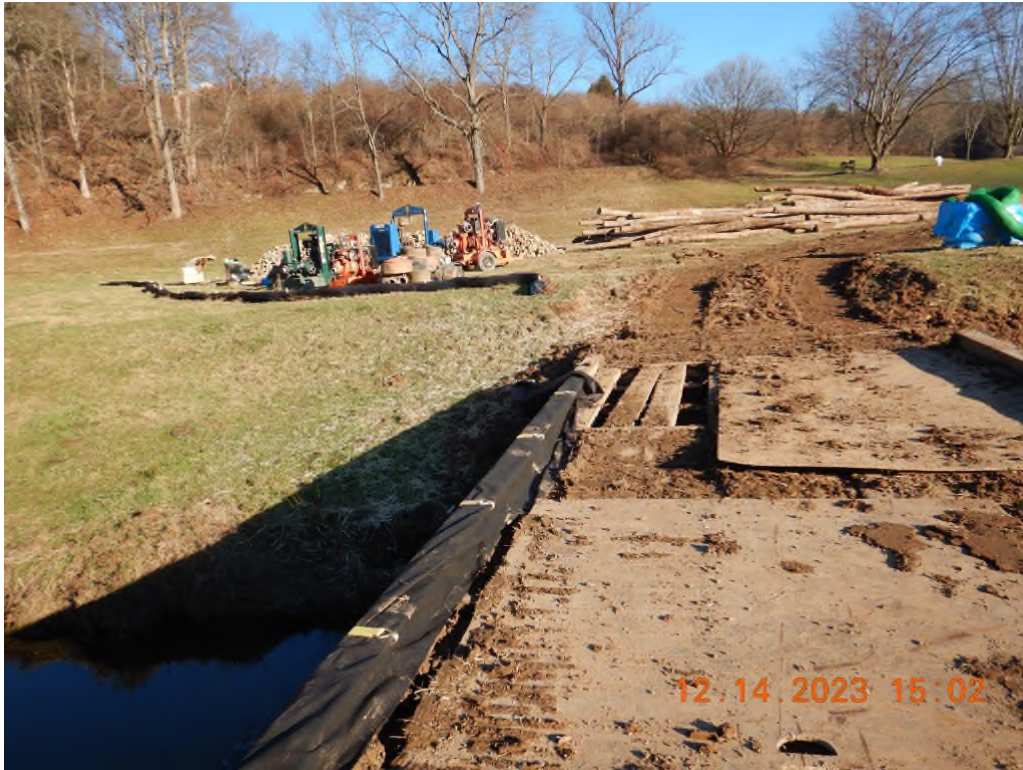
Approximately 30 feet of unprotected area close to Warrior Fork lacked perimeter controls.

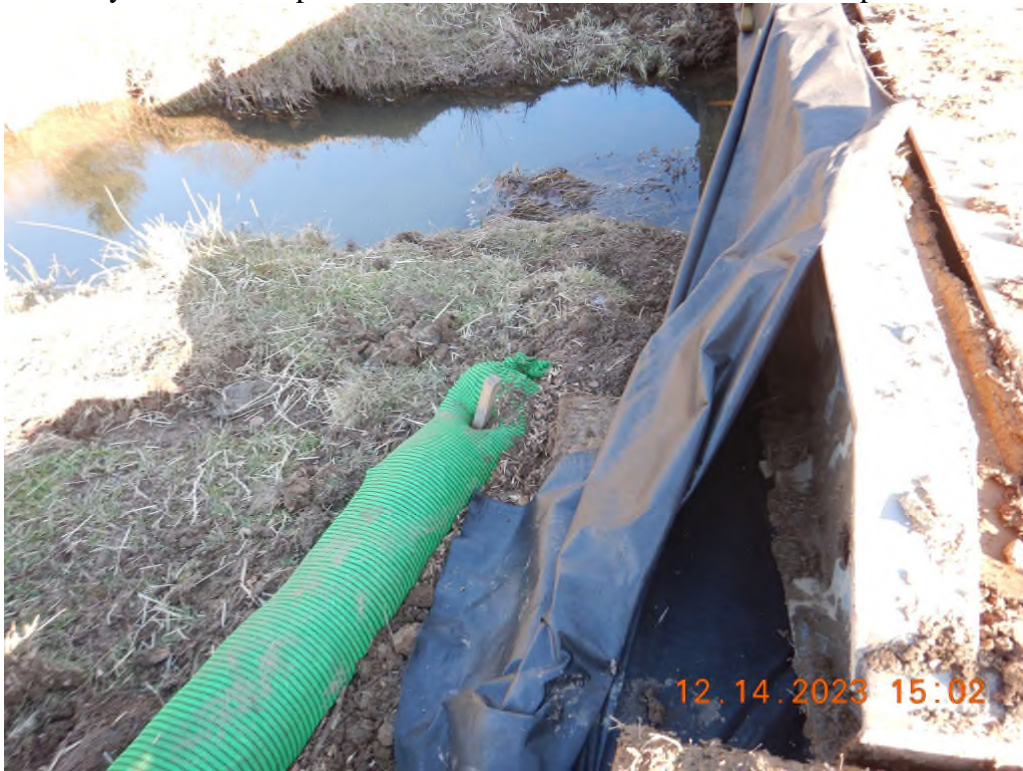
Perimeter controls were not tied to the bridge correctly, creating bypasses in the controls.

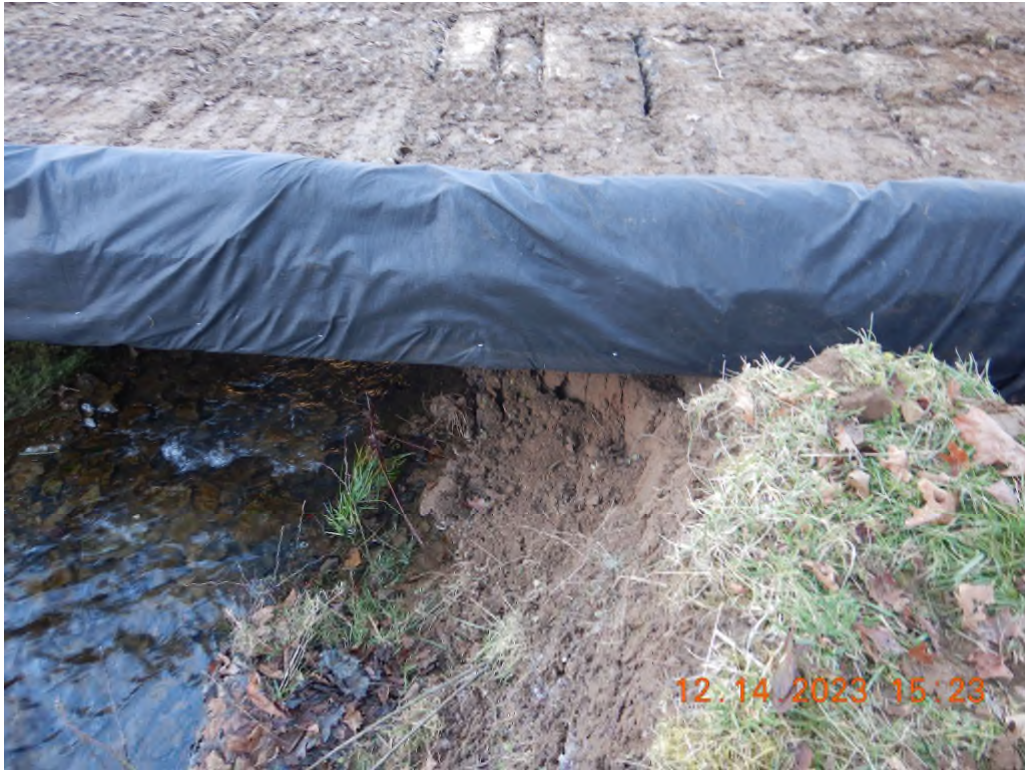
By excavating the temporary bridge down to ground level, sediment is being placed directly in the stream where it can be transported outside the LOD during a rain event.

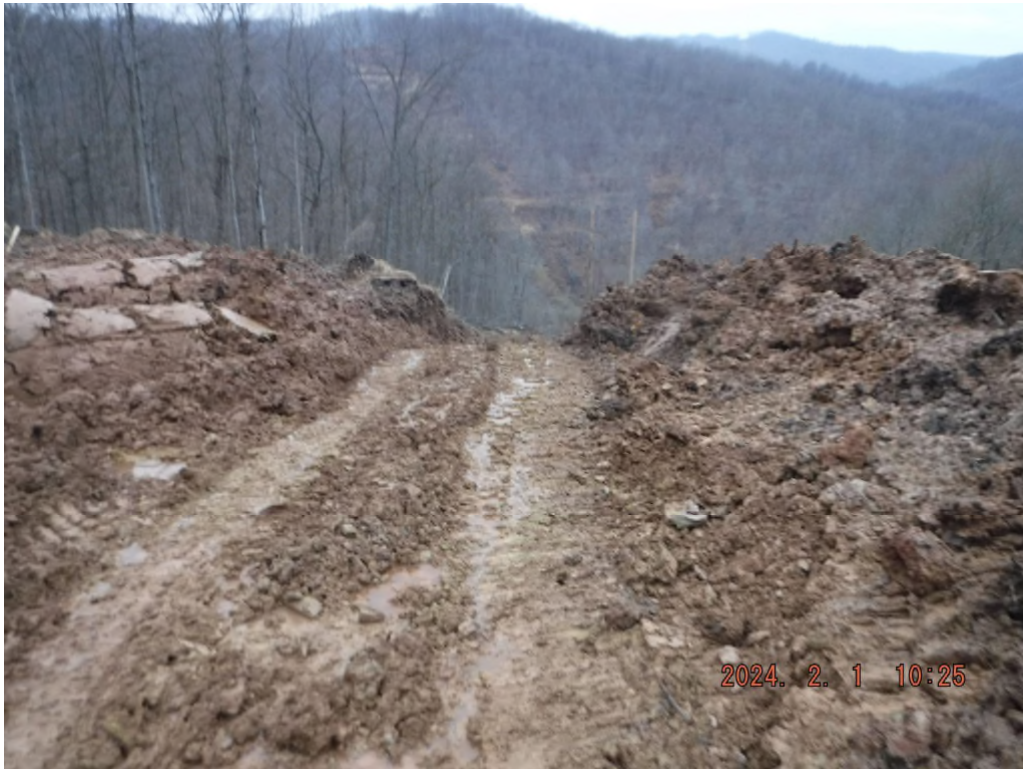
Photo # DSCF1498: Disturbed travel lane outside of LOD at or near station 170+00.

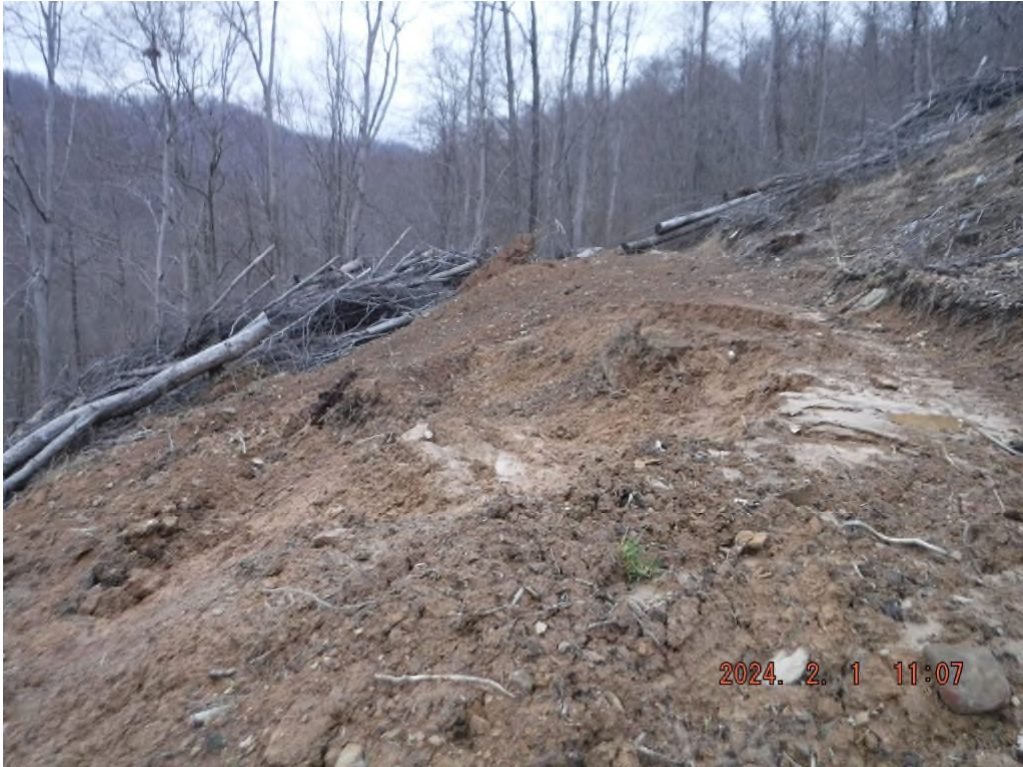
Photo # DSCF1572: Slip in disturbed area off LOD at or near station 145+00.

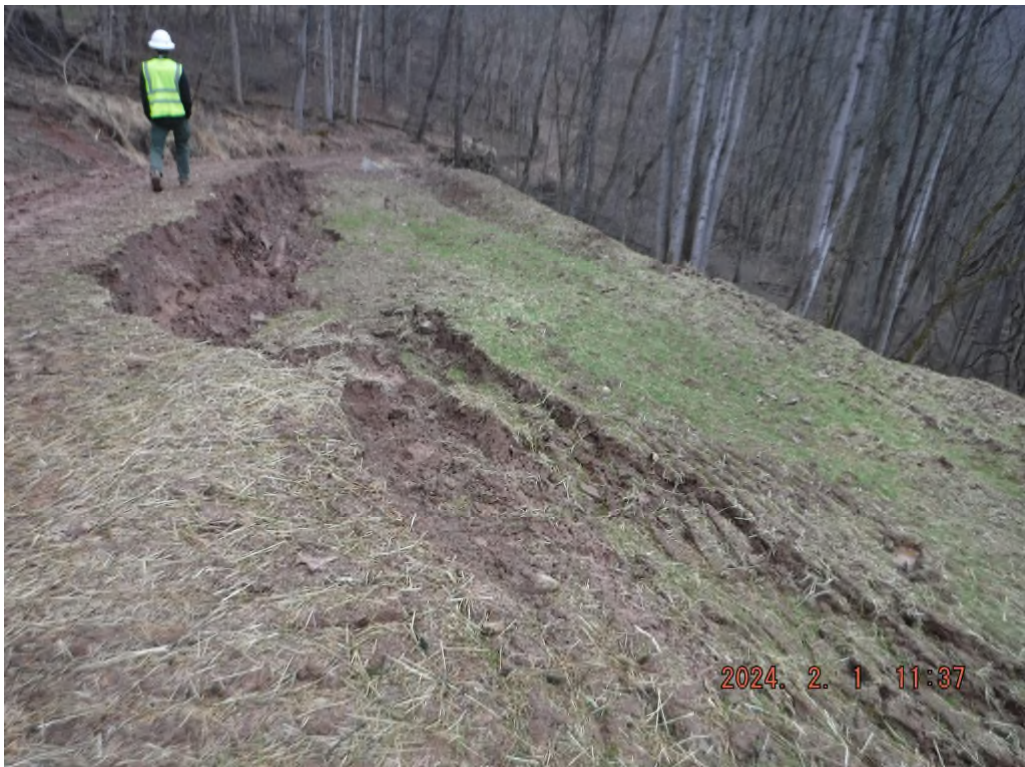
Photo # DSCF1620: Slip adjacent to the proposed access road on sheets 3 and 4.

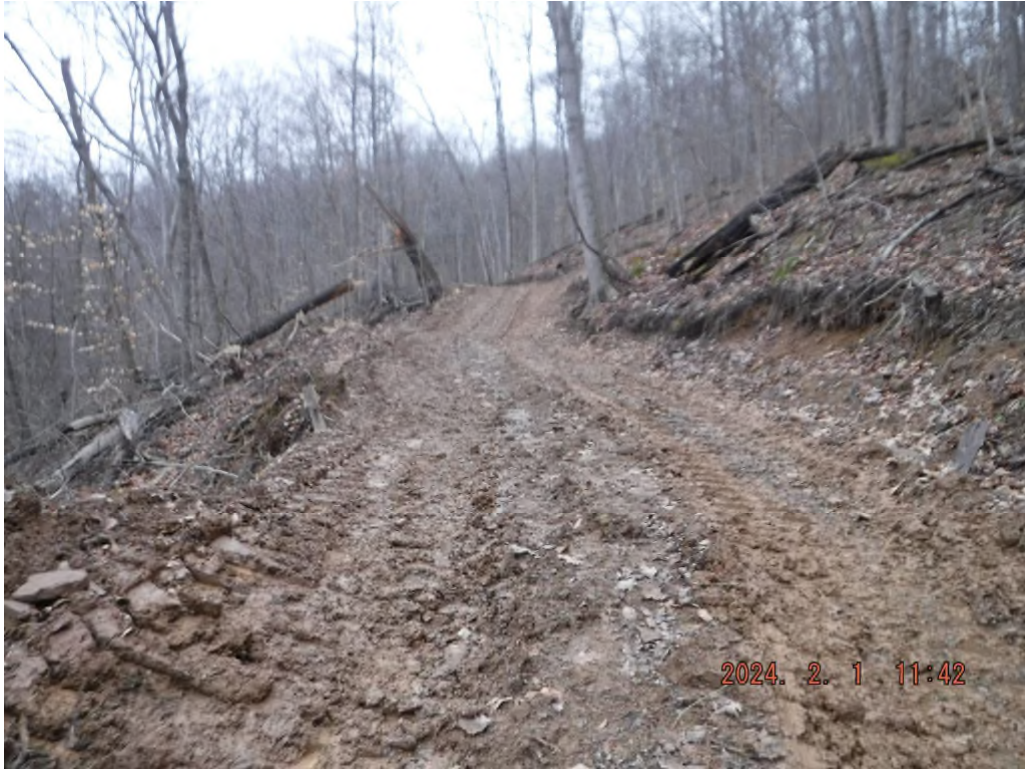
Photo # DSCF1625: Unstabilized proposed access road on sheet 3 and 4.

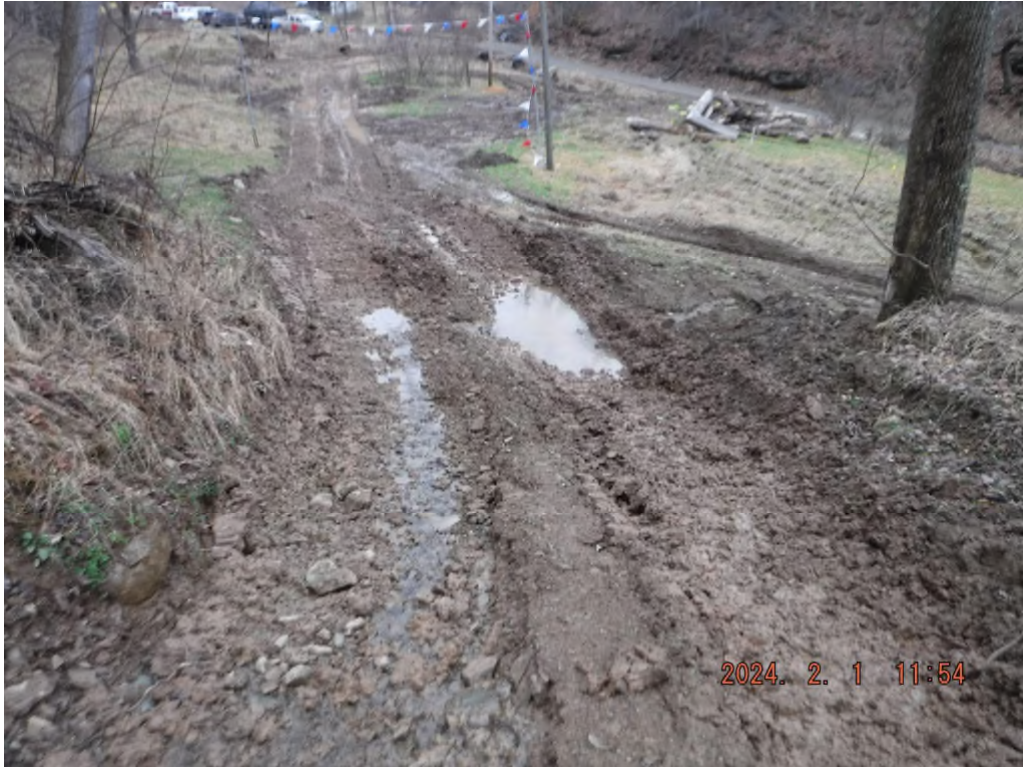
Photo # DSCF1639: Unpermitted access road on the north side of the ROW from station 123+00 leading down to the west side of Buck Run.

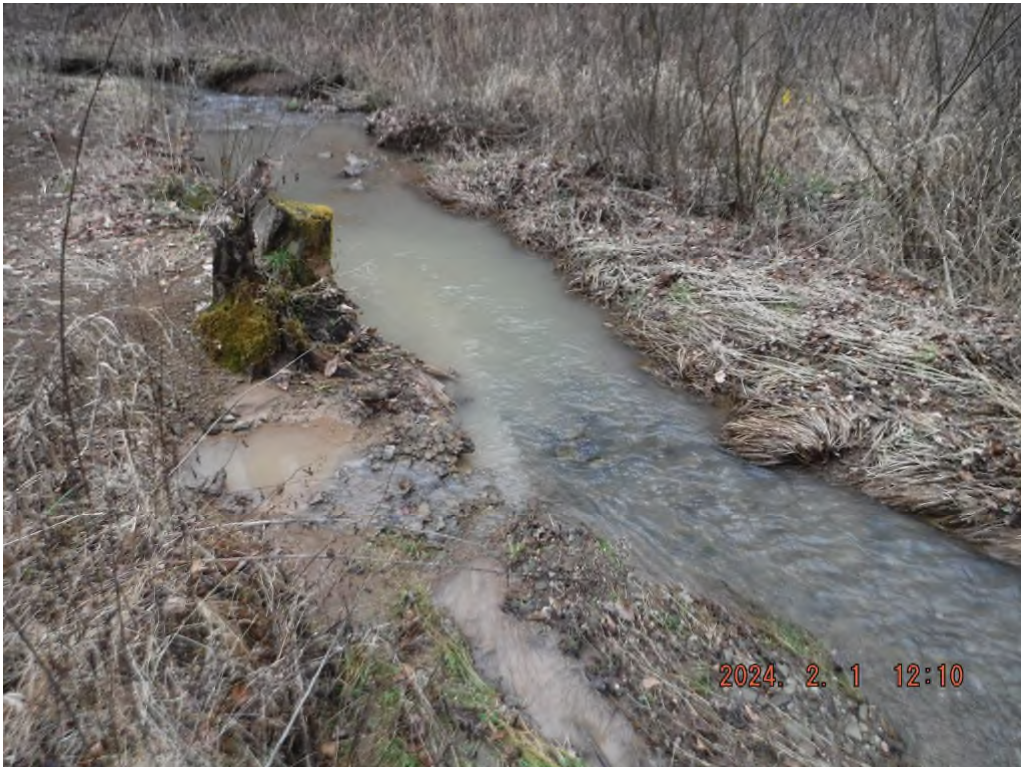
Photo # DSCF1678: Confluence of UNT and Buck Run at N 39° 31.0559', W 80° 31.2483'.

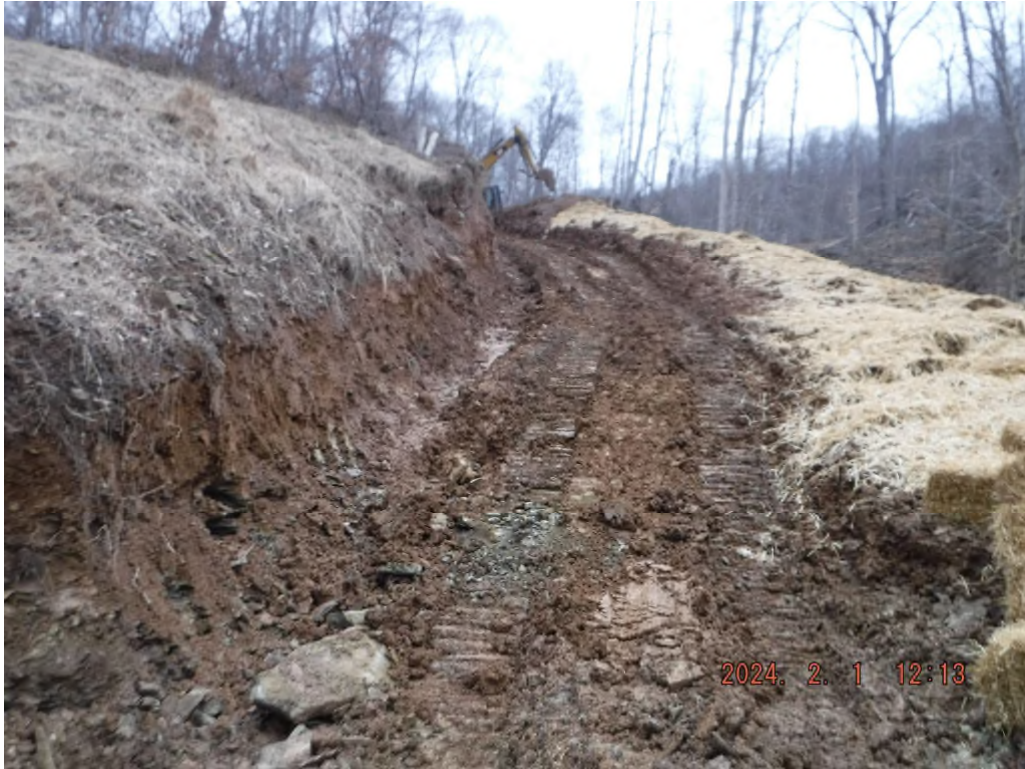
Photo # DSCF1680: Unpermitted access road off of the east side of Buck Run Rd at or near station 115+00.

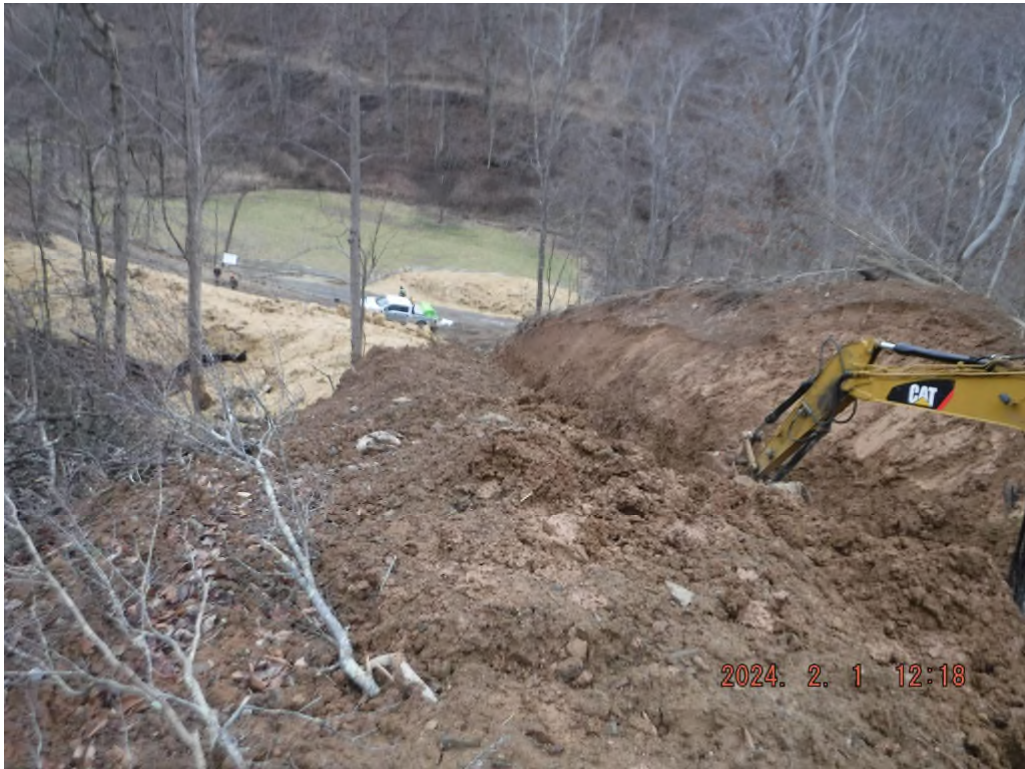
Photo # DSCF1683: Unpermitted access road off of the east side of Buck Run Rd at or near station 112+00.

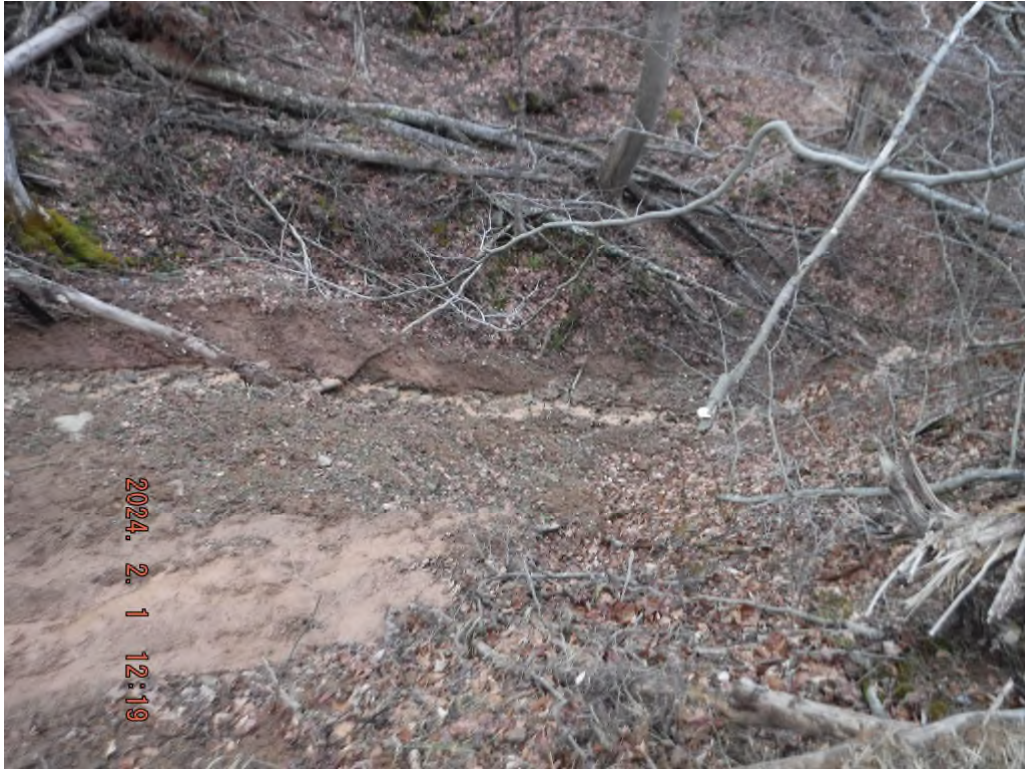
Photo # DSCF1685: Sediment laden water leaving adjacent to the unpermitted access road off the east side of Buck Run Rd at or near station 112+00.

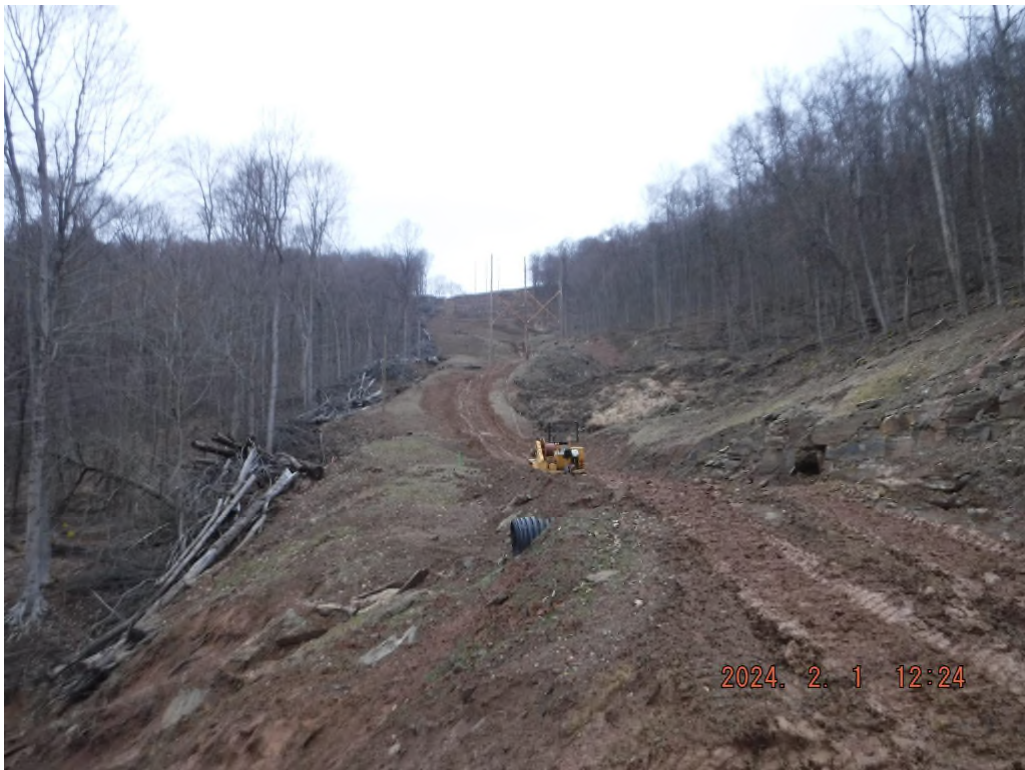
Photo # DSCF1694: Unpermitted disturbance off the LOD in the powerline ROW between stations 112+00 and 100+00. No BMPs installed.

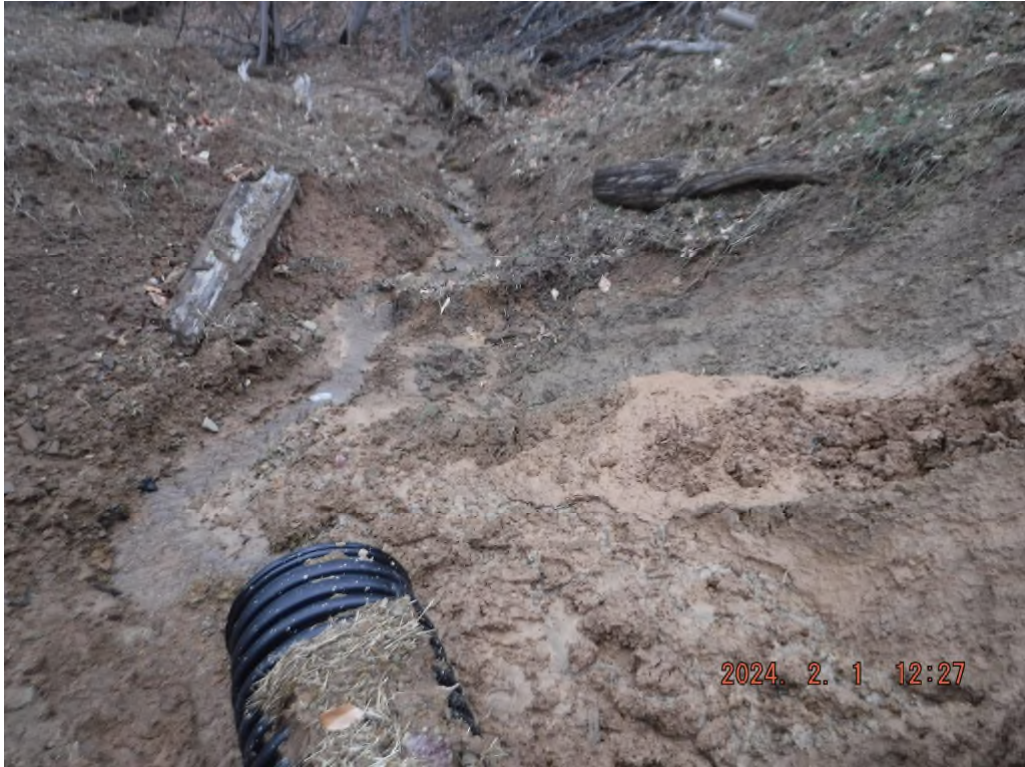
Photo # DSCF1700: Sediment off LOD leading to a UNT near station 110+00.

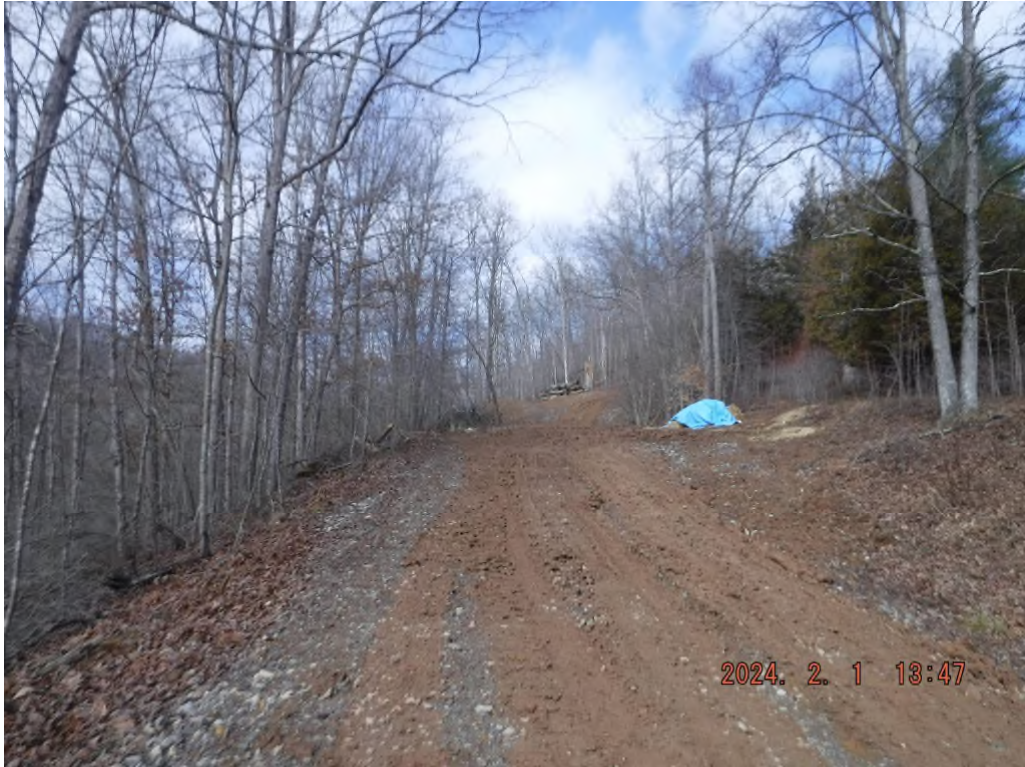
Photo # DSCF1744: Unpermitted access road that starts off Mannington Rd. (CR 2/1) at or near 39°30'24.4"N 80°31'44.1"W.

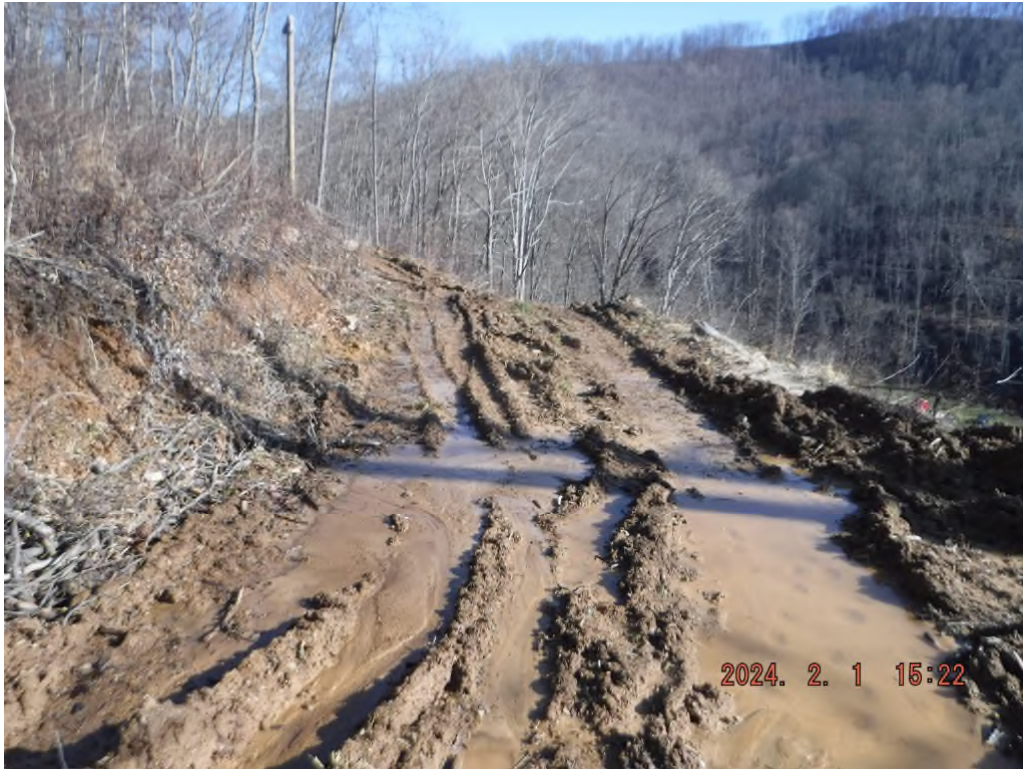
Photo # DSCF1843: Disturbed area outside of the permitted LOD between stations 47+00 and 38+00.

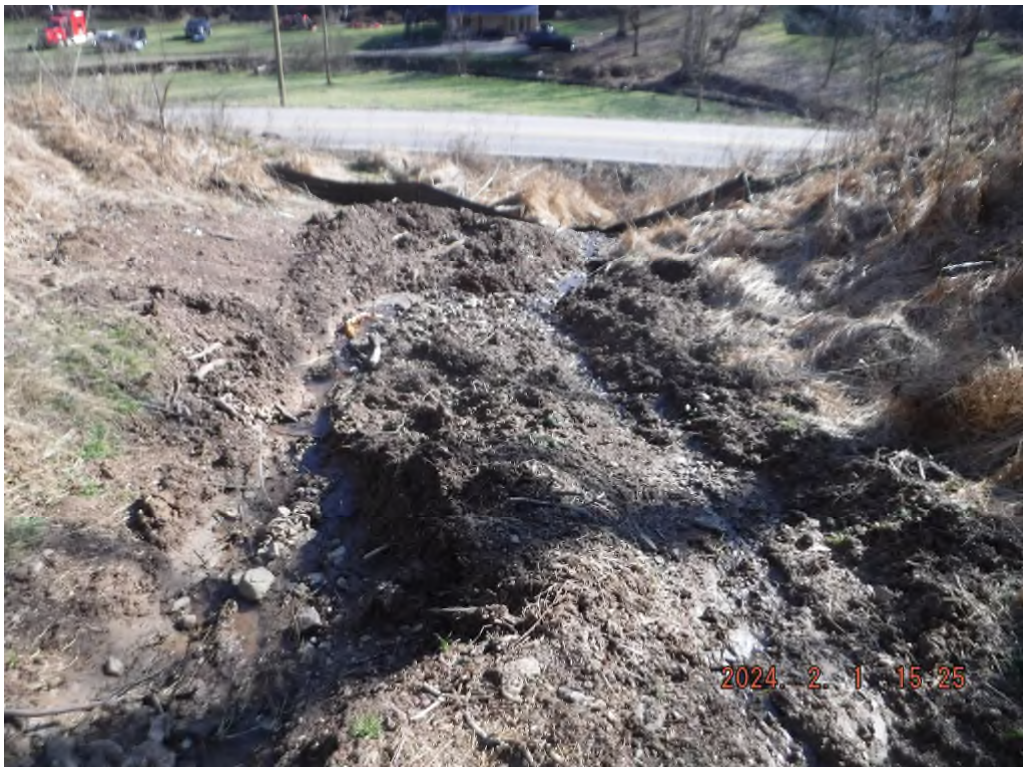
Photo # DSCF1846: Sediment deposits in UNT Glade Fork at or near N 39° 30.5966', W 80° 29.8266.

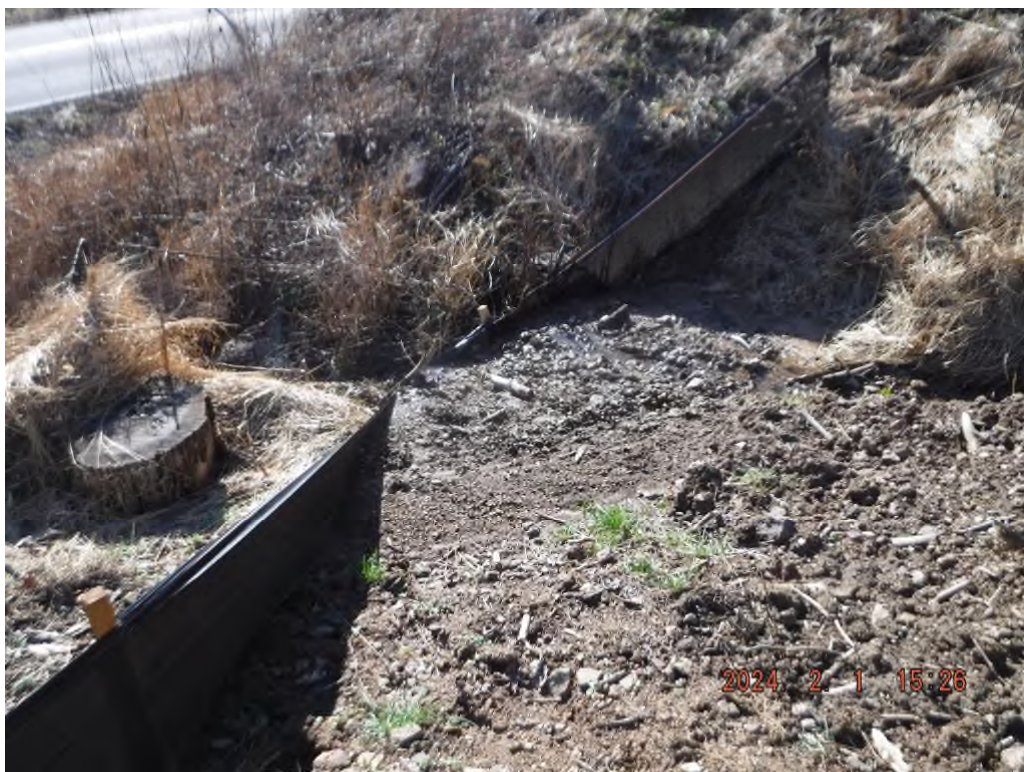
Photo # DSCF1850: Sediment deposits in UNT Glade Fork at or near N 39° 30.5966', W 80° 29.8266.

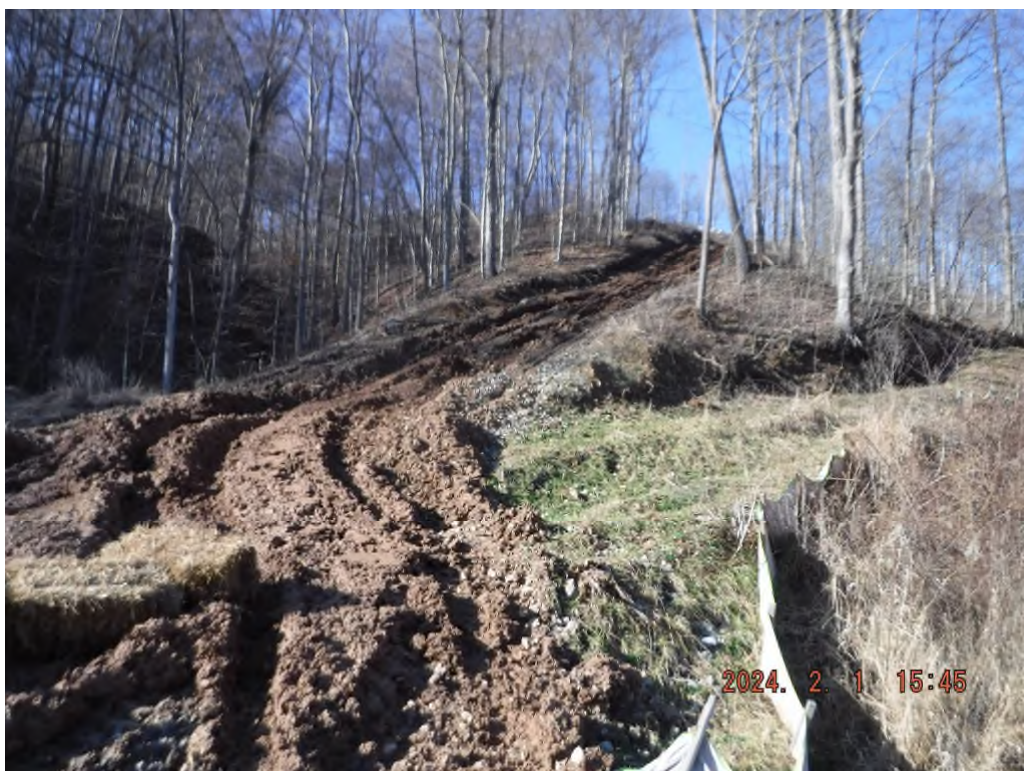
Photo # DSCF1856: Unpermitted access road off of Pickenpaw Rd. at or near 39°30'52.62"N, 80°30'28.76"W.

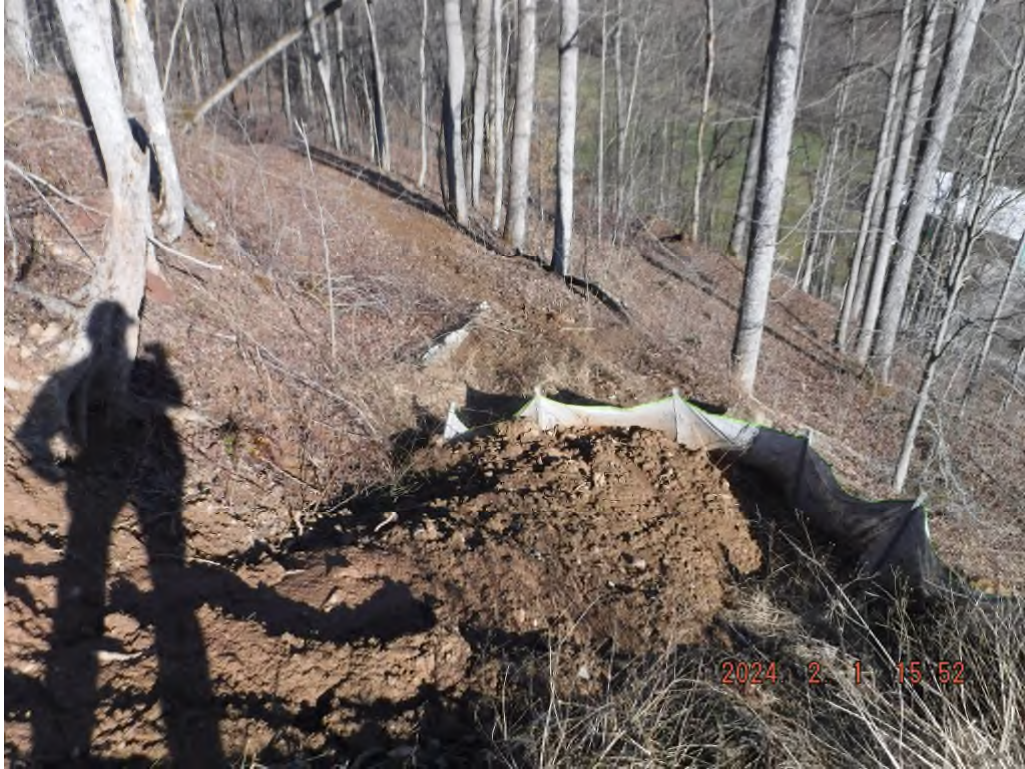
Photo # DSCF1861: BMPs lack maintenance between stations 75+00 and 80+00.

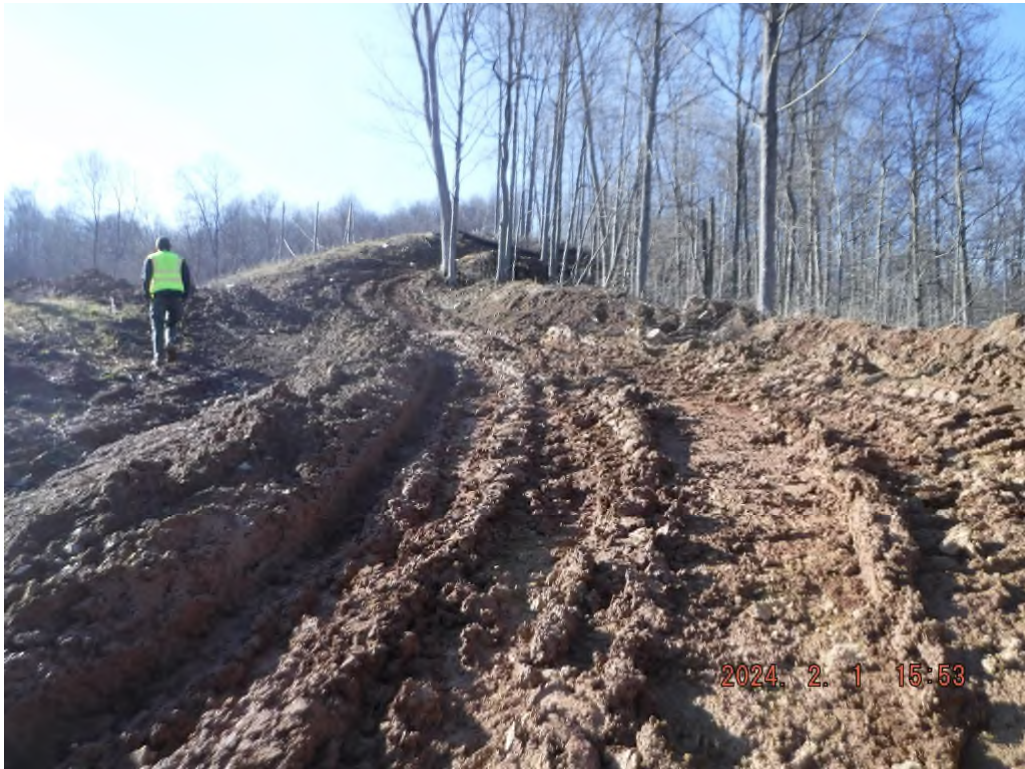
Photo # DSCF1863: Disturbed area outside of LOD between stations 75+00 and 80+00.

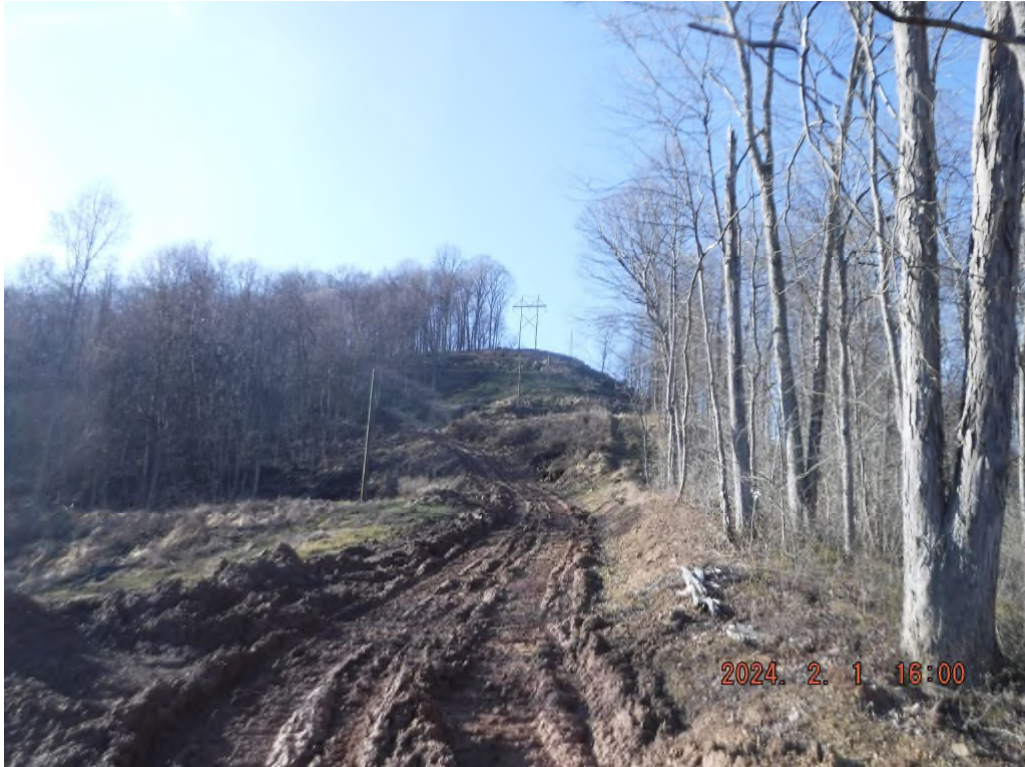
Photo # DSCF18785: Disturbed area outside of LOD between stations 80+00 and 100+00.

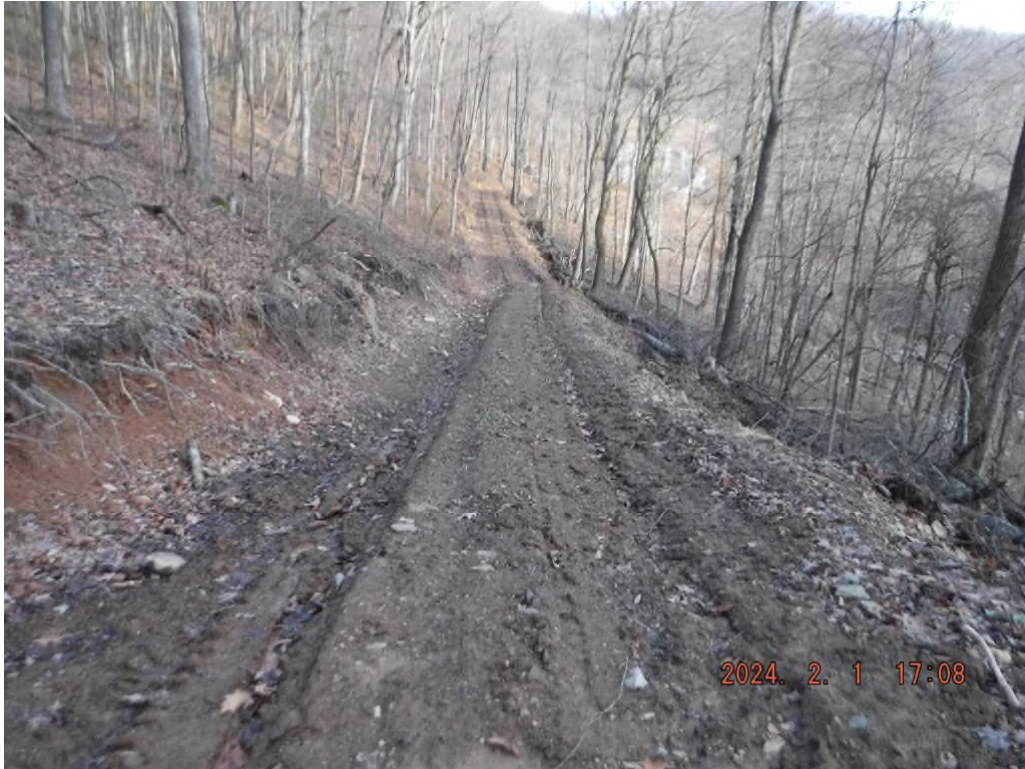
Photo # DSCF1889: Proposed access road on drawing Sheet 1 lacks stabilization.

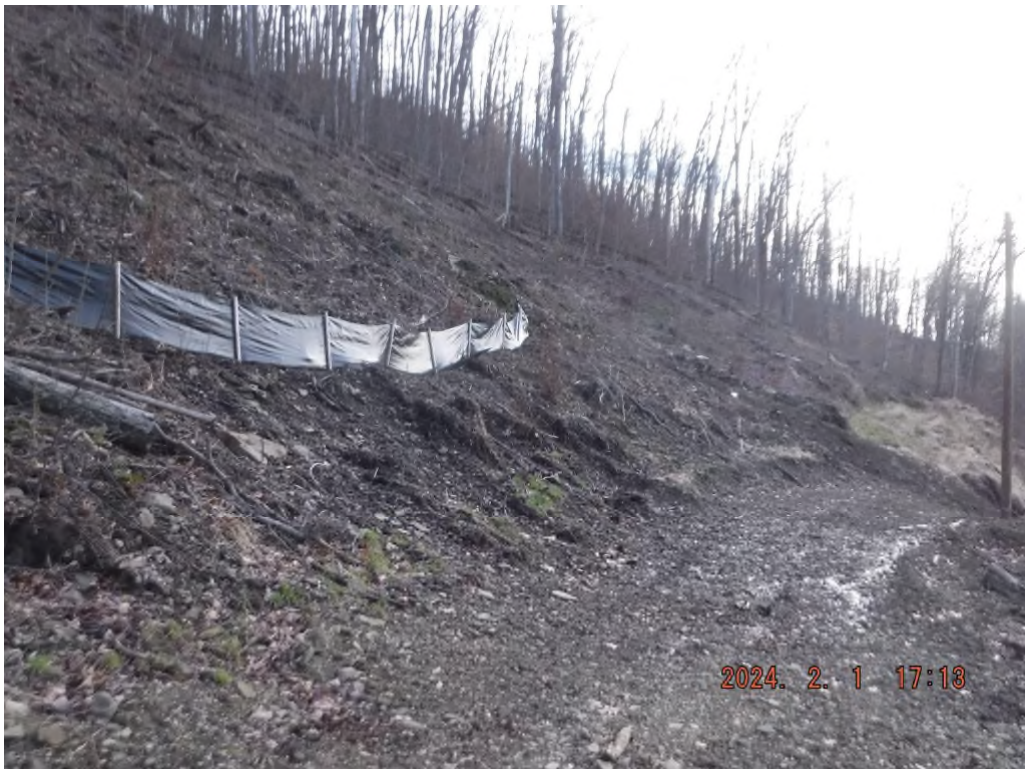
Photo # DSCF1892: Installed BMPs are not installed as detailed in the SWPPP at or near station 12+00.
