**CONSENT ORDER
ISSUED UNDER THE
WATER POLLUTION CONTROL ACT
WEST VIRGINIA CODE CHAPTER 22, ARTICLE 11**

TO: Harrison County Coal Resources, Inc.
Attn: James R. Turner, Jr.
46226 National Road West
St. Clairsville, OH 43950

ORDER NO.: 10302

Rymer I & II Stream Restoration Site – WVR112355

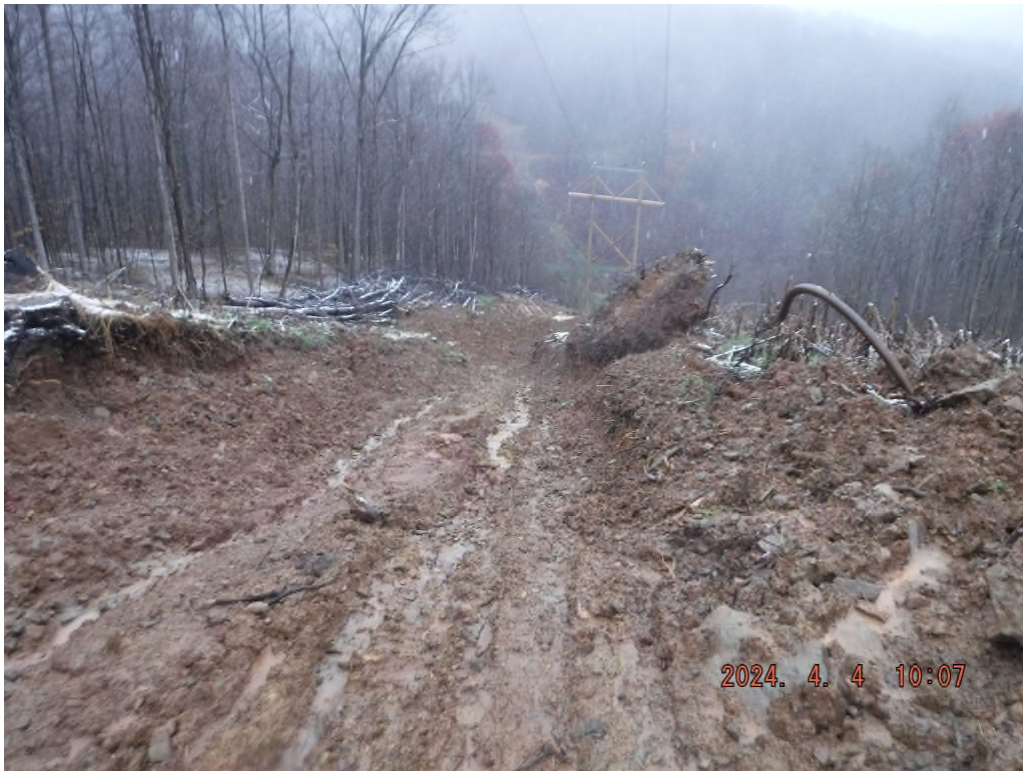
Photo # DSCF3591: ROW and travel lane between stations 165+00 and 152+00.

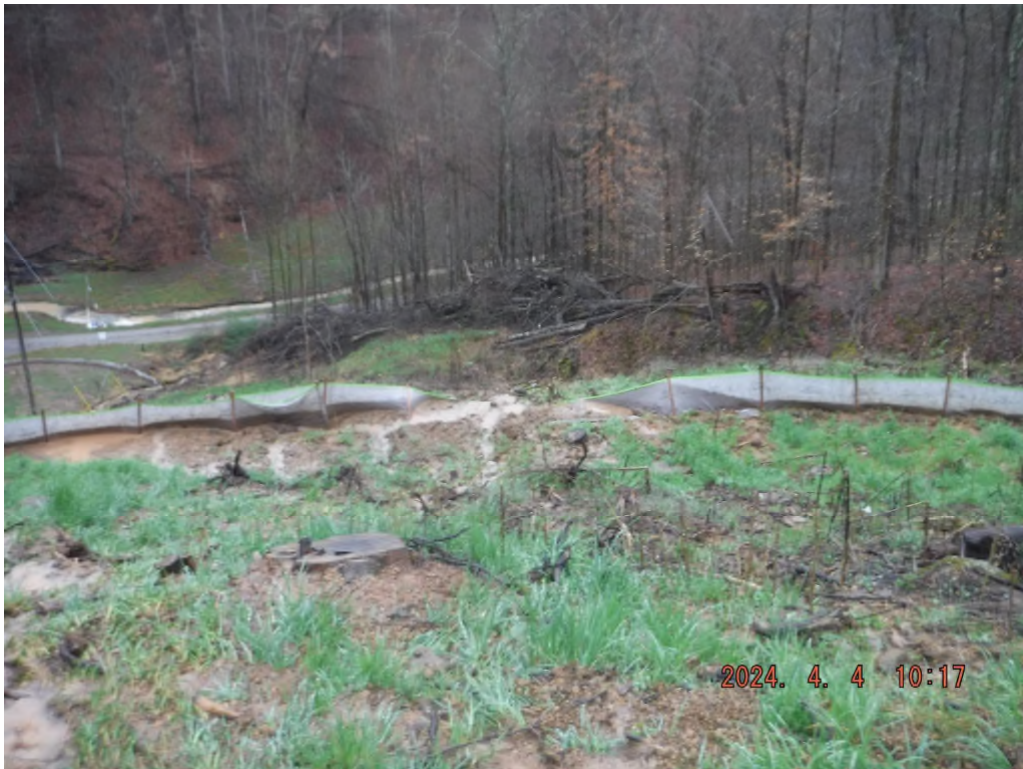
Photo # DSCF3605: BMPs lack maintenance at or near station 157+00.

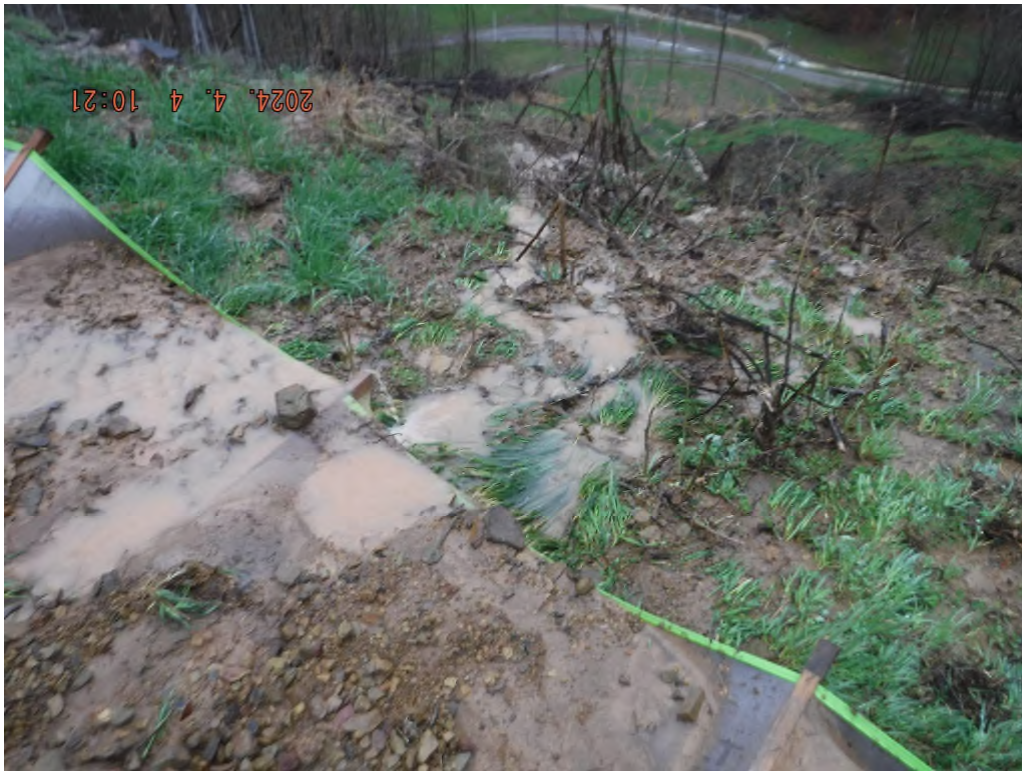
Photo # DSCF3612: BMPs lack maintenance near station 155+00.

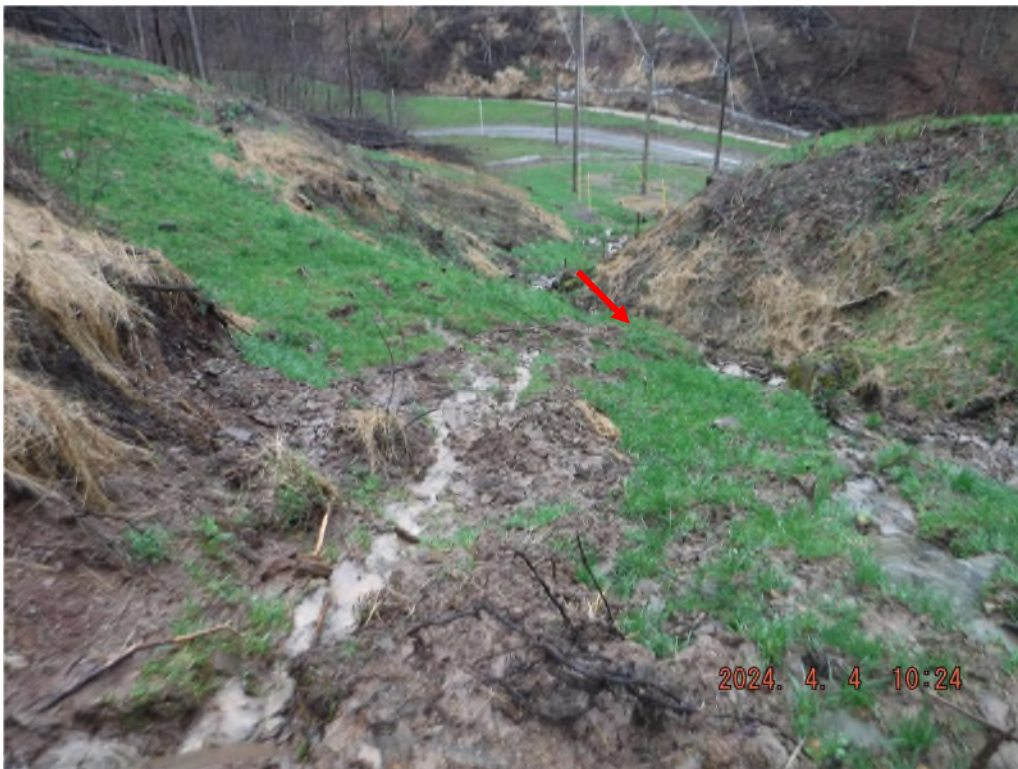
Photo # DSCF3616: Slip material at or near N 39° 30.7218', W 80° 31.9736' entering UNT Price Run.

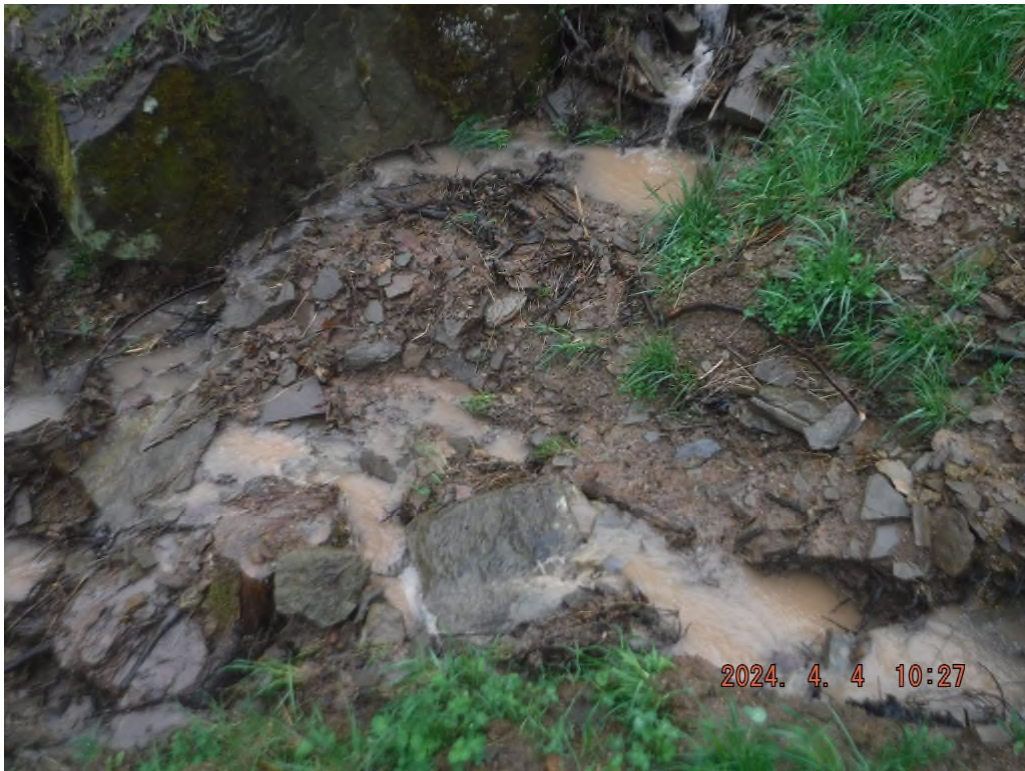
Photo # DSCF3626: Sediment deposits on the bottom of UNT Price Run at or near N 39° 30.7218', W 80° 31.9736'.

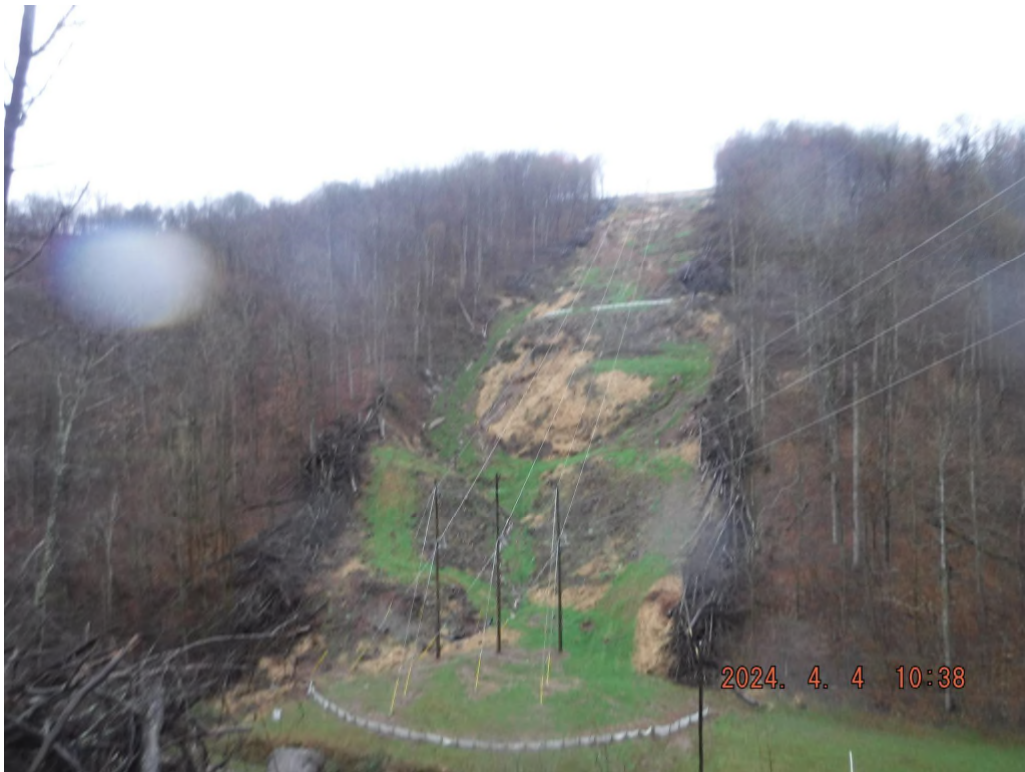
Photo # DSCF3639: Overview of the project ROW between stations 152+00 to 165+00.

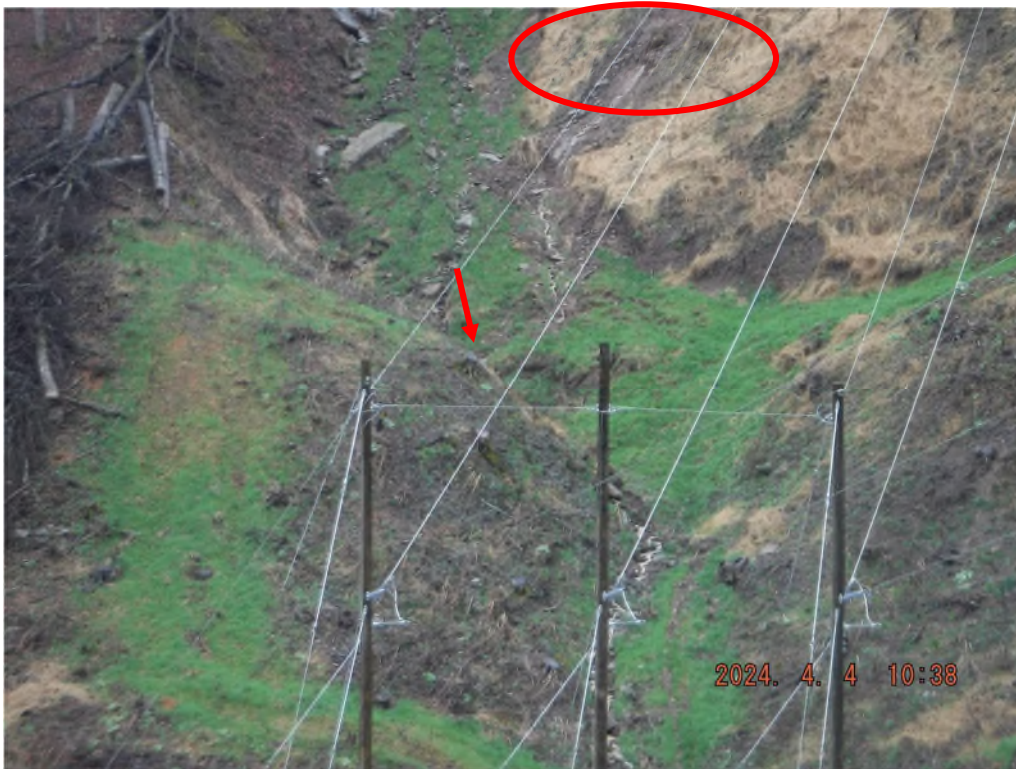
Photo # DSCF3640: Slip (circled) and material (arrow) entering UNT Price Run at or near N 39° 30.7218', W 80° 31.9736'.

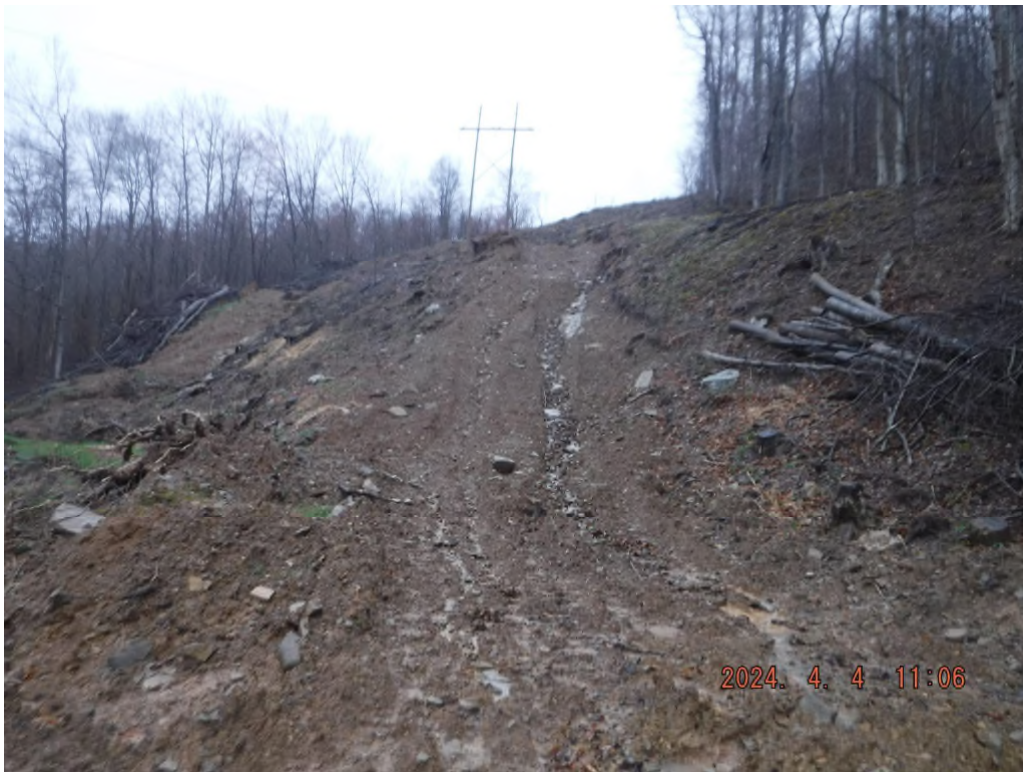
Photo # DSCF3652: Travel lane on the ROW between stations 150+00 and 140+00.

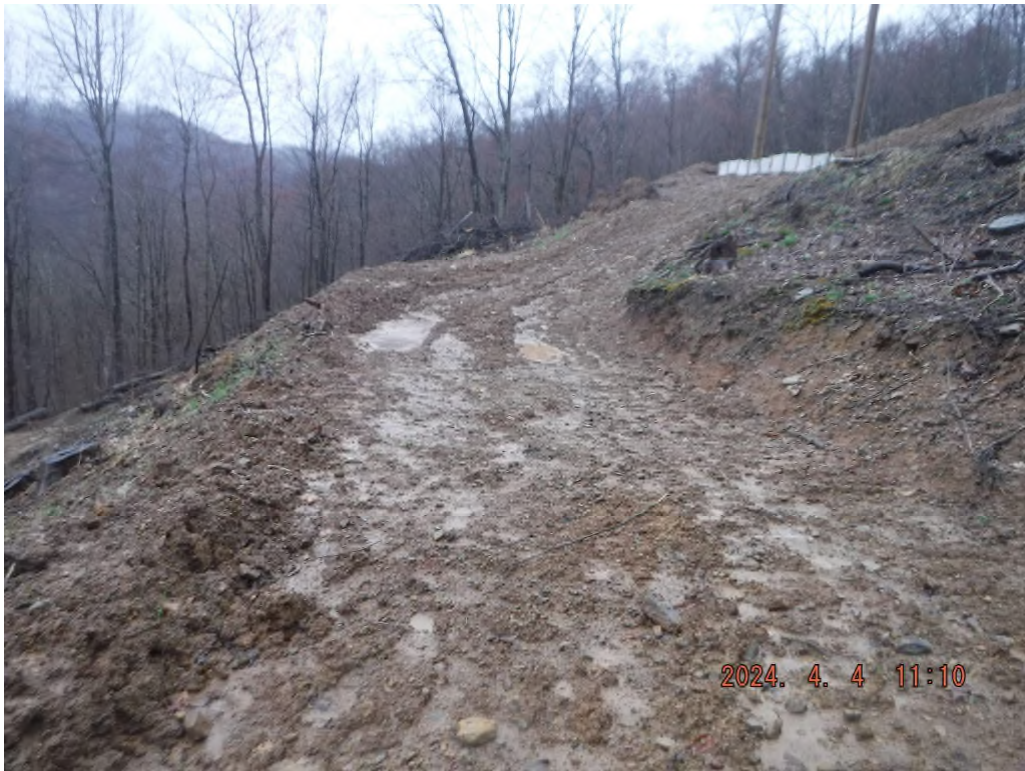
Photo # DSCF3661: Disturbed travel lane in ROW off LOD between stations 150+00 and 140+00.

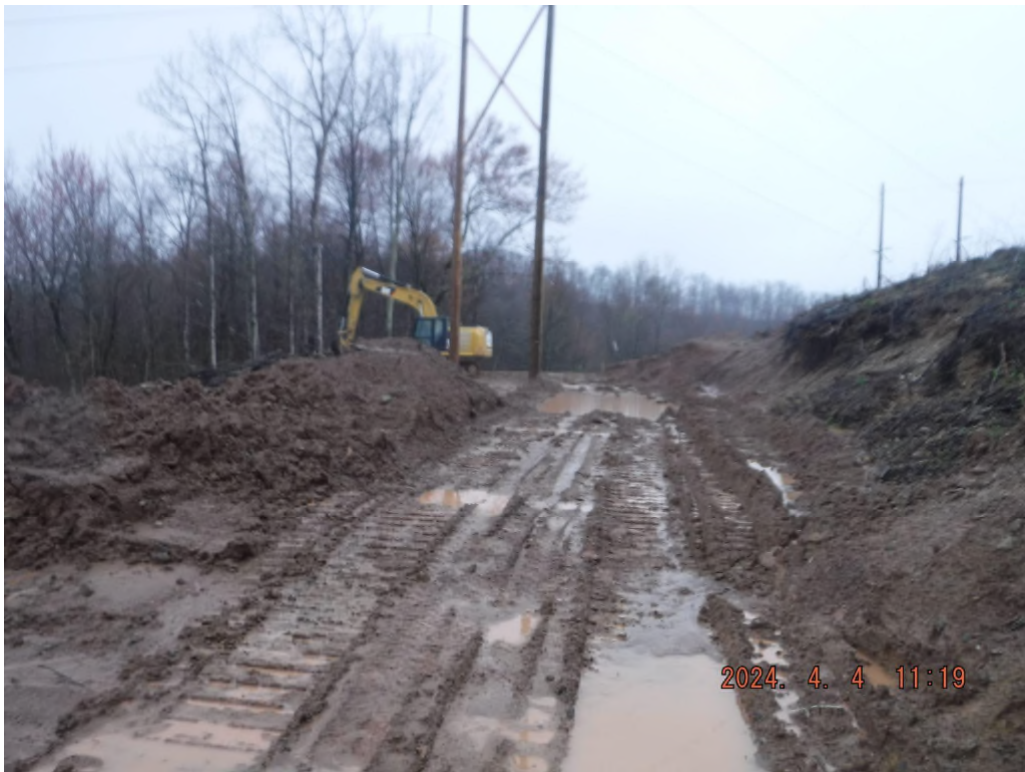
Photo # DSCF3673: Unpermitted access road at station 137+00 at or near N 39° 30.8187', W 80° 31.6944'.

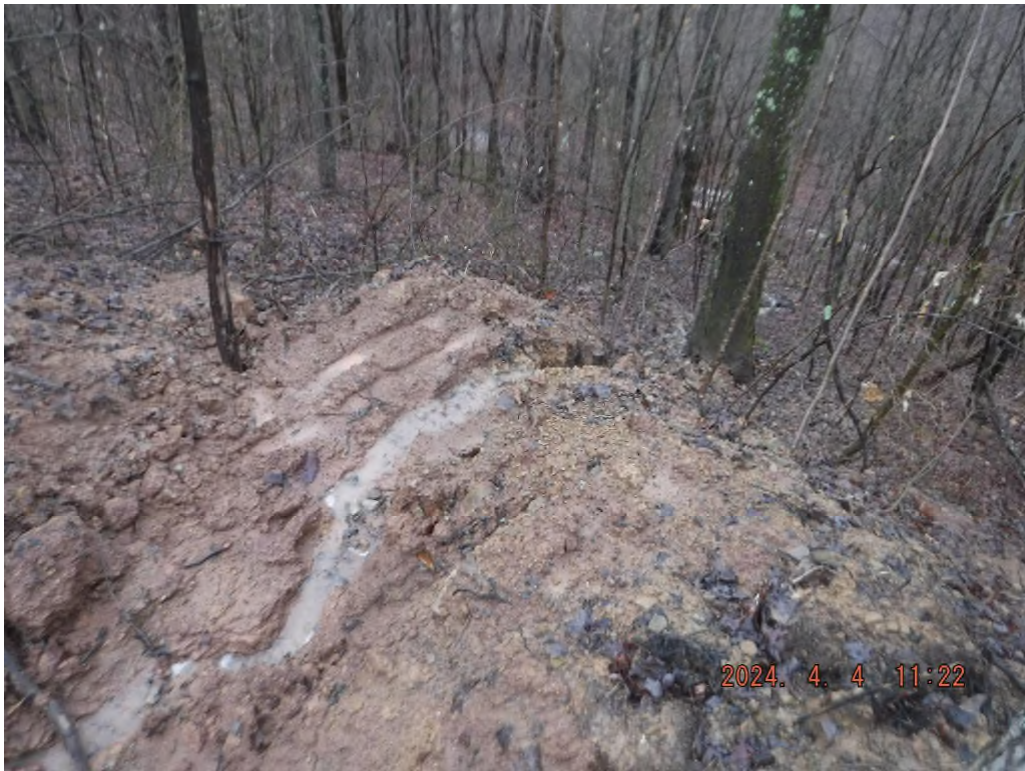
Photo # DSCF3681: Sediment laden water leaving unpermitted access road at or near N 39° 30.7677', W 80° 31.7202'.

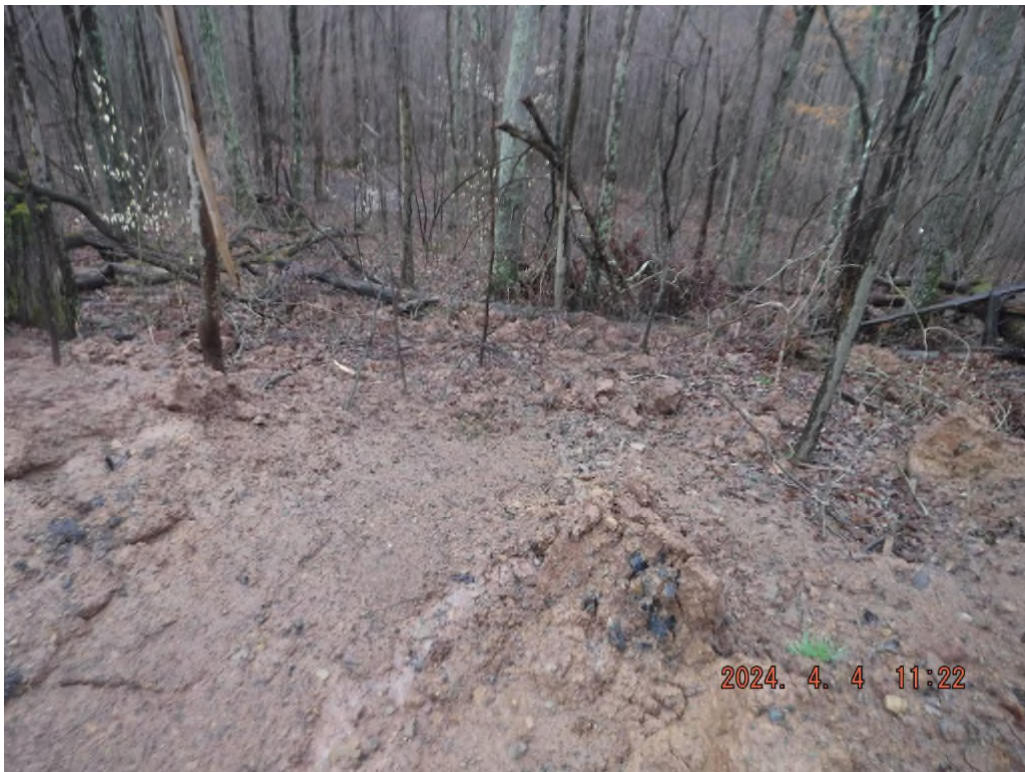
Photo # DSCF3682: Sediment laden water and sediment leaving the unpermitted access road at or near N 39° 30.7563', W 80° 31.7213'.

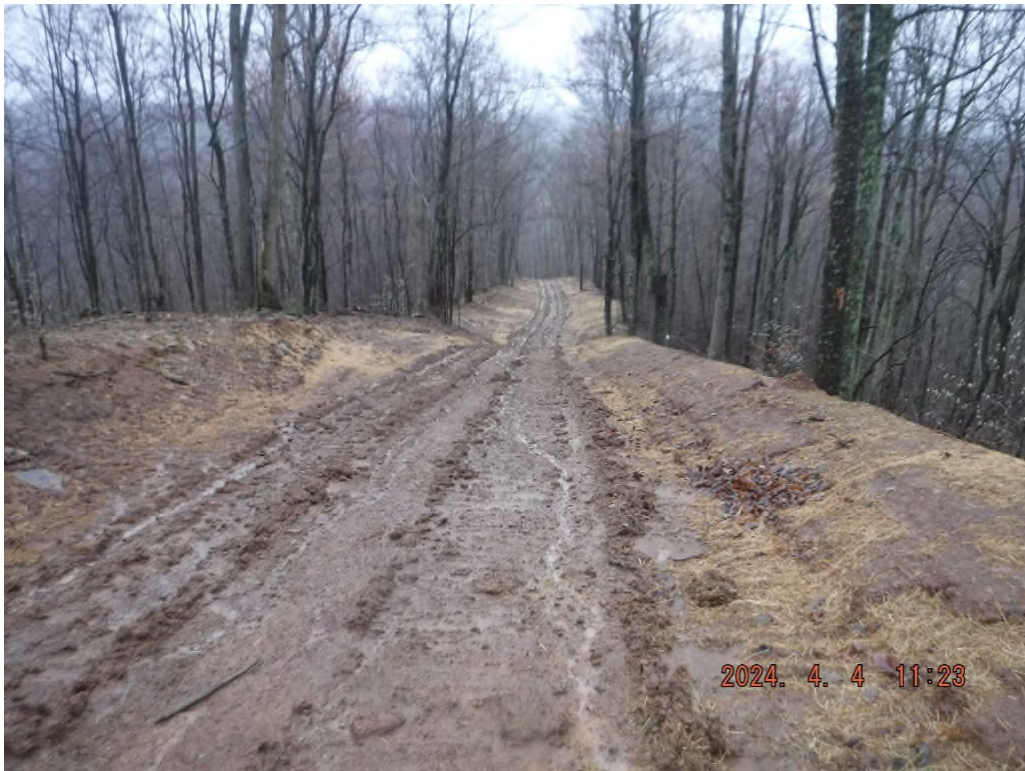
Photo # DSCF3684: Unpermitted access road that starts at ROW at or near N 39° 30.8187', W 80° 31.6944' with no BMPs or stabilization.

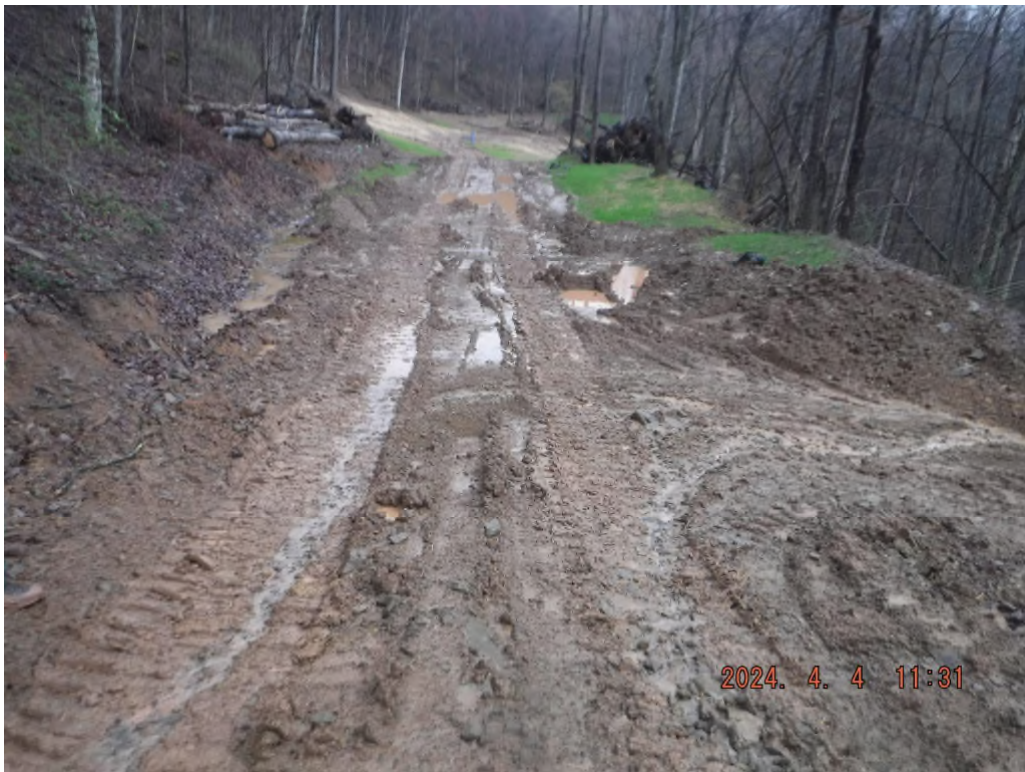
Photo # DSCF3690: Proposed access road on drawing sheet 3 of the SWPPP lacks stabilization.

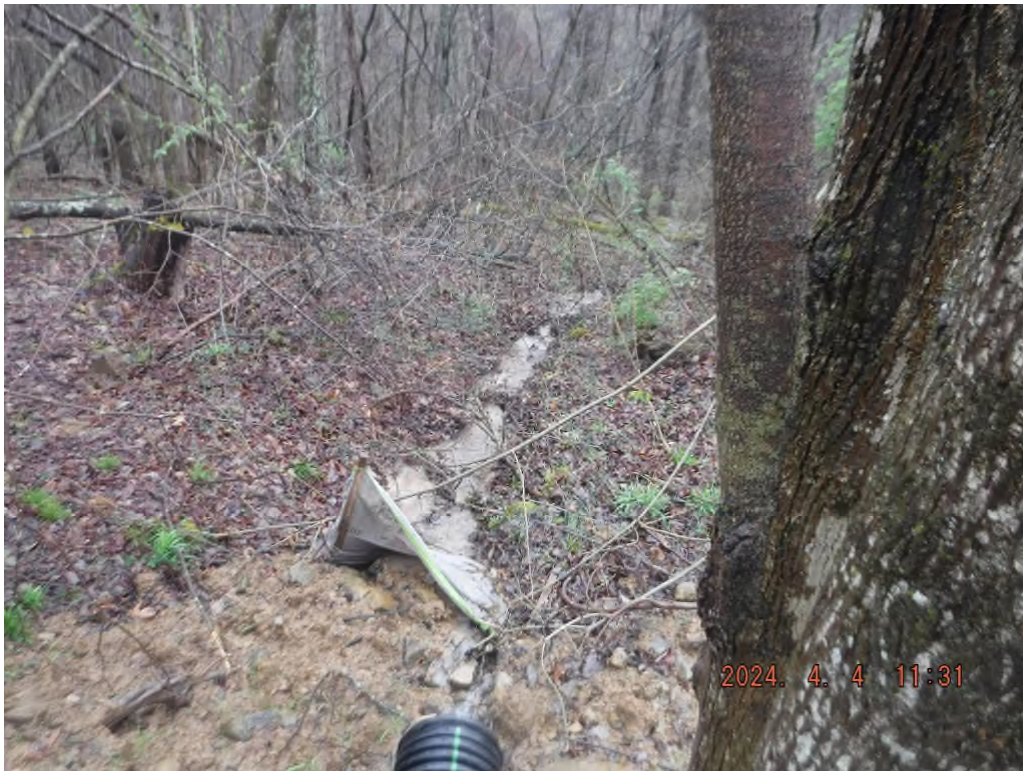
Photo # DSCF3694: Sediment laden water leaving the proposed access road on sheet 3 at or near N 39° 30.8977', W 80° 31.6754'.

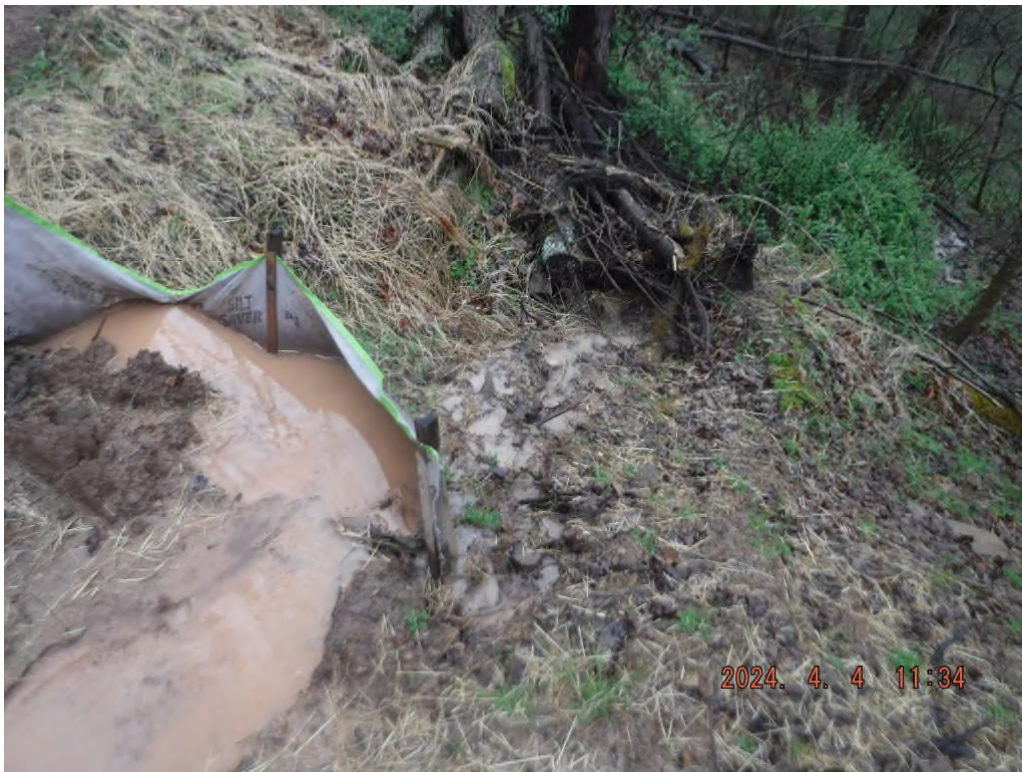
Photo # DSCF3699: Sediment laden water leaving the proposed access road on sheet 3 at or near N 39° 30.9685', W 80° 31.6435'.

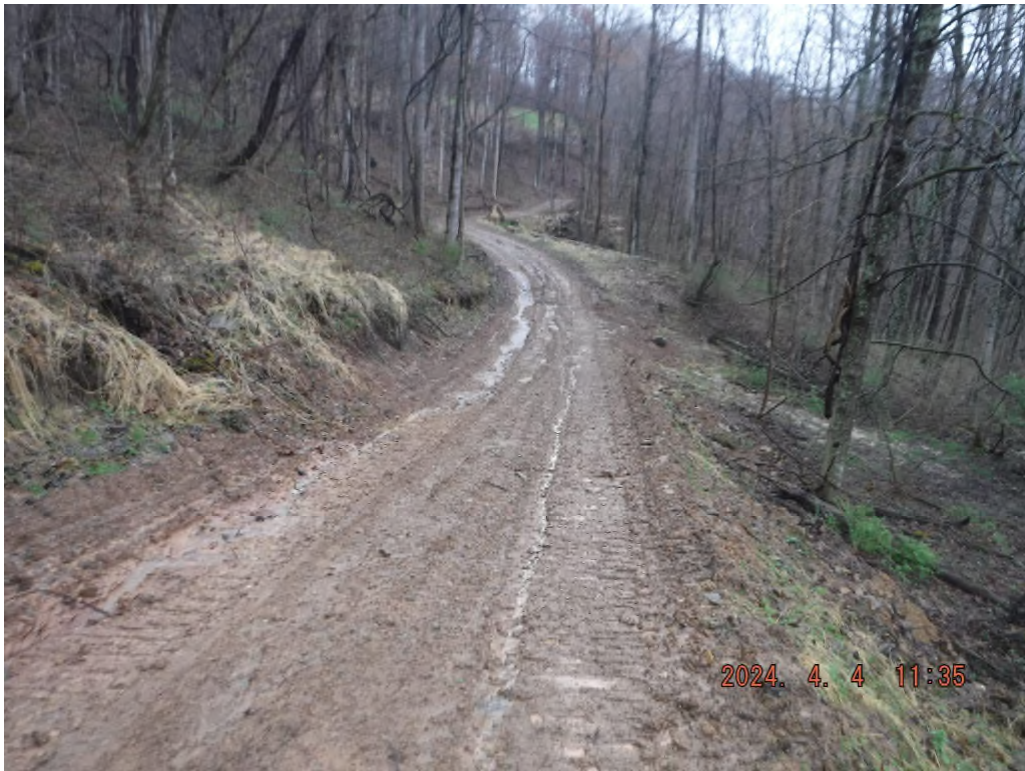
Photo # DSCF3700: Proposed access road on drawing sheet 3 of the approved SWPPP lacks stabilization and BMPs.

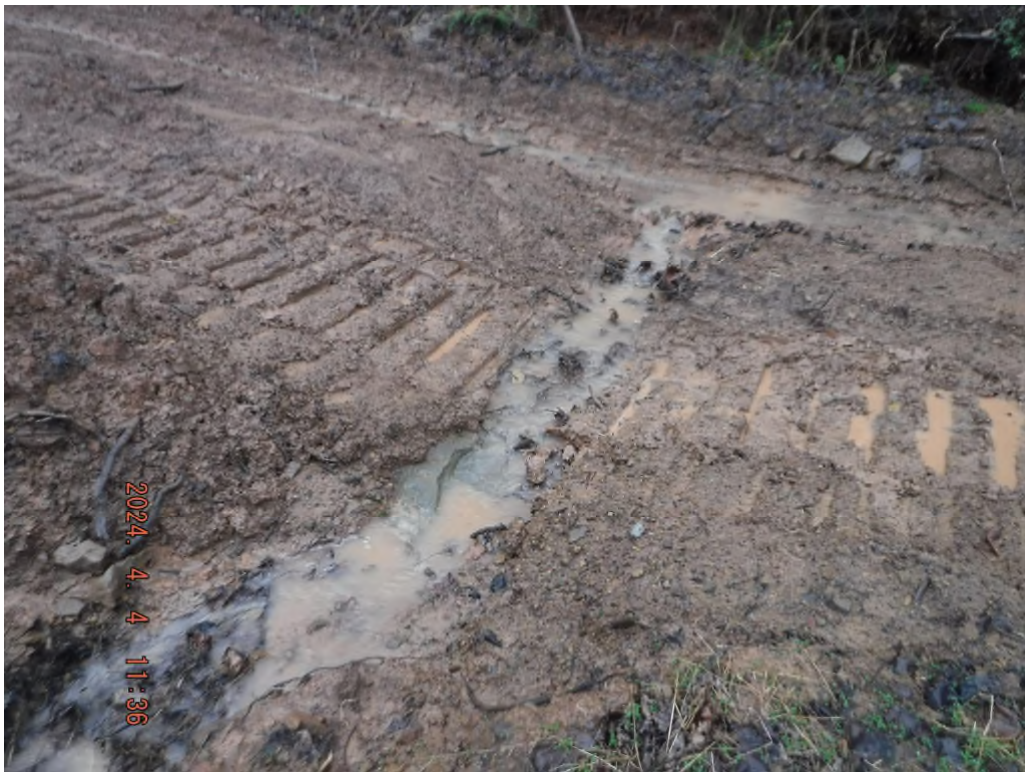
Photo # DSCF3704: Source of sediment laden water leaving the proposed access road on sheet 3 at or near N 39° 30.9789', W 80° 31.6173'.

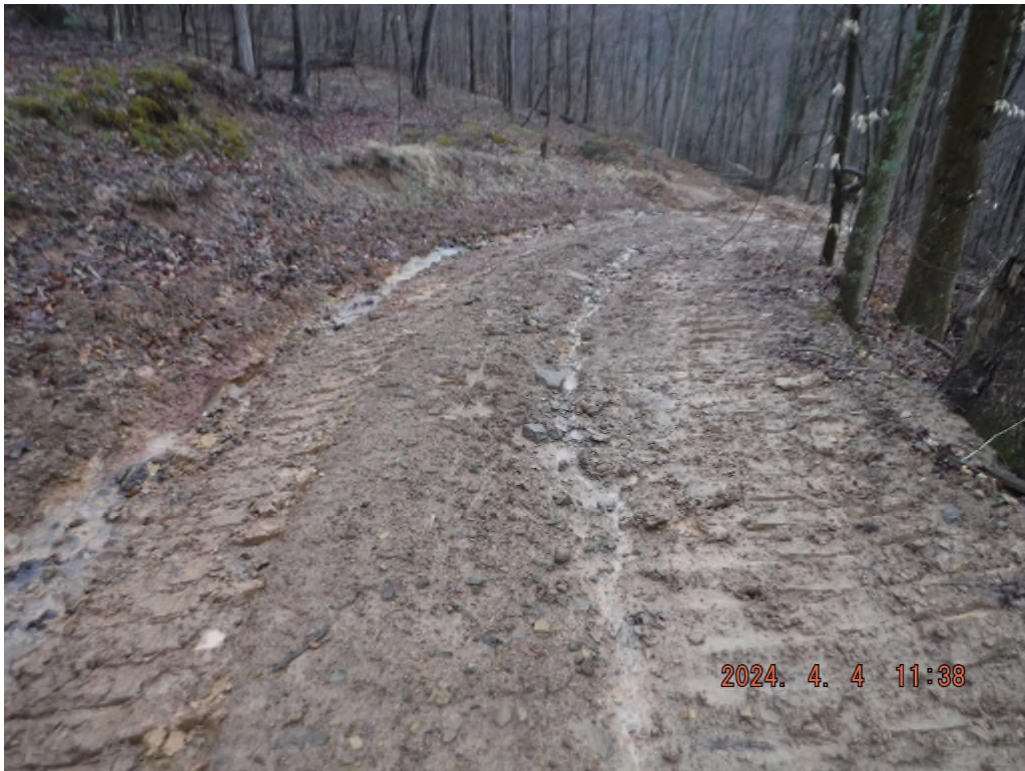
Photo # DSCF3714: Proposed access road on drawing sheet 3 of the approved SWPPP lacks stabilization and BMPs.

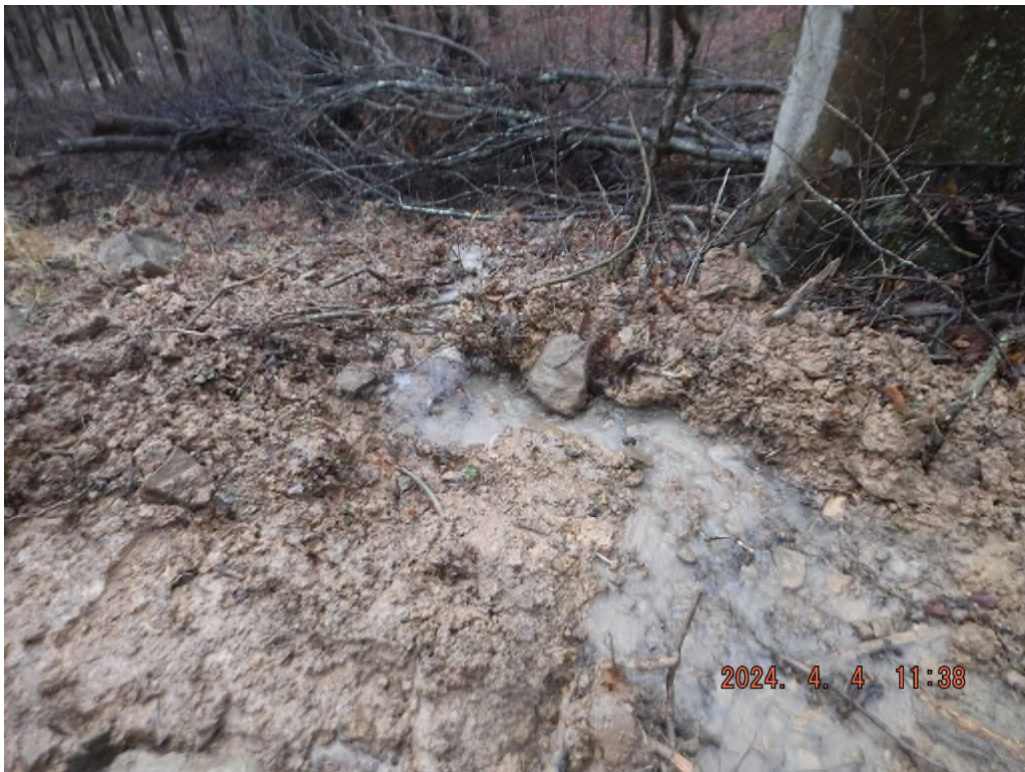
Photo # DSCF3718: Sediment laden water leaving the proposed access road on sheet 3 at or near N 39° 30.9891', W 80° 31.5432'.

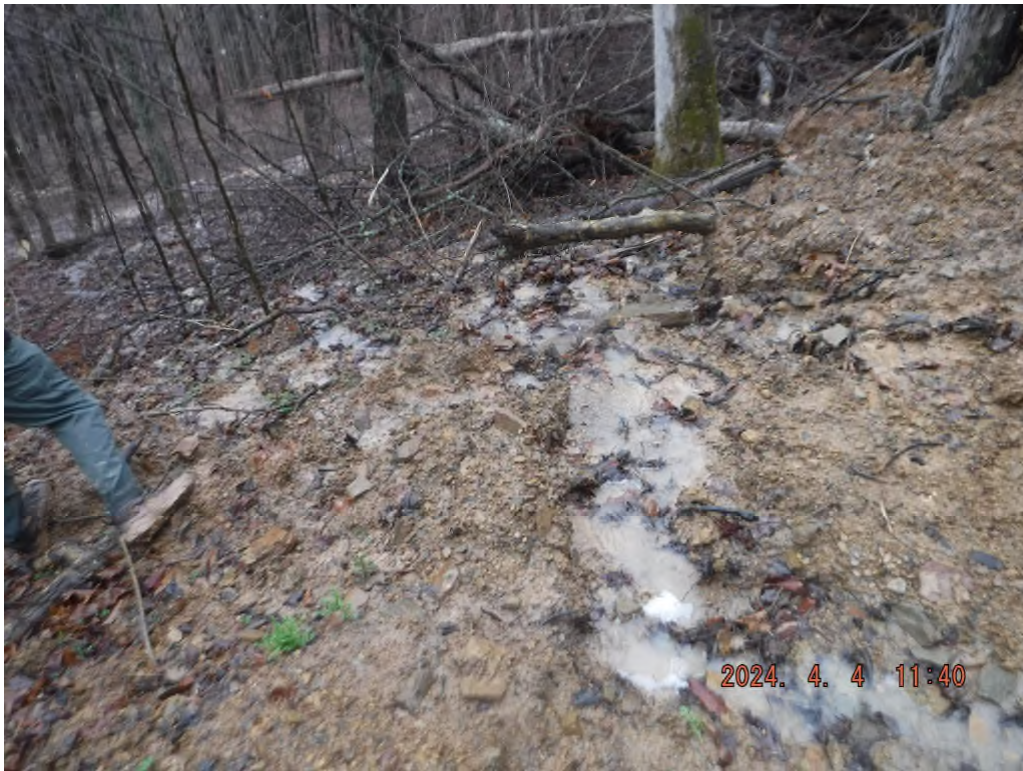
Photo # DSCF3725: Sediment laden water leaving the proposed access road on sheet 3 at or near N 39° 30.9749', W 80° 31.5214'.

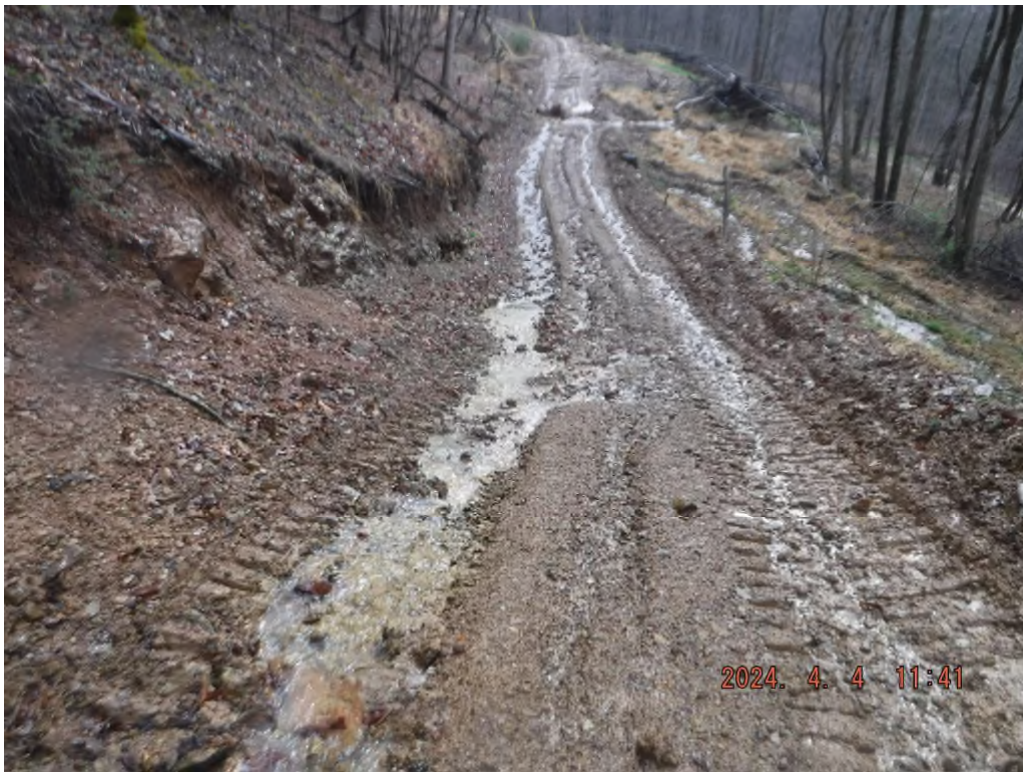
Photo # DSCF3727: Proposed access road on drawing sheet 3 of the approved SWPPP lacks stabilization and BMPs.

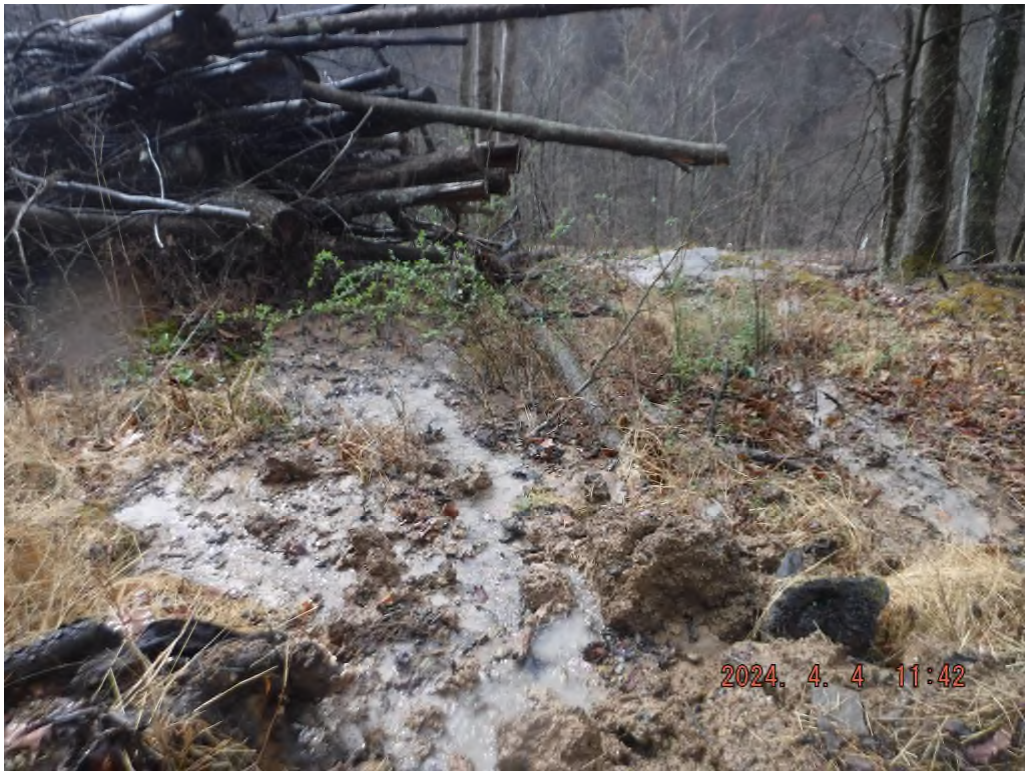
Photo # DSCF3730: Sediment laden water leaving the proposed access road on sheet 3 at or near N 39° 30.9694', W 80° 31.4477'.

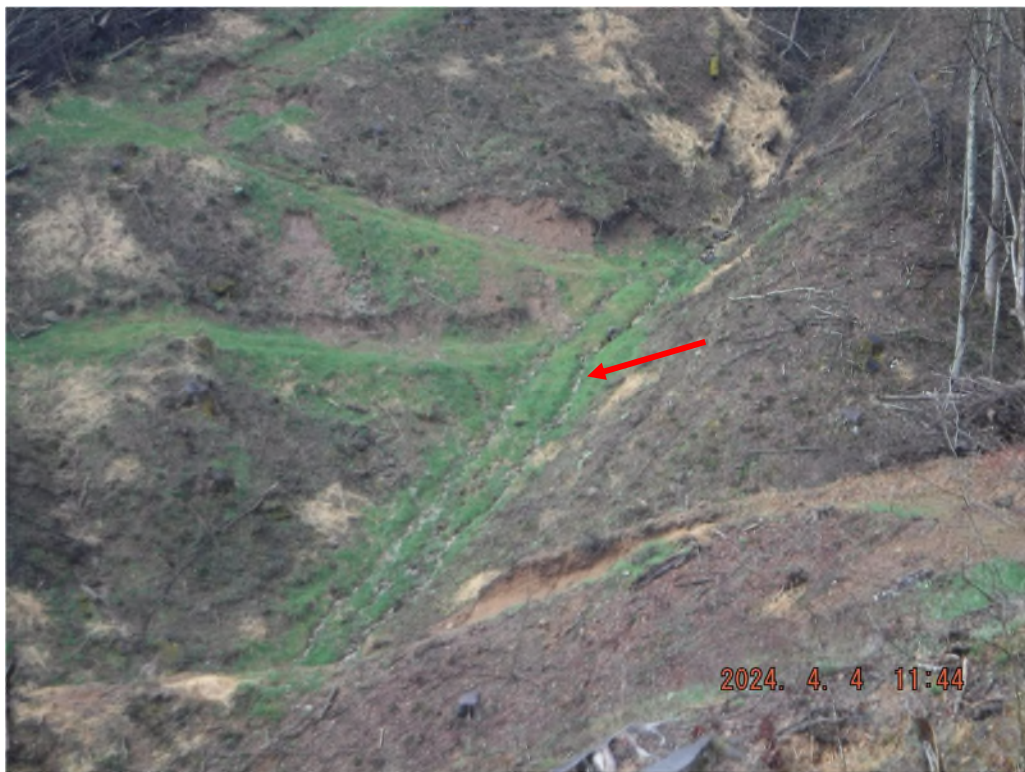
Photo # DSCF3733: Erosion in the travel lane off LOD in the ROW between stations 130+00 and 135+00.

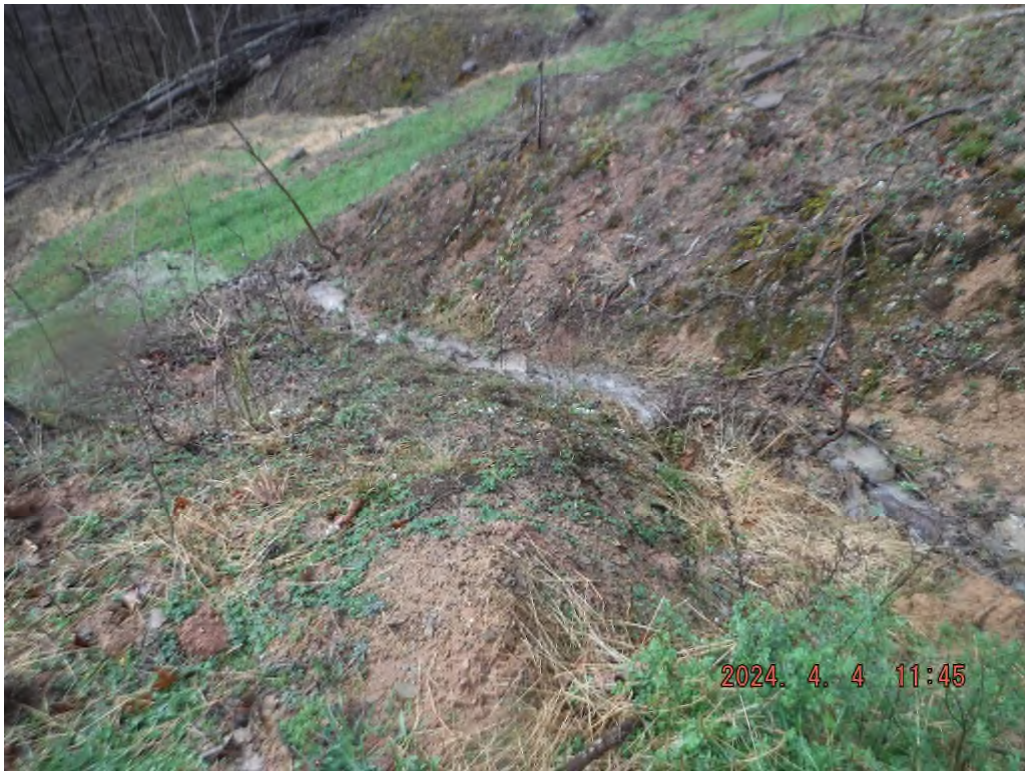
Photo # DSCF3737: Sediment laden water leaving from the ROW between stations 120+00 and 125+00 at or near N 39° 30.9457', W 80° 31.4481'.

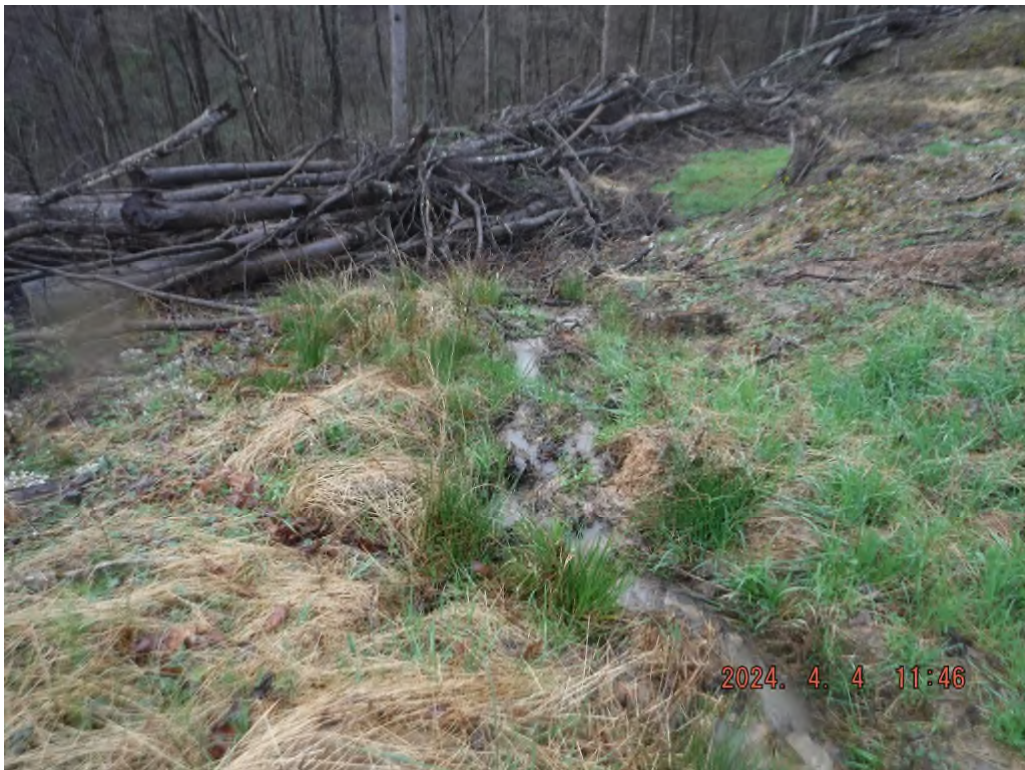
Photo # DSCF3740: Sediment laden water leaving from the ROW between stations 120+00 and 125+00 at or near N 39° 30.9490', W 80° 31.4326'.

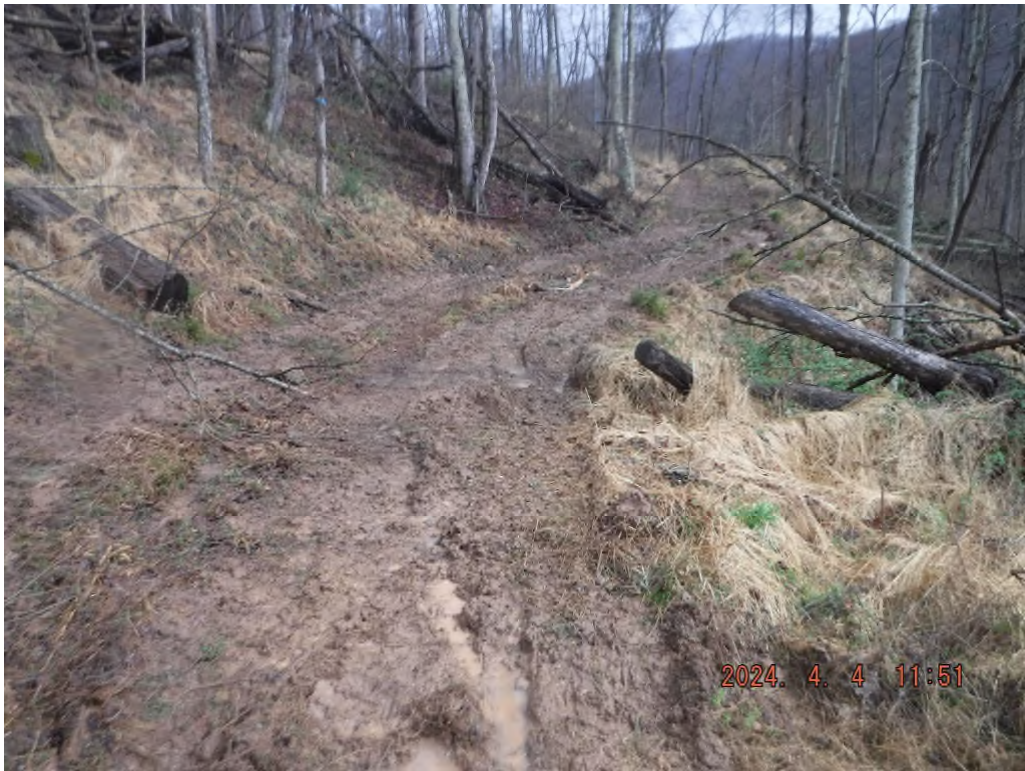
Photo # DSCF3744: Unpermitted access road at or near N 39° 30.9806', W 80° 31.3774' that leads down to Buck Run Rd. and lacks stabilization and BMPs.

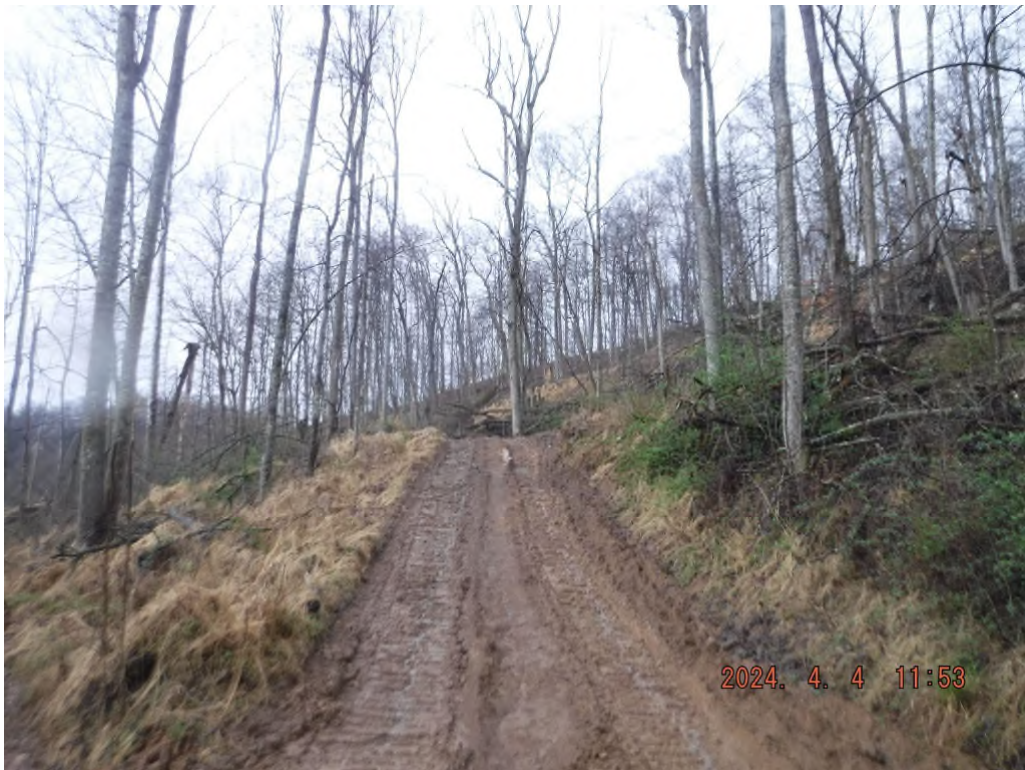
Photo # DSCF3751: Unpermitted access road at or near N 39° 30.9806', W 80° 31.3774' that leads down to Buck Run Rd. and lacks stabilization and BMPs.
