**CONSENT ORDER
ISSUED UNDER THE
WATER POLLUTION CONTROL ACT
WEST VIRGINIA CODE CHAPTER 22, ARTICLE 11**

TO: Harrison County Coal Resources, Inc.
Attn: James R. Turner, Jr.
46226 National Road West
St. Clairsville, OH 43950

ORDER NO.: 10302

Rymer I & II Stream Restoration Site – WVR112355

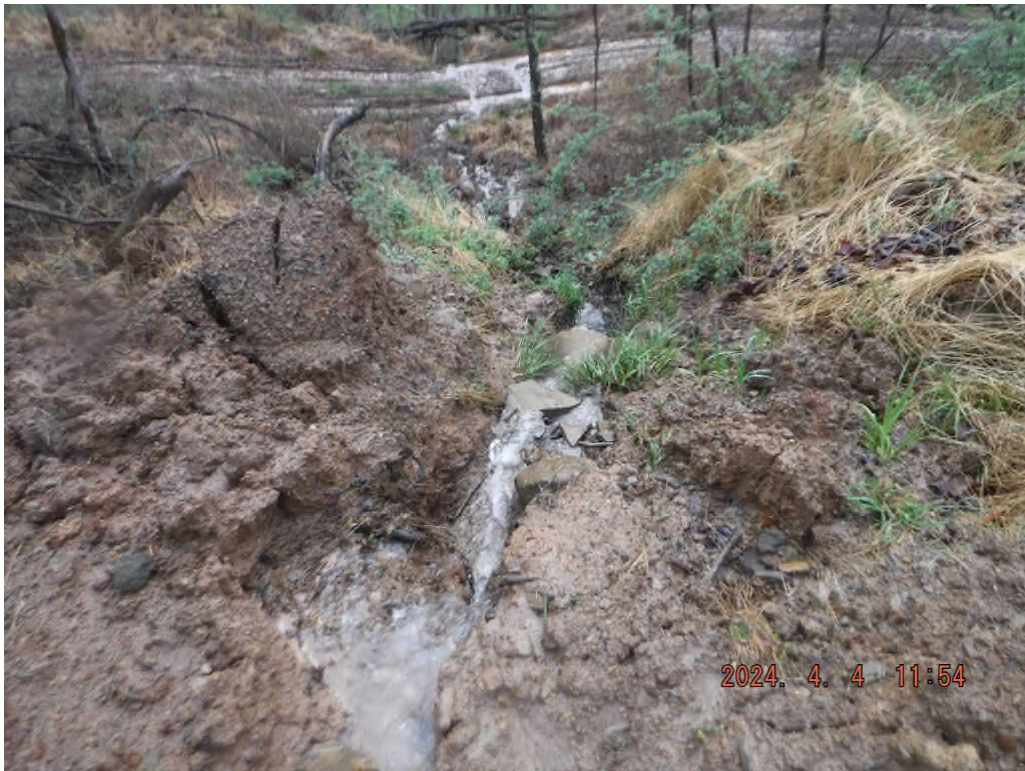
Photo # DSCF3757: Sediment laden water leaving the unpermitted access road to Buck Run Rd.
at or near N 39° 31.0243', W 80° 31.3335'.

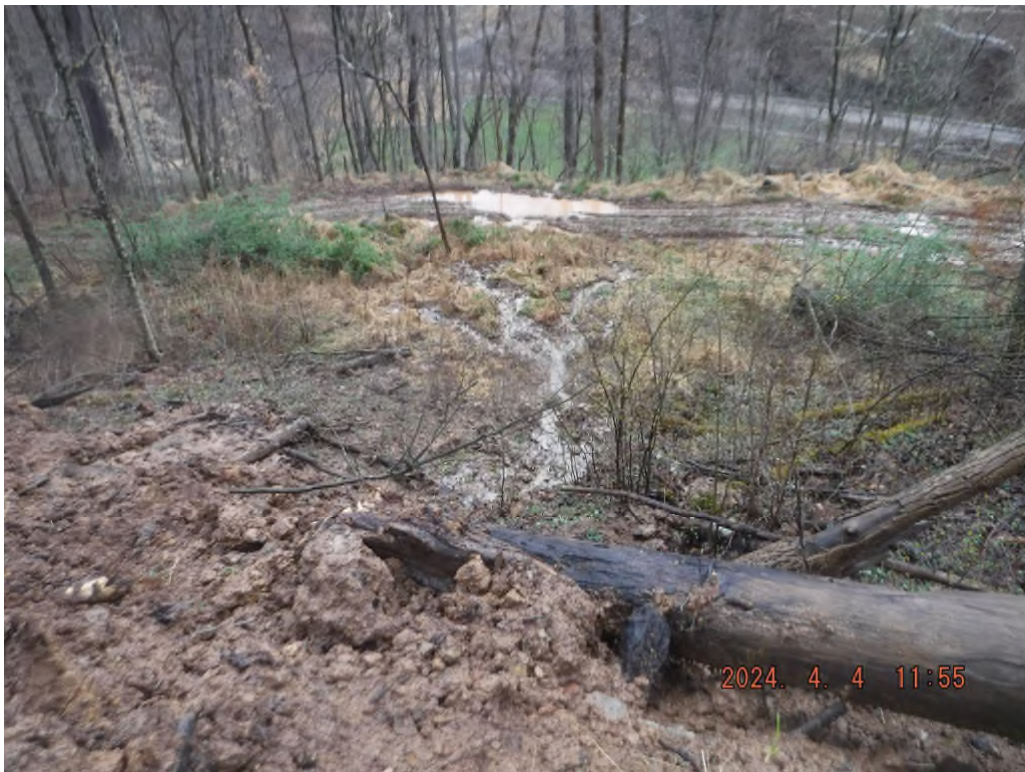
Photo # DSCF3761: Sediment laden water leaving the unpermitted access road to Buck Run Rd.
at or near N 39° 31.8484', W 80° 31.3387'.

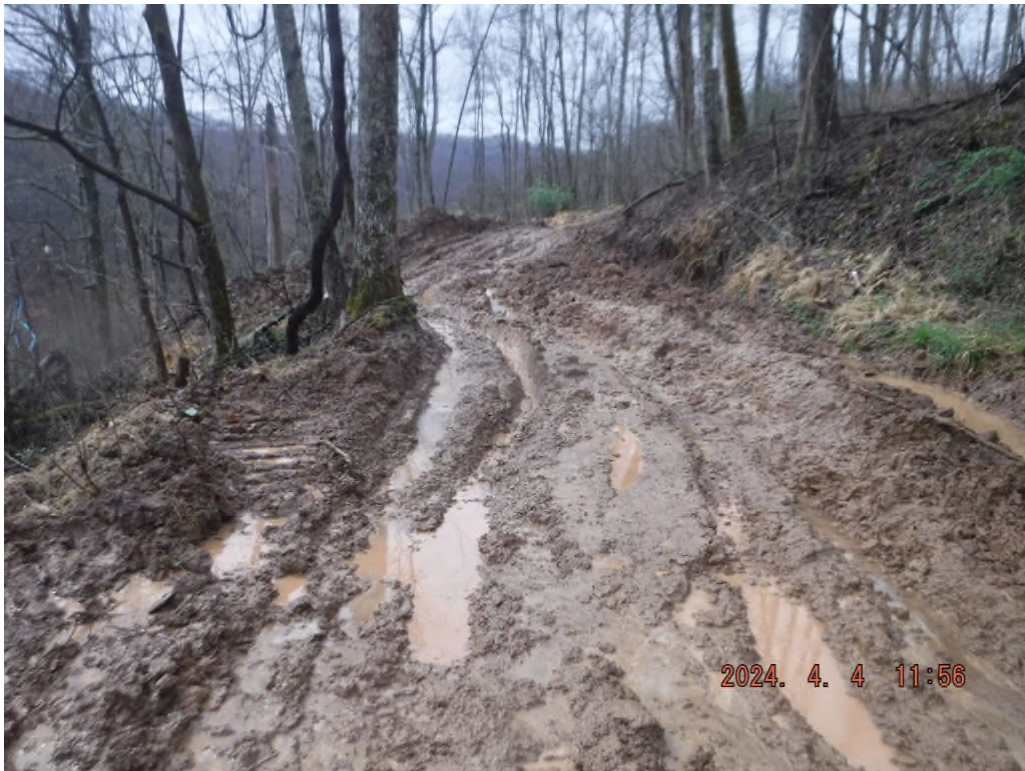
Photo # DSCF3762: Unpermitted access road at or near N 39° 30.9806', W 80° 31.3774' that leads down to Buck Run Rd. and lacks stabilization and BMPs.

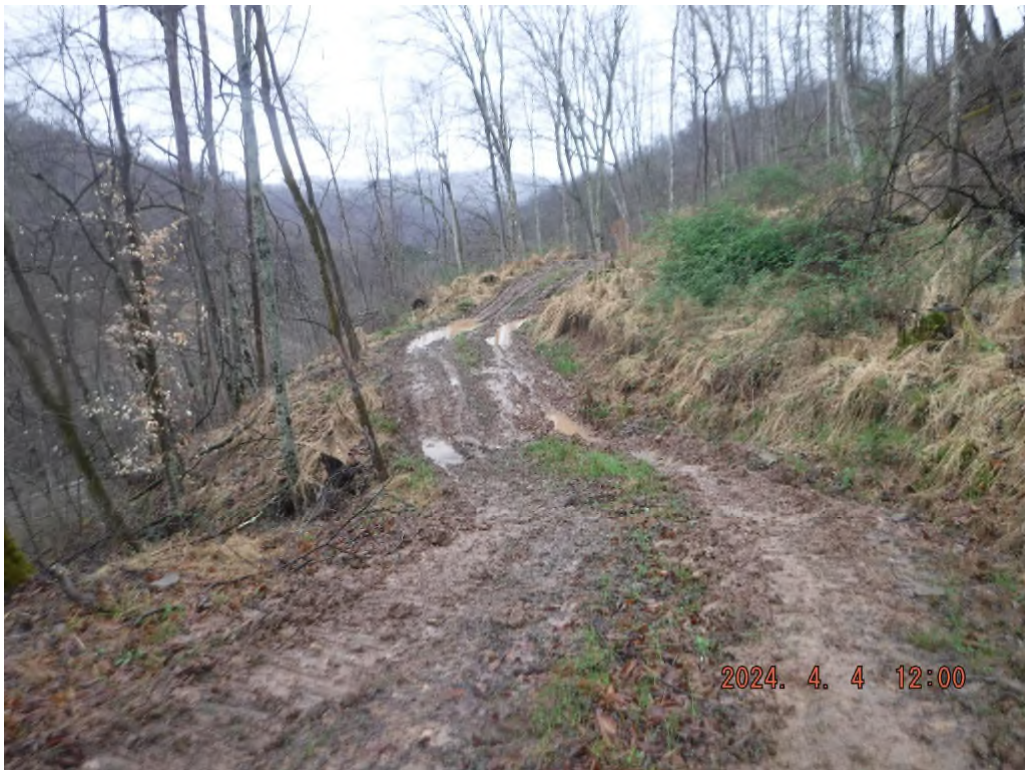
Photo # DSCF3774: Unpermitted access road at or near N 39° 31.0736', W 80° 30.3038' that lacks stabilization and BMPs.

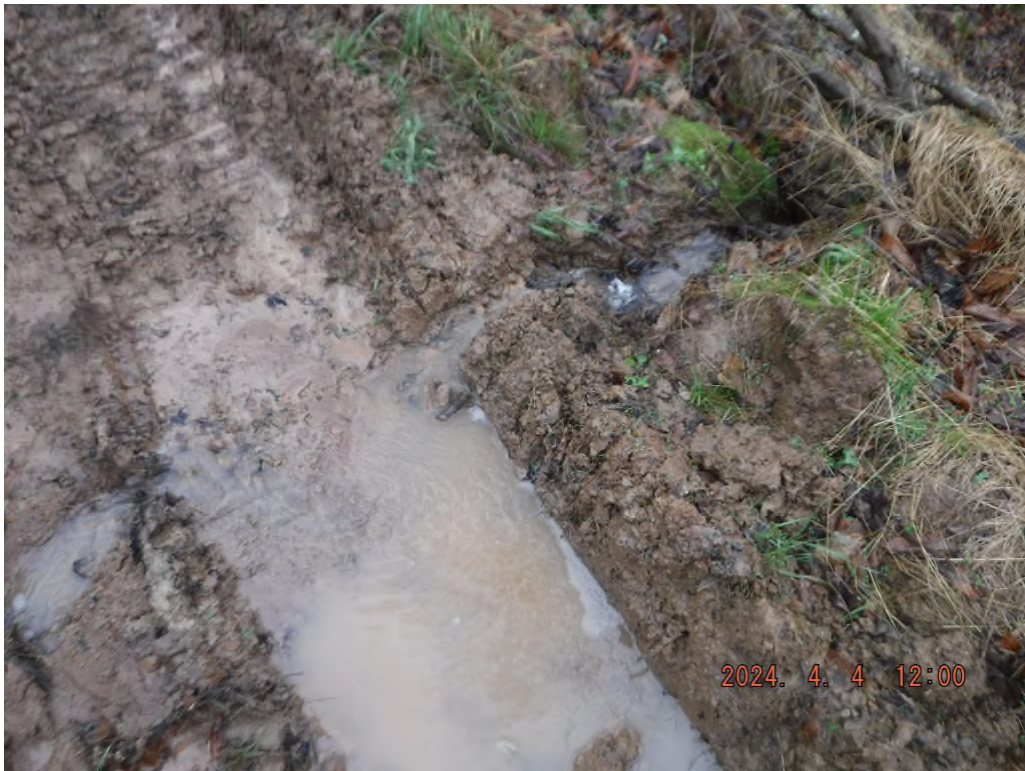
Photo # DSCF3776: Sediment laden water leaving the unpermitted access road at N 39° 31.0736', W 80° 30.3038' at or near N 39° 31.0410', W 80° 31.3097'

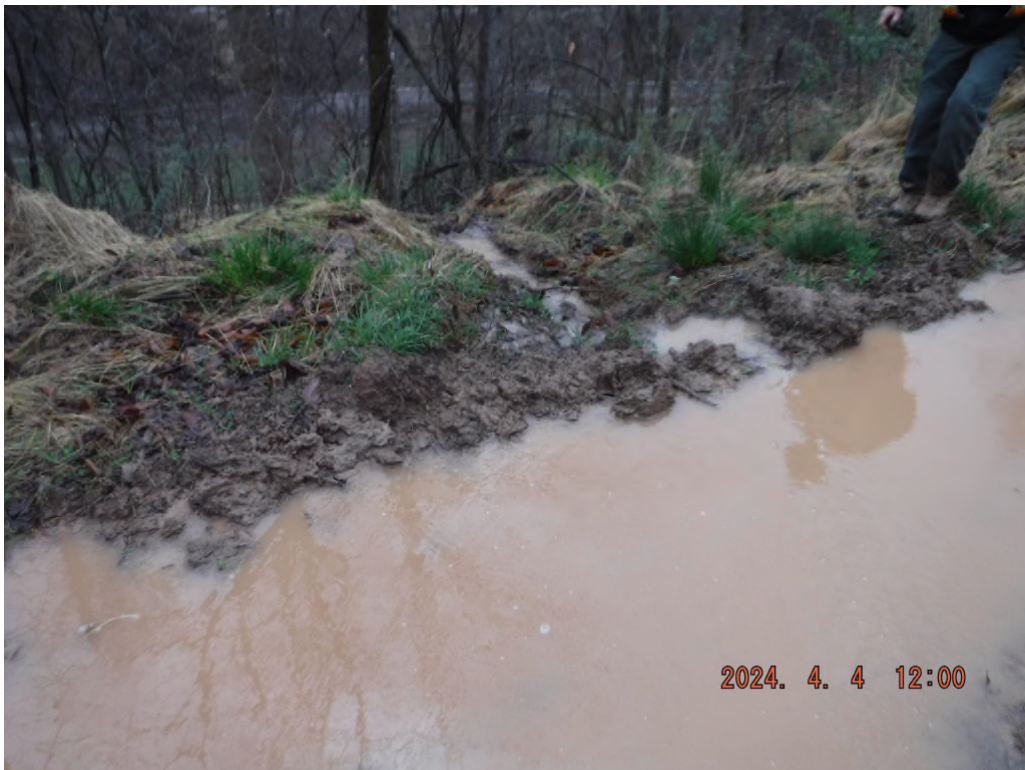
Photo # DSCF3779: Sediment laden water leaving the unpermitted access road at N 39° 31.0736', W 80° 30.3038' at or near N 39° 31.0373', W 80° 31.3126'.

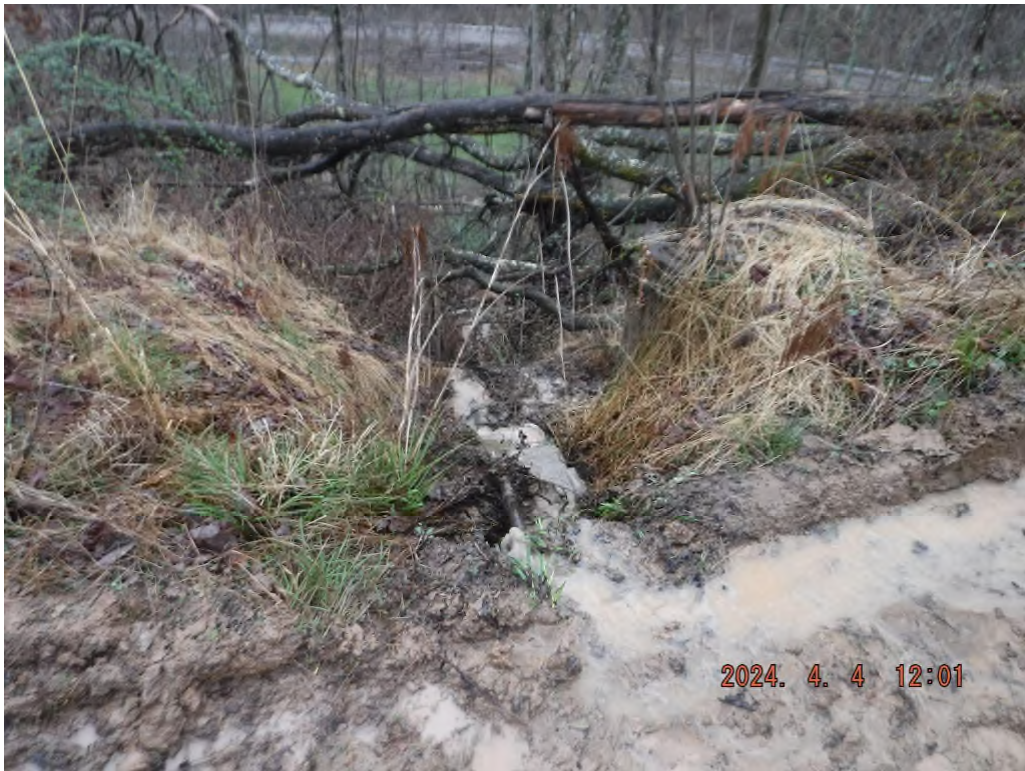
Photo # DSCF3783: Sediment laden water leaving the unpermitted access road at N 39° 31.0736', W 80° 30.3038' at or near N 39° 31.0187', W 80° 31.3165'.

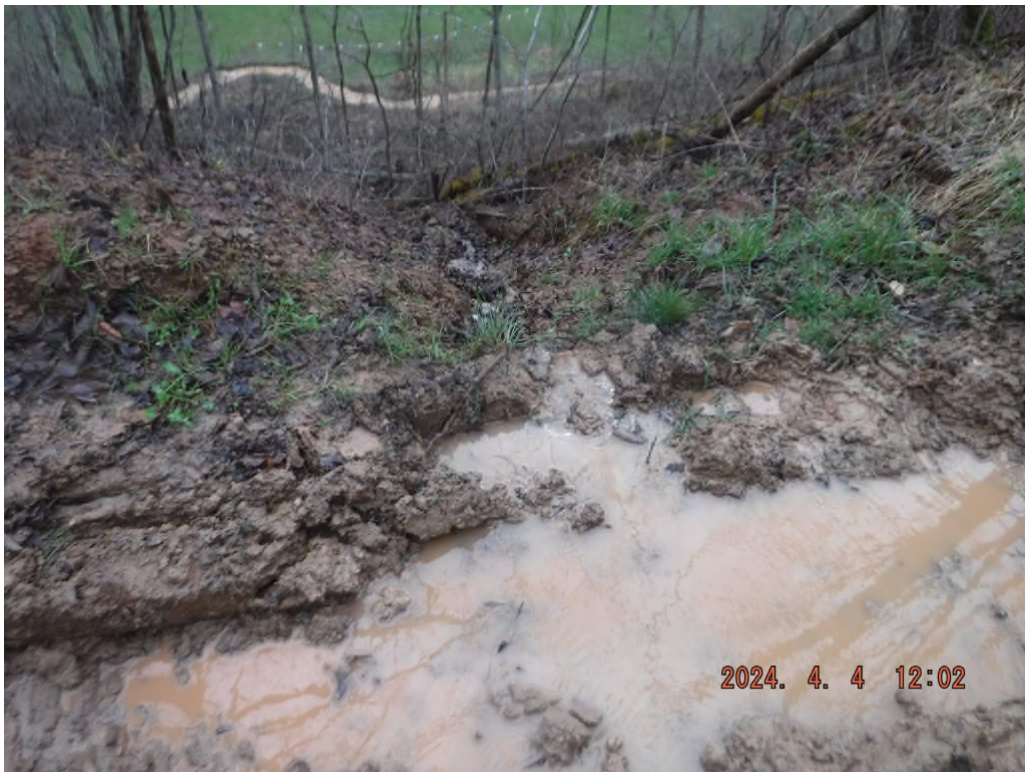
Photo # DSCF3785: Sediment laden water leaving the unpermitted access road at N 39° 31.0736', W 80° 30.3038' at or near N 39° 31.0050', W 80° 31.3265'.

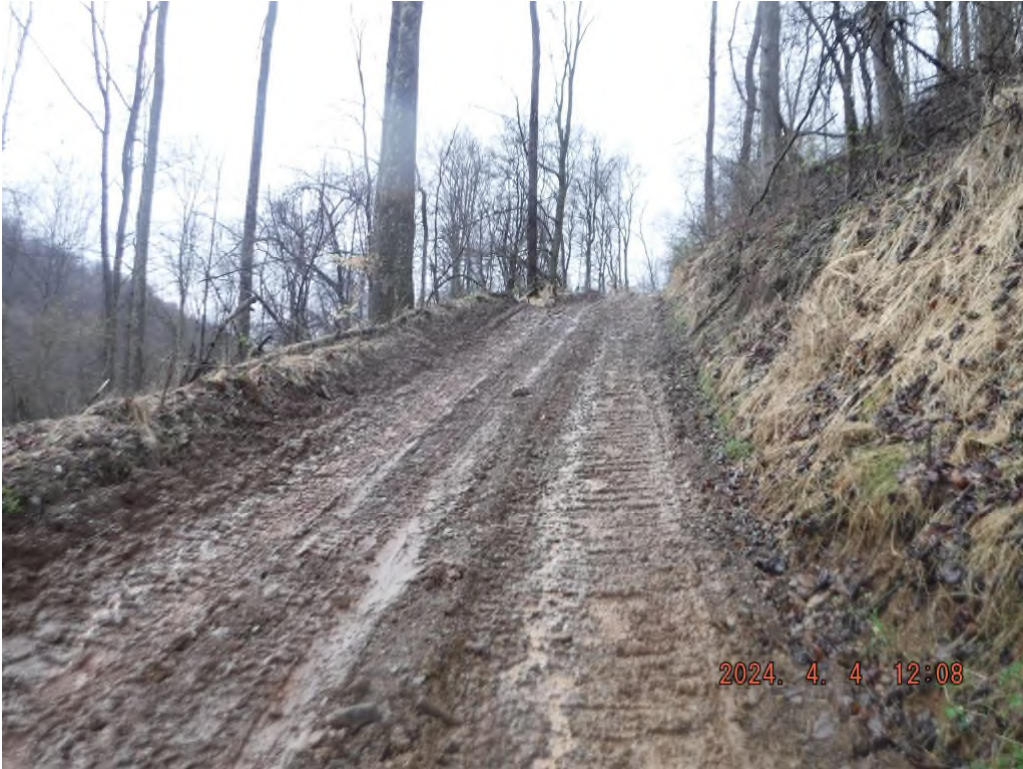
Photo # DSCF3793: Unpermitted access road to Buck Run that lacks stabilization and BMPs.

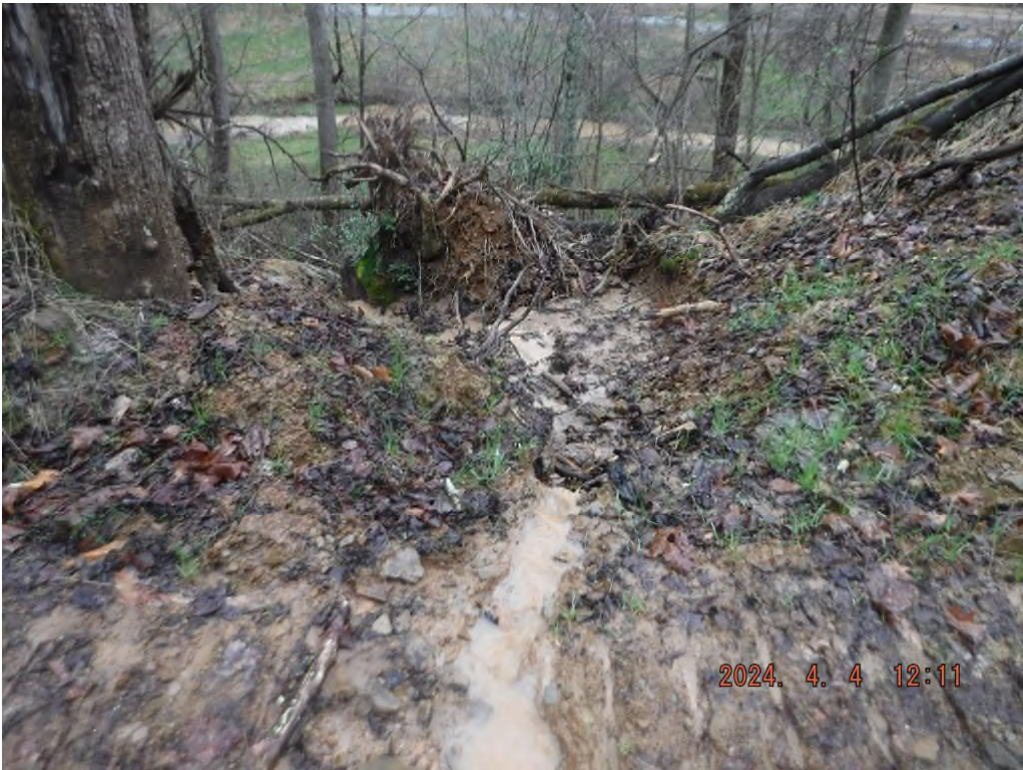
Photo # DSCF3800: Sediment laden water leaving the unpermitted access road near N 39° 31.1366', W 80° 31.2743' at or near N 39° 31.0703', W 80° 31.2682'.

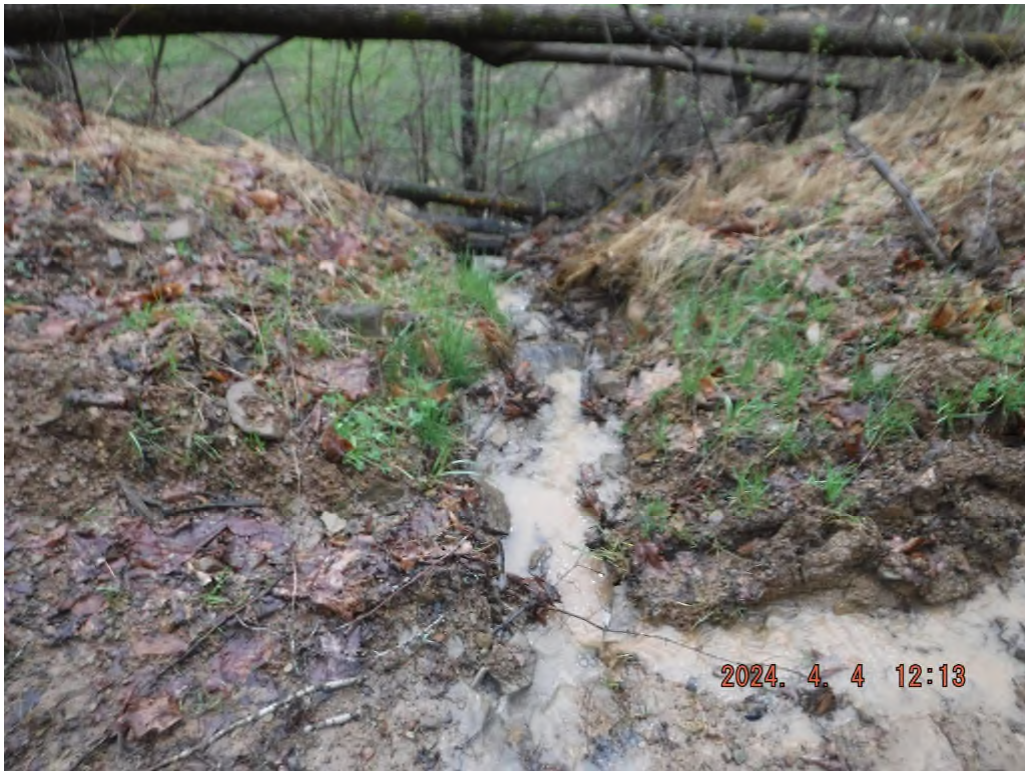
Photo # DSCF3805: Sediment laden water leaving the unpermitted access road near N 39° 31.1366', W 80° 31.2743' at or near N 39° 31.0366', W 80° 31.2721'.

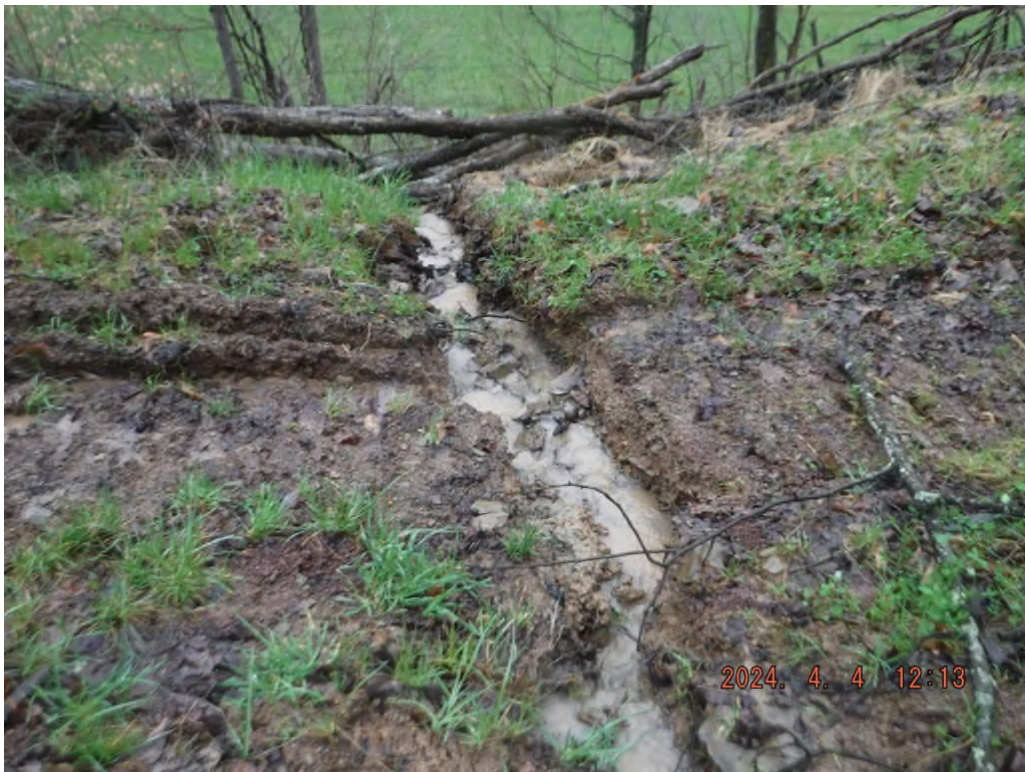
Photo # DSCF3808: Sediment laden water leaving the unpermitted access road near N 39° 31.1366', W 80° 31.2743' at or near N 39° 31.0110', W 80° 31.2872'.

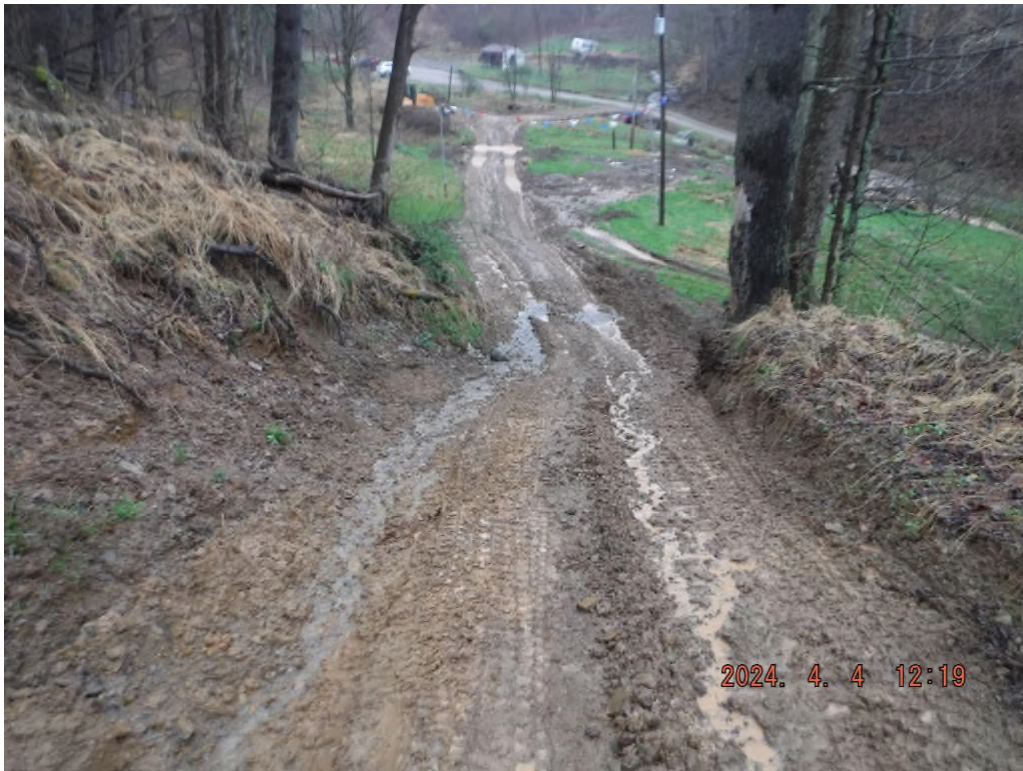
Photo # DSCF3812: Unpermitted access road to Buck Run that lacks stabilization and BMPs.

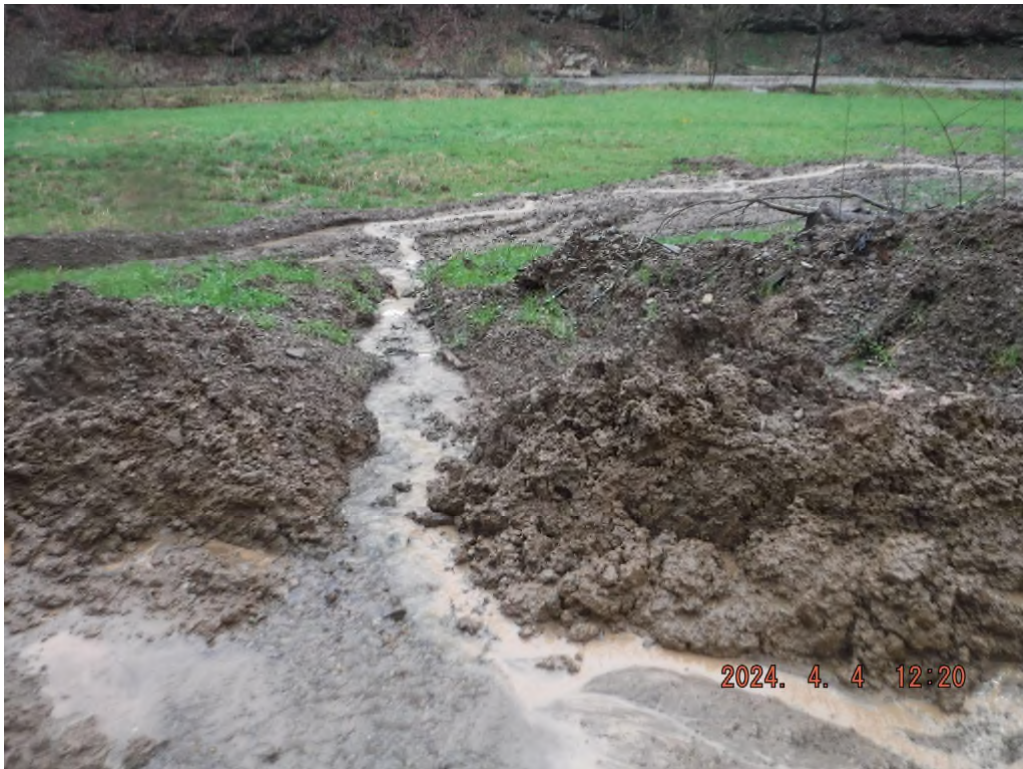
Photo # DSCF3813: Sediment laden water leaving the unpermitted access road to Buck Run.

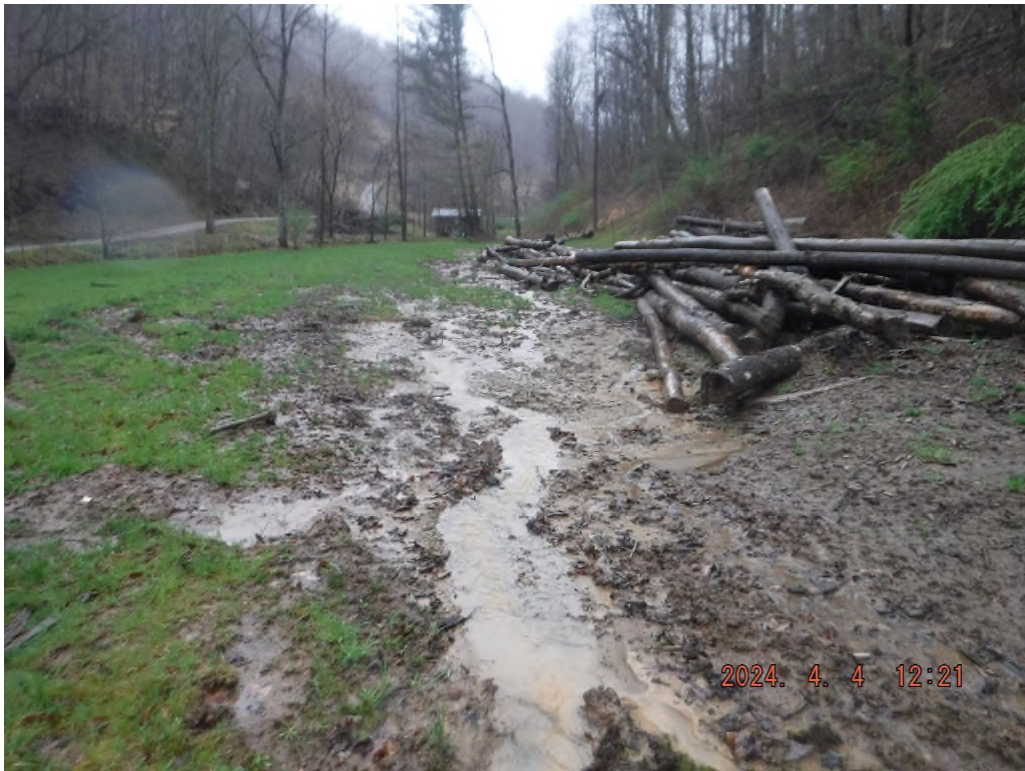
Photo # DSCF3818: Sediment laden water and sediment off of the unpermitted road to Buck Run.

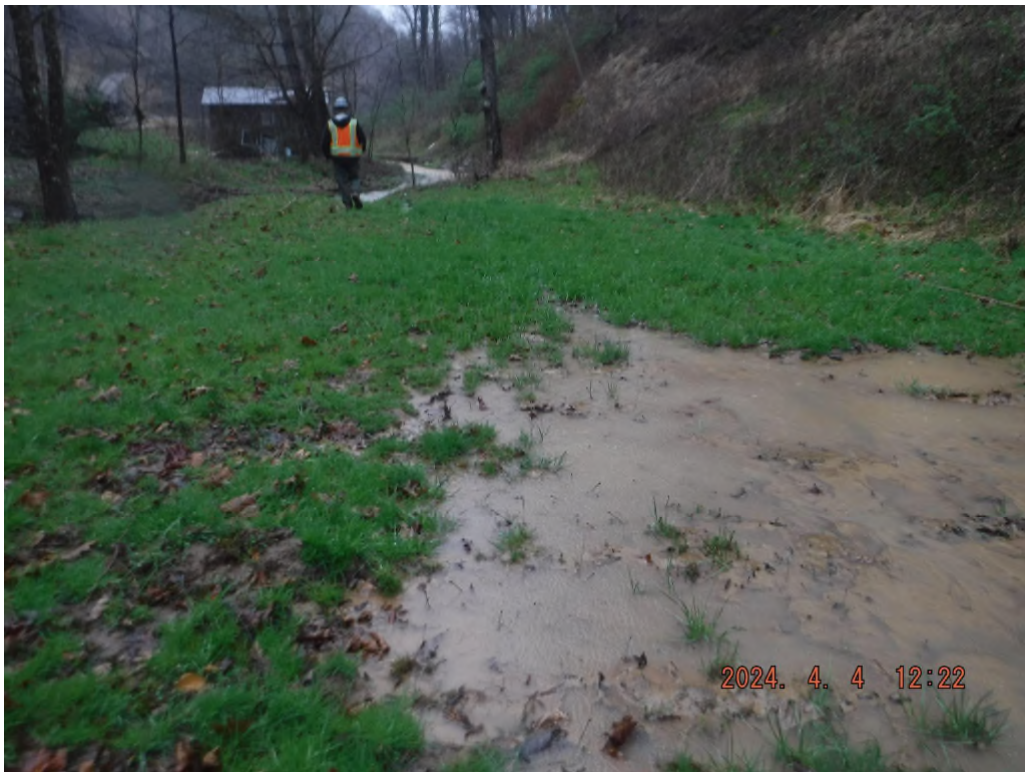
Photo # DSCF3821: Sediment laden water from the unpermitted access road to Buck Run flowing toward Buck run.

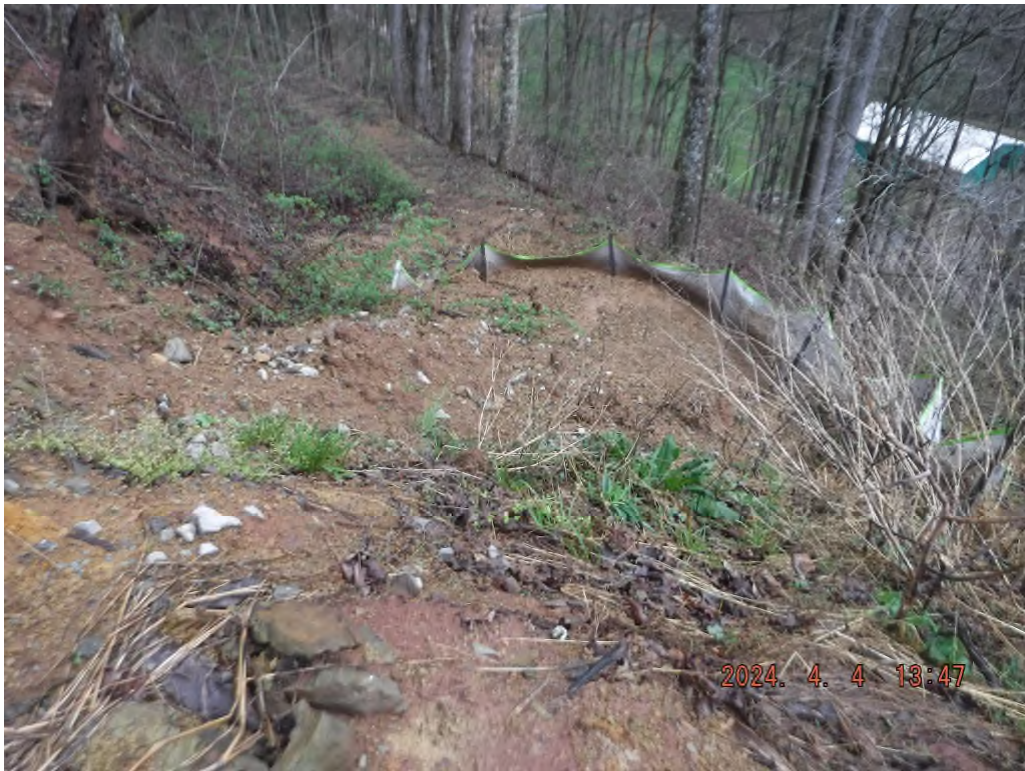
Photo # DSCF3857: Silt fence lacks maintenance at or near N 39° 30.9564', W 80° 30.5013'.

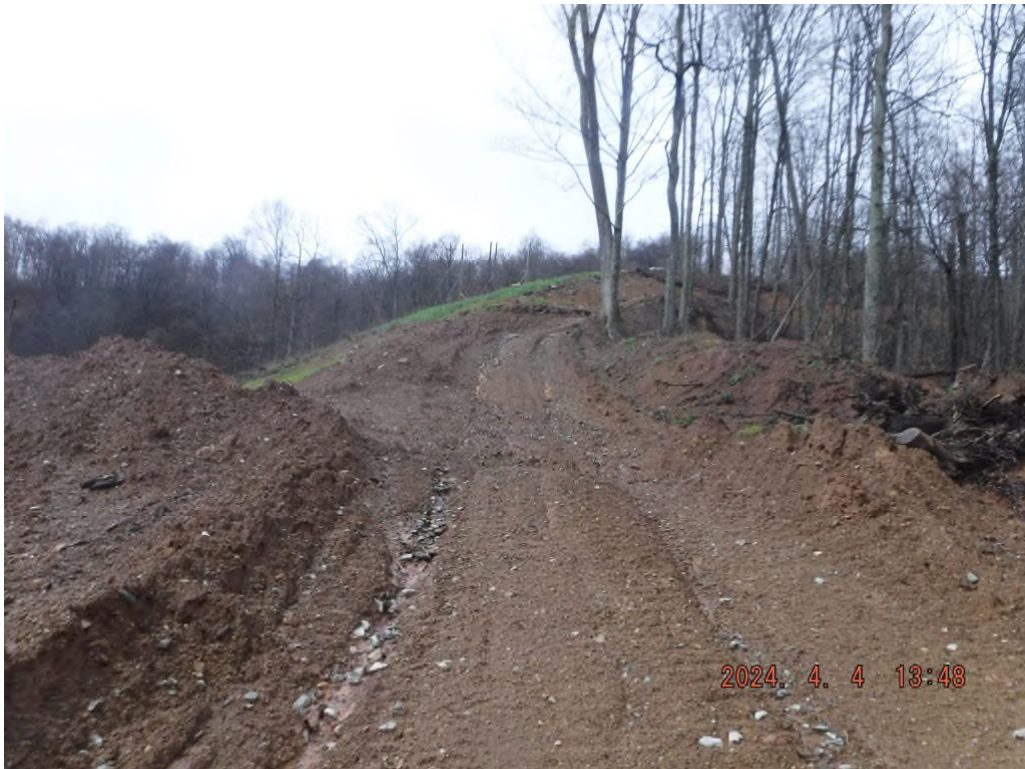
Photo # DSCF3858: Existing access road on sheets 2 and 3 from Pickenpaw Rd. lacks stabilization and BMPs.

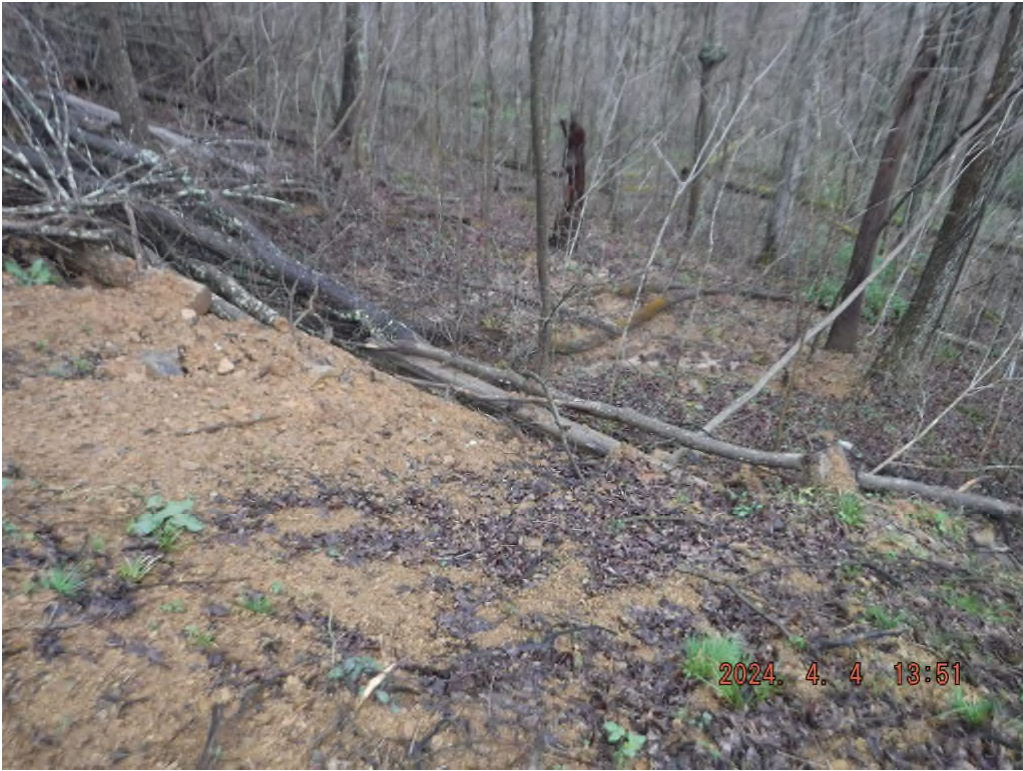
Photo # DSCF3867: Sediment laden water leaving the existing access road on sheets 2 and 3 from Pickenpaw Rd. at or near N 39° 30.9805', W 80° 30.5575'.

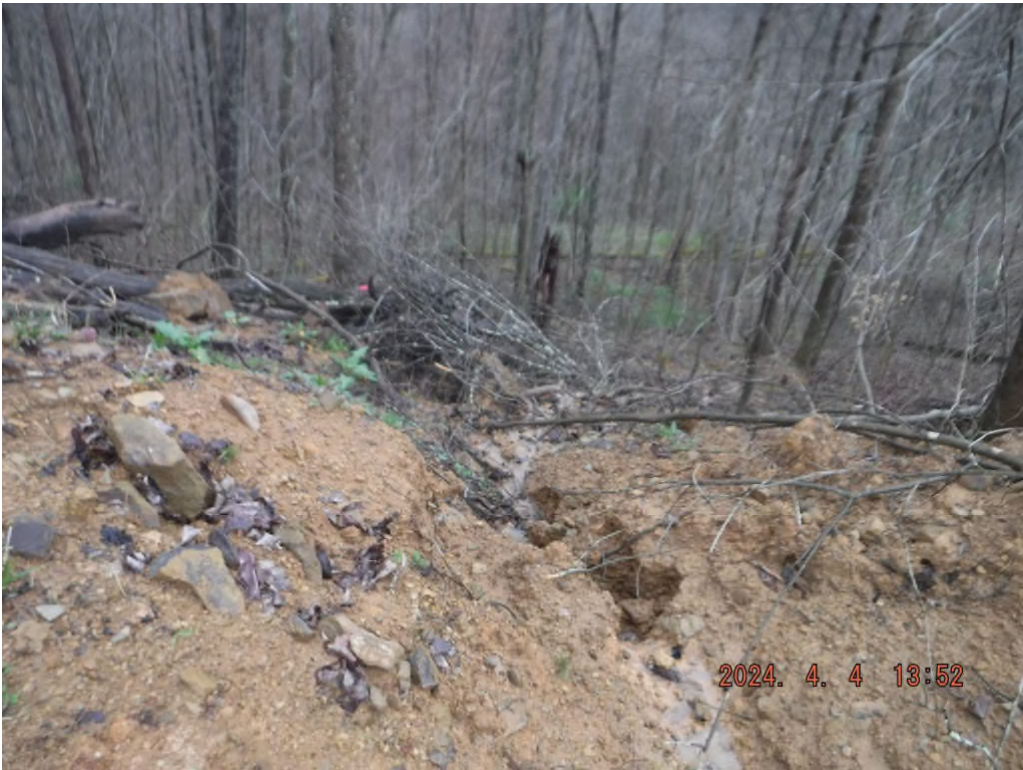
Photo # DSCF3870: Sediment laden water leaving the existing access road on sheets 2 and 3 from Pickenpaw Rd. at or near N 39° 30.9827', W 80° 30.5636'.

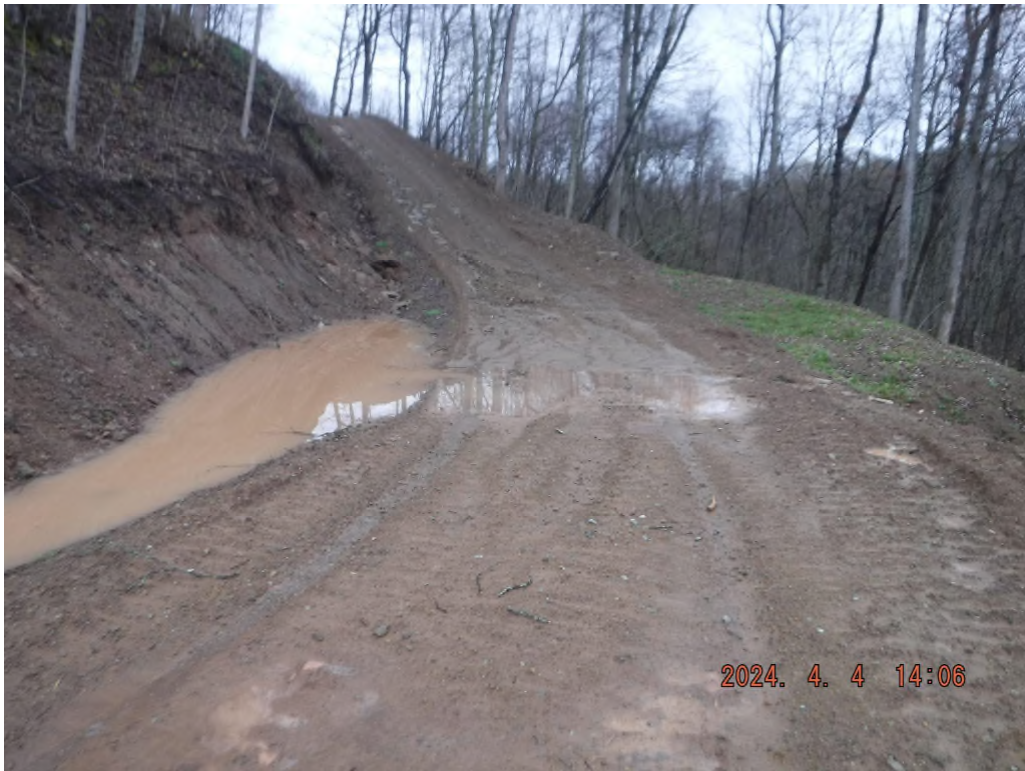
Photo # DSCF3891: Existing access road on sheets 2 and 3 from Pickenpaw Rd. lacks stabilization and BMPs.

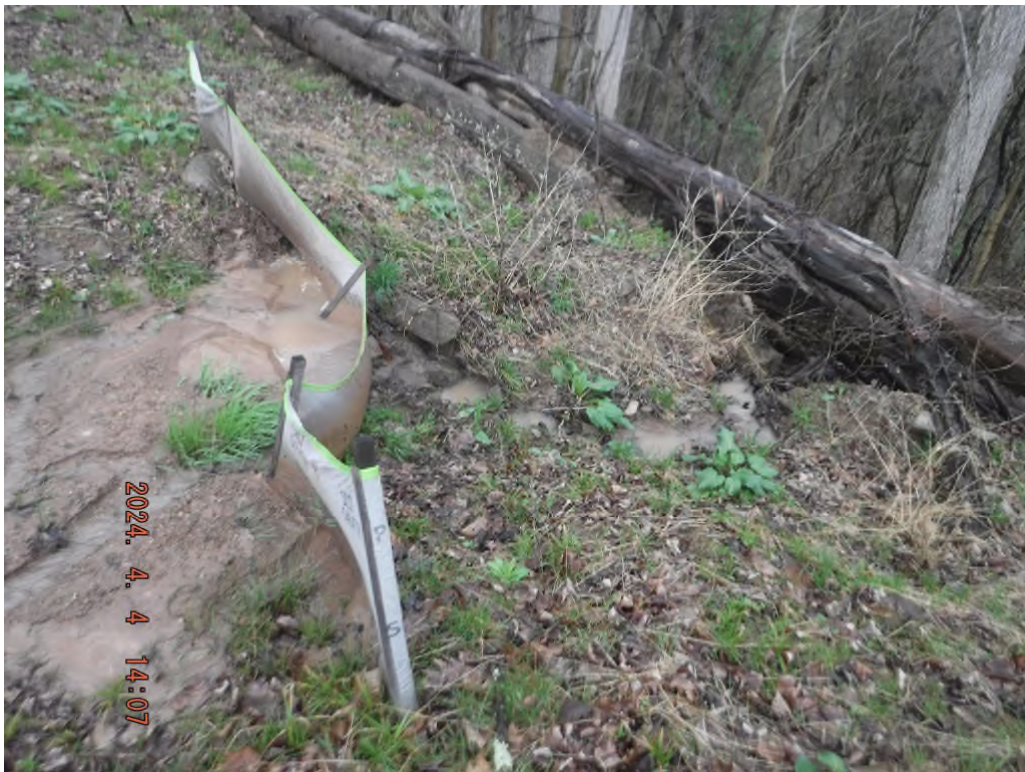
Photo # DSCF3896: Sediment laden water leaving the existing access road on sheets 2 and 3 from Pickenpaw Rd. at or near N 39° 31.0252', W 80° 30.7007'.

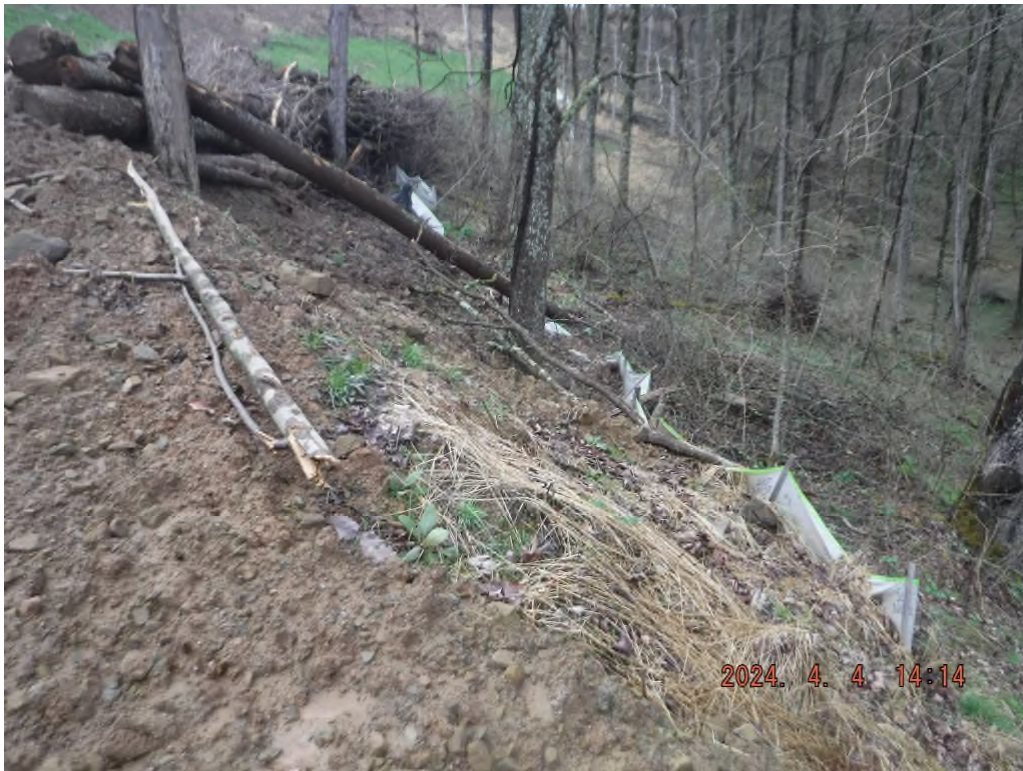
Photo # DSCF3902: Silt fence lacks maintenance at or near N 39° 31.0547', W 80° 30.8078.

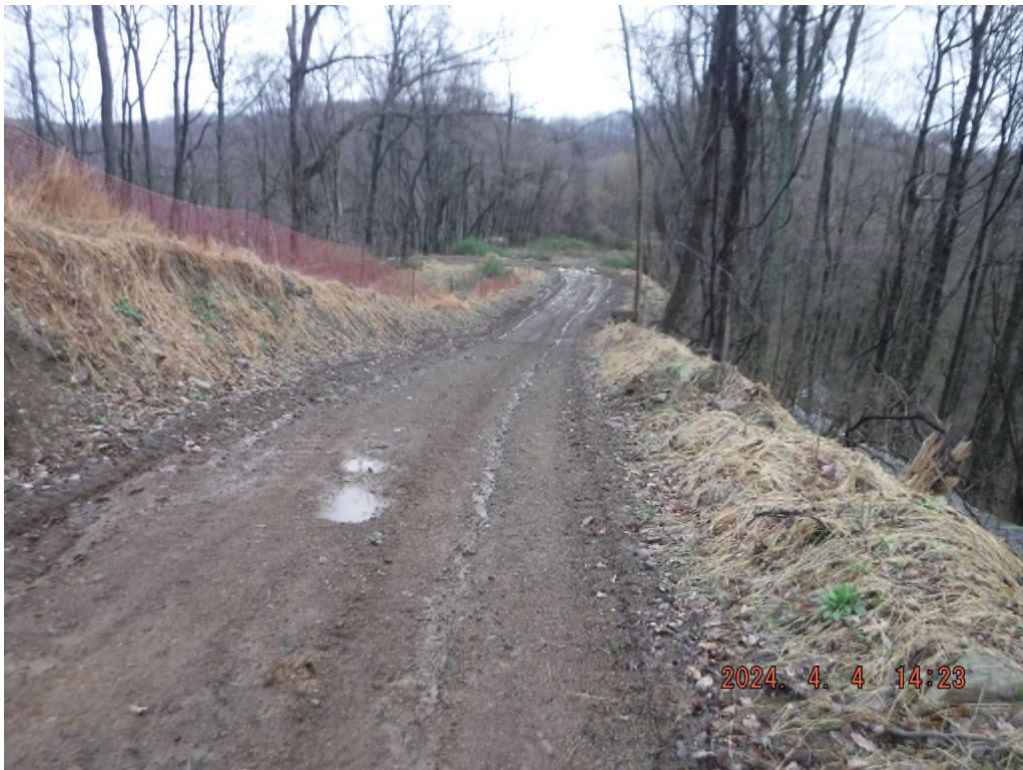
Photo # DSCF3913: Unpermitted access road between Buck Run Rd. and Pickenpaw Rd. at or near N 39° 31.0950', W 80° 30.9033' that lacks stabilization and BMPs.

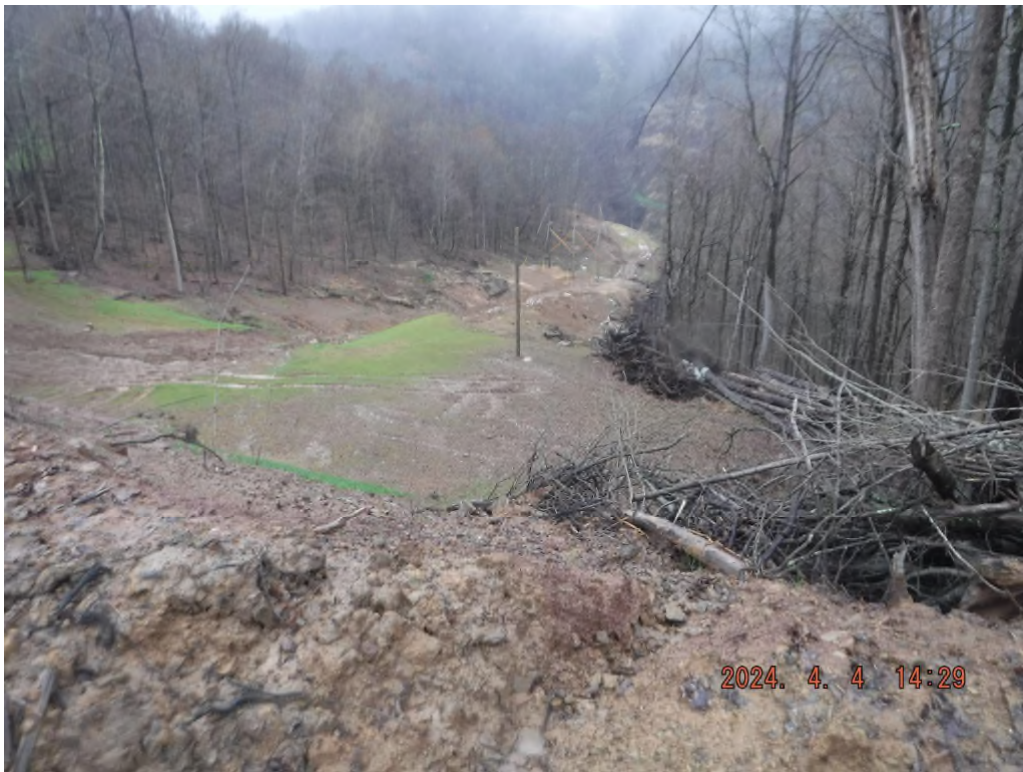
Photo # DSCF3925: Sediment laden water leaving the unpermitted access road between Buck Run Rd. and Pickenpaw Rd. at or near N 39° 31.1043', W 80° 30.9749'.

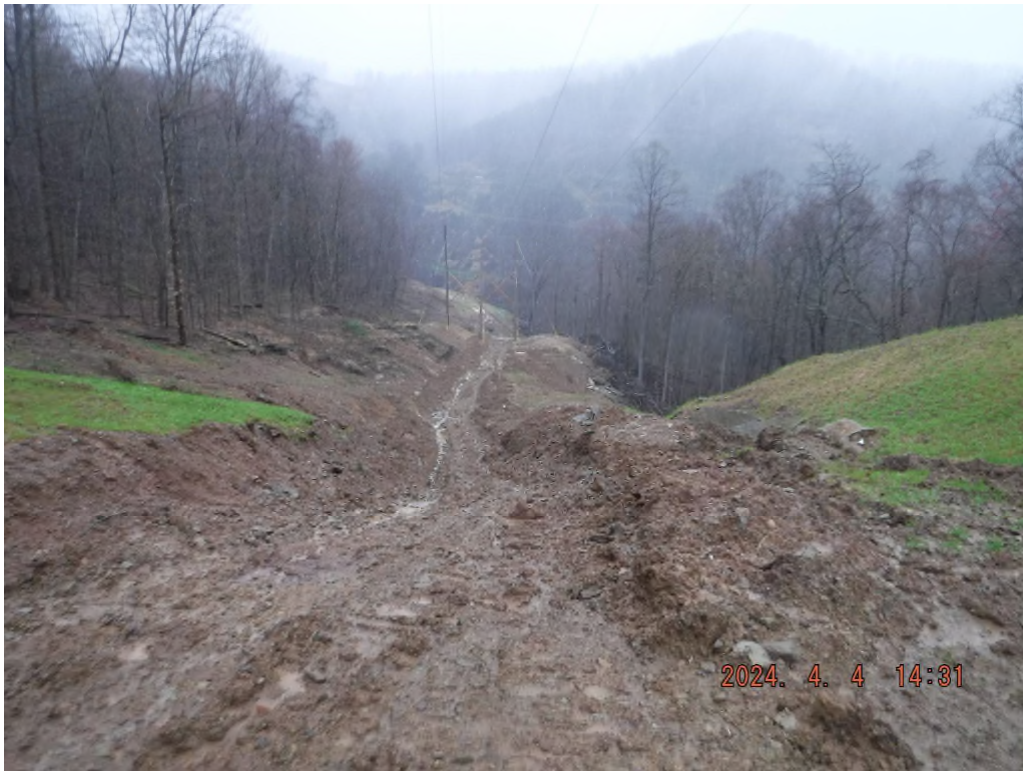
Photo # DSCF3928: Overview of the ROW from stations 100+00 to 115+00.

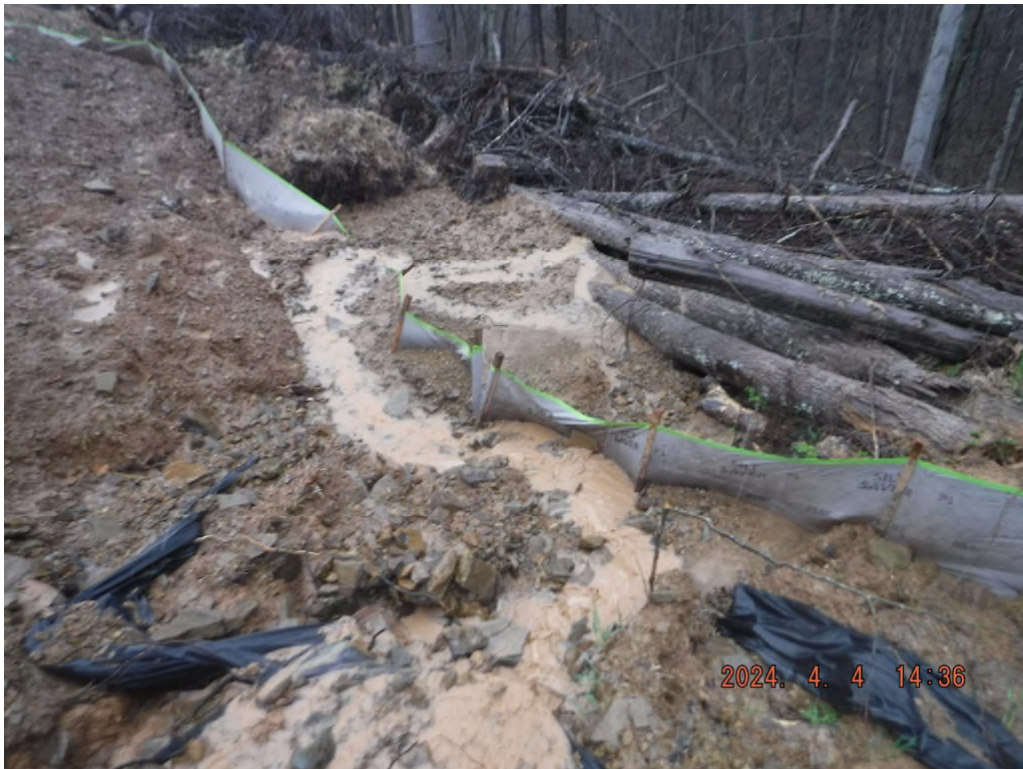
Photo # DSCF3932: Overview of the ROW from stations 100+00 to 115+00.

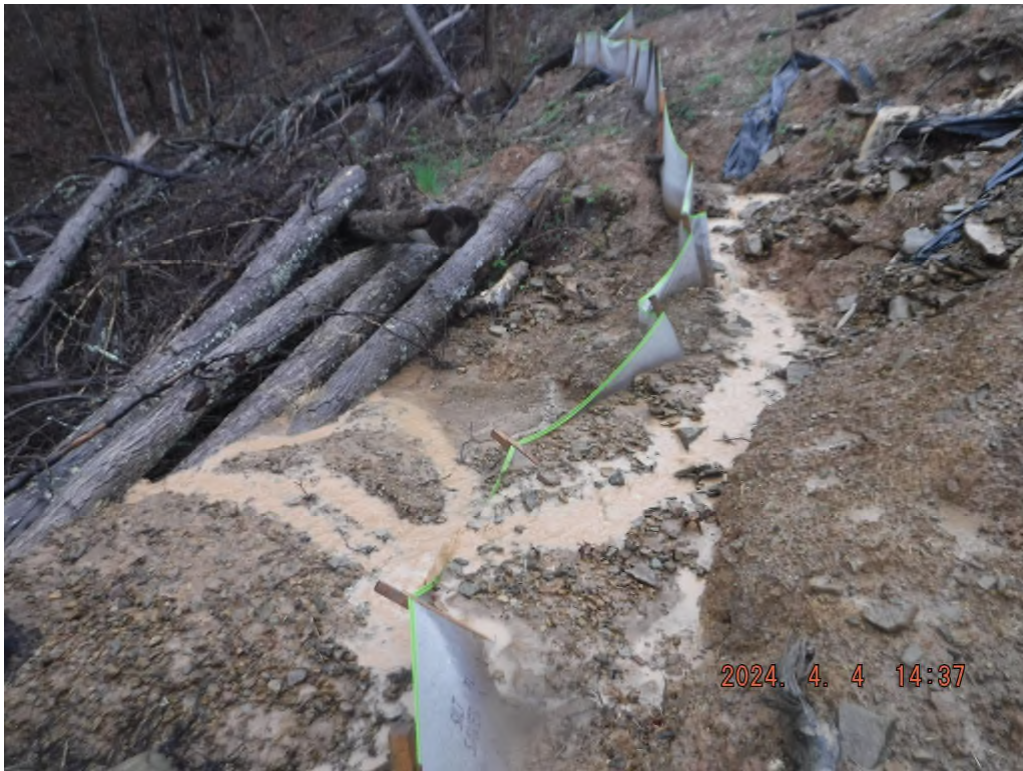
Photo # DSCF3942: BMPs lacking maintenance and sediment laden water leaving the ROW at or near N 39° 31.0460', W 80° 31.0529'.
