**CONSENT ORDER
ISSUED UNDER THE
WATER POLLUTION CONTROL ACT
WEST VIRGINIA CODE CHAPTER 22, ARTICLE 11**

TO: Harrison County Coal Resources, Inc.
Attn: James R. Turner, Jr.
46226 National Road West
St. Clairsville, OH 43950

ORDER NO.: 10302

Rymer I & II Stream Restoration Site – WVR112355

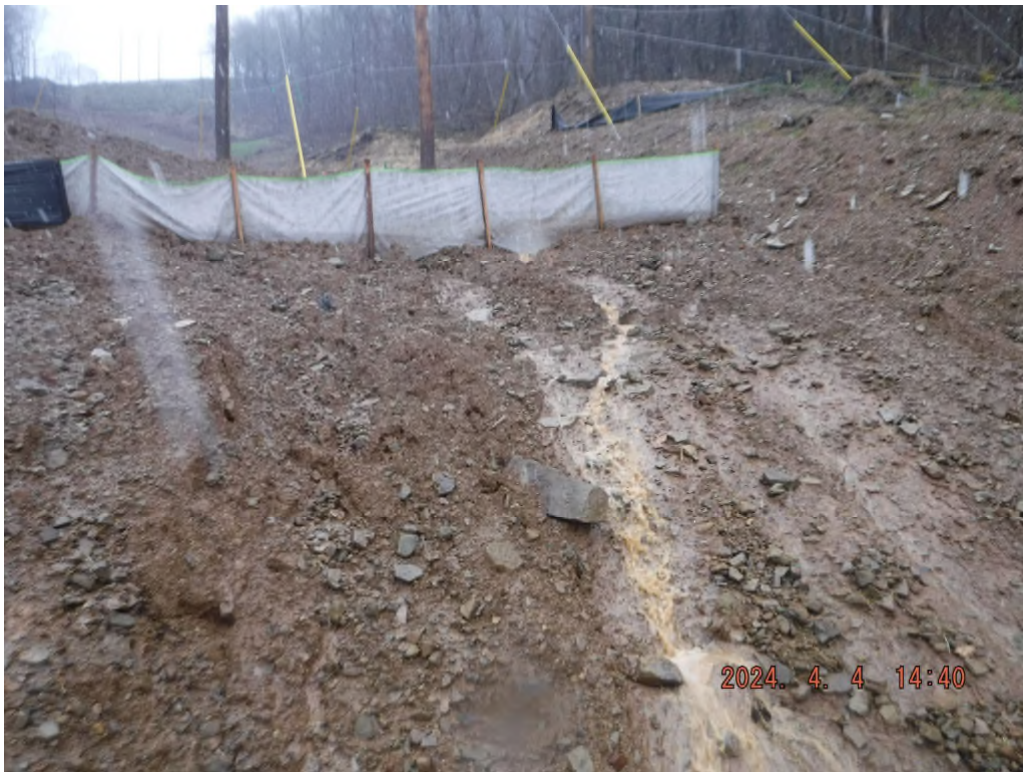
Photo # DSCF3945: BMPs lacking maintenance and sediment laden water leaving the ROW at or near N 39° 31.0460', W 80° 31.0529'.

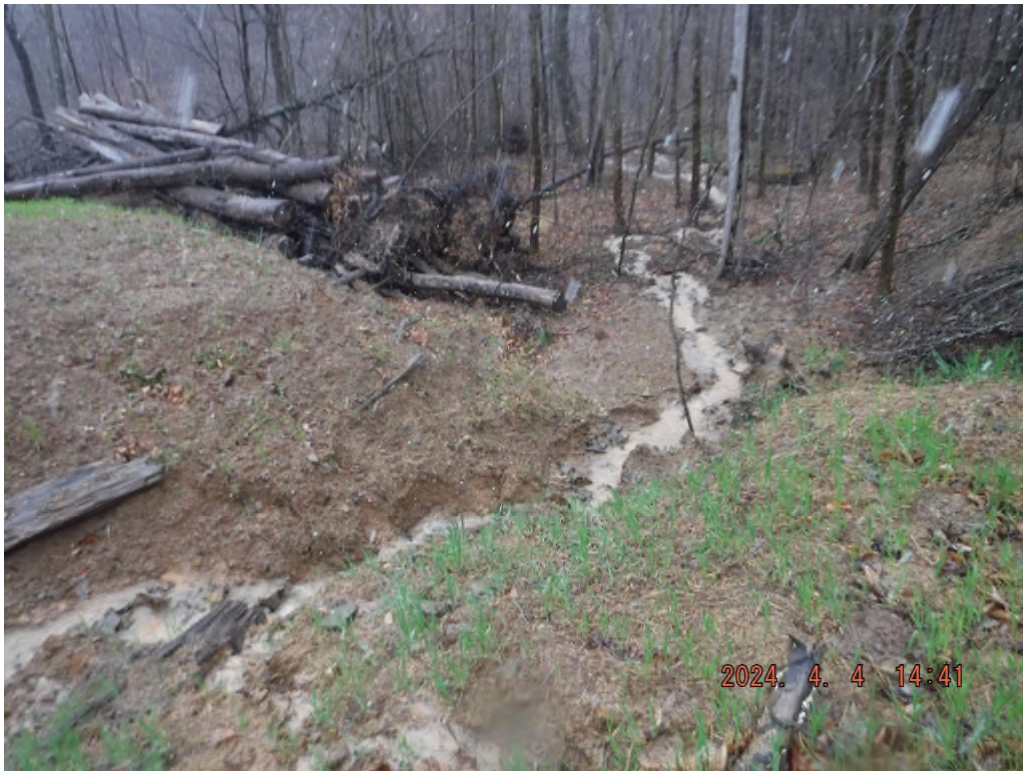
Photo # DSCF3952: BMPs lack maintenance (undercut) at station 110+00.

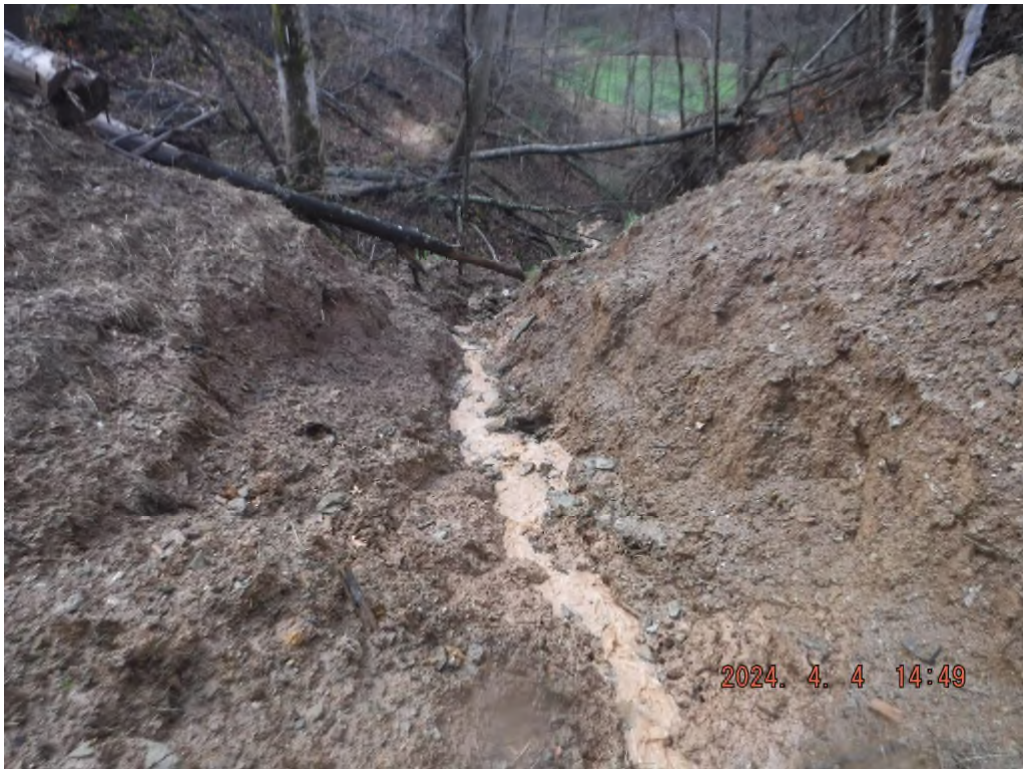
Photo # DSCF3967: Unpermitted road from Buck Run Rd. at station 115+00.

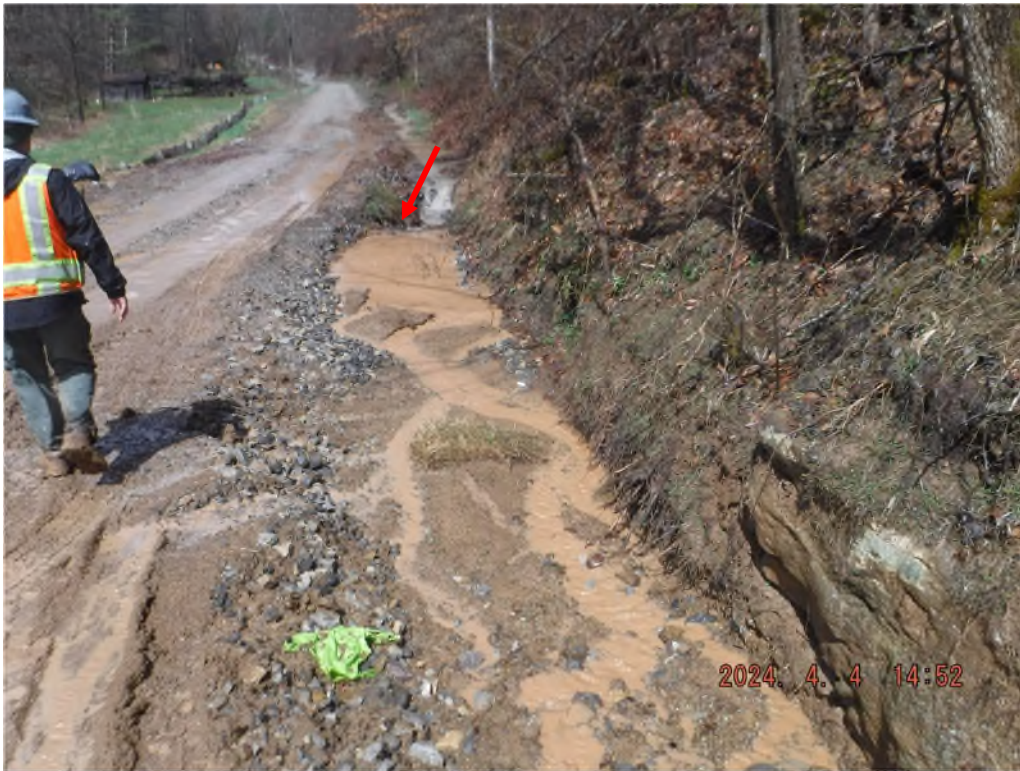
Photo # DSCF3973: Sediment laden water leaving the unpermitted road from Buck Run Rd. at station 115+00 at or near N 39° 31.0380, W 80° 31.1585'.

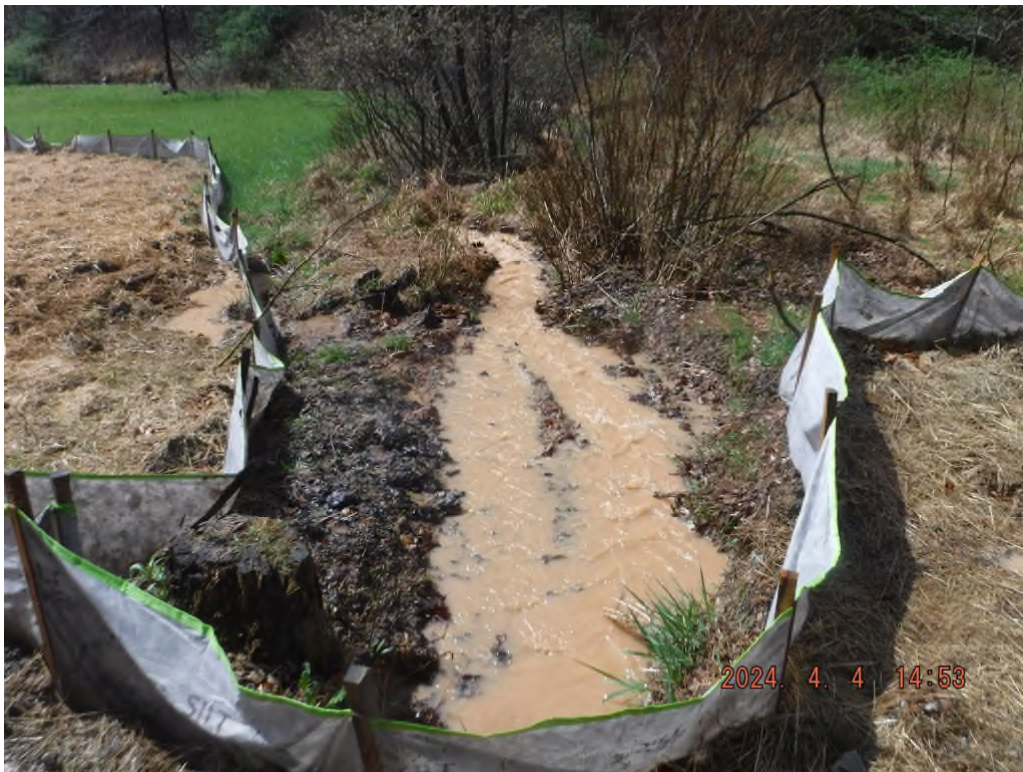
Photo # DSCF3981: Sediment laden water from unpermitted access road at station 115+00 entering a culvert (red arrow) along Buck Run Rd.

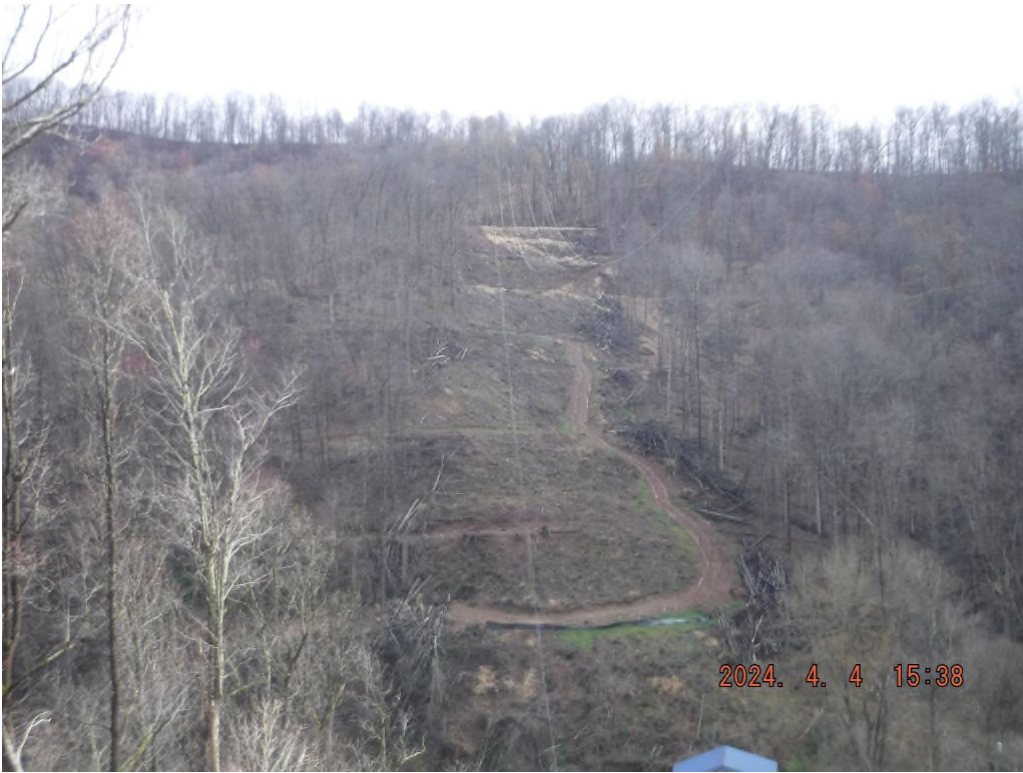
Photo # DSCF4007: Sediment deposits creating conditions not allowable in UNT Glade Fork at or near N 39° 30.5966', W 80° 29.8266'.

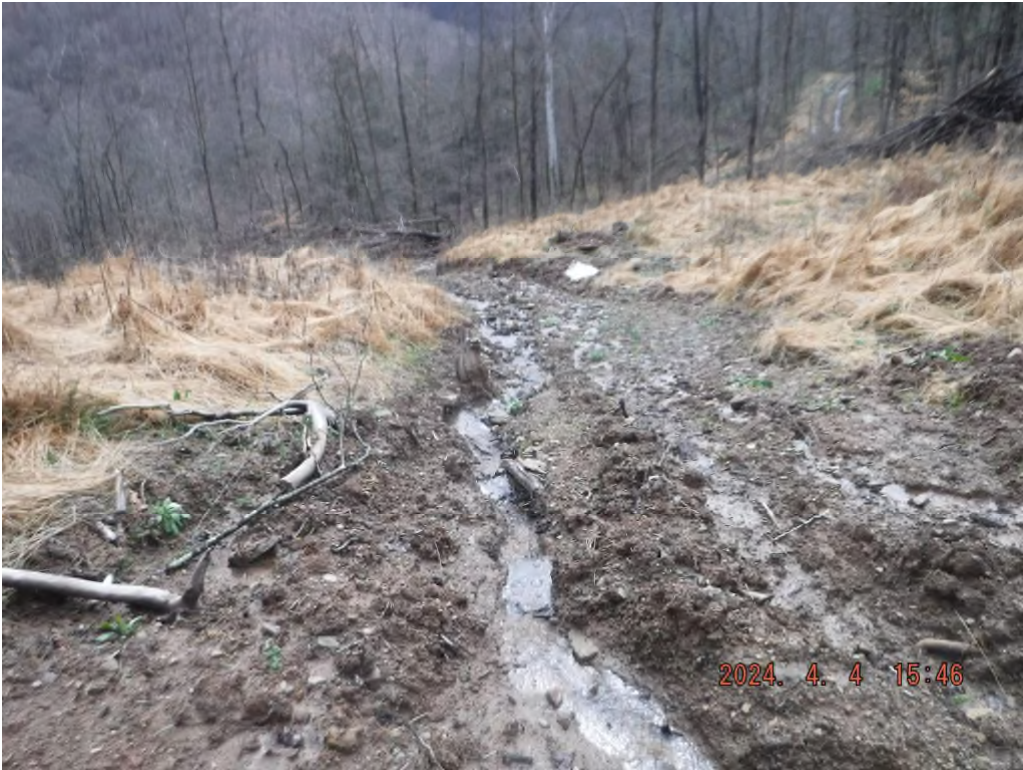
Photo # DSCF4010: Overview of the disturbed ROW between stations 35+00 and 28+00.

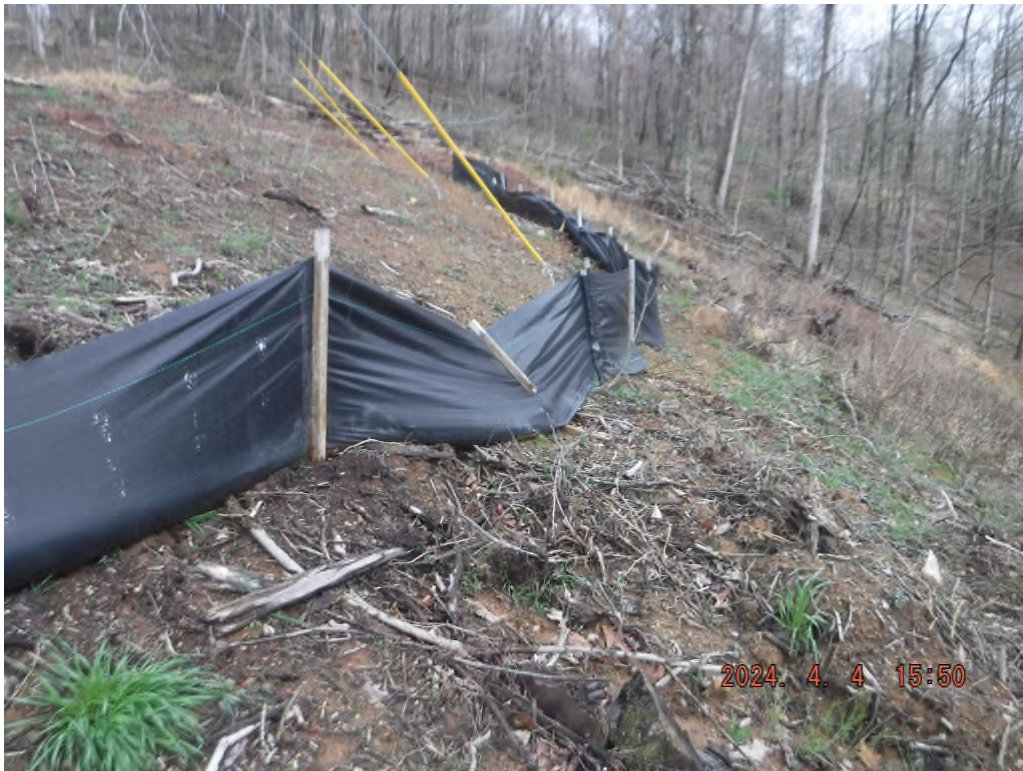
Photo # DSCF4024: Disturbed travel lane in ROW between stations 40+00 and 47+00. No BMPs installed.

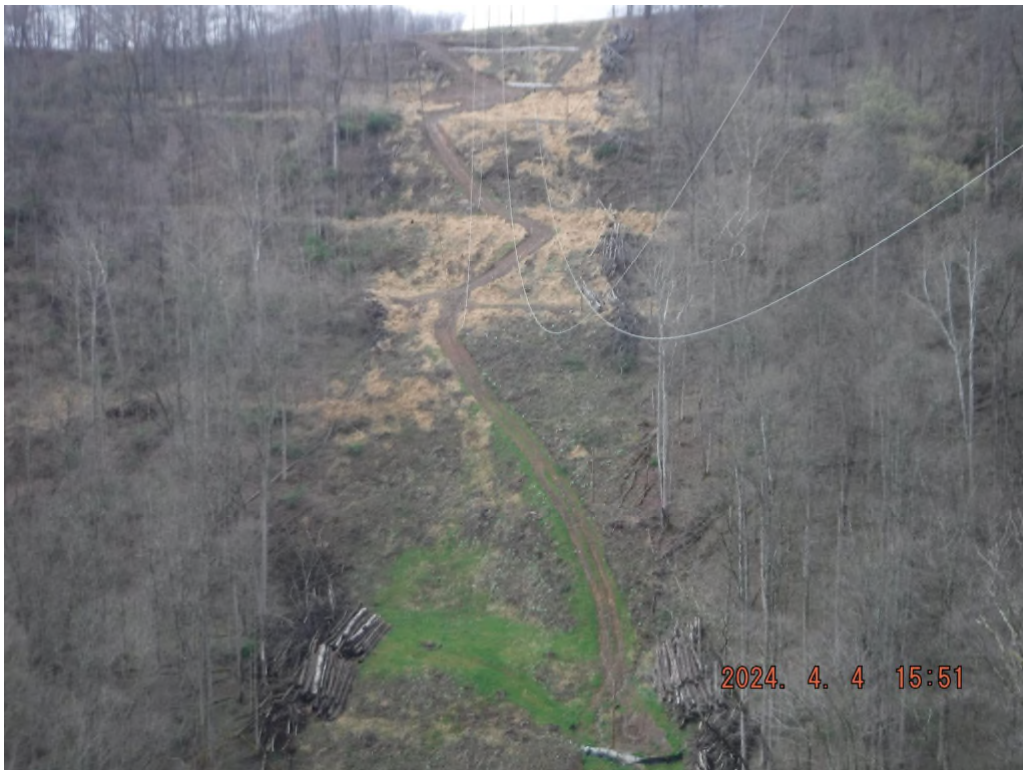
Photo # DSCF4030: Incorrect BMPs installed at station 48+00 at or near N 39° 30.7266', W 80° 29.9277'.

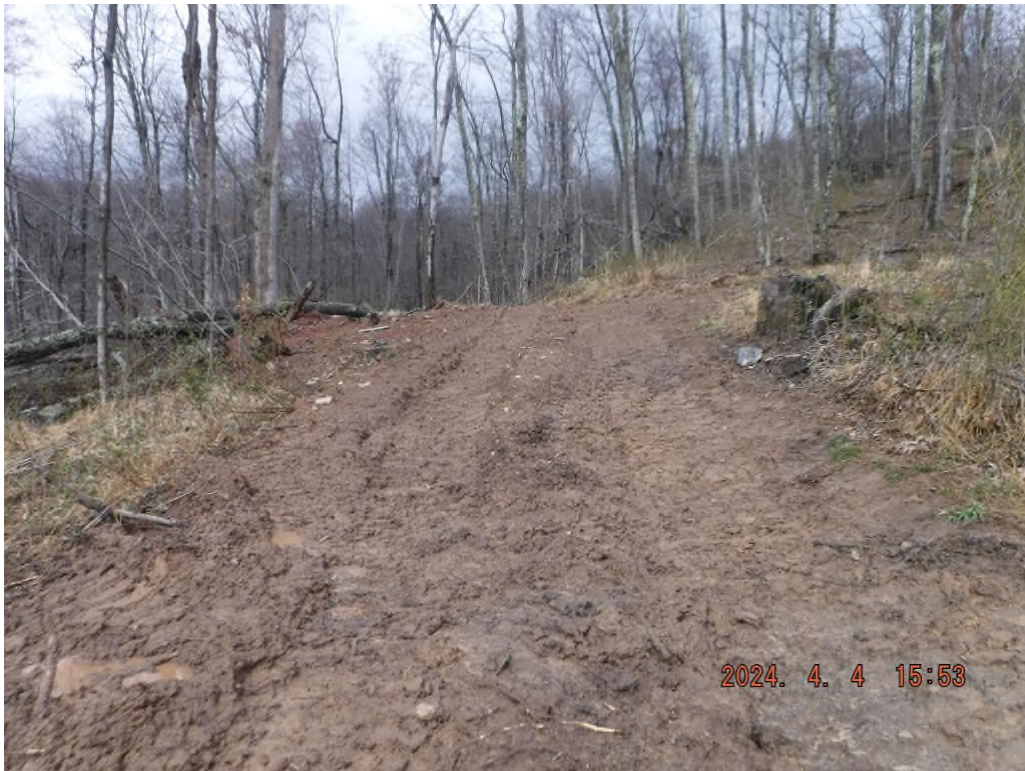
Photo # DSCF4032: Overview of disturbed ROW between stations 52+00 and 63+00.

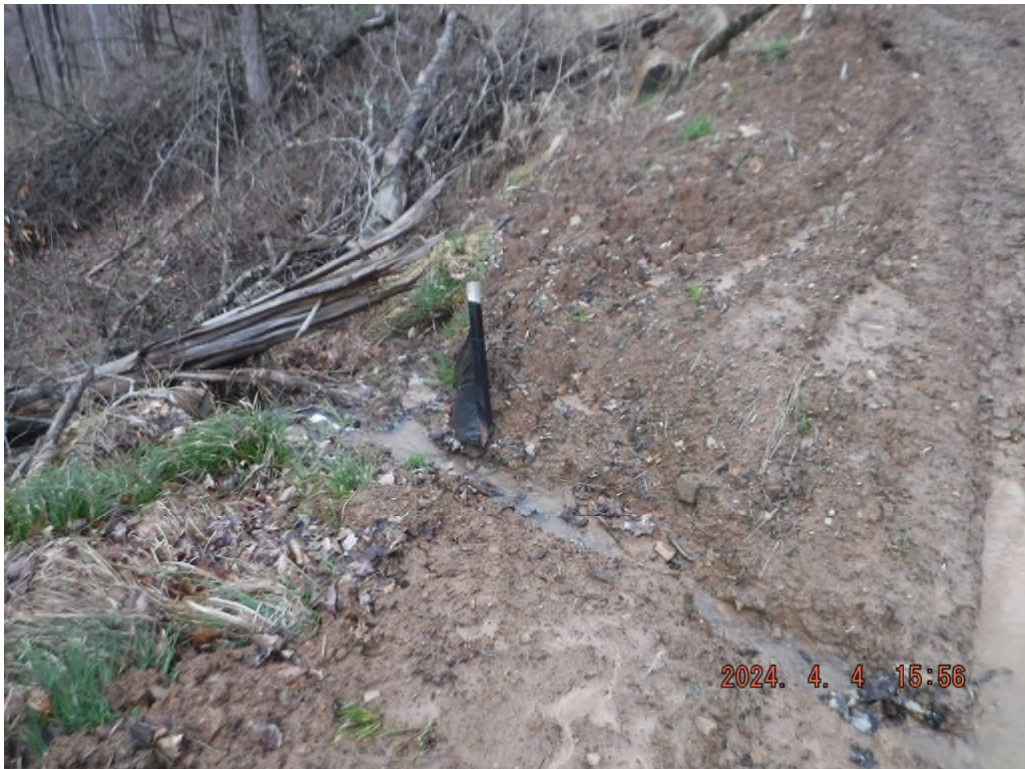
Photo # DSCF4034: Proposed access road on drawing sheet 2 lacks stabilization and BMPs.

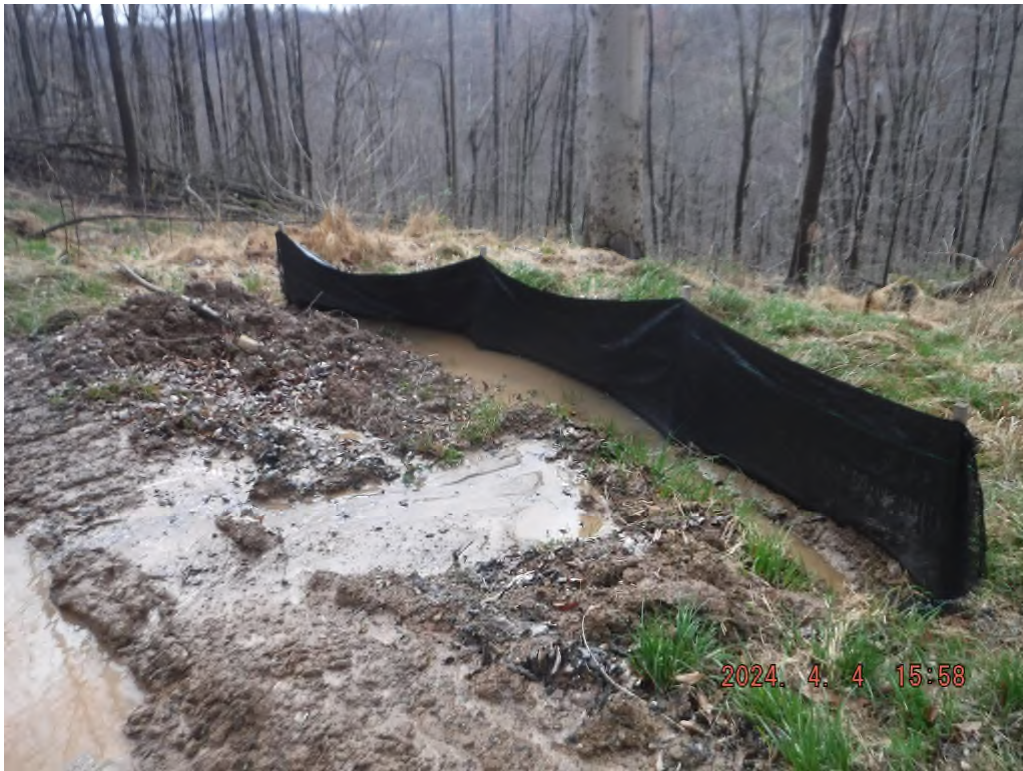
Photo # DSCF4040: Sediment laden water leaving the proposed access road on drawing sheet 2 at or near N 39° 30.8158', W 80° 29.8998'. Note lack of maintenance on the incorrect silt fence.

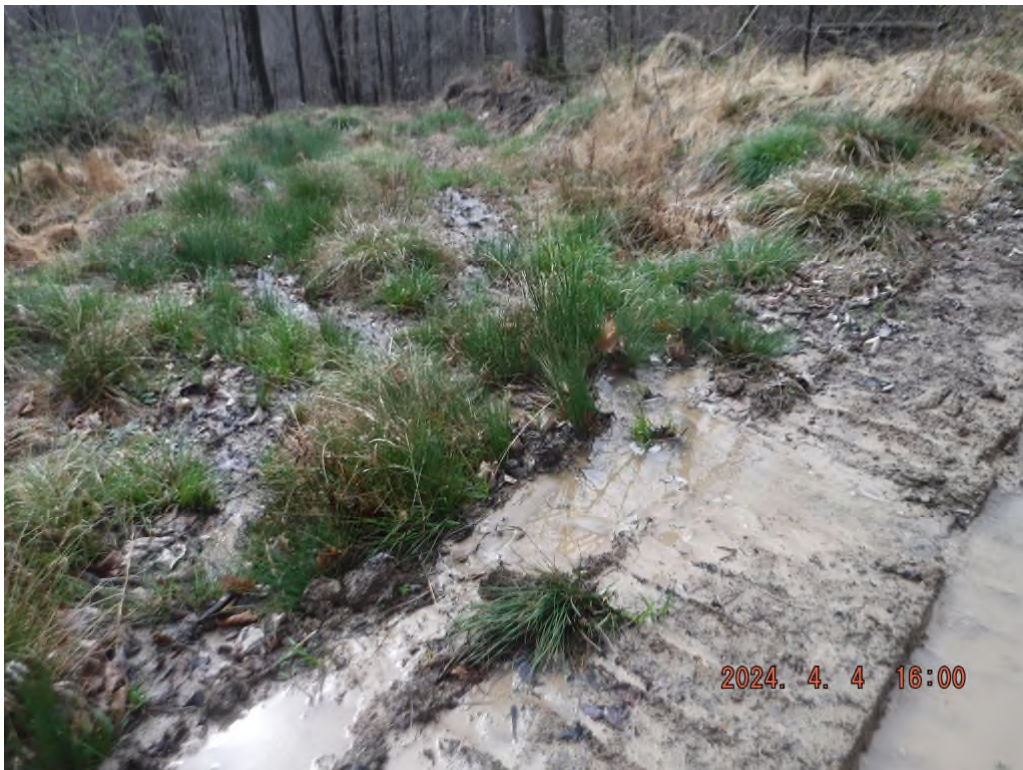
Photo #DSCF4045: Incorrect silt fence along the proposed access road on drawing sheet 2 of the approved SWPPP.

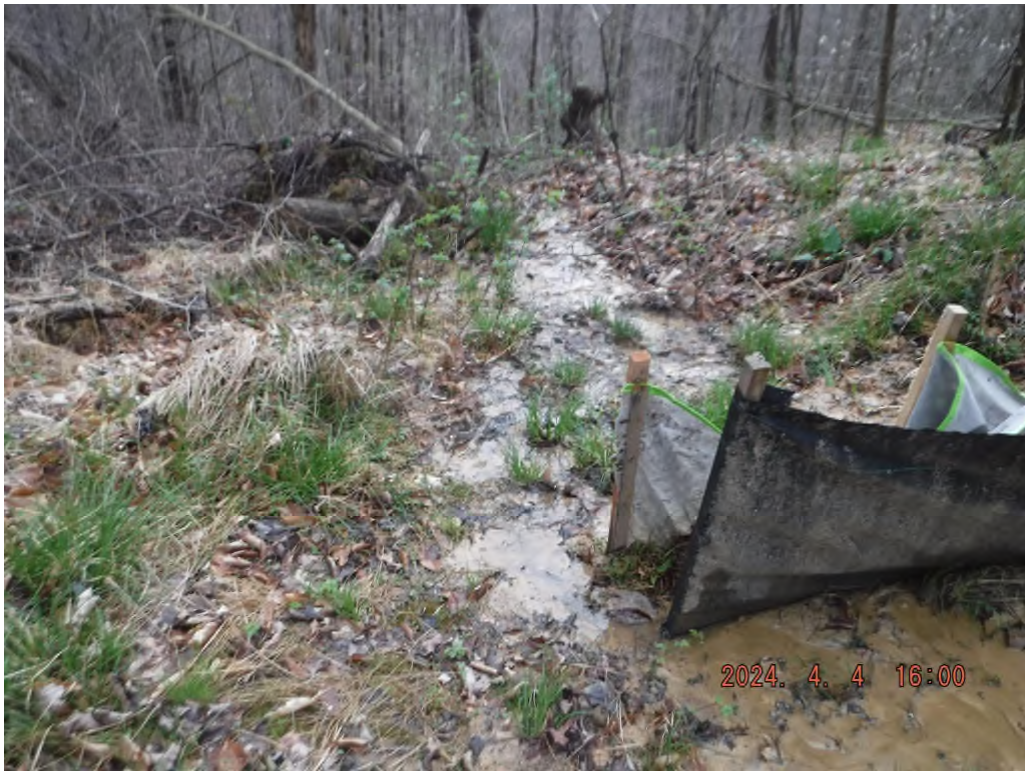
Photo # DSCF4049: Sediment laden water leaving the proposed access road on drawing sheet 2 at or near N 39° 30.8884', W 80° 29.9053'.

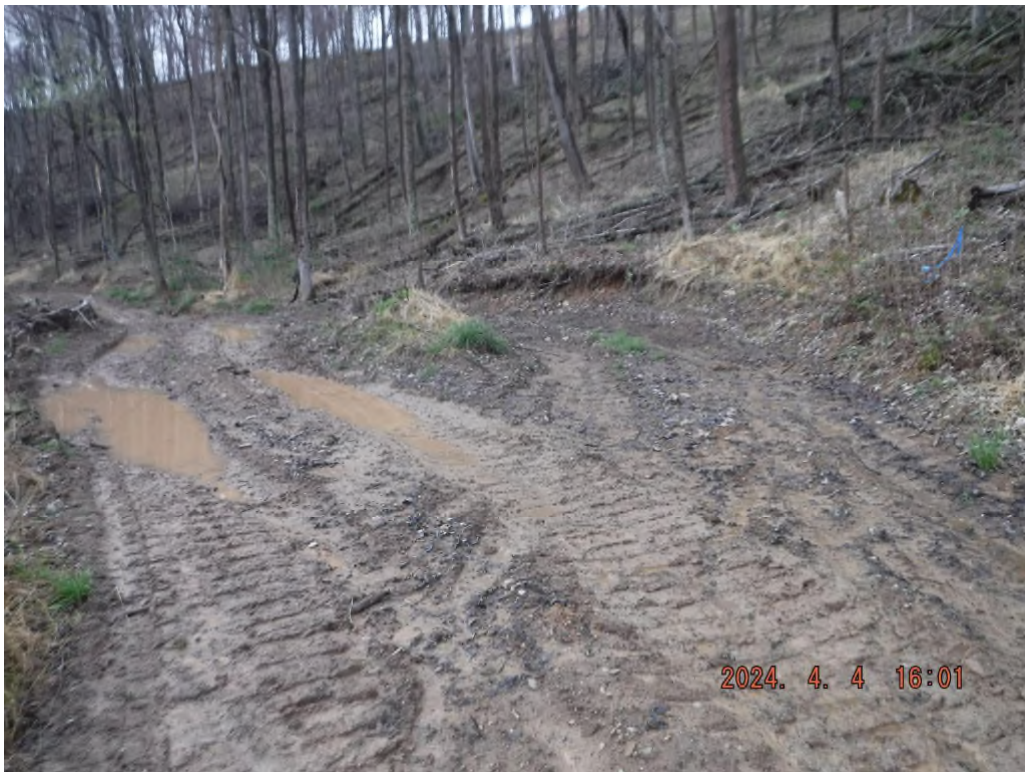
Photo # DSCF4052: Sediment laden water leaving the proposed access road on drawing sheet 2 at or near N 39° 30.8959', W 80° 29.9284'

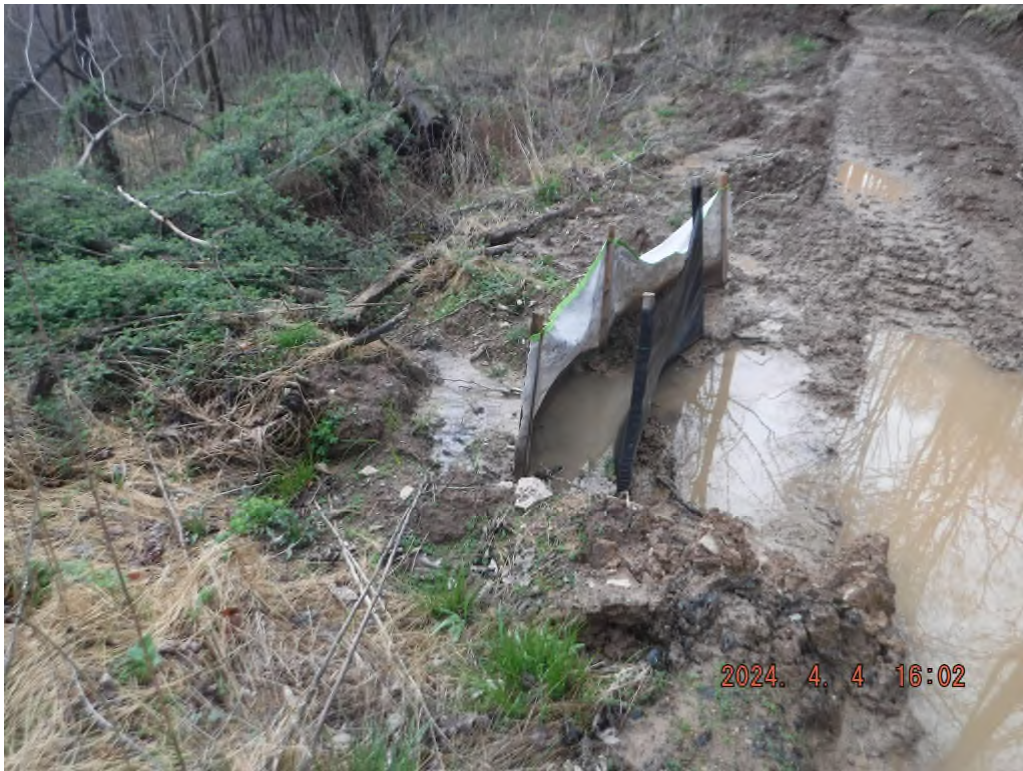
Photo # DSCF4054: Proposed access road on drawing sheet 2 lacks stabilization and BMPs.

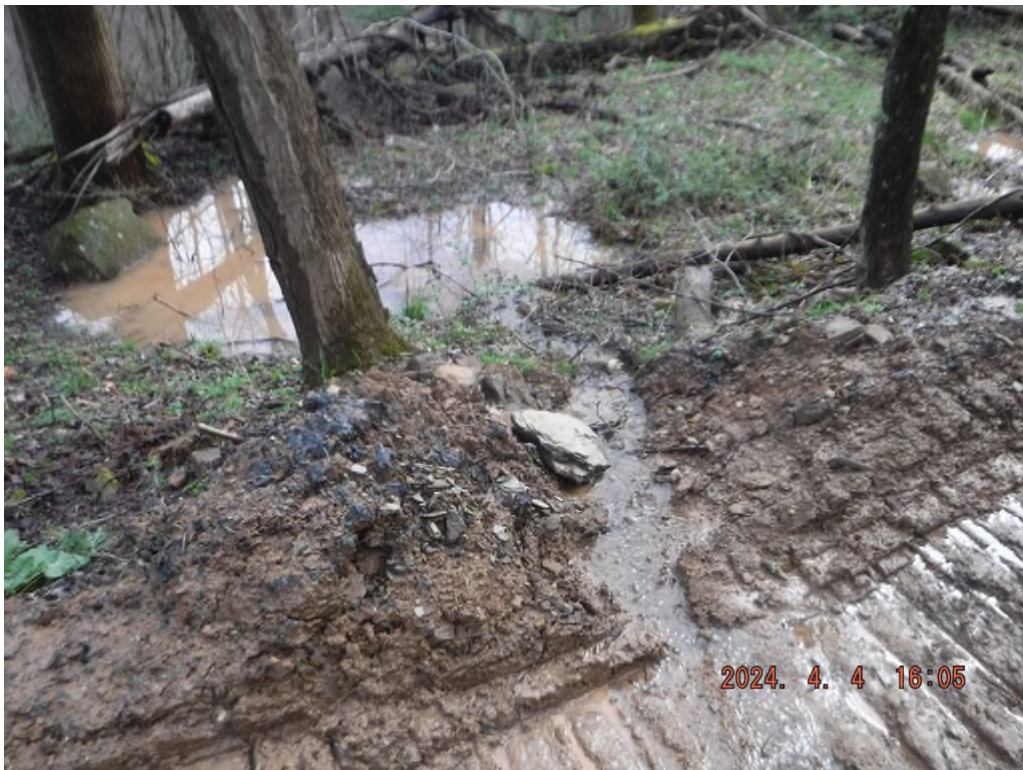
Photo # DSCF4056: Sediment laden water leaving the proposed access road on drawing sheet 2 at or near N 39° 30.9030', W 80° 29.9669'.

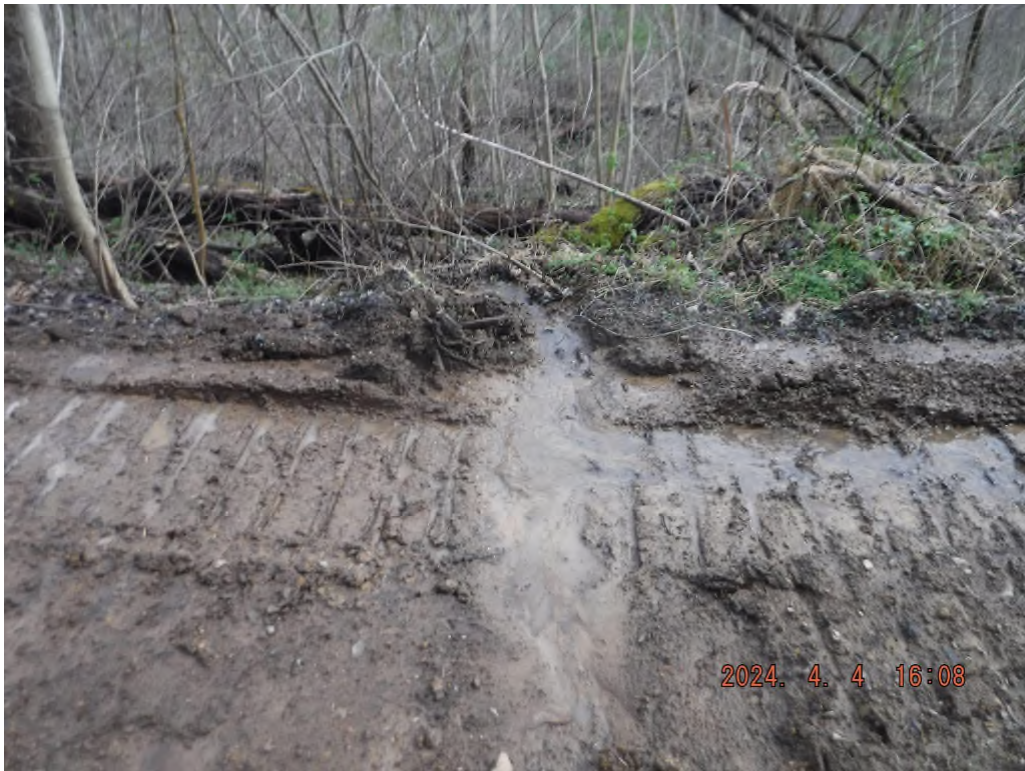
Photo # DSCF4061: Sediment laden water leaving the proposed access road on drawing sheet 2 at or near N 39° 30.8934', W 80° 30.0364'.

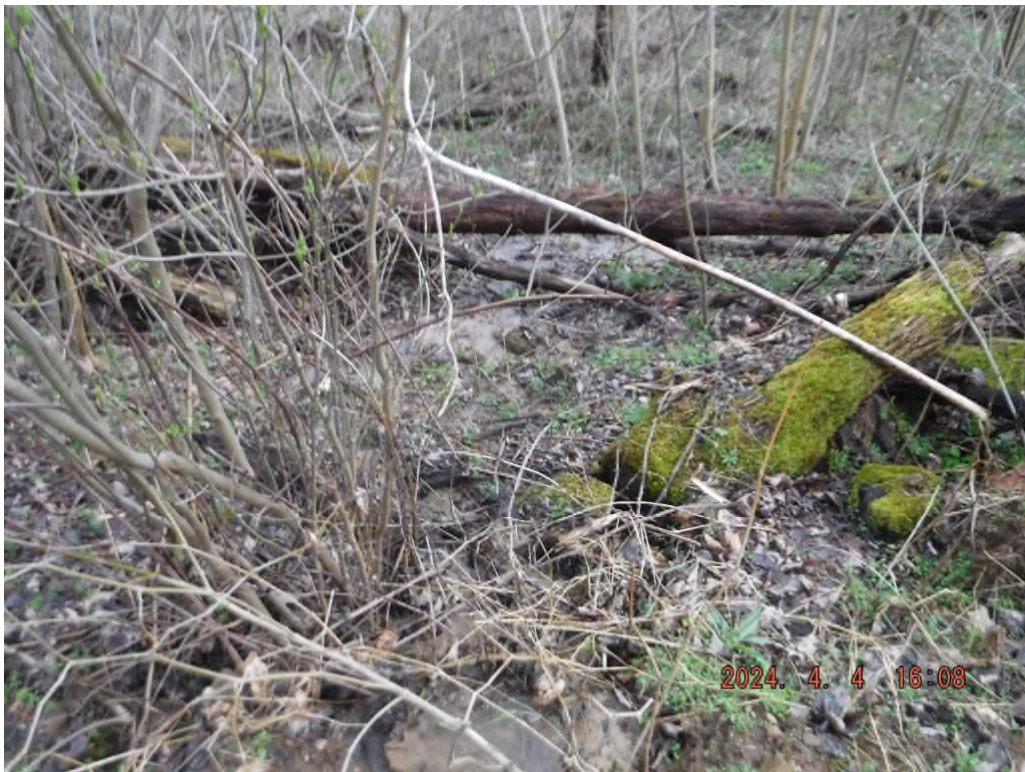
Photo # DSCF4067: Sediment laden water leaving the proposed access road on drawing sheet 2 at or near N 39° 30.8552', W 80° 30.1391'.

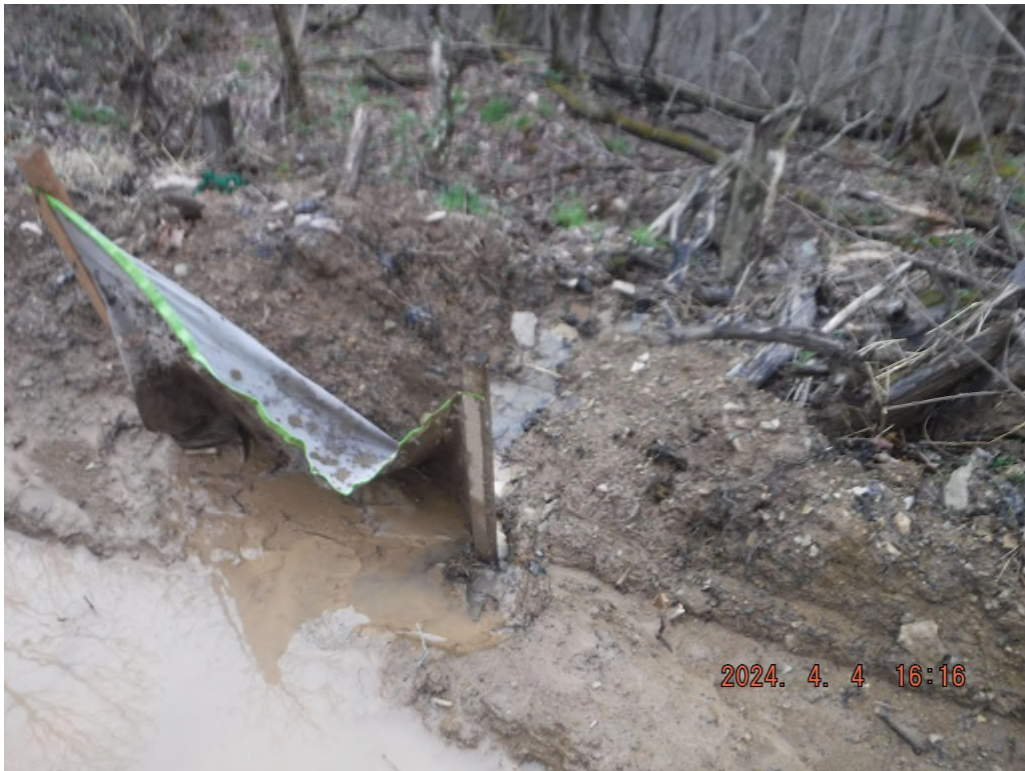
Photo # DSCF4068: Sediment laden water leaving the proposed access road on drawing sheet 2 at or near N 39° 30.8552', W 80° 30.1391'.

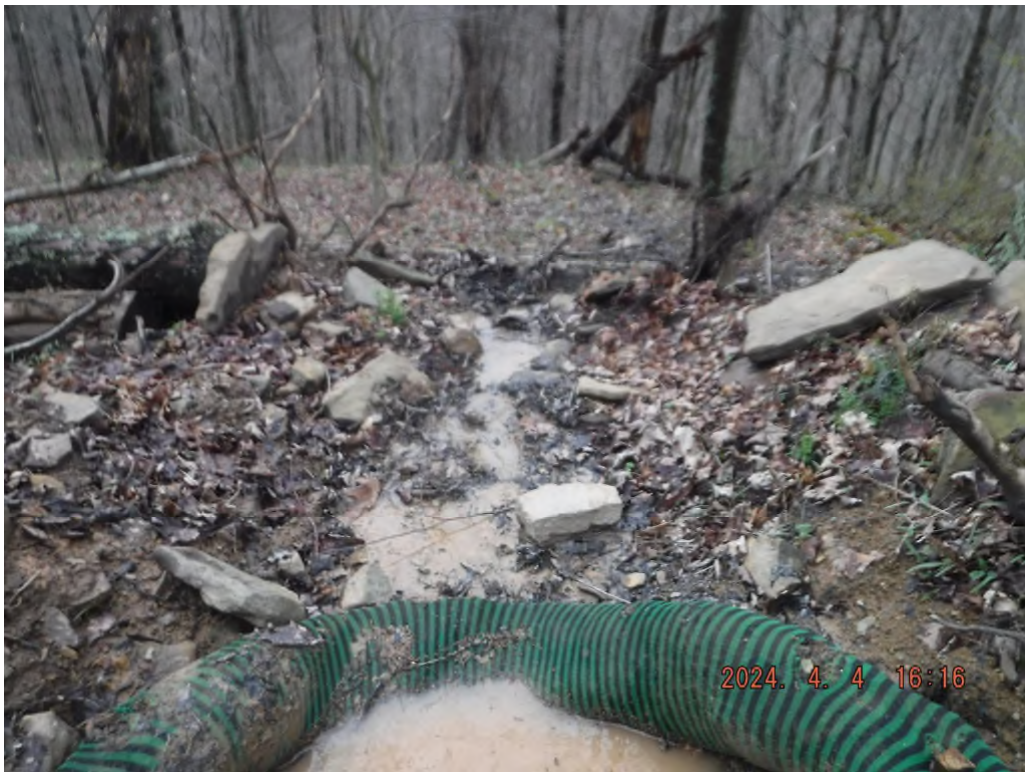
Photo # DSCF4084: Sediment laden water leaving the existing access road on sheet 2 at or near N 39° 30.8219', W 80° 30.2317'.

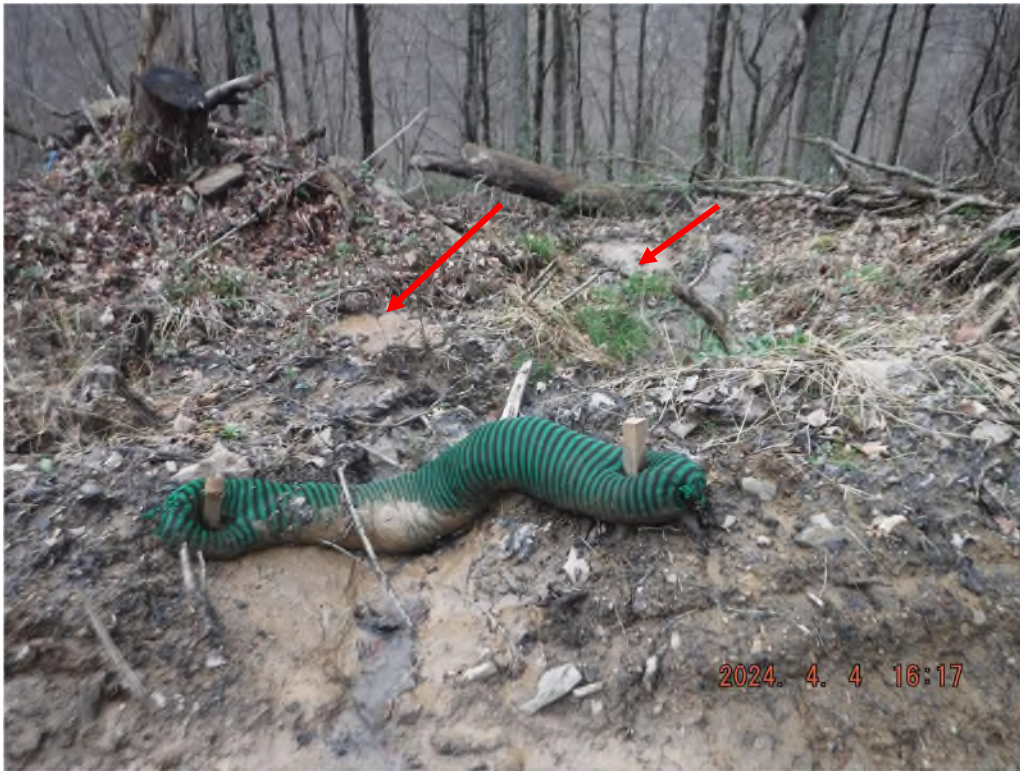
Photo # DSCF4088: Sediment laden water leaving the existing access road on sheet 2 at or near N 39° 30.8112', W 80° 30.2427'.

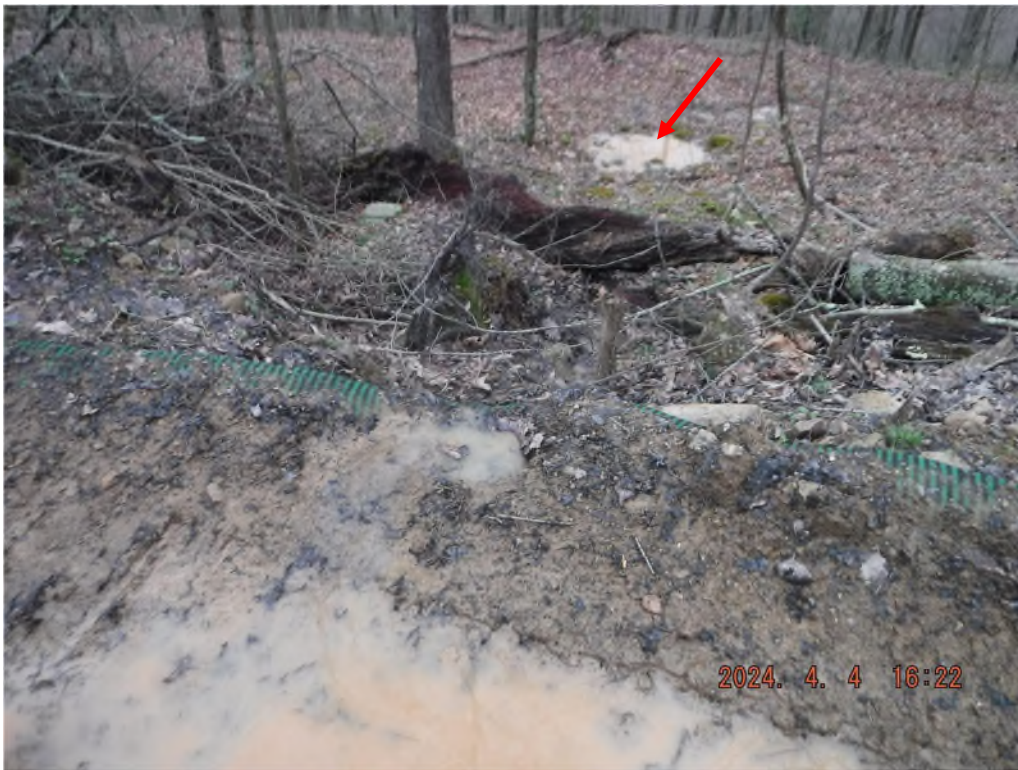
PHoto # DSCF4090: Sediment laden water leaving the existing access road on sheet 2 at or near N 39° 30.7948', W 80° 30.2454'.

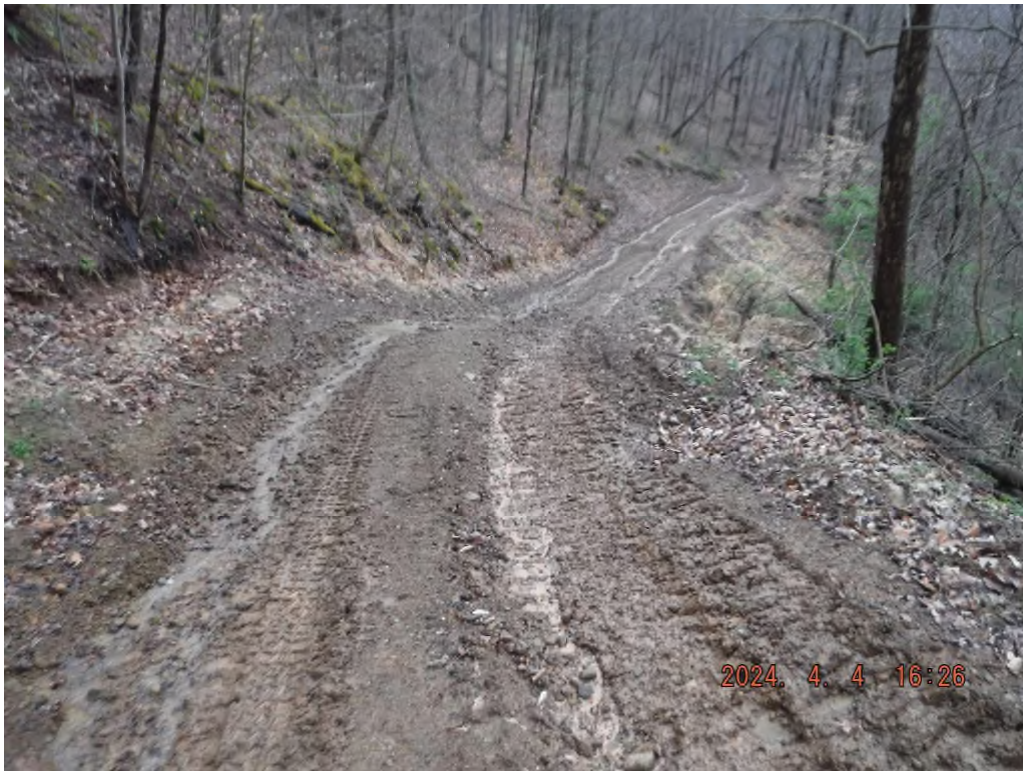
Photo # DSCF4102: Sediment laden water leaving the existing access road on sheet 2 at or near N 39° 30.6554', W 80° 30.3161'

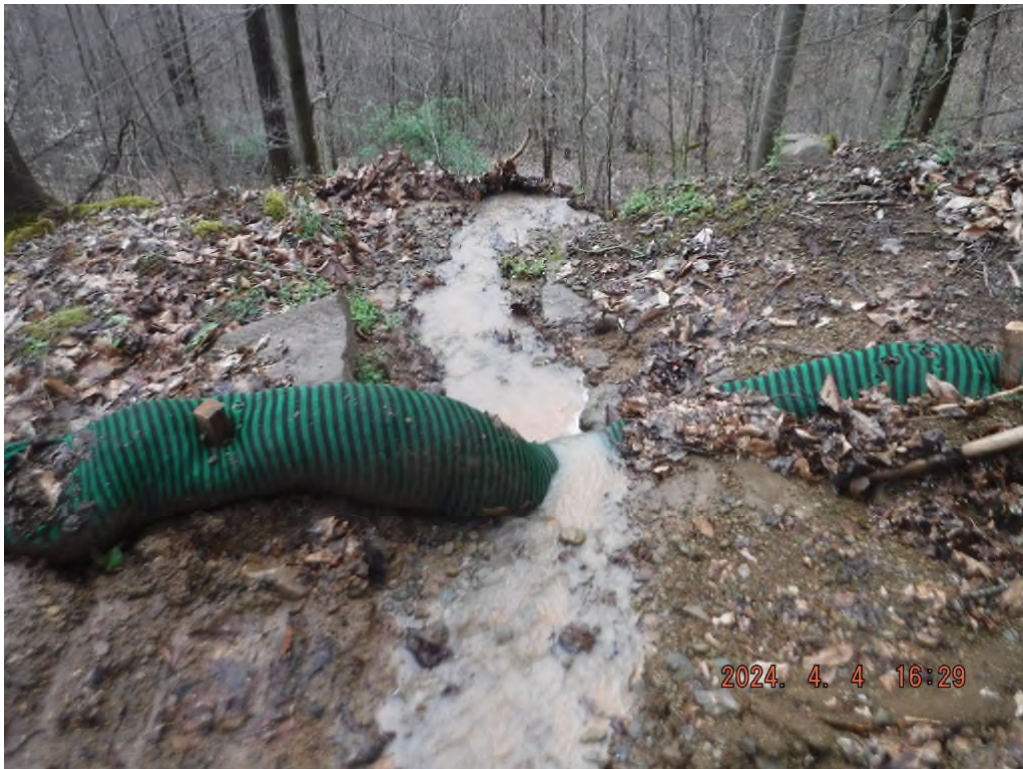
Photo # DSCF4106: Existing access road on sheet 2 lacks stabilization and BMPs.

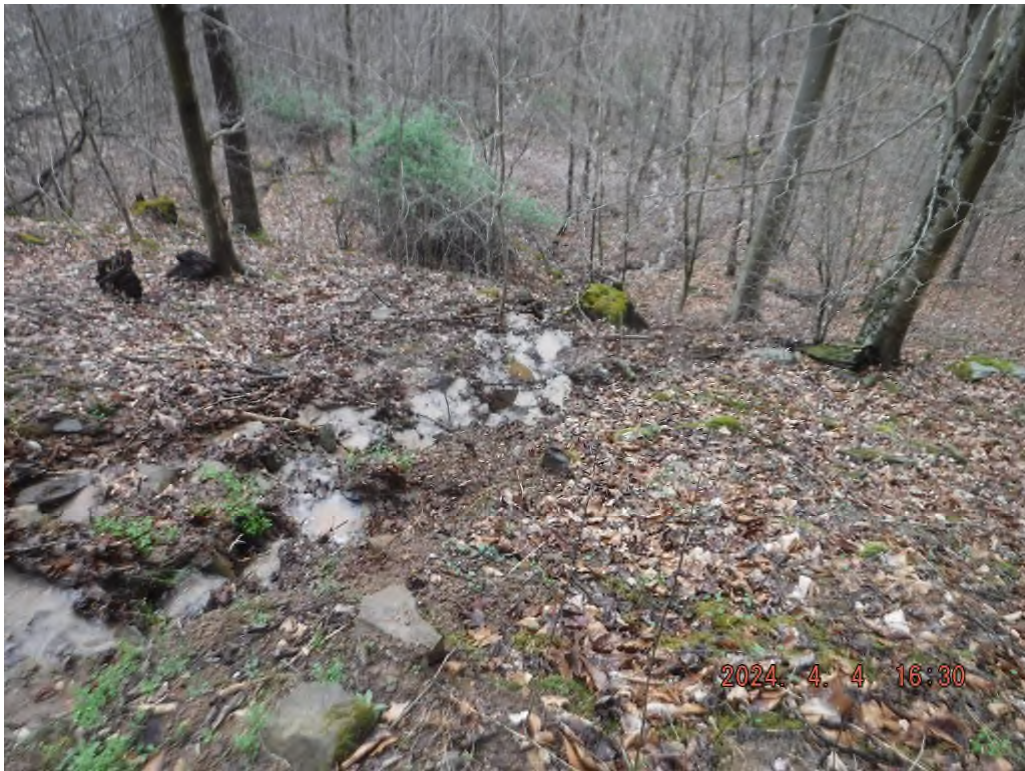
Photo # DSCF4111: Sediment laden water leaving the existing access road on sheet 2 at or near N 39° 30.5328', W 80° 30.4918'.

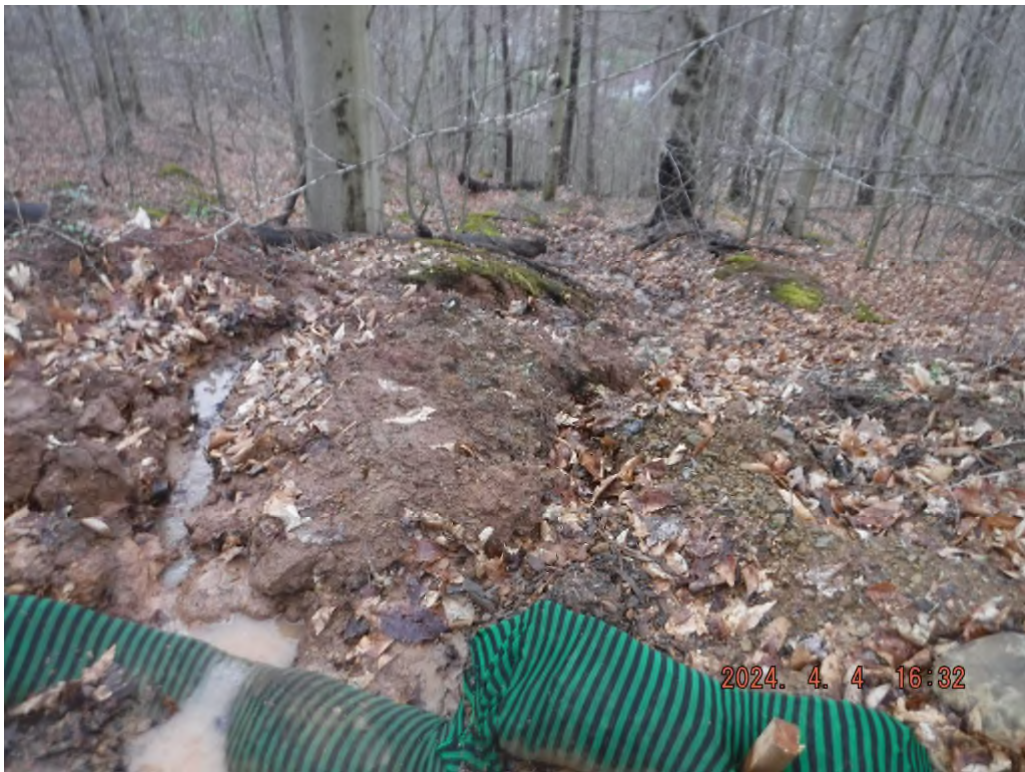
Photo # DSCF4112:Sediment laden water leaving the existing access road on sheet 2 at or near N 39° 30.5328', W 80° 30.4918'.

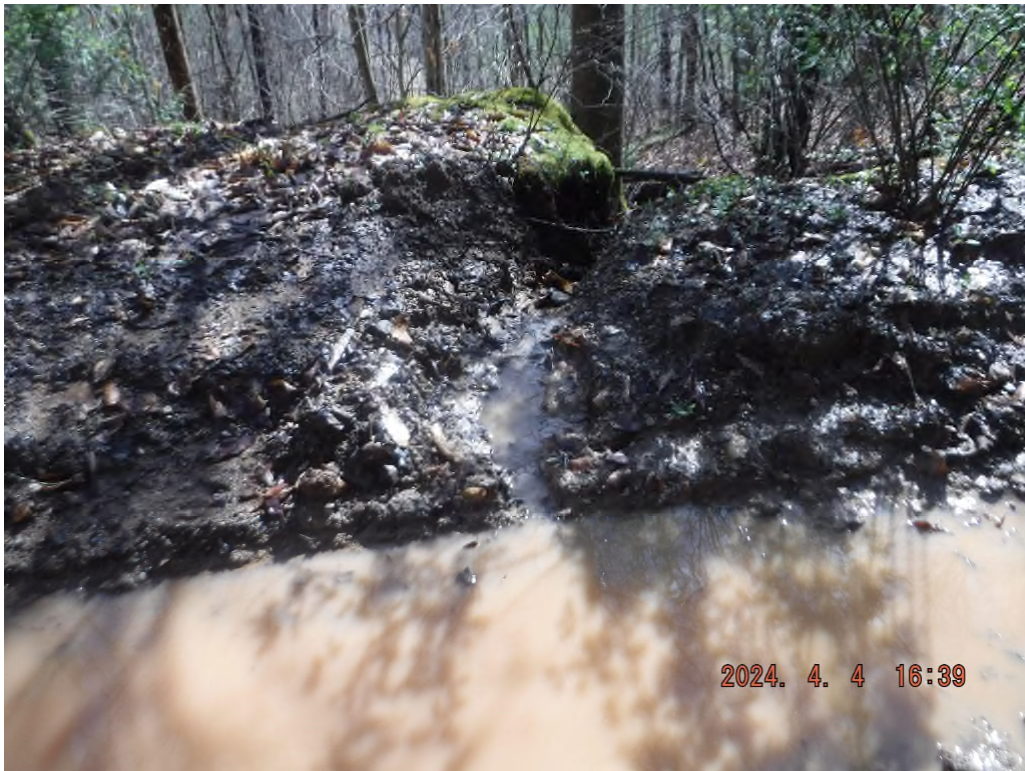
Photo # DSCF4117:Sediment laden water leaving the existing access road on sheet 2 at or near N 39° 30.5143', W 80° 30.5347'.
