**CONSENT ORDER
ISSUED UNDER THE
WATER POLLUTION CONTROL ACT
WEST VIRGINIA CODE CHAPTER 22, ARTICLE 11**

TO: Harrison County Coal Resources, Inc.
Attn: James R. Turner, Jr.
46226 National Road West
St. Clairsville, OH 43950

ORDER NO.: 10302

Rymer I & II Stream Restoration Site – WVR112355

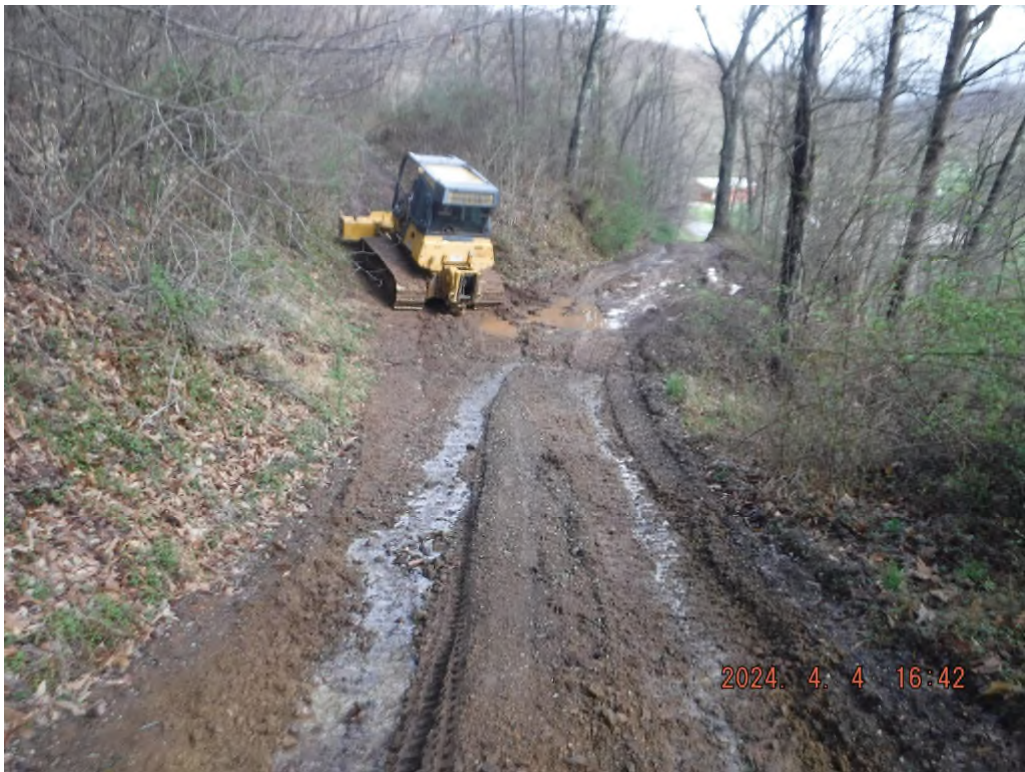
Photo # DSCF4131: Sediment laden water leaving the existing access road on sheet 2 at or near N 39° 30.3899', W 80° 30.4622'.

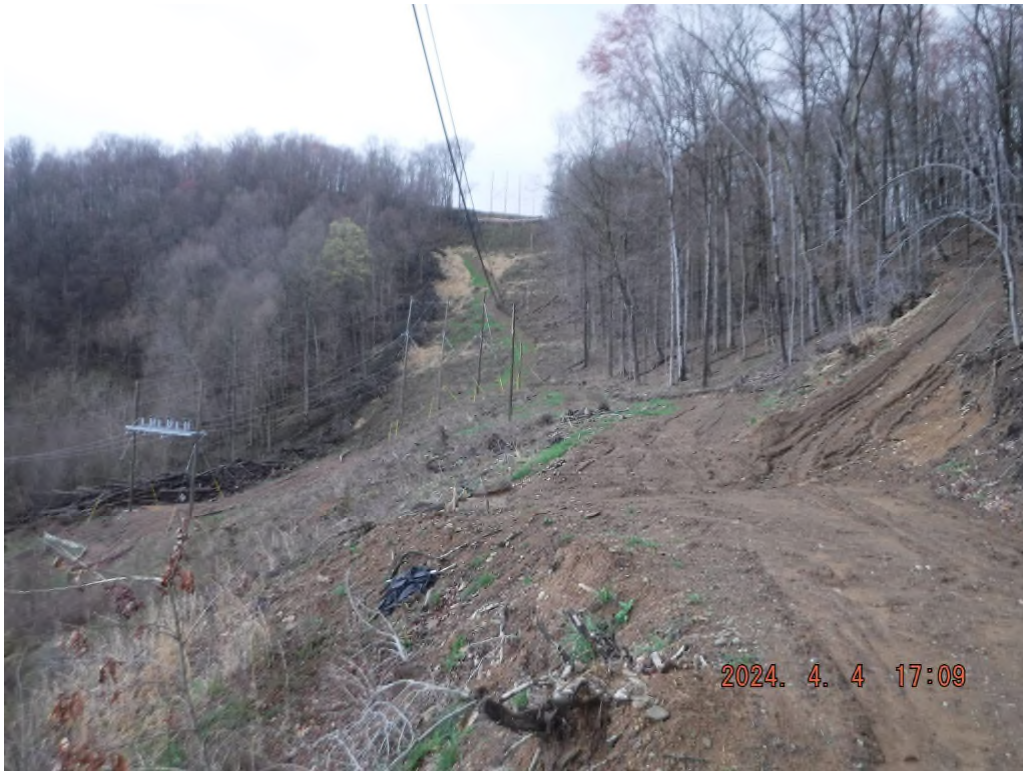
Photo # DSCF4137: Existing access road on sheet 2 lacks stabilization and BMPs.

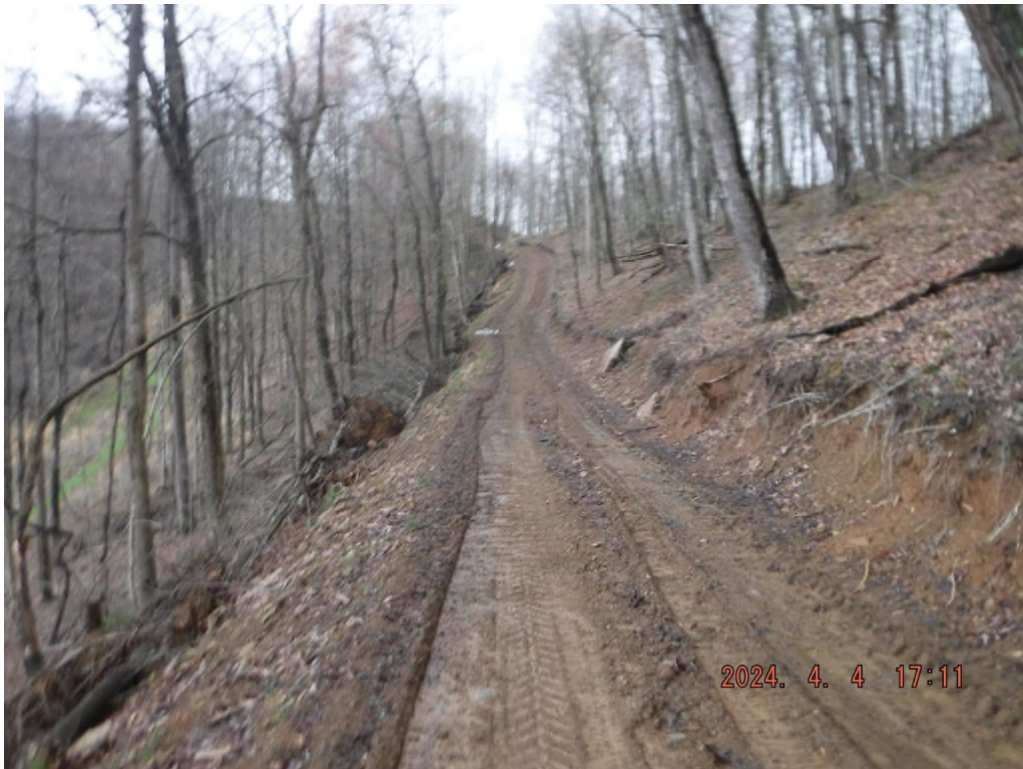
Photo # DSCF4143: Overview of the disturbed ROW between stations 5+00 and 15+00.

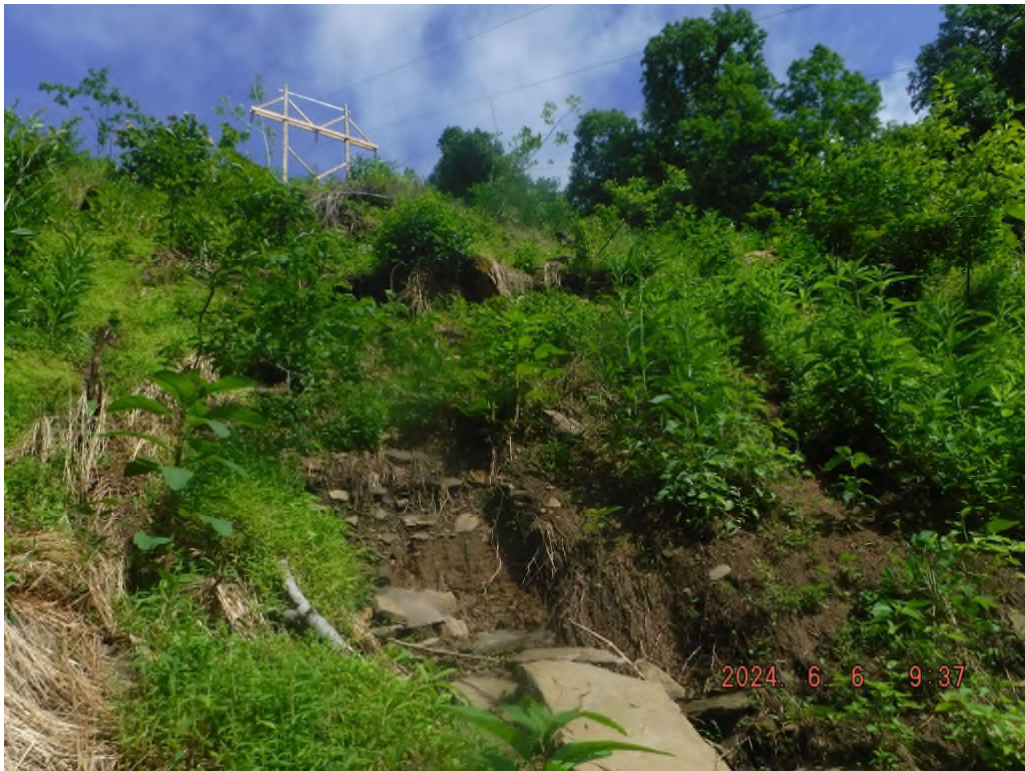
Photo # DSCF5130: Sediment deposits at or near N 39° 30.7209', W 80° 32.0479' in UNT Price Run.

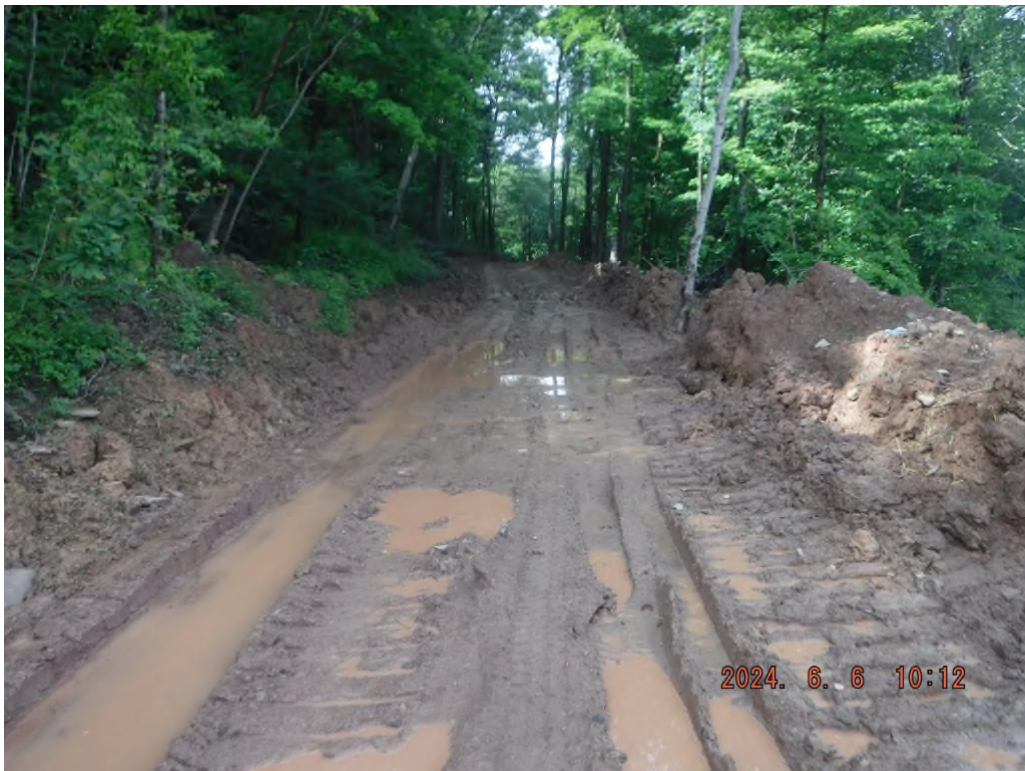
Photo # DSCF5148: Slip on the ROW but off of the LOD at or near N 39° 30.7195', W 80° 31.9785'.

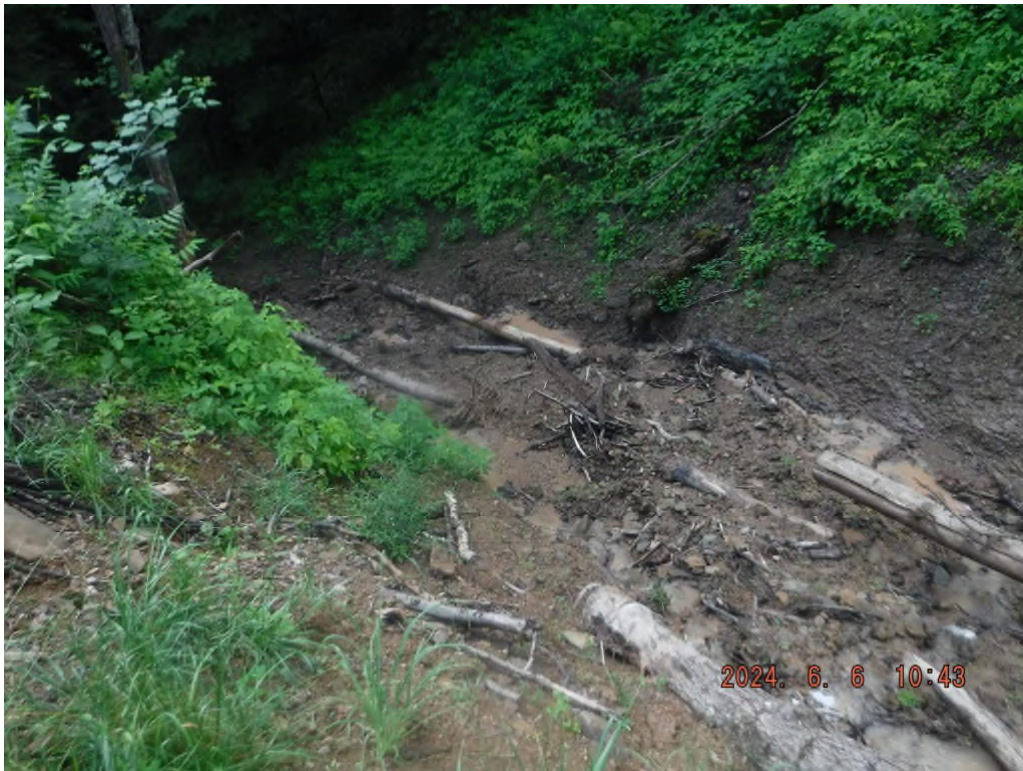
Photo # DSCF5241: Slip material in UNT Buck Run at or near N 39° 30.9039', W 80° 31.5246'.

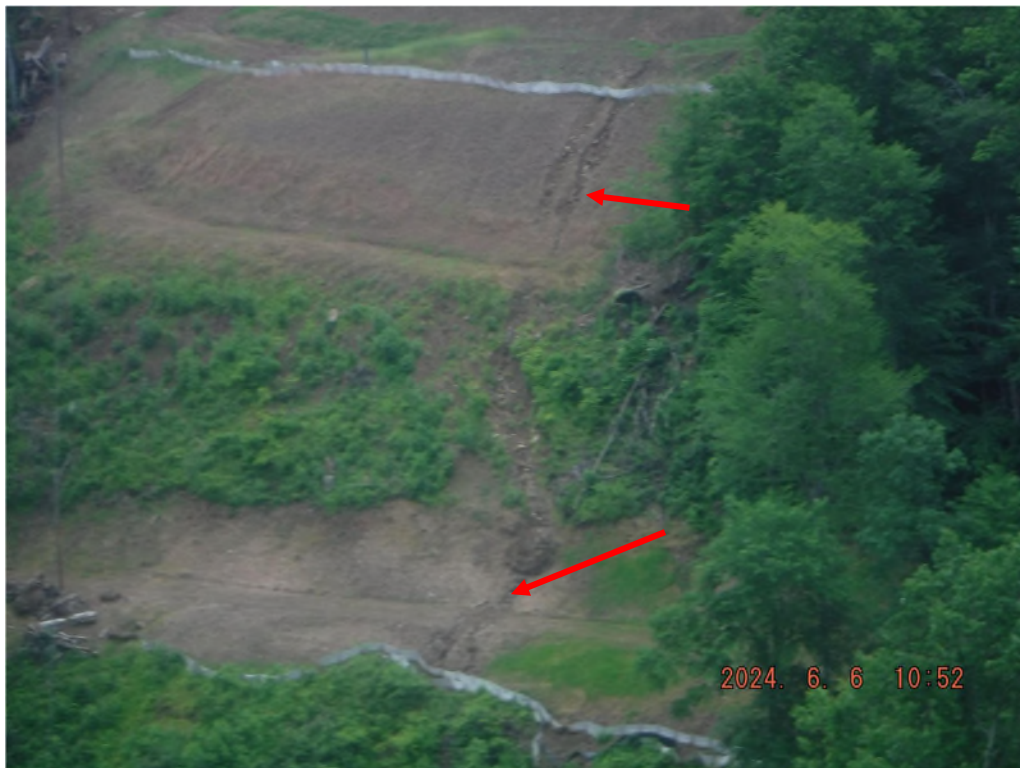
Photo # DSCF5243: Slip material and distinctly visible settleable solids in UNT Buck Run at or near N 39° 30.9039', W 80° 31.5246'.

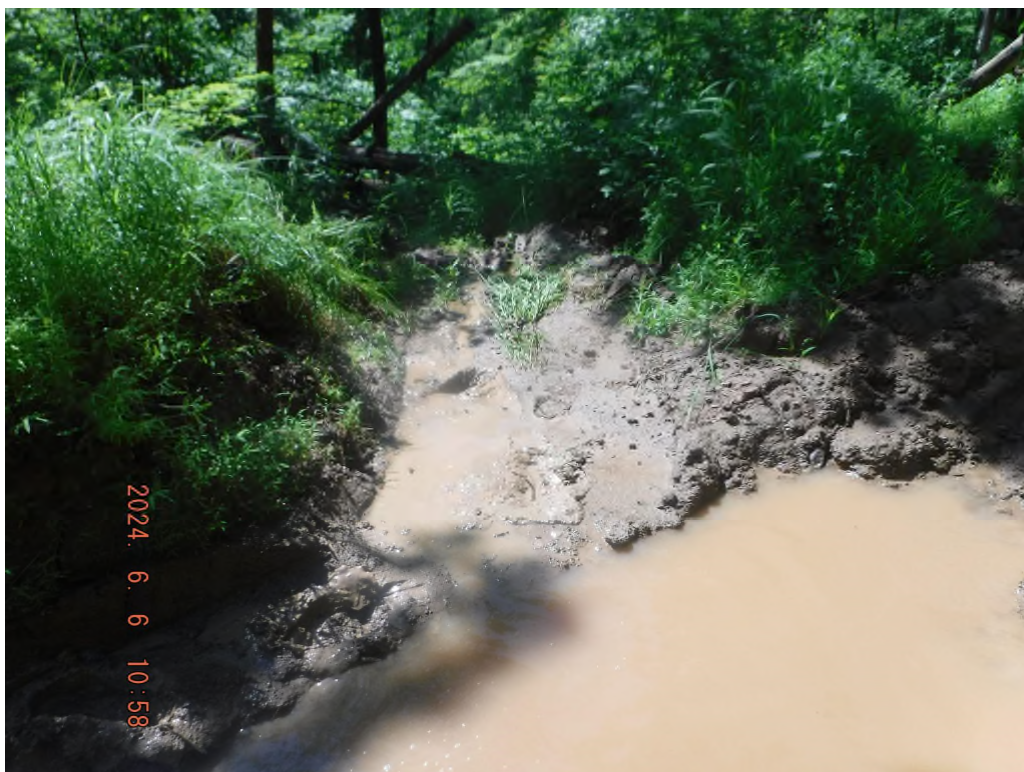
Photo # DSCF5258: Sediment laden water leaving the unpermitted access road to buck run that begins at or near N 39° 30.9806', W 80° 31.3774'.

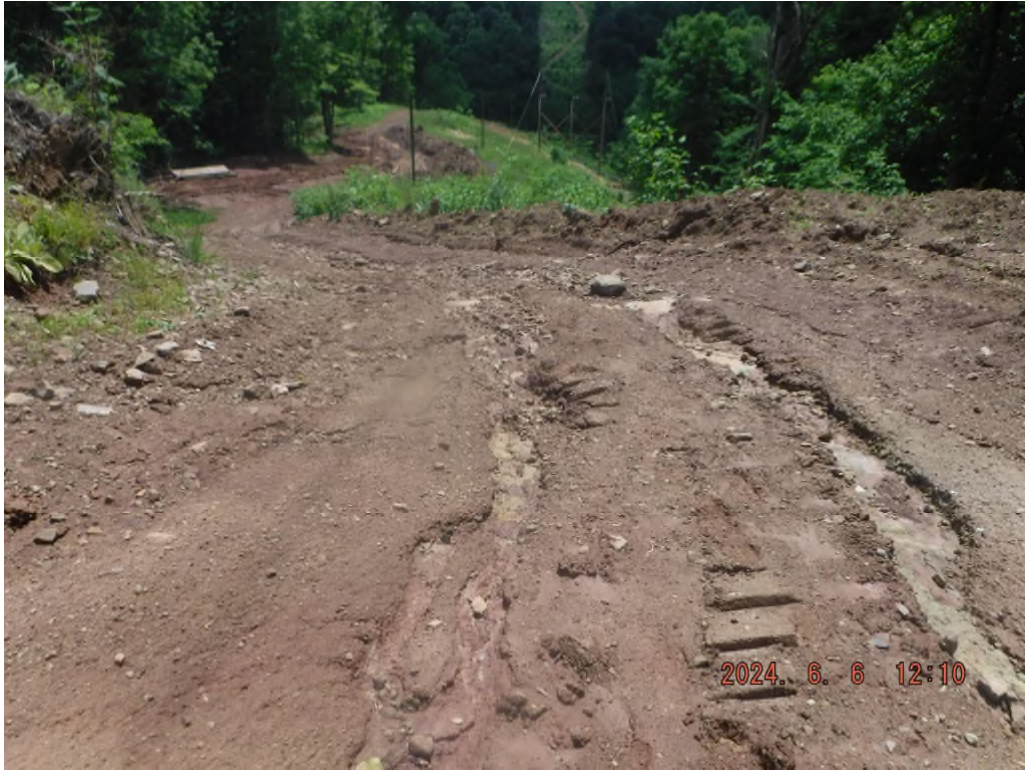
Photo # DSCF5268: Sediment laden water leaving the unpermitted access road that begins at or near N 39° 30.9806', W 80° 31.3774'.

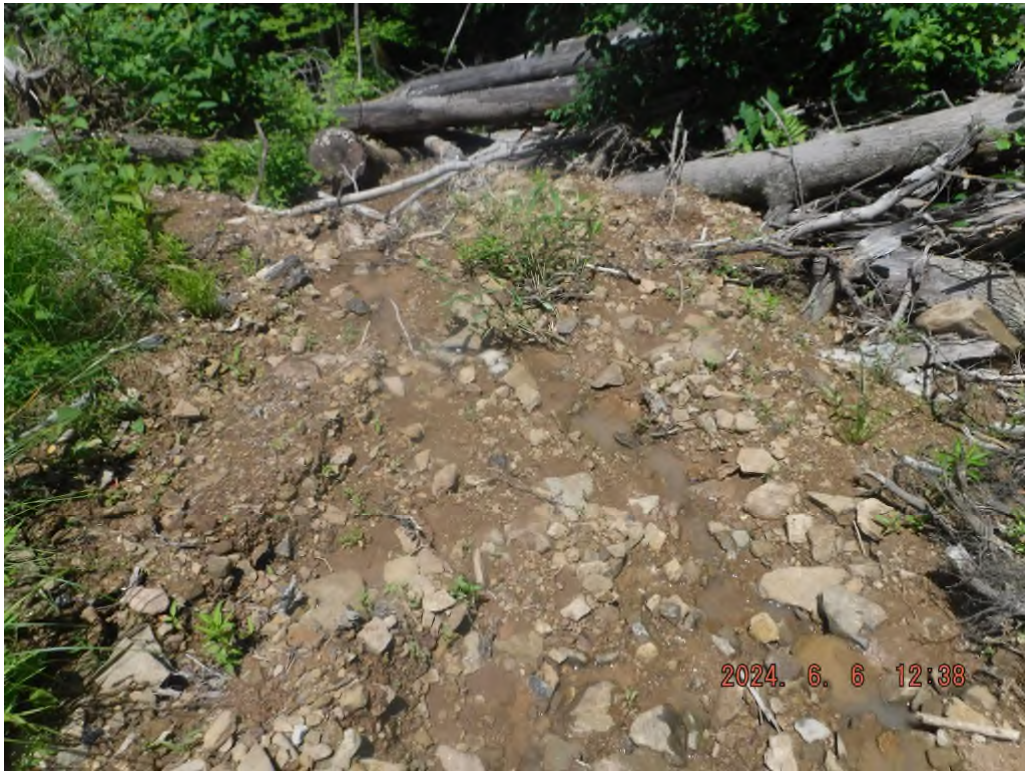
Photo # DSCF5324: Erosion rilling on the existing access road between stations 75+00 and 100+00.

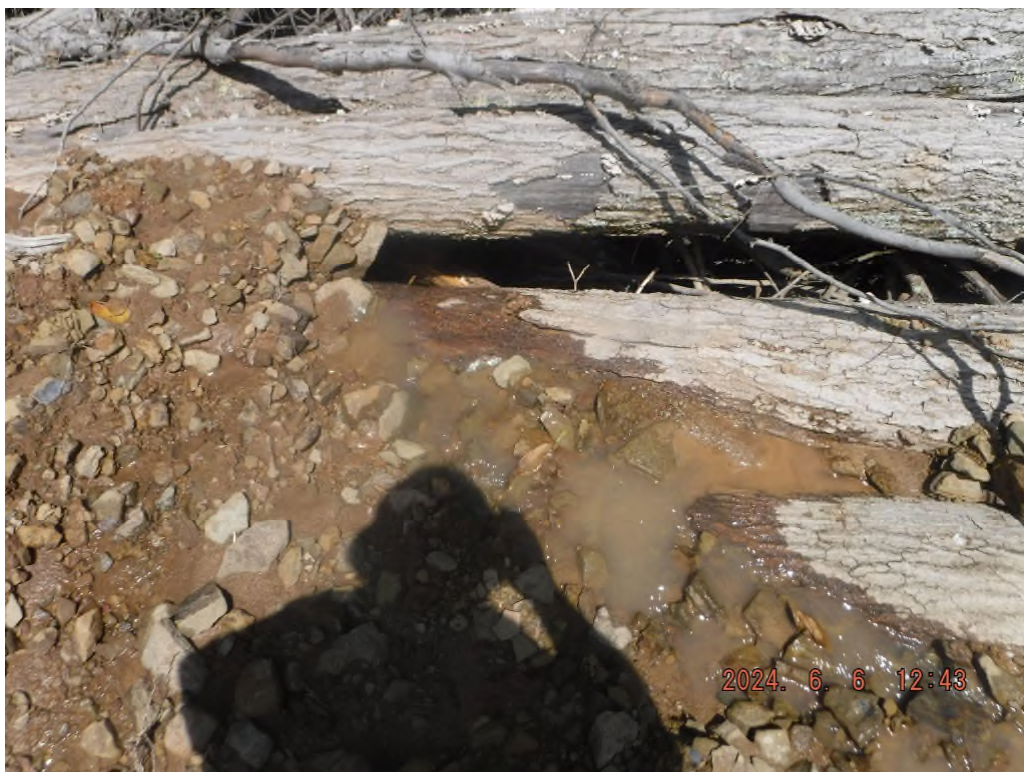
Photo # DSCF5374: silt fence lacks maintenance and sediment laden water leaving the site at station 110+00 at or near N 39° 31.0430', W 80° 31.0574'.

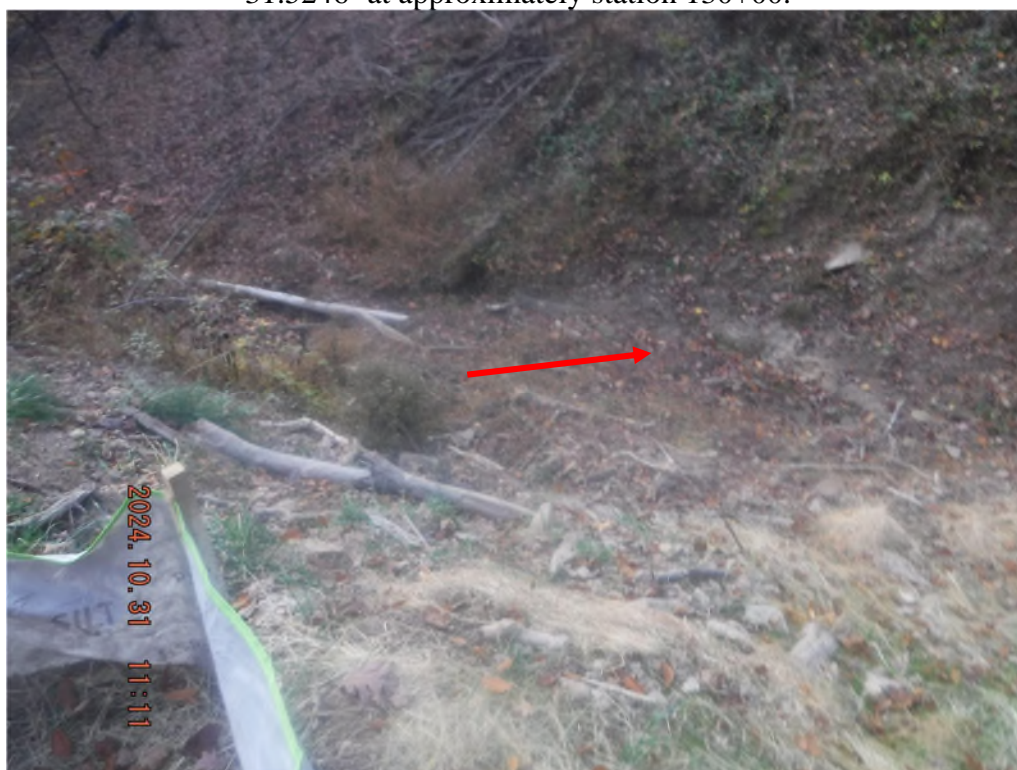
Photo # DSCF0008: Slip material remaining in UNT Buck Run at or near N 39° 30.9039', W 80° 31.5246' at approximately station 130+00.

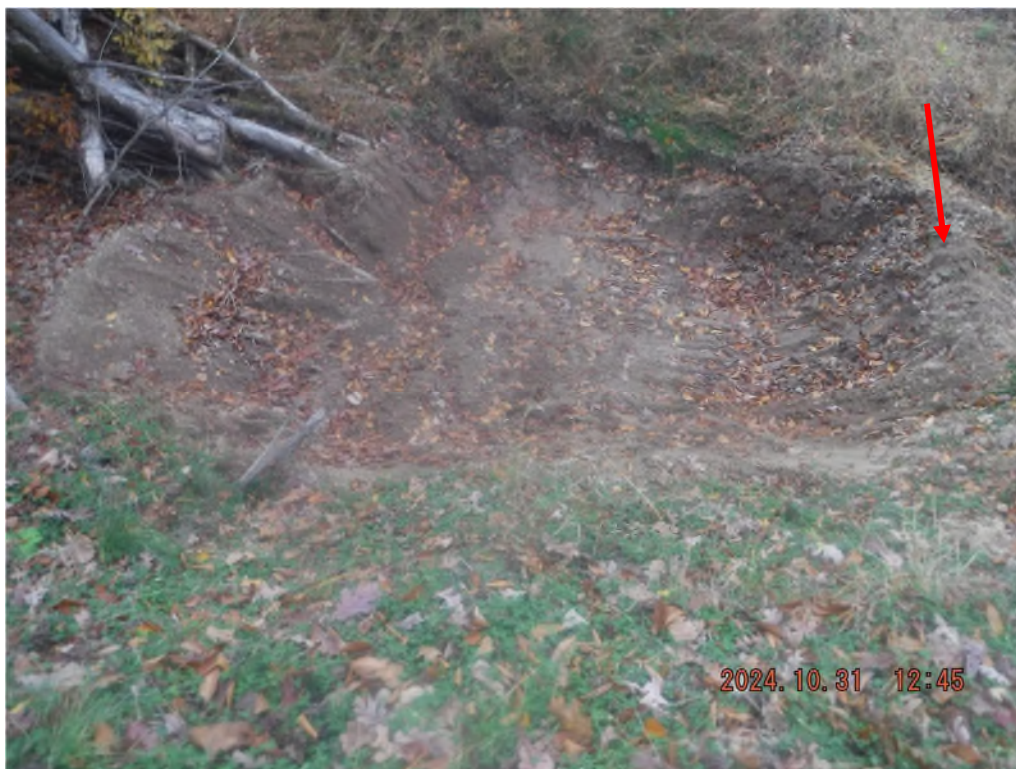
Photo # DSCF0039: Rollout at or near N 39° 30.9679', W 80° 30.5184'.

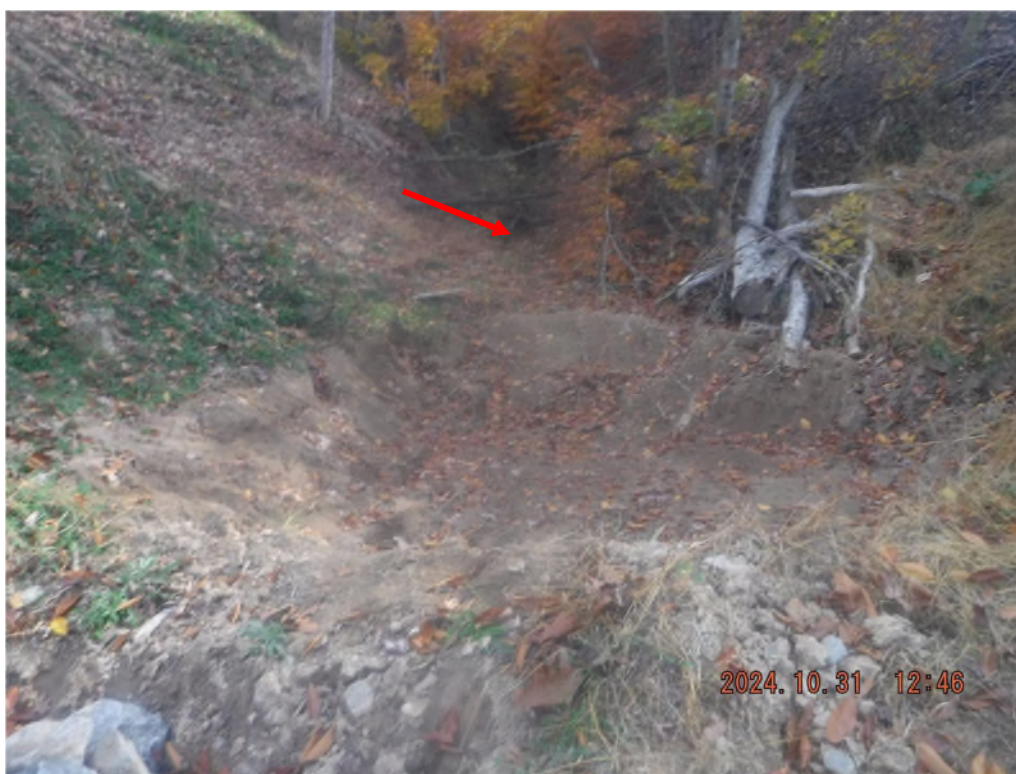
Photo # DSCF0077: Sediment deposit (red arrow) from digging a large sump in UNT Buck Run at or near 39° 31 '01.2"N 80° 31' 11.8"W.

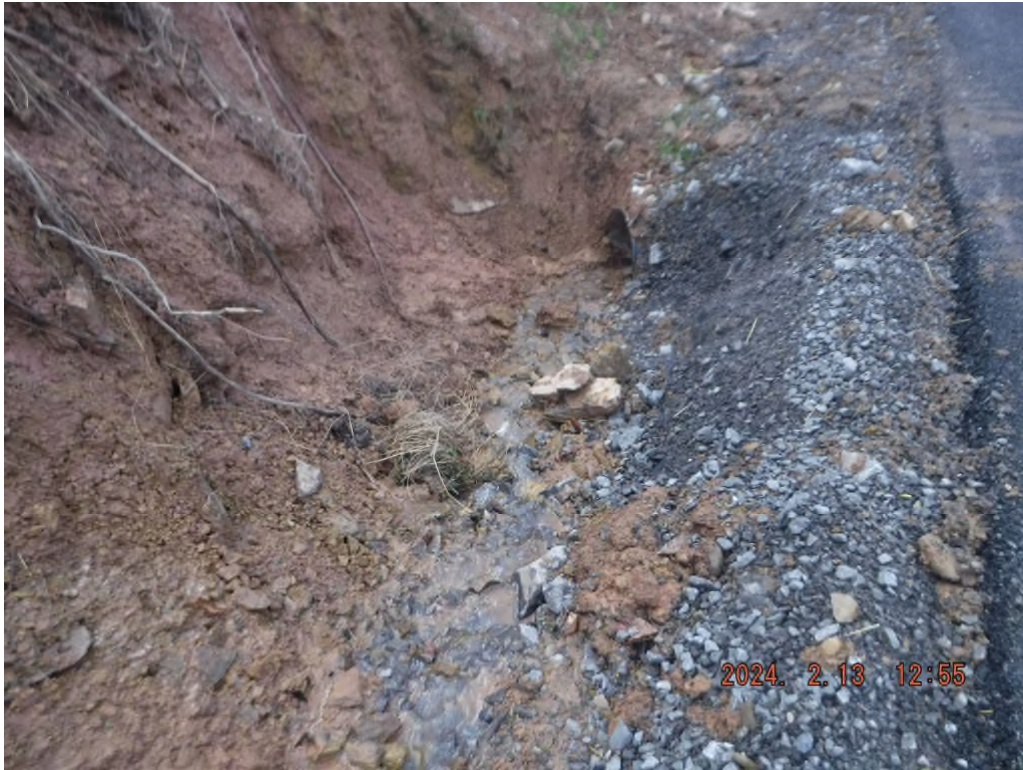
Photo # DSCF0080: Sediment deposit in UNT Buck Run from digging a large sump at or near 39° 31 '01.2"N 80° 31' 11.8"W. Original stream channel labeled with red arrow.

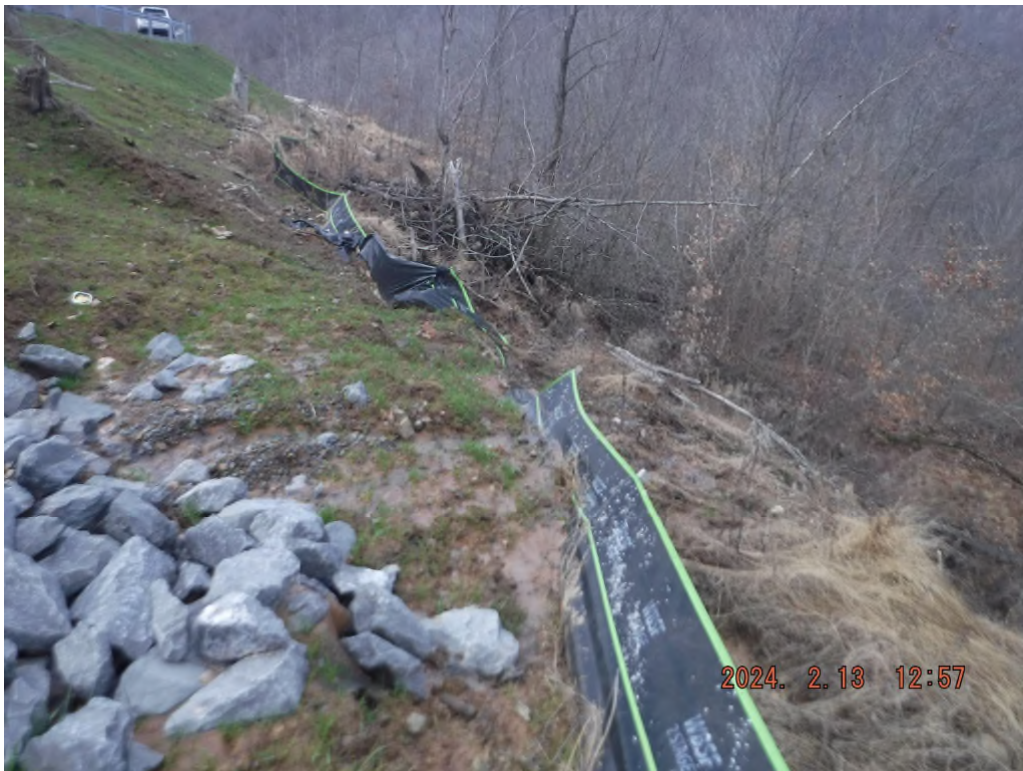
Photo # DSCF2042: No inlet protection present at the culvert inlet for Ephemeral 11 at or near station 37+00.

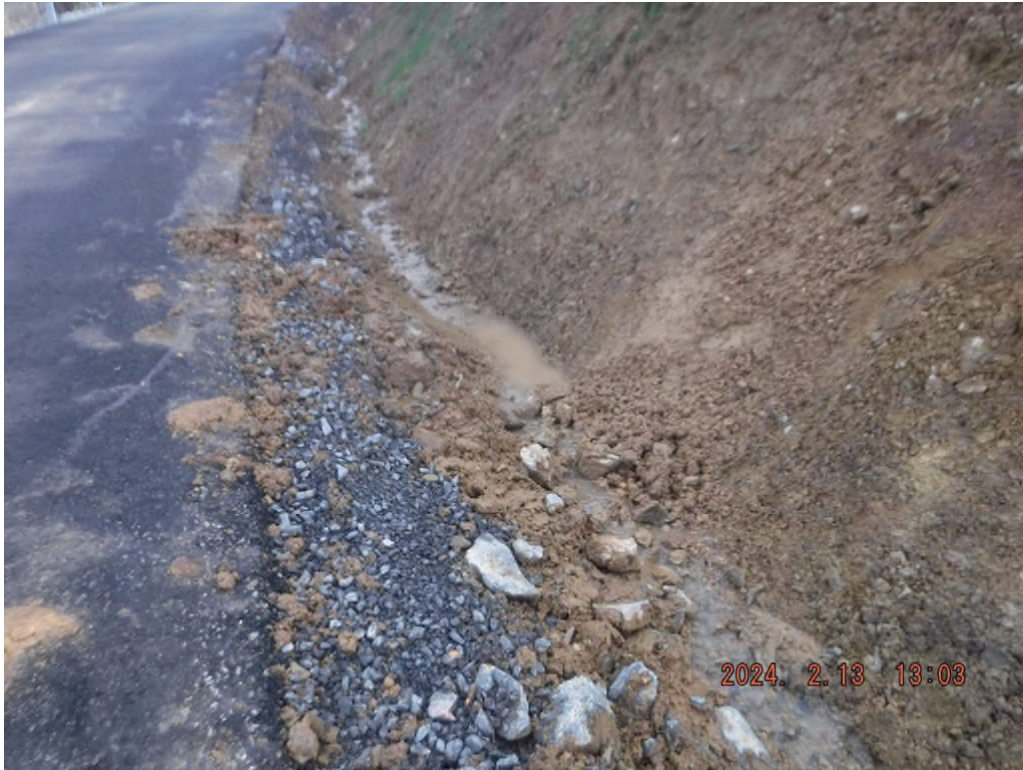
Photo # DSCF2052: Silt fence lacks maintenance below stormwater discharge point 11.

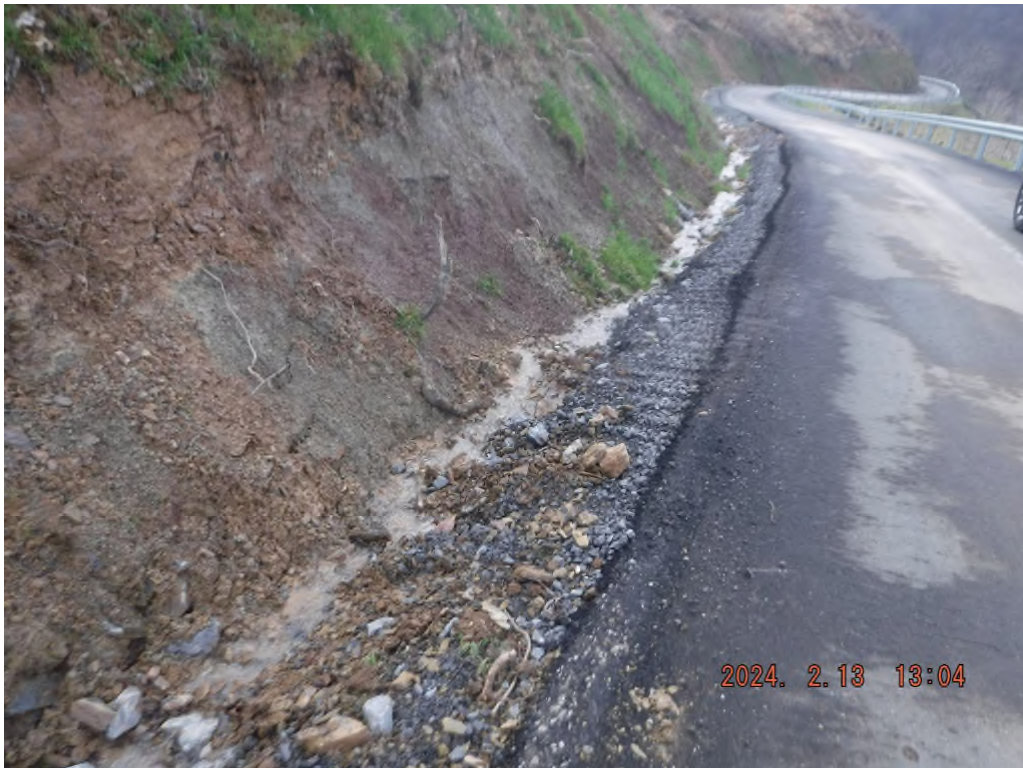
Photo # DSCF2065: Area between station 35+00 and 37+00 that lacks rock check dams.

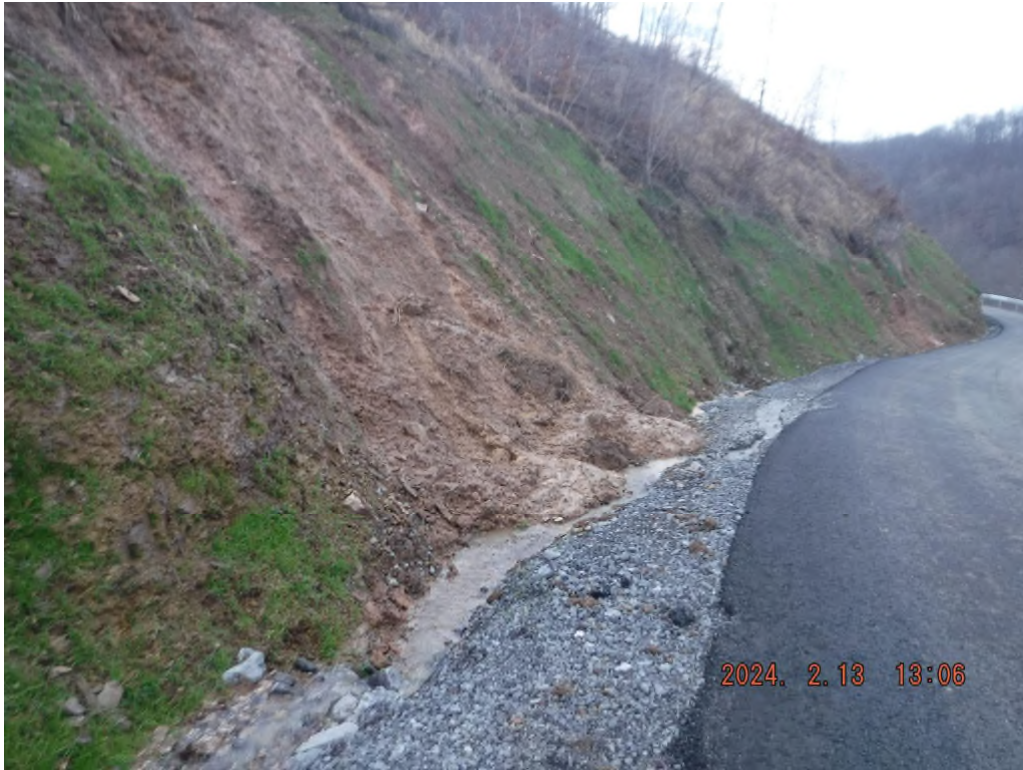
Photo # DSCF2067: Area between stations 30+00 and 32+00 that lacks rock check dams.

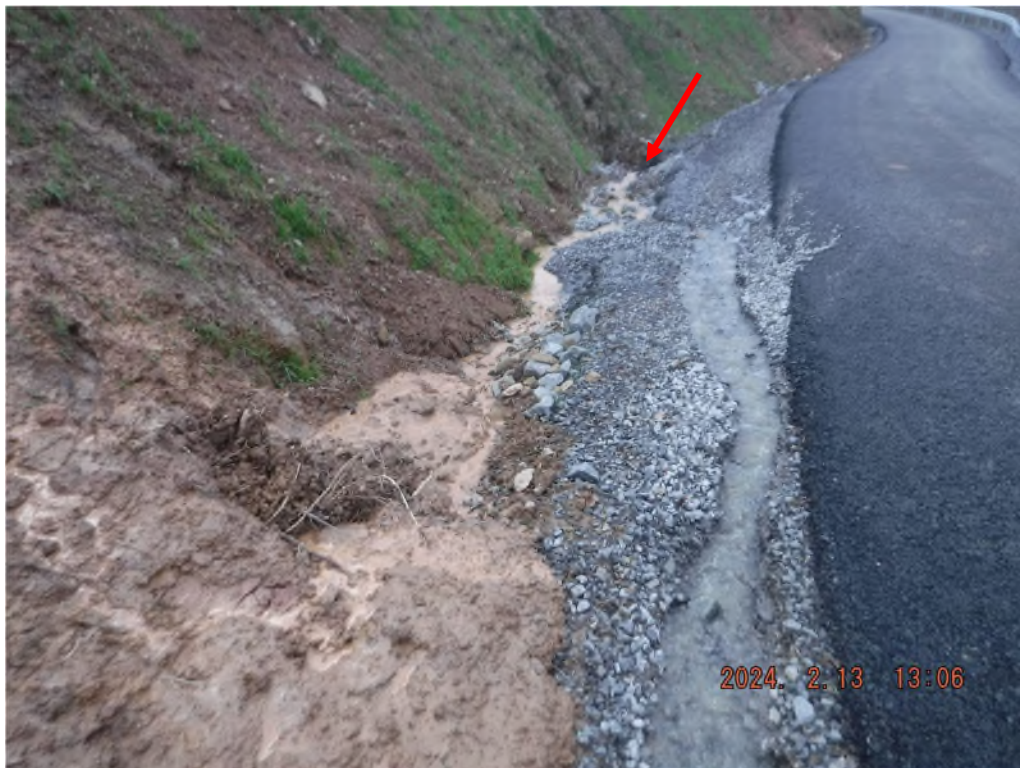
Photo # DSCF2074: Slip in ditch A-6 at or near station 29+25.

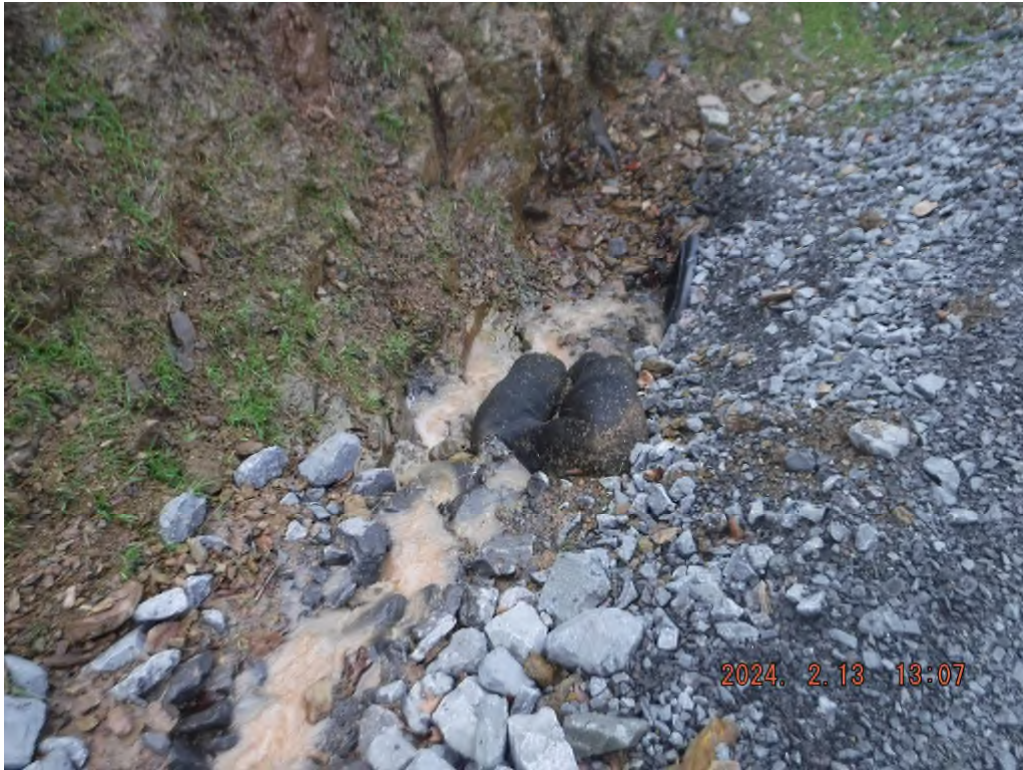
Photo # DSCF2075: Slip in ditch A-6 at or near station 29+25. Inlet for culvert to ephemeral 8 denoted by red arrow.

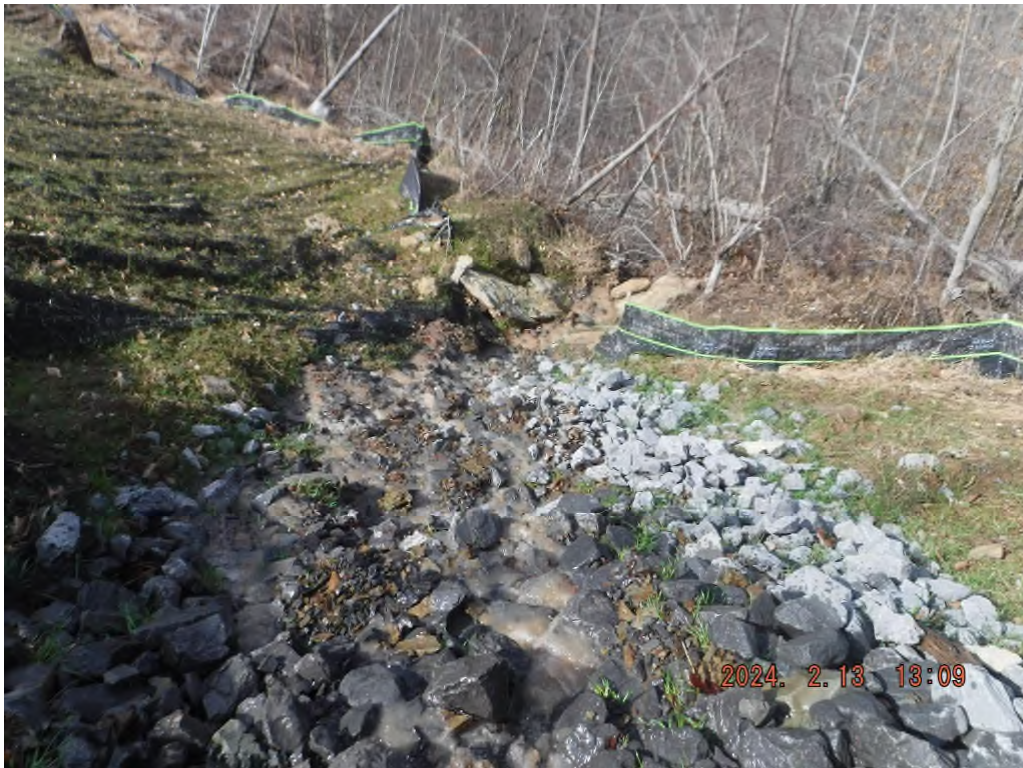
Photo # DSCF2076: Inlet protection lacks maintenance at or near station 29+20.

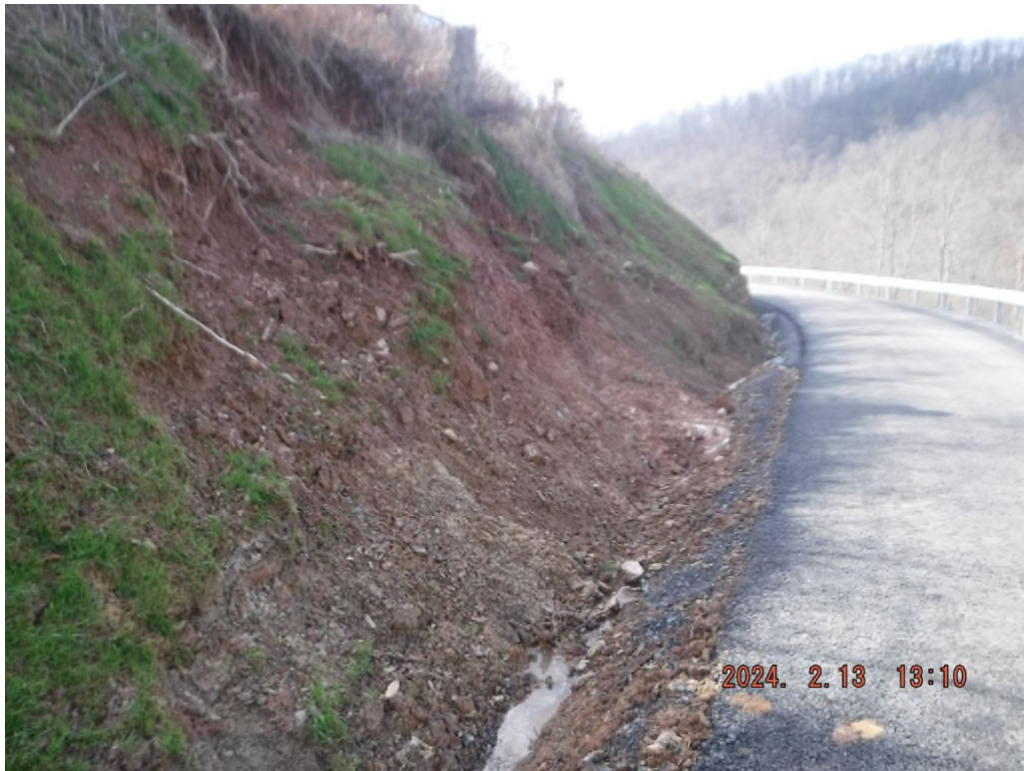
Photo # DSCF2082: Stormwater discharge point 10 at or near station 29+00. Silt fence lacks maintenance leading into ephemeral 8.

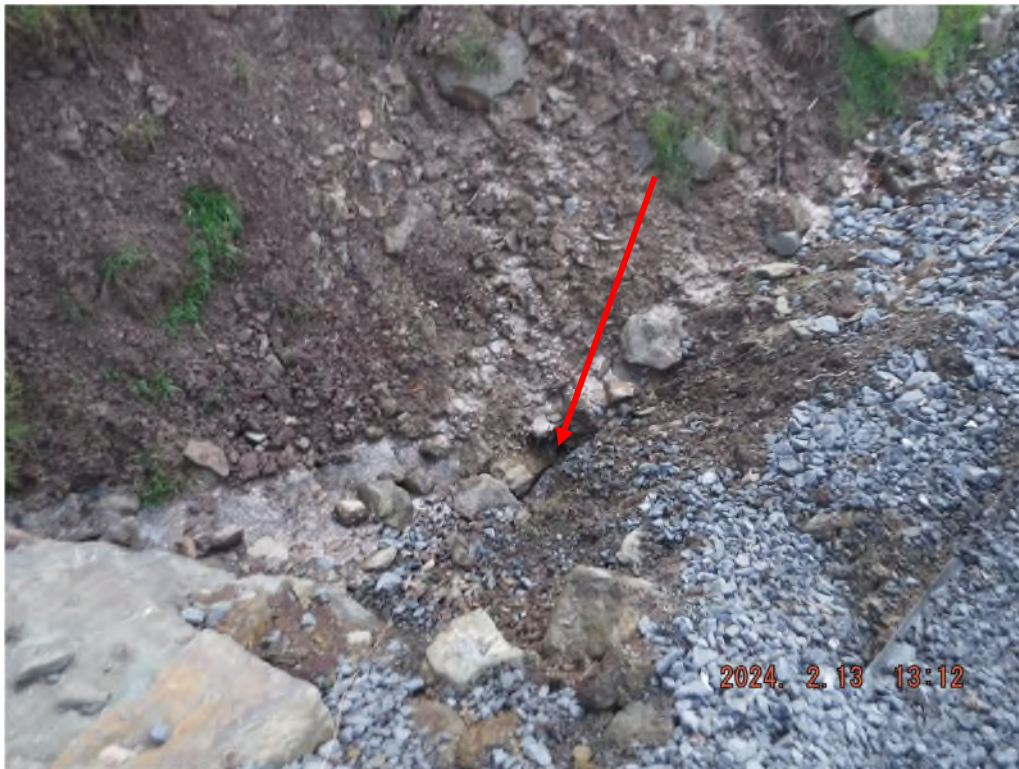
Photo # DSCF2087: Fill material in ditch near station 28+00.

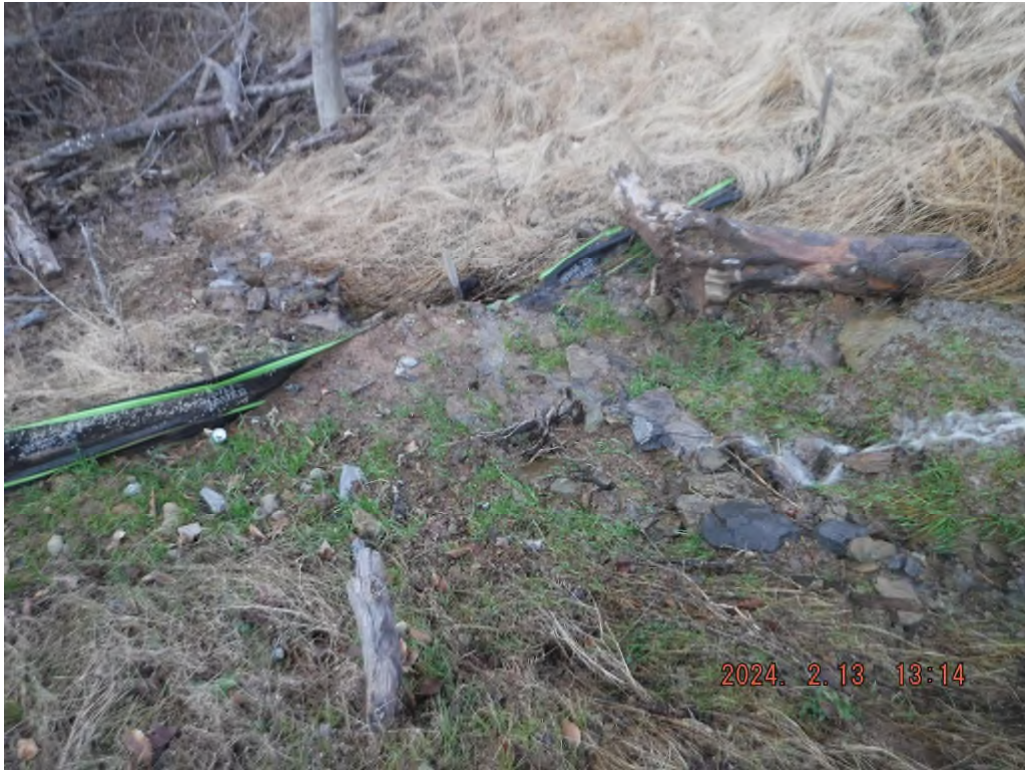
Photo# DSCF2093: No inlet protection at the culvert inlet (red arrow) at station 25+00.

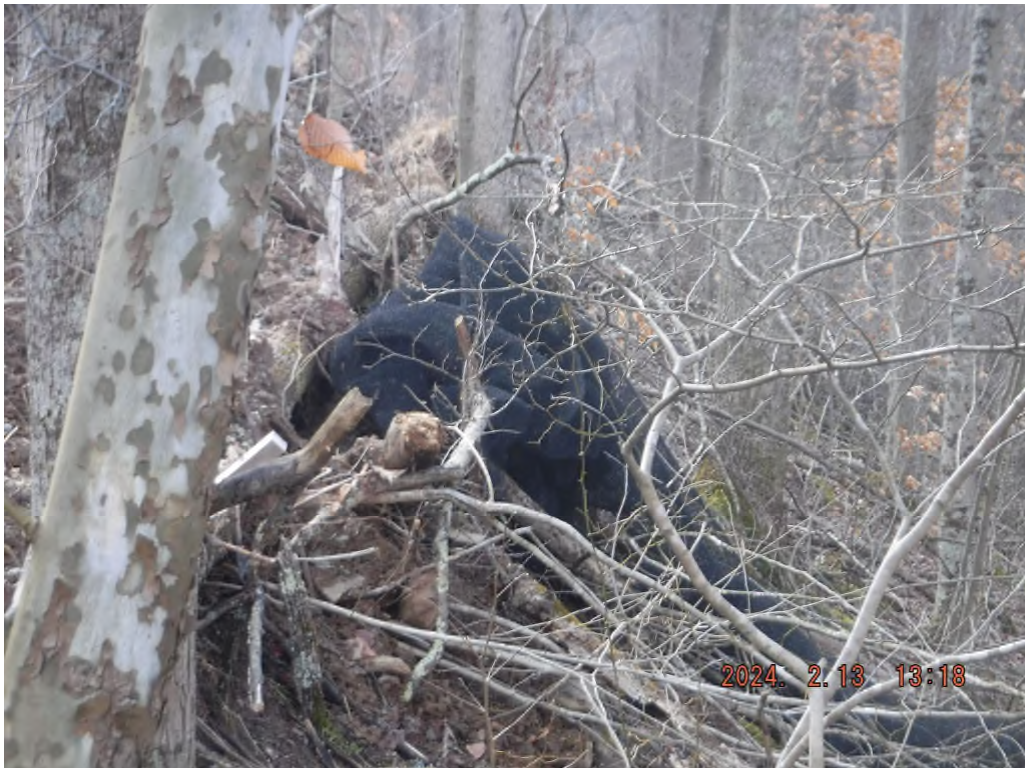
Photo # DSCF2096: Silt fence lacks maintenance below the culvert outlet at station 25+00.

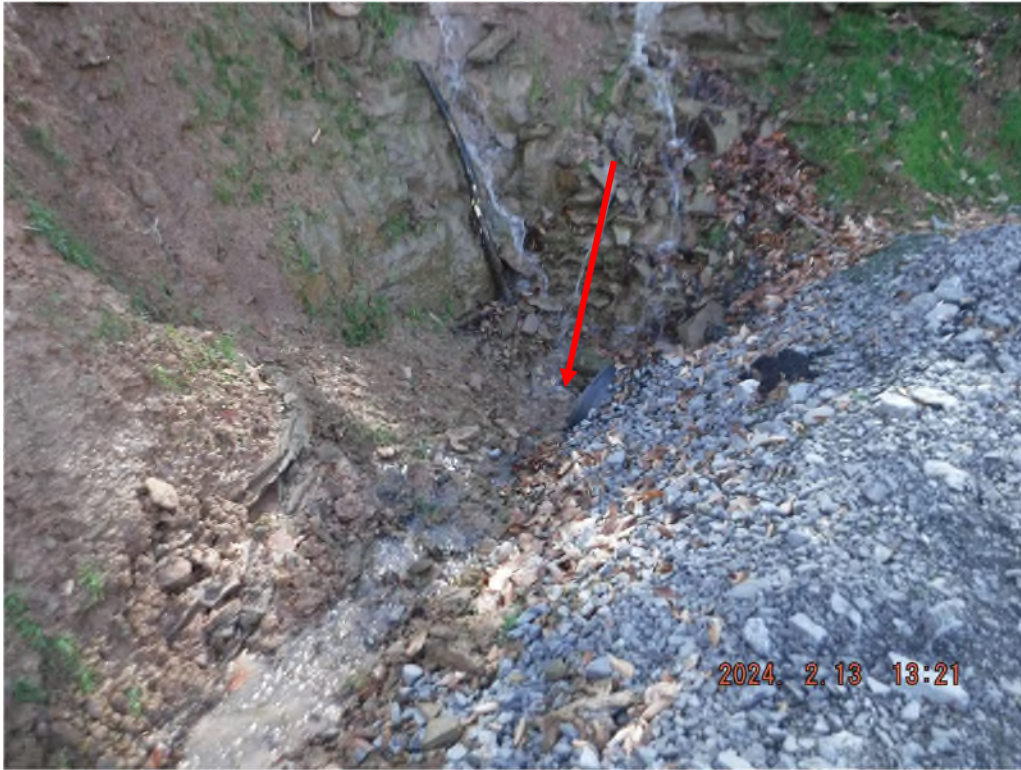
Photo # DSCF2112: Pile of TRM off LOD at or near station 24+00.

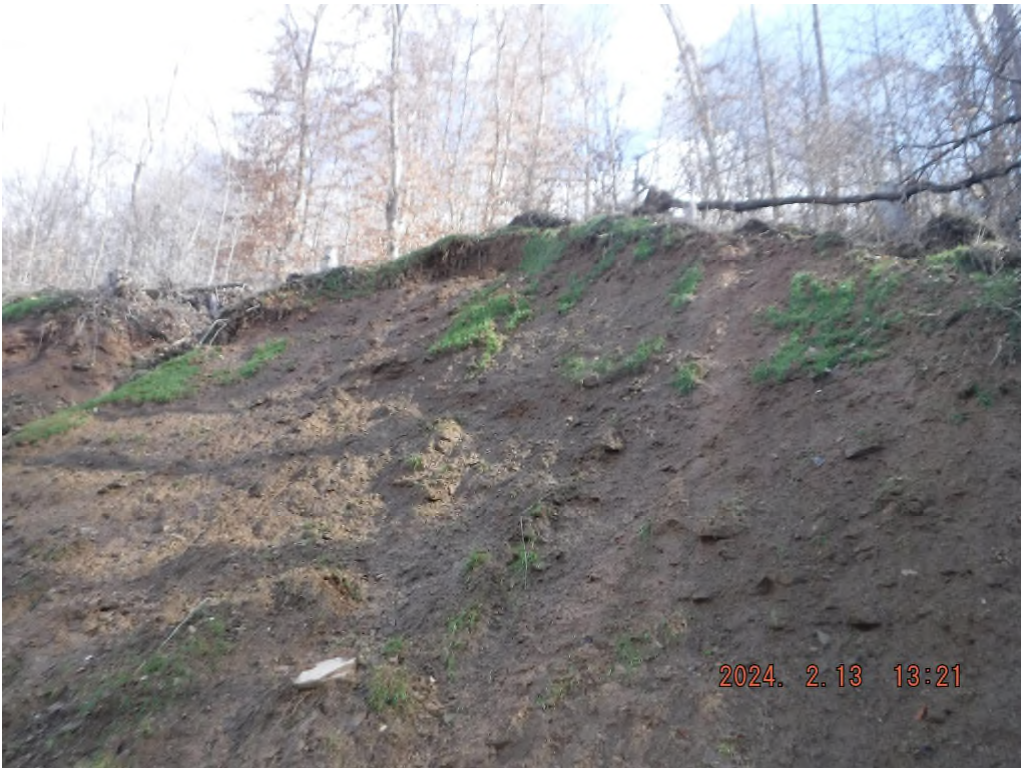
Photo # DSCF2118: No inlet protection at or near station 20+00.
