**CONSENT ORDER
ISSUED UNDER THE
WATER POLLUTION CONTROL ACT
WEST VIRGINIA CODE CHAPTER 22, ARTICLE 11**

TO: Harrison County Coal Resources, Inc.
Attn: James R. Turner, Jr.
46226 National Road West
St. Clairsville, OH 43950

ORDER NO.: 10302

Rymer I & II Stream Restoration Site – WVR112355

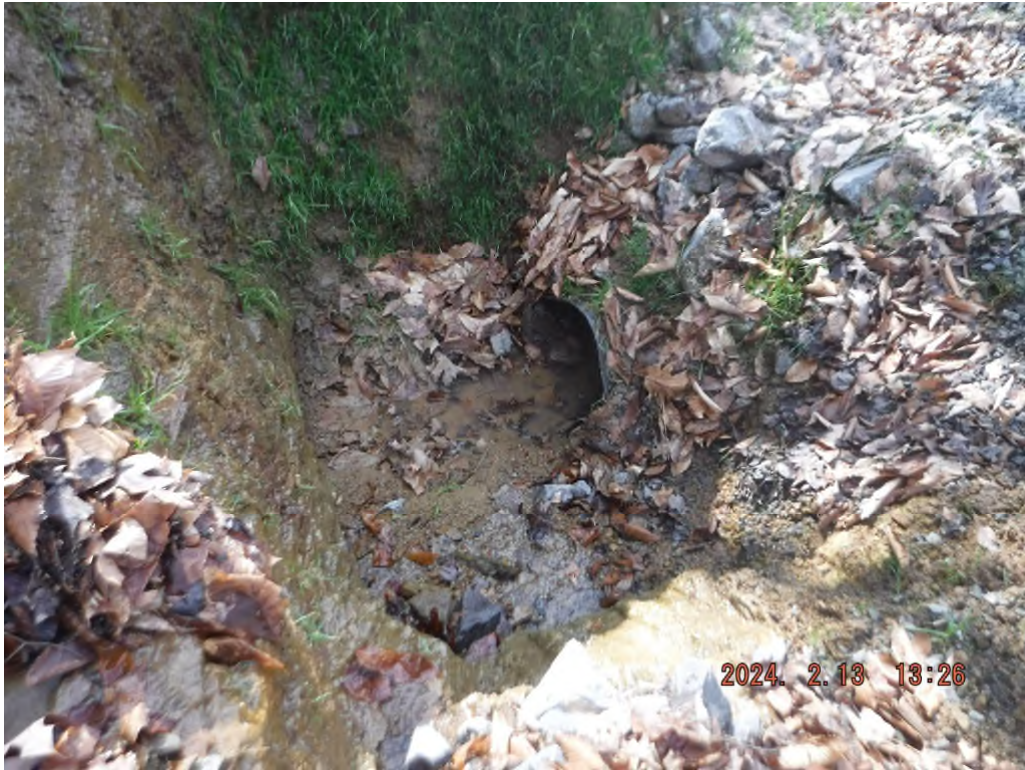
Photo # DSCF2119: Slope above the inlet lacking inlet protection at station 20+00.

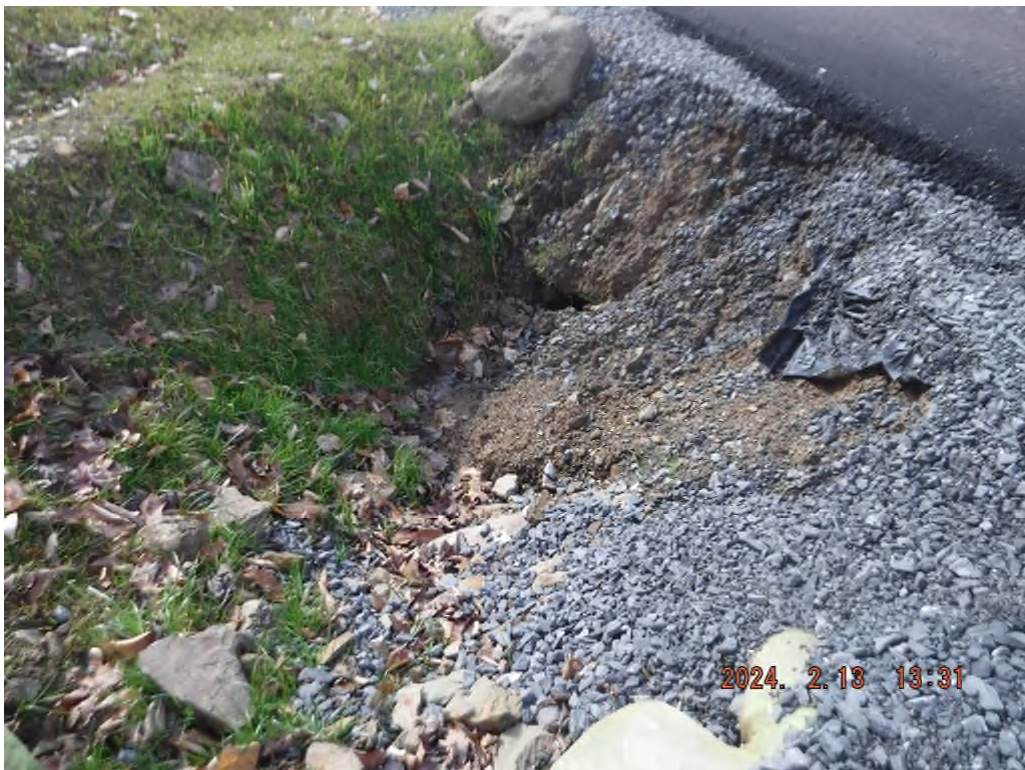
Photo # DSCF2128: No inlet protection present at or near station 15+50.

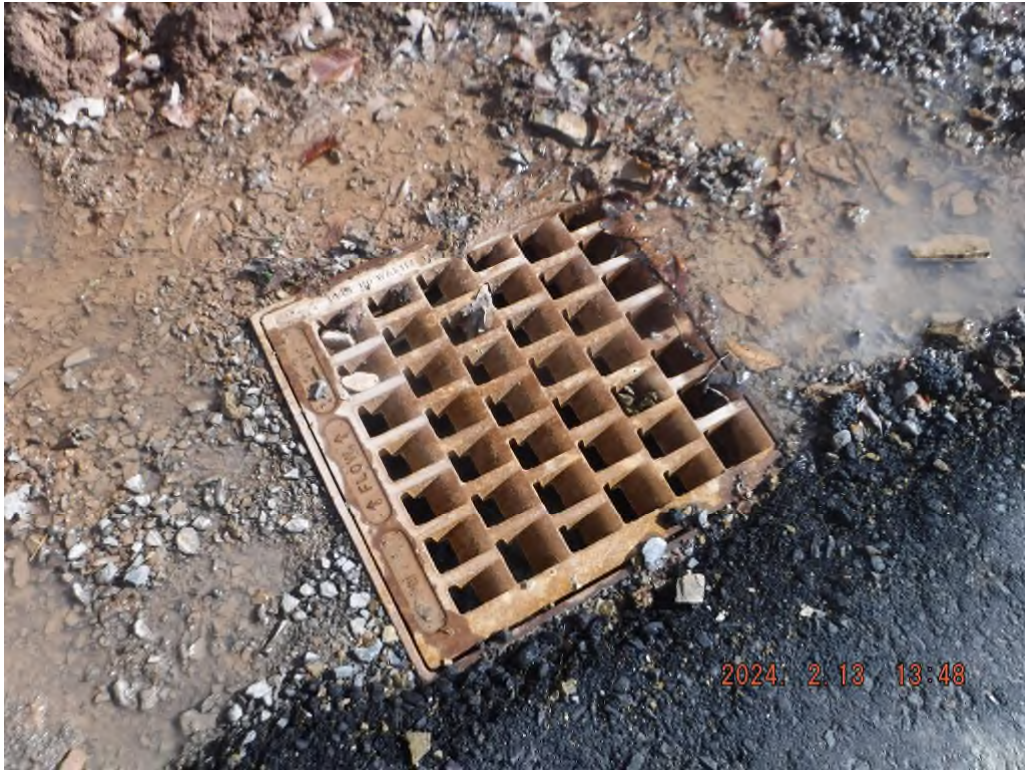
Photo # DSCF2139: No inlet protection at or near 14+50.

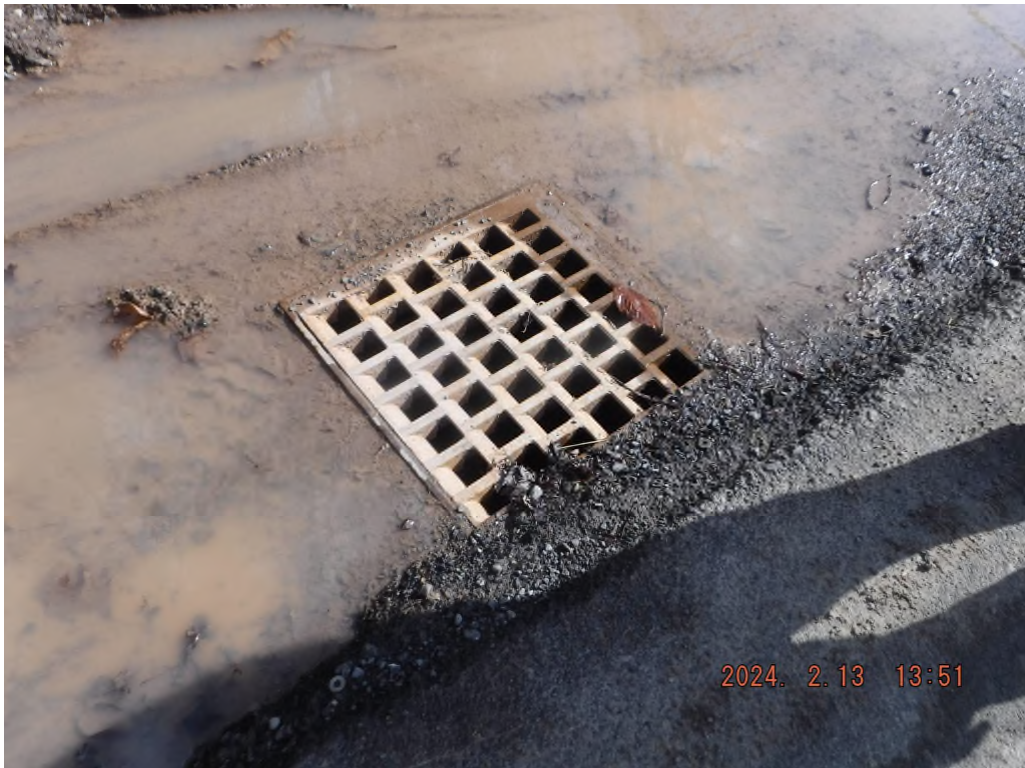
Photo # DSCF2153: No inlet protection at drop inlet B4.

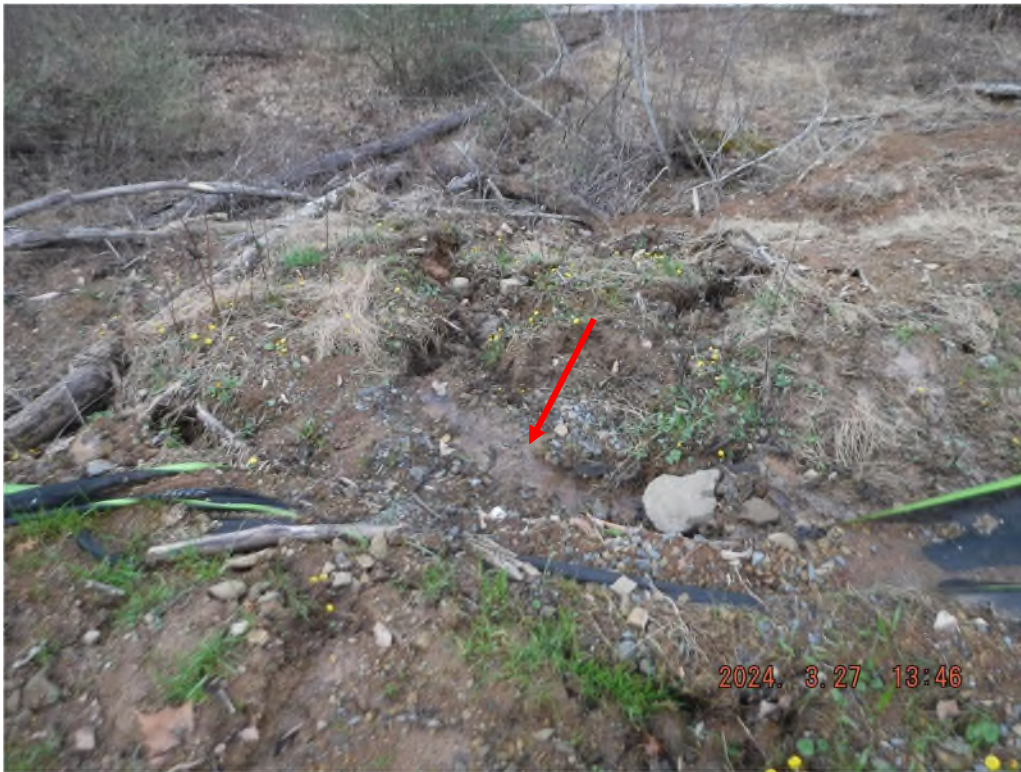
Photo # DSCF2155: No inlet protection at drop inlet B3.

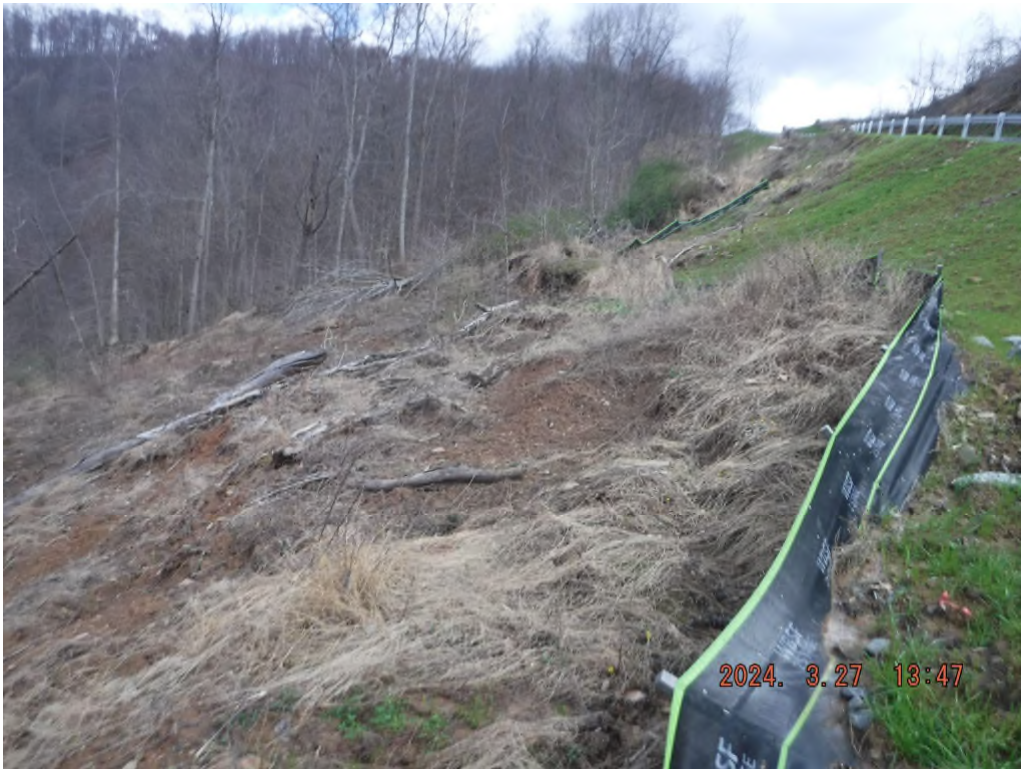
Photo # DSCF3329: Sediment laden water leaving the site from discharge point 11 at station 37+00, and silt fence lacks maintenance.

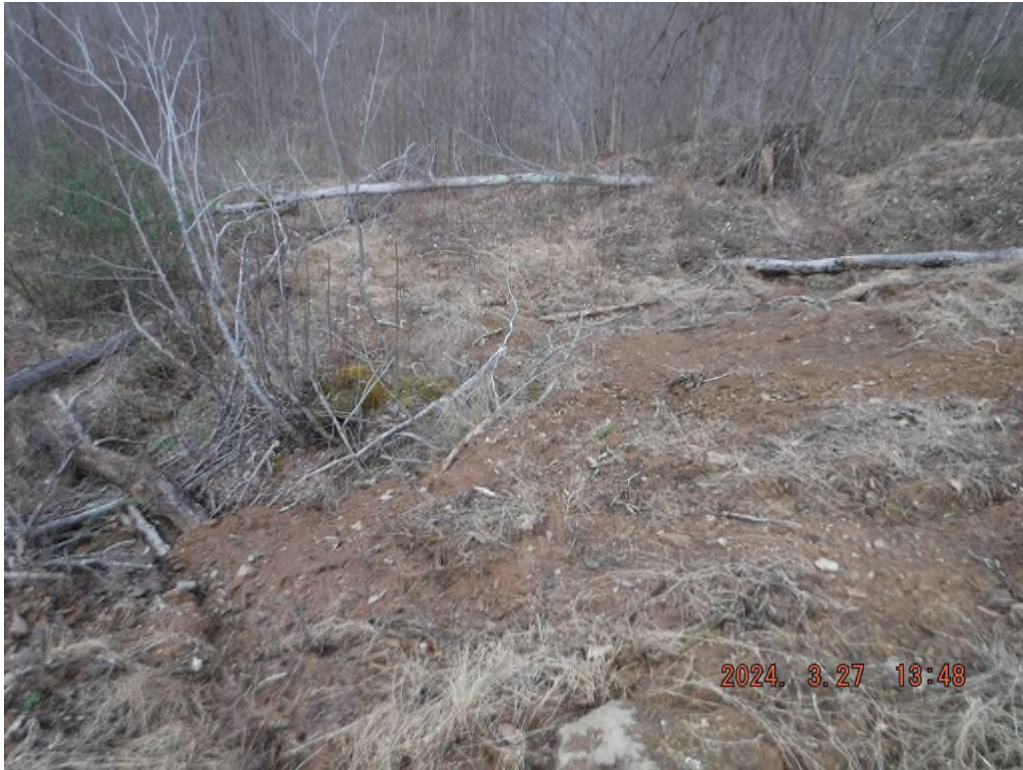
Photo # DSCF3332: Slip in wetland F near station 37+00.

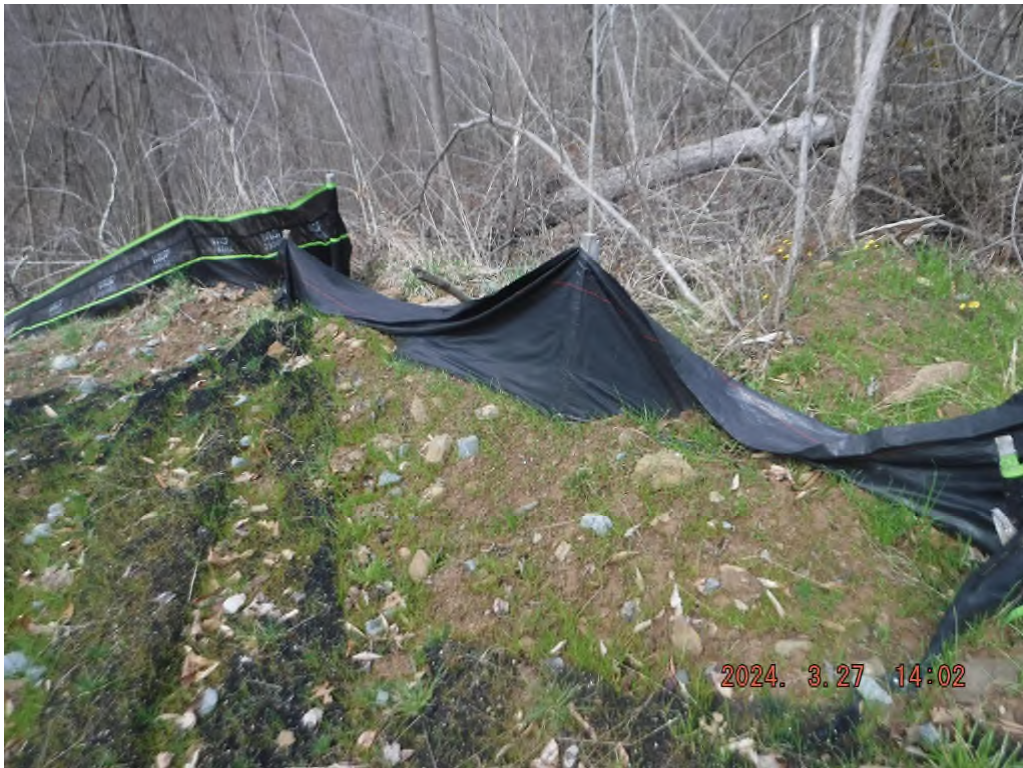
Photo # DSCF3352: Slip in roadside ditch at or near N 39° 30.7076', W 80° 32.7174'.

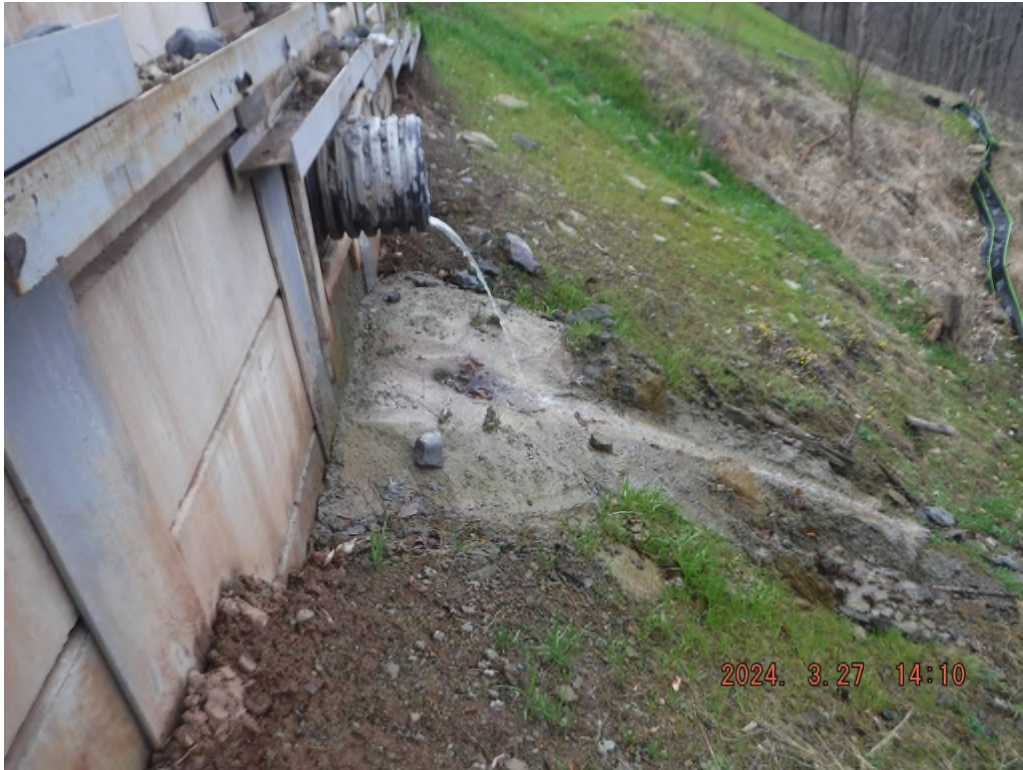
Photo # DSCF3361: Incorrect silt fence installed at station 29+50.

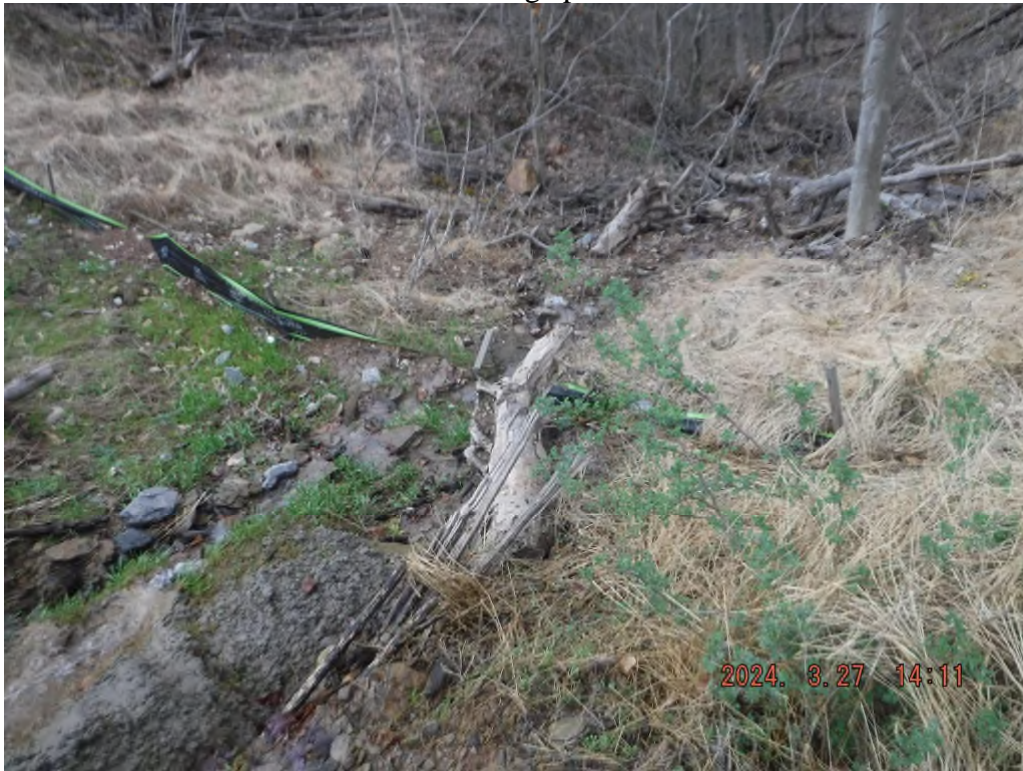
Photo # DSCF3377: Discharge point 9 at station 25+00.

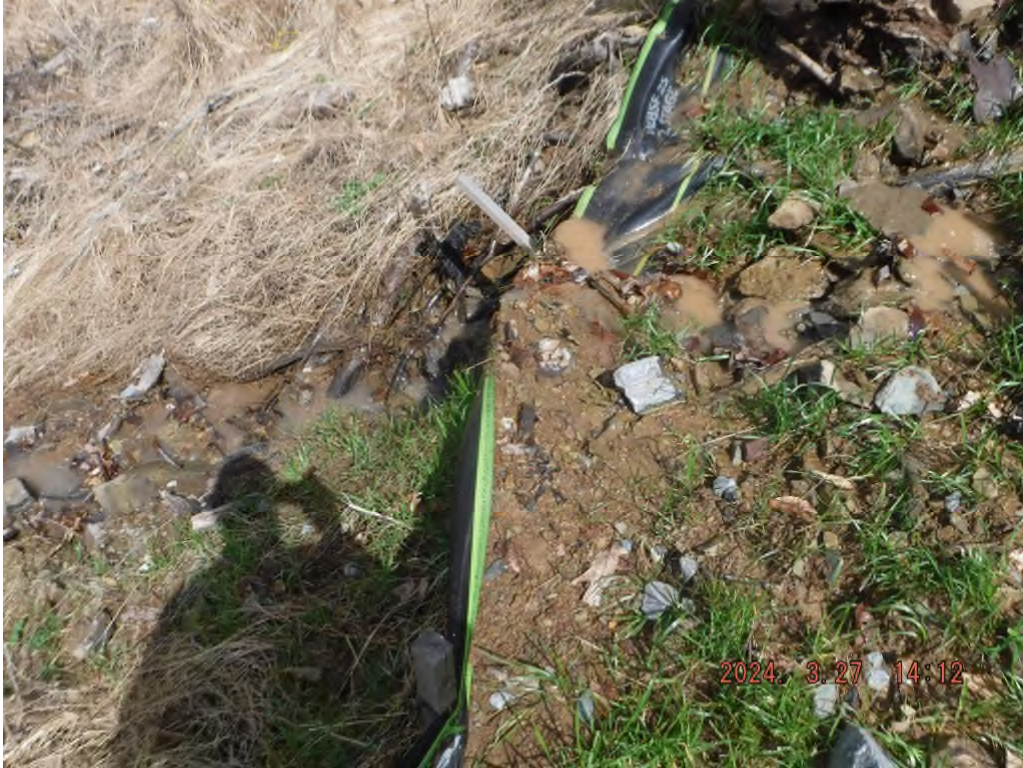
Photo # DSCF3380: BMPs lack maintenance at station 25+00.

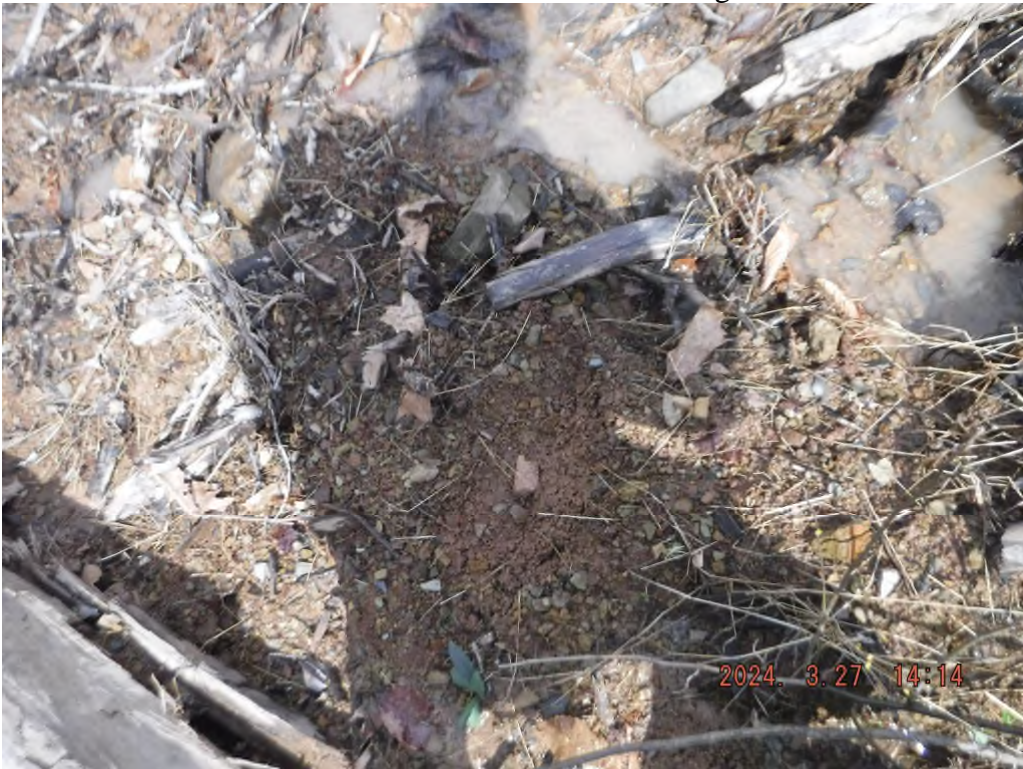
Photo # DSCF3382: Sediment laden water leaving at station 25+00

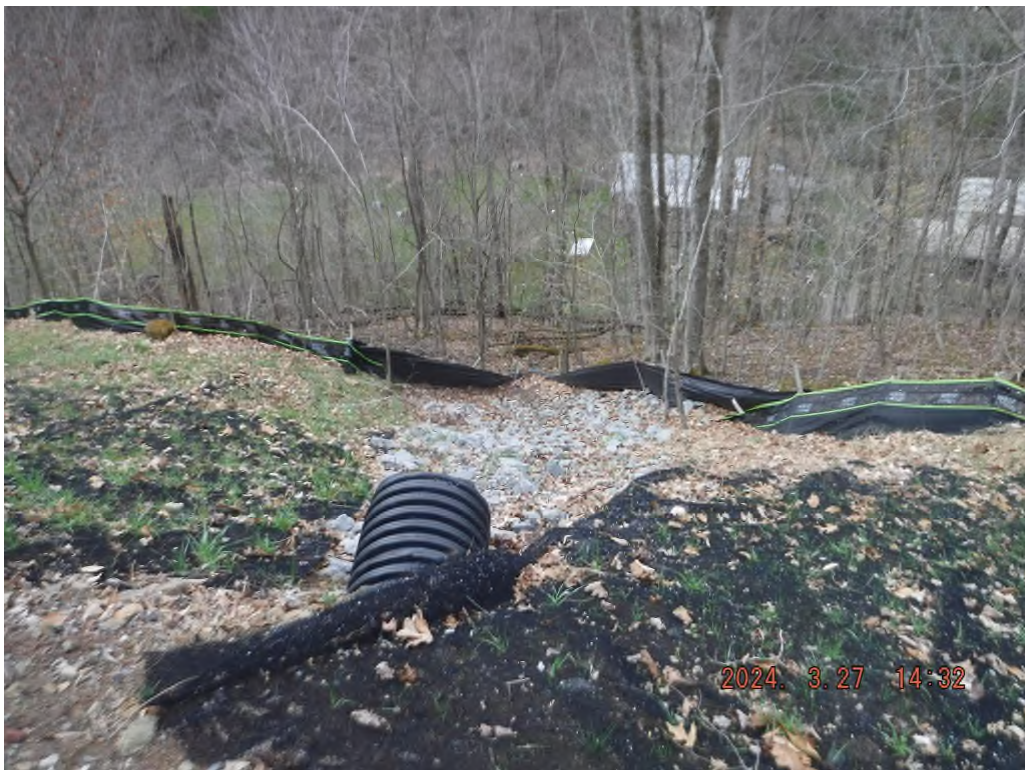
Photo # DSCF3404: Discarded turf matting between stations 15+00 and 20+00
