**CONSENT ORDER
ISSUED UNDER THE
WATER POLLUTION CONTROL ACT
WEST VIRGINIA CODE, CHAPTER 22, ARTICLE 11**

TO: Columbia Gas Transmission, LLC
Attn: Troy Tally, Vice President
1700 MacCorkle Ave
Charleston, WV 25314

DATE: October 1, 2020
ORDER NO.: 9061

1. Columbia Gas Transmission, LLC is conducting land disturbance activity associated with construction of the Mountaineer Xpress Project in Marshall, Wetzel, Tyler, Doddridge, Ritchie, Calhoun, Wirt, Roane, Jackson, Mason, Putnam, and Cabell Counties, West Virginia. On January 31, 2018, Columbia Gas Transmission, LLC was issued Water Pollution Control Permit No. WV0116815, Registration No. WVR310872, for Stormwater Associated With Oil and Gas Related Construction Activities.

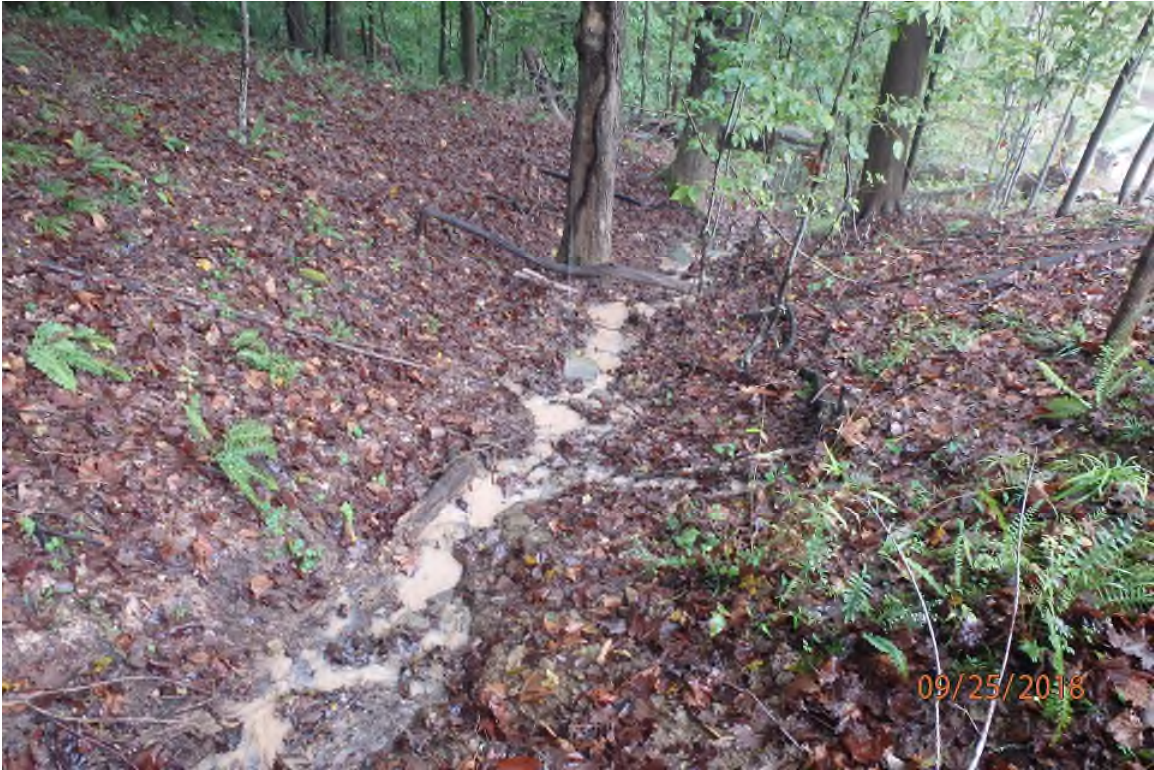
CNA distinctly visible settleable solids in UNT Neds Run (39° 21.099' X 80° 41.670').

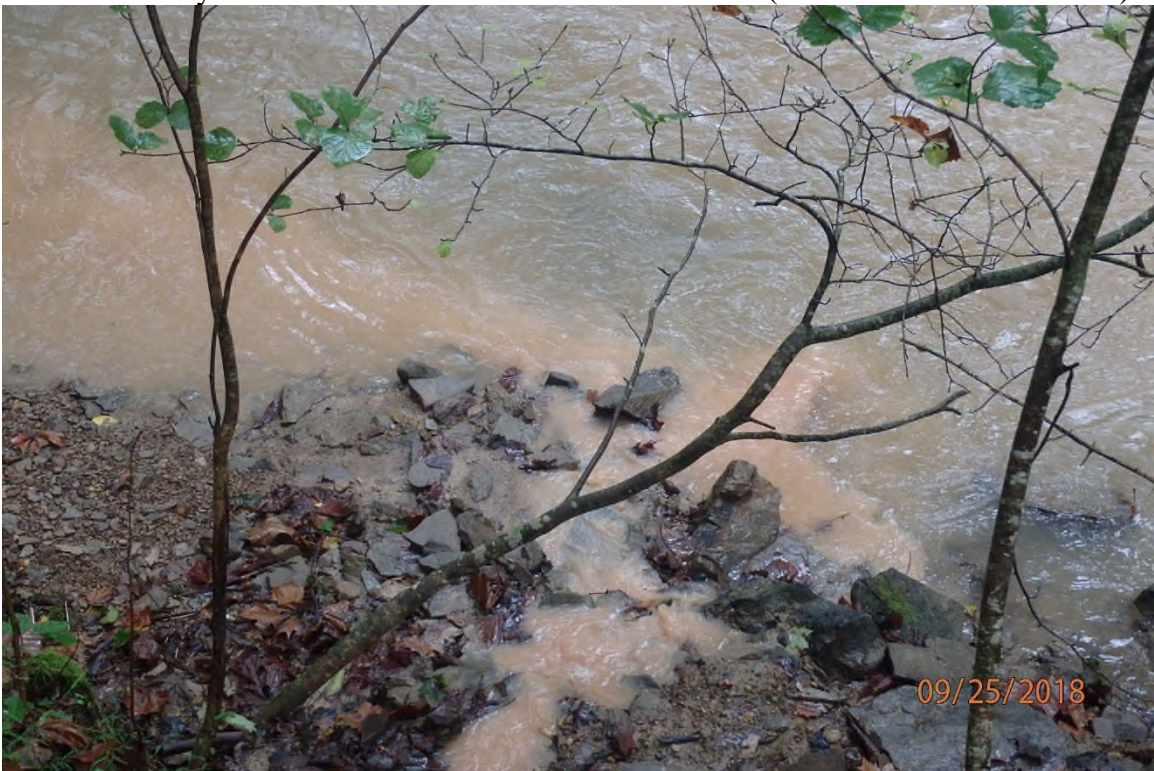
CNA distinctly visible settleable solids in UNT Neds Run (39° 21.099' X 80° 41.670').

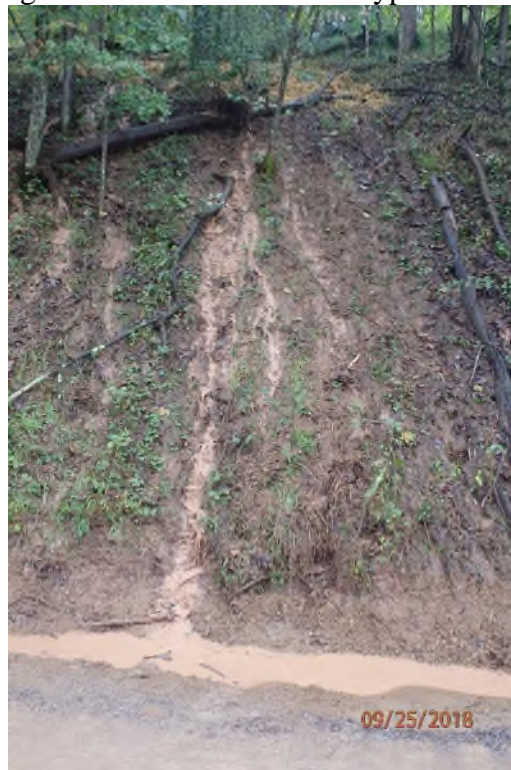
Offsite sediment laden water that originates from site adjacent to ARDO002.8.

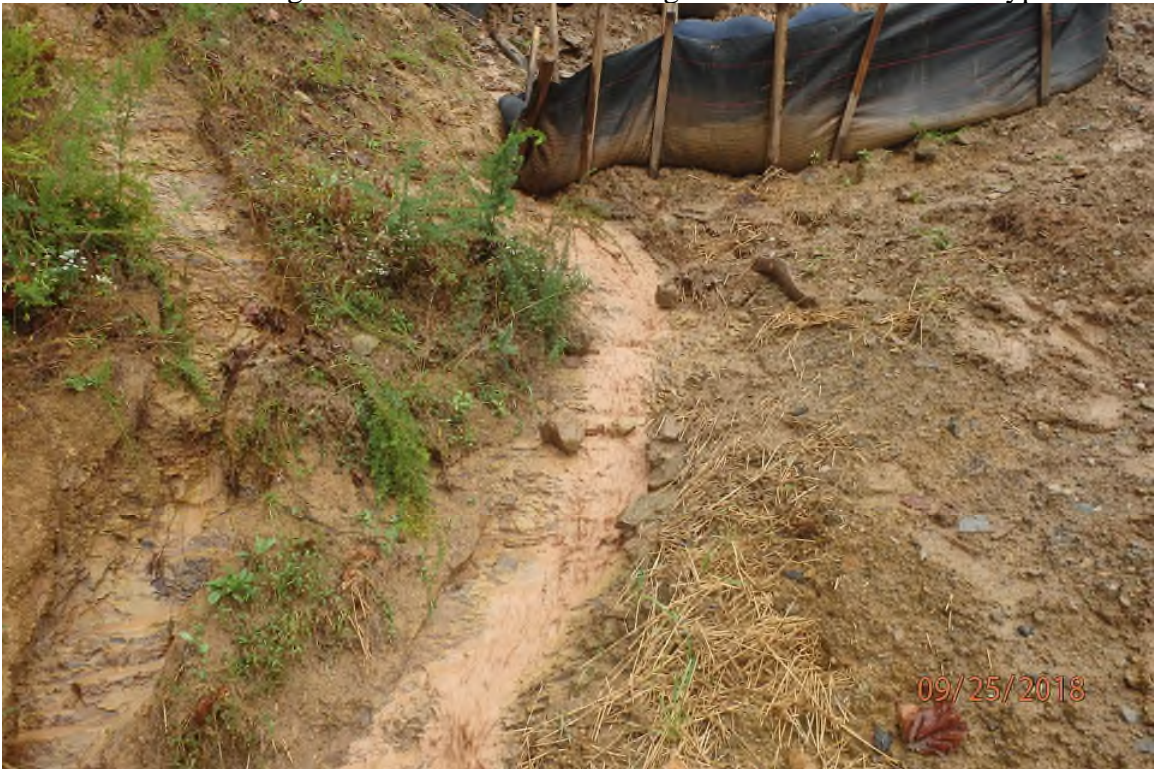
Ditch check along ARDO002.8 that is allowing a sediment laden water bypass.

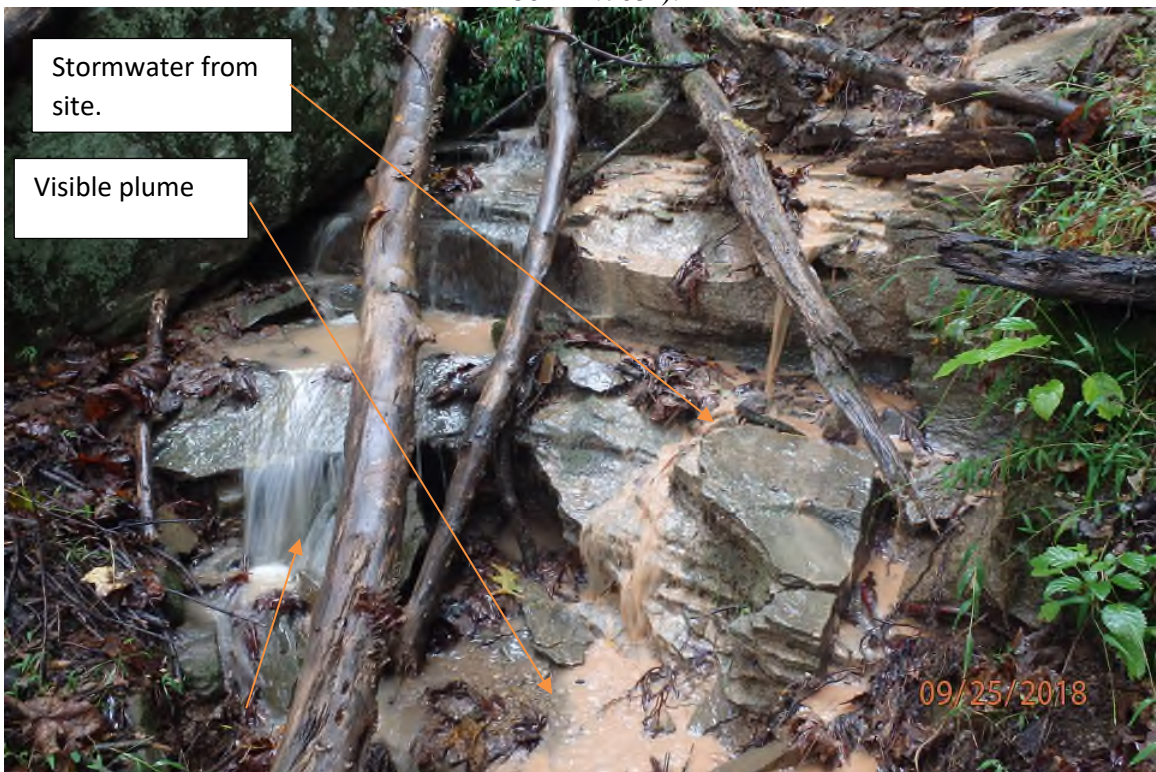
CNA oily slick, settleable solids, and odors in the vicinity of UNT Neds Run (39° 21.175 X 80° 41.705').

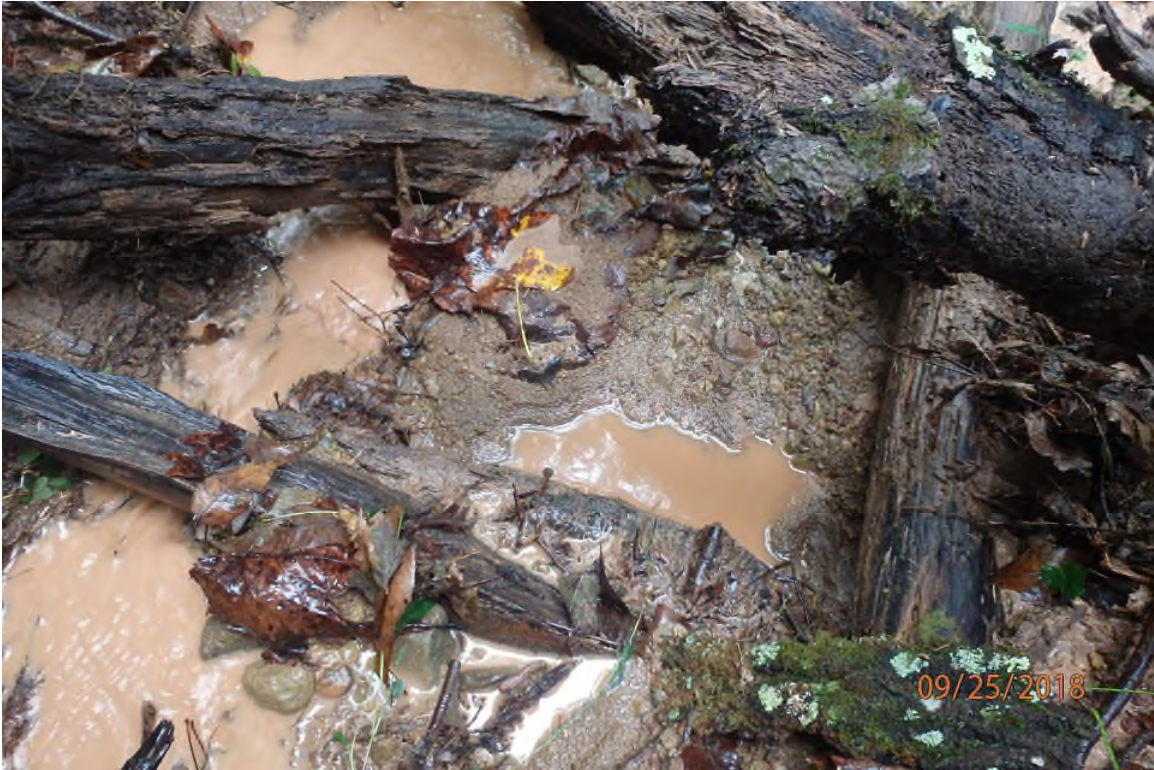
CNA oily slick, settleable solids, and odors in the vicinity of UNT Neds Run (39° 21.175 X 80° 41.705').

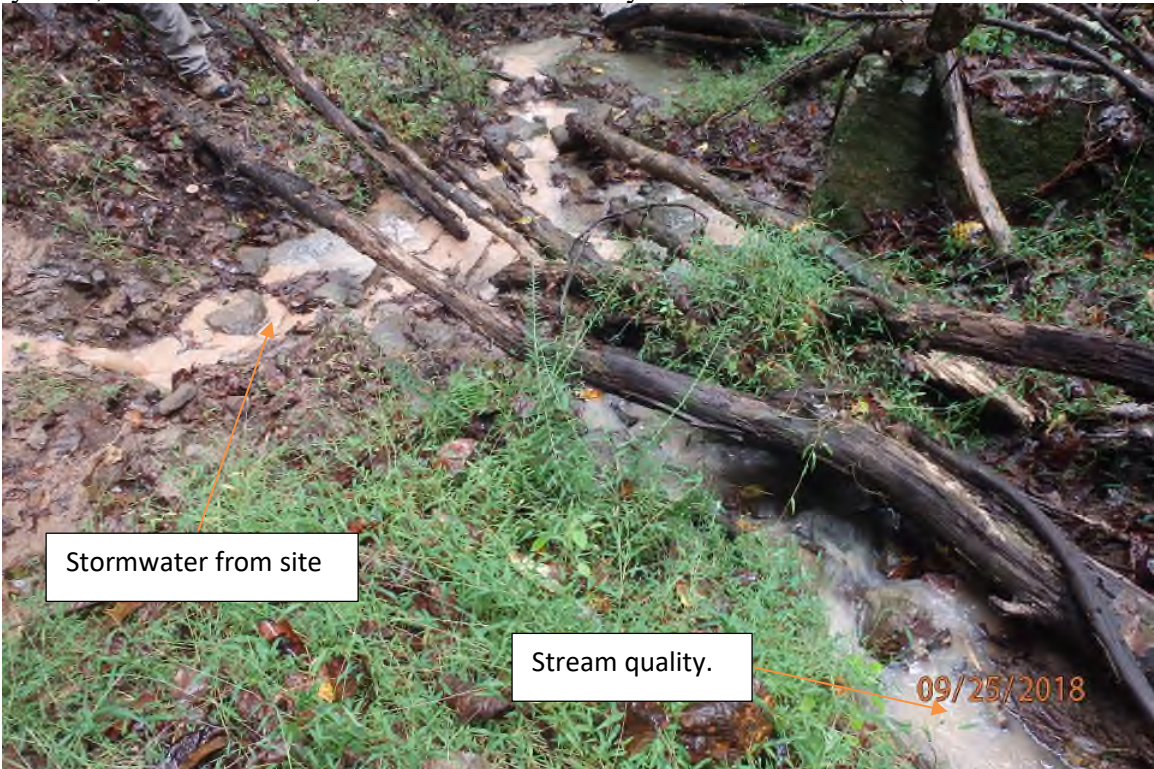
CNA oily slick, settleable solids, and odors in the vicinity of UNT Neds Run (39° 21.175 X 80° 41.705').

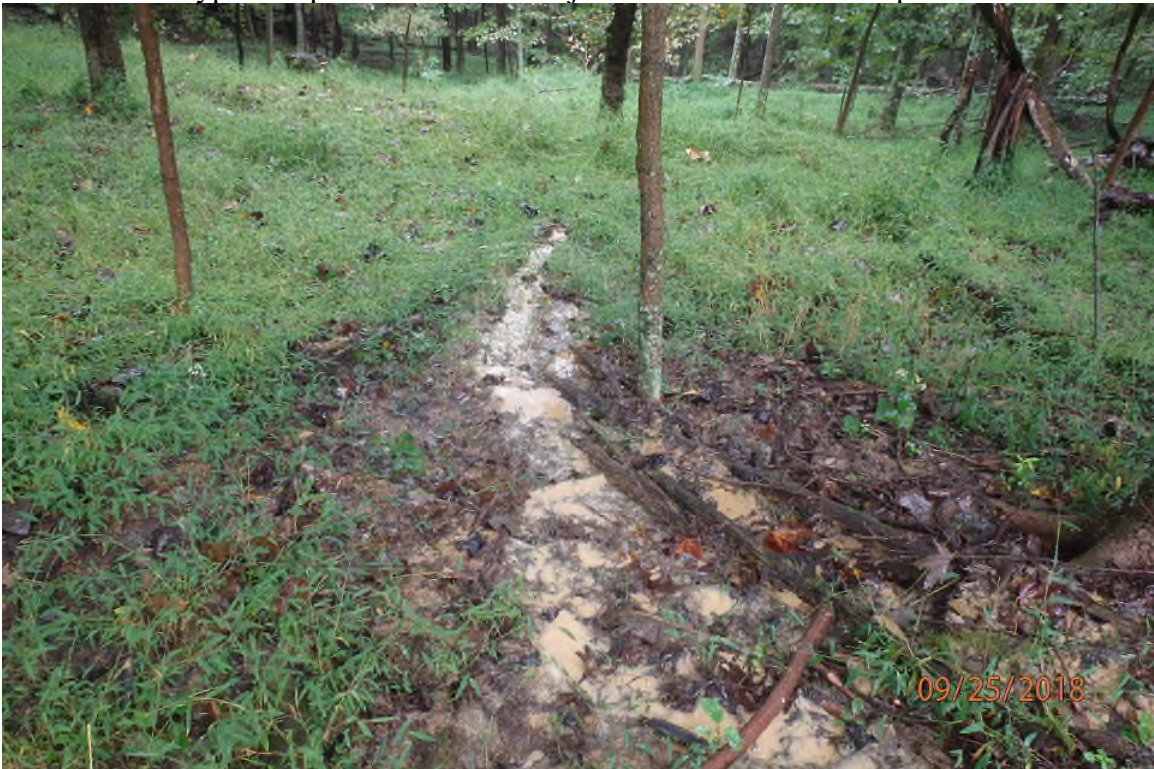
Offsite sediment laden water that bypassed the above pictured BMP.

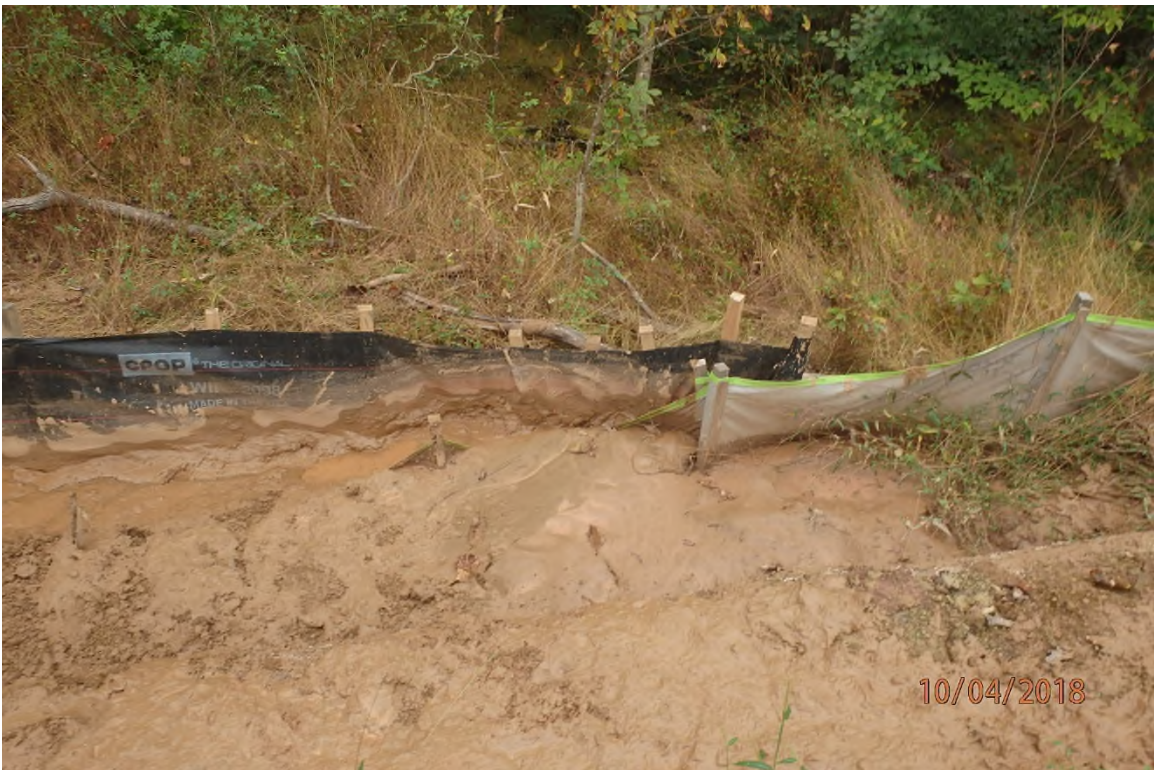
BMP adjacent to SDOI 008. Offsite sediment deposits and CNA downslope of the BMP.

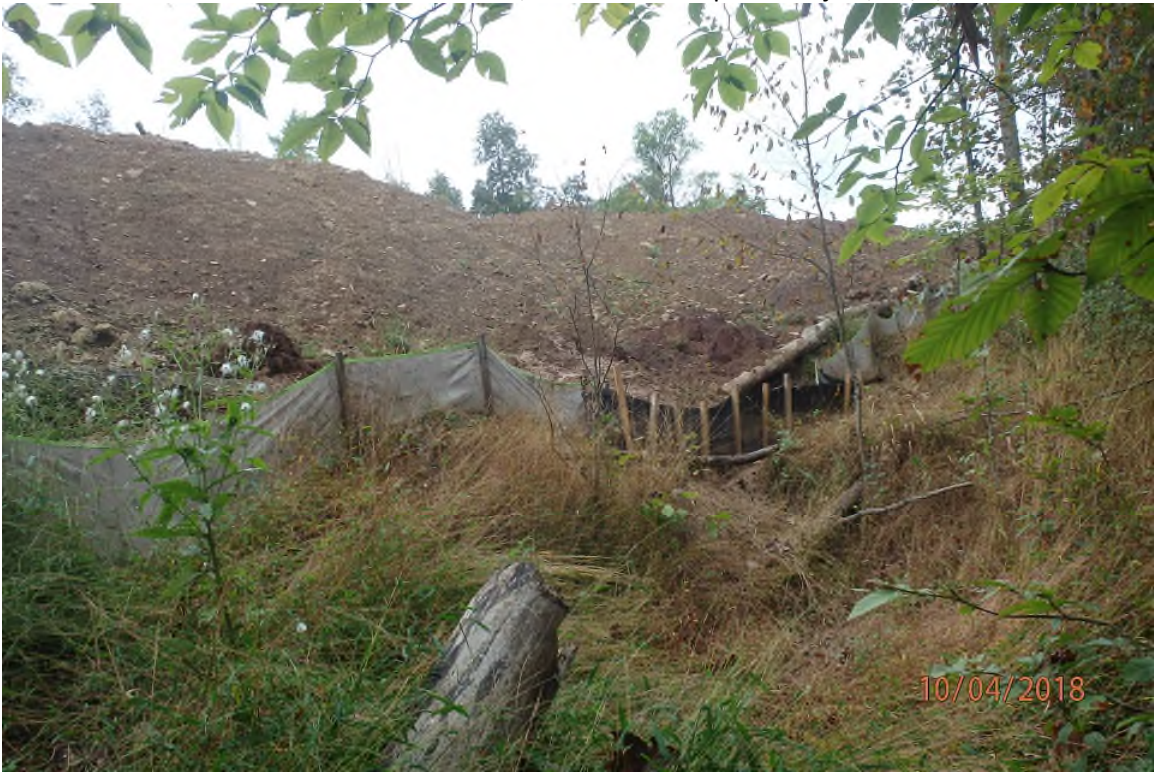
BMP adjacent to SDOI 008. Offsite sediment deposits and CNA downslope of the BMP.

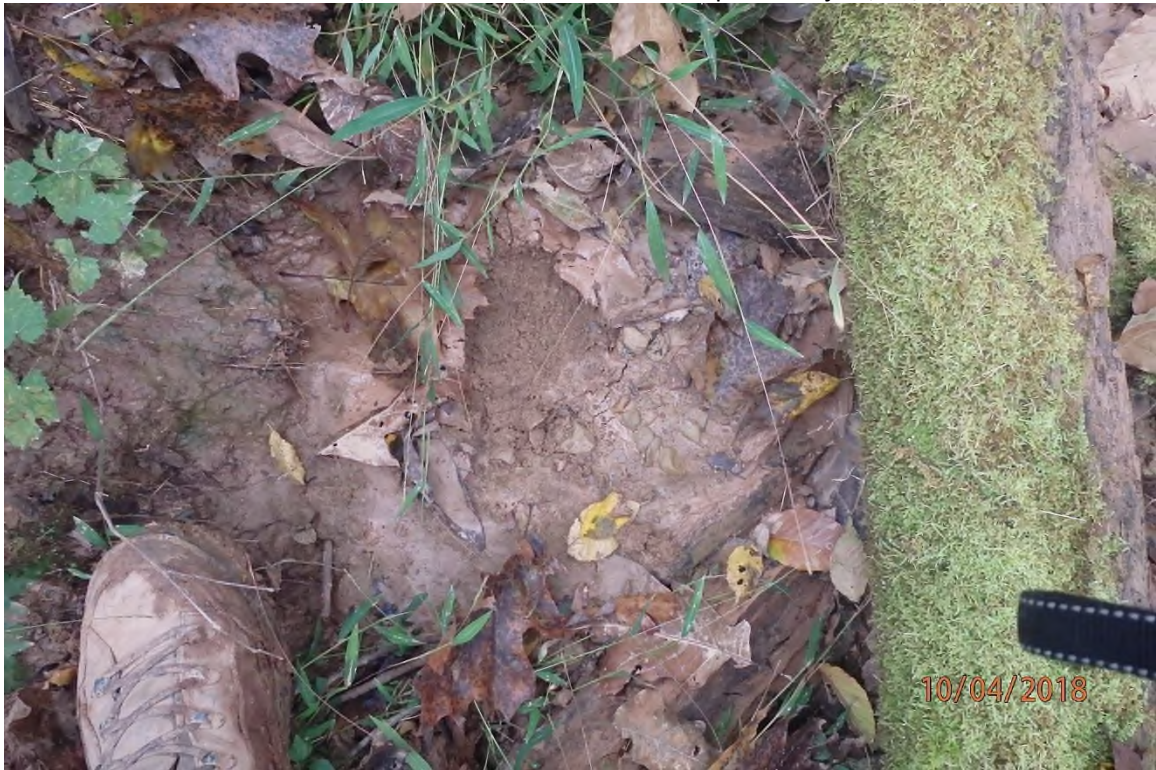
Offsite CNA deposits in UNT Riggins Run (SDOI006) (39°23.824' X 80° 41.061').

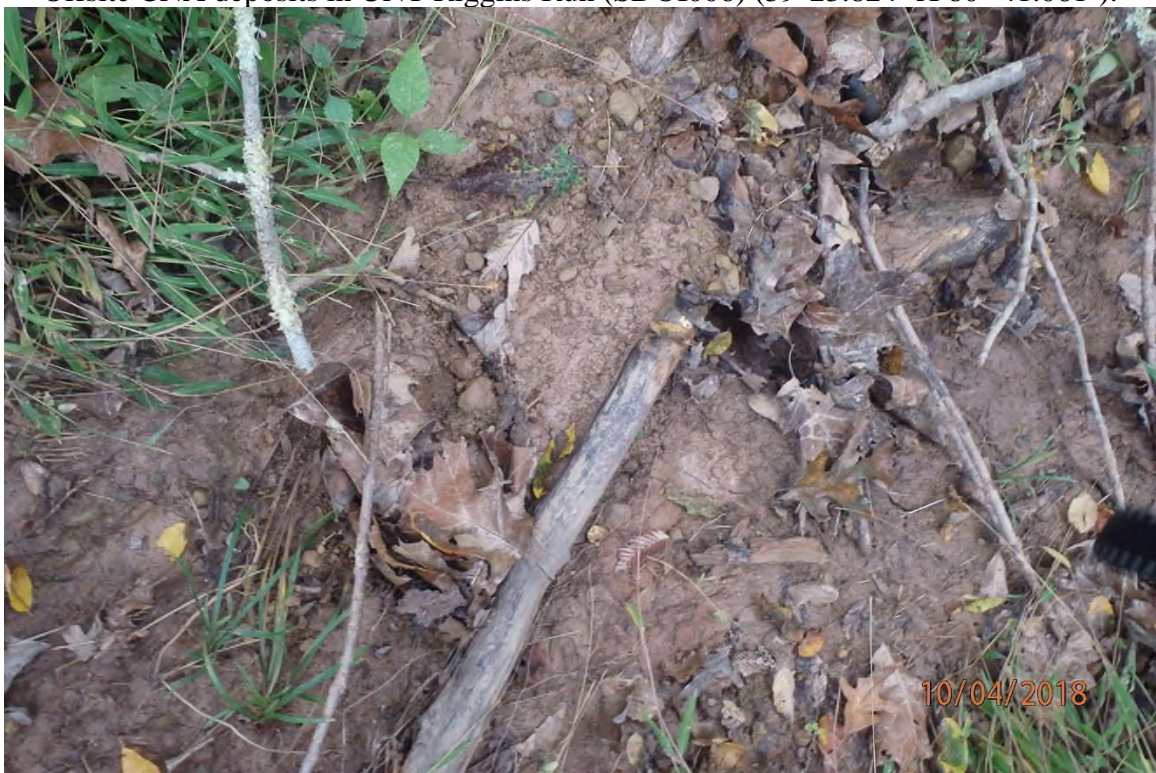
Offsite CNA deposits in UNT Riggins Run (SDOI006) (39°23.824' X 80° 41.061').

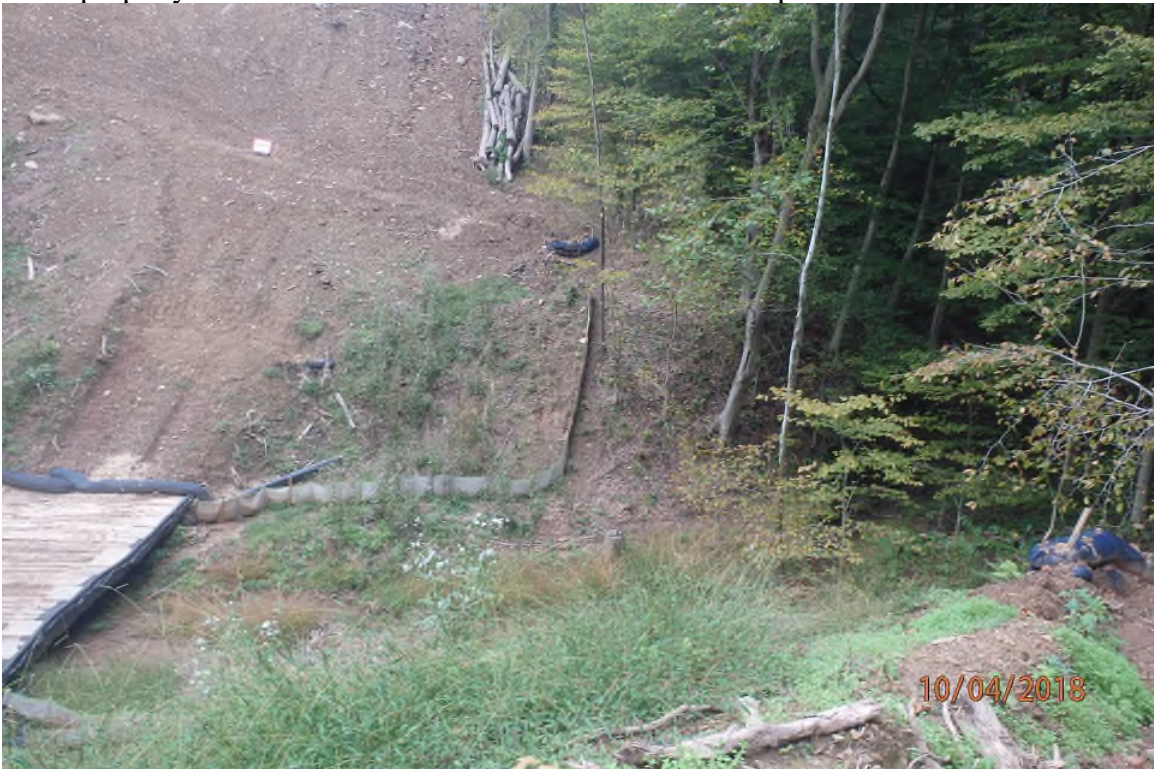
Improperly installed water bars and the associated fill slope erosion near SDOI008.

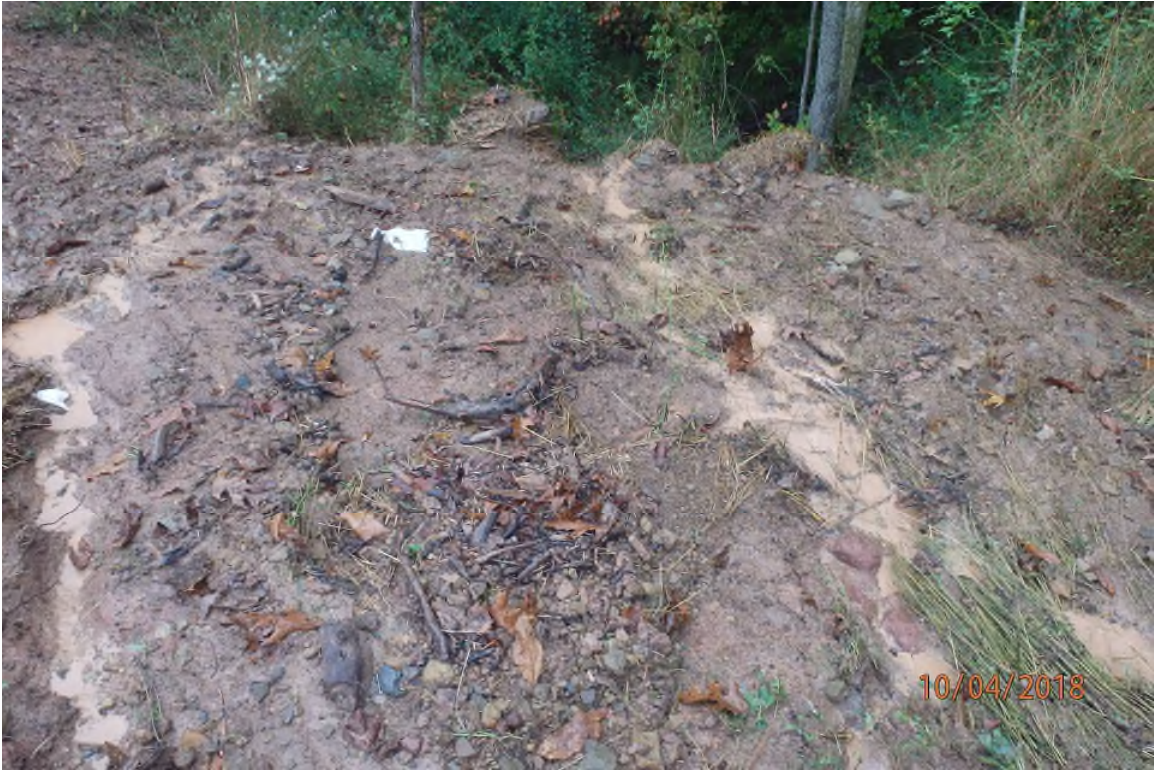
Project area near 2019+00 showing a lack of perimeter silt fence as indicated in the approved SWPPP.

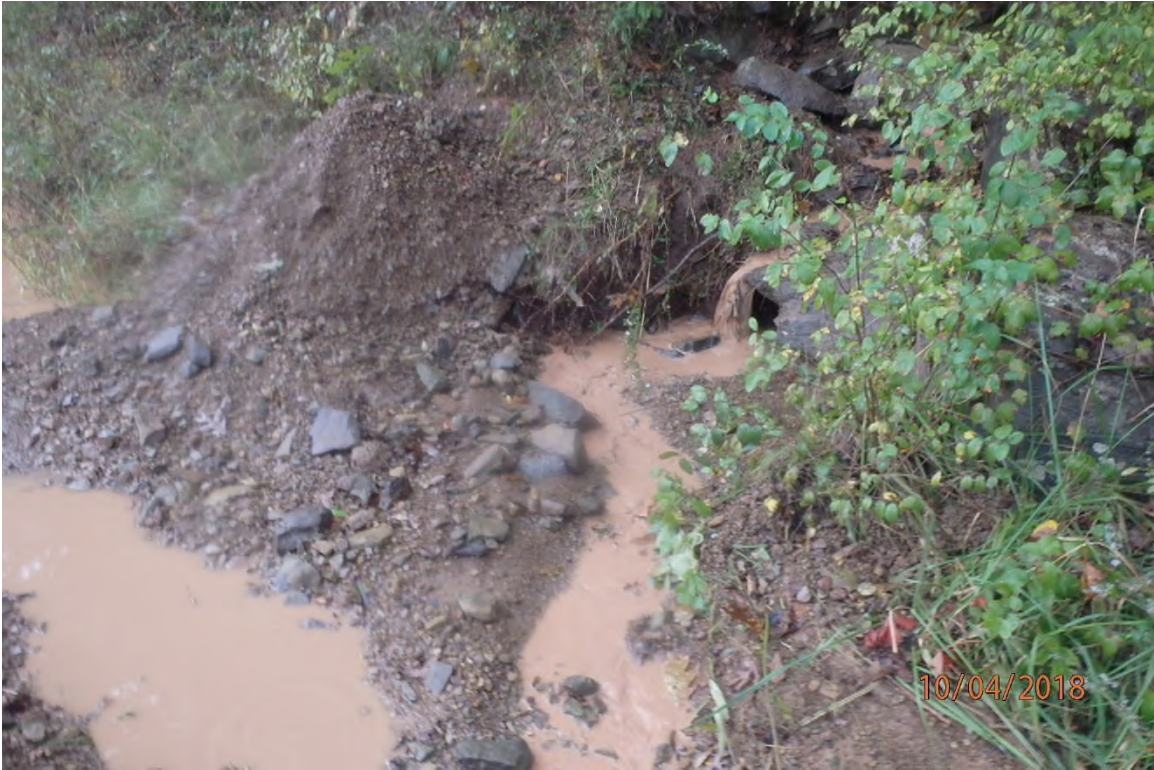
CNA distinctly visible settleable solids and deposits in UNT McElroy Creek (SDOI 201 & SDOI202) (39° 24.456' X 80° 40.816').

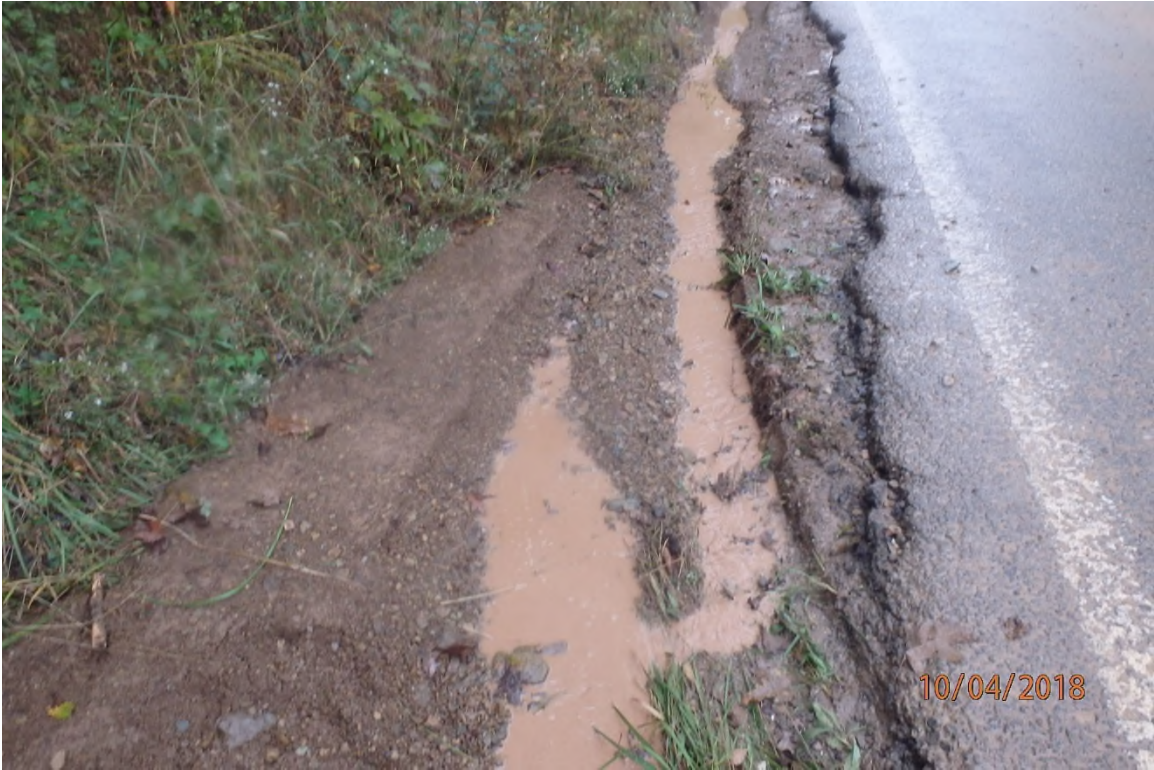
CNA distinctly visible settleable solids and deposits in UNT McElroy Creek (SDOI 201 & SDOI202) (39° 24.456' X 80° 40.816').

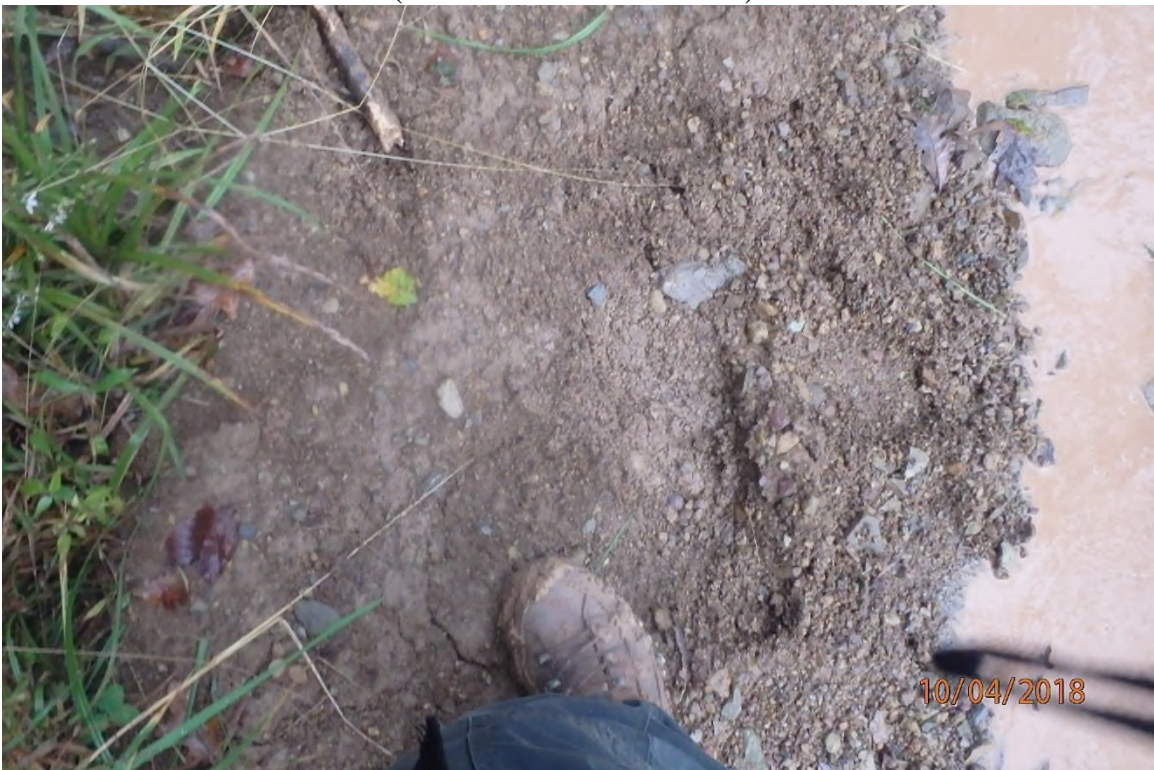
CNA distinctly visible settleable solids and deposits in UNT McElroy Creek (SDOI 201 & SDOI202) (39° 24.456' X 80° 40.816').

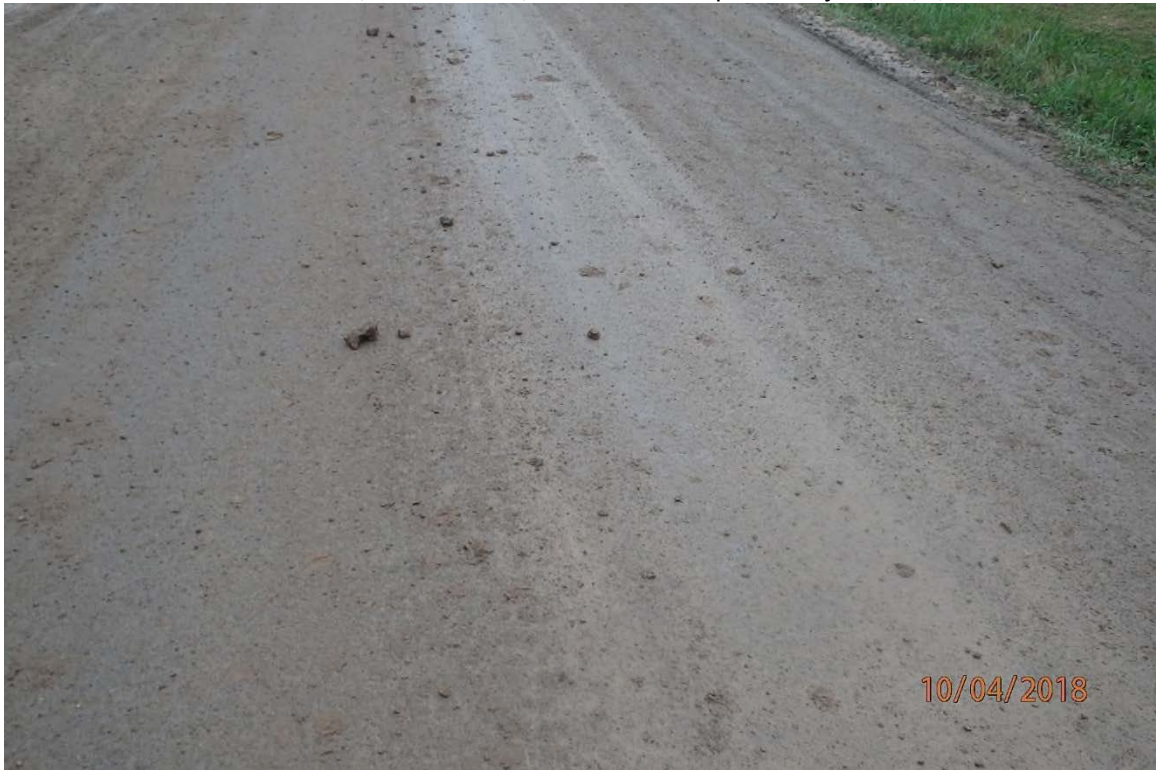
Mud on CR 5 originating from ARDO-001.5.

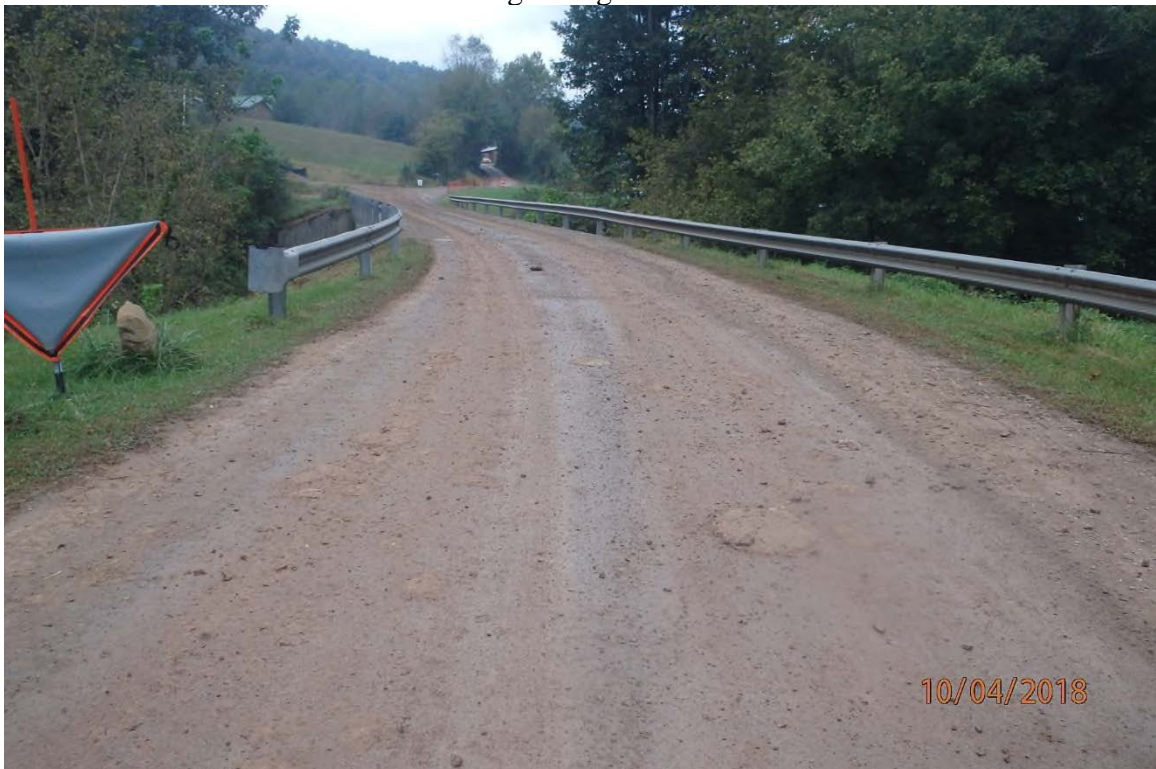
Mud on CR 5 originating from ARDO-001.5.

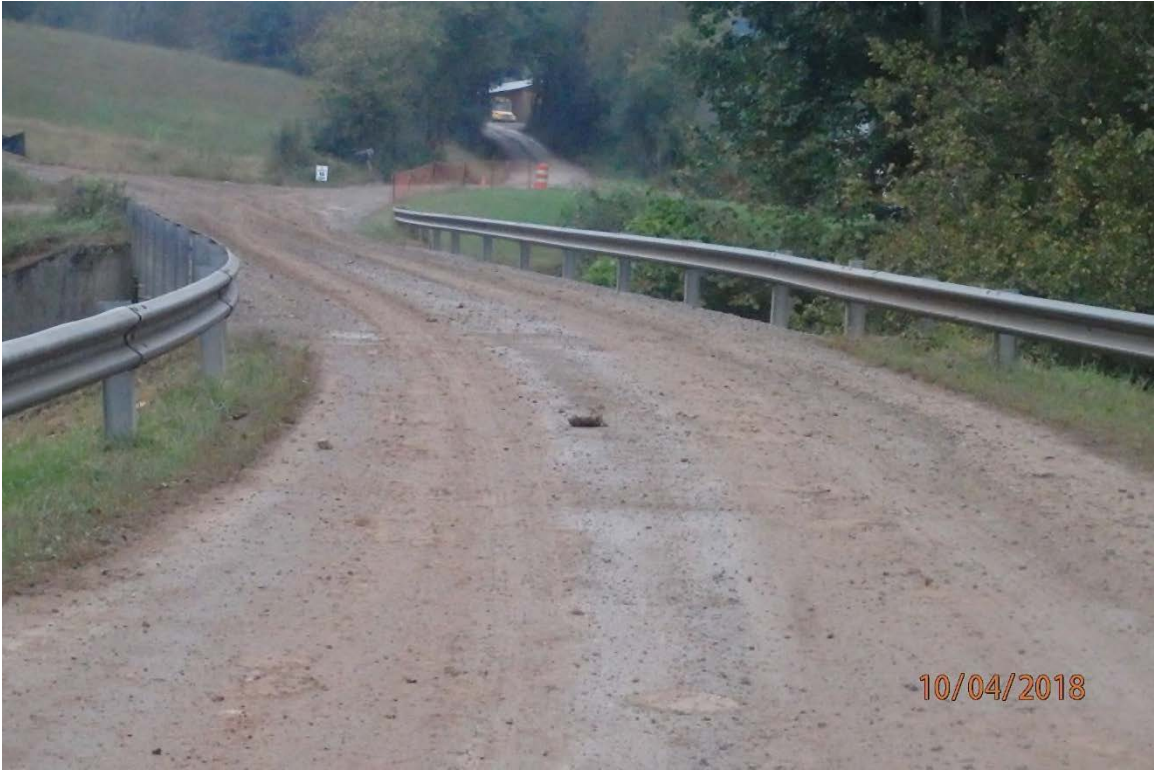
Mud on CR 5 originating from ARDO-001.5.

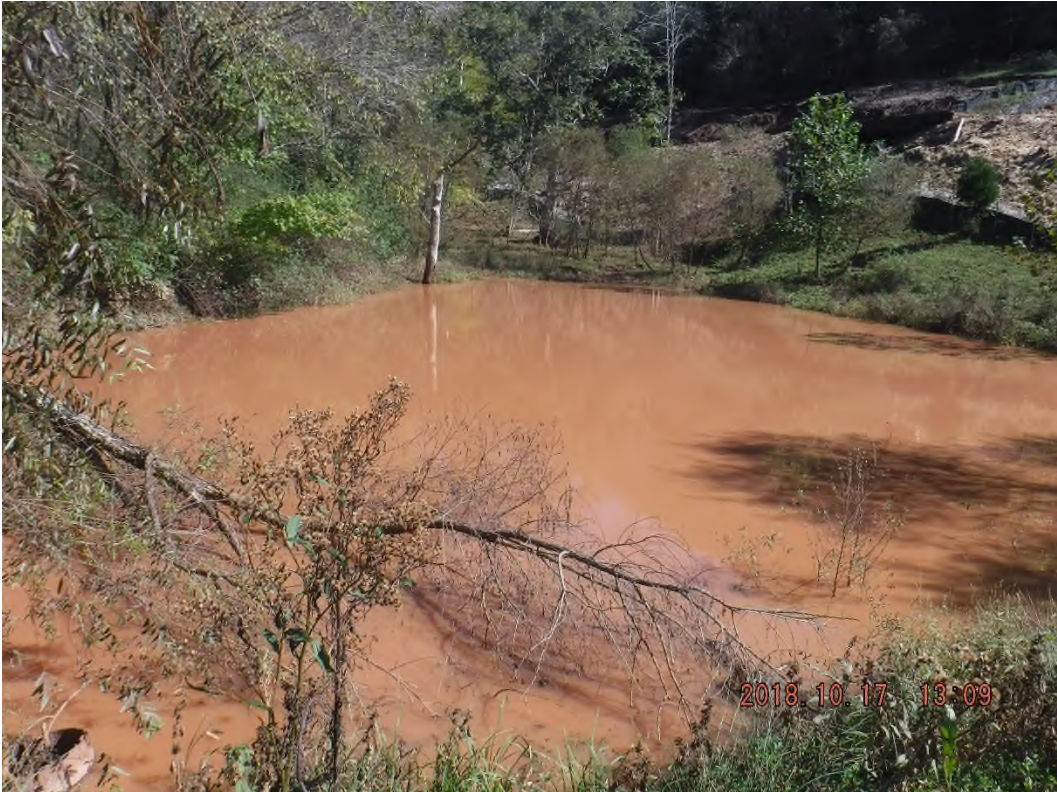
The farm pond.

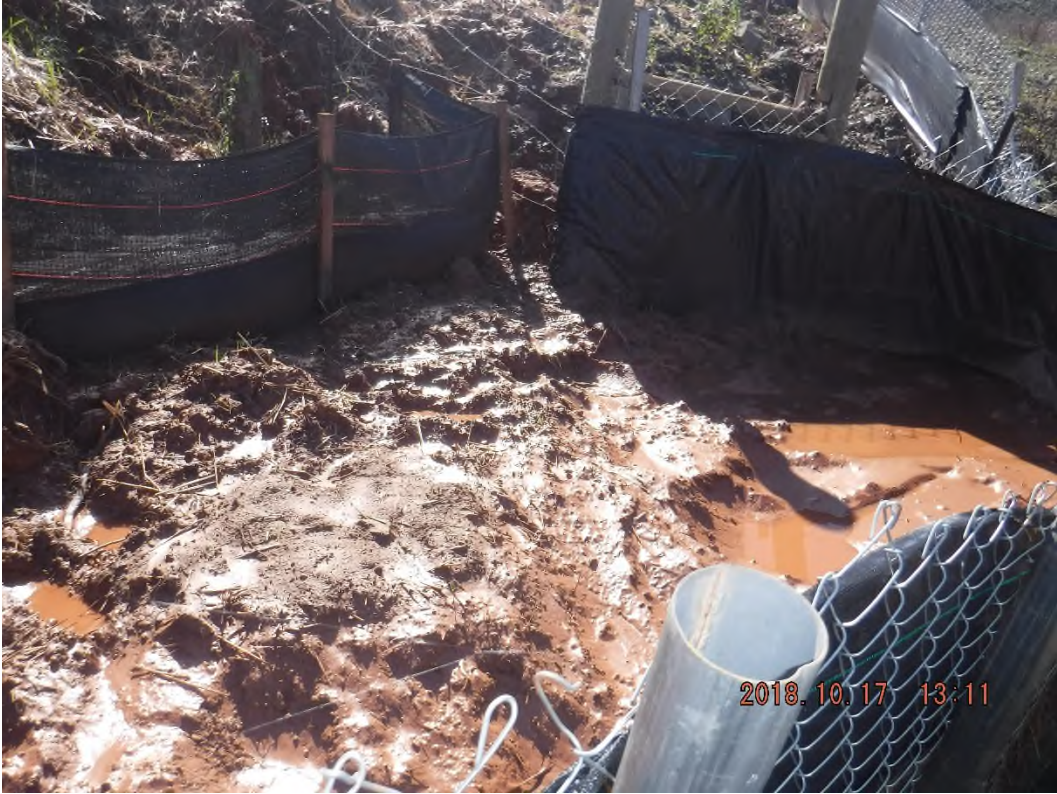
Sediment collected inside silt fence.

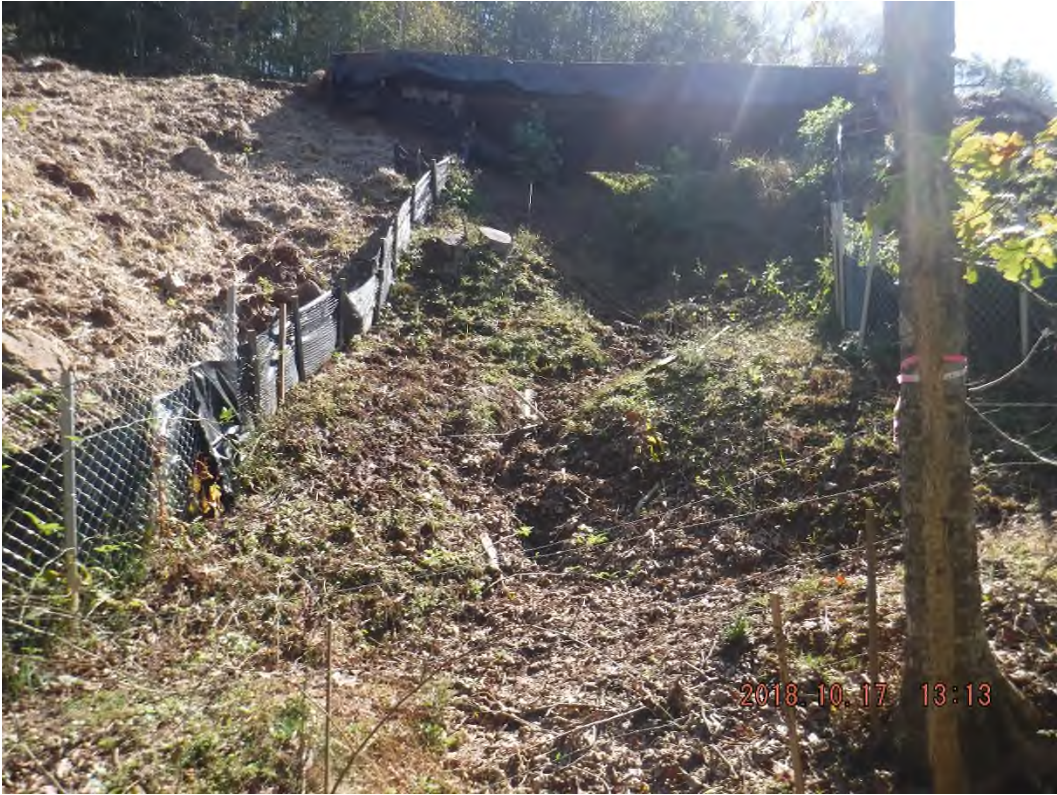
Crossing at SJAG321.

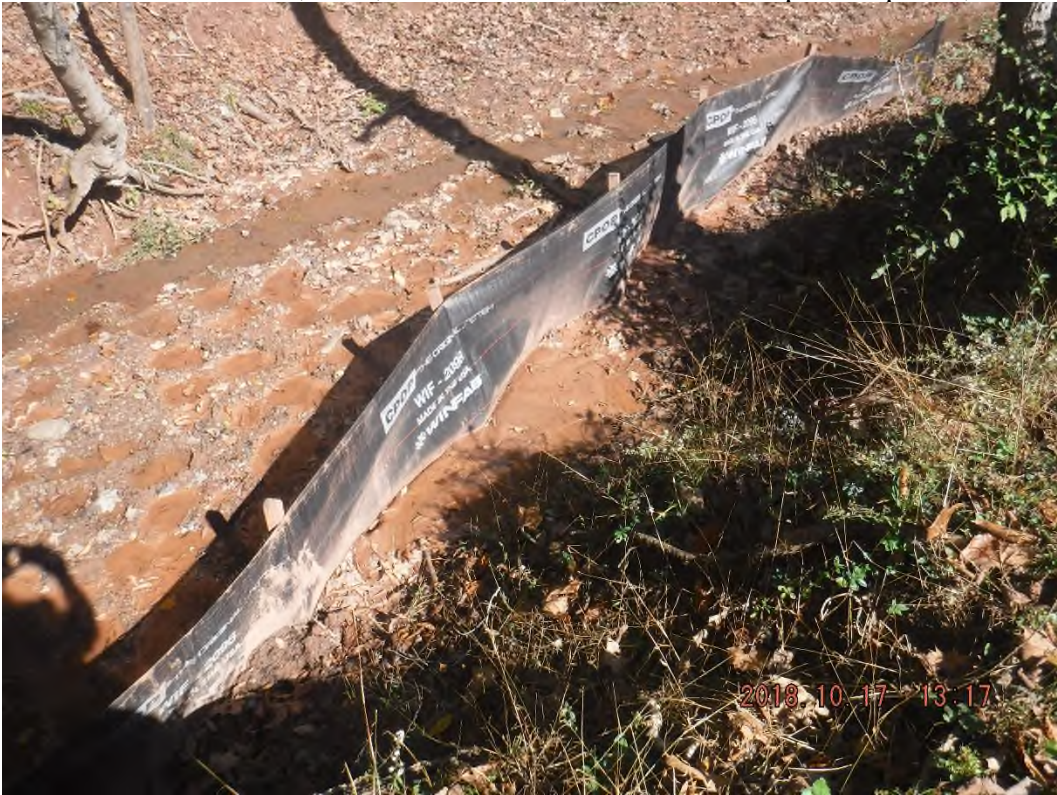
Sediment collected behind the in-stream silt fence.

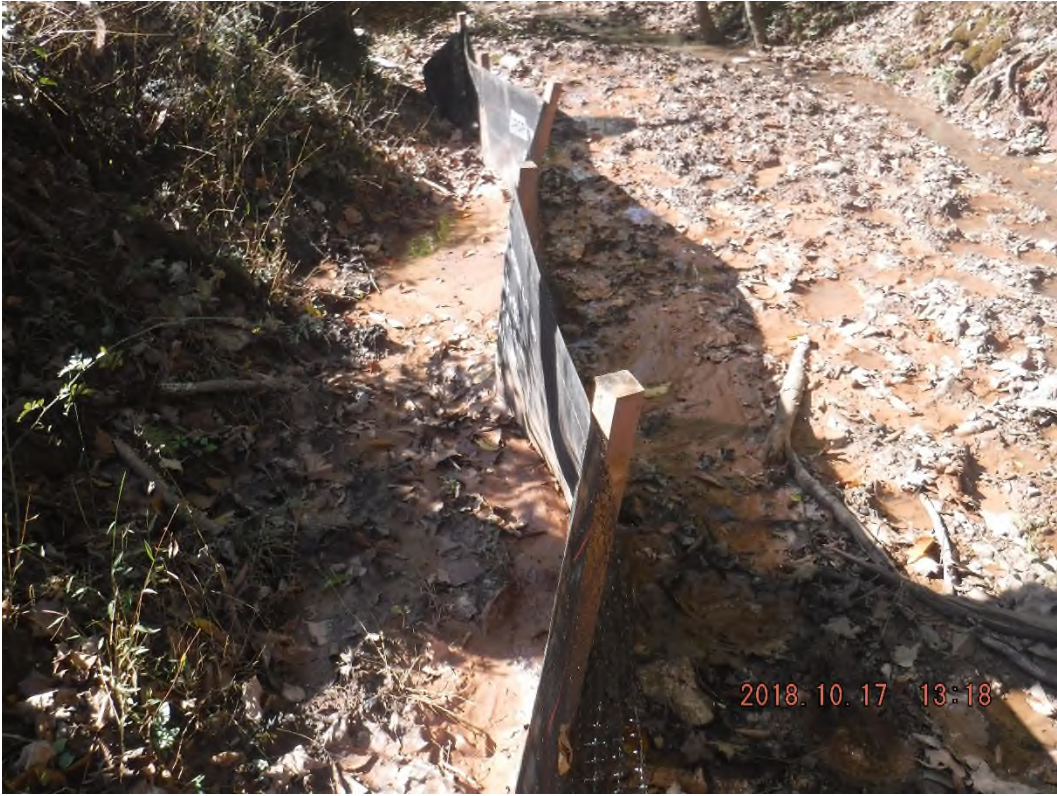
Sediment deposits in stream leading to the farm pond below.

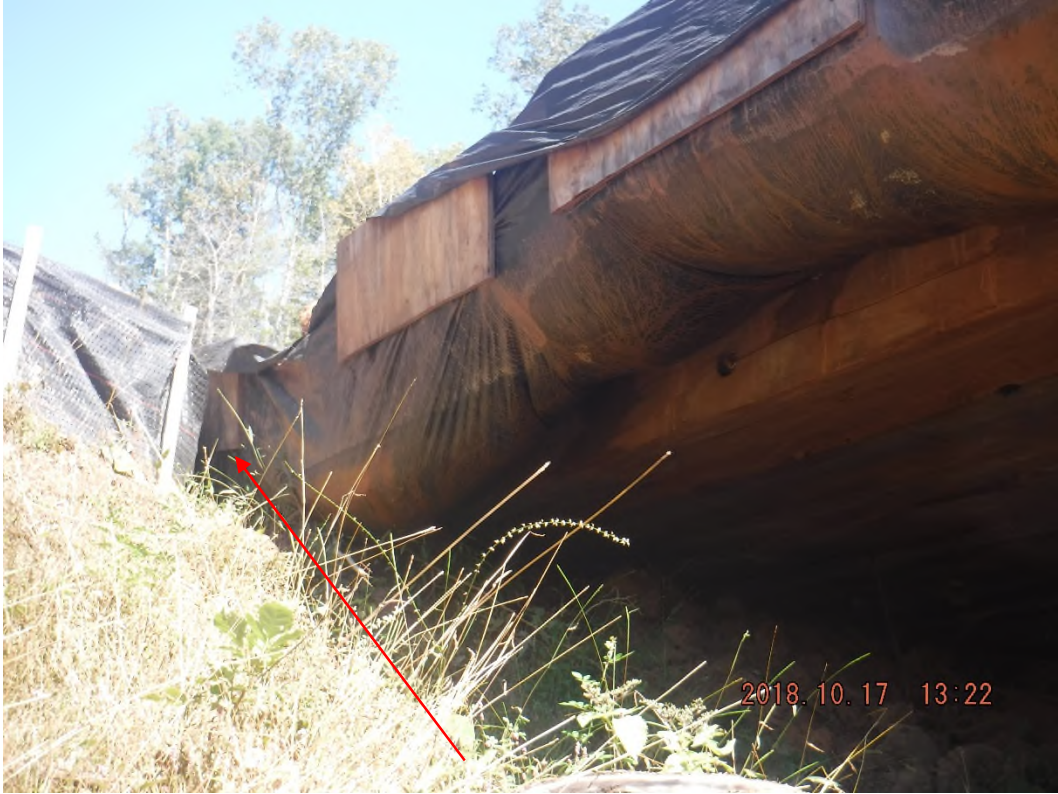
Sediment collected in fabric under timber mat bridge.
