**CONSENT ORDER
ISSUED UNDER THE
WATER POLLUTION CONTROL ACT
WEST VIRGINIA CODE, CHAPTER 22, ARTICLE 11**

TO: Columbia Gas Transmission, LLC
Attn: Troy Tally, Vice President
1700 MacCorkle Ave
Charleston, WV 25314

DATE: October 1, 2020
ORDER NO.: 9061

1. Columbia Gas Transmission, LLC is conducting land disturbance activity associated with construction of the Mountaineer Xpress Project in Marshall, Wetzel, Tyler, Doddridge, Ritchie, Calhoun, Wirt, Roane, Jackson, Mason, Putnam, and Cabell Counties, West Virginia. On January 31, 2018, Columbia Gas Transmission, LLC was issued Water Pollution Control Permit No. WV0116815, Registration No. WVR310872, for Stormwater Associated With Oil and Gas Related Construction Activities.

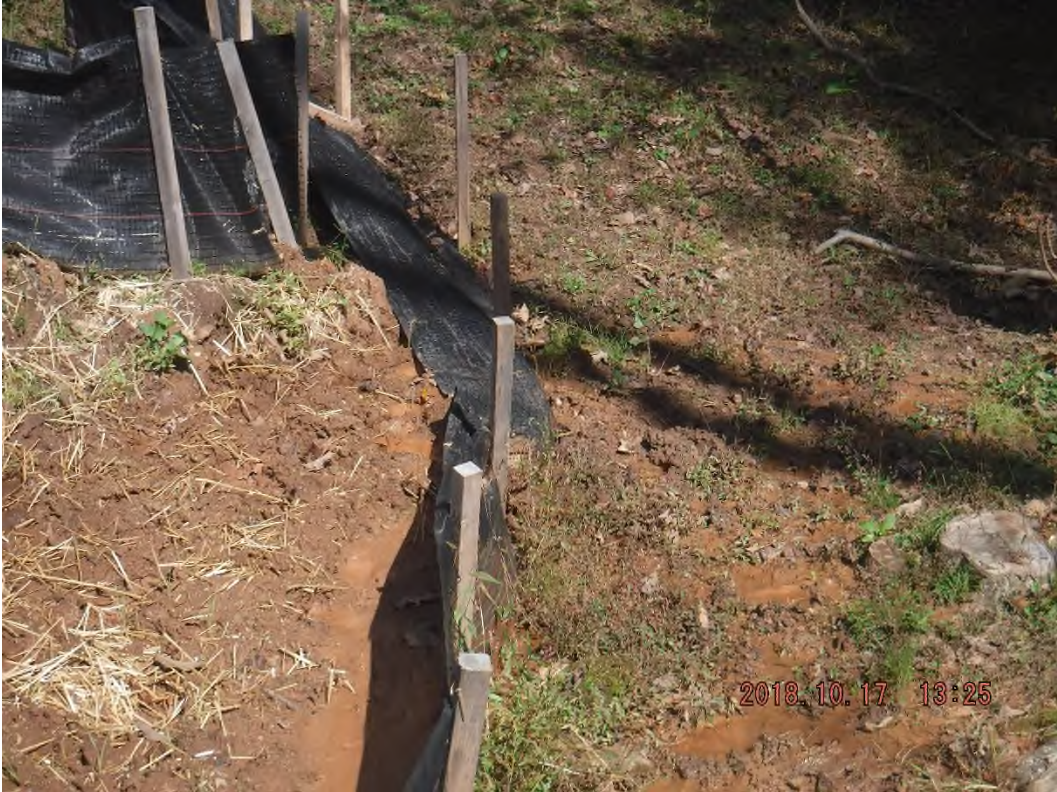
Silt fence in disrepair directly above crossing at Station 6705+00.

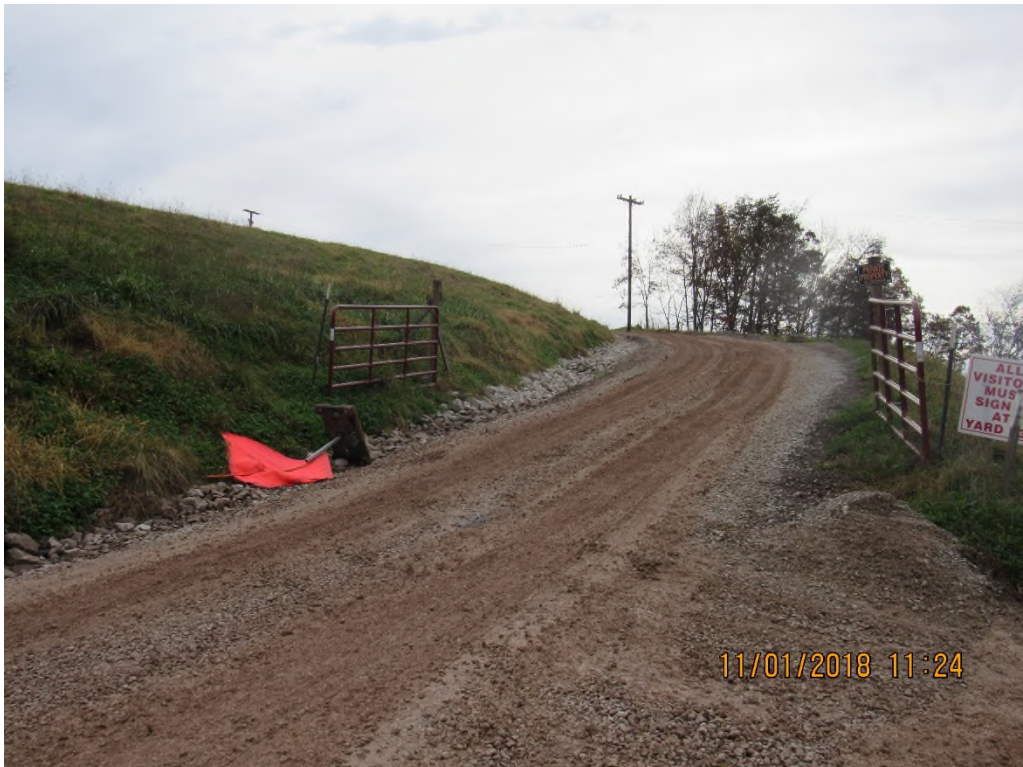
Road used to circumvent washing station.

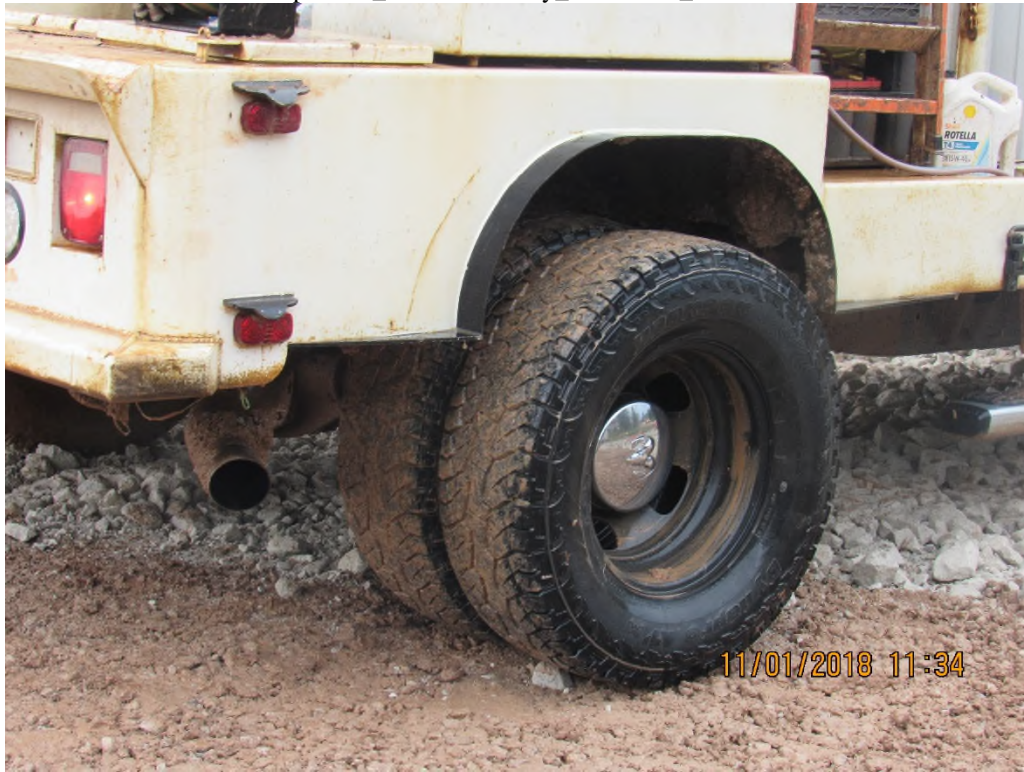
Recently washed truck as it exits the site.

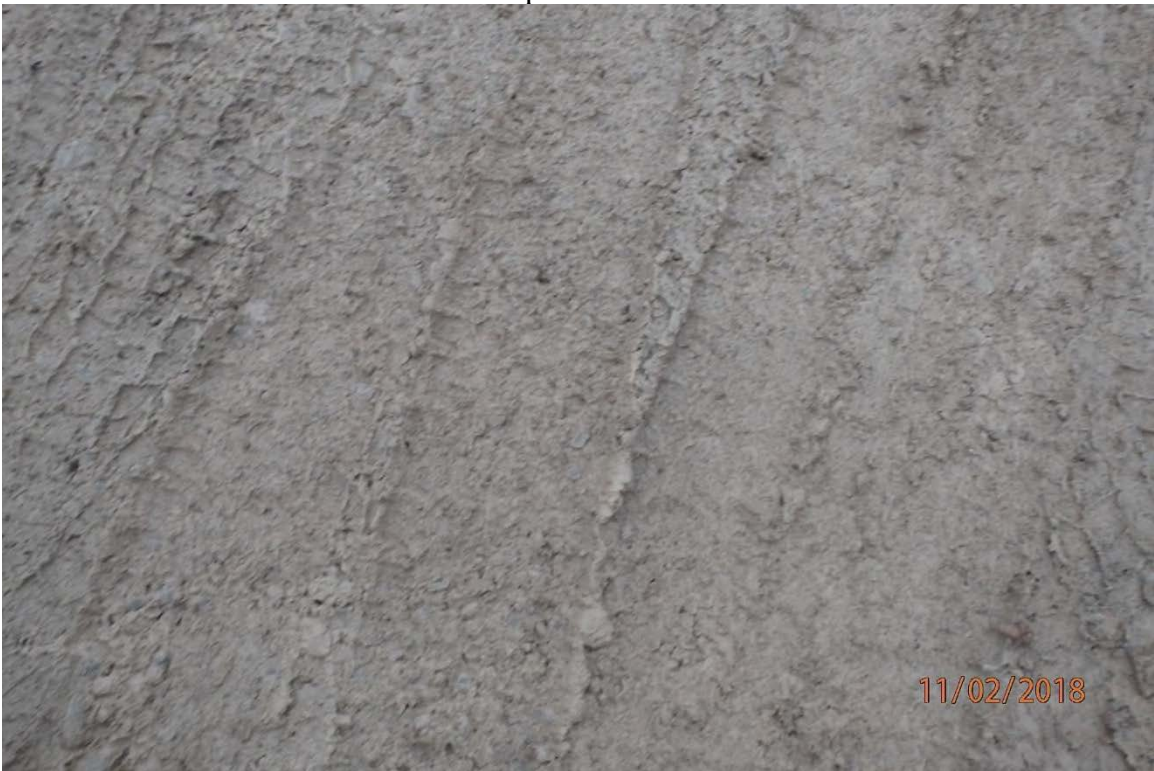
AR-20 (ARDO-001.5) showing an unstable construction entrance that is causing track-out onto the public road.

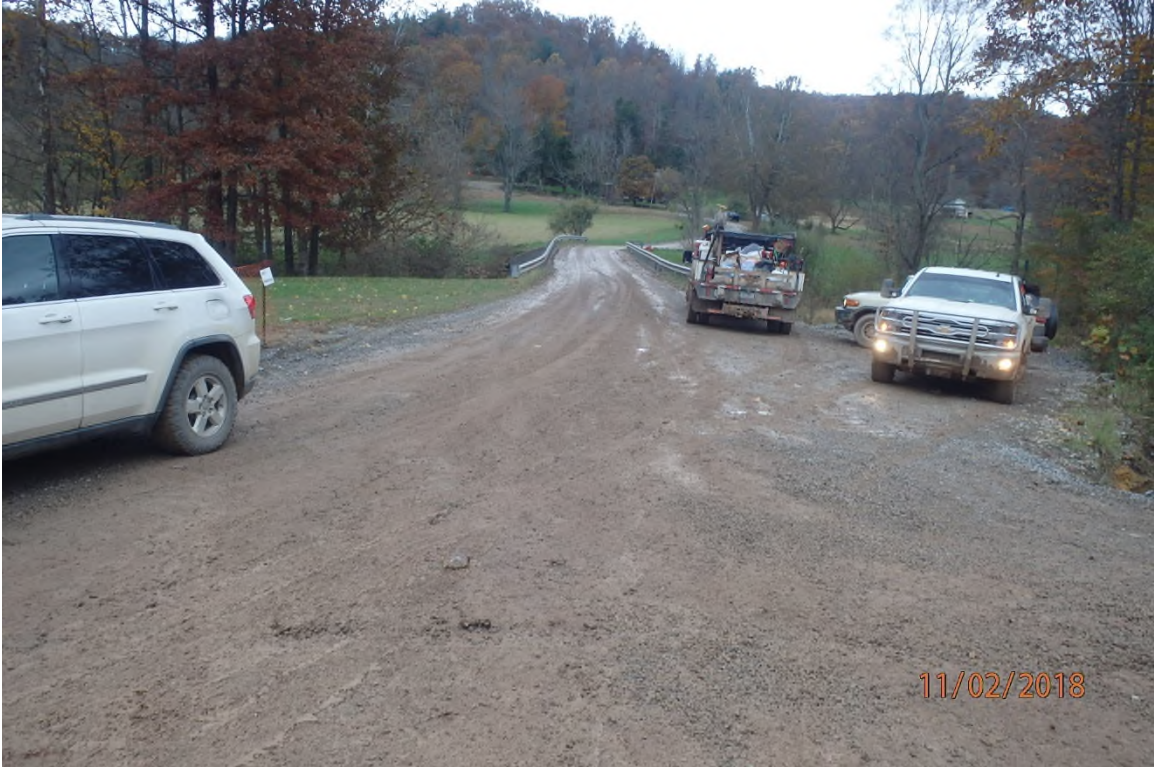
AR-20 (ARDO-001.5) showing an unstable construction entrance that is causing track-out onto the public road.

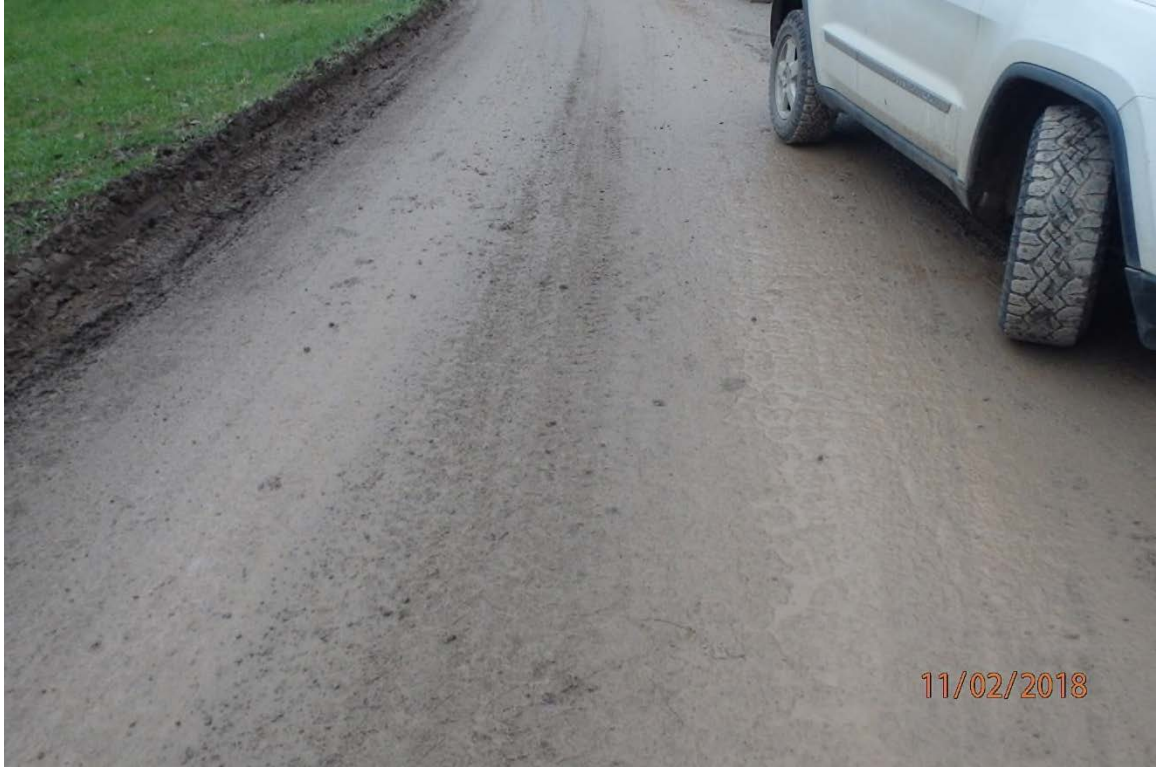
Mud on CR 5 (Riggins Run Road) that originates from AR-20 (ARDO-001.5).

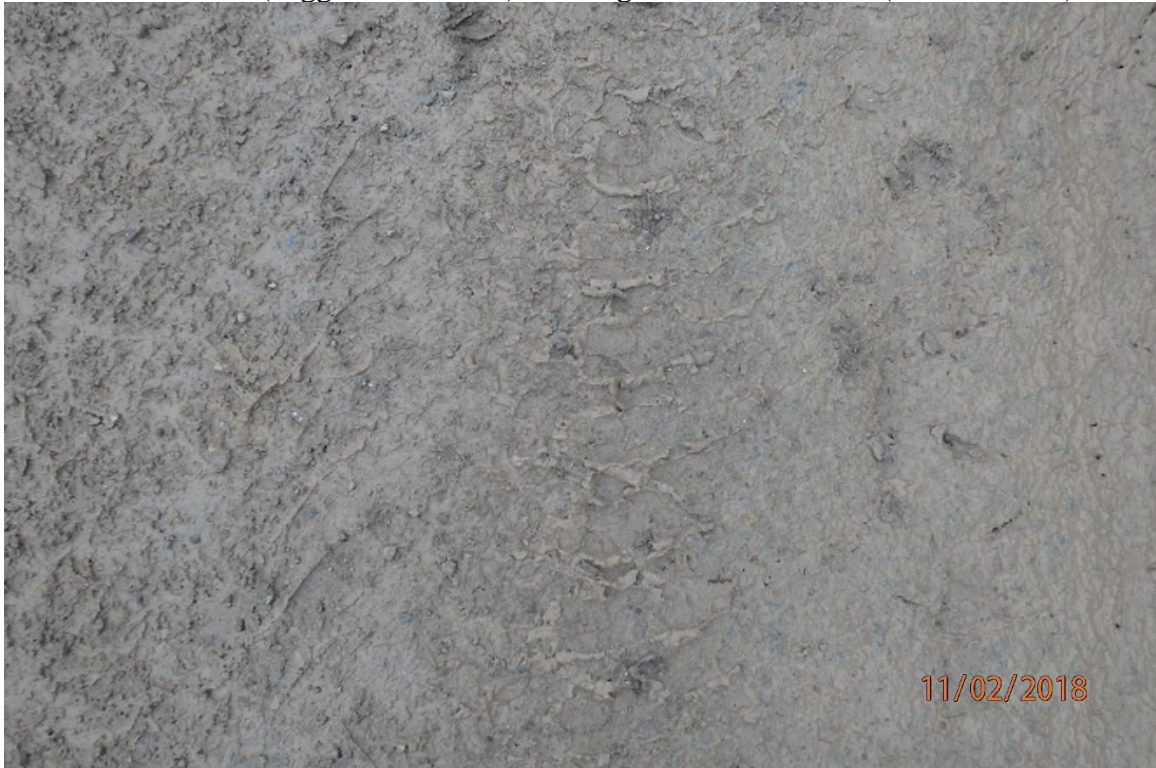
Mud on CR 5 (Riggins Run Road) that originates from AR-20 (ARDO-001.5).

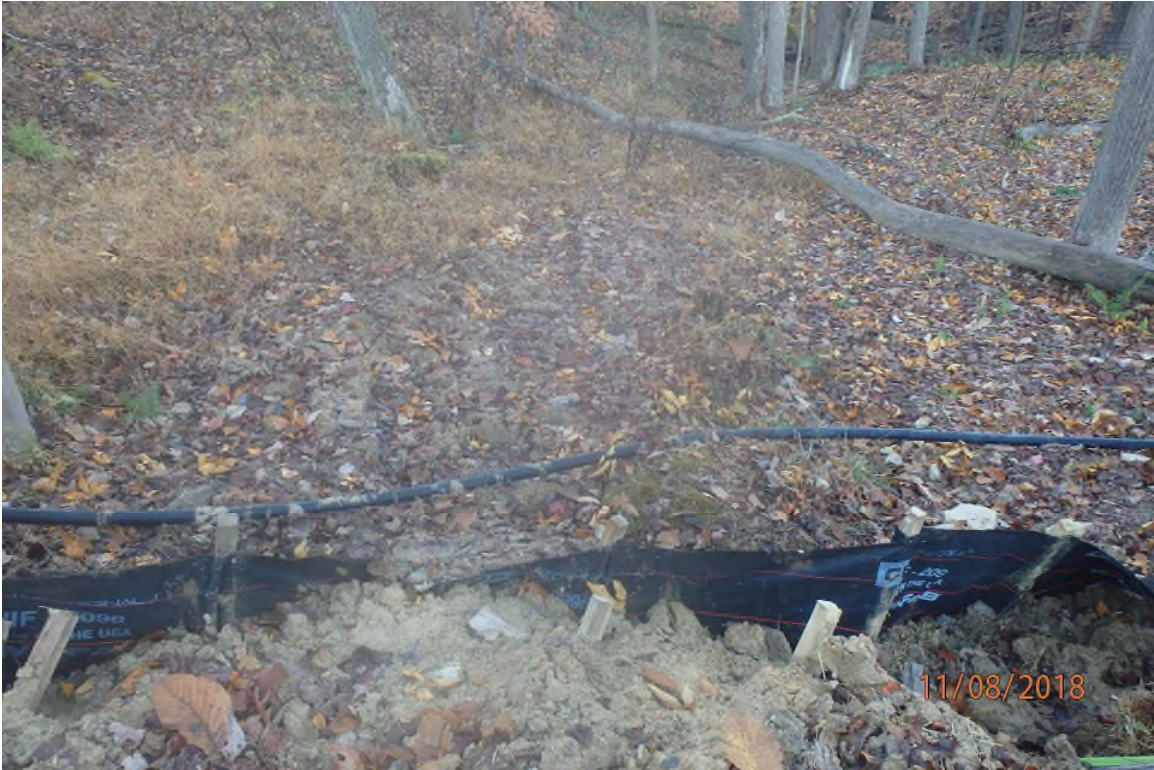
Unmaintained perimeter control and associated offsite sediment deposits in the Bluestone Creek watershed.

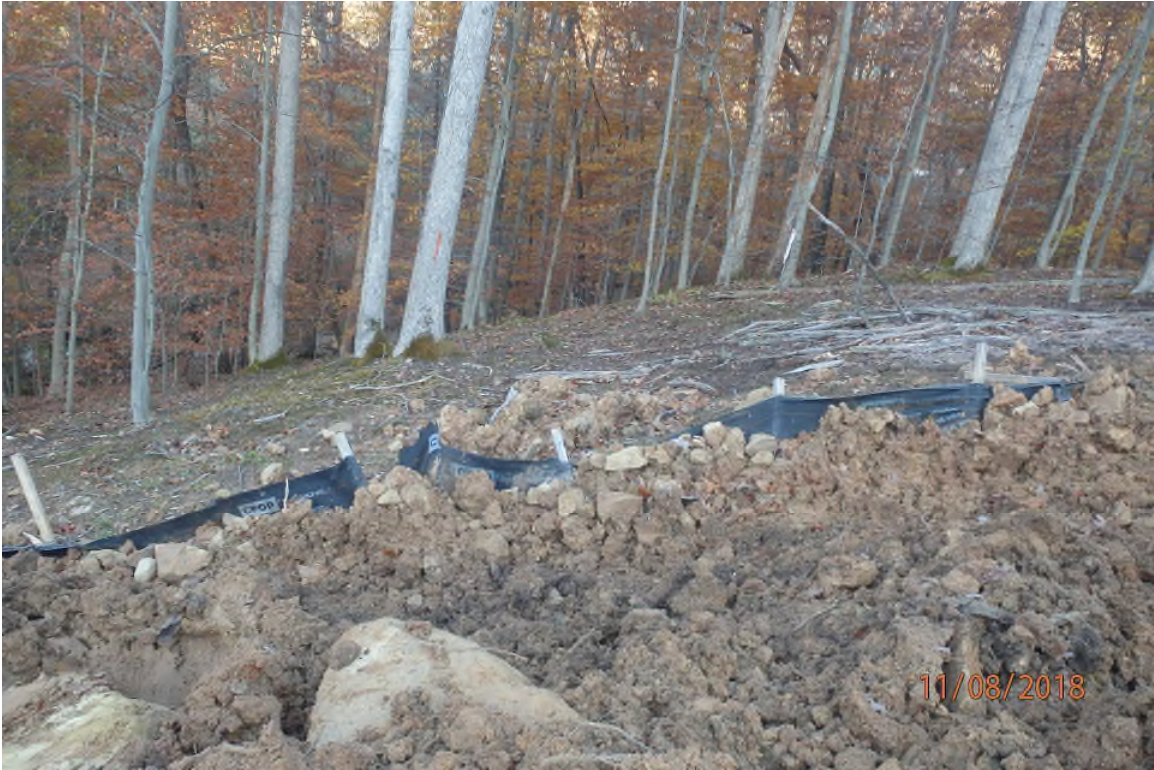
Unmaintained perimeter control and associated offsite sediment deposits in the Bluestone Creek watershed.

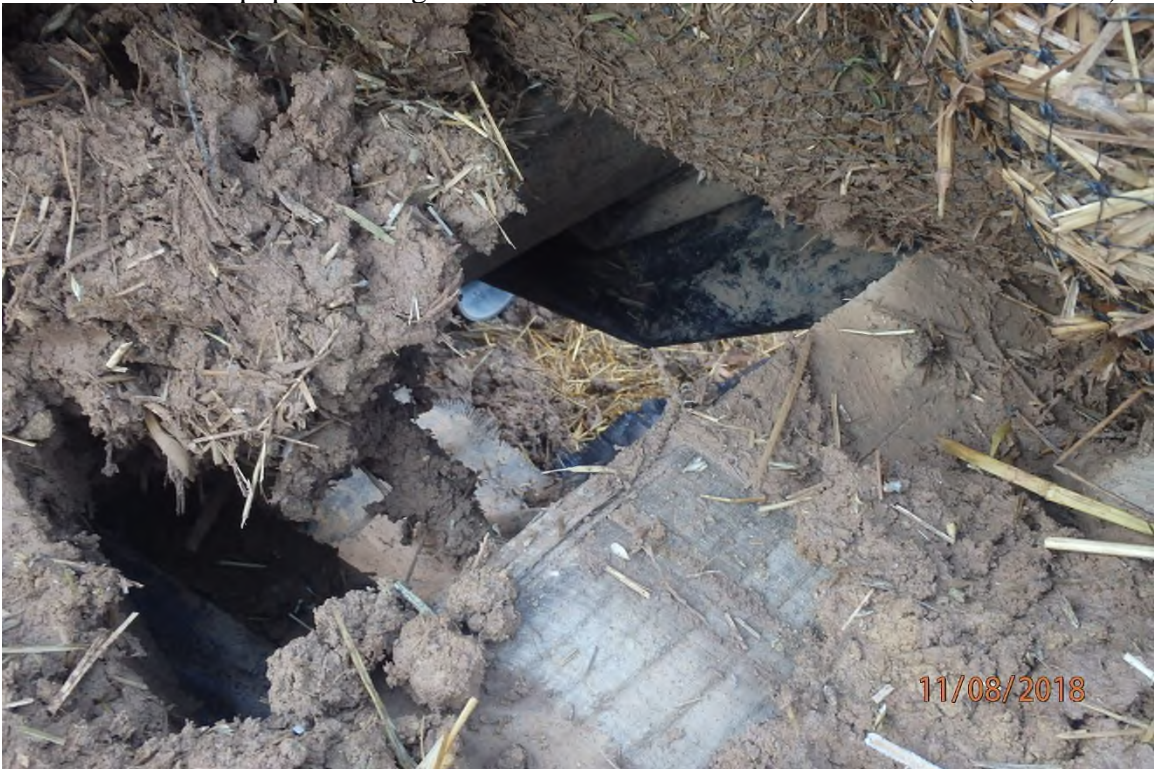
Unmaintained equipment bridge BMP in the Bluestone Creek watershed (SDOG537).

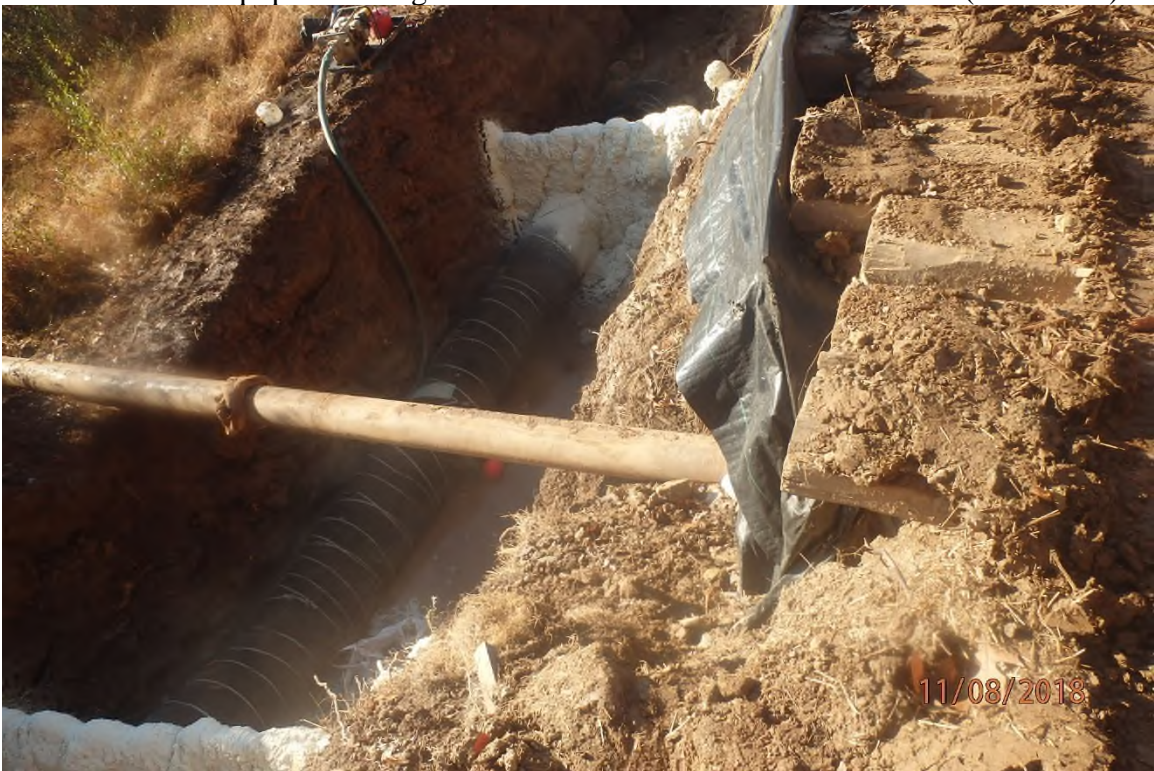
Unmaintained equipment bridge BMP in the Bluestone Creek watershed (SDOG543).

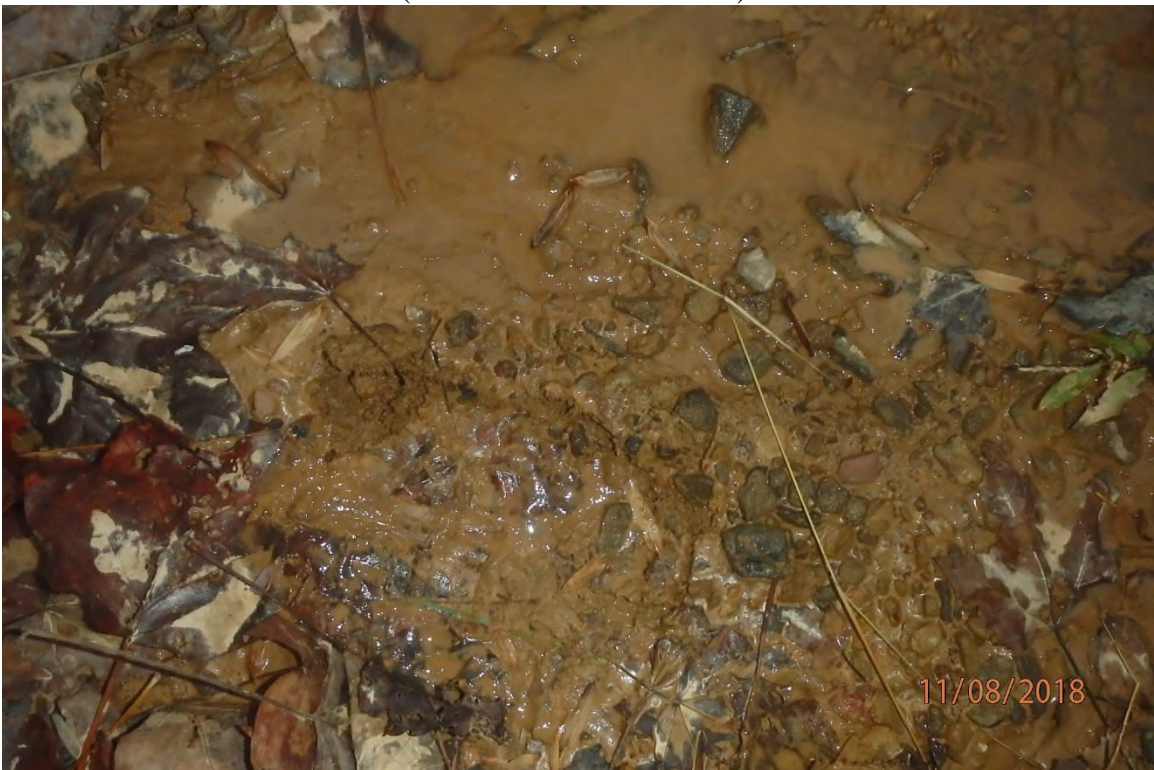
Offsite CNA deposits in UNT Sugar Run (SDOH008) (39°11.070' X 80°51.112').

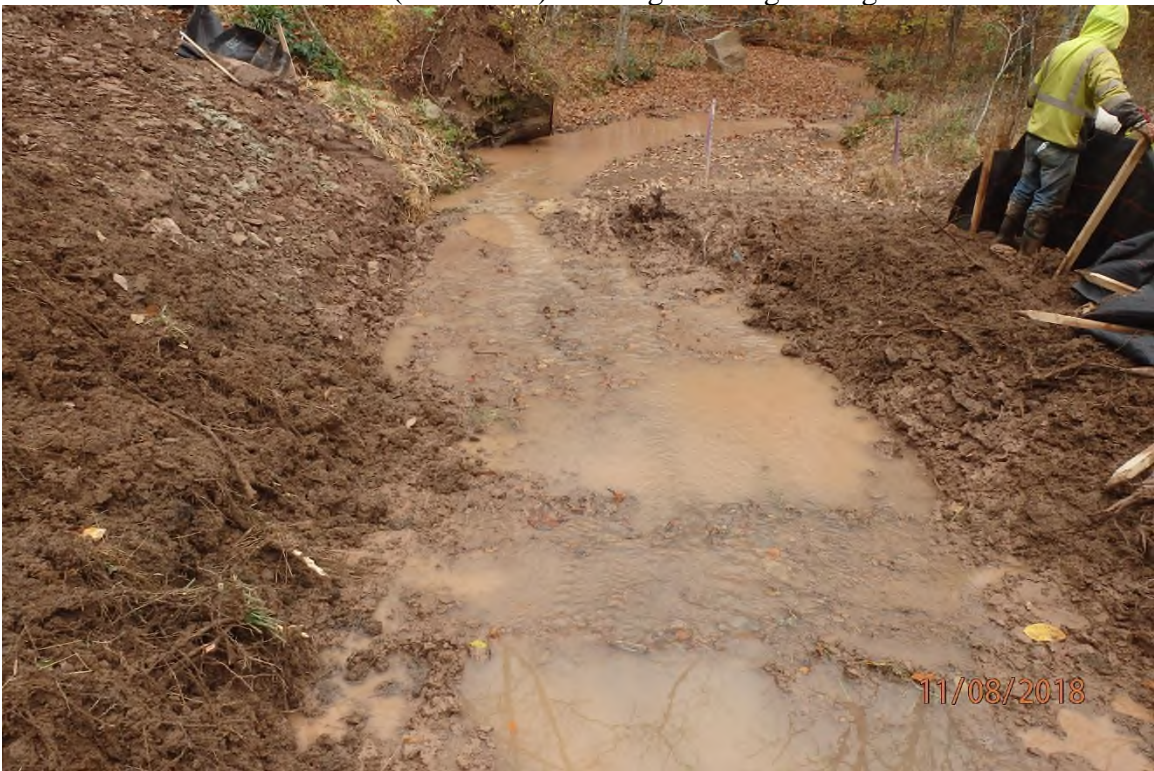
CNA distinctly visible settleable solids in UNT Left Fork of Arnolds Creek (SDOG040) (39°13.294' X 80°46.957').

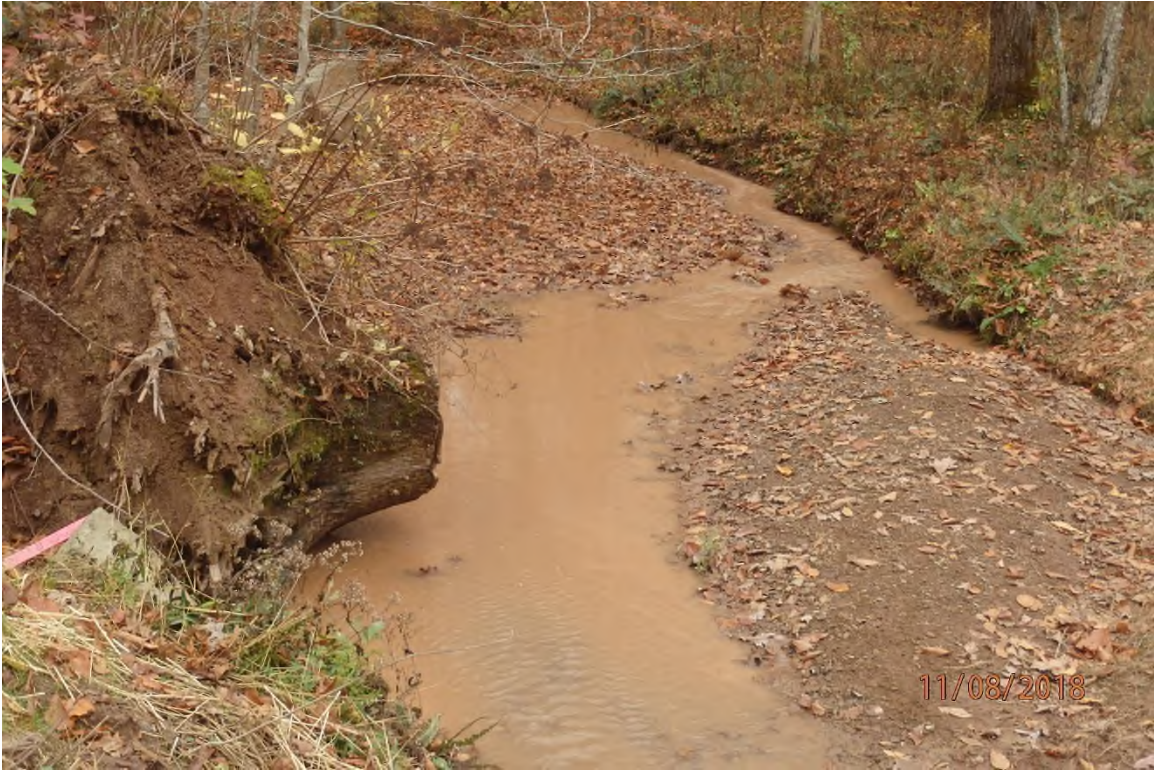
CNA distinctly visible settleable solids in UNT Left Fork of Arnolds Creek (SDOG040) (39°13.294' X 80°46.957').

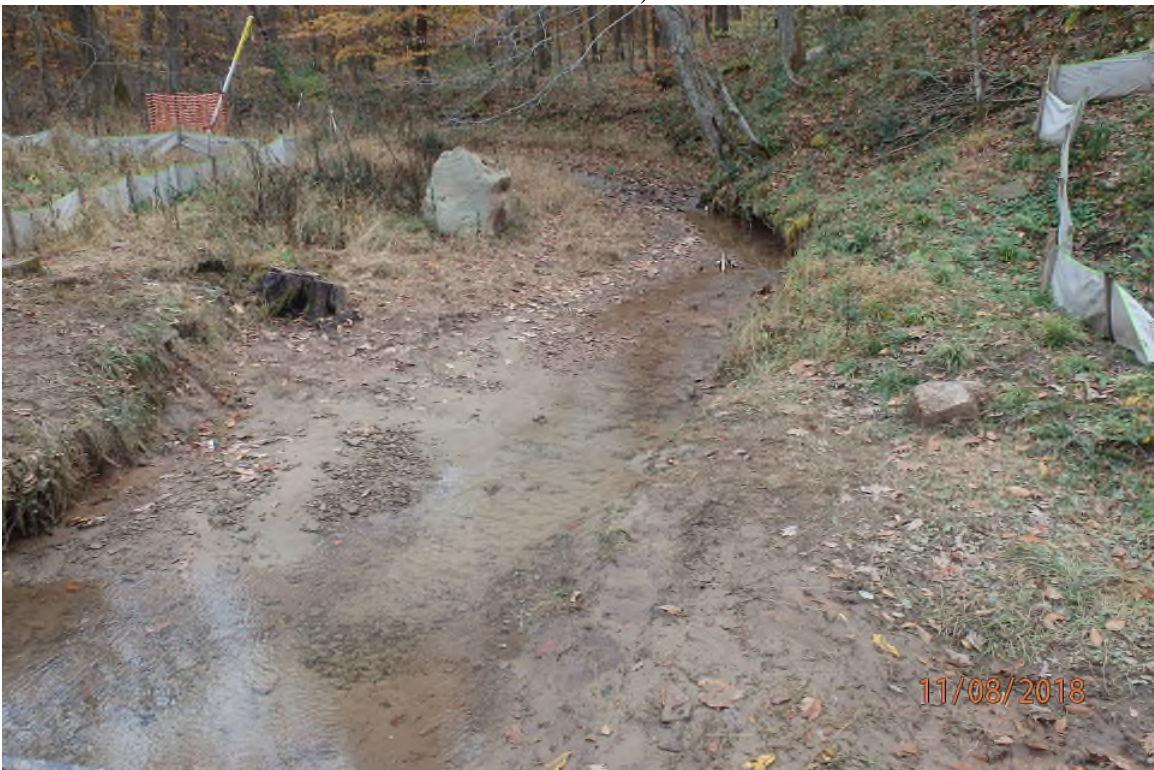
Water quality upstream of UNT Left Fork of Arnolds Creek (SDOG040) (39°13.294' X 80°46.957') crossing.

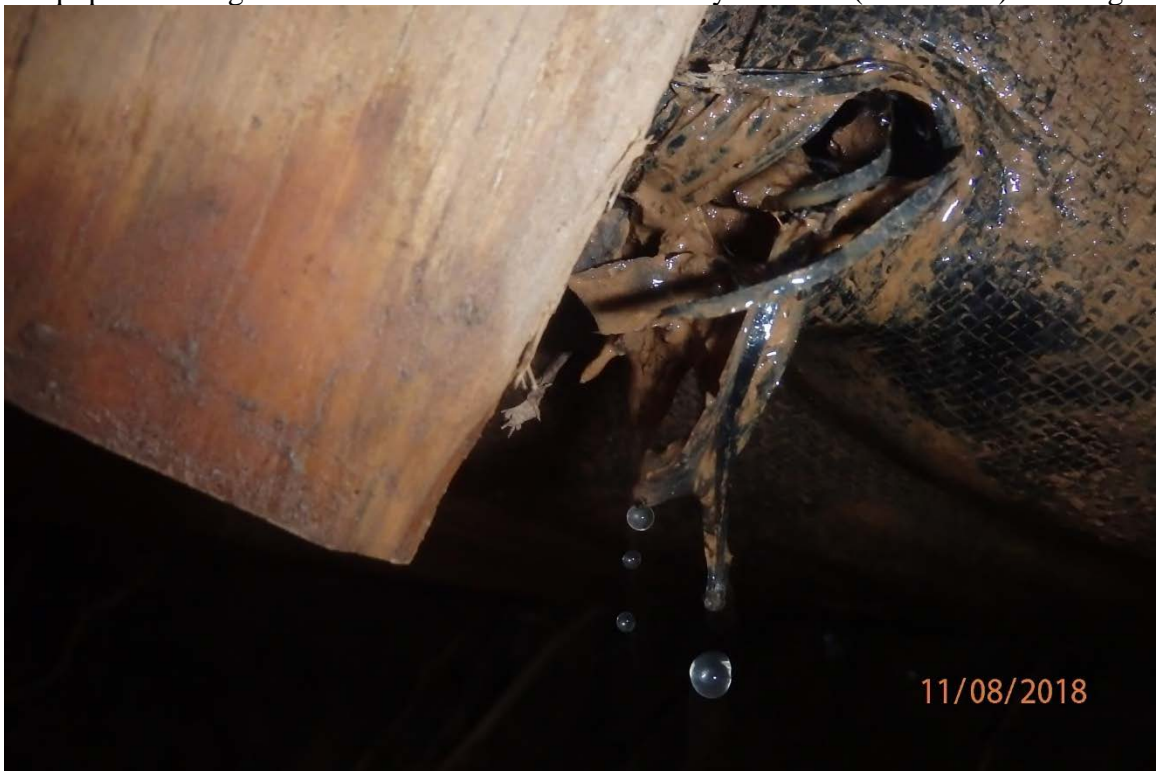
Equipment bridge BMP in need of maintenance at Taylor Drain (SDOG071) crossing.

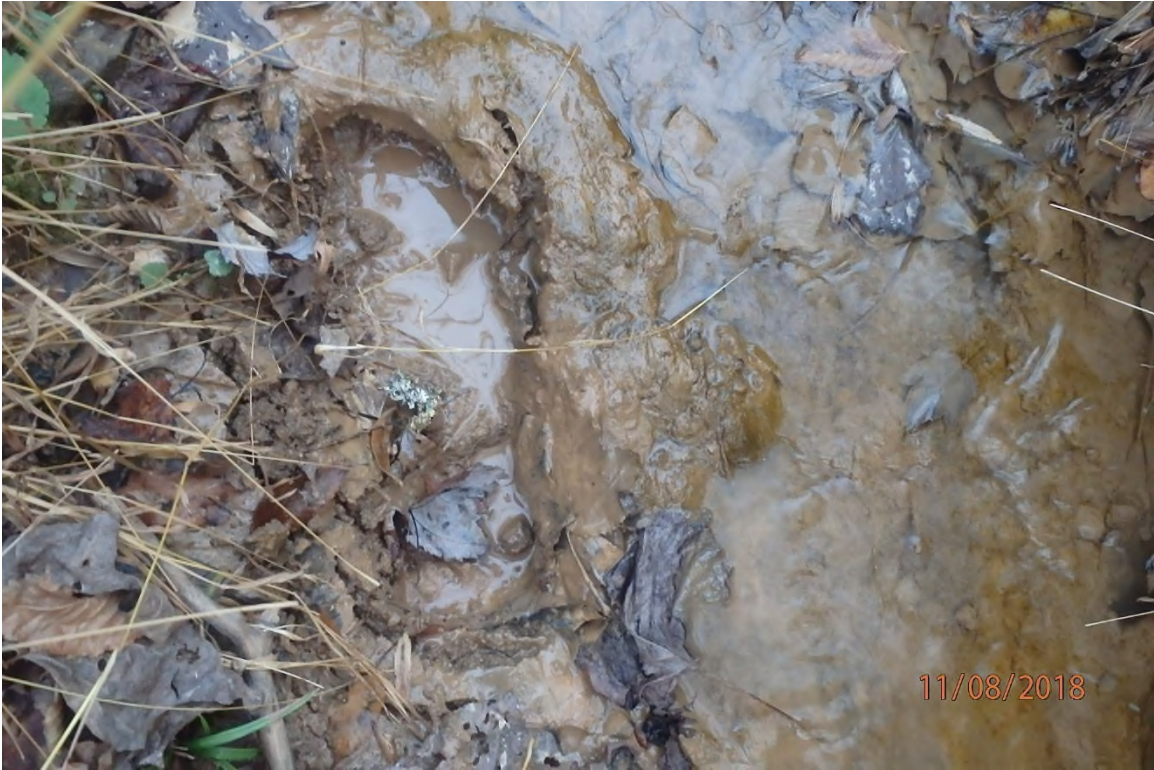
Offsite CNA in Taylor Drain (SDOG071) (39°11.469' X 80°50.183') that originate from site.

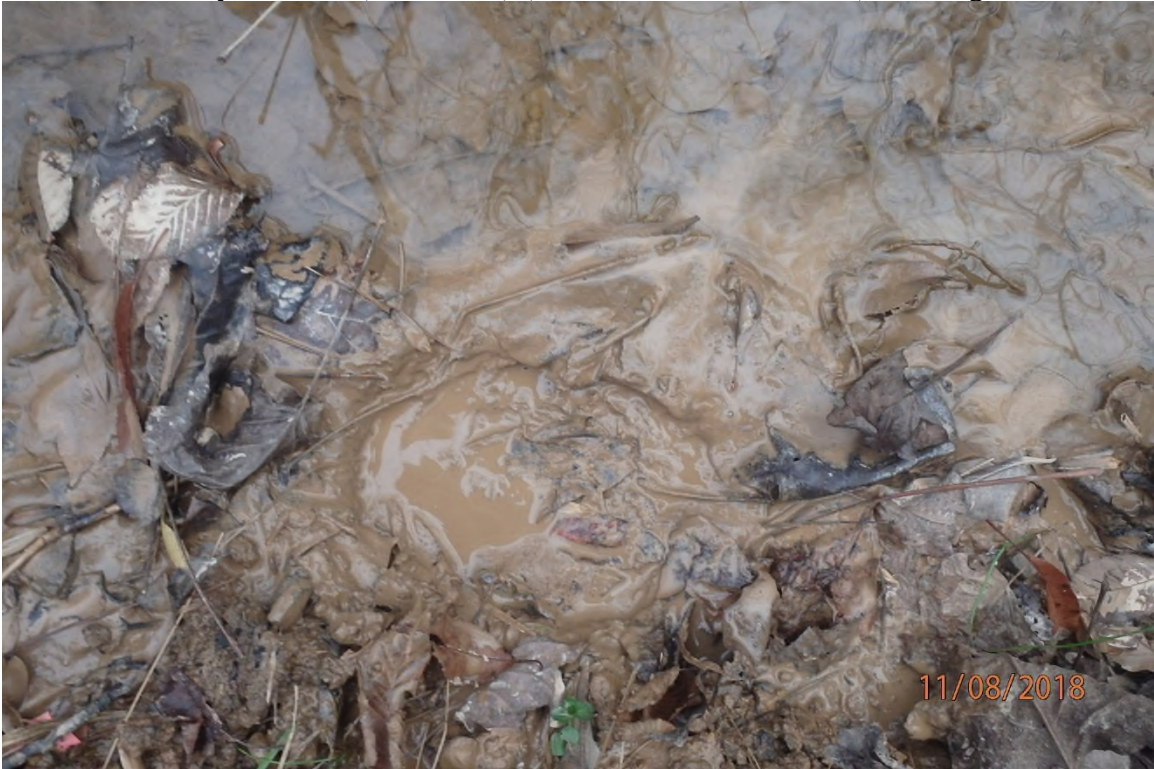
Offsite CNA in Taylor Drain (SDOG071) (39°11.469' X 80°50.183') that originate from site.

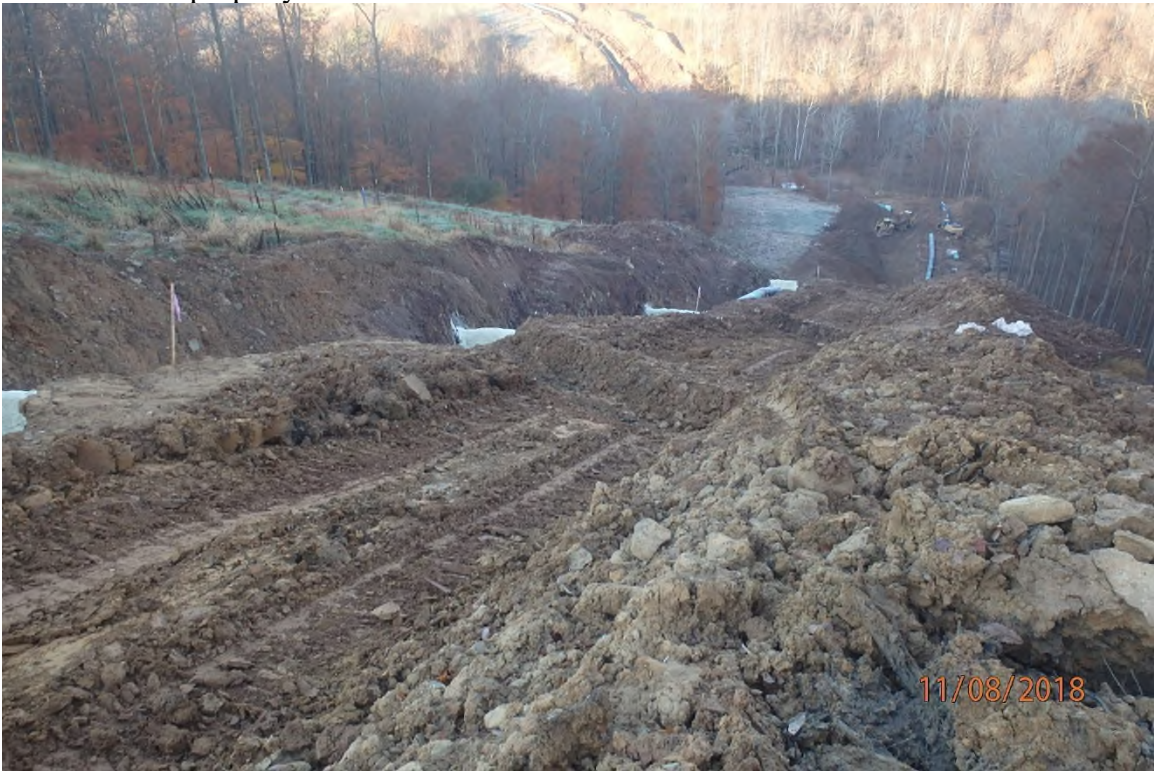
Improperly installed water bars in the Bluestone Creek watershed.

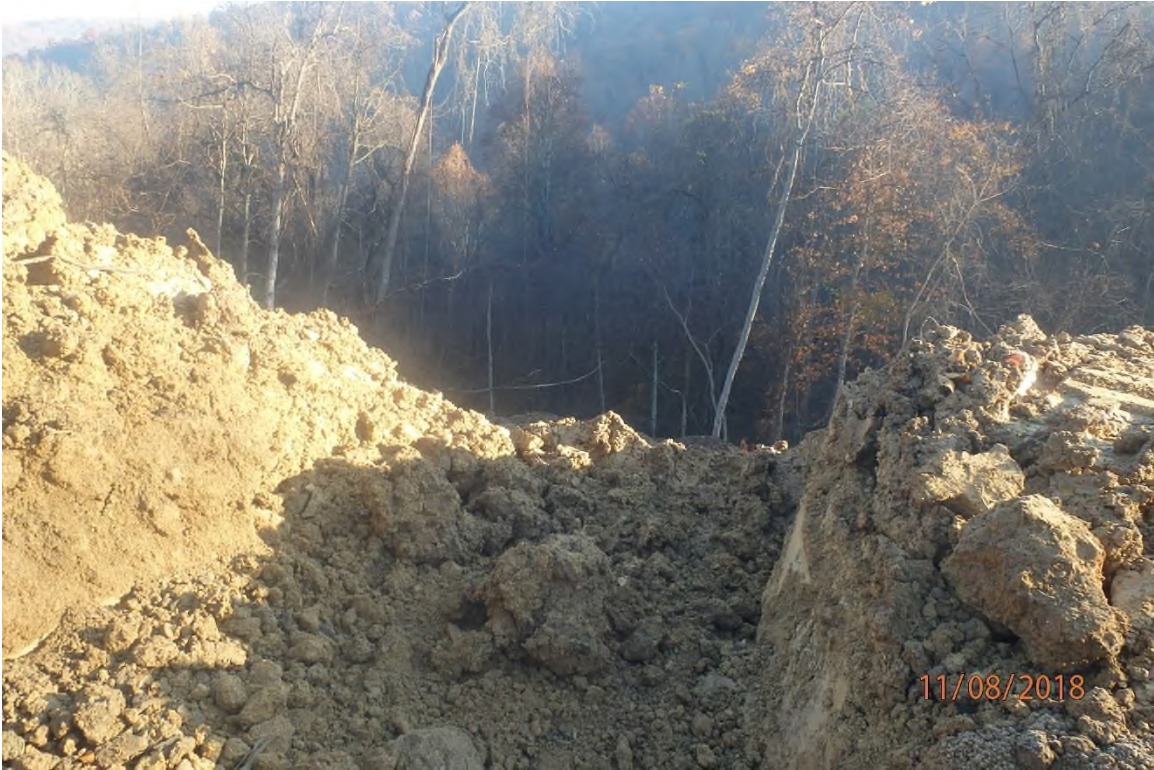
Water bar outlet that discharges concentrated flow over a fill slope adjacent to 2822+00.

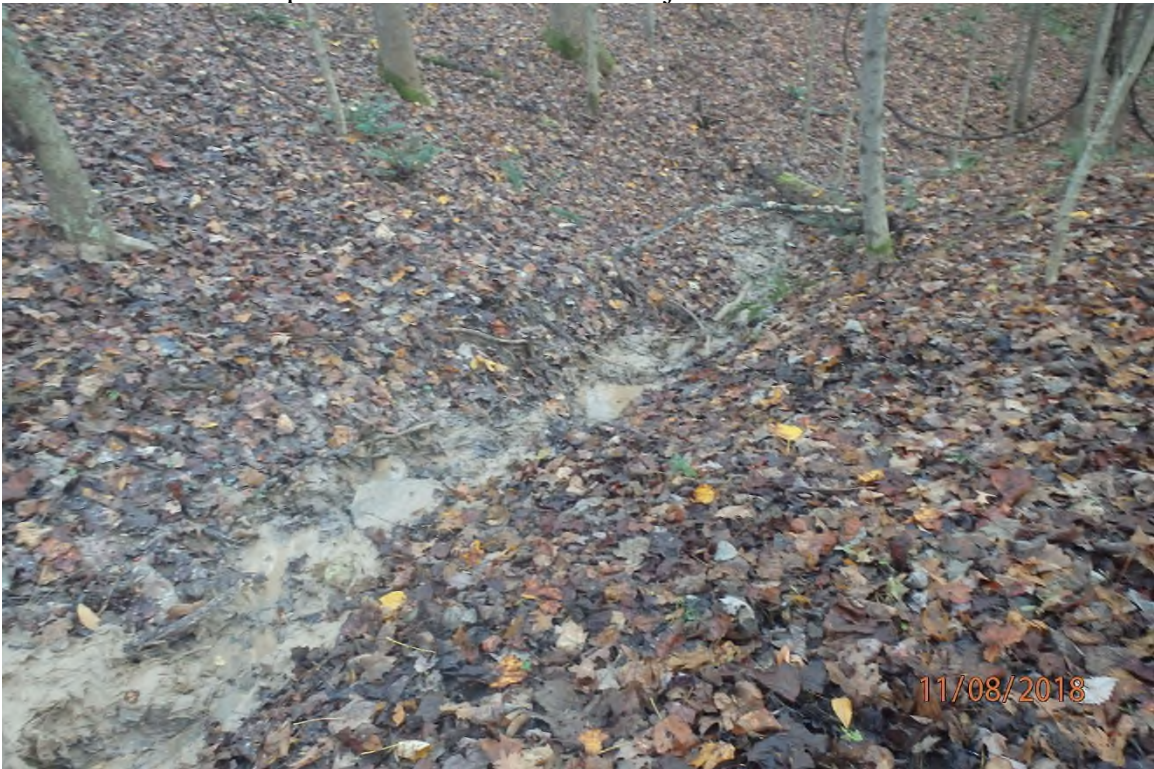
CNA deposits in UNT Bluestone Creek (SDOG0215) ($39^{\circ}14.754'$ X $80^{\circ}45.138'$) adjacent to 2822+00.

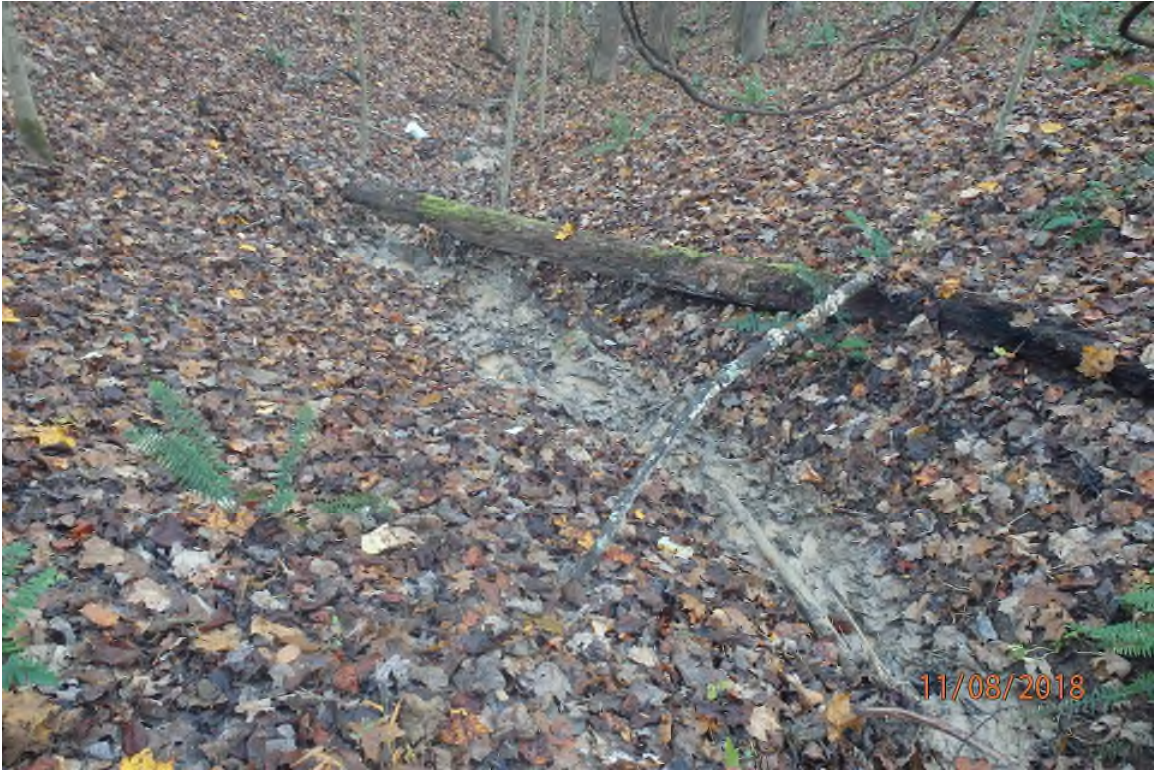
CNA deposits in UNT Bluestone Creek (SDOG0215) ($39^{\circ}14.754'$ X $80^{\circ}45.138'$) adjacent to 2822+00.

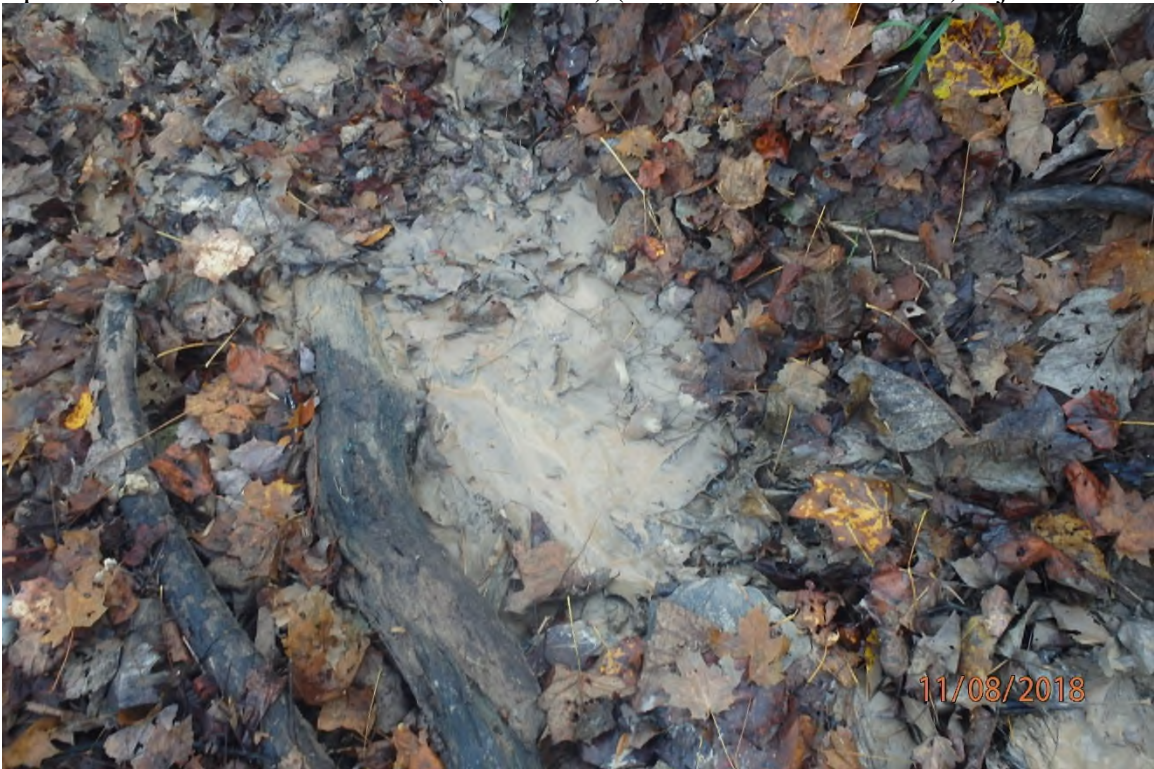
CNA deposits in UNT Bluestone Creek (SDOG0215) ($39^{\circ}14.754'$ X $80^{\circ}45.138'$) adjacent to 2822+00.

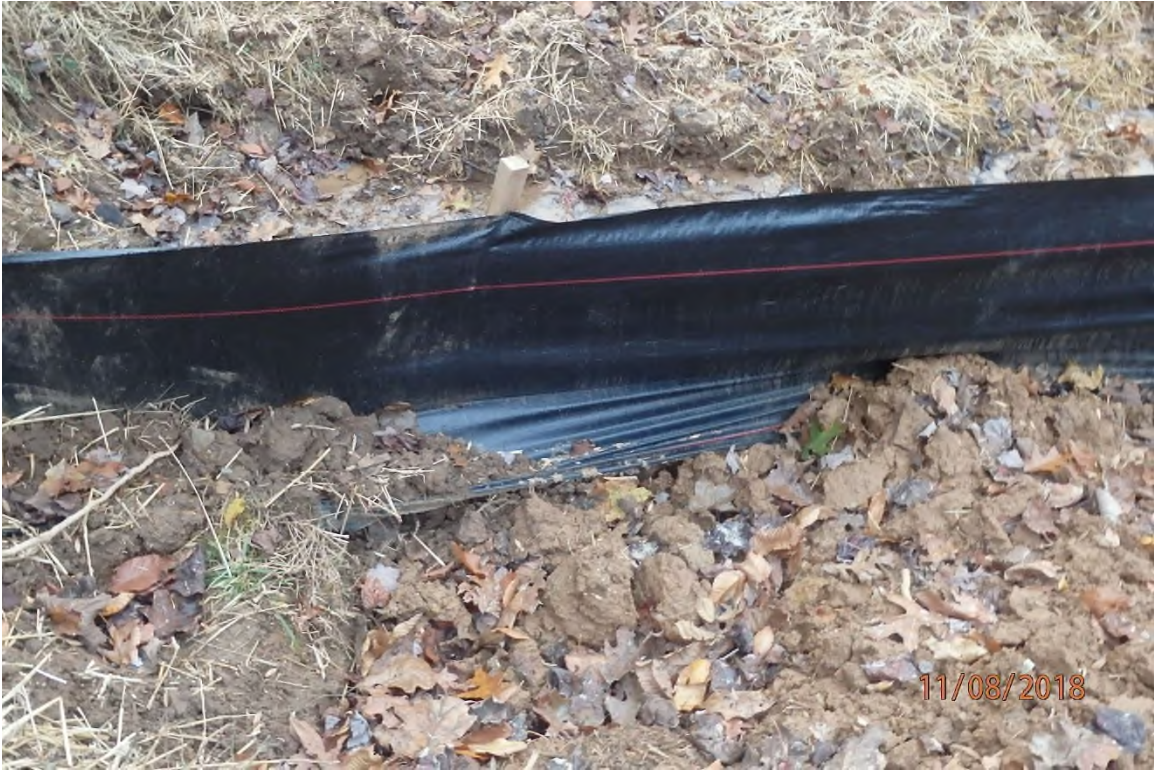
Improperly installed perimeter control adjacent to UNT Taylor Drain (SDOH012).

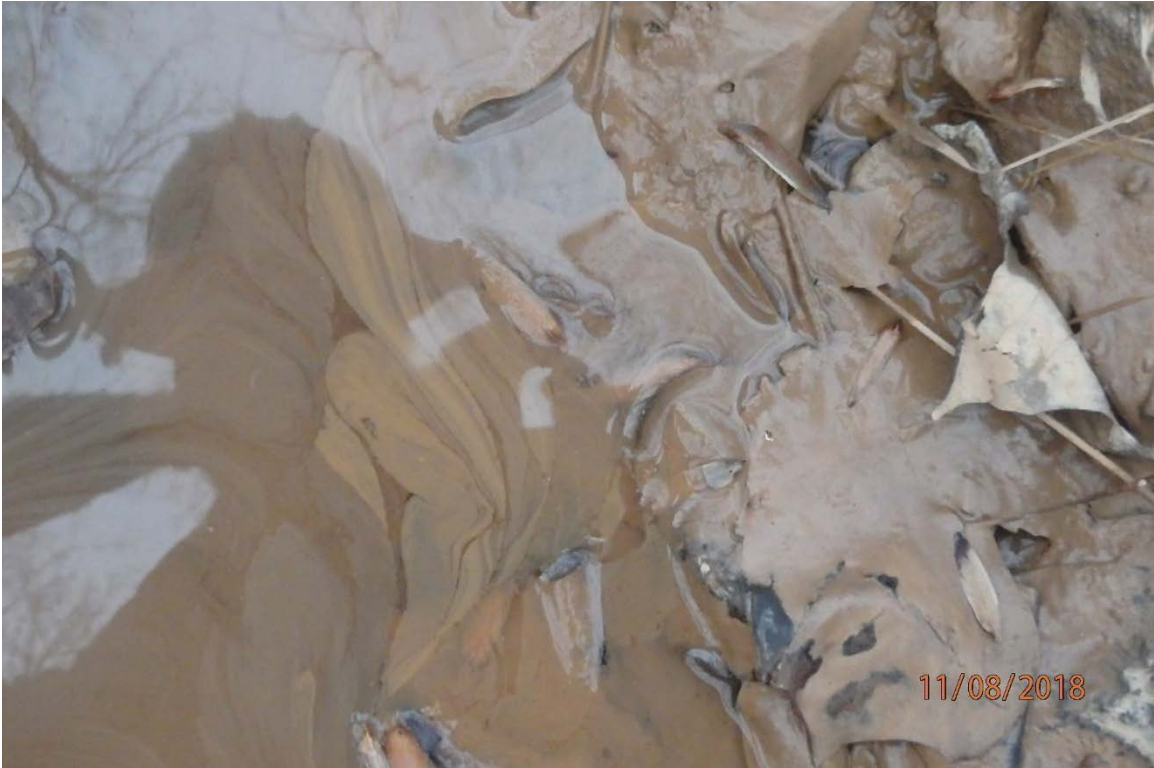
Offsite CNA deposits in UNT Taylor Drain (SDOH012) (39°11.386' X 80°50.309').
