**CONSENT ORDER
ISSUED UNDER THE
WATER POLLUTION CONTROL ACT
WEST VIRGINIA CODE, CHAPTER 22, ARTICLE 11**

TO: Columbia Gas Transmission, LLC
Attn: Troy Tally, Vice President
1700 MacCorkle Ave
Charleston, WV 25314

DATE: October 1, 2020
ORDER NO.: 9061

1. Columbia Gas Transmission, LLC is conducting land disturbance activity associated with construction of the Mountaineer Xpress Project in Marshall, Wetzel, Tyler, Doddridge, Ritchie, Calhoun, Wirt, Roane, Jackson, Mason, Putnam, and Cabell Counties, West Virginia. On January 31, 2018, Columbia Gas Transmission, LLC was issued Water Pollution Control Permit No. WV0116815, Registration No. WVR310872, for Stormwater Associated With Oil and Gas Related Construction Activities.

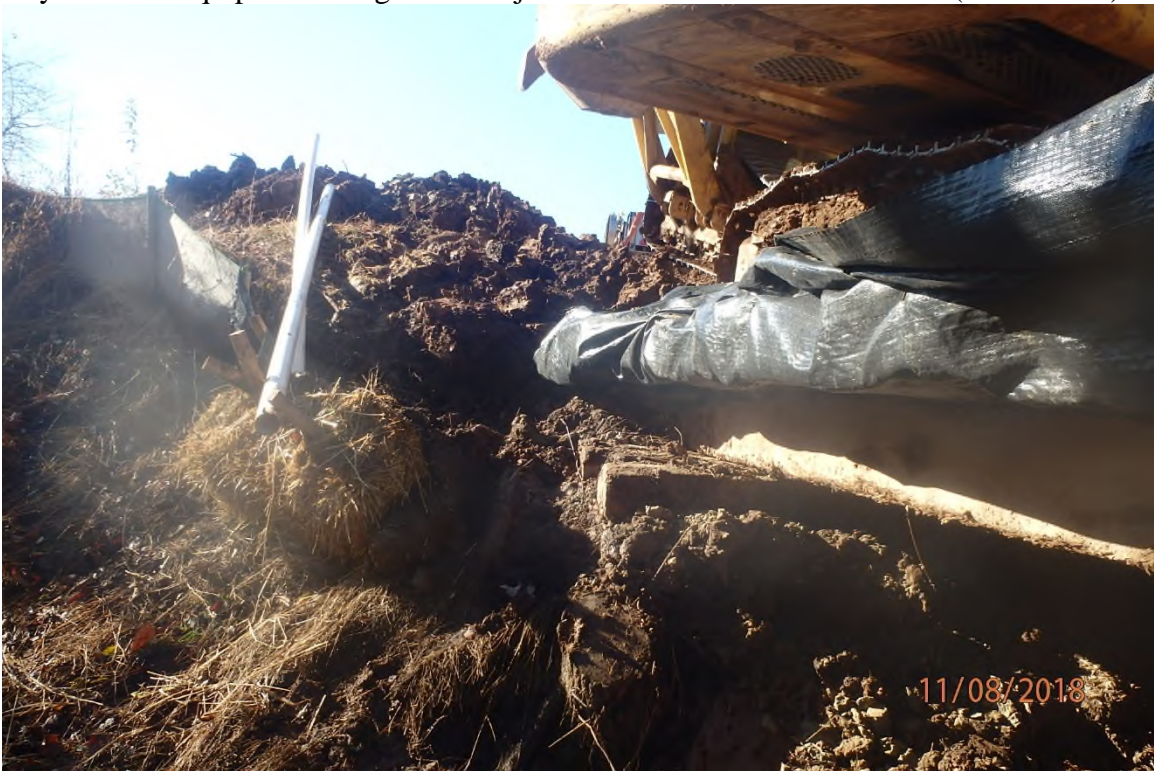
Improperly installed equipment bridge tie in adjacent to wetland UNT Bluestone (WDOG502) crossing.

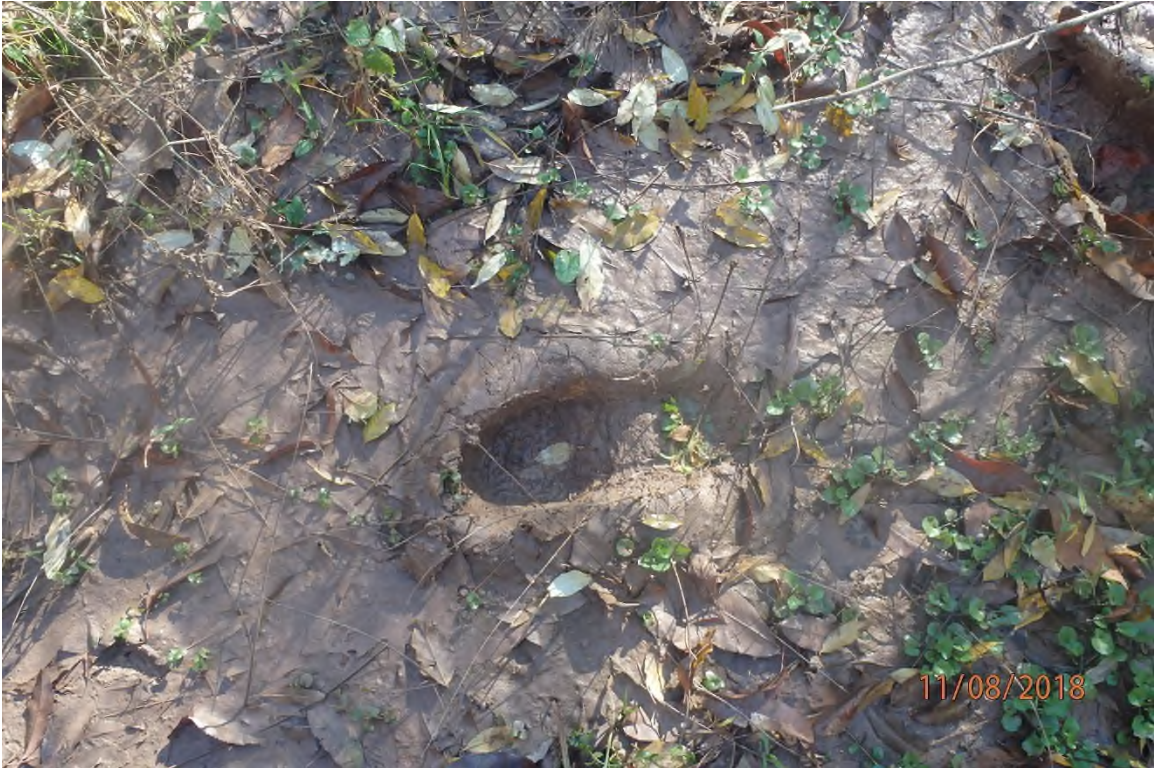
Offsite CNA deposits in wetland UNT Bluestone Creek (WDOG502) (39°14.422' X 80°45.863').

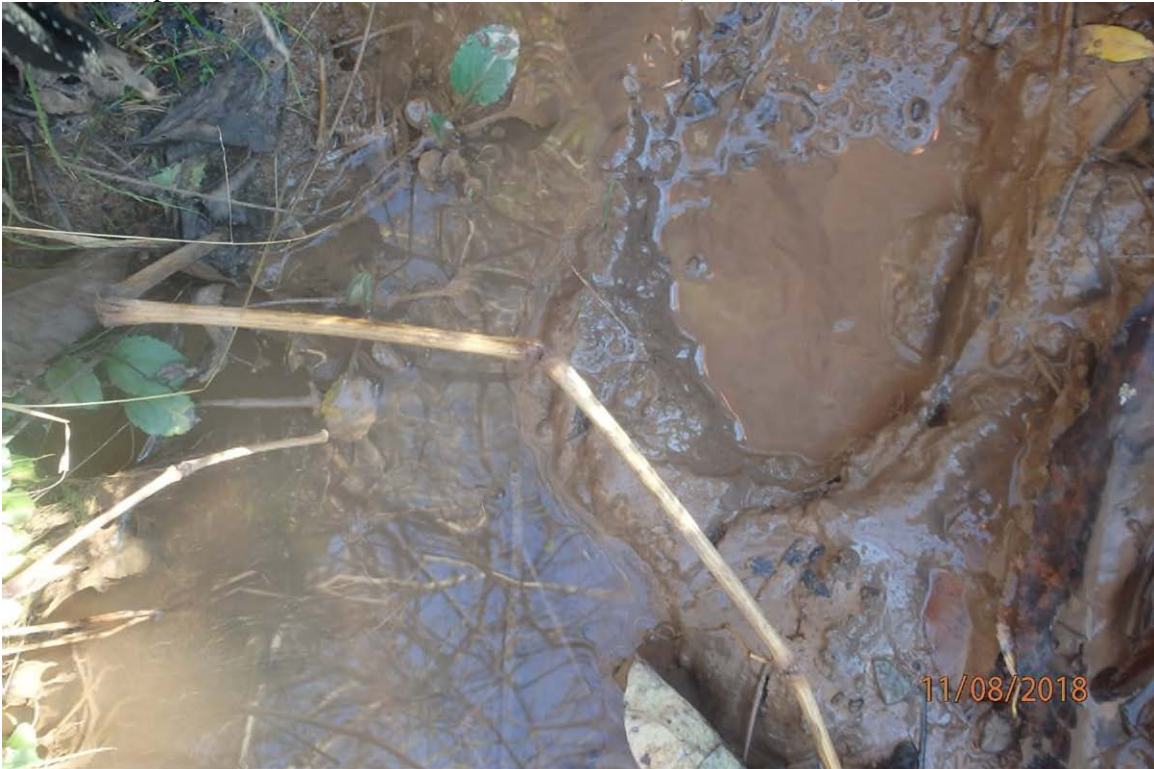
Offsite CNA deposits in wetland UNT Bluestone Creek (WDOG502) (39°14.422' X 80°45.863').

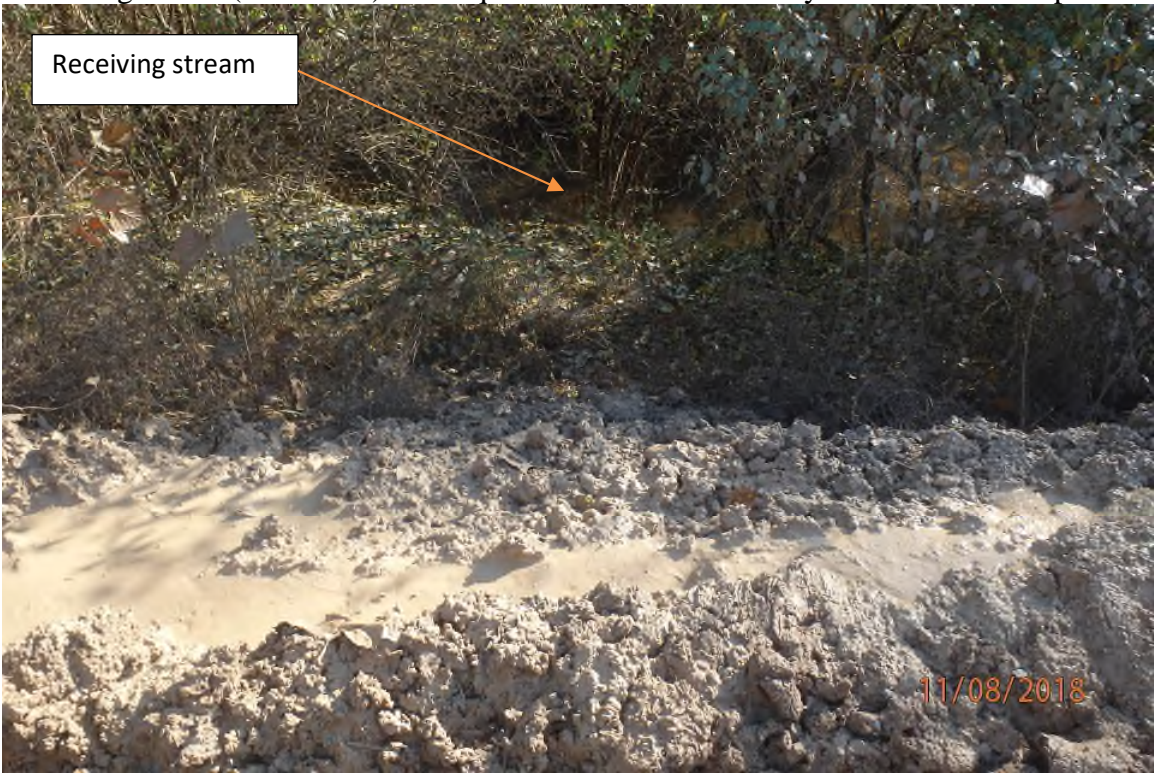
Existing access (ARDO9.3) that requires construction activity with no BMPs in place.

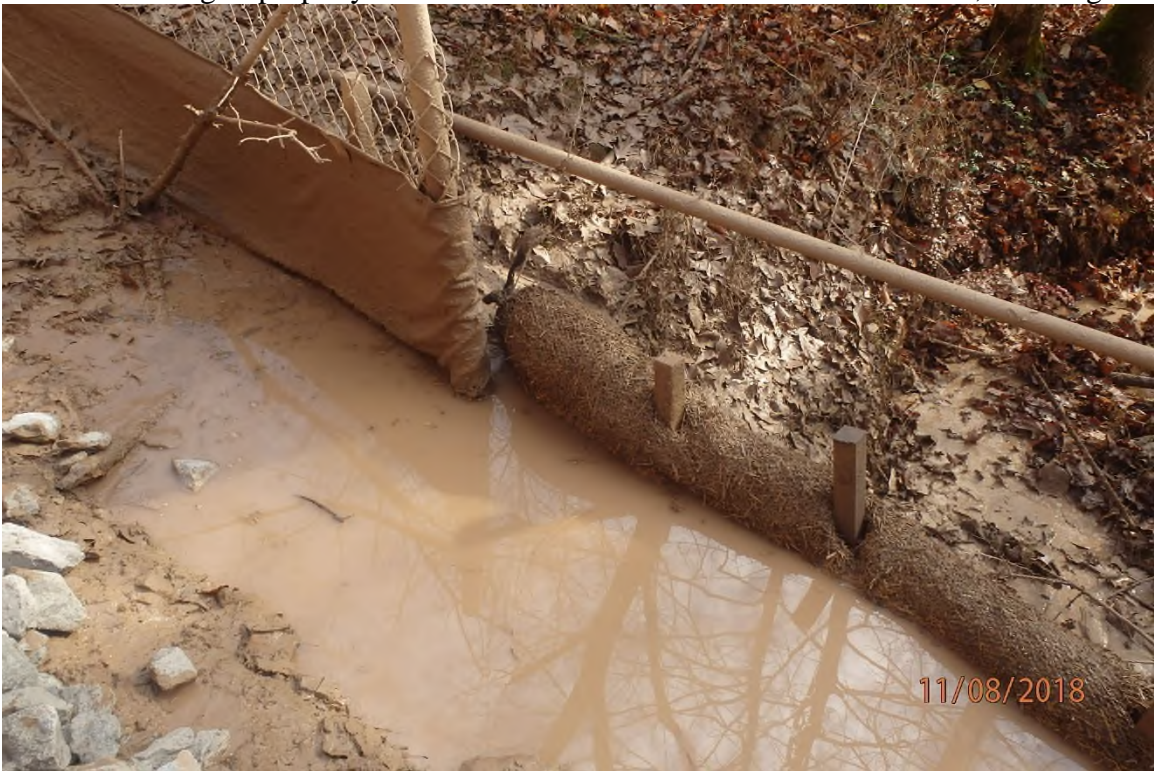
ARDO008.2 showing improperly installed controls and failure to follow SWPPP, resulting in CNA.

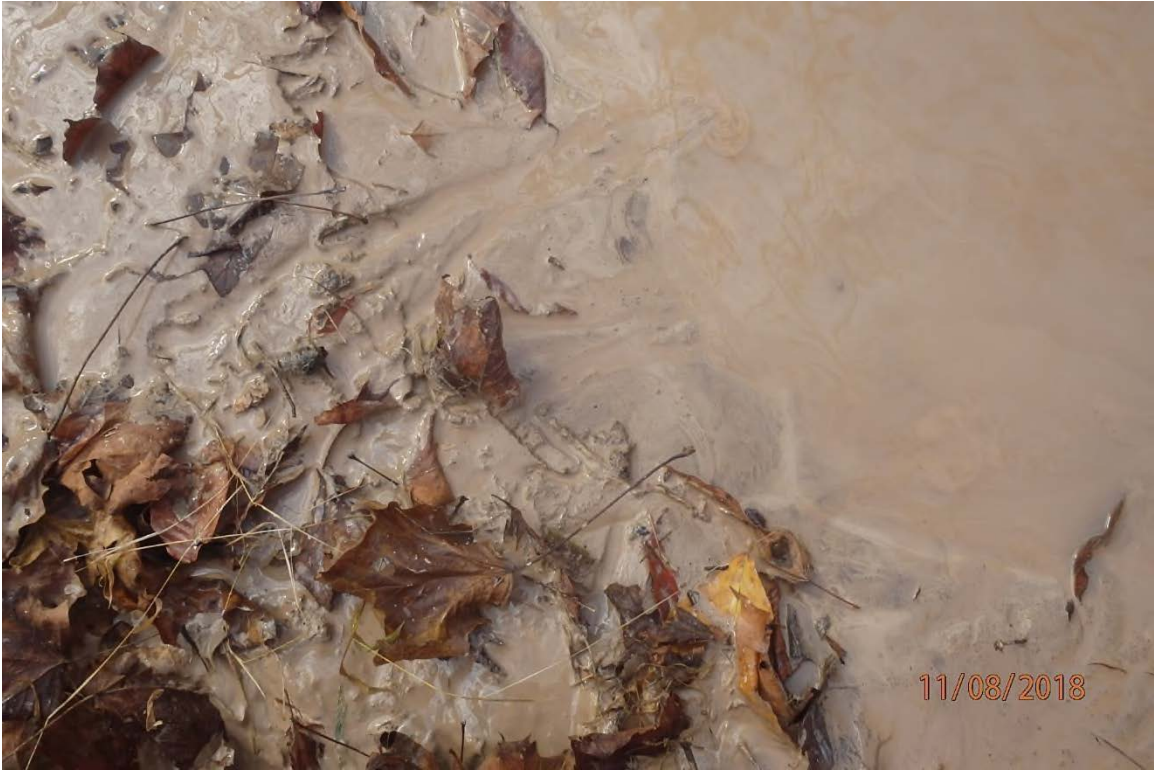
CNA distinctly visible settleable solids and deposits in Georgescamp Run (39°14.817' X 80°44.531').

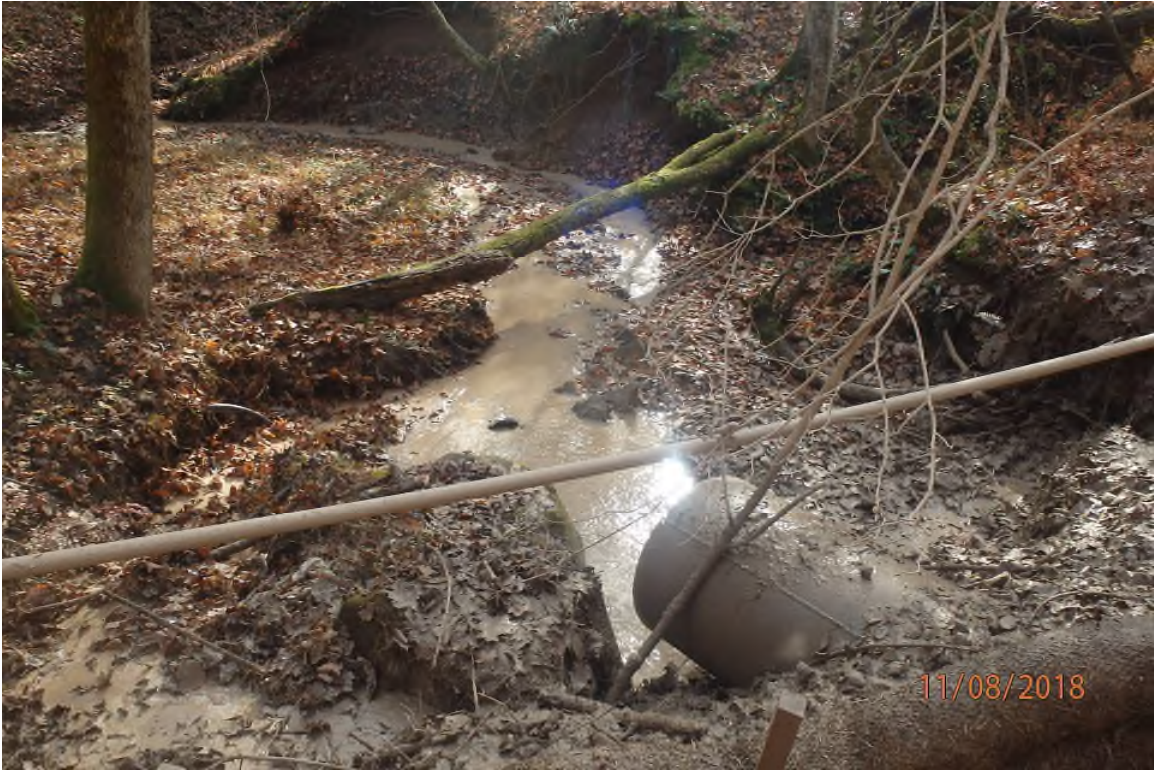
CNA distinctly visible settleable solids and deposits in Georgescamp Run (39°14.817' X 80°44.531').

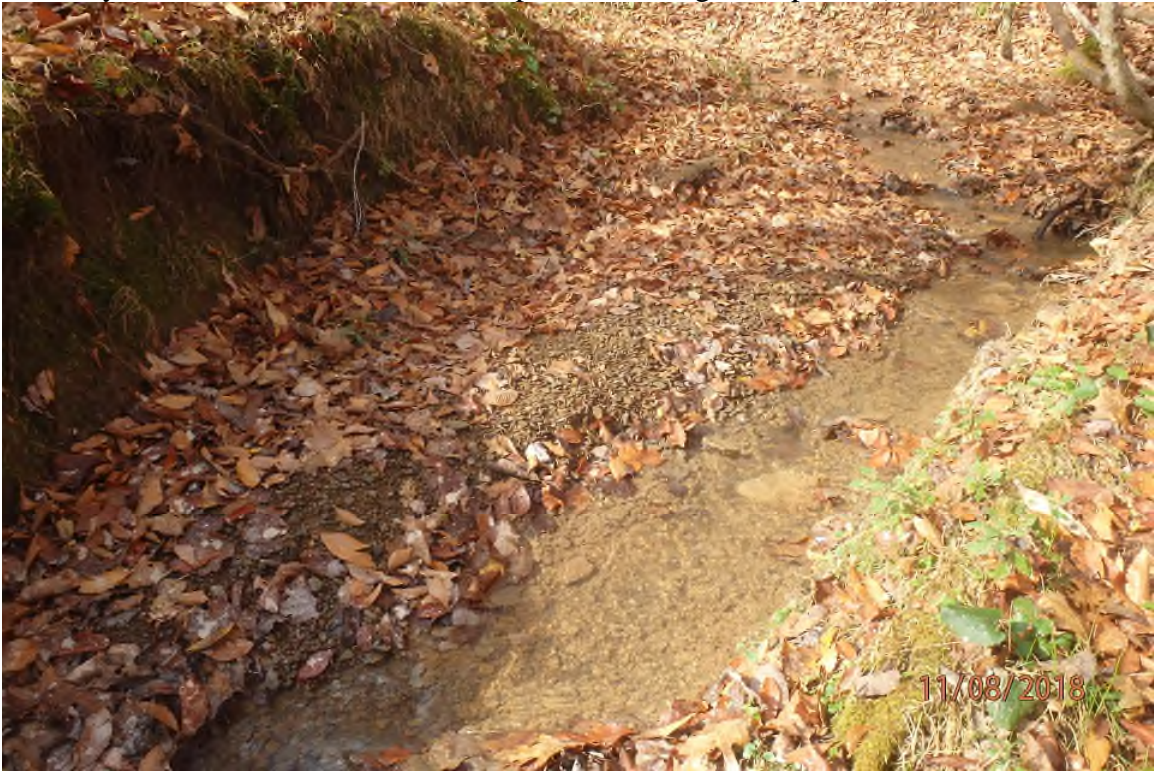
Water quality upstream of the ARDO08.2 Georgescamp Run crossing.

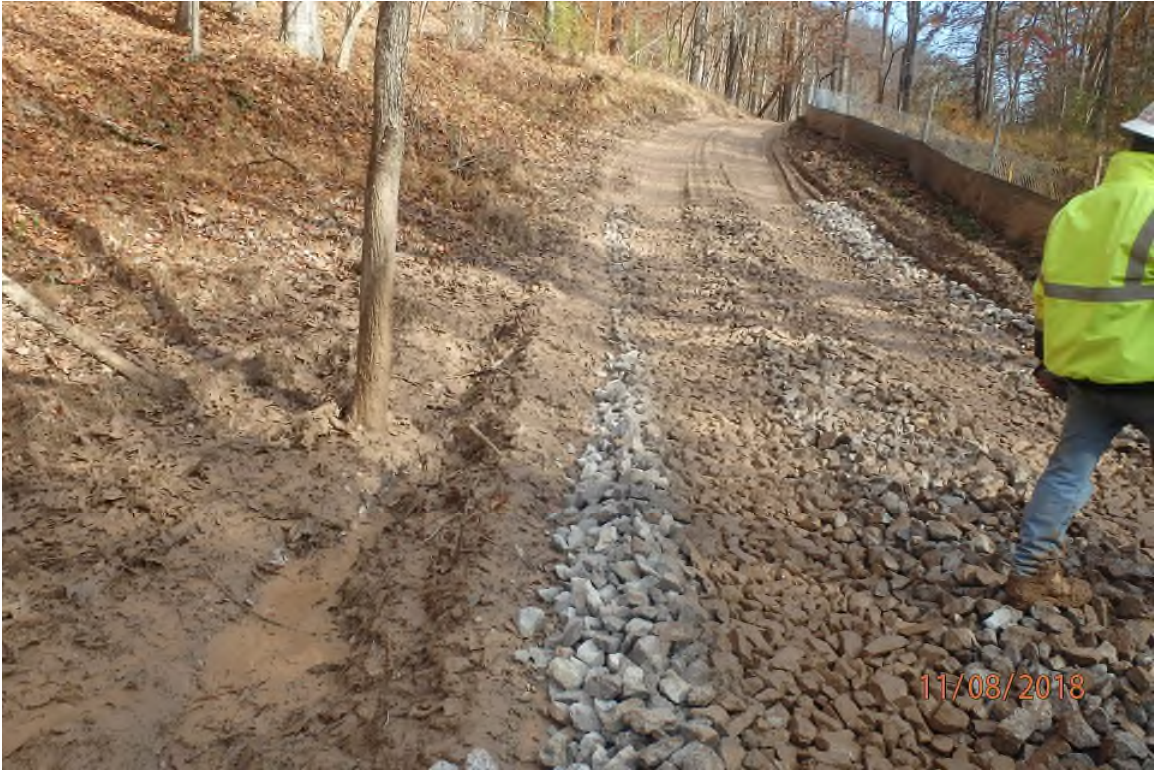
ARDO08.5 showing a lack of upslope ditches to collect run-on stormwater as indicated in the approved SWPPP.

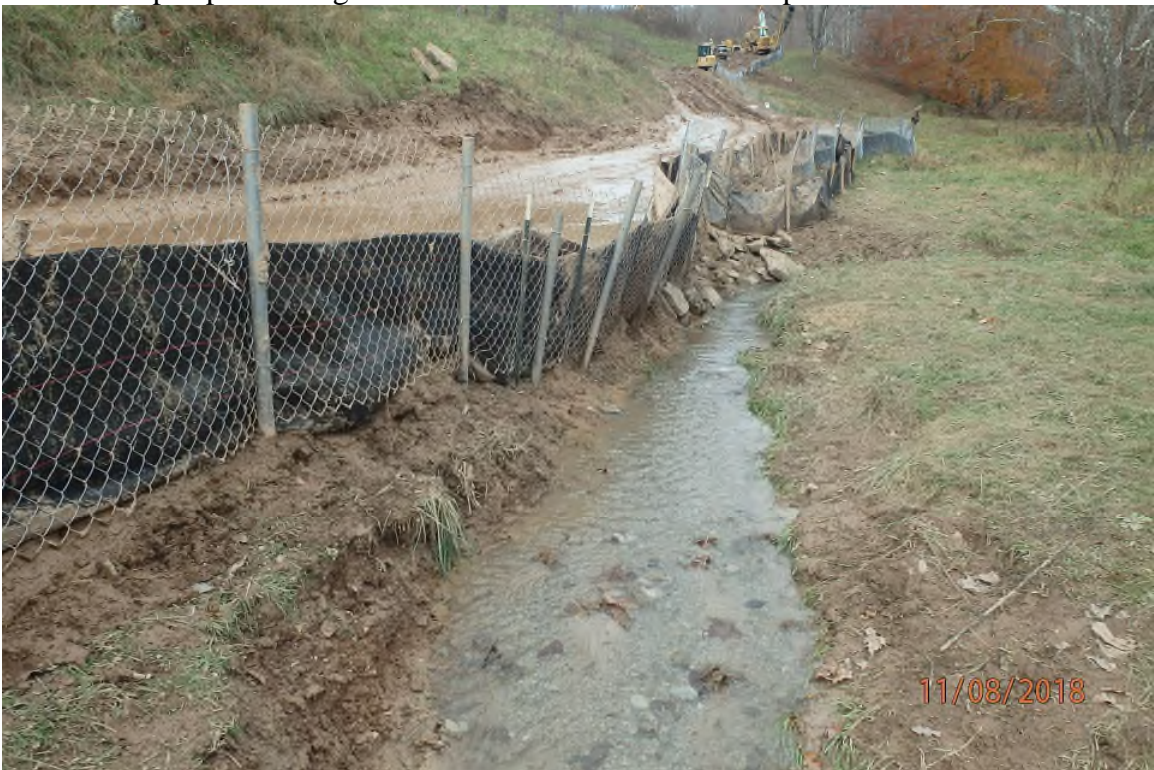
ARDO08.5 showing concentration of mud in a low area adjacent to the receiving stream due to a lack of upslope ditching to handle run-on stormwater and poor maintenance.

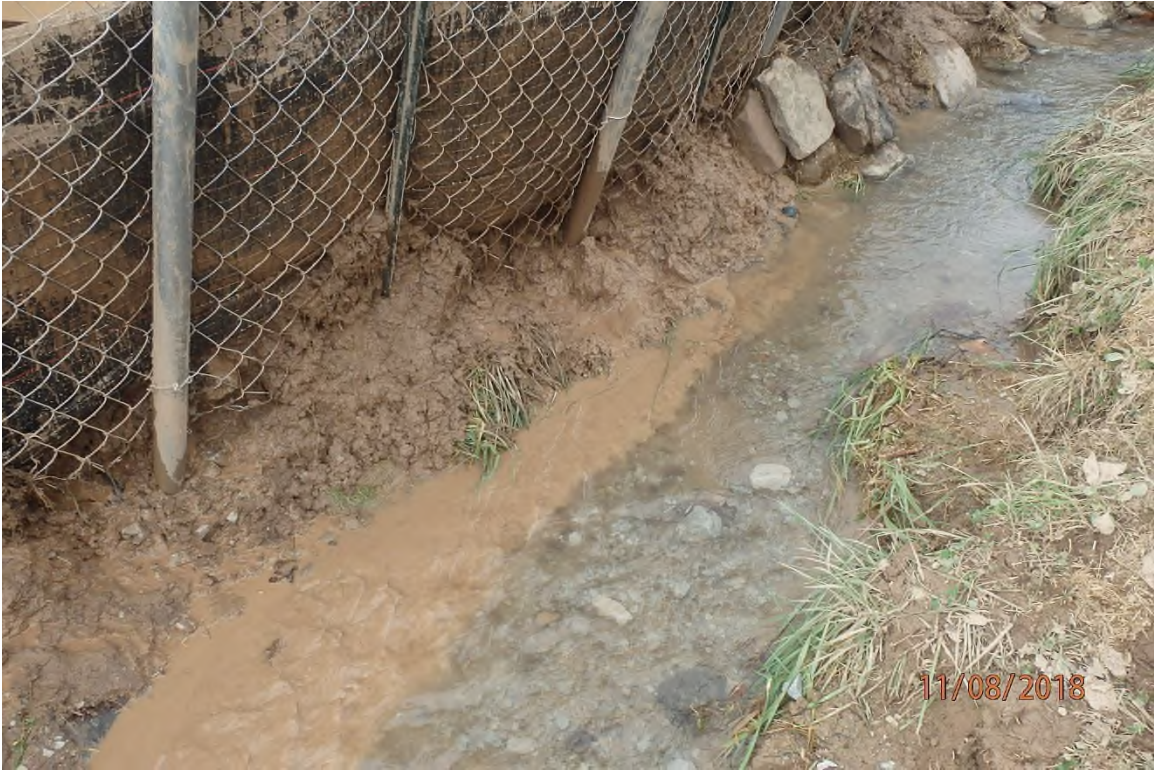
CNA distinctly visible settleable solids and deposits in UNT Georgescamp Run (39°15.200' X 80°44.046').

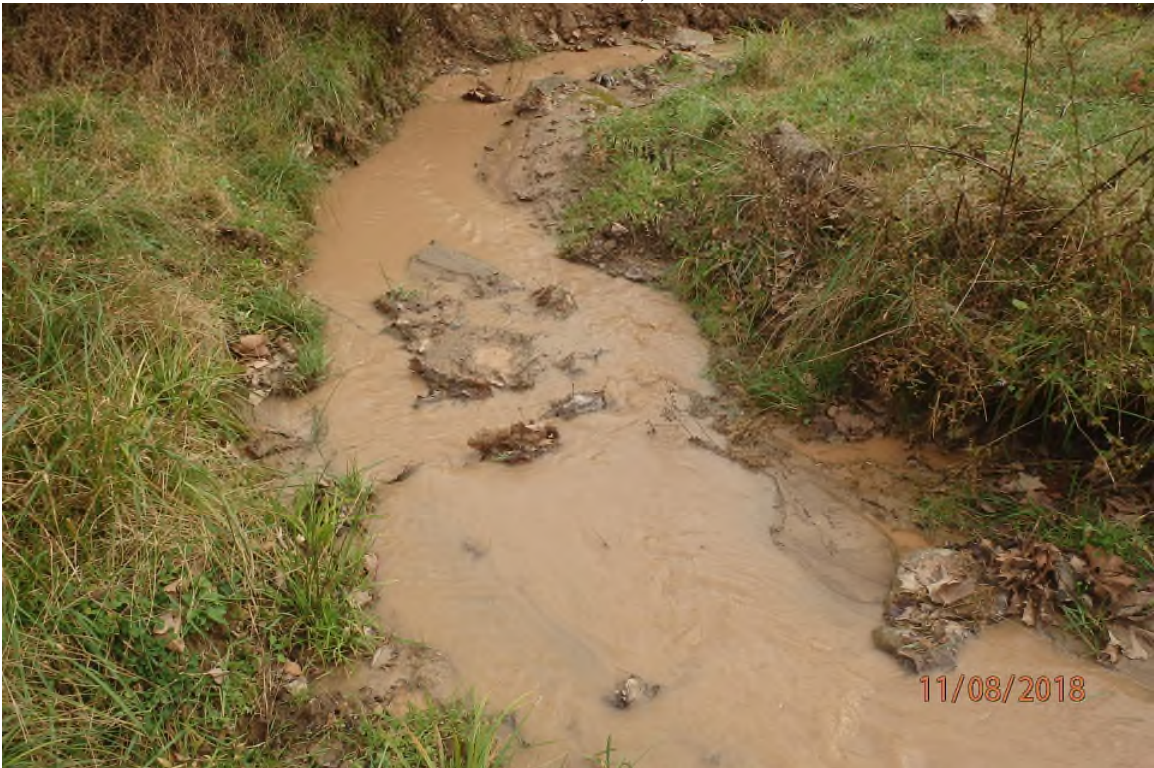
CNA distinctly visible settleable solids and deposits in UNT Georgescamp Run (39°15.200' X 80°44.046').

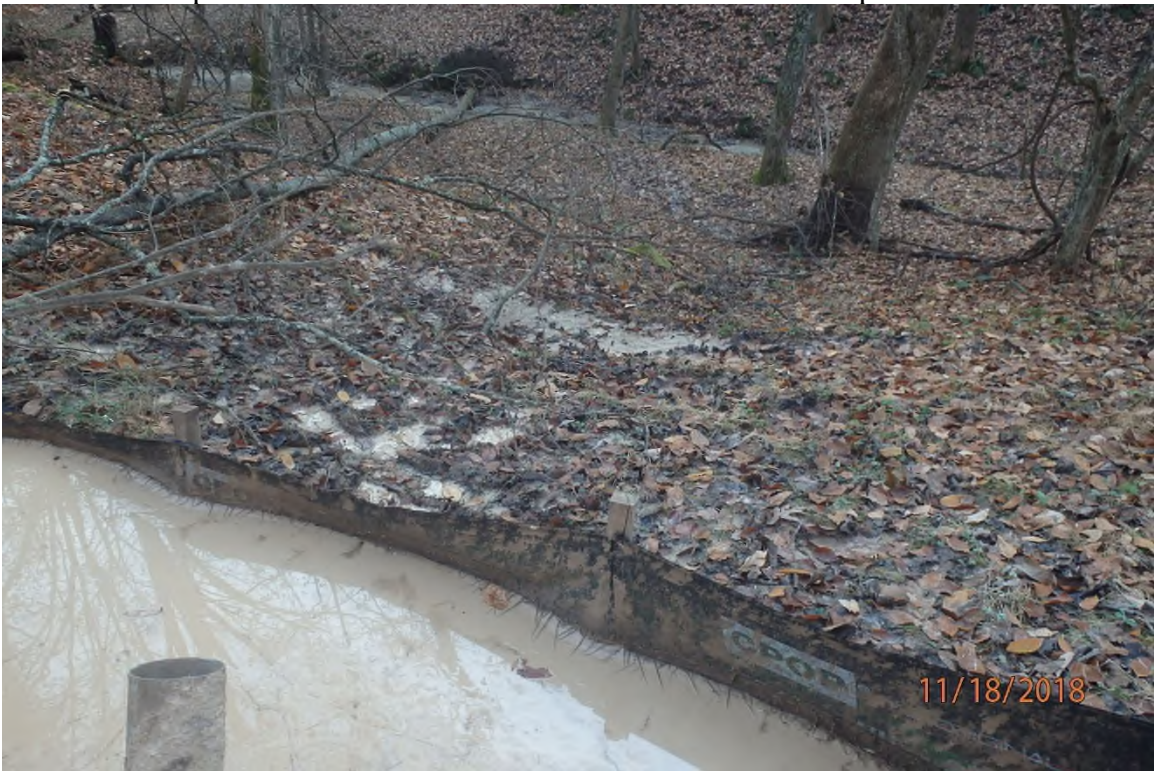
Unmaintained perimeter control and associated offsite sediment deposits on ARDO008.2.

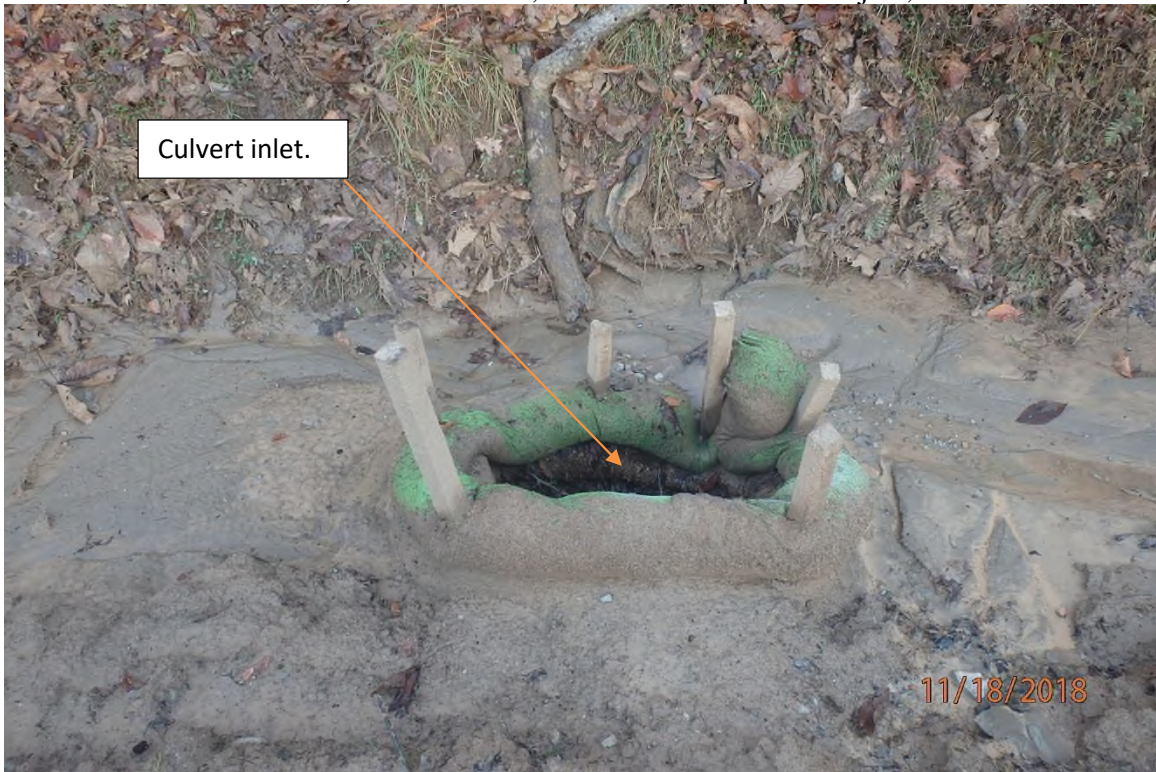
Unmaintained BMP and associated offsite sediment deposits on ARDO008.2.

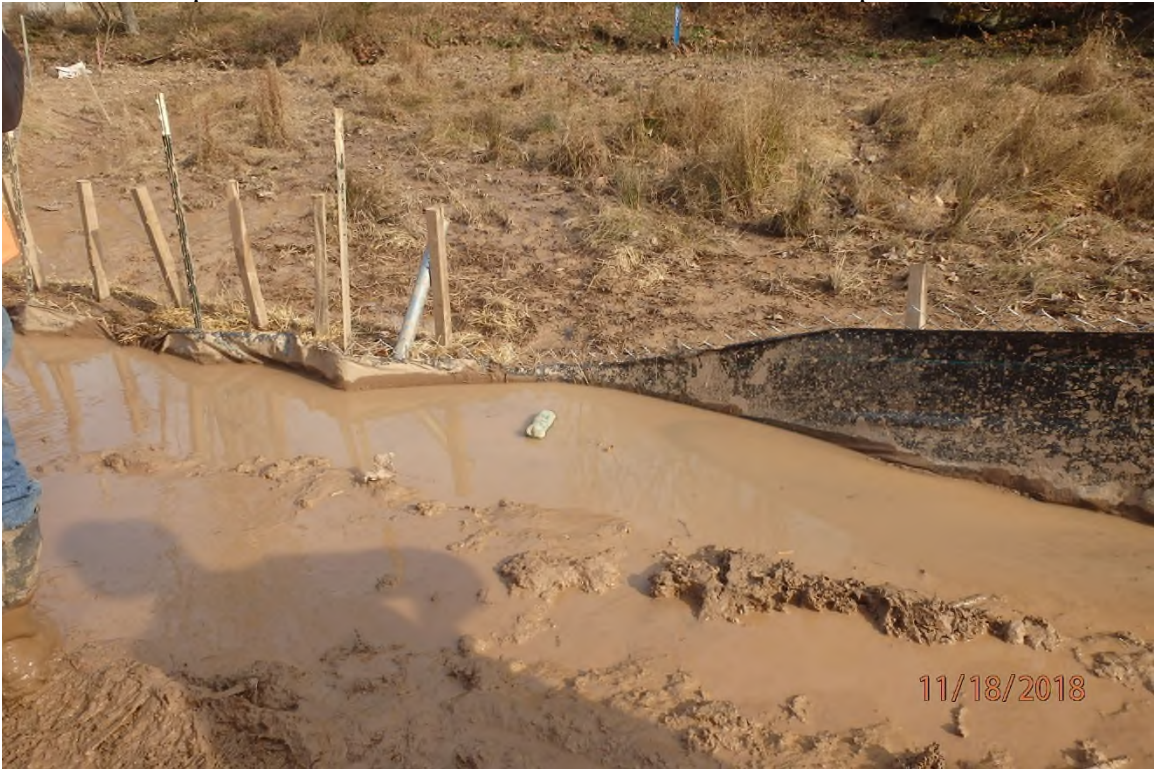
Unmaintained perimeter control and associated offsite sediment deposits on ARDO009.1.

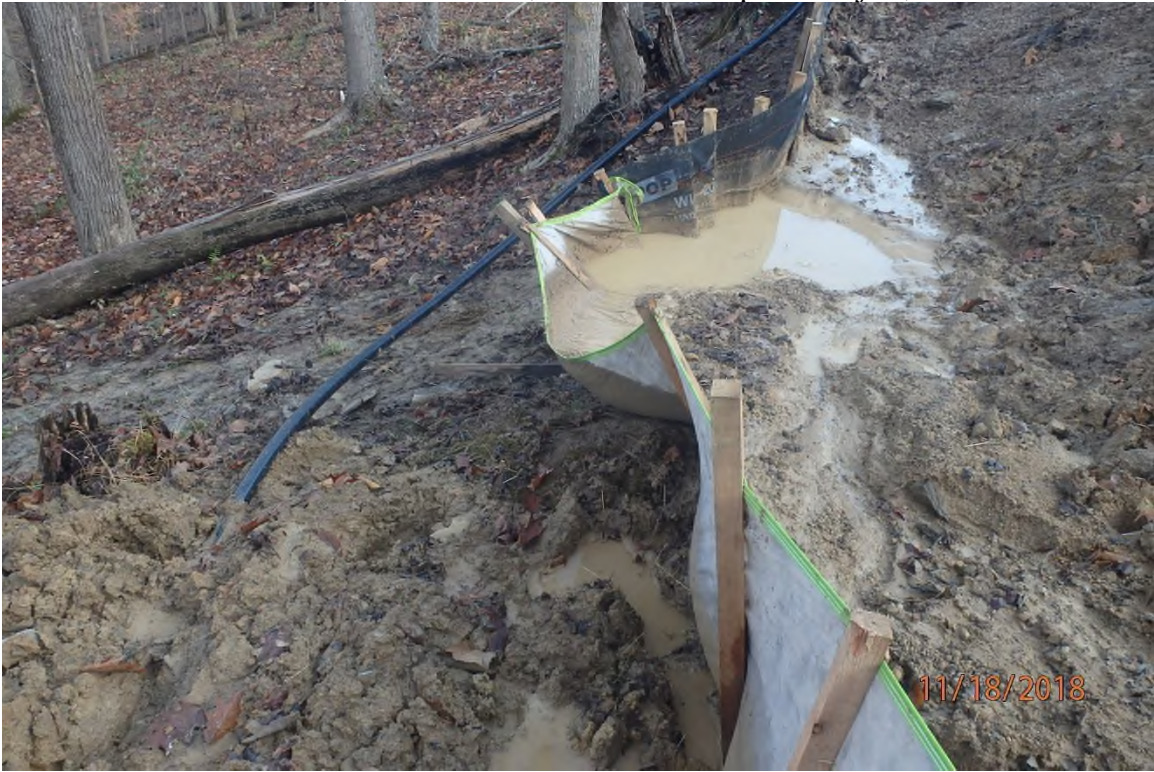
Unmaintained perimeter control and associated offsite sediment deposits near 2815+00.

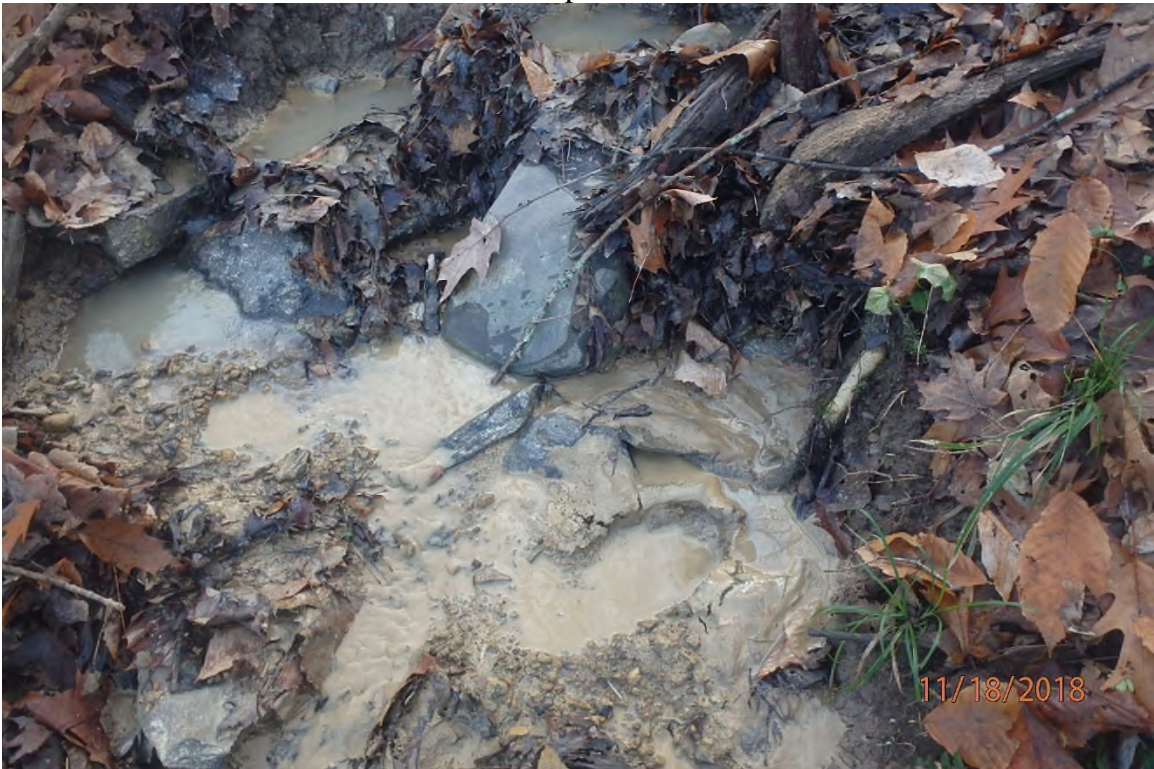
CNA deposits in UNT Bluestone Creek (39° 14.761' X 80° 45.019') near 2815+00 due to poor maintenance of perimeter control.

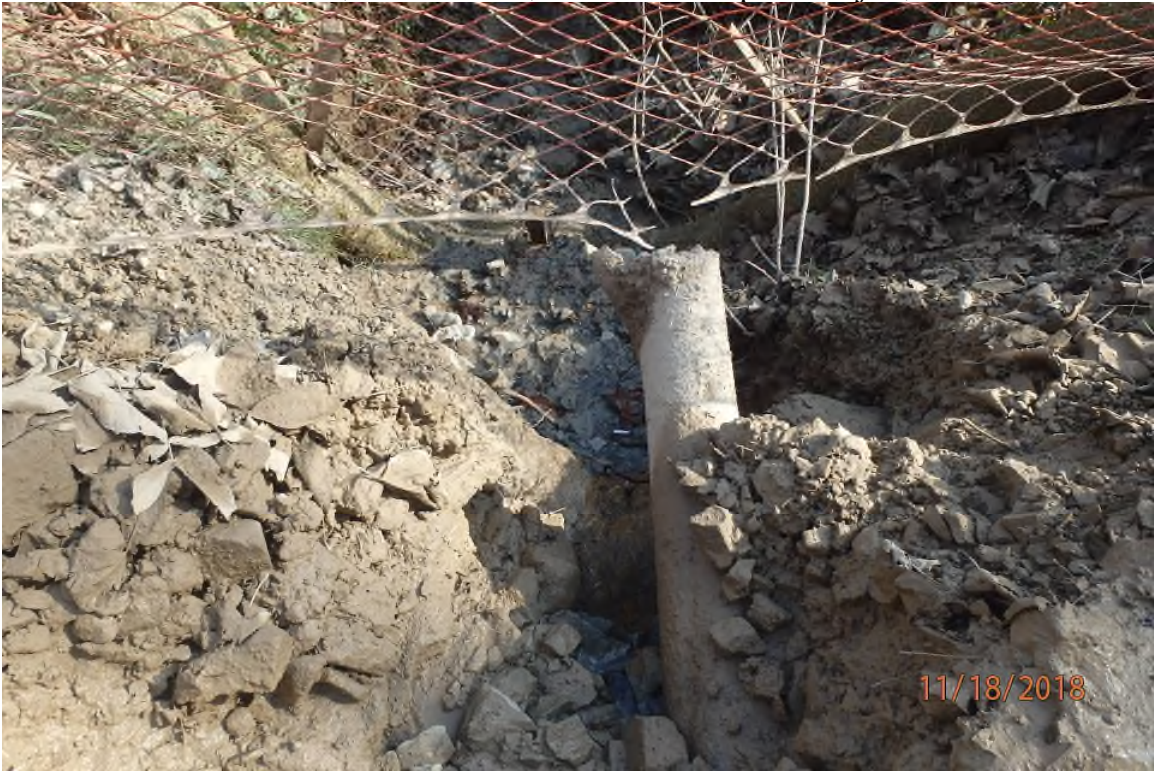
Unmaintained BMP and associated offsite sediment deposits on ARDO008.2.

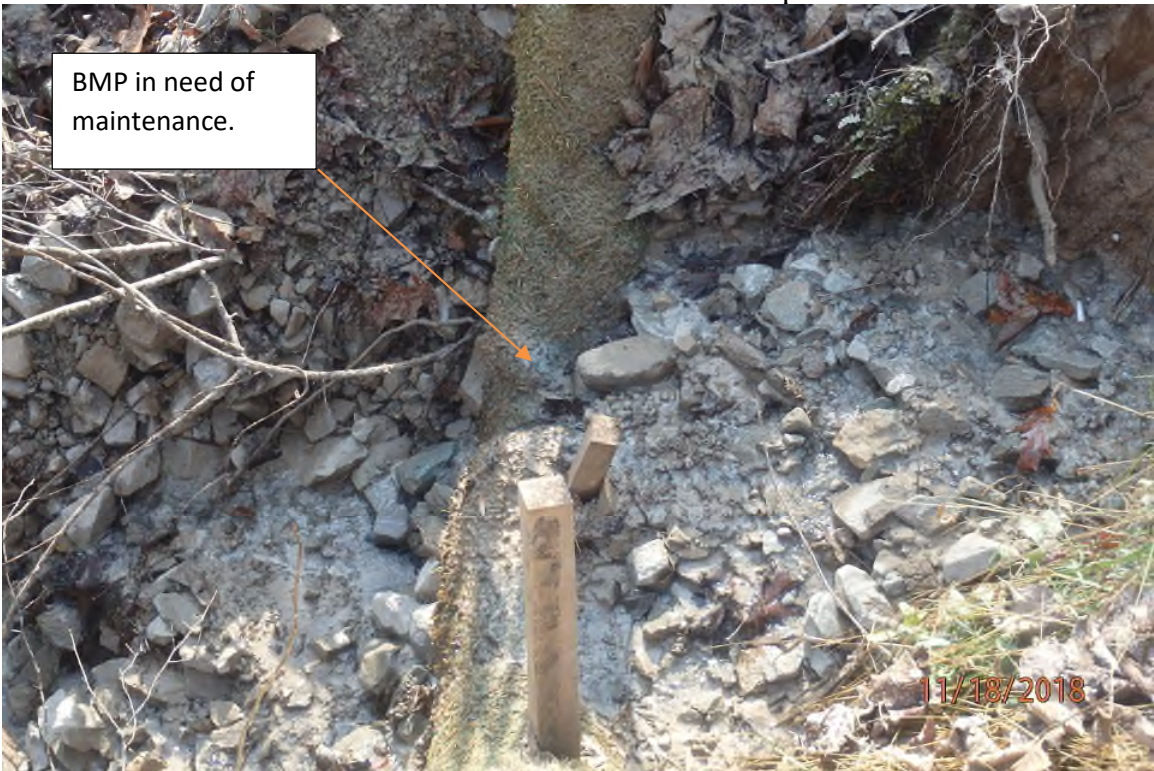
BMP in need of maintenance.

Unmaintained BMP and associated offsite sediment deposits on ARDO008.2.

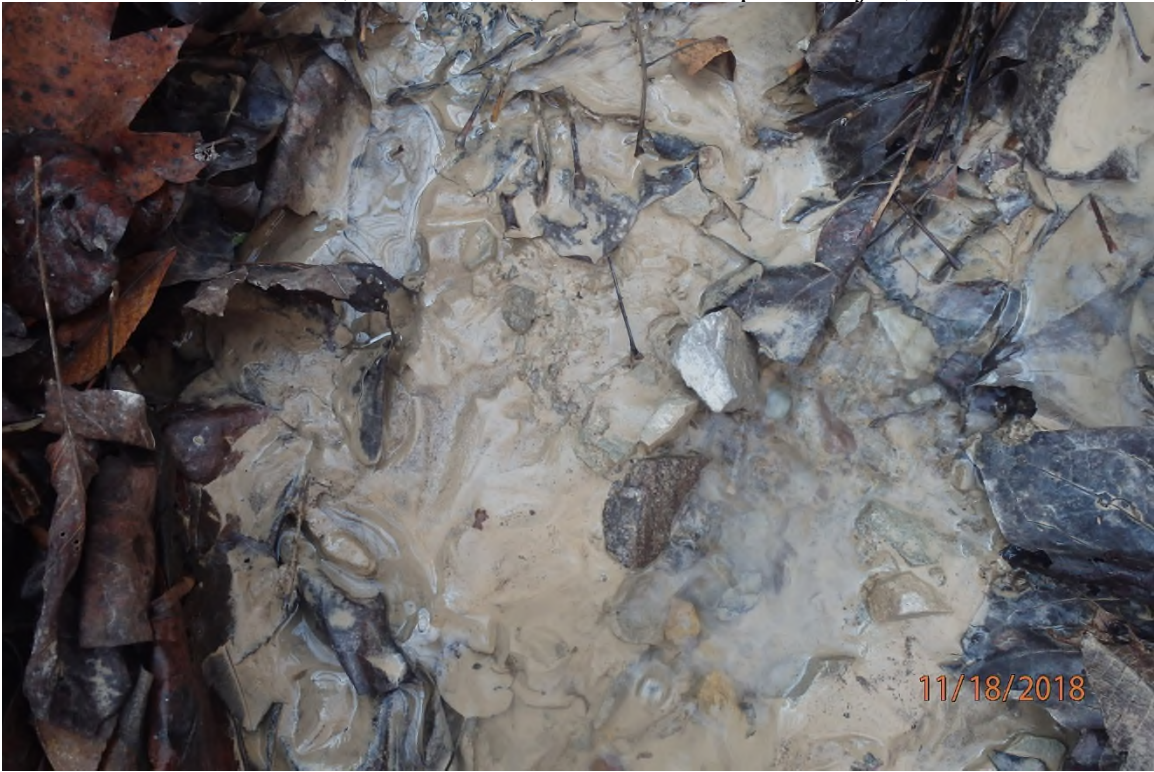
CNA deposits in UNT Georgescamp Run (39° 14.614' X 80° 44.951') on ARDO008.2 due to poor maintenance of installed BMP.

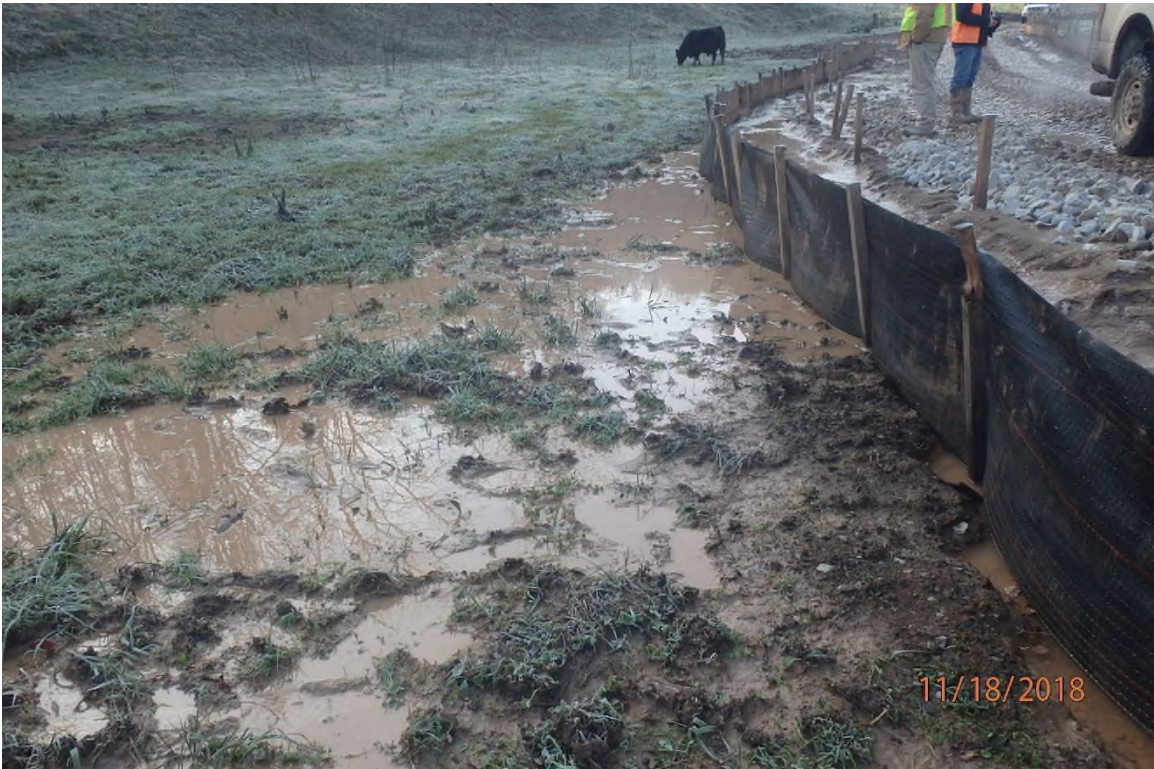
Improperly installed perimeter control on ARDO008.2 allowing sediment laden water to bypass under the installed BMP.

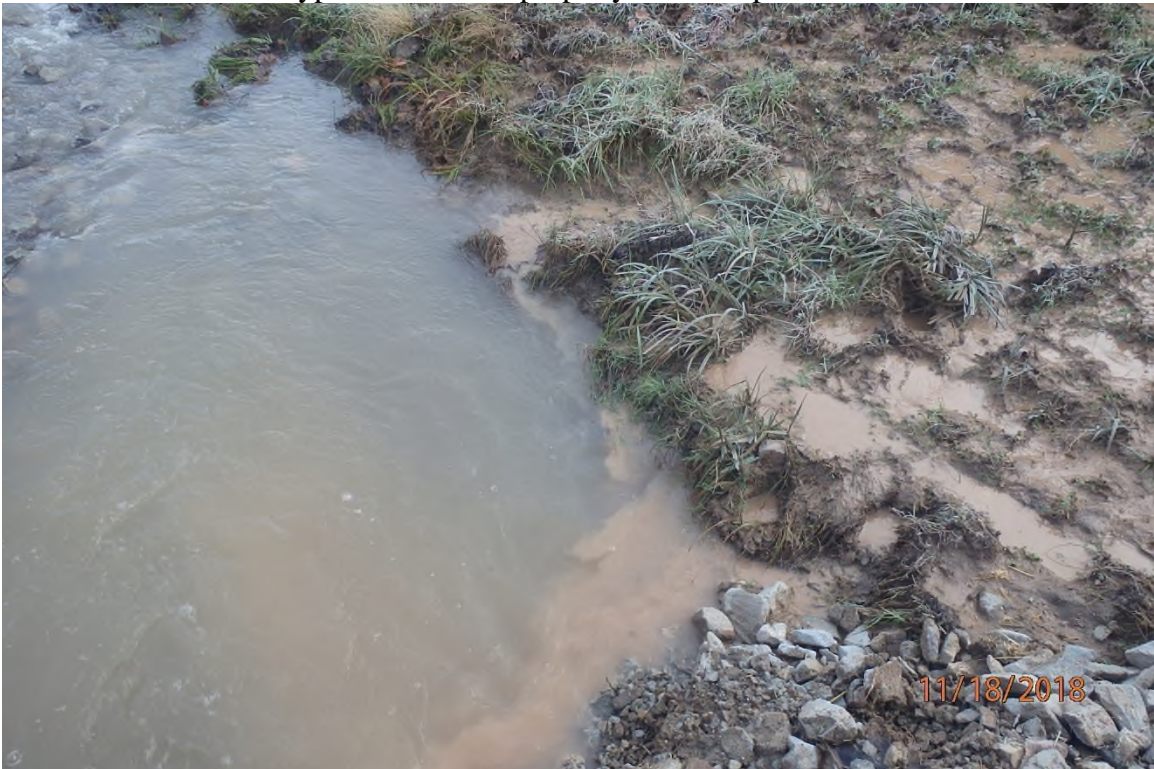
CNA distinctly visible settleable solids in Georgescamp Run (39° 15.092' X 80° 43.970') on ARDO008.2 due to a bypass from an improperly installed perimeter control.

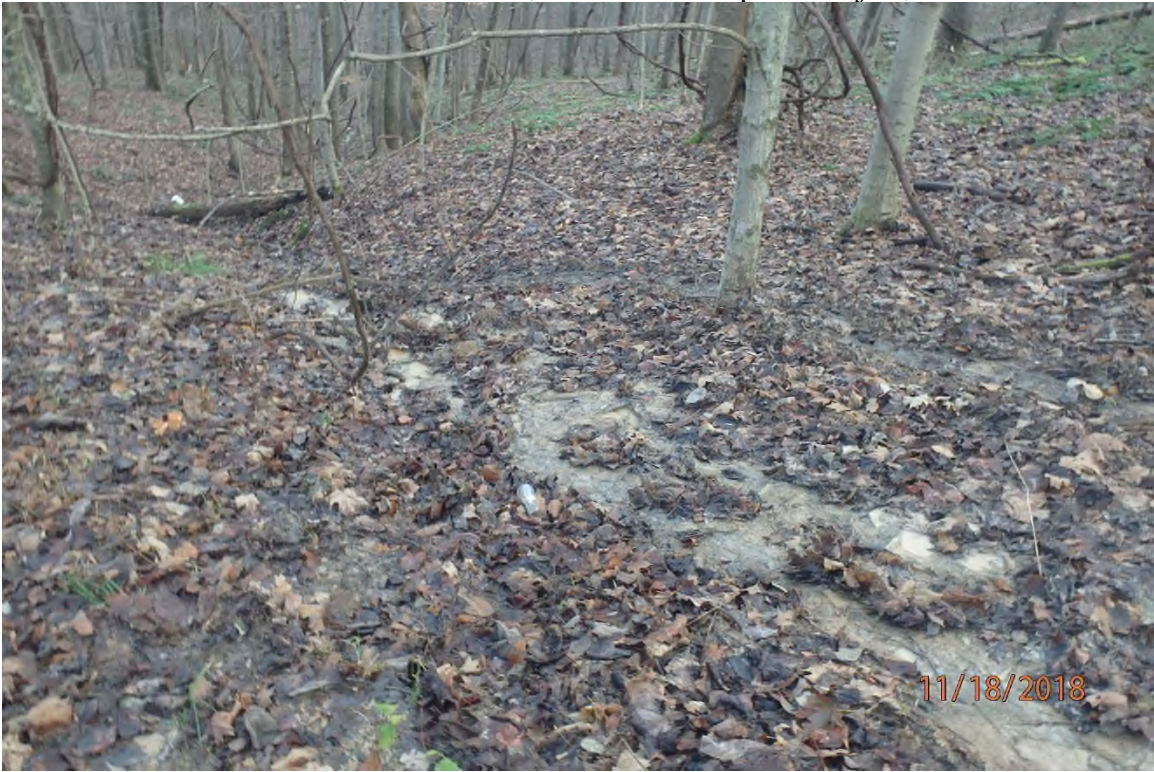
Flow of sediment laden water from the site to the receiving stream.

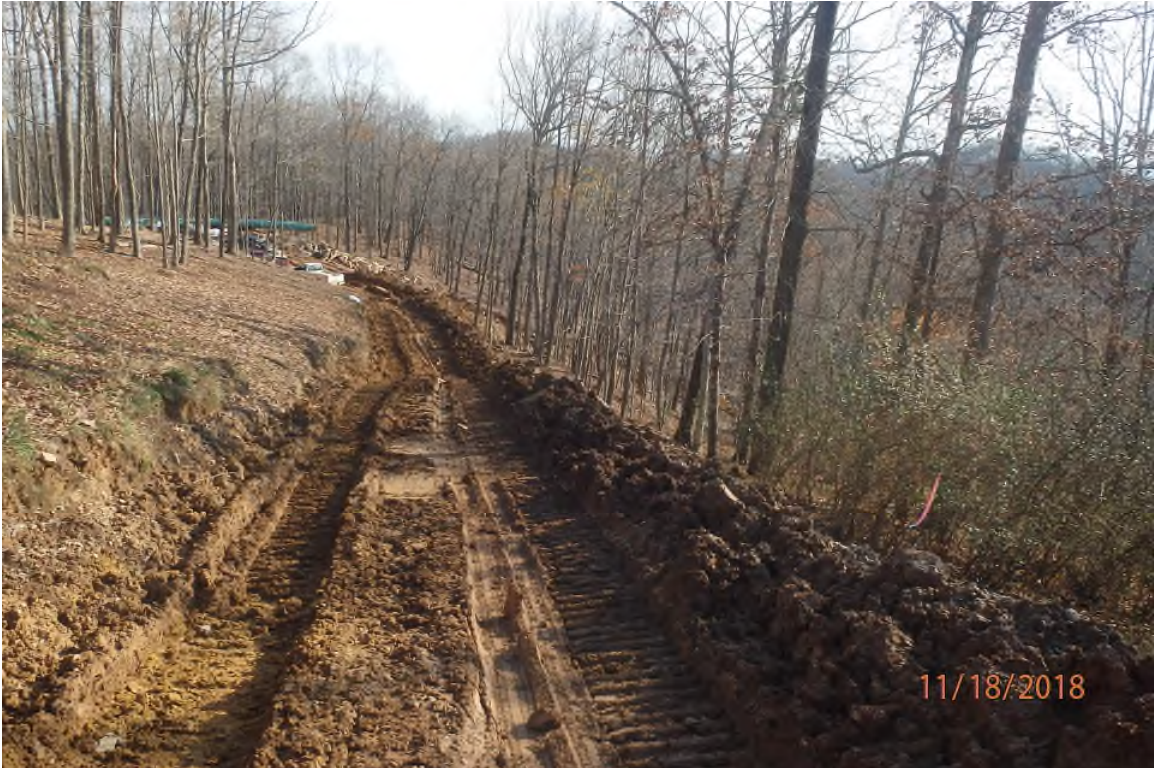
ARDO008.4 showing the lack of a graveled surface and the lack of perimeter controls, even though the road shows evidence of recent construction activity.

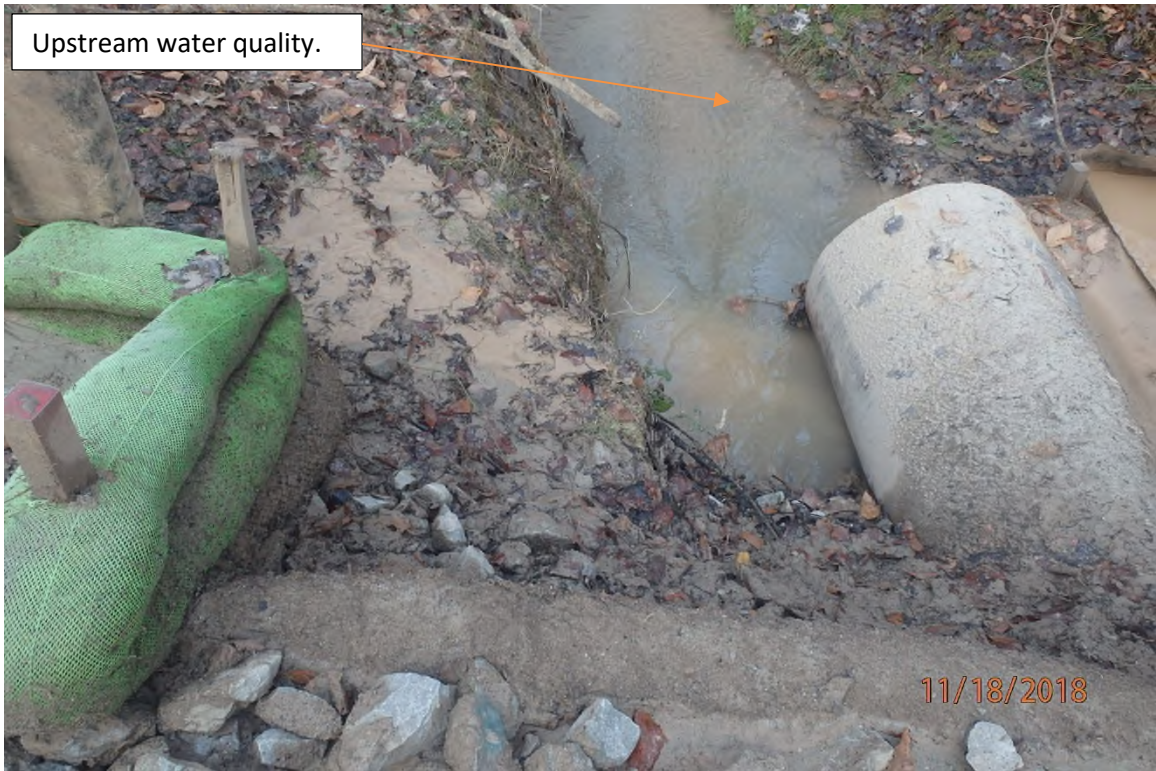
BMPS adjacent to Georgescamp Run that are overwhelmed due to the lack of drainage on the access road, causing sediment laden stormwater to bypass the devices.
