**CONSENT ORDER
ISSUED UNDER THE
WATER POLLUTION CONTROL ACT
WEST VIRGINIA CODE, CHAPTER 22, ARTICLE 11**

TO: Columbia Gas Transmission, LLC
Attn: Troy Tally, Vice President
1700 MacCorkle Ave
Charleston, WV 25314

DATE: October 1, 2020
ORDER NO.: 9061

1. Columbia Gas Transmission, LLC is conducting land disturbance activity associated with construction of the Mountaineer Xpress Project in Marshall, Wetzel, Tyler, Doddridge, Ritchie, Calhoun, Wirt, Roane, Jackson, Mason, Putnam, and Cabell Counties, West Virginia. On January 31, 2018, Columbia Gas Transmission, LLC was issued Water Pollution Control Permit No. WV0116815, Registration No. WVR310872, for Stormwater Associated With Oil and Gas Related Construction Activities.

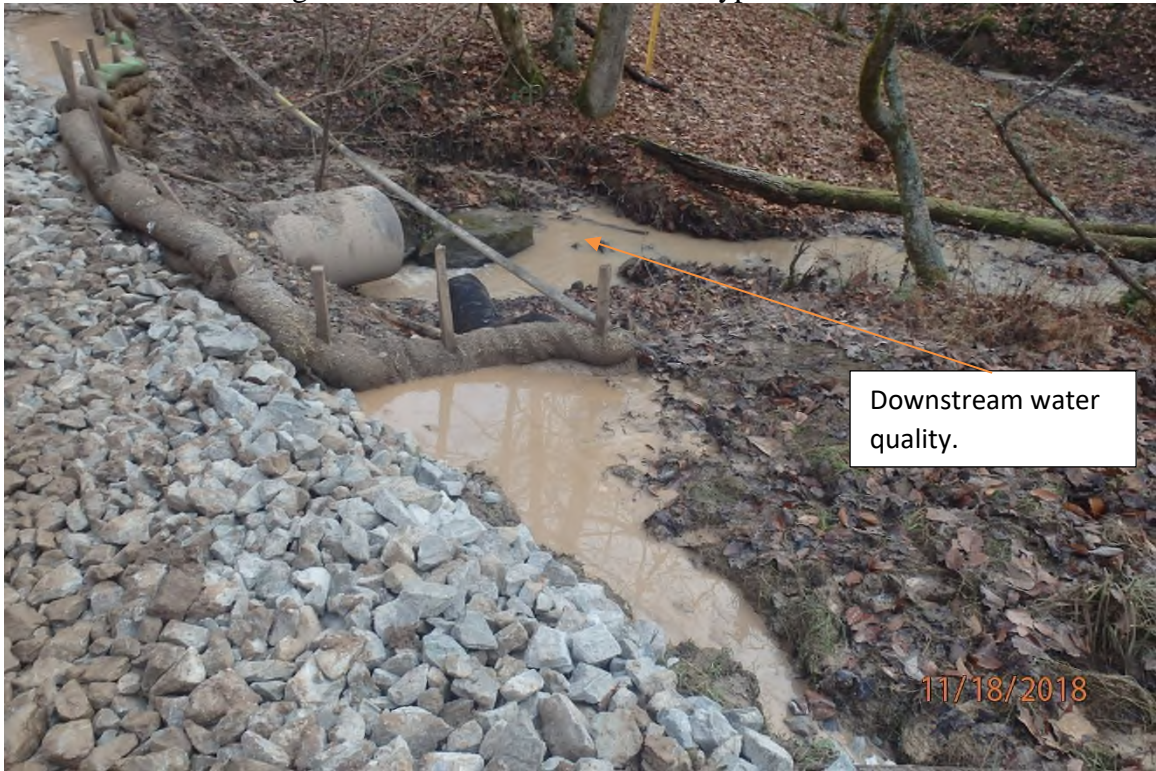
BMPS adjacent to Georgescamp Run that are overwhelmed due to the lack of drainage on the access road, causing sediment laden stormwater to bypass the devices.

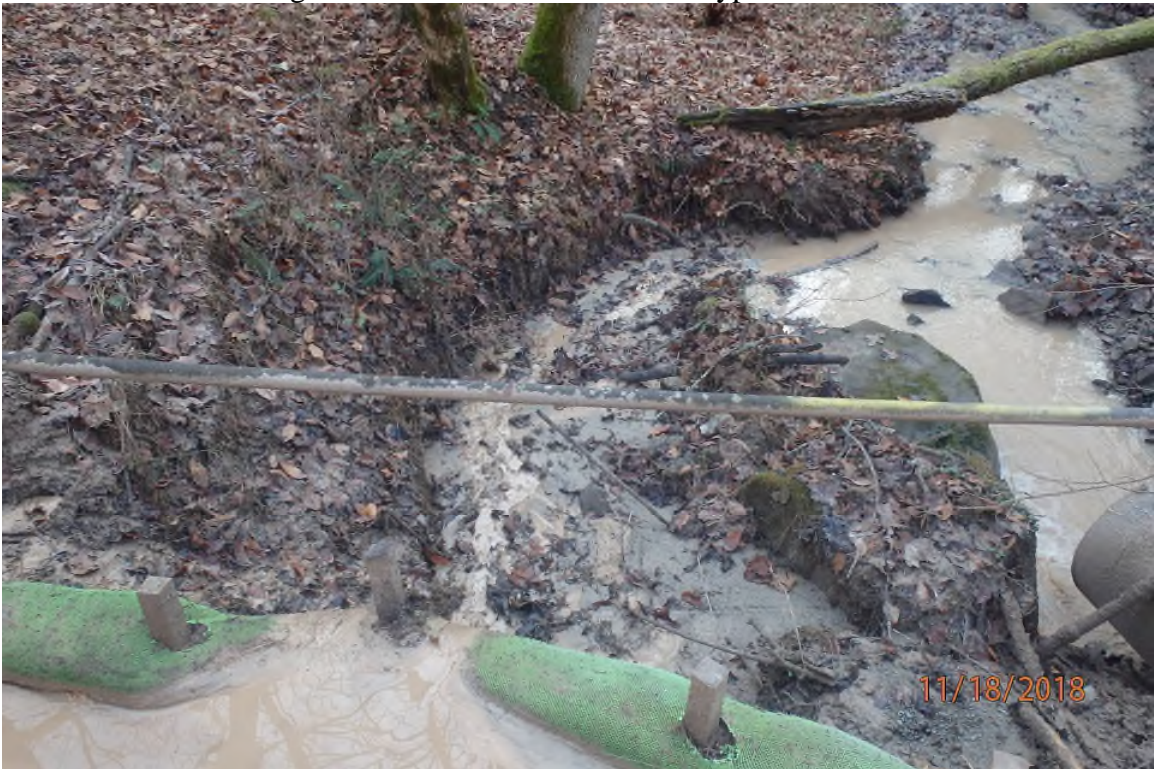
CNA distinctly visible settleable solids in Georgescamp Run (39° 14.817' X 80° 44.539') as a result of the above pictured deficiency.

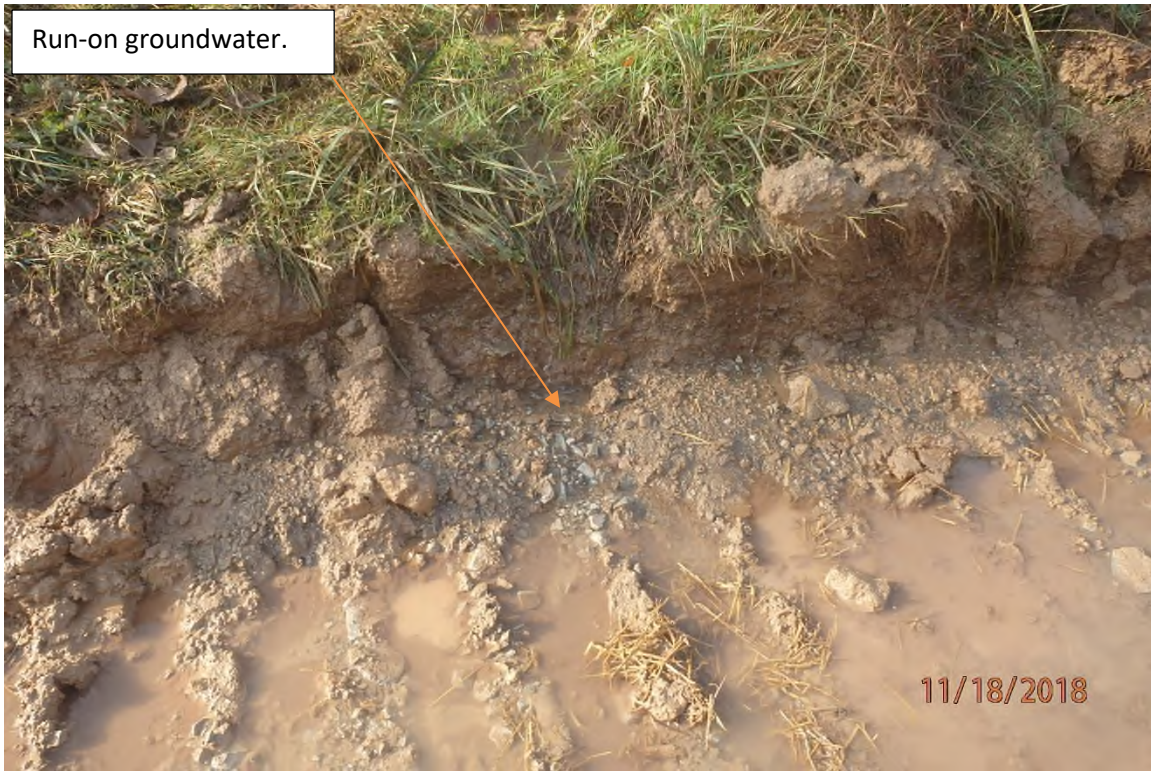
Run-on groundwater on ARDO008.5 that is running into the road surface contrary to the approved SWPPP.

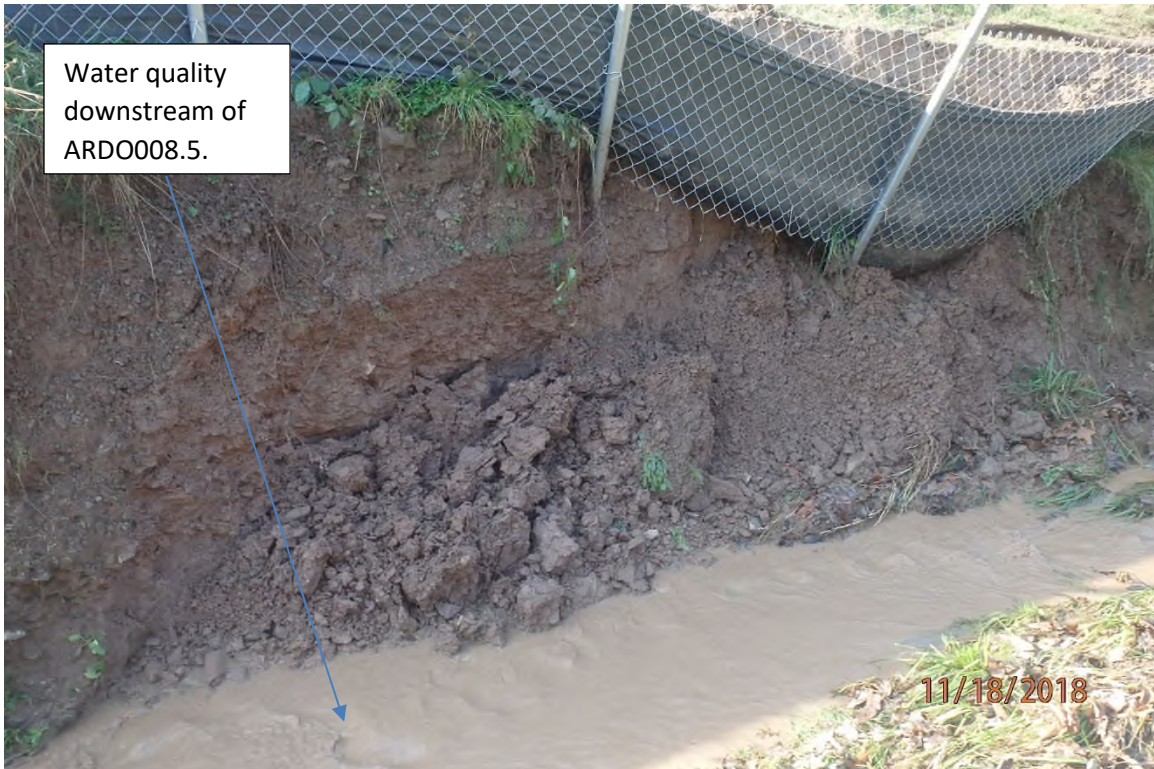
11/18/2018

Water quality
downstream of
ARDO008.5.

Third installed BMP failed and caused CNA deposits in UNT Georgescamp Run (39°15.182' X 80° 44.033').

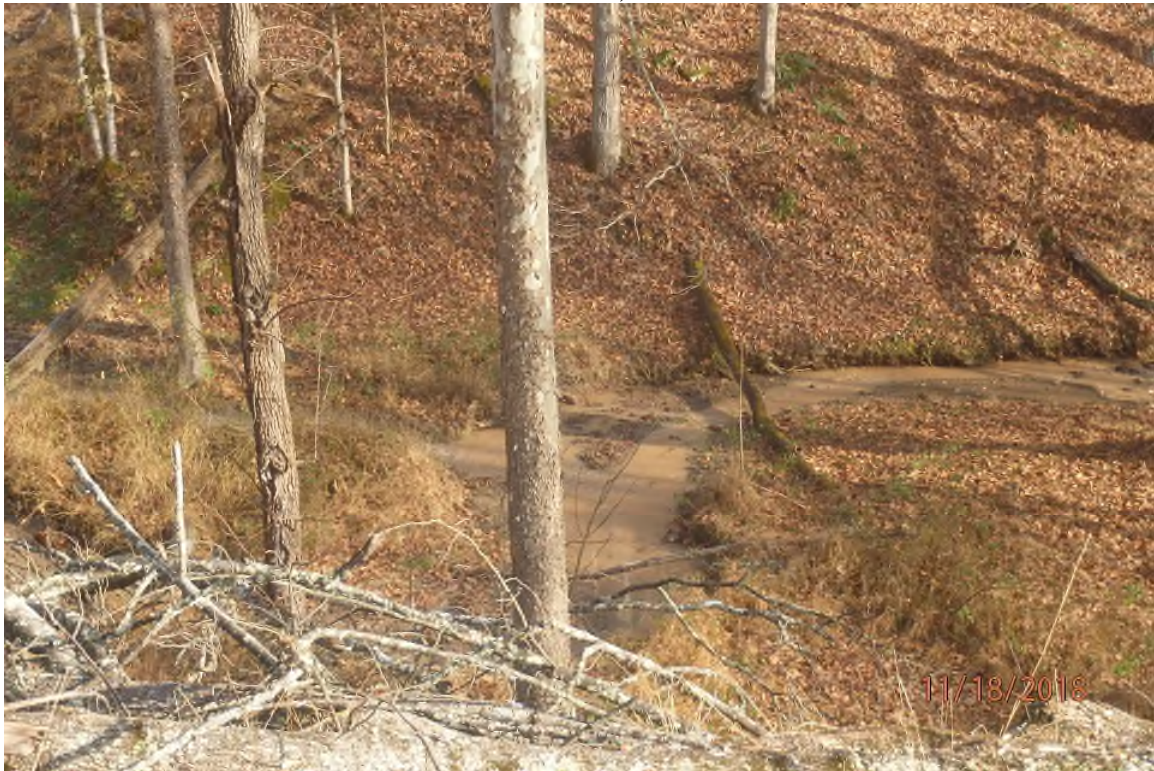
11/18/2018

Stream quality upstream of ARDO008.5 showing turbidity that originates from documented dewatering of the pipe trench. Water quality is further degraded downstream of ARDO008.5 due to the above pictured deficiencies.

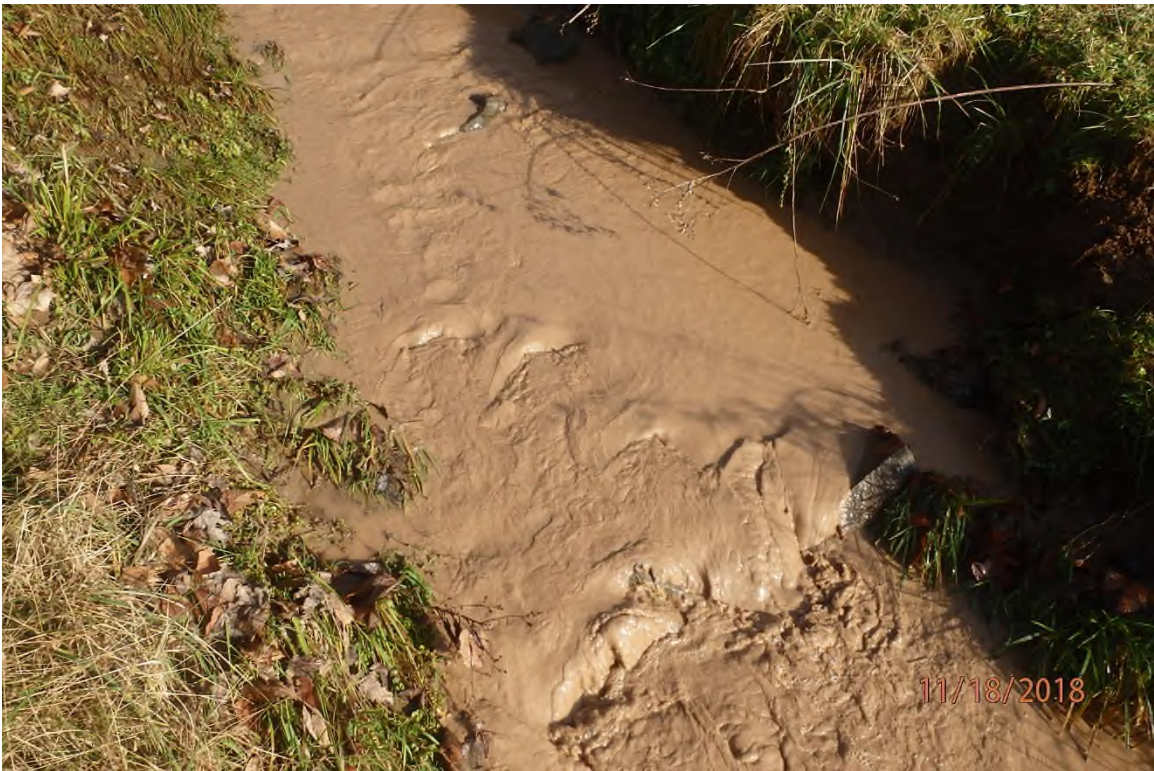
Water quality downstream of ARDO008.5

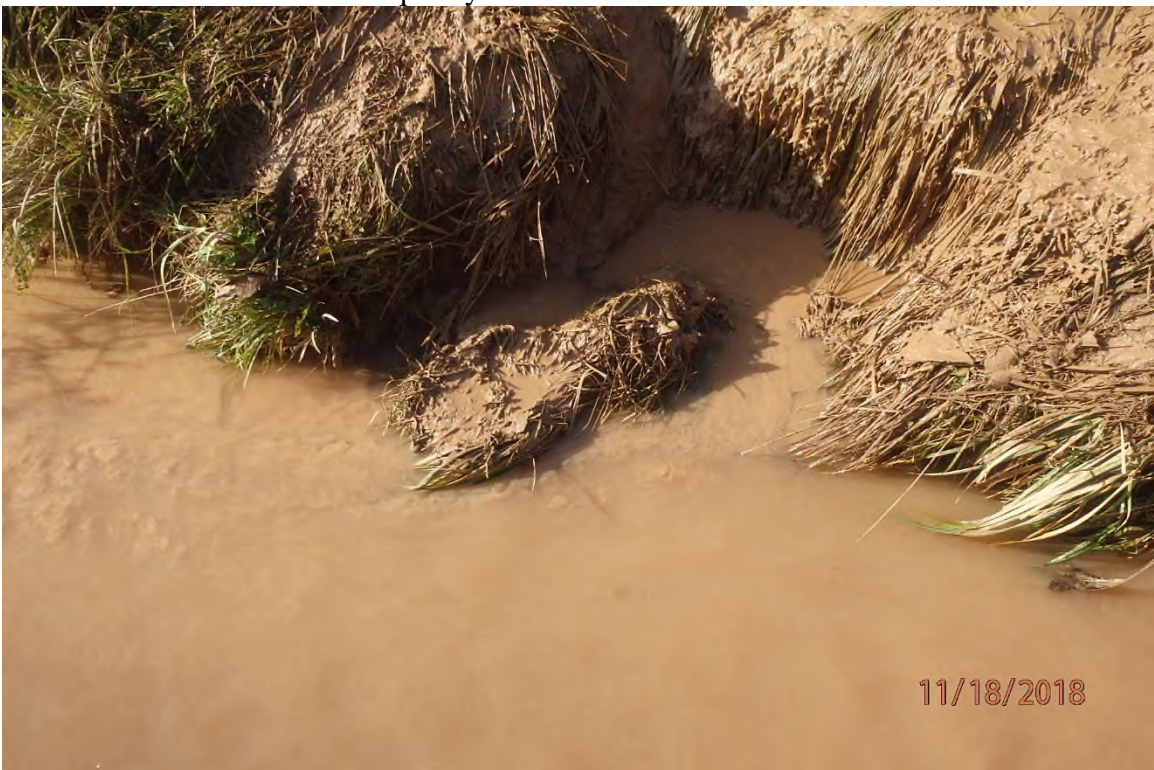
Visible plume in UNT Georgescamp Run ($39^{\circ}15.182'$ X $80^{\circ}44.033'$) adjacent to ARDO008.5

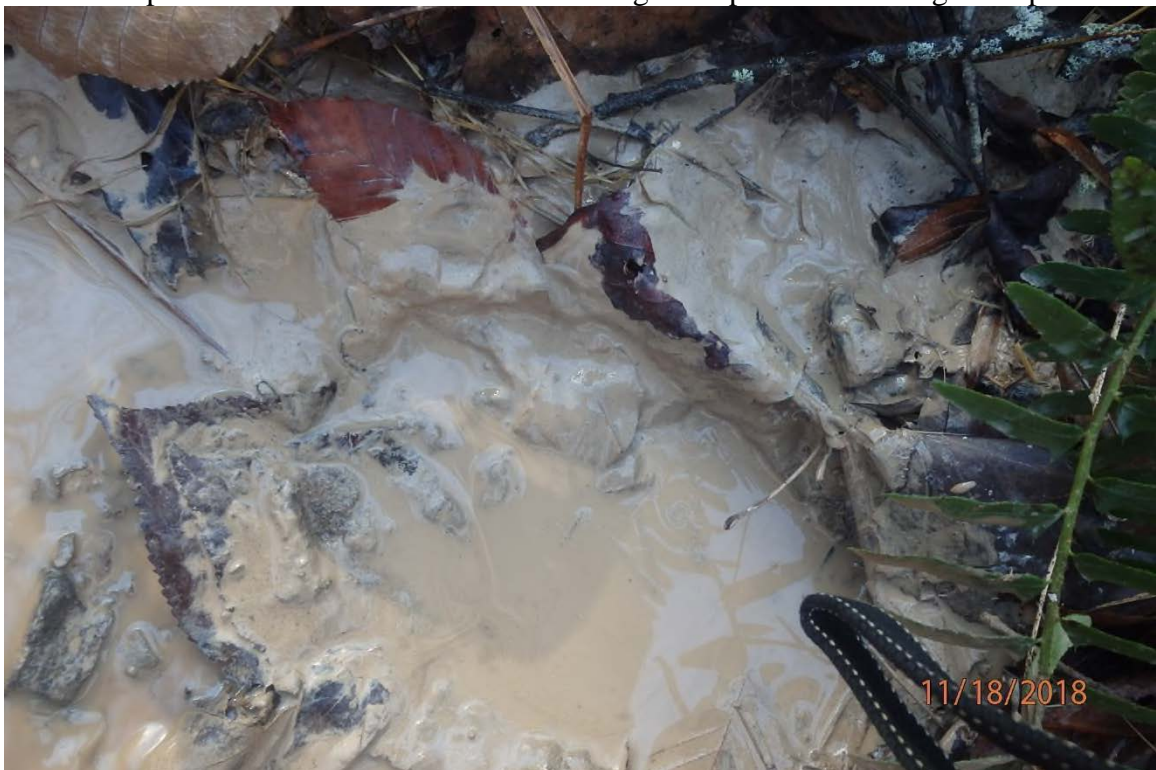
CNA deposits in UNT Georgescamp Run (39°14.764' X 80° 44.733') that originate from site.

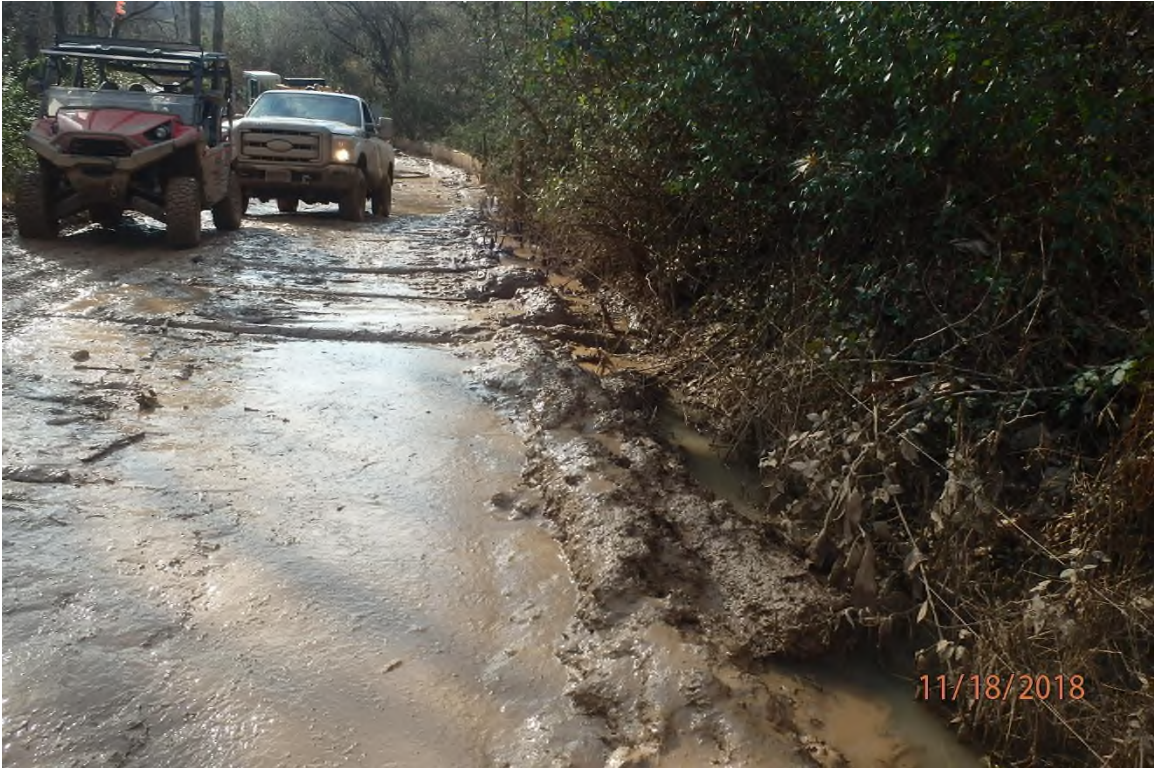
ARDO009.3 showing stormwater in an upslope ditch that is overflowing onto the road surface due to the lack of adequate drainage.

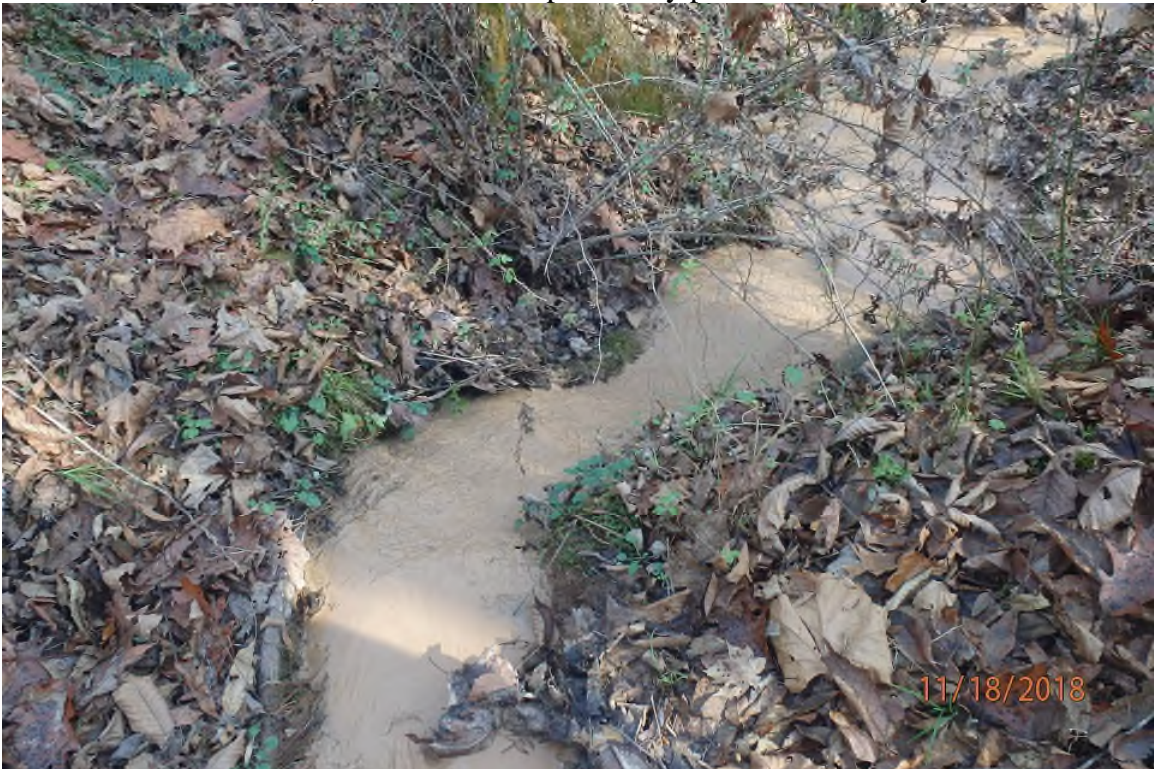
CNA distinctly visible settleable solids and deposits in UNT Bluestone Creek (39° 14.425' X 80° 45.817') as a result of the previously pictured deficiency.

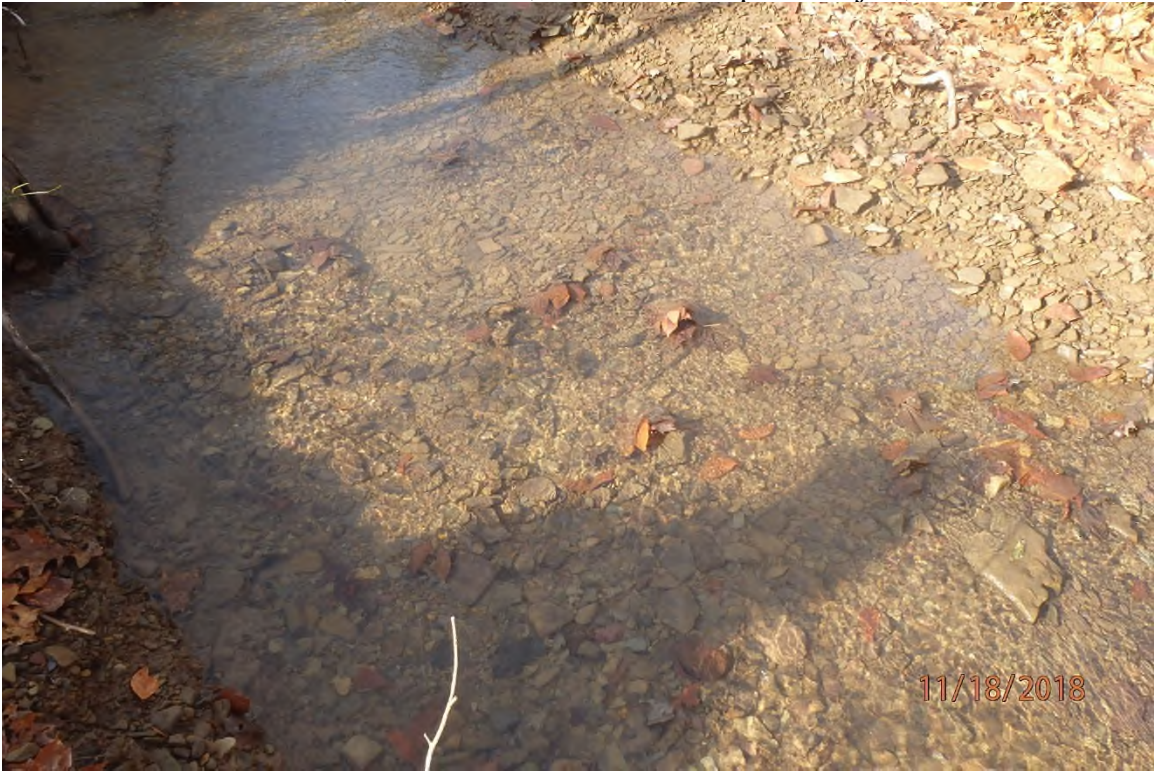
Water quality of UNT Georgescamp Run upstream of the dewatering operation as well as ARDO008.5.

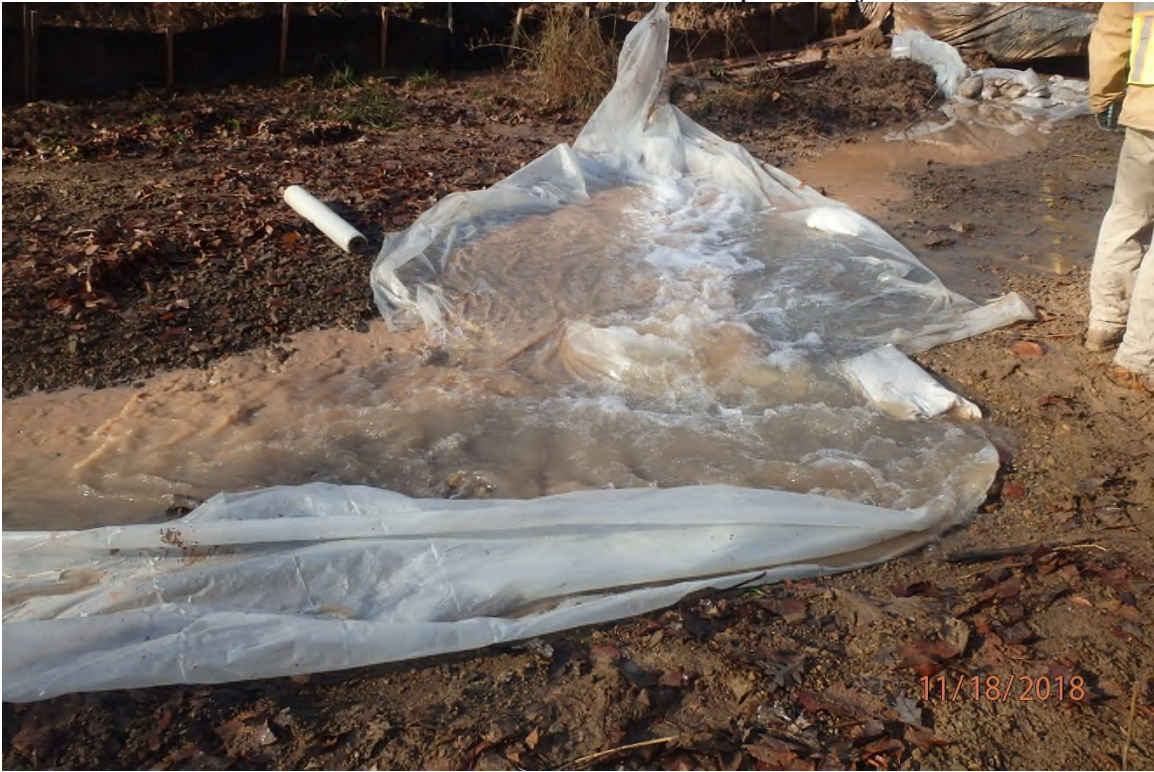
Visible plume in UNT Georgescamp Run (SDOG048) ($39^{\circ} 15.261'$ X $80^{\circ} 44.096'$) at outflow of the installed pump-around.

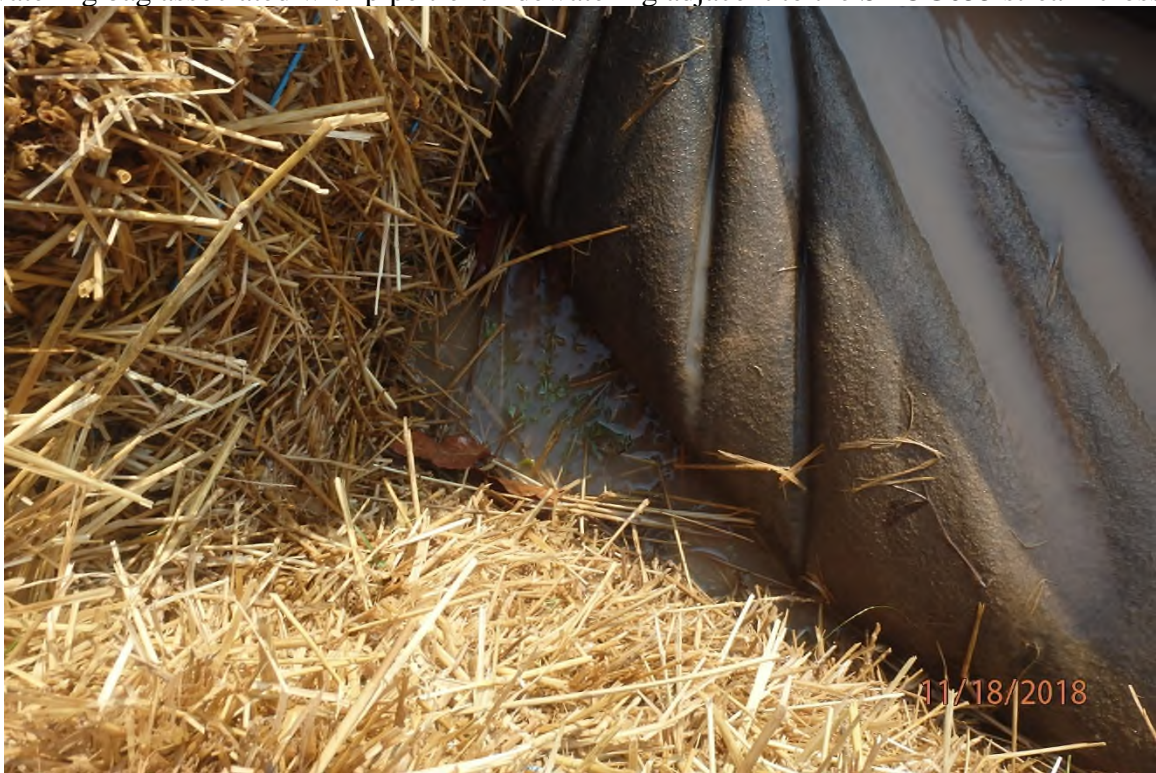
Dewatering bag associated with pipe trench dewatering adjacent to the SDOG055 stream crossing.

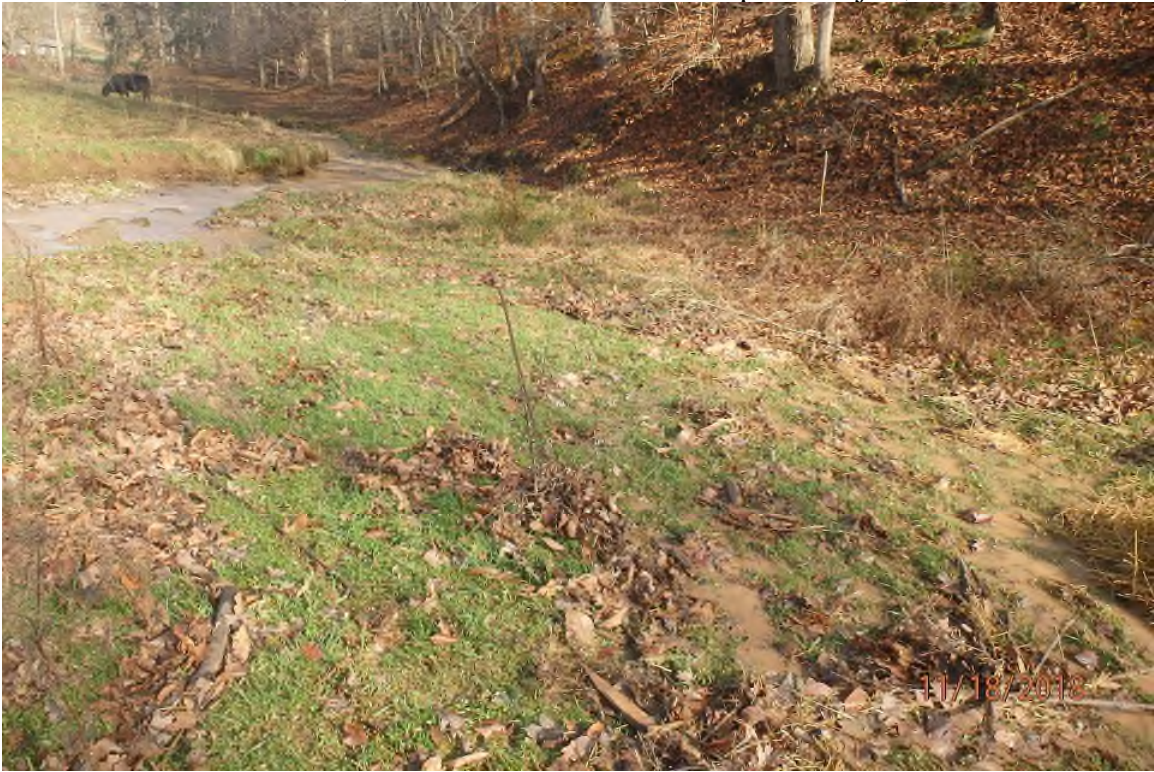
Stream of sediment laden water downslope of the above pictured dewatering bag that is flowing to the adjacent receiving stream.

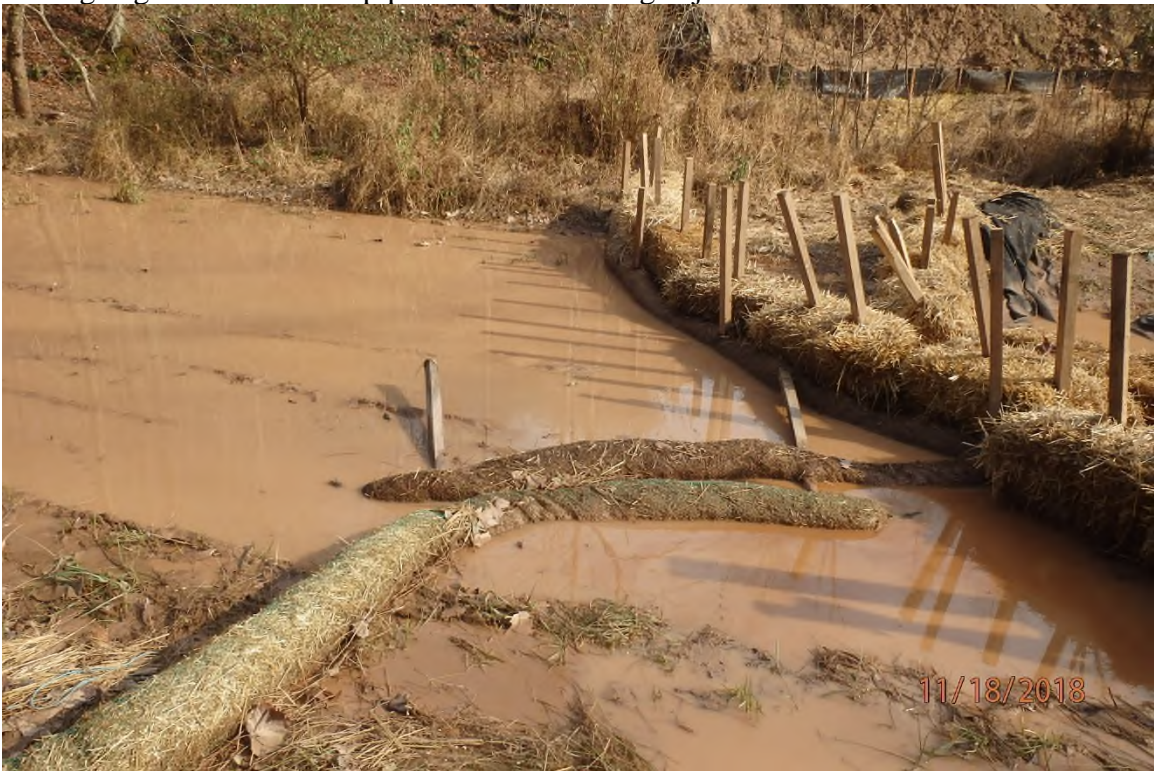
Dewatering bag associated with pipe trench dewatering adjacent to the SDOG536 stream crossing.

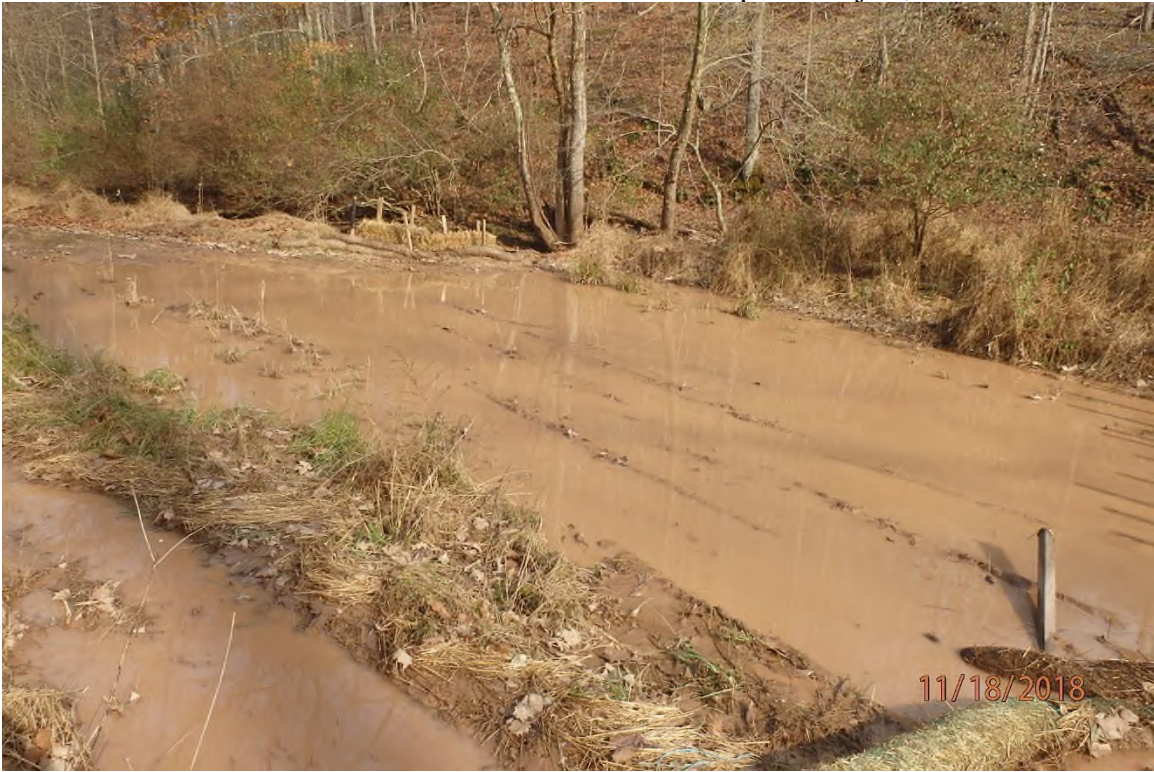
Stream of sediment laden water downslope of the above pictured dewatering bag that is flowing to the adjacent receiving stream.

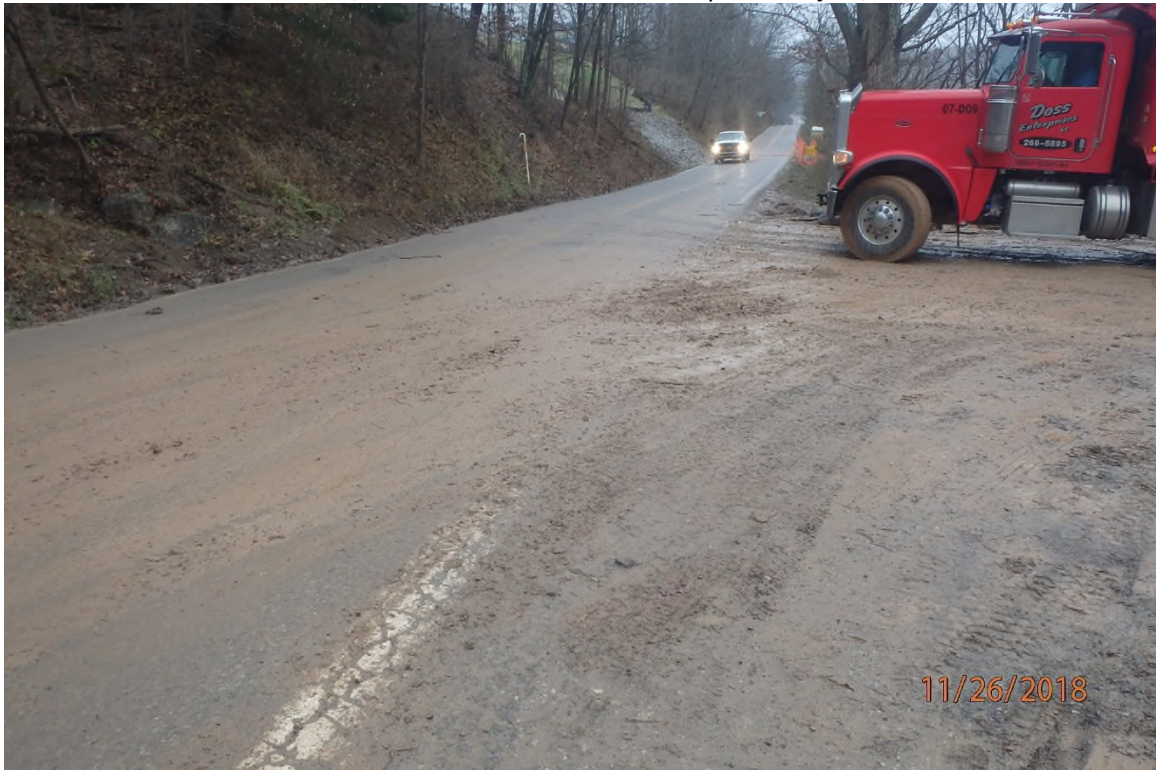
Construction entrance at the WV 23 crossing showing the lack of a stabilized entrance and the associated track out onto the public road.

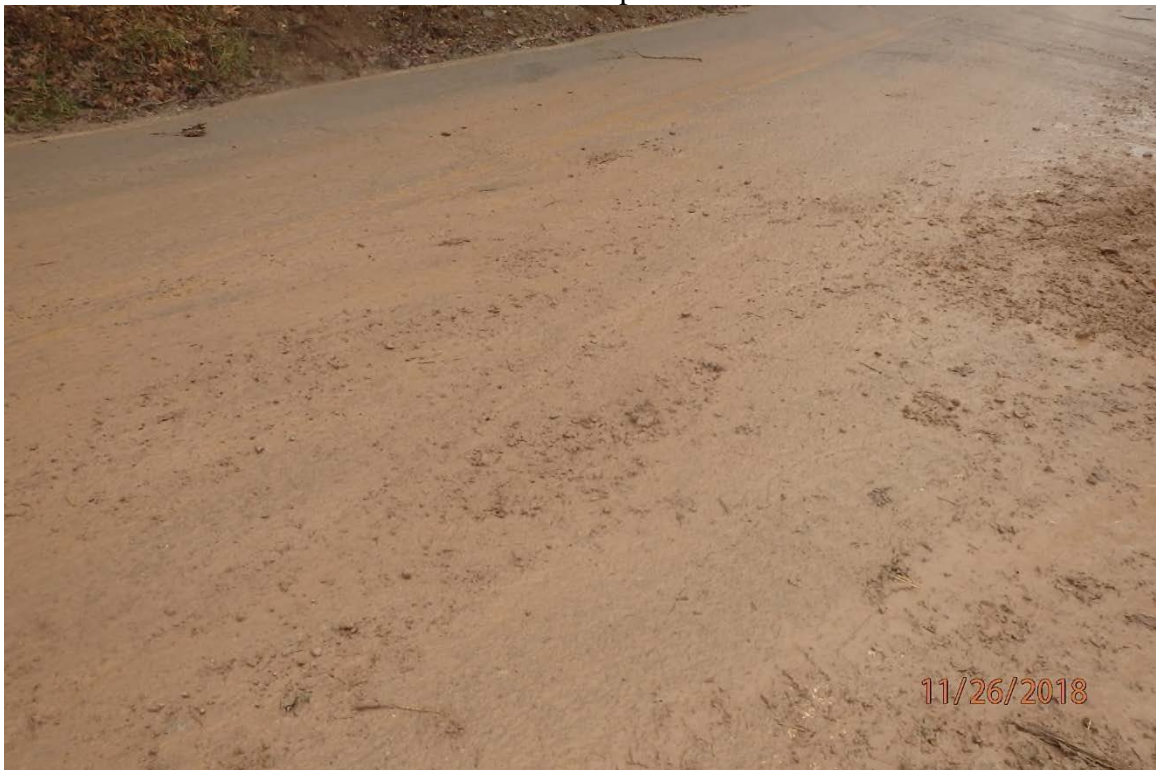
Construction entrance at the WV 23 crossing showing the lack of a stabilized entrance and the associated track out onto the public road.

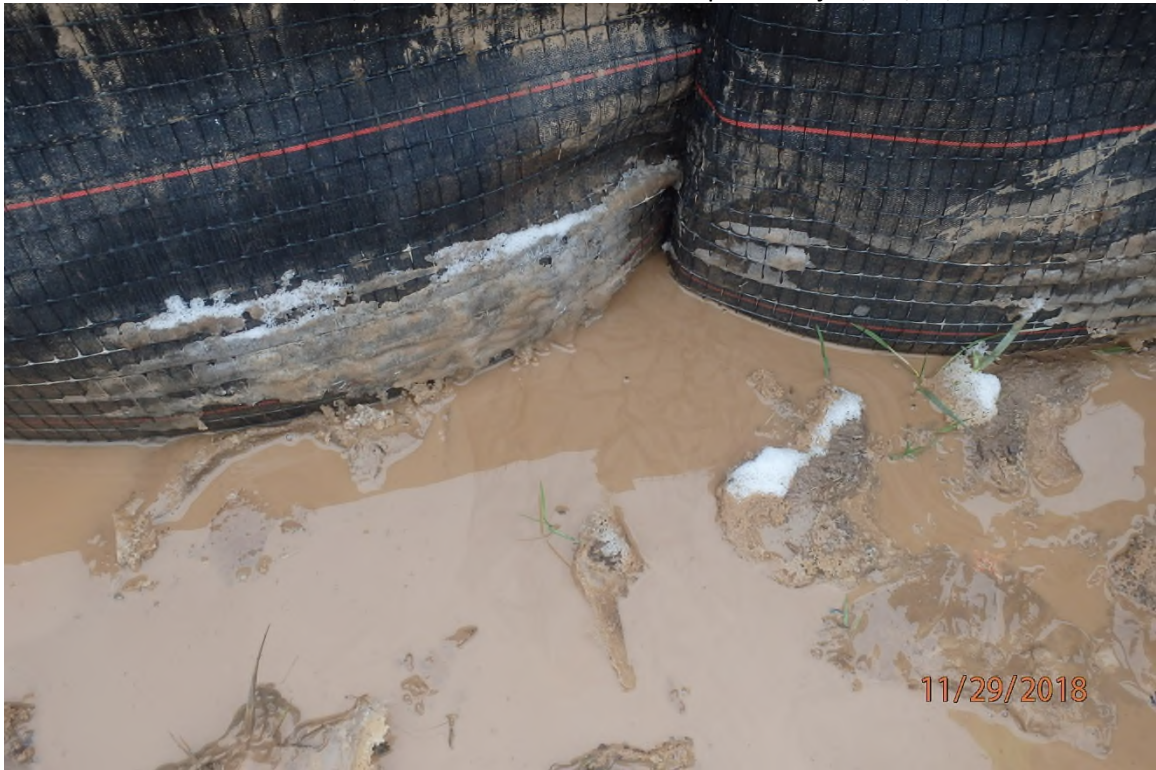
Unmaintained perimeter control on ARDO009.1.

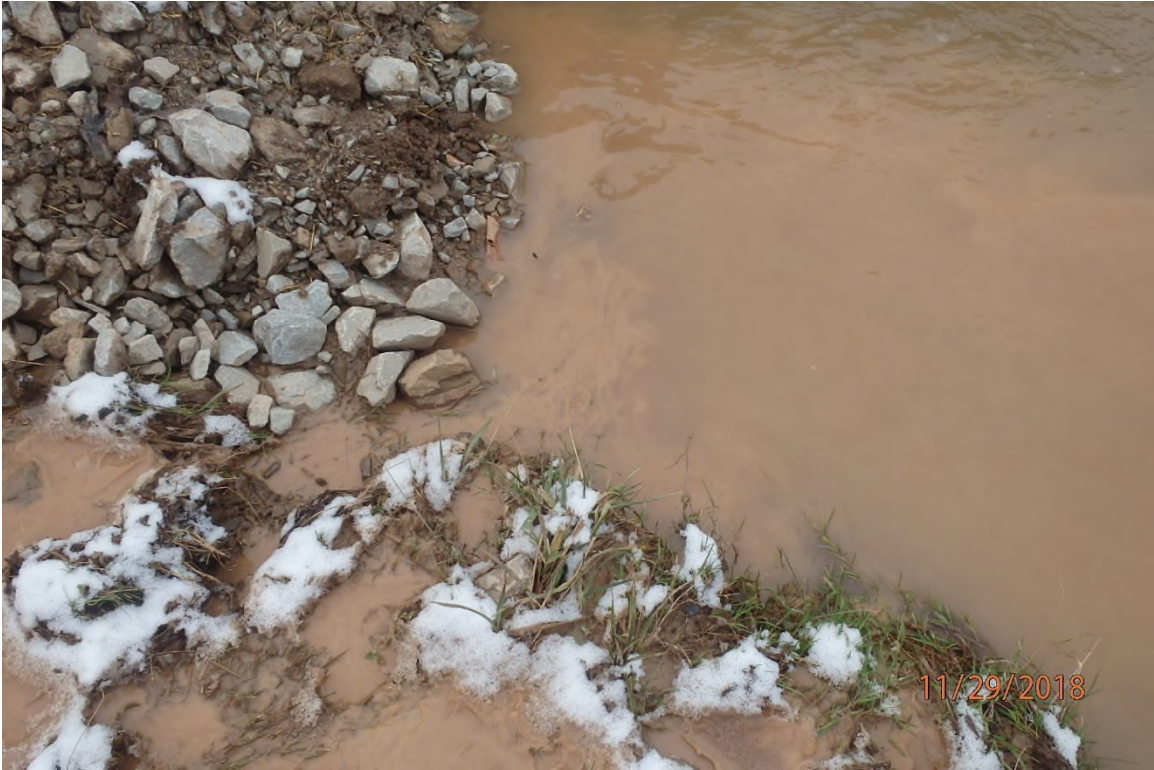
Improperly operated BMP on ARDO008.2 that allows sediment laden water to bypass under the device.

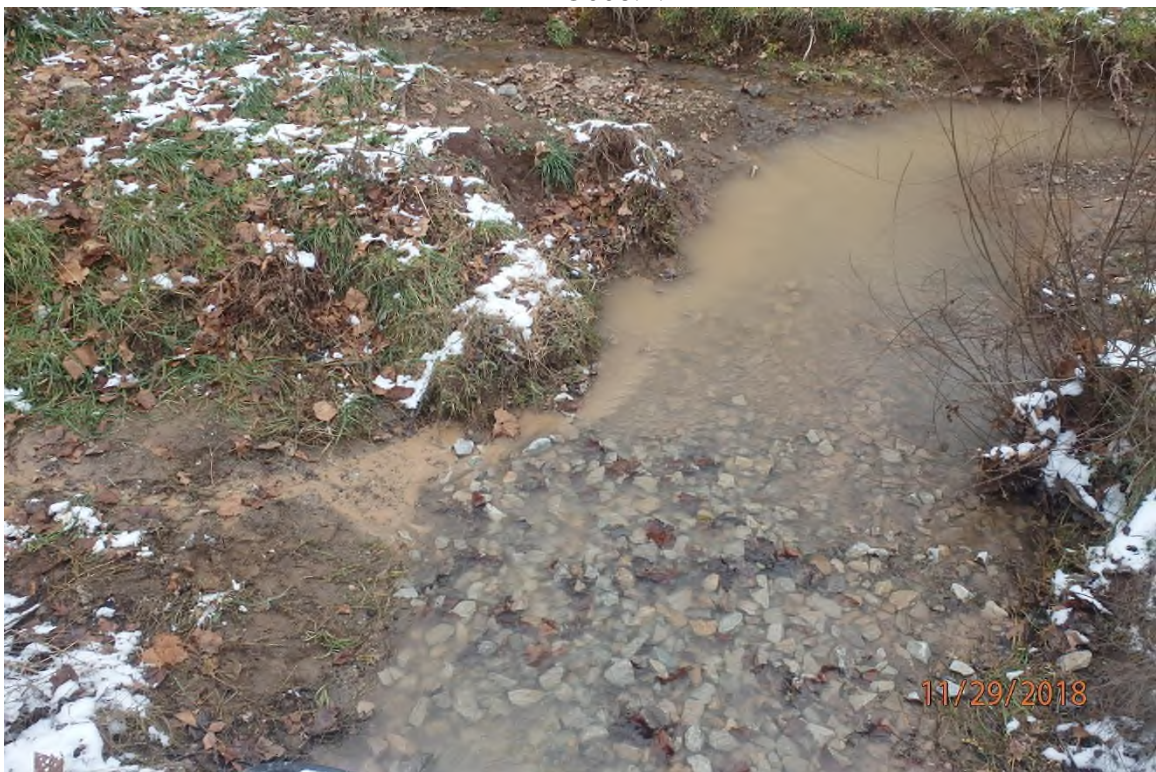
Trail of sediment laden water leading to the receiving stream from the previously pictured BMP on ARDO008.2.

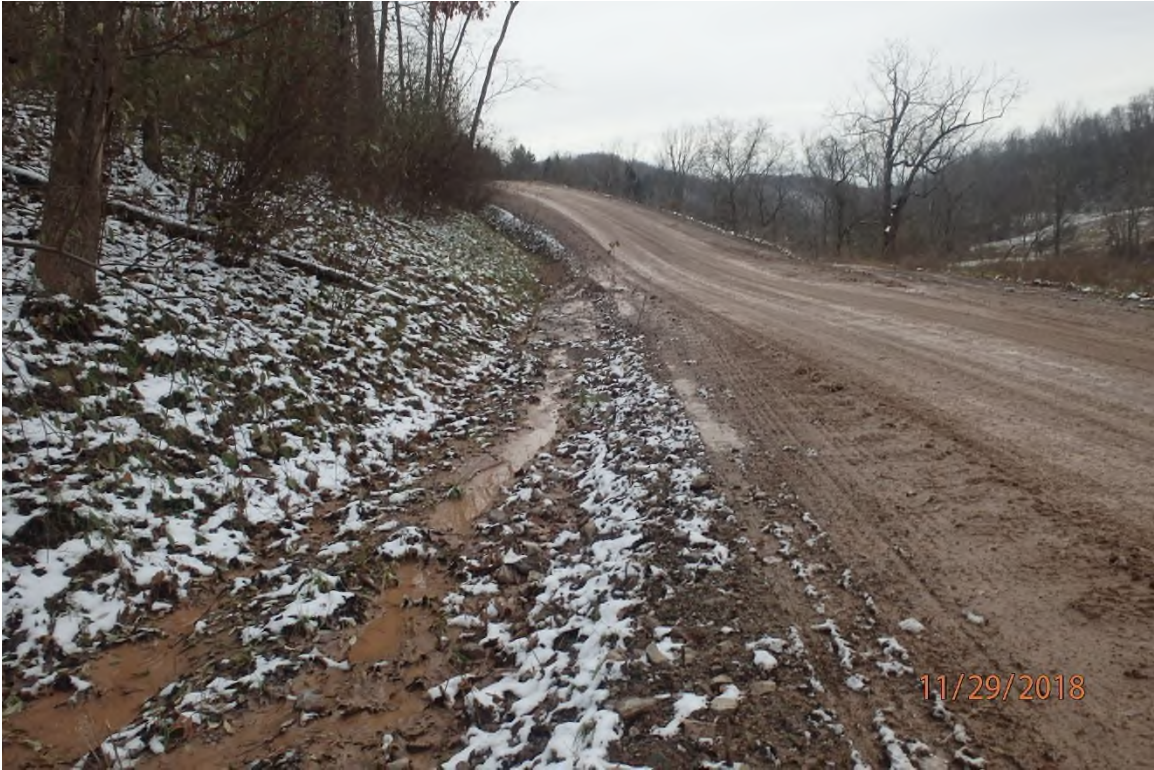
ARDO009.3 showing an unstable road surface that requires construction activity with no BMPs in place as indicated in the approved SWPPP.

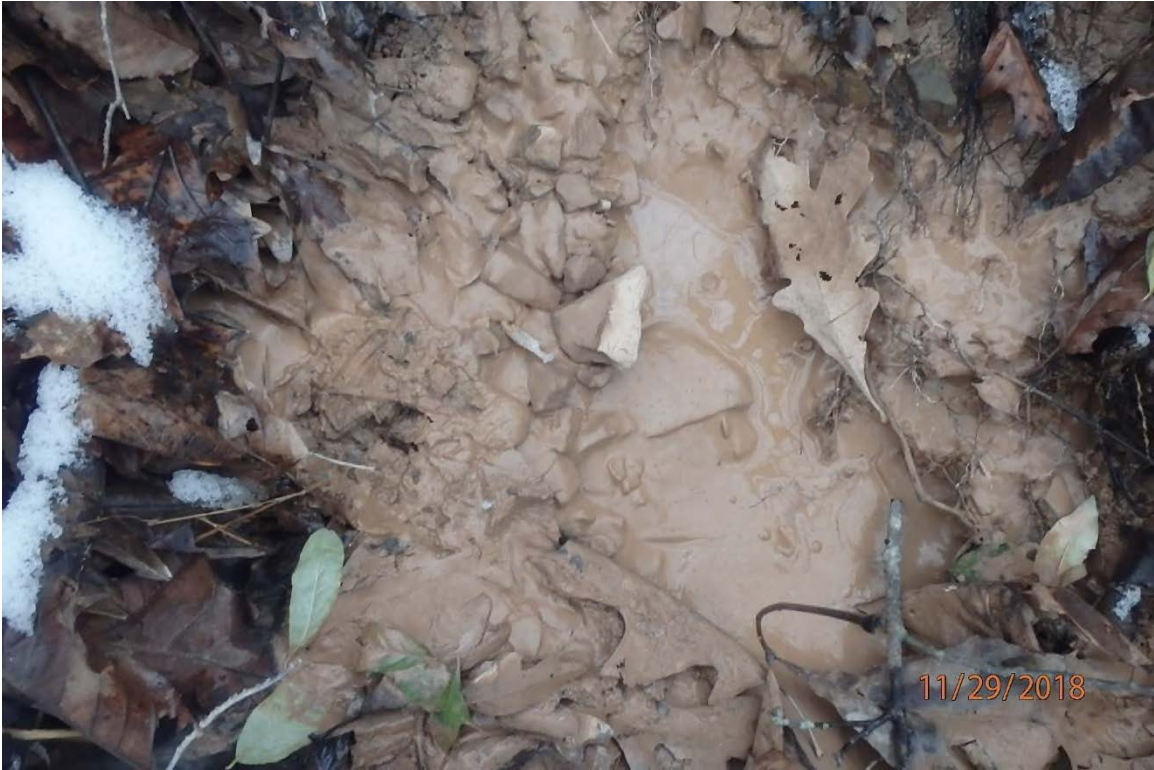
CNA deposits in UNT Bluestone Creek (39° 13.496' X 80° 45.815') that originate from the previously pictured area on ARDO009.3 that is unstable and lacks BMPs.

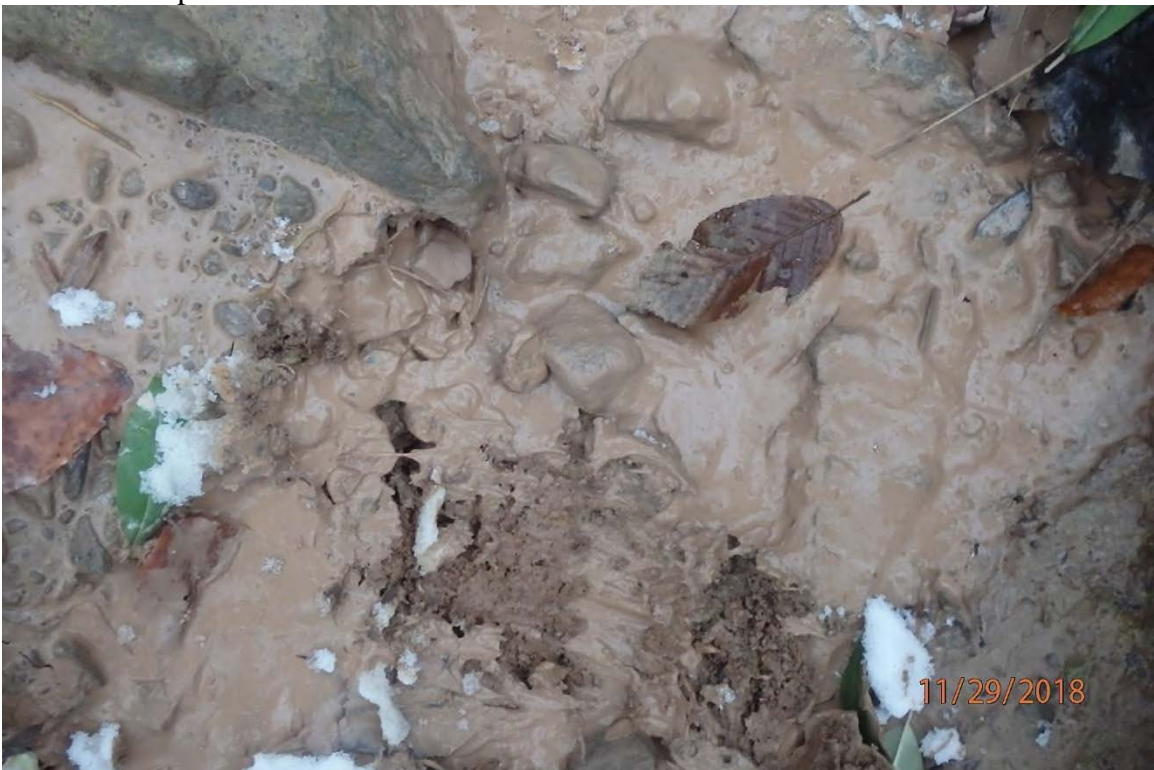
CNA deposits in UNT Bluestone Creek (39° 13.496' X 80° 45.815') that originate from the previously pictured area on ARDO009.3 that is unstable and lacks BMPs.

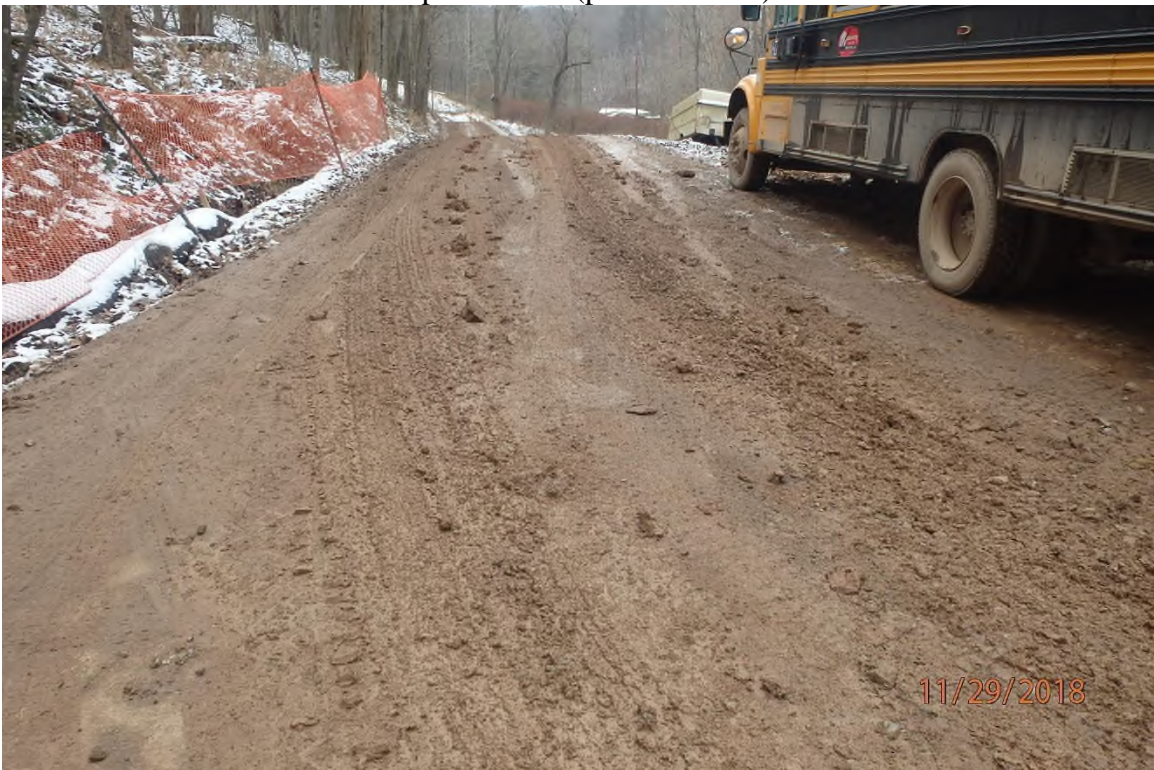
ARDO002.41 (Ralphs Run Access) showing the lack of a stable construction entrance and track-out onto the public road (paved surface).
