**CONSENT ORDER
ISSUED UNDER THE
WATER POLLUTION CONTROL ACT
WEST VIRGINIA CODE, CHAPTER 22, ARTICLE 11**

TO: Columbia Gas Transmission, LLC
Attn: Troy Tally, Vice President
1700 MacCorkle Ave
Charleston, WV 25314

DATE: October 1, 2020
ORDER NO.: 9061

1. Columbia Gas Transmission, LLC is conducting land disturbance activity associated with construction of the Mountaineer Xpress Project in Marshall, Wetzel, Tyler, Doddridge, Ritchie, Calhoun, Wirt, Roane, Jackson, Mason, Putnam, and Cabell Counties, West Virginia. On January 31, 2018, Columbia Gas Transmission, LLC was issued Water Pollution Control Permit No. WV0116815, Registration No. WVR310872, for Stormwater Associated With Oil and Gas Related Construction Activities.

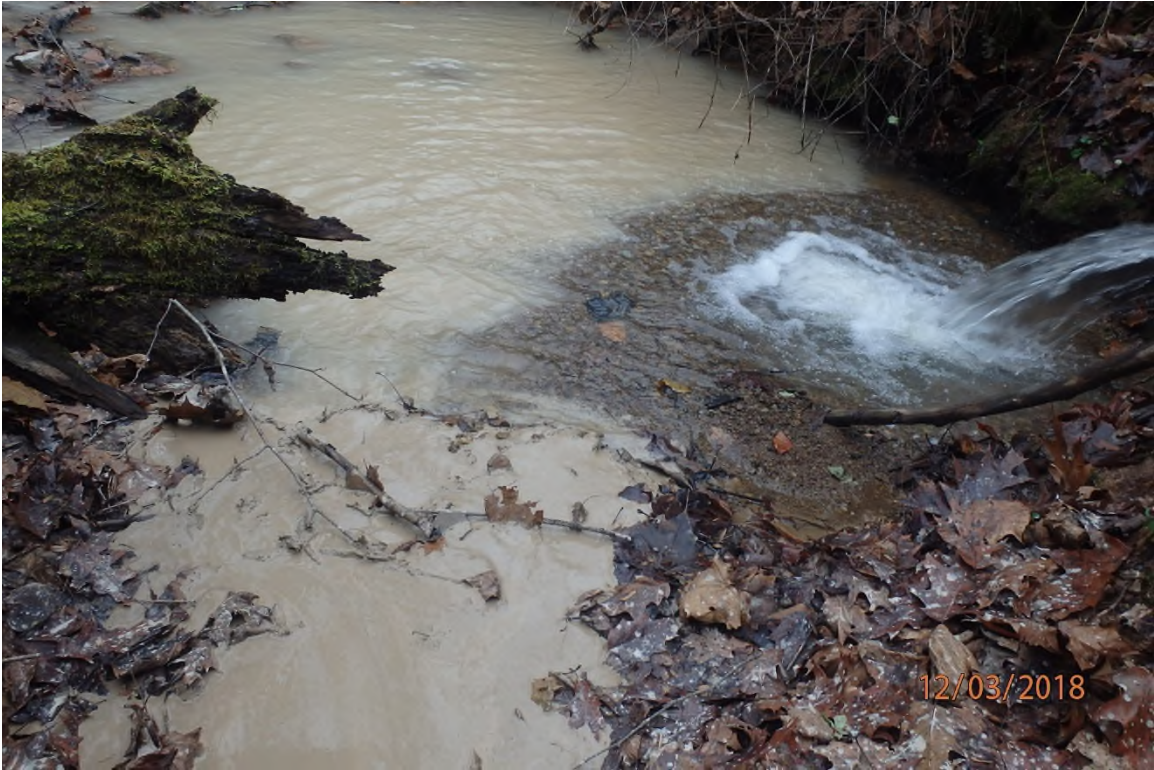
Offsite sediment deposits and CNA in UNT Douglascamp Run as a result of sediment laden water bypassing the equipment bridge BMP due to poor maintenance.

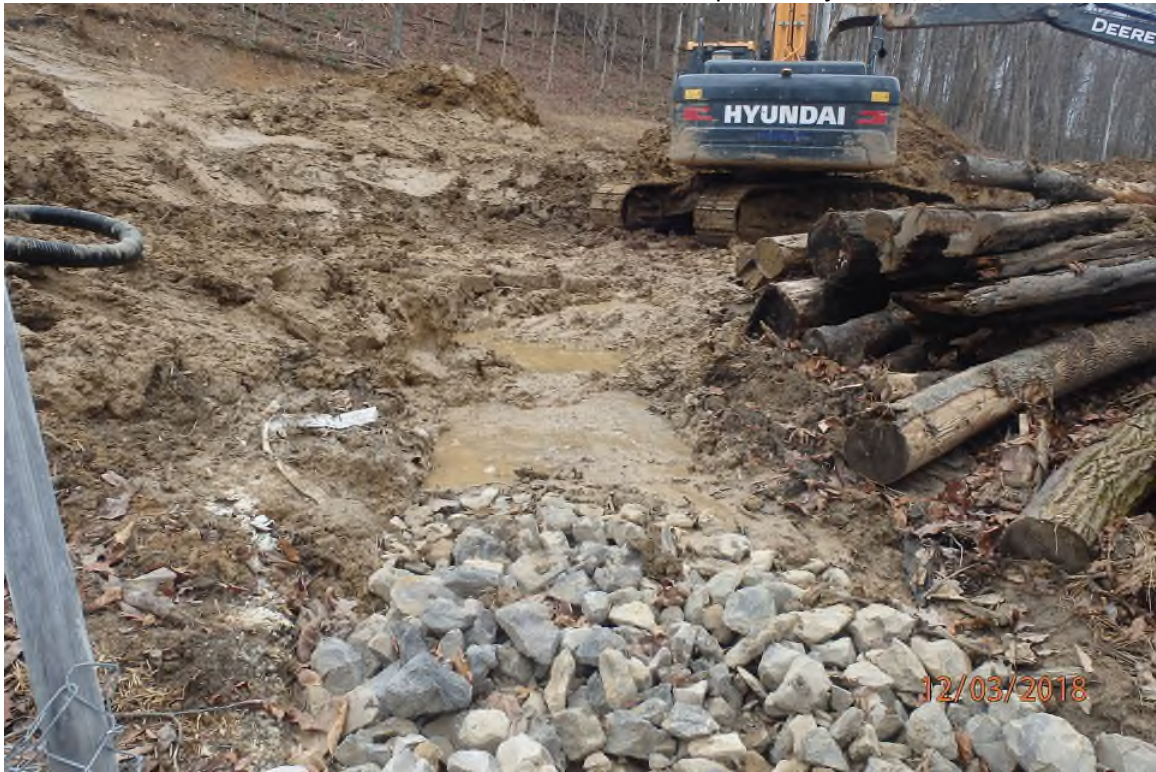
CNA distinctly visible settleable solids and deposits in UNT Douglascamp Run (39° 16.284' X 80° 42.421') as a result of the previously pictured unmaintained equipment bridge BMP.

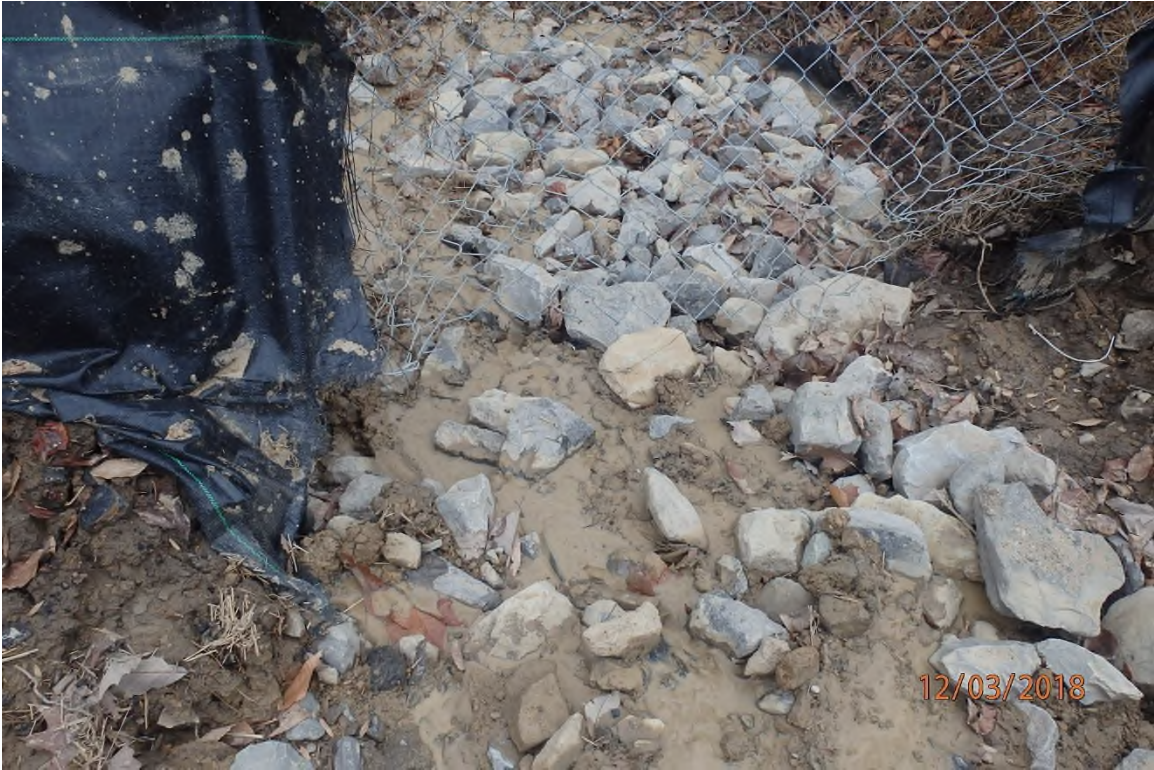
Project area adjacent to 2611+00 showing gaps in the installed perimeter control that allow sediment laden water to leave the site without going through an appropriate device.

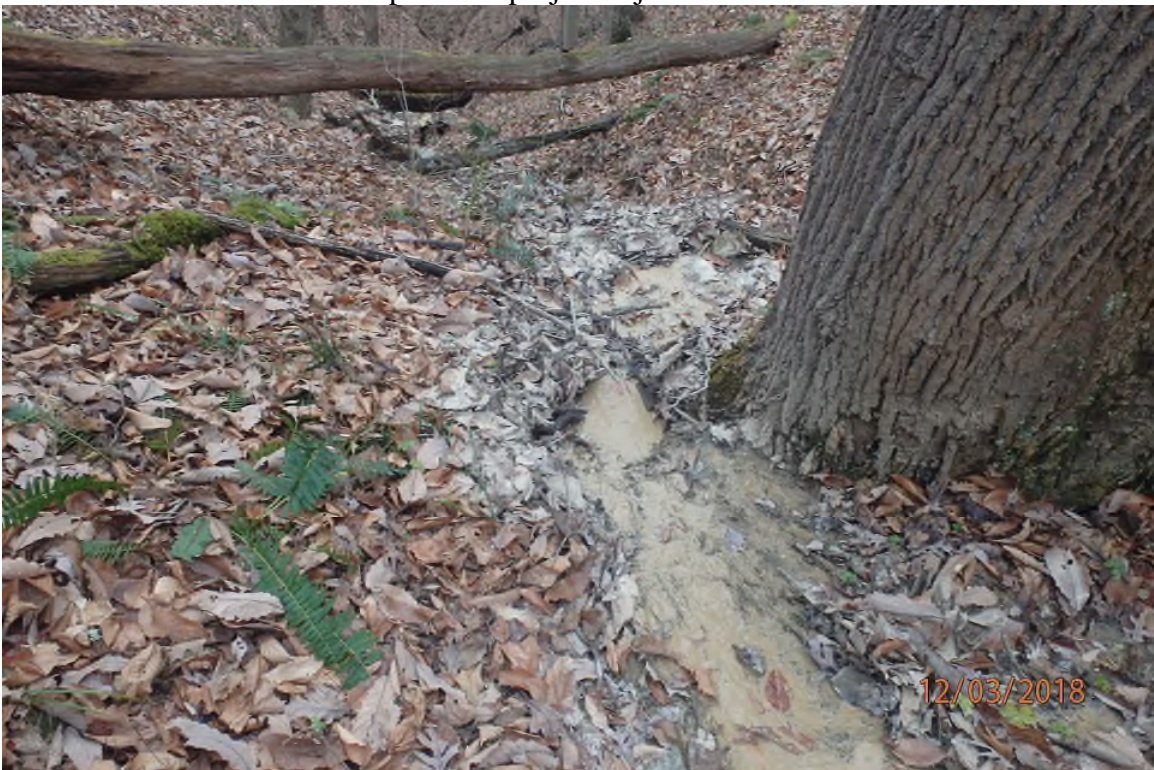
Offsite CNA distinctly visible settleable solids in UNT Meathouse Fork (39° 16.512' X 80° 43.125') downslope of the project adjacent to 2611+00.

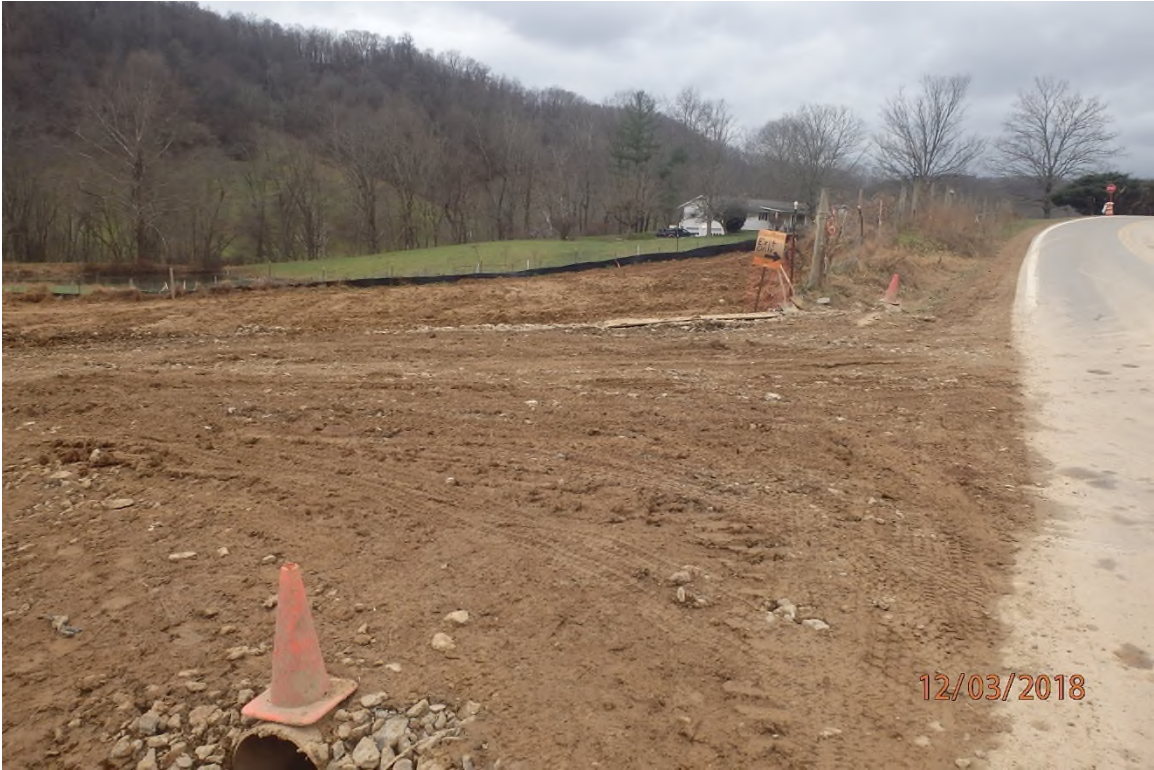
ARDO008/WV 18 crossing showing the lack of a stable construction entrance and the associated track-out onto the public roadway.

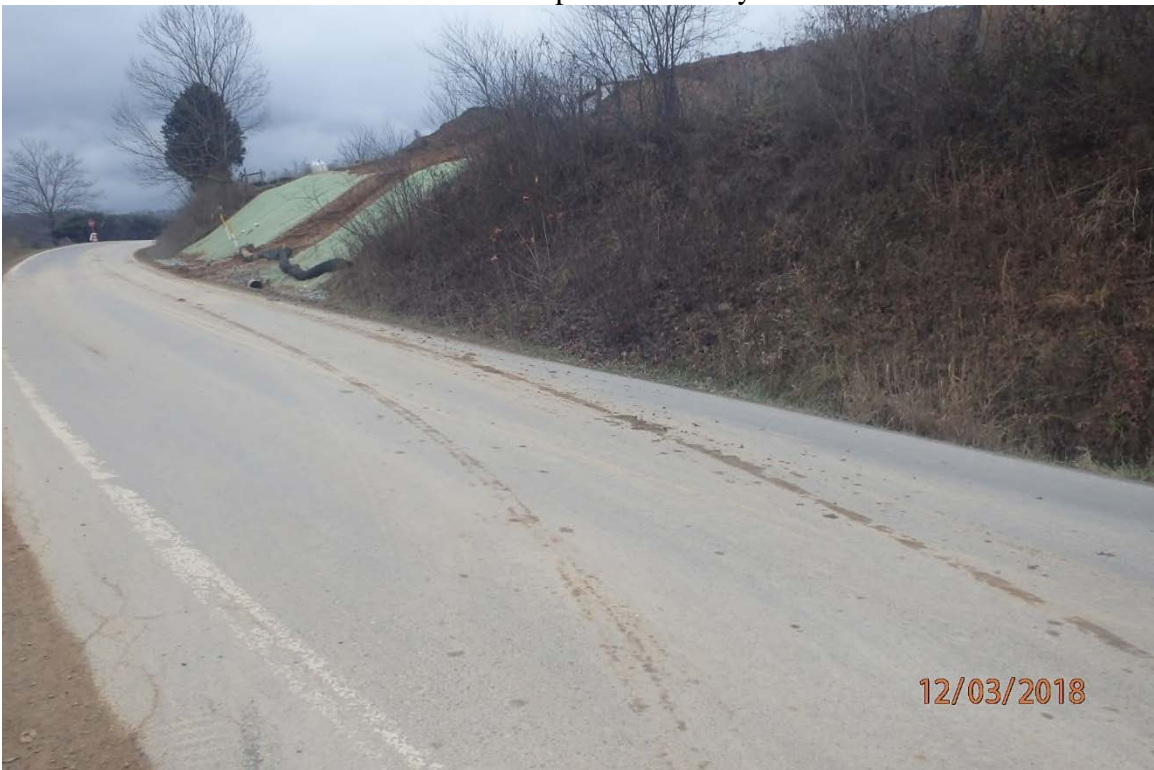
ARDO008/WV 18 crossing showing the lack of a stable construction entrance and the associated track-out onto the public roadway.

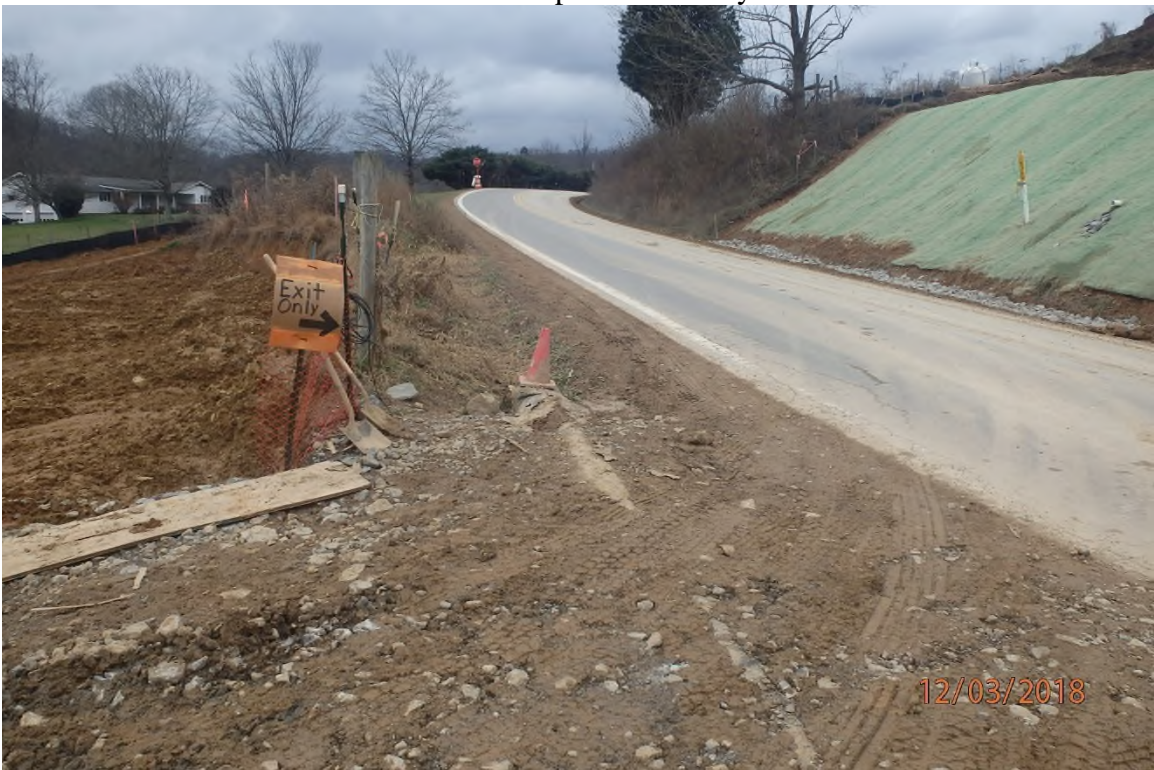
ARDO008/WV 18 crossing showing the lack of a stable construction entrance and the associated track-out onto the public roadway.

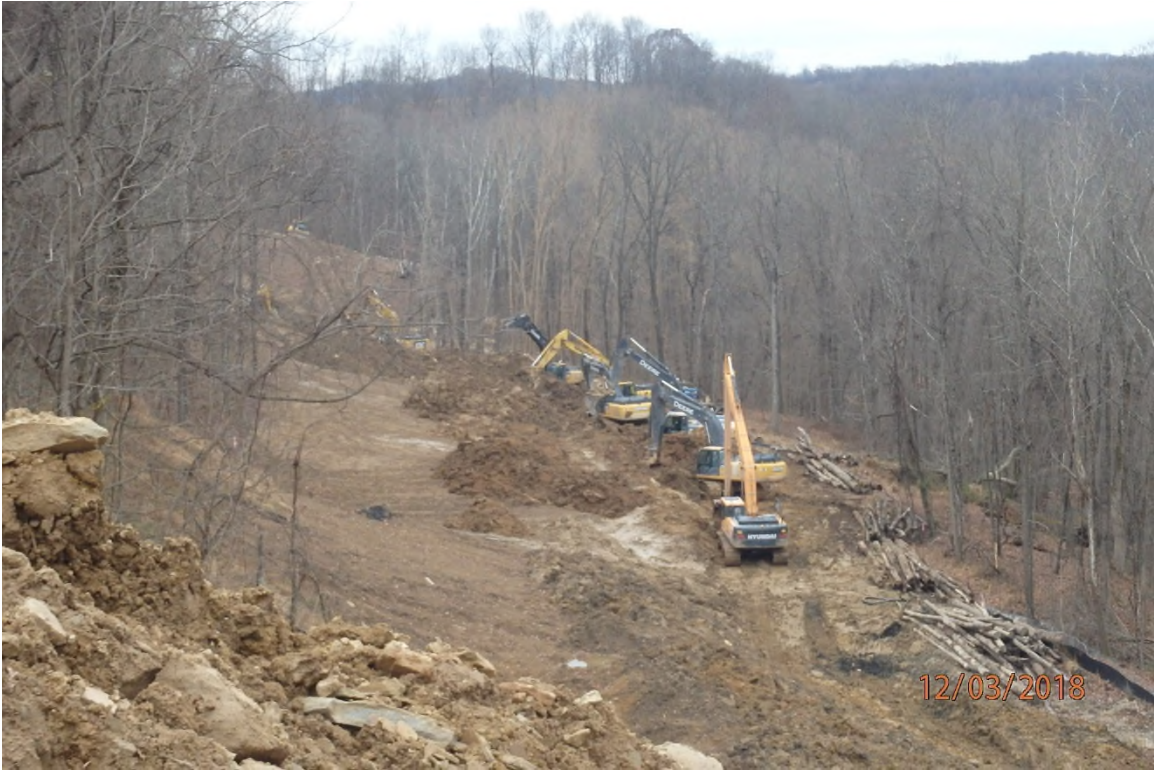
Work being conducted to mitigate the slip associated with spill report number 09-83236 (A).

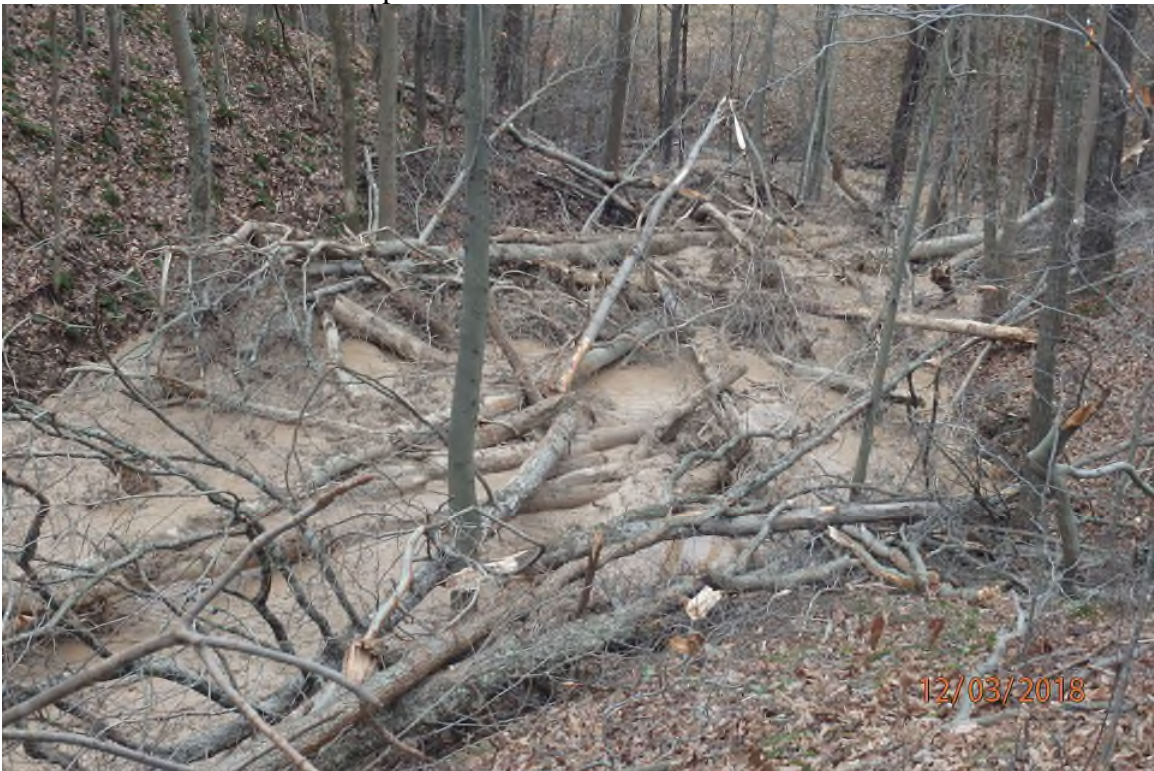
CNA deposits in ephemeral UNT Meathouse Fork (39° 16.354' X 80° 43.179') as a result of the slip associated with spill report number 09-83236 (A).

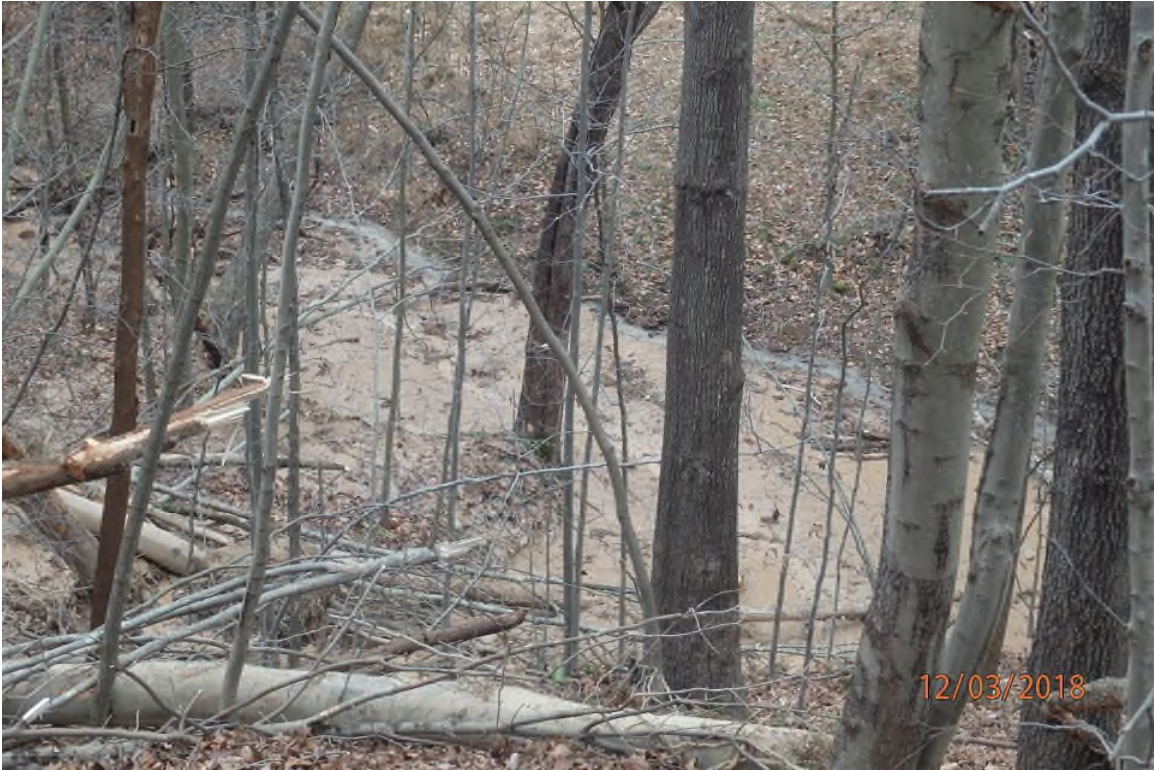
CNA deposits in intermittent UNT Meathouse Fork (39° 16.402' X 80° 43.295') as a result of the slip associated with spill report number 09-83236 (A).

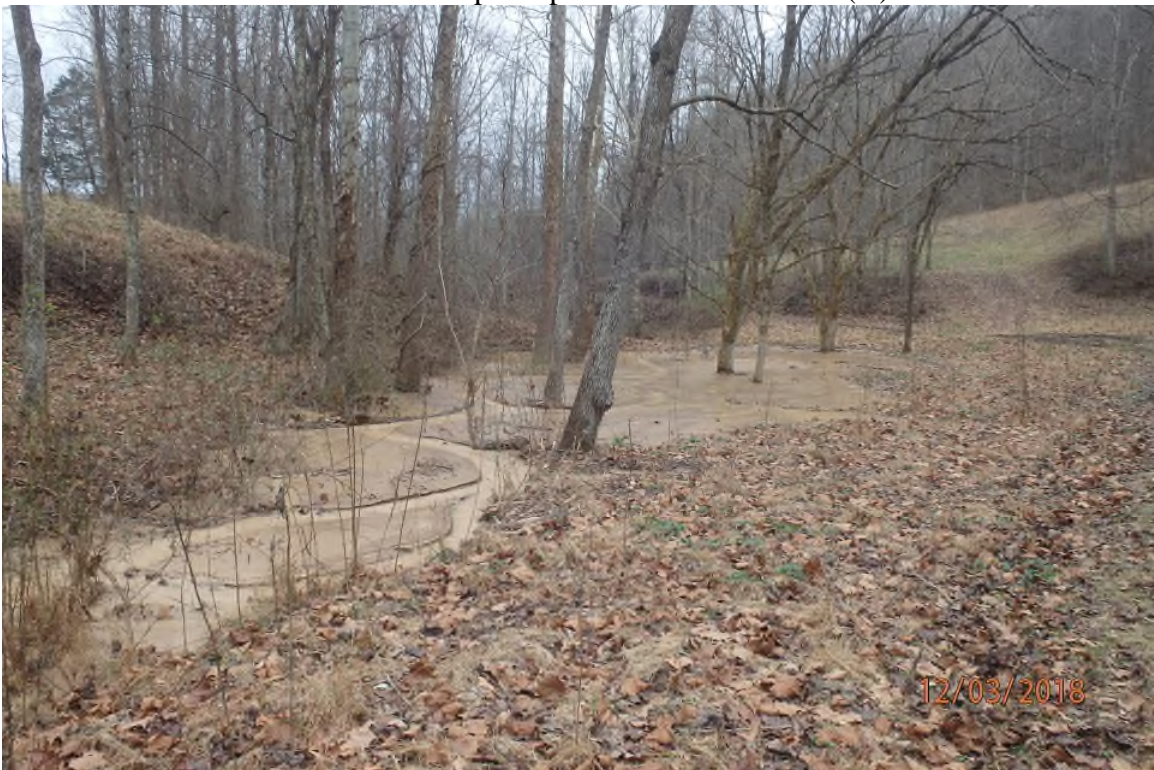
CNA deposits in intermittent UNT Meathouse Fork as a result of the slip associated with spill report number 09-83236 (A).

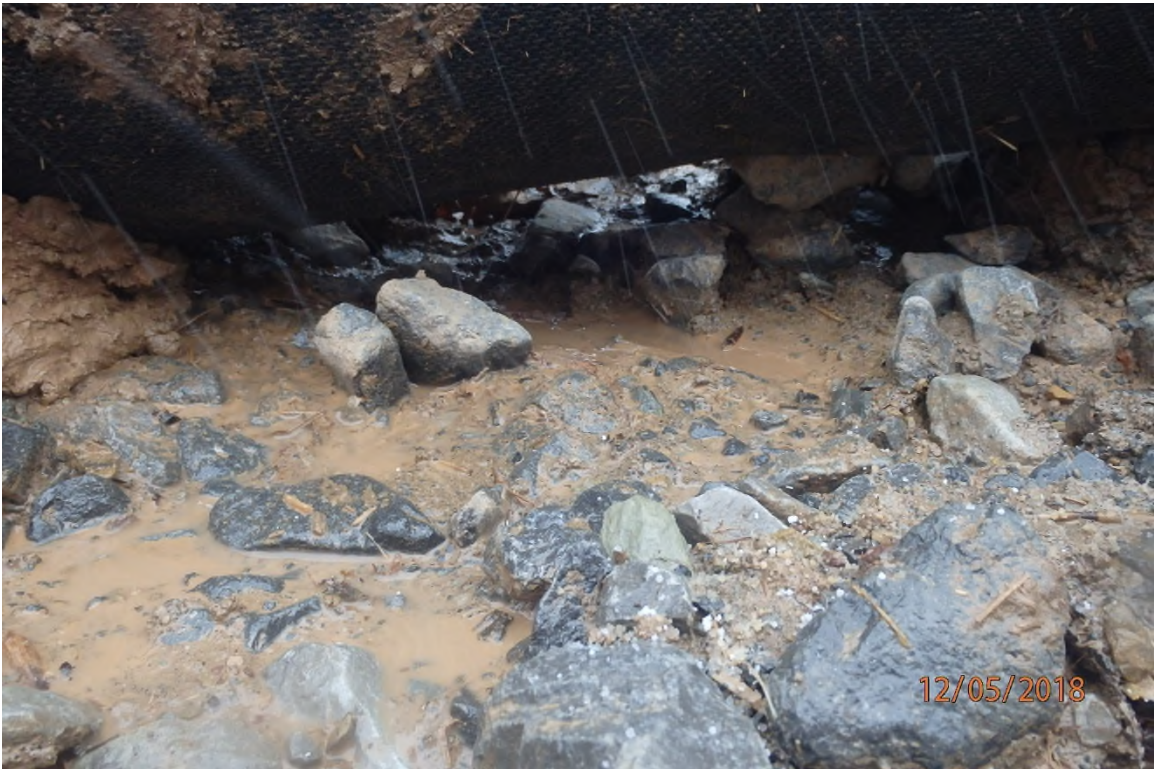
ARDO002.9 showing improperly installed perimeter control that allows sediment laden water to bypass under the device.

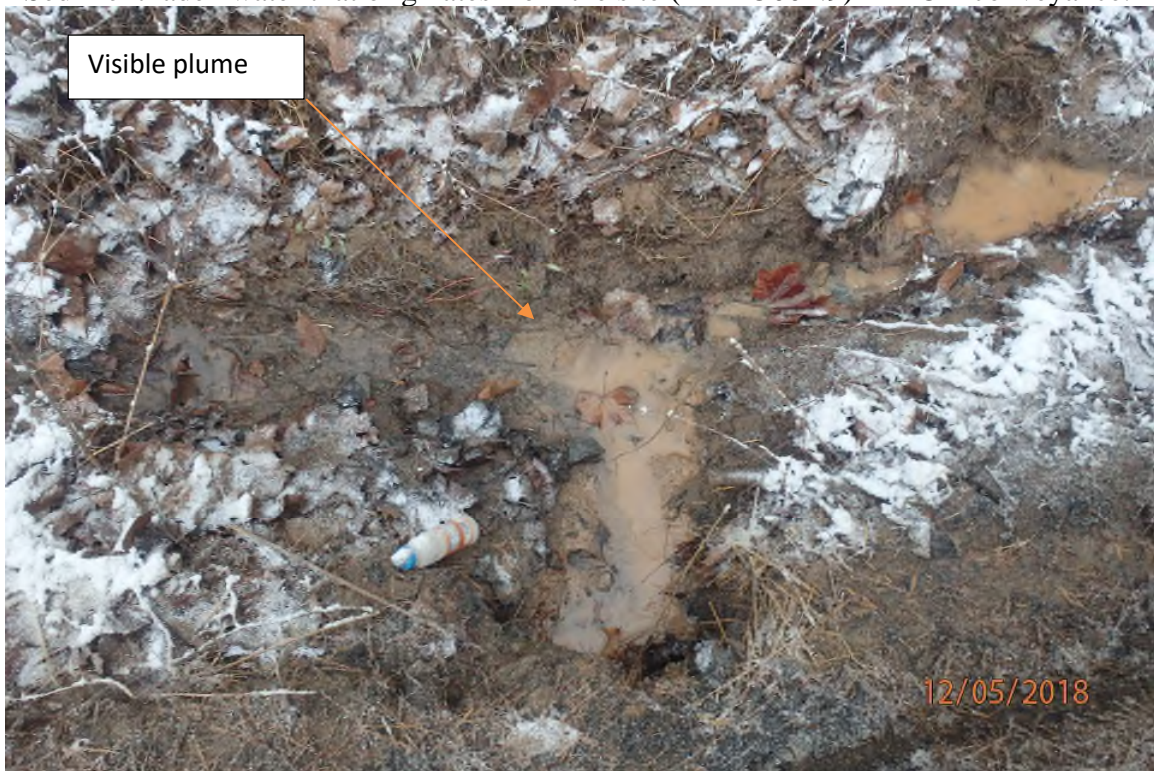
Sediment laden water that originates from the site (ARDO002.9) in DOH conveyance.

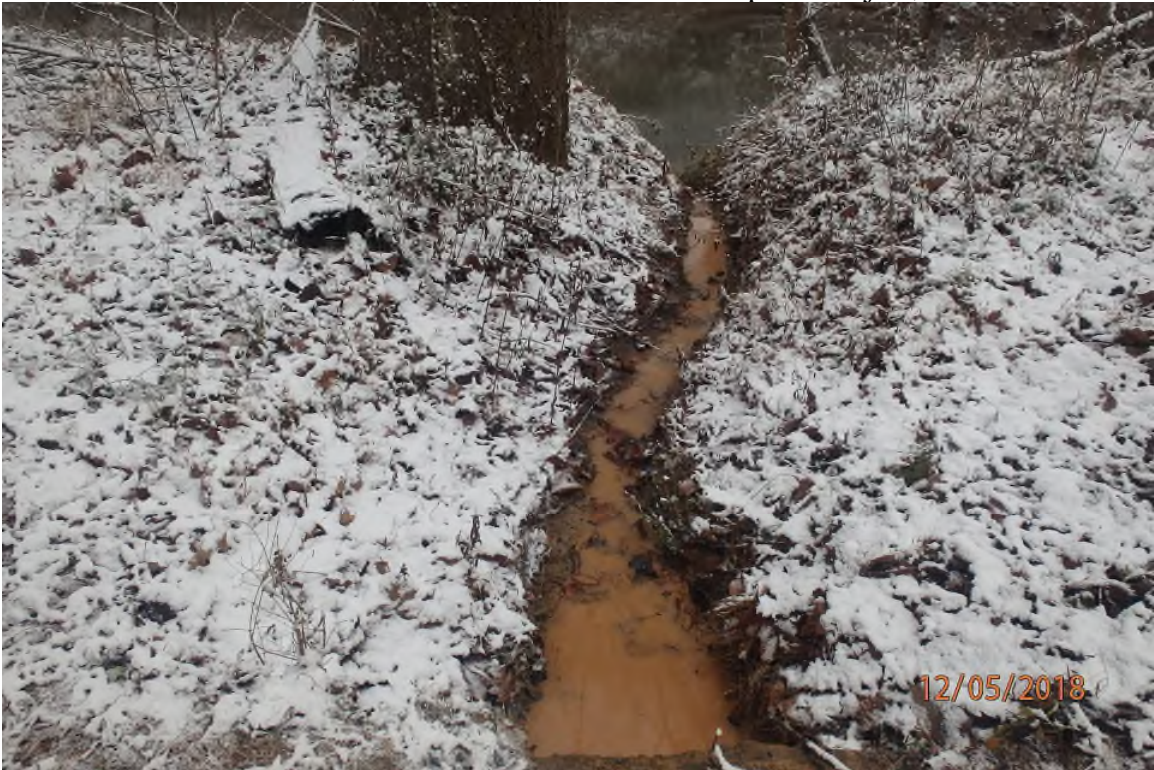
CNA distinctly visible settleable solids in UNT Flint Run (39° 20.930' X 80° 42.406').

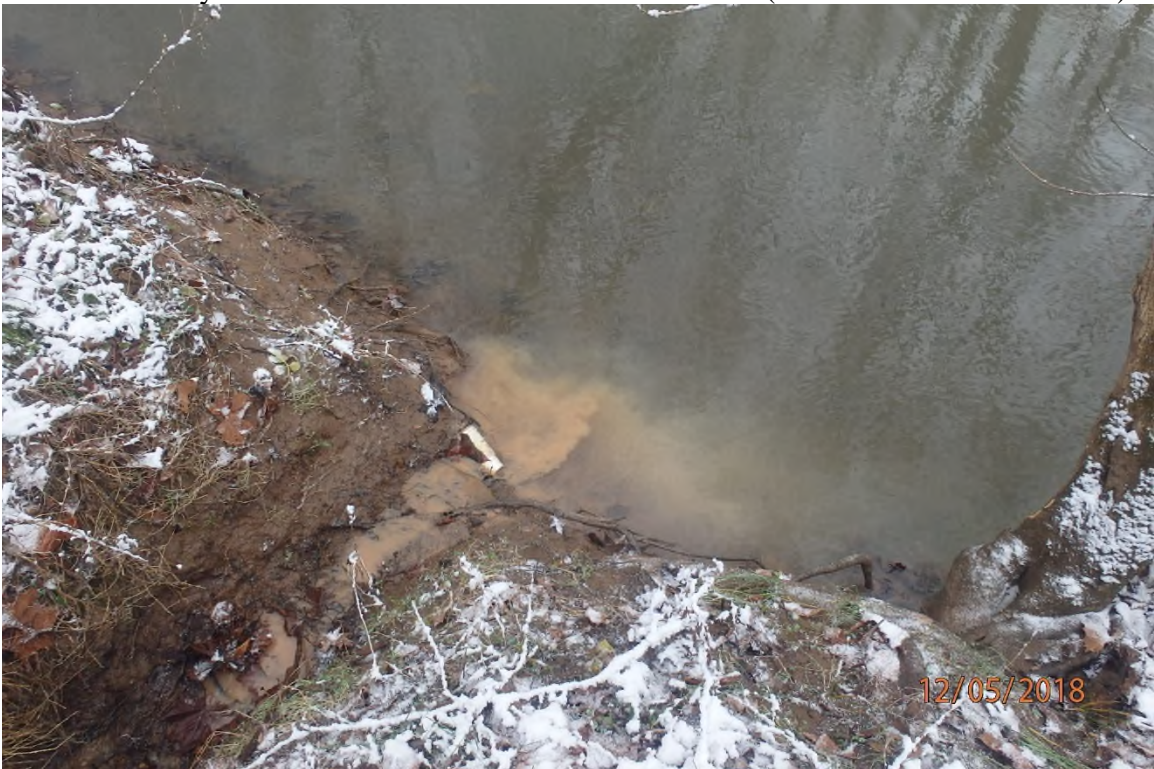
Visible plume at the confluence of UNT Flint Run and Flint Run.

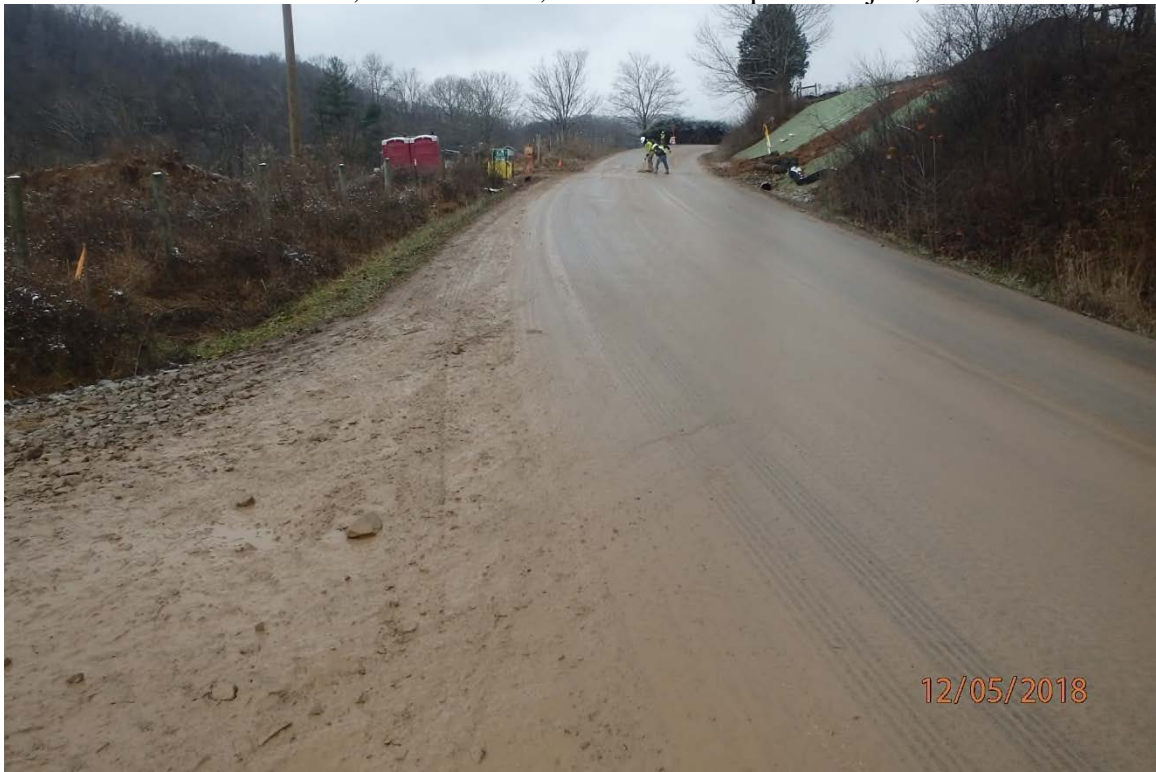
ARDO008/WV18 crossing accesses showing the lack of a stable construction entrance and the associated track out/slick film of mud that originates from site.

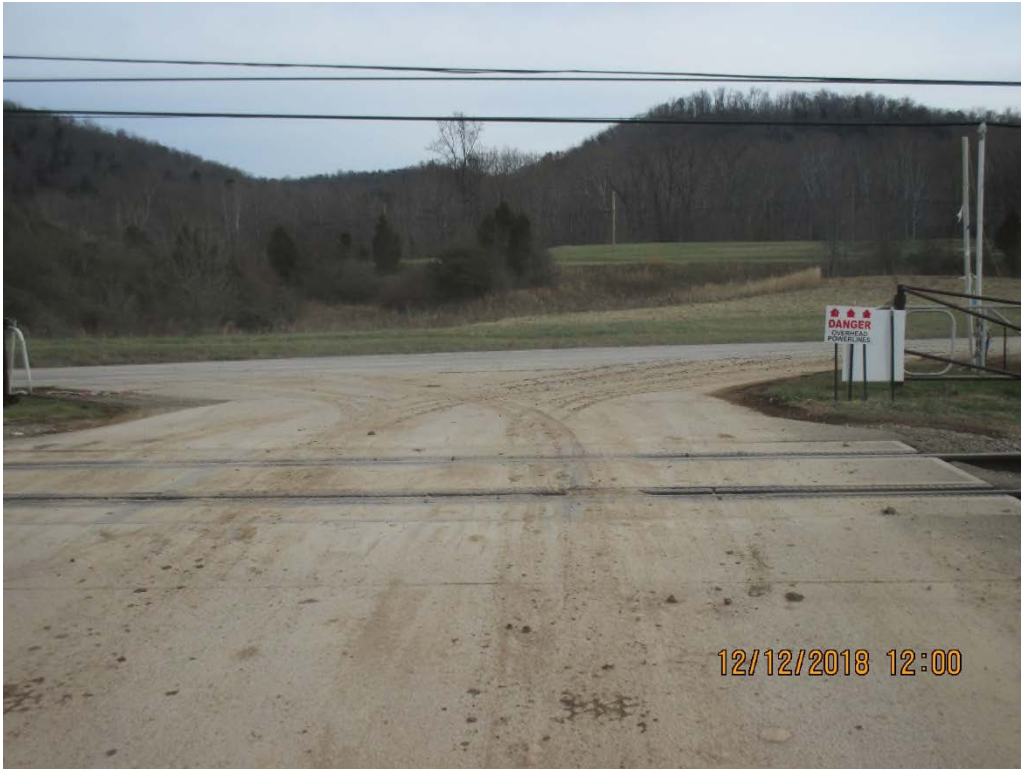
Facing Route 62. Tracking visible in both directions (East and West) along Route 62.

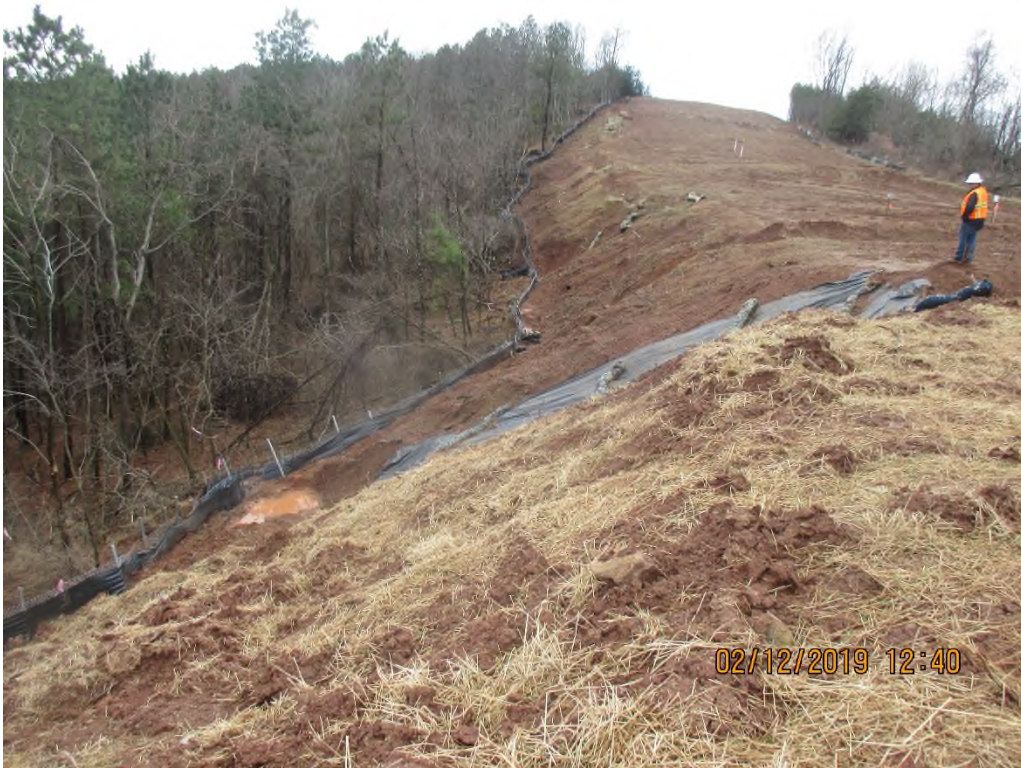
SLW flowing under controls at station number 5359+00 and past LOD

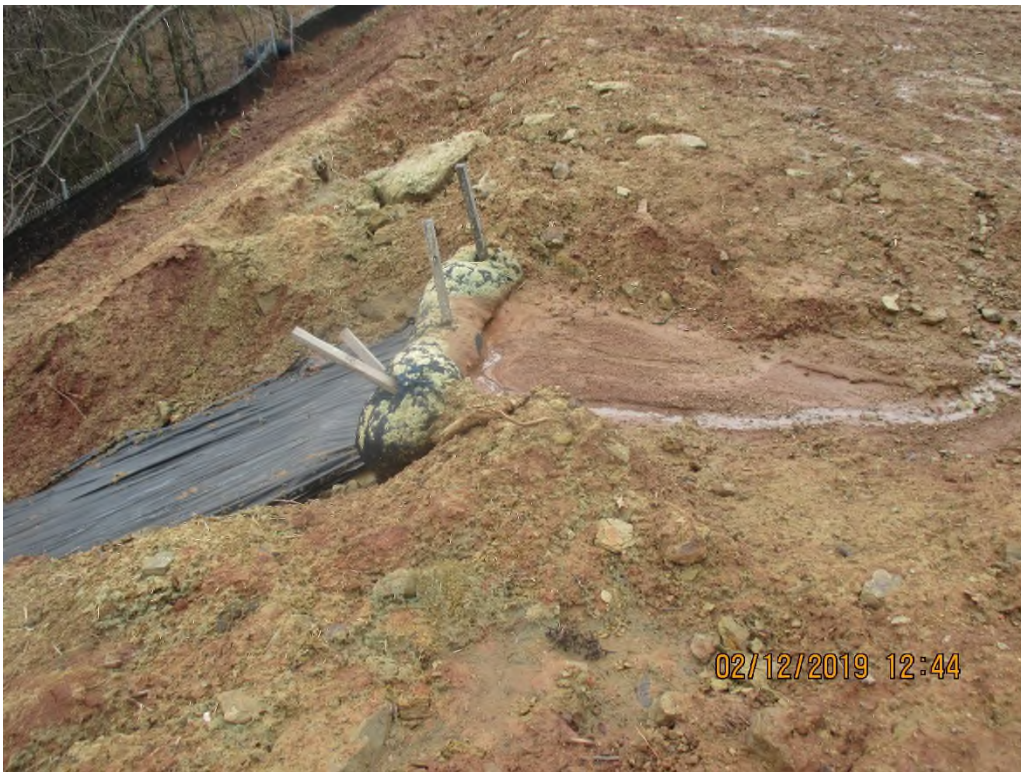
Waterbar near station 5376+00 facing upslope

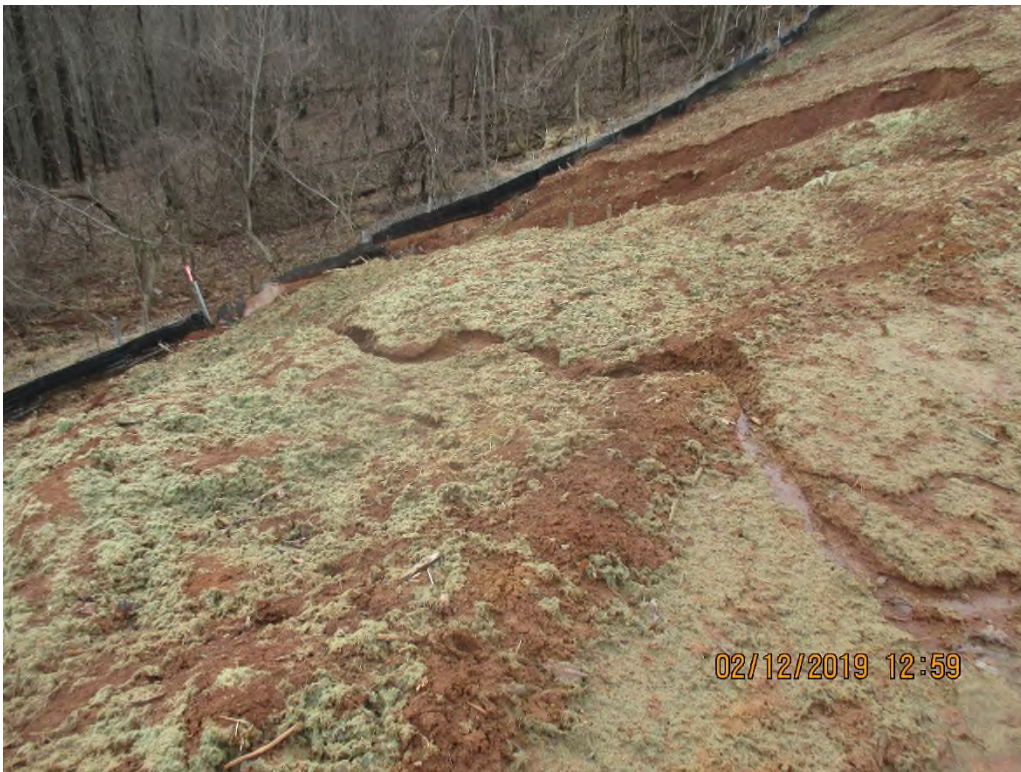
Facing South at station 5388+00 downslope at perimeter controls and top of slope

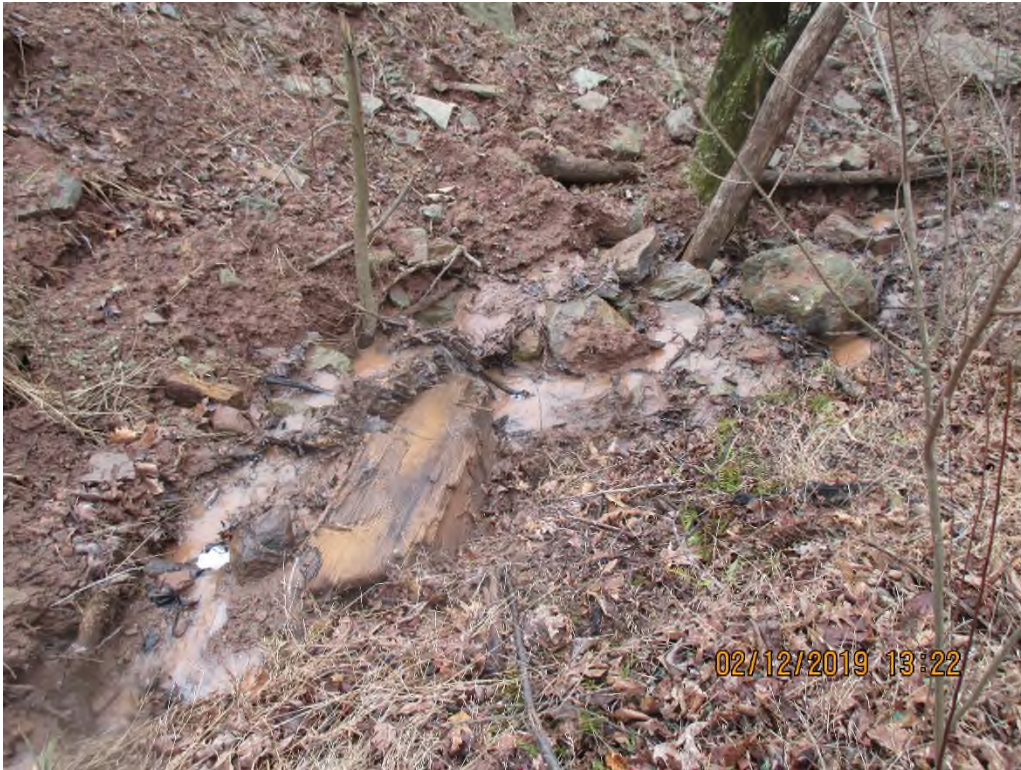
Off site sediment deposits present and SLW flowing past controls above log pile near station 5400+00

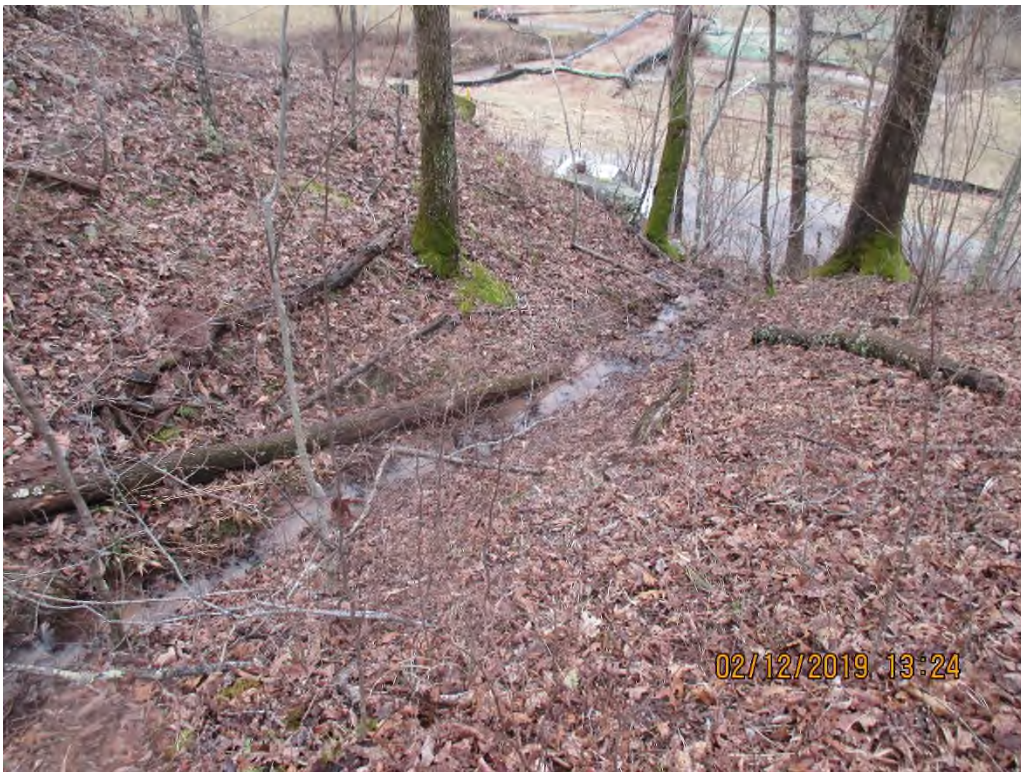
SLW present in ephemeral downslope of log pile near station #5405+07

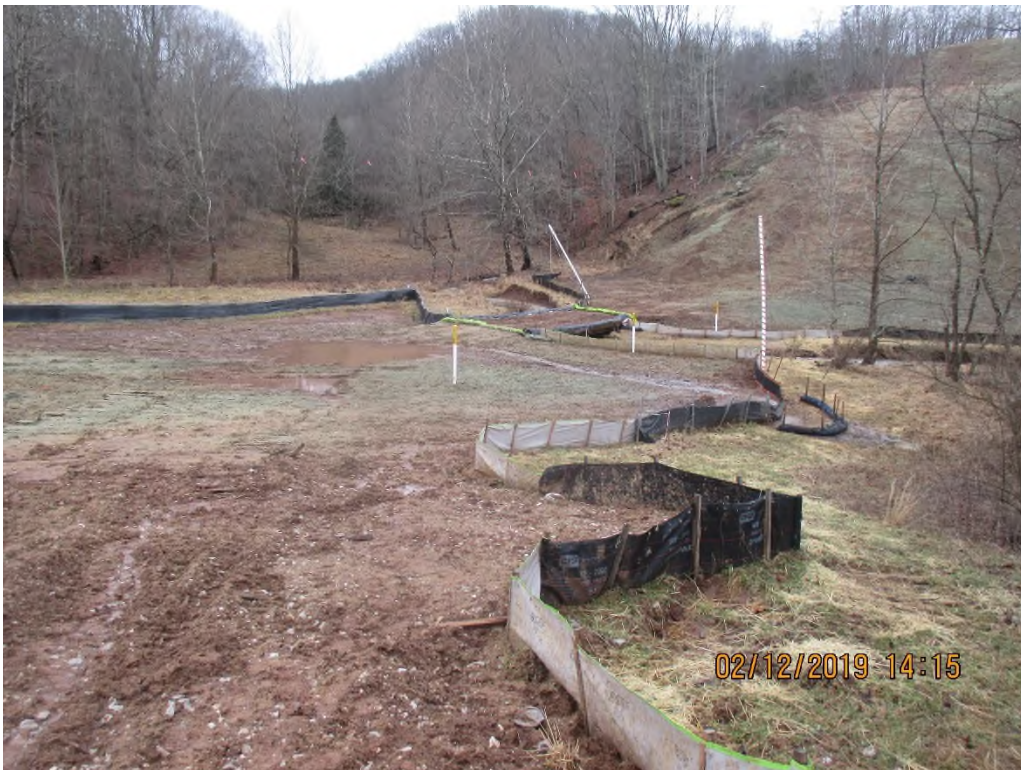
Munchausen Road crossing at station #5407+07 facing south. Erosion present on slopes due to concentrated flow

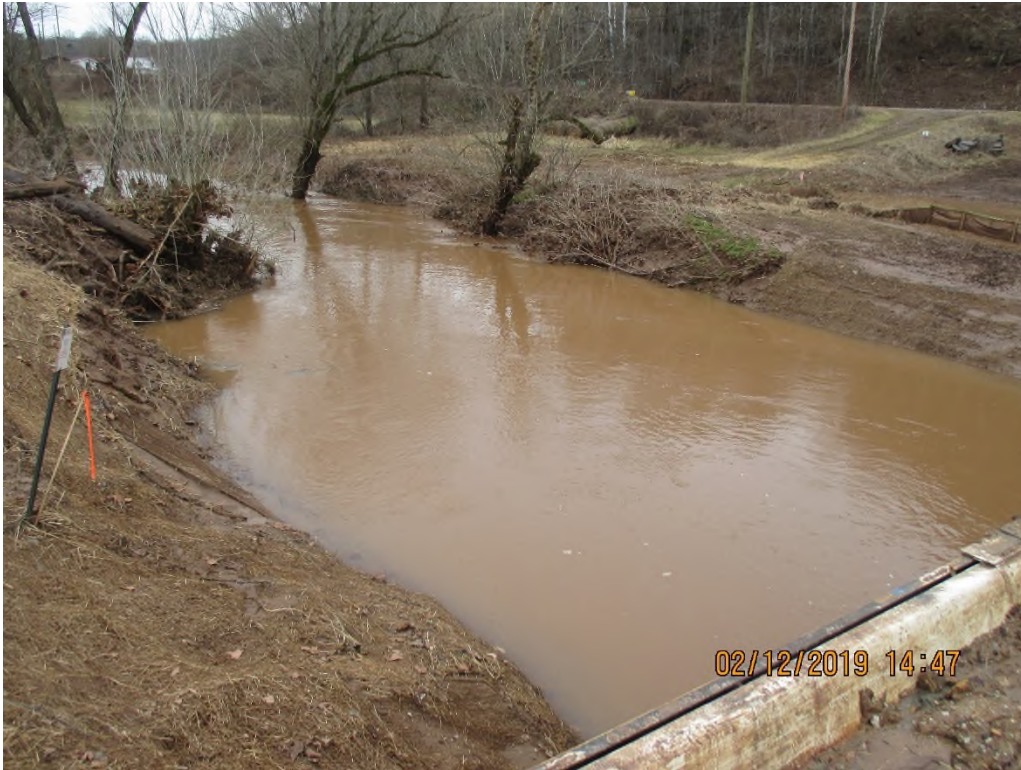
SLW entering stream SROC-002. SROC-002 has visible settable solids present at time of inspection

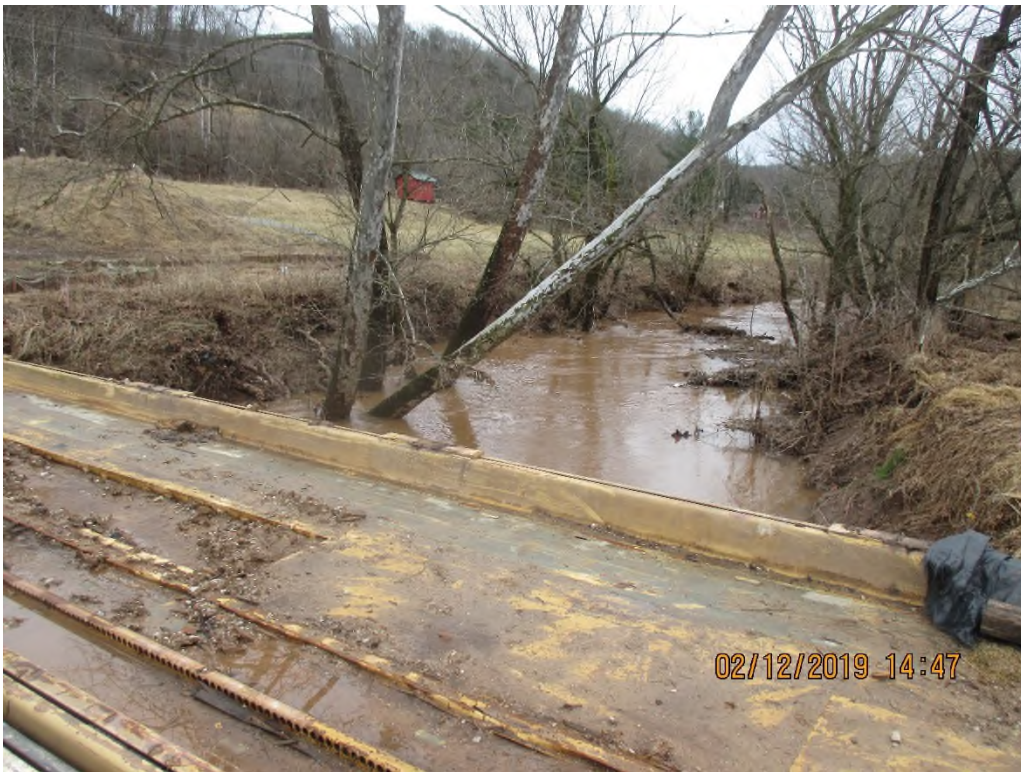
Stream SROC-030 facing upstream

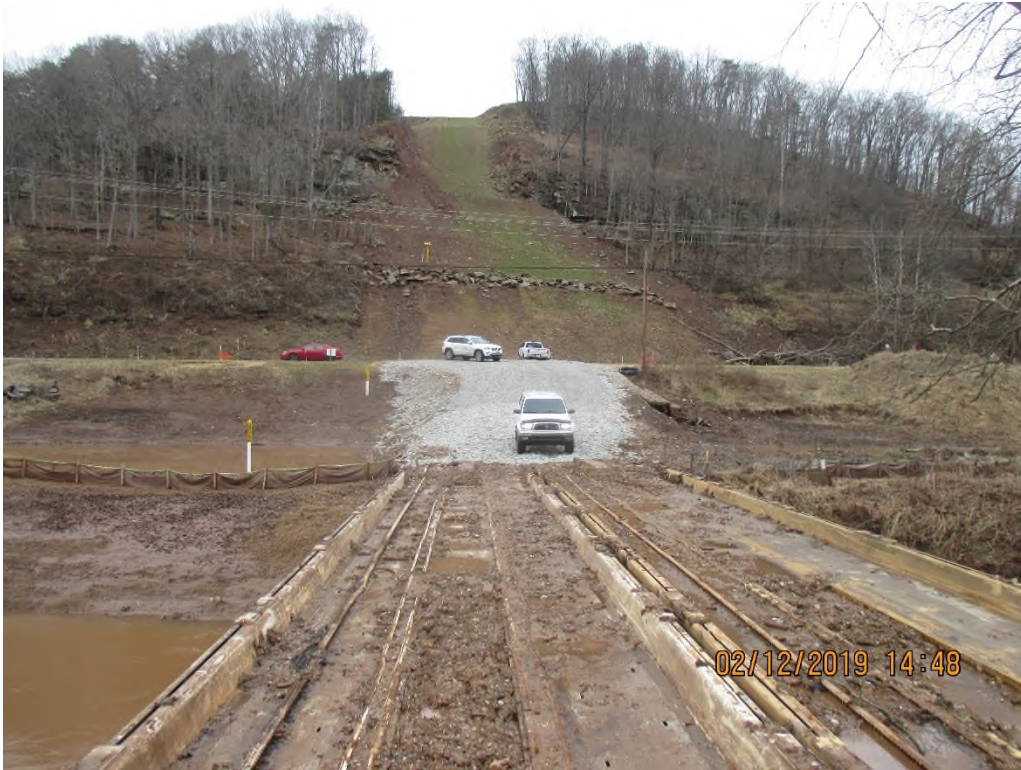
Stream SROC-030 facing downstream
