**CONSENT ORDER
ISSUED UNDER THE
WATER POLLUTION CONTROL ACT
WEST VIRGINIA CODE, CHAPTER 22, ARTICLE 11**

TO: Columbia Gas Transmission, LLC
Attn: Troy Tally, Vice President
1700 MacCorkle Ave
Charleston, WV 25314

DATE: October 1, 2020
ORDER NO.: 9061

1. Columbia Gas Transmission, LLC is conducting land disturbance activity associated with construction of the Mountaineer Xpress Project in Marshall, Wetzel, Tyler, Doddridge, Ritchie, Calhoun, Wirt, Roane, Jackson, Mason, Putnam, and Cabell Counties, West Virginia. On January 31, 2018, Columbia Gas Transmission, LLC was issued Water Pollution Control Permit No. WV0116815, Registration No. WVR310872, for Stormwater Associated With Oil and Gas Related Construction Activities.

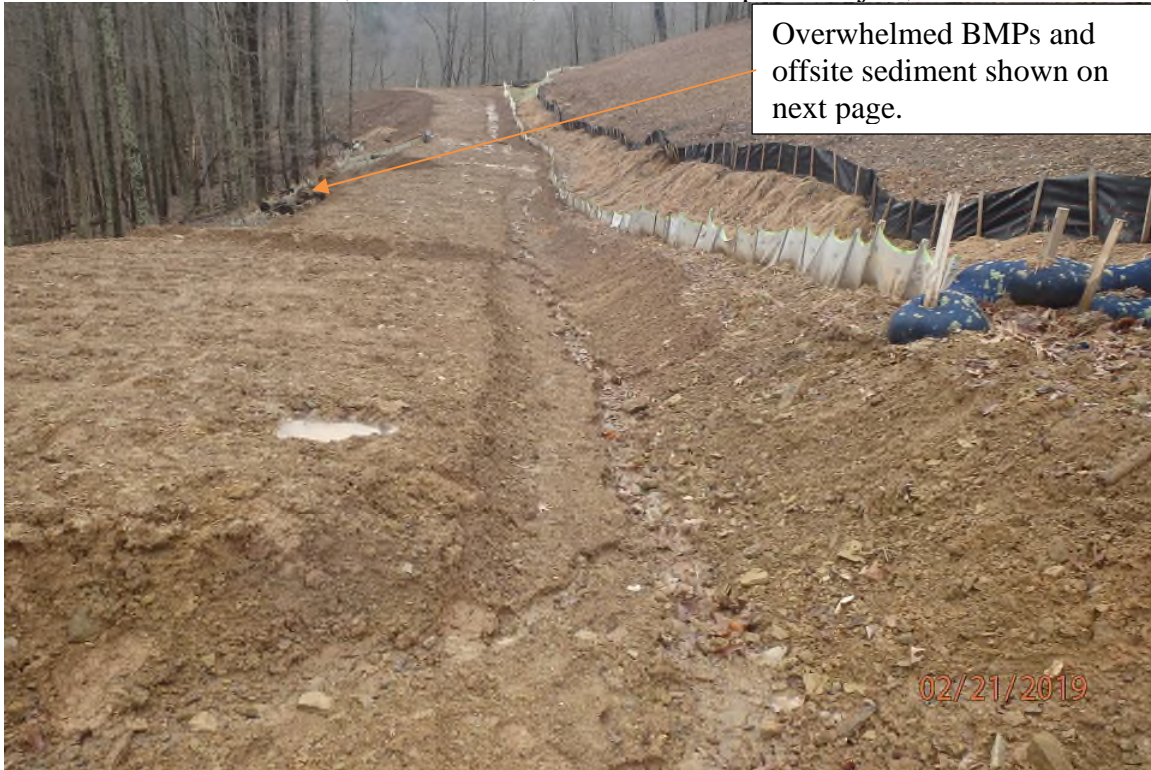
Installed ditch checks and water bars on ARDO002.8 that are overwhelmed by stormwater flow resulting from the lack of installed cross drains/culverts as indicated in the approved SWPPP.

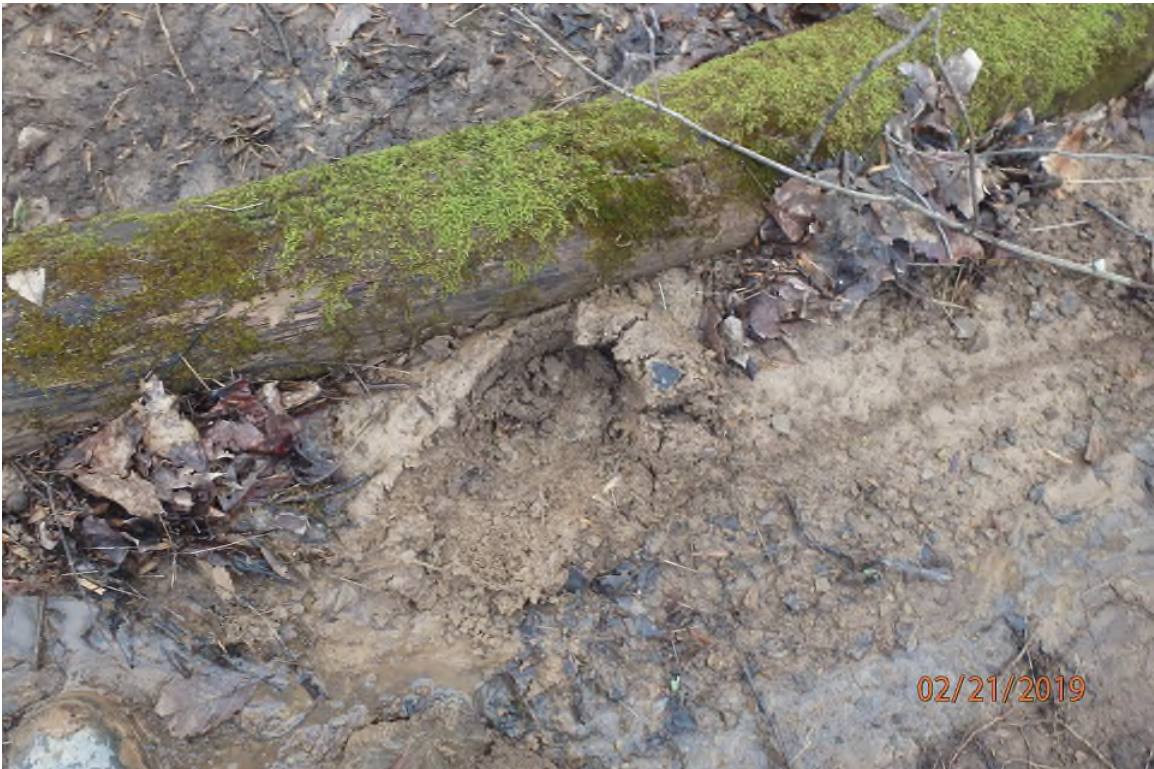
Installed perimeter control adjacent to 2256+00 that has been overwhelmed due to improperly installed water bars.

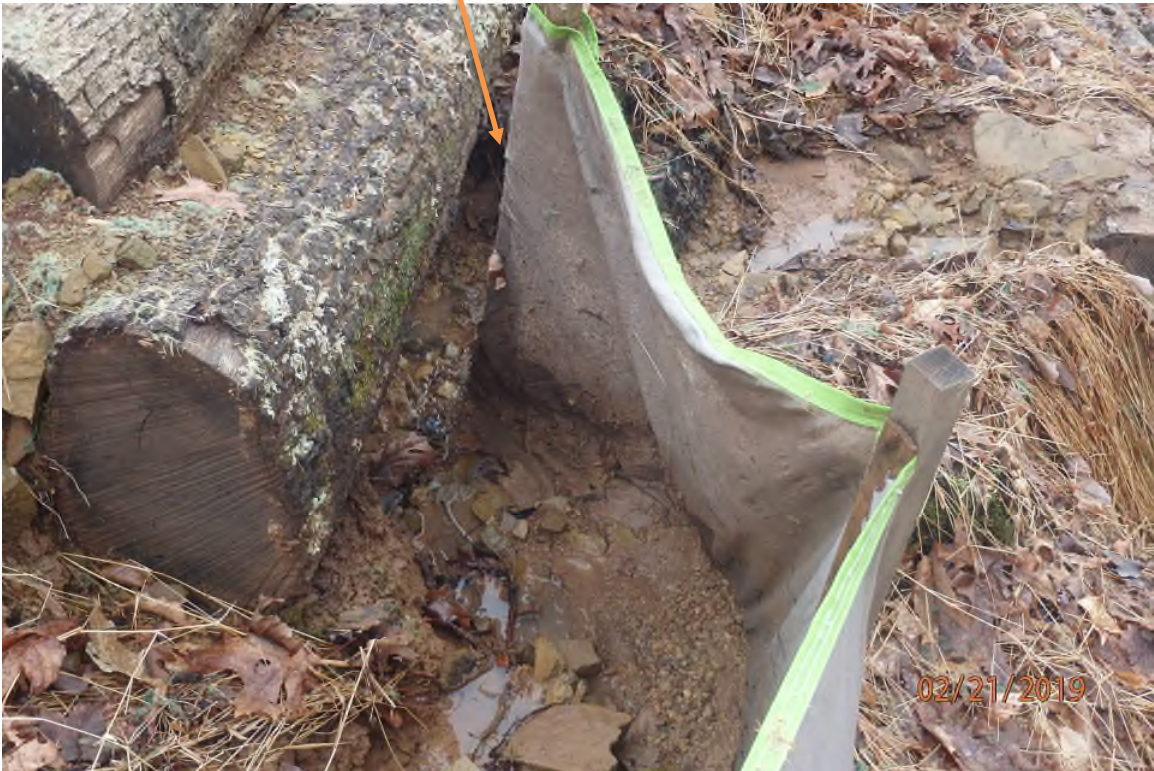
Improperly installed perimeter control adjacent to 2260+00 that allows sediment laden water to bypass the device.

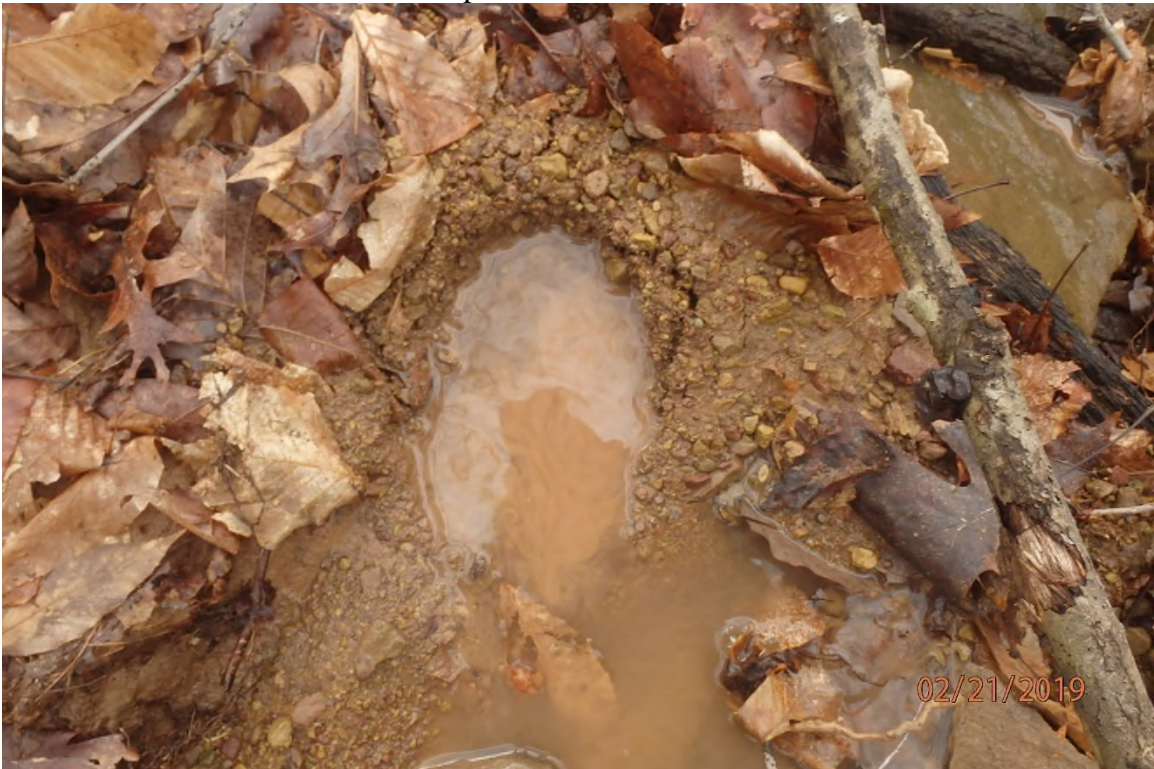
Offsite sediment trail leading to the receiving stream from the previously pictured improperly installed perimeter control.

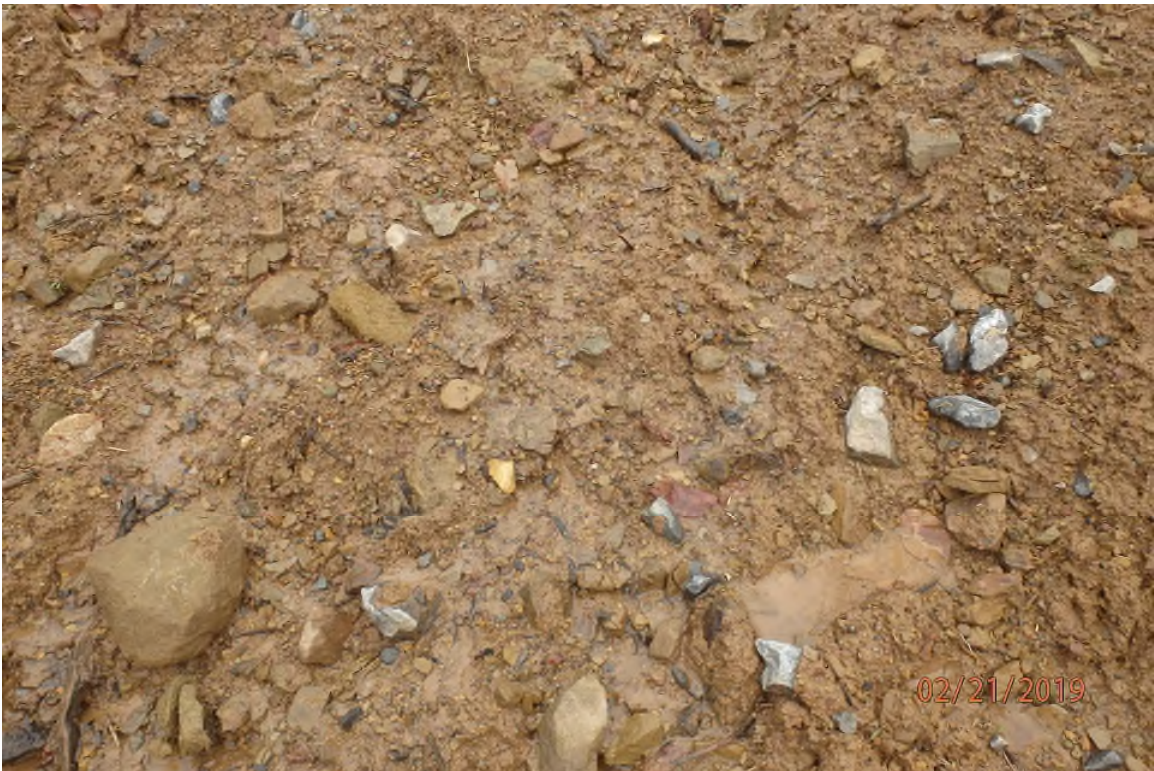
Perimeter control in need of maintenance.

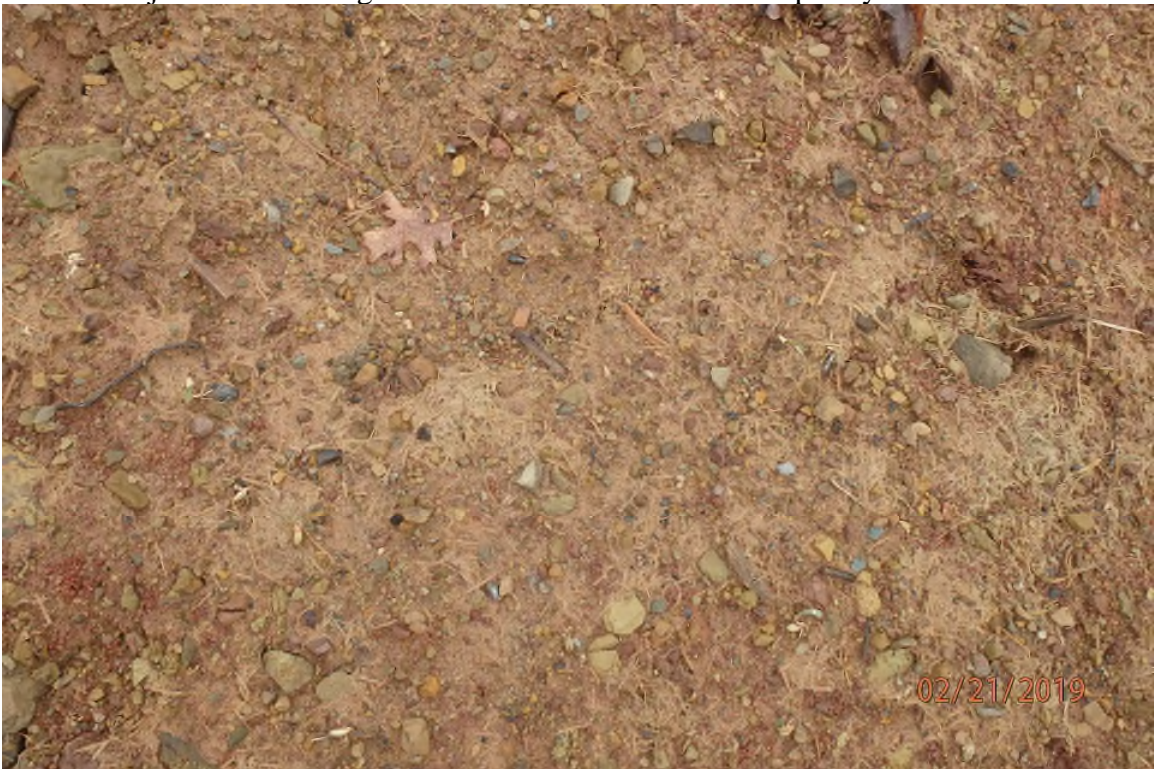
Project area showing the need for maintenance of temporary stabilization.

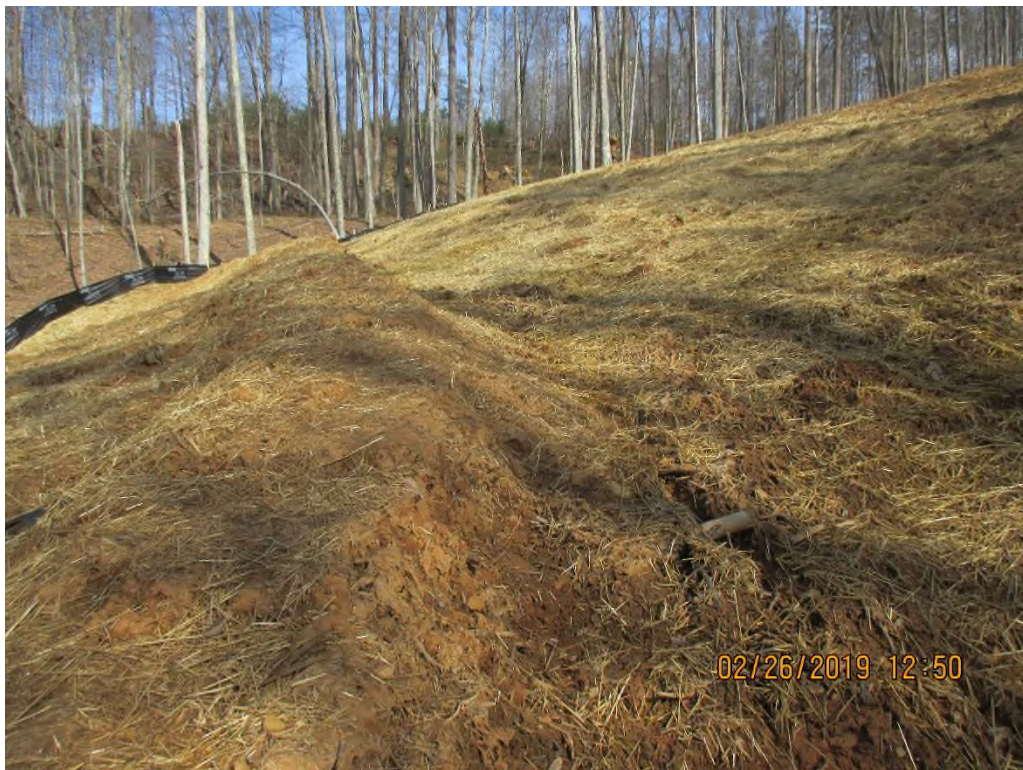
Controls above Stream SJAD-008 near station #6655+00 (per SWPPP). Arrow depicts where erosion is occurring above controls on slope.

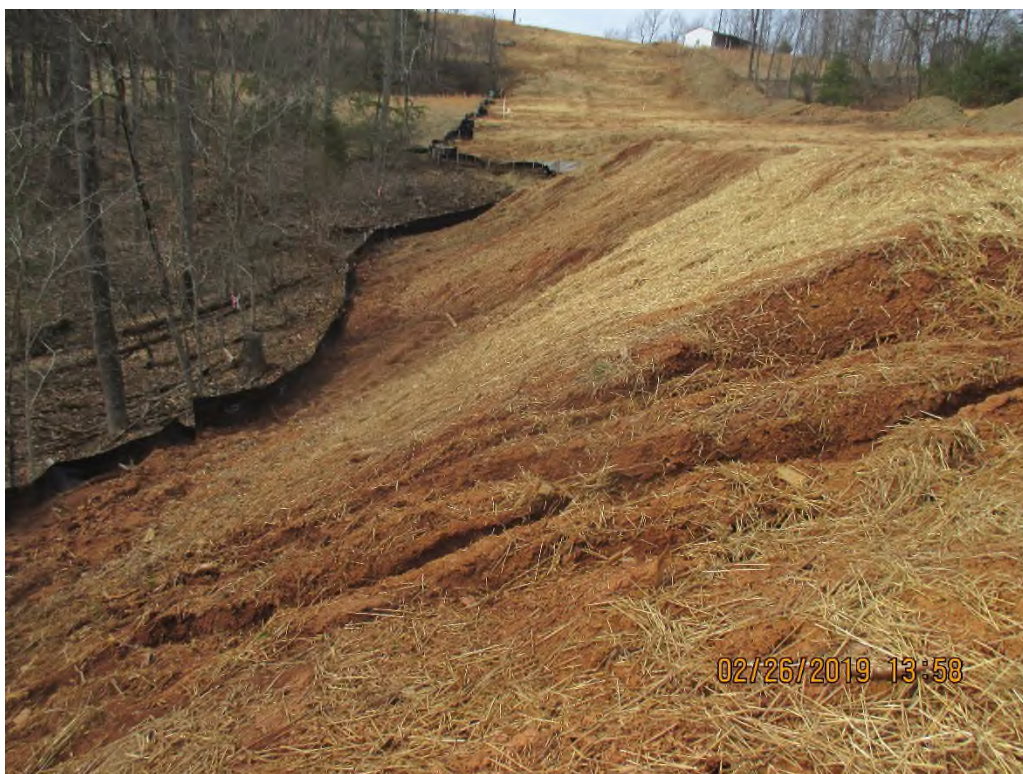
Run-on from adjacent field flowing across ROW, creating rill/gully erosion on slope near station #6742+60 and sediment being deposited against perimeter control.

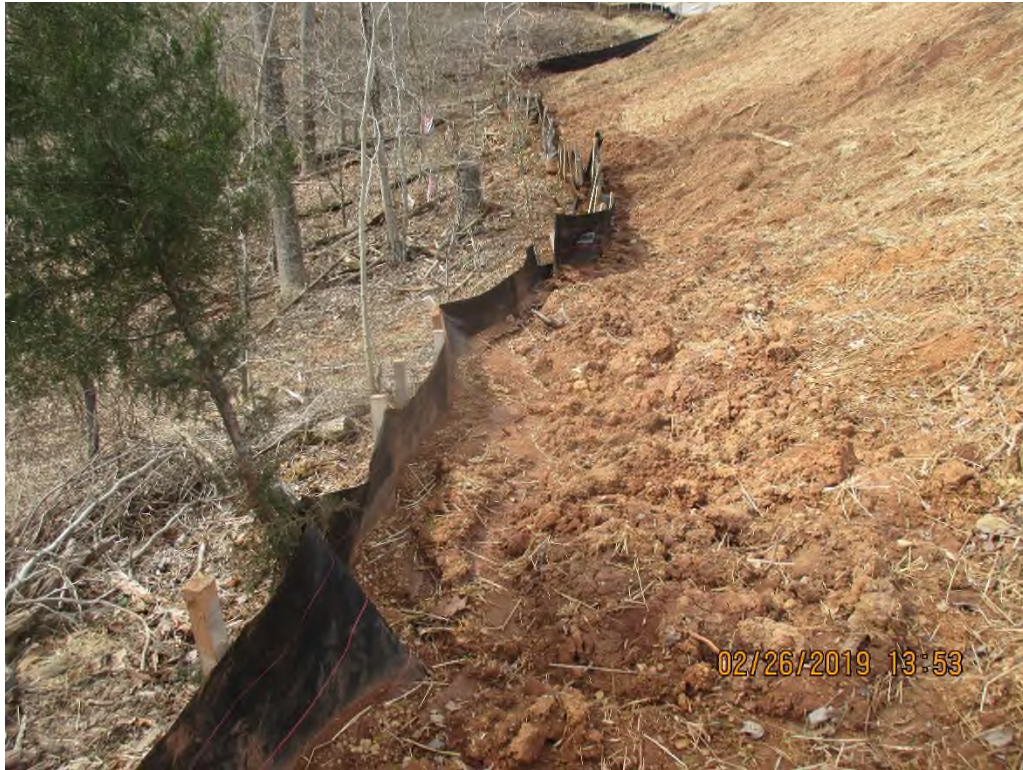
Run-on from adjacent field flowing across ROW, creating rill/gully erosion on slope near station #6742+60 and sediment being deposited against perimeter control.

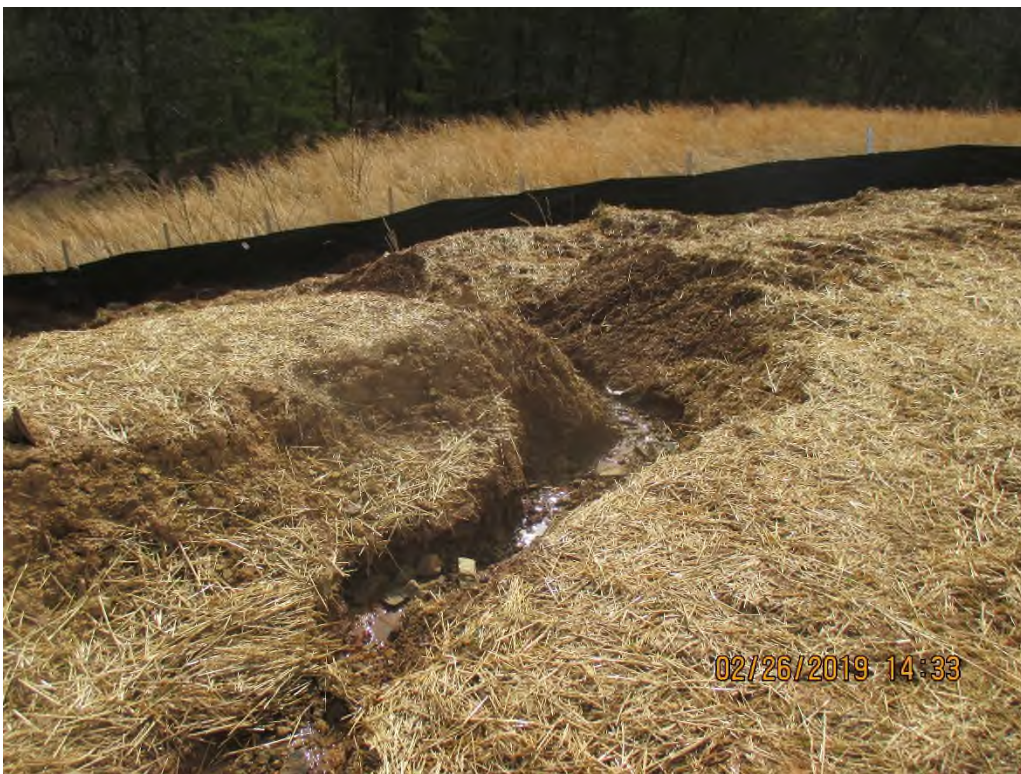
Waterbar terminus with gully erosion present leading toward perimeter controls near station #6727+53

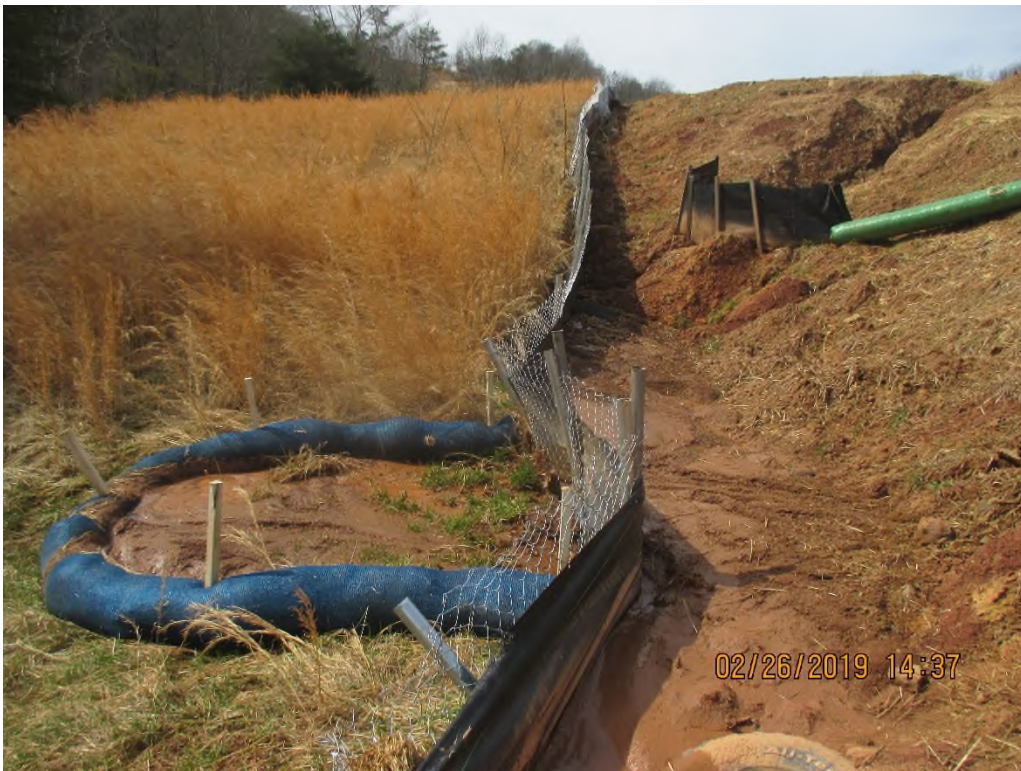
Waterbar terminus with gully erosion present leading toward perimeter controls near station #6727+53

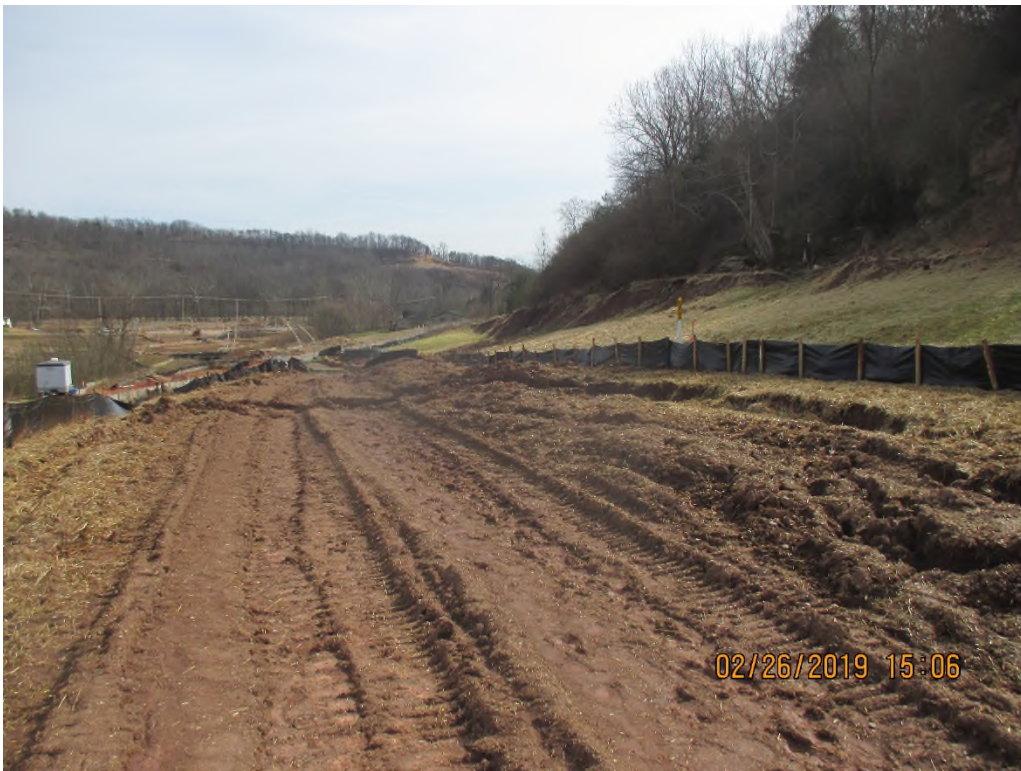
Section of ROW between Ripley regulator station and Rt. 21 with multiple slips on ROW

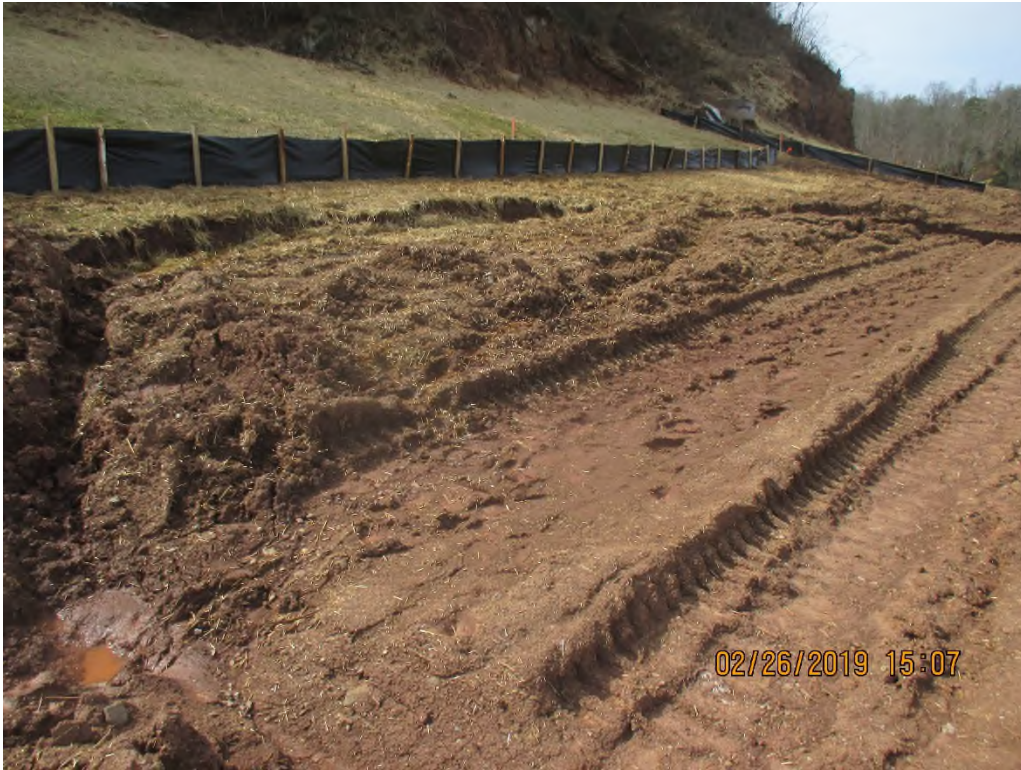
Section of ROW between Ripley regulator station and Rt. 21 with multiple slips on ROW

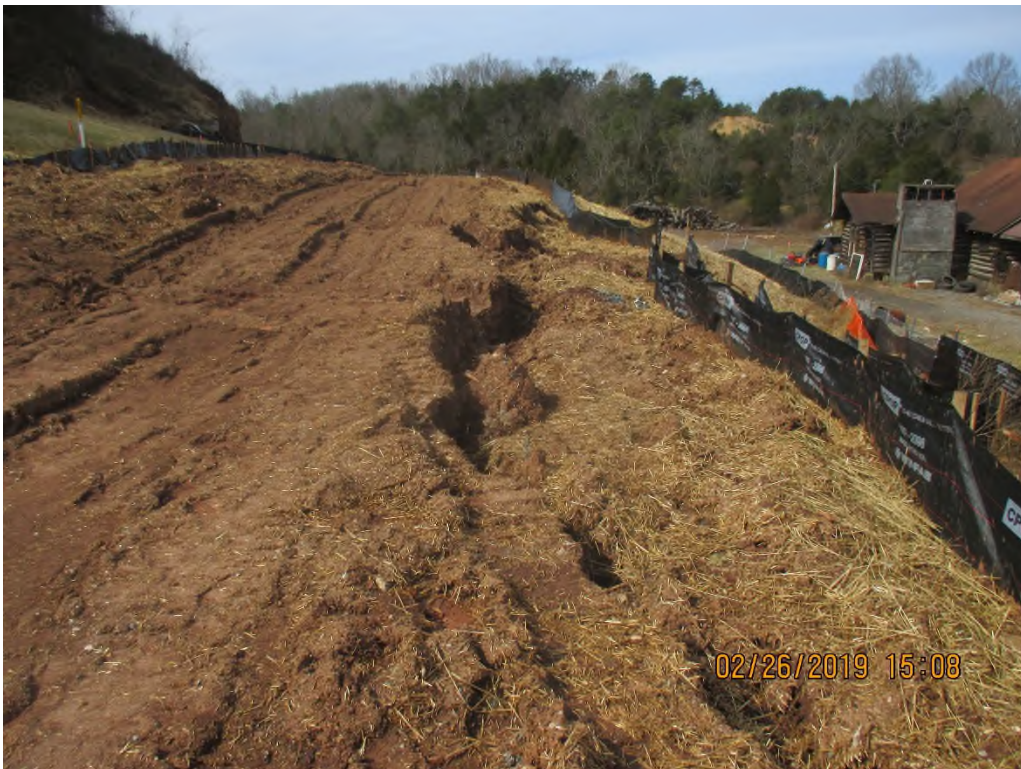
Section of ROW between Ripley regulator station and Rt. 21 with multiple slips on ROW.

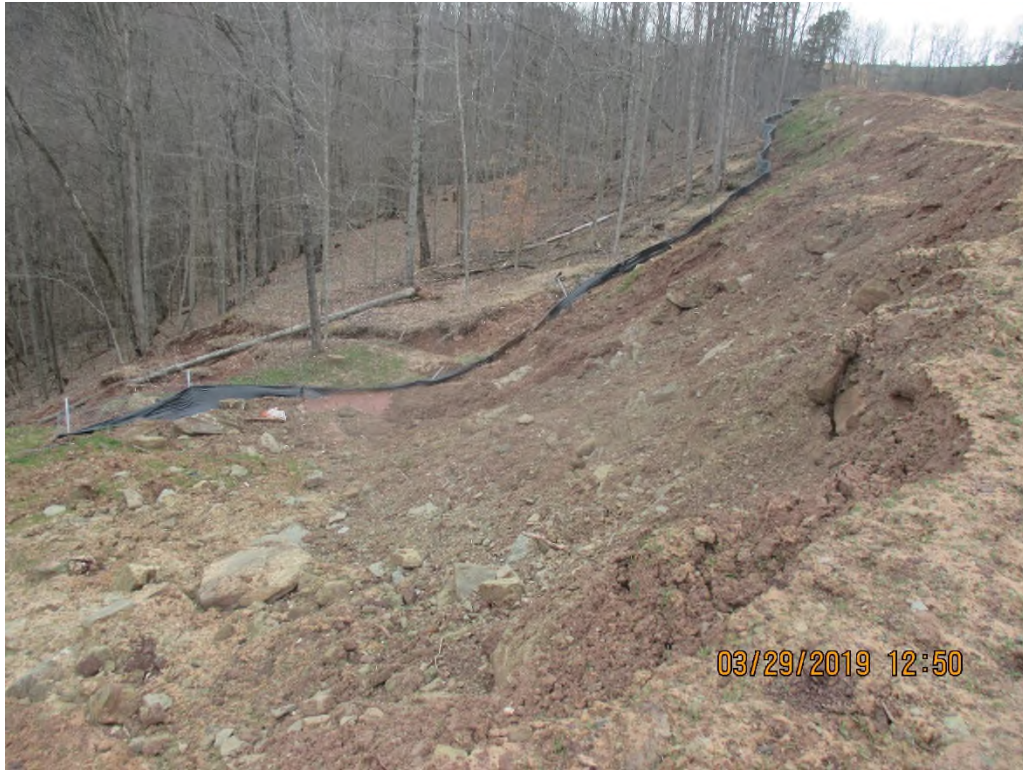
Slip at station #5171+34 facing South. Sediment deposited past LOD

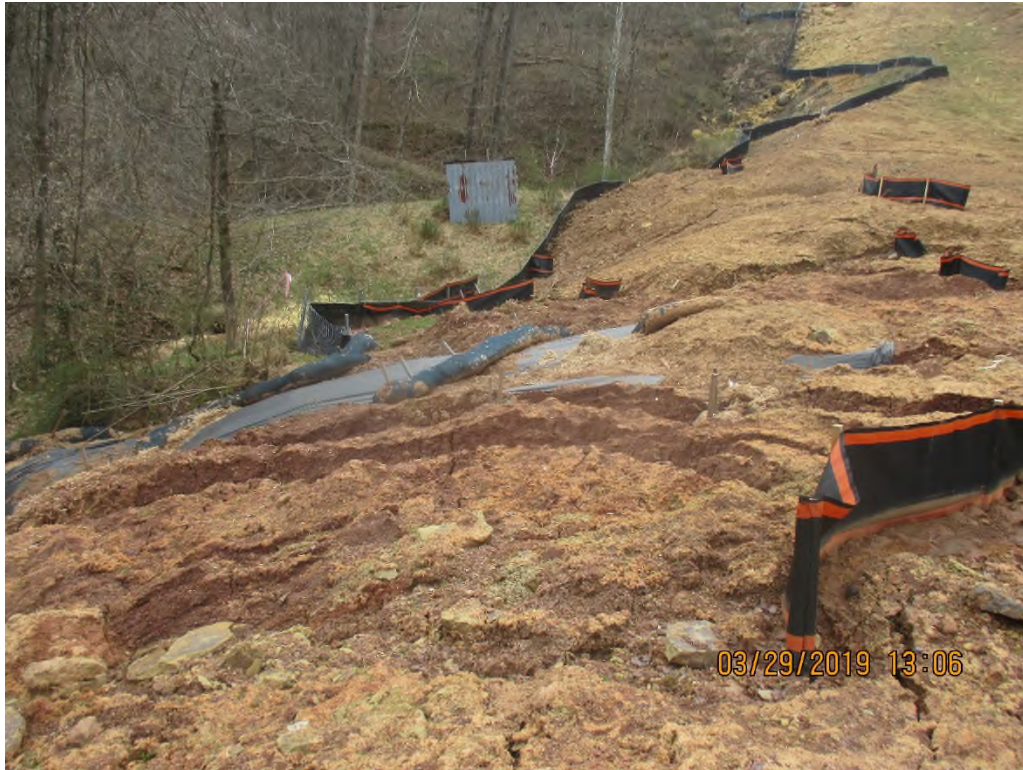
Section of adjacent land that slipped into ROW and within LOD near station #5180+43

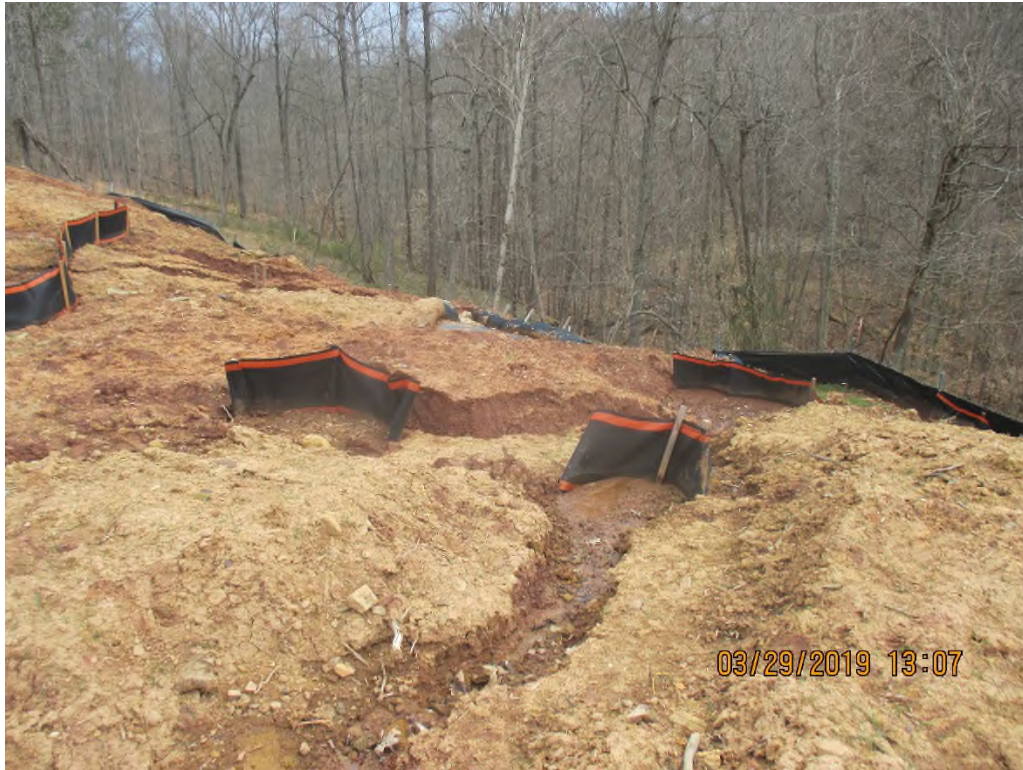
Standing in front of downslope controls facing slips. Arrow depicts slips occurring above and below where the pipeline is located.

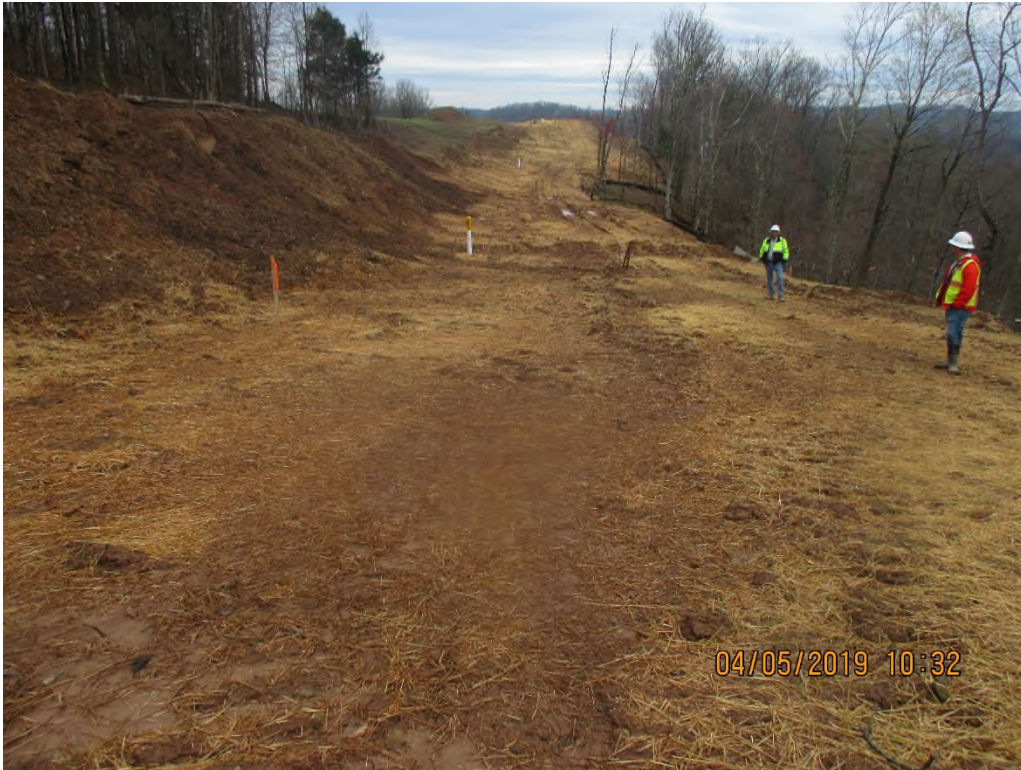
Downslope of slip occurring above ROW at station #6792+40. Scouring of temporary stabilization occurring.

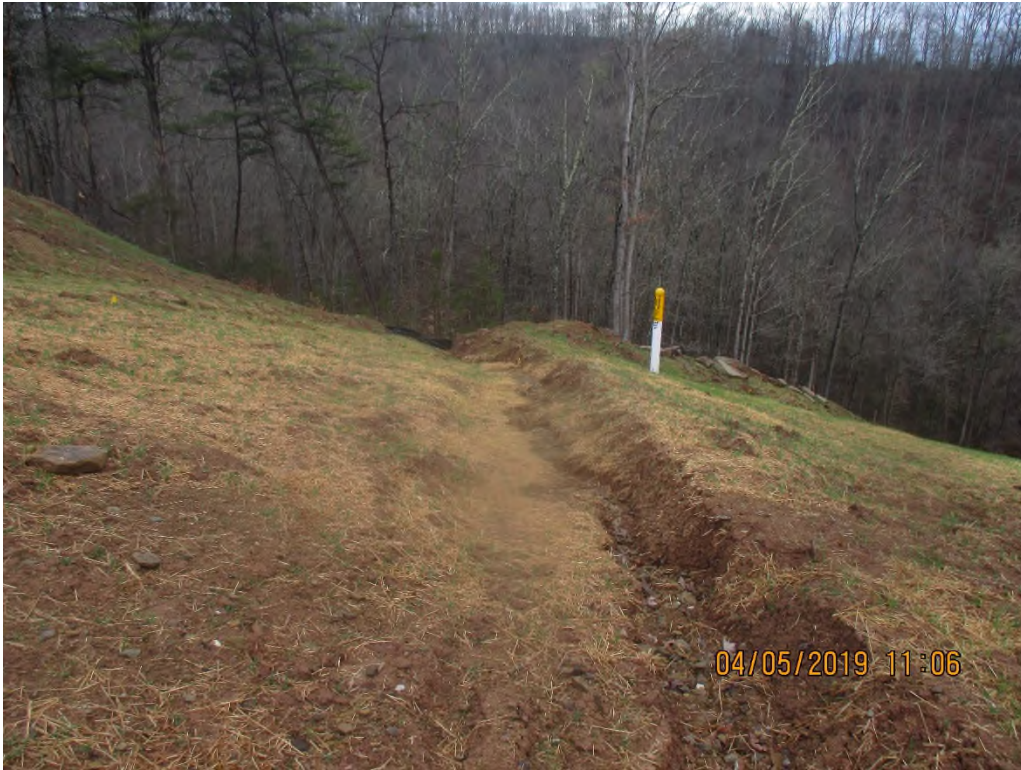
Slip that was reported at station #6810+00.

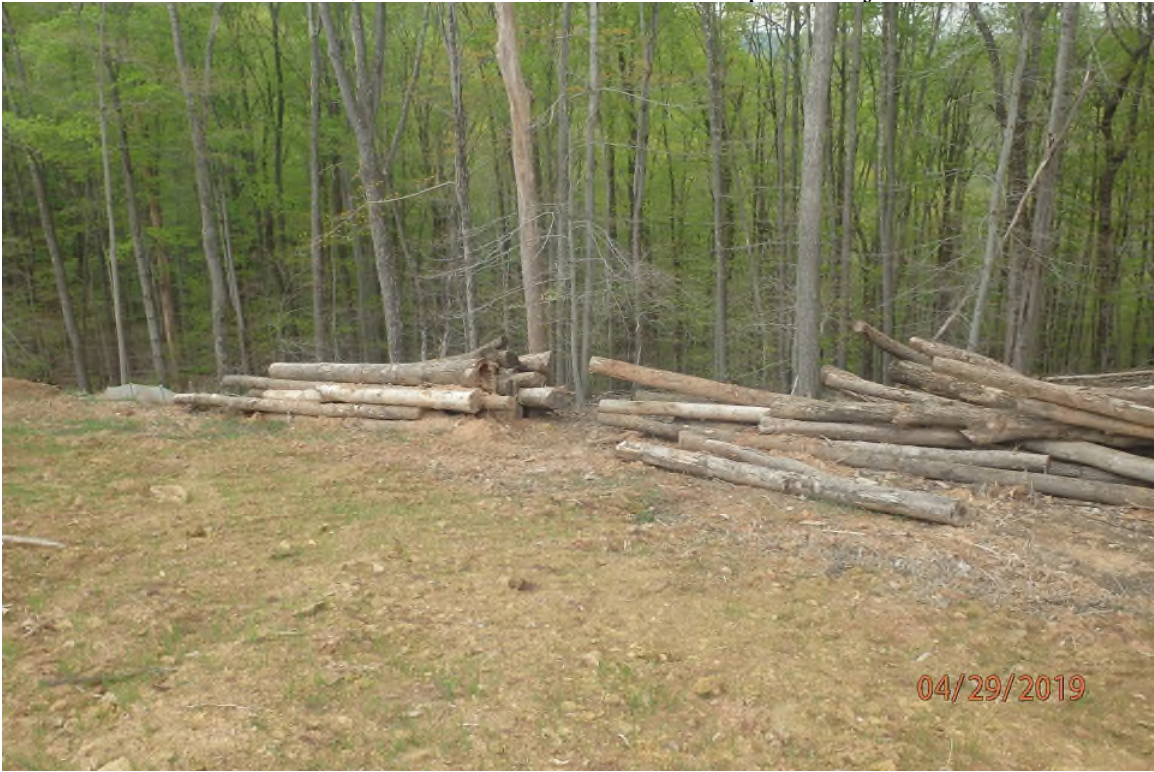
AR - 17 showing the need for maintenance to the ditch check upslope of the interceptor culvert.

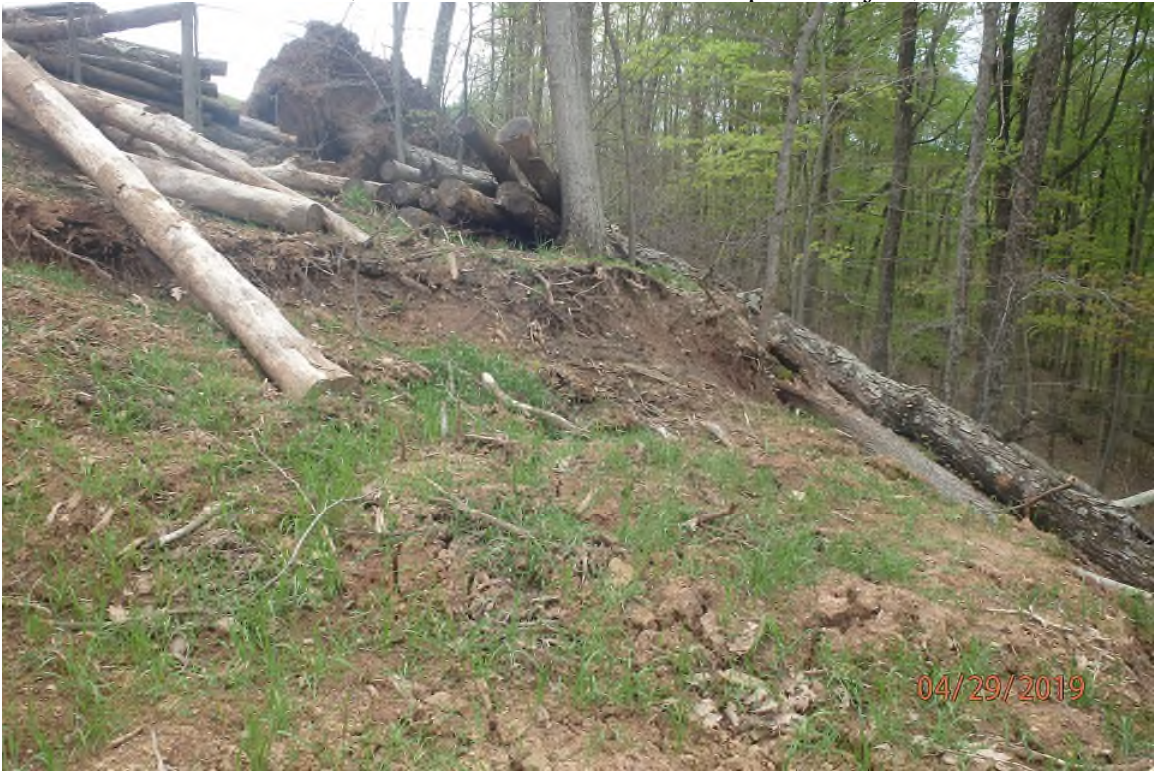
Project area adjacent to 2229+00 showing the need for perimeter controls where the approved SWPPP does not indicate the need.

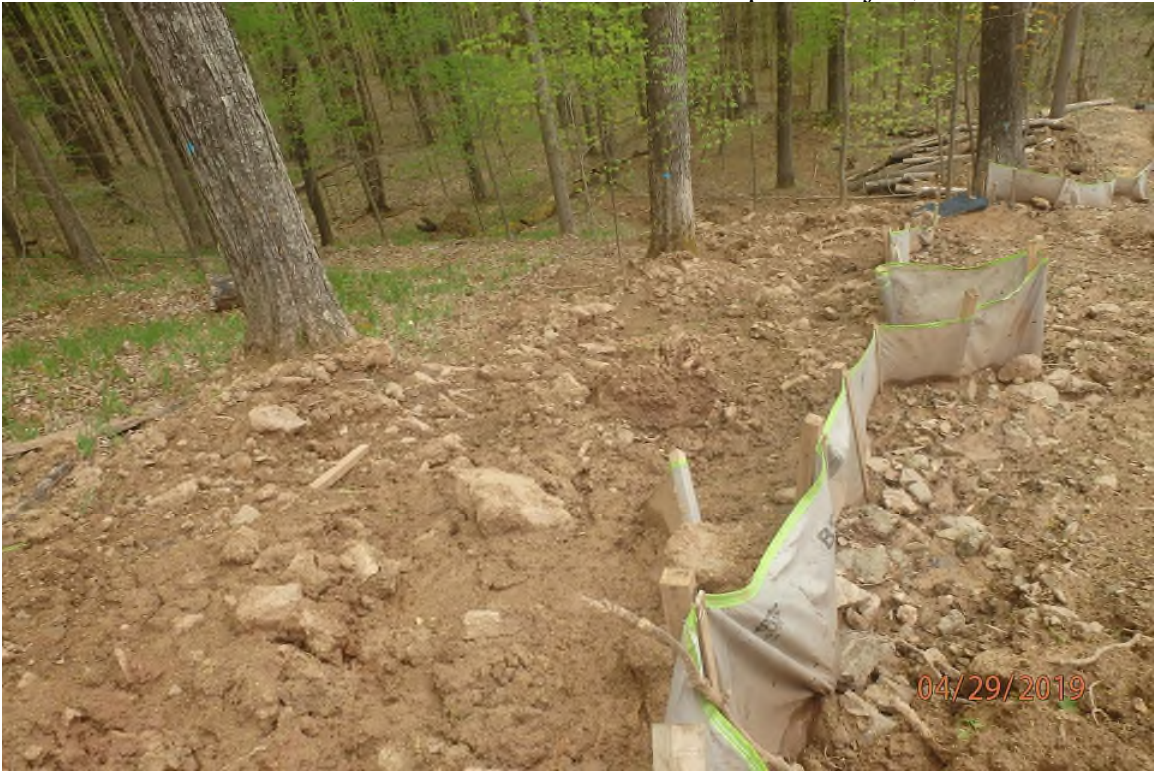
Offsite sediment downslope of the previously pictured slip.

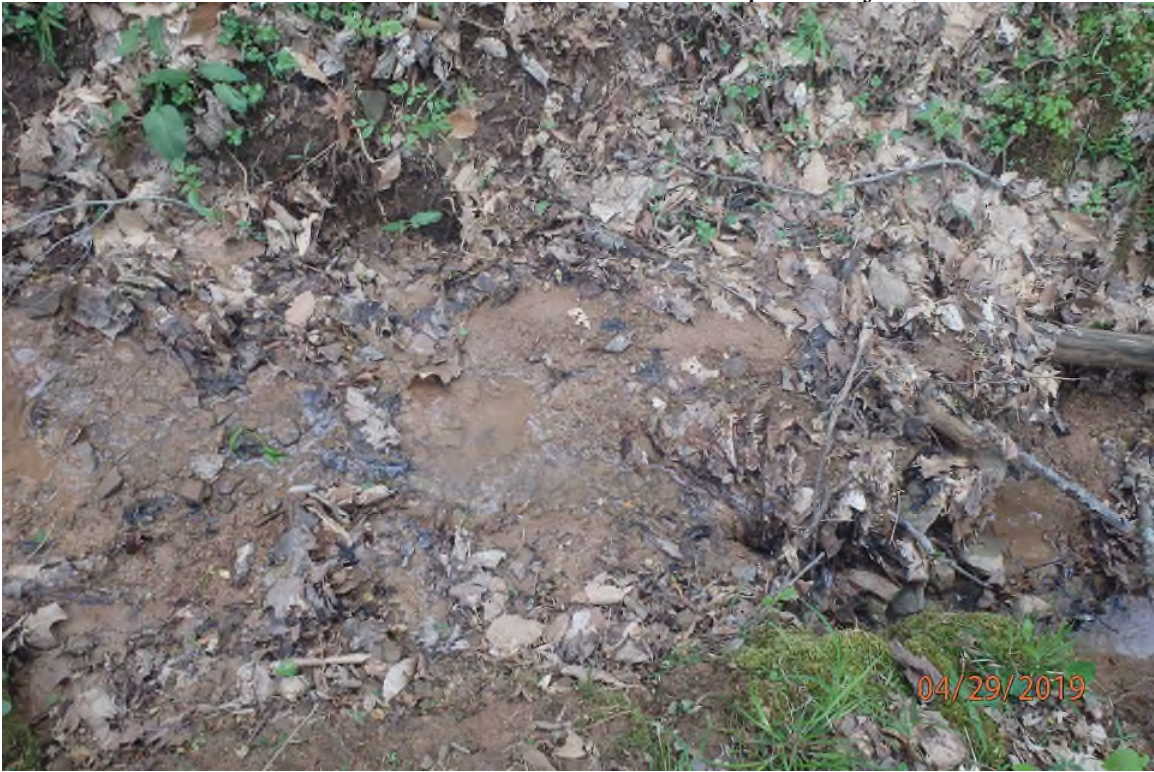
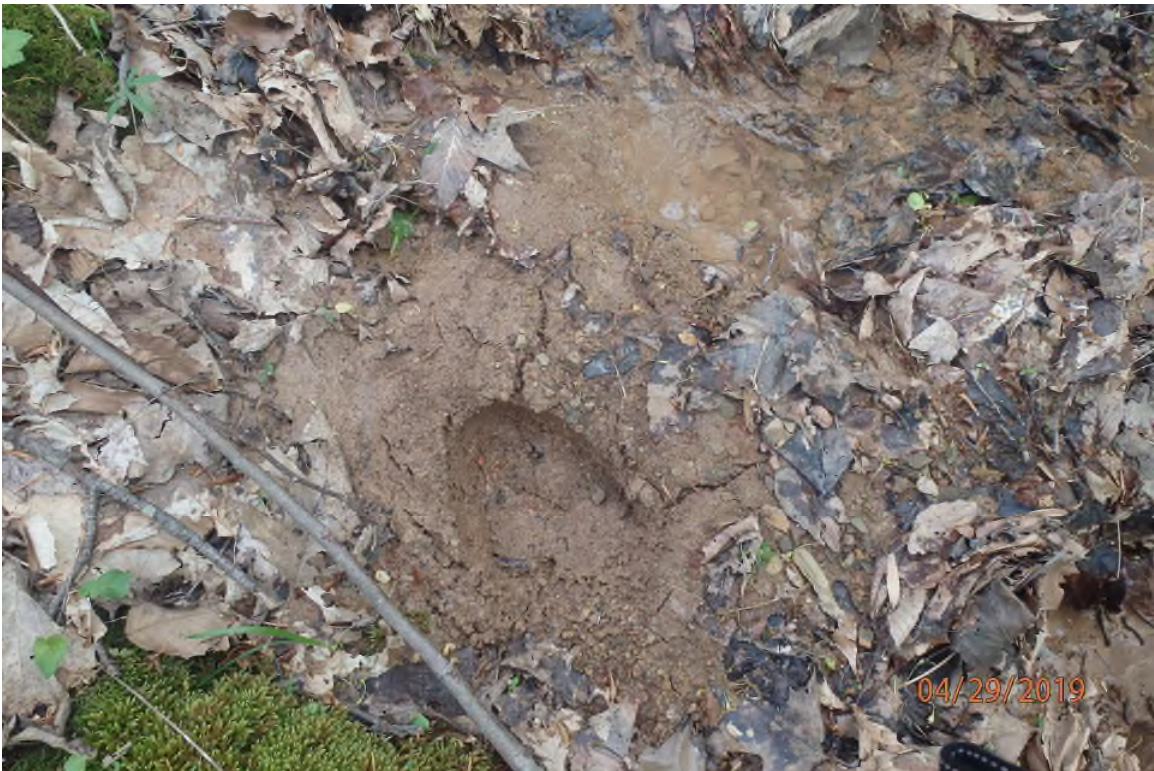
Offsite sediment deposits in SDOG243 (UNT Brush Run).

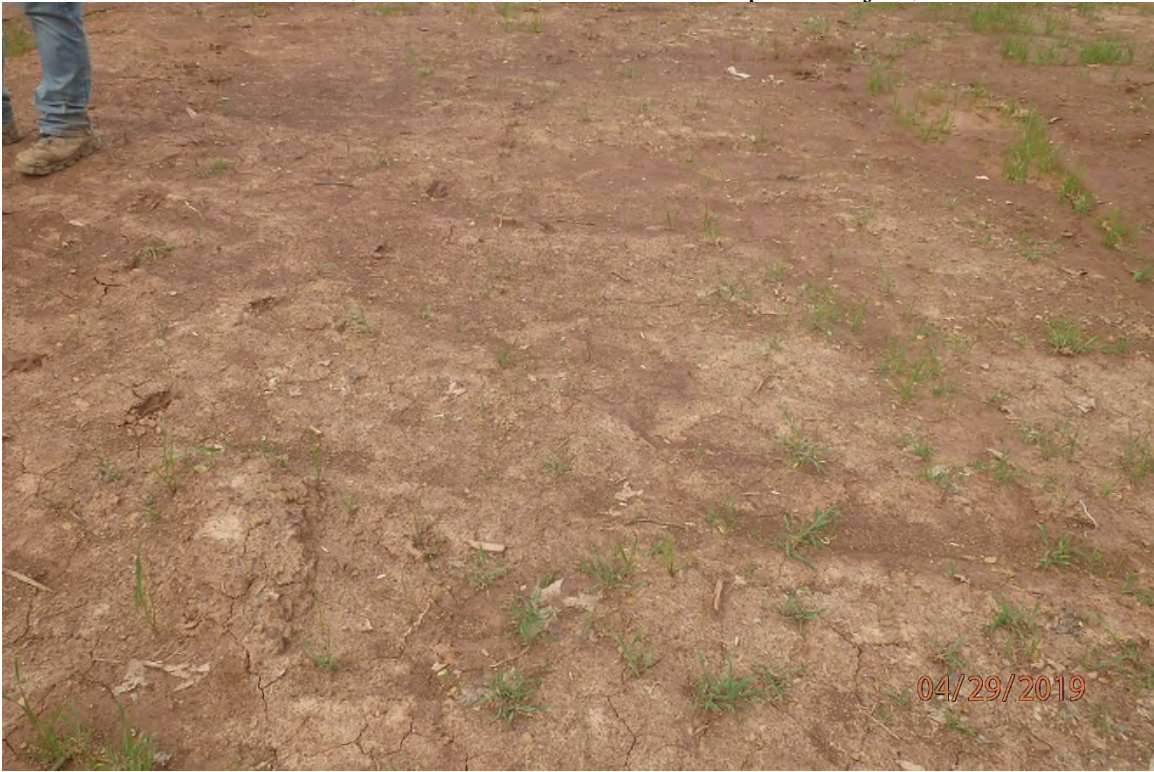
Disturbed areas of the project that are in need of reseeding.

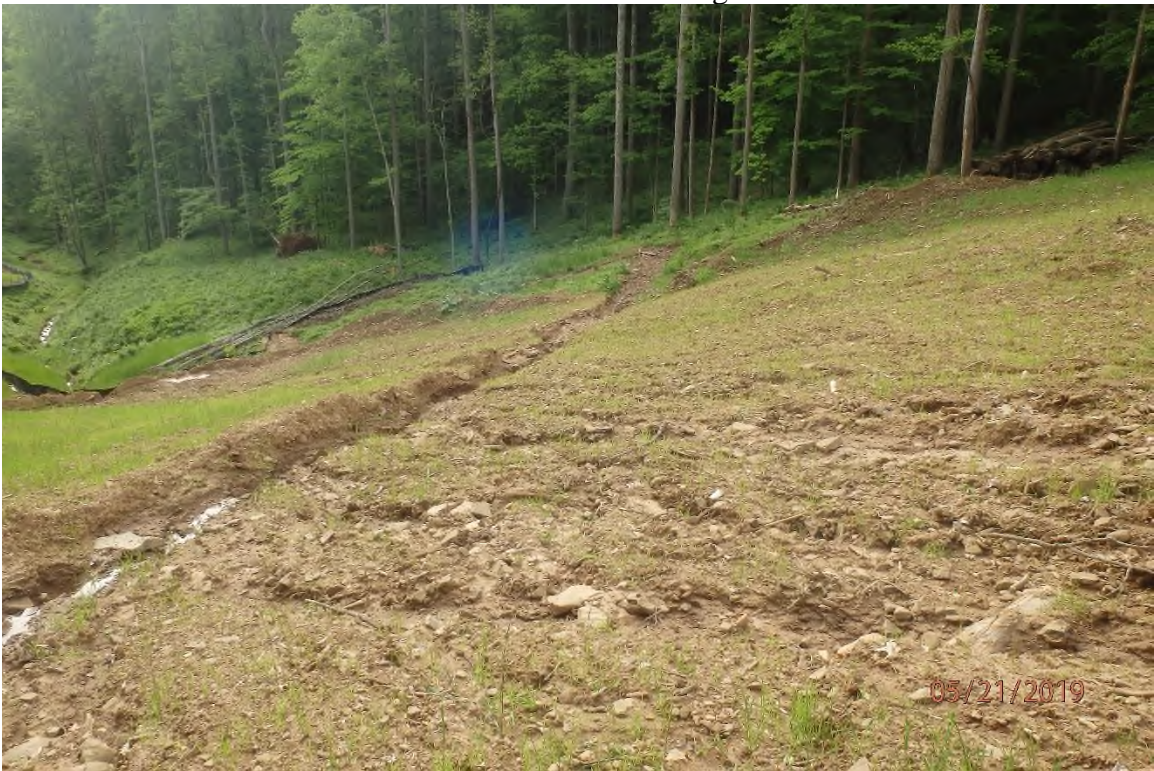
Unmaintained water bars in the UNT Sugar Run watershed.
