**CONSENT ORDER
ISSUED UNDER THE
WATER POLLUTION CONTROL ACT
WEST VIRGINIA CODE, CHAPTER 22, ARTICLE 11**

TO: Columbia Gas Transmission, LLC
Attn: Troy Tally, Vice President
1700 MacCorkle Ave
Charleston, WV 25314

DATE: October 1, 2020
ORDER NO.: 9061

1. Columbia Gas Transmission, LLC is conducting land disturbance activity associated with construction of the Mountaineer Xpress Project in Marshall, Wetzel, Tyler, Doddridge, Ritchie, Calhoun, Wirt, Roane, Jackson, Mason, Putnam, and Cabell Counties, West Virginia. On January 31, 2018, Columbia Gas Transmission, LLC was issued Water Pollution Control Permit No. WV0116815, Registration No. WVR310872, for Stormwater Associated With Oil and Gas Related Construction Activities.

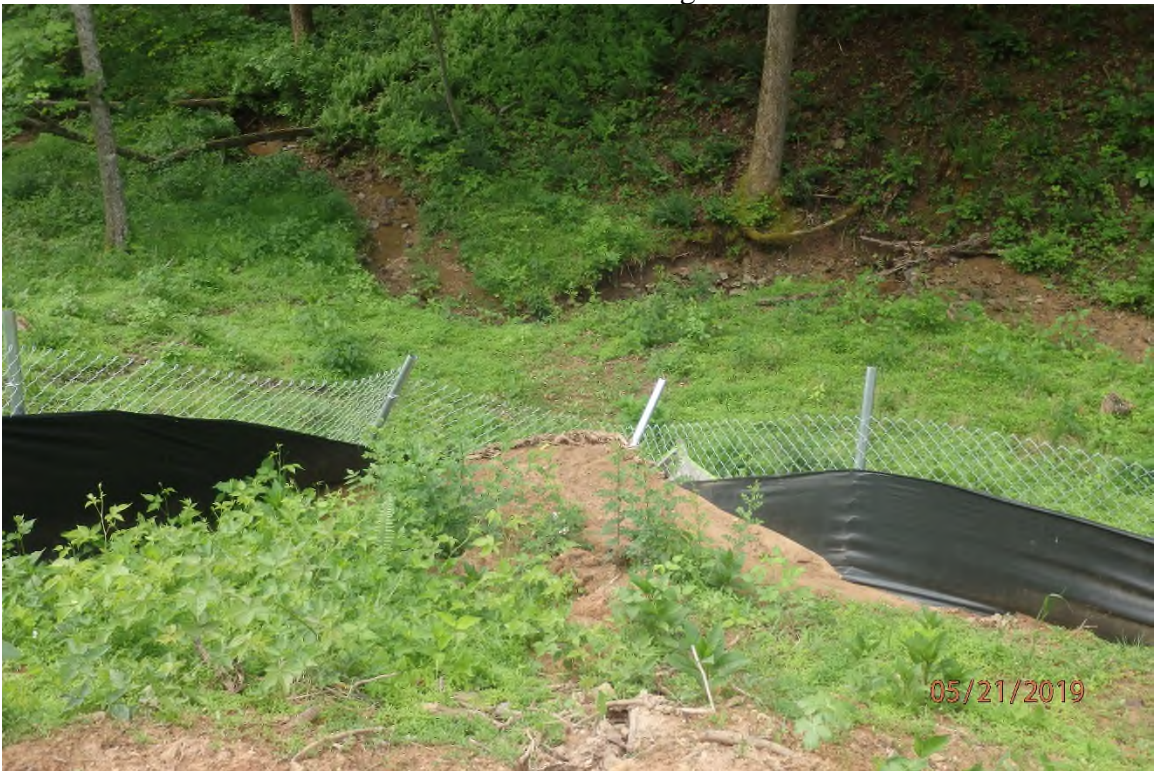
Unmaintained BMP in the UNT Sugar Run watershed.

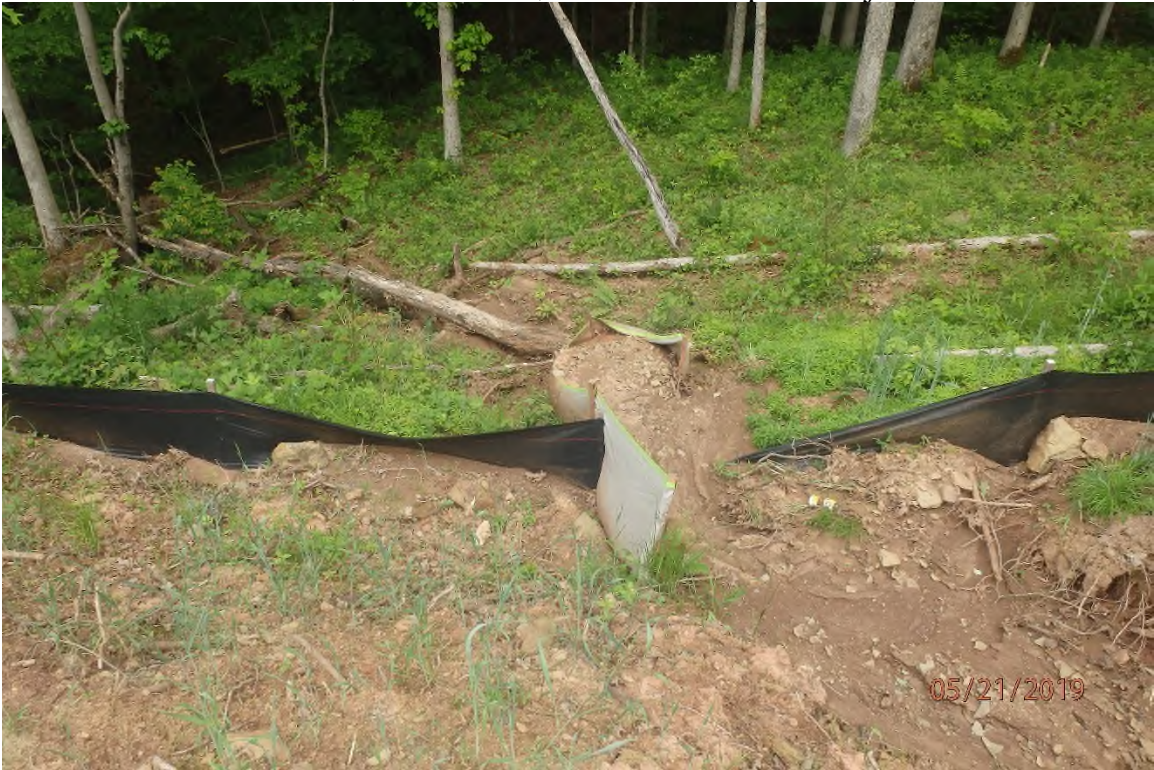
Unmaintained BMP in the UNT S. Fork of the Hughes River watershed.

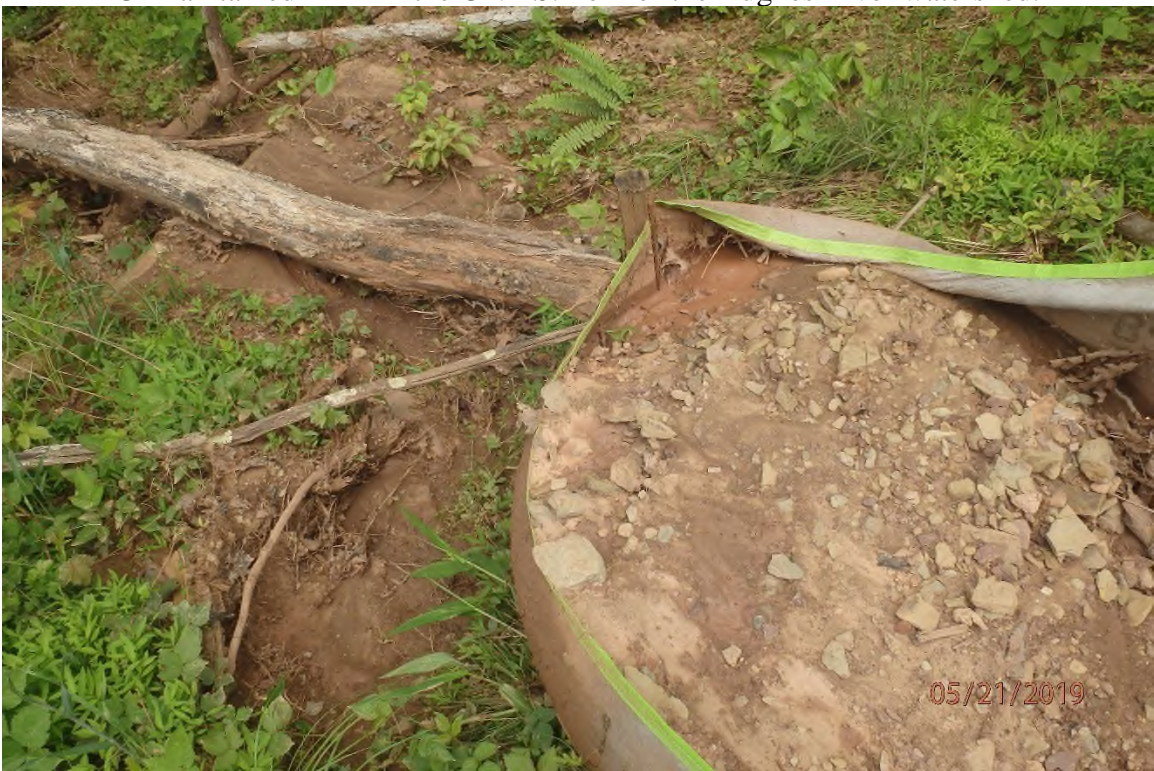
Unmaintained BMP in the UNT S. Fork of the Hughes River watershed.

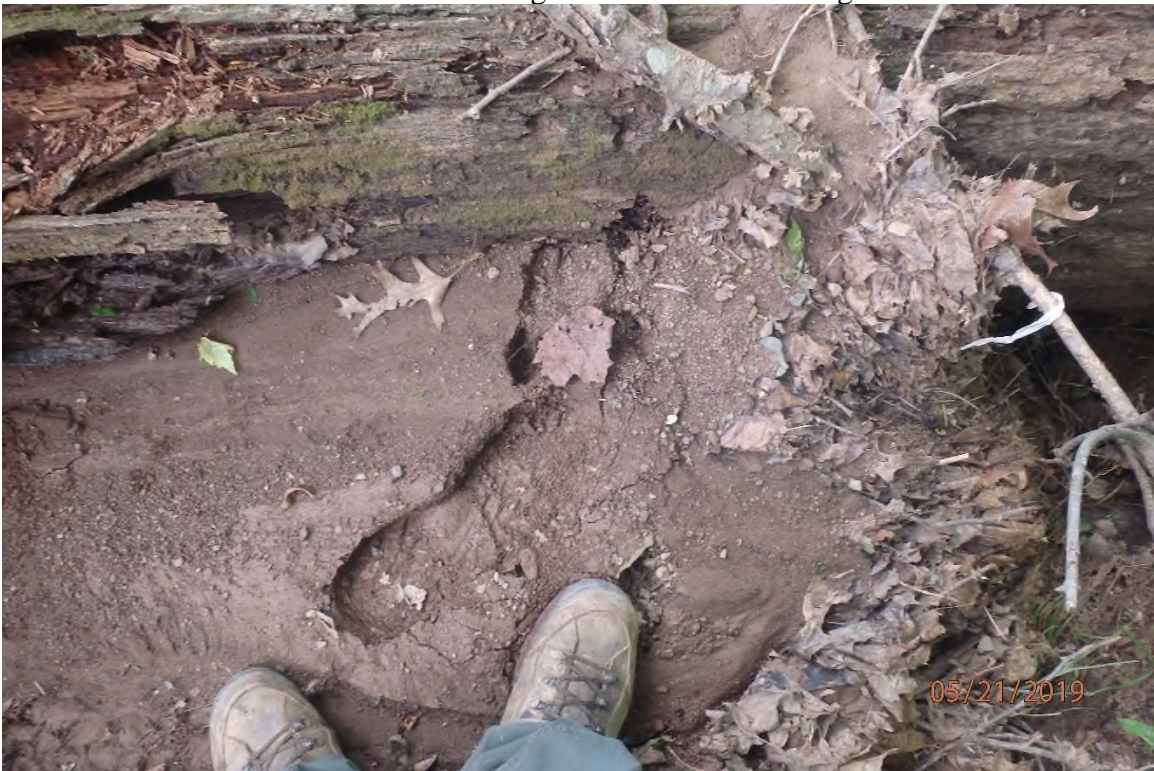
Offsite CNA deposits in UNT S. Fork of Hughes River (39° 11.596' X 80° 49.384') that originate from site.

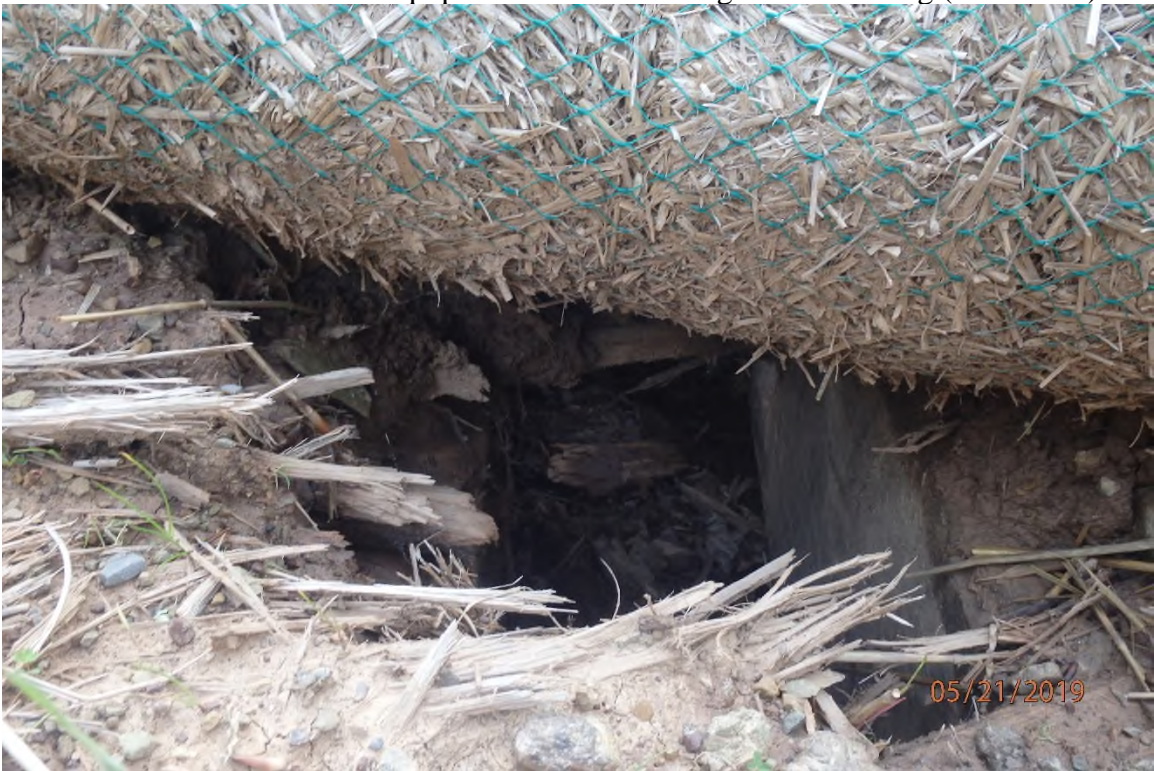
Unmaintained timber mat equipment BMP at the Sugar Run crossing (SDOH009).

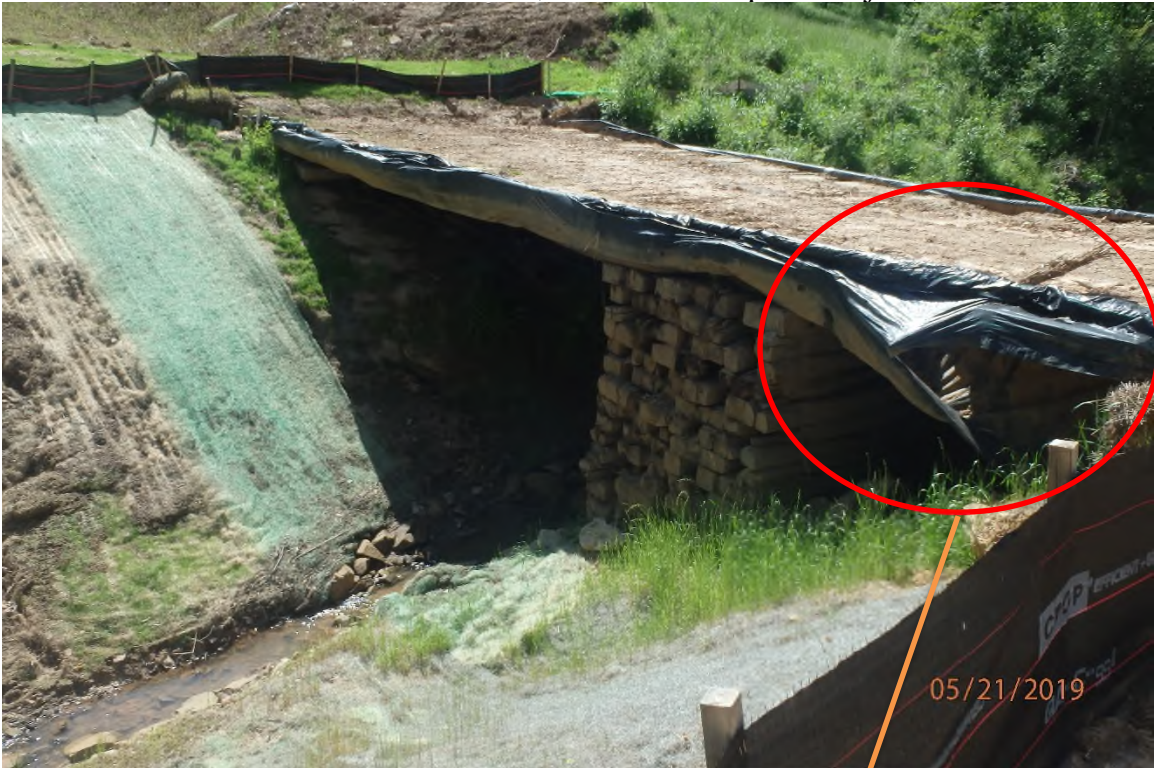
Unmaintained timber mat equipment BMP at the UNT Bluestone Creek crossing (SDOG539).

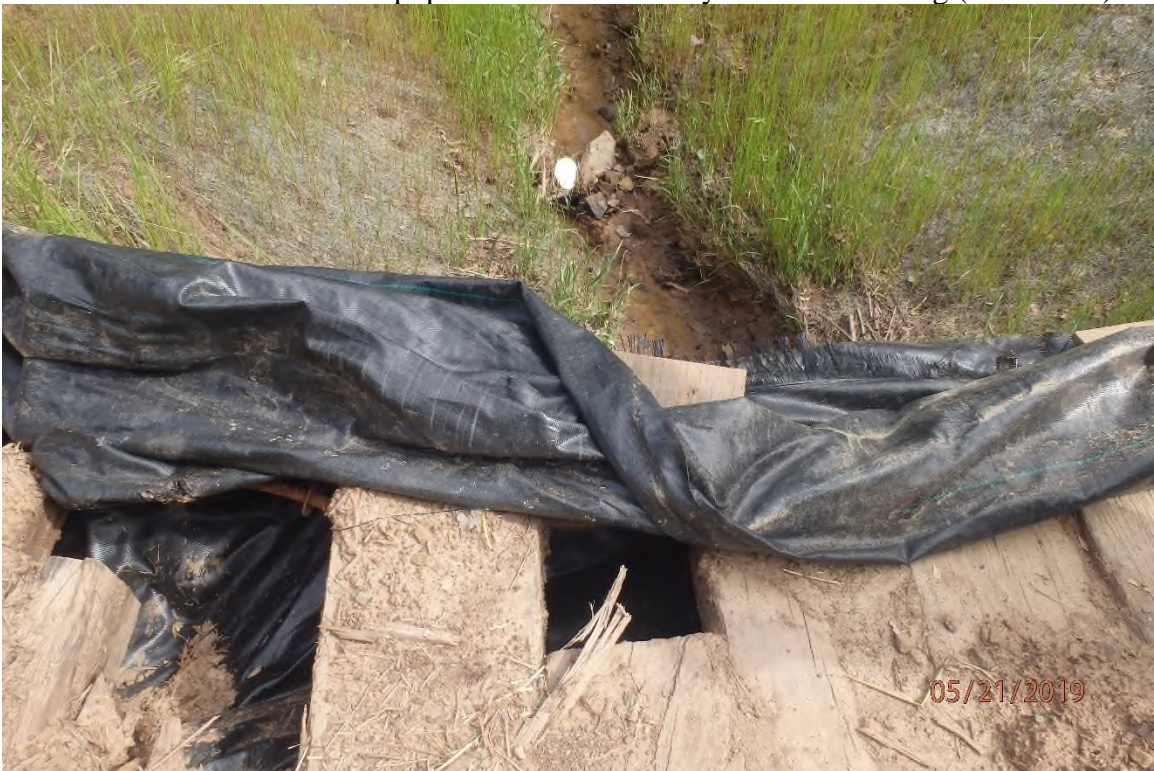
Unmaintained timber mat equipment BMP at the Taylor Drain crossing (SDON837).

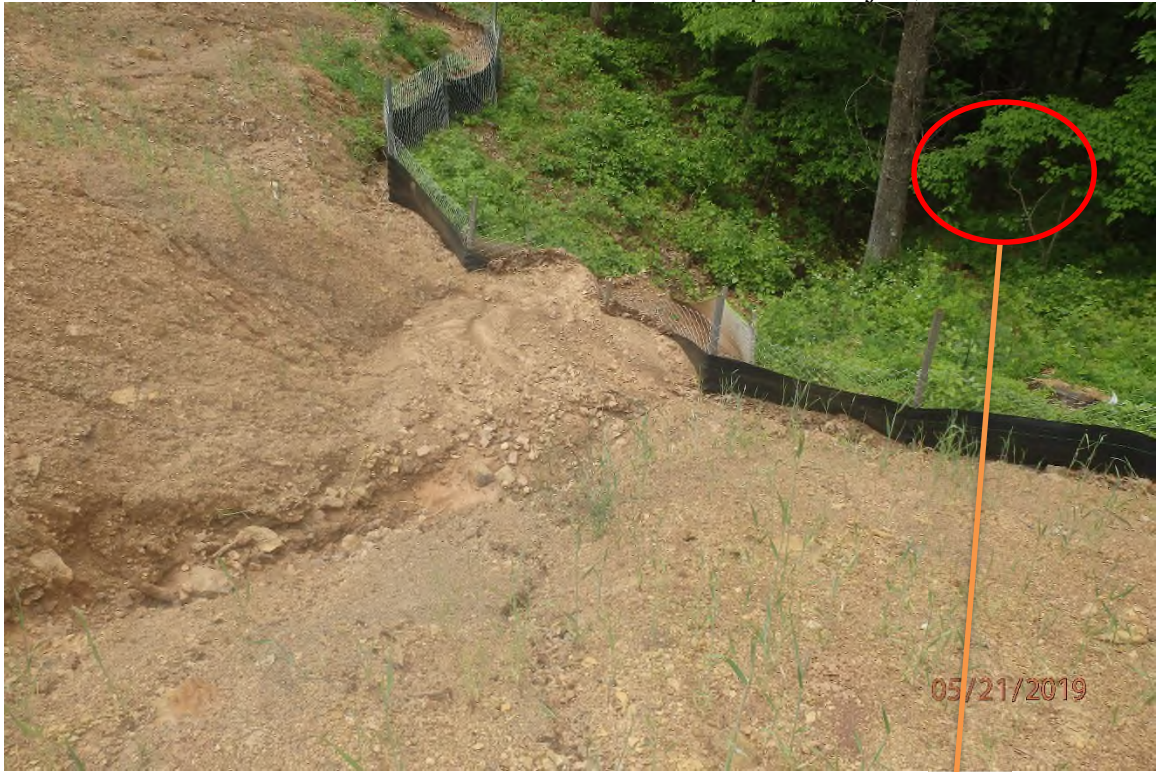
Unmaintained BMP in the UNT Trap Run watershed.

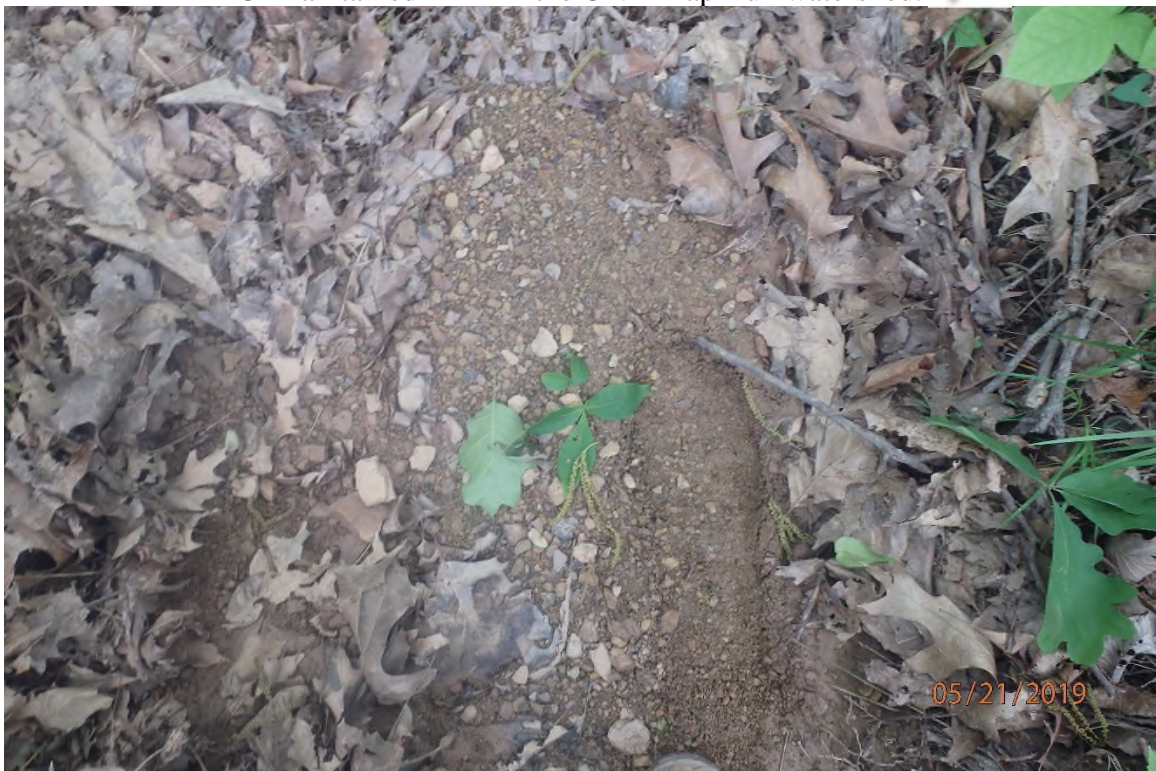
Offsite CNA deposits in UNT Trap Run (39° 11.375' X 80° 49.679') that originate from site.

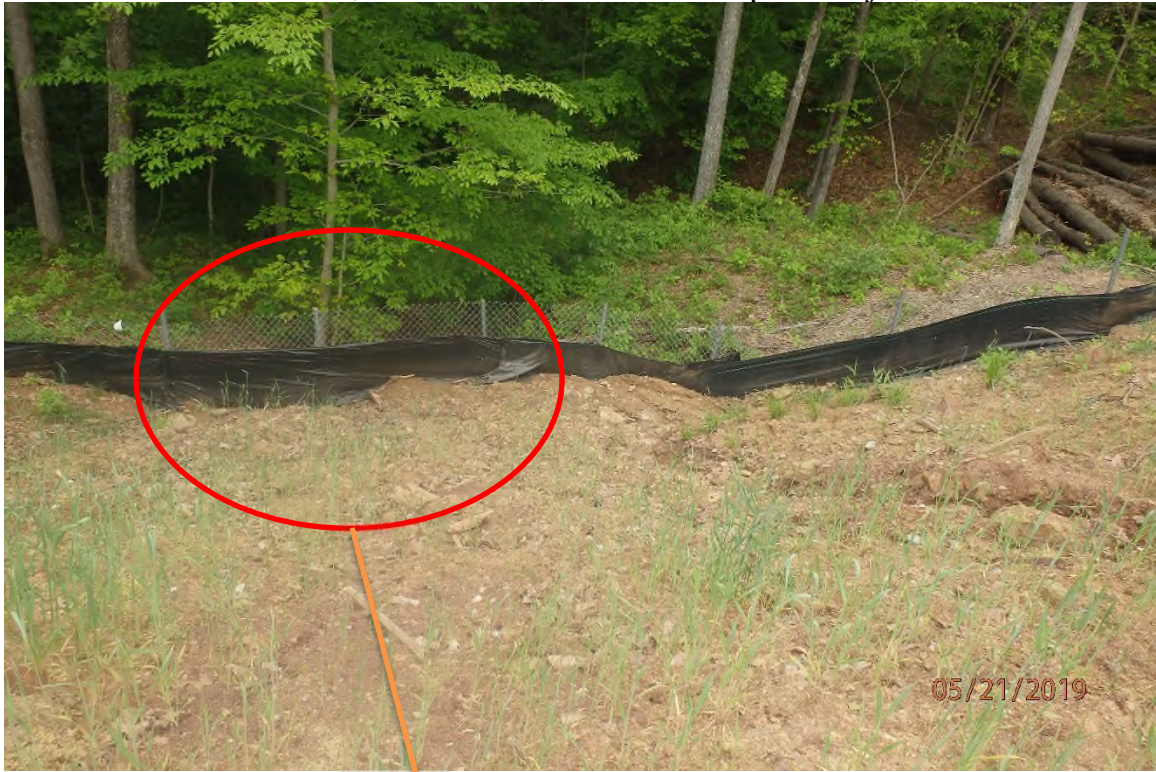
Unmaintained BMP in the UNT Trap Run watershed.

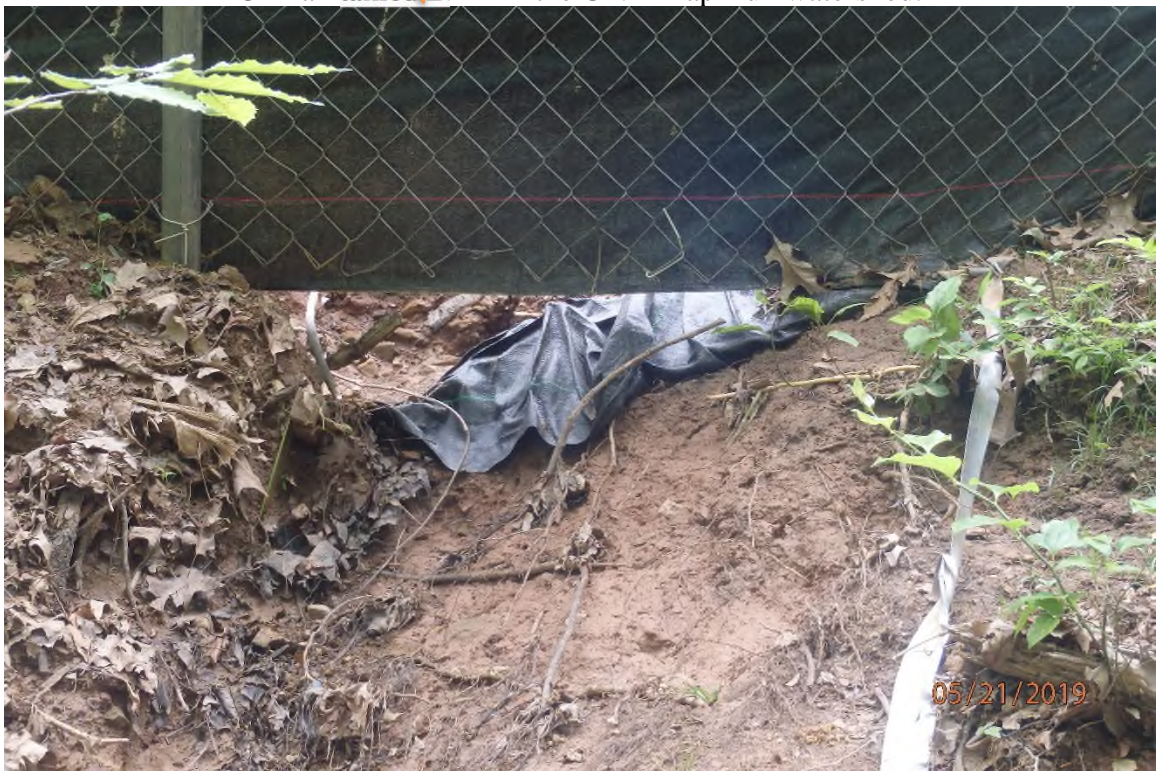
Unmaintained BMP in the UNT Trap Run watershed.

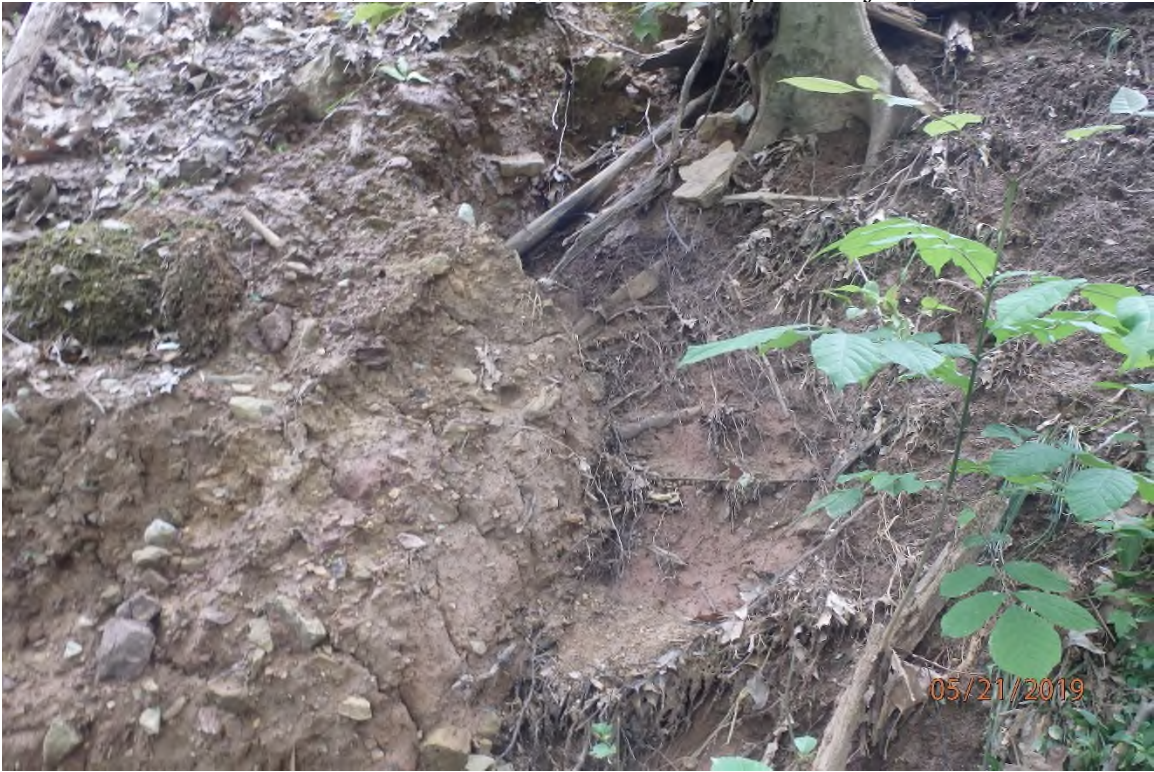
Offsite CNA deposits in UNT Trap Run ($39^{\circ} 11.342'$ X $80^{\circ} 49.611'$) that originate from site.

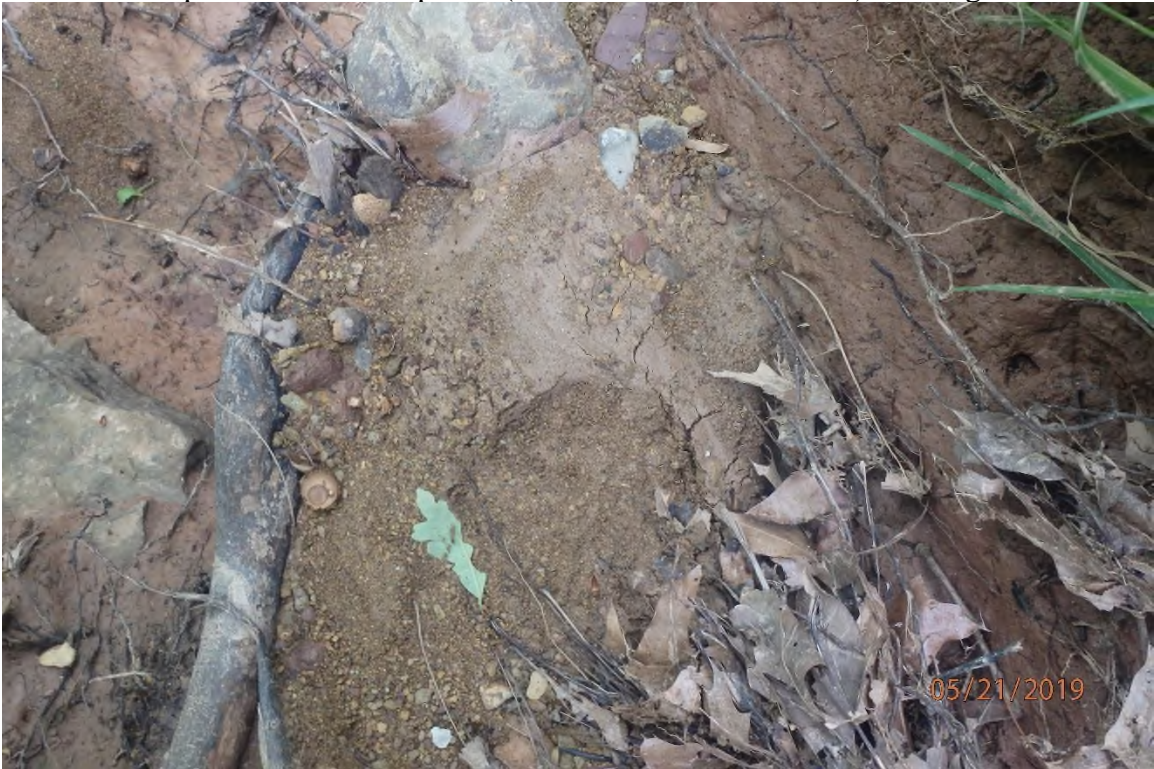
Offsite CNA deposits in UNT Trap Run ($39^{\circ} 11.342'$ X $80^{\circ} 49.611'$) that originate from site.

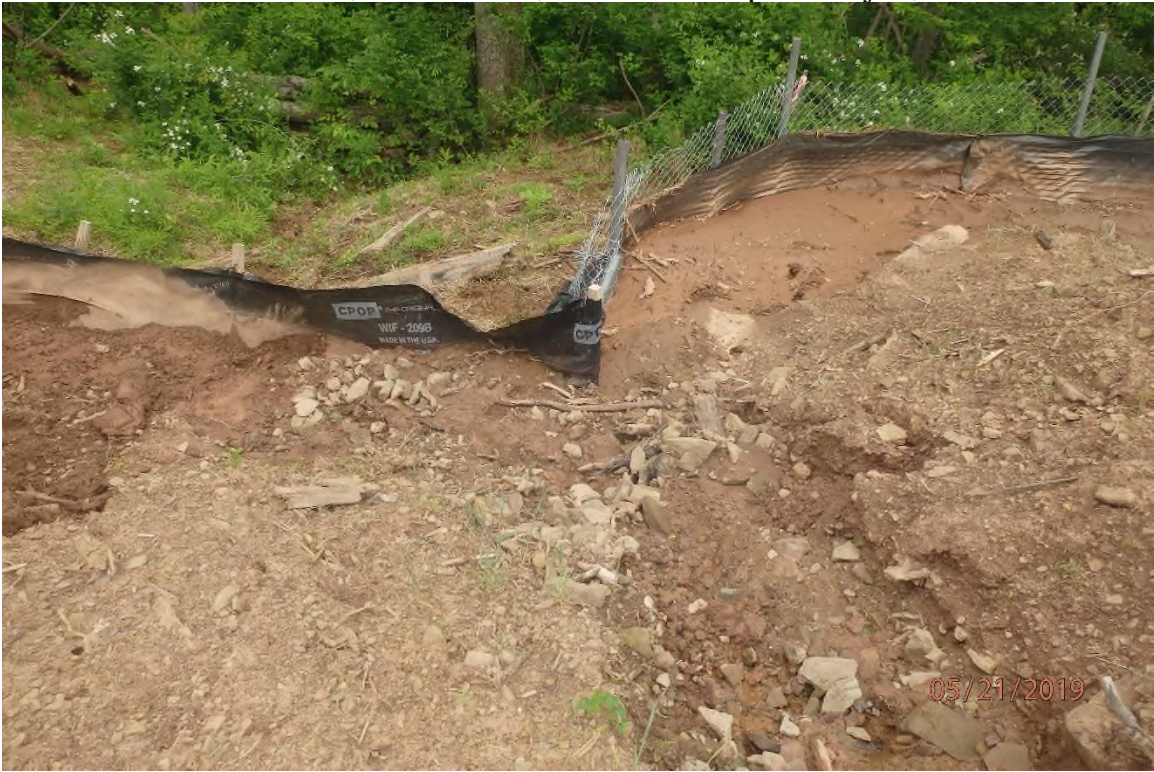
Unmaintained BMP in the UNT S. Fork of the Hughes River watershed.

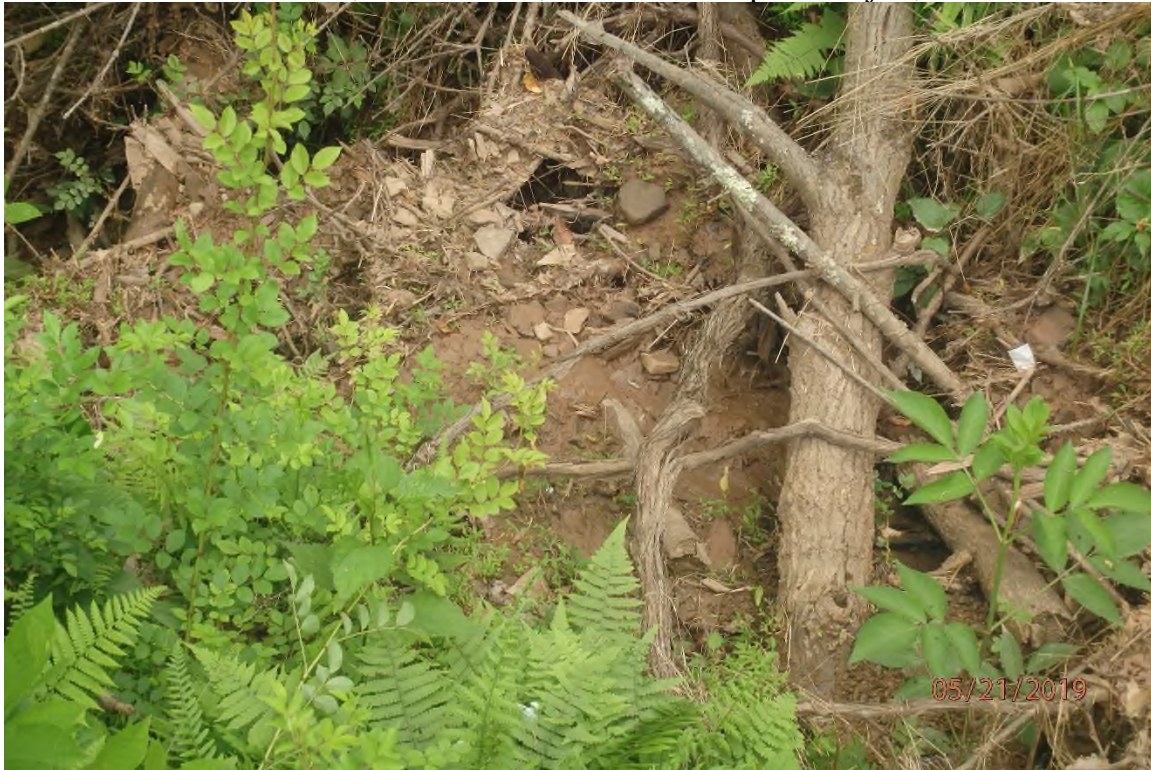
Offsite CNA deposits resulting from the previously unmaintained BMP in the UNT S. Fork of Hughes River (39° 11.467' X 80° 49.011').

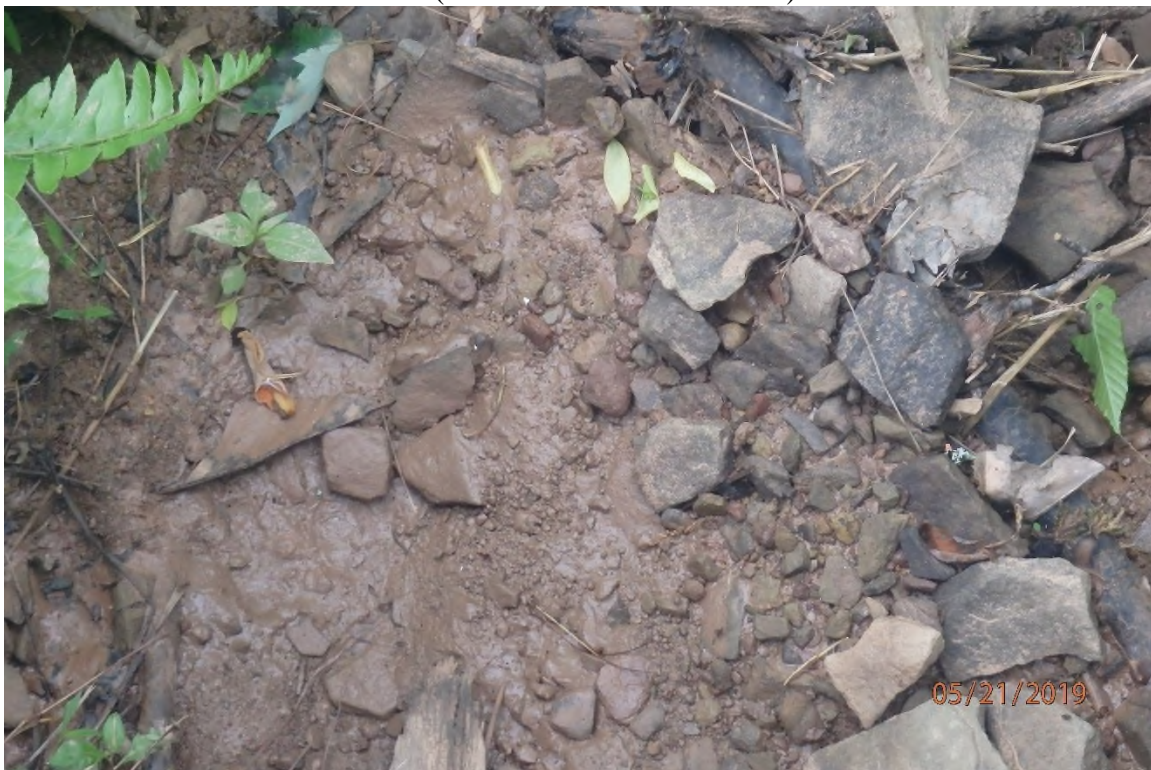
Offsite CNA deposits in the UNT S. Fork of Hughes River (39° 11.467' X 80° 49.011') that originate from site.

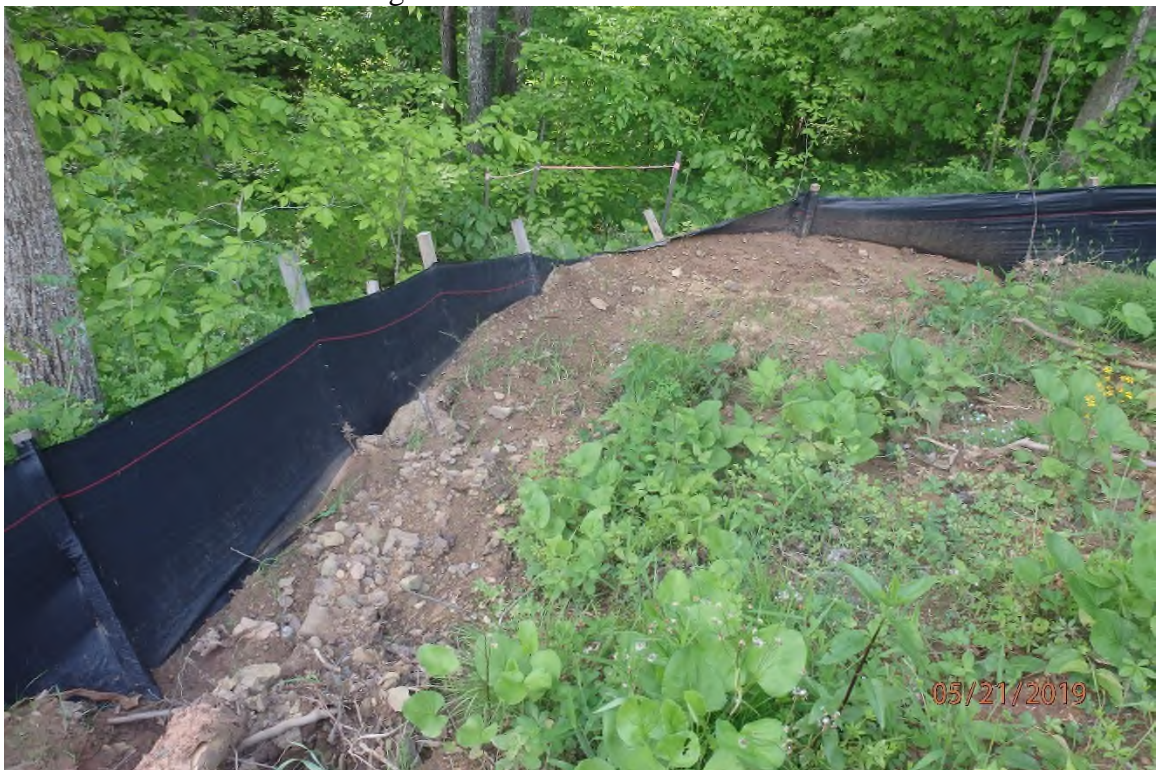
Sheet flow BMP installed in a concentrated flow area in the Sugar Run watershed. Pictured silt fence is not designed for concentrated flow treatment.

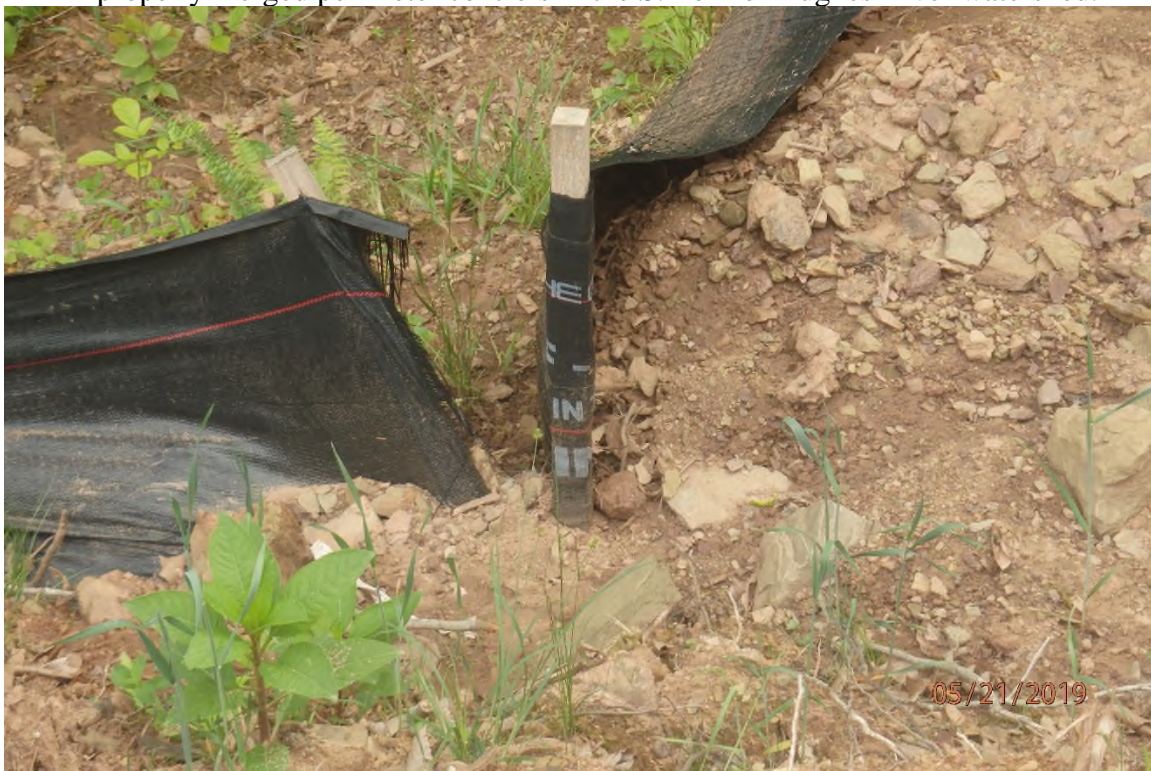
Improperly merged perimeter controls in the S. Fork of Hughes River watershed.

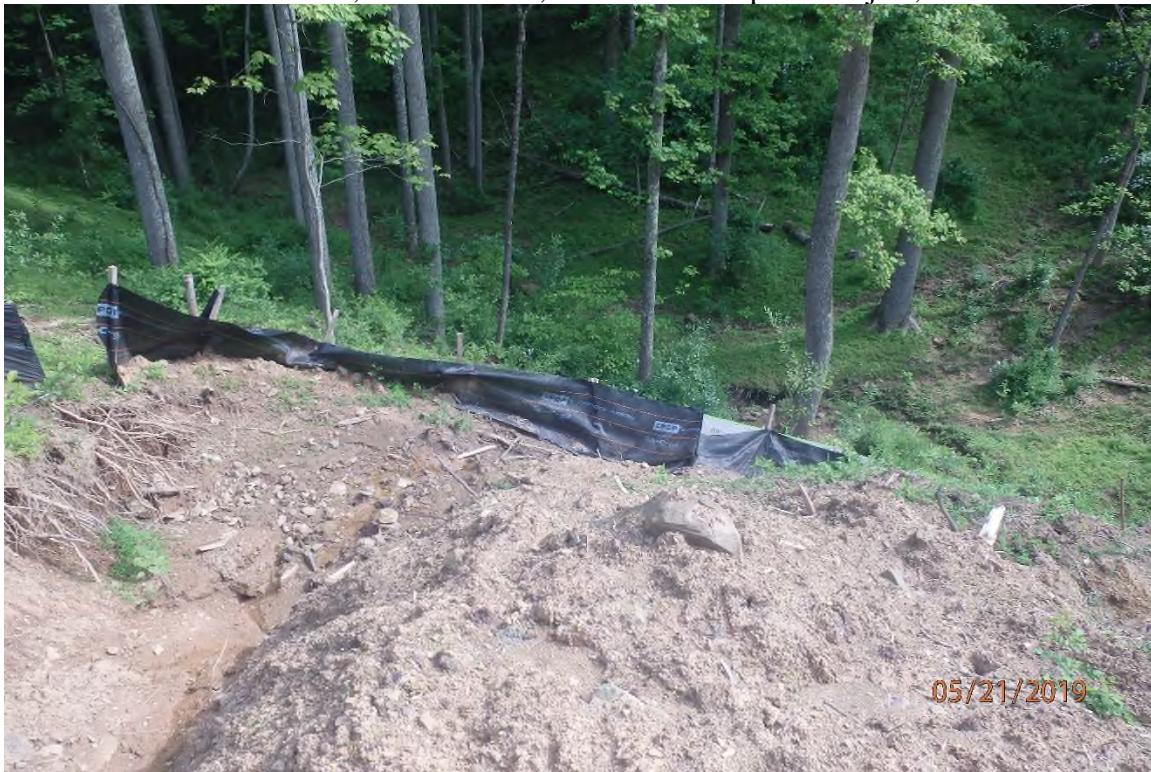
Improperly installed water bar in the Taylor Drain watershed. Water bar outlet discharges inside of the installed perimeter control and an appropriate outlet was not provided.

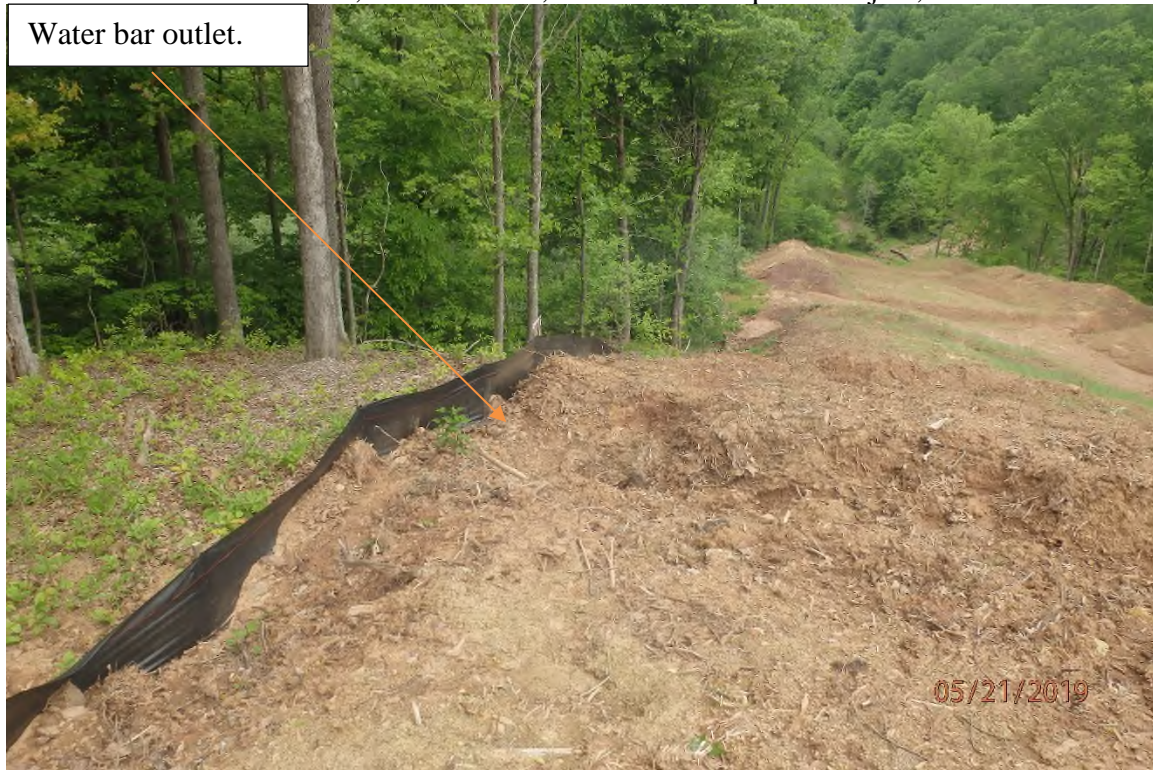
Improperly installed water bar in the Taylor Drain watershed. Water bar outlet discharges inside of the installed perimeter control and an appropriate outlet was not provided.

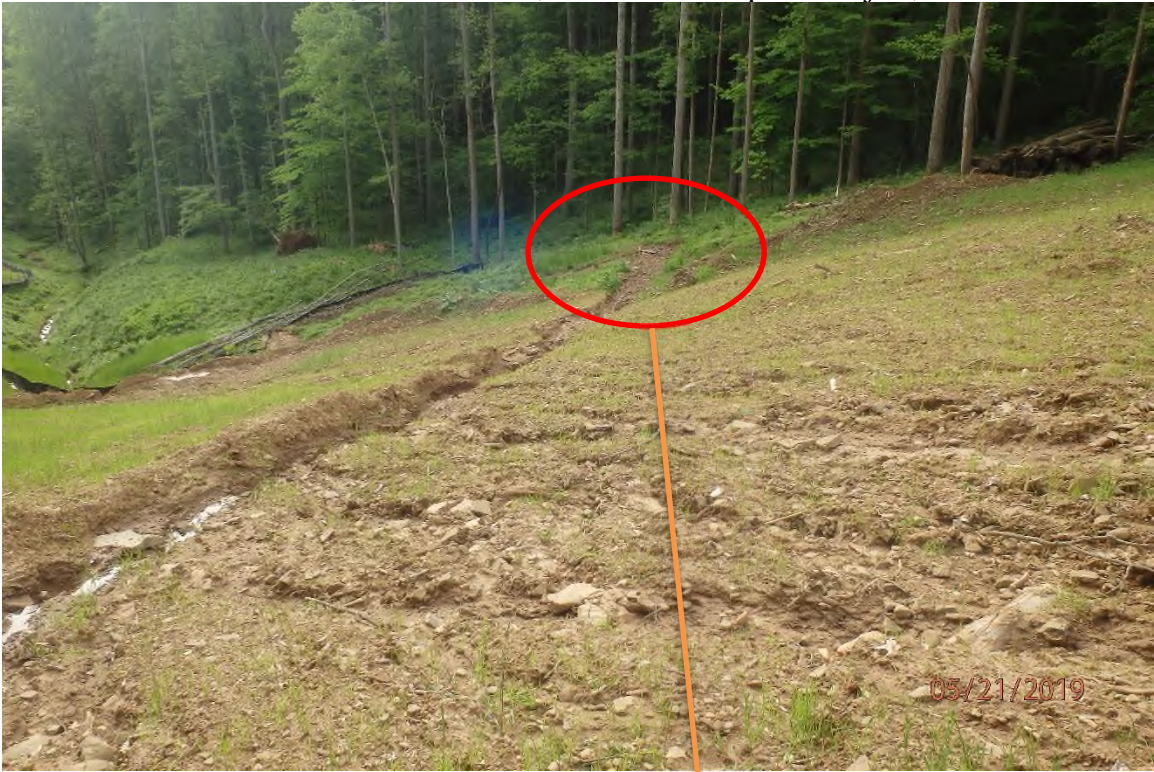
Water bar that lacks the outlet BMP indicated in the approved SWPPP in the UNT Sugar Run watershed.

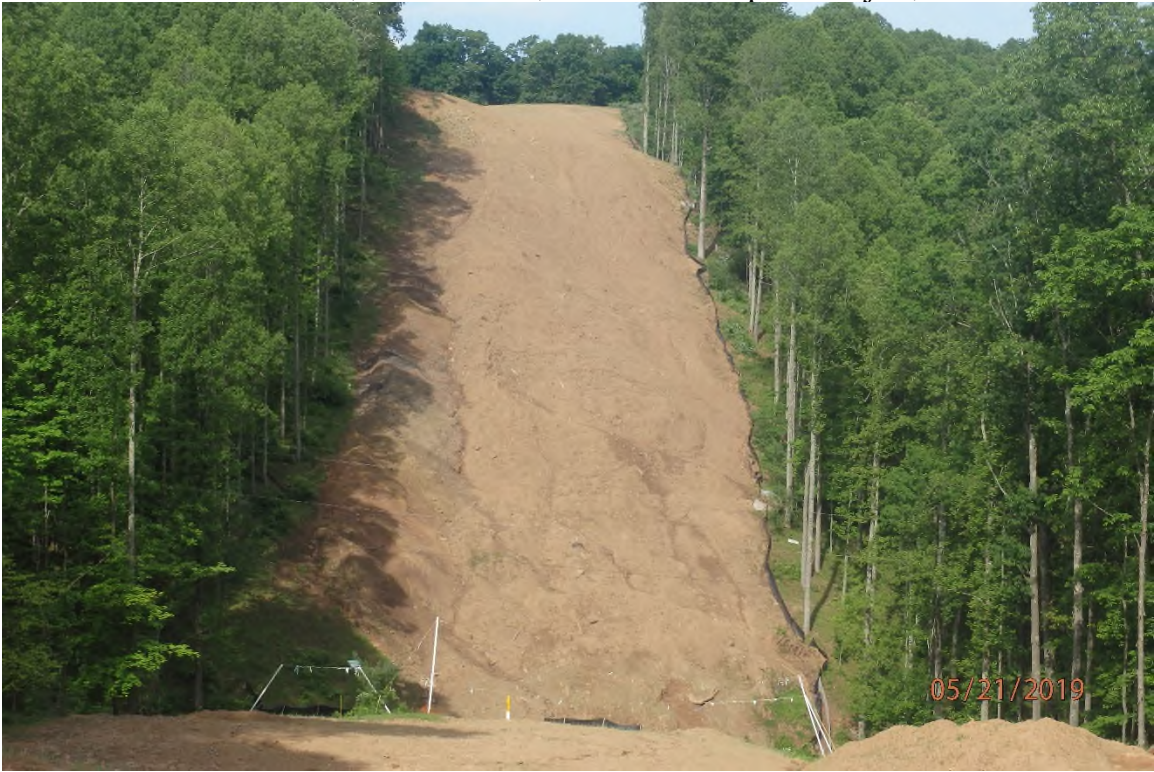
Areas of disturbance that were temporarily stabilized in December that have not germinated and have not been reseeded in the Taylor Drain watershed.

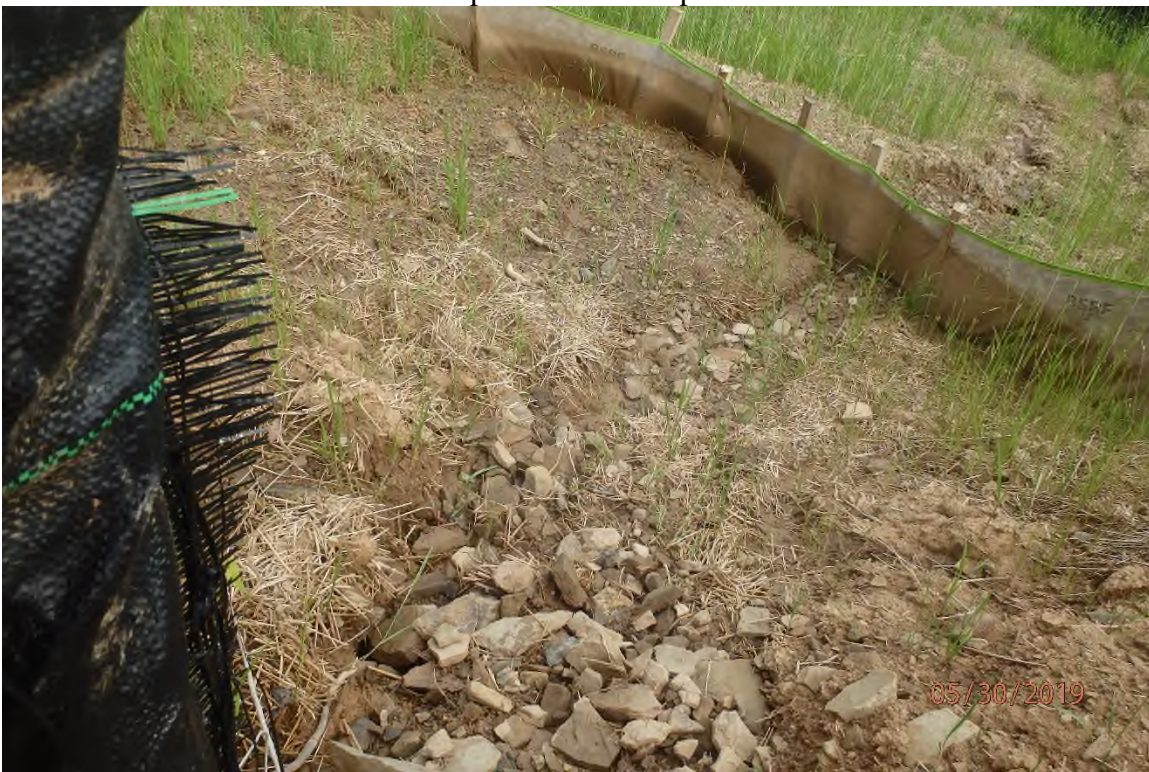
Fill slope erosion downslope of the above pictured water bar.

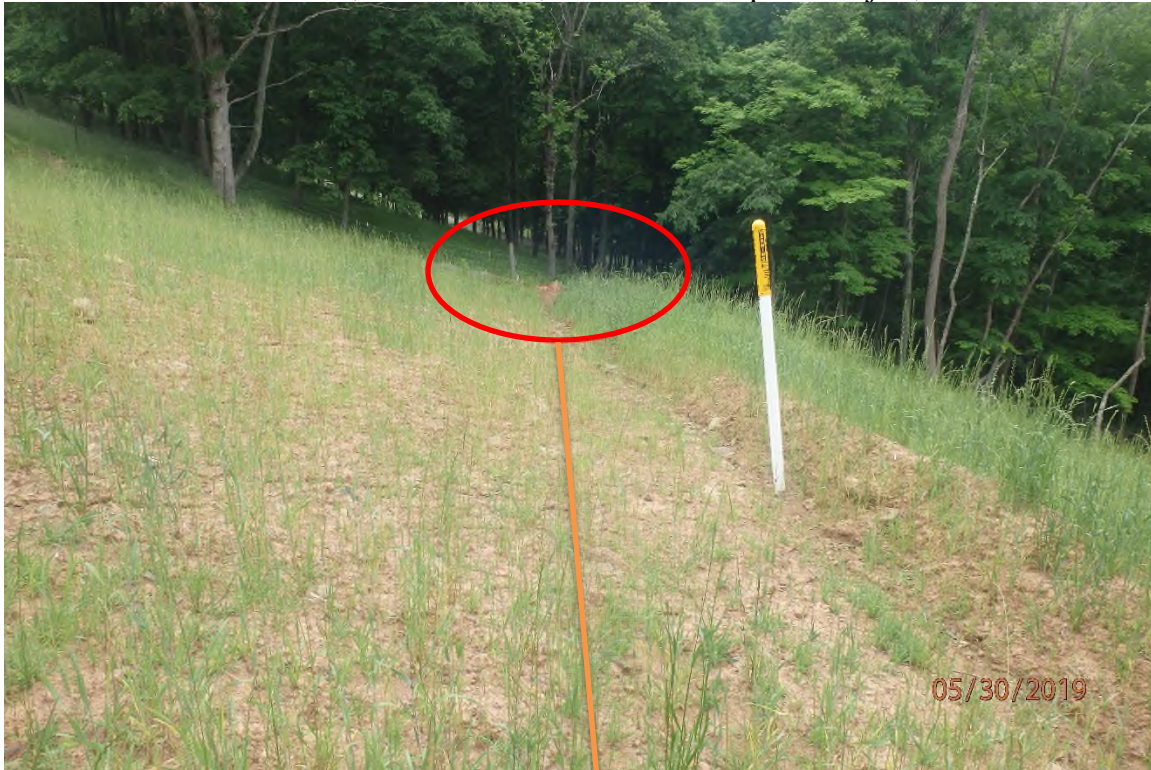
Above pictured water bars showing fill slope erosion downslope of the outlet.
