**CONSENT ORDER
ISSUED UNDER THE
WATER POLLUTION CONTROL ACT
WEST VIRGINIA CODE, CHAPTER 22, ARTICLE 11**

TO: Columbia Gas Transmission, LLC
Attn: Troy Tally, Vice President
1700 MacCorkle Ave
Charleston, WV 25314

DATE: October 1, 2020
ORDER NO.: 9061

1. Columbia Gas Transmission, LLC is conducting land disturbance activity associated with construction of the Mountaineer Xpress Project in Marshall, Wetzel, Tyler, Doddridge, Ritchie, Calhoun, Wirt, Roane, Jackson, Mason, Putnam, and Cabell Counties, West Virginia. On January 31, 2018, Columbia Gas Transmission, LLC was issued Water Pollution Control Permit No. WV0116815, Registration No. WVR310872, for Stormwater Associated With Oil and Gas Related Construction Activities.

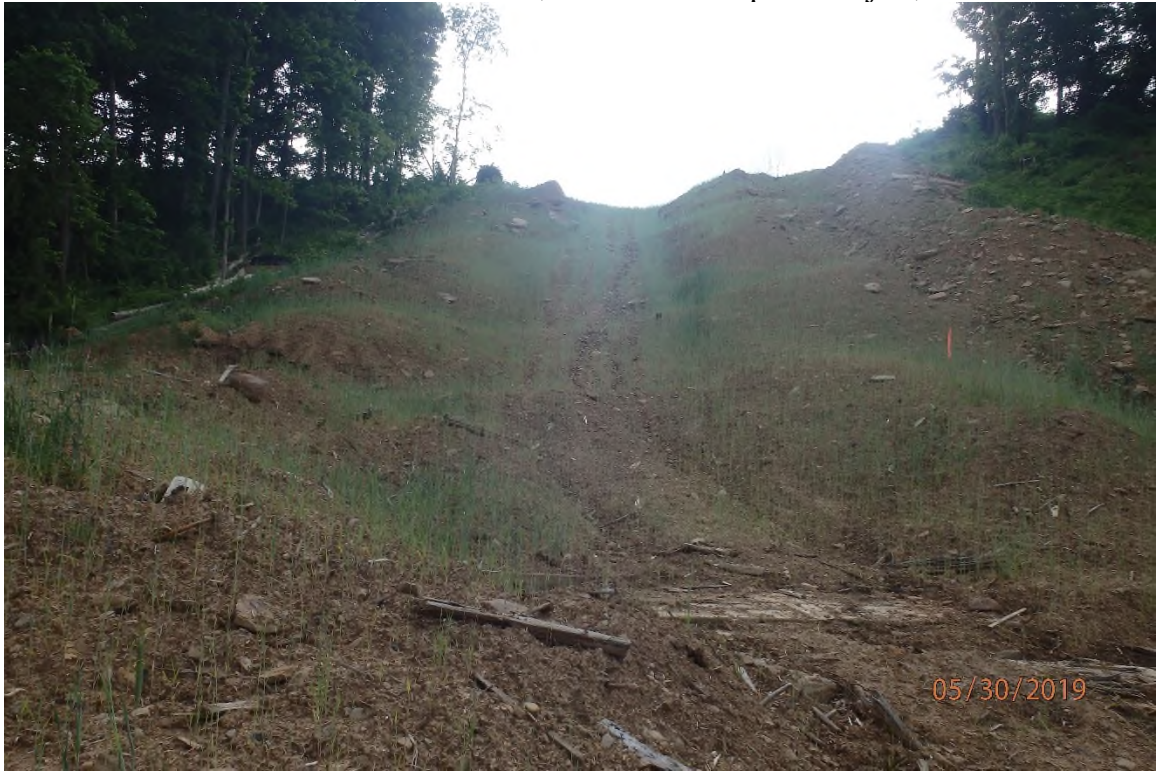
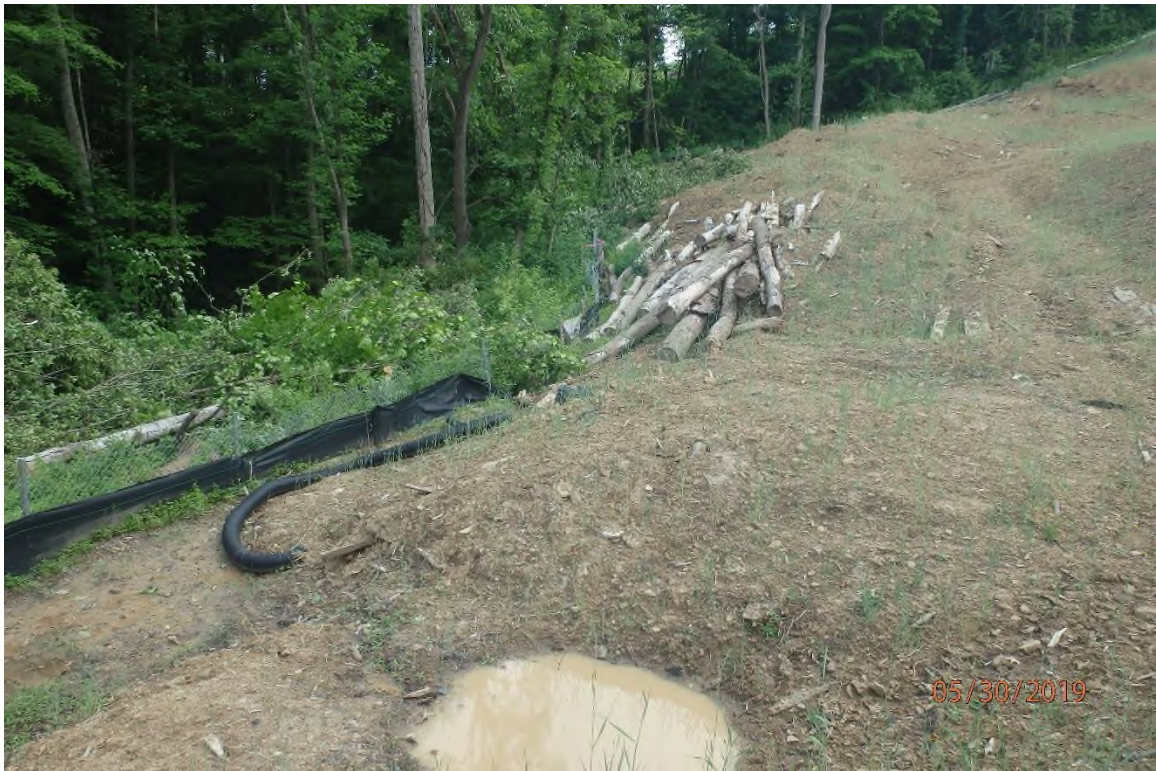
Water bar outlet in need of maintenance and the associated offsite sediment deposits in the UNT Wolfepen Run watershed.

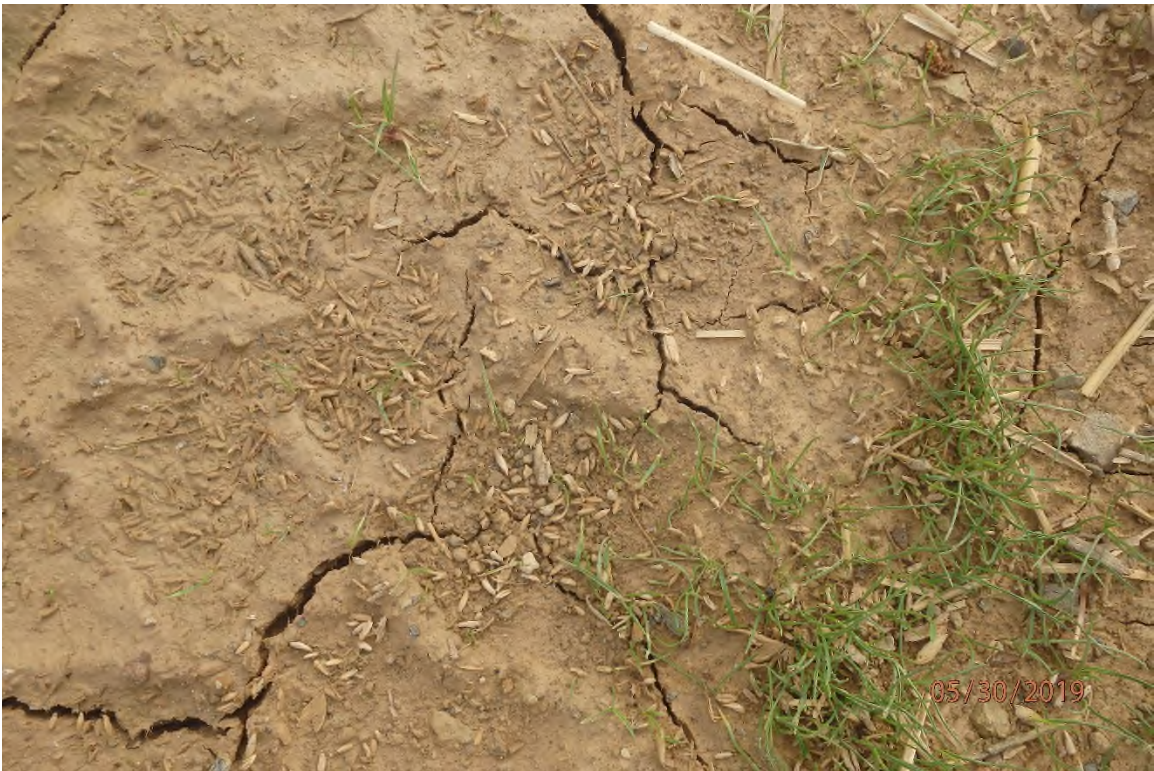
Areas in the Meathouse Fork watershed on the MXP-100 that are in need of reseeding.

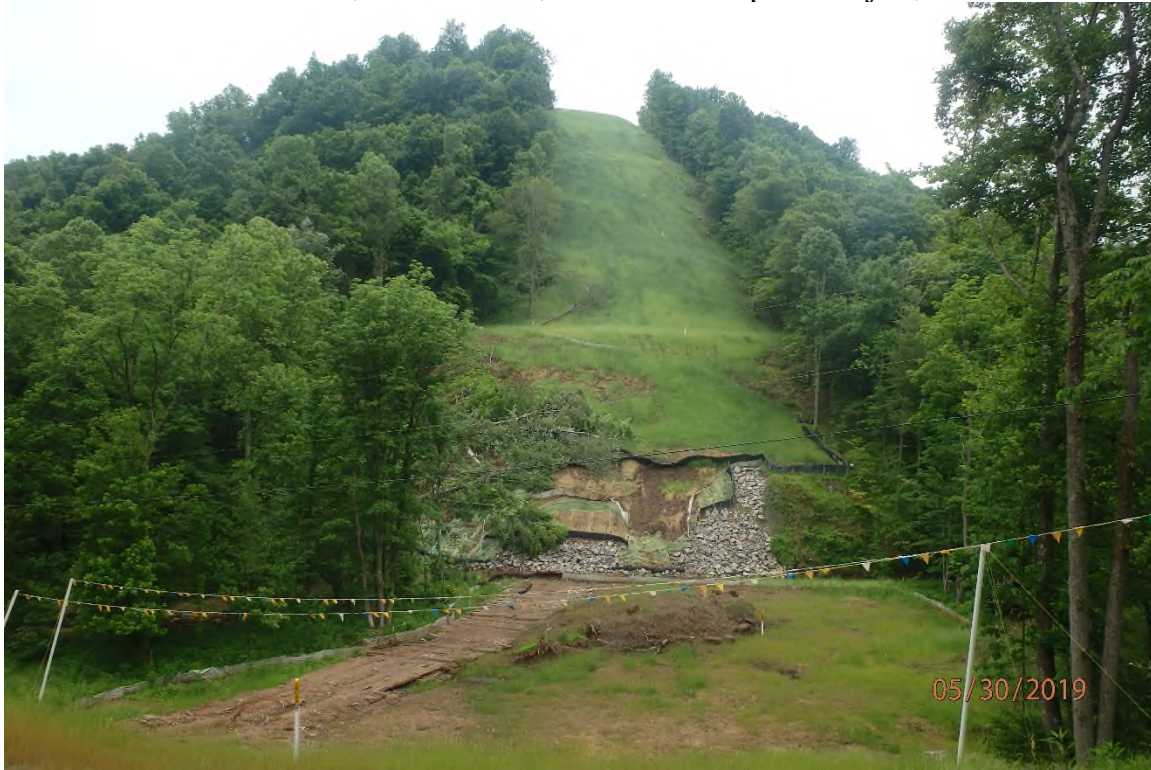
Water bars in the Meathouse Fork watershed that have been temporarily repaired with silt fence and need to be reestablished with equipment.

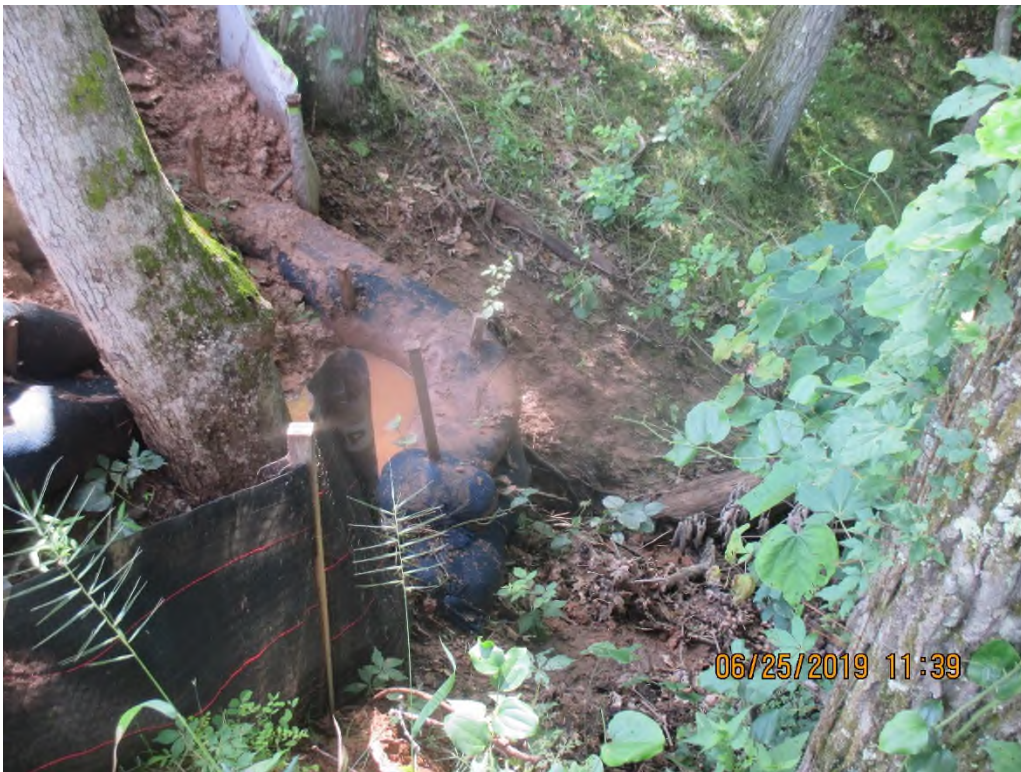
Perimeter controls overwhelmed with sediment downslope of slip area at station No. 5355+67

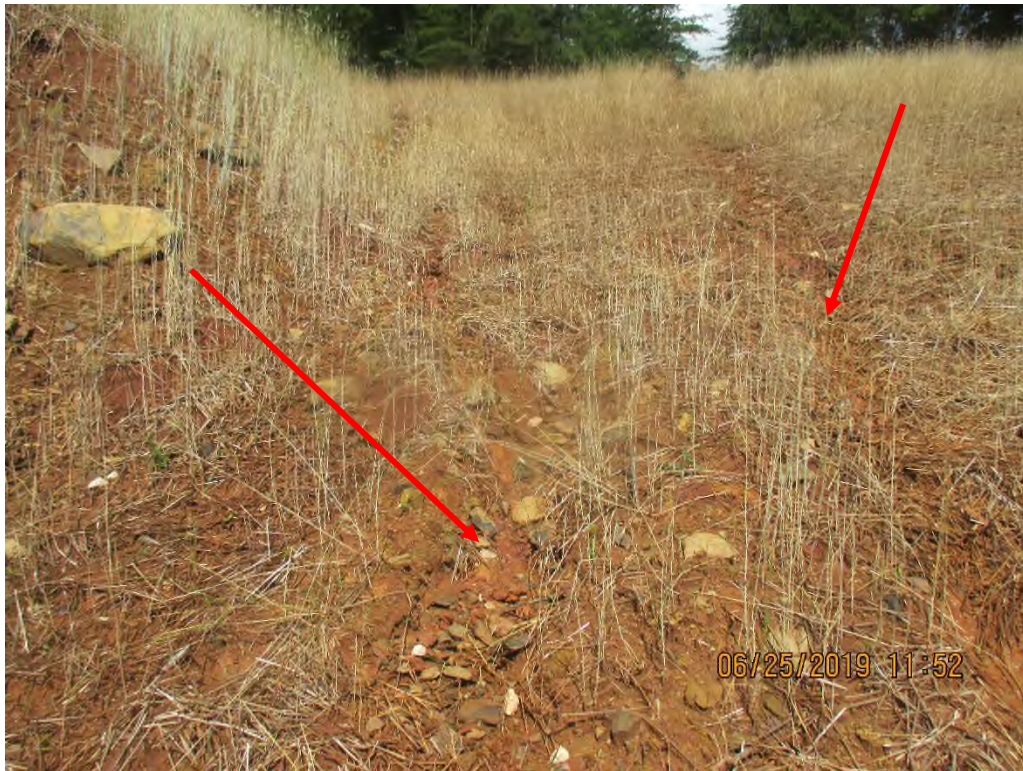
Past slip area with sediment deposited against super silt fence near station No. 5355+67. Arrow depicts where erosion was occurring on slope.

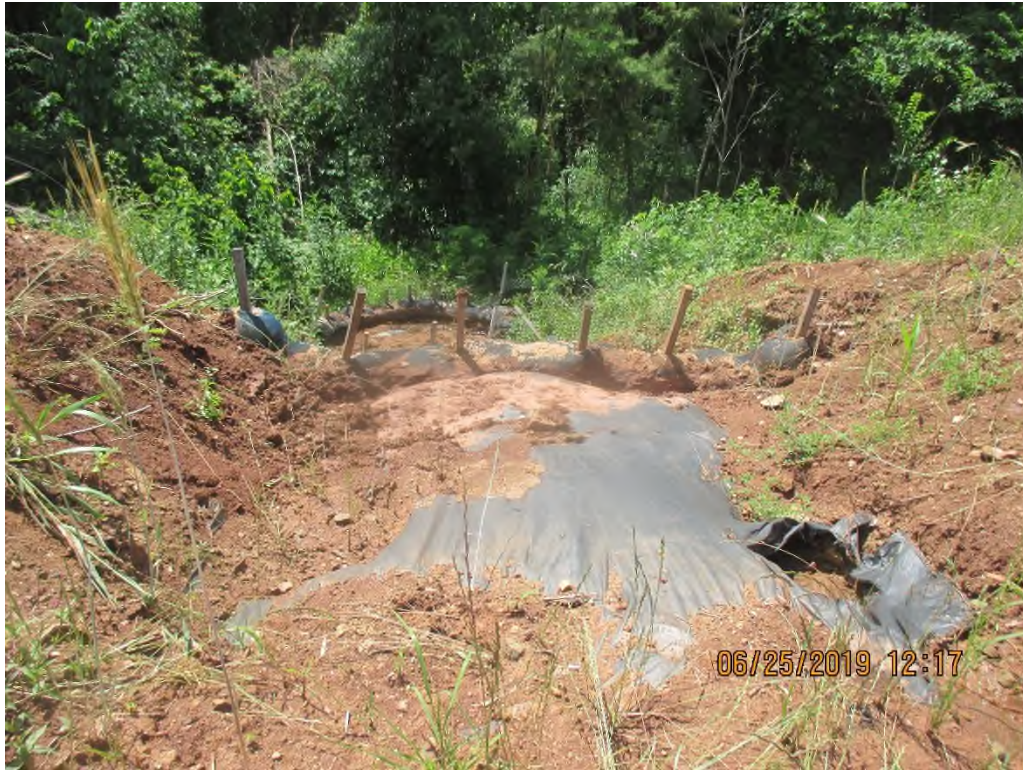
Waterbar outlet controls on slope south of ARWI 024 near station No. 5372+00. Perimeter controls overwhelmed with sediment. Erosion occurring under and next to Geotech fabric.

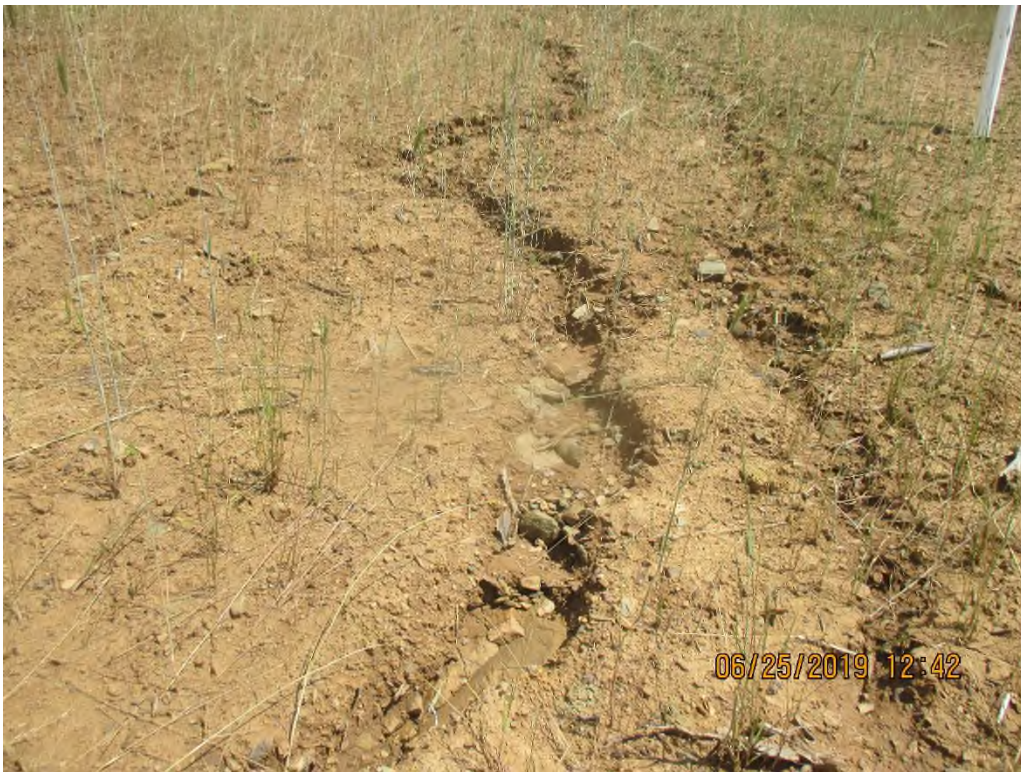
Erosion occurring on slope above waterbar at station No. 5396+00

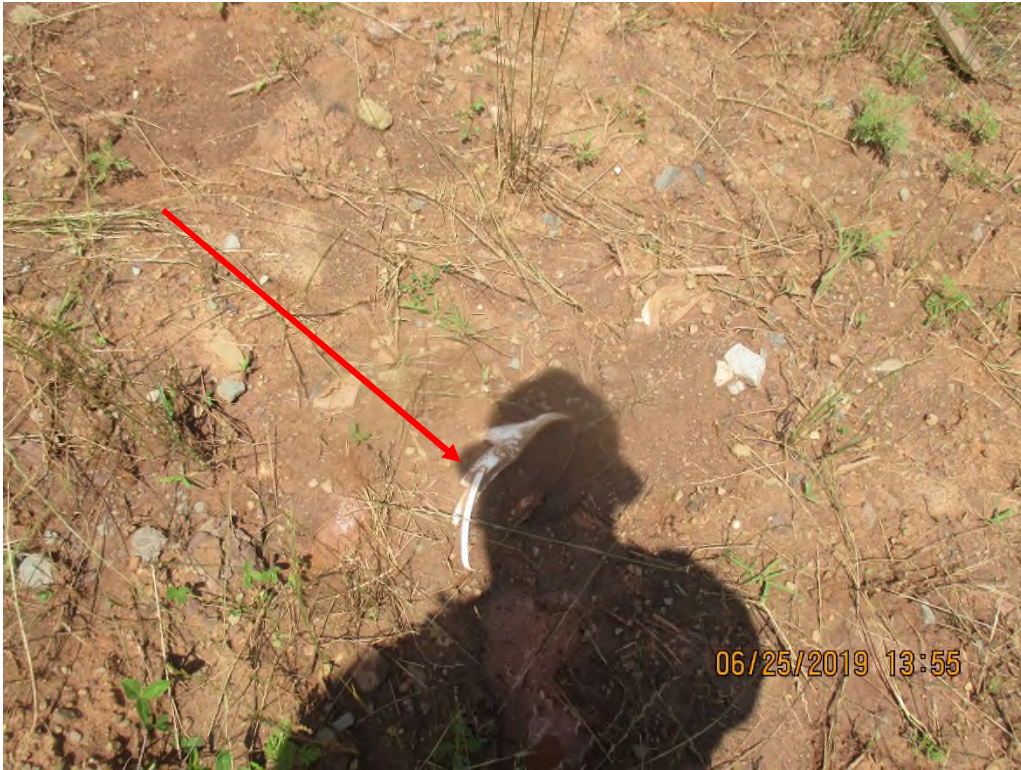
Solid waste present at station No. 5643+50.

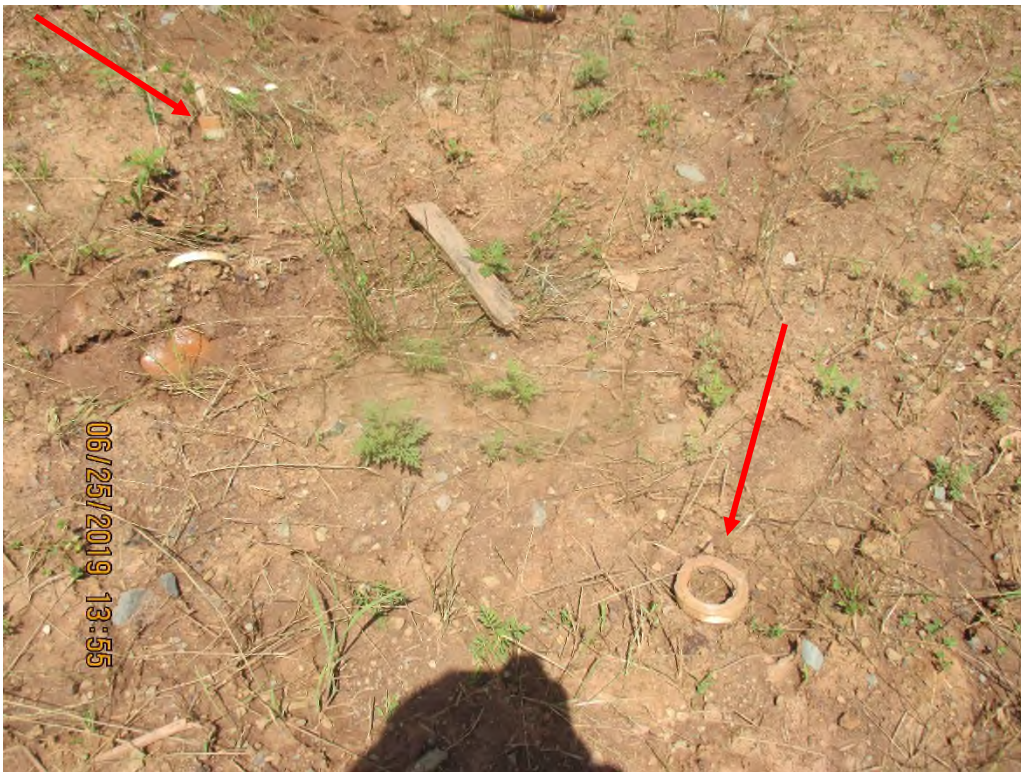
Solid waste at station No. 5643+50.

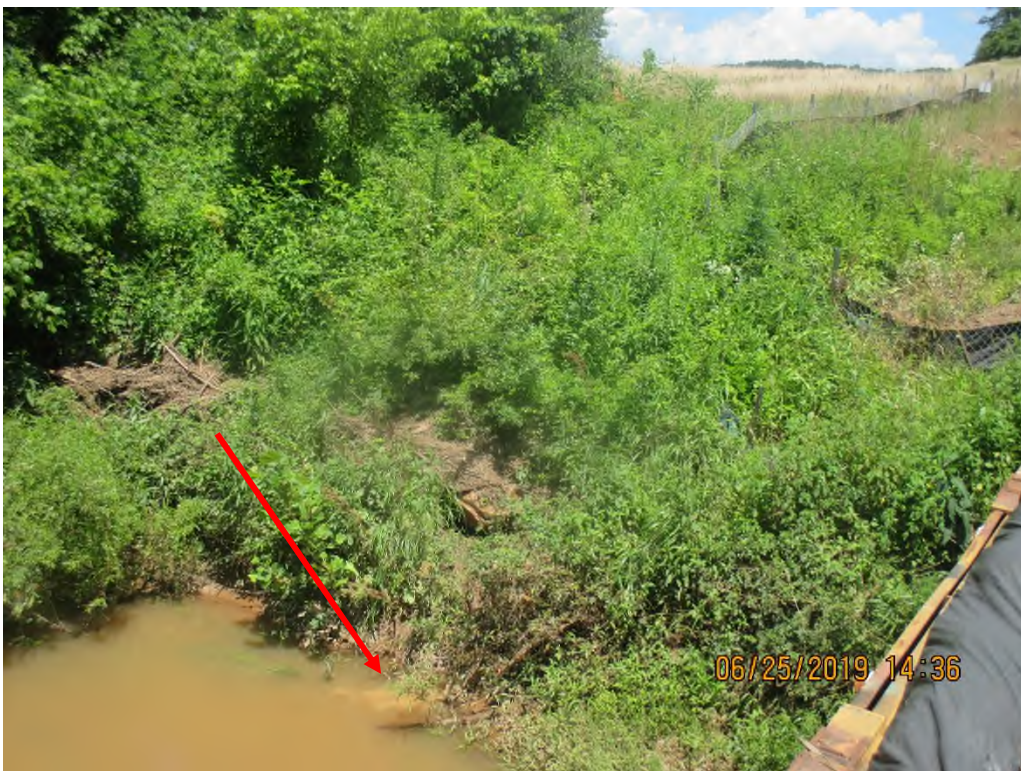
Impacted pond culvert outlet conveying sediment laden water towards Stream SROC 029 at station No. 5638+47. Arrow depicts culvert outlet.

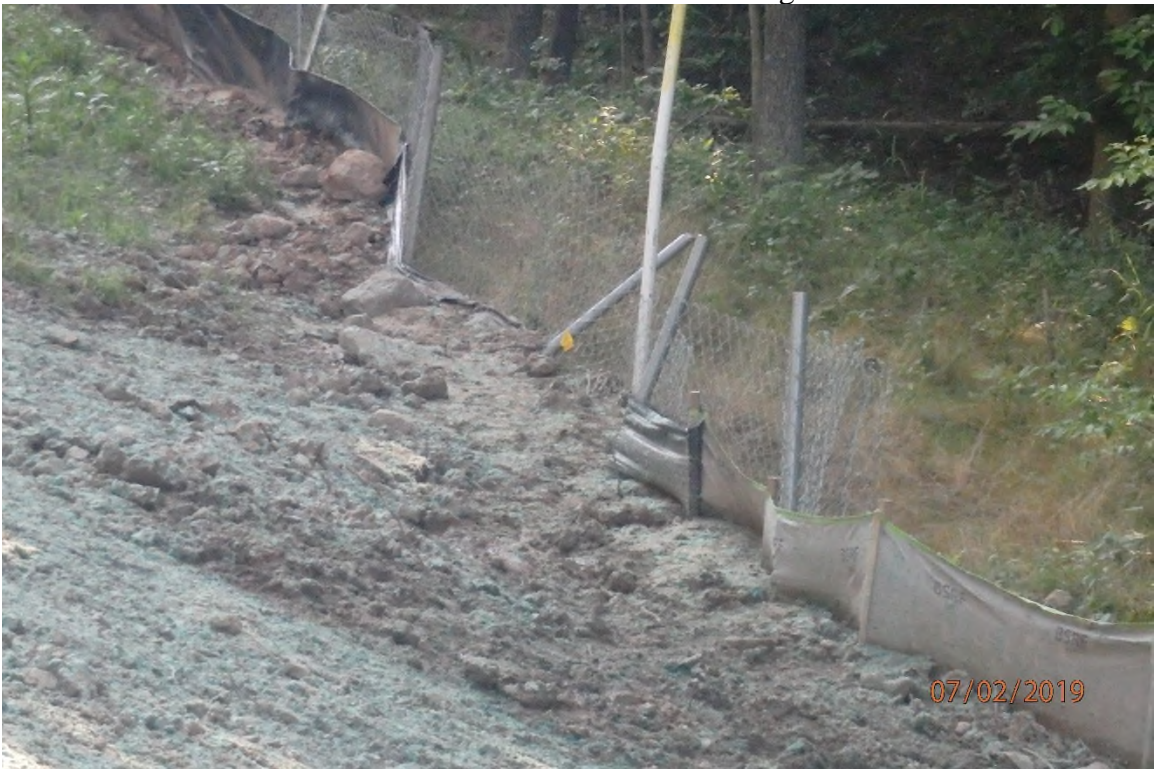
Perimeter control in need of maintenance in the Sugar Run watershed.

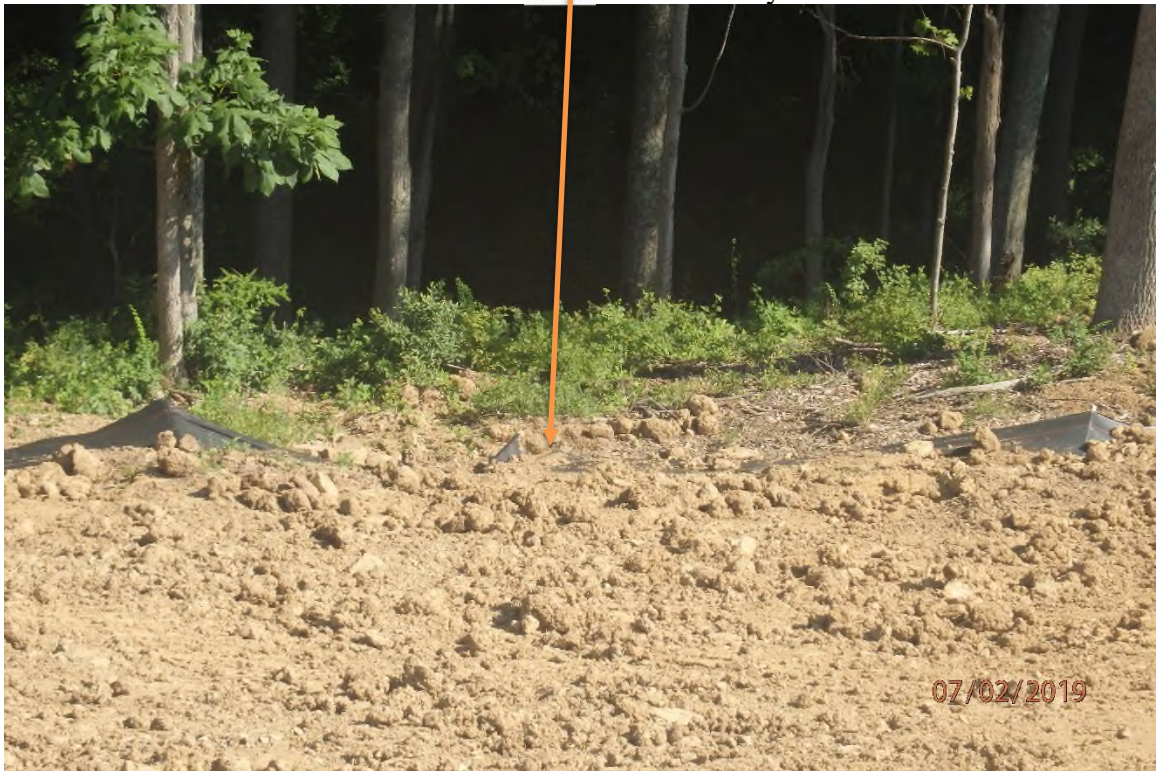
Perimeter control in need of maintenance in the Taylor Drain watershed.

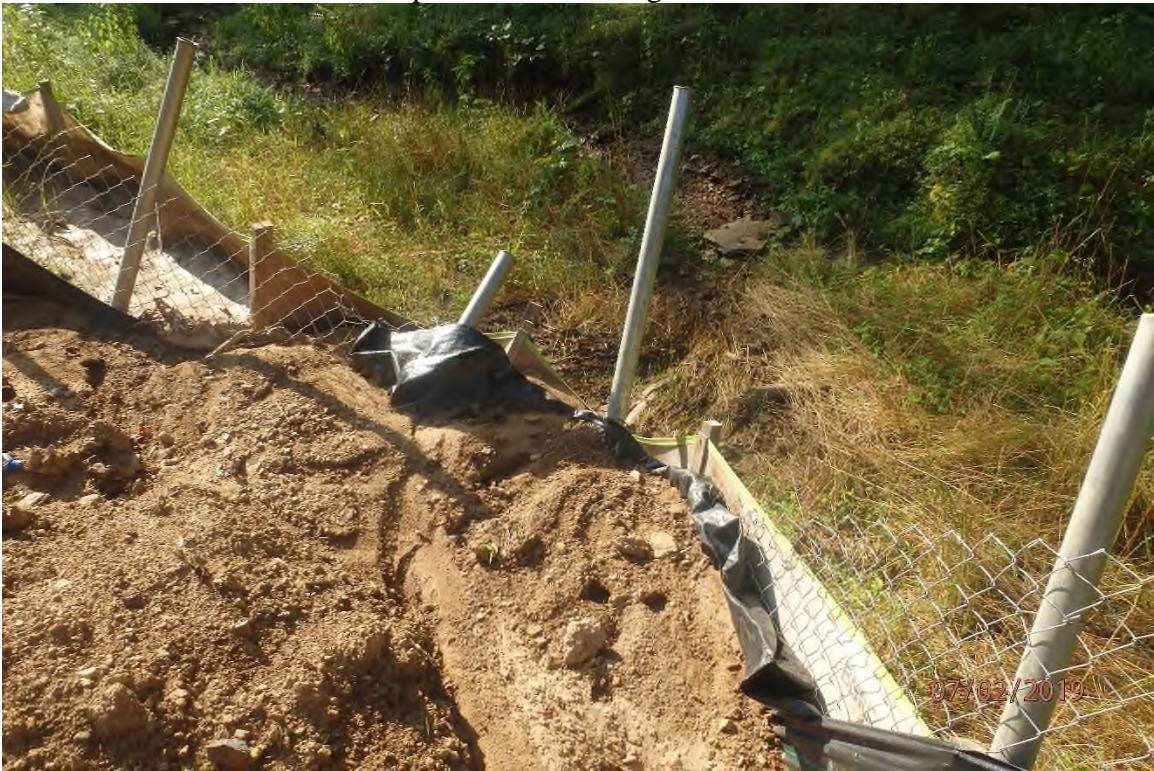
Unmaintained perimeter control in the Sugar Run watershed that is placing sediment into onsite ephemeral UNT Sugar Run.

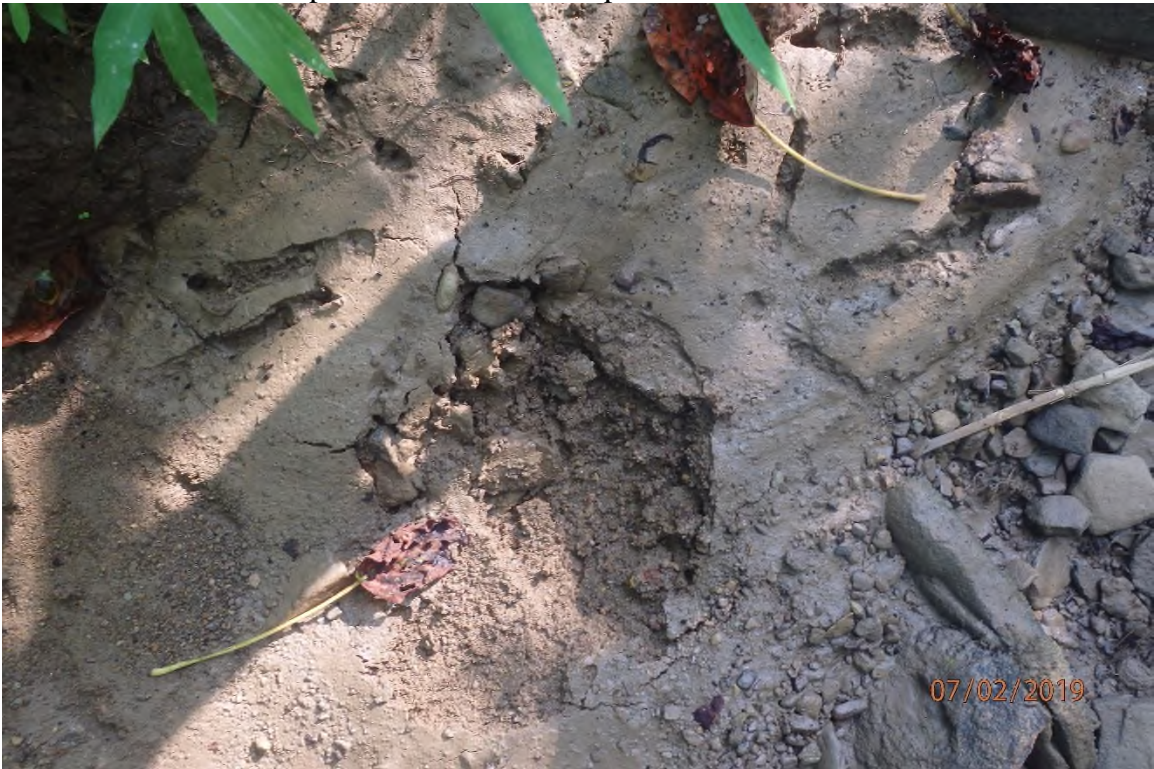
Offsite CNA deposits in UNT Sugar Run (39° 11.075' X 80° 51.108') as a result of the three previously pictured unmaintained perimeter controls.

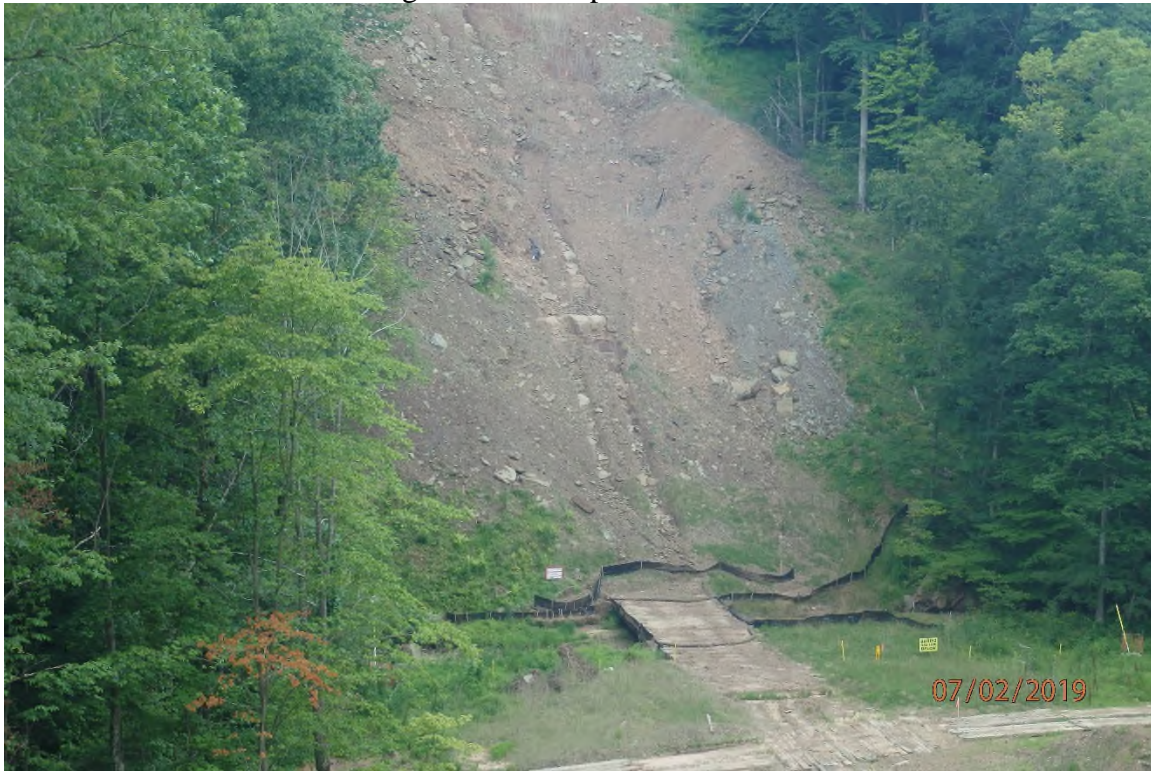
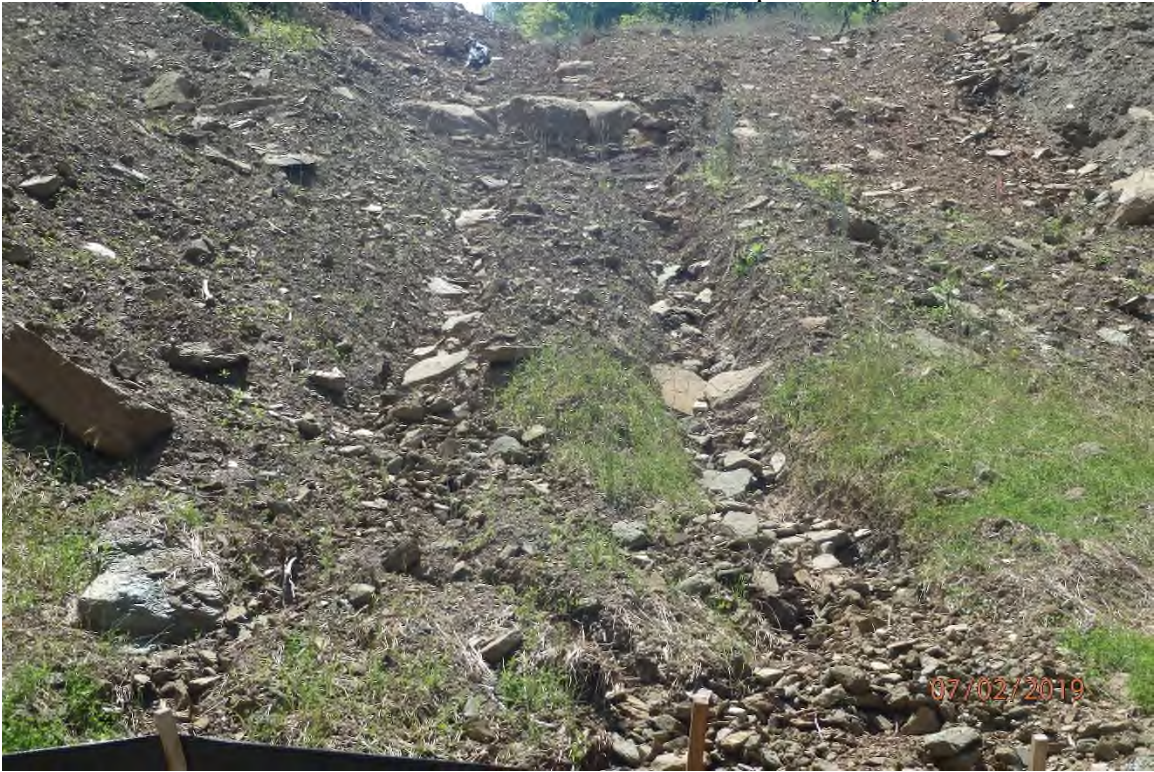
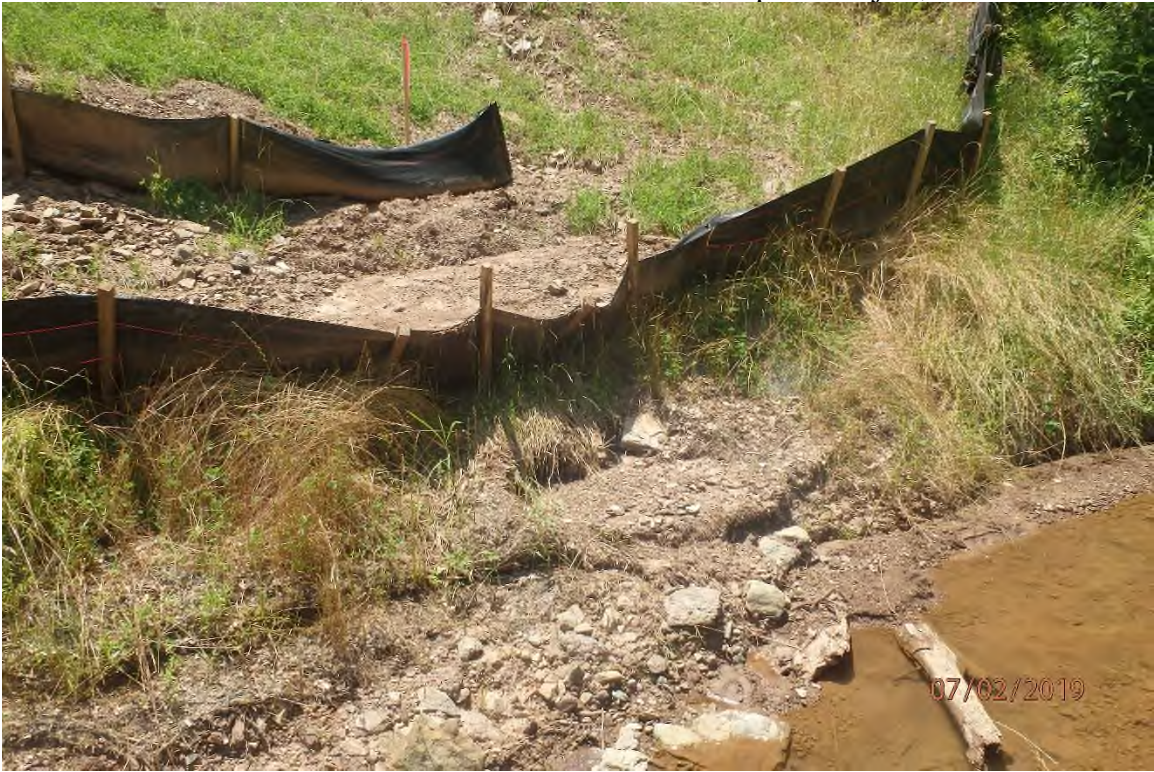
Erosion gullies that run from the top of the slope to the bottom of the slope adjacent to UNT Left Fork of Arnolds Creek (SDOG040) due to poor maintenance of installed water bars. Concentrated flow stormwater is overwhelming the installed perimeter controls at the base of the hill.

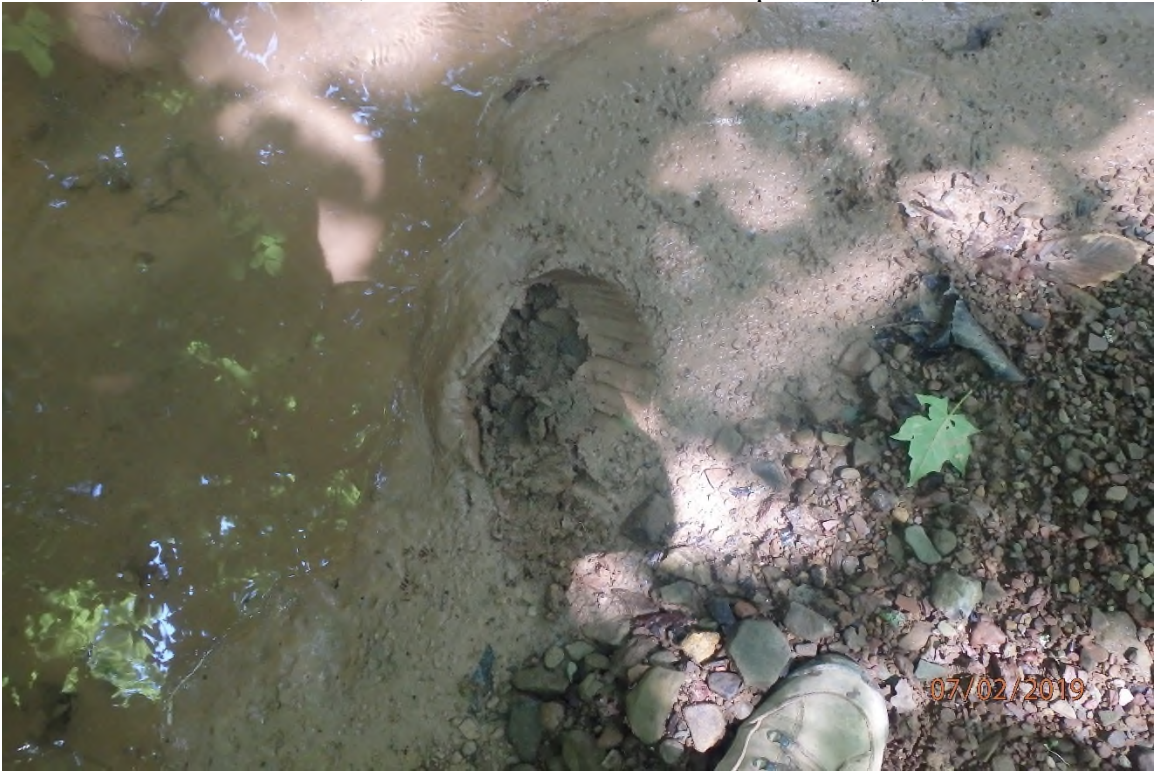
Offsite CNA deposits in UNT Left Fork of Arnolds Creek (SDOG040) as a result of the previously pictured unmaintained water bars and associated fill slope erosion.

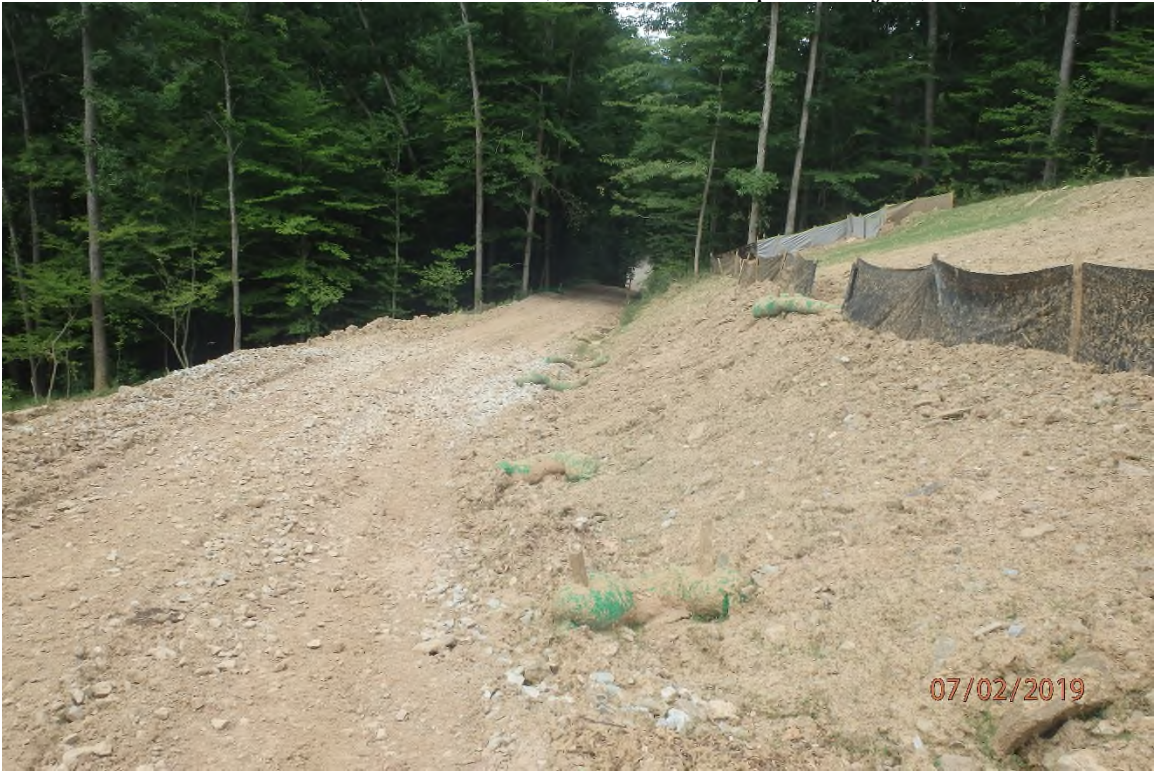
ARDO13.5 showing the need for maintenance to the stabilized surface.

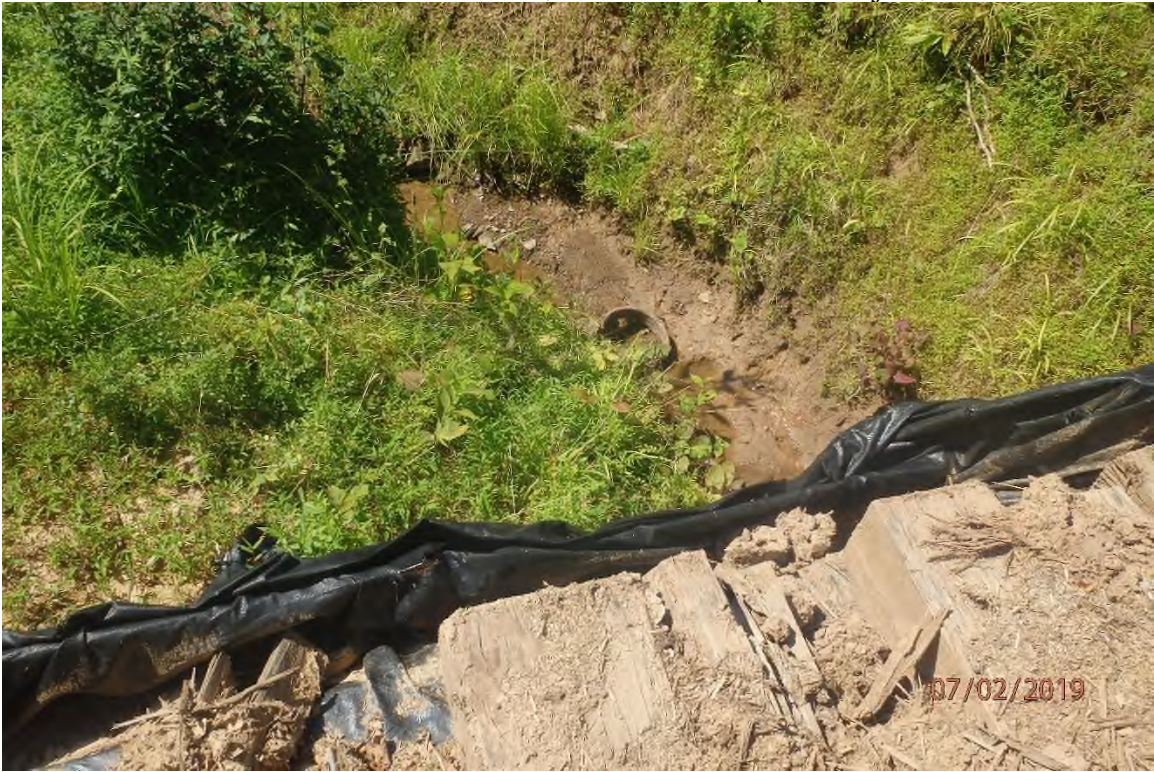
The installed timber mat bridge at the Taylor Drain crossing showing the need for maintenance.

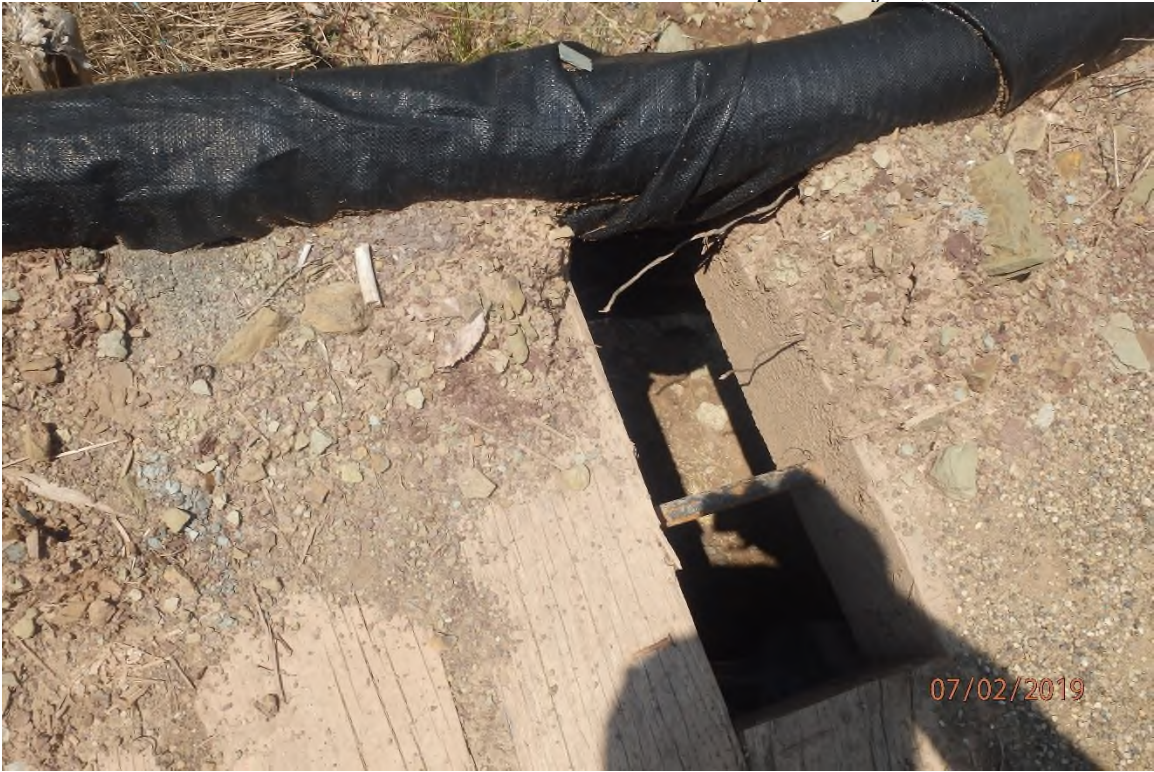
The installed timber mat bridge at the UNT Left Fork of Arnolds Creek (SDOG040) crossing showing the need for maintenance.

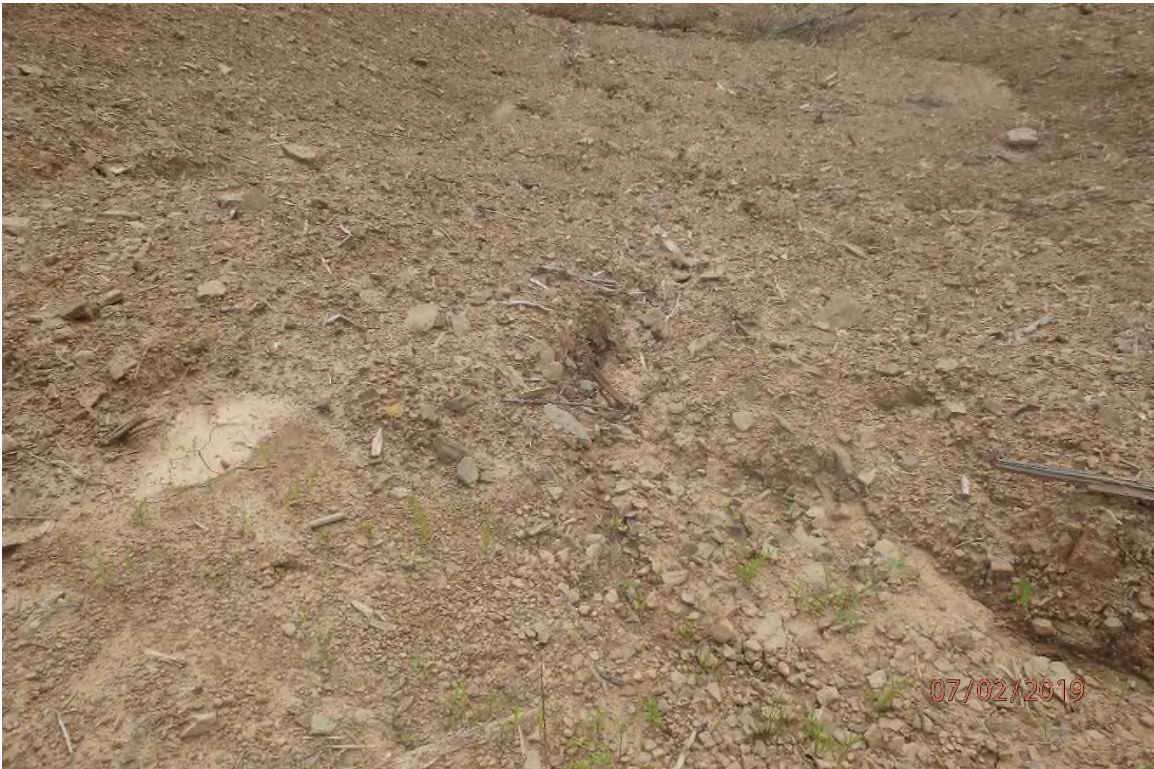
Area in the Trap Run watershed where the applied seed has failed to germinate, and the area was not reseeded.

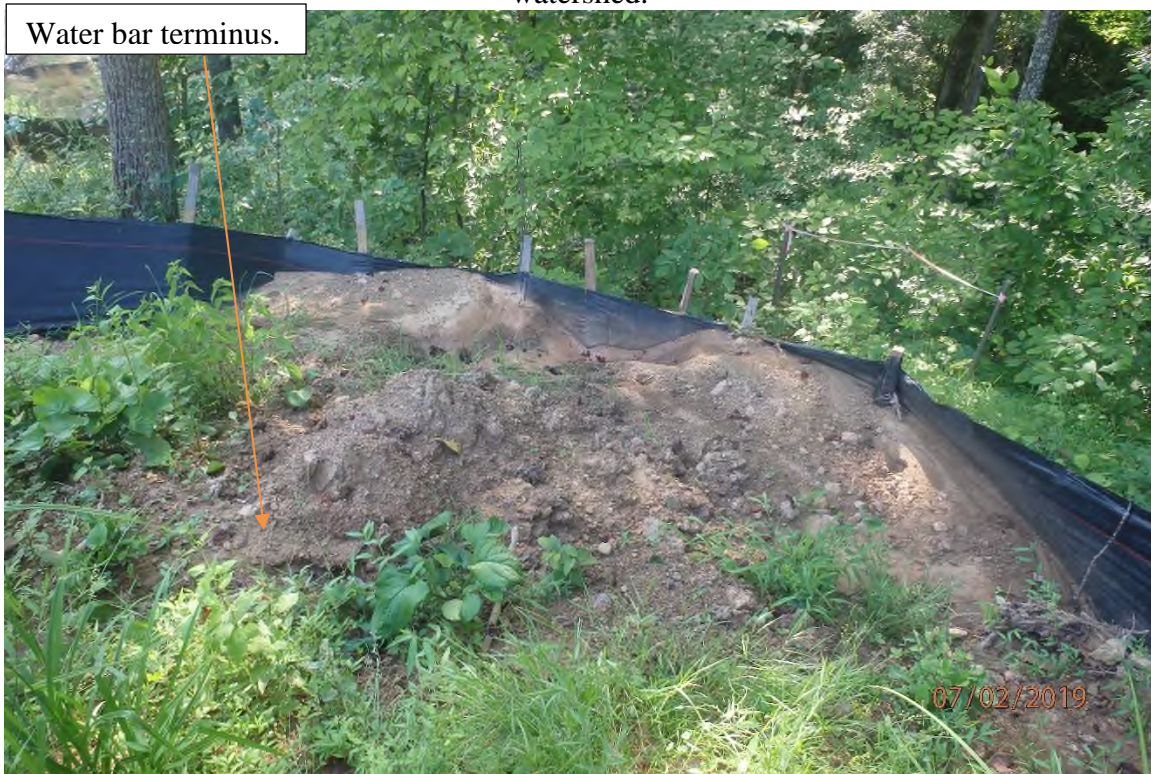
Sheet flow silt fence placed in a concentrated flow area at the terminus of a water bar in the Sugar Run watershed.

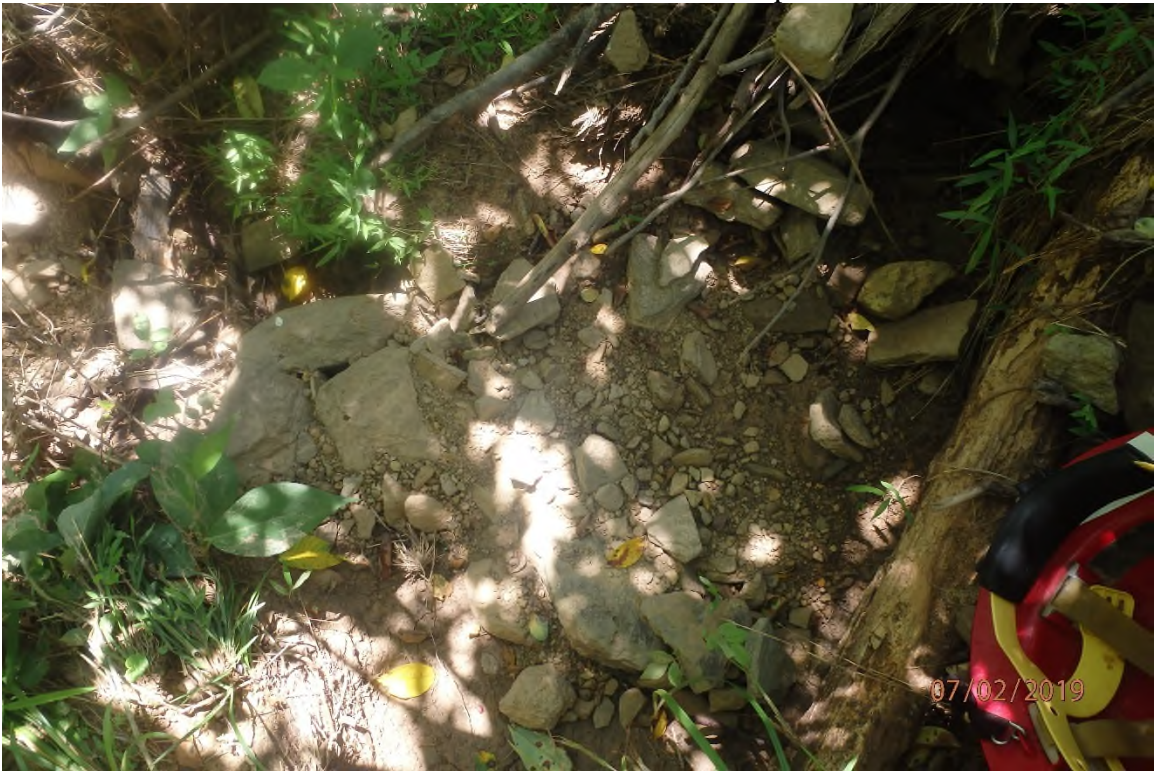
Offsite CNA deposits in UNT Trap Run (SDON826) as a result of the previously pictured improperly installed water bars and associated fill slope erosion.
