**CONSENT ORDER
ISSUED UNDER THE
WATER POLLUTION CONTROL ACT
WEST VIRGINIA CODE, CHAPTER 22, ARTICLE 11**

TO: Columbia Gas Transmission, LLC
Attn: Troy Tally, Vice President
1700 MacCorkle Ave
Charleston, WV 25314

DATE: October 1, 2020
ORDER NO.: 9061

1. Columbia Gas Transmission, LLC is conducting land disturbance activity associated with construction of the Mountaineer Xpress Project in Marshall, Wetzel, Tyler, Doddridge, Ritchie, Calhoun, Wirt, Roane, Jackson, Mason, Putnam, and Cabell Counties, West Virginia. On January 31, 2018, Columbia Gas Transmission, LLC was issued Water Pollution Control Permit No. WV0116815, Registration No. WVR310872, for Stormwater Associated With Oil and Gas Related Construction Activities.

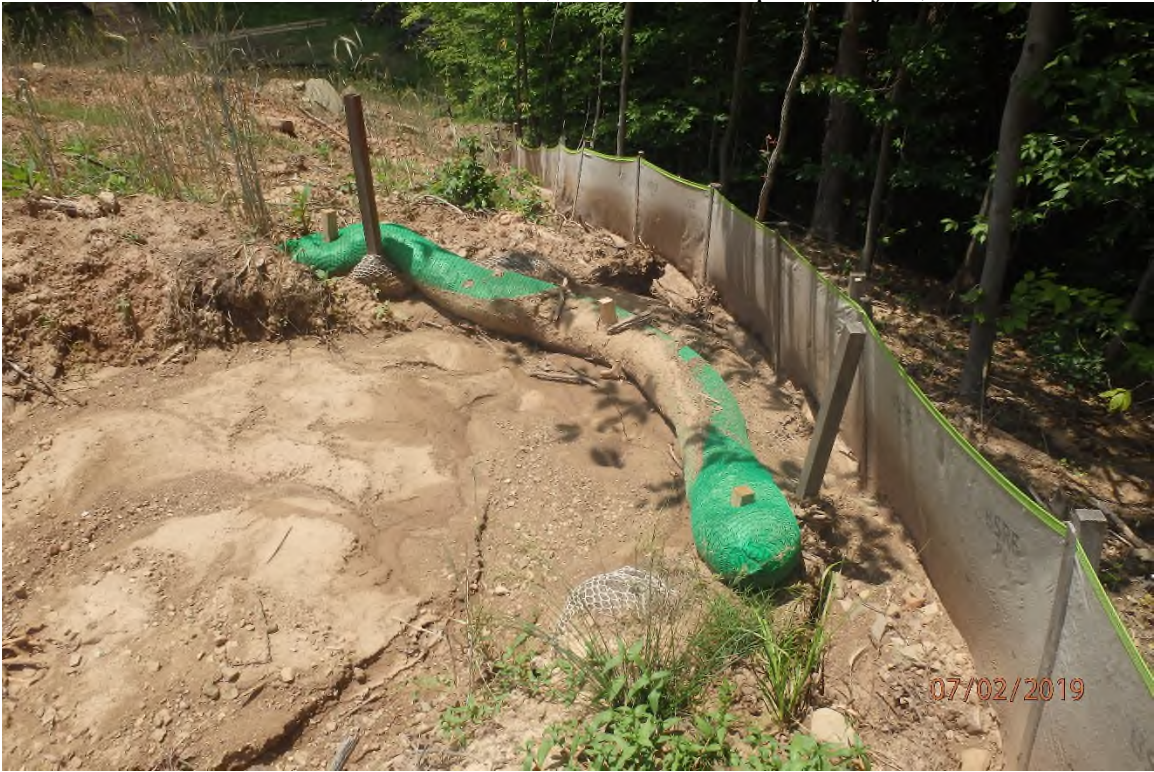
Project area adjacent to 2965+00 showing perimeter controls installed to protect the delineated UNT Left Fork of Arnolds Creek (SDOG057). The pictured accumulated instream sediment deposits originate from the previously documented CNA deposits in SDOG056 & SDOG057.

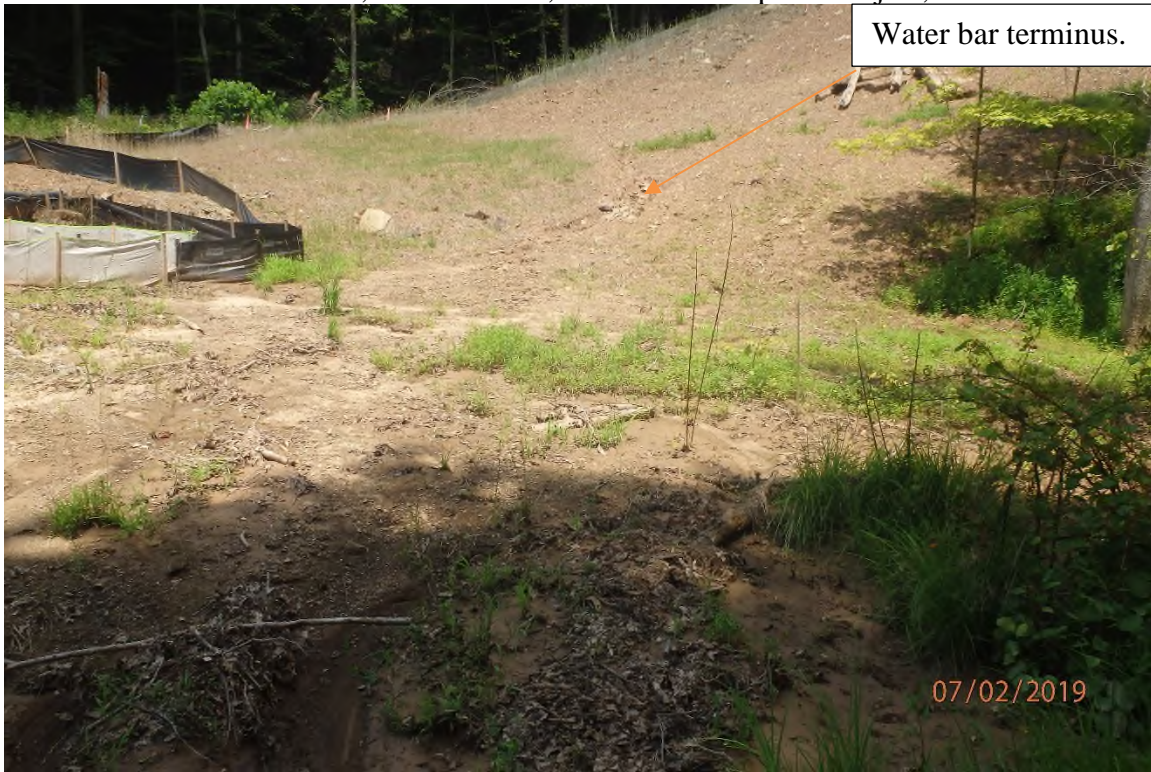
Water bar that lacks the water bar terminus BMP indicated in the approved SWPPP in the UNT Left Fork of Arnolds Creek watershed.

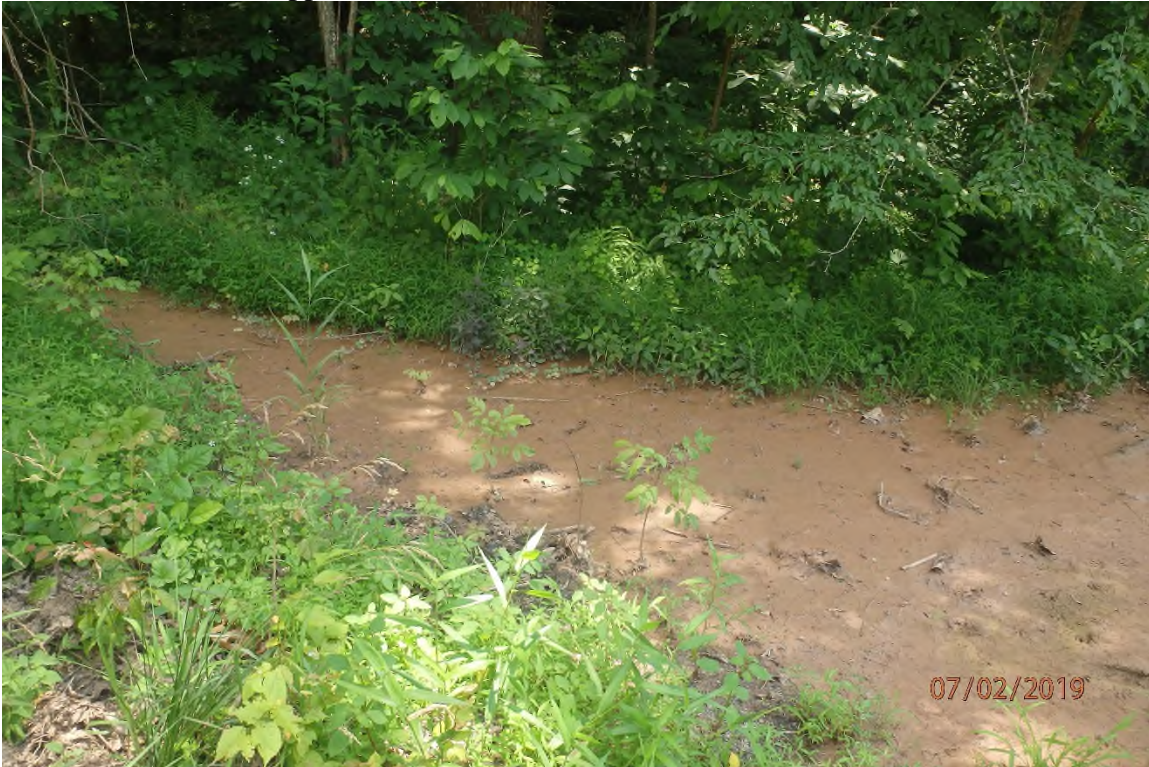
Offsite sediment deposits downslope of the previously pictured water bar that lacks the water bar terminus BMP indicated in the approved SWPPP in the UNT Left Fork of Arnolds Creek watershed.

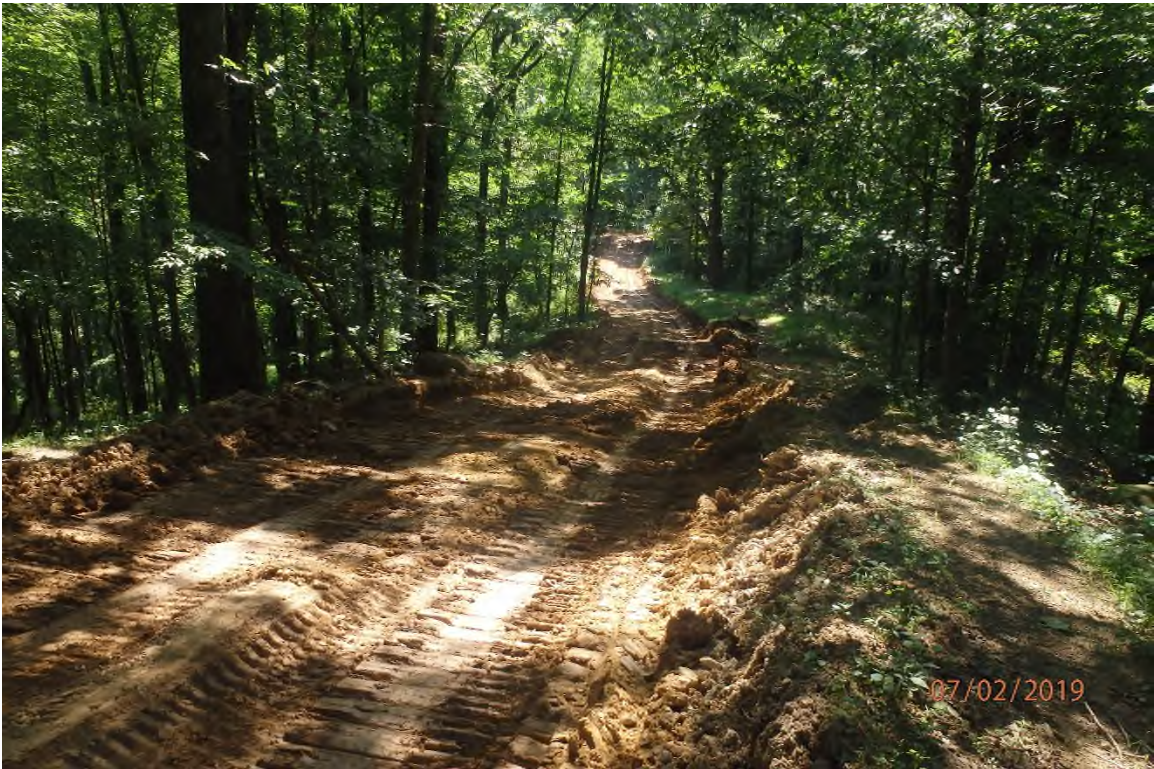
ARDO015.12 - lack of installed BMPs and lack of a graveled surface as indicated in the approved SWPPP.

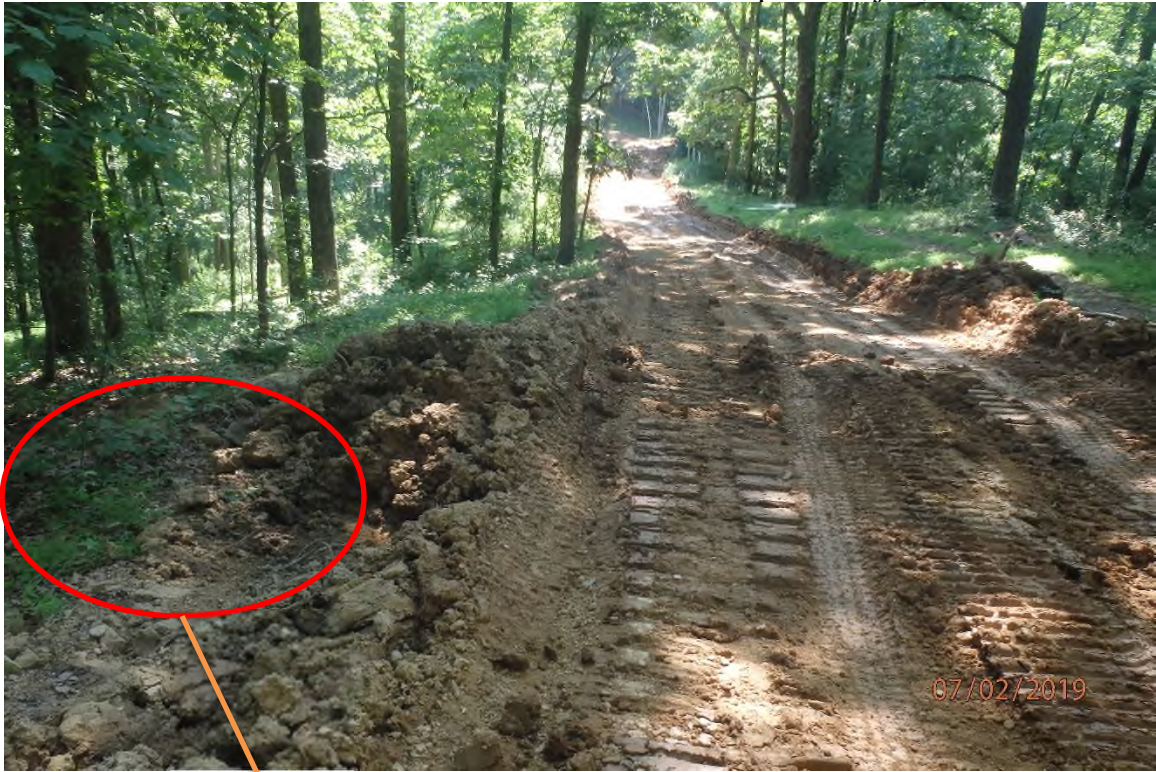
ARDO015.12 - lack of installed BMPs and lack of a graveled surface as indicated in the approved SWPPP.

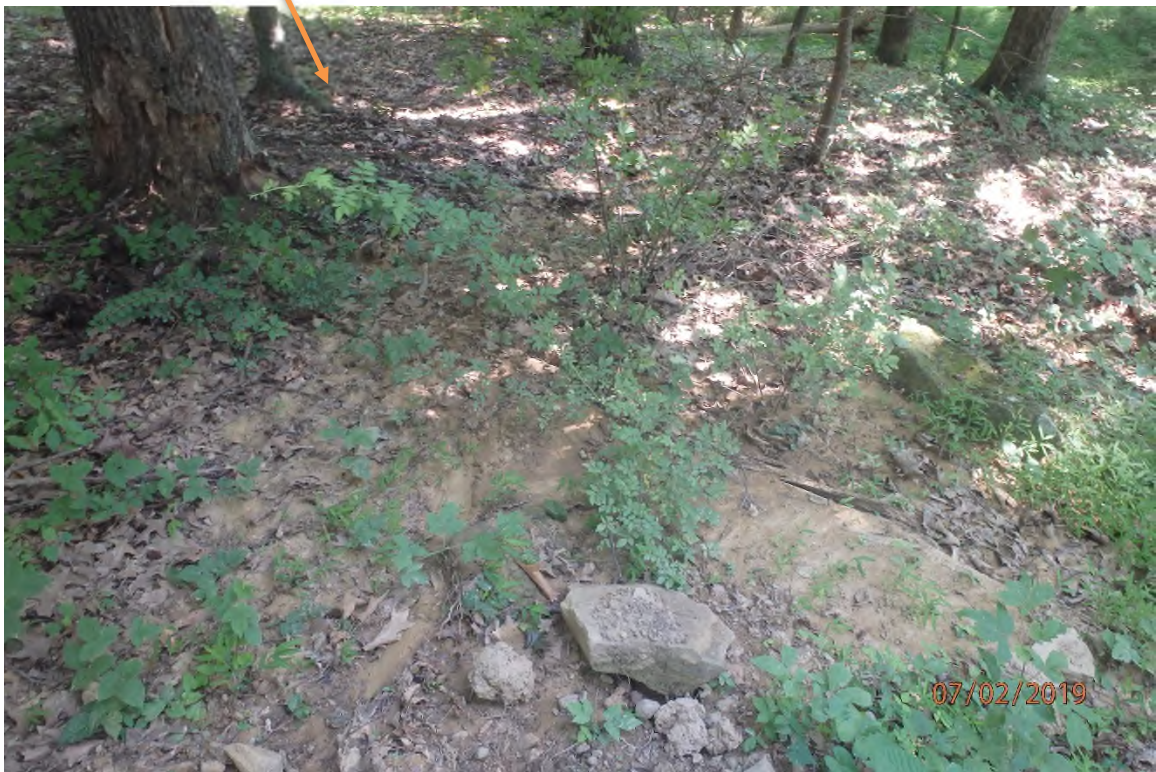
ARDO015.12 - lack of installed BMPs and lack of a graveled surface as indicated in the approved SWPPP.

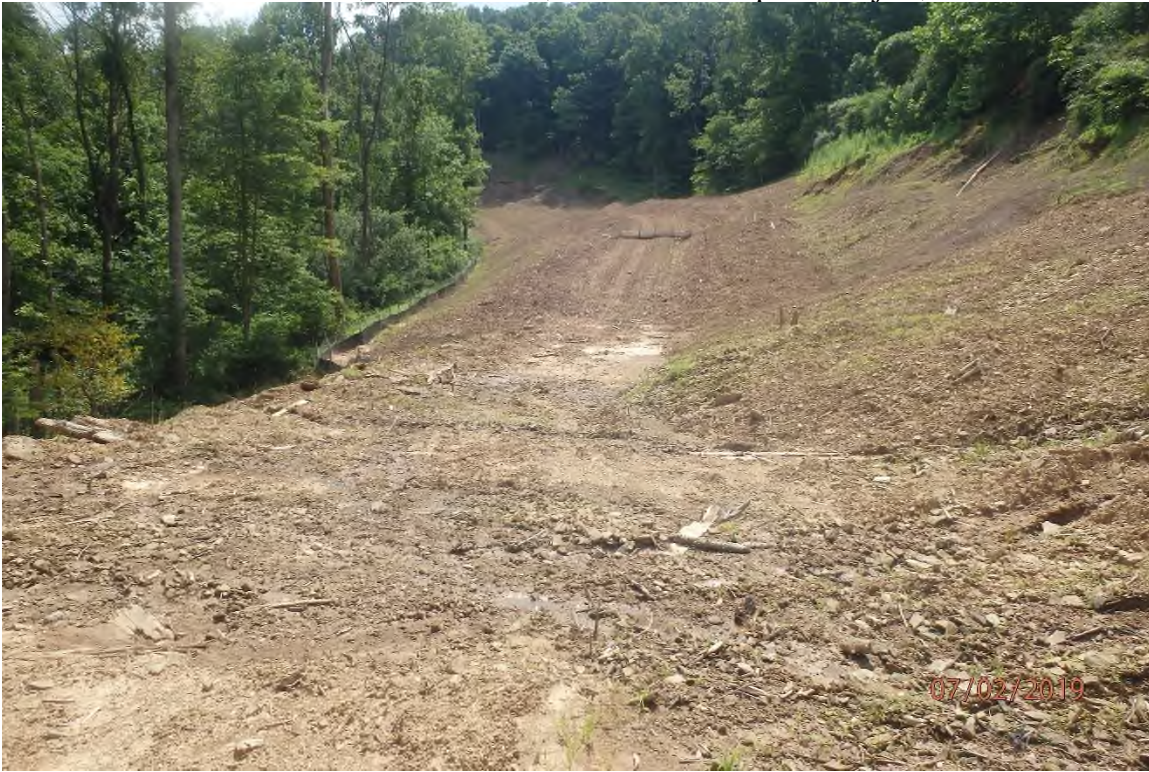
Offsite sediment deposits associated with the above pictured deficiency.

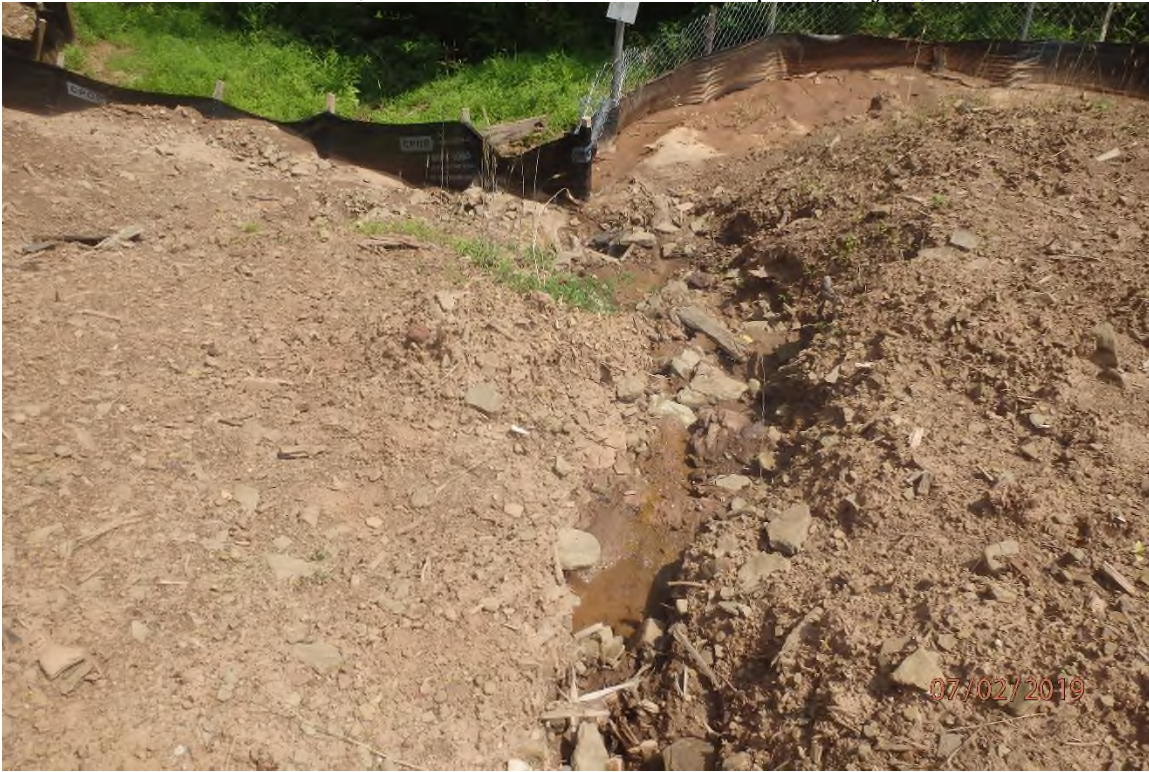
Project area adjacent to 3214+00 showing erosion gullies associated with concentrated flow run on stormwater. The approved SWPPP does not address this situation and the plan has not been modified in this area.

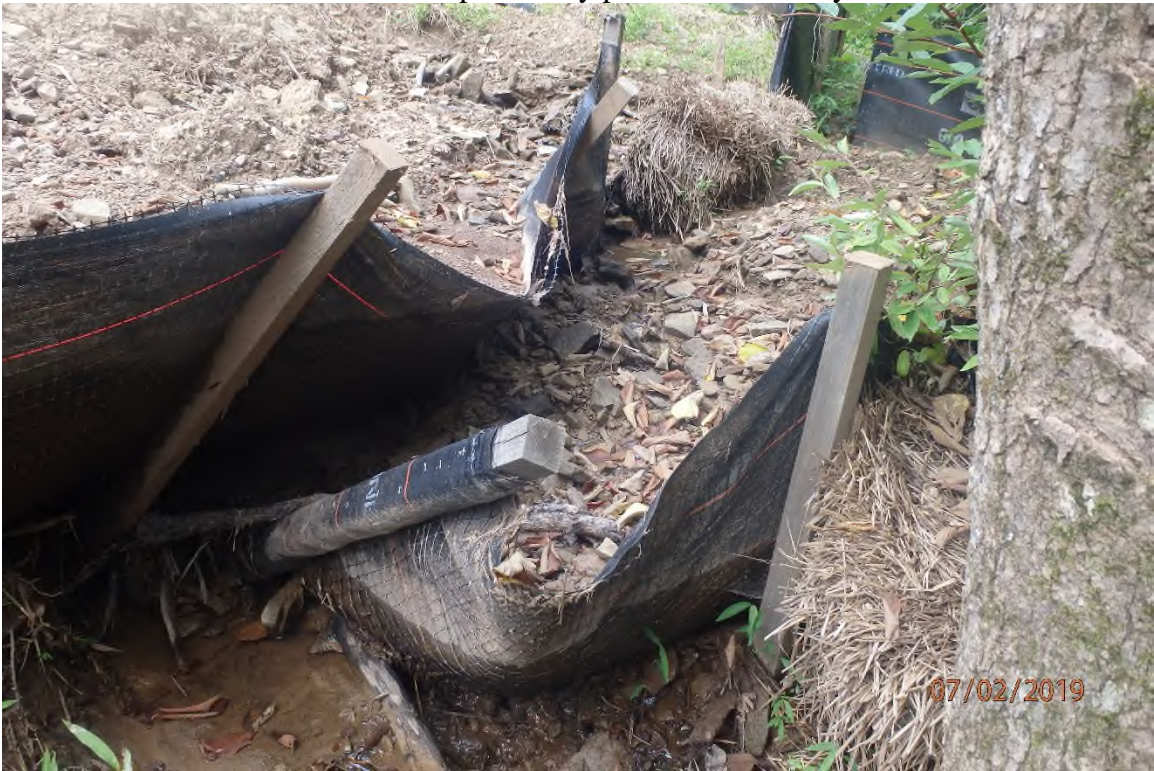
Perimeter controls adjacent to 3214+00 that are inundated with sediment and in need of maintenance as a result of the previously pictured deficiency.

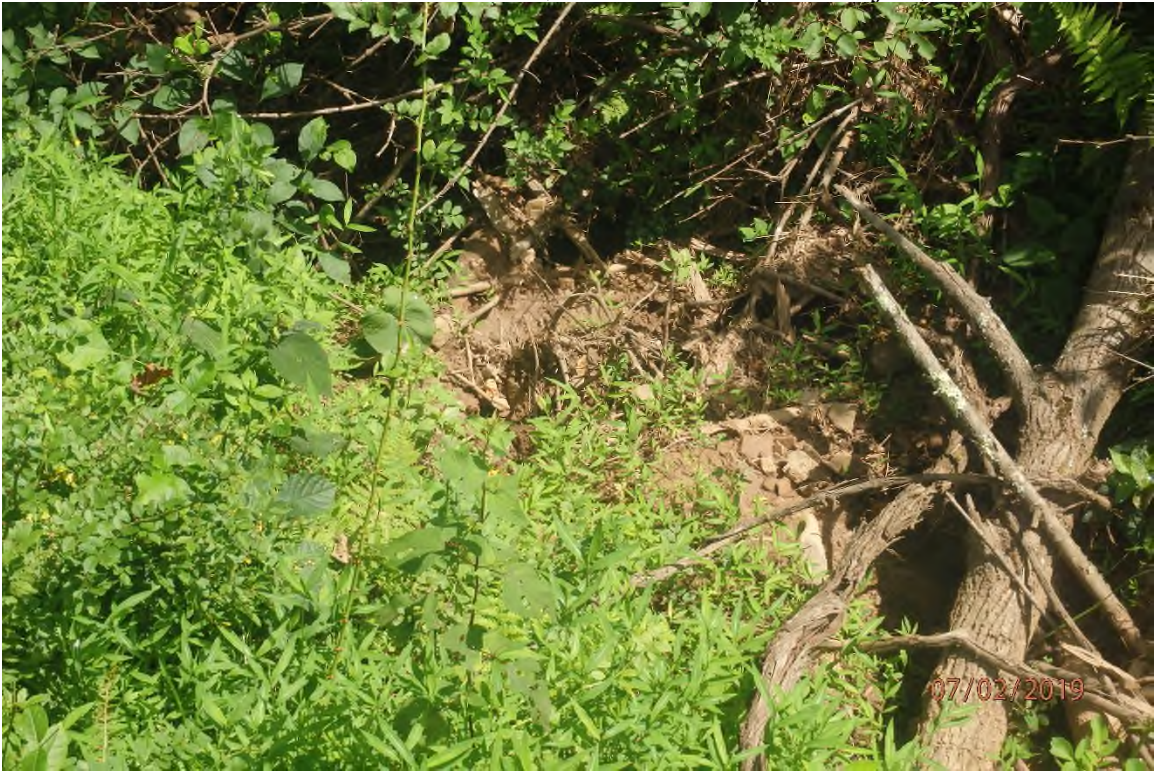
Trail of offsite sediment deposits leading to UNT Trap Run (SDON829) from the previously pictured deficiencies adjacent to 3214+00.

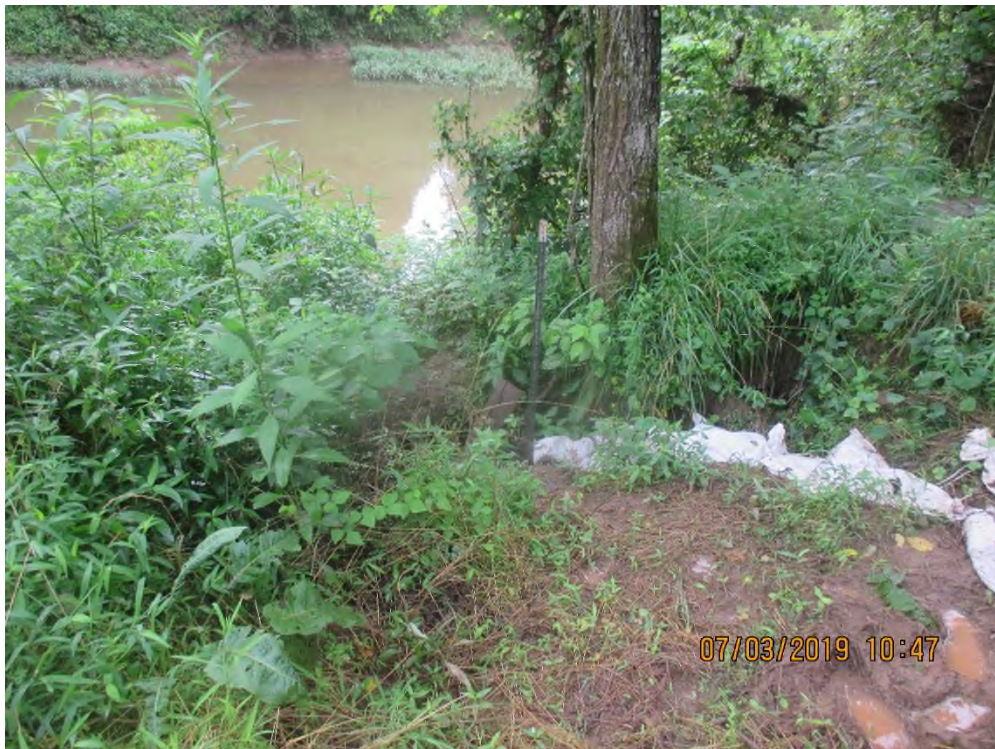
Last silt fence above 18-mile creek. Arrow depicts where sediment laden water was flowing into sandbags.

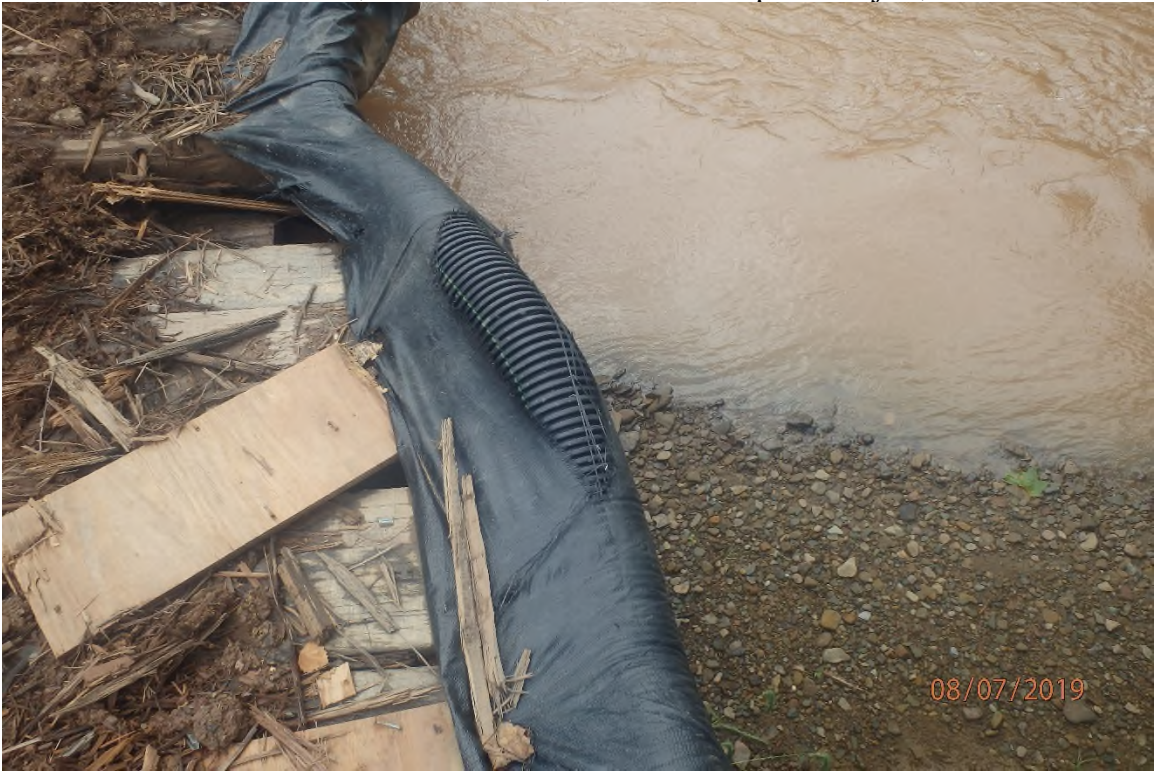
Installed timber mat equipment bridge at UNT Riggins Run (SDOG902) showing the need for maintenance.

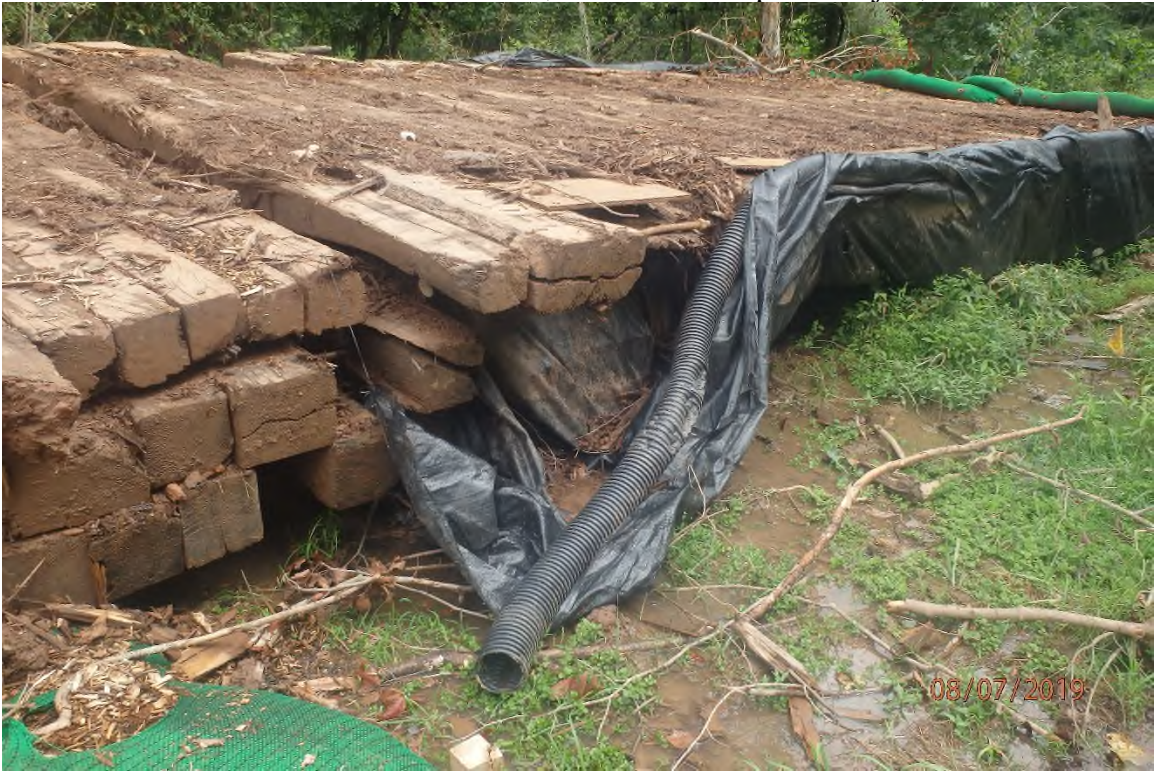
Installed timber mat equipment bridge at UNT Riggins Run (SDOG903) showing the need for maintenance.

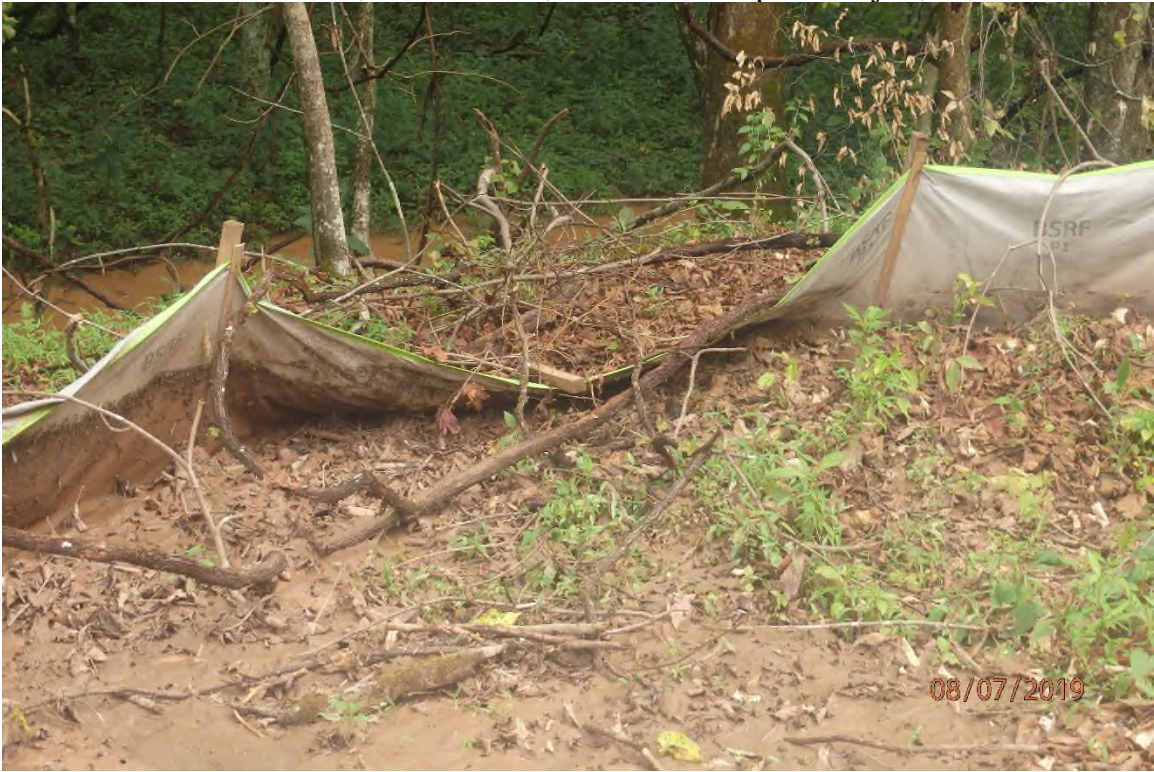
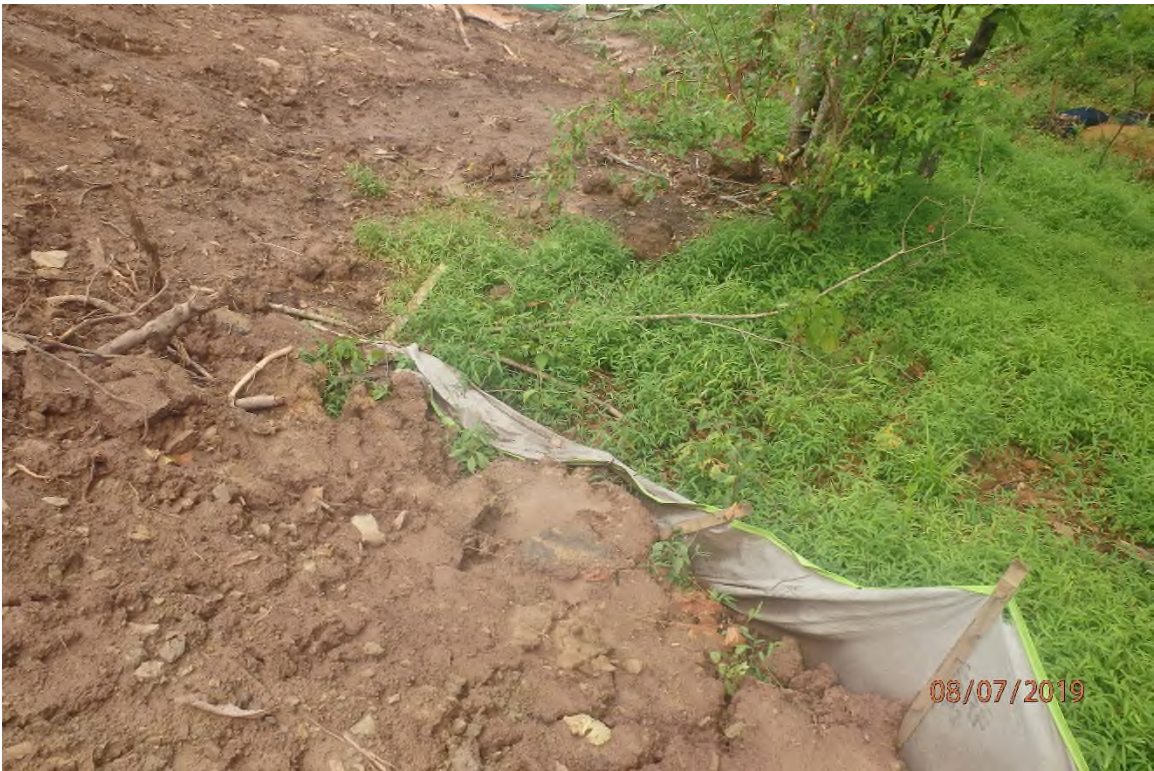
Perimeter controls at the slip repair site showing the need for maintenance.

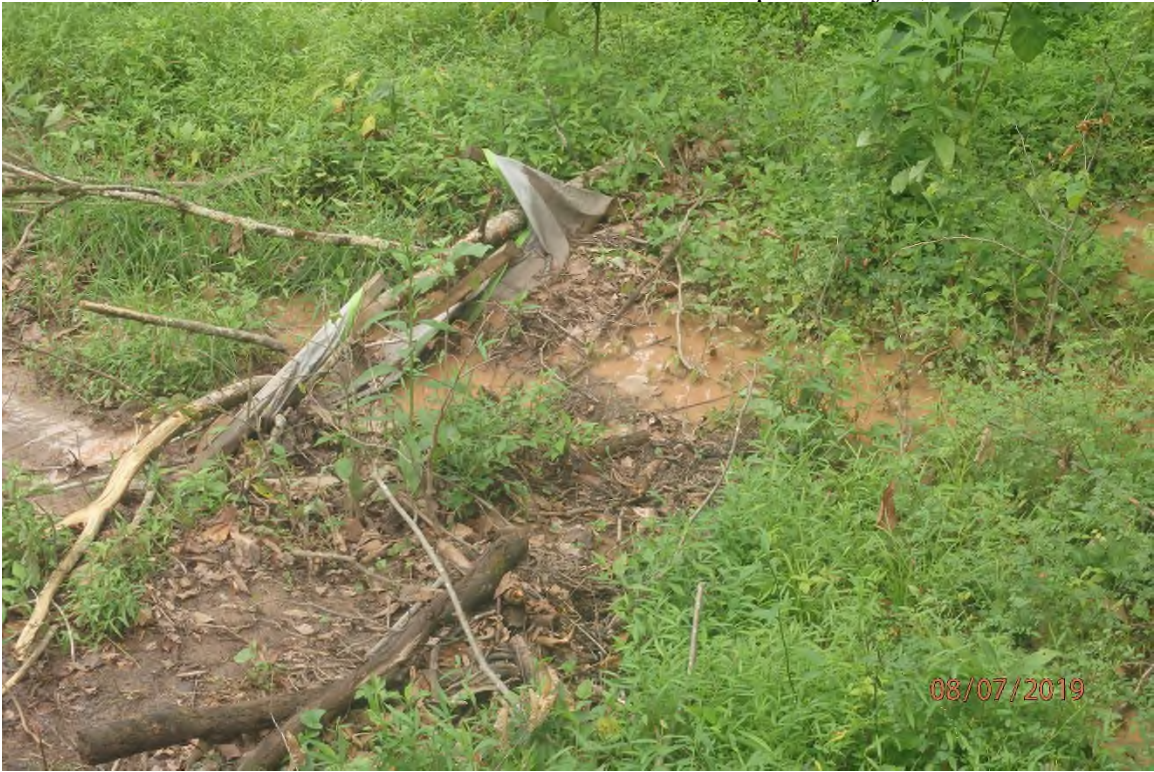
Perimeter controls at the slip repair site showing the need for maintenance.

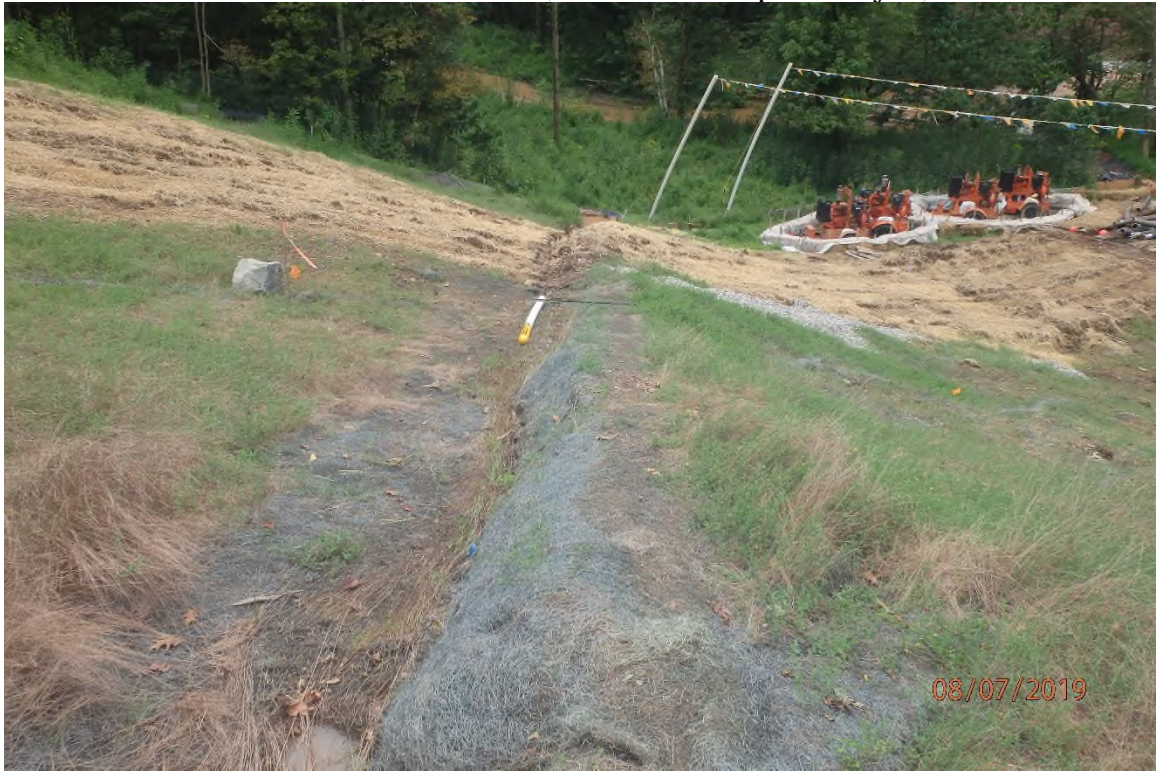
Water bars that were installed at steep angles in the Riggins Run watershed.

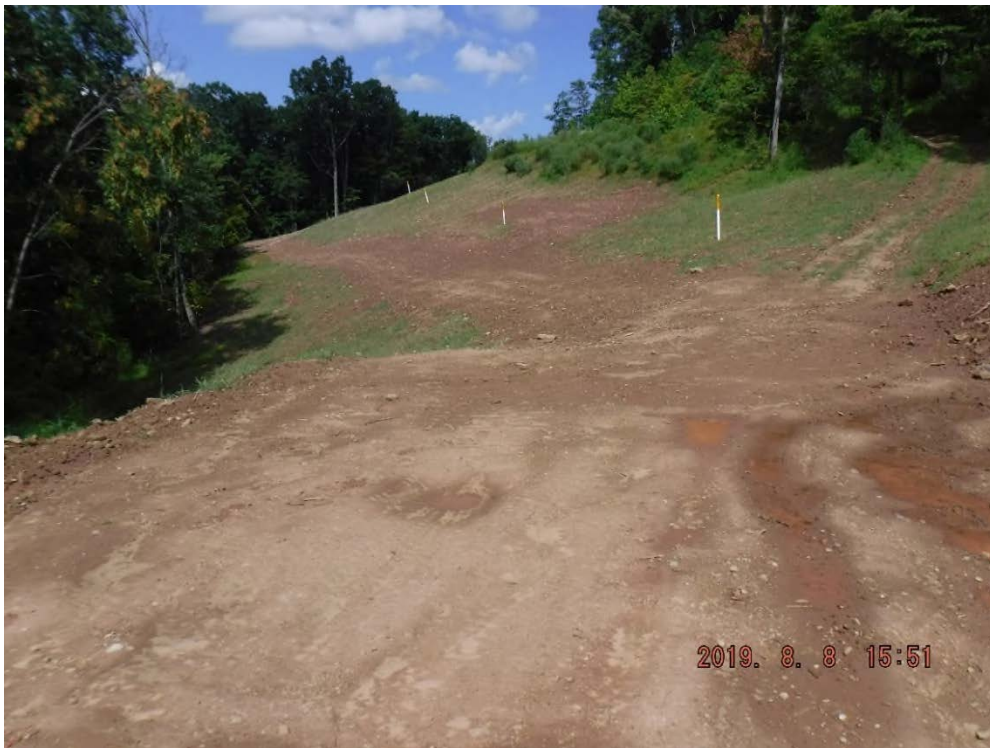
Seed failed to germinate within 30 days.

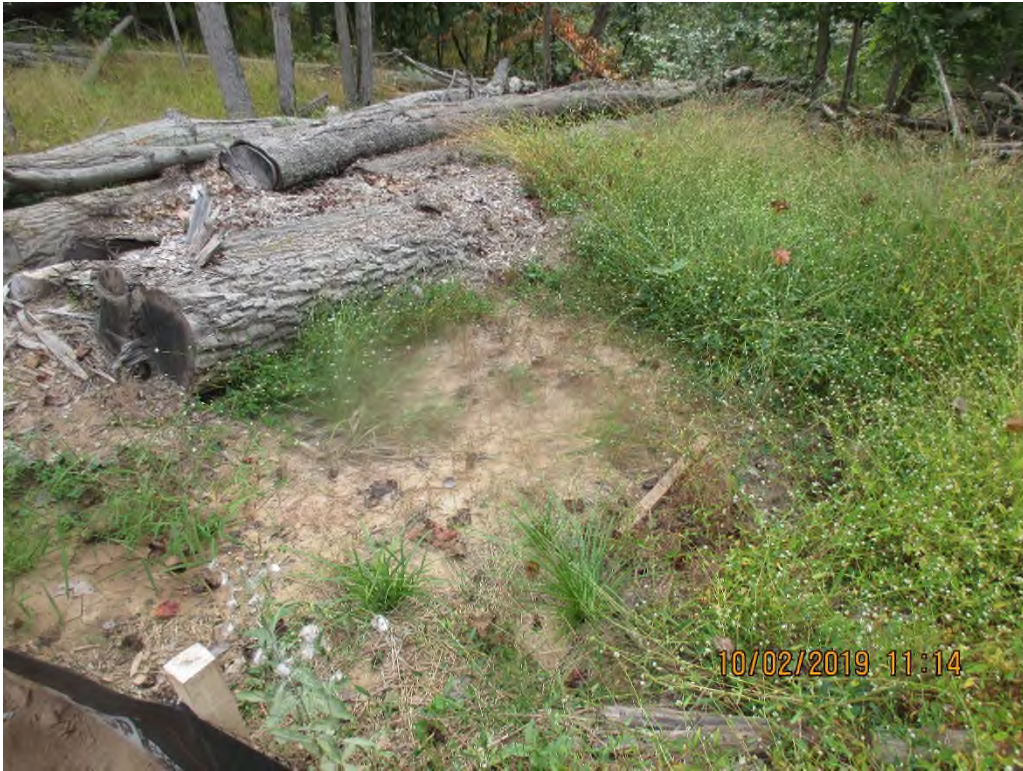
Downslope of gully erosion occurring on slope. Sediment deposited behind and past controls near station No. 3368+00.

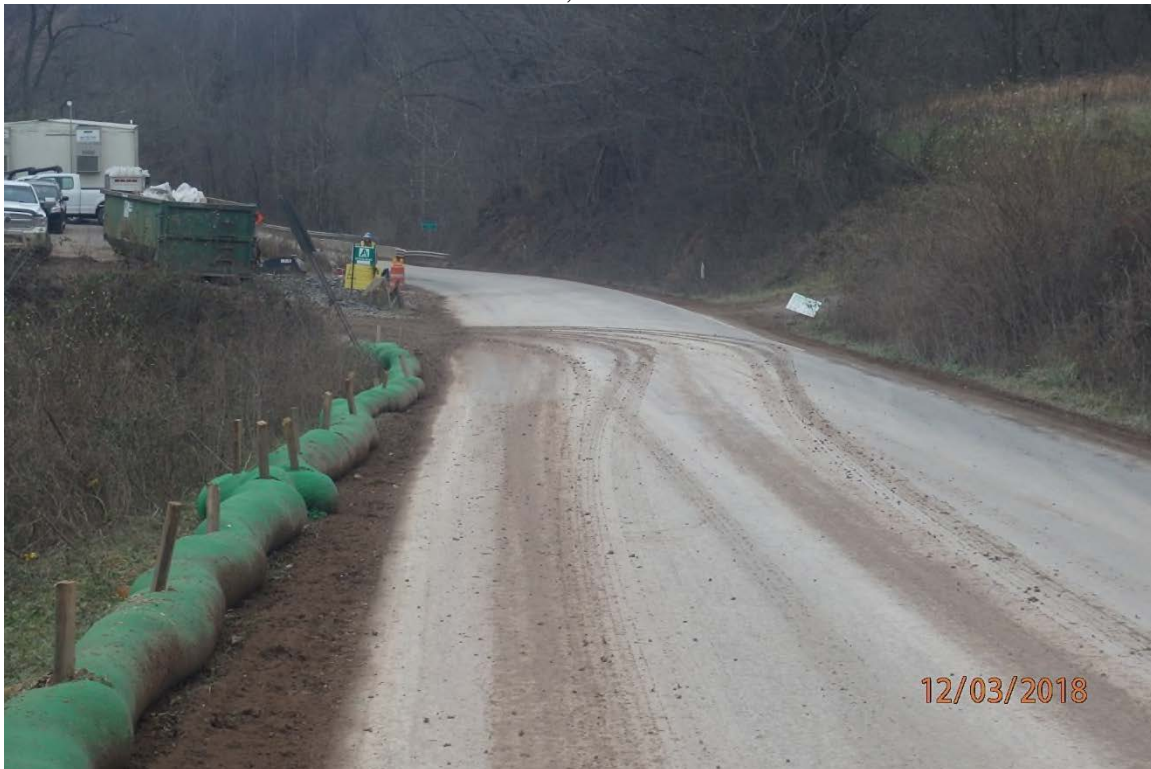
The construction access road to WV 18 showing the lack of a stable construction entrance and the associated track-out onto the public roadway.

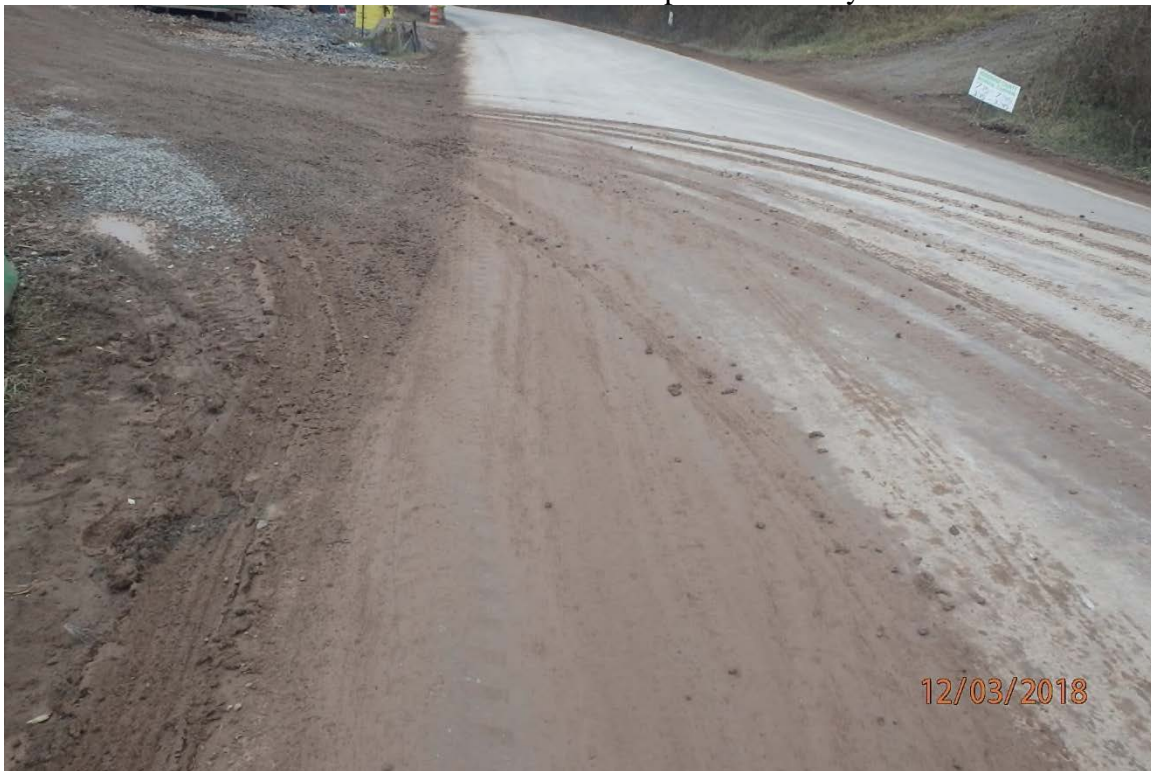
The construction access road to WV 18 showing the lack of a stable construction entrance and the associated track-out onto the public roadway.

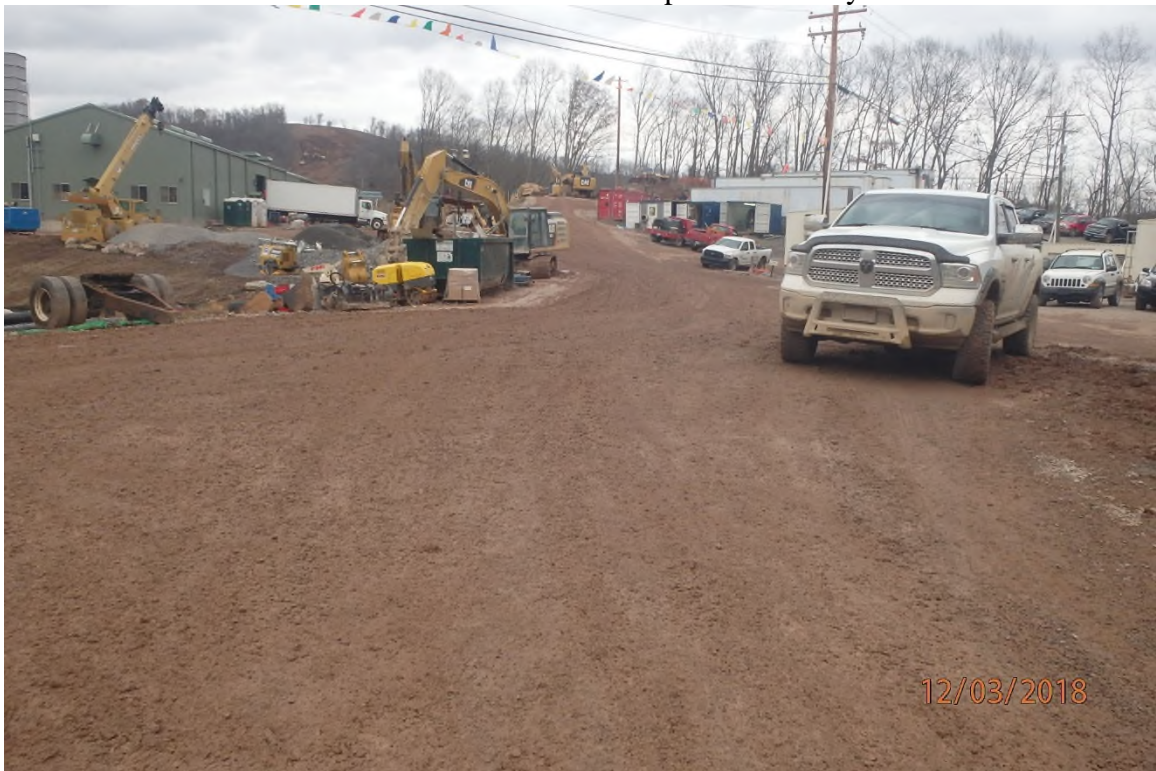
The construction access road to WV 18 showing the lack of a stable construction entrance and the associated track-out onto the public roadway.

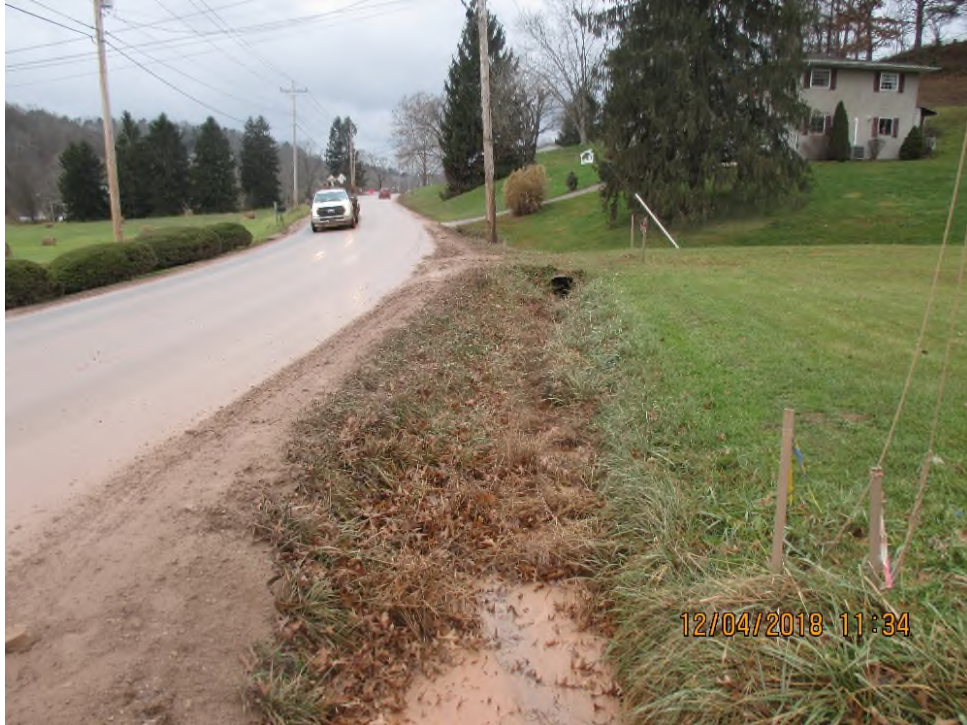
Facing North at impacted ditch and route 21.

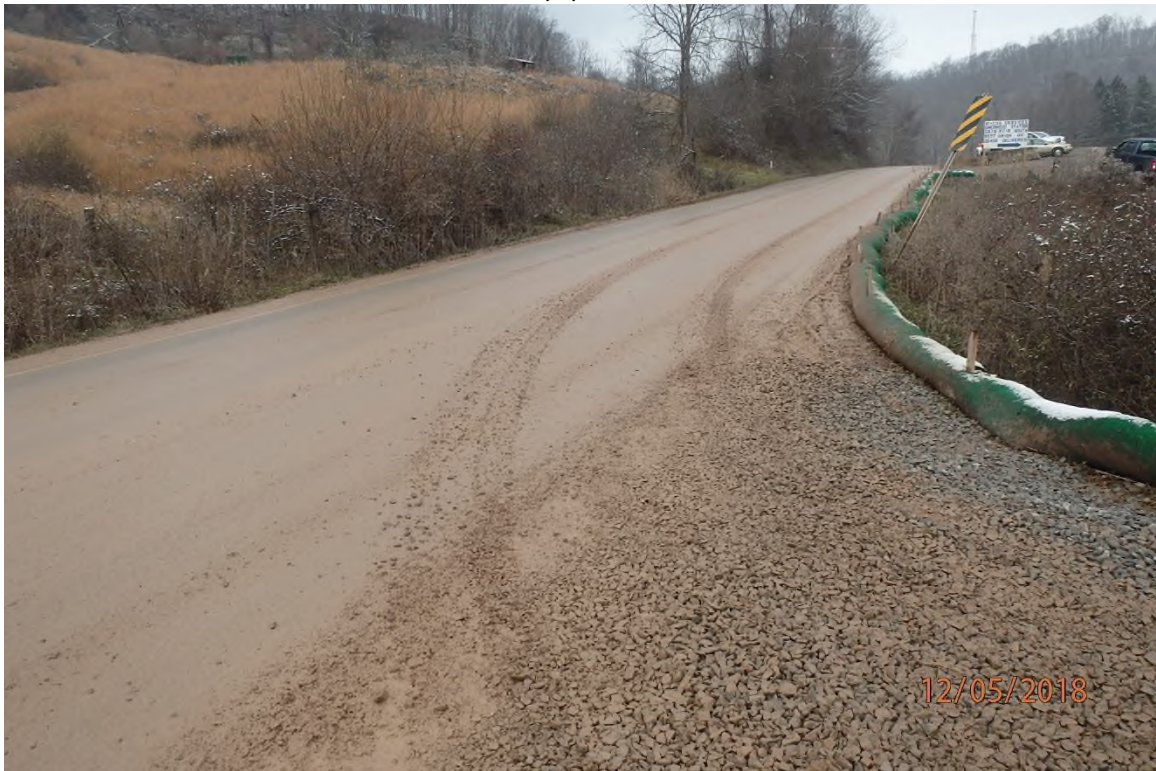
The construction access road to WV 18 showing the ineffectiveness of the construction entrance at preventing track-out onto the public roadway.

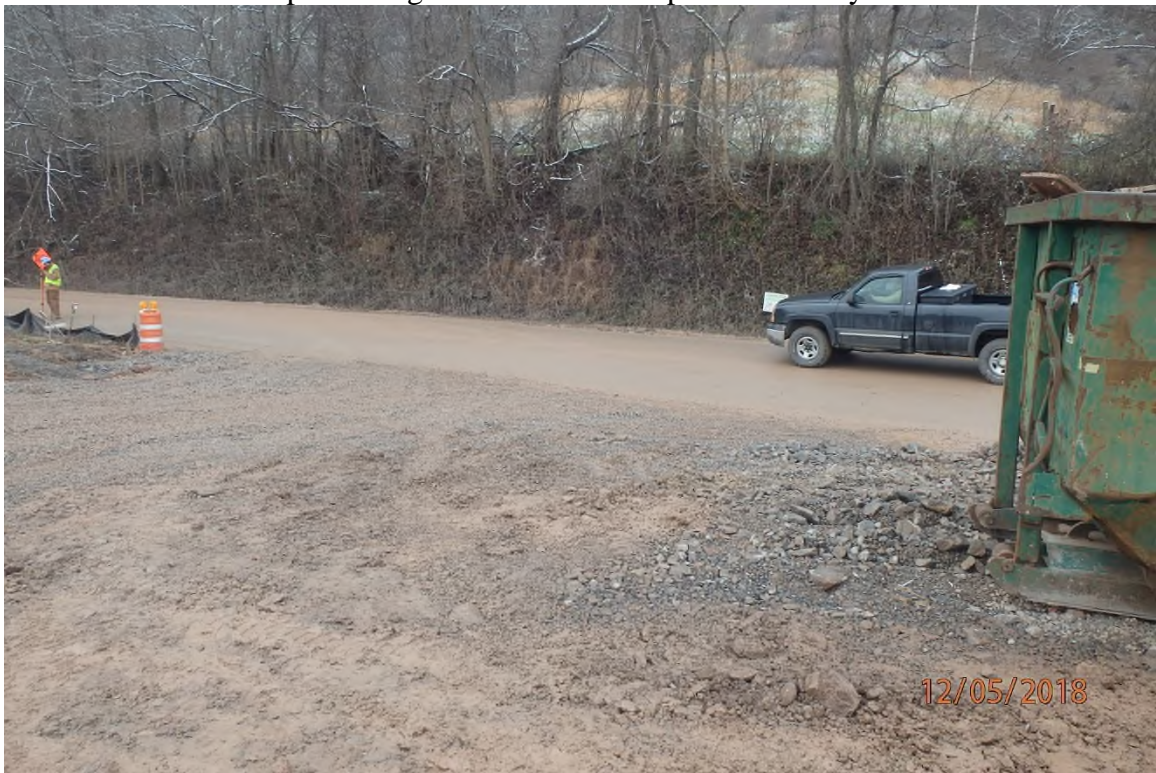
The construction access road to WV 18 showing the ineffectiveness of the construction entrance at preventing track-out onto the public roadway.
