**CONSENT ORDER
ISSUED UNDER THE
WATER POLLUTION CONTROL ACT
WEST VIRGINIA CODE, CHAPTER 22, ARTICLE 11**

TO: Columbia Gas Transmission, LLC
Attn: Troy Tally, Vice President
1700 MacCorkle Ave
Charleston, WV 25314

DATE: October 1, 2020
ORDER NO.: 9061

1. Columbia Gas Transmission, LLC is conducting land disturbance activity associated with construction of the Mountaineer Xpress Project in Marshall, Wetzel, Tyler, Doddridge, Ritchie, Calhoun, Wirt, Roane, Jackson, Mason, Putnam, and Cabell Counties, West Virginia. On January 31, 2018, Columbia Gas Transmission, LLC was issued Water Pollution Control Permit No. WV0116815, Registration No. WVR310872, for Stormwater Associated With Oil and Gas Related Construction Activities.

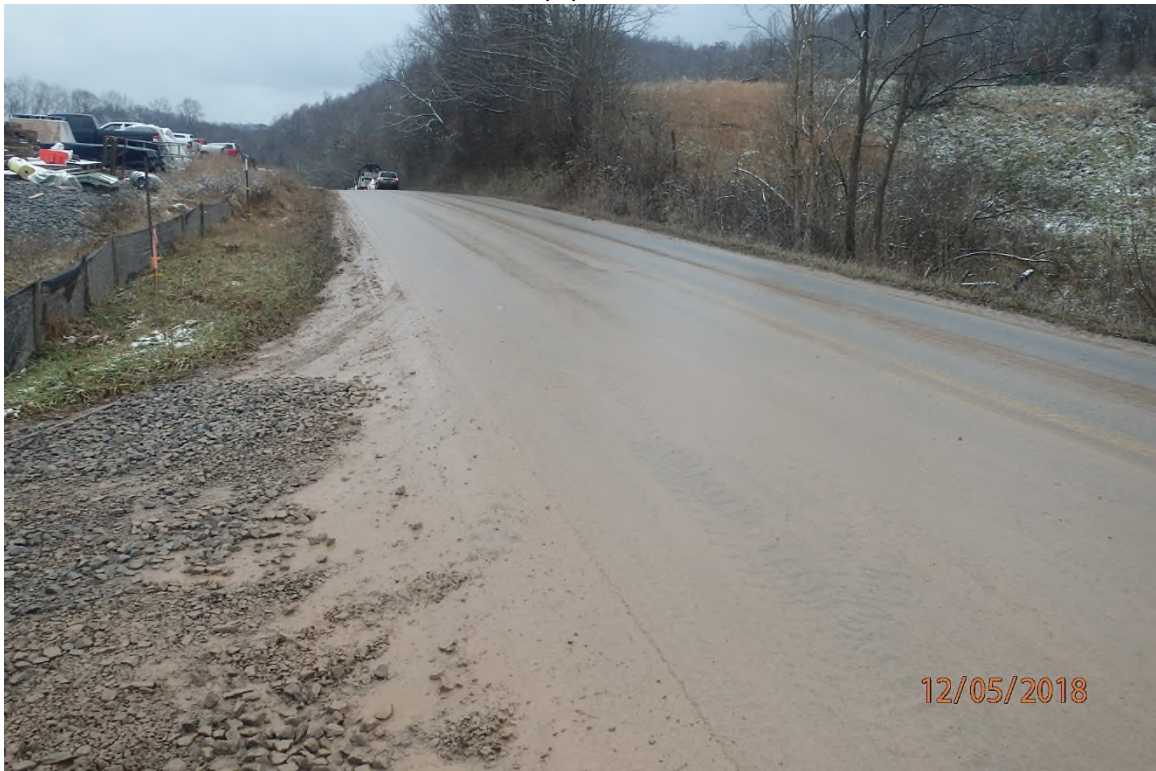
The construction access road to WV 18 showing the ineffectiveness of the construction entrance at preventing track-out onto the public roadway.

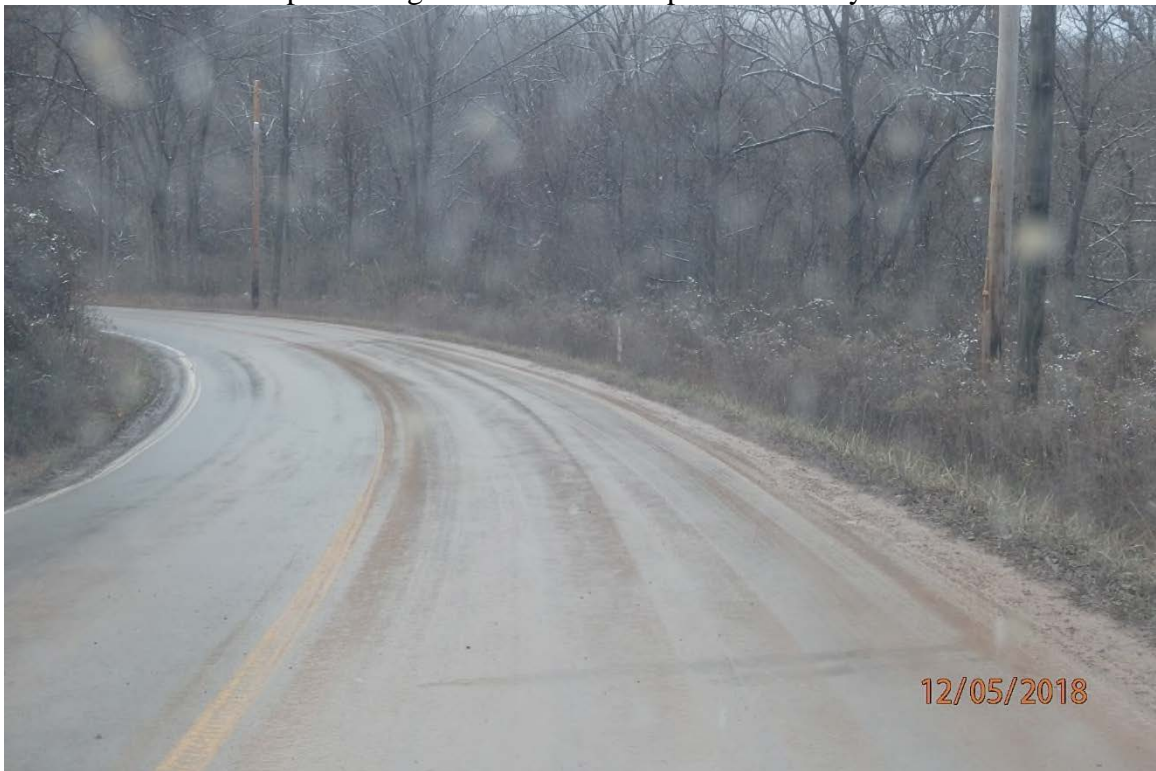
WV 18 showing track-out and slick film of mud on the public roadway that originates from project.

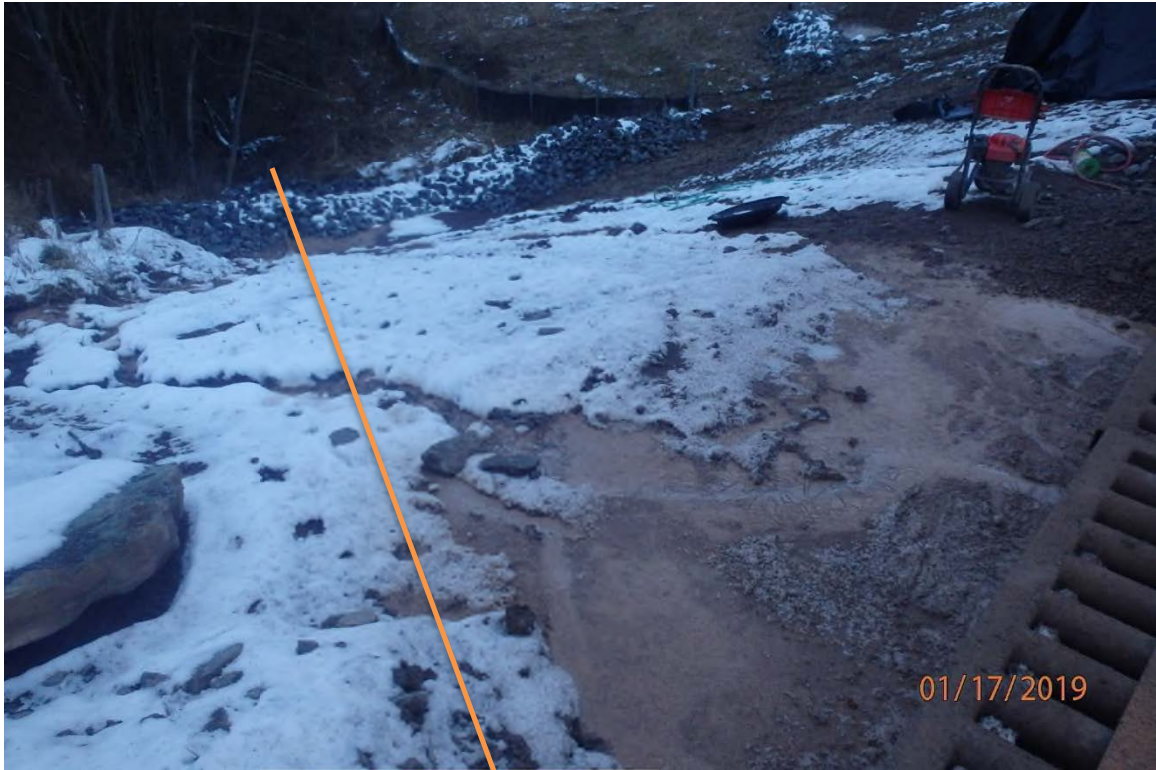
Area below truck wash showing path of sediment laden water.

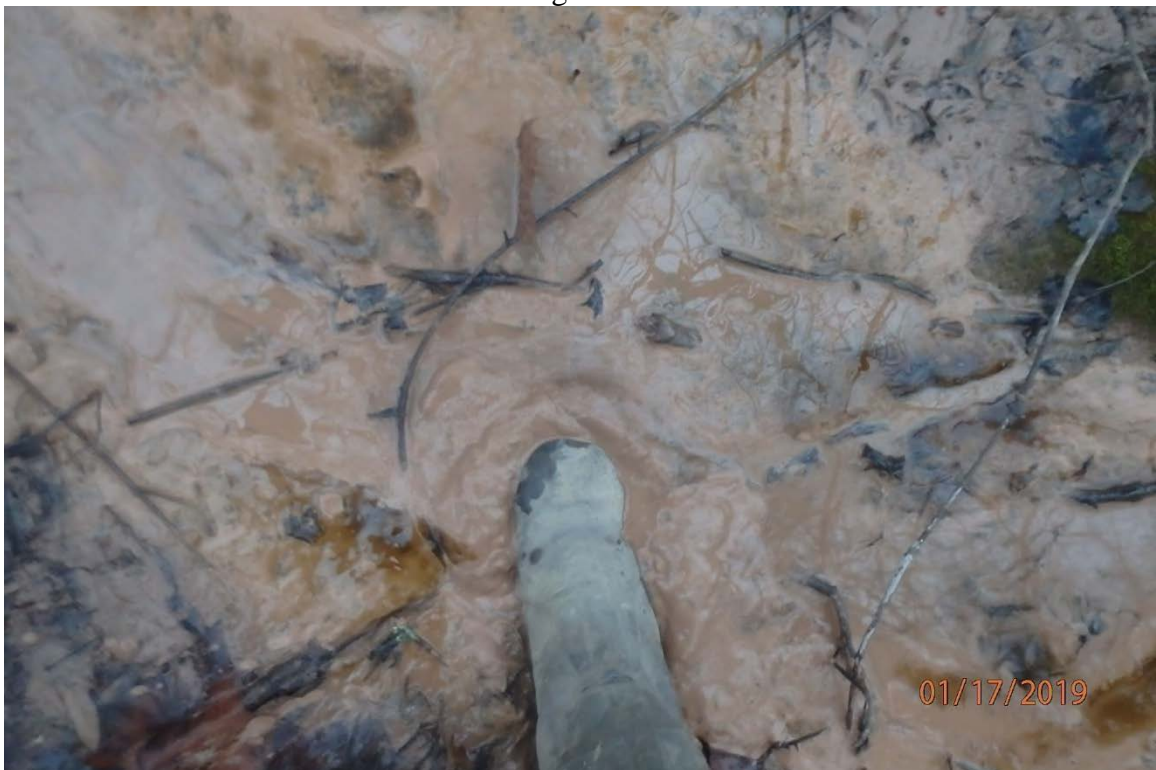
Offsite CNA in UNT Meathouse Fork.

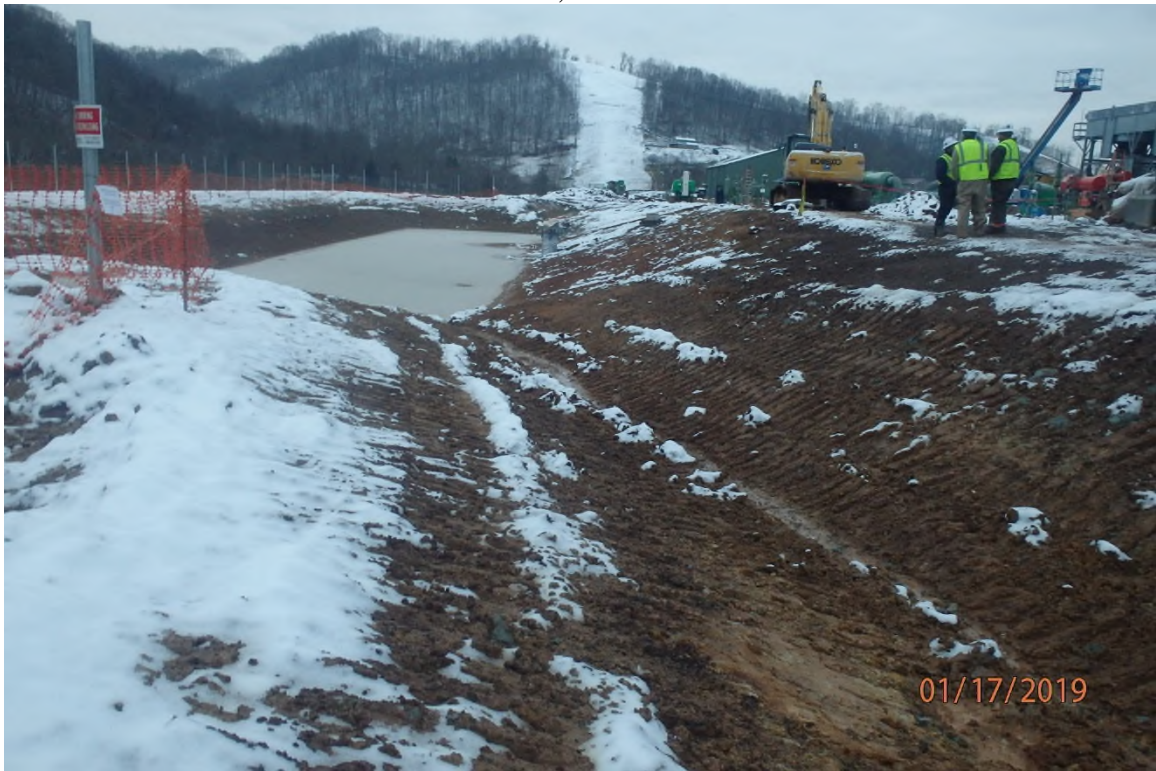
Basin 1 inlet showing the lack of a stabilized inlet.

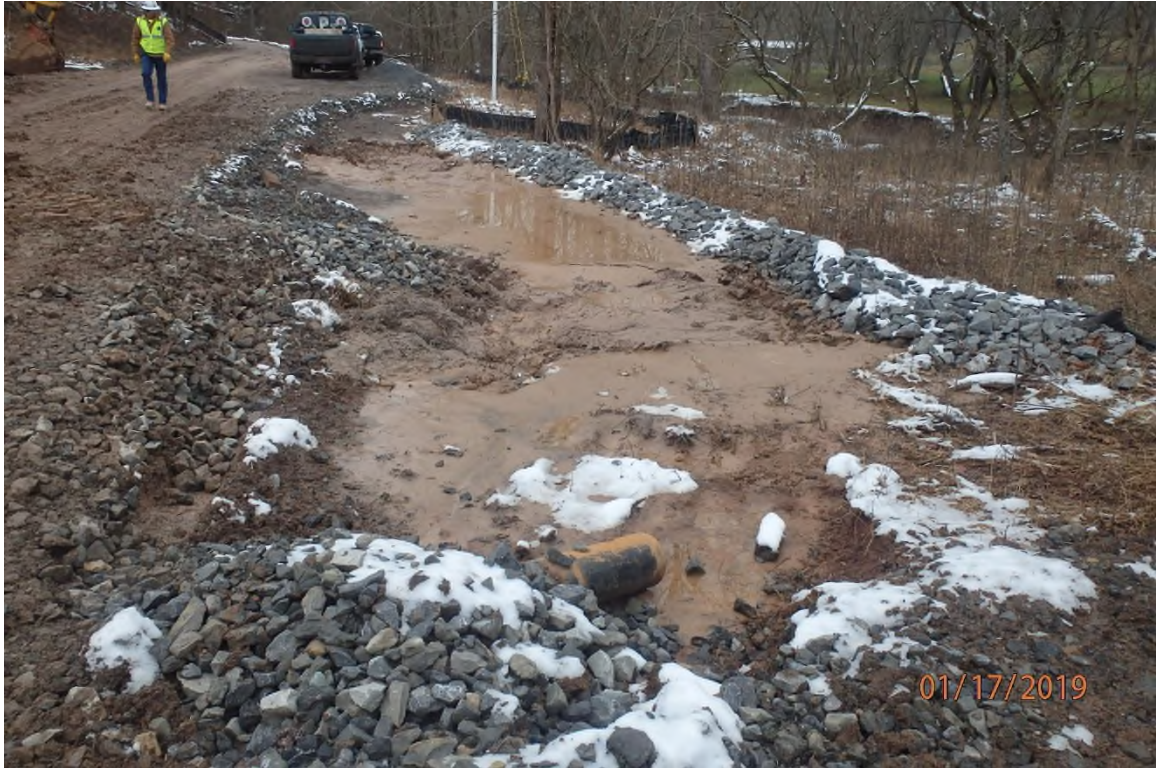
Rock filtration device that is in place. The proposed sediment basin in the approved SWPPP is not in place as designed.

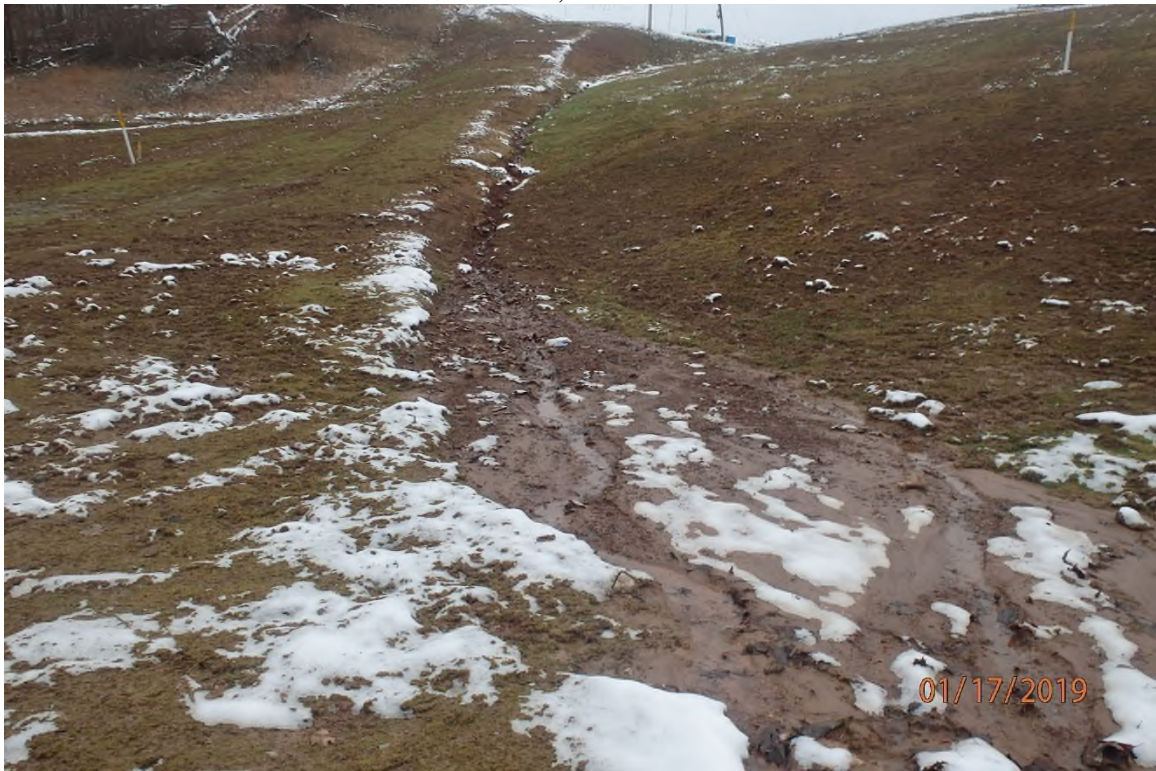
The installed diversion along the southern edge of the project that is eroded and in need of maintenance.

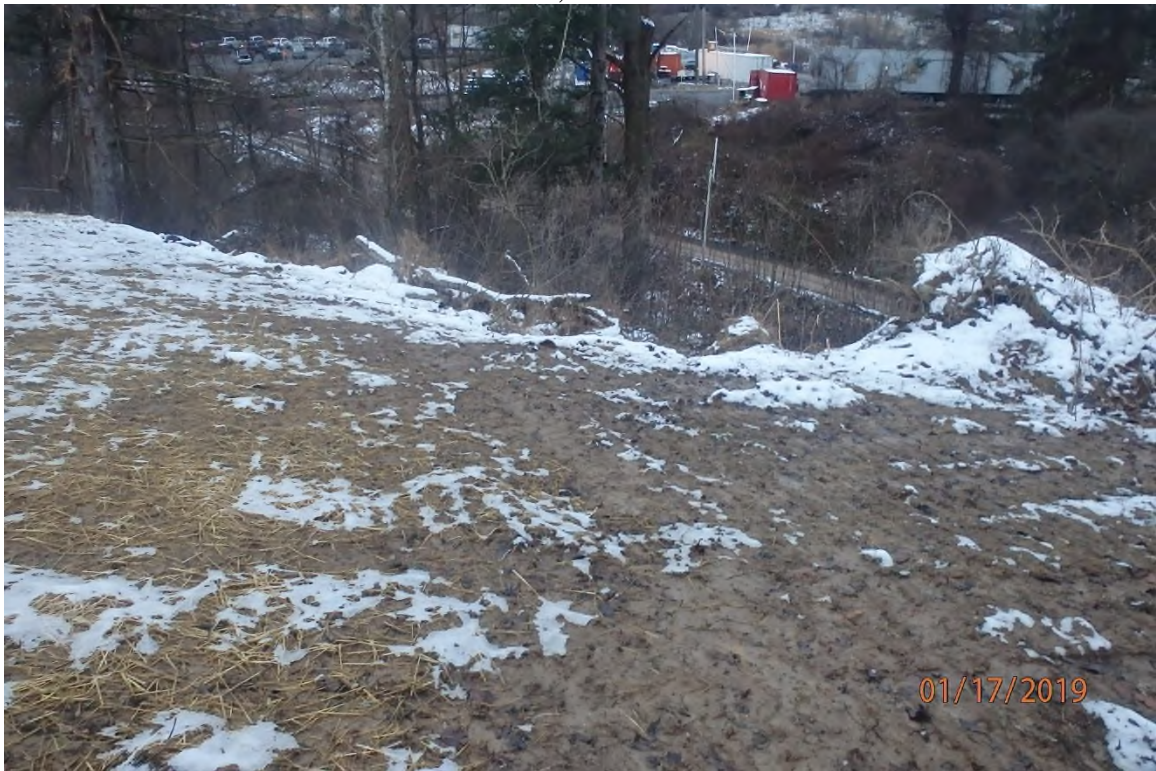
Northwestern perimeter of the project showing the lack of perimeter silt fence that is indicated in the approved SWPPP.

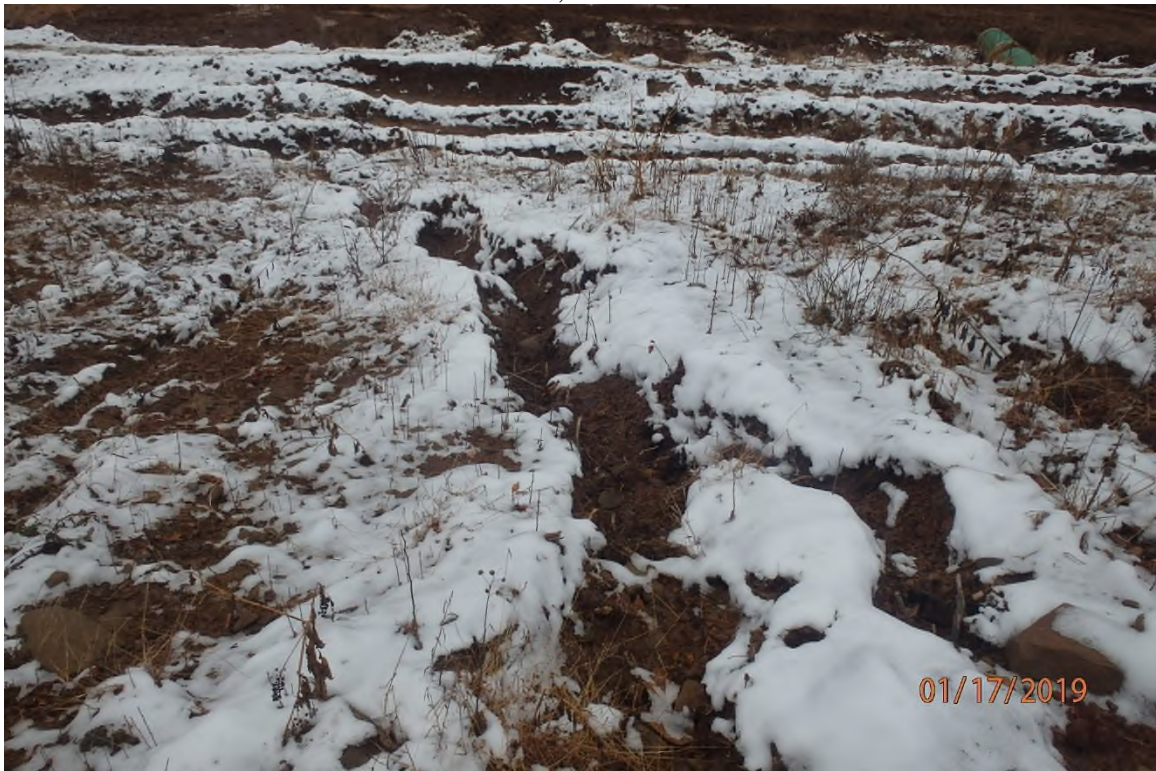
Slope that lacks adequate temporary stabilization in the northwestern portion of the project.

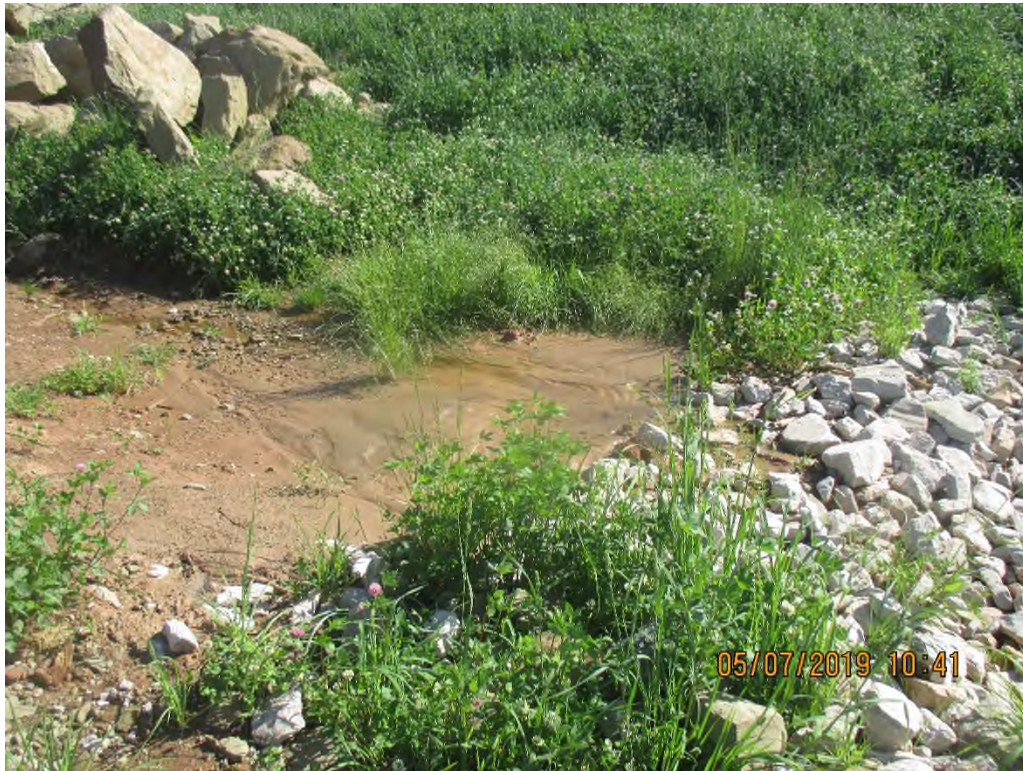
Sediment present above smaller rock in diversion.

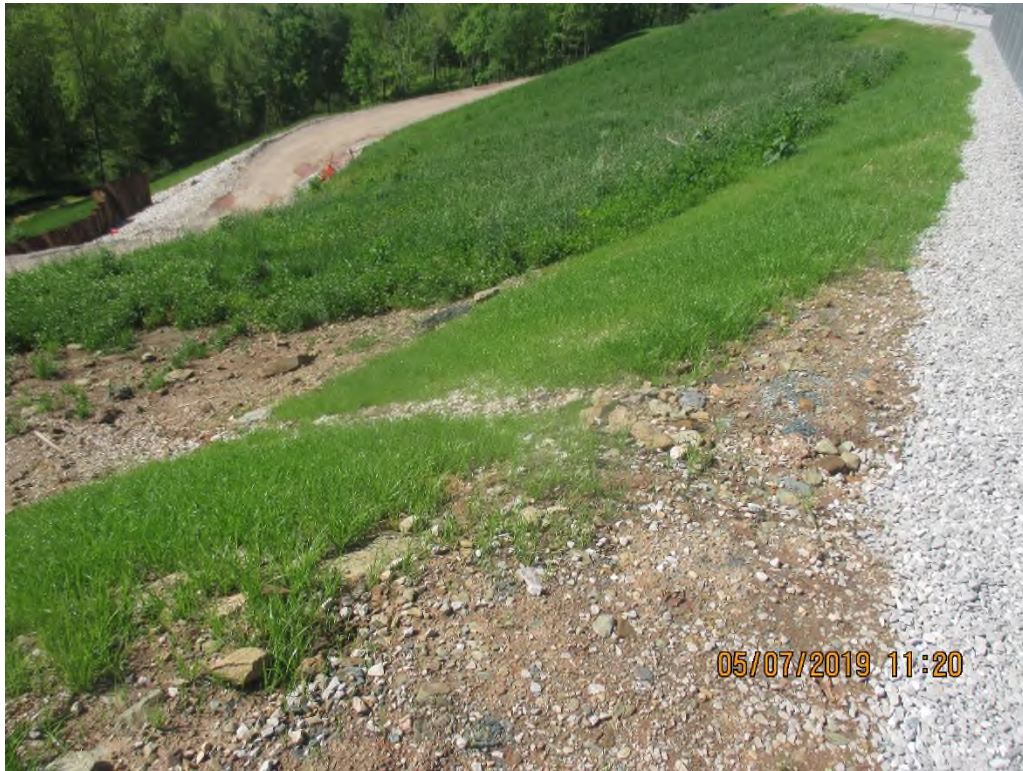
Erosion occurring adjacent to diversion swale outlet. Run-off from pad eroding fill slope on south side of pad.

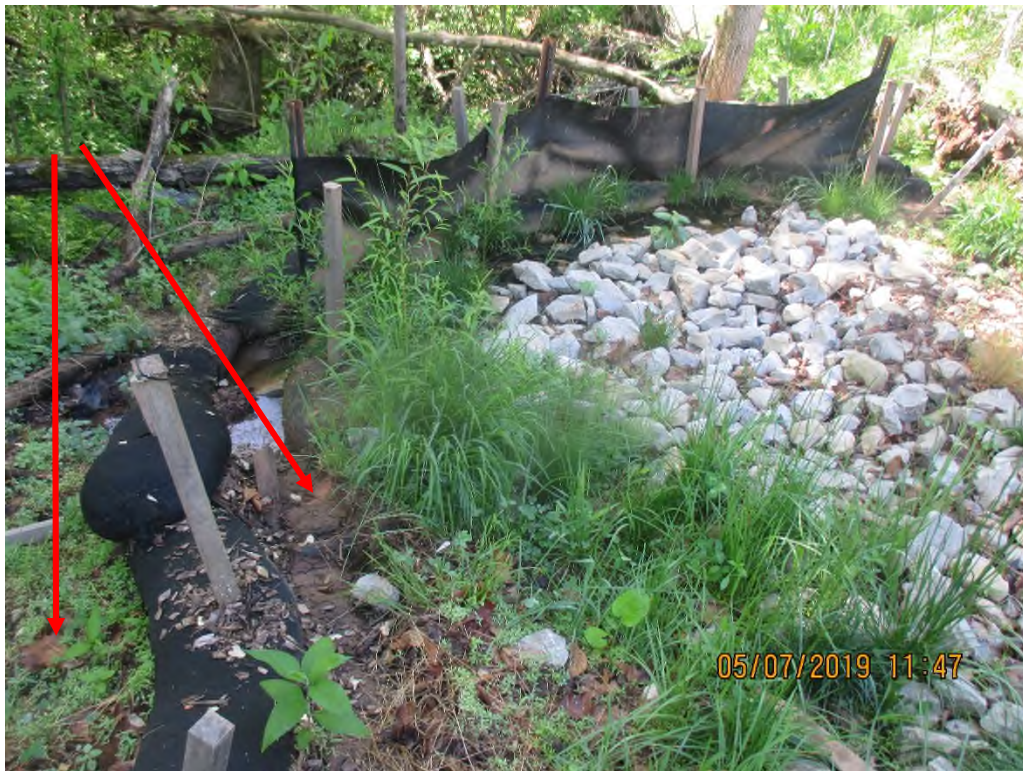
Perimeter controls on south west slope of project LOD. Arrow depicts evidence that sediment laden water had flowed past controls.

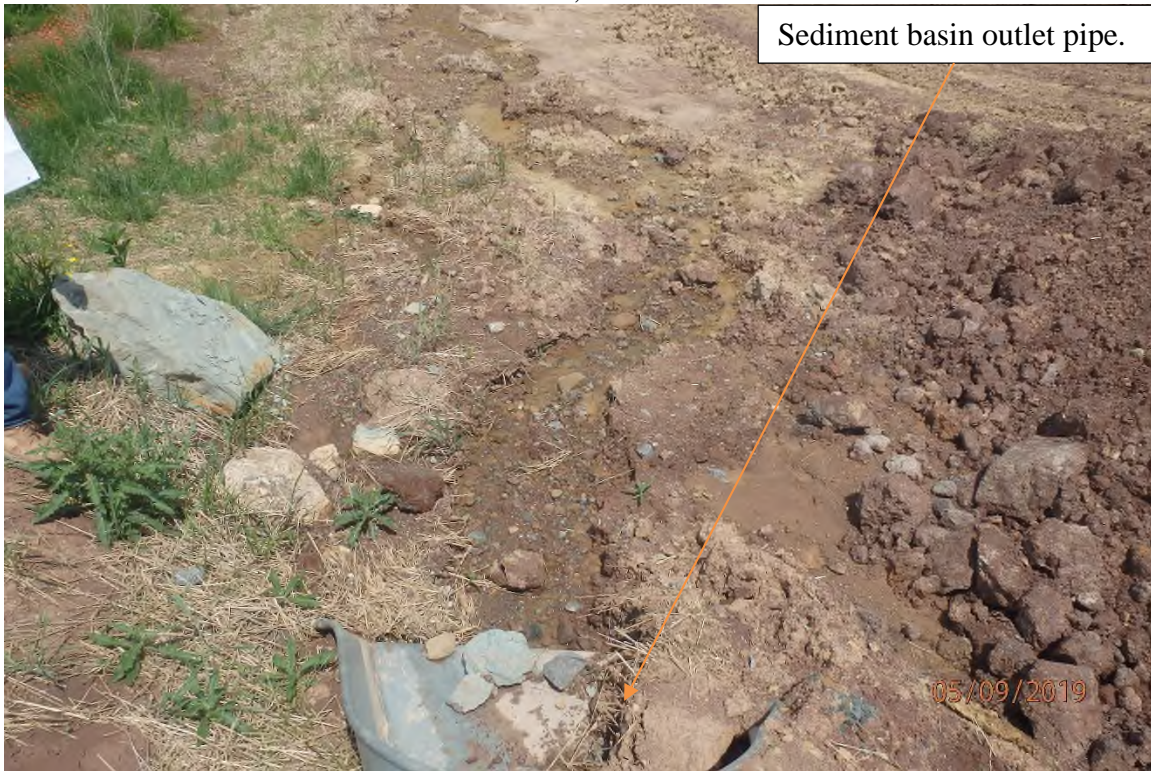
Sediment basin outlet pipe.

Diversion downslope of the sediment basin outlet pipe showing the lack of a riprap channel and weir.

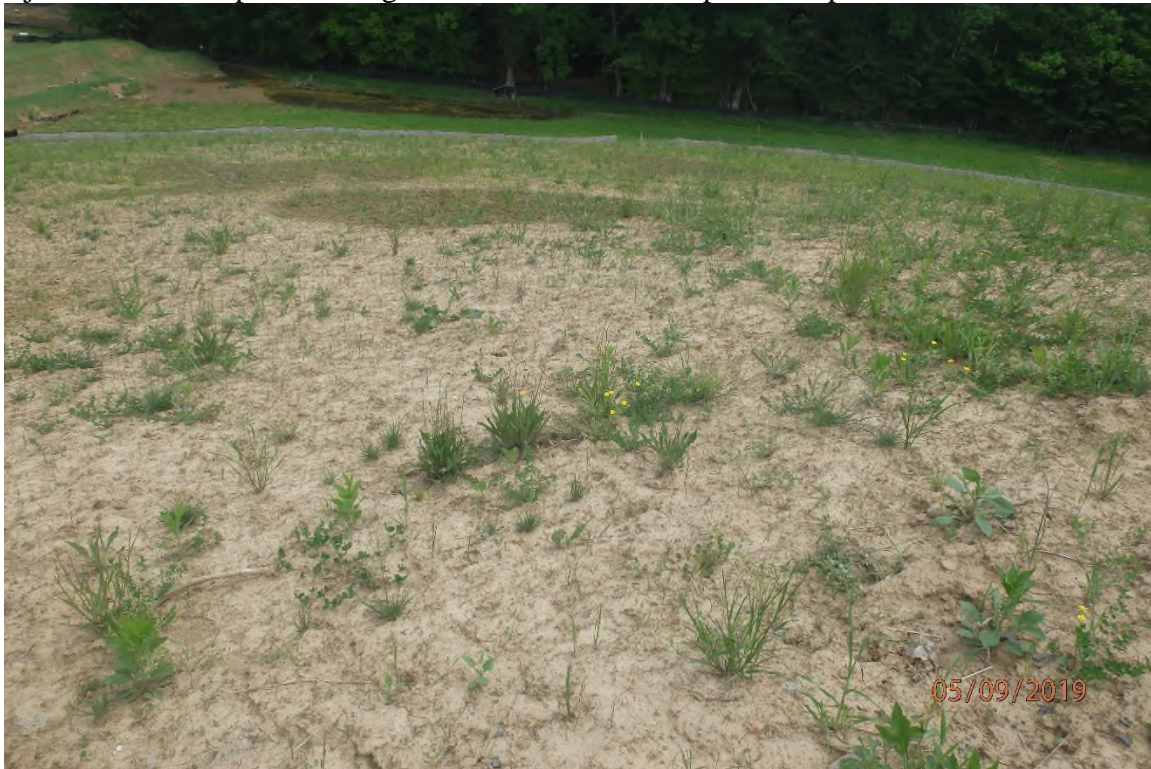
Slope adjacent to the fill pad showing the lack of installed slope interceptors. Area in need of reseeding.

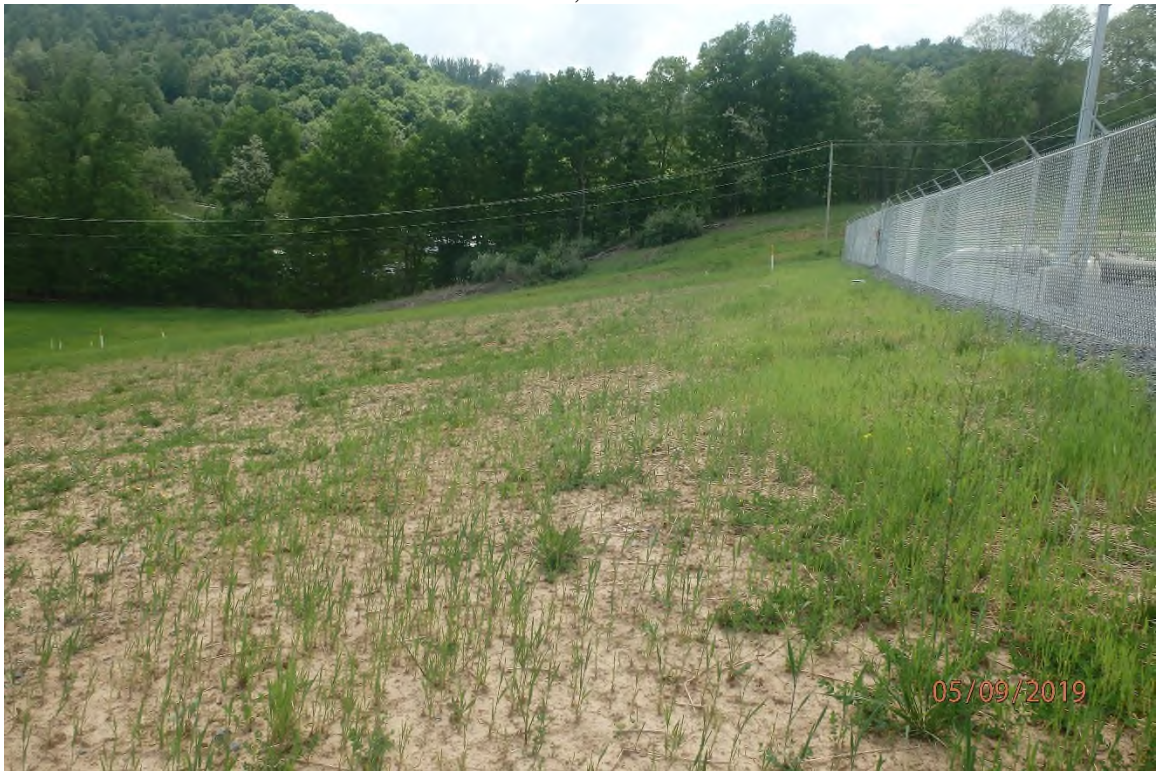
Slope adjacent to the fill pad showing the lack of installed slope interceptors. Area in need of reseeding.

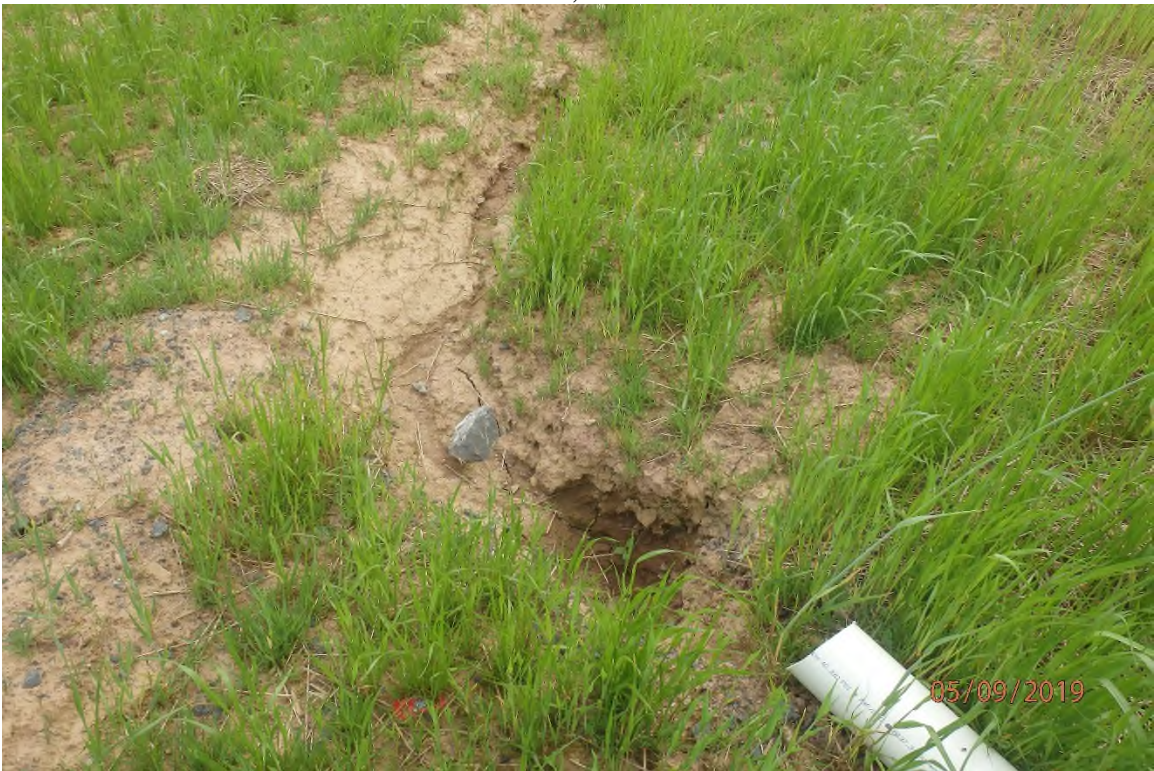
Concentrated flow stormwater being directed over an unprotected fill slope and associated fill slope erosion adjacent to the fill pad.

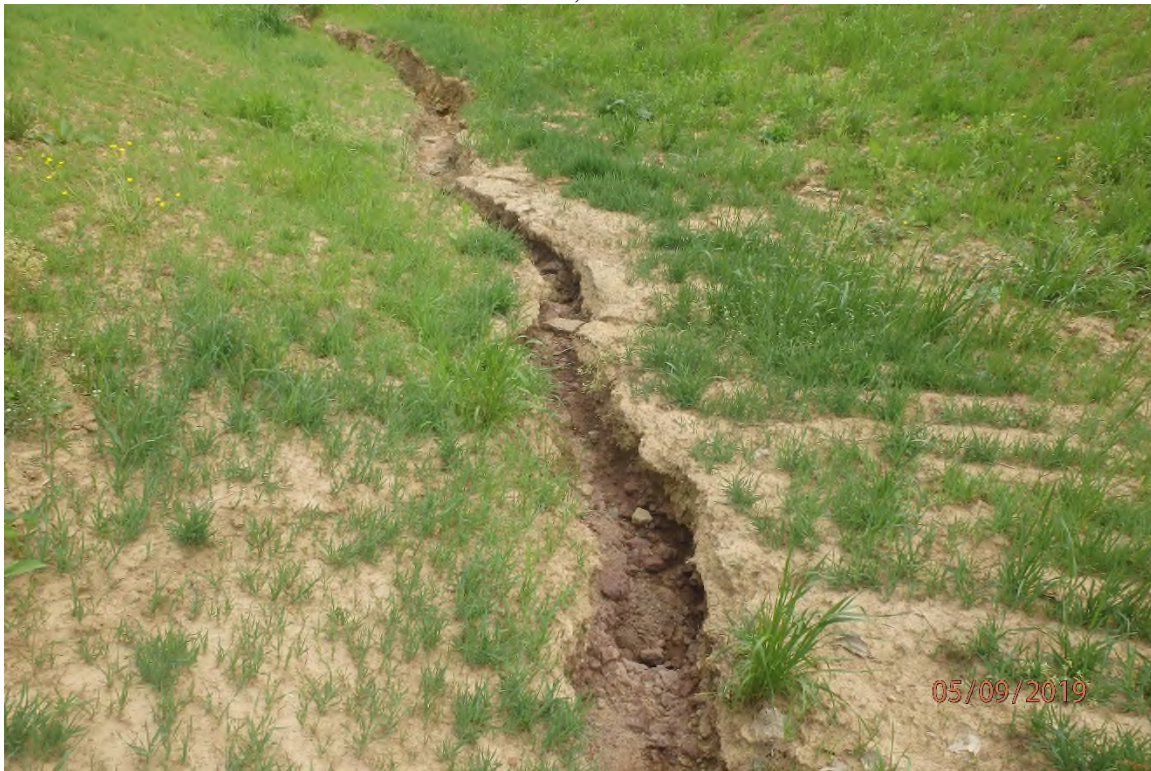
Diversion in the southern portion of the project that is eroded and in need of maintenance.

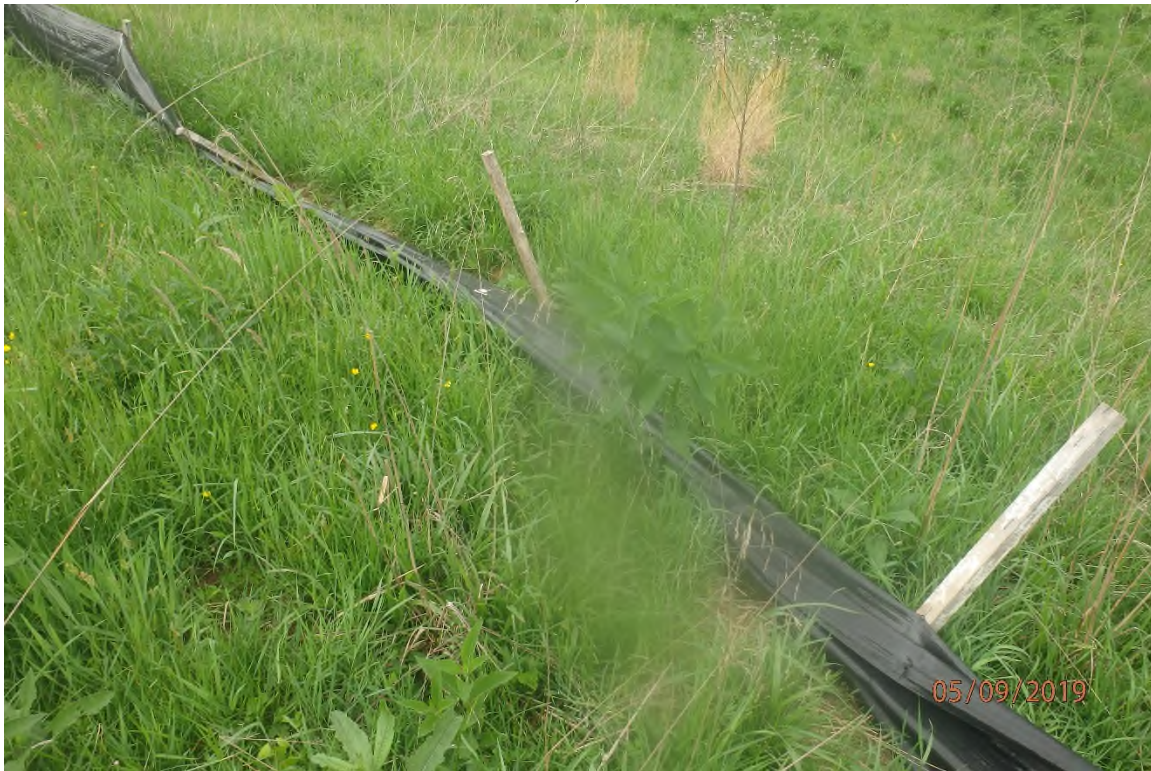
Perimeter control along the northern edge of the project in need of maintenance.

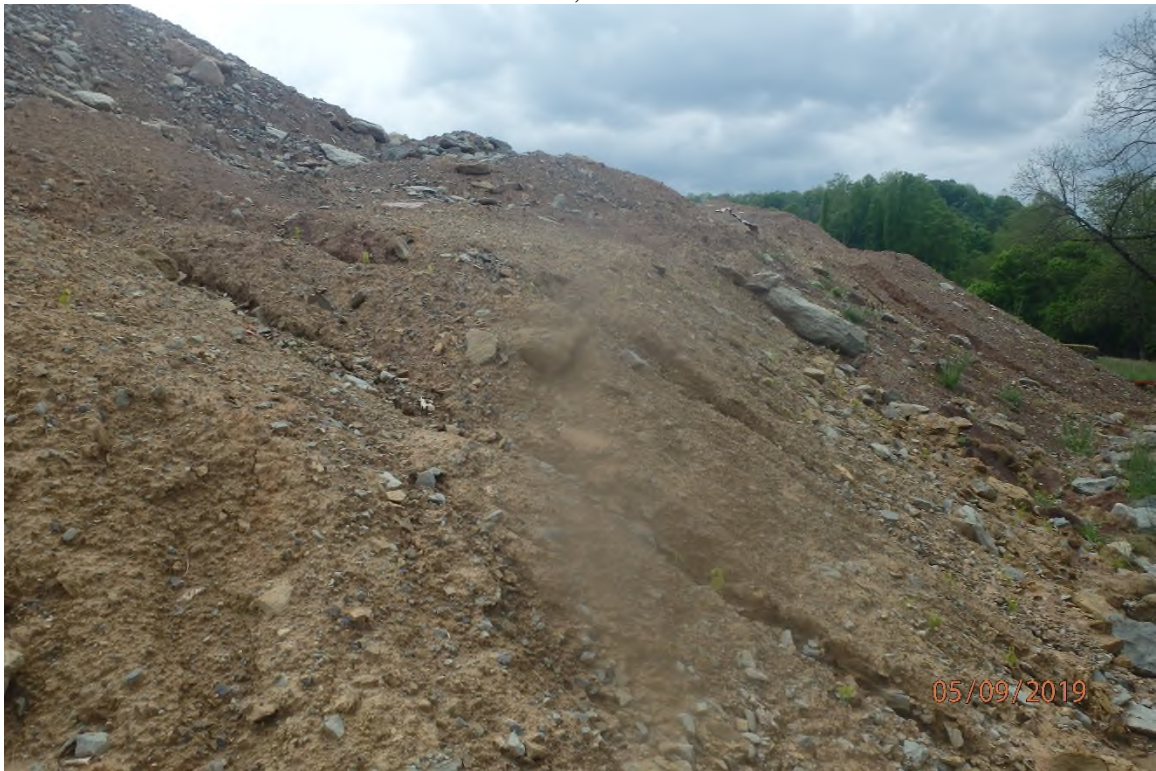
Soil stockpiles have been idle for greater than 21 days and have not been temporarily stabilized.
