**CONSENT ORDER
ISSUED UNDER THE
WATER POLLUTION CONTROL ACT
WEST VIRGINIA CODE, CHAPTER 22, ARTICLE 11**

TO: Mountain Valley Pipeline, LLC
Robert J. Cooper
2200 Energy Drive
Canonsburg, PA 15317

DATE: December 17, 2020

ORDER NO.: 9925

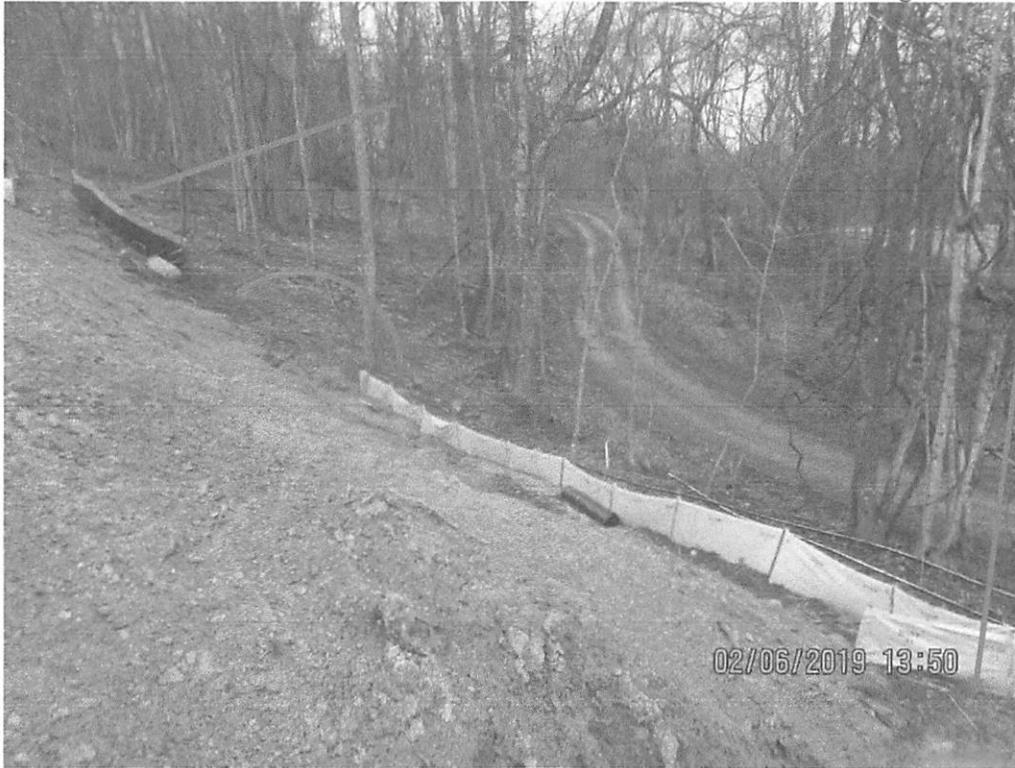
Waterbar outlets depicted with arrows near station number 8816+00. Area where temporary water diversion was not installed per SWPPP depicted with red line.

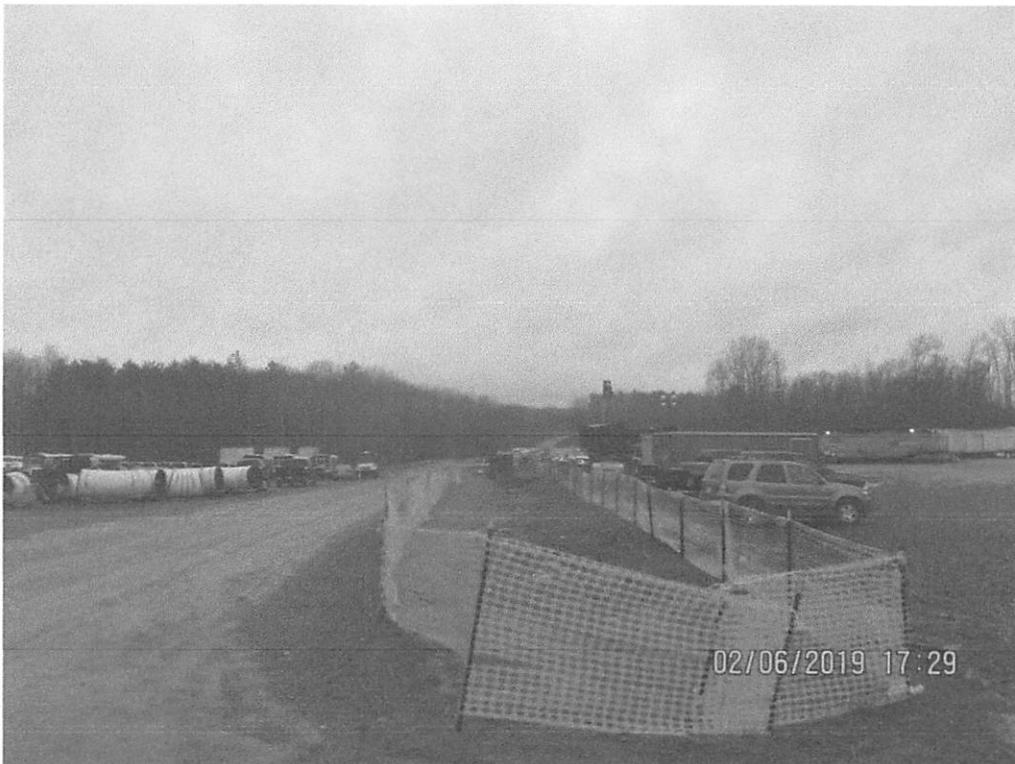
MVP contractor yard facing West toward drainage ditch and entrance.

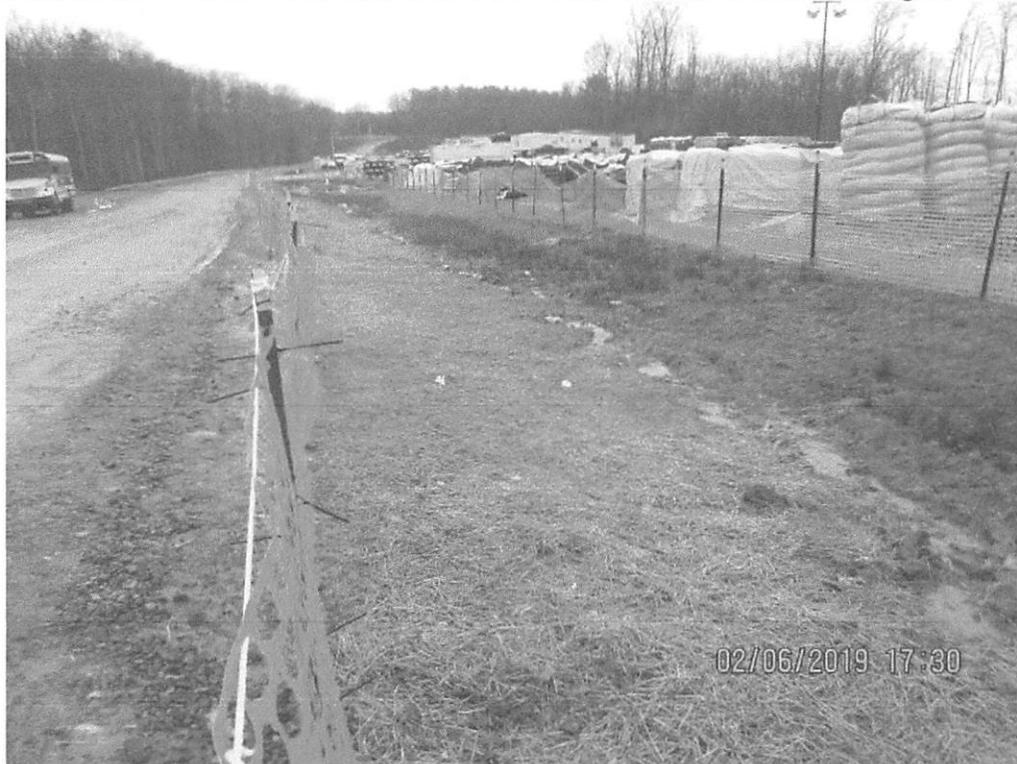
Facing West toward entrance and wetland located in ditch.

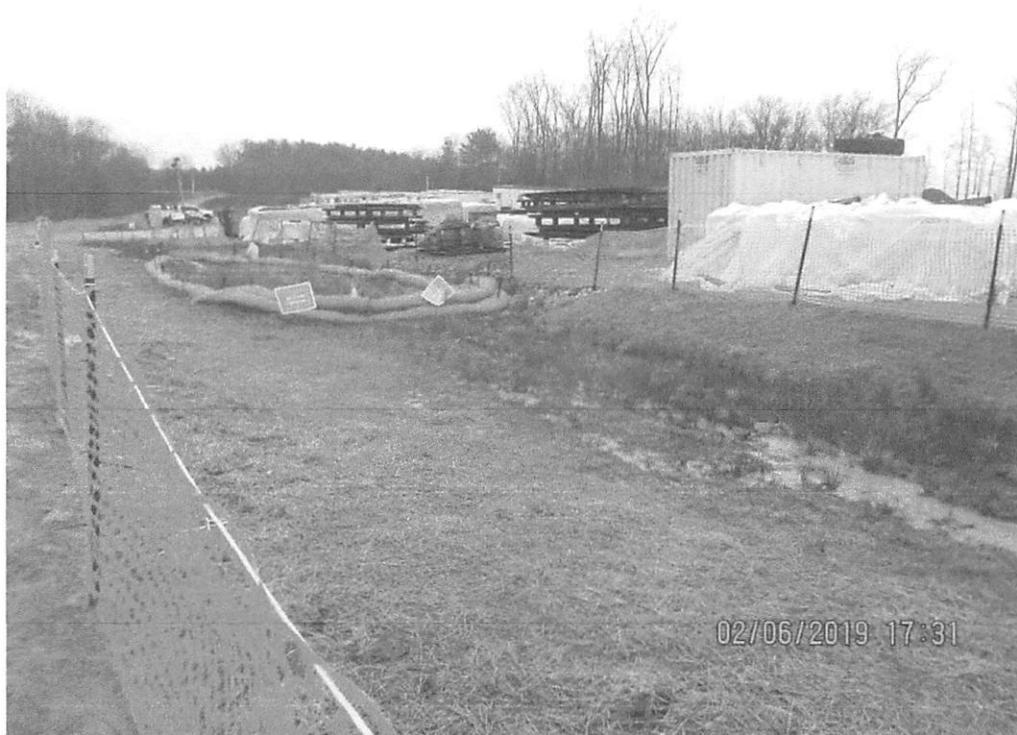
Facing toward wetland in drainage ditch. Sediment-laden water (SLW) present in ditch and wetland.

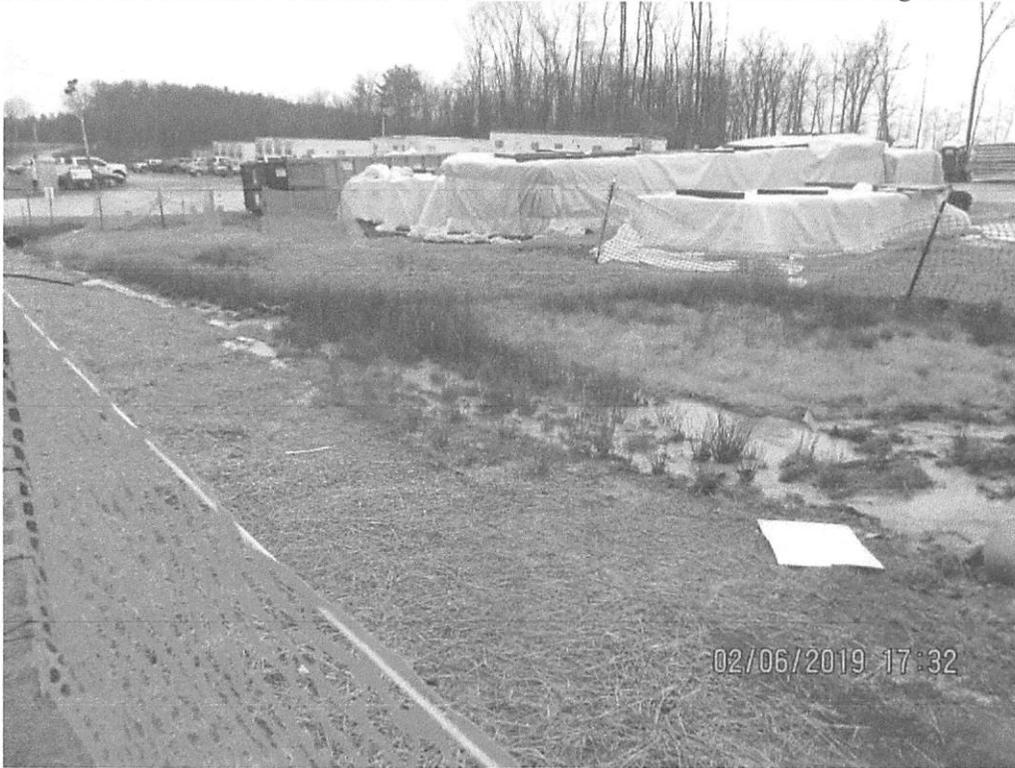
End of wetland. SLW conveying toward culvert.

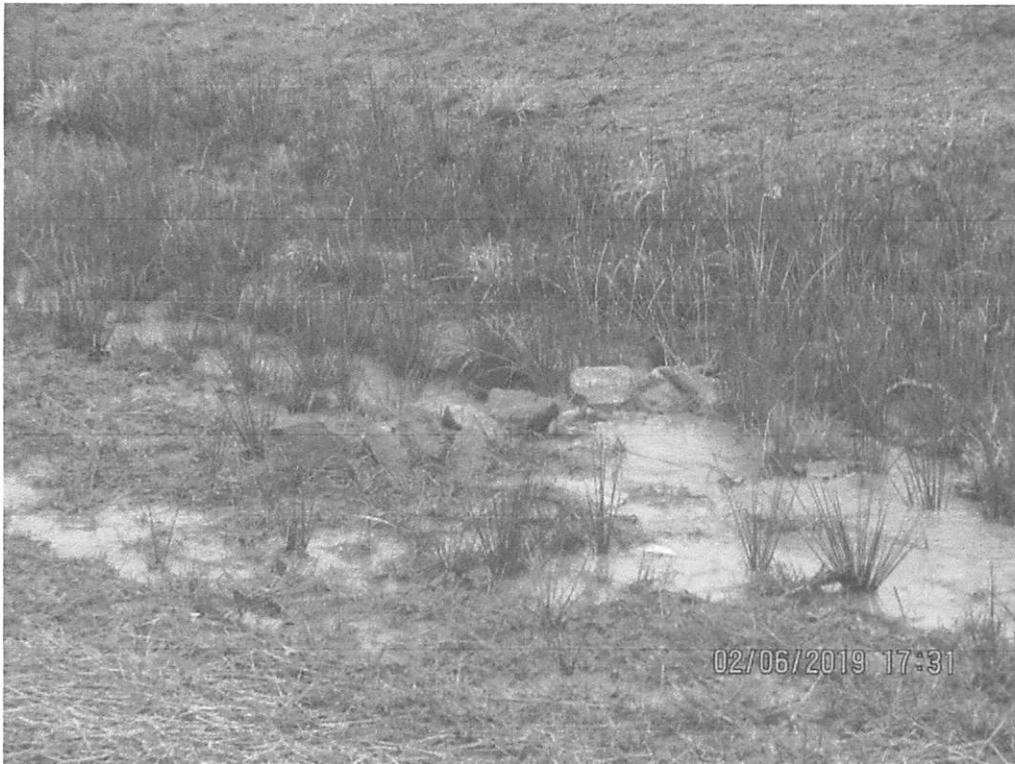
Rock check in ditch with SLW present, draining toward culvert.

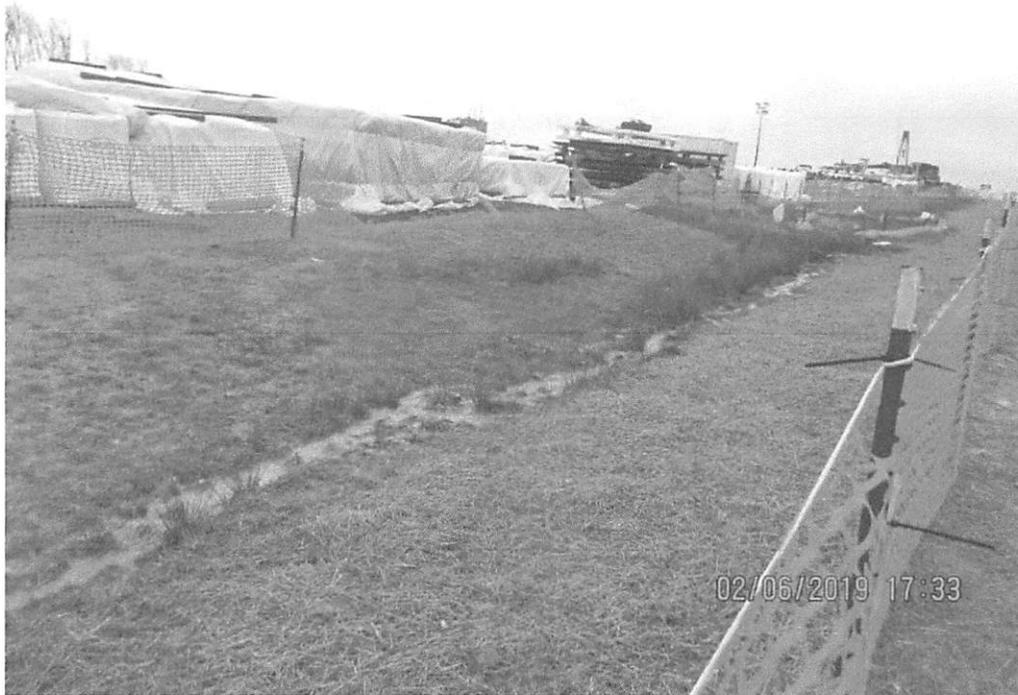
Drainage ditch and wetland facing upslope (west).

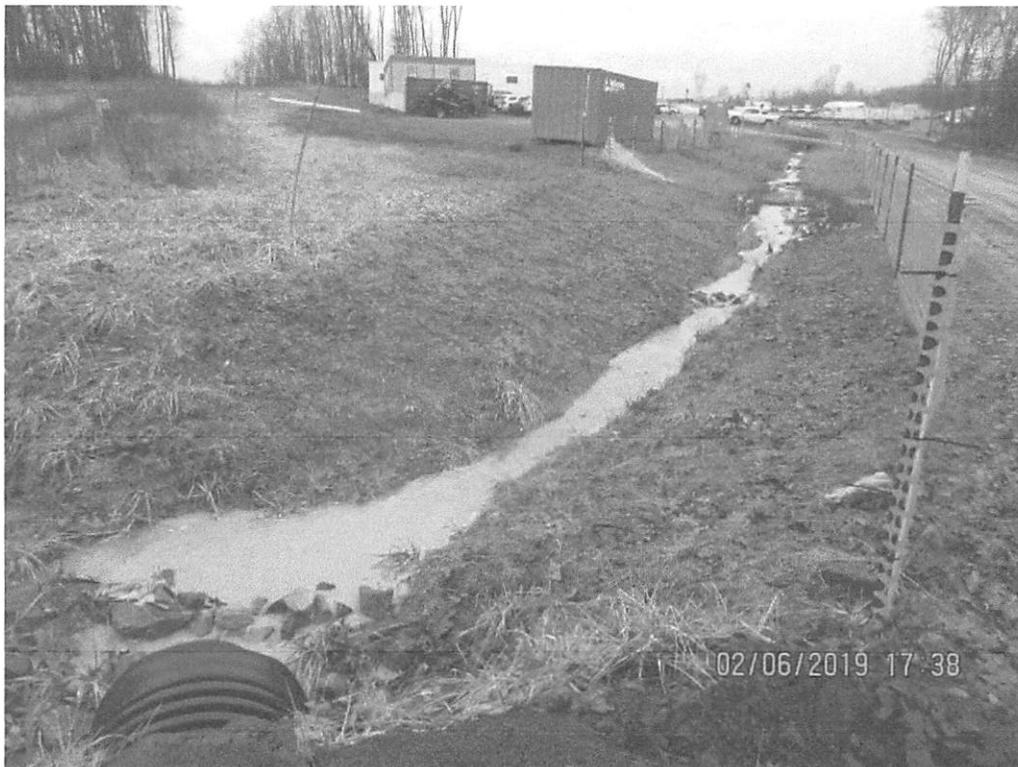
Ditch facing west (upslope) toward culvert and wetland.

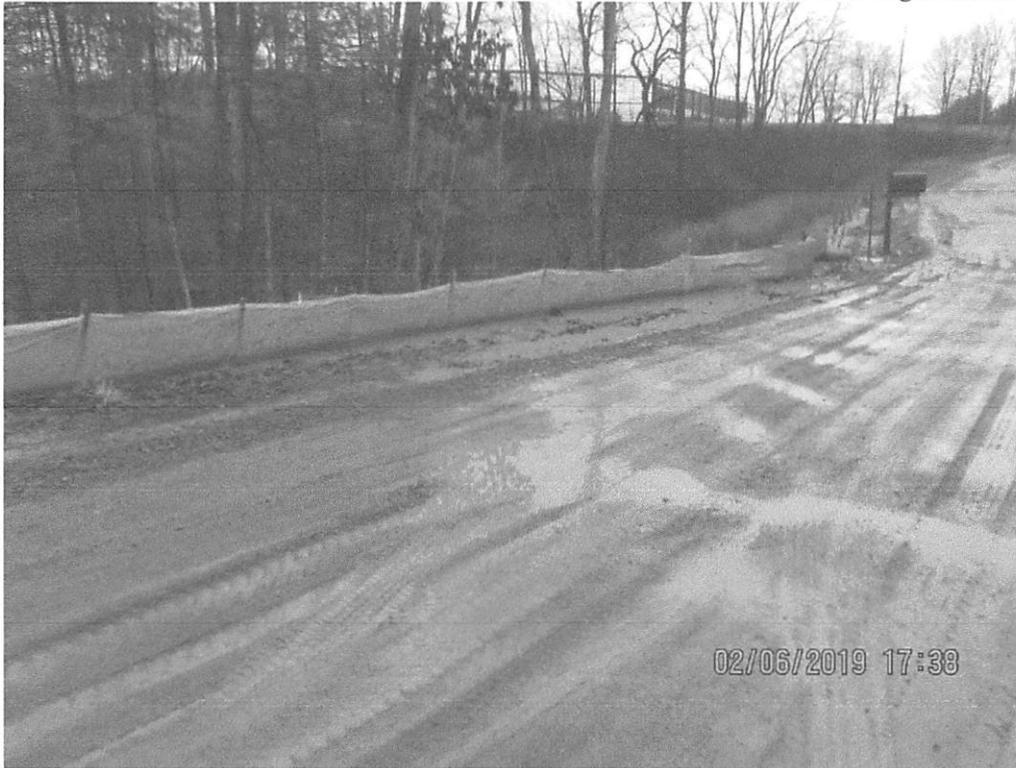
Facing toward culvert outflow and MVP yard entrance.

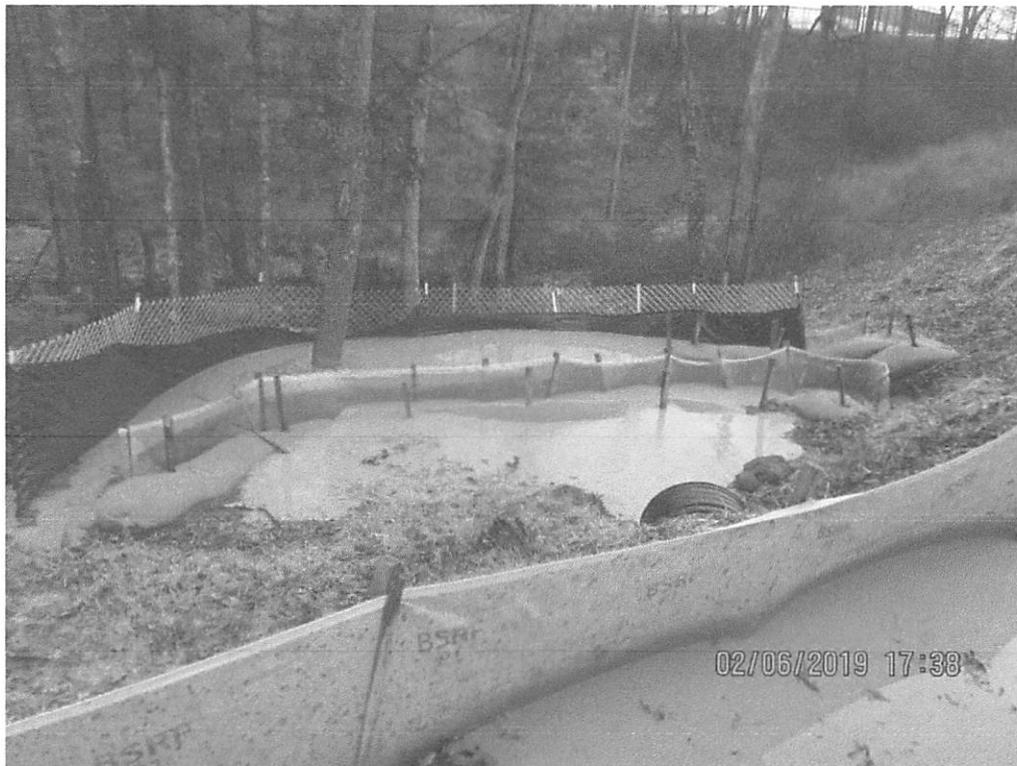
Culvert outflow into multiple controls with SLW present.

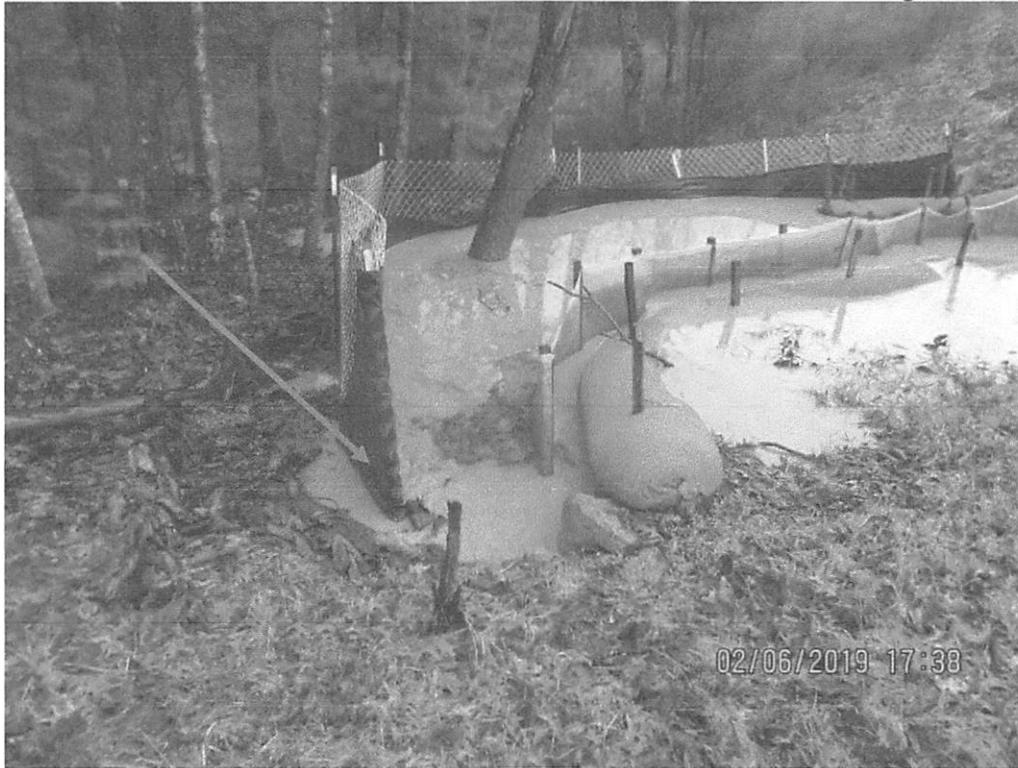
Controls downstream of culvert. SLW going around controls.

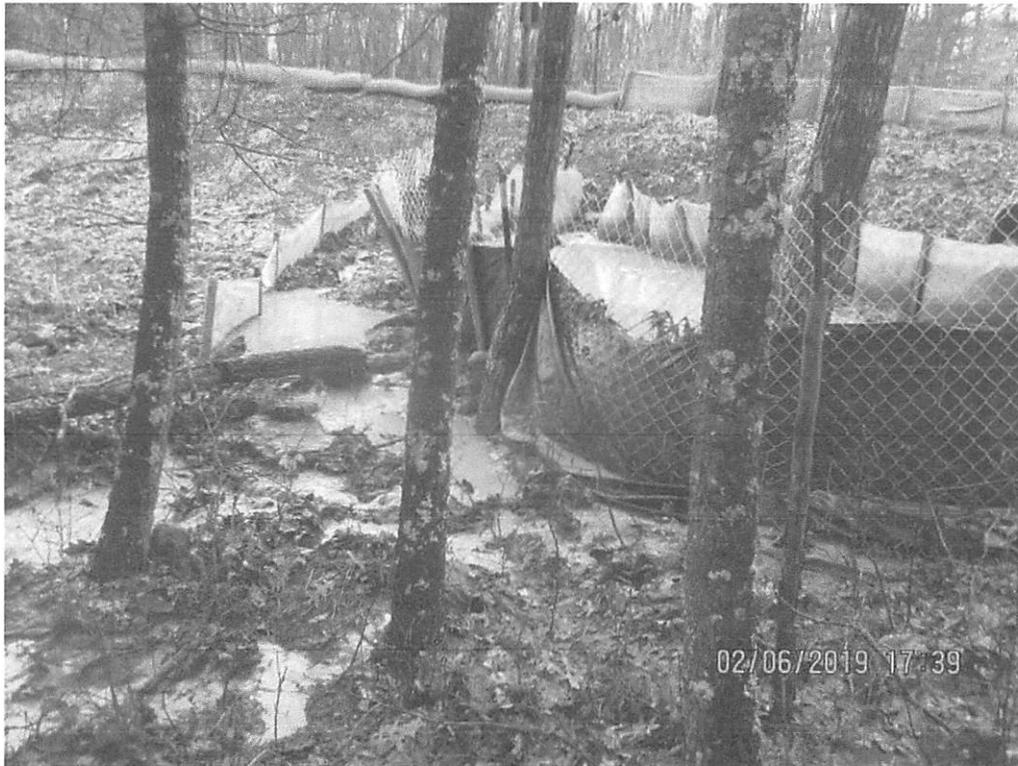
SLW flowing past controls and downslope to UNT of Brammer Branch. Back side of silt fence fallen over.

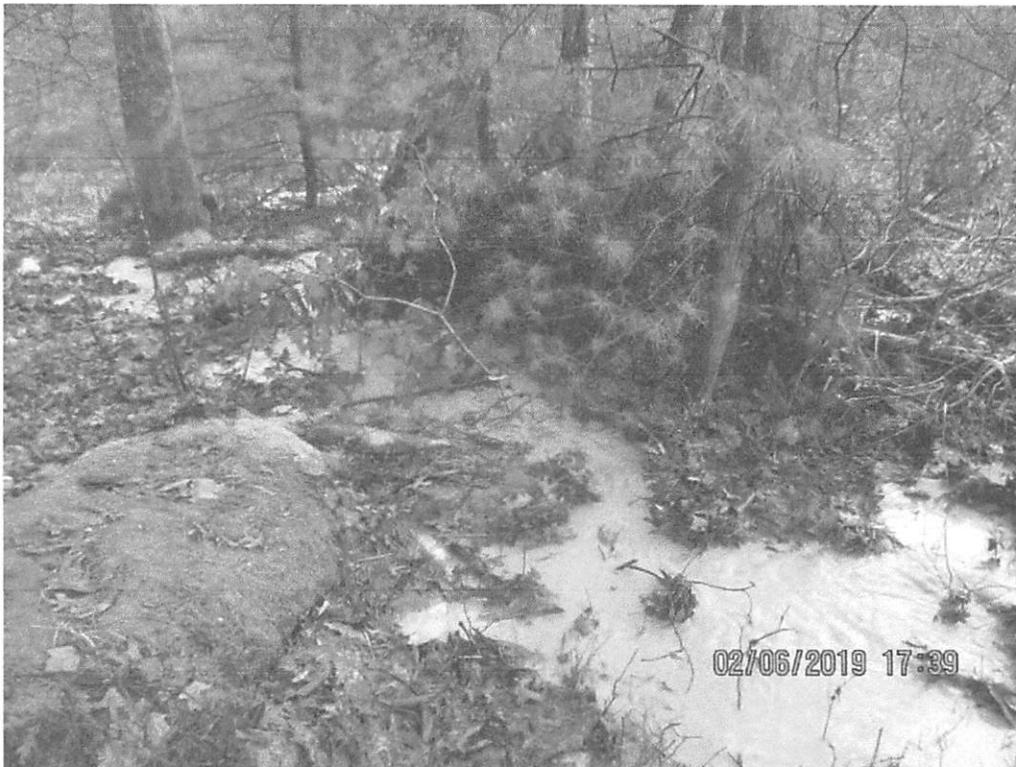
SLW flowing downslope toward UNT of Brammer Branch.

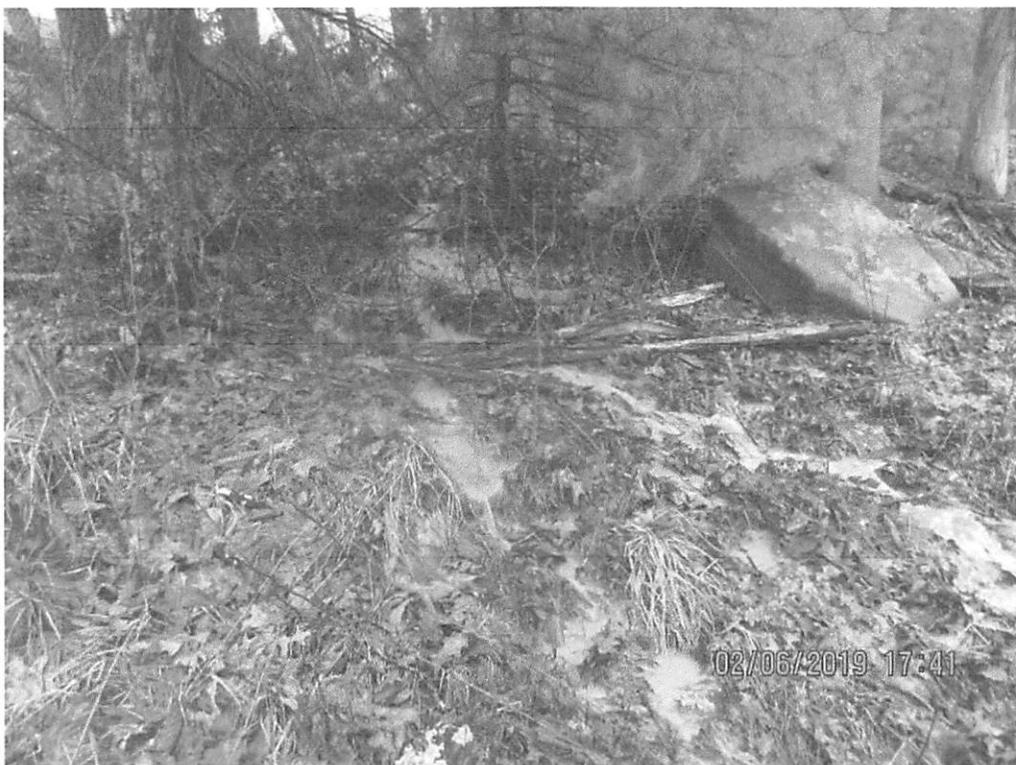
SLW flowing downslope toward UNT of Brammer Branch due to failing controls

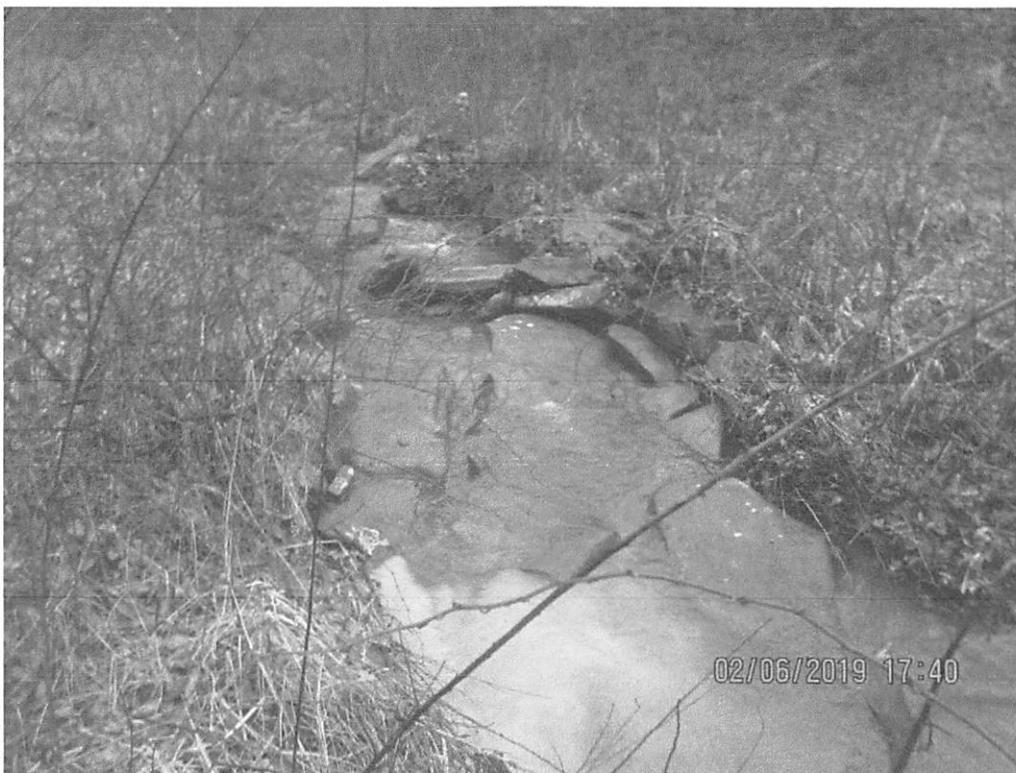
SLW entering UNT of Brammer Branch. Stream clear above this location.

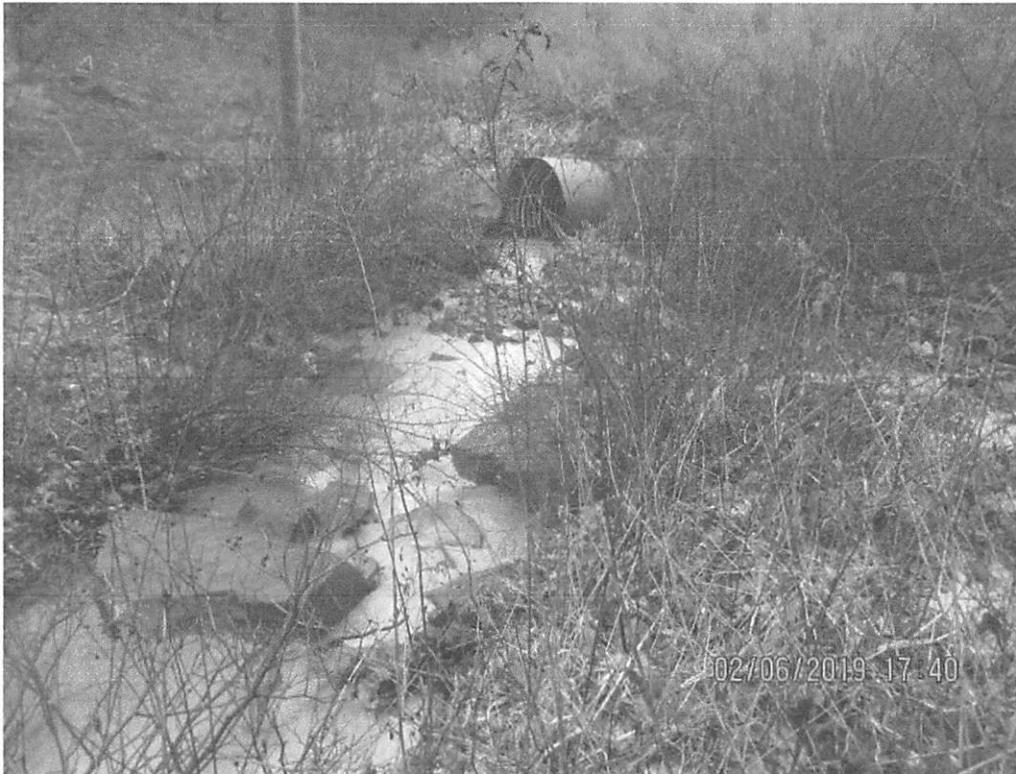
SLW entering UNT of Brammer Branch.

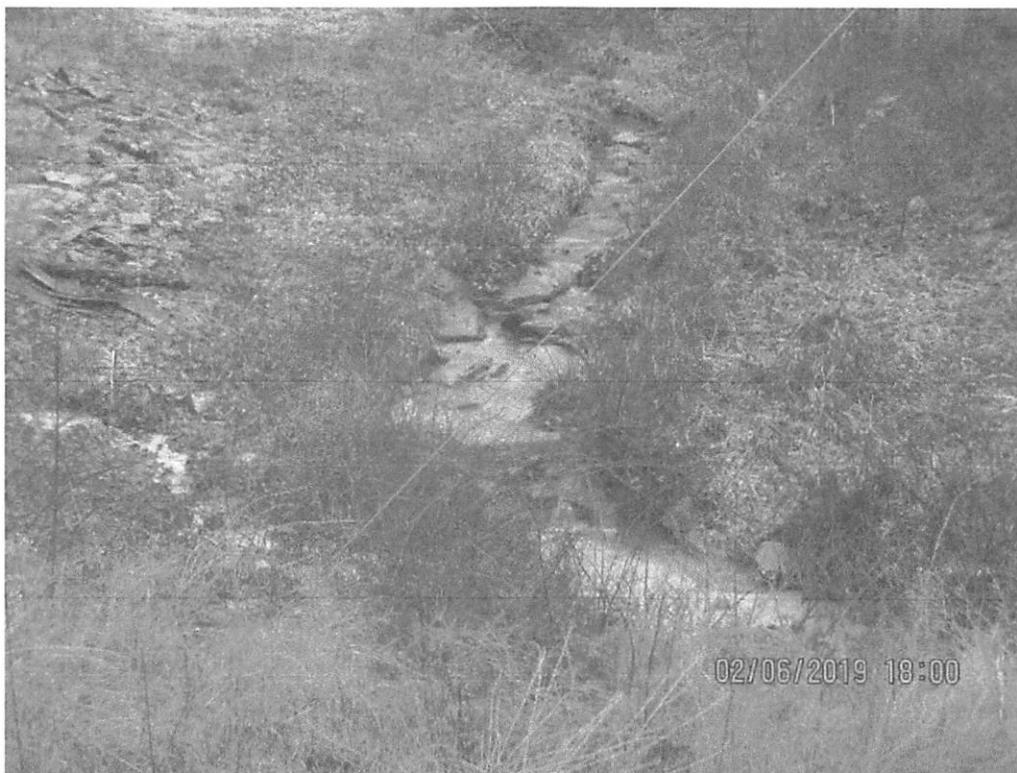
Facing Southeast toward UNT of Brammer Branch. SLW flowing from controls and into creek.

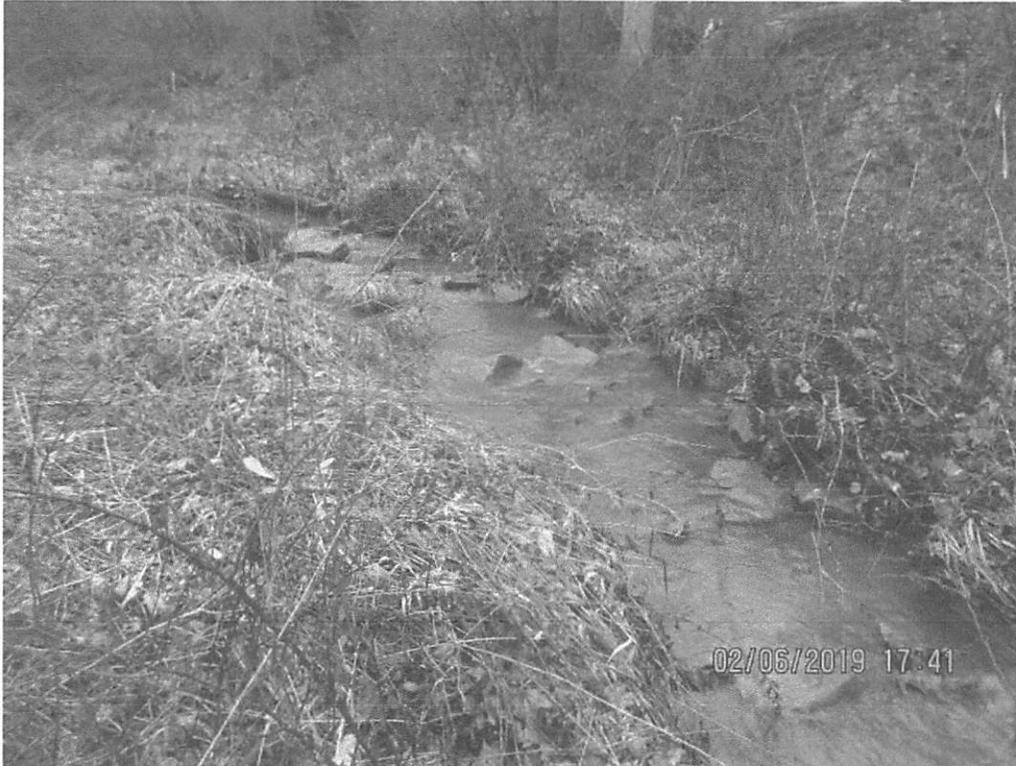
UNT of Brammer Branch above location that SLW was entering creek.

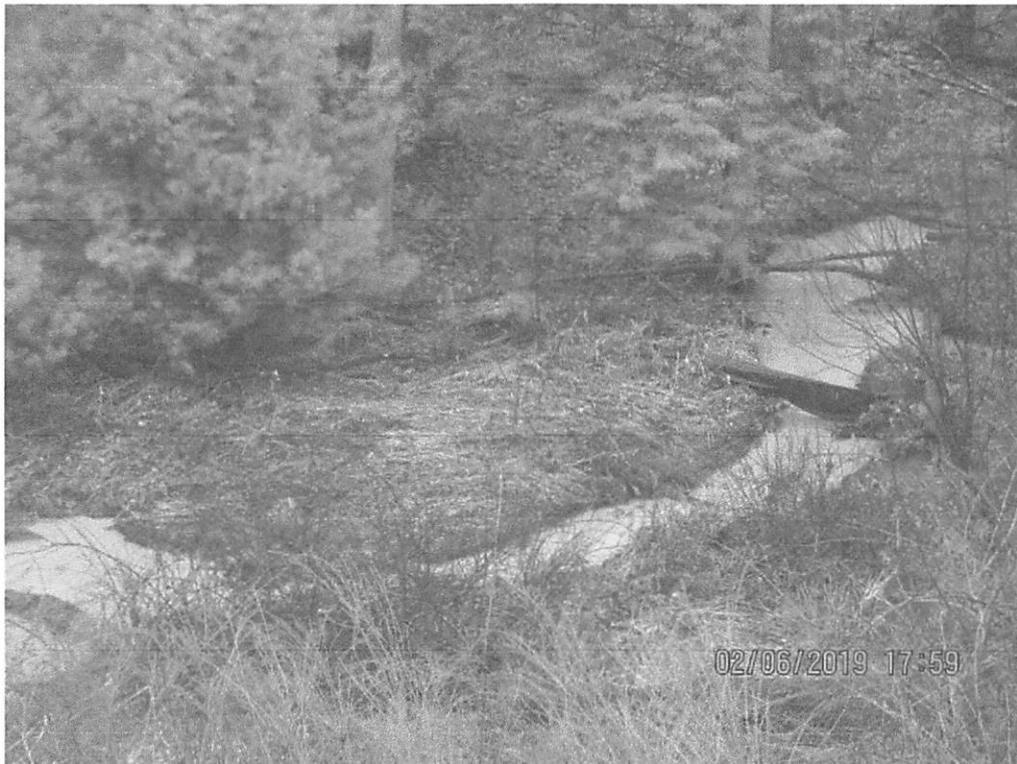
UNT of Brammer Branch downstream of culvert that conveys under MVP construction yard entrance.

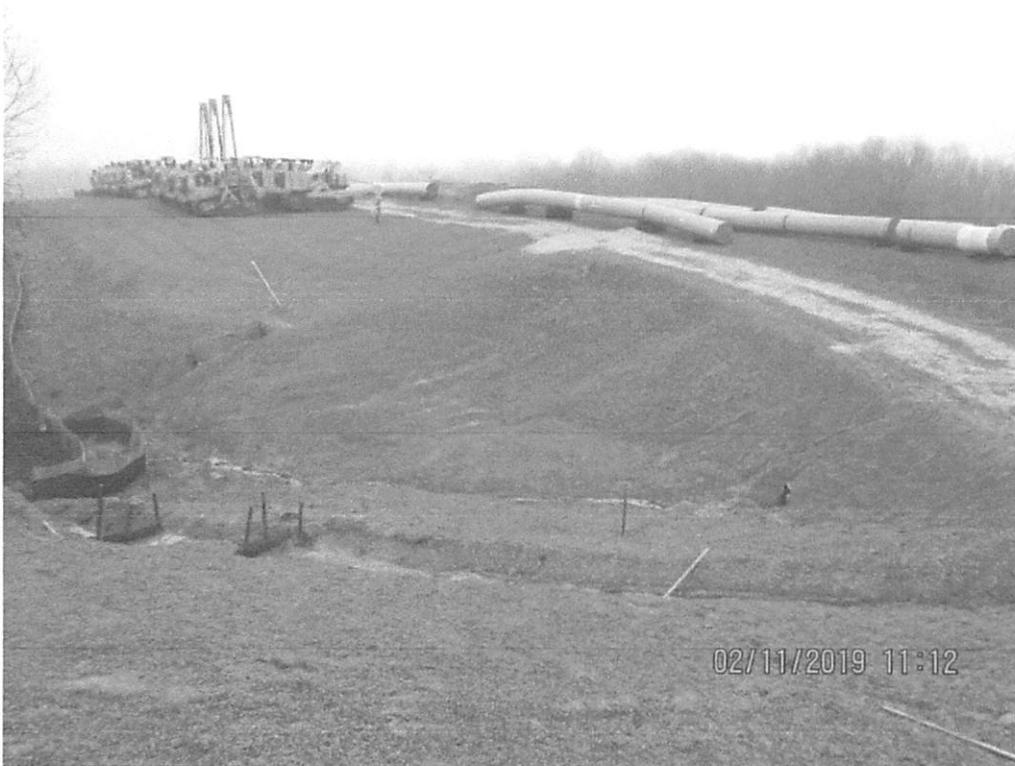
MVP ROW facing North at Rt 55 crossing at station 6017+50

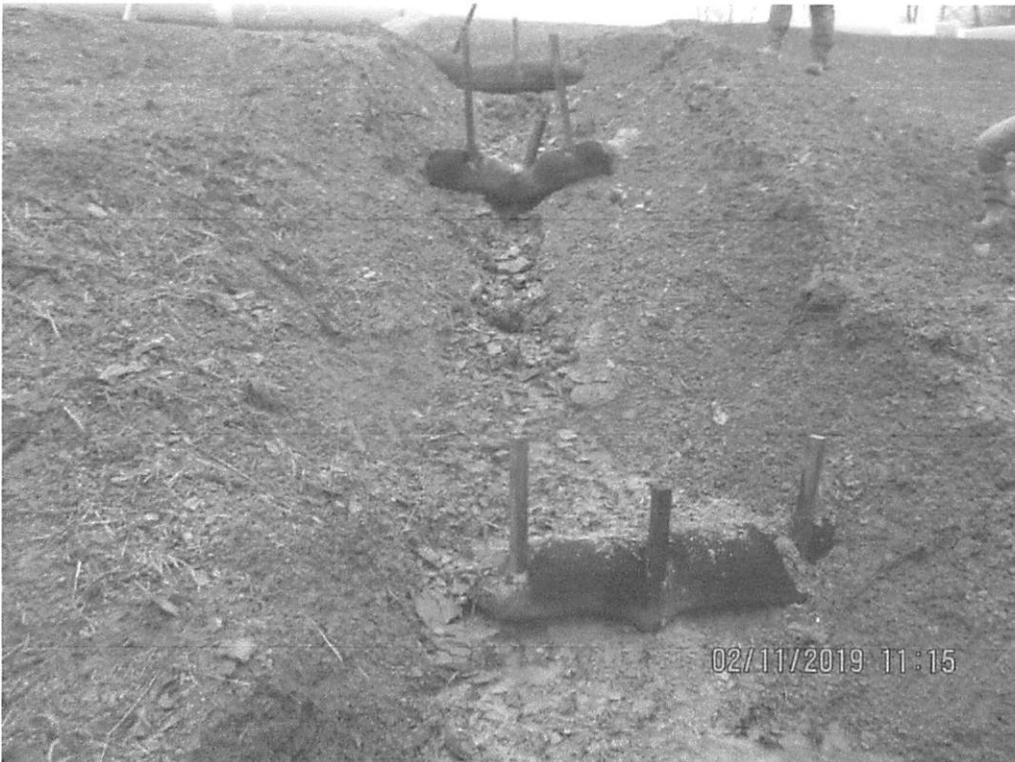
Waterbar on steep slope leading to outlet near station 6017+50

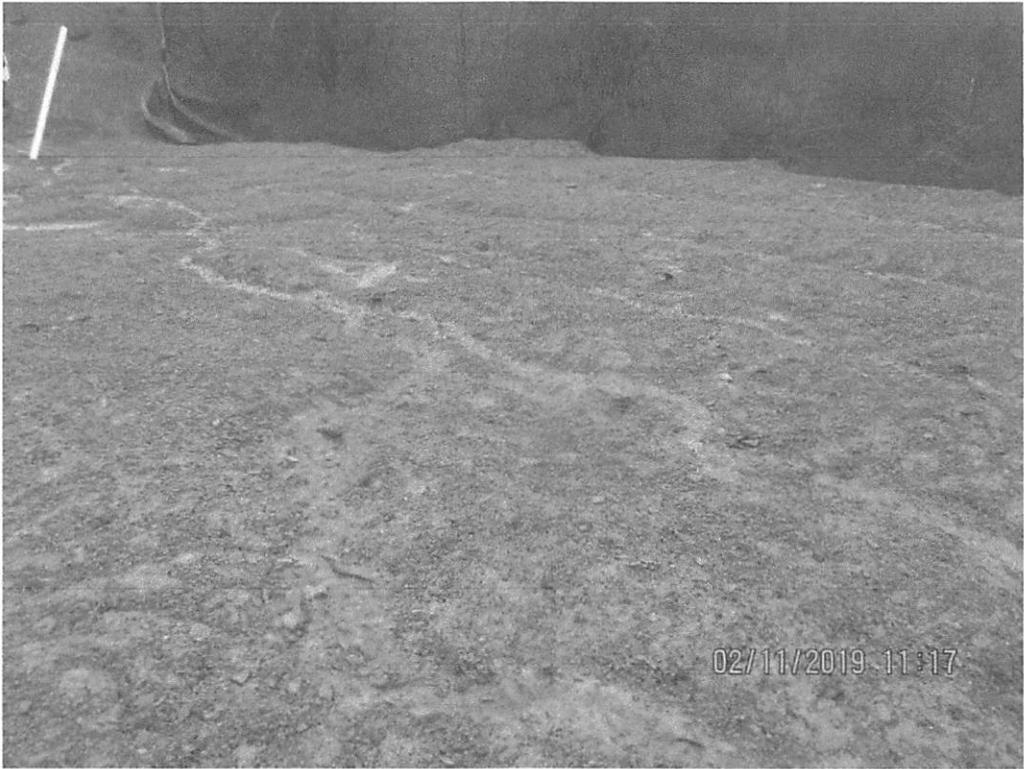
North side of slope leading to outlet near station 6017+50

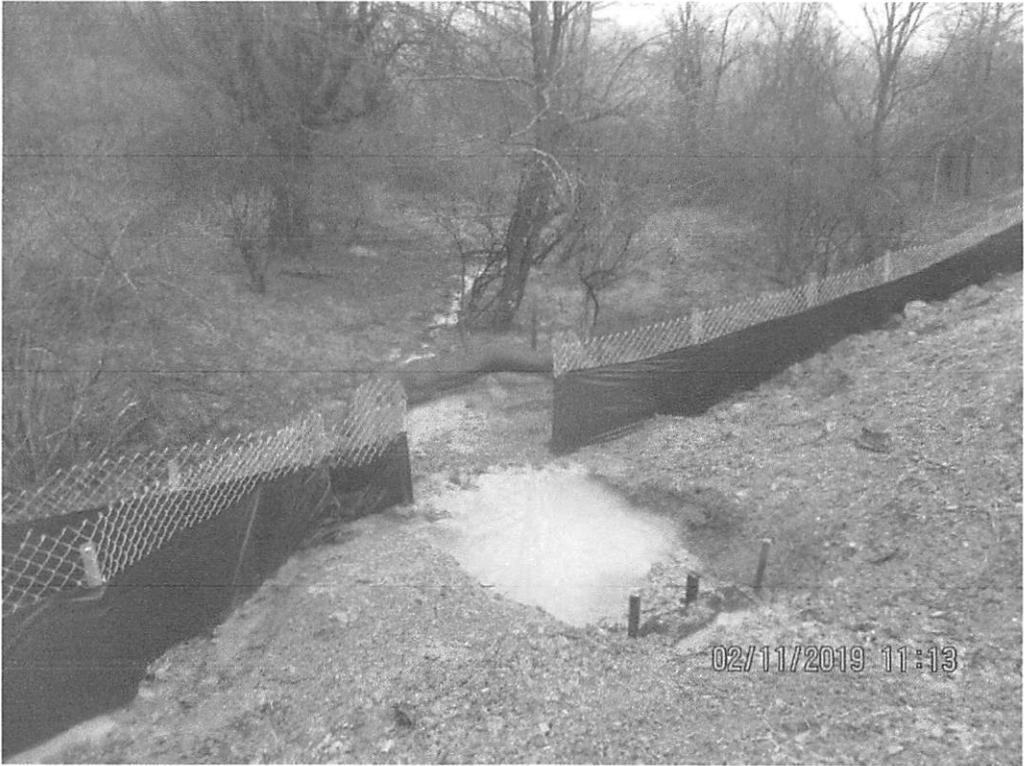
Outlet along perimeter control near station 6017+50

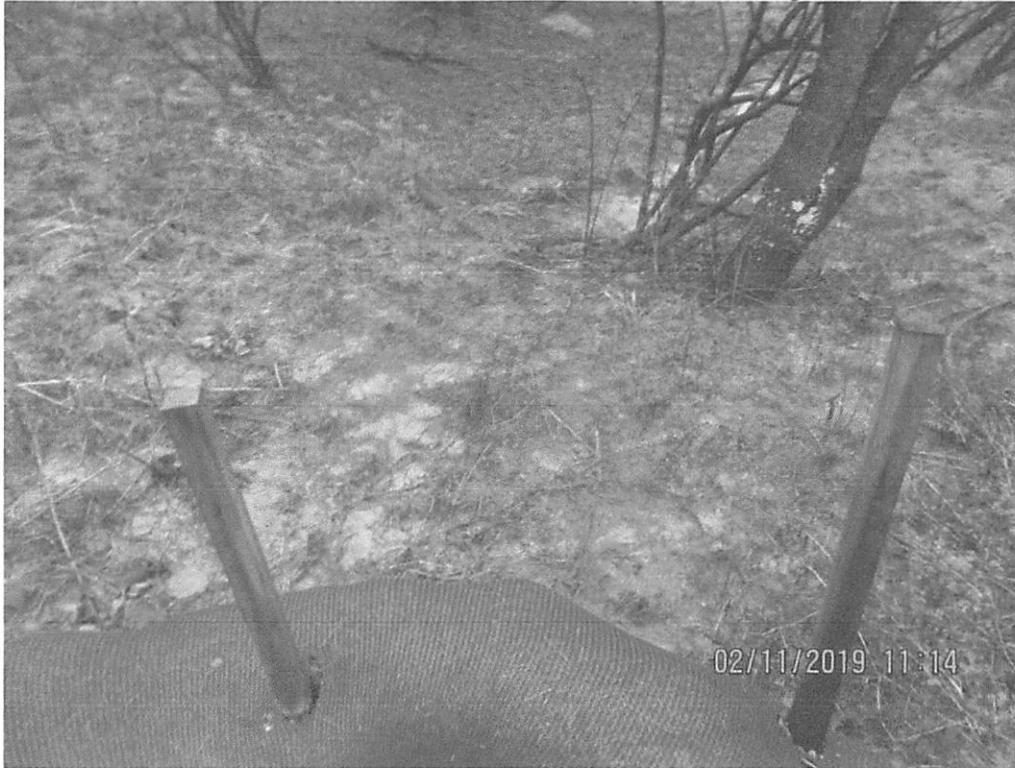
Evidence of sediment being deposited past LOD near station 6017+50

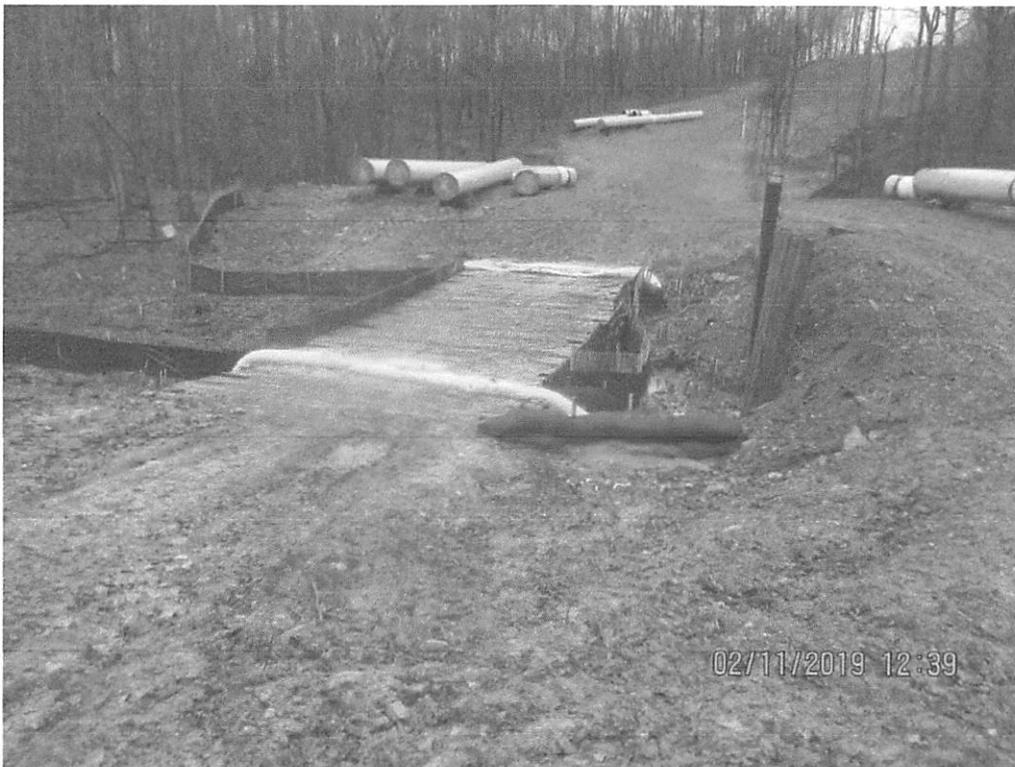
Wetland W-IJ-55 crossing at station 5960+50

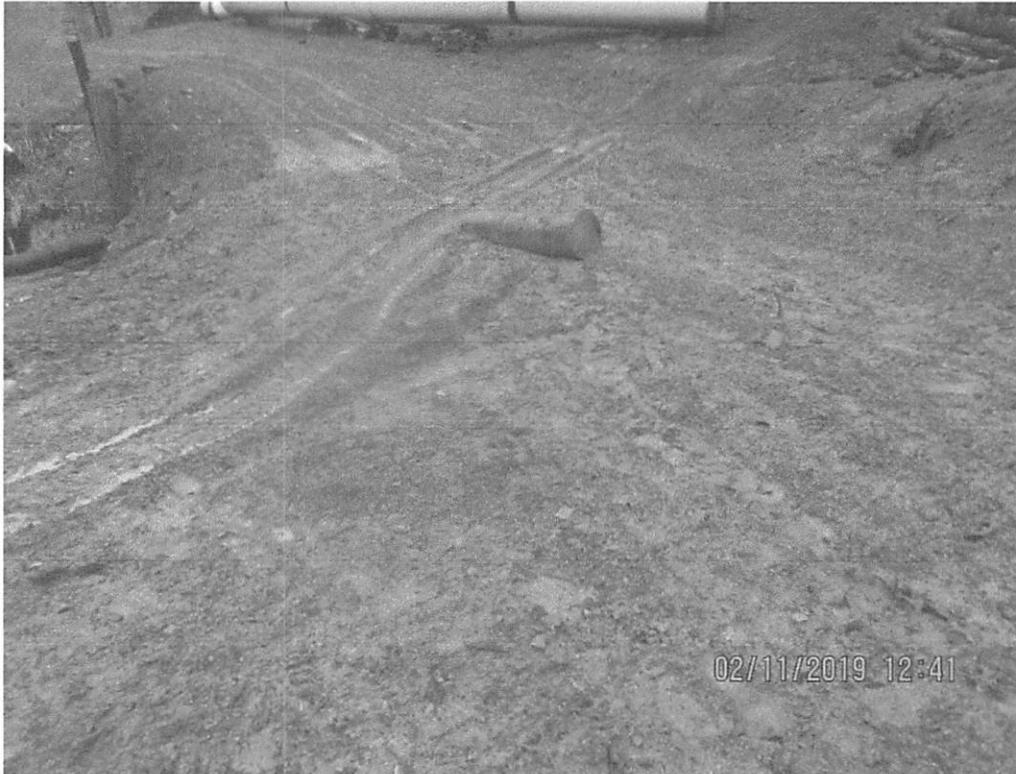
Disturbed slope upslope of Wetland Crossing W-IJ-55

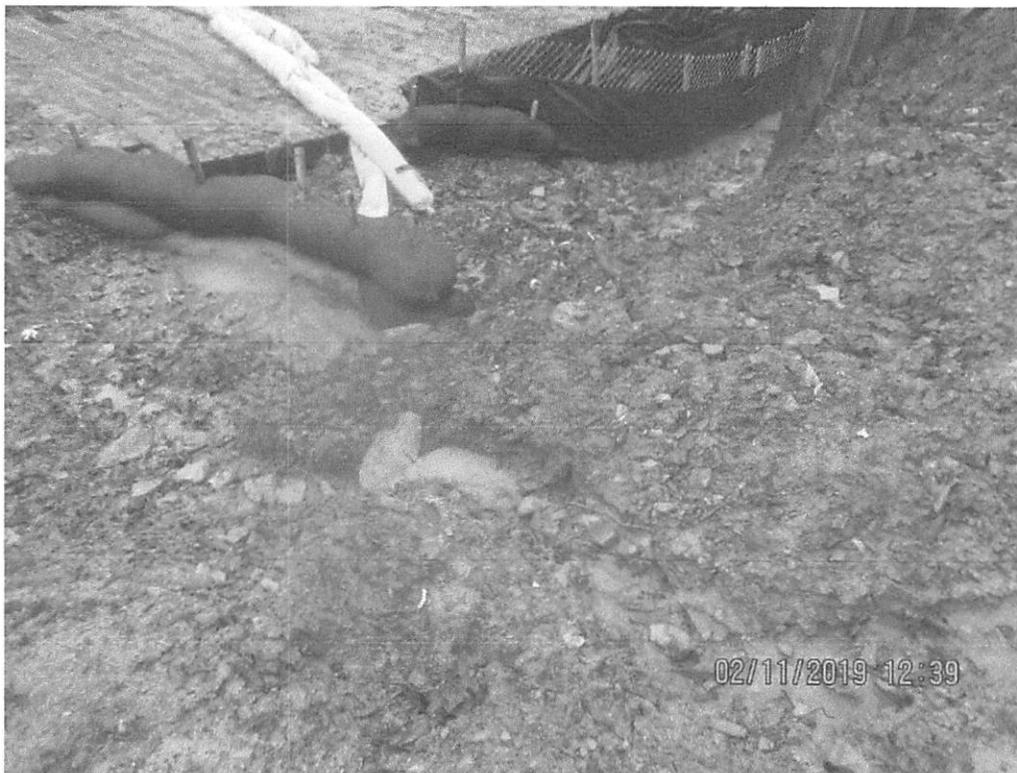
Erosion occurring due to runoff from ROW and being diverted to Wetland W-IJ-55

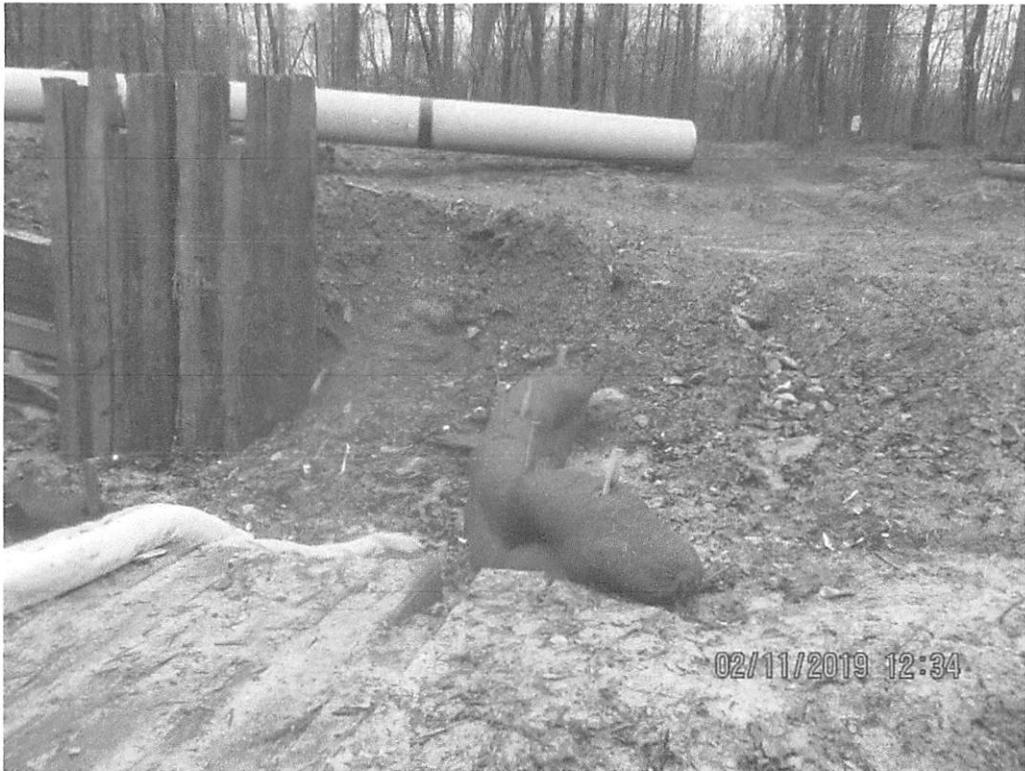
Facing upslope above wetland W-IJ-55

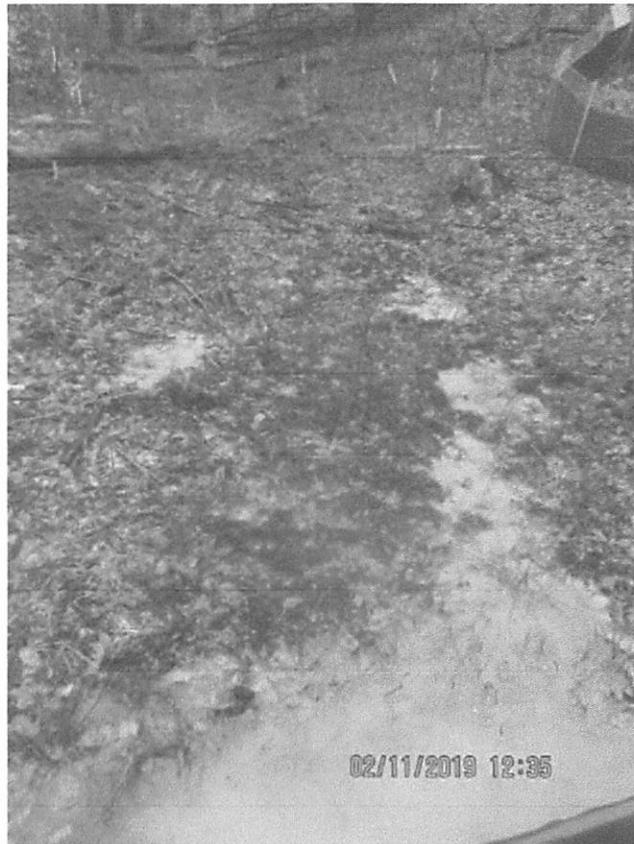
SLW in Wetland W-IJ-55 migrating toward LOD
