**CONSENT ORDER
ISSUED UNDER THE
WATER POLLUTION CONTROL ACT
WEST VIRGINIA CODE, CHAPTER 22, ARTICLE 11**

TO: Mountain Valley Pipeline, LLC
Robert J. Cooper
2200 Energy Drive
Canonsburg, PA 15317

DATE: December 17, 2020

ORDER NO.: 9925

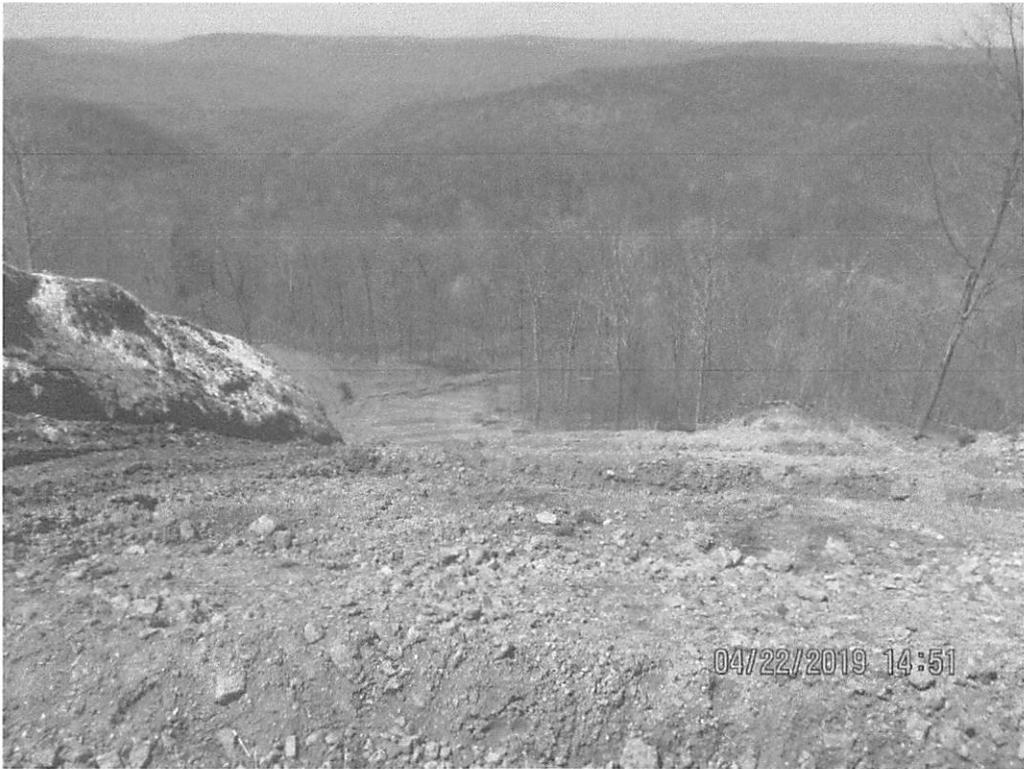
Steep slope above Lick creek crossing facing North above station 8633+71 and Stream S-T35(A).

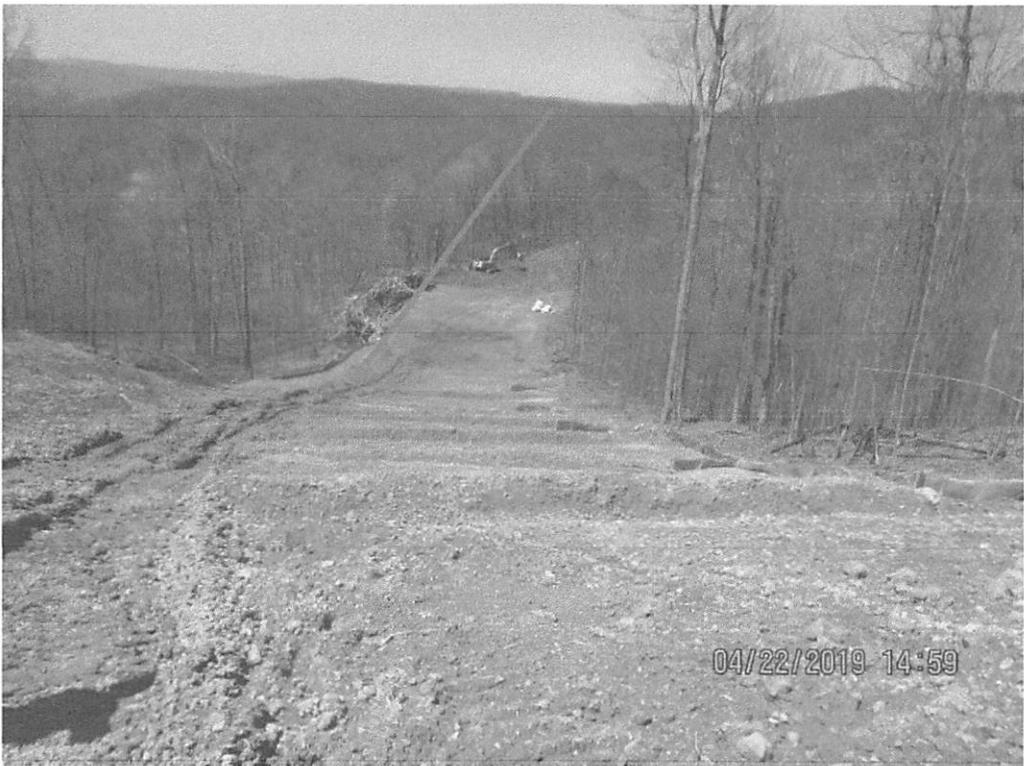
above station 8633+71. Arrow depicts where waterbar conveyed sediment into Stream S-T35(A).

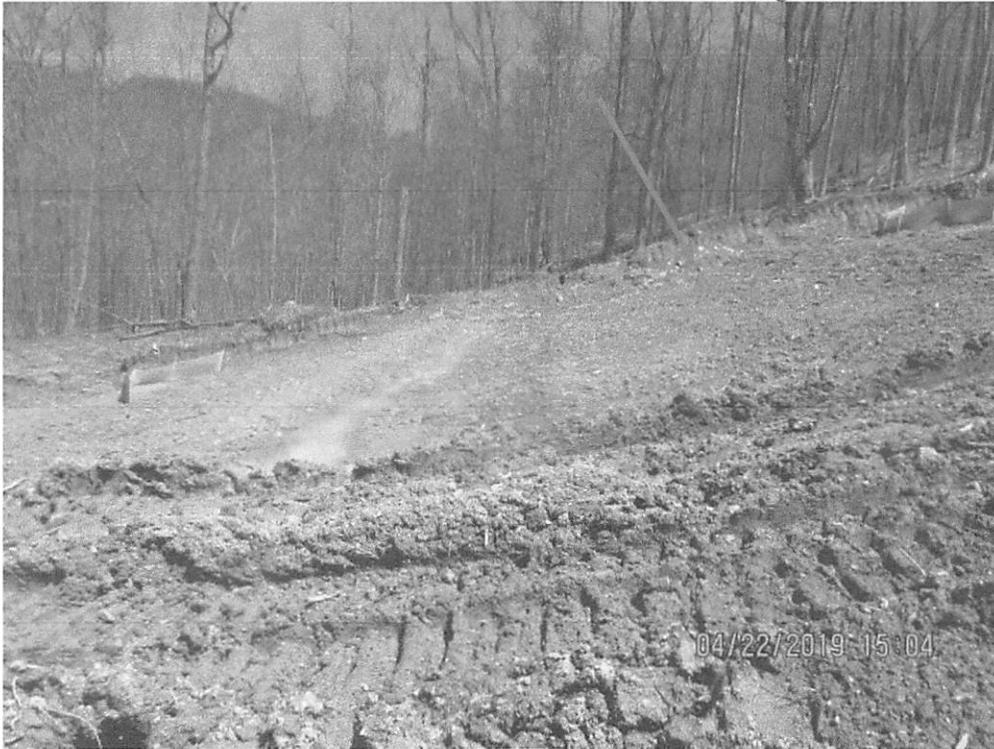
Facing toward cut slope and where waterbars terminated onto ROW. Arrow depicts where waterbars were terminating into cut slope at Station 8633+71.

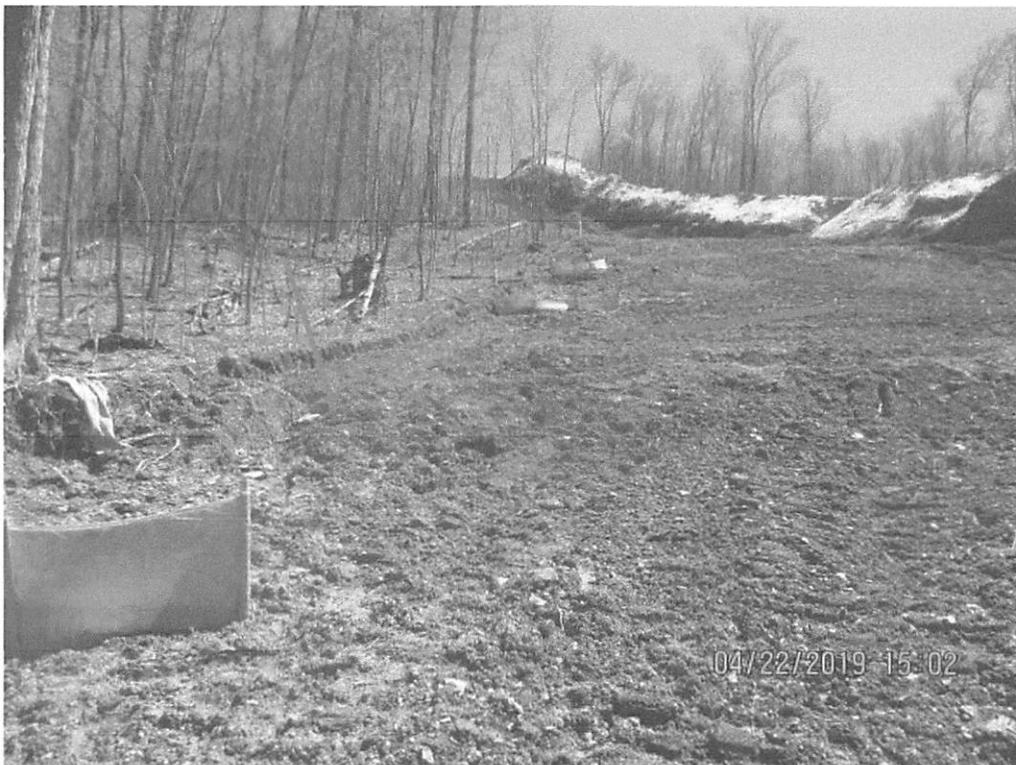
Facing upslope at station 8633+71. Arrow depicts where erosion is occurring between waterbars.

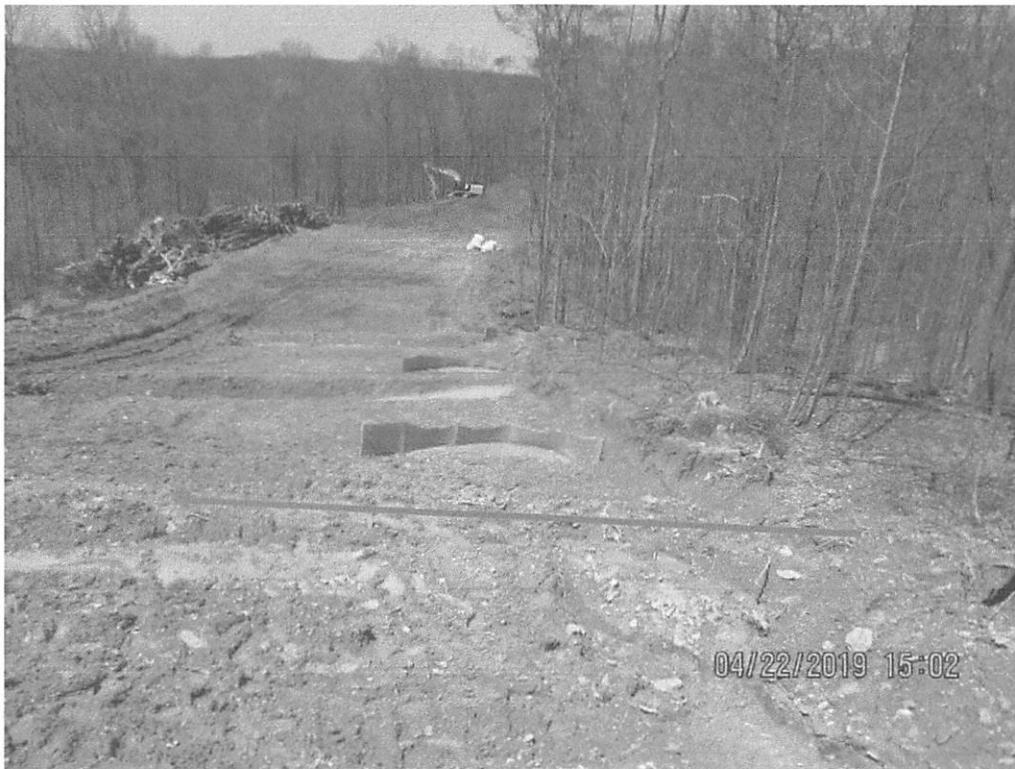
Waterbars terminating onto ROW at station 8633+71 facing North/Downslope. Arrow depicts waterbar overwhelmed with sediment that impacted stream S-T35(A).

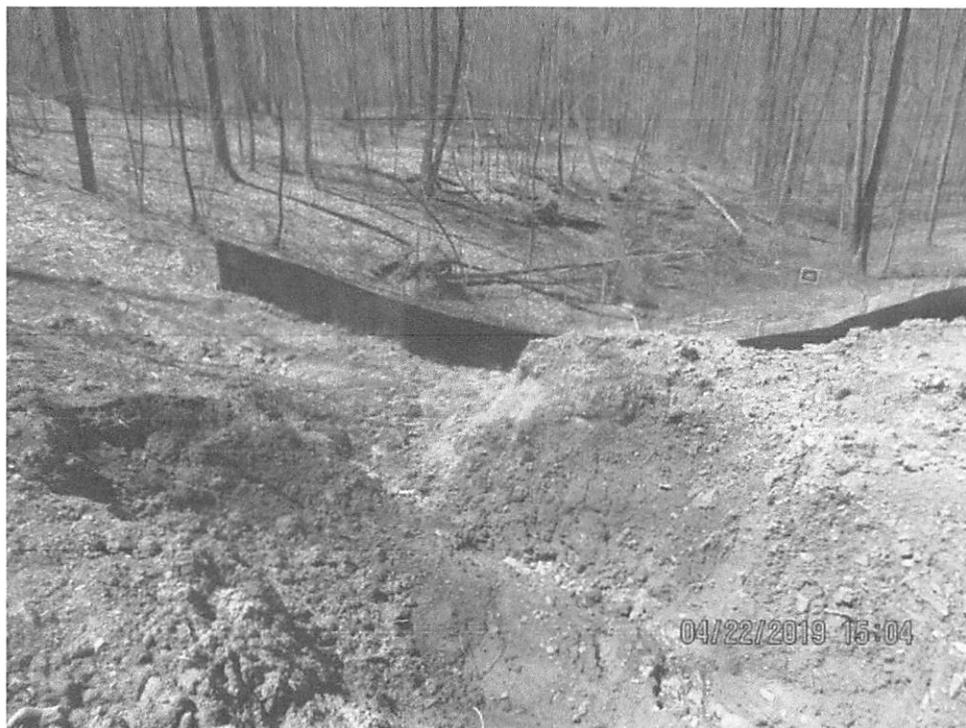
Stream S-T35(A) facing downslope waterbar terminus at Station 8633+71. Waterbar appeared to be directed toward stream. Controls were buried in sediment where erosion was present. Super silt fence was added after clean-up occurred. Sediment deposits were present in stream.

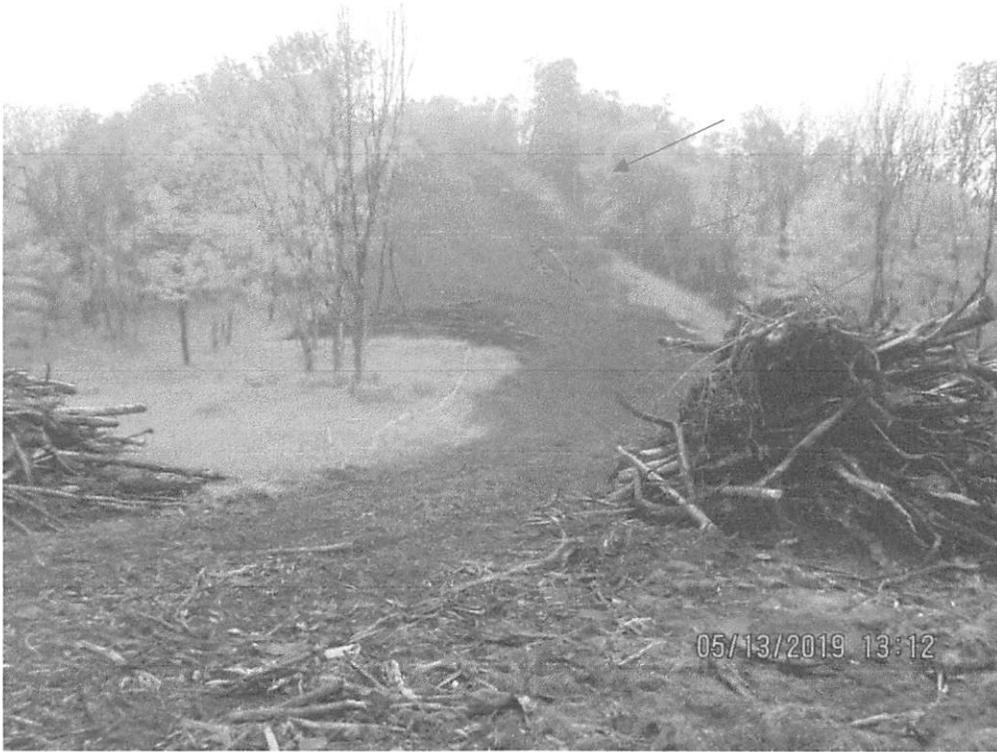
Facing upslope near station 8399+10. Arrows depict waterbar outlets.

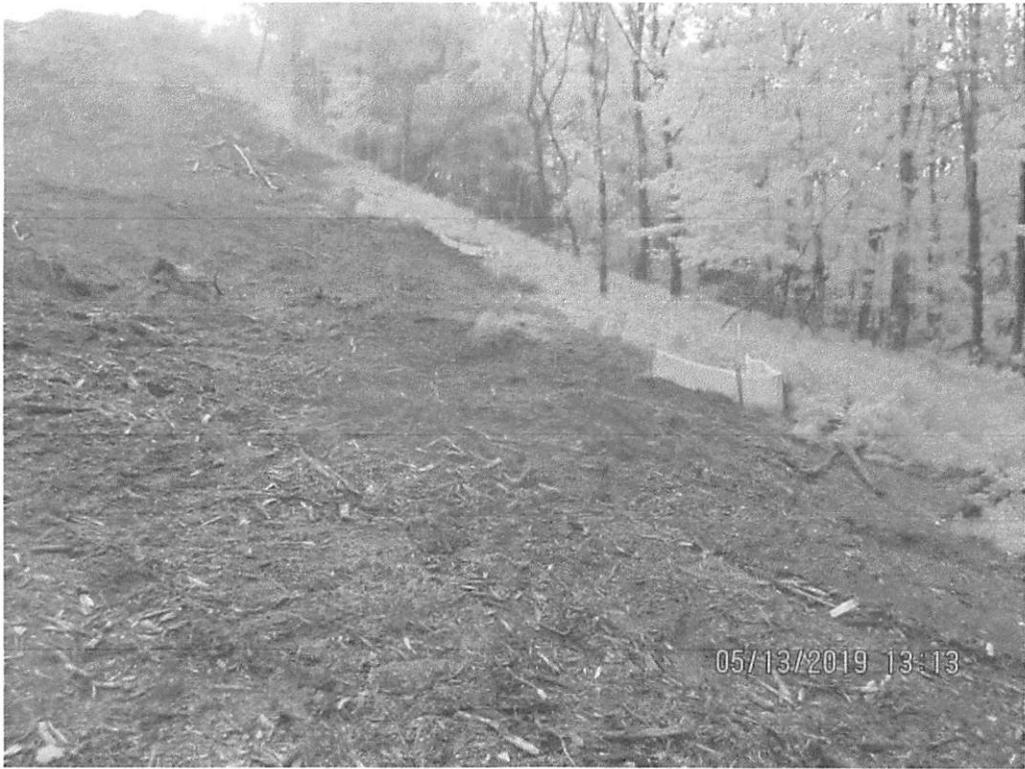
Facing upslope near station 8399+10.

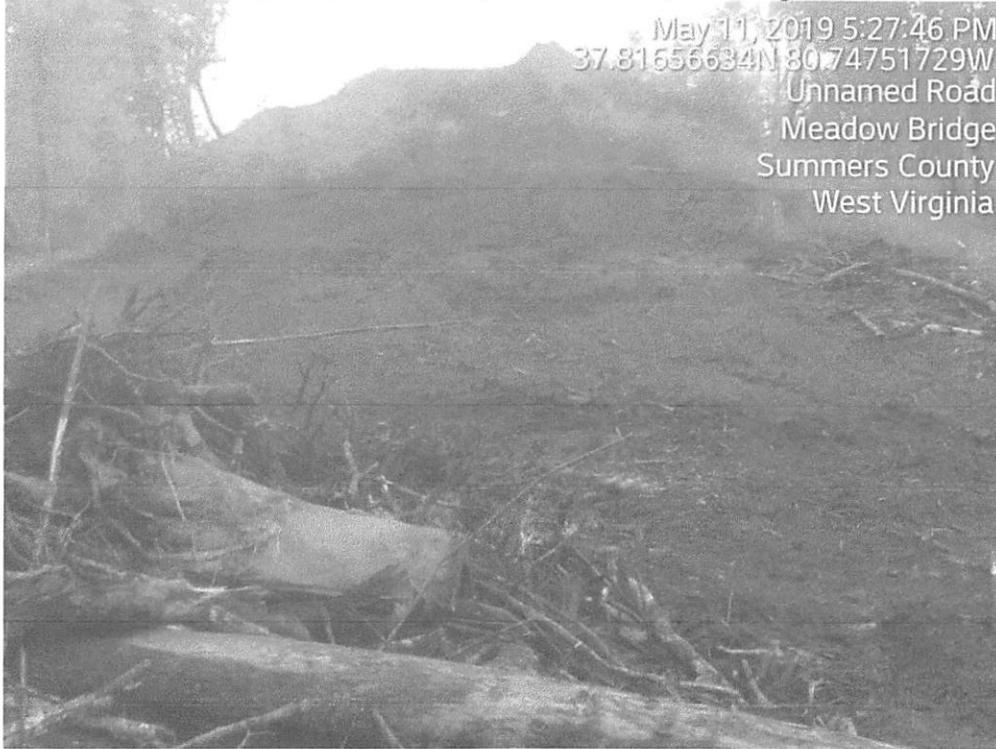
Steep slope near station 8399+10 depicting no controls in place

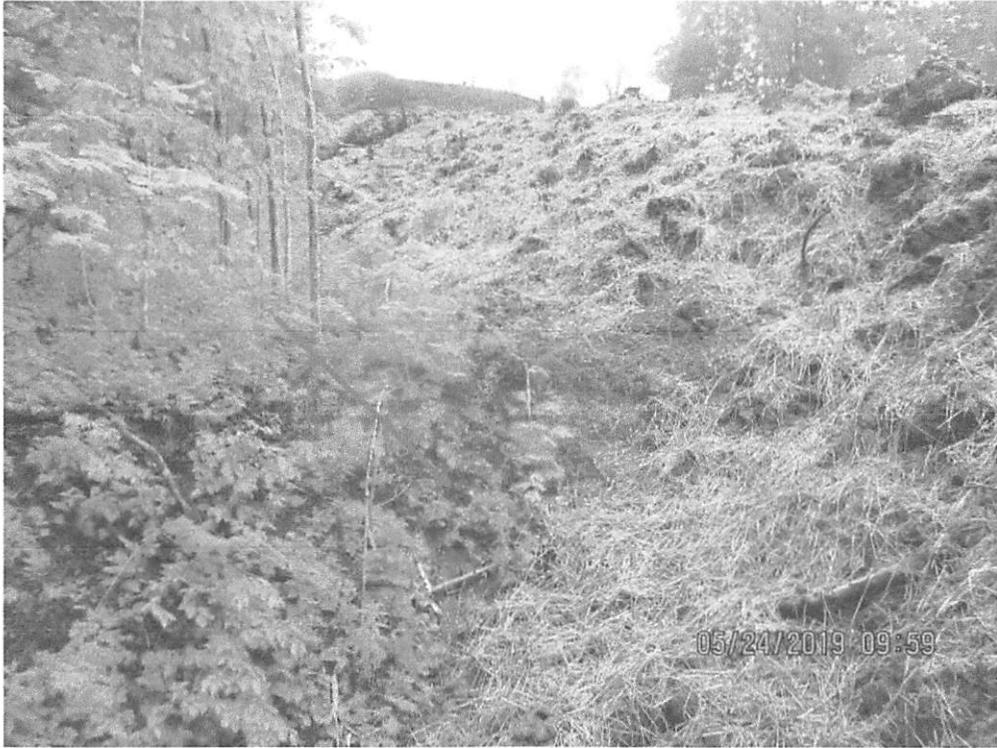
Topsoil pile near station 8387+96 facing South at MVP ROW LOD. Arrow depicts LOD.

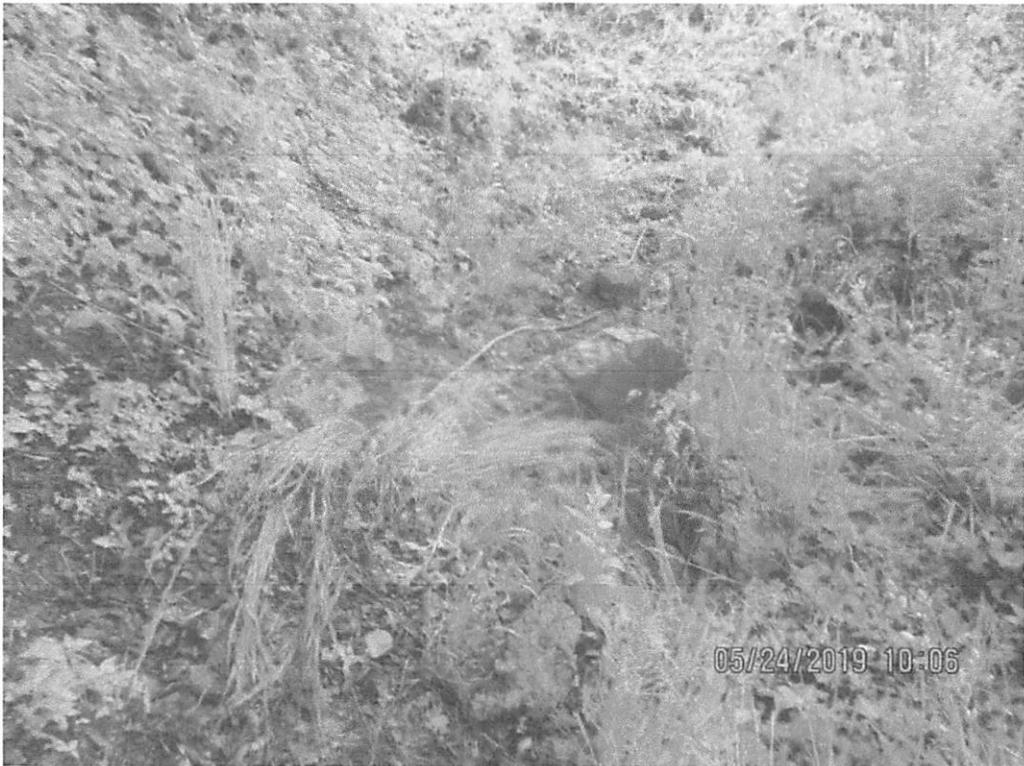
Facing toward MVP LOD near station 8387+96. Material had slipped from pile off ROW past LOD. No perimeter controls in place.

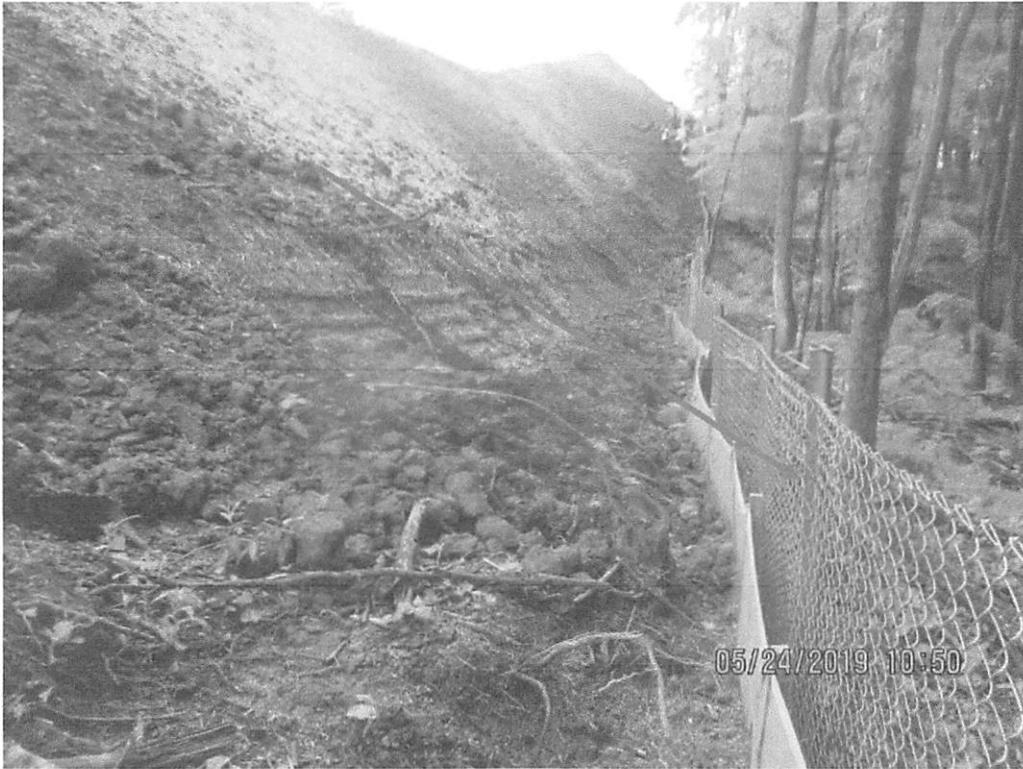
Near station 8419+00 facing South. Arrow depicts where material has slipped into P1 silt fence.

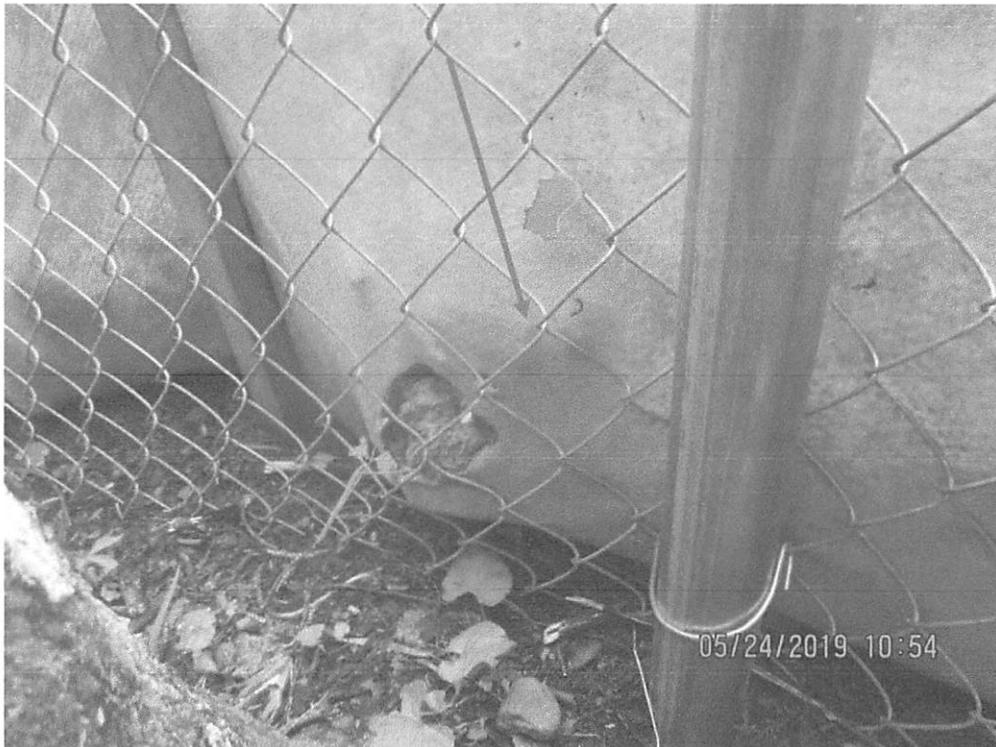
Near station 8410+00. Hole in P1 silt fence due to material slipping into controls.

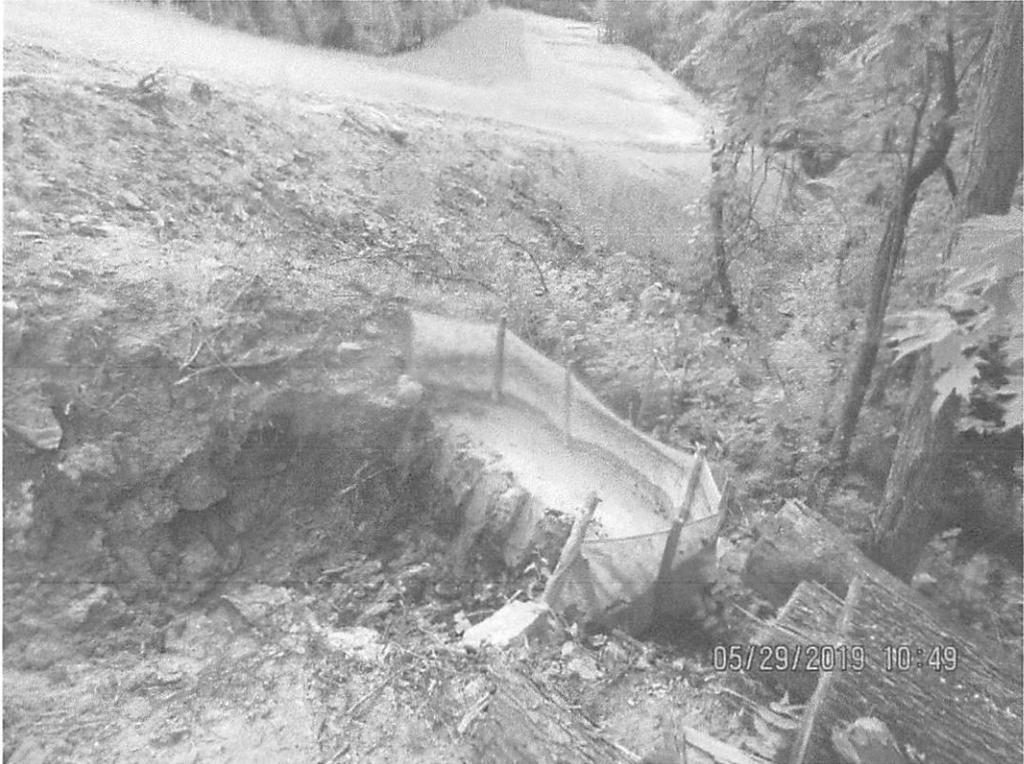
Waterbar outlet above fill slope at station 4031+00 facing downslope.

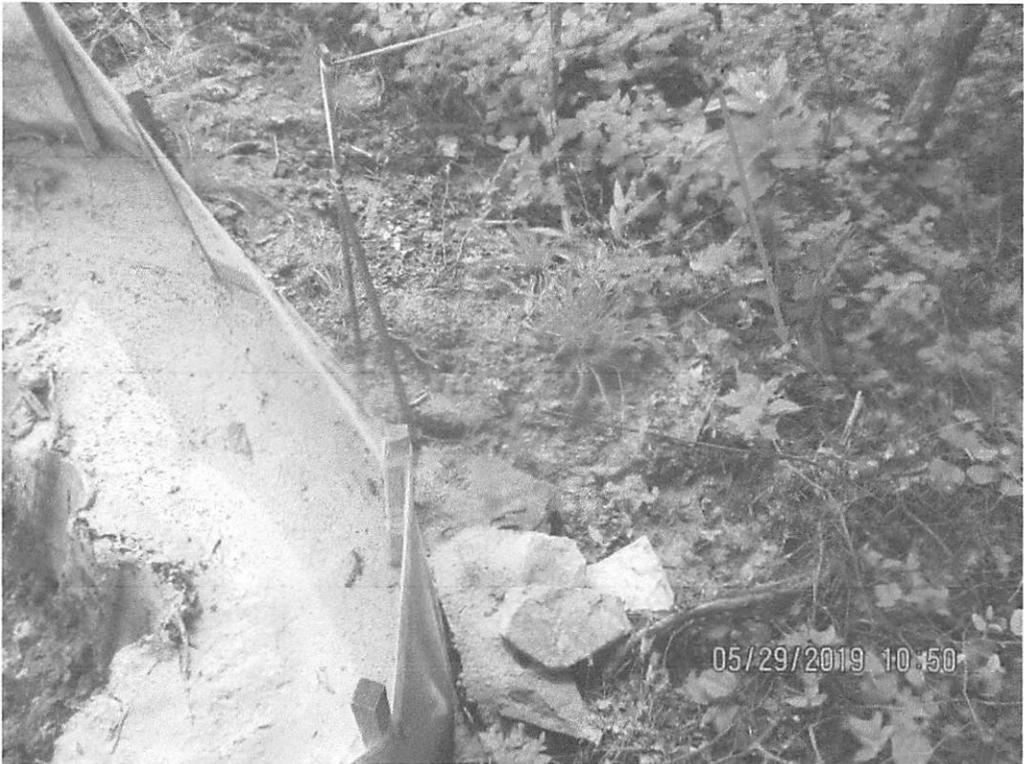
Waterbar outlet above fill slope at station 4031+00 facing downslope. Sediment deposits past LOD.

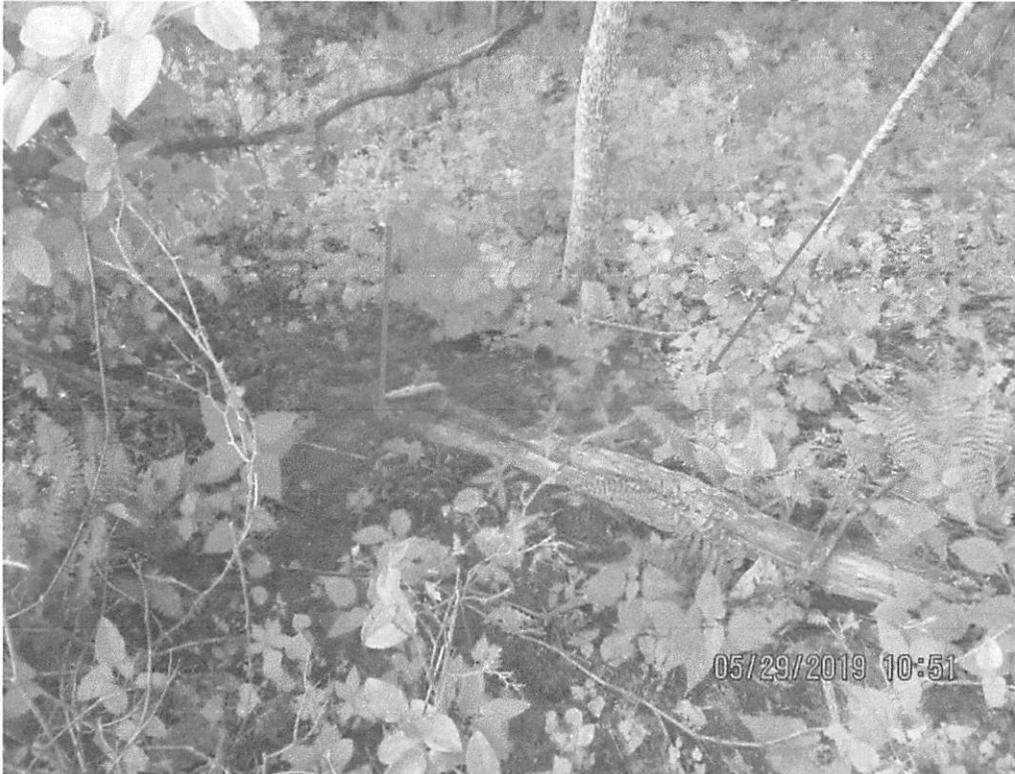
Waterbar outlet above fill slope at station 4031+00 facing downslope. Sediment deposits past LOD. Scouring from concentrated flow.

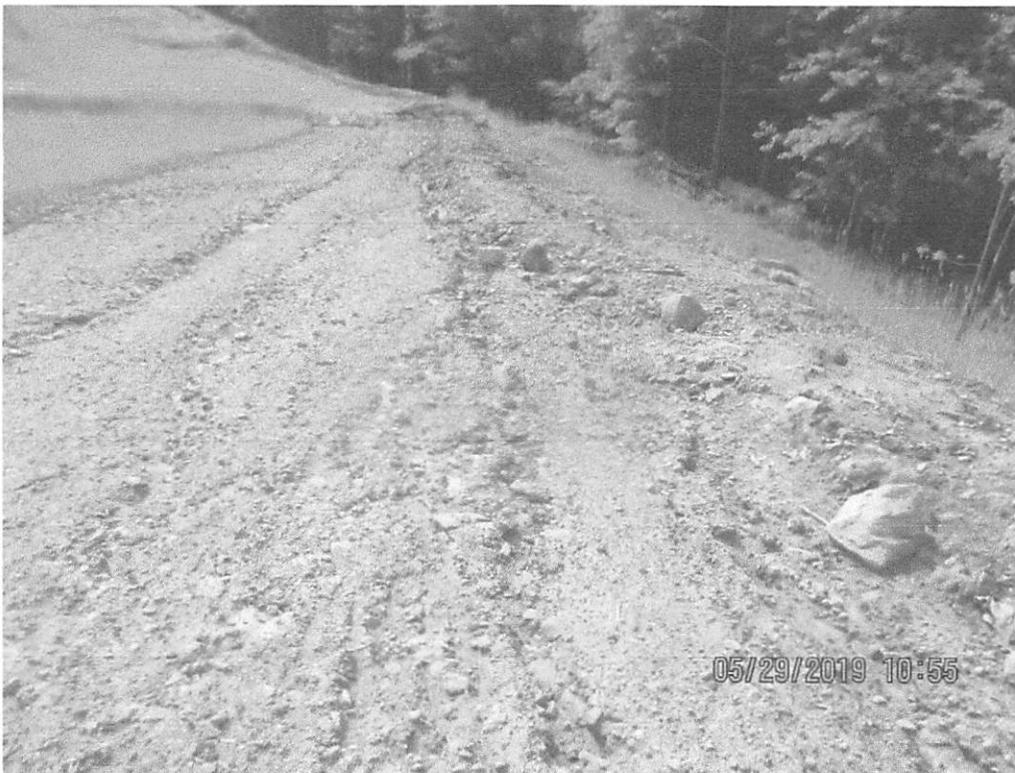
Near station 4031+00 facing downslope. Erosion on ROW where grass had not germinated in travel lane.

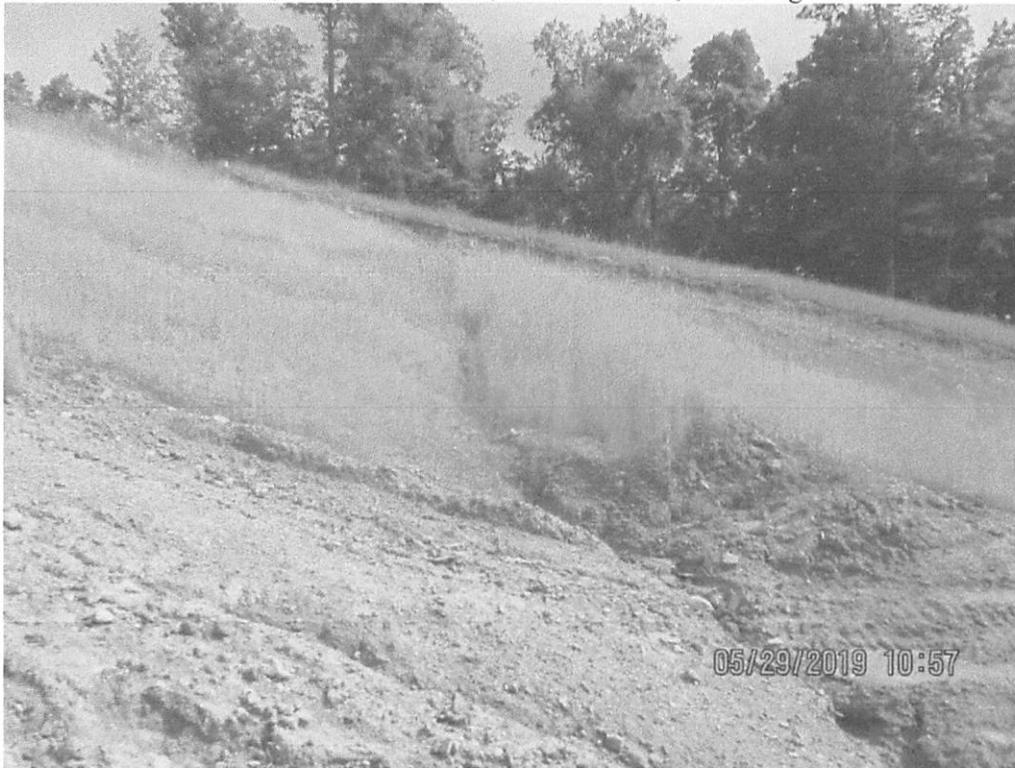
Facing toward cut in slope/ROW at station 4031+00. Waterbar had erosion.

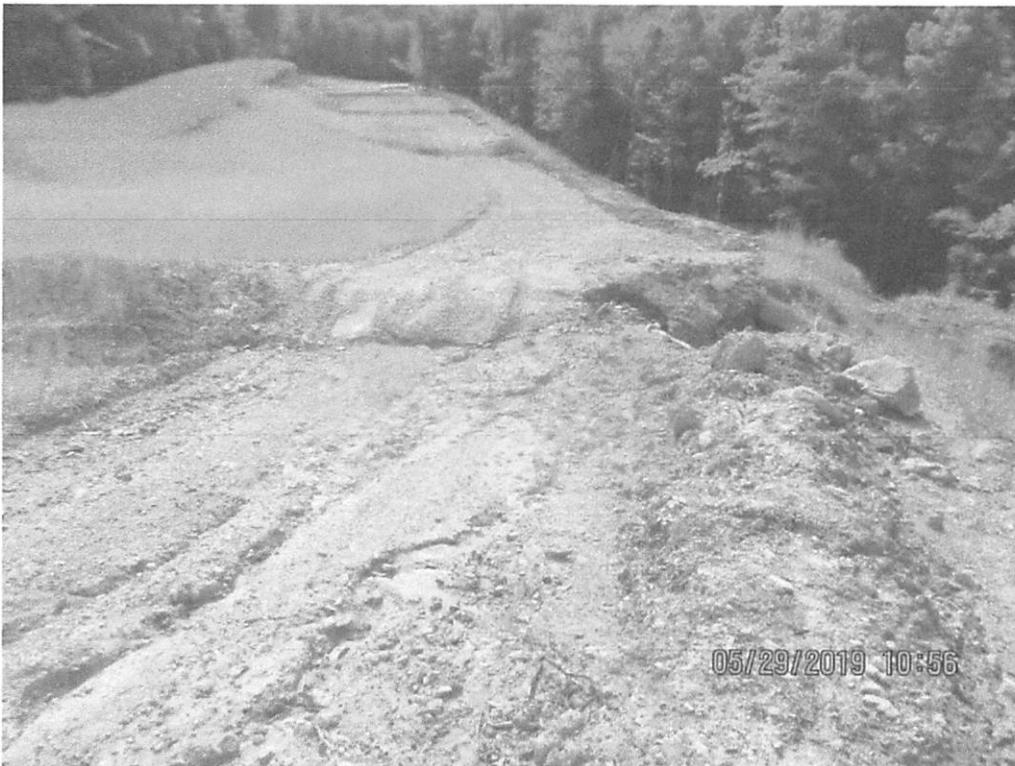
above waterbar outlet terminating onto fill slope at station 4031+00.

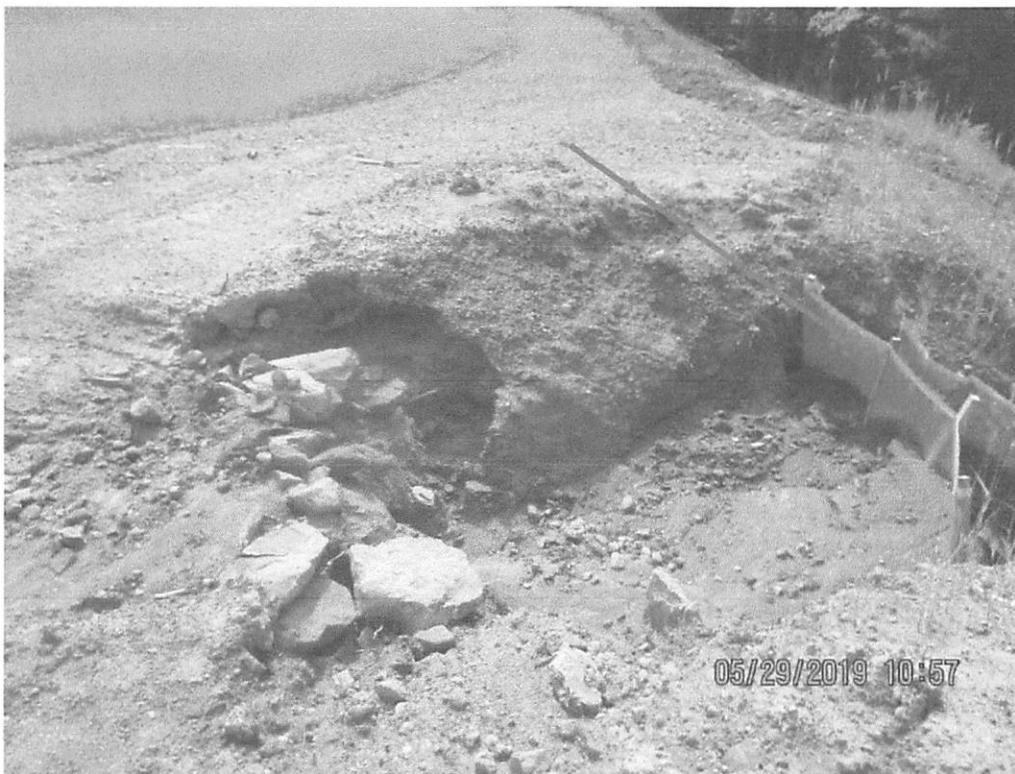
Waterbar outlet at station 4031+00. Arrow depicts where runoff was flowing around control and causing increased erosion.

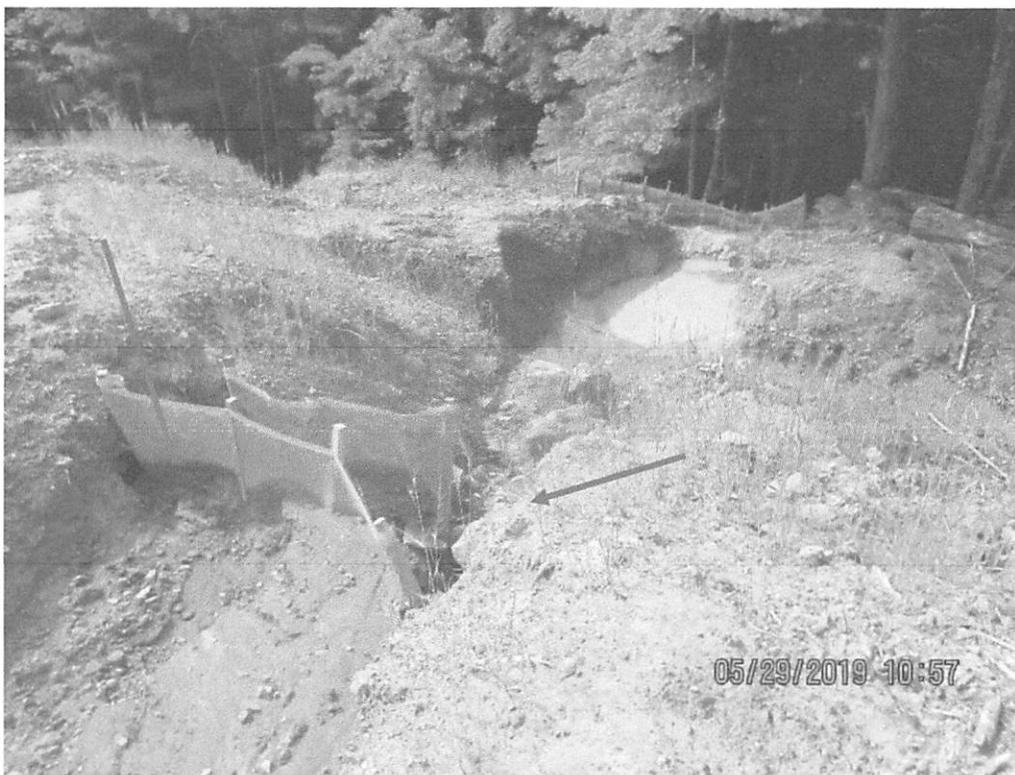
Waterbar outlet and diversion berm outlet at station 4031+00. Sediment was being deposited behind controls. Arrow depicts where runoff was flowing around controls.

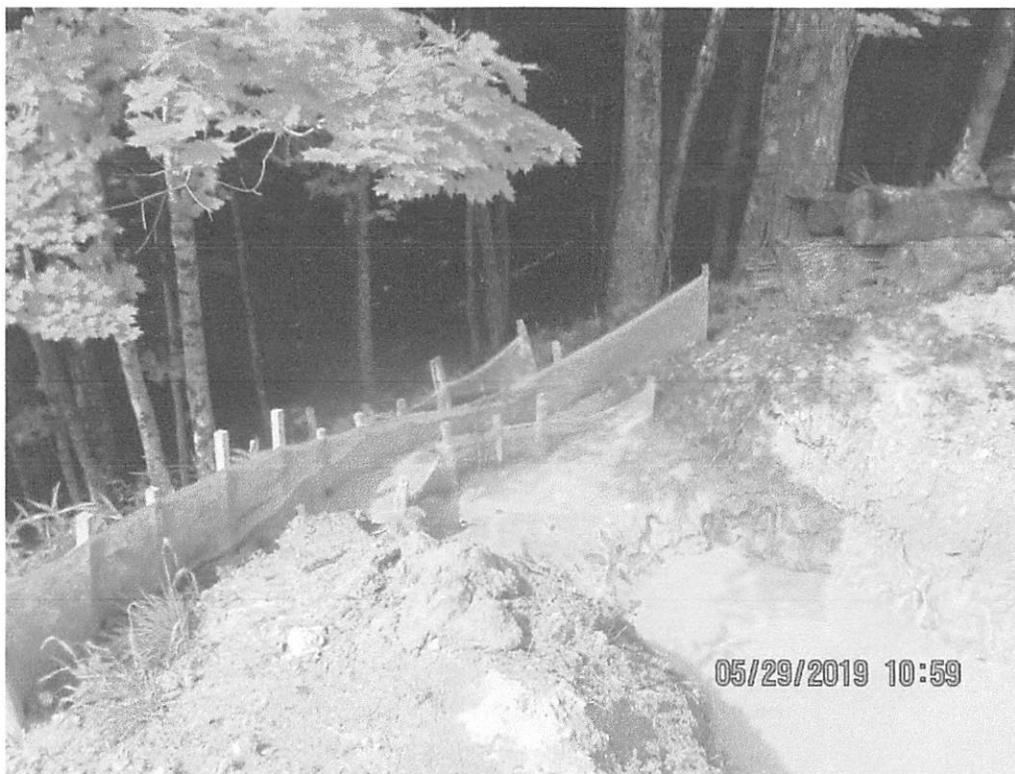
Diversion berm Outlet 1 at station 4031+00. Controls in need of maintenance.

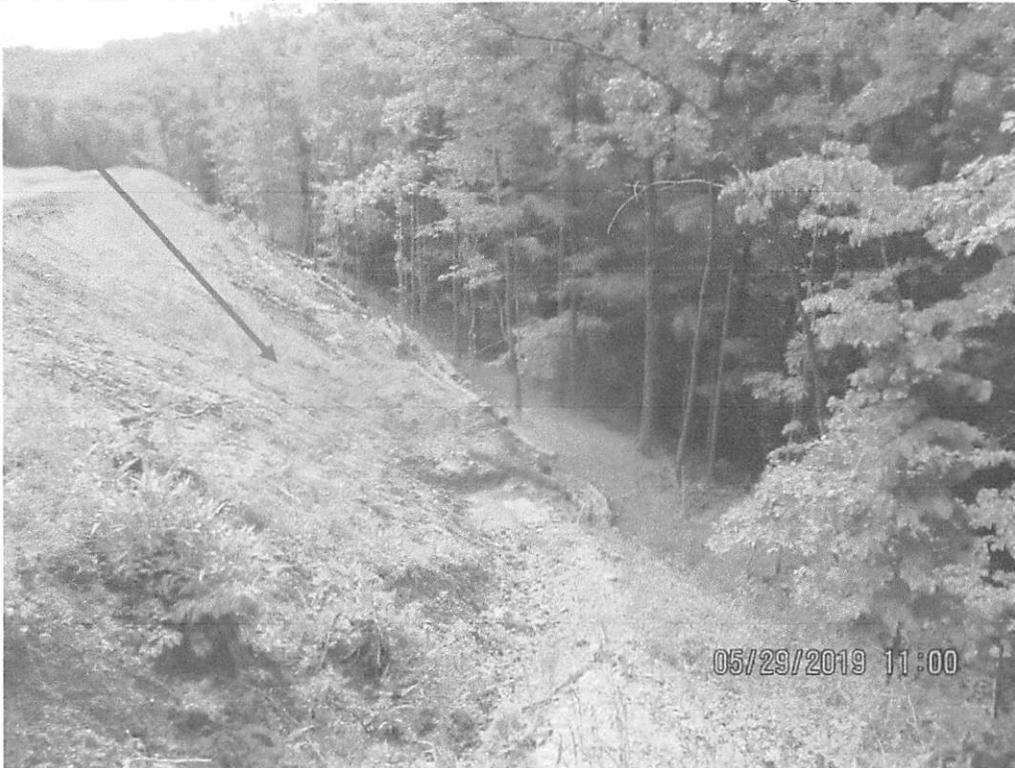
Near station 4031+00 facing downslope at diversion berm Outlet 2. Arrow depicts erosion on fill slope.

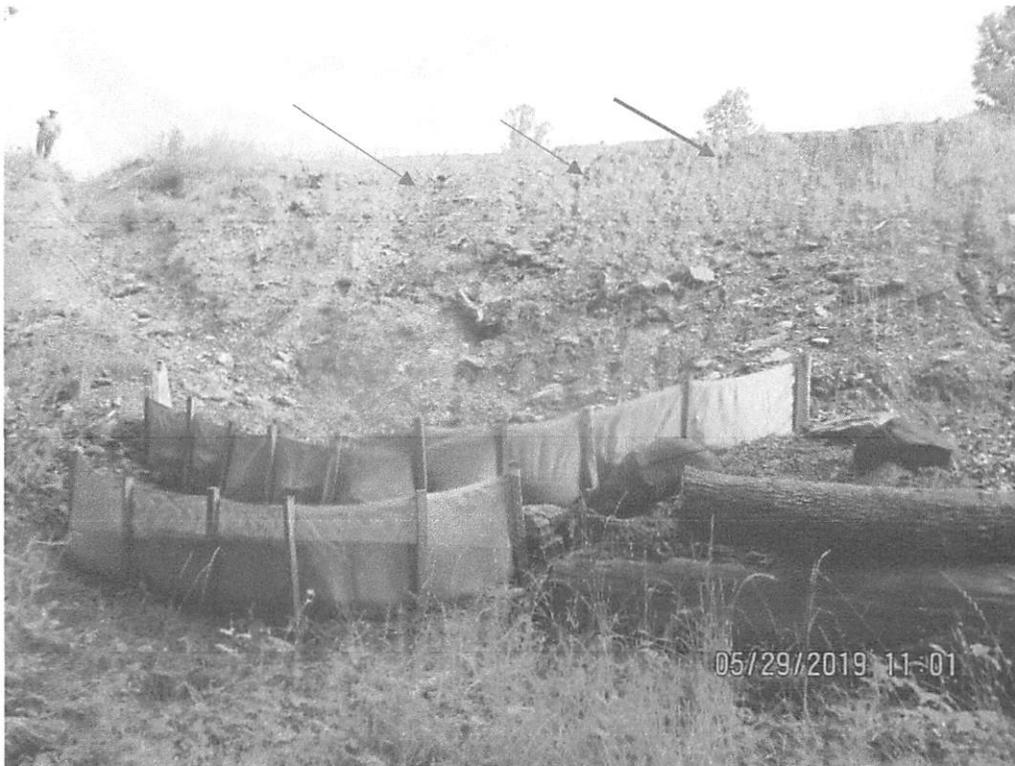
Facing upslope near station 4031+00 at diversion berm Outlet 2. Waterbar was terminating onto slope with no controls. Arrow depicts erosion on slope.

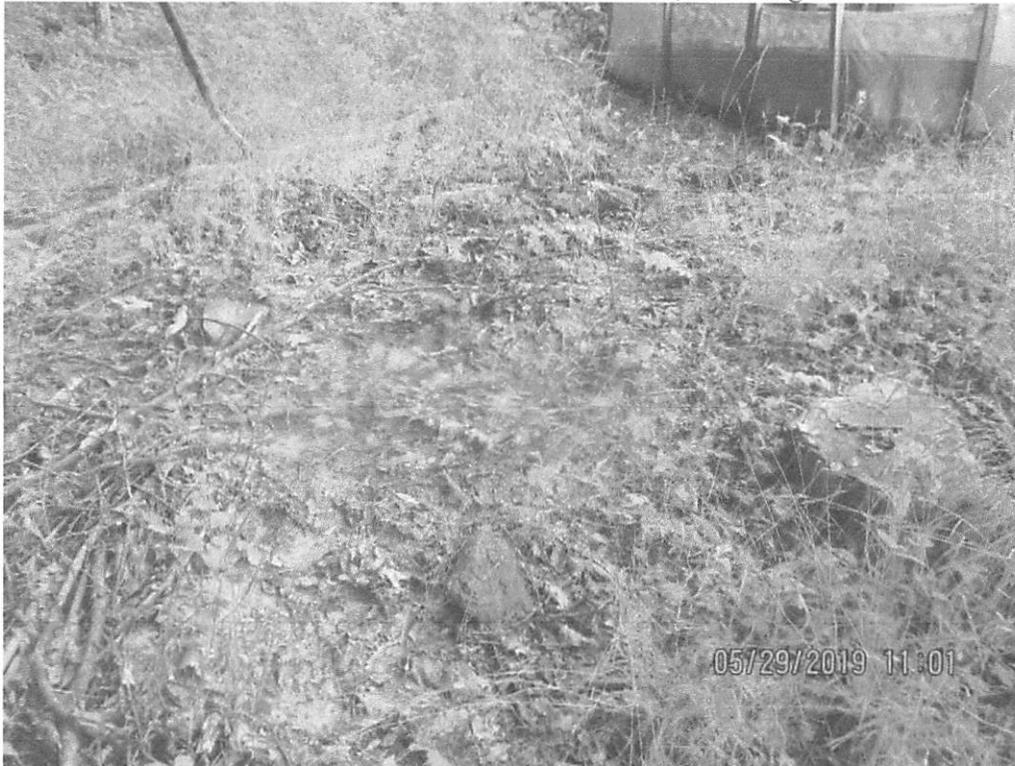
below diversion berm Outlet 2 near 4031+00. Scouring of vegetation below control.

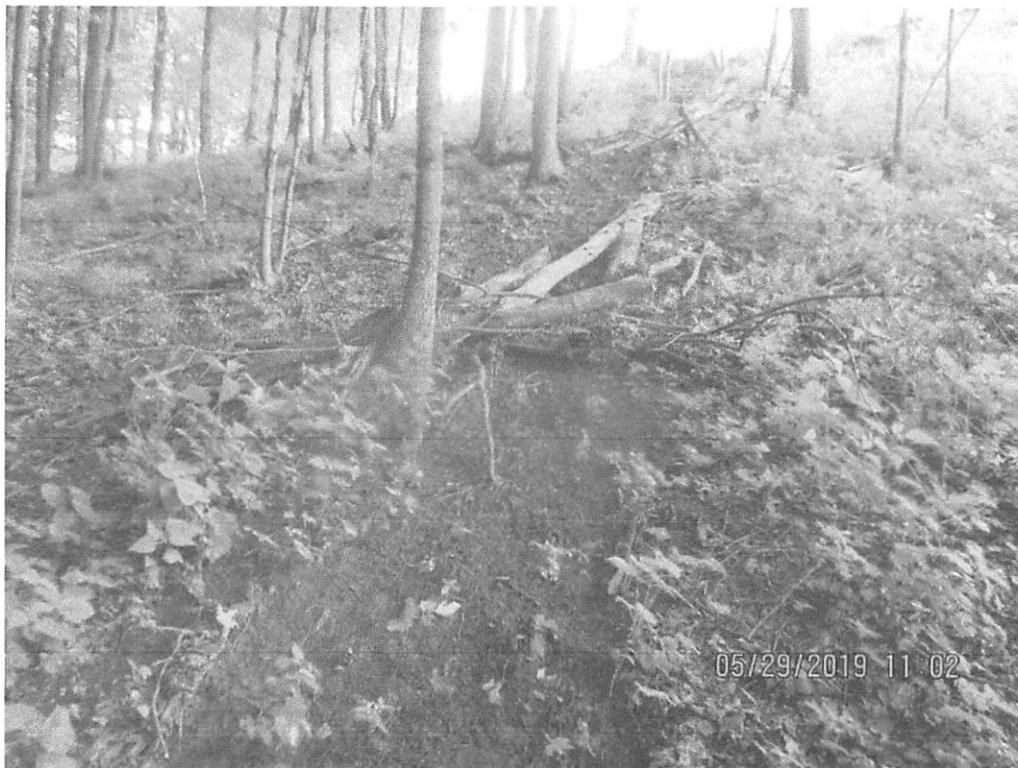
further downslope below diversion berm Outlet 2 near 4031+00. Scouring of vegetation below control.

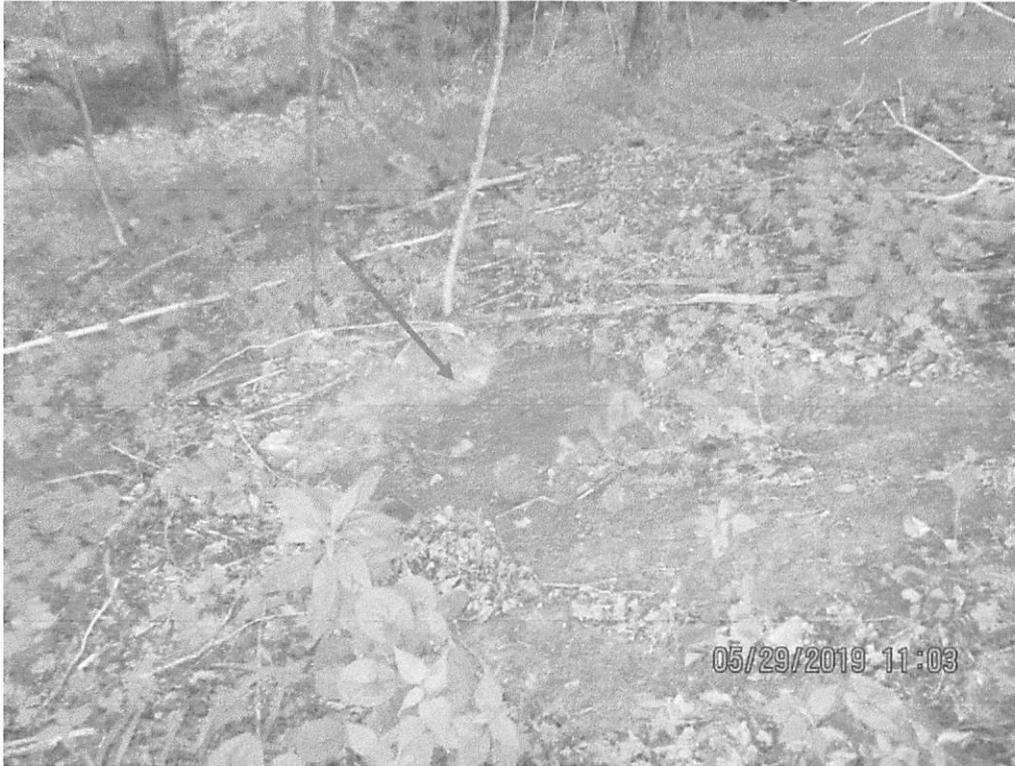
Below diversion berm Outlet 2 near 4031+00. Scouring of vegetation present below control. Sediment deposits were observed approximately 150 ft downslope of controls.

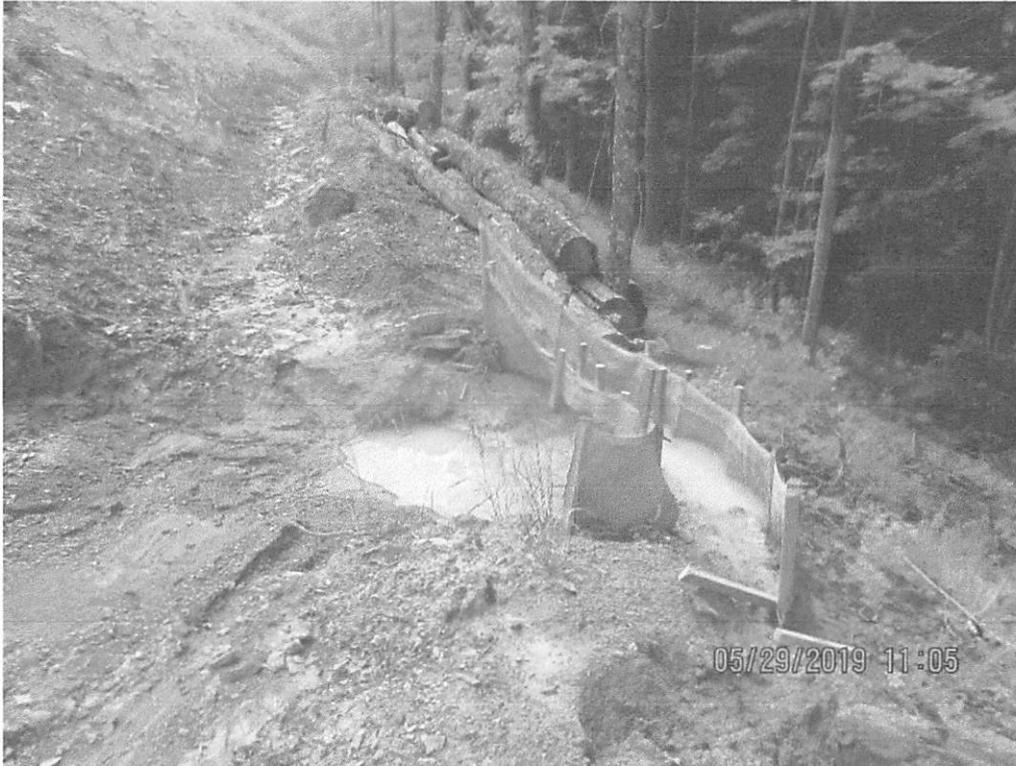
Diversion berm Outlet 3. Sediment being deposited behind controls.

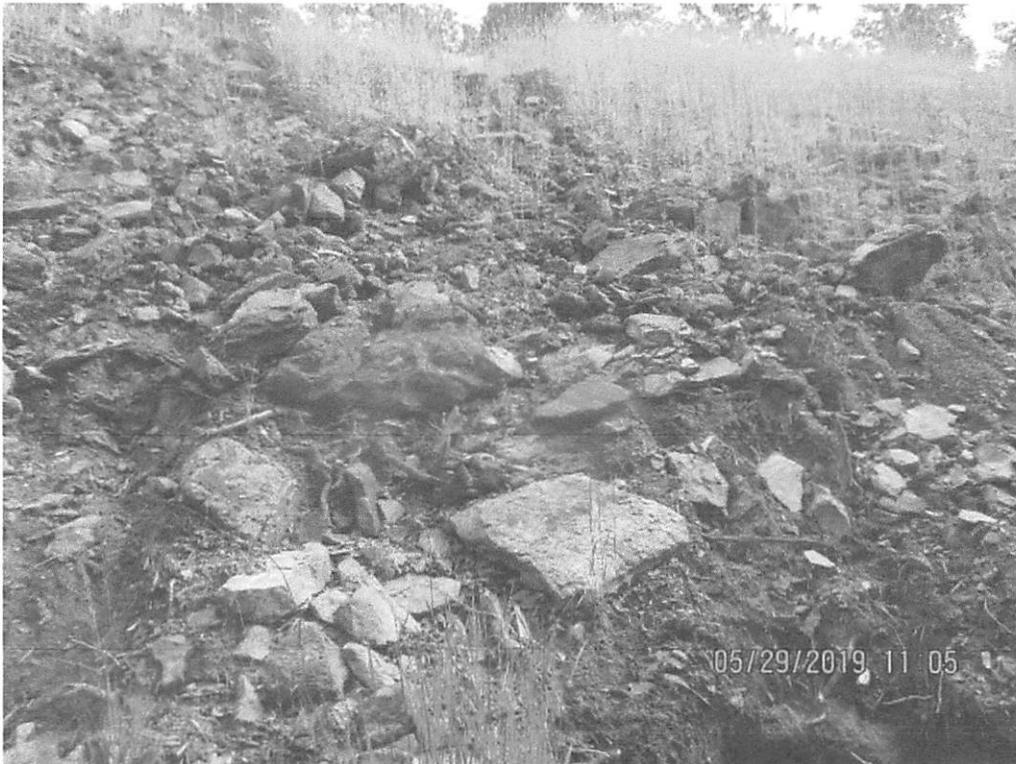
Fill slope with erosion present above diversion berm Outlet 3 near station 4031+00.
