**CONSENT ORDER
ISSUED UNDER THE
WATER POLLUTION CONTROL ACT
WEST VIRGINIA CODE, CHAPTER 22, ARTICLE 11**

TO: Mountain Valley Pipeline, LLC
Robert J. Cooper
2200 Energy Drive
Canonsburg, PA 15317

DATE: December 17, 2020

ORDER NO.: 9925

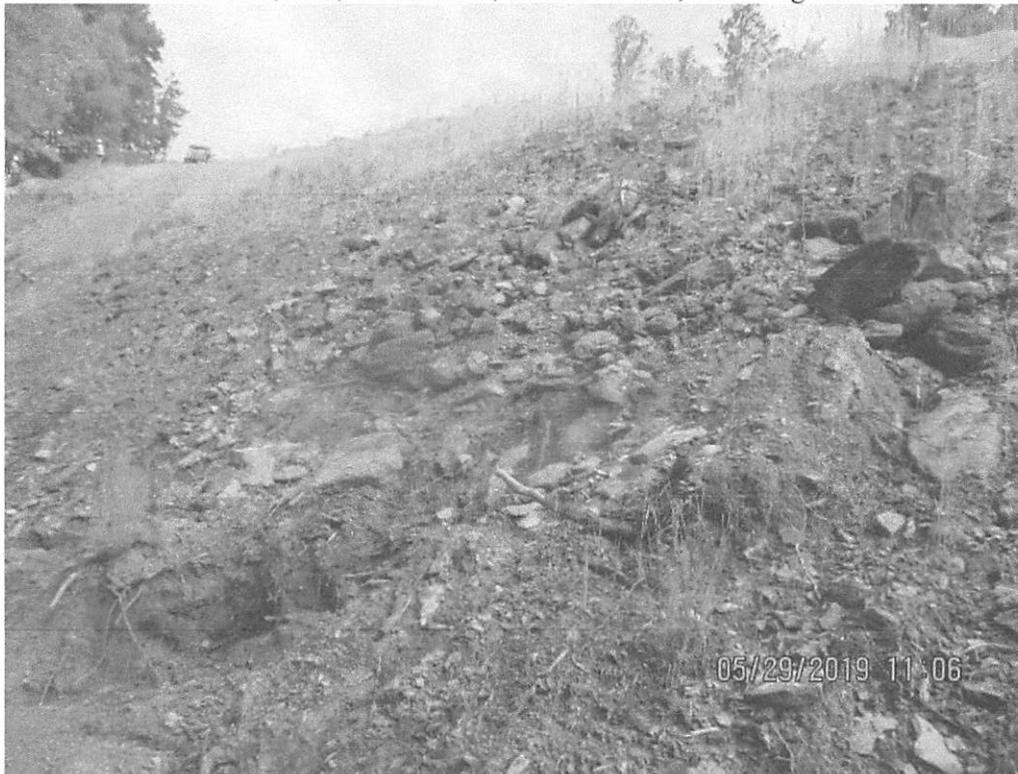
Fill slope with erosion present above diversion berm Outlet 3.

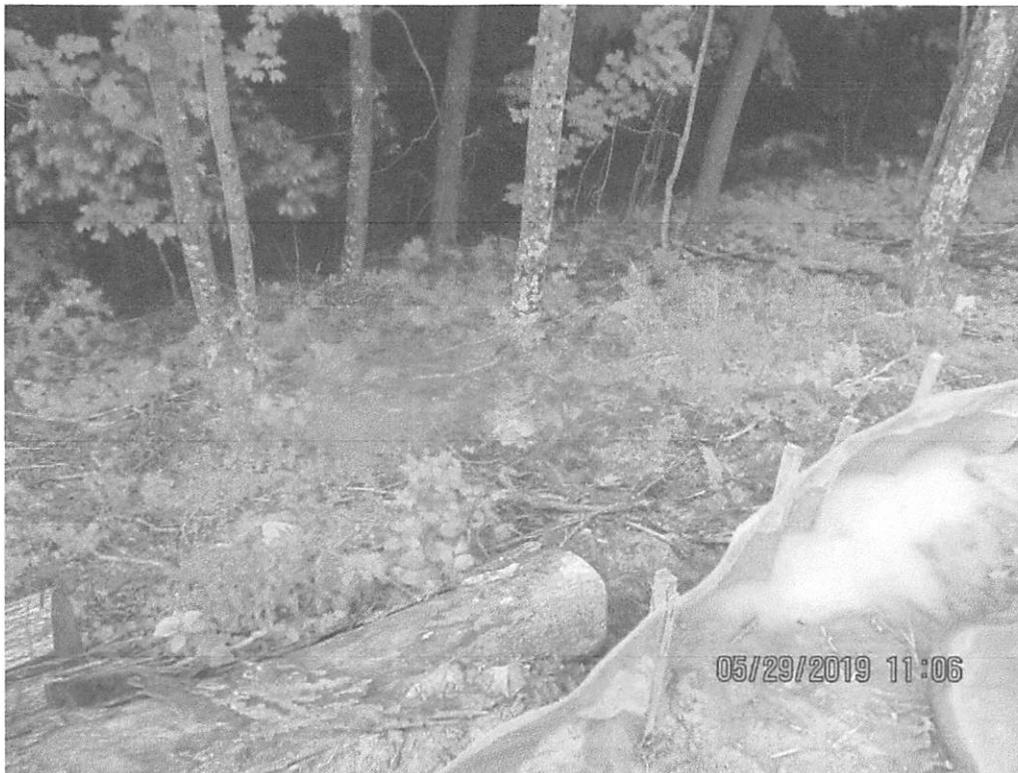
Downslope of diversion berm Outlet 3 controls. Scouring of vegetation with sediment deposits present past LOD.

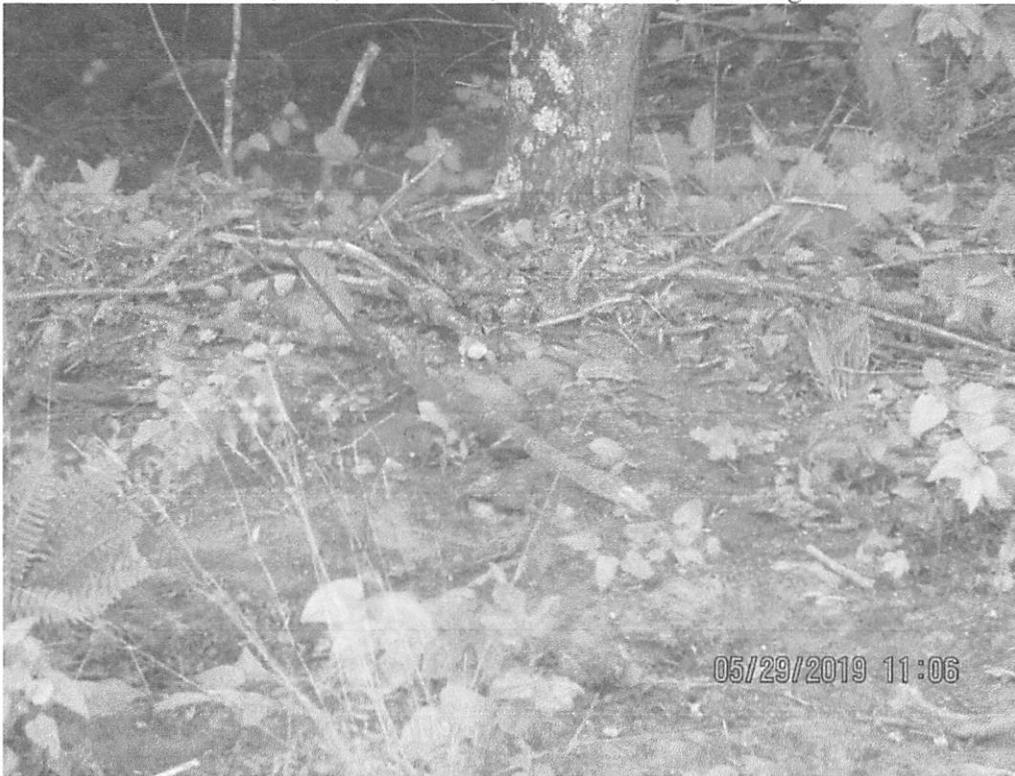
Downslope of diversion berm Outlet 3. Sediment deposits present.

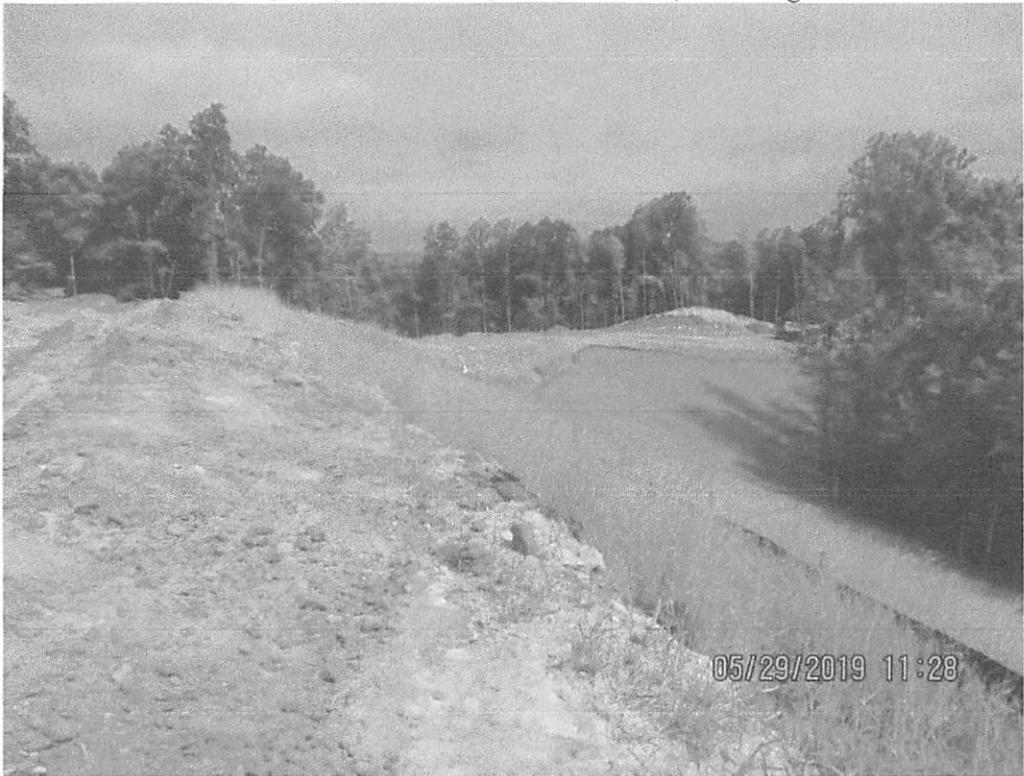
At station 4031+00 facing South at MVP ROW and western edge of LOD.

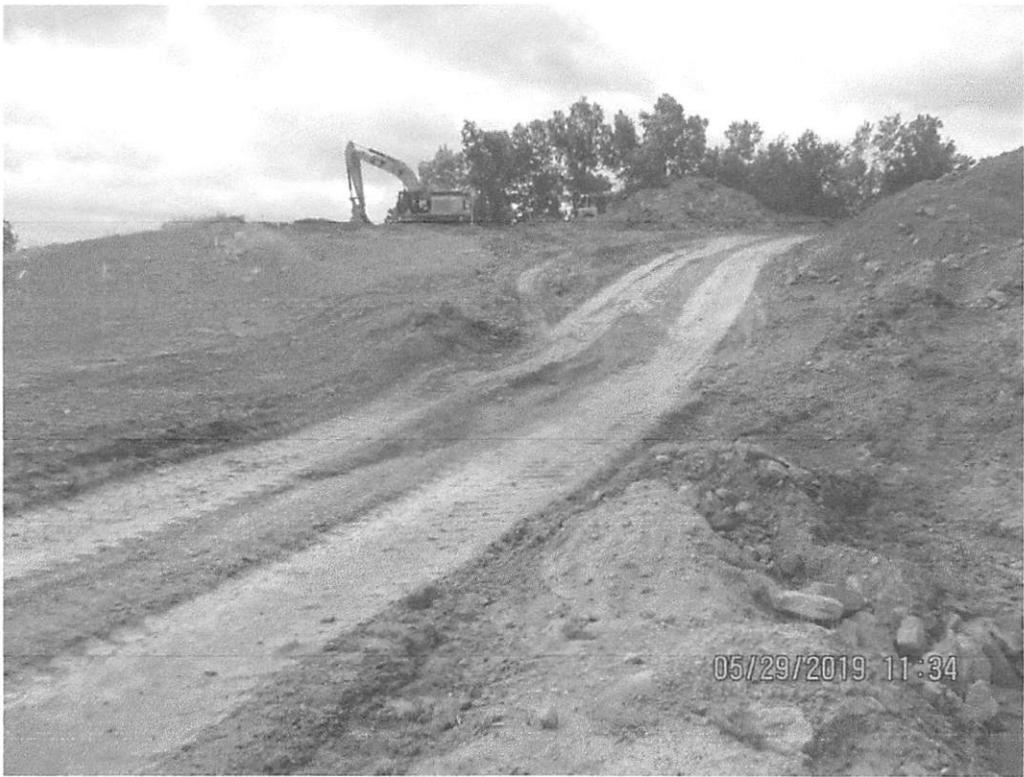
above waterbar outlet at station 4027+00 facing upslope at work area.

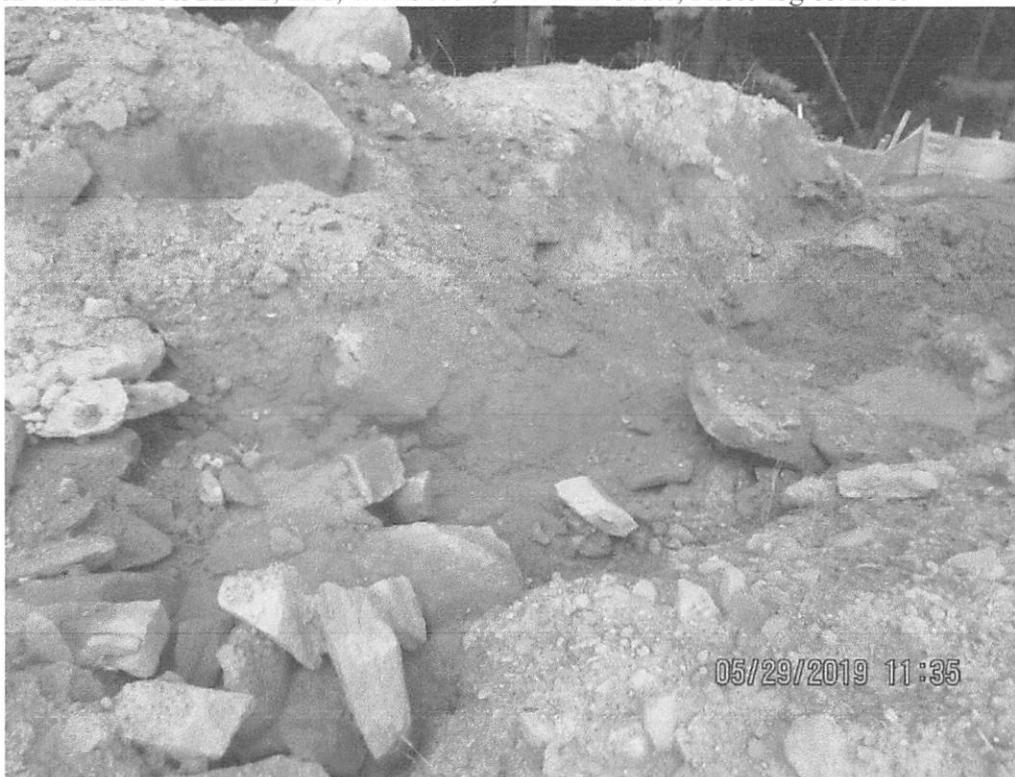
Waterbar outlet terminating onto slope at station 4027+00

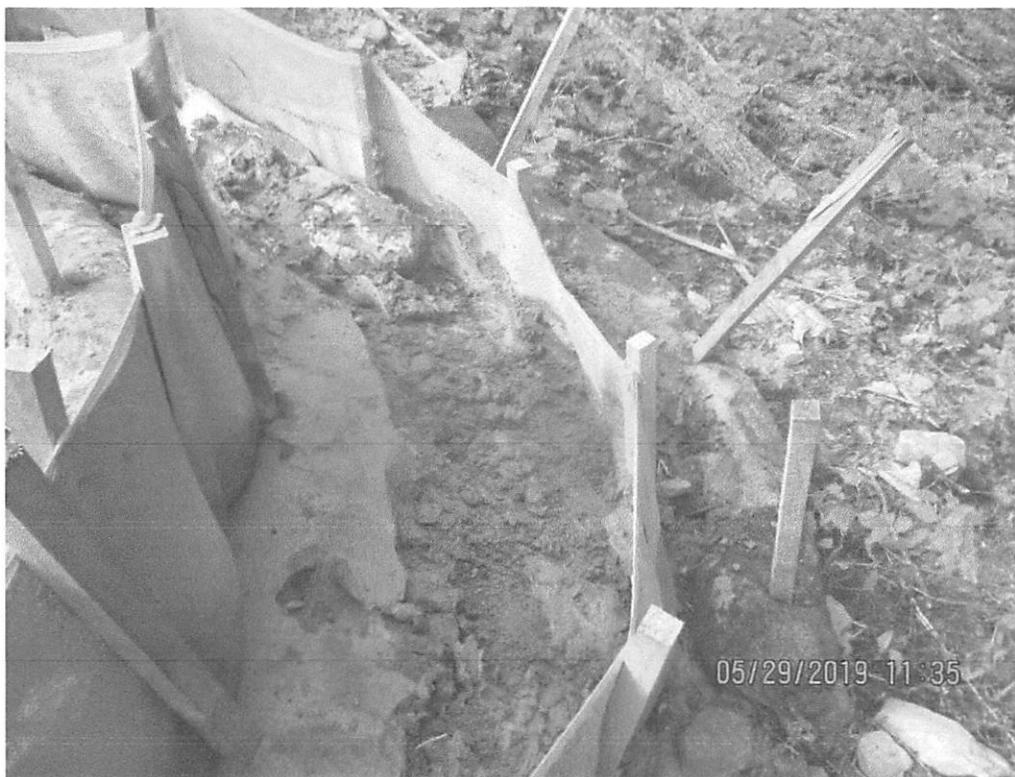
Perimeter outlet controls below waterbar terminus at station 4027+00.

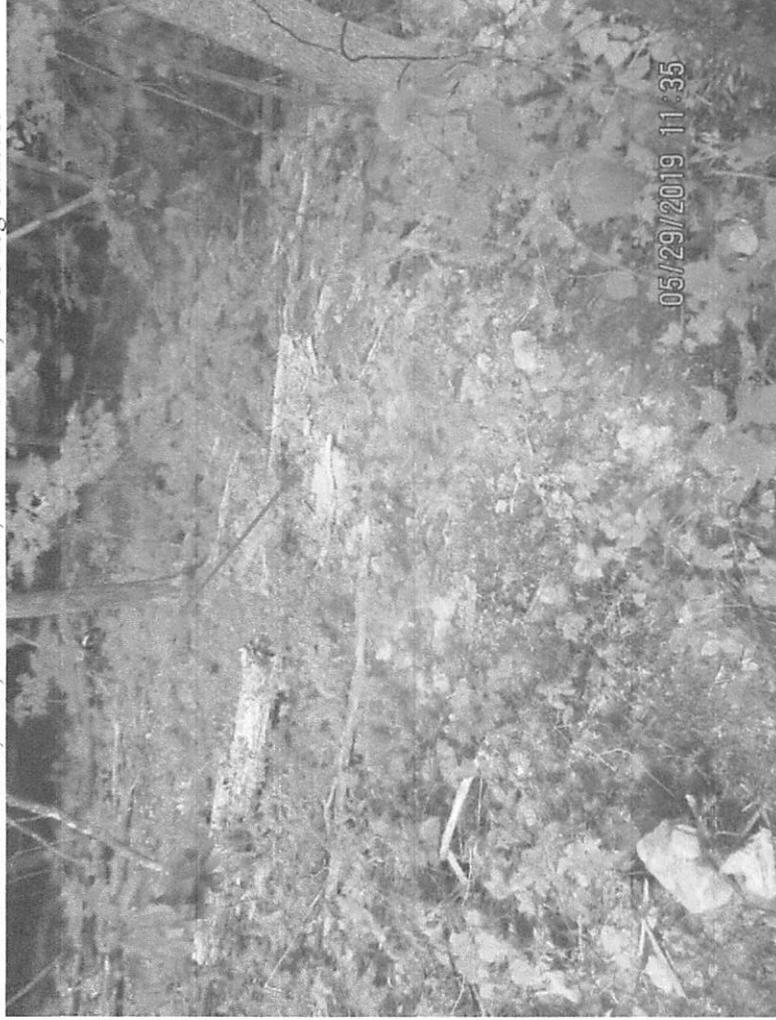
Sediment deposits present past LOD at station 4027+00 facing downslope of perimeter outlet.

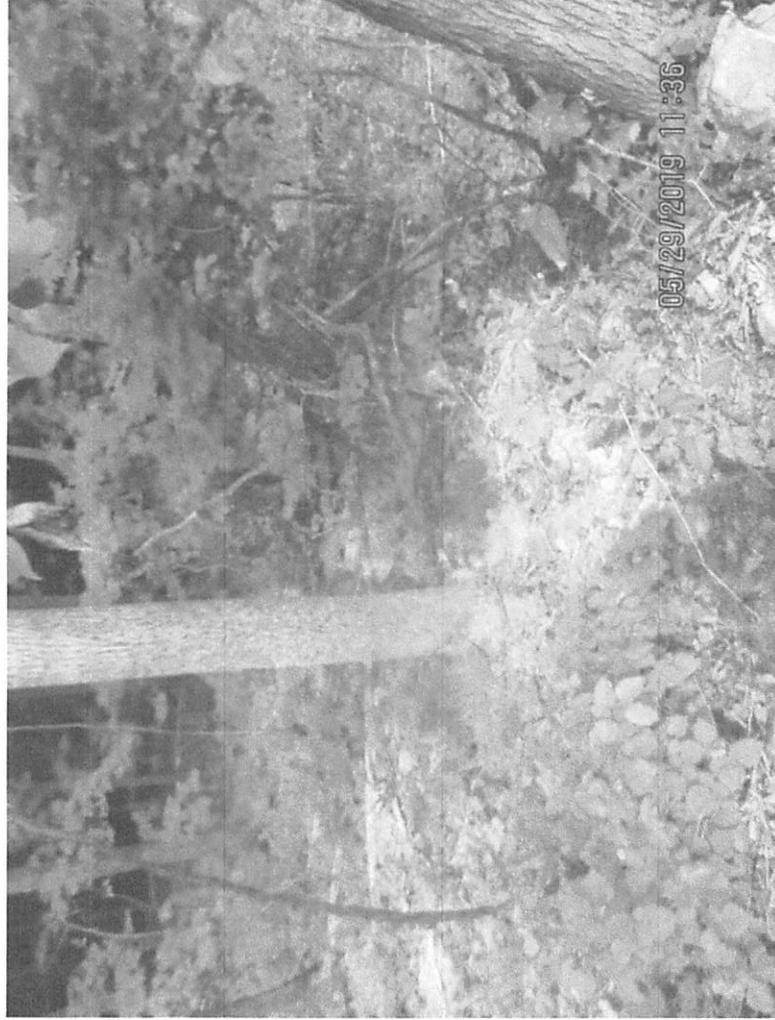
Sediment deposits present past LOD at station 4027+00 facing downslope of perimeter outlet.

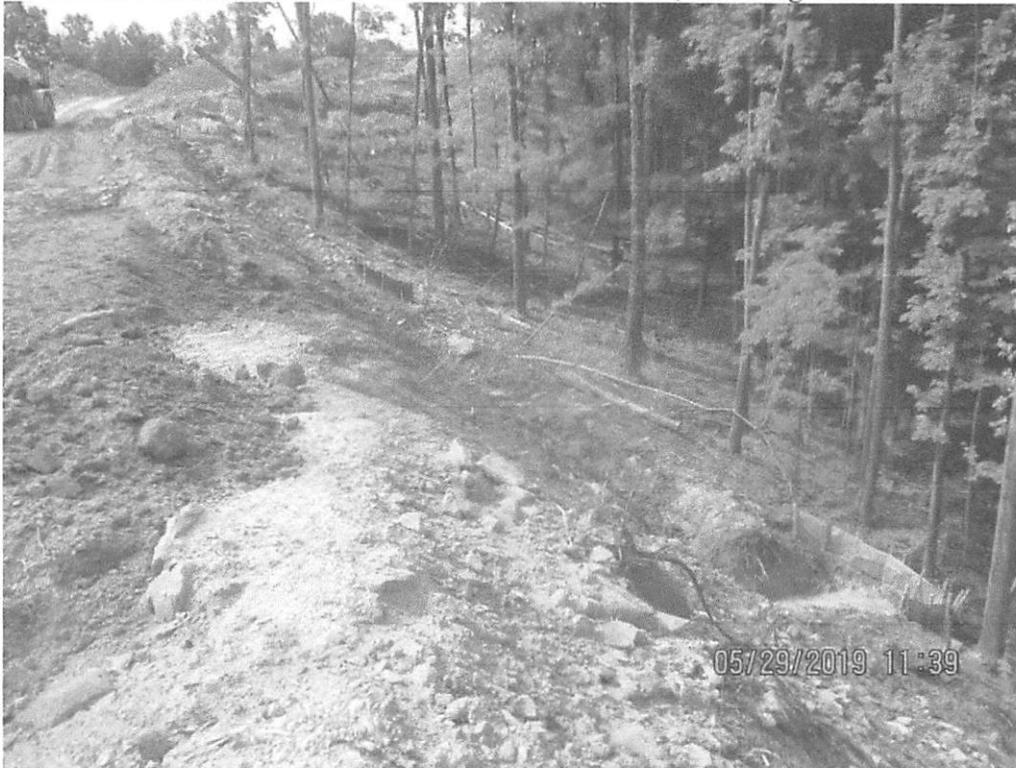
Facing upslope near station 4027+00. Arrow depicts waterbar and sediment deposits. Diversion berm installed as perimeter control with multiple outlets.

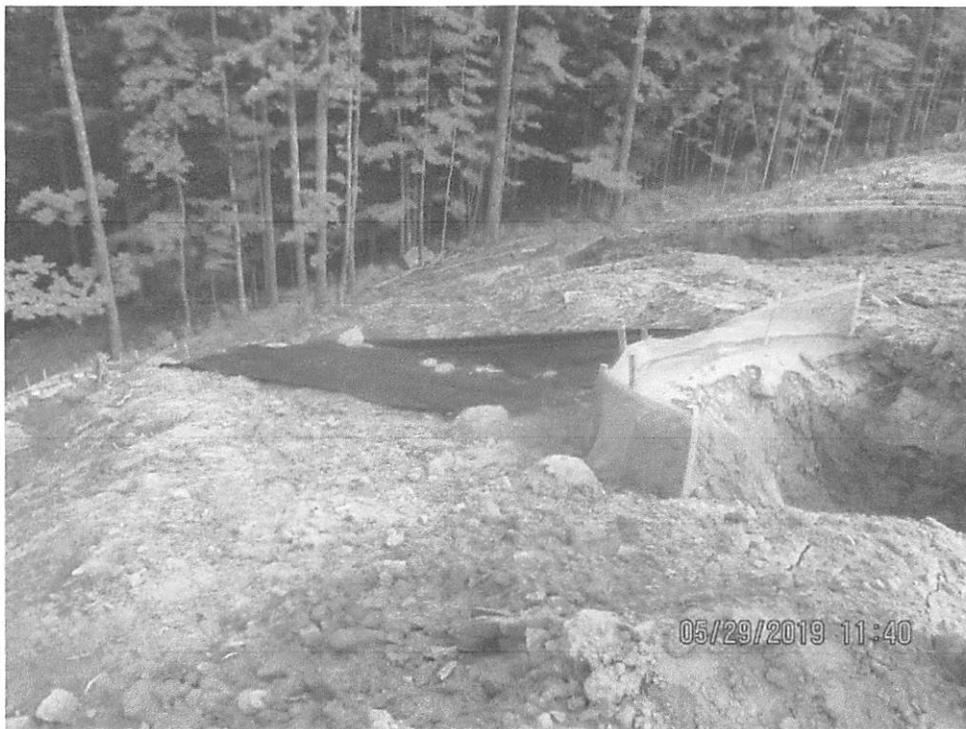
Waterbar outlet downslope of station 4027+00. Waterbar terminating on slope. Fabric installed below control on slope above perimeter outlet.

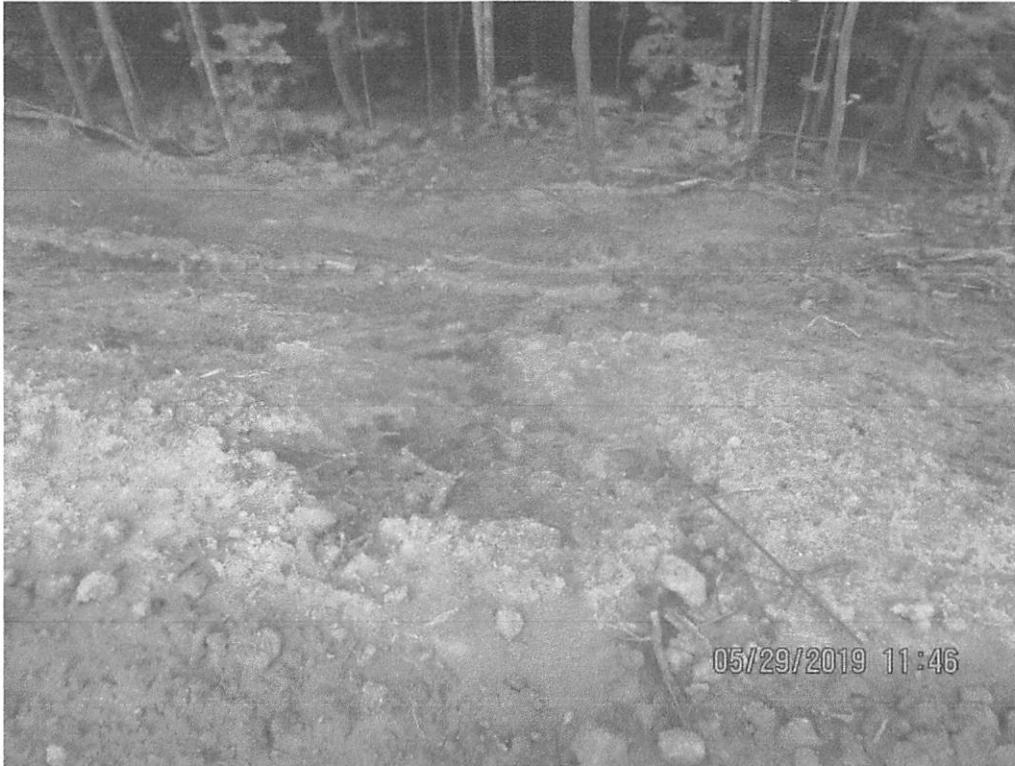
near station 4027+00 facing downslope. Erosion present on fill slope. Perimeter control being overwhelmed with sediment, resulting in sediment-laden water being present past controls. According to representative, logging disturbance had taken place.

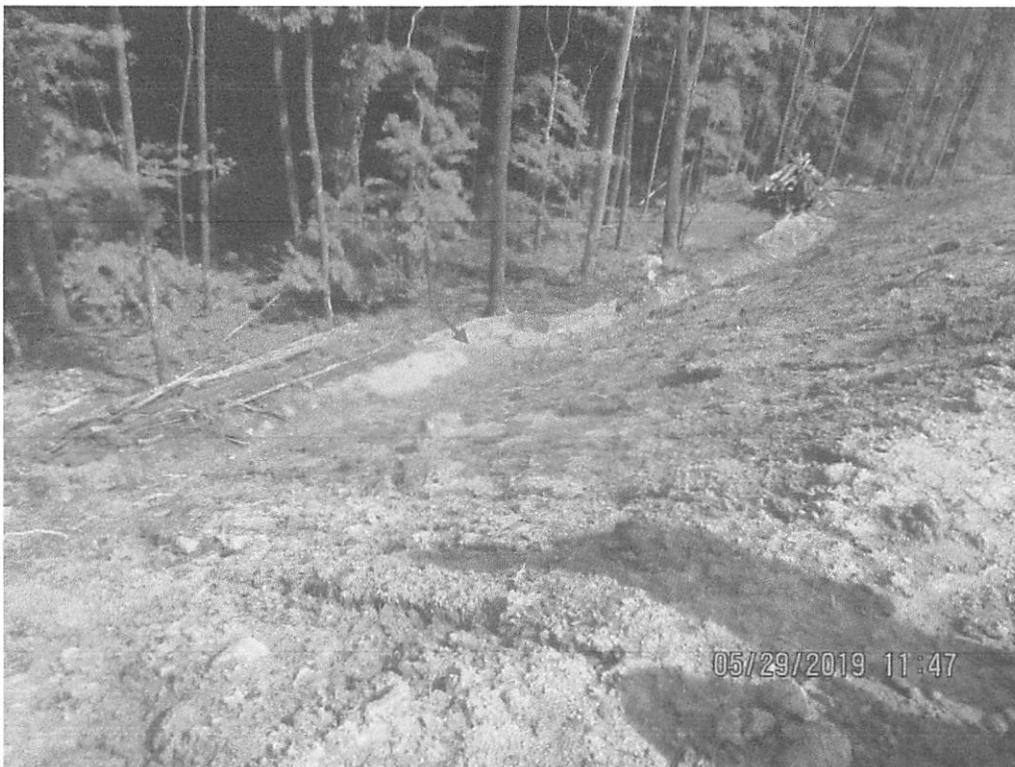
Erosion present on slope near Station 4017+00. Perimeter controls overwhelmed with sediment.

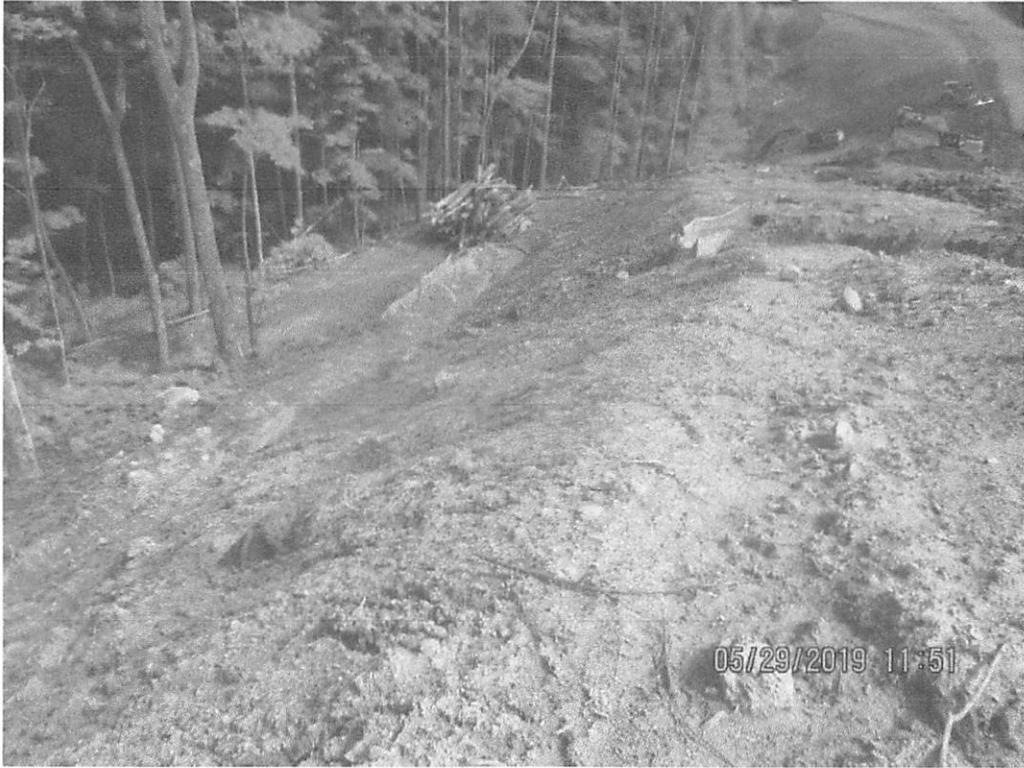
Near station 4017+00. Waterbar terminating onto slope.

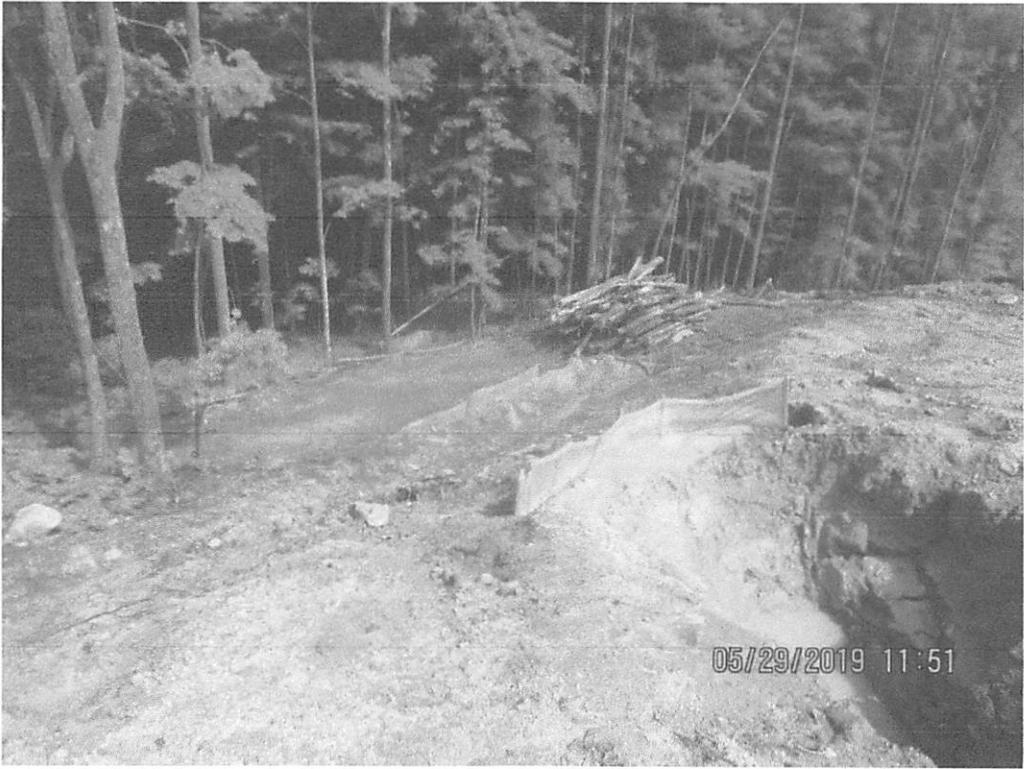
Below waterbar outlet near station 4017+00. Sediment-laden water flowed past LOD.

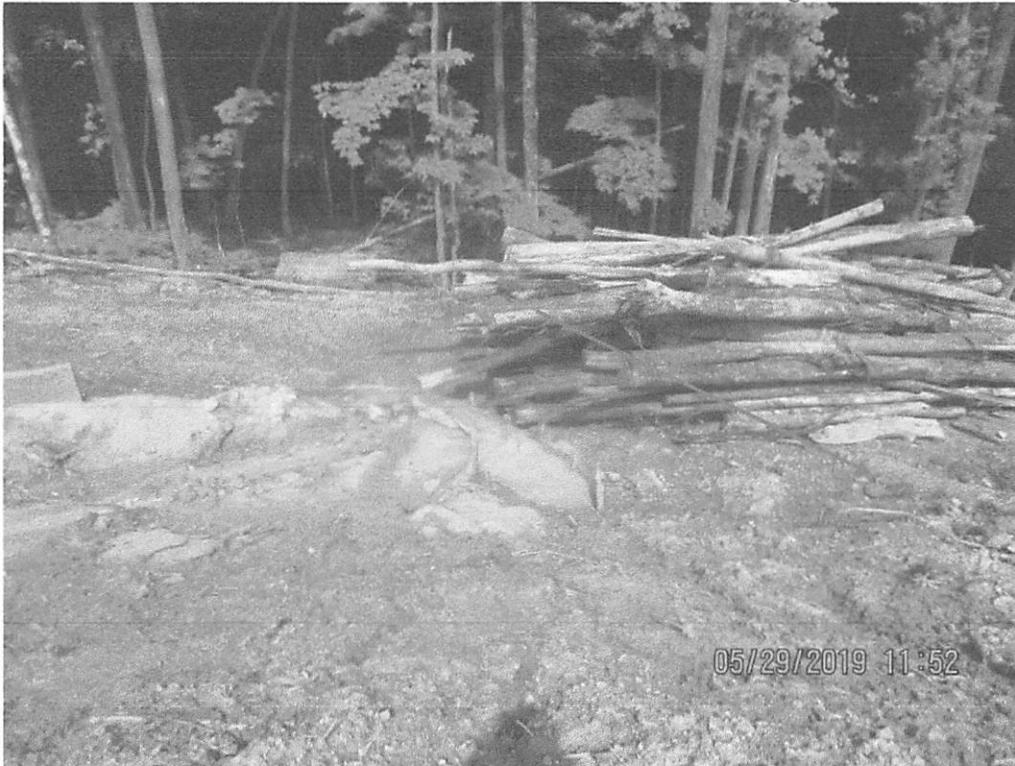
Below waterbar outlet near station 4017+00. sediment-laden water flowed past LOD. Arrow depicts where run-off was flowing.

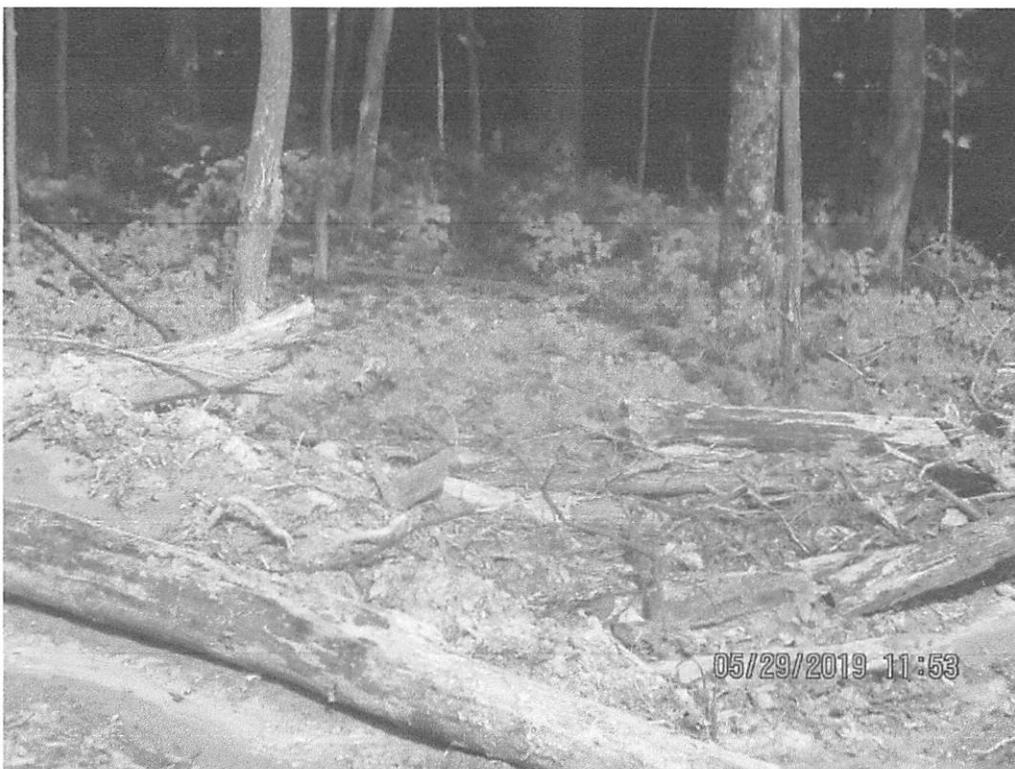
Below perimeter controls near station 4017+00. Sediment deposits were present past LOD.

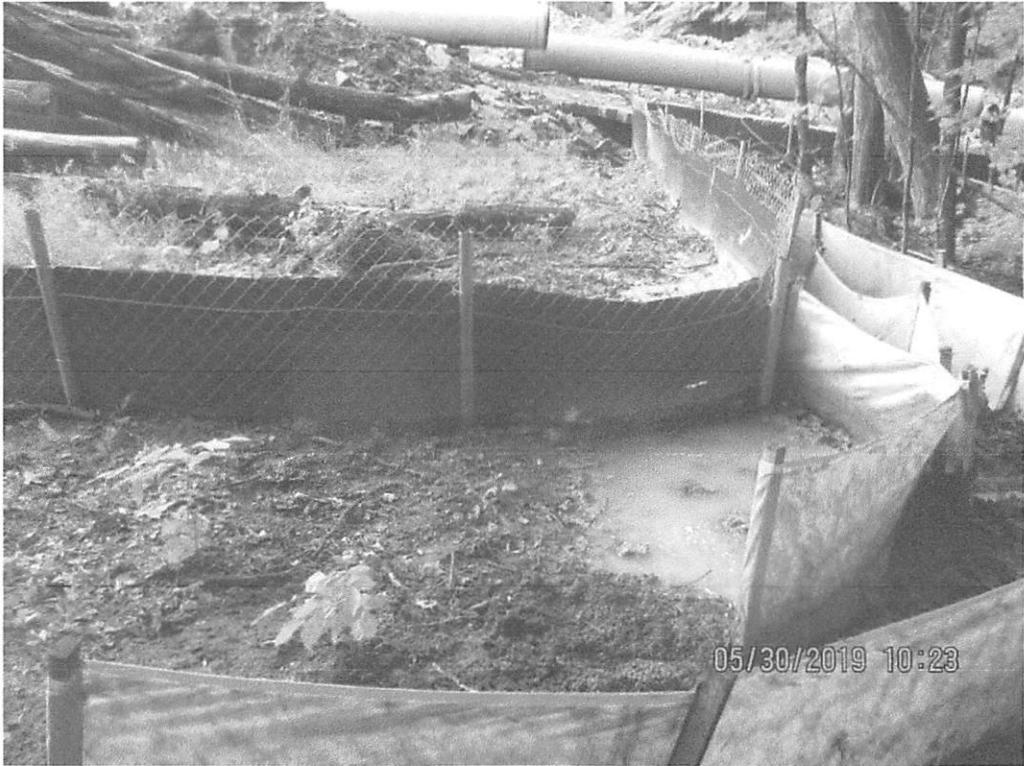
Controls at station 6474+16.

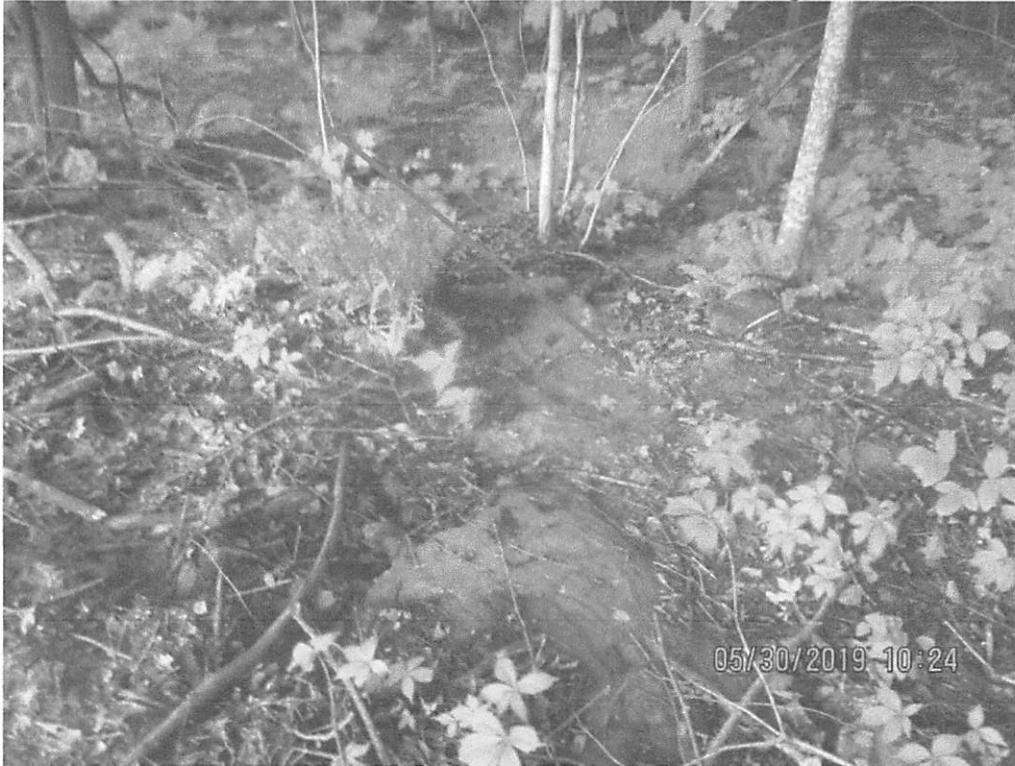
Sediment deposits past LOD and controls at station 6474+16. Arrow depicts deposits.

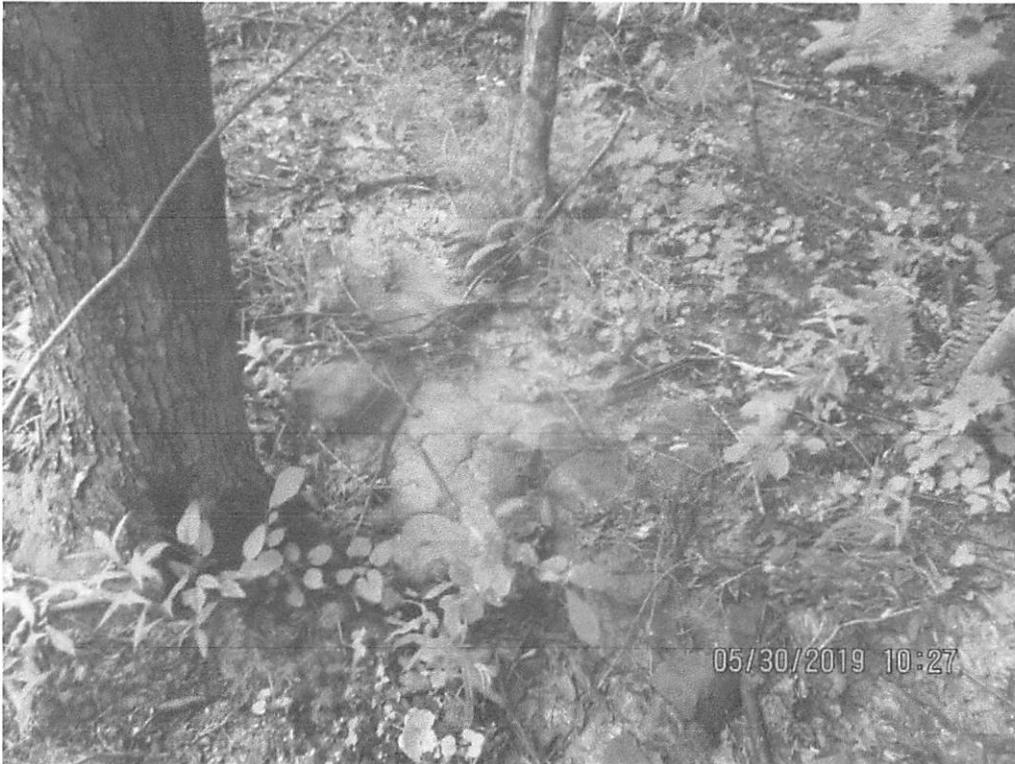
Sediment deposits past the LOD and controls at station 6474+16.

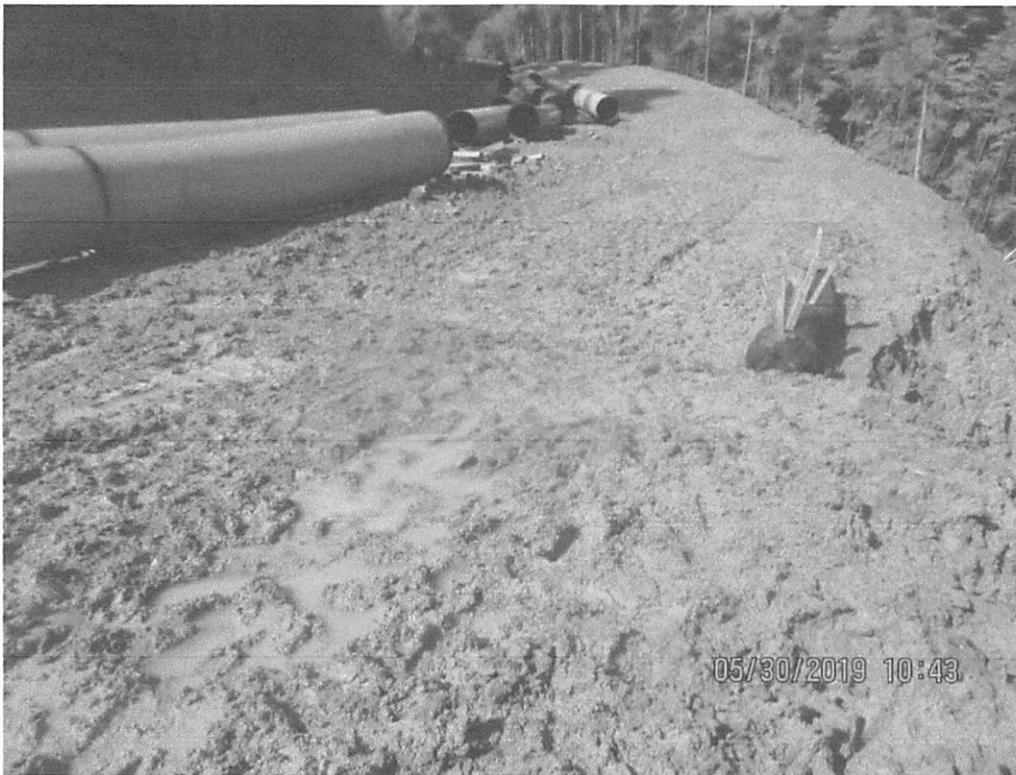
Stream S-N10 facing downstream near station 6478+48

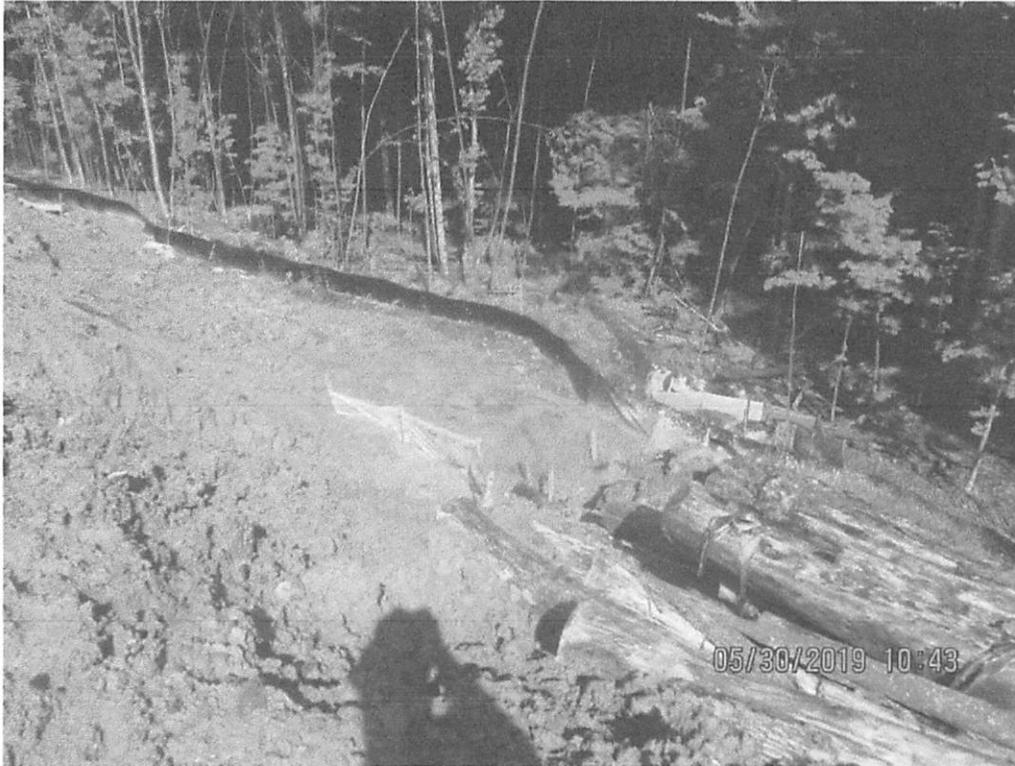
Waterbar outlet terminating onto slope near station 6485+10.

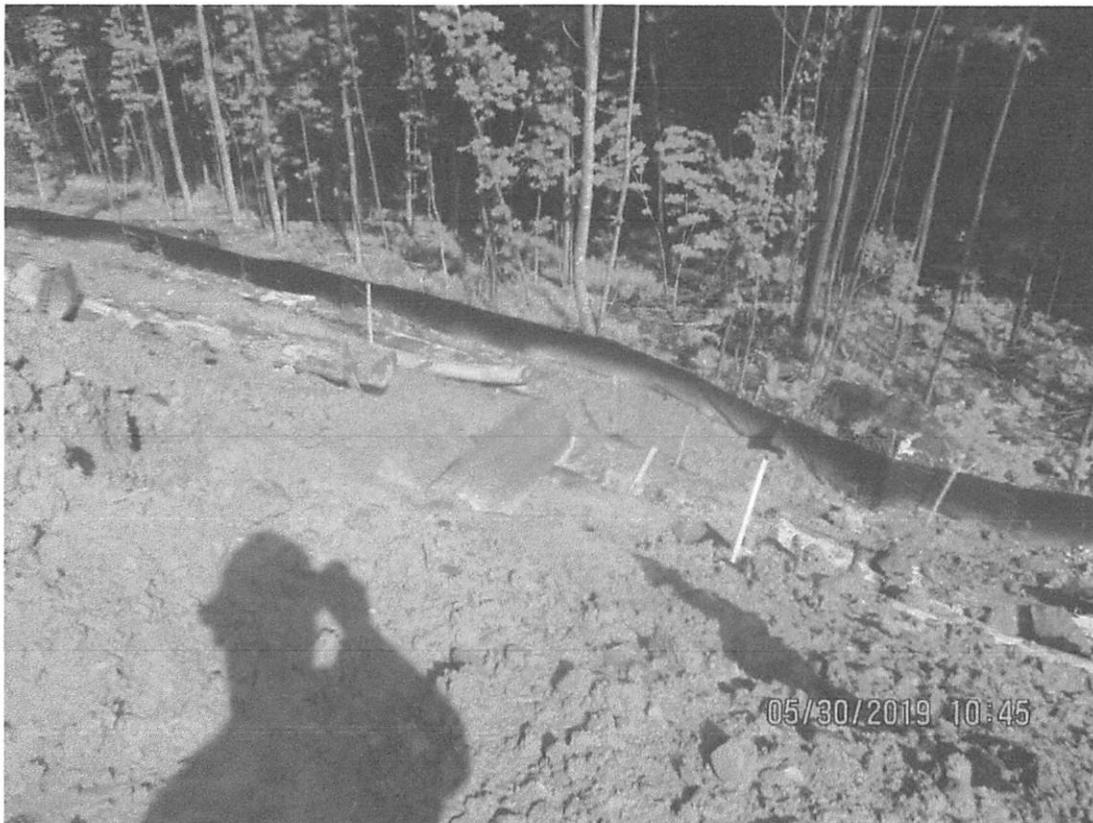
Slope below waterbar terminus. Perimeter controls becoming overwhelmed with sediment.

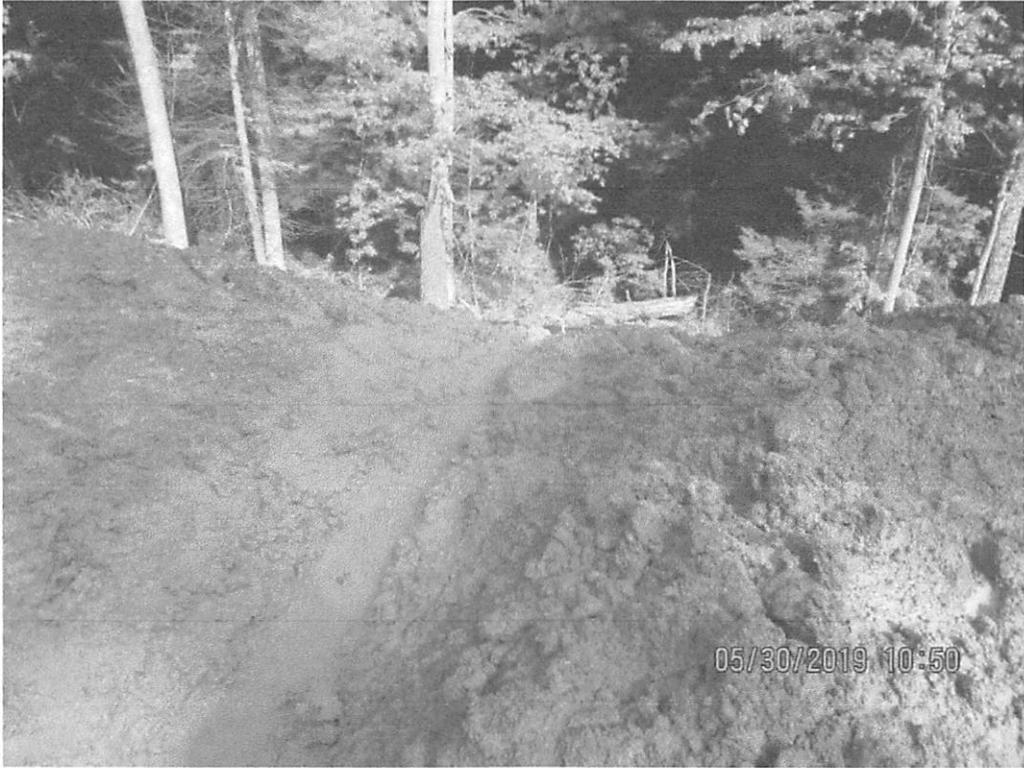
Pipe outlet below seep. Diversion not stabilized and no rip rap apron installed as required per SWPPP near station 6485+10. The inlet had been cut due to trench being dug.

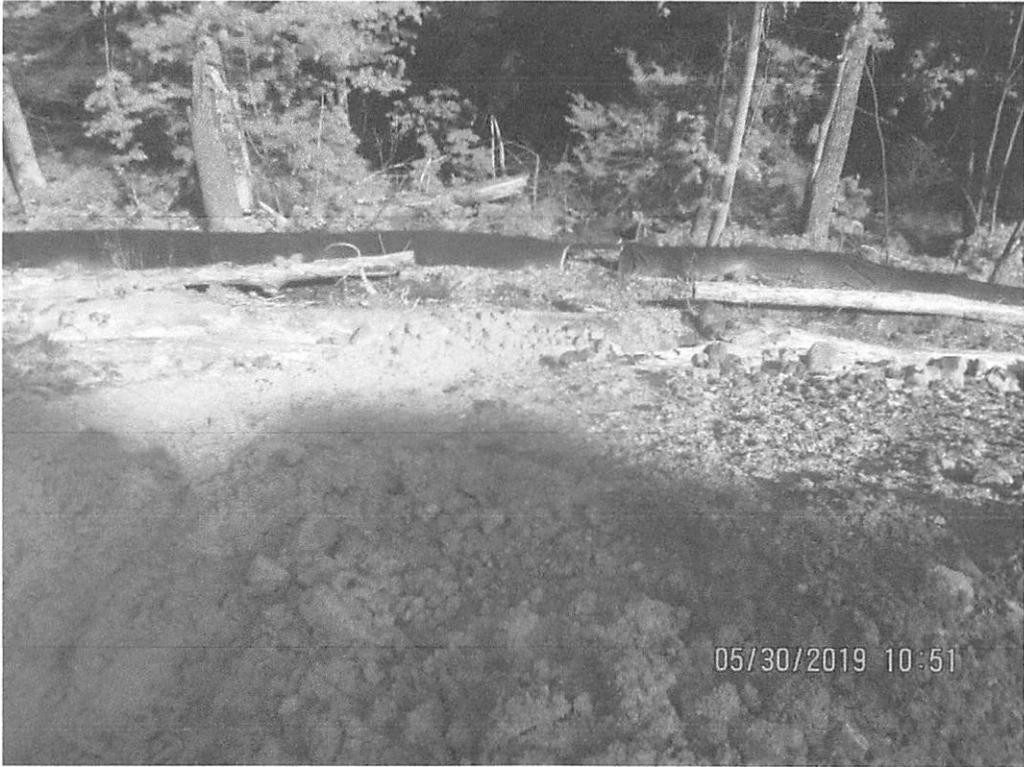
Waterbar outlet terminating onto slope at station 6485+10.

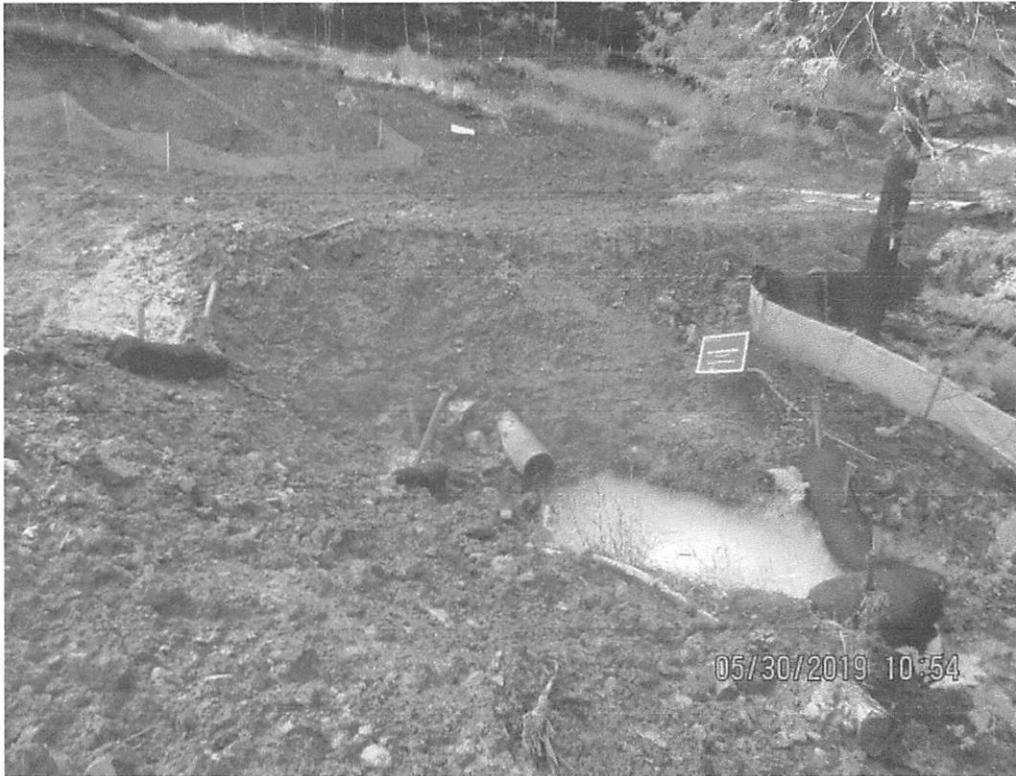
Waterbar outlet terminating onto slope at station 6485+10. Erosion present on slope above perimeter controls.

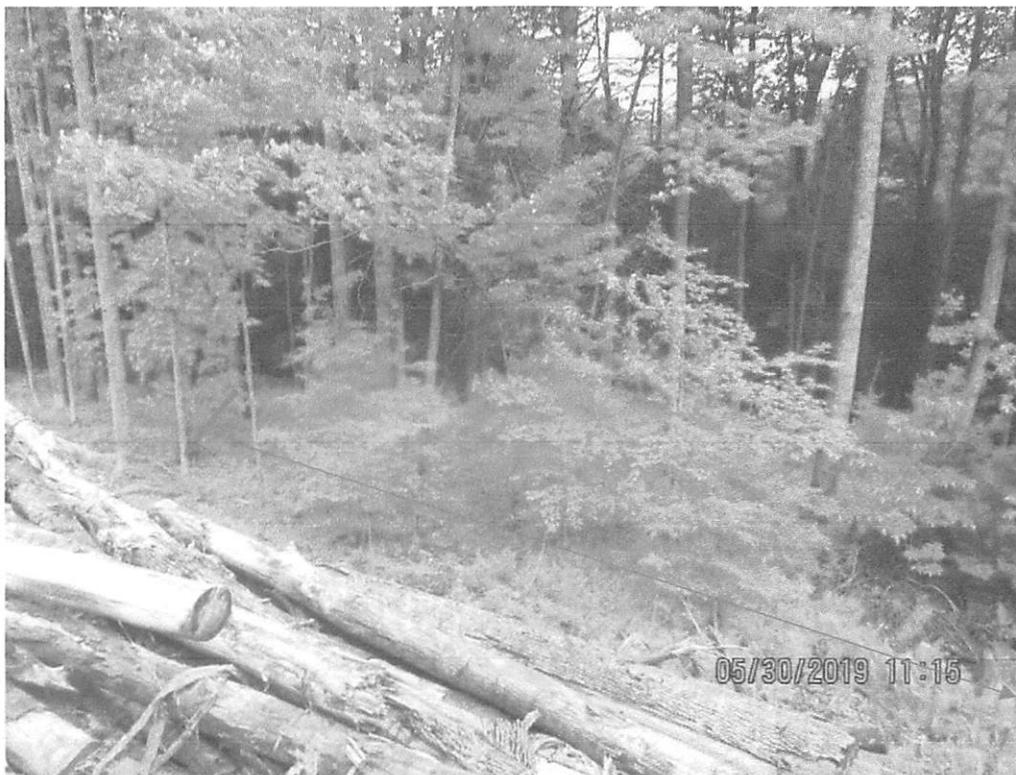
Drain outlet above Stream S-EE1. Clean water diversion not stabilized above or below inlet/outlet. Clean water was being conveyed approximately 15 ft across disturbed soil to a sump where the inlet was located. The topsoil pile around the inlet was eroding into the sump. Arrow depicts inlet.

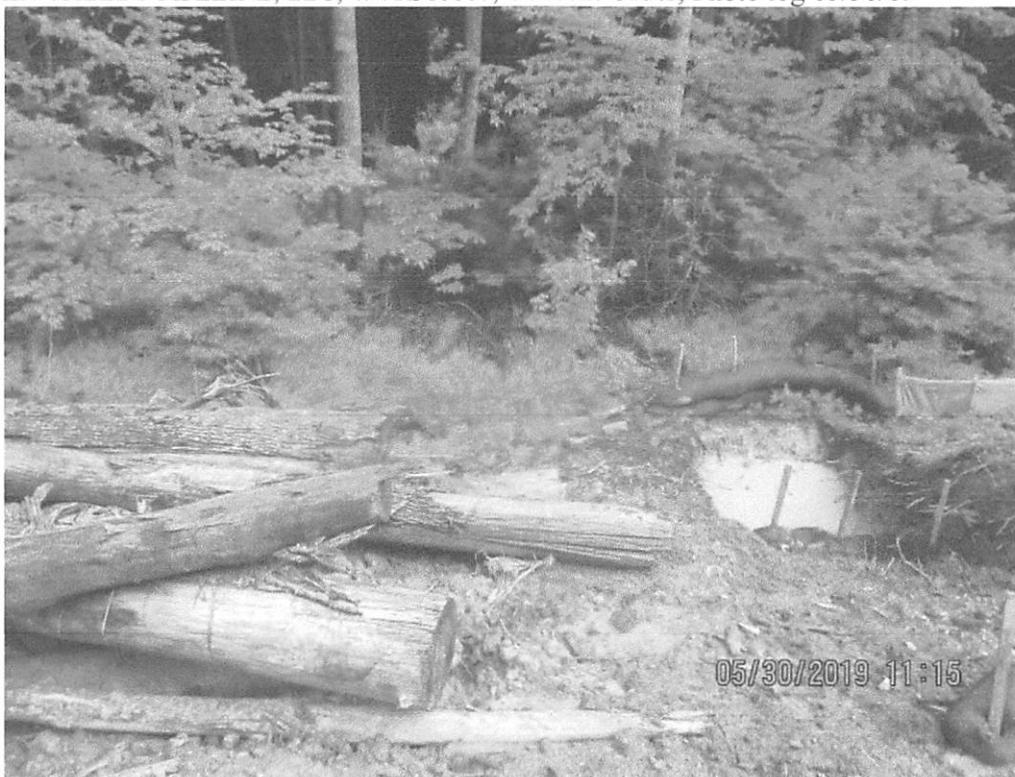
No perimeter control installed per SWPPP on downslope side of fill slope at station 6945+00.
