**CONSENT ORDER
ISSUED UNDER THE
WATER POLLUTION CONTROL ACT
WEST VIRGINIA CODE, CHAPTER 22, ARTICLE 11**

TO: Mountain Valley Pipeline, LLC
Robert J. Cooper
2200 Energy Drive
Canonsburg, PA 15317

DATE: December 17, 2020

ORDER NO.: 9925

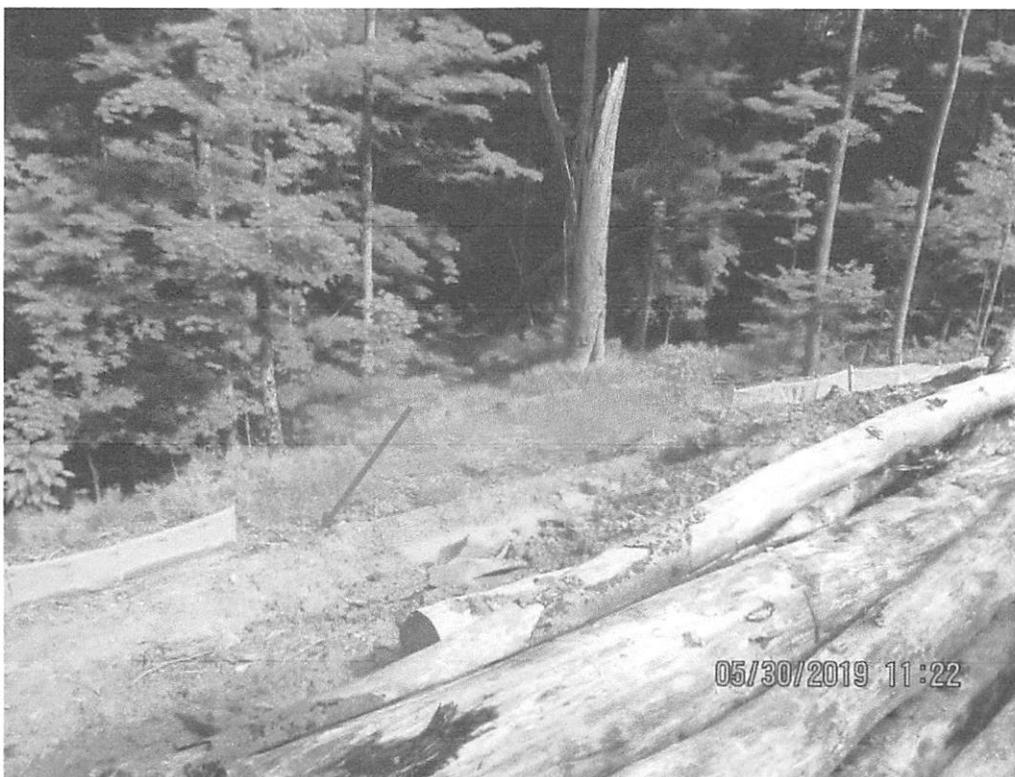
Same area near station 6945+00. Perimeter controls not extended per SWPPP into outlet controls.

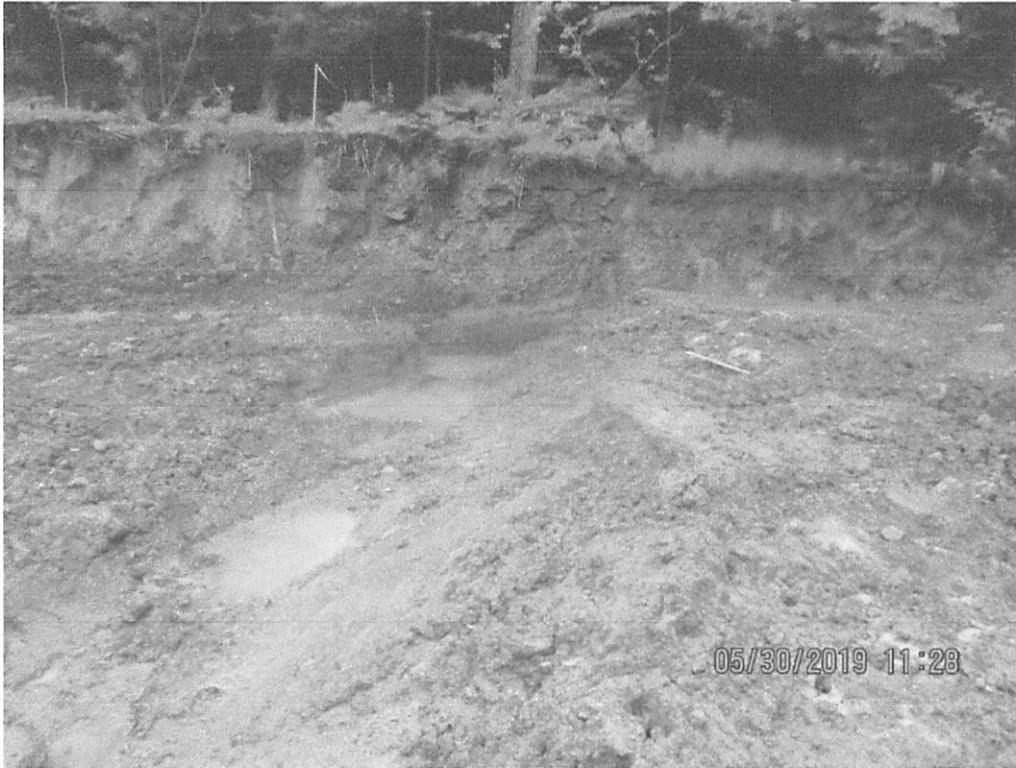
Station 6497+50. Perimeter controls not installed per SWPPP. Diversion berm installed, however, arrow depicts section where sediment was being deposited against controls which were not tied-in to berm.

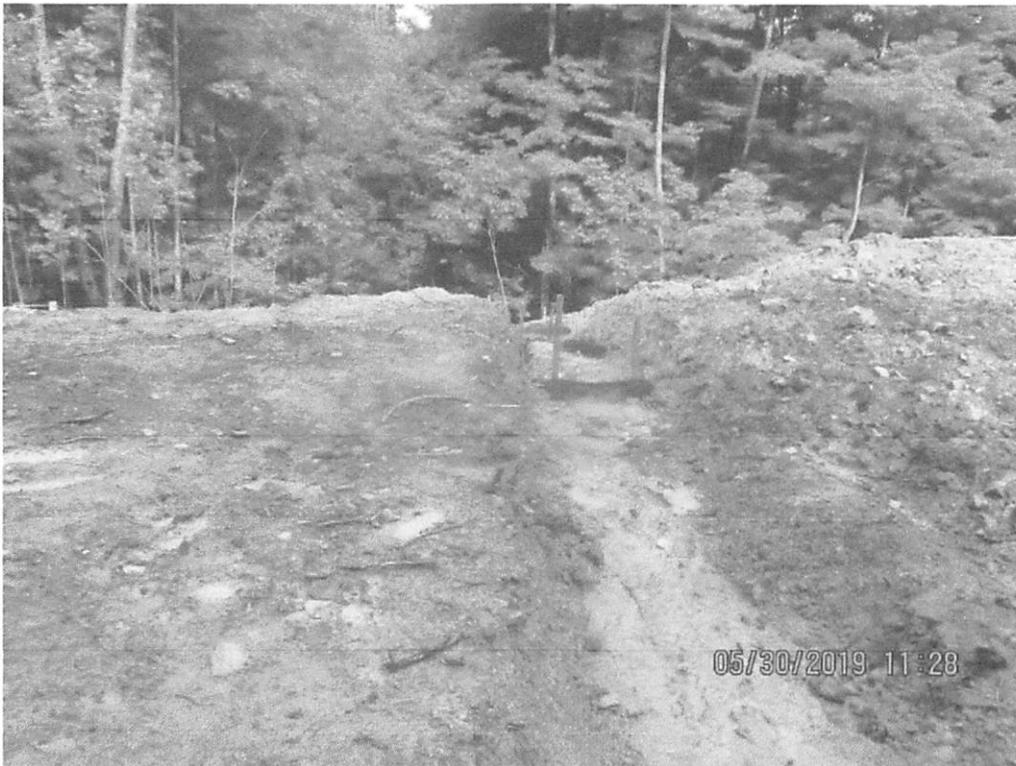
Seep running onto ROW above Stream S-N13. Diversion not stabilized near station 6940+00.

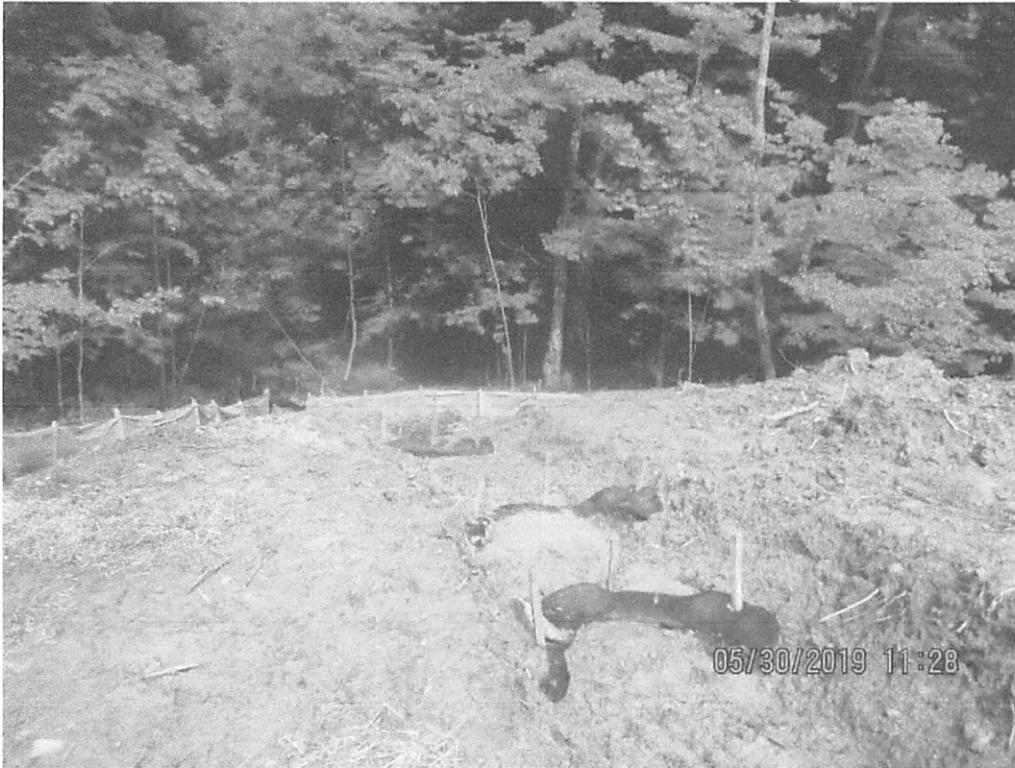
Seep running onto ROW via waterbar above Stream S-N13. Diversion not stabilized near station 6940+00.

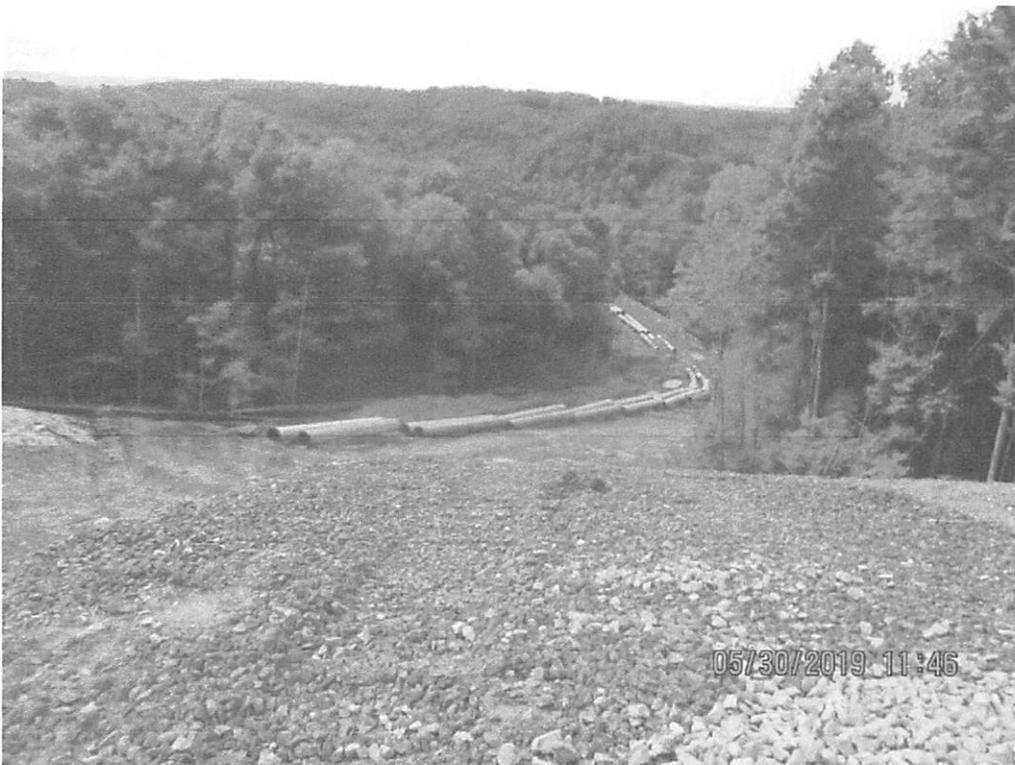
Seep running onto ROW via waterbar above Stream S-N13. Diversion not stabilized near station 6940+00.

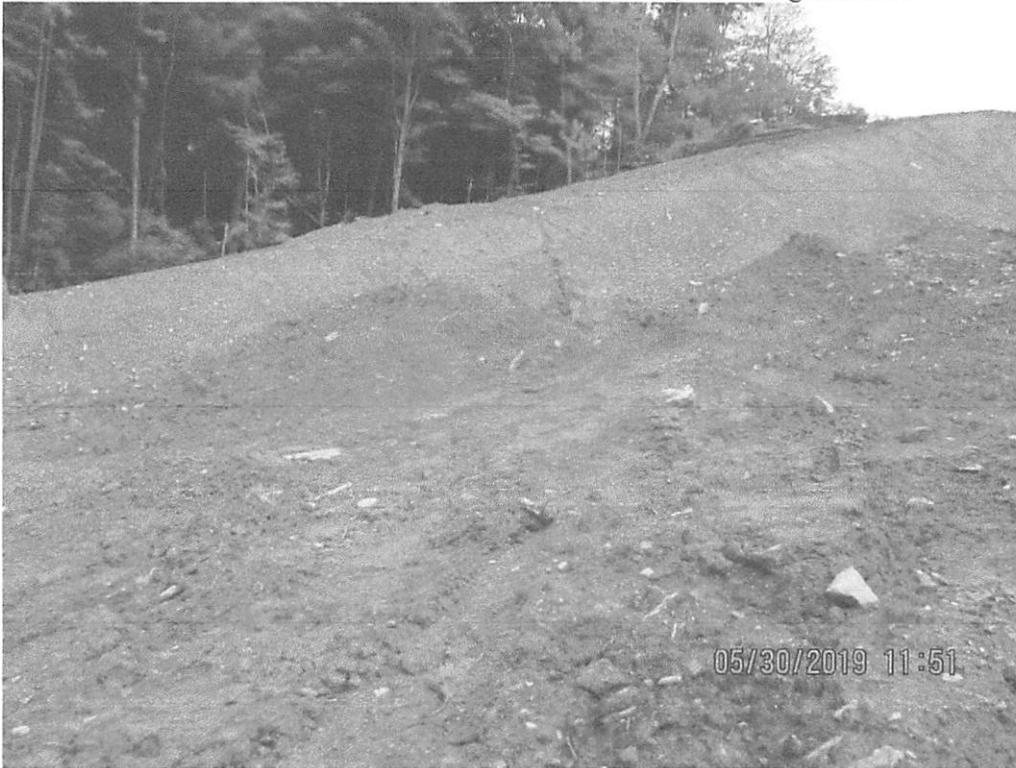
Construction entrance at Deepwell road crossing facing South at station 6504+20.

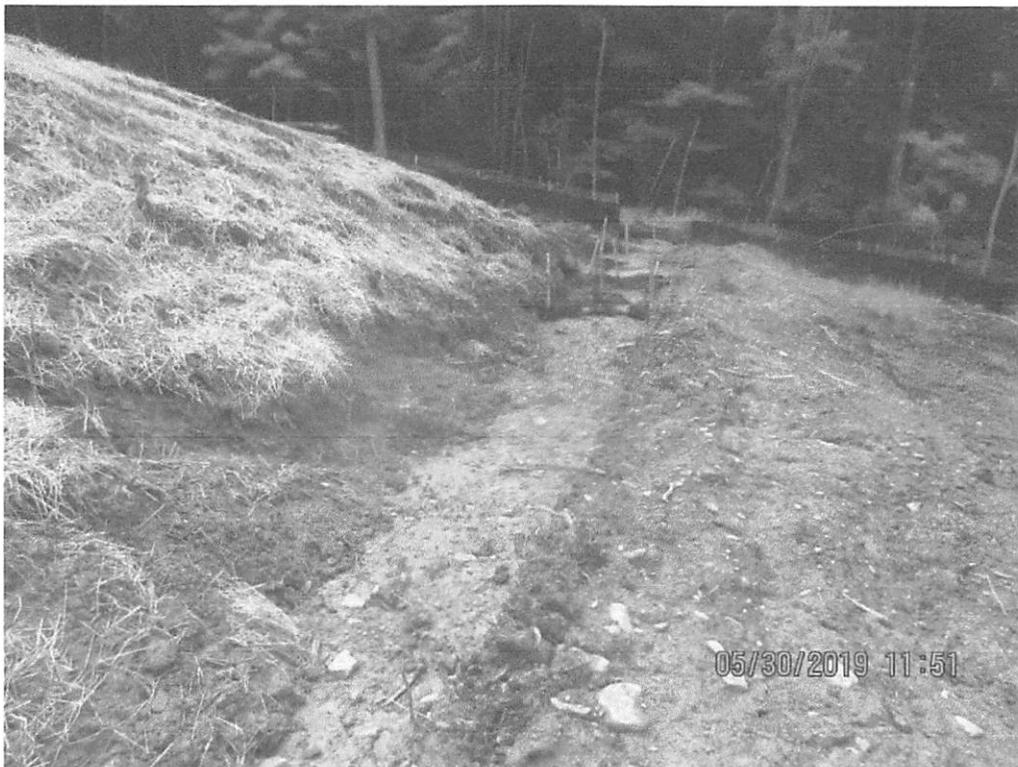
Facing upslope at Deepwell road construction entrance near station 6504+20. Erosion present on fill slope and ROW leading to waterbar.

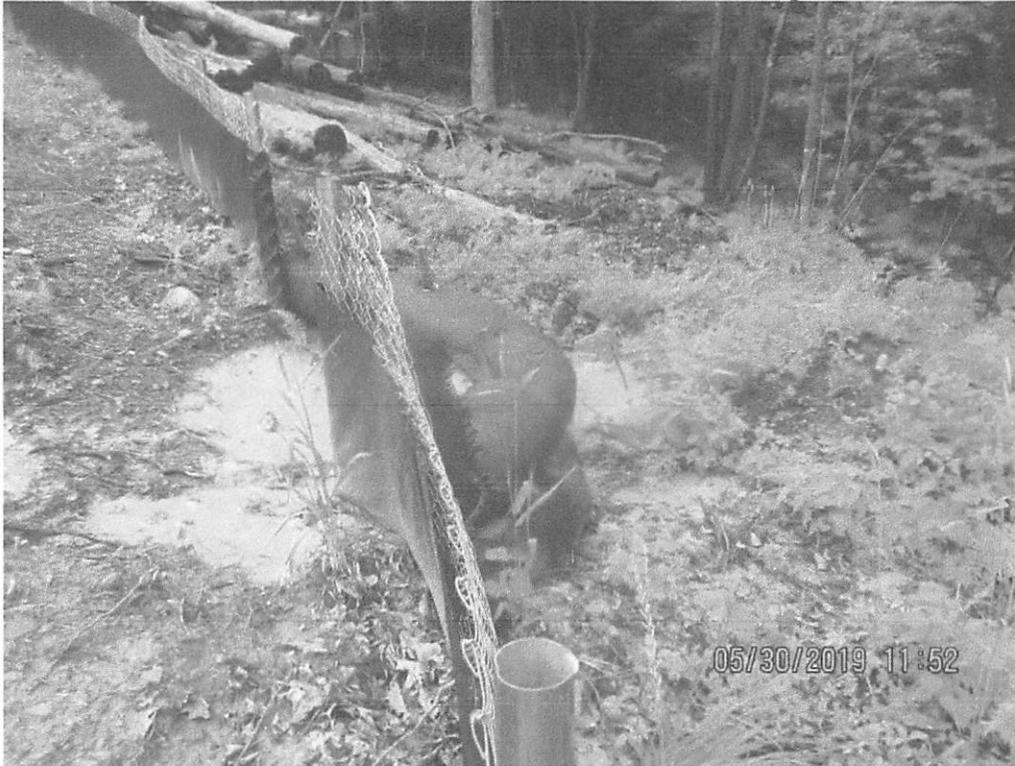
Waterbar with CFS checks installed and scouring topsoil pile below Deepwell road crossing at Station 6508+30.

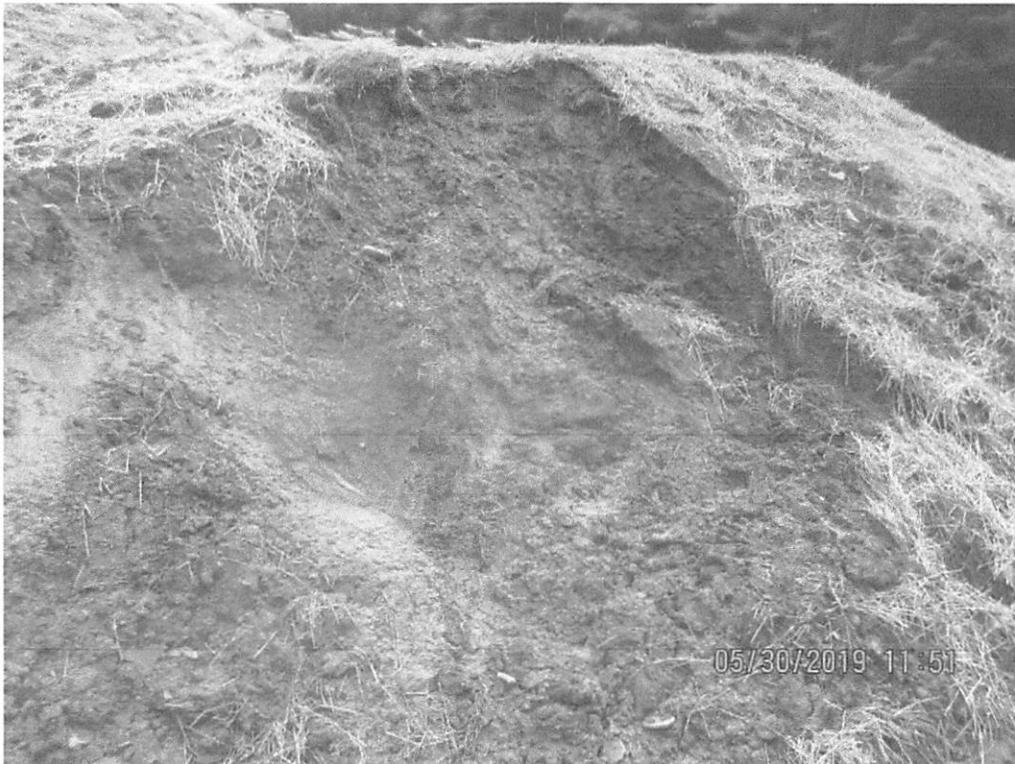
Waterbar outlet near station 6508+30. Sediment deposits past controls and LOD.

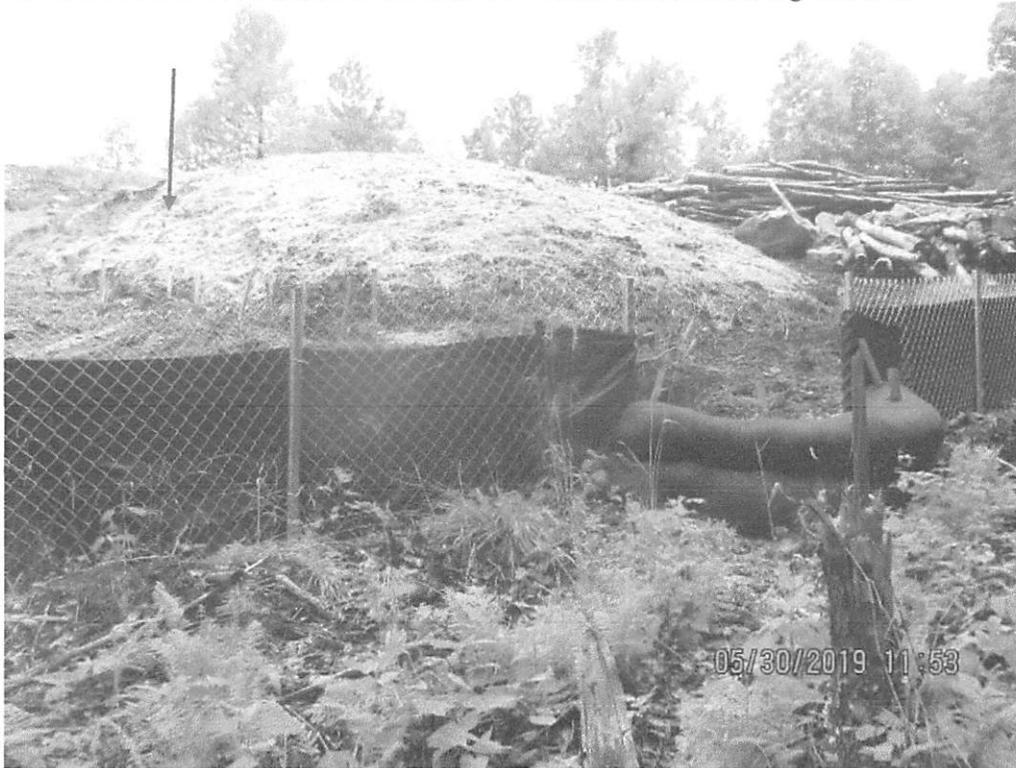
Topsoil pile slipping into waterbar at station 6508+40.

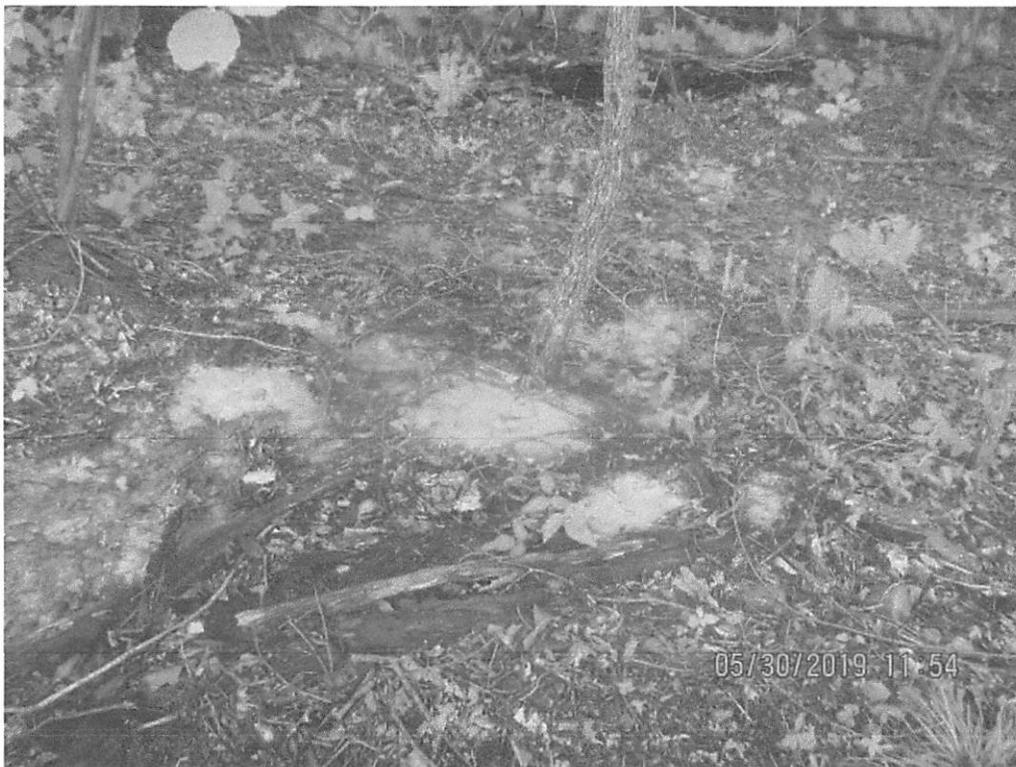
Facing upslope at waterbar and topsoil pile at station 6508+30. Arrow depicts topsoil pile that is slipping into waterbar.

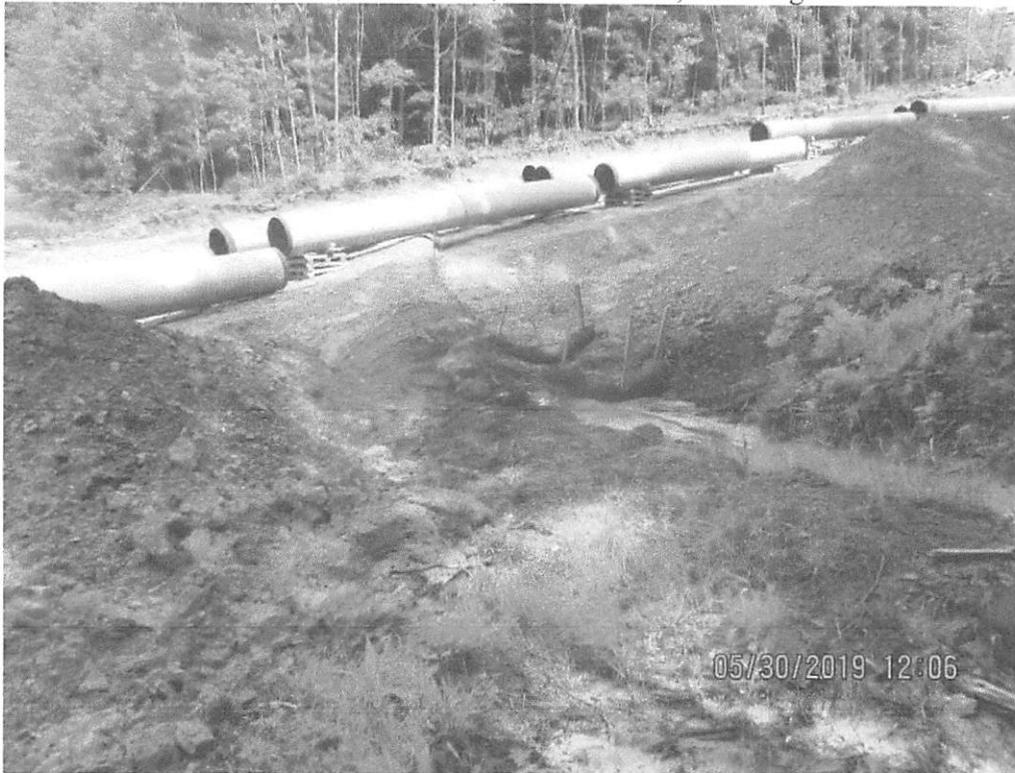
Sediment deposits observed past LOD and controls below waterbar and topsoil pile at station 6508+30.

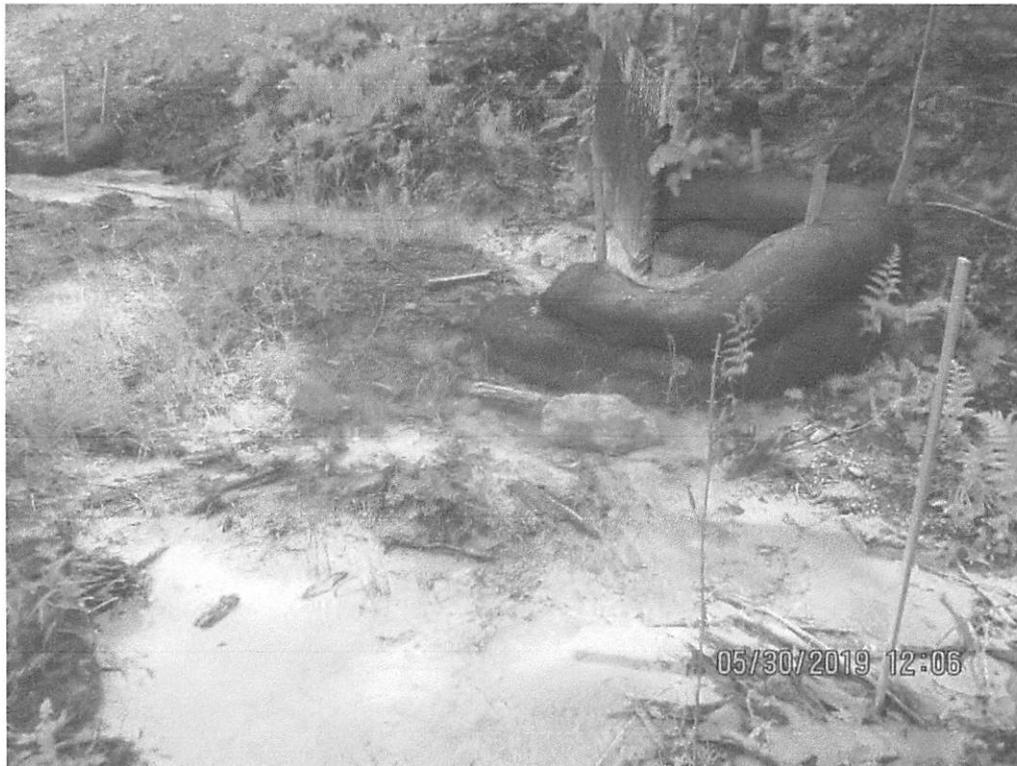
Waterbar at station 6510+40 facing upslope.

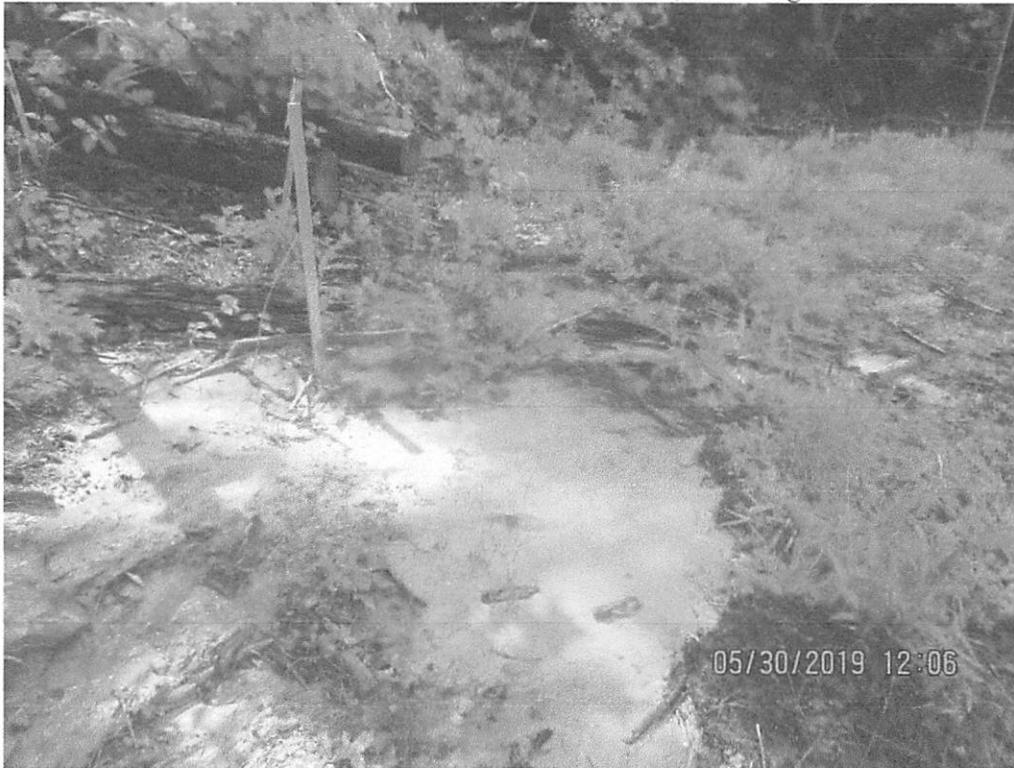
Waterbar outlet at station 6510+40 facing upslope. Sediment deposits were observed past LOD and were conveyed toward Wetland W-N18.

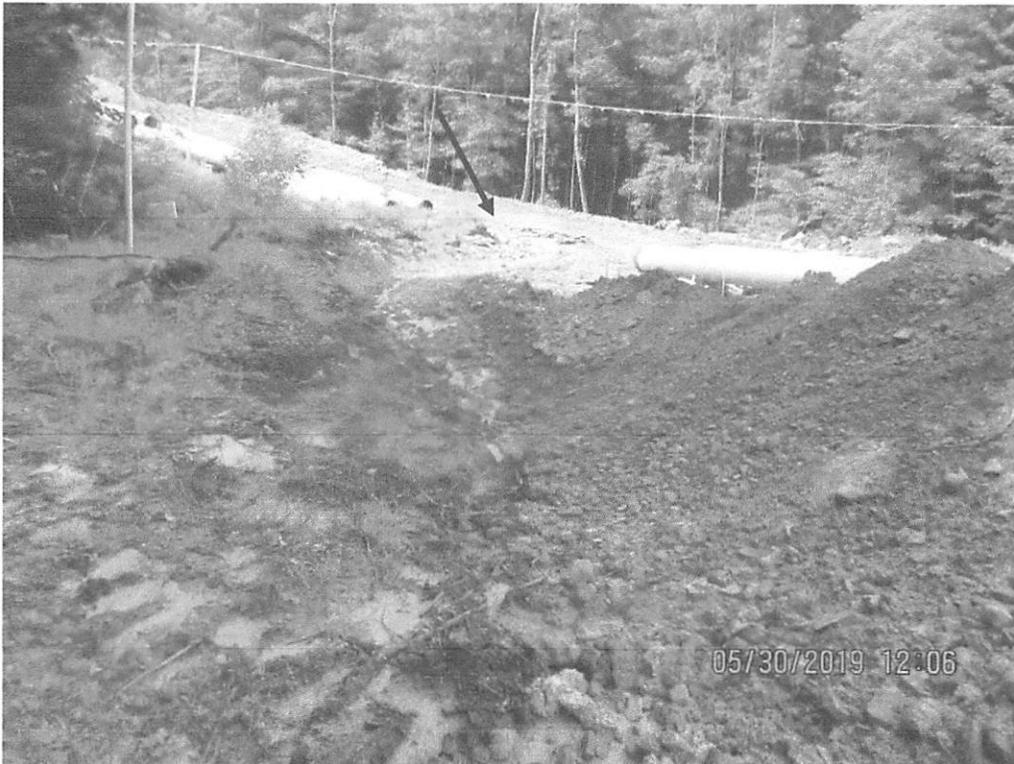
Sediment deposits downslope of waterbar outlet at station 6510+40.

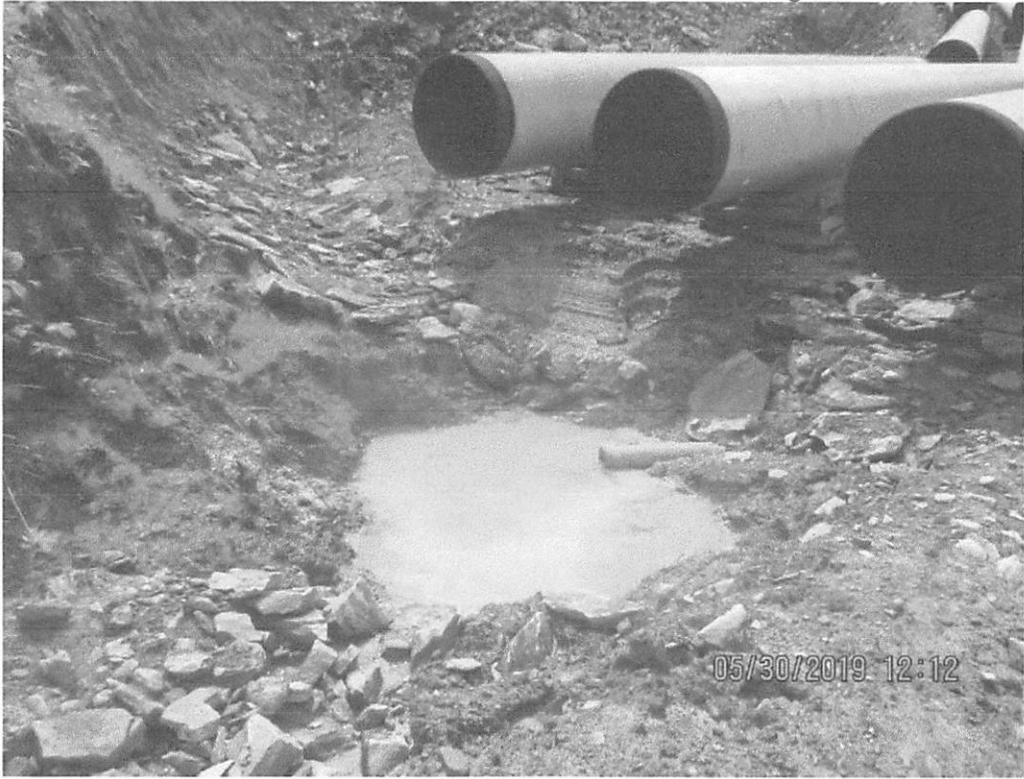
Sediment deposits and SLW traveling downslope at station 6510+40. Seep was present in cut next to topsoil pile. Channel was not stabilized and conveyed to a sump with a slope drain that crosses ROW. Arrow depicts seep. Black arrow shows sump with slope drain inlet.

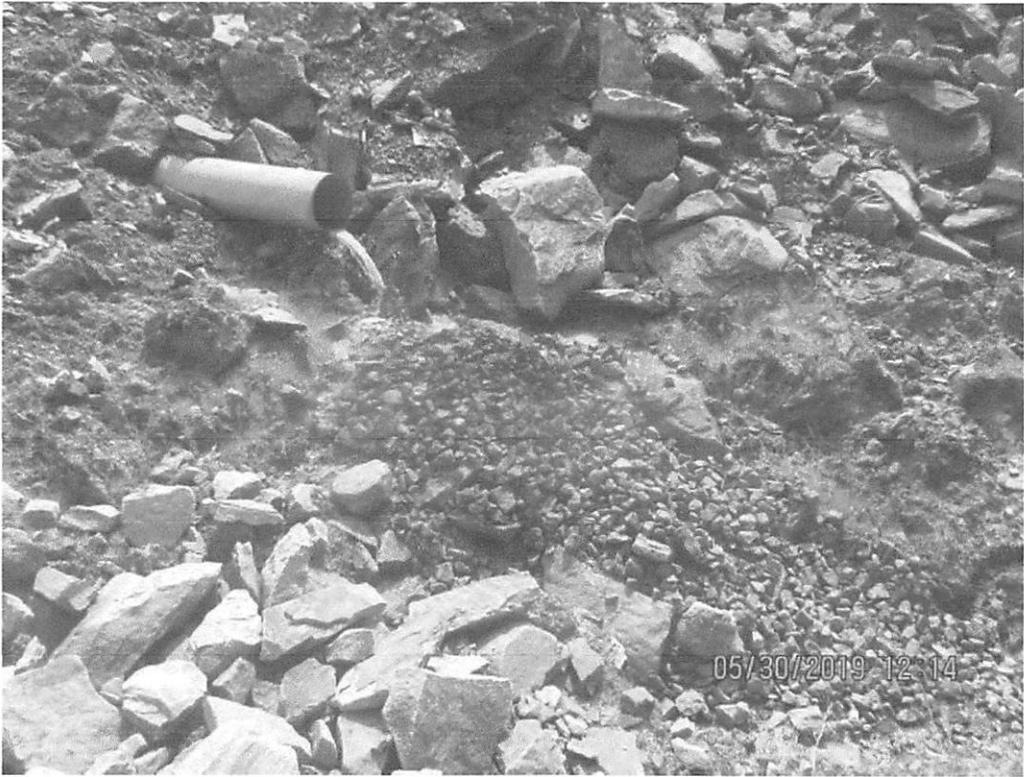
Sump present downslope of seep with culvert inlet at station 6510+40.

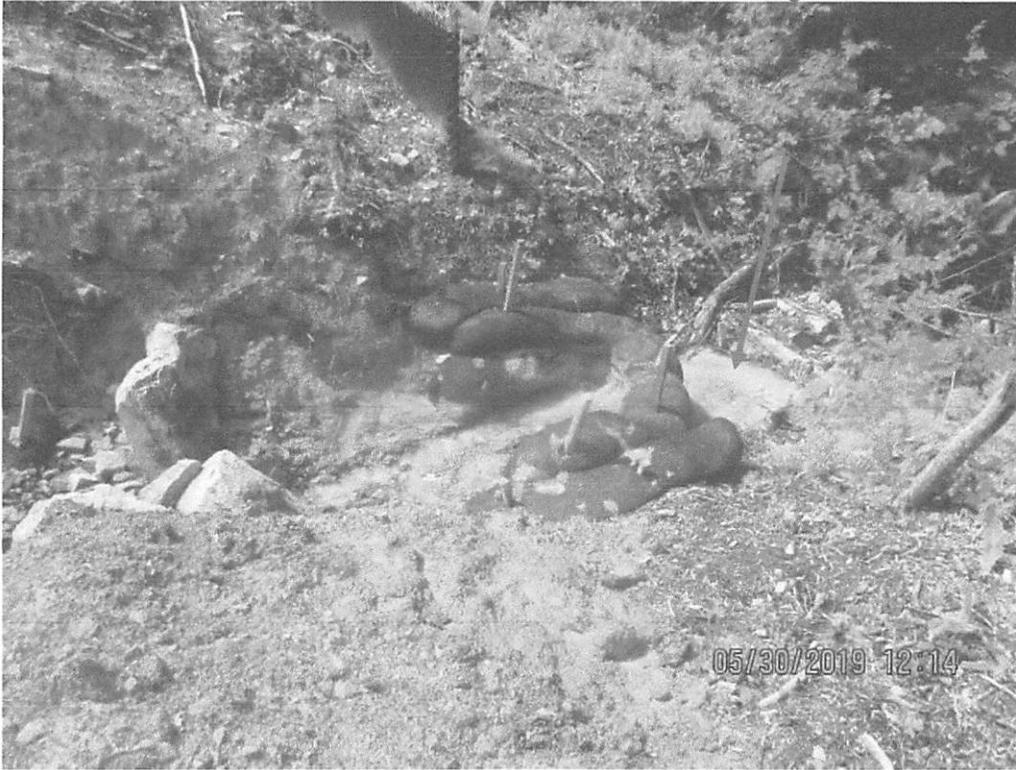
Culvert outlet downslope of seep at Station 6510+40.

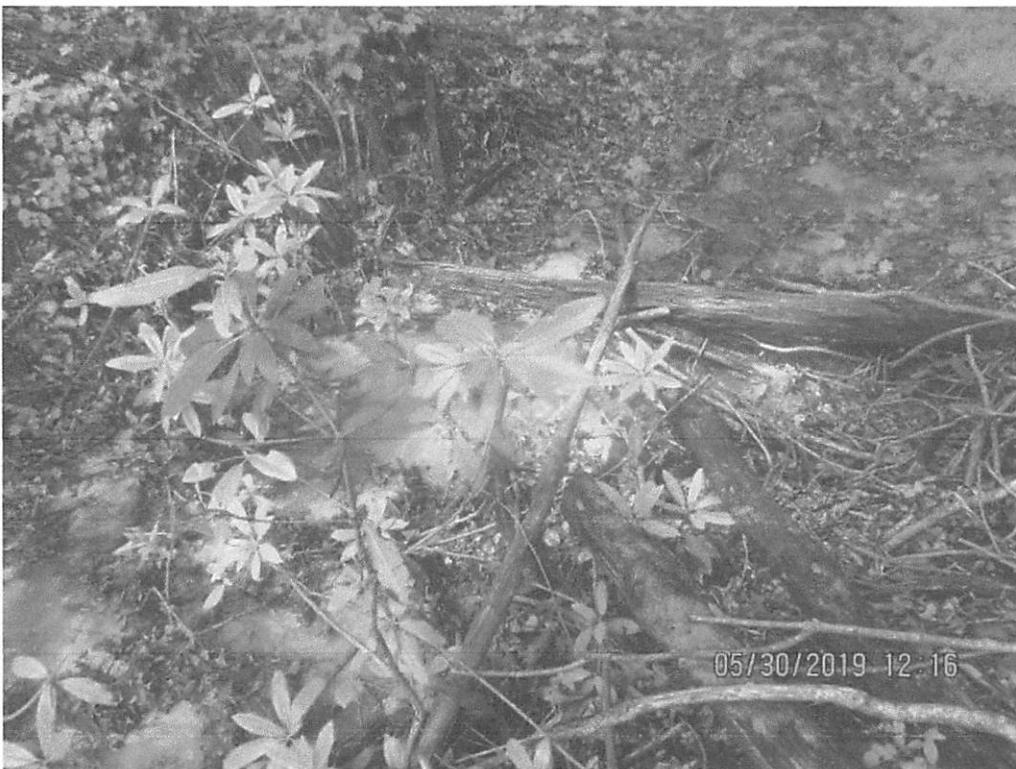
Downslope of slope drain outlet below seep coming onto ROW at Station 6510+40. SLW and sediment overwhelming controls.

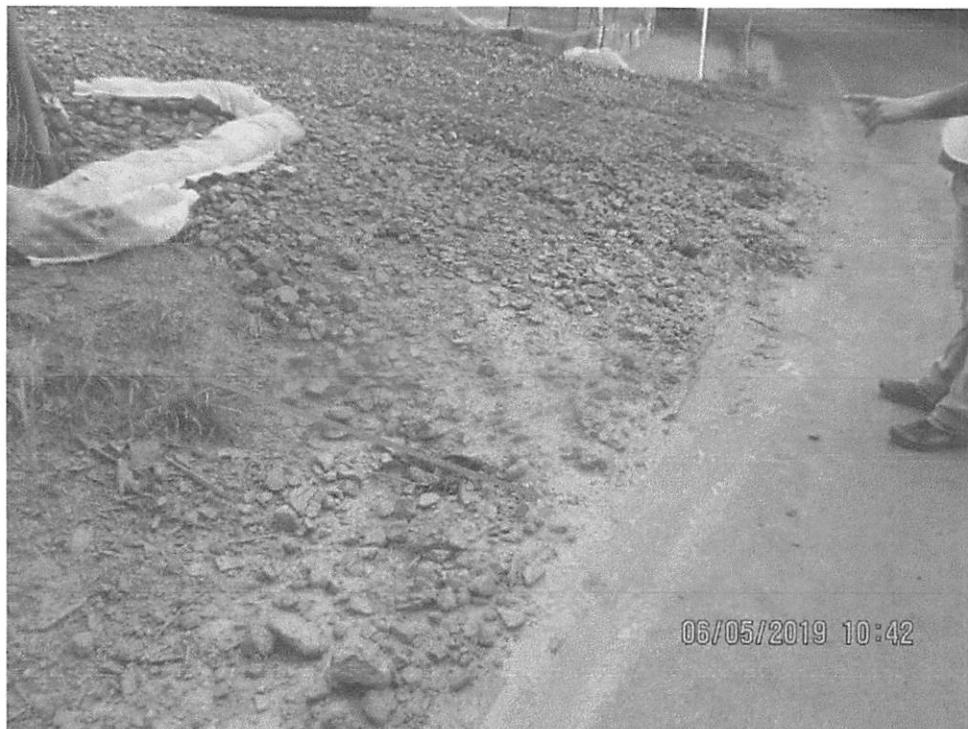
Erosion (Red Arrow) and Sediment/SLW overwhelming perimeter controls at ATWS-22-7A at station 6514+60. Sediment deposits observed past controls and LOD.

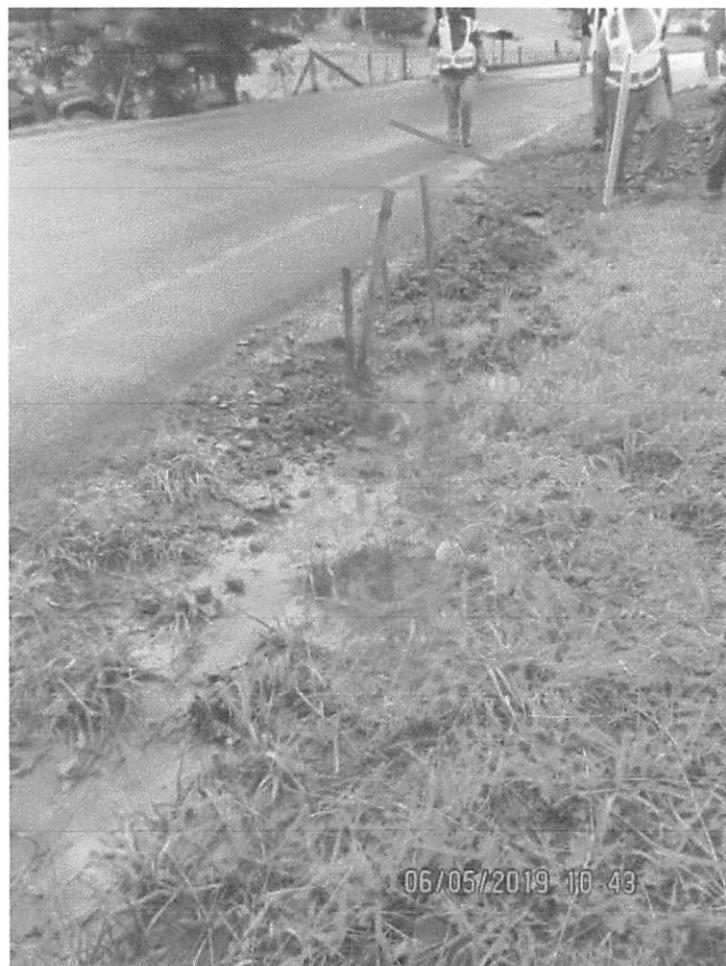
Construction entrance at the Route 82 crossing at station 5539+00. Arrow depicts culvert inlet.

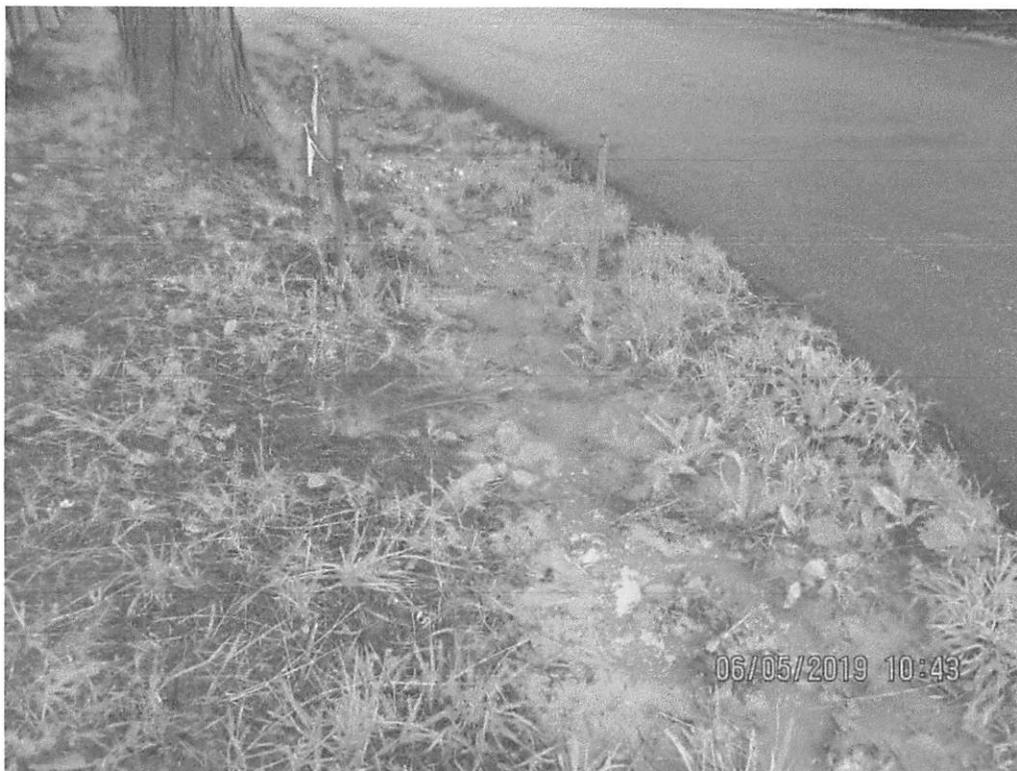
Roadside ditch and culvert outlet. Sediment-laden water being conveyed downslope.

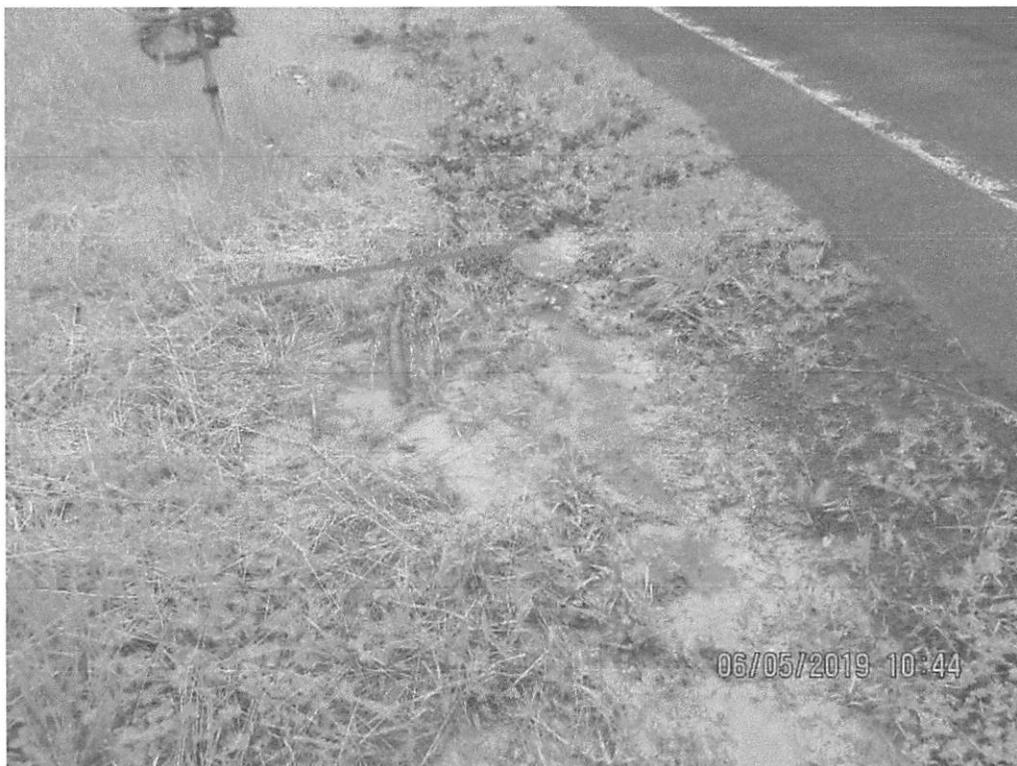
Sediment deposits and sediment-laden water being conveyed past the LOD along Route 82.

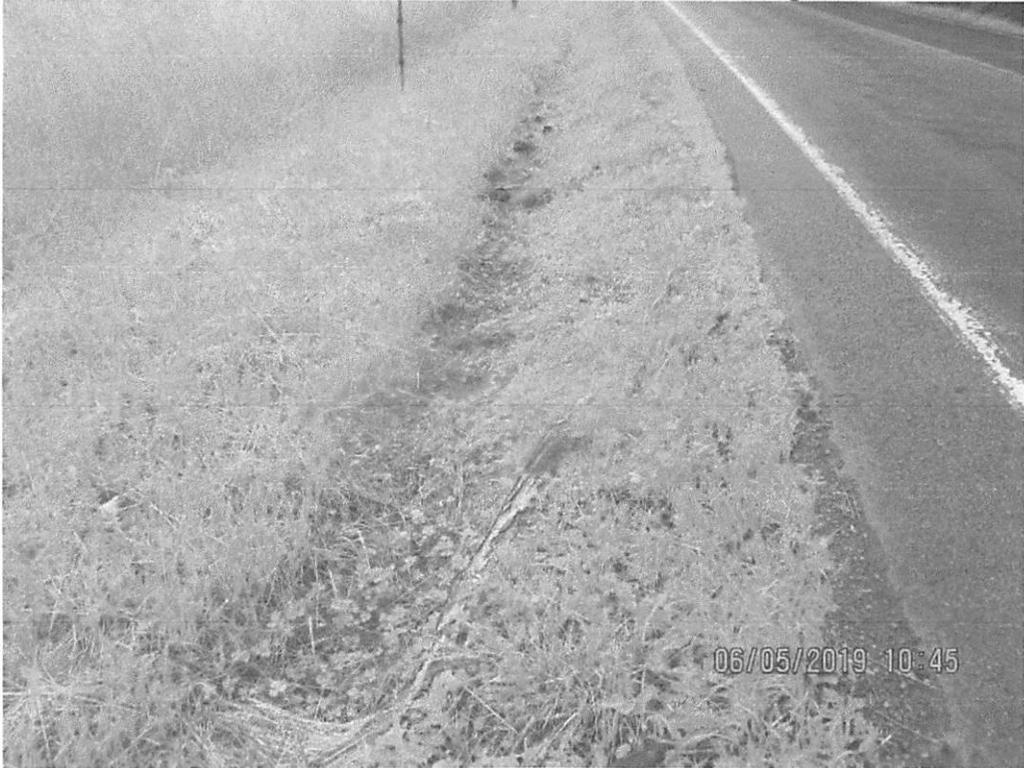
Sediment deposits in roadside ditch that parallels route 82. Arrow depicts culvert intake that conveys under route 82.

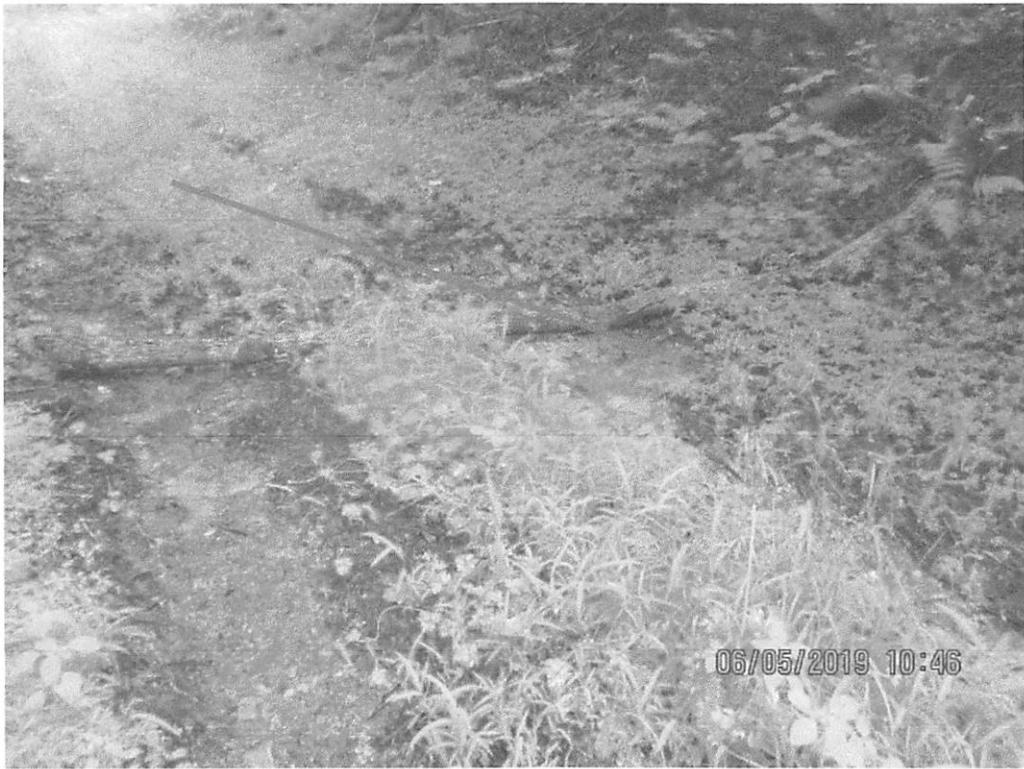
Upslope of culvert intake that conveys under route 82.

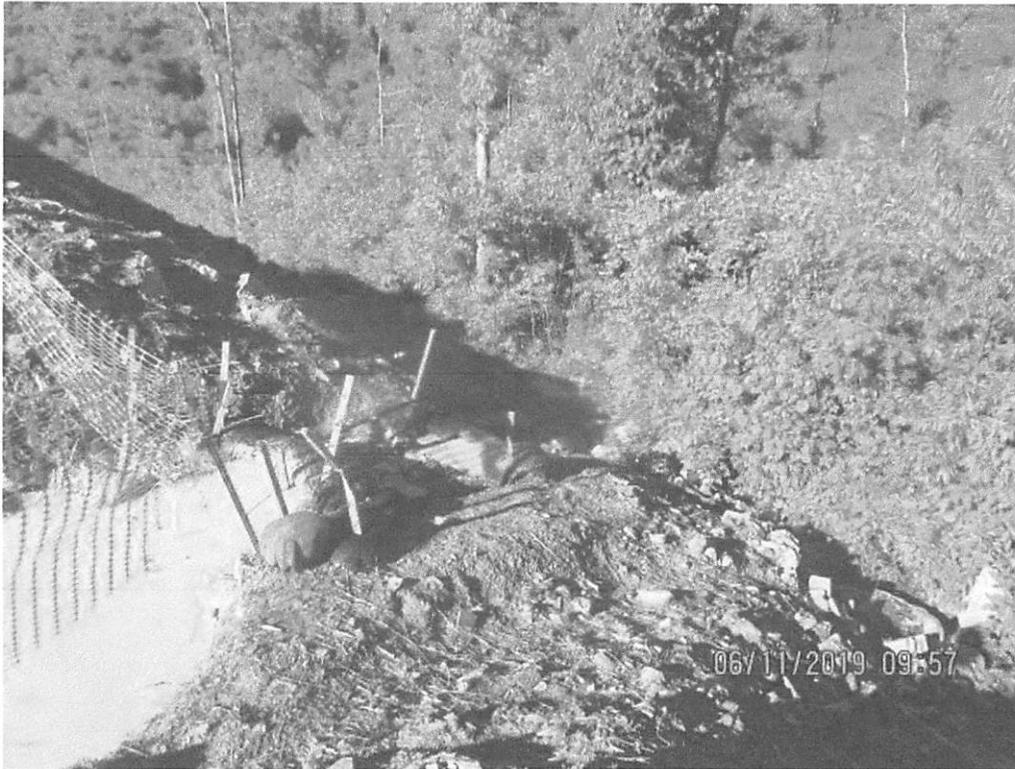
Sediment deposits approximately 500 ft past the LOD downslope of construction entrance.

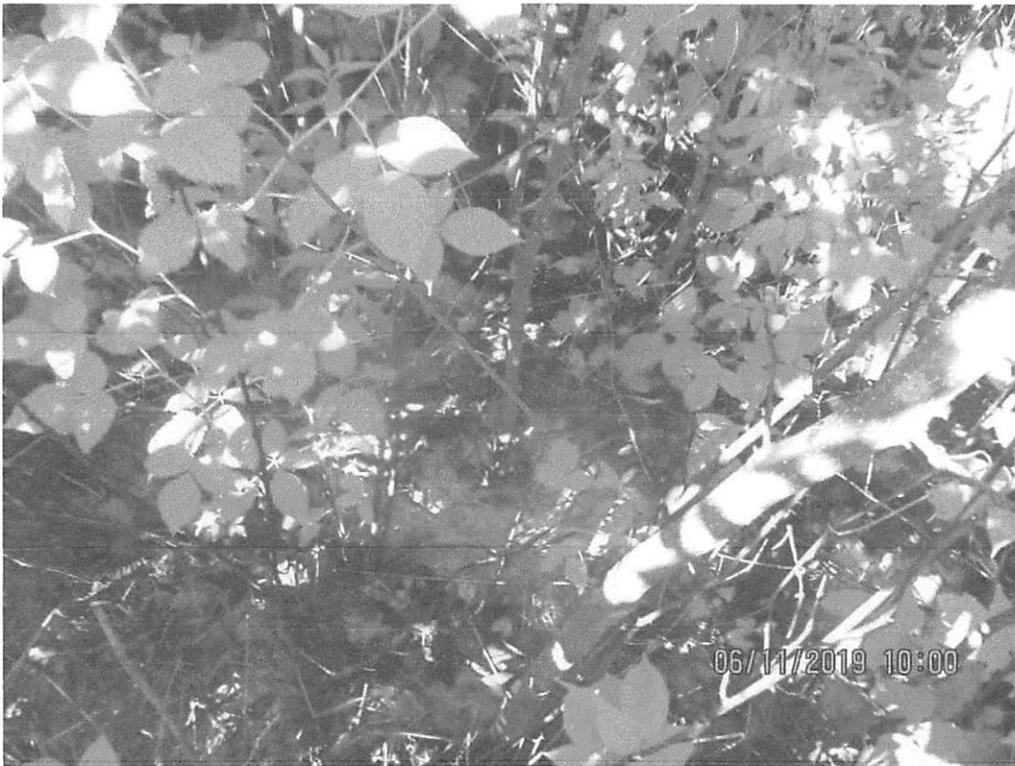
Station 7590. Waterbar outlet was overwhelmed with sediment and deposits were present past the LOD.

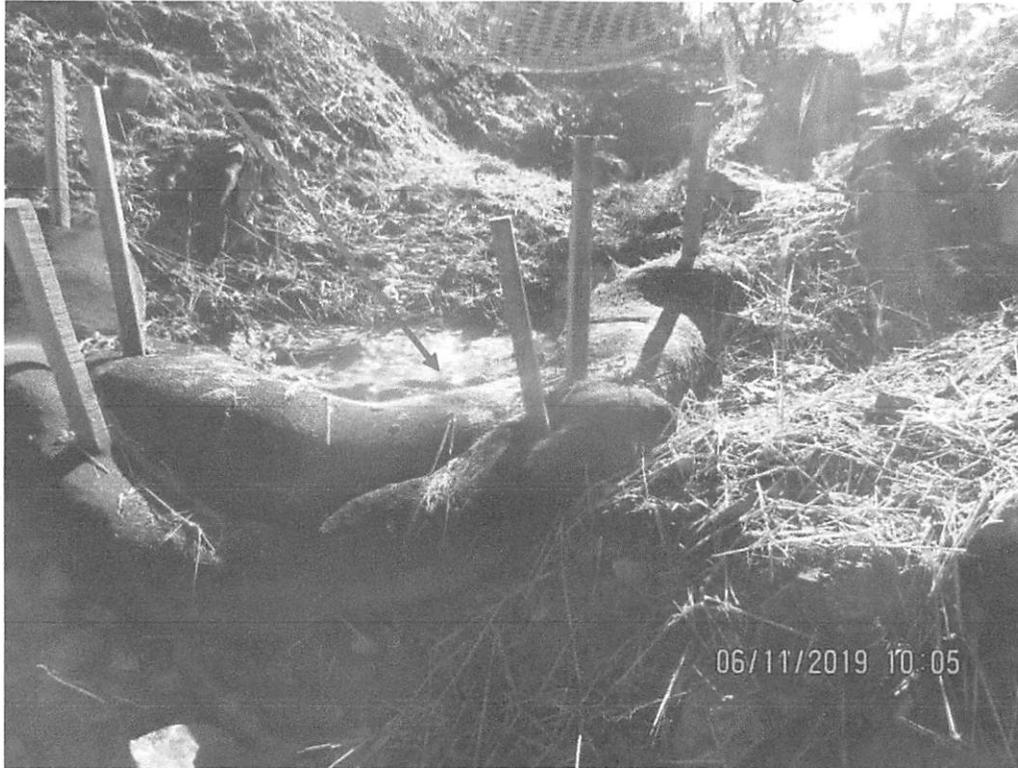
At station 7590 downslope of waterbar outlet sediment deposits were present past the LOD.
