**CONSENT ORDER
ISSUED UNDER THE
WATER POLLUTION CONTROL ACT
WEST VIRGINIA CODE, CHAPTER 22, ARTICLE 11**

TO: Mountain Valley Pipeline, LLC
Robert J. Cooper
2200 Energy Drive
Canonsburg, PA 15317

DATE: December 17, 2020

ORDER NO.: 9925

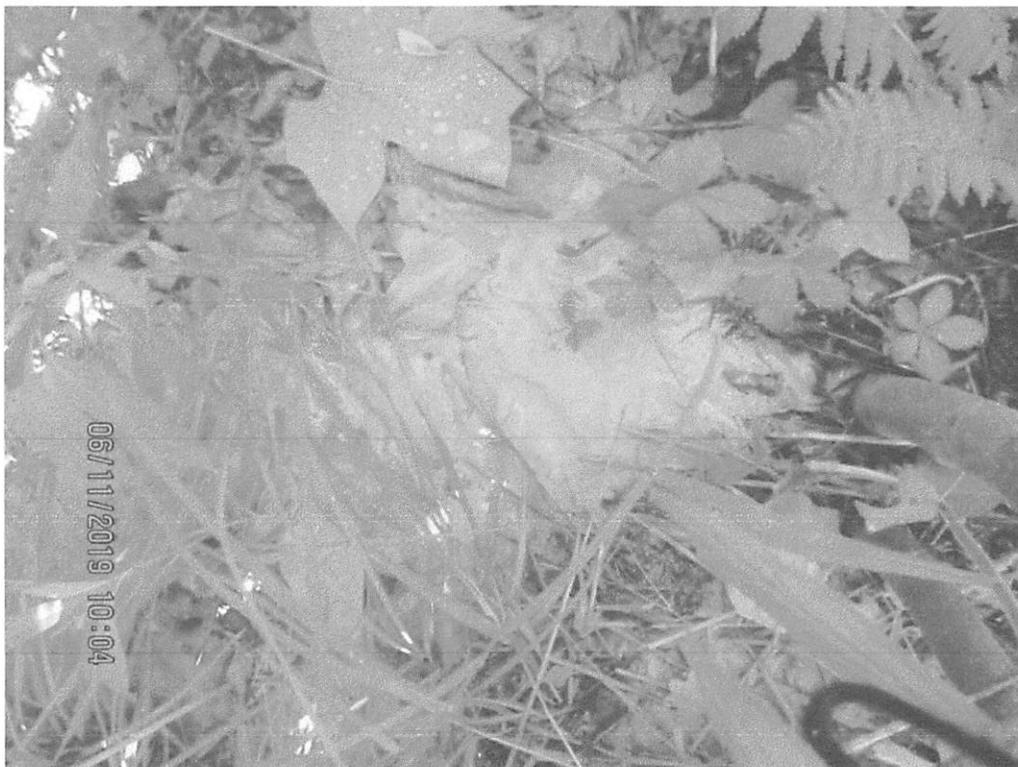
200 ft upslope of Krosier road crossing. Waterbar outlet in need of maintenance. Controls overwhelmed with sediment. Deposits present past LOD.

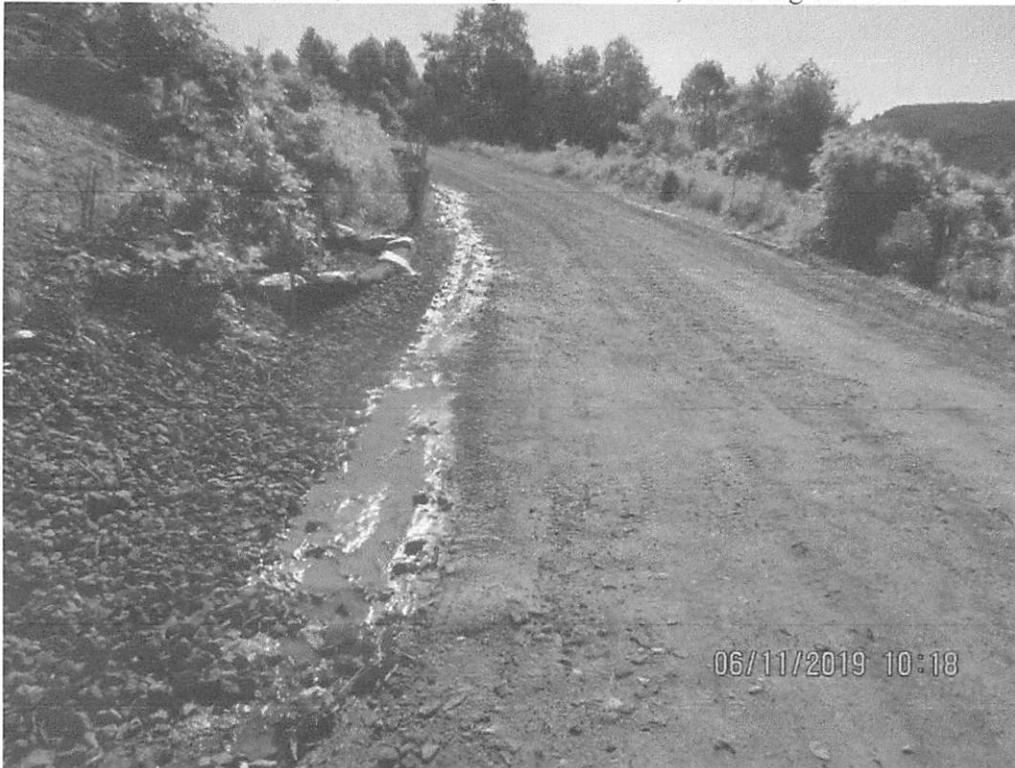
200 ft upslope of Krosier road crossing. Deposits present past LOD downslope of waterbar outlet.

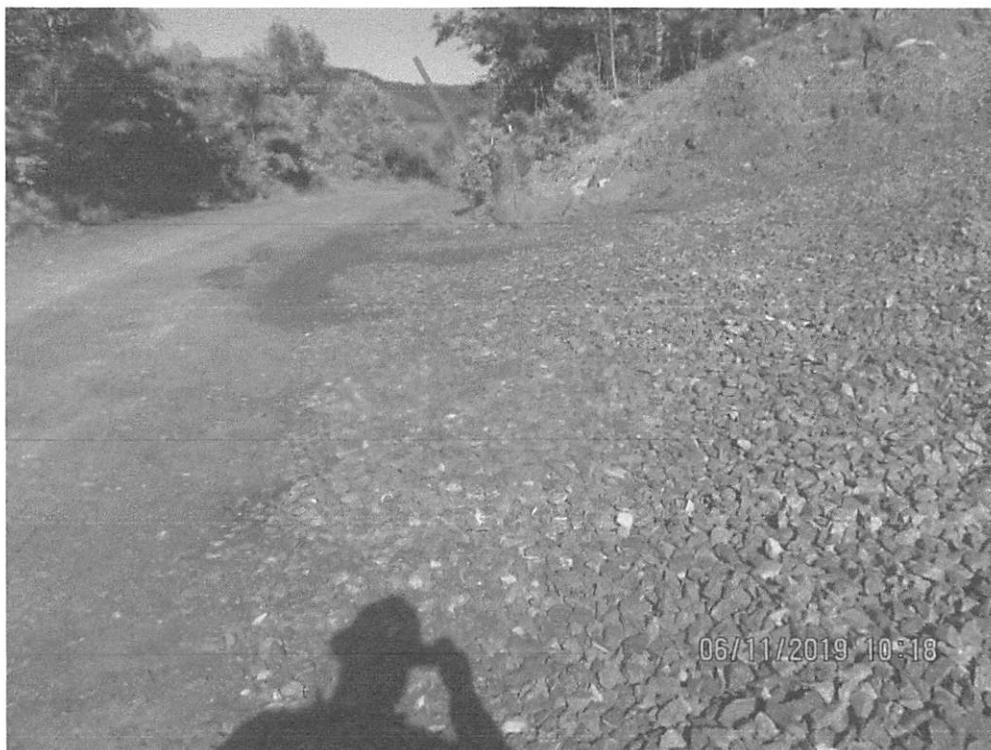
Upper Krosier Road Crossing facing East.

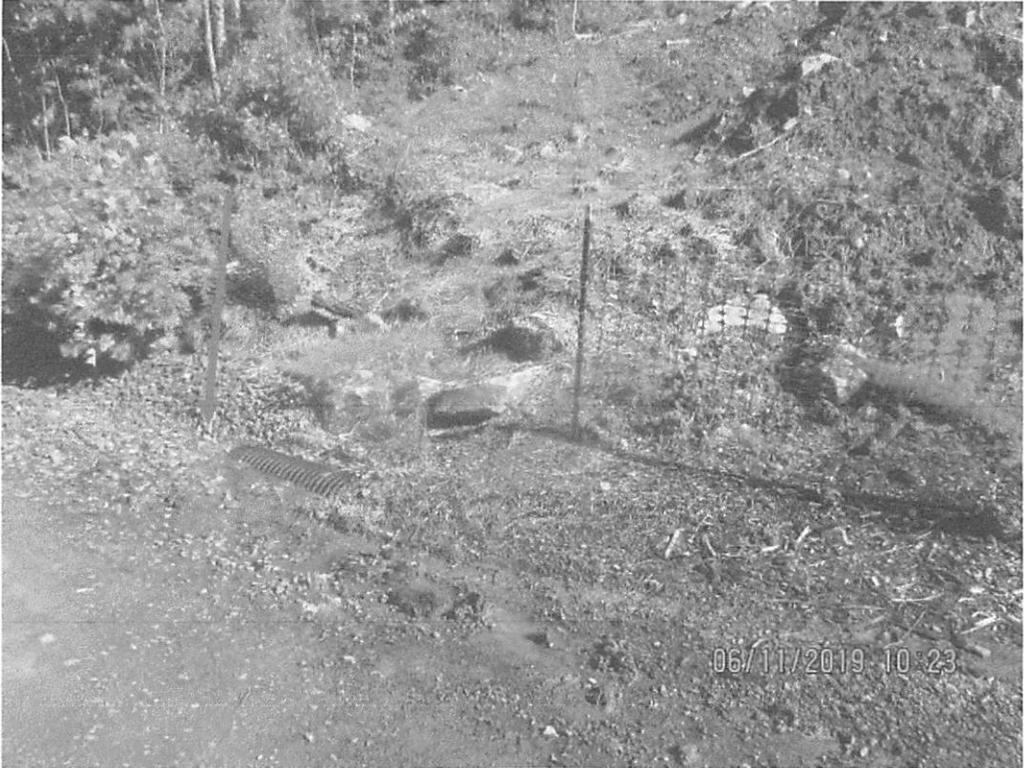
Culvert outlet with sediment deposits in ditch line. Erosion present on slope above outlet. Arrow depicts deposits present in ditch.

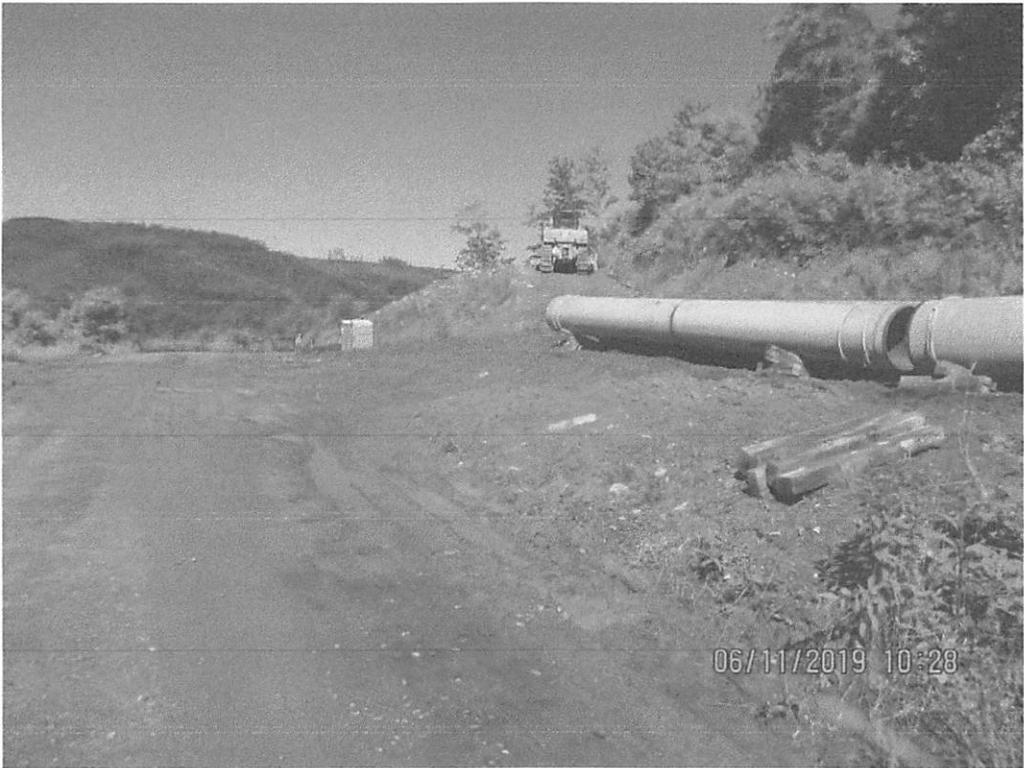
on Krosier road facing east at additional workspace and ROW crossing. Mud and sediment present on road. Run-off flowing toward culvert inlet along Krosier road. Arrow depicts culvert inlet location.

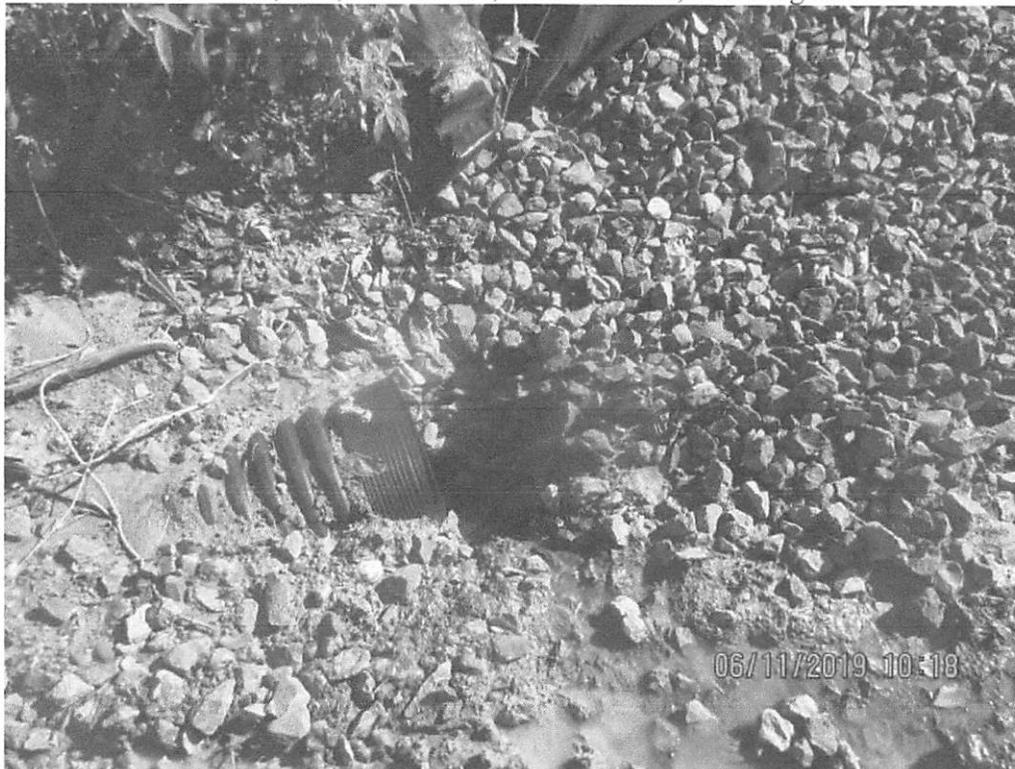
Culvert inlet with sediment present around the inlet at Krosier road ROW crossing. Downslope of additional workspace and upslope of construction entrance and crossing.

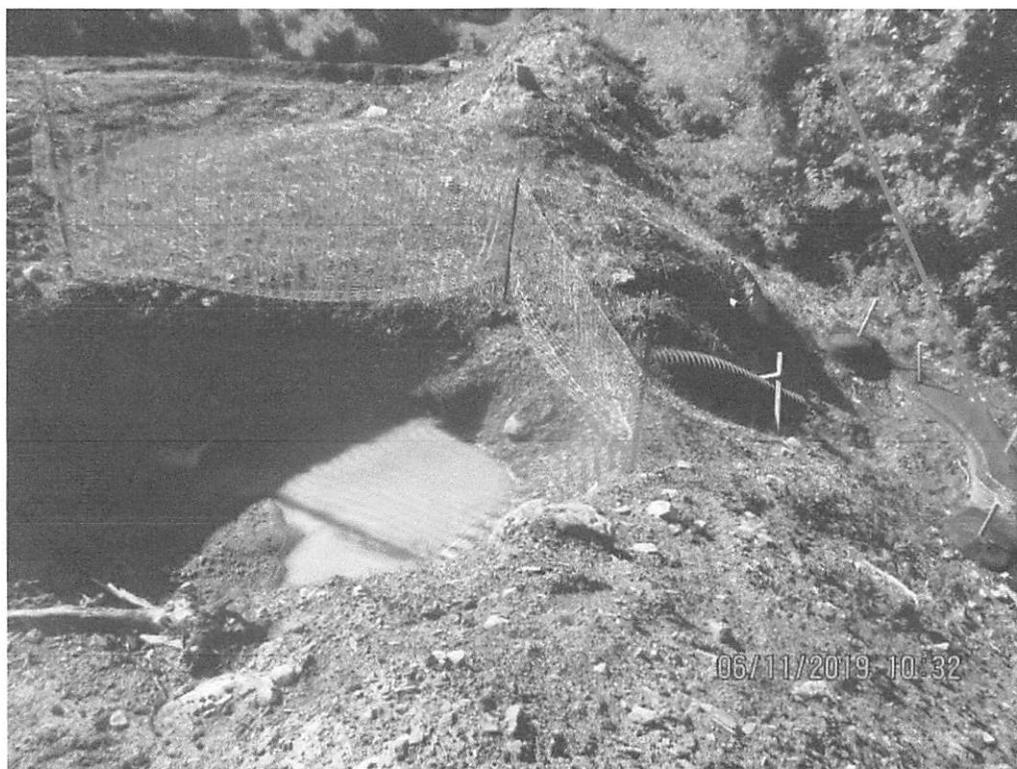
Downslope of Krosier Road Crossing near station 7576+01. Waterbar outlet perimeter controls in need of maintenance. SLW and deposits were present past controls and LOD. Arrow depicts sediment backed up behind controls causing SLW to overtop the control.

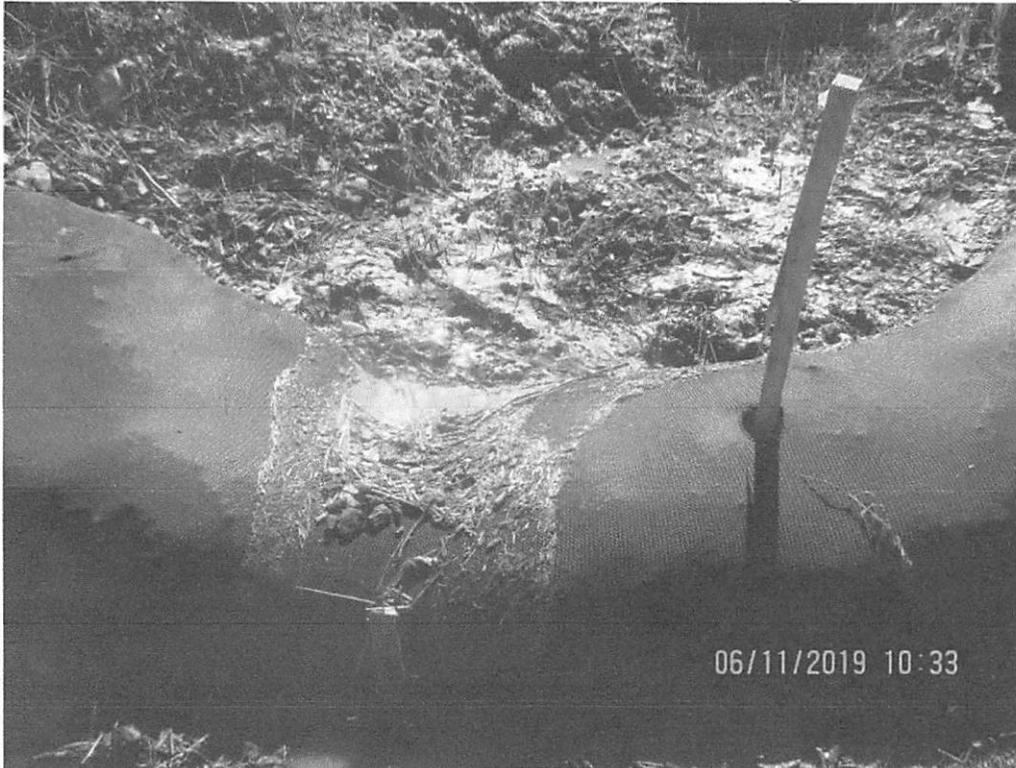
Perimeter control being overtopped with SLW and sediment backed up behind control.

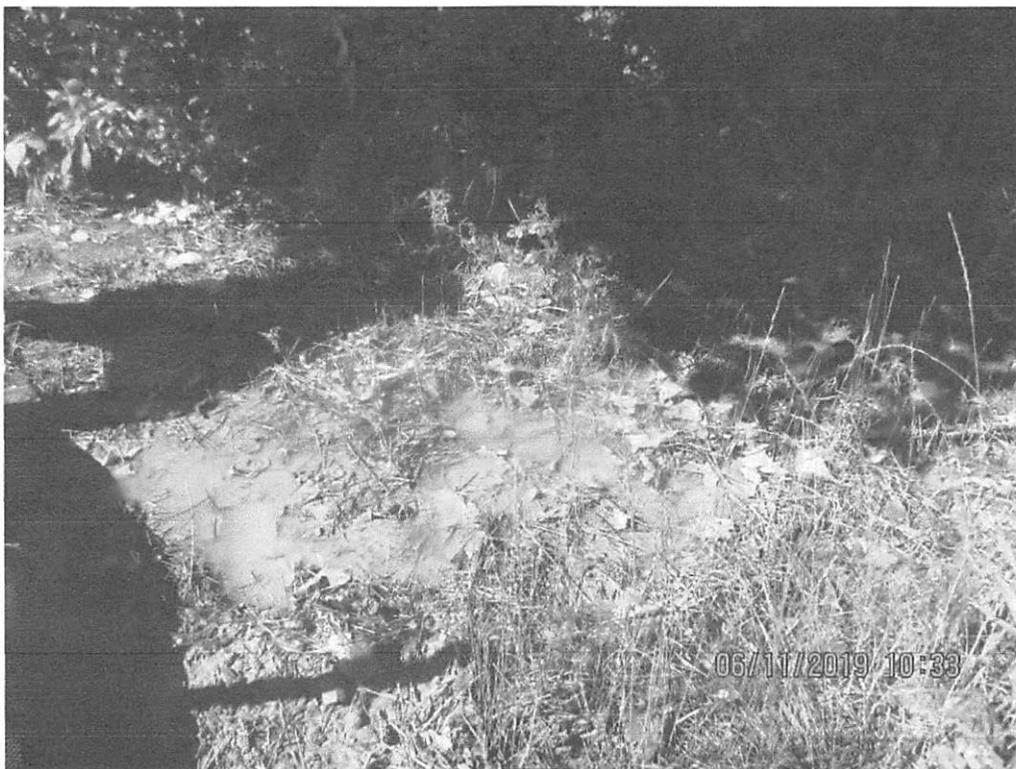
Downslope of Krosier Road Crossing near station 7576+01. SLW and deposits were present past controls and LOD.

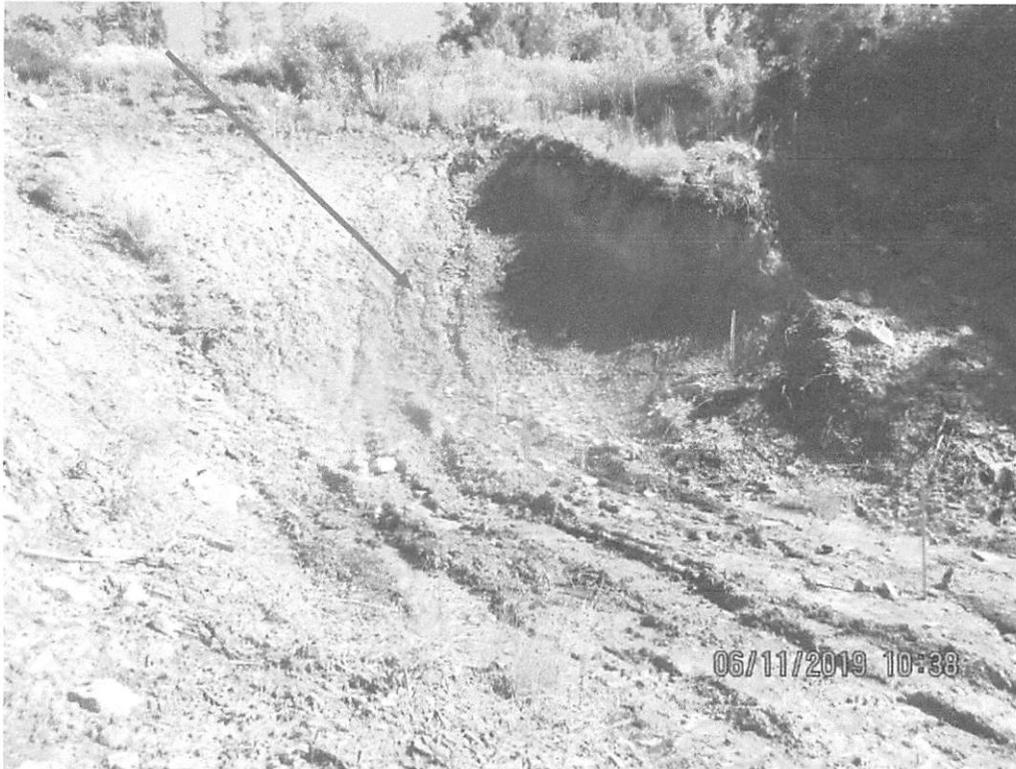
Below upper Krosier Road crossing near station 7576+01 facing North. Erosion present on slope due to seep running onto ROW.

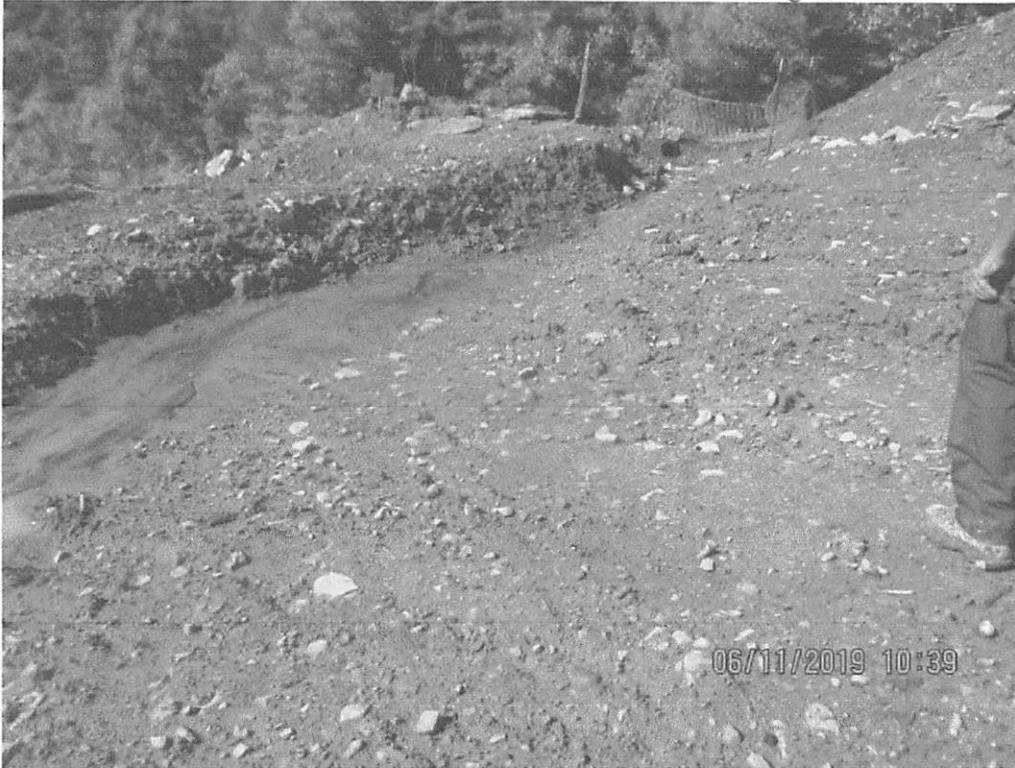
Below upper Krosier Road crossing near station 7576+01 facing toward waterbar outlet. Erosion present on slope due to seep running onto ROW causing sediment to be deposited in waterbar.

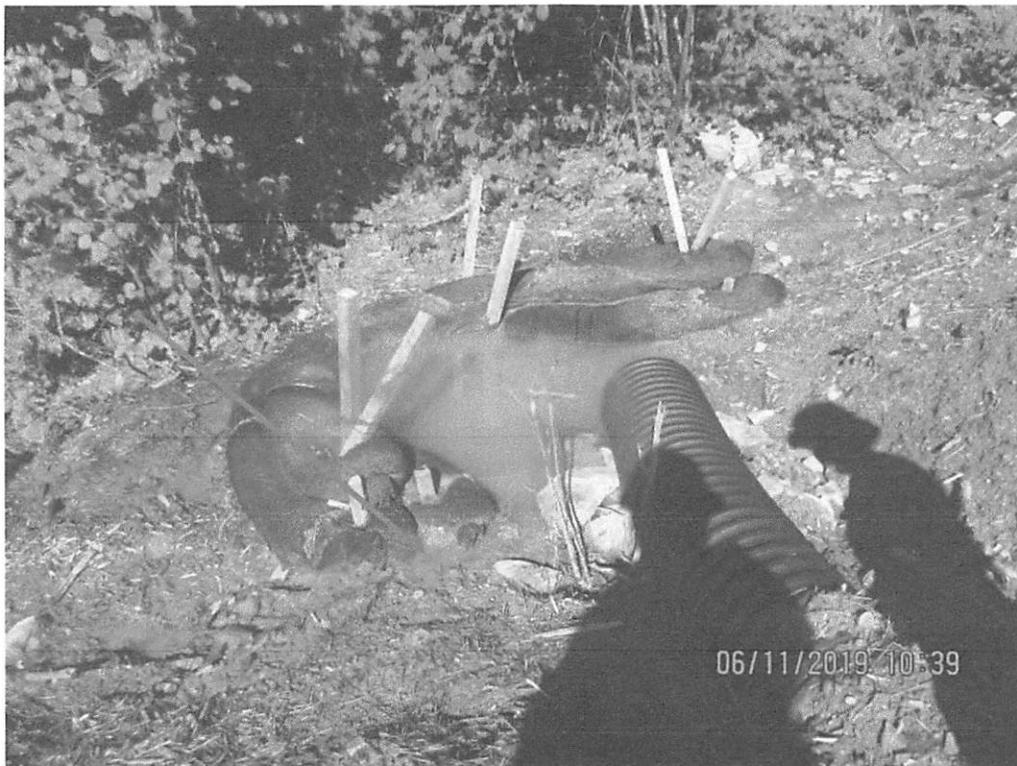
Below upper Krosier Road crossing near station 7576+01 facing downslope below waterbar outlet. Arrow depicts where run-off was flowing around controls and causing erosion downslope of controls.

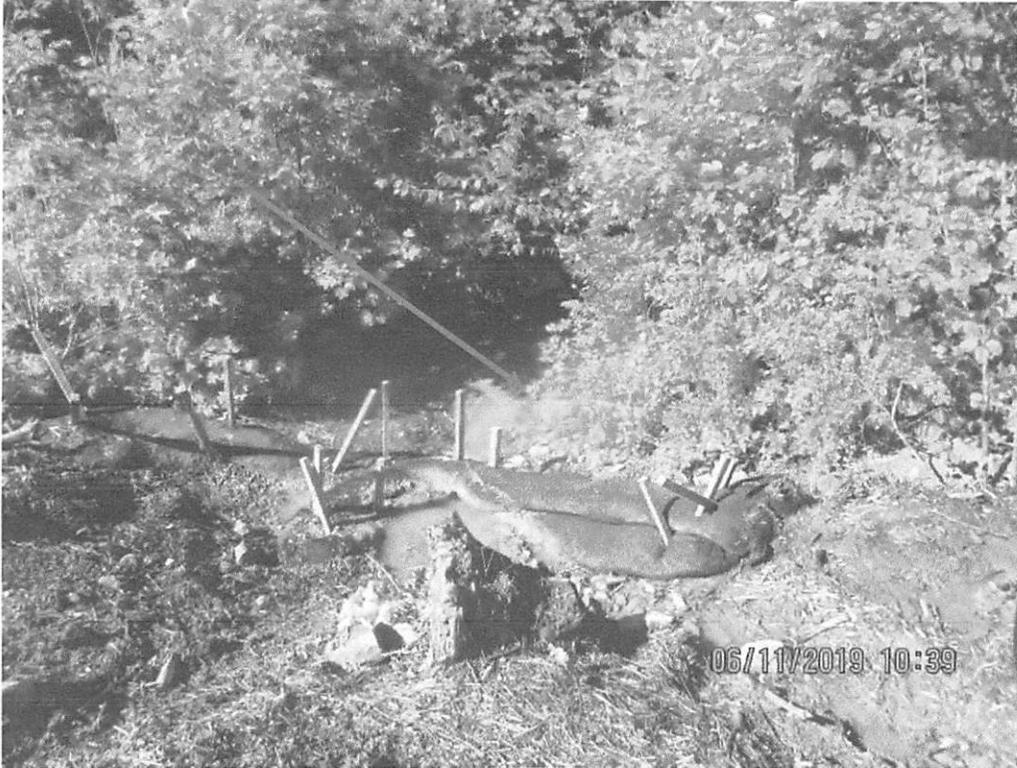
at station 7576+01 downslope of waterbar with sediment deposits due to run-on from seep. Controls overwhelmed with sediment. Erosion on slope, SLW, and deposits observed past LOD and controls.

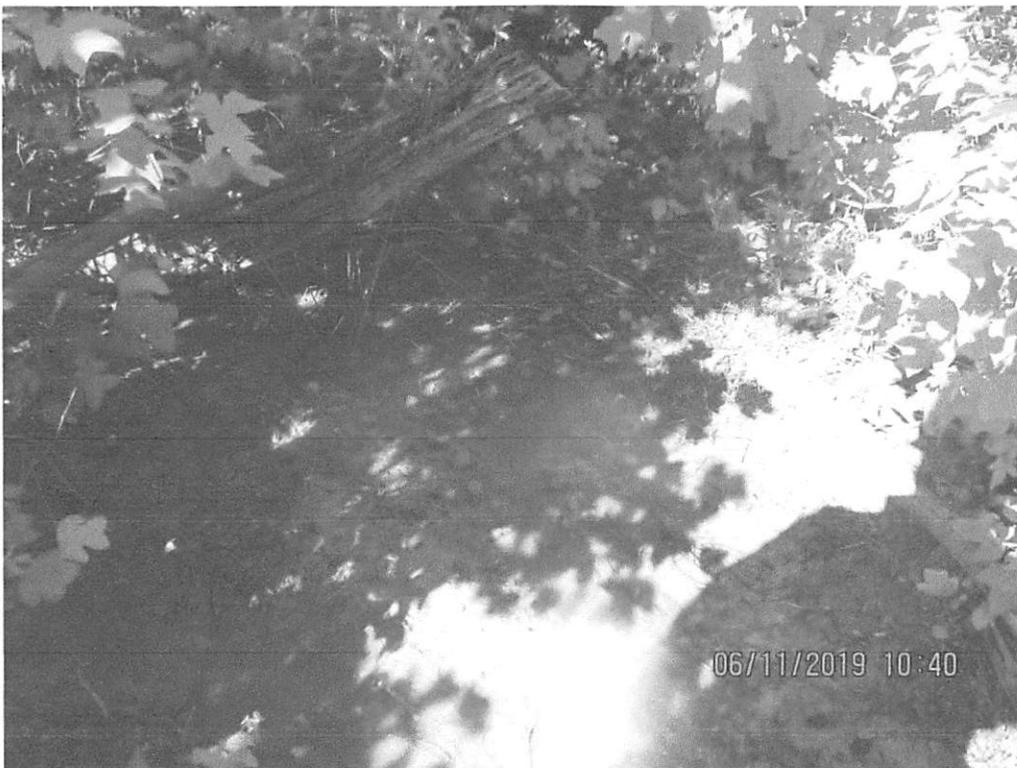
Station 7576+01 downslope of waterbar with sediment deposits due to run-on from seep. SLW and deposits observed past LOD and controls.

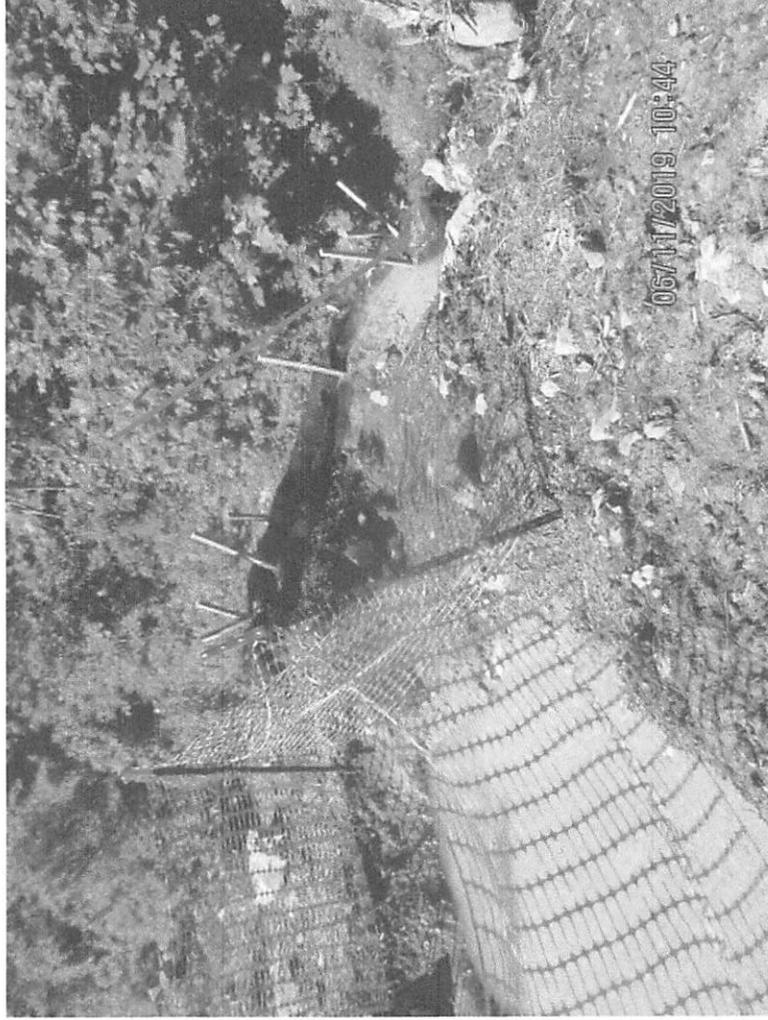
Waterbar outlet near 7604+41. Sump and perimeter controls in need of maintenance. Sediment deposited behind perimeter controls.

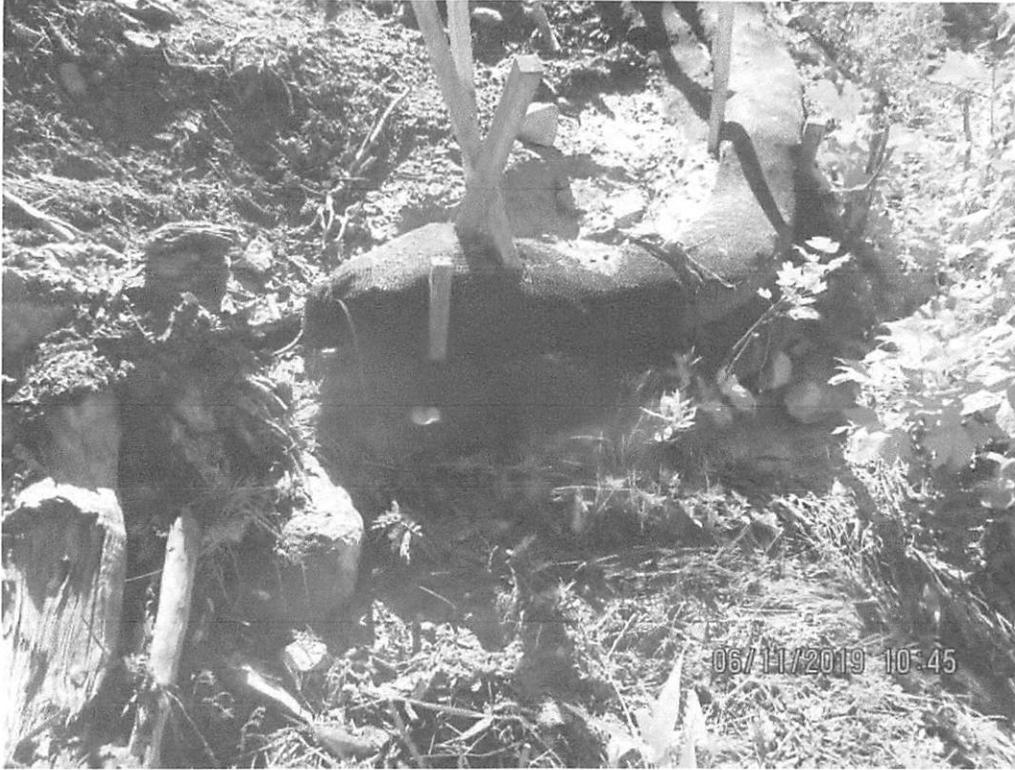
Downslope of waterbar outlet near 7604+41. Perimeter controls in need of maintenance. Sediment deposited behind perimeter controls. Sediment deposits observed past controls and LOD.

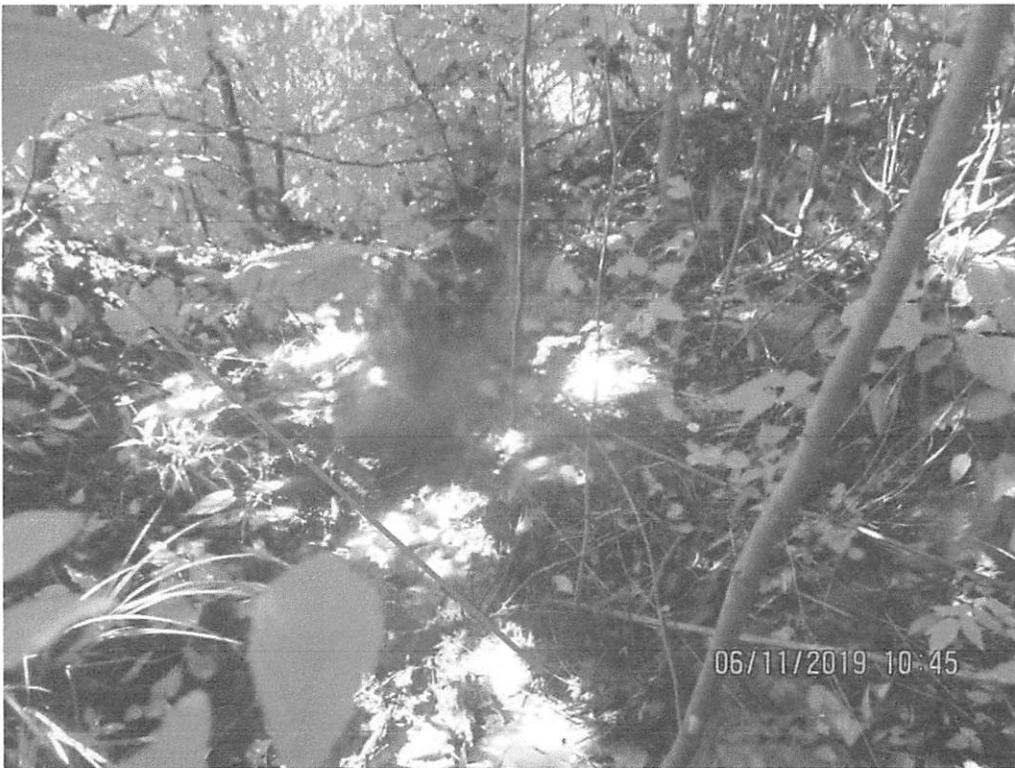
Downslope of waterbar outlet near 7604+41. Sediment deposits observed past controls and LOD.

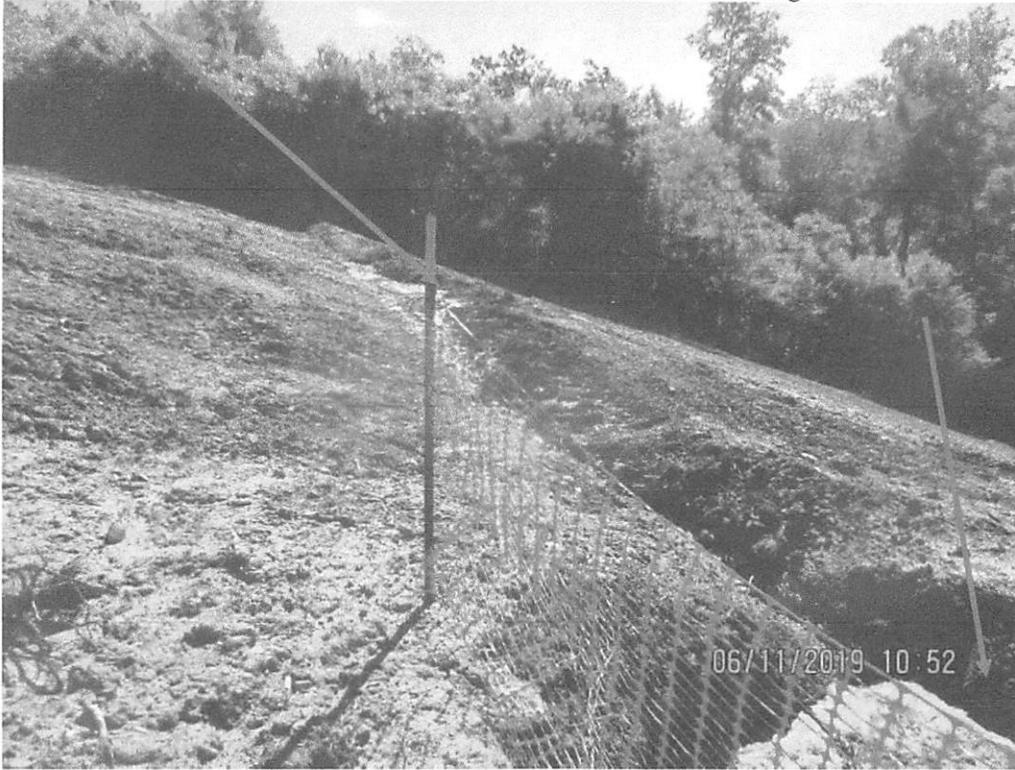
Above Station 7604+41. Waterbar with sediment deposits due to erosion upslope. Sump was full of sediment and needed maintained. Arrow depicts sediment in waterbar and sump.

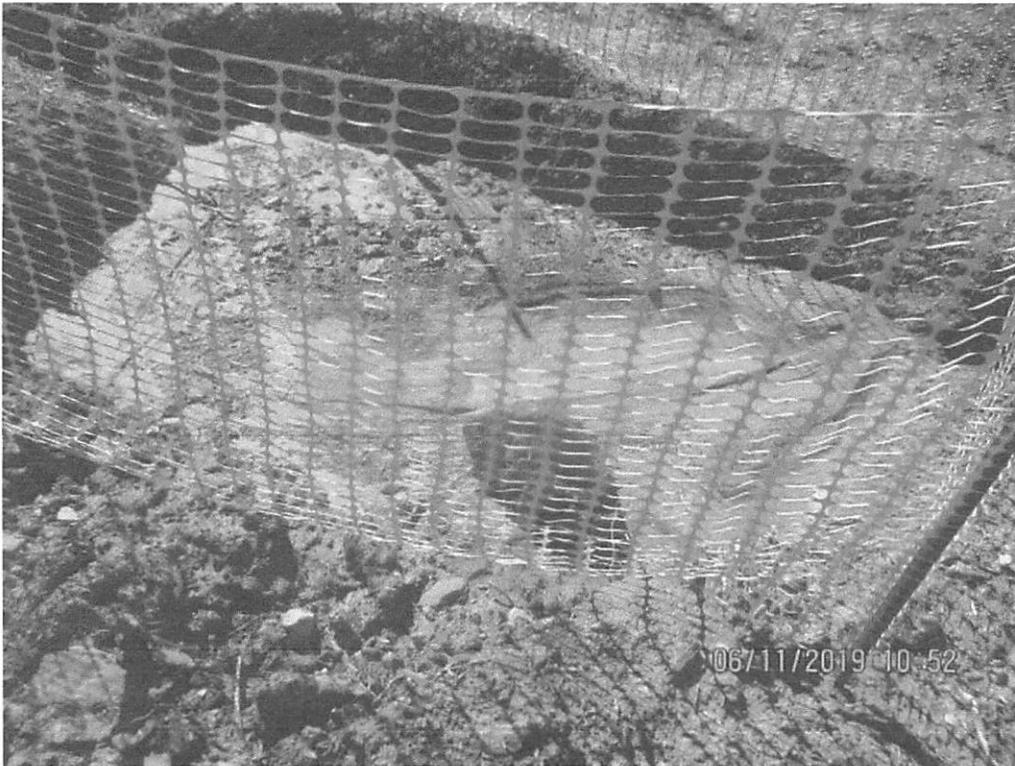
Above station 7604+41. Waterbar had sediment from erosion, causing sump to be full of sediment.

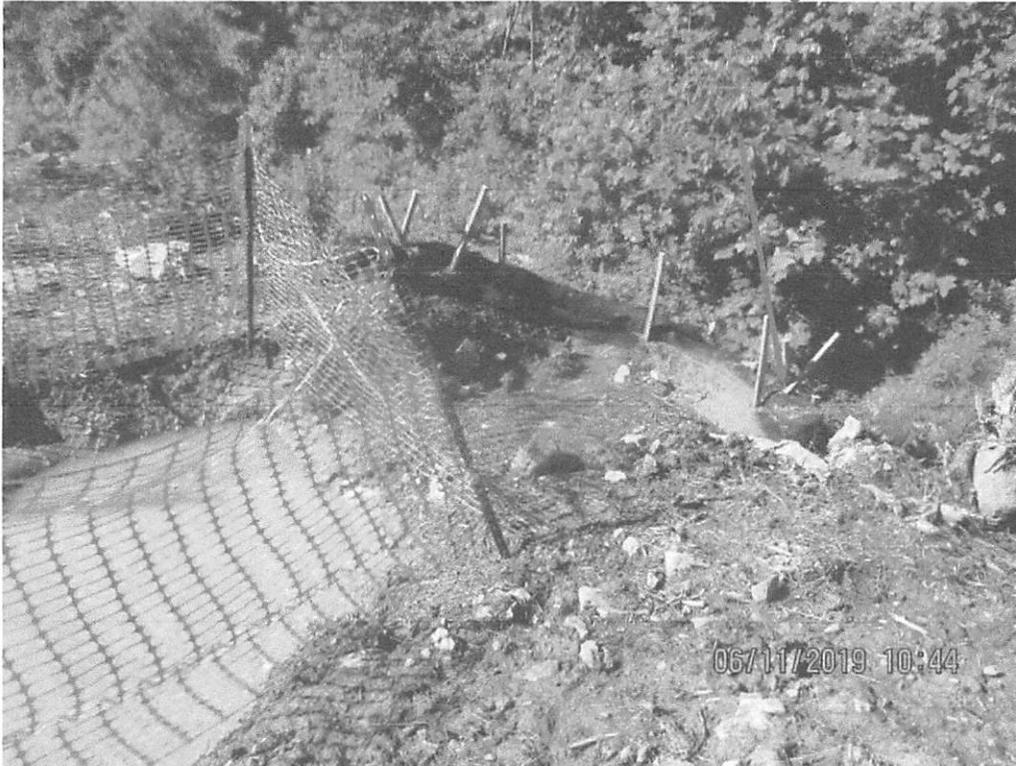
Above Station 7604+41. Controls below waterbar and sump had sediment due to erosion. Perimeter controls being overwhelmed with sediment.

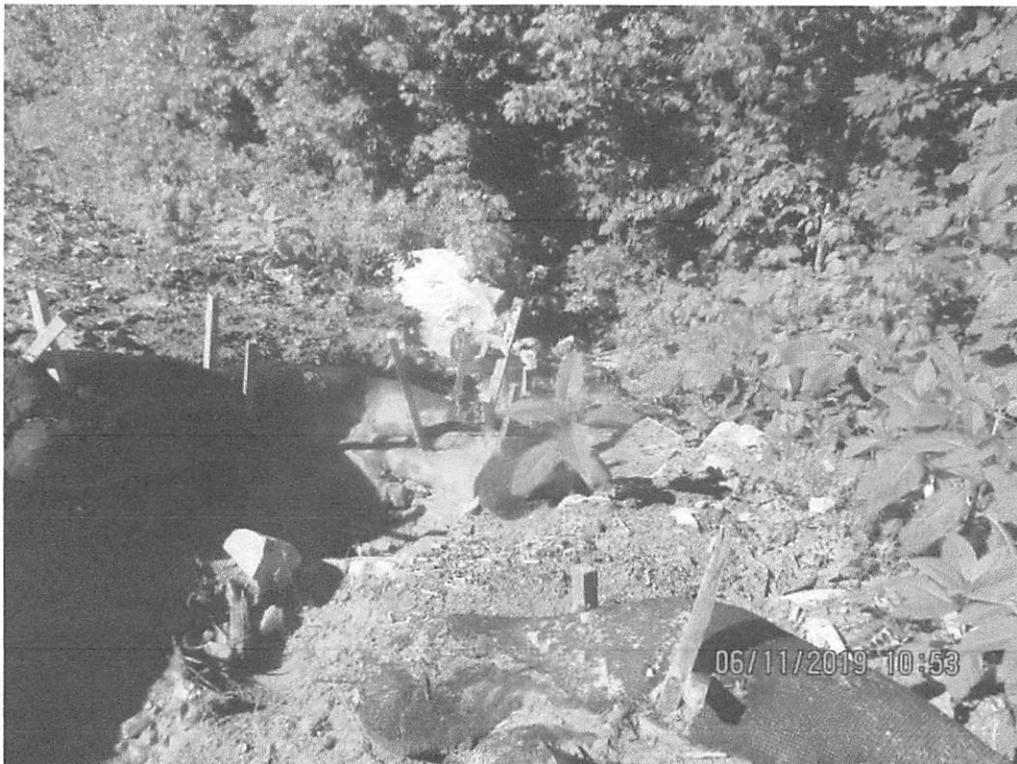
Above Station 7604+41. Perimeter controls overwhelmed with sediment. Sediment deposits present past LOD.

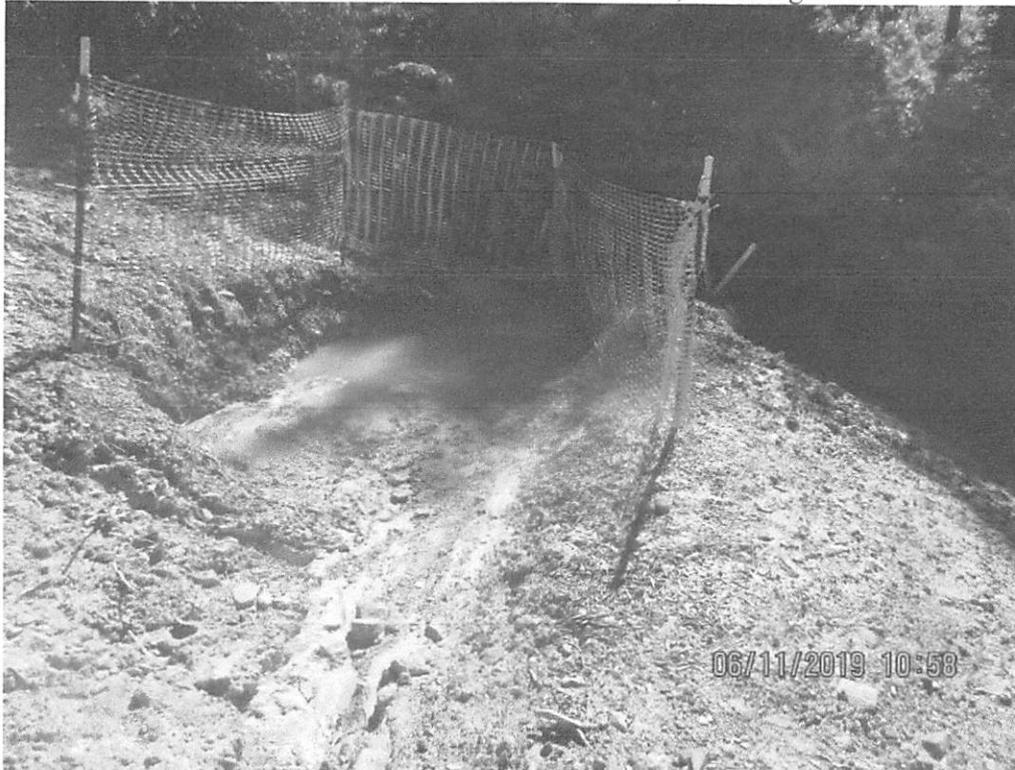
Above Lower Krosier Road crossing. Erosion present on ROW above waterbar. Sediment being deposited in waterbar and sump, overwhelming sump and perimeter controls near station 7604+41.

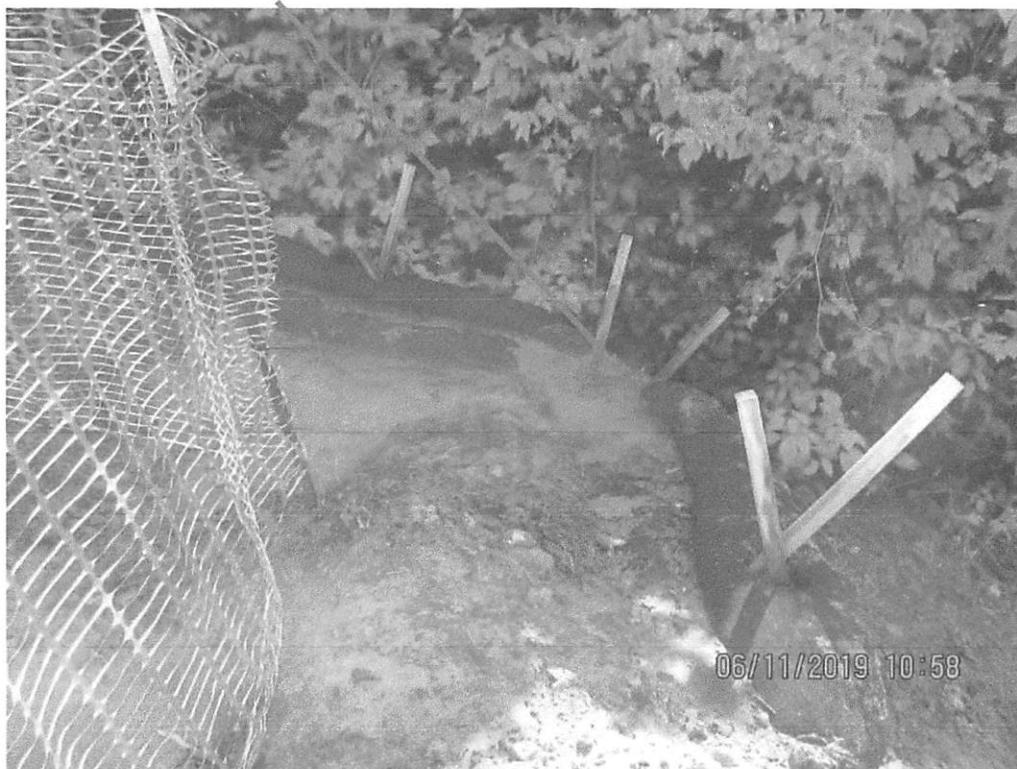
Above Lower Krosier Road crossing. Erosion present on ROW above waterbar. Sediment being deposited in waterbar and sump, overwhelming sump and perimeter controls near station 7604+41.

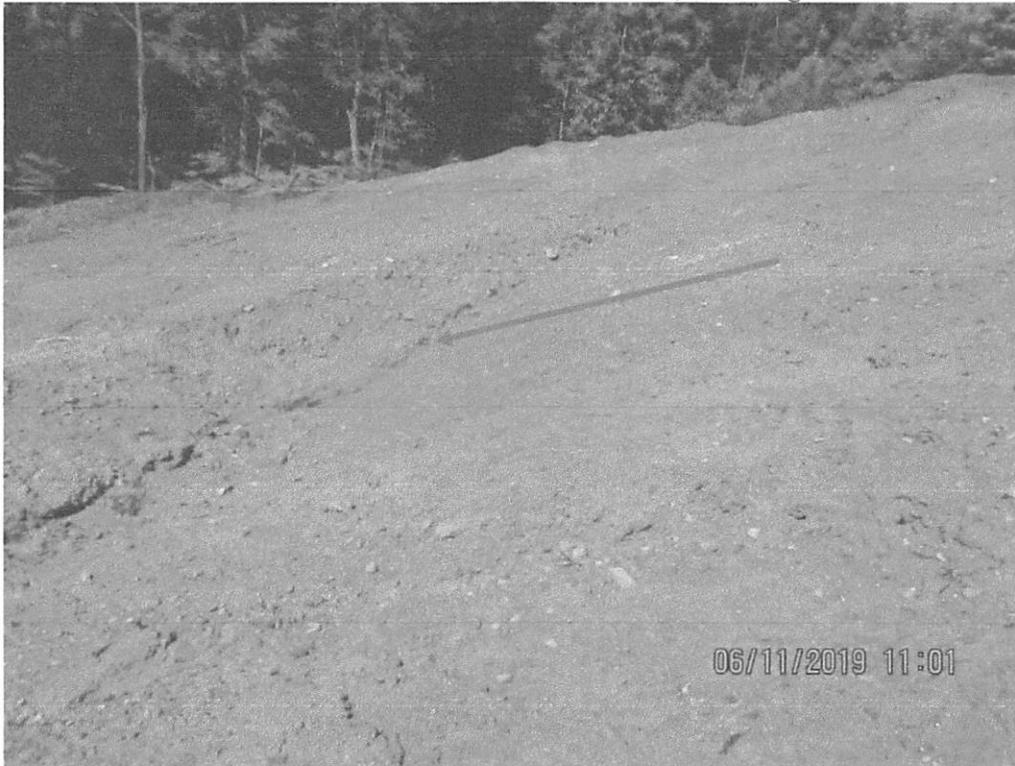
Above Lower Krosier Road crossing. Erosion present in waterbar near station 7604+41.

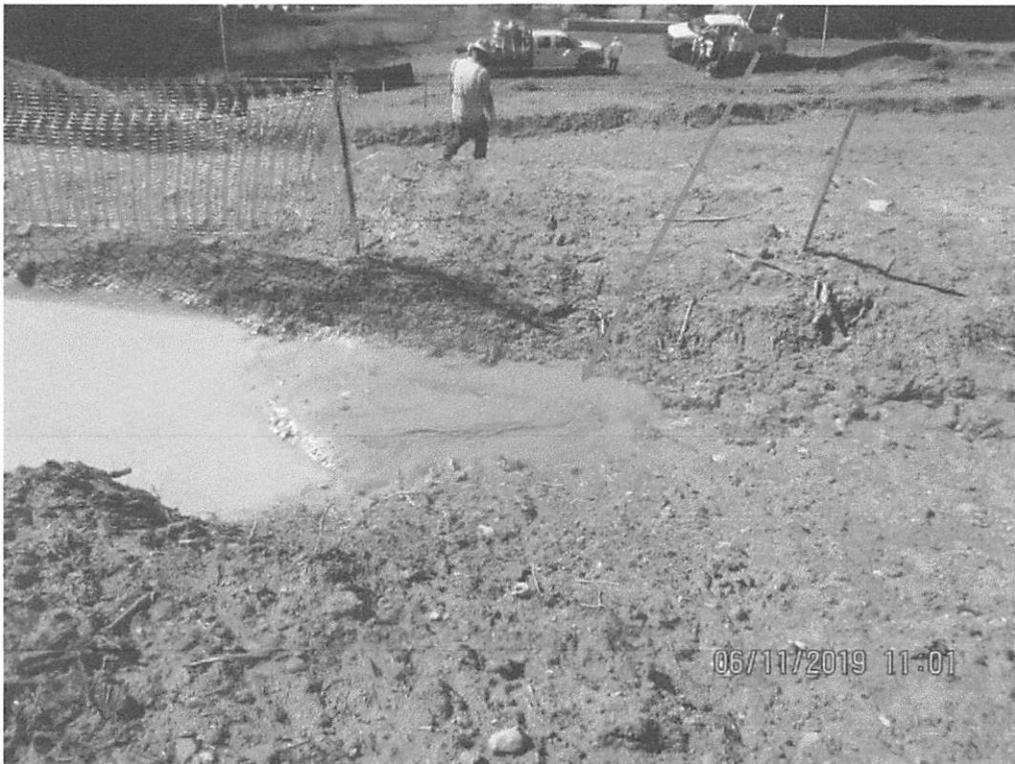
Above Lower Krosier Road crossing. Erosion present in waterbar causing sediment to be deposited in sump. Sump in need of maintenance.

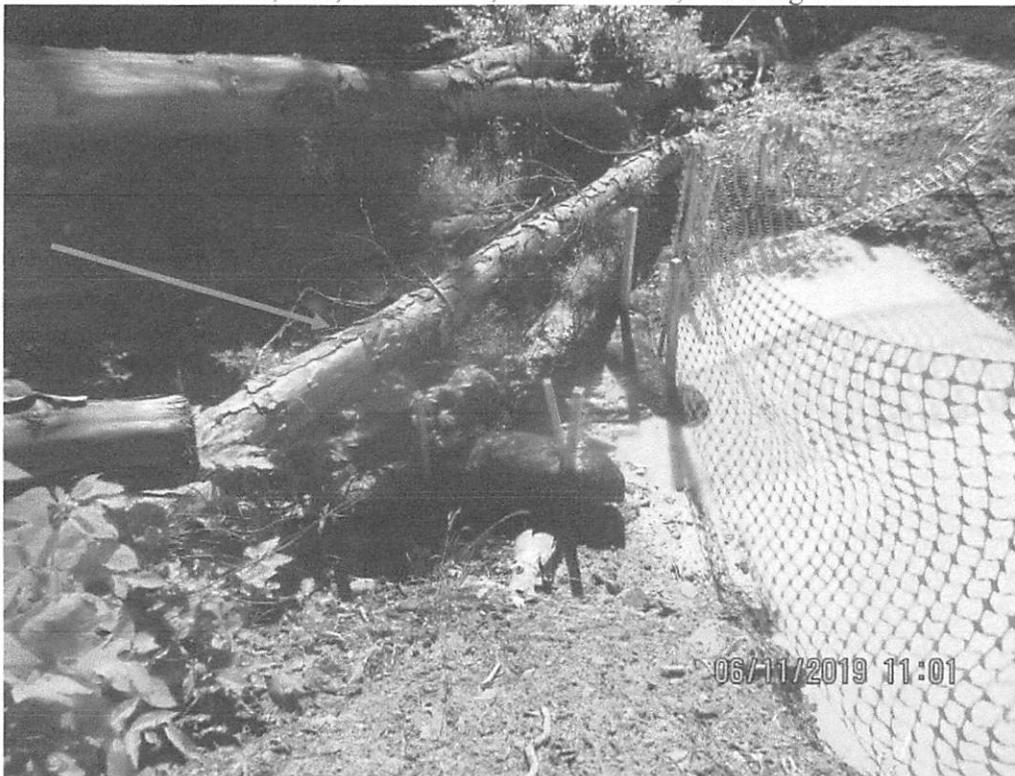
Above Lower Krosier Road crossing. Sediment and SLW overwhelming sump and perimeter controls near station 7604+41. Sediment deposits and SLW past controls and LOD.

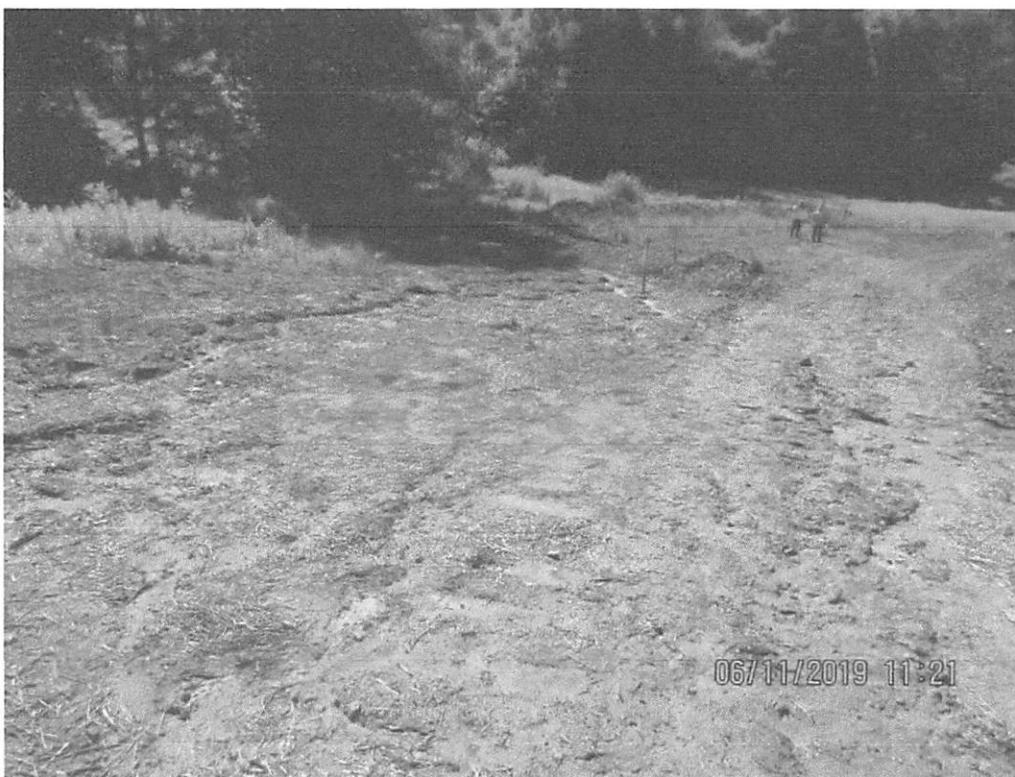
Facing South (Downslope) at station 7609+50. Waterbar receiving sediment due to erosion on slope.

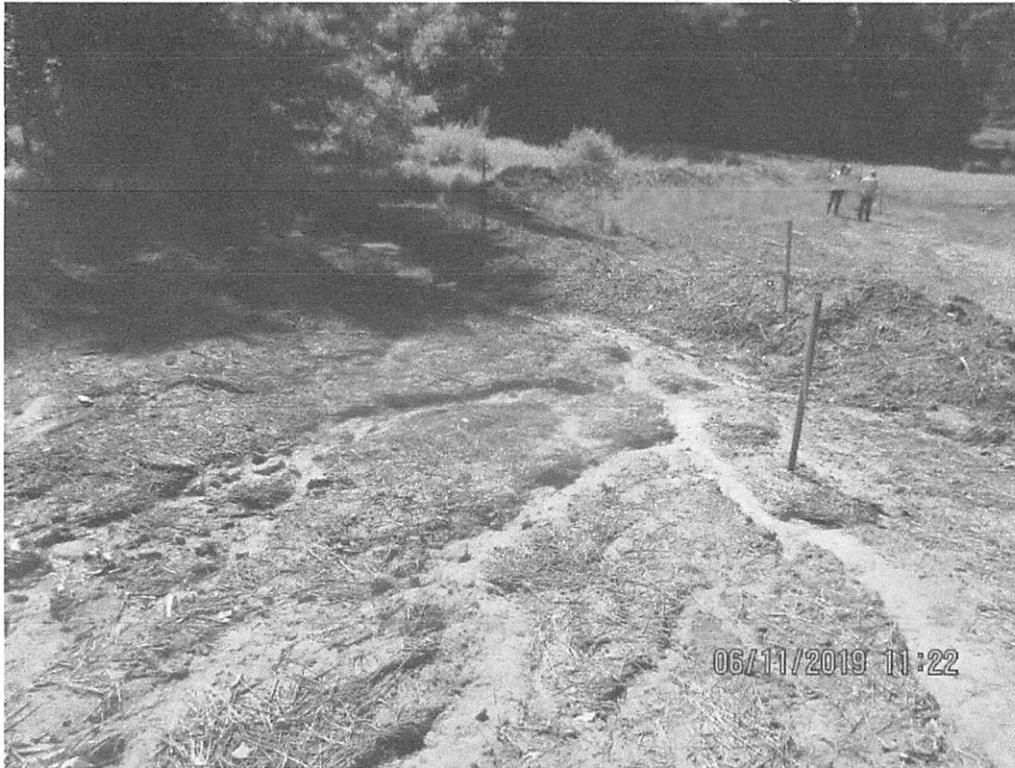
Facing South (Downslope) at station 7609+50. Waterbar receiving sediment due to erosion on slope. Controls overwhelmed with SLW and sediment.
