**CONSENT ORDER
ISSUED UNDER THE
WATER POLLUTION CONTROL ACT
WEST VIRGINIA CODE, CHAPTER 22, ARTICLE 11**

TO: Mountain Valley Pipeline, LLC
Robert J. Cooper
2200 Energy Drive
Canonsburg, PA 15317

DATE: December 17, 2020

ORDER NO.: 9925

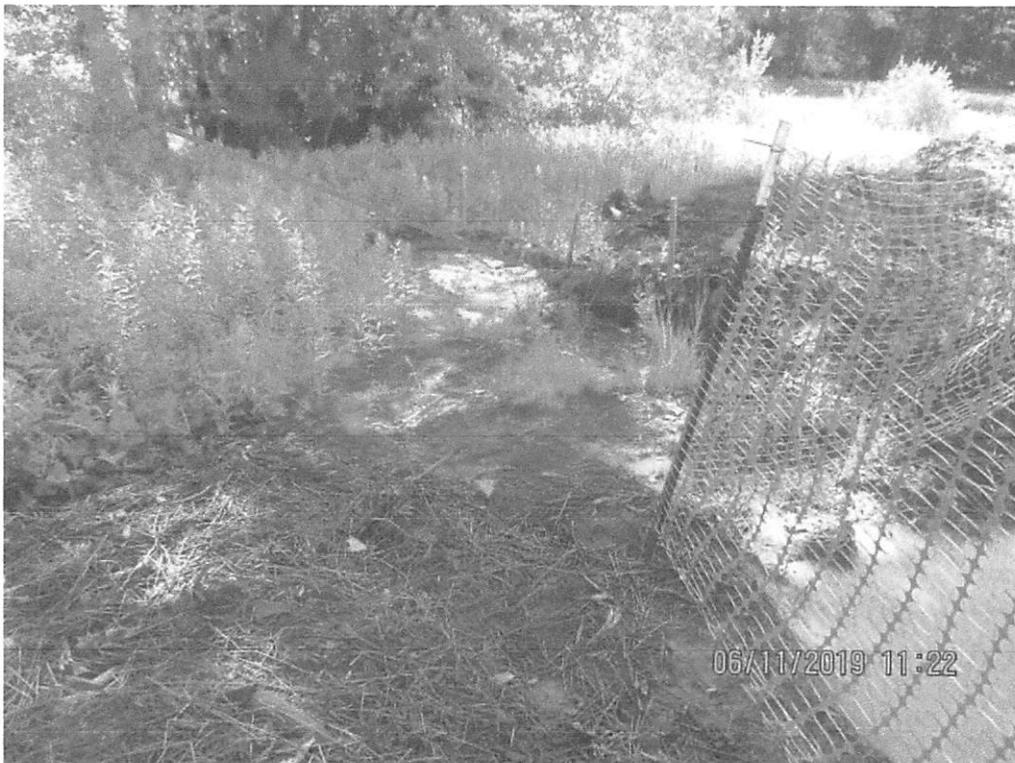
Facing South (Downslope) at station 7609+50. Waterbar outlet controls overwhelmed with SLW and deposits.

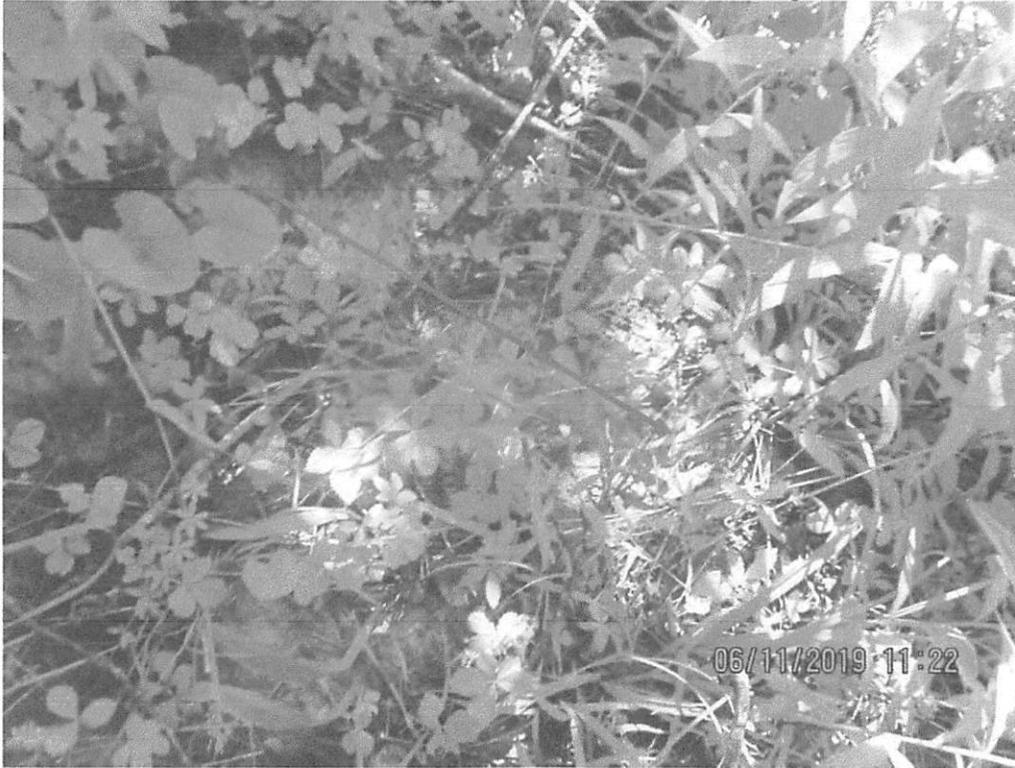
Facing South (Downslope) at station 7609+50. Waterbar outlet controls overwhelmed with SLW and deposits. Deposits observed past controls and LOD above wetland W-QR2. This is an area of concern due to deposits potentially being transported into a stream that was not delineated and parallels the LOD and terminates back onto the ROW above the Meadow River.

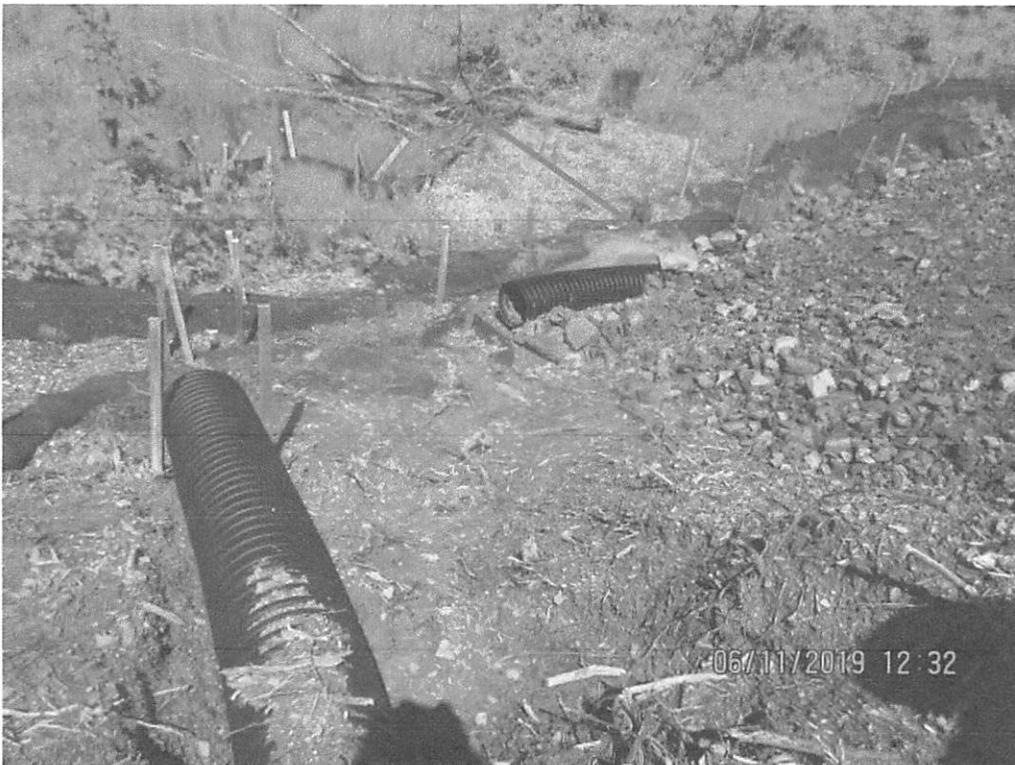
at station 7636+00 at waterbar outlet and slope drain. Slope drain was being undercut. Sediment was overwhelming perimeter control. Sediment deposits observed past controls and LOD.

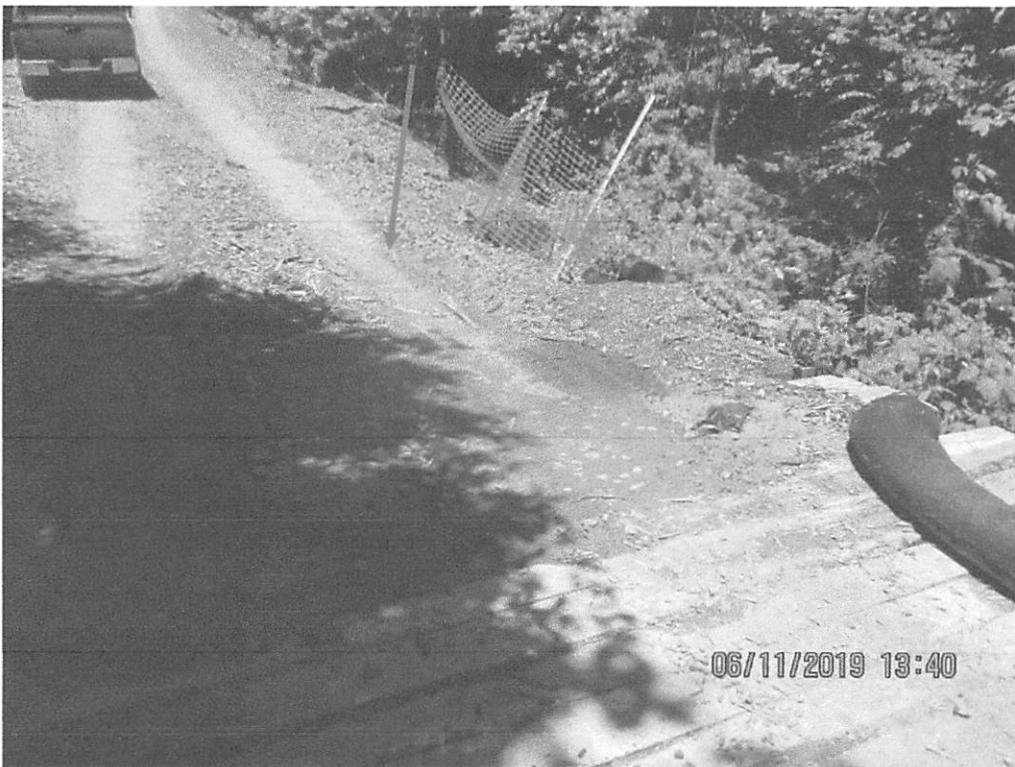
Facing up grade on Access Road 192.5 at wetland crossing W-V6. SWPPP detailed waterbar above this crossing. waterbar had been eroded and was barely distinguishable. Arrow depicts where waterbar was installed and terminated on road bank (slope).

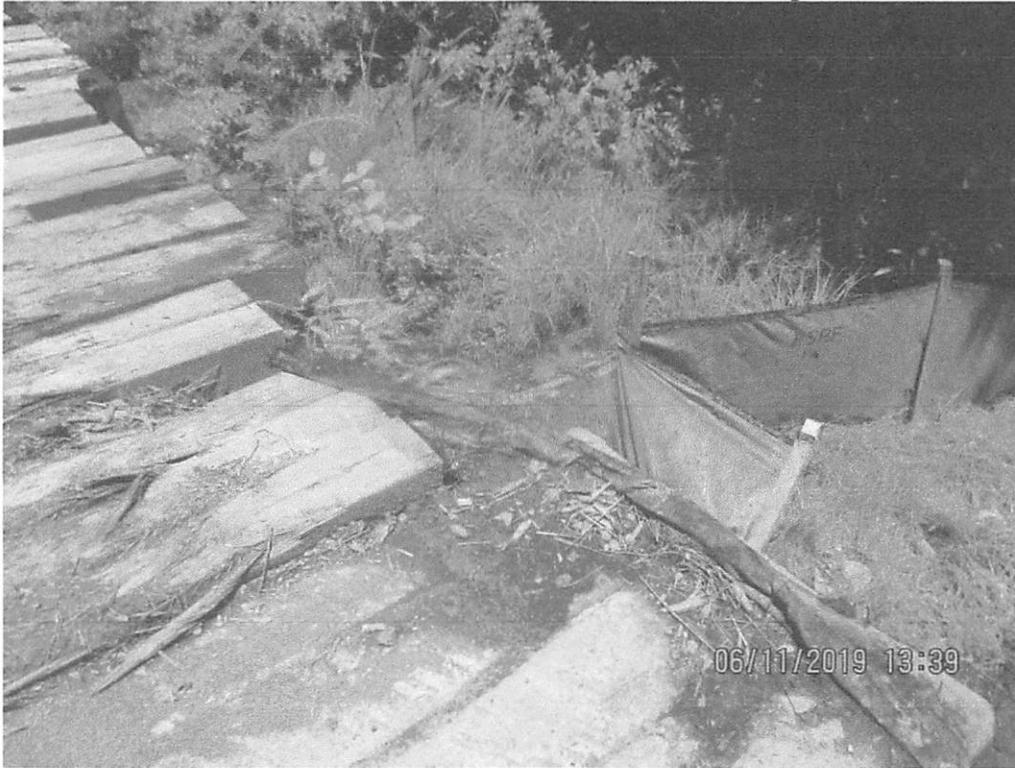
Wetland W-V2 crossing with AR-182.5. Sediment tracked onto bridge migrated past controls and into wetland. Arrow depicts deposits.

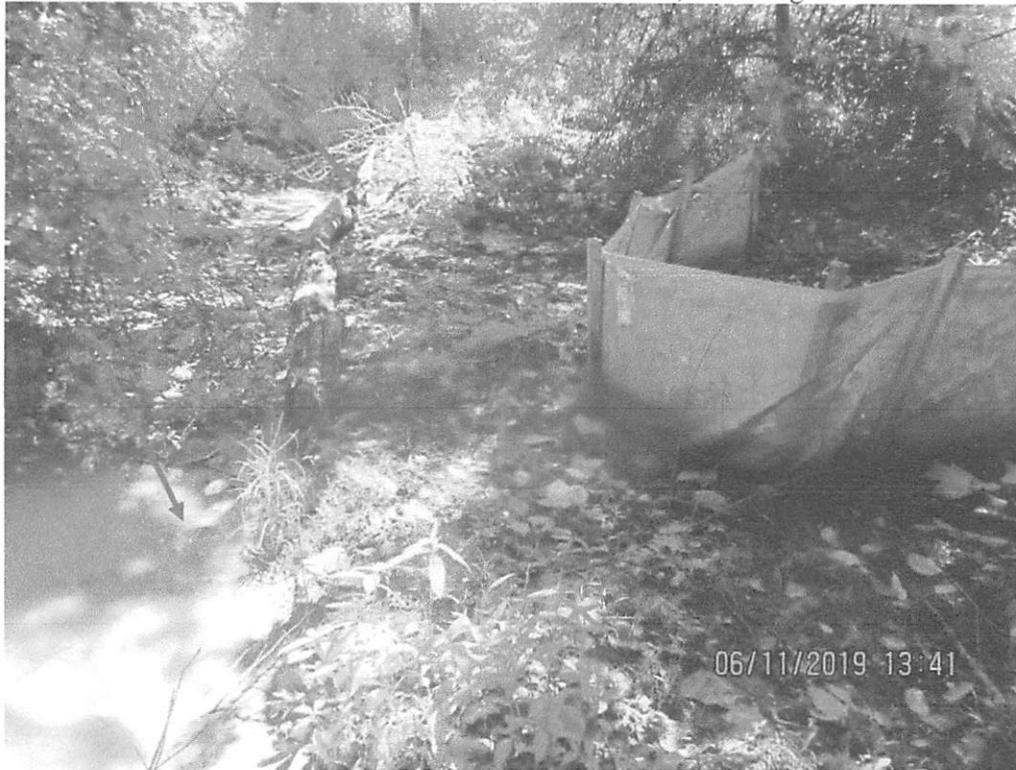
Further downslope of culvert outlet and bridge crossing with AR-182.5, below second culvert outlet where P1 silt fence was installed. Sediment deposits and SLW present past LOD. Arrows depict outlet controls and where SLW and deposits were observed.

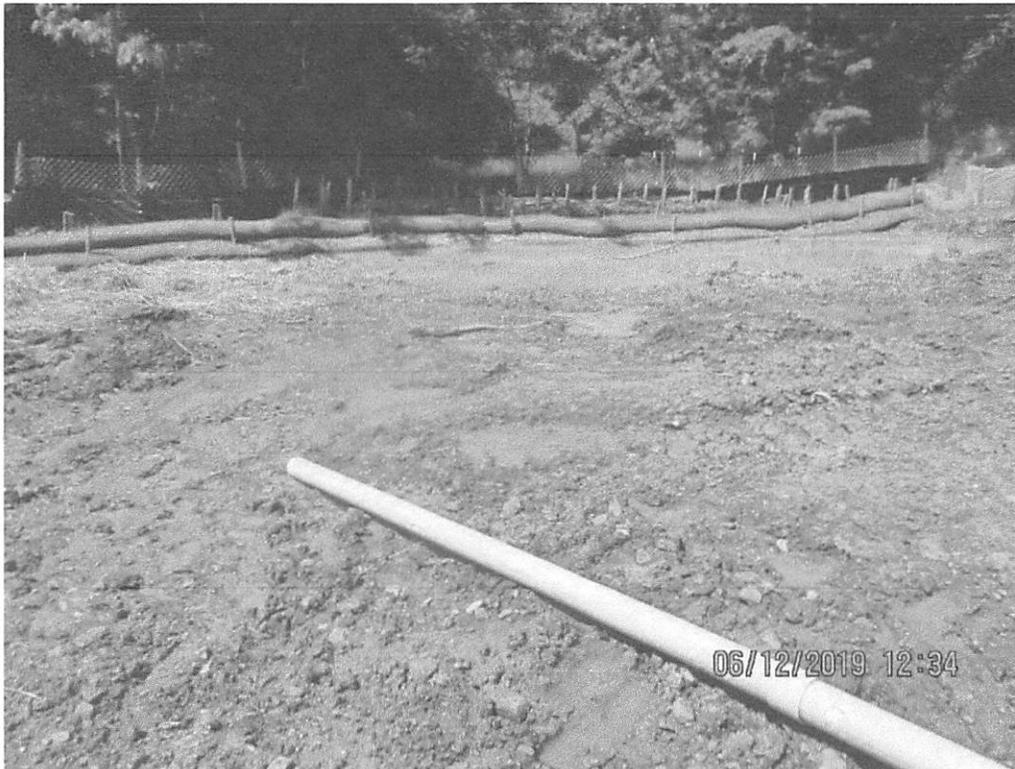
Pipe slope drain terminating onto ROW above controls (Dargo silt fence).

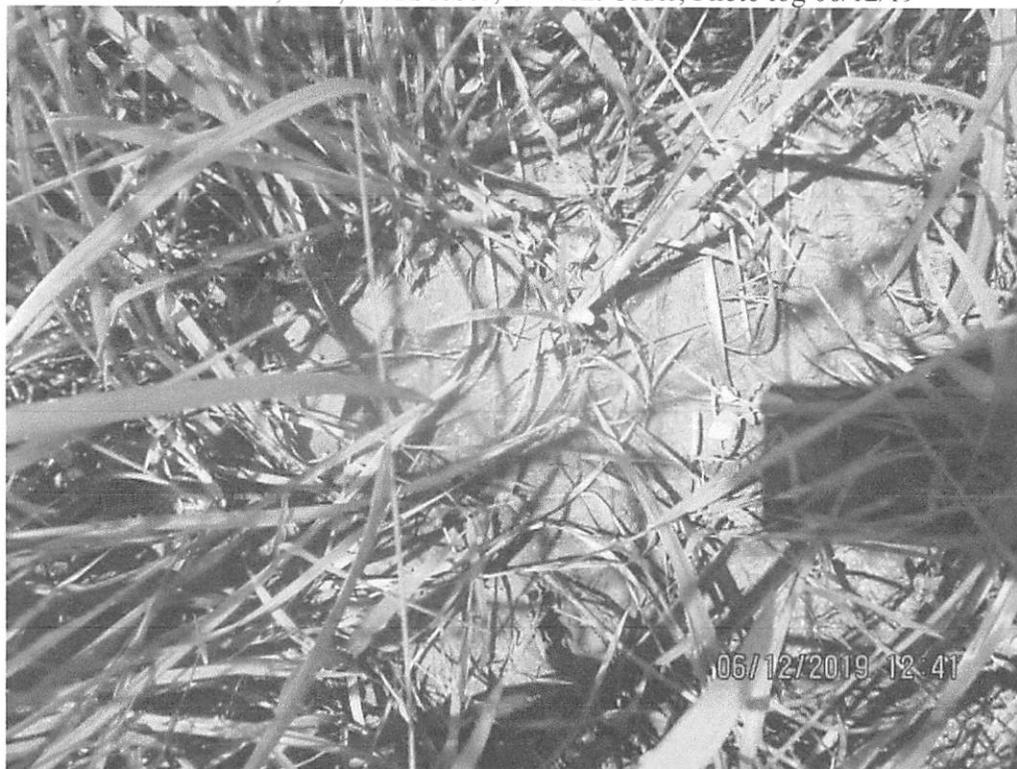
Downslope past Dargo silt fence. Sediment deposits observed past LOD and low-lying area not delineated as a wetland.

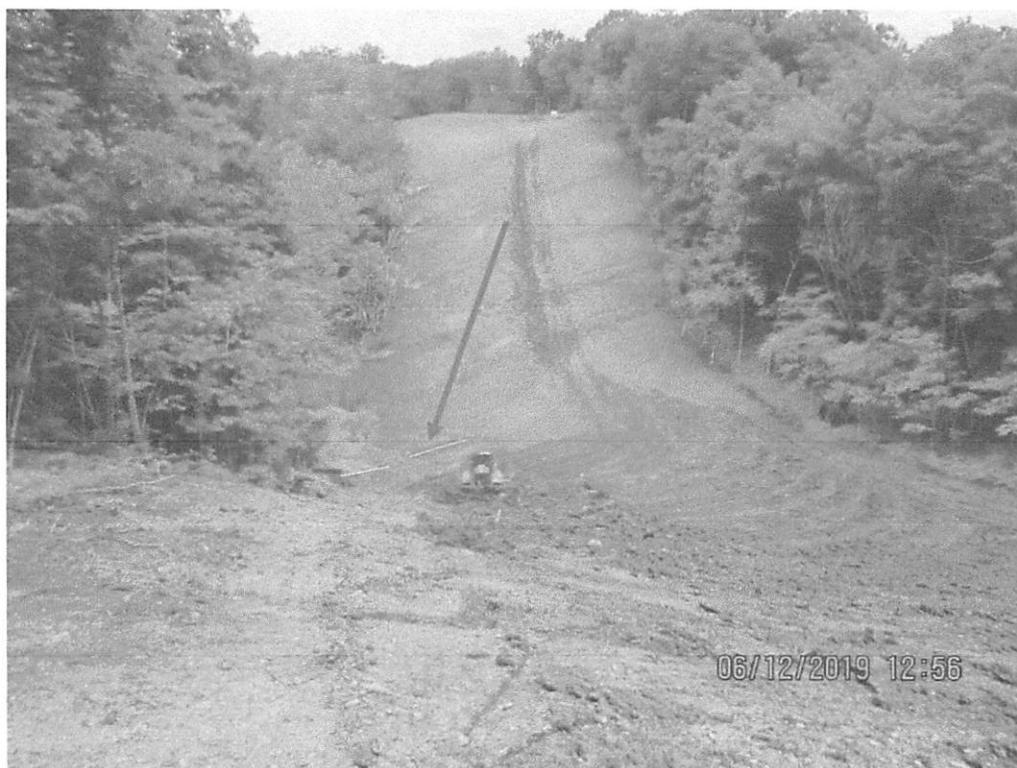
South Side slope facing downslope (North) at Dargo Silt fence. Red Arrow depicts where slope drain terminated onto ROW.

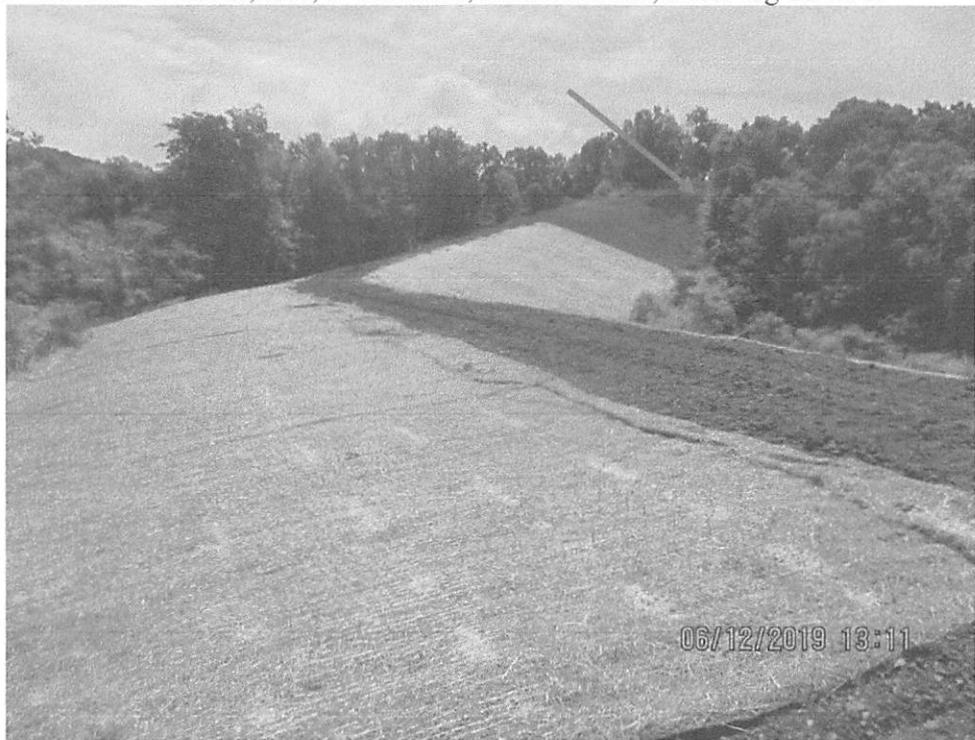
Upslope of Dargo silt fence. Facing South toward AR-221. Arrow depicts where dozer work was ongoing during inspection and controls needed maintenance.

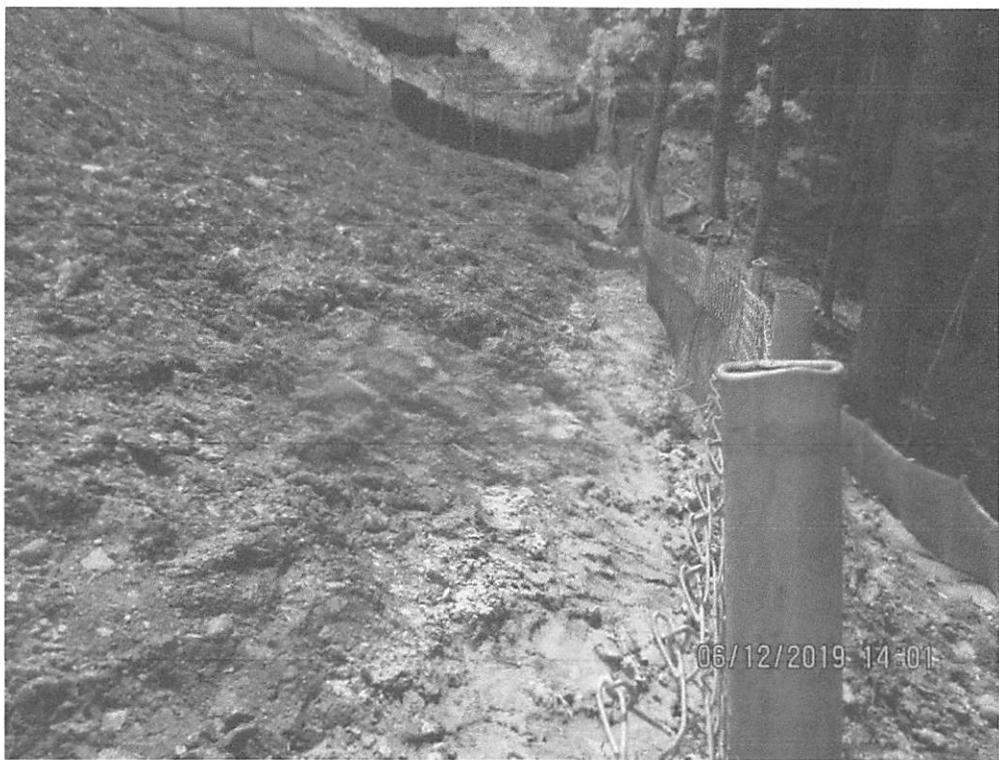
Controls below where dozer work was taking place. Sediment deposits observed below these controls at station 9780+00.

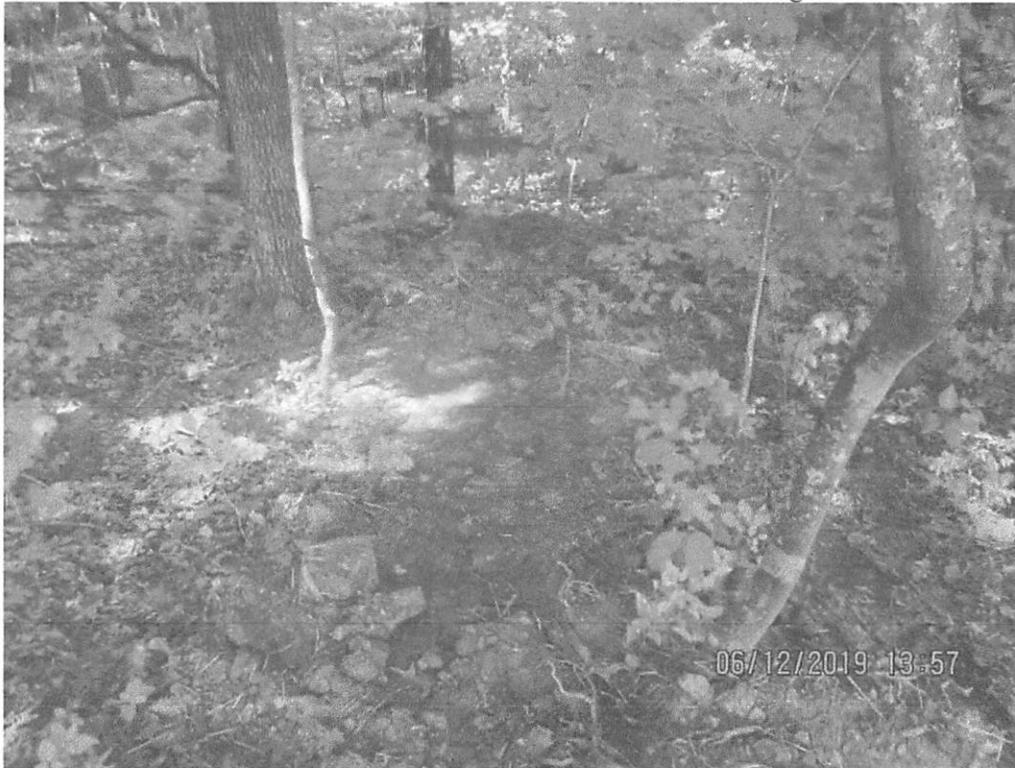
Below controls at station 9780+00 facing downslope at sediment deposits and scouring of leaf litter. Arrow depicts deposits.

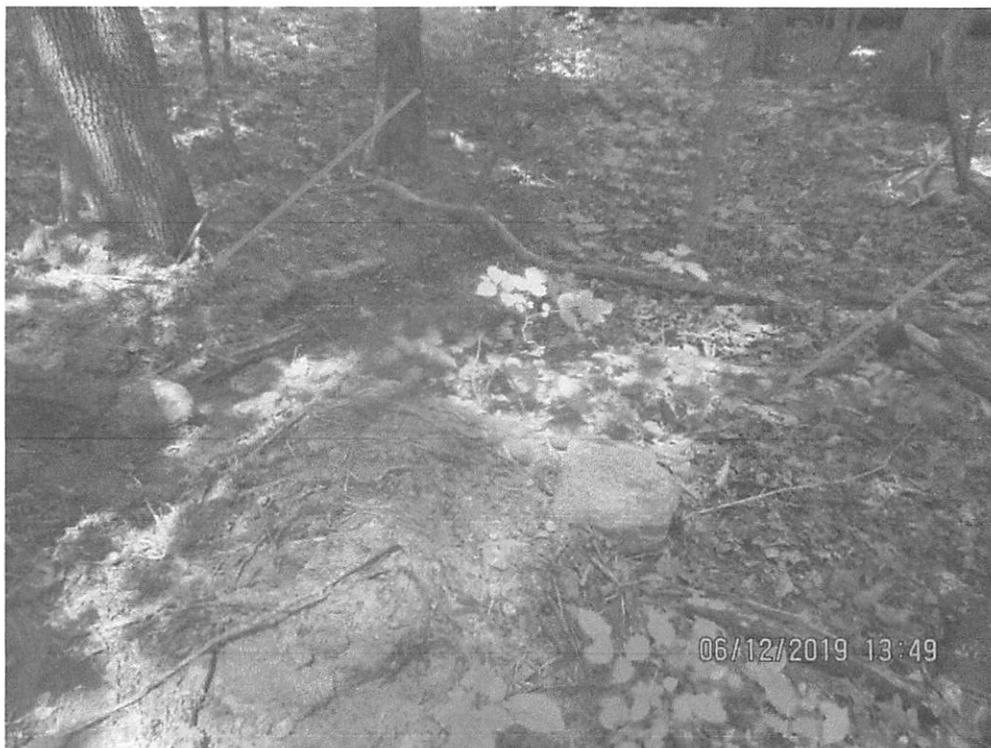
Sediment deposits below and past controls/LOD at station 9780+00. Arrow depicts deposits.

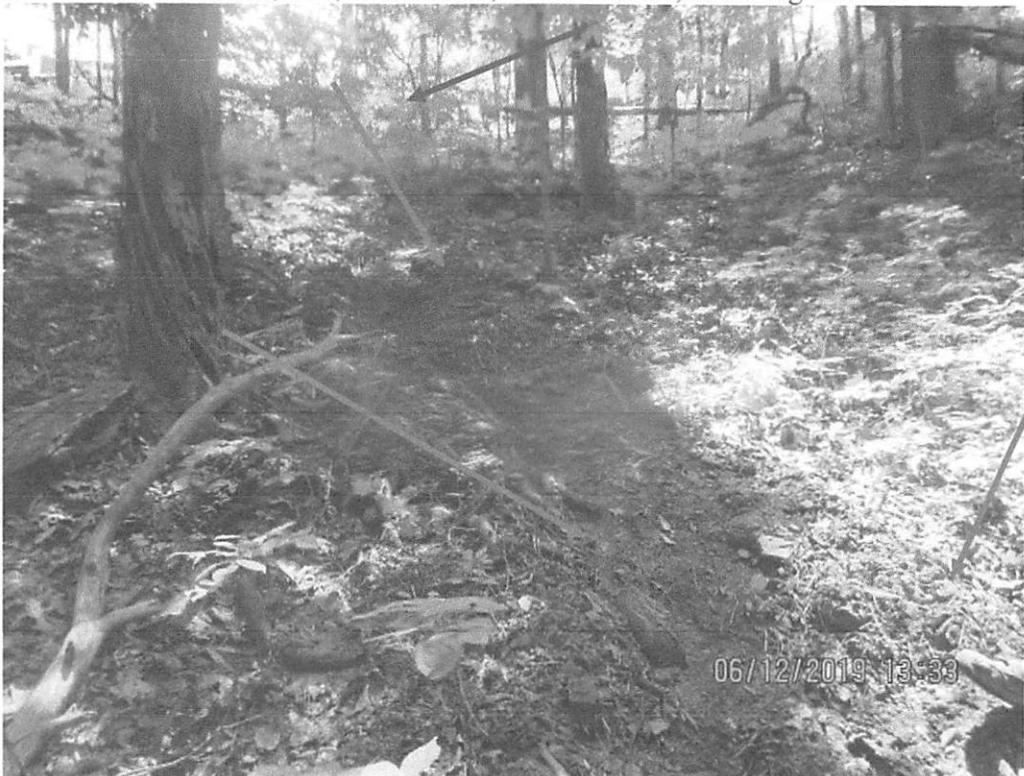
Scoring and sediment deposits below controls at station 9780+00. Red Arrow depicts deposits. Blue arrow depicts controls at edge of LOD.

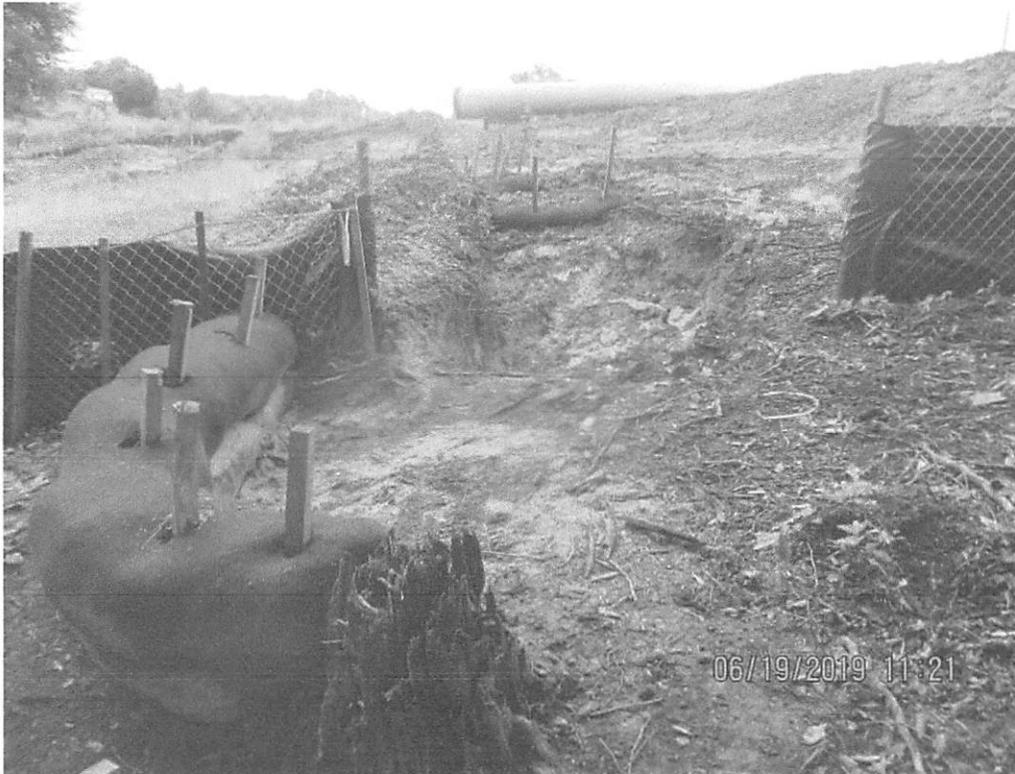
Waterbar outlet and primary controls at Station 6587+00 facing toward Additional Workspace and CR 18.

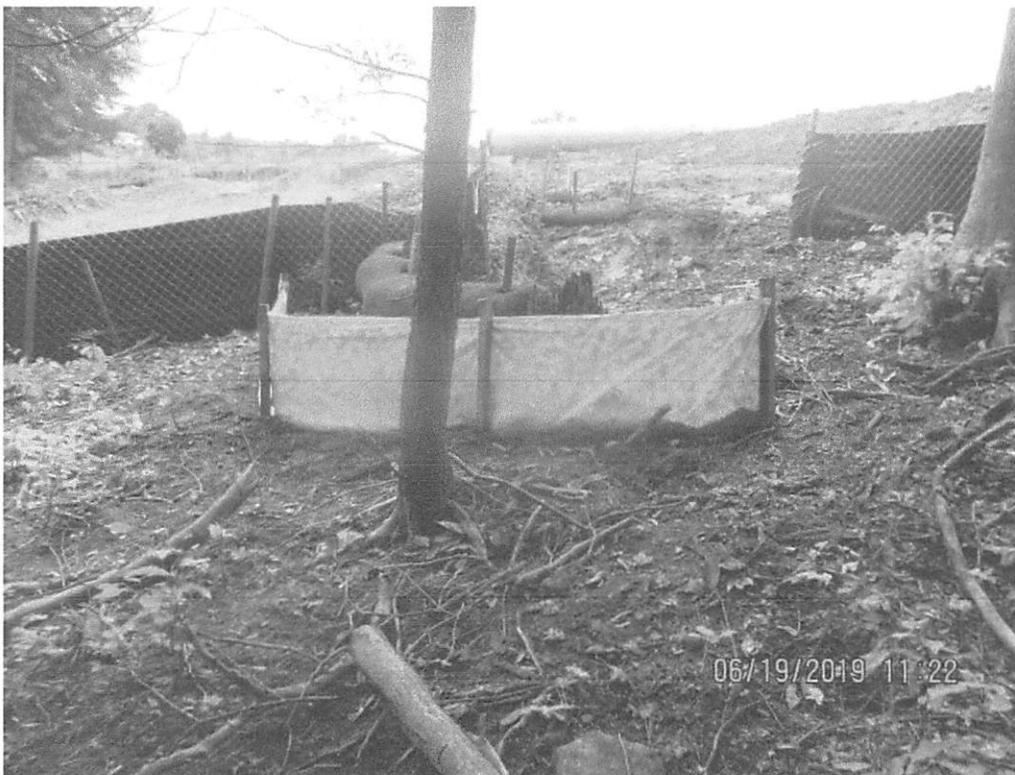
Waterbar outlet with enhanced secondary controls added at Station 6587+00.

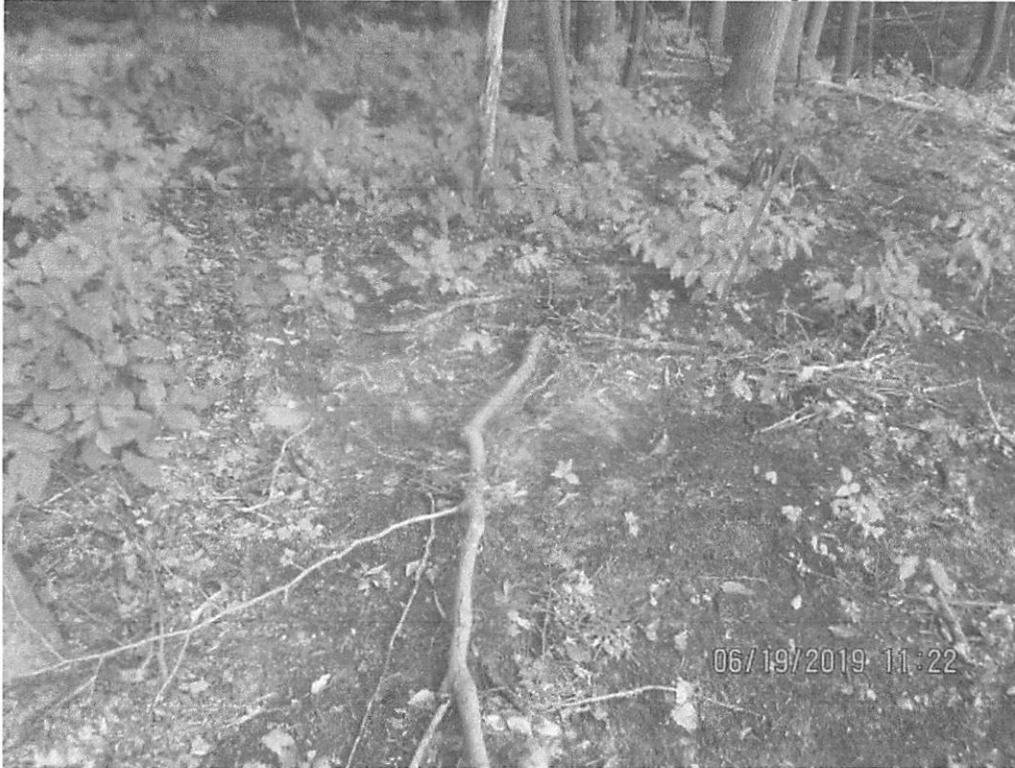
Downslope of waterbar outlet controls at Station 6587+00. Arrow depicts sediment deposits.

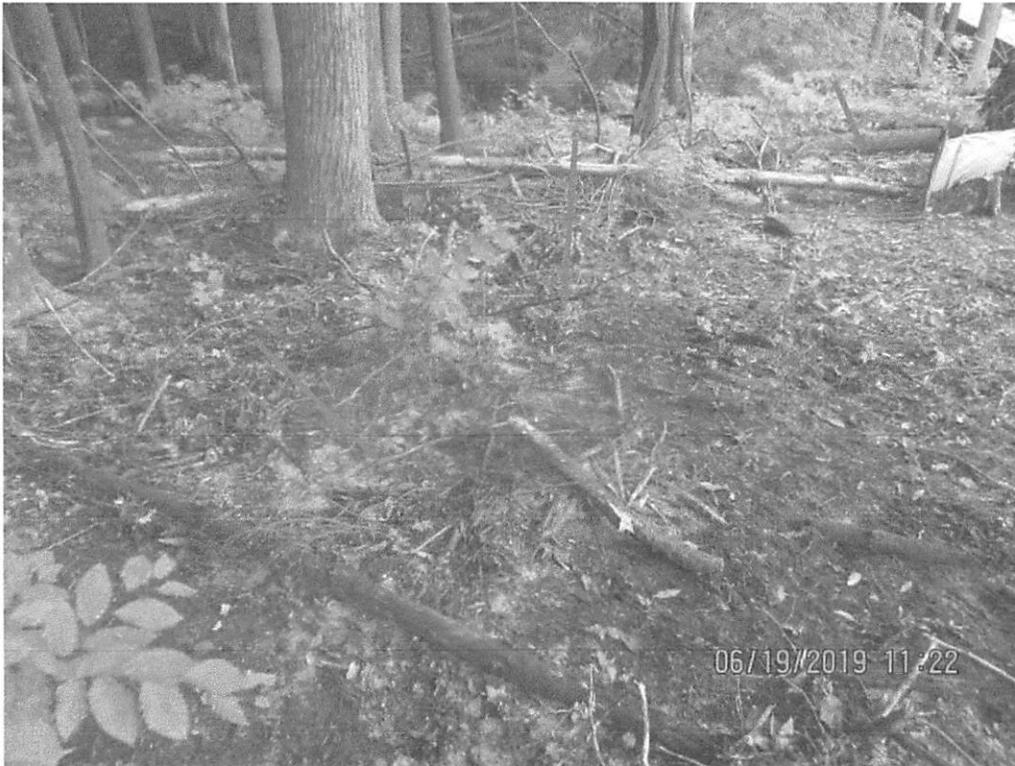
Downslope of waterbar outlet controls at Station 6587+00. Arrow depicts sediment deposits.

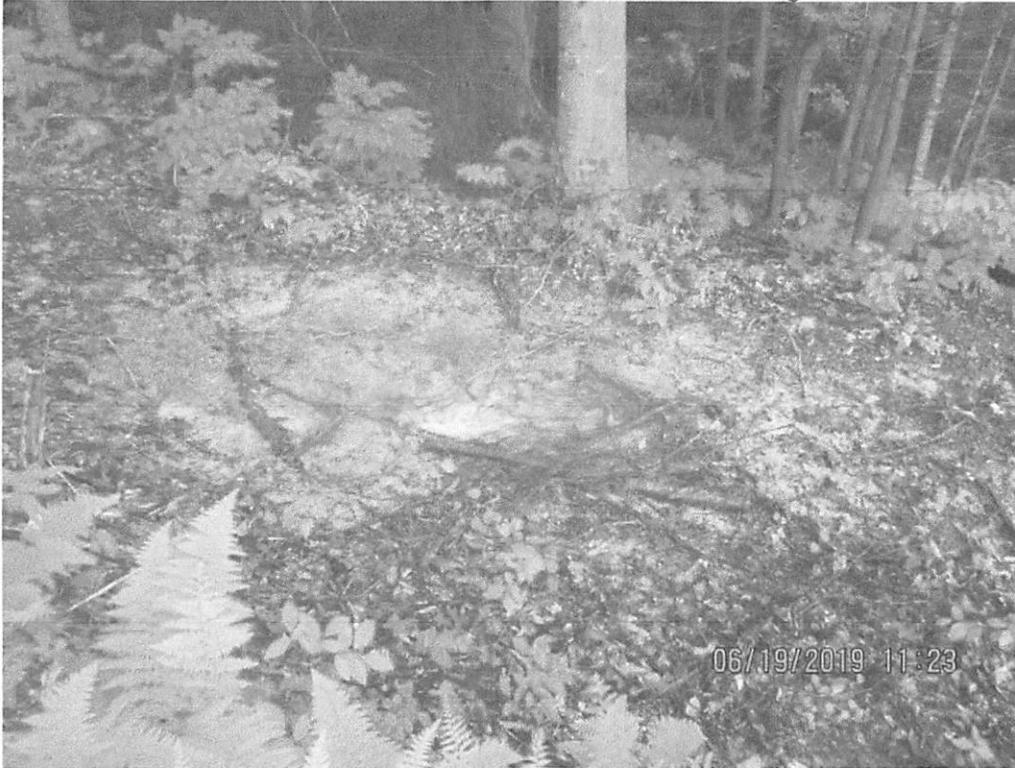
Sediment deposits present above Stream S-L38 near Station 6587+00.

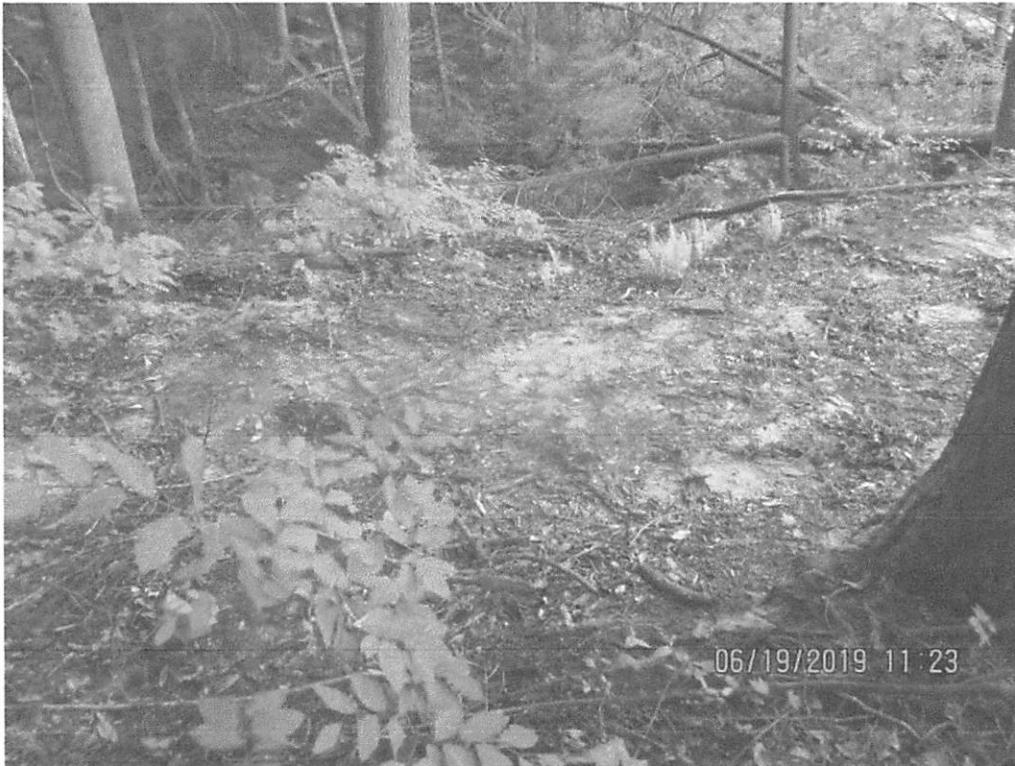
Sediment deposits above Stream S-L38 near Station 6587+00. Arrow depicts stream location.

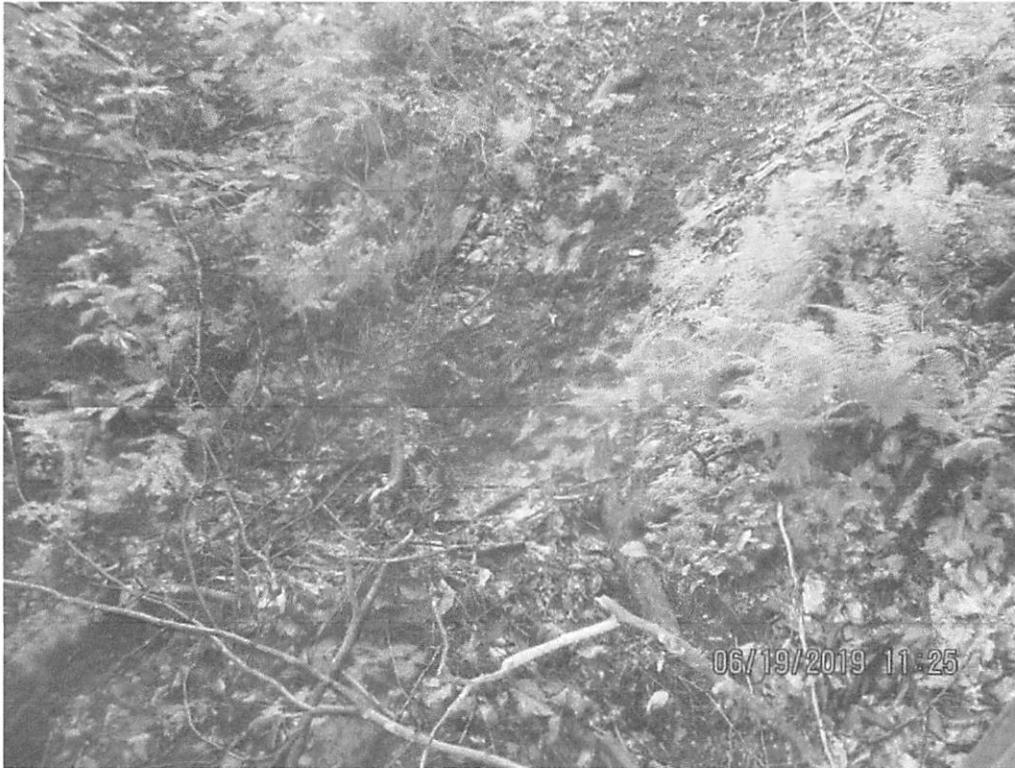
Scouring of stream bank below sediment deposits observed above Stream S-L38 near Station 6587+00.

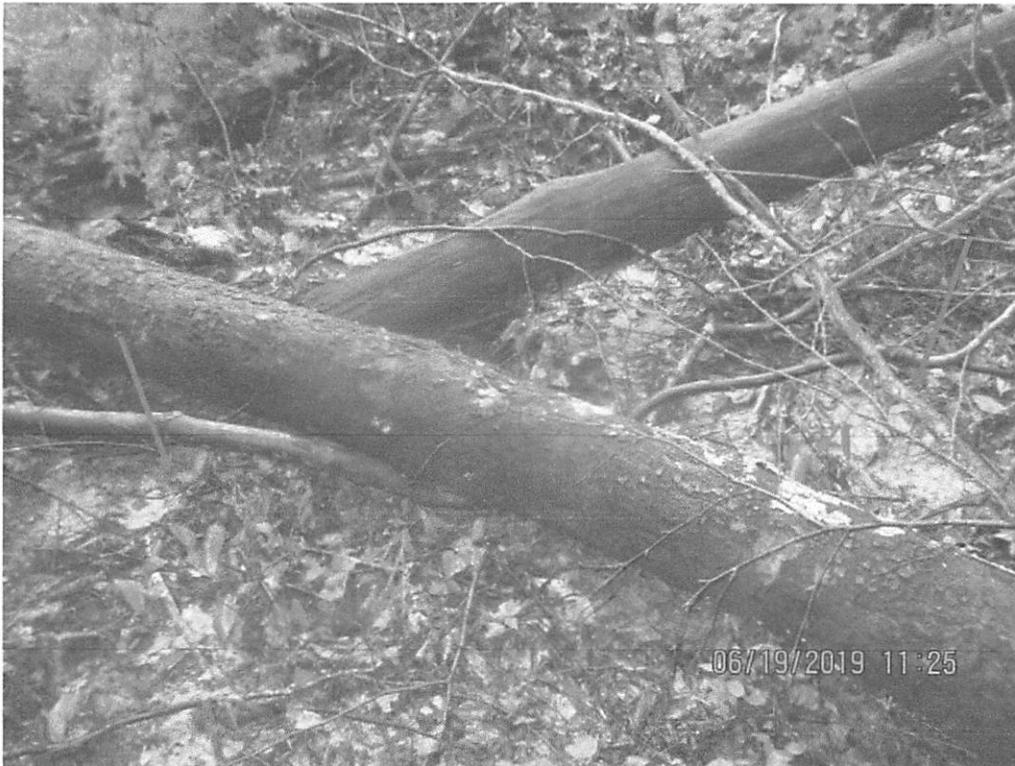
Sediment deposits below scouring on stream bank of S-L38 and below controls approximately 75 ft downslope of Station 6587+00. Arrow depicts sediment deposits.

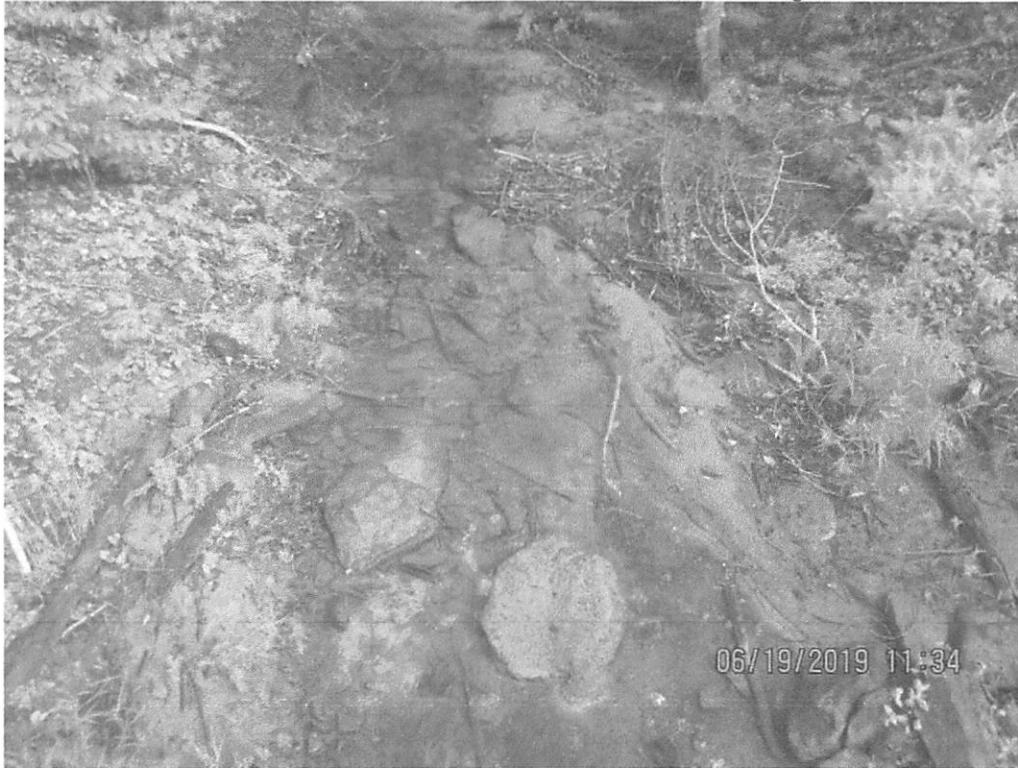
Stream S-L38 facing downstream at MVP ROW crossing near Station 6587+00.

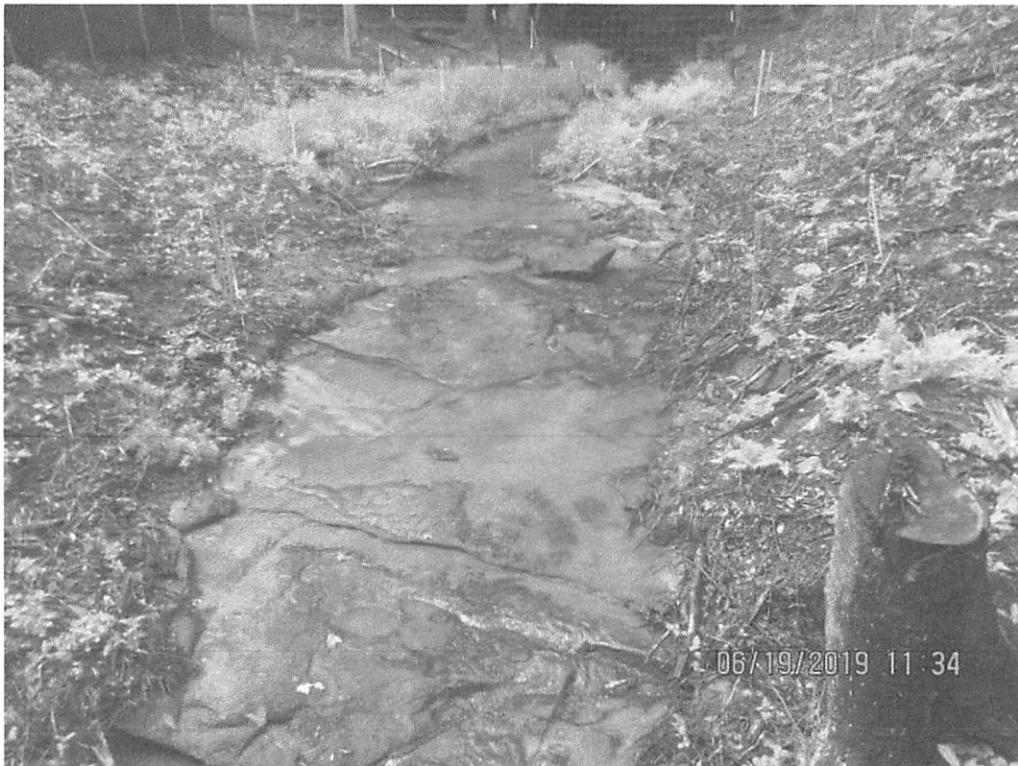
Stream S-L38 facing upstream at MVP ROW crossing near Station 6587+00.

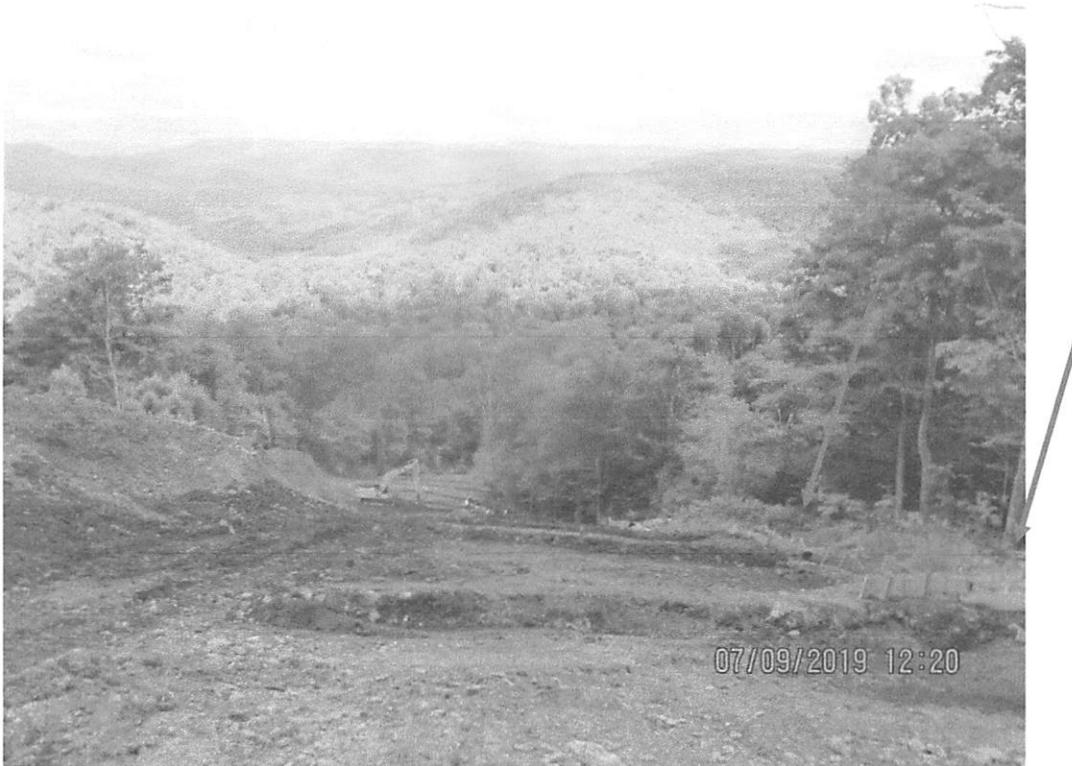
Overview of Lick Creek basin facing North above Station 8634+00 on upper section of slope. Arrow depicts cut into natural grade that continues down to lower portion of slope.

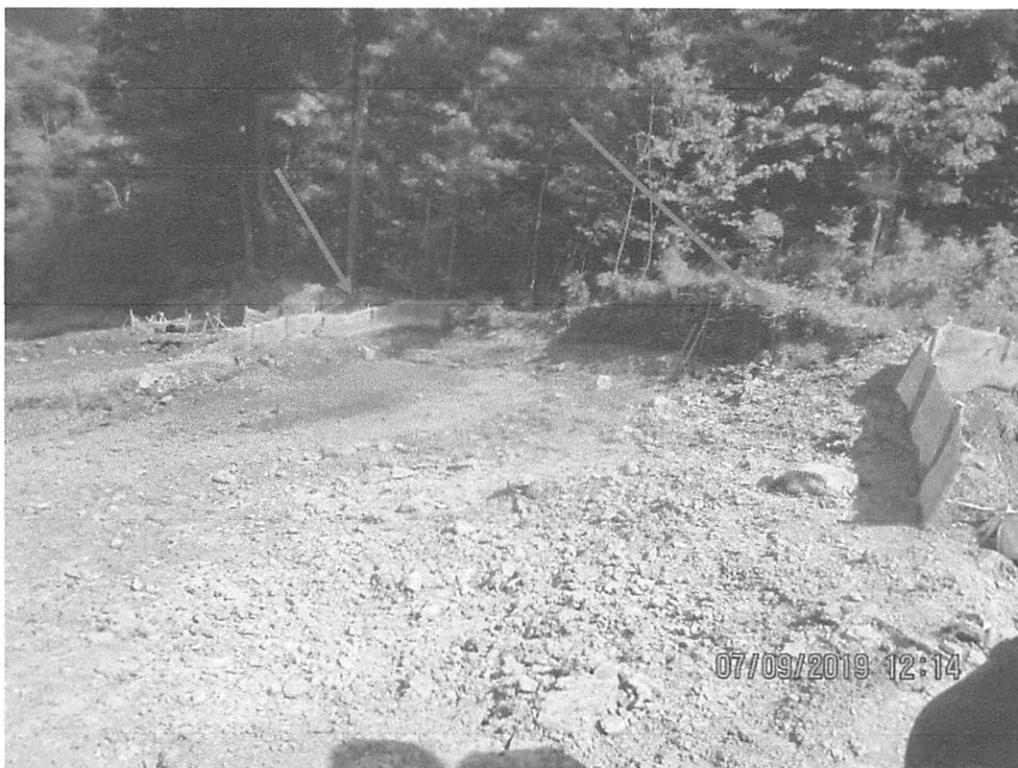
Above Stream S-T35A near station 8634+00 facing toward the East side of the LOD. Arrows depict the original cut to grade ROW that created a wall, preventing proper waterbar outlet installation.

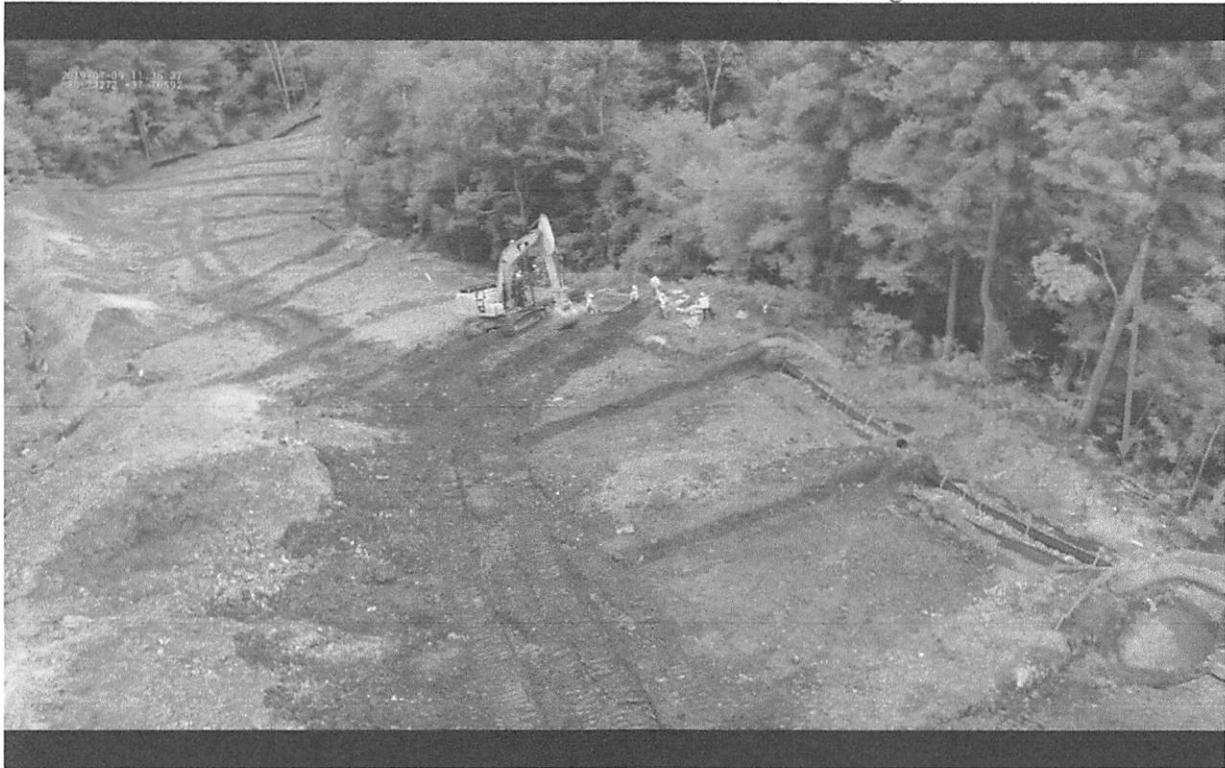
Overview of upper portion of slope near station 8634+00. Arrow depicts cut original cut that created a “wall” effect not allowing for proper waterbar outlets to be installed per the SWPPP.

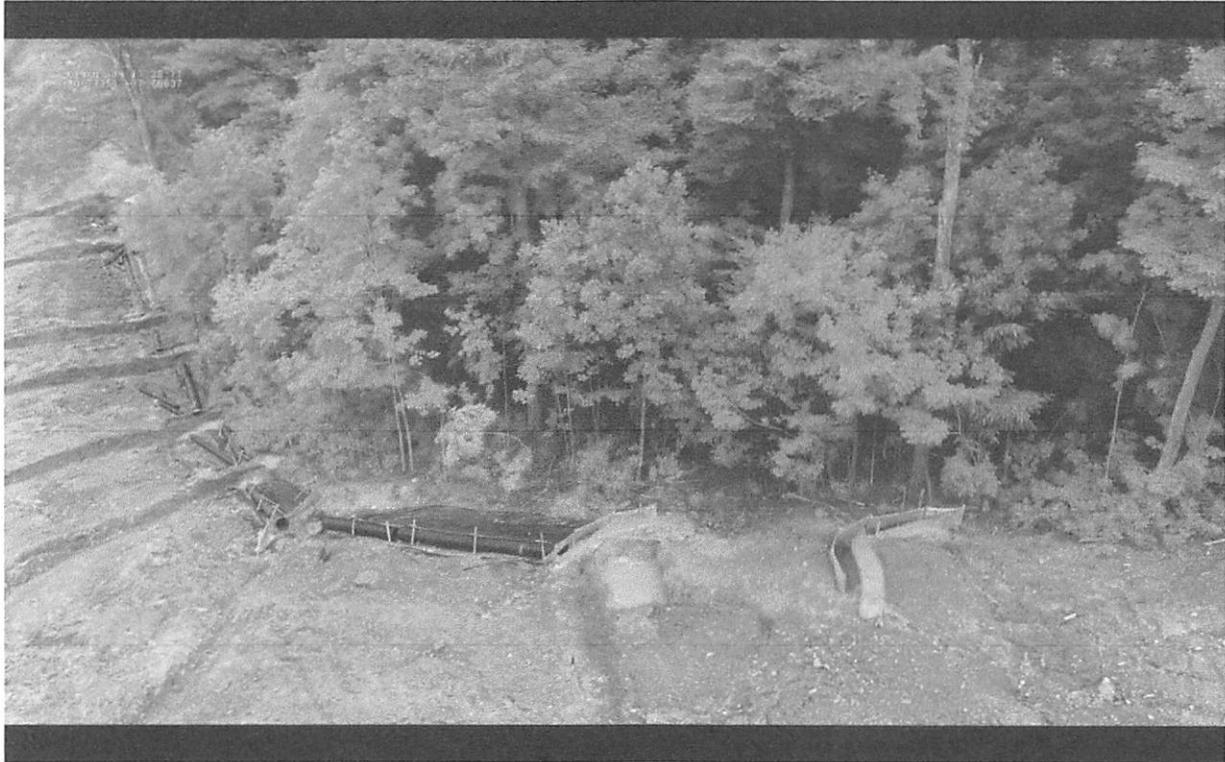
Lower portion of slope with flume pipe system. Arrow depicts where single outlet received concentrated flow from run-off. Impacts occurred to East side of LOD.
