**CONSENT ORDER
ISSUED UNDER THE
WATER POLLUTION CONTROL ACT
WEST VIRGINIA CODE, CHAPTER 22, ARTICLE 11**

TO: Mountain Valley Pipeline, LLC
Robert J. Cooper
2200 Energy Drive
Canonsburg, PA 15317

DATE: December 17, 2020

ORDER NO.: 9925

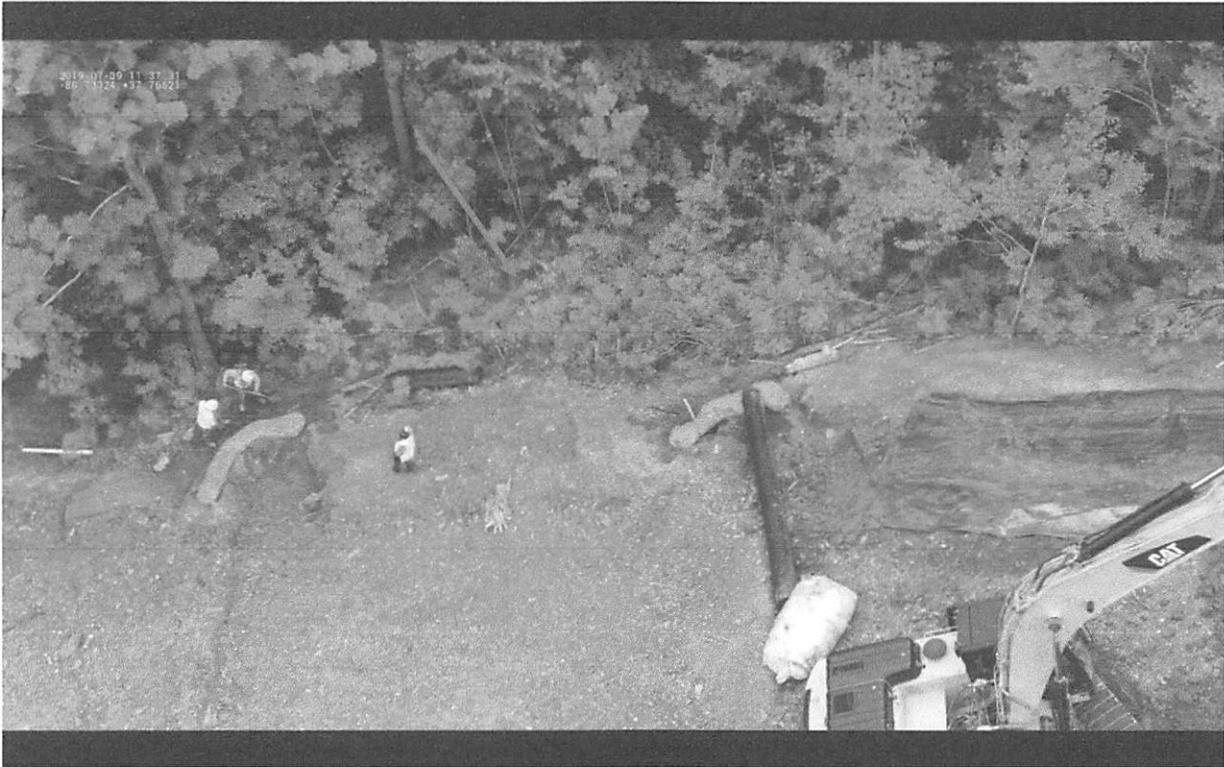
View above Stream S-T35A and station 8634+00 facing East side of LOD. Arrow depicts off-site impacts.

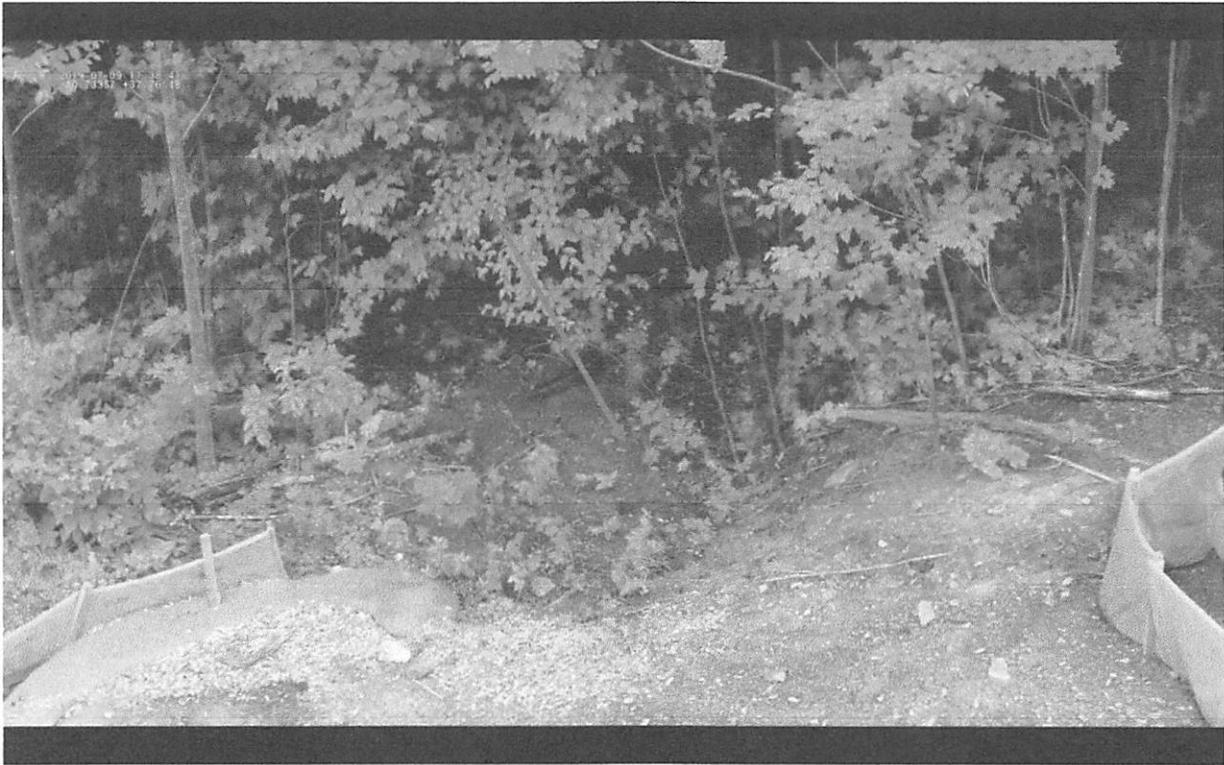
View above Stream S-T35A and station 8634+00 facing East side of LOD. Arrow depicts off site impacts.

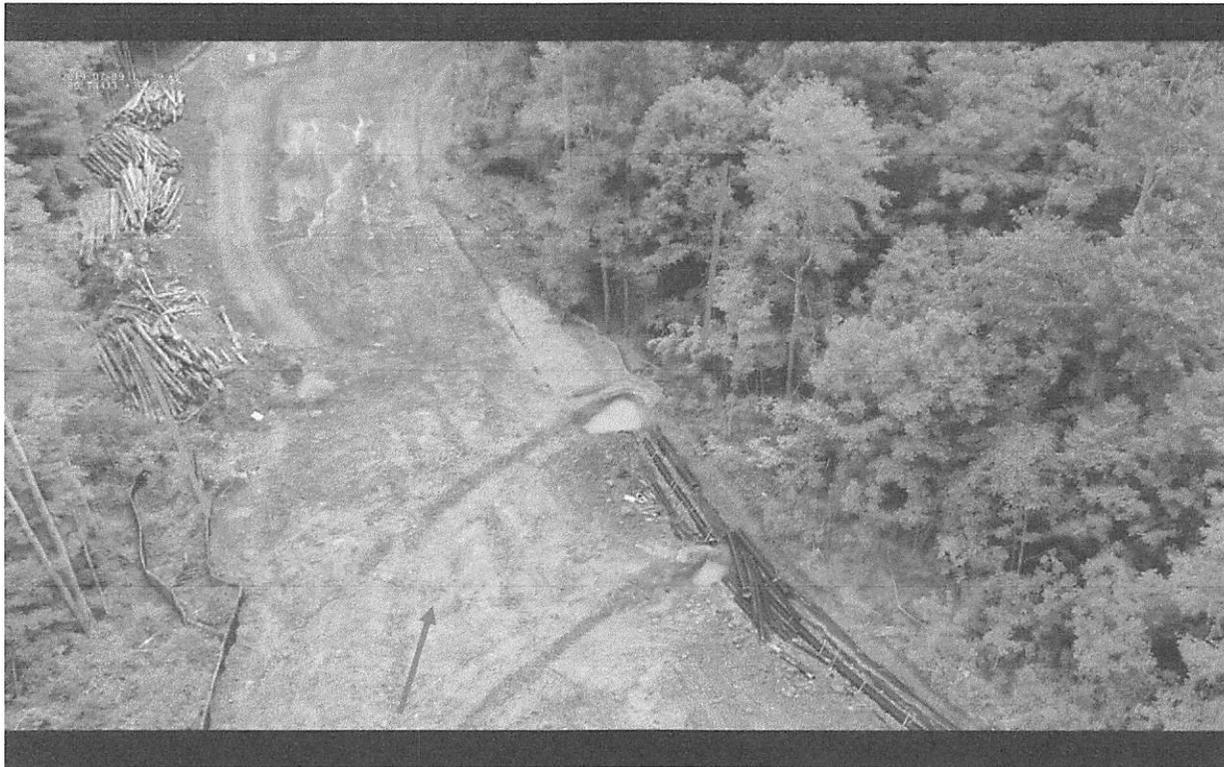
View of East and West side of MVP ROW and LOD. Red arrow depicts last waterbar at base of slope, which was overwhelmed. Blue arrow depicts stream S-T35A. Orange arrow depicts where additional waterbars were installed to redirect run-off toward East side of LOD.

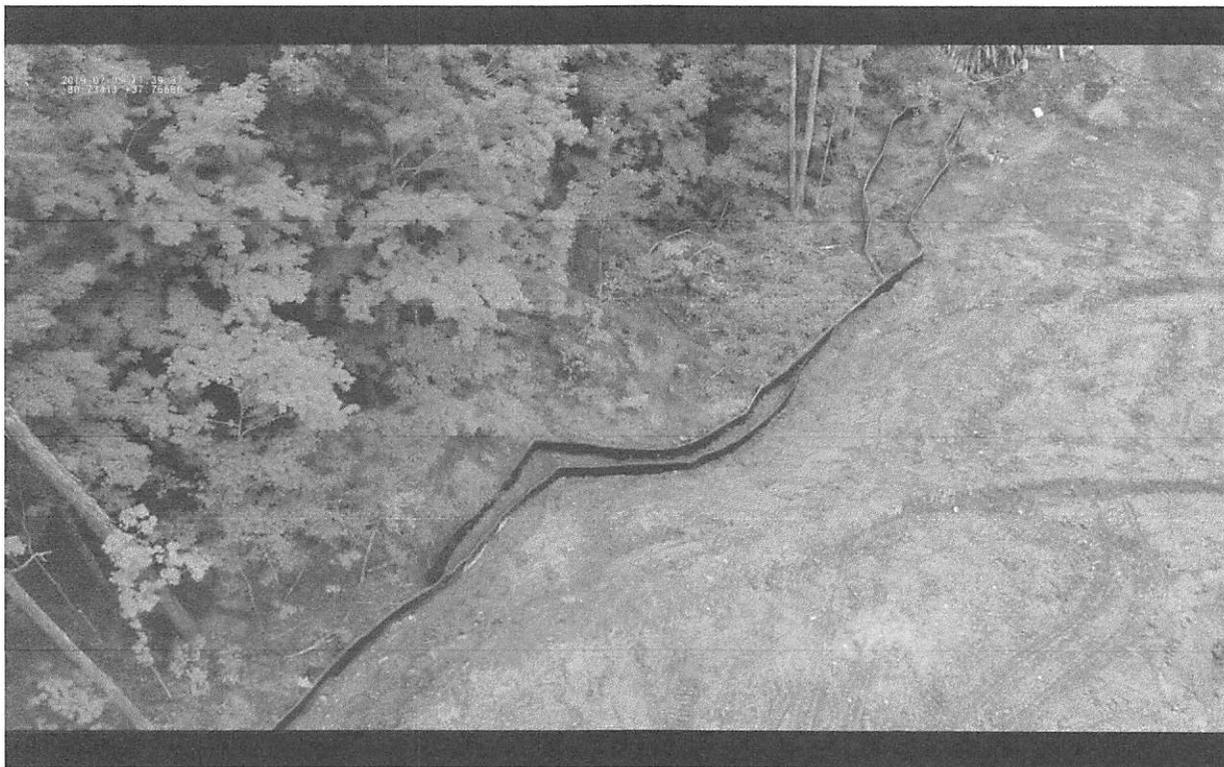
Stream S-T35A at station 8634+00 at the West side of the LOD. Arrow depicts additional super silt fence installed after impacts. Sediment deposits in stream.

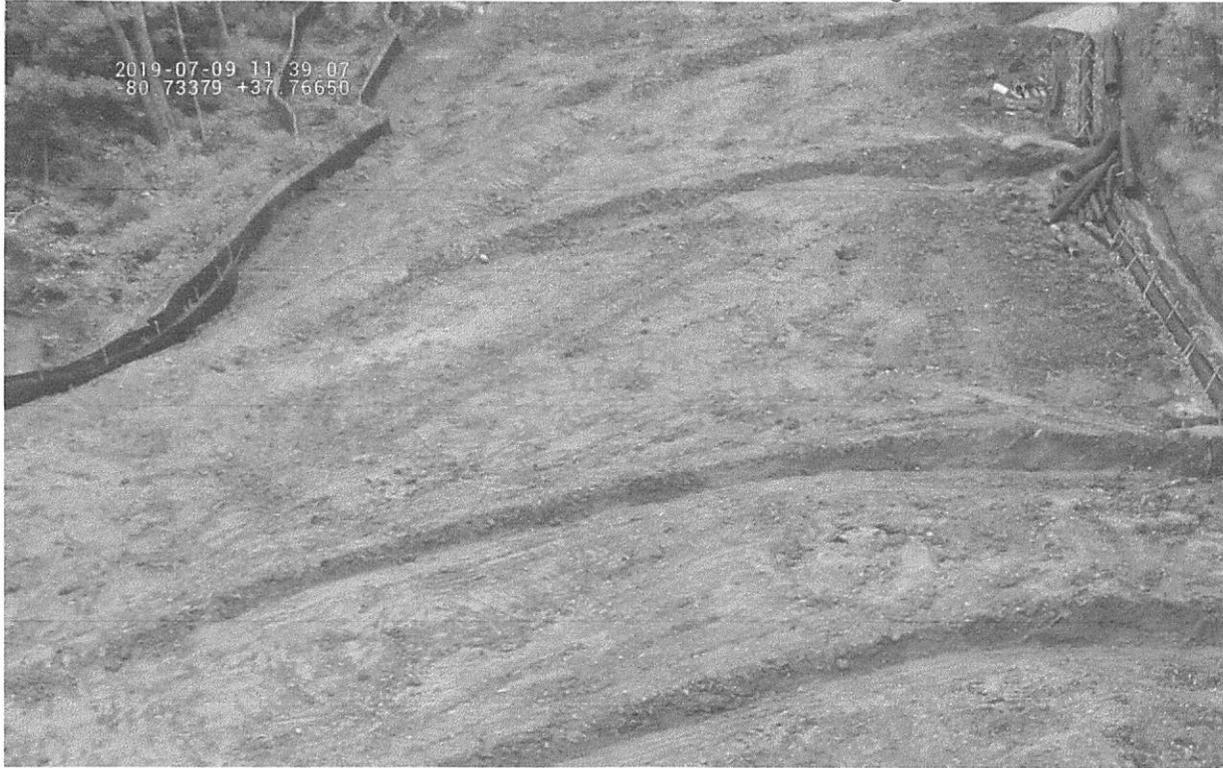
Additional waterbars added to re-direct run-off to East side of LOD. Arrow depicts sediment in stream S-T35A.

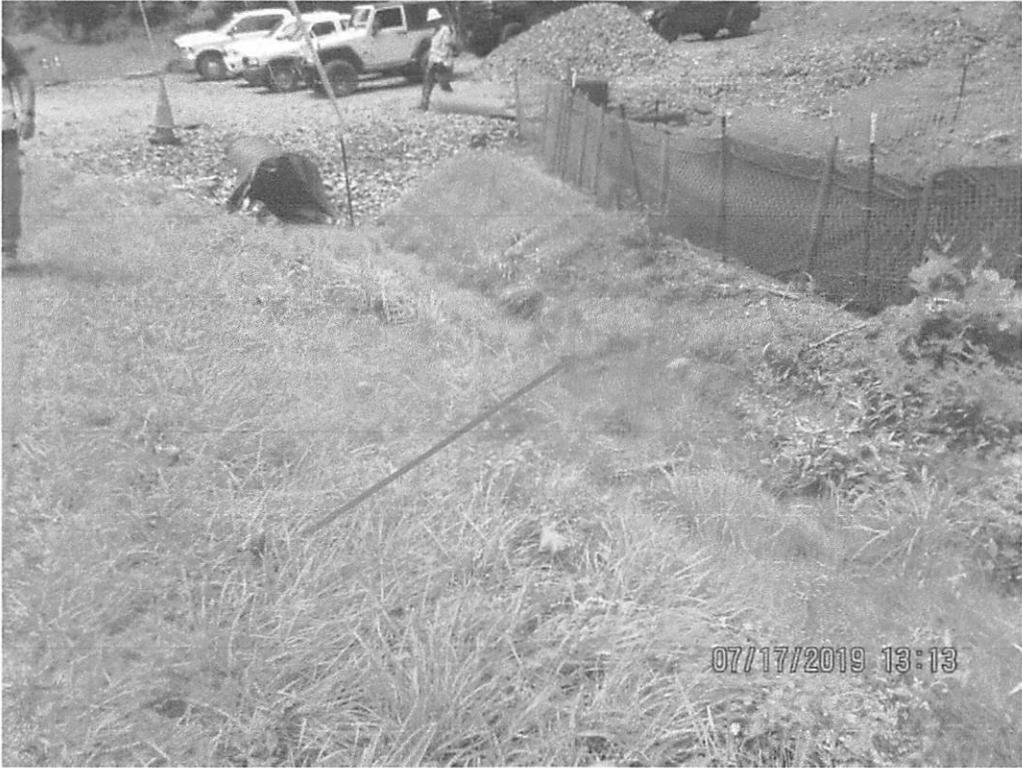
Sediment deposits and sediment-laden water present in ditch that conveys under ROW construction entrance, connects to elbow, conveys under CR23, and outlets on South side of road above Stream S-UV12.

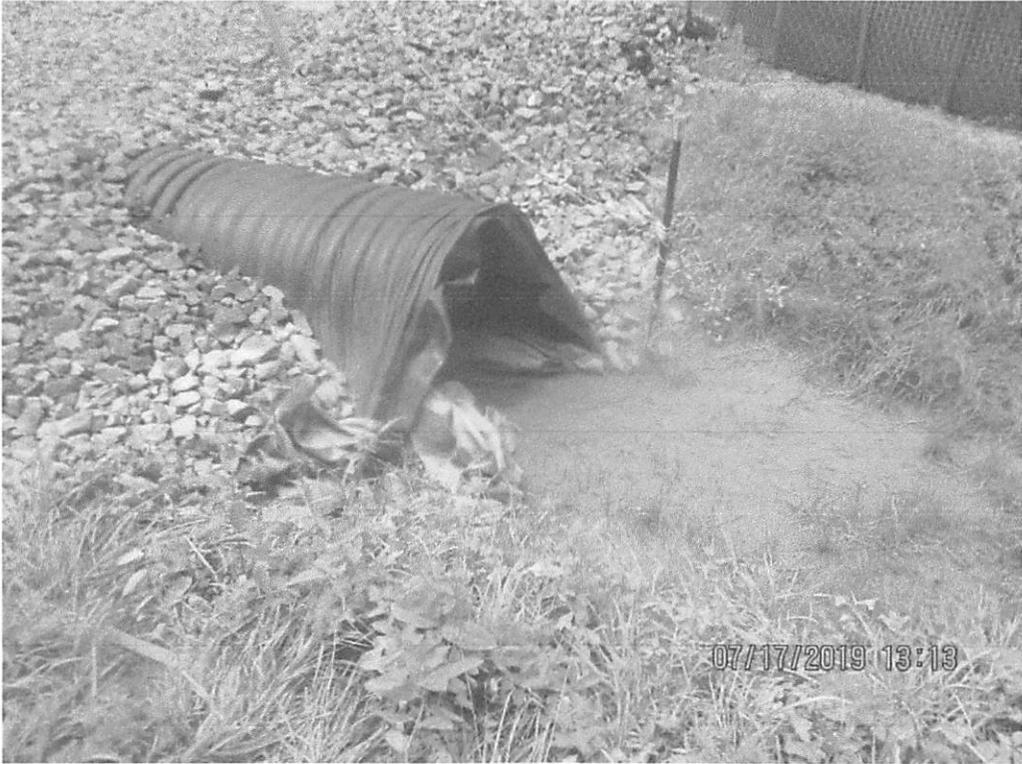
Culvert outlet that conveys under ROW construction entrance. Sediment deposits and SLW present in ditch.

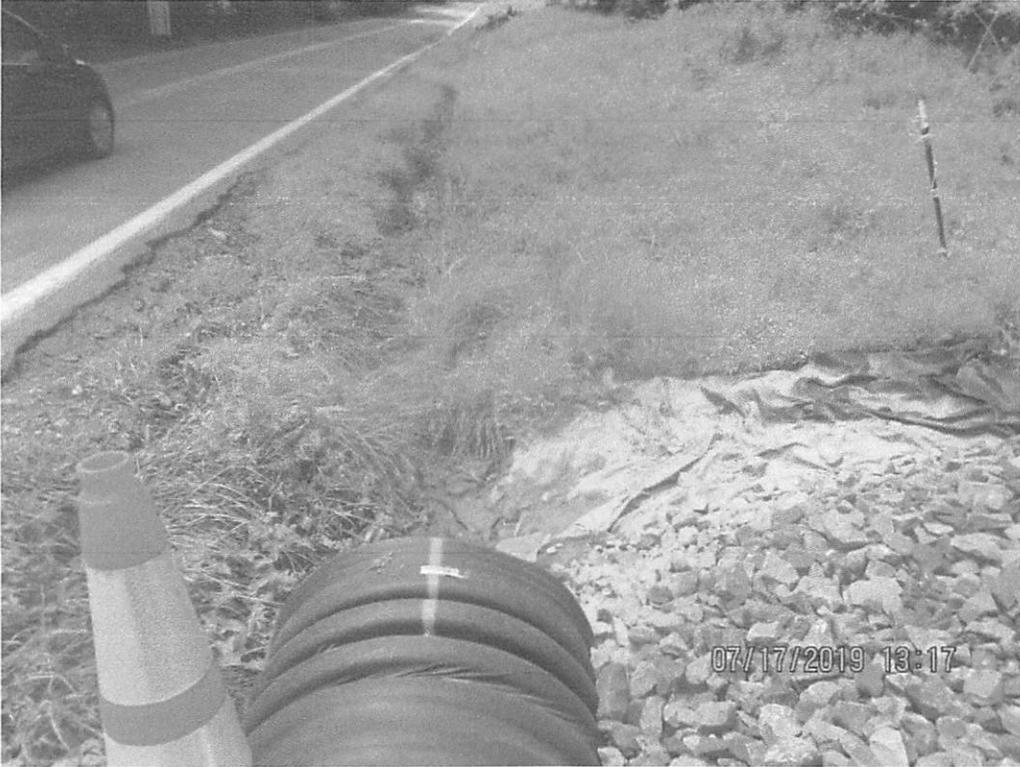
Ditch line past LOD and MVP ROW entrance along CR 23 at station 3192+50.

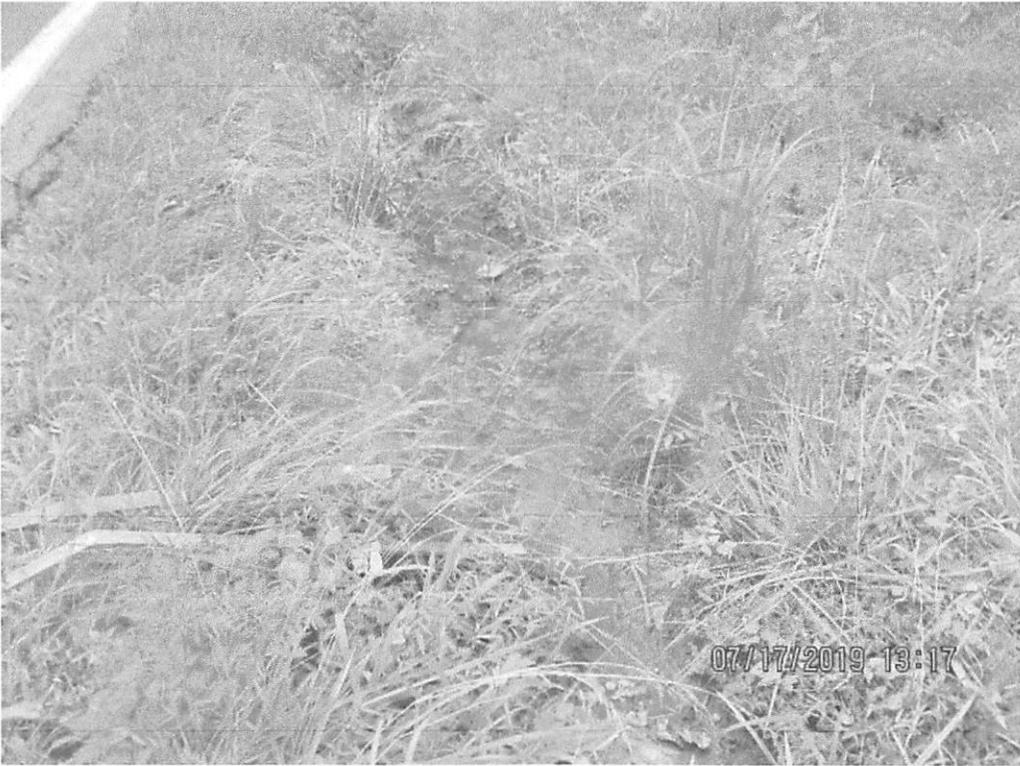
Culvert outlet depicted by arrow. Outlet from elbow that occurs under construction entrance and conveys under CR 23.

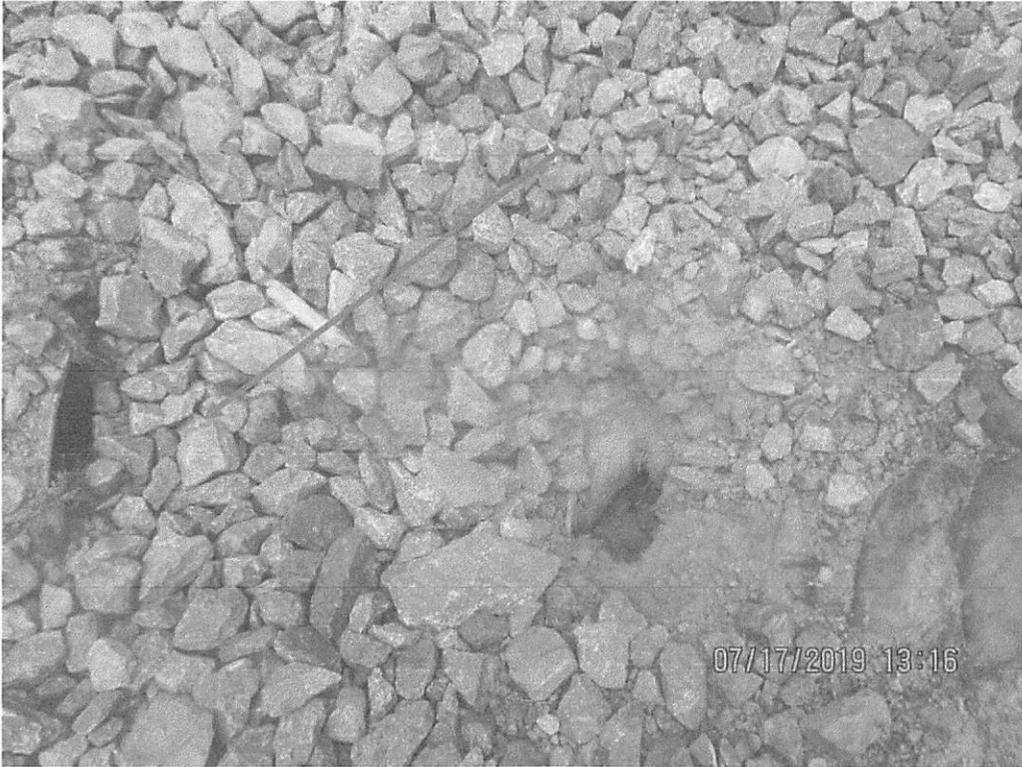
Above Stream S-UV12. Culvert outlets where sediment-laden water was conveyed that overtopped controls.

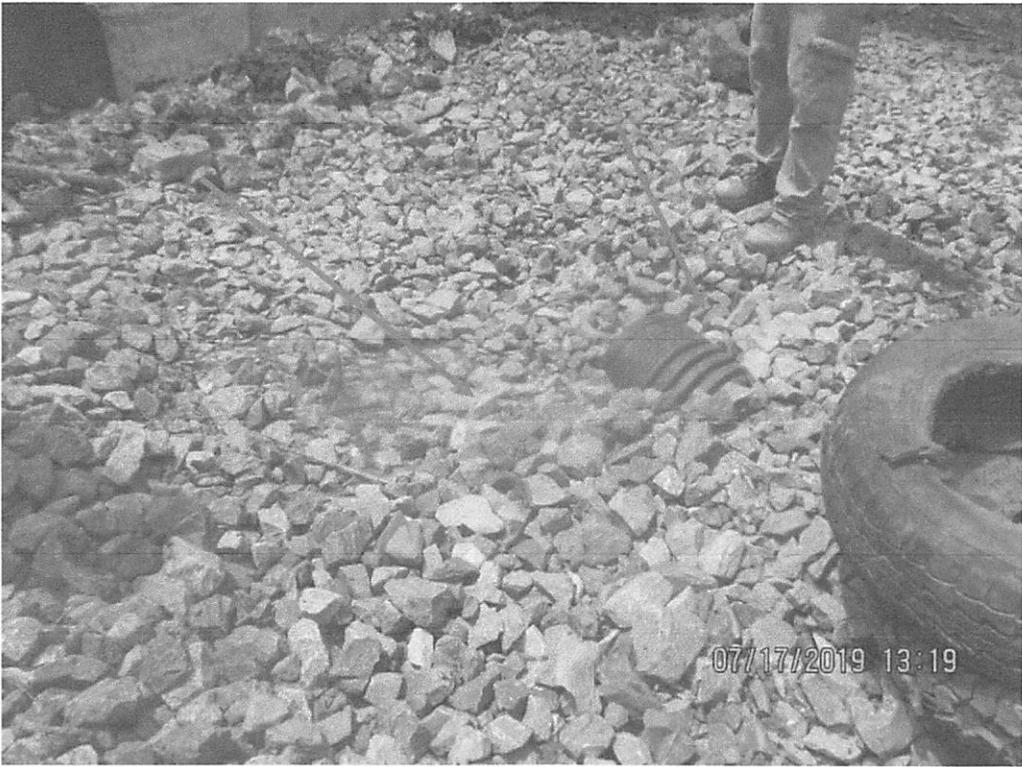
Controls below culvert outlets at station 3192+50. Sediment had been removed from behind controls and new controls had been installed. Sediment-laden water had left the site.

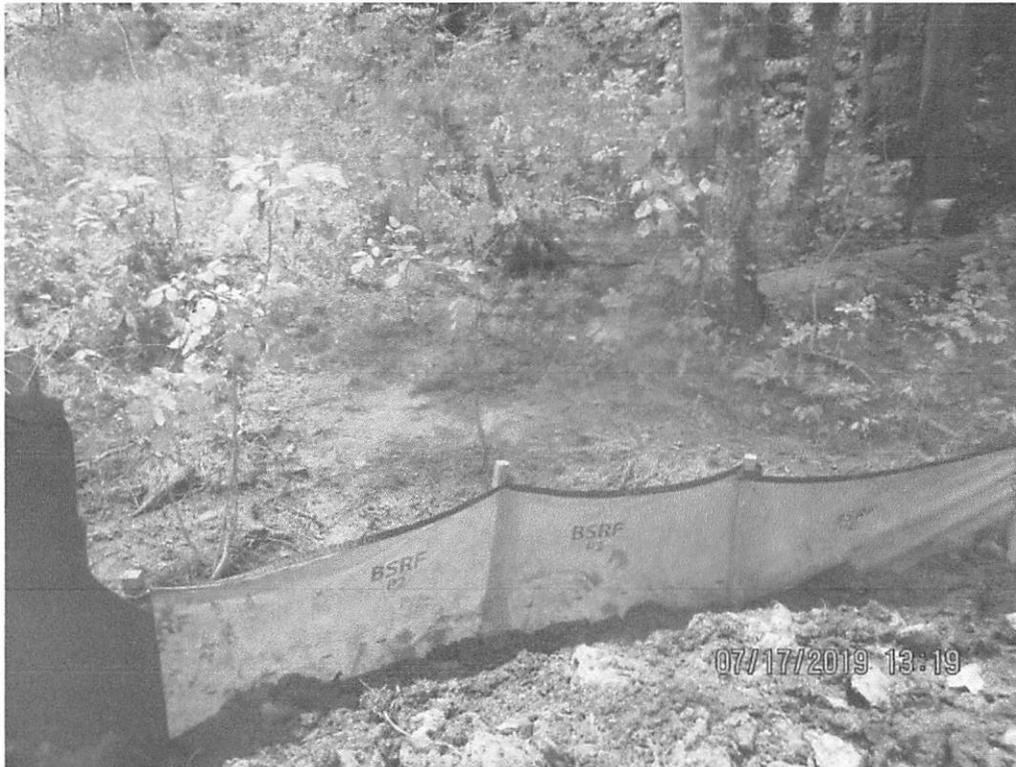
Fill slope erosion occurring at station 3159+46 facing edge of MVP LOD. Sediment deposits observed past the LOD.

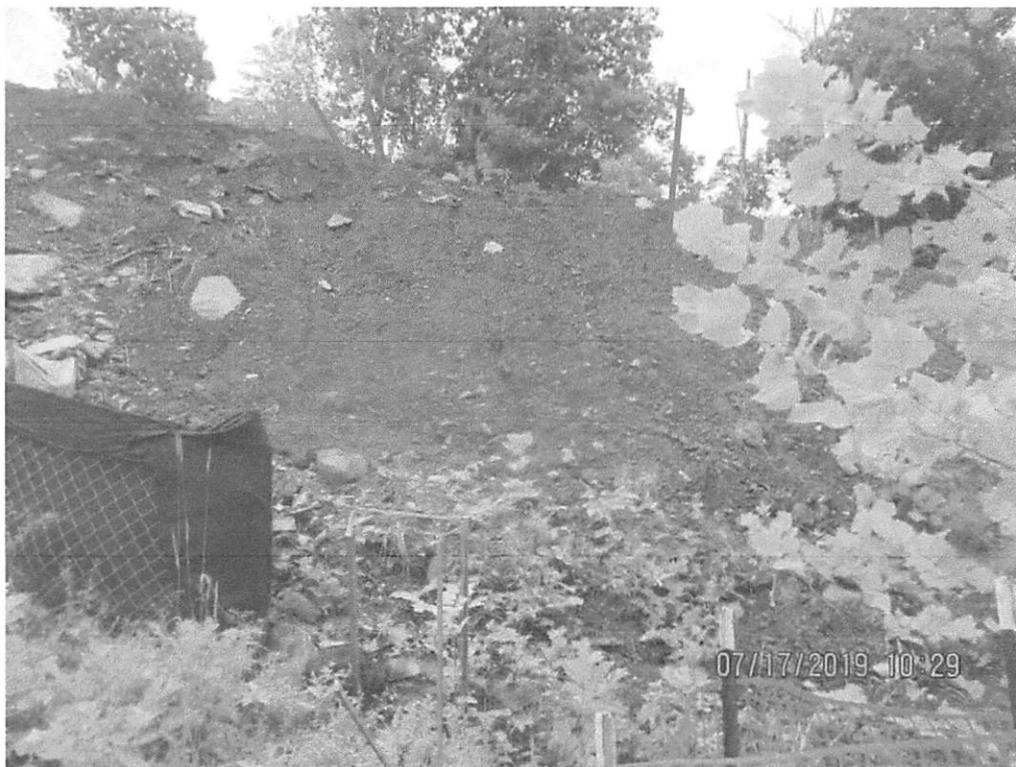
Facing downslope toward LOD at station 3159+46. Arrows depict fill slope erosion.

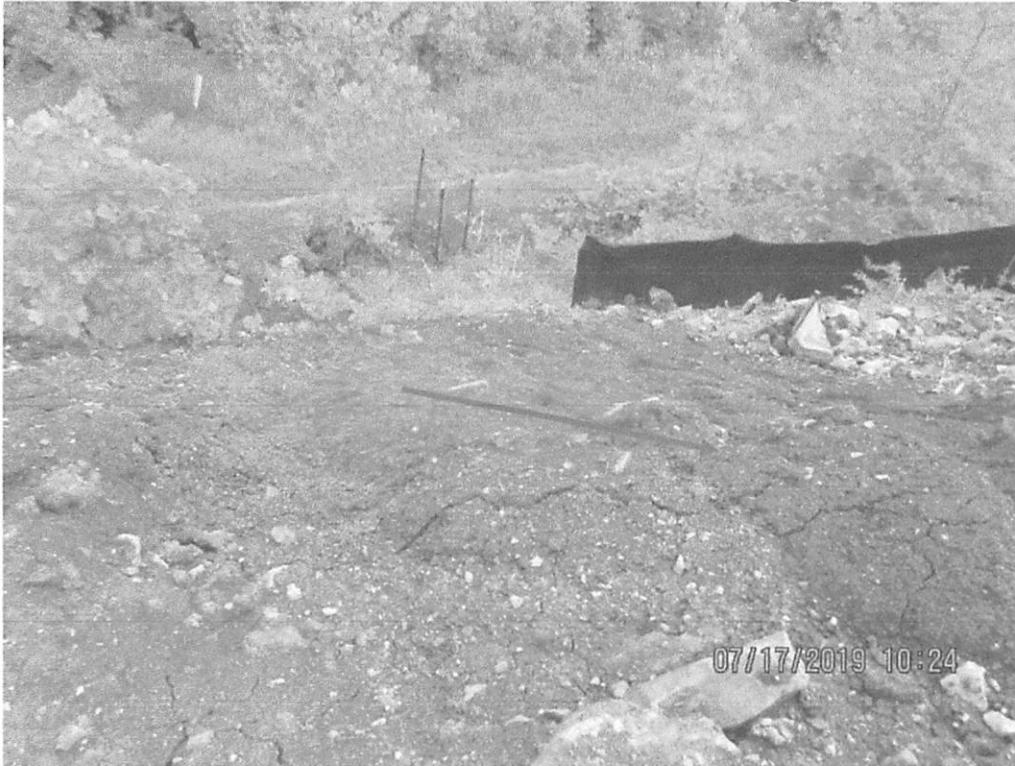
Area where sediment deposits were observed due to fill slope erosion at station 3159+46. Arrow depicts ditch line where deposits were present.

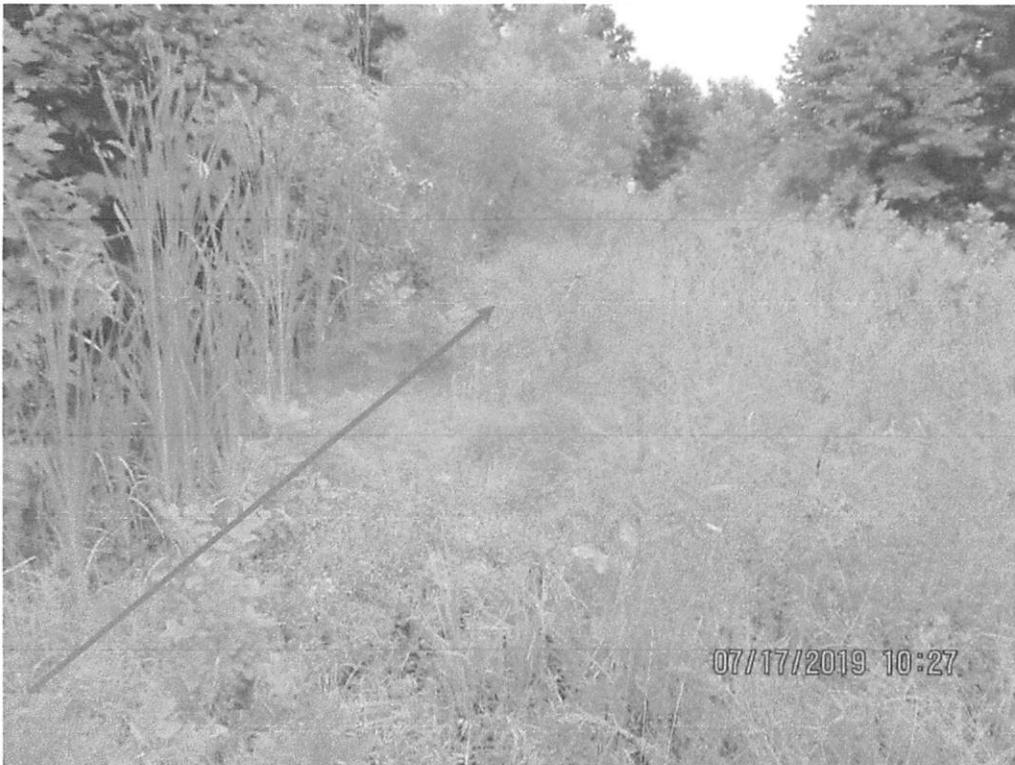
Sediment deposits present in ditch line that parallels MVP LOD at station 3159+46.

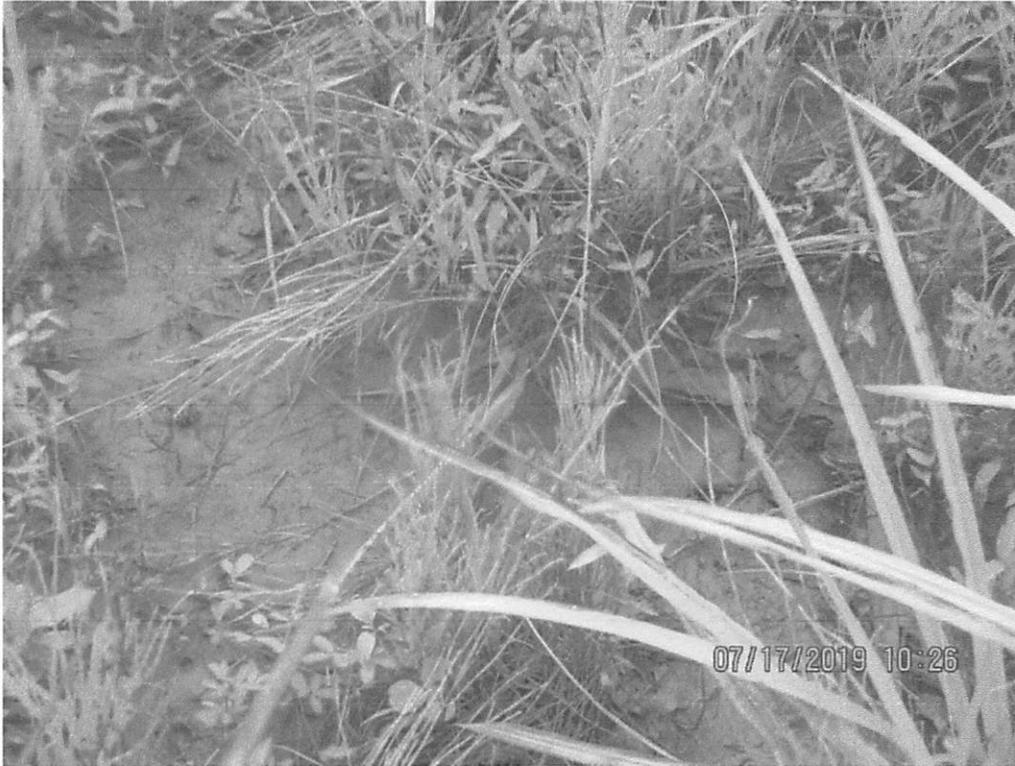
Sump at waterbar terminus near station 3151+47. Sediment deposits present past LOD due to lack of sump maintenance.

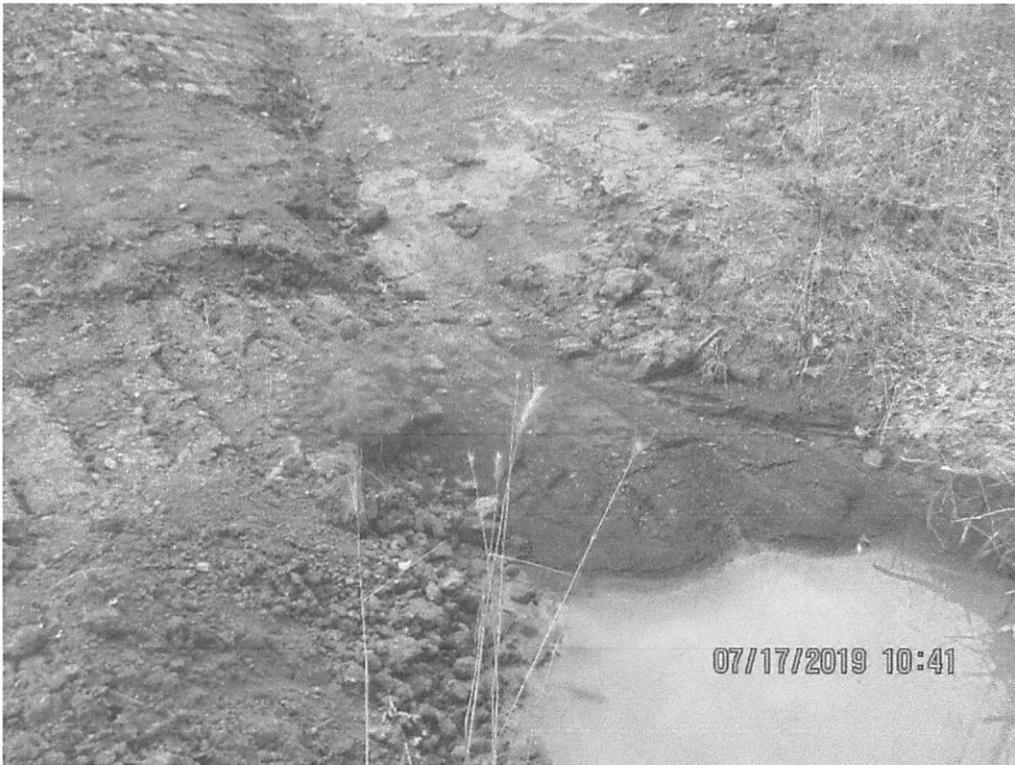
Sump at waterbar terminus near station 3151+47. Sediment deposits present past LOD due to lack of sump maintenance. Sump becoming overwhelmed with sediment.

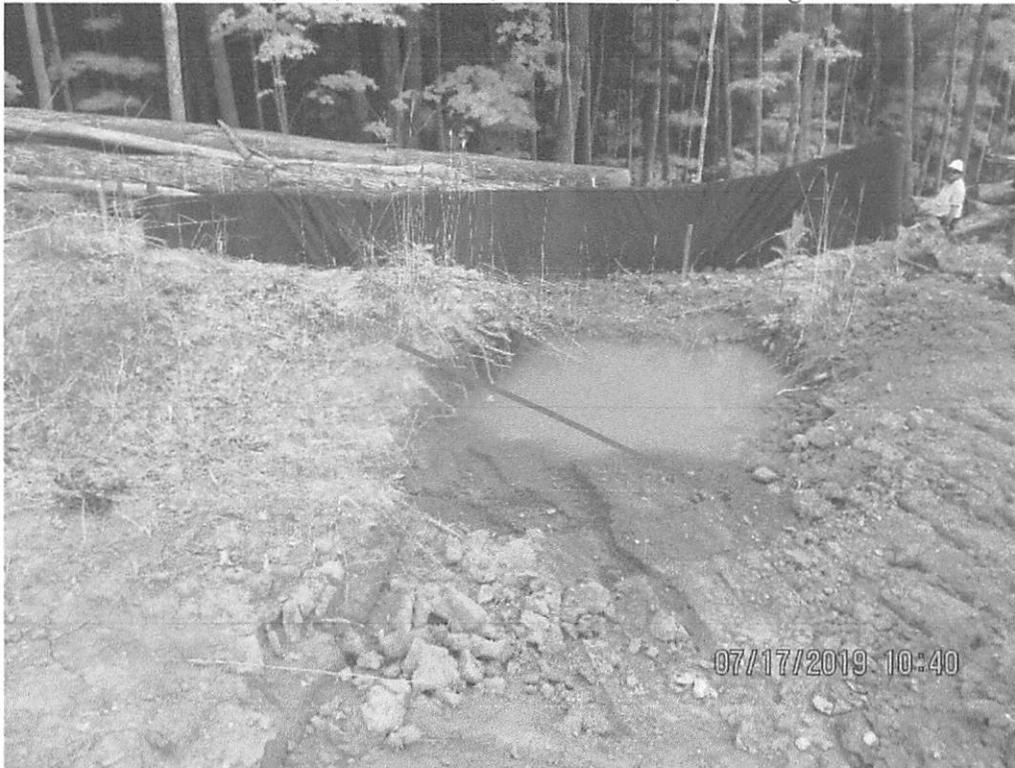
Scouring of vegetation and sediment deposits present past LOD near station 3151+47. Arrow depicts sediment deposits.

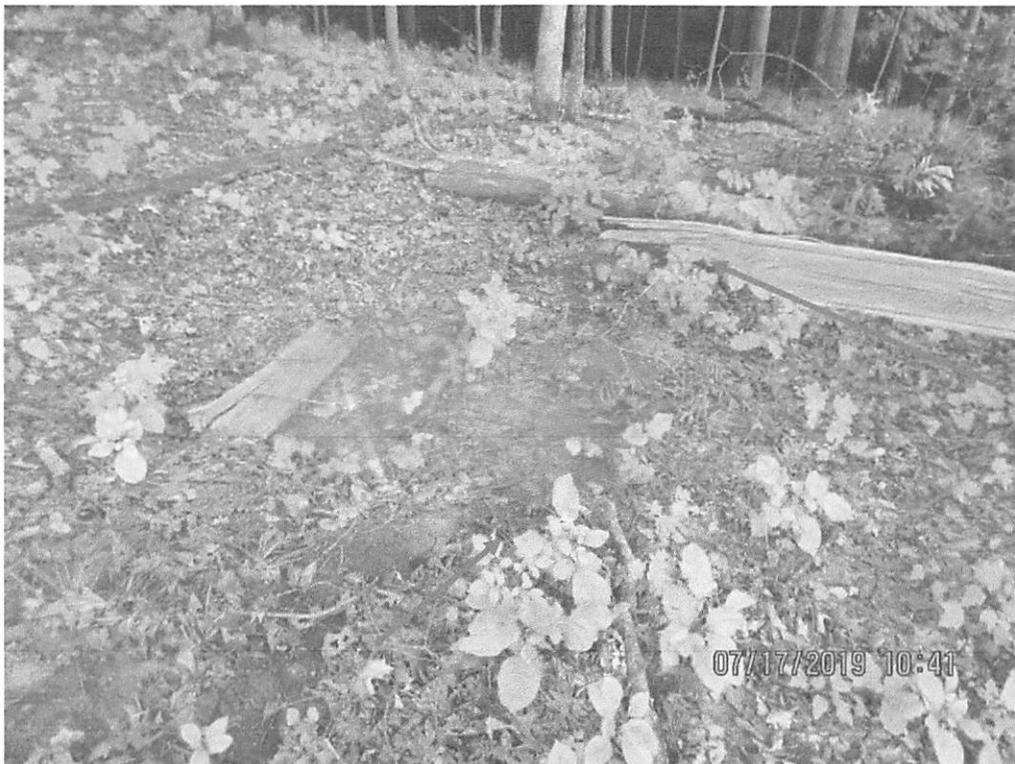
Sediment deposits past LOD near station 3151+47. Arrow depicts sediment deposits.

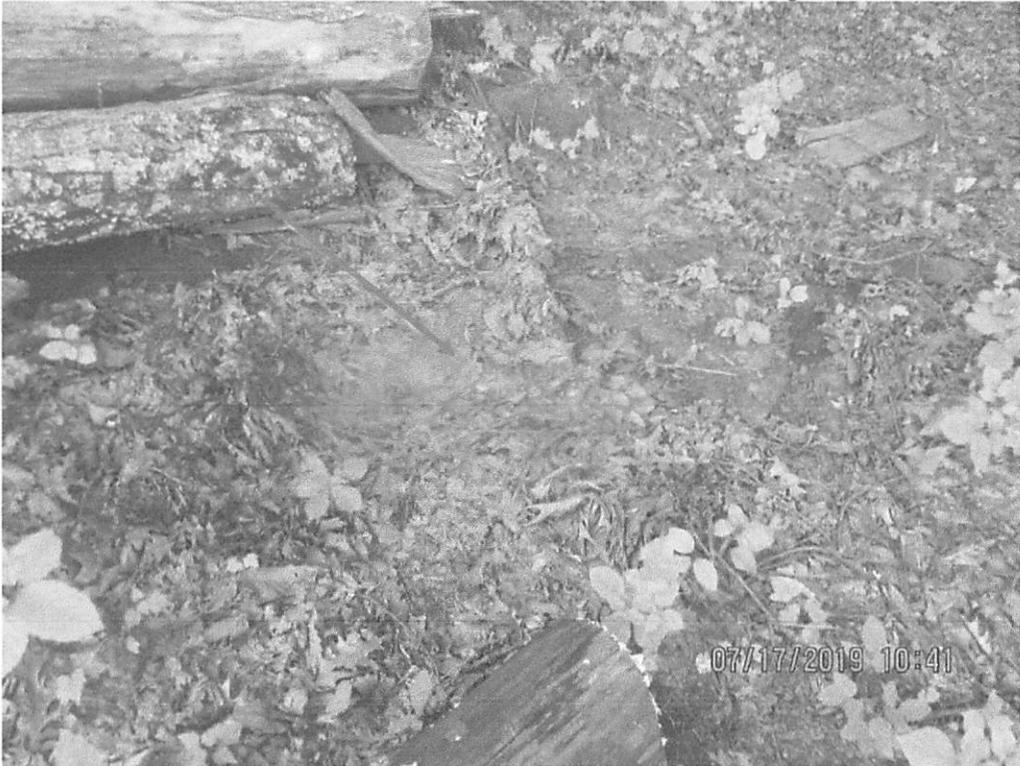
Waterbar with erosion at station 3149+00.

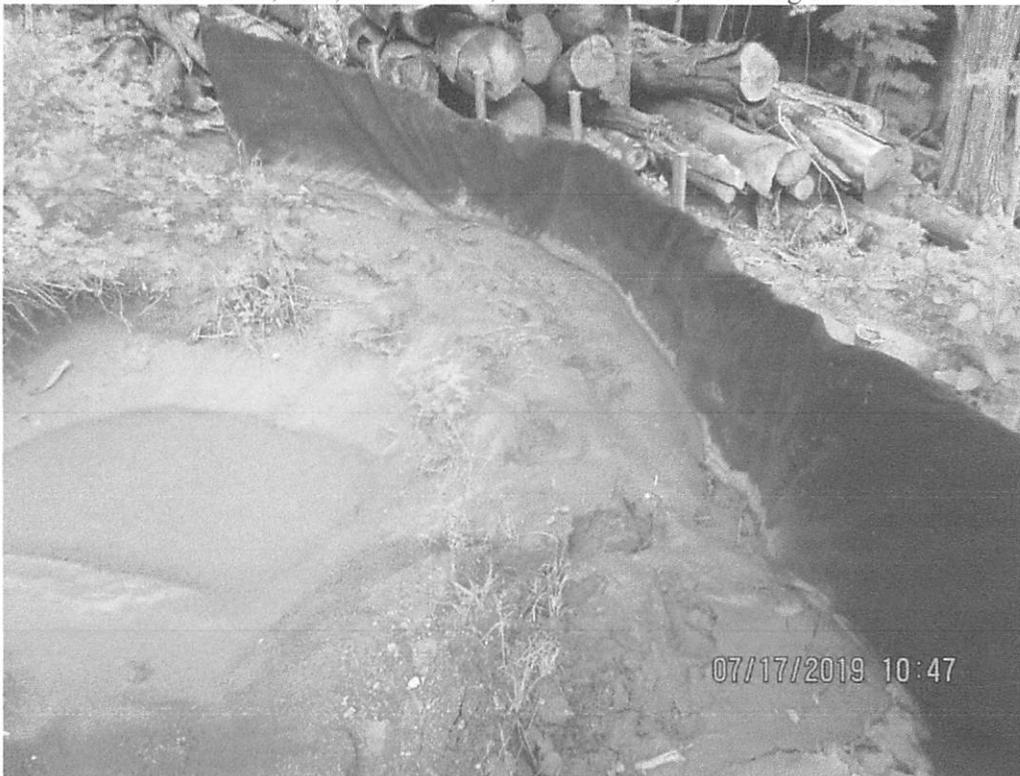
Waterbar terminus and sump at station 3149+00. Sump full of sediment and sediment deposits past LOD.

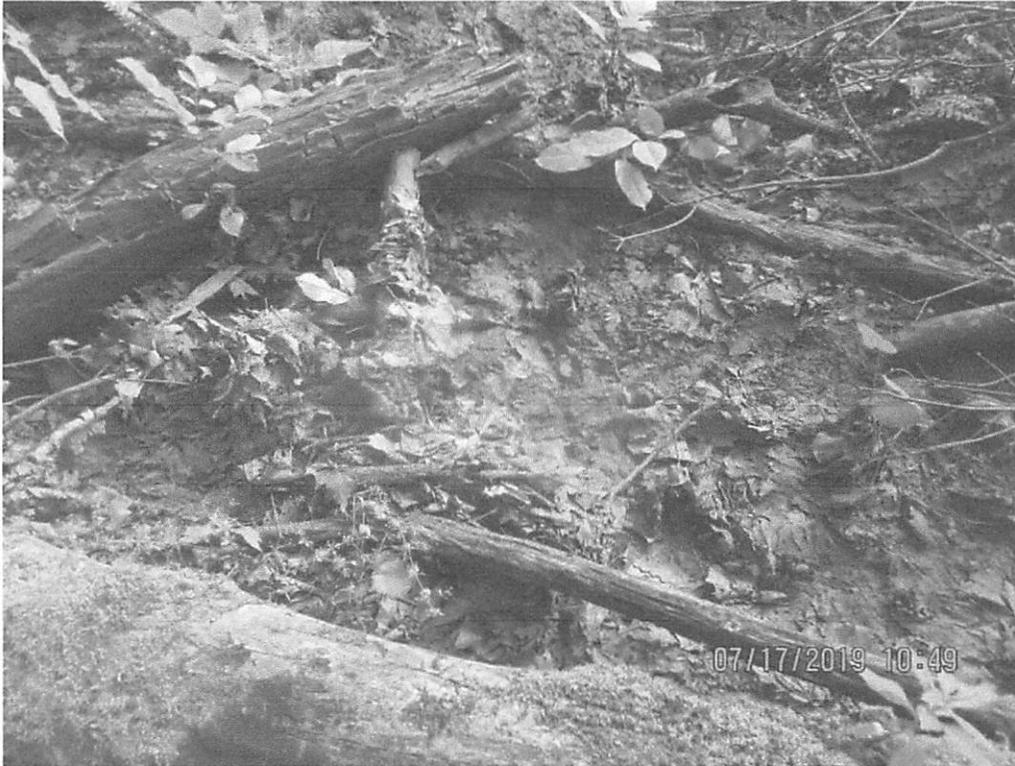
Below waterbar terminus at station 3149+00. Sediment deposits observed past LOD.

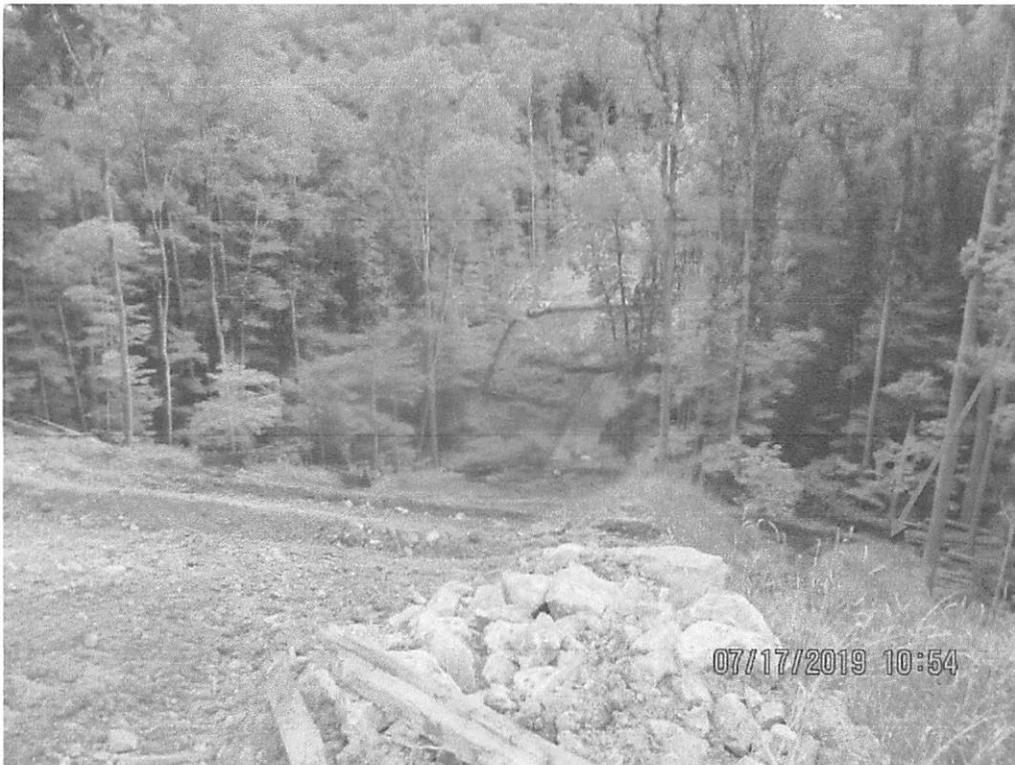
Upslope of Streams H-154 and H-153 near station 3147+11. Arrow depicts diversion berm on edge of LOD installed on steep slope.

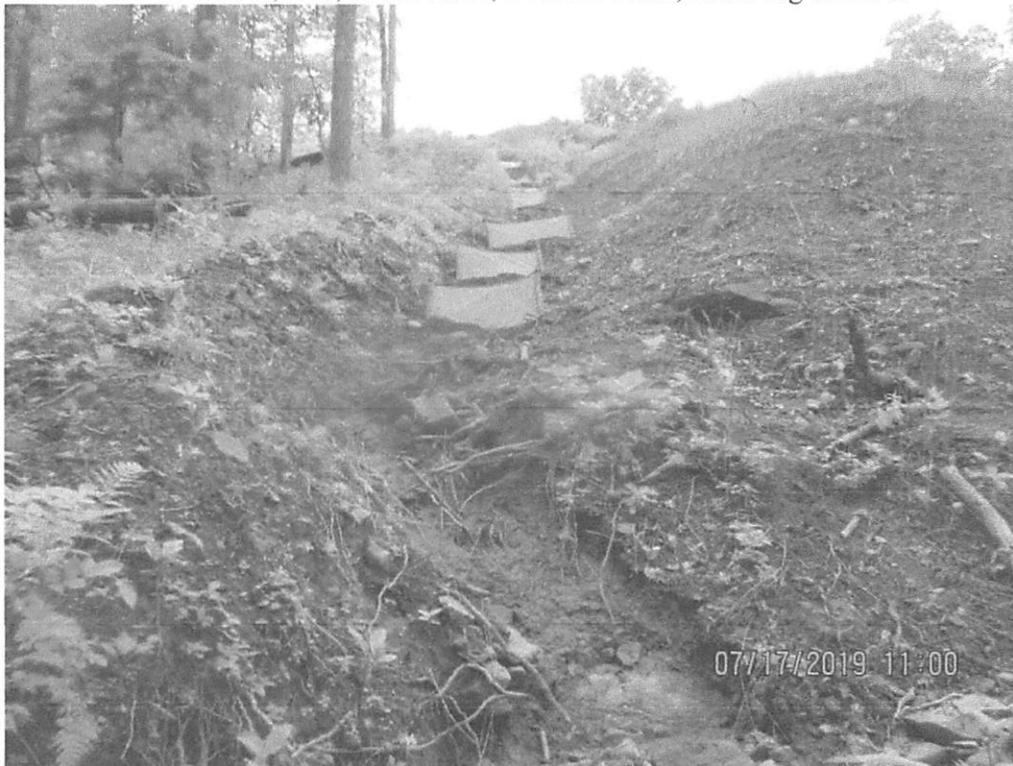
Diversion berm with erosion present above stream S-H154 at station 3147+11. Silt fence installed on steep slope where channelized/concentrated flow was occurring.

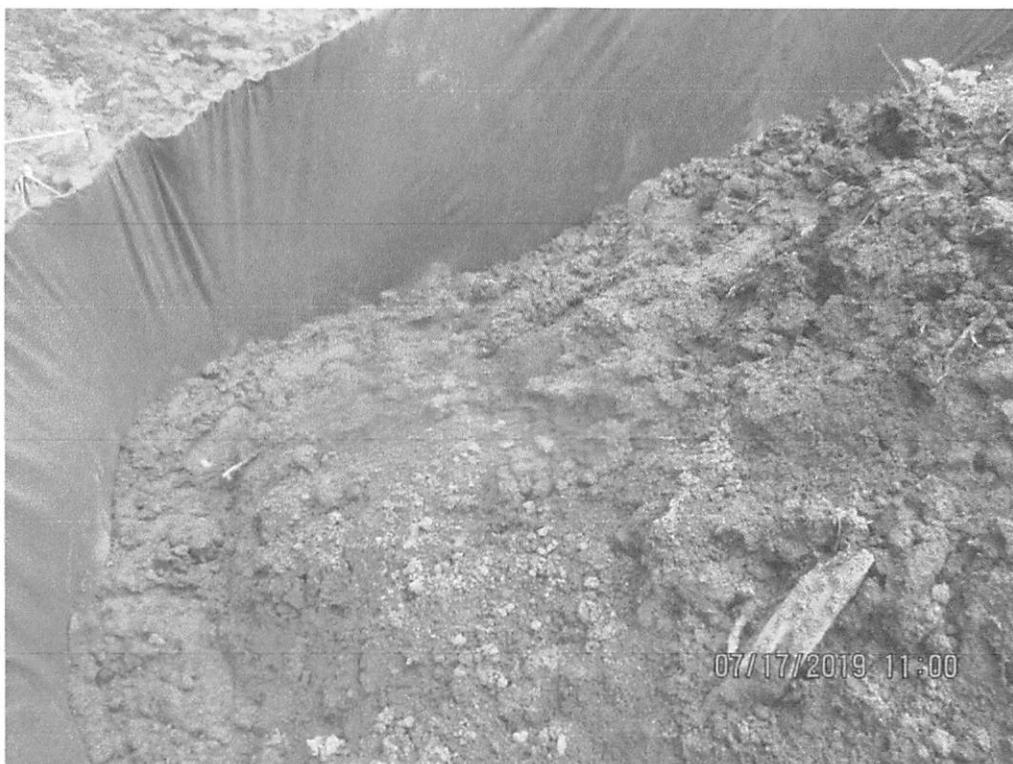
Controls at base of diversion berm. Sediment deposits had been removed from behind controls and new fabric installed over super silt fence at station 3147+11.

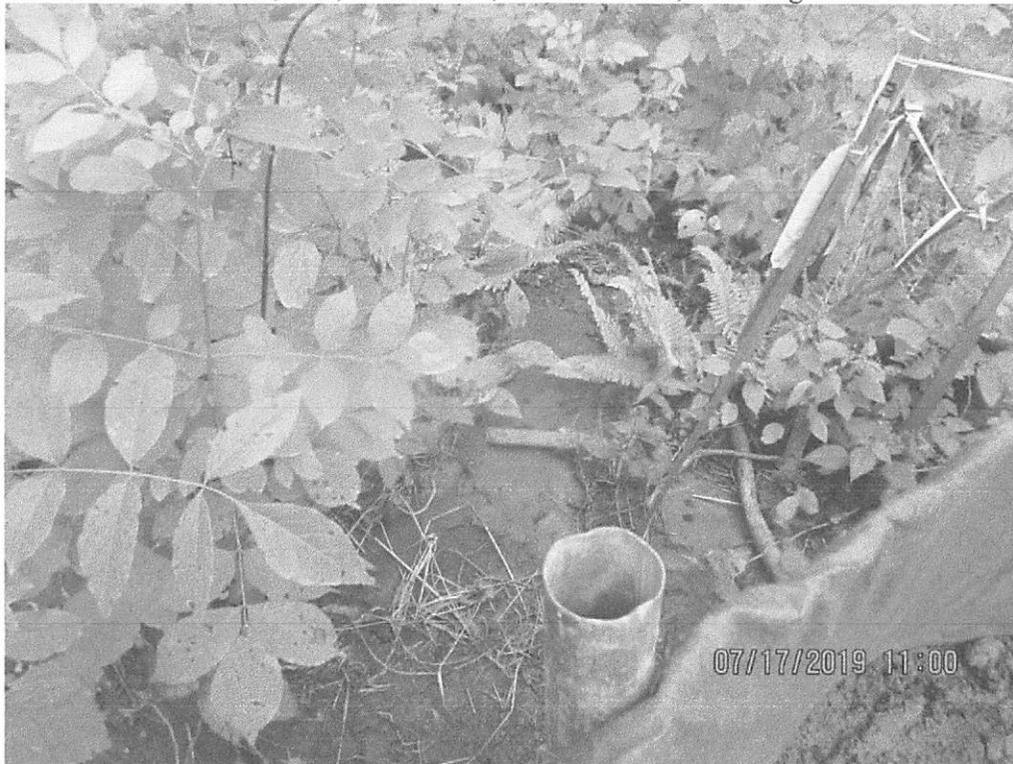
Sediment deposits past the LOD at station 3147+11 above Stream S-H154.

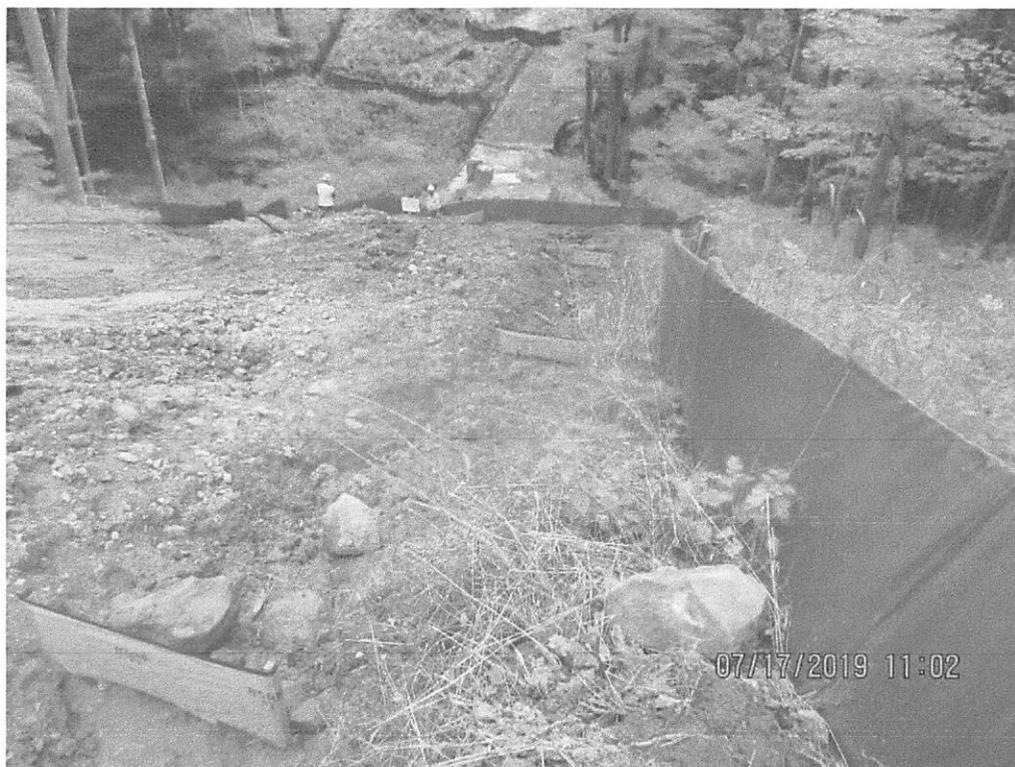
Facing downslope at station 3146+00 toward stream S-H153. Diversion berm installed on slope leading to sump above stream.
