**CONSENT ORDER
ISSUED UNDER THE
WATER POLLUTION CONTROL ACT
WEST VIRGINIA CODE, CHAPTER 22, ARTICLE 11**

TO: Mountain Valley Pipeline, LLC
Robert J. Cooper
2200 Energy Drive
Canonsburg, PA 15317

DATE: December 17, 2020

ORDER NO.: 9925

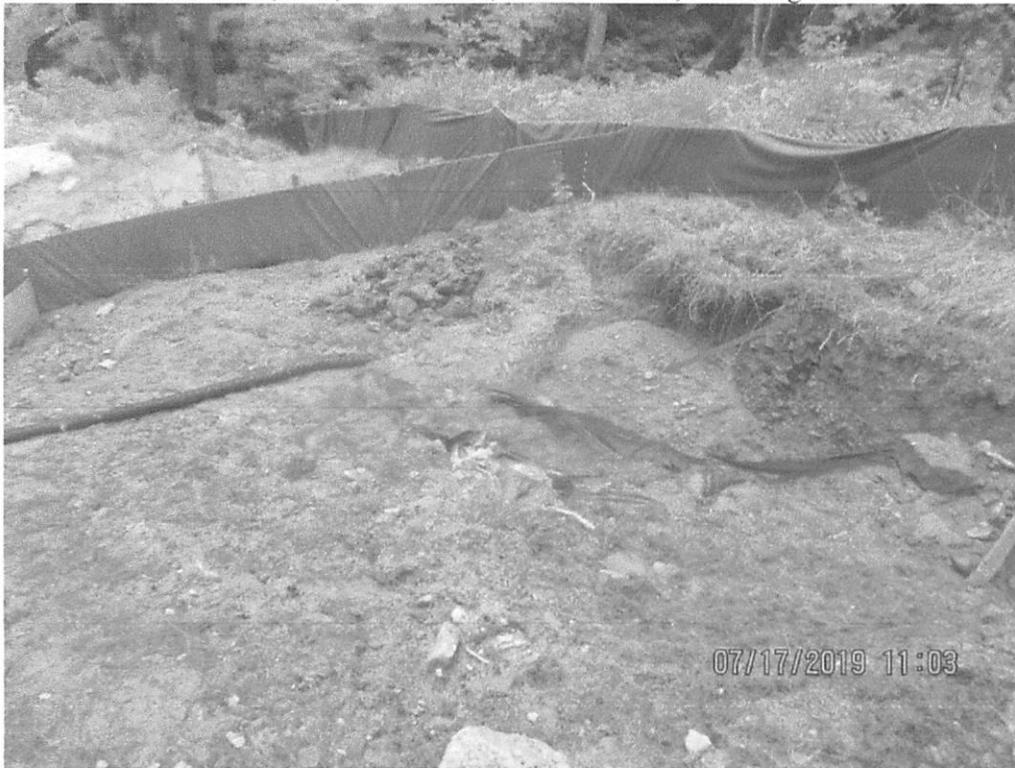
Sump at base of slope where diversion berm terminates above Stream S-H153. Slope drain installed in sump overwhelmed with sediment which was conveyed past the LOD. Arrow depicts slope drain inlet approximate location.

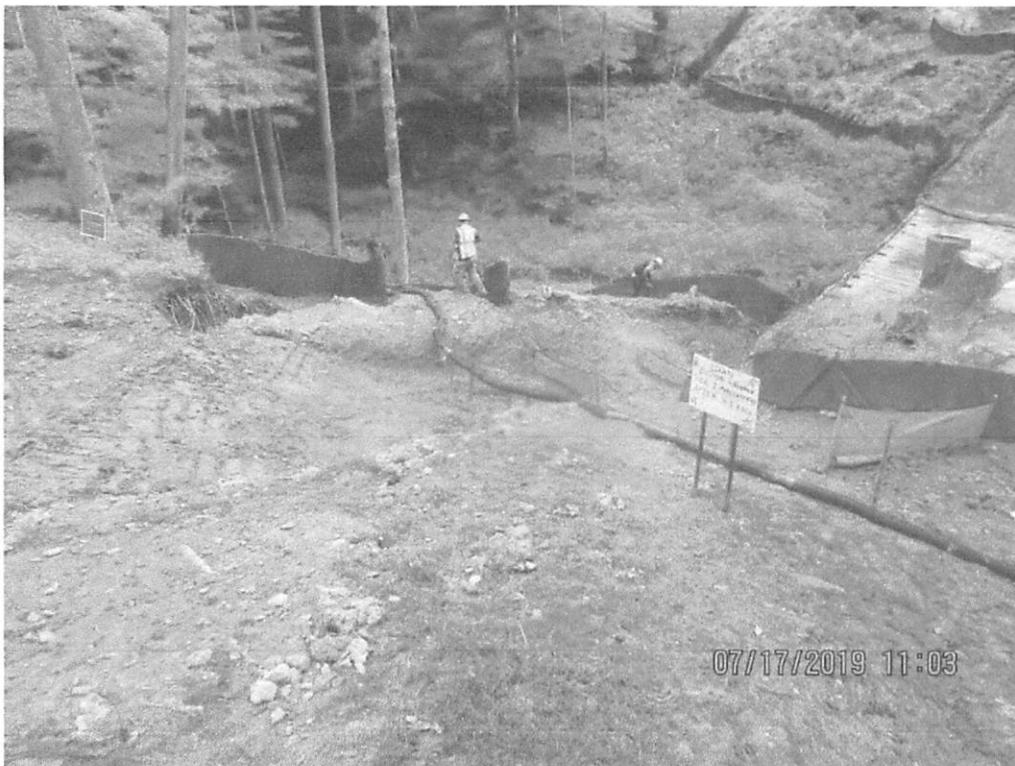
Slope drain conveying across ROW and terminating past LOD and controls. Control failures occurred in this location and impacted stream S-H153.

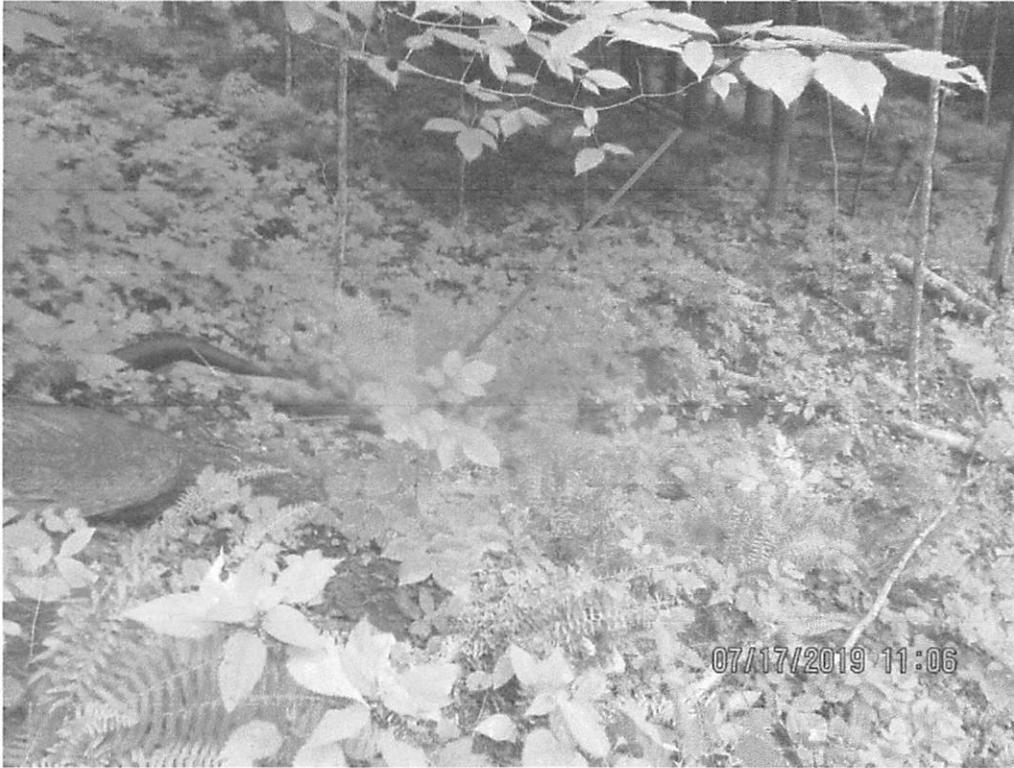
Pipe slope drain extended past LOD and controls, terminating above Stream S-H153. Arrow depicts drain outlet location.

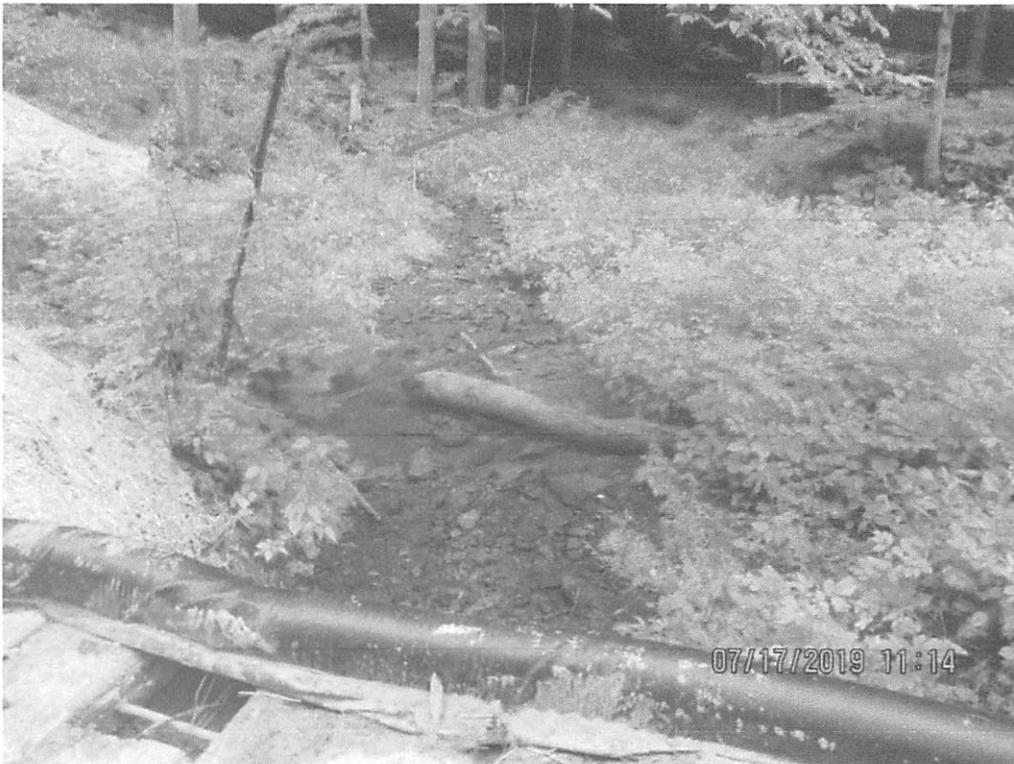
Facing upstream toward impacts to Stream S-H153 reported to spill hotline. Arrows depict where impacts occurred on North side of stream.

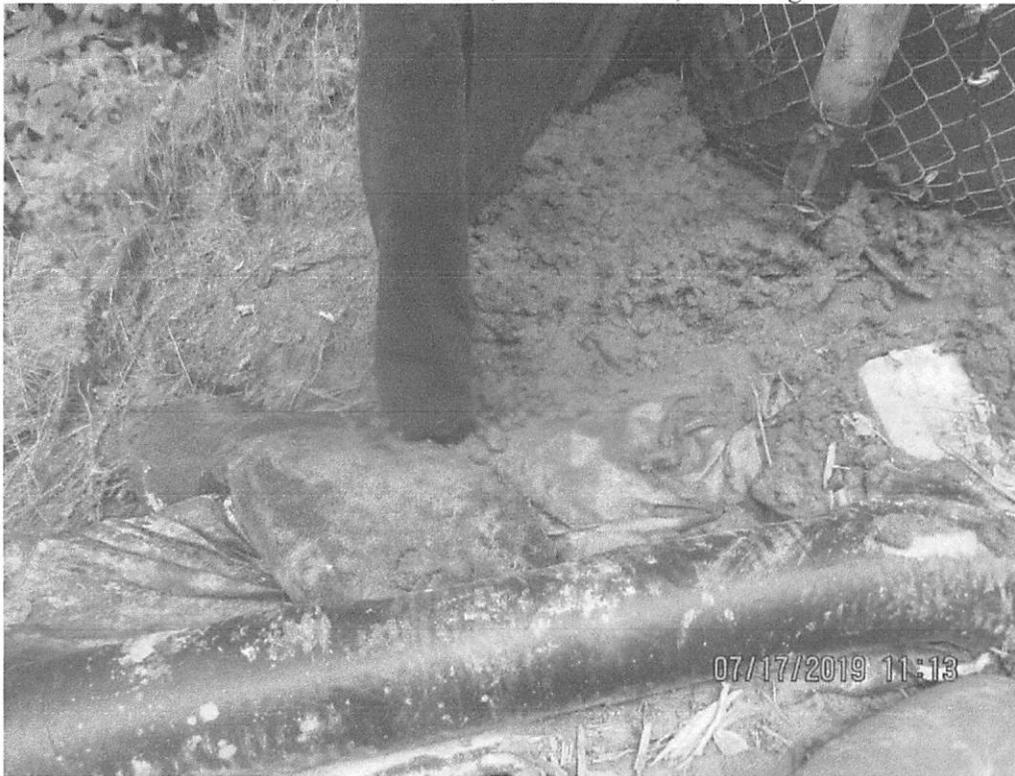
Controls at bridge that crosses Stream S-H153. Controls were overwhelmed with sediment.

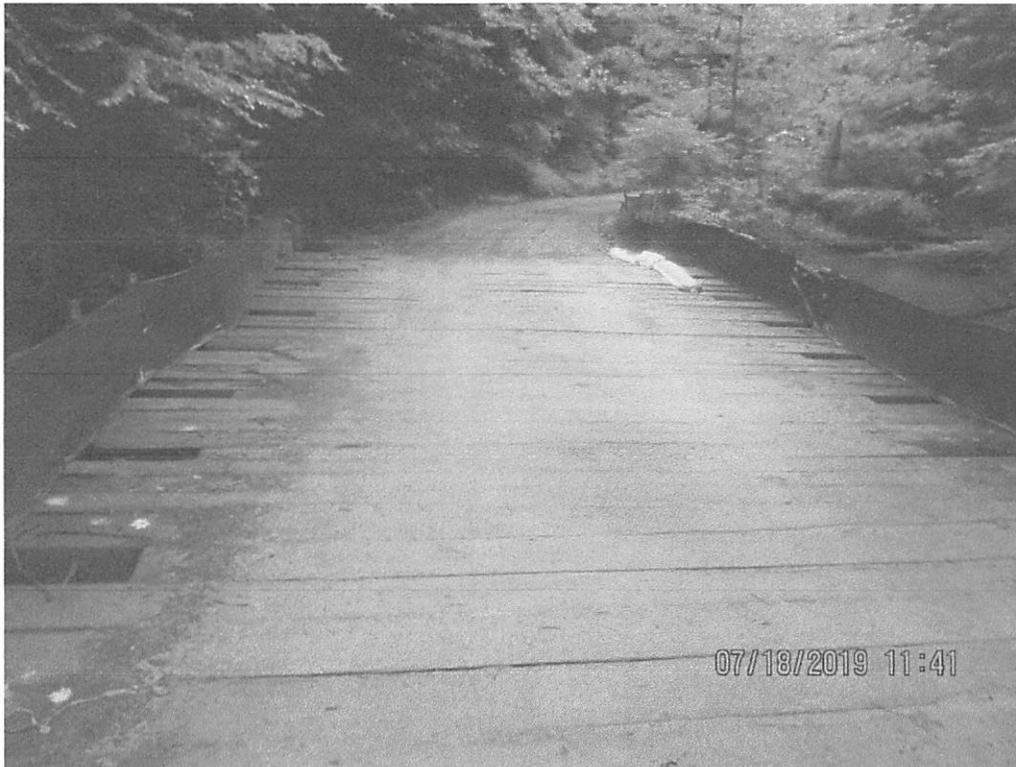
Access Road MVP-WB-119 crossing with Stream SB-02 (Narrows Run) a tributary of Holly River.

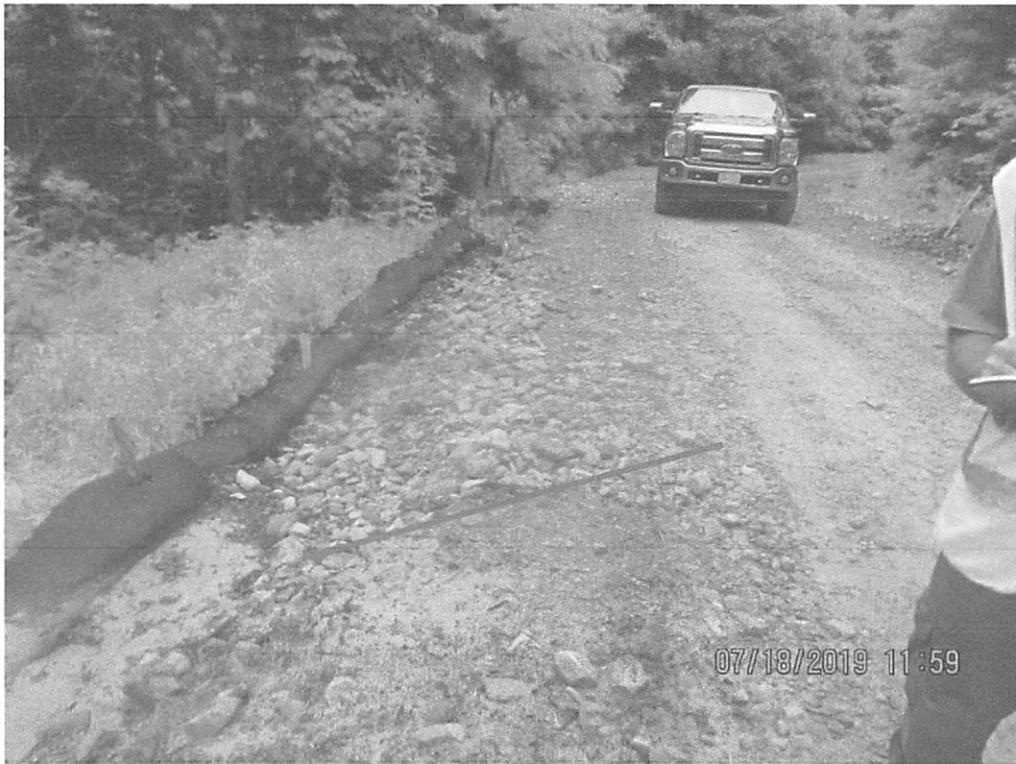
Facing perimeter controls along access road MVP-WB-119. Controls were overwhelmed with sediment.

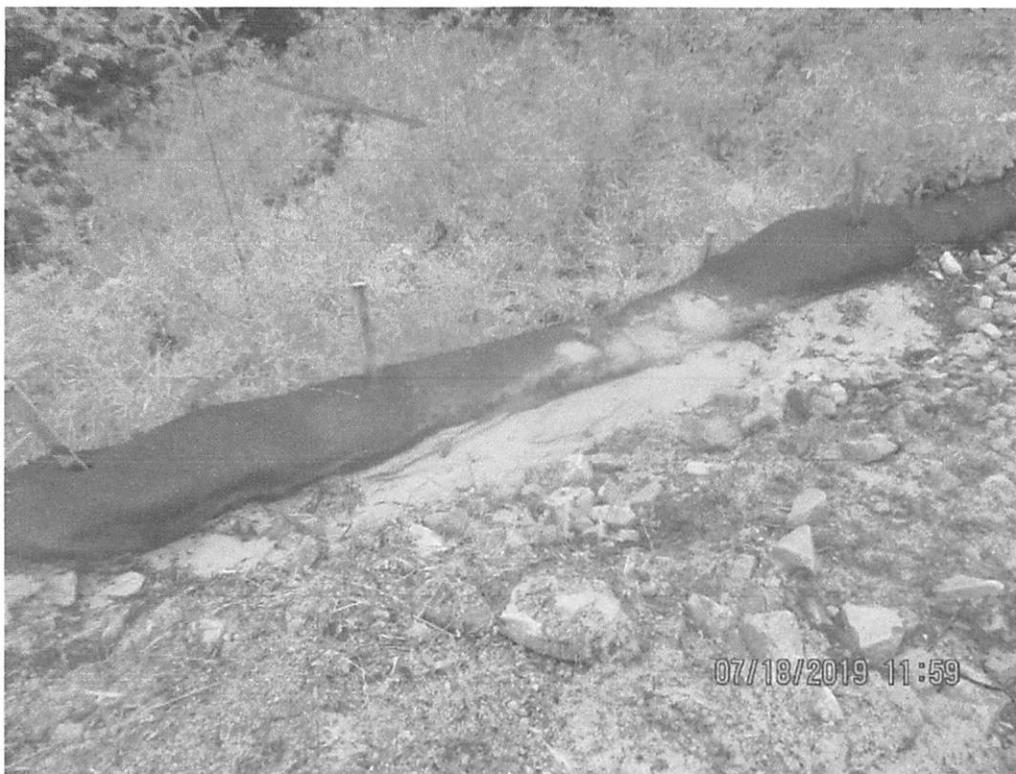
Perimeter controls along MVP-WB-119 overwhelmed with sediment with sediment deposits past the LOD. Arrow depicts sediment deposits.

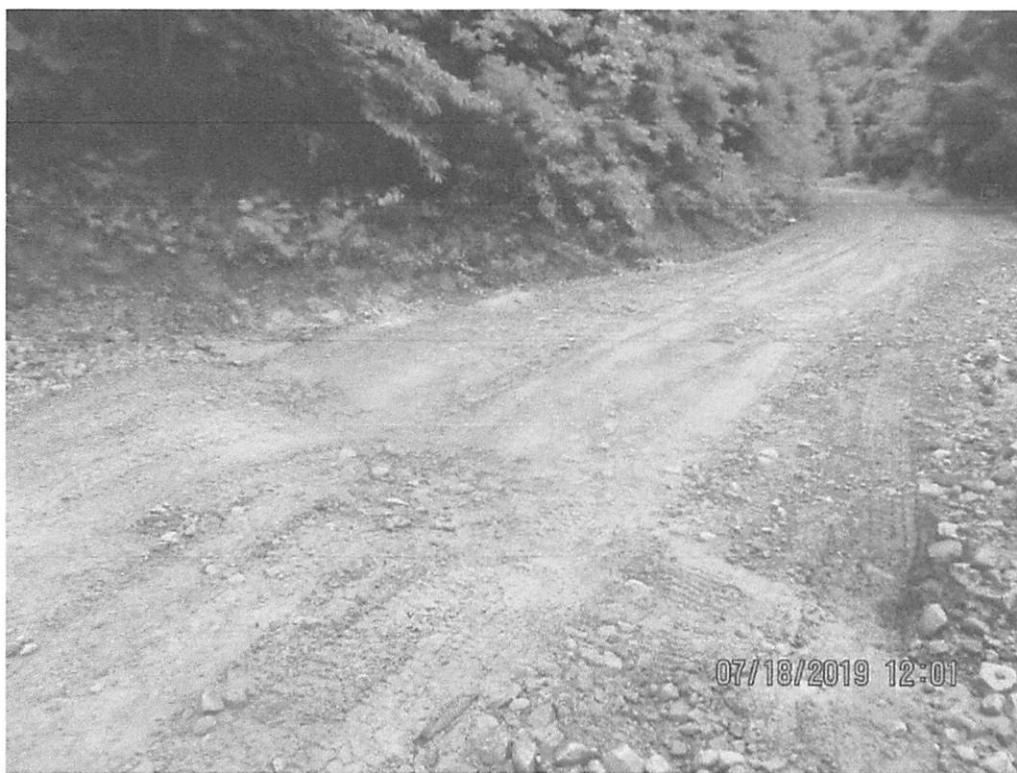
Waterbar installed on Access Road MVP-WB-119. Ditch line had rock checks present. Sediment deposits overwhelmed perimeter controls downslope of waterbar.

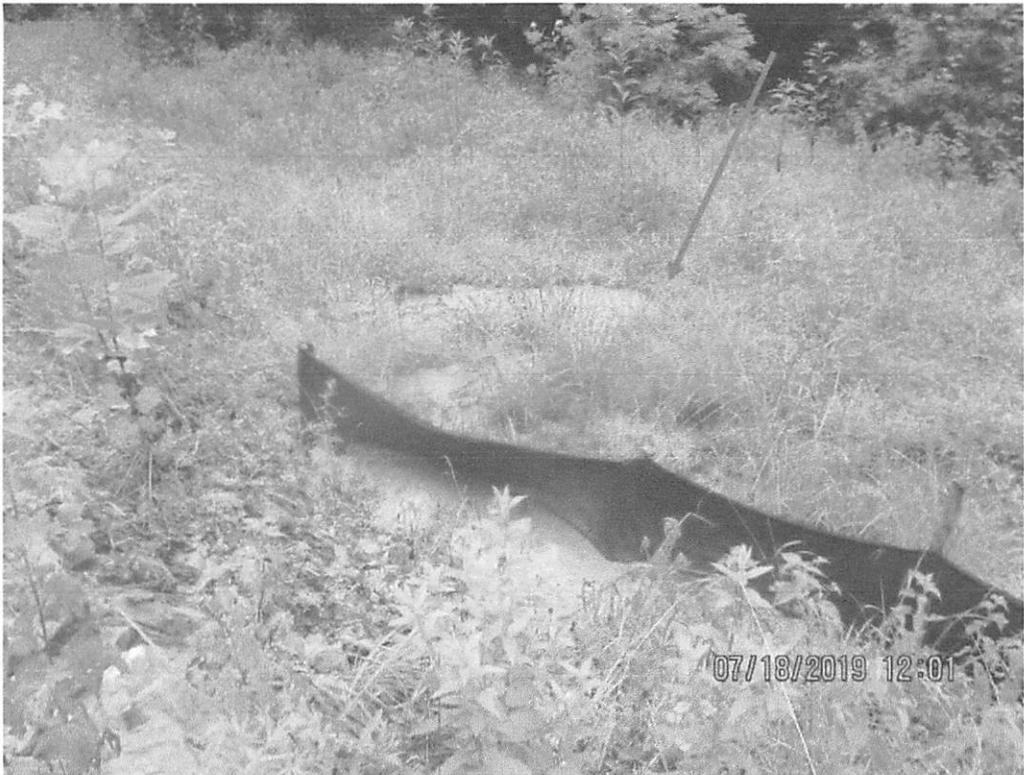
Downslope of waterbar outlet terminating on slope. Controls overwhelmed with sediment and deposits were present past the LOD and Controls. Arrow depicts sediment deposits.

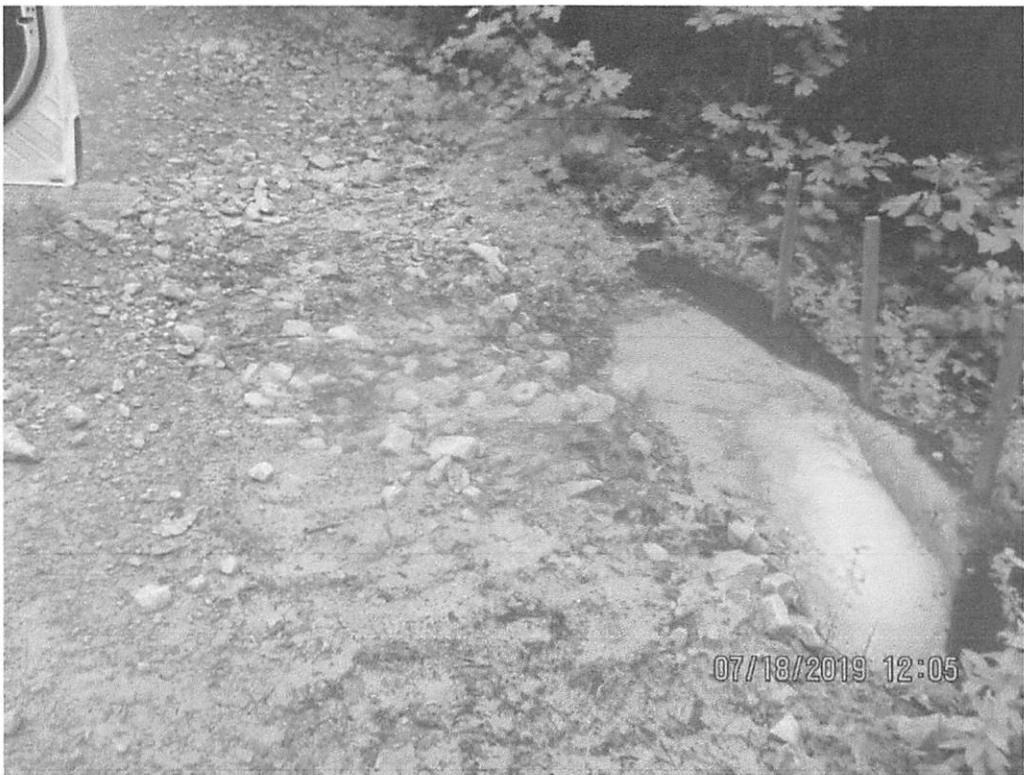
Perimeter controls overwhelmed with sediment along access road MVP-WB-119

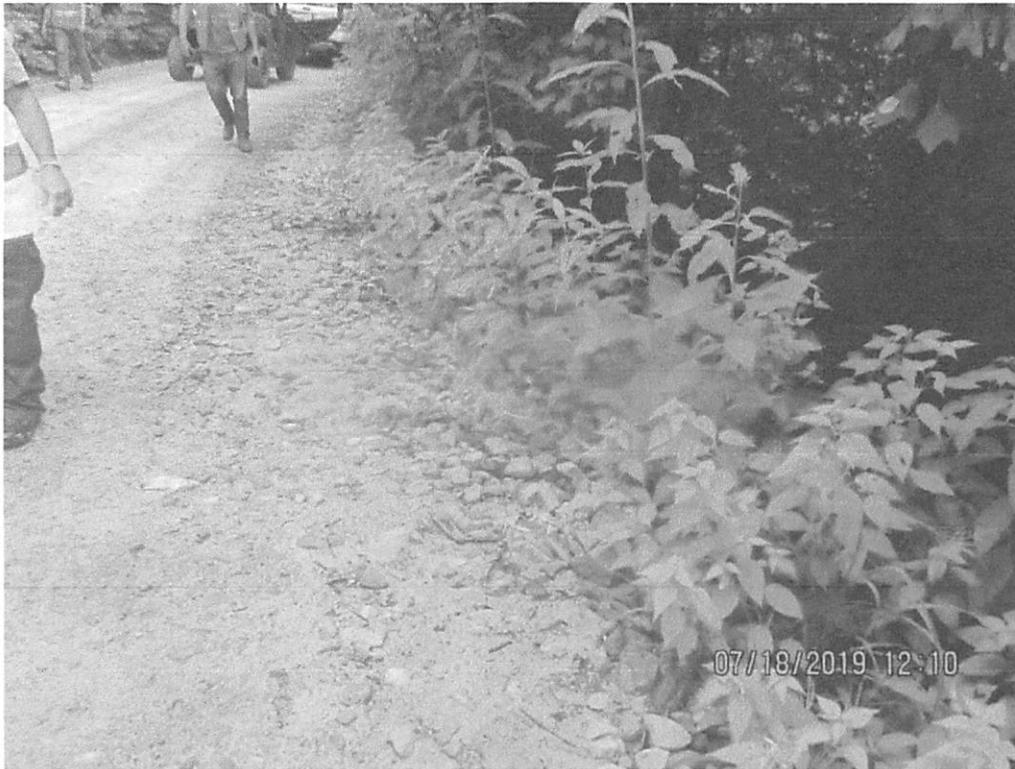
Section of MVP-WB-119 with no perimeter controls installed. Sediment deposits were observed past the LOD.

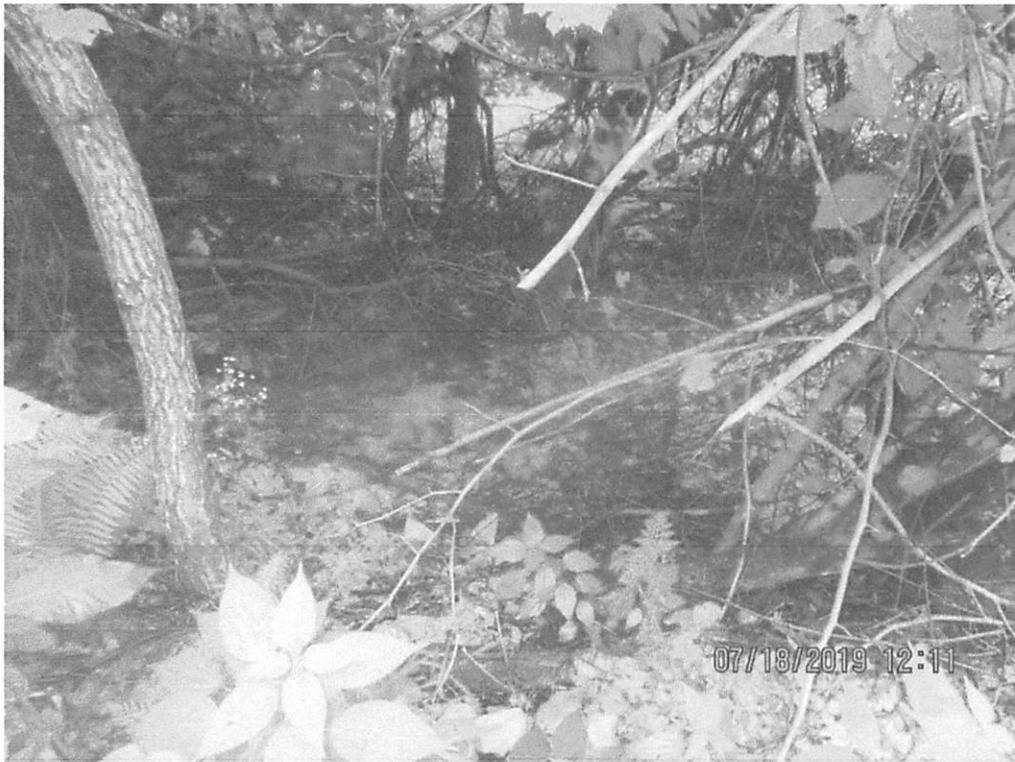
Section of MVP-WB-119 with no perimeter controls installed. Sediment deposits were observed past the LOD throughout the vegetated area downslope of the road.

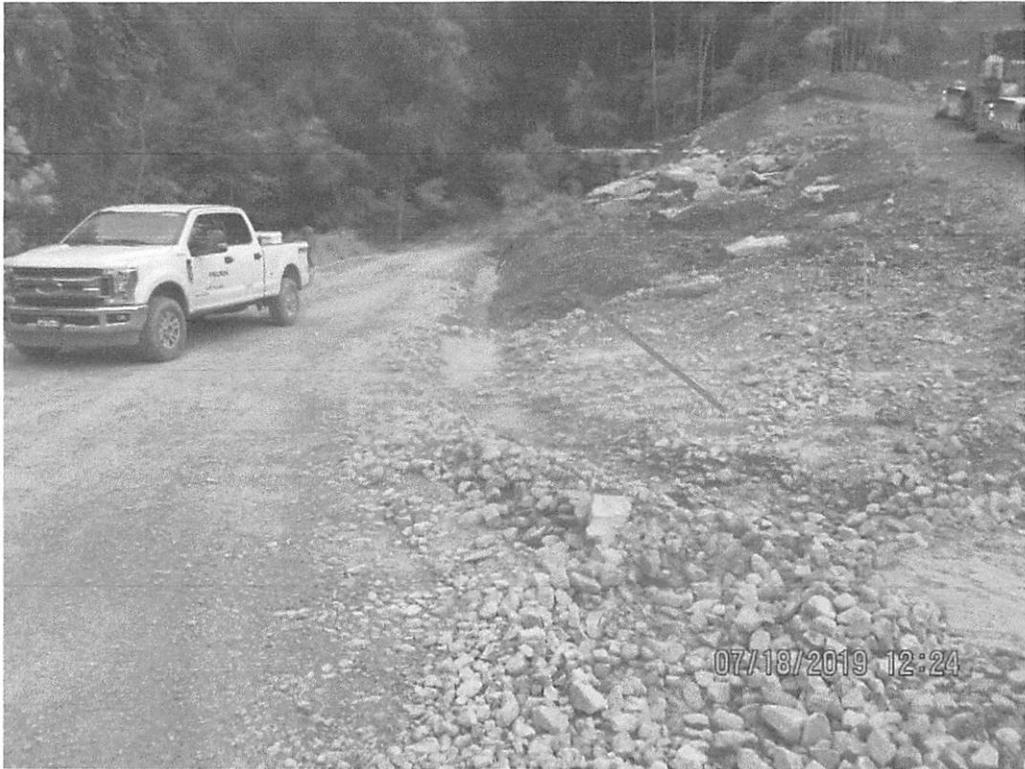
At station 4559+96 facing Access Road MVP-WB-119. Sediment deposits present in roadside ditch.

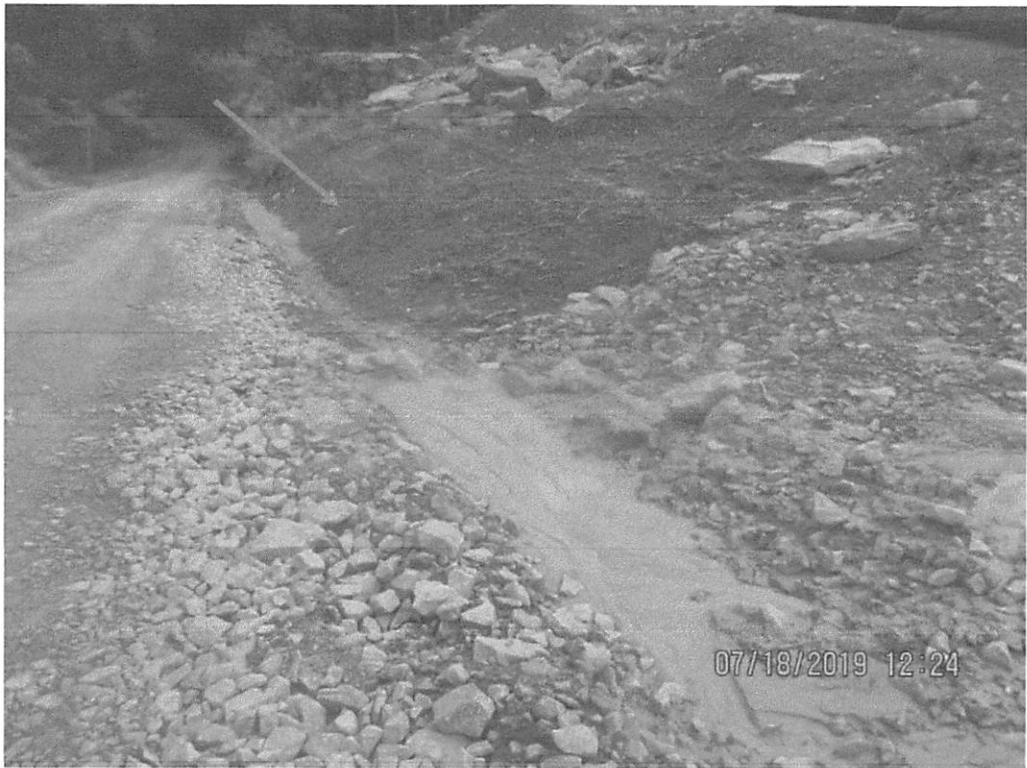
At station 4559+96 facing Access Road MVP-WB-119. Sediment deposits present in roadside ditch.

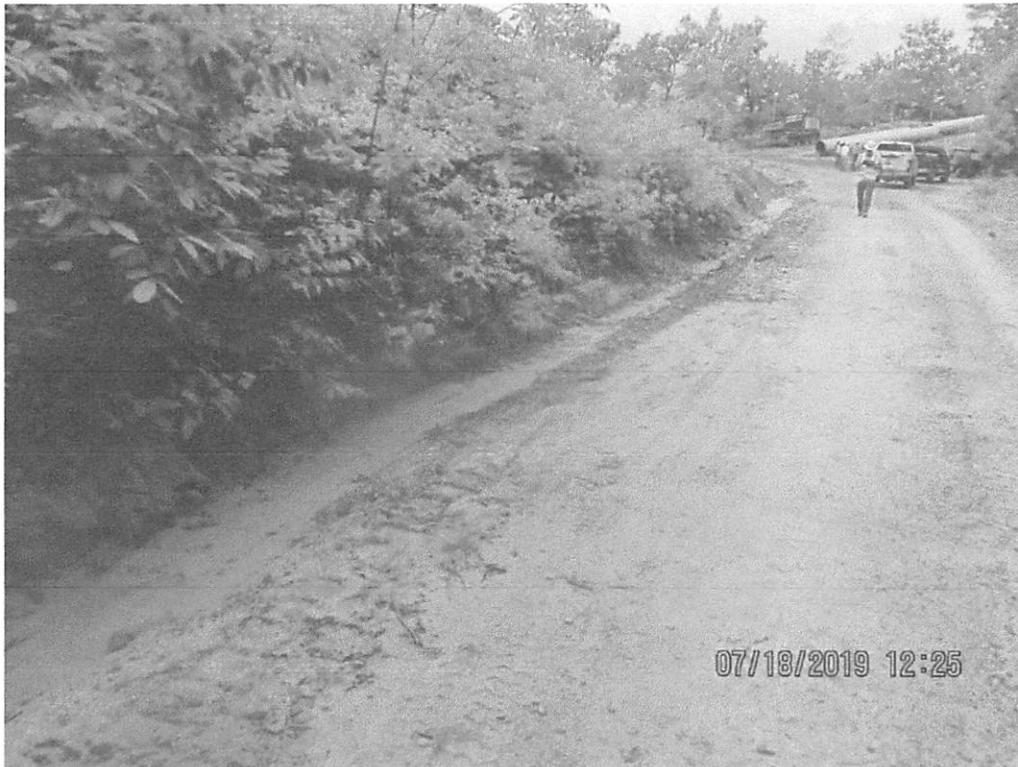
Downslope from station 4559+96 from Access Road MVP-WB-119 facing toward MVP ROW. Sediment deposits present in roadside ditch.

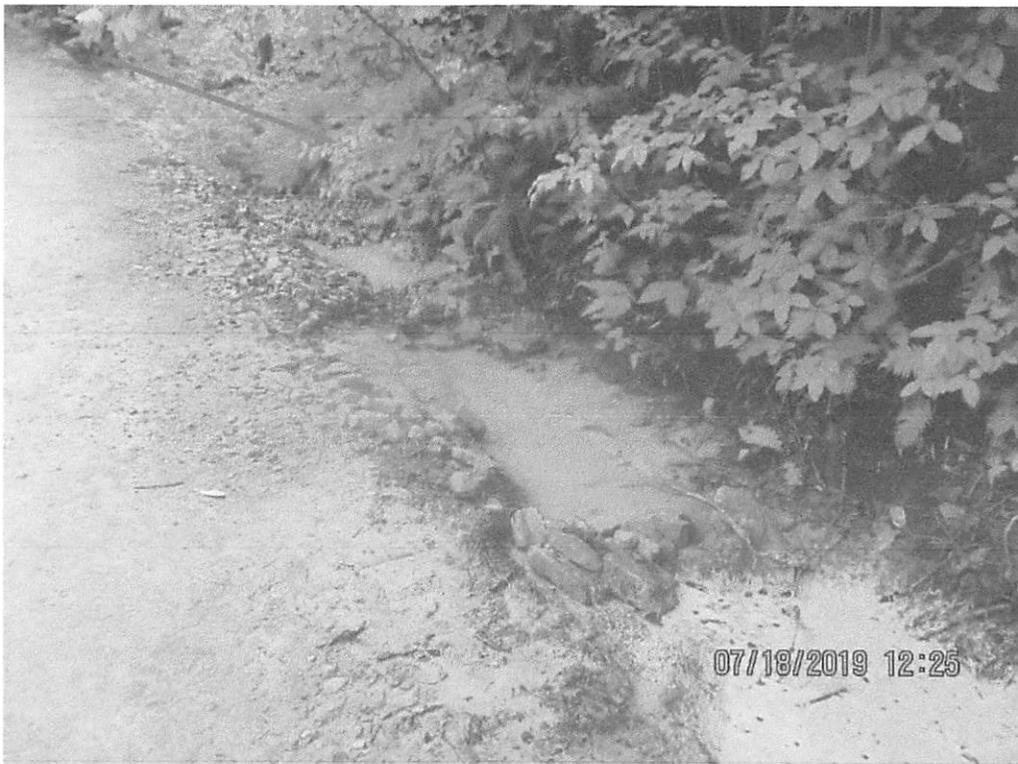
Downslope of station 4559+96 on Access Road MVP-WB-119. Sediment deposits present in roadside ditch and conveying to culvert inlet. Arrow depicts approximate location of culvert inlet.

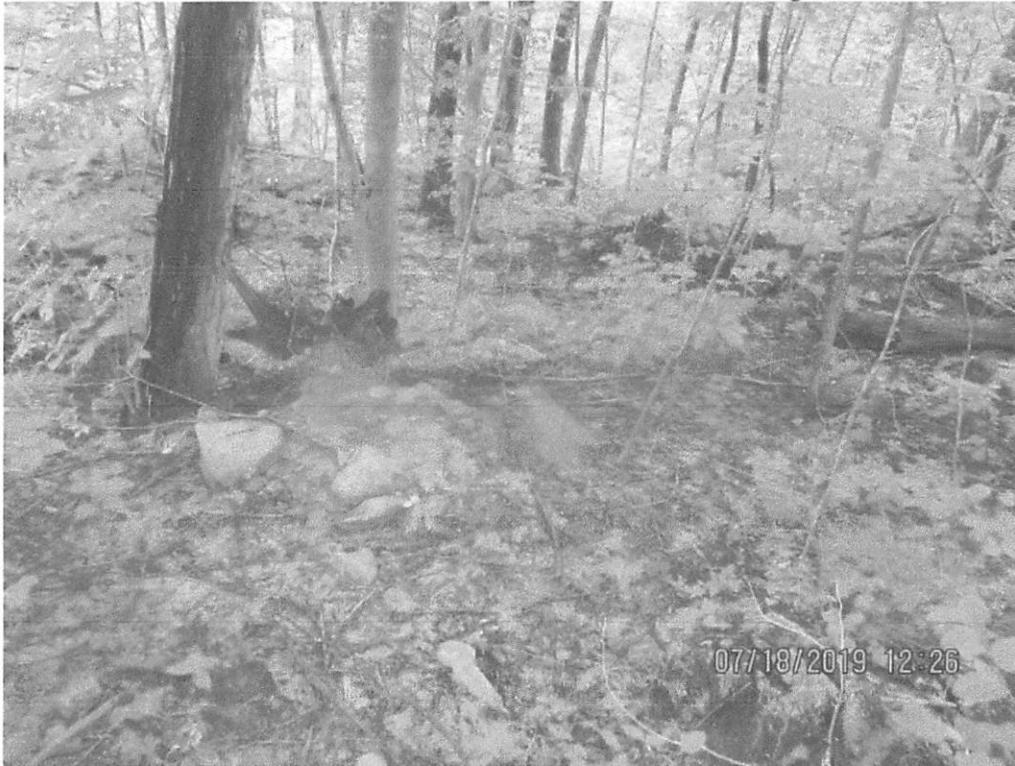
Downslope of culvert outlet. Significant sediment deposits present past controls and LOD.

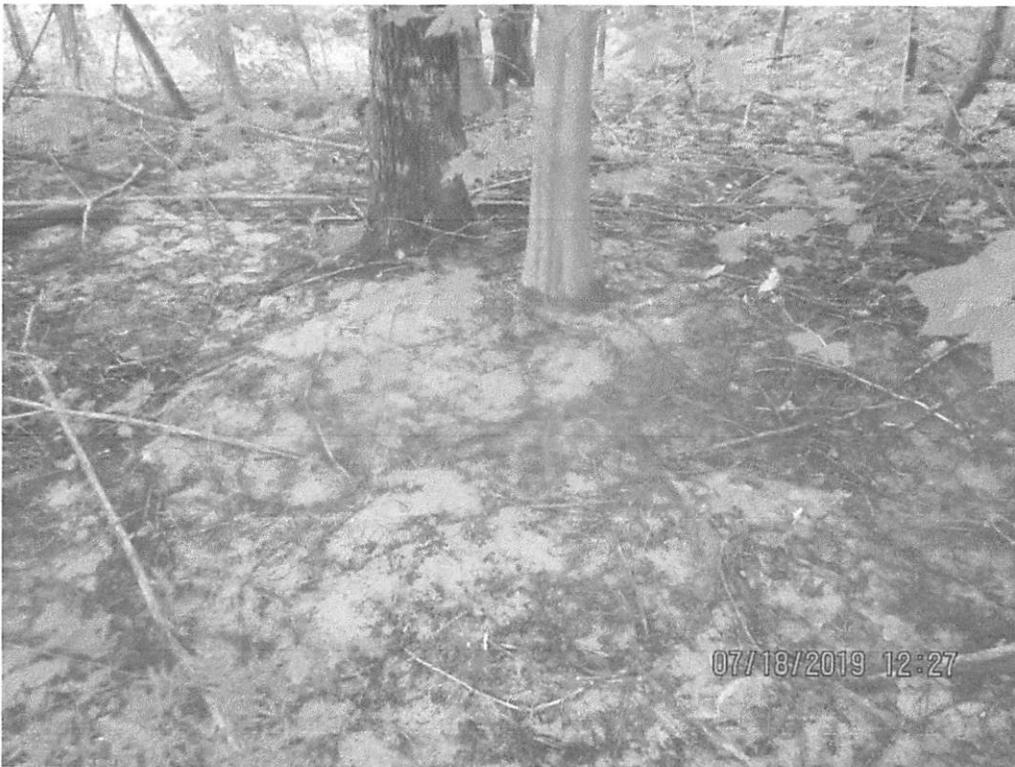
Downslope of culvert outlet. Significant sediment deposits present past controls and LOD.

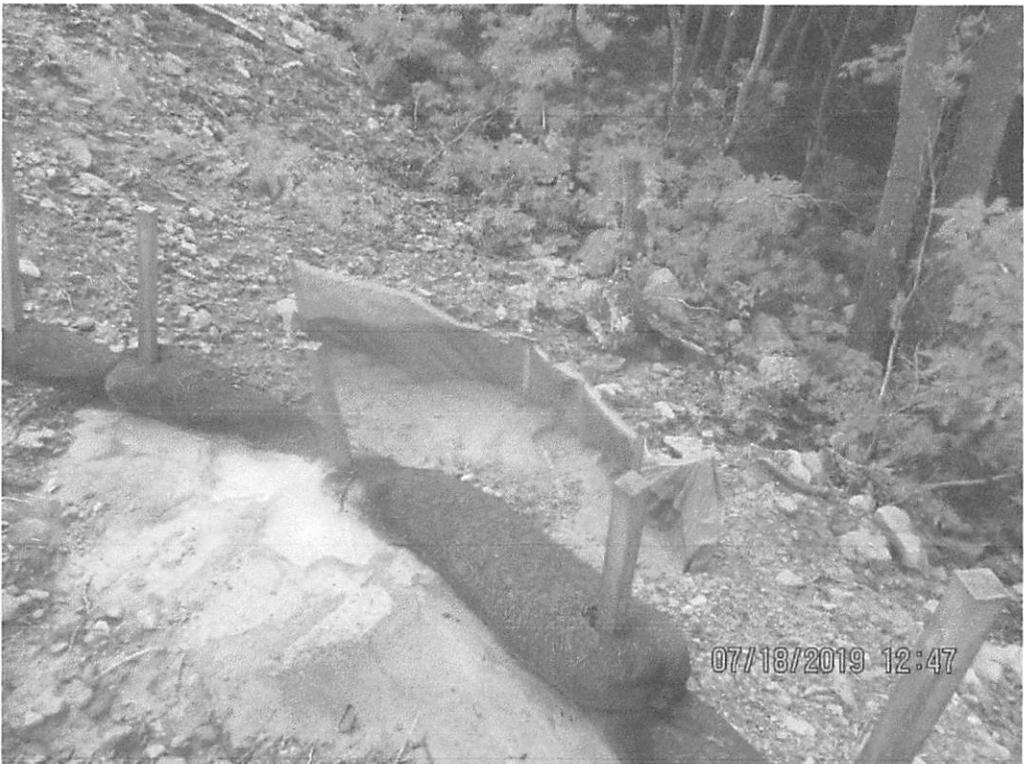
Waterbar outlet on opposite side of ROW at station 4559+96. Controls undercut and sediment deposits observed past controls and LOD.

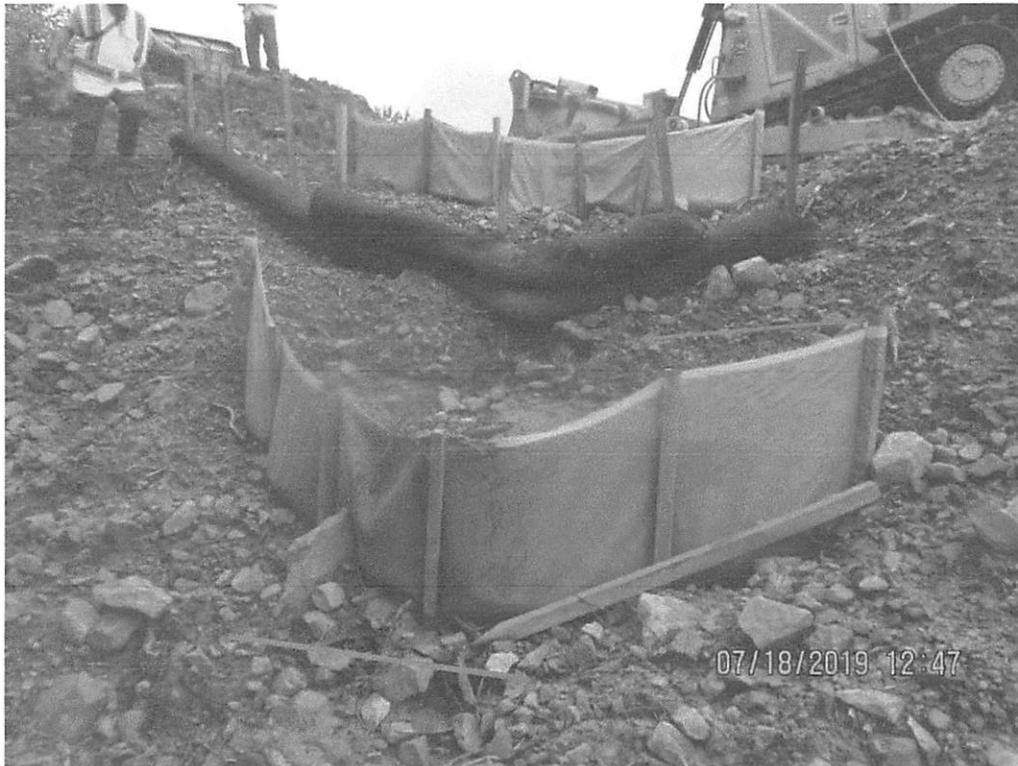
Waterbar outlet on opposite side of ROW at station 4559+96. Controls undercut and sediment deposits observed past controls and LOD. Arrow depicts undercut controls.

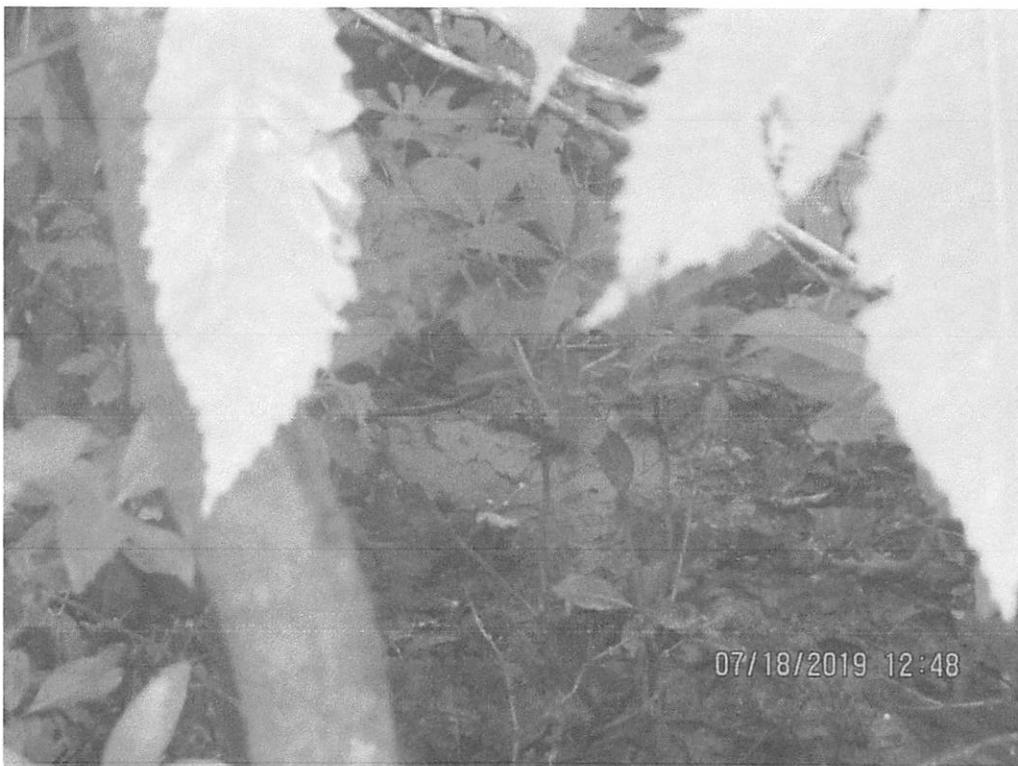
Waterbar outlet on opposite side of ROW at station 4559+96. Controls undercut and sediment deposits observed past controls and LOD.

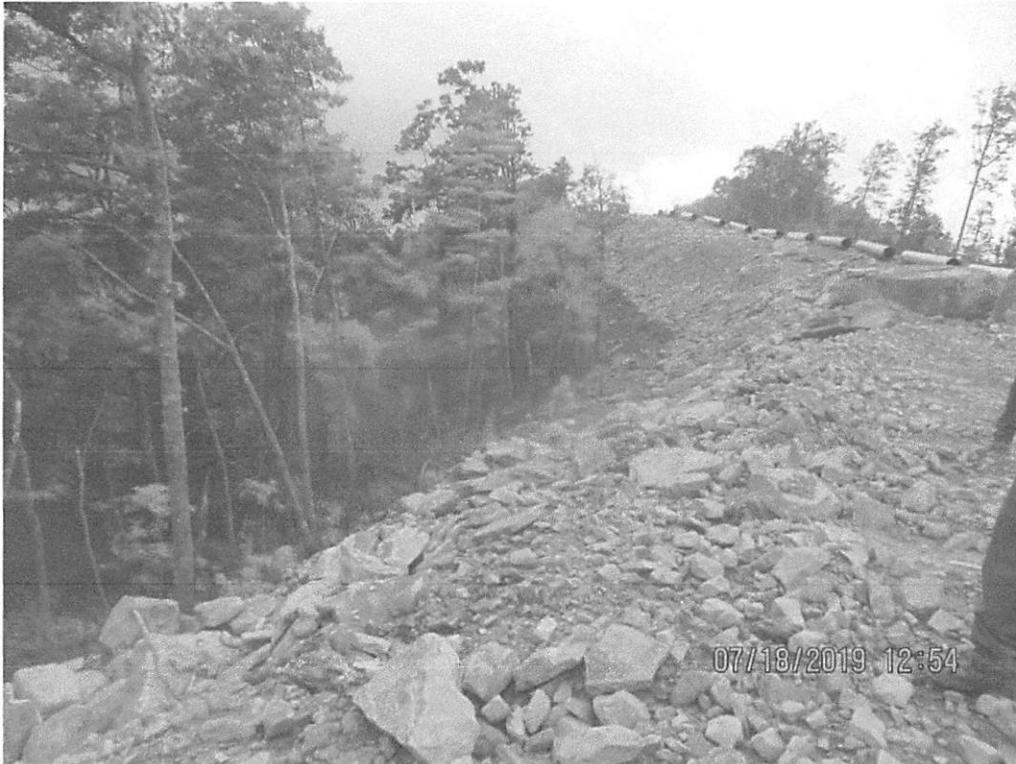
Near station 4559+96 facing ROW fill slope.

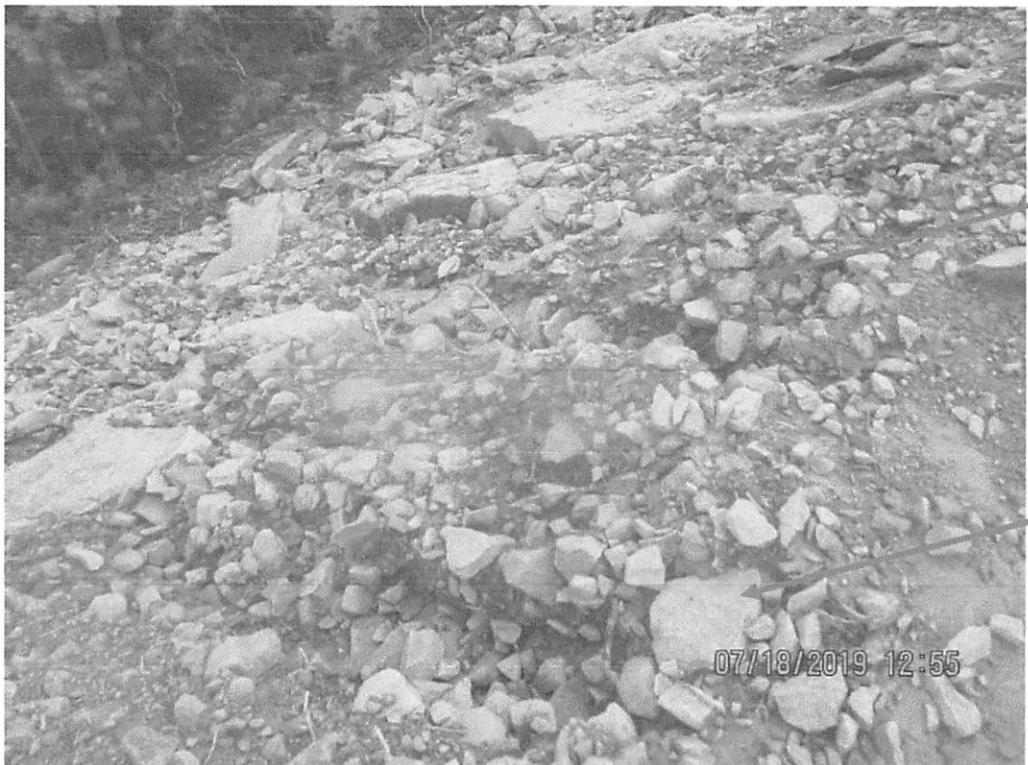
Near station 4559+96, erosion present on fill slope. Arrows depict erosion.

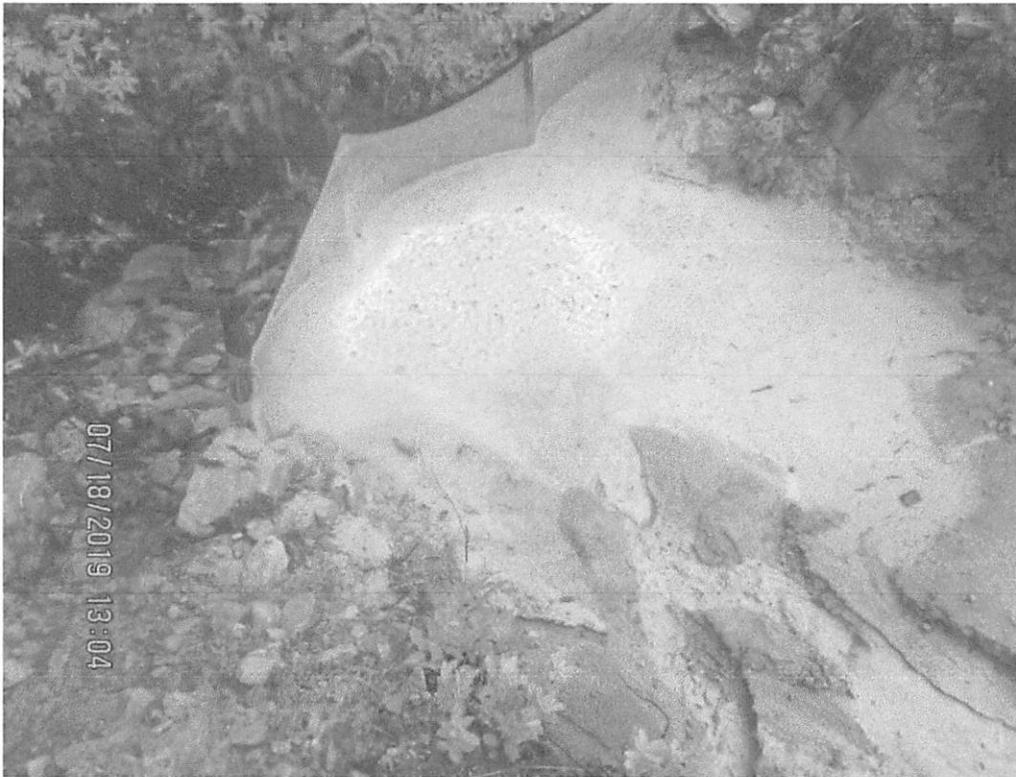
Above station 4539+00 during rain event. Sump full of sediment and in need of maintenance. Sediment-laden water undercutting silt fence and flowing past LOD.

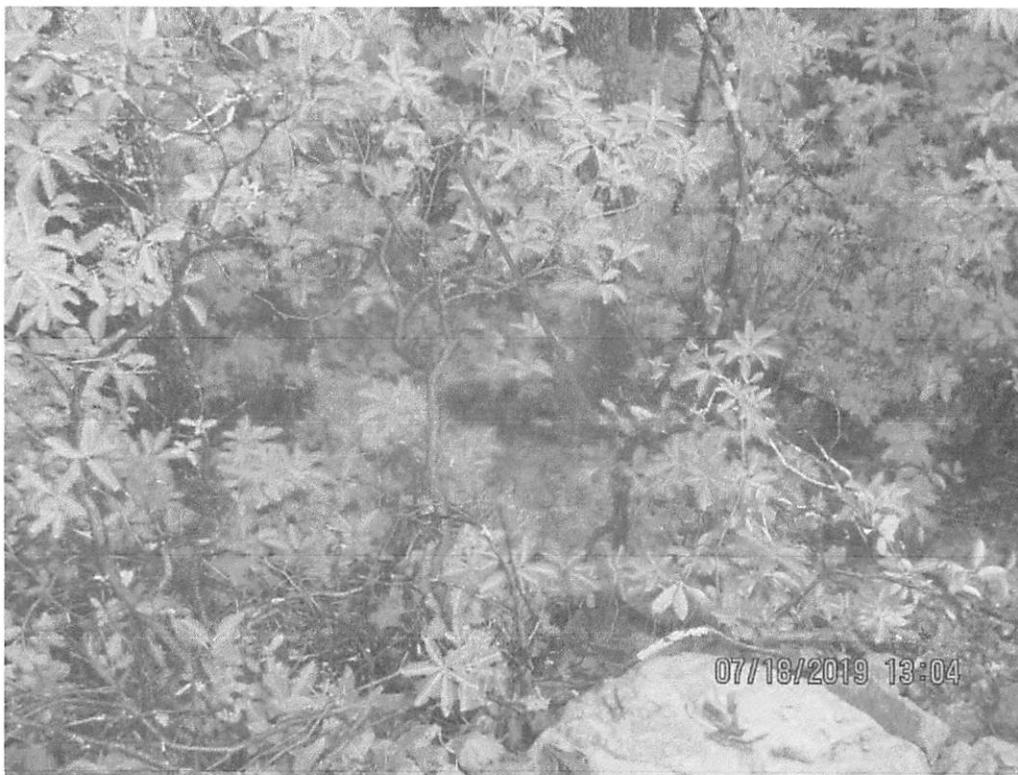
Above station 4539+00 during rain event. Sediment-laden water undercutting silt fence and flowing past LOD. Arrow depicts SLW leaving site.

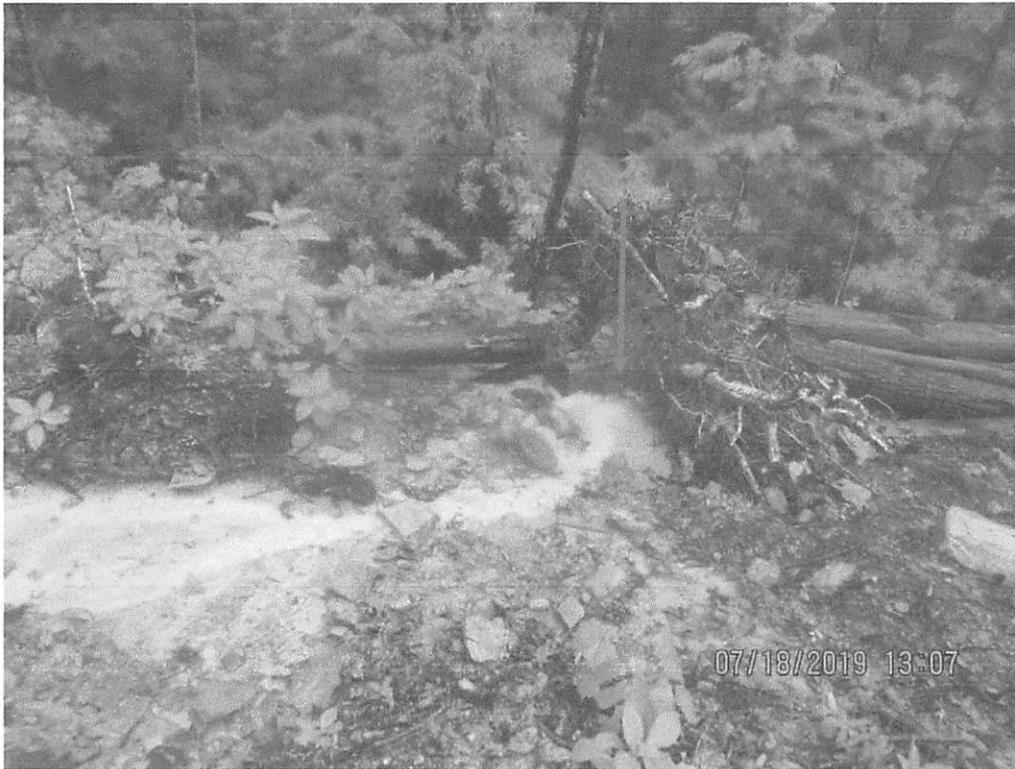
Sediment-laden water flowing off ROW and through log pile during rain event. No perimeter controls were present at the base of the slope. Arrow depicts where SLW was flowing through log pile.

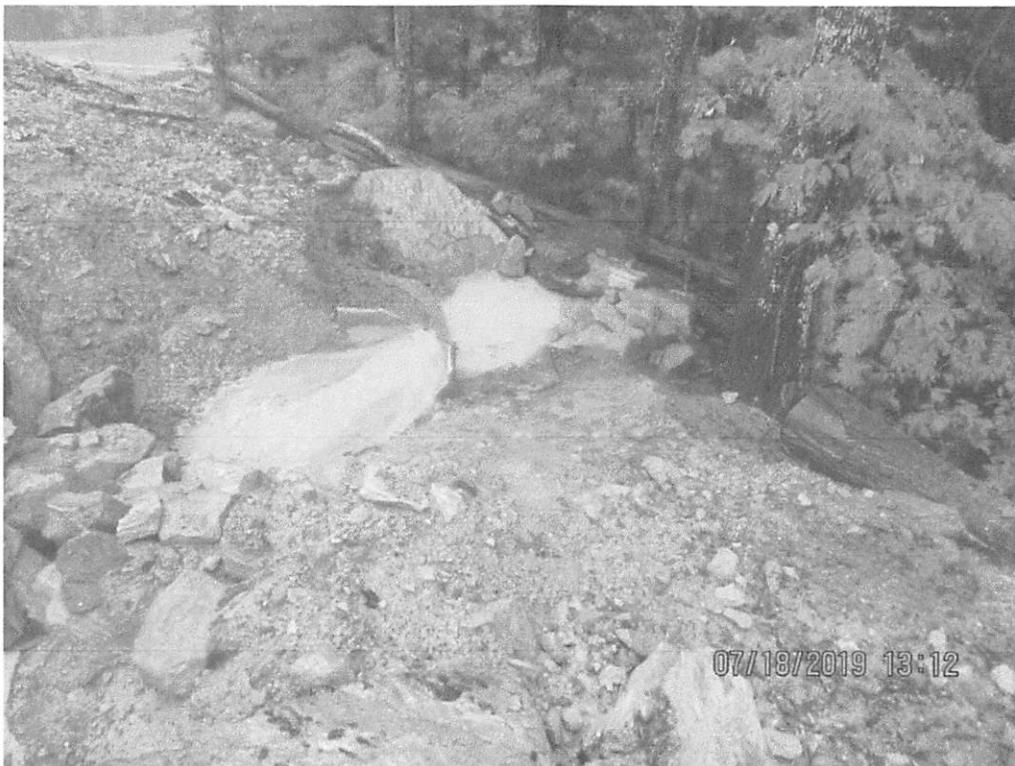
Waterbar terminating onto fill slope at station 4539+00. Large rocks installed as checks in eroded channel. SLW was flowing under and through these checks, overwhelming controls.
