**CONSENT ORDER
ISSUED UNDER THE
WATER POLLUTION CONTROL ACT
WEST VIRGINIA CODE, CHAPTER 22, ARTICLE 11**

TO: Mountain Valley Pipeline, LLC
Robert J. Cooper
2200 Energy Drive
Canonsburg, PA 15317

DATE: December 17, 2020

ORDER NO.: 9925

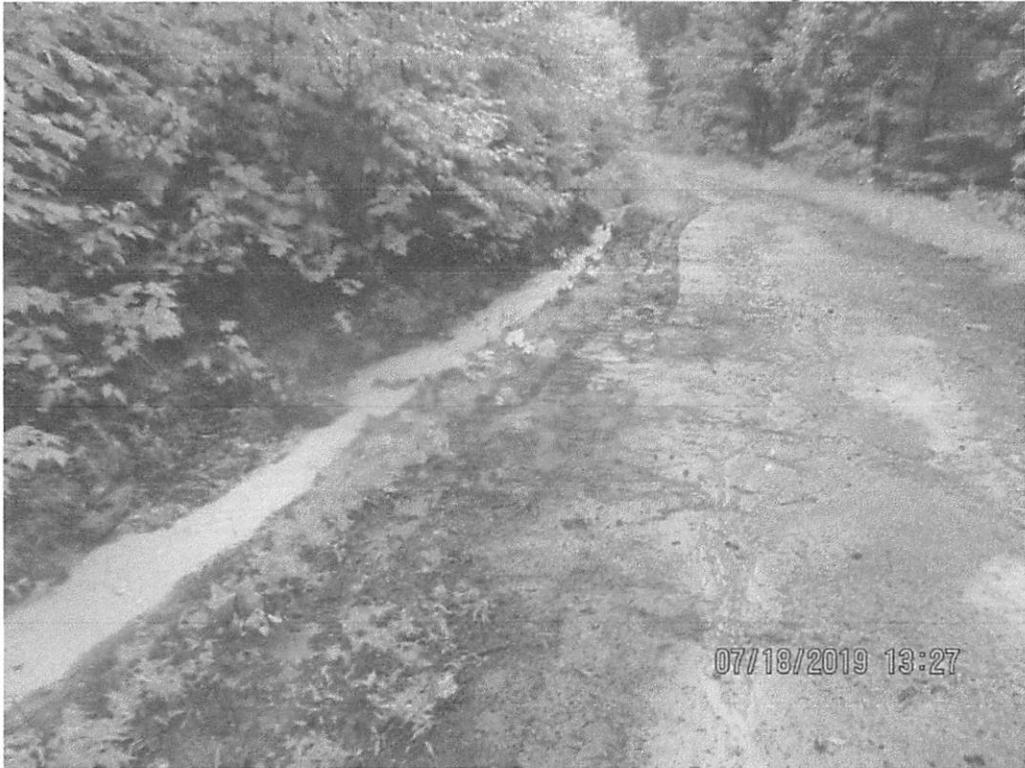
Approximately 200 ft downslope of ROW crossing with MVP-WB-119. SLW being conveyed to culvert.

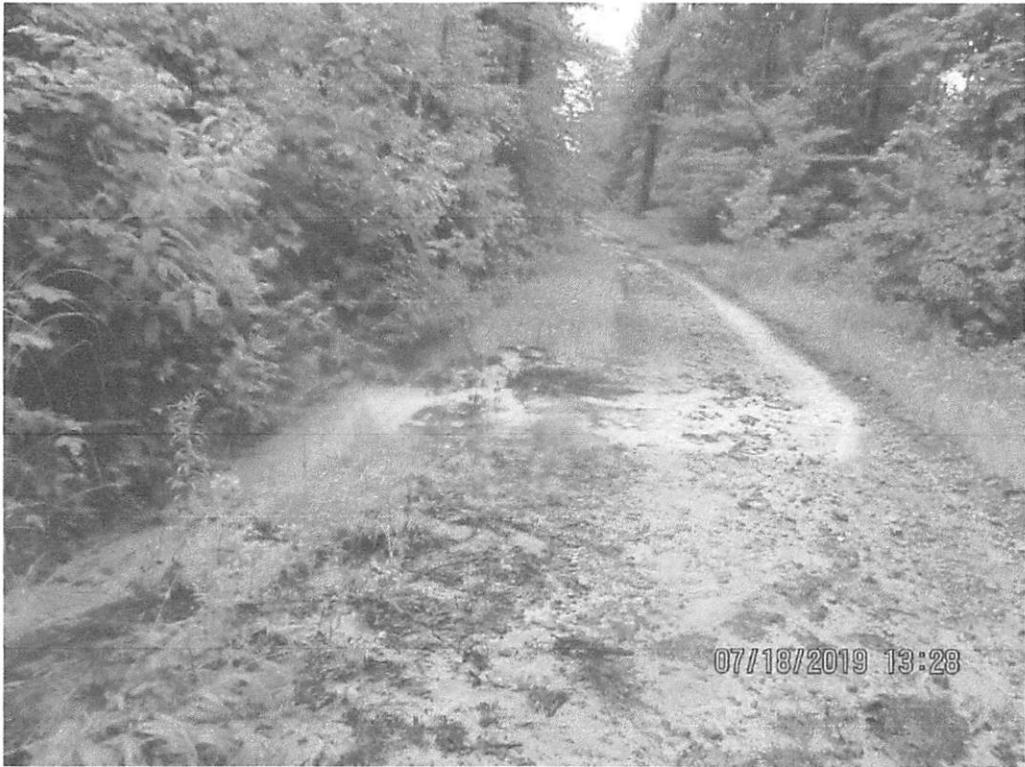
Culvert inlet that conveys under unapproved access road.

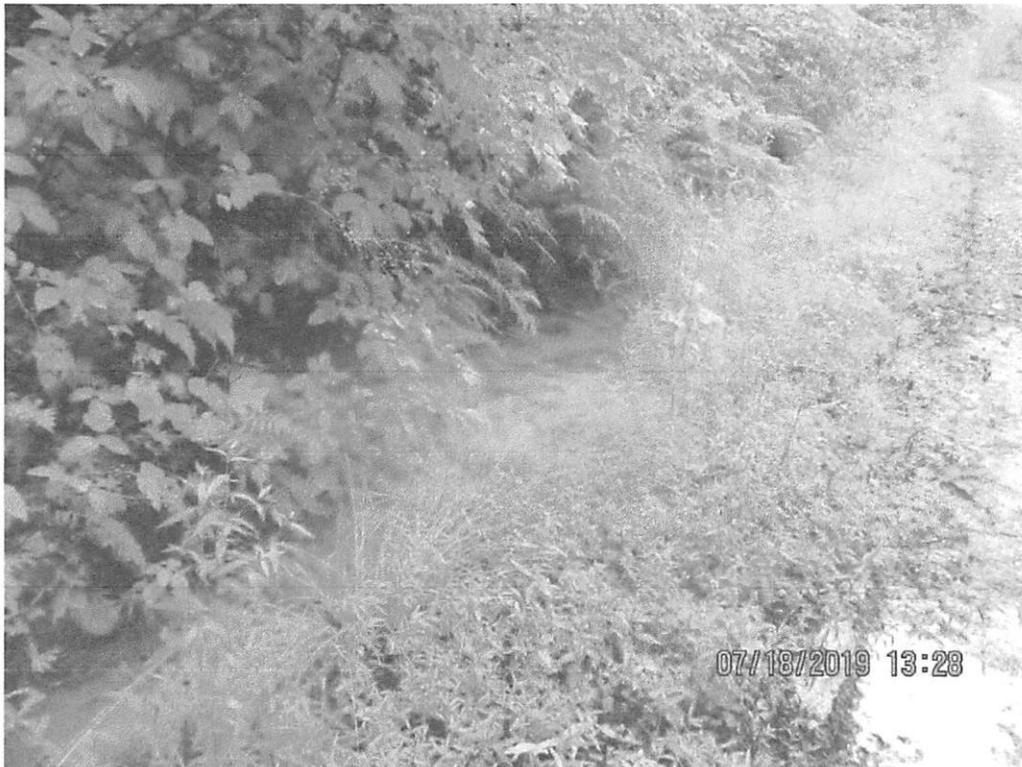
Upslope of culvert inlet receiving sediment-laden water. Run-off present in ditch line distinguishably different than what was originating from upslope and entering culvert.

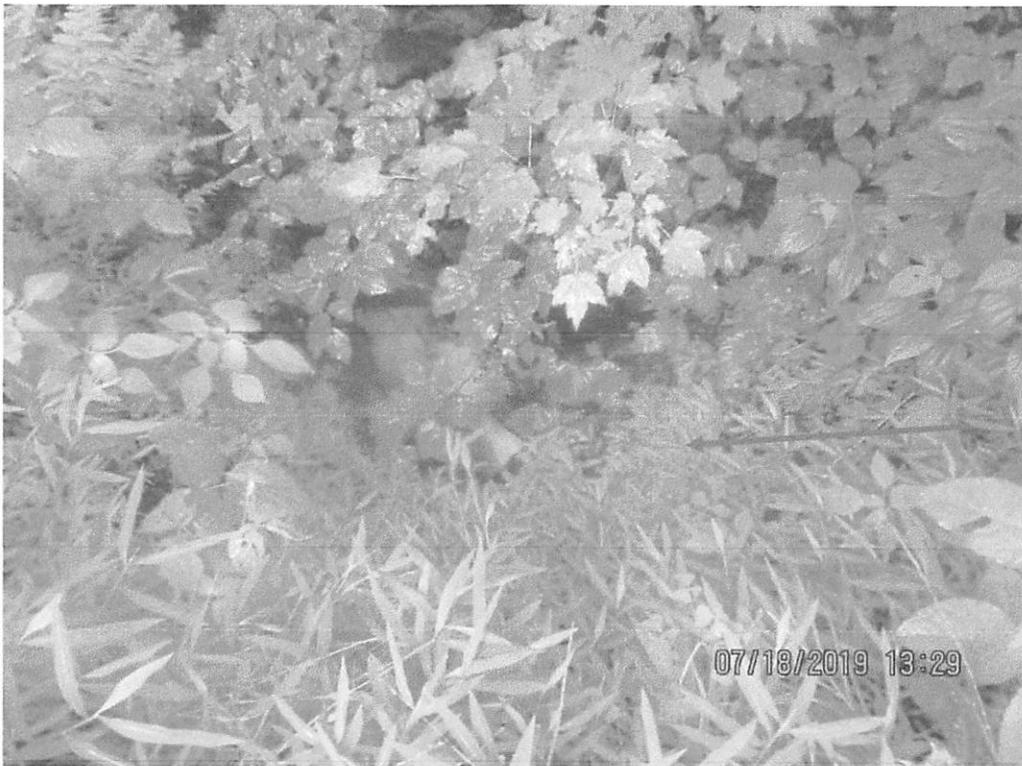
Culvert outlet conveying SLW downslope toward Fall Run a tributary of Holly River. Arrow depicts culvert.

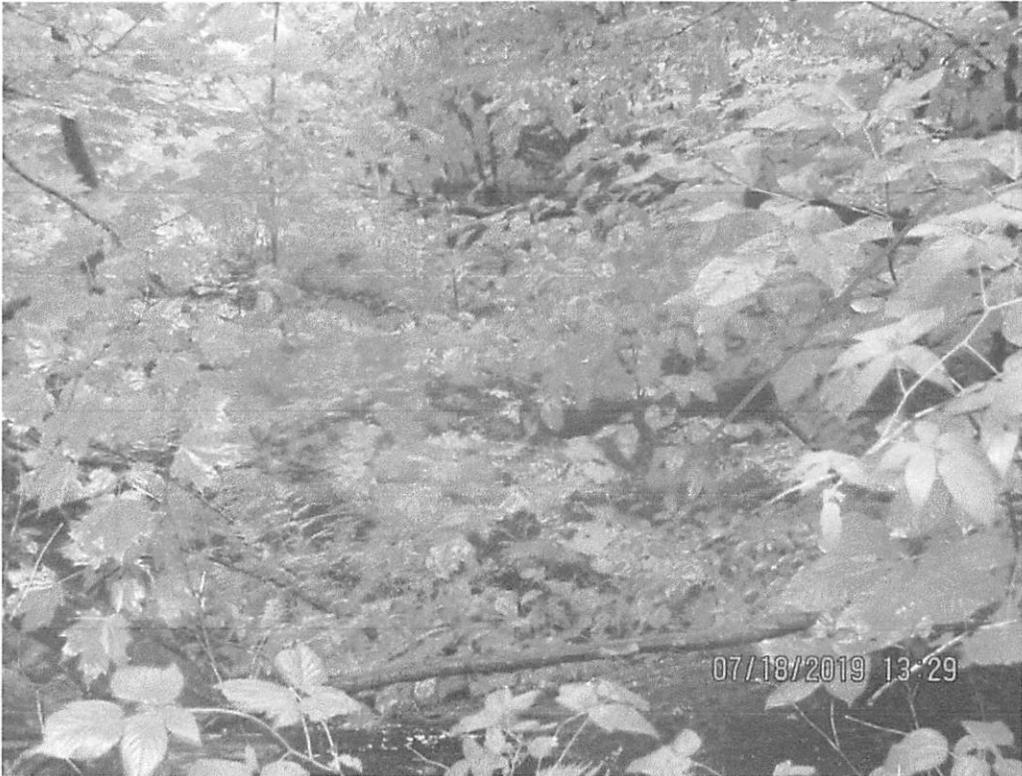
SLW conveying downslope toward Fall Run a tributary of the Holly River.

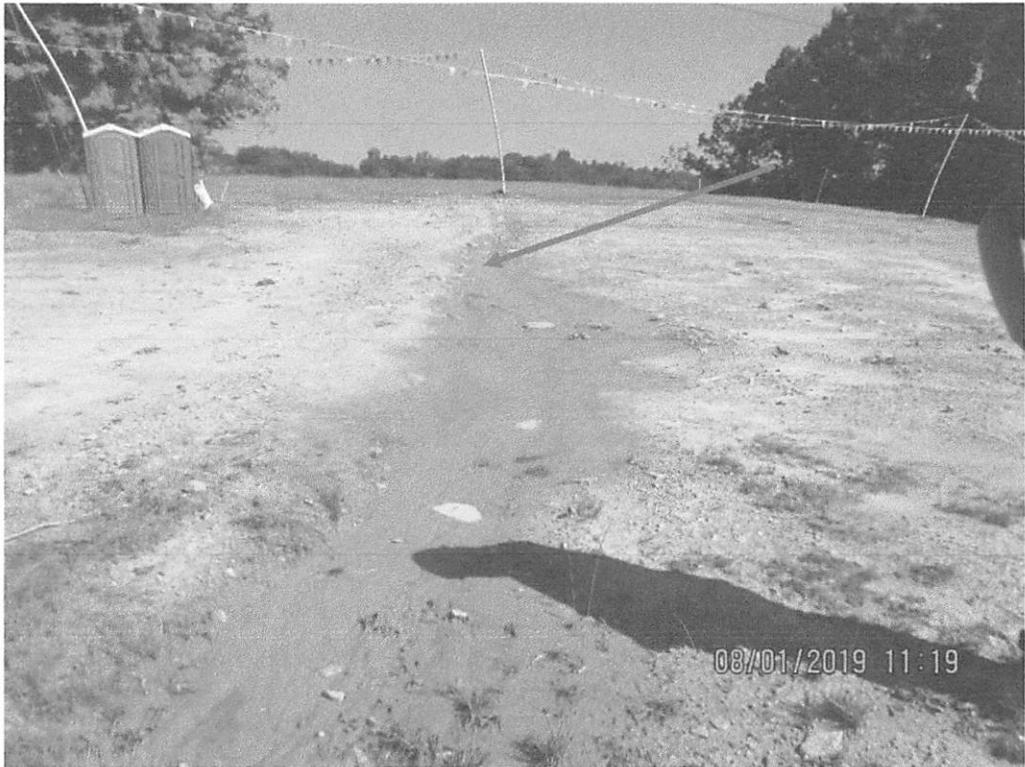
Facing North where Access Road MVP-BR-099 intersects ROW near station 3897+75. Arrow depicts where run-off was overtopping the diversion berm and flowing downslope.

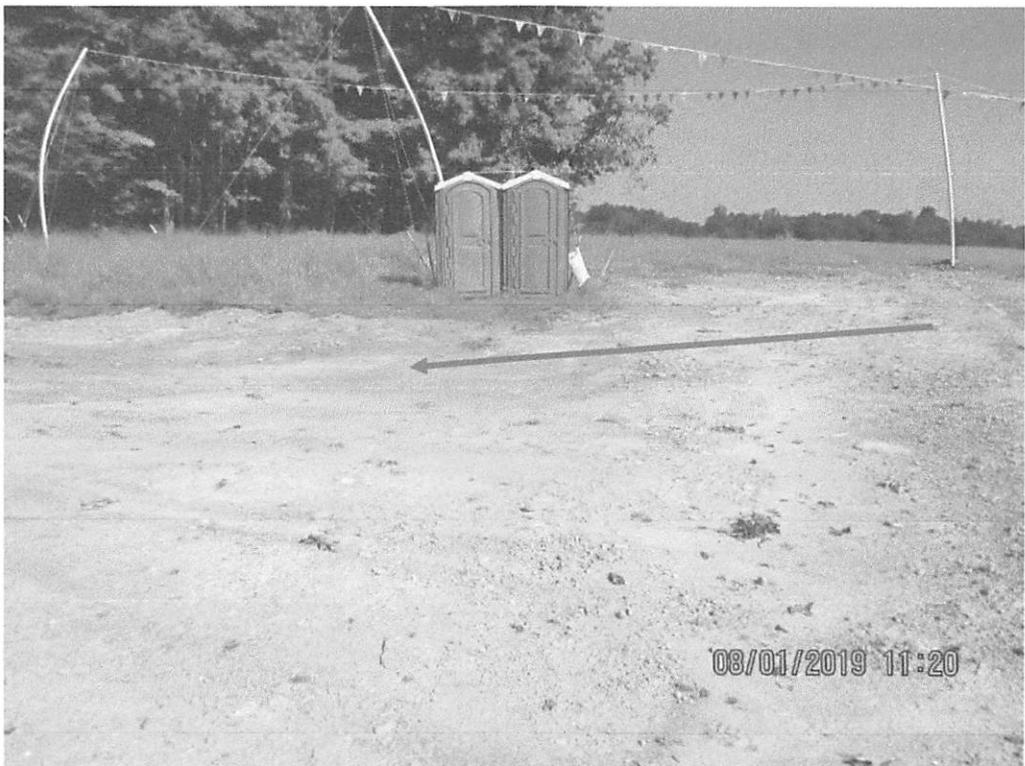
Downslope of diversion berm near station 3897+75. Arrow depicts where sheet flow due to run-off was occurring.

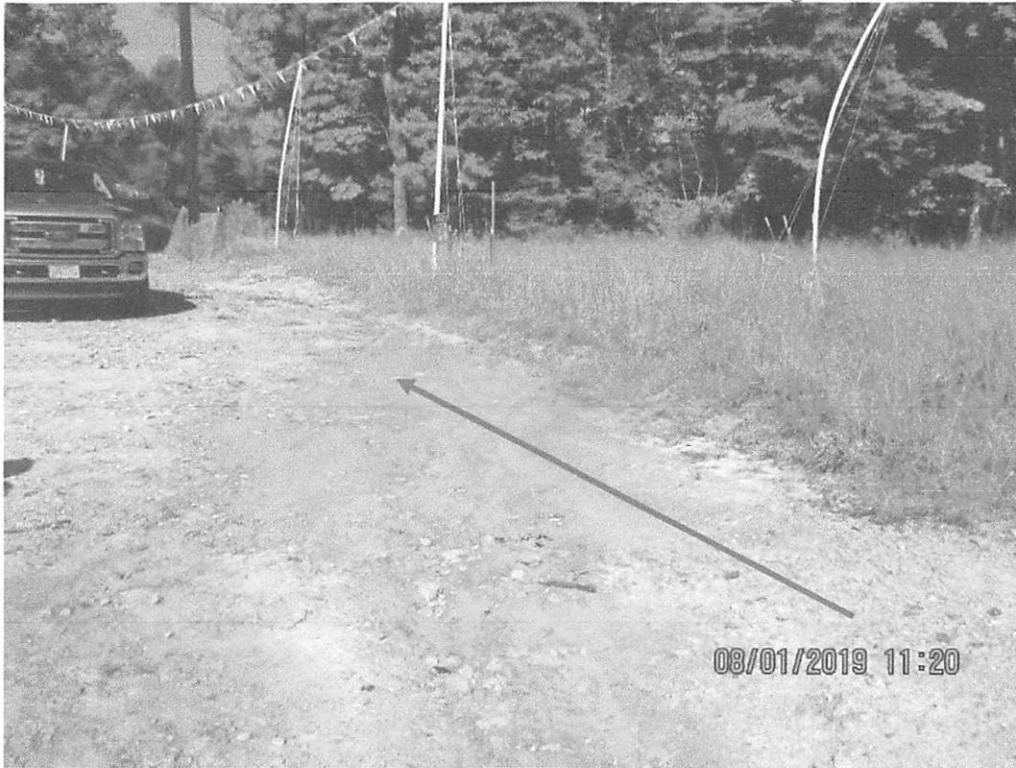
Below diversion berm and facing CR 24 and MVP-BR-099. Arrow depicts direction of sheet flow and sediment transportation downslope toward CR24.

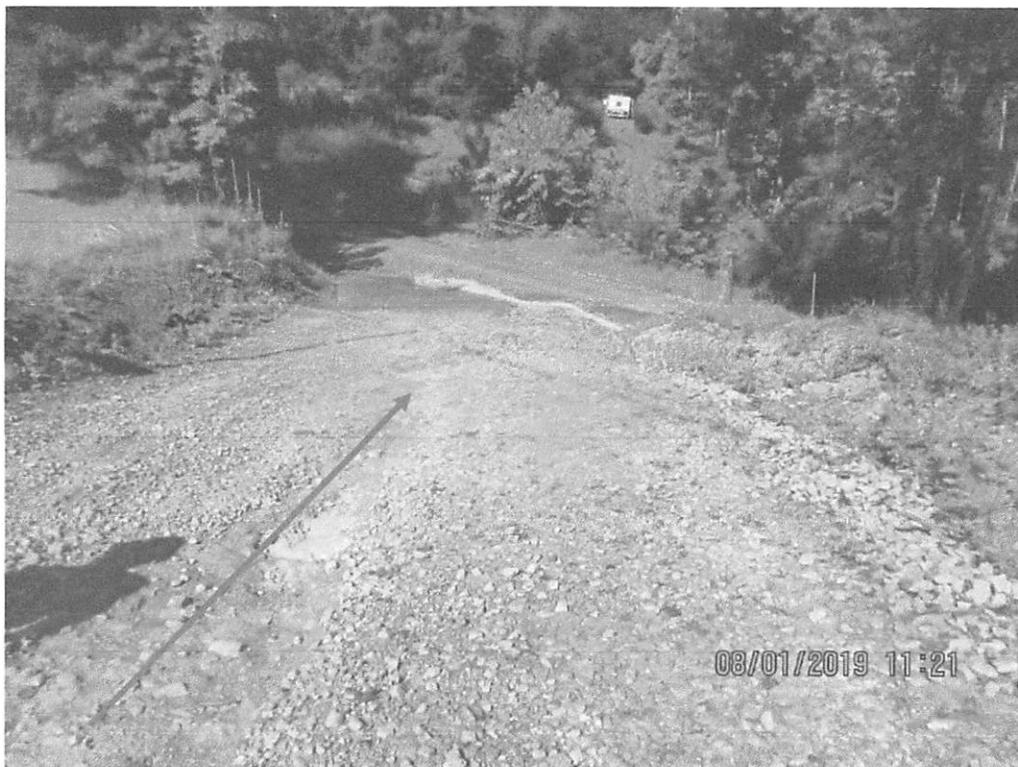
Access Road MVP-BR-099 facing CR 24 (Green Hill Road) ditch line. Arrow depicts where run-off was conveying toward ditch.

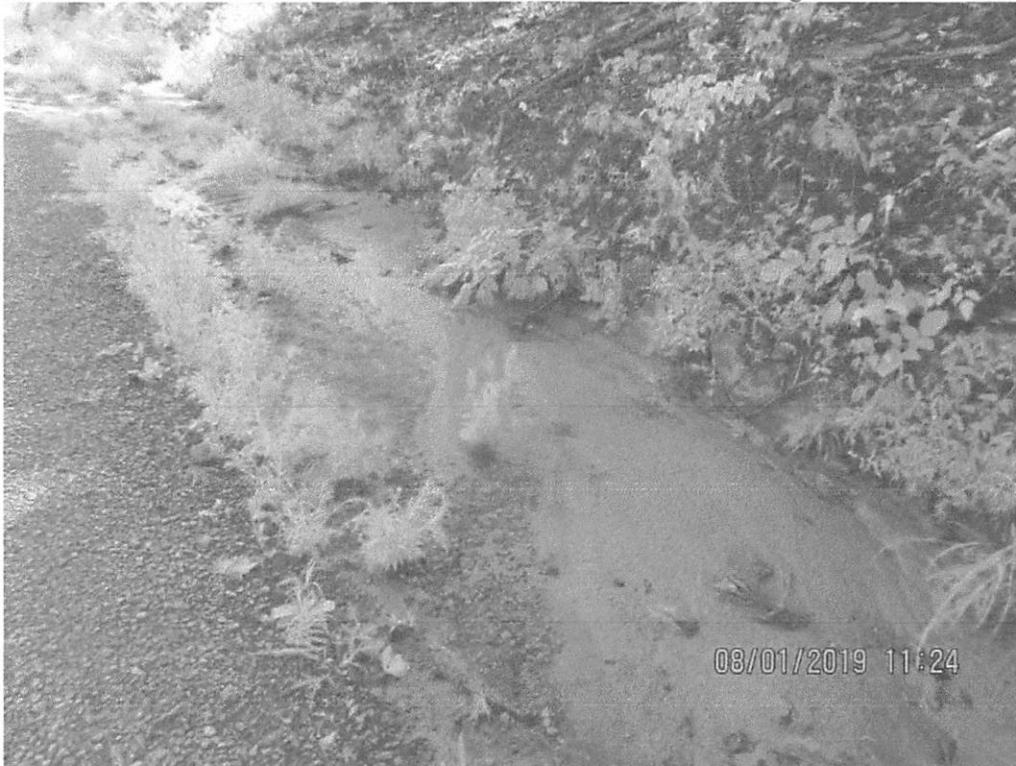
Sediment deposits observed along CR 24 downslope of Access Road MVP-BR-99 near station 3897+75.

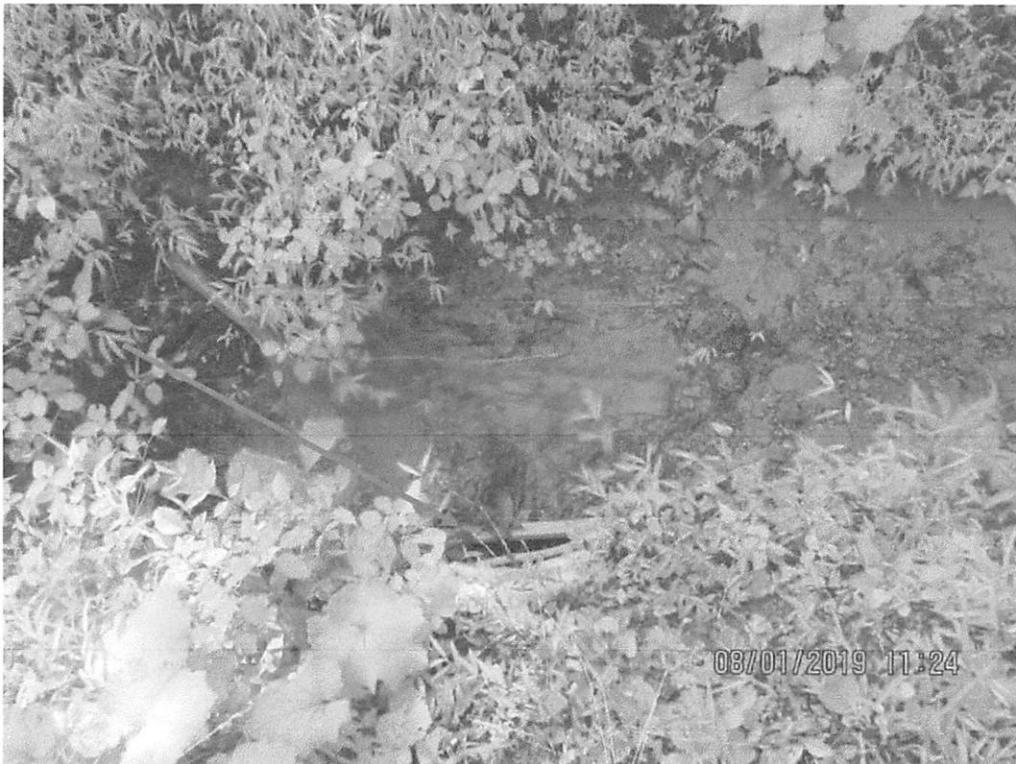
Sediment deposits observed along CR 24 downslope of Access Road MVP-BR-099 near station 3897+75. Arrow depicts culvert location that conveys under CR 24. Culvert inlet also demarcates where delineated stream S-K35 begins.

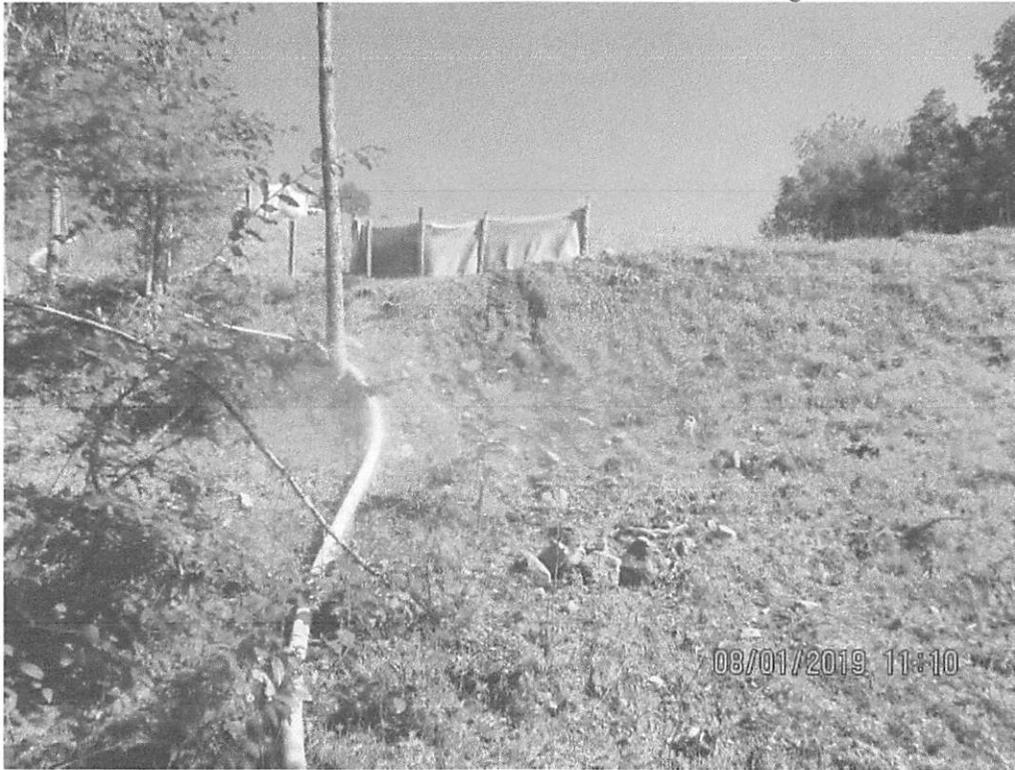
Waterbar that was overwhelmed with run-off causing undermining of controls leading to erosion downslope of controls South of BR-099 near station 3897+75.

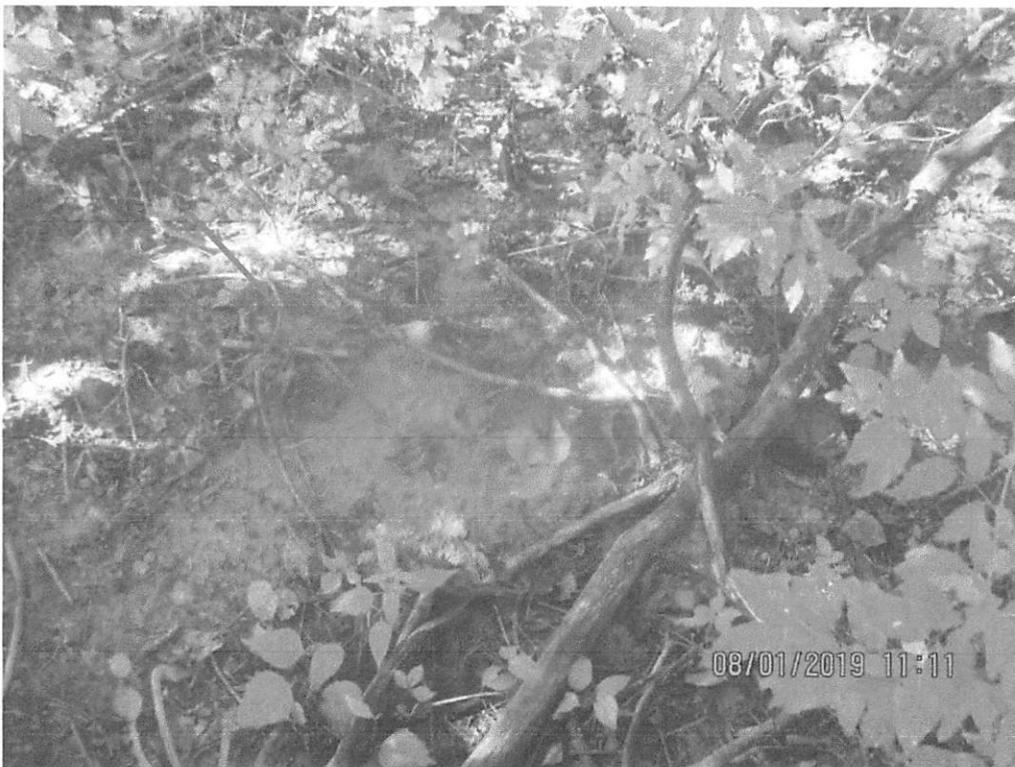
Downslope of waterbar control failure South of BR-099 near station 3897+75. Sediment deposits observed past the LOD.

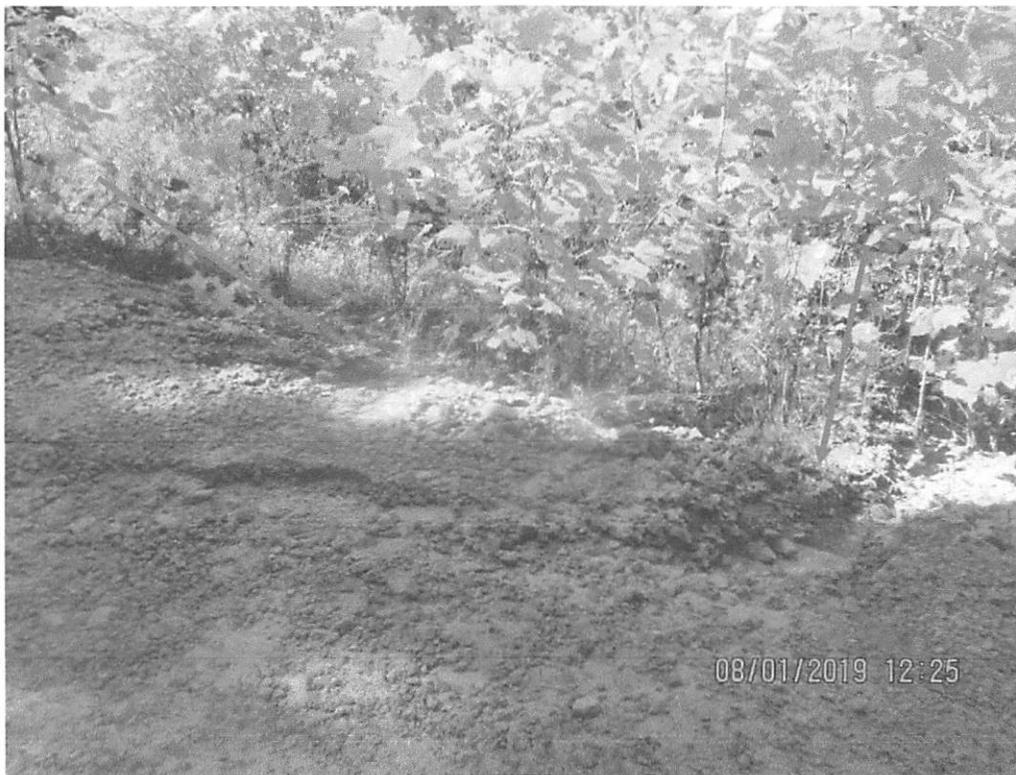
MVP-AR-095 upslope above CR 19. Arrow depicts where road was eroded out, overwhelming downslope controls.

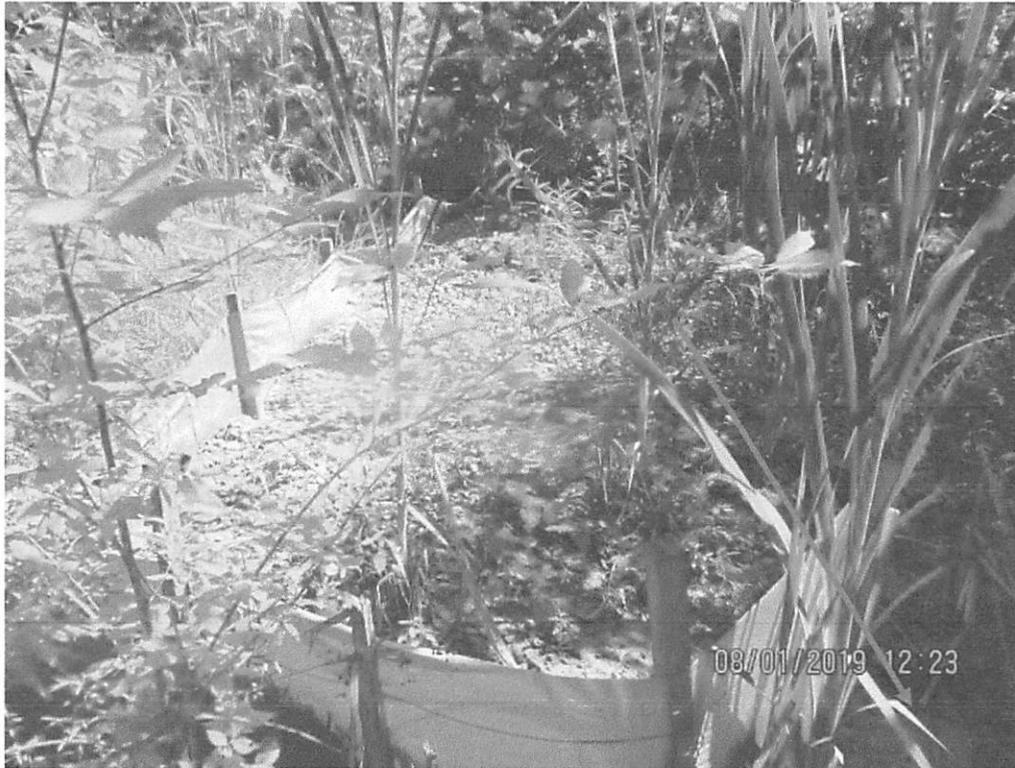
Controls located below washed out section of AR-095 and above stream S-J74 and Wetland W-J42. Arrow depicts where controls were overwhelmed and sediment-laden water had flowed past controls.

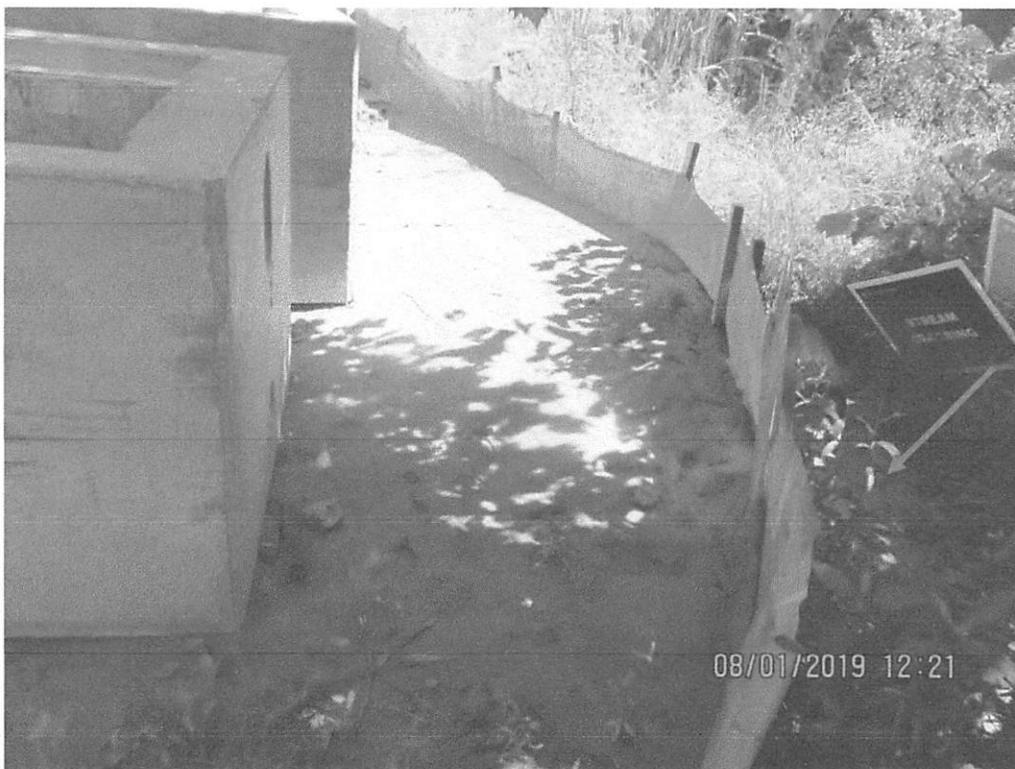
Sediment deposited behind controls at the entrance to BR-095 adjacent to US 19/Hwy 4. Arrow depicts sediment deposits past LOD above Stream S-J74 and Wetland W-J42.

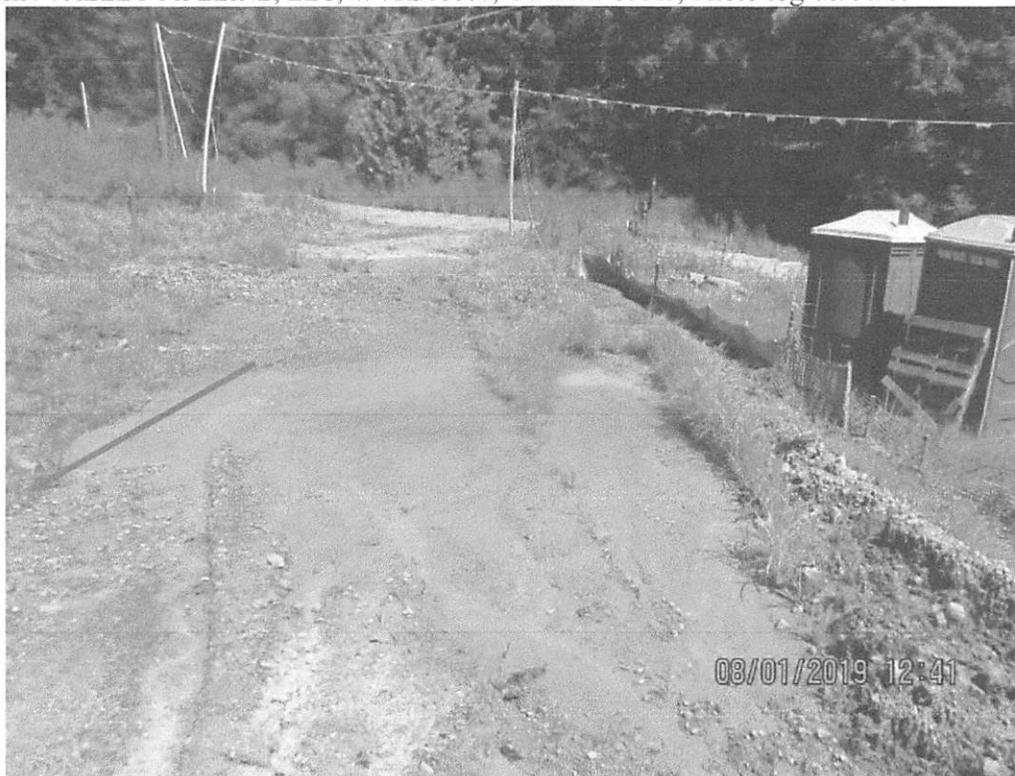
Above Access Road MVP-BR-097 and Falls Run (Stream S-J70) facing North. Run-on entering LOD and causing sediment to overwhelm controls. Arrow depicts where run-on was coming onto Access Road.

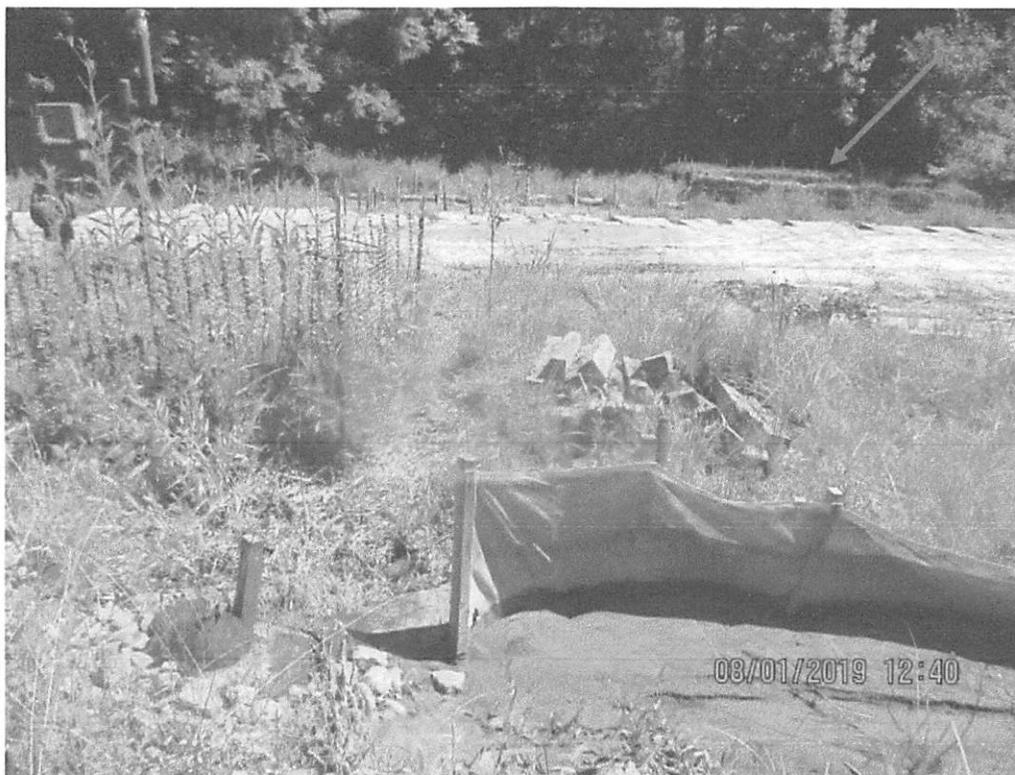
Facing Access Road MVP-BR-097. Controls overwhelmed with sediment due to run-on causing erosion. Controls had not been maintained. Arrow depicts dewatering structure.

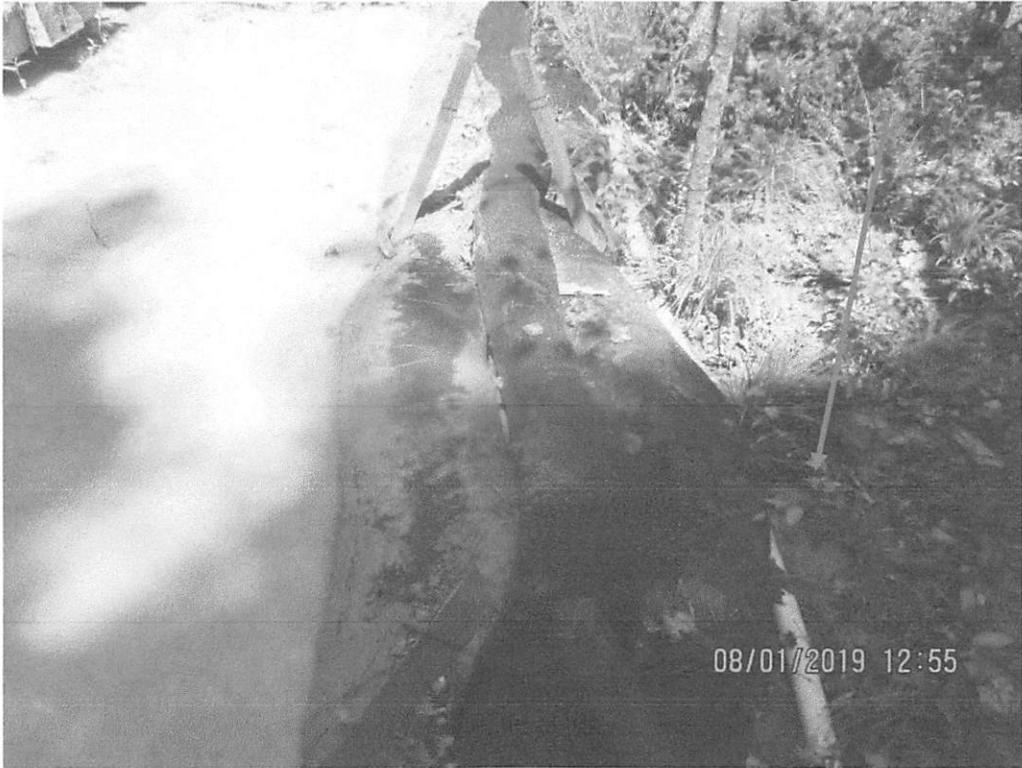
Perimeter controls below timber mat bridge on edge of LOD with sediment deposits past the LOD below MVP-BR-097.

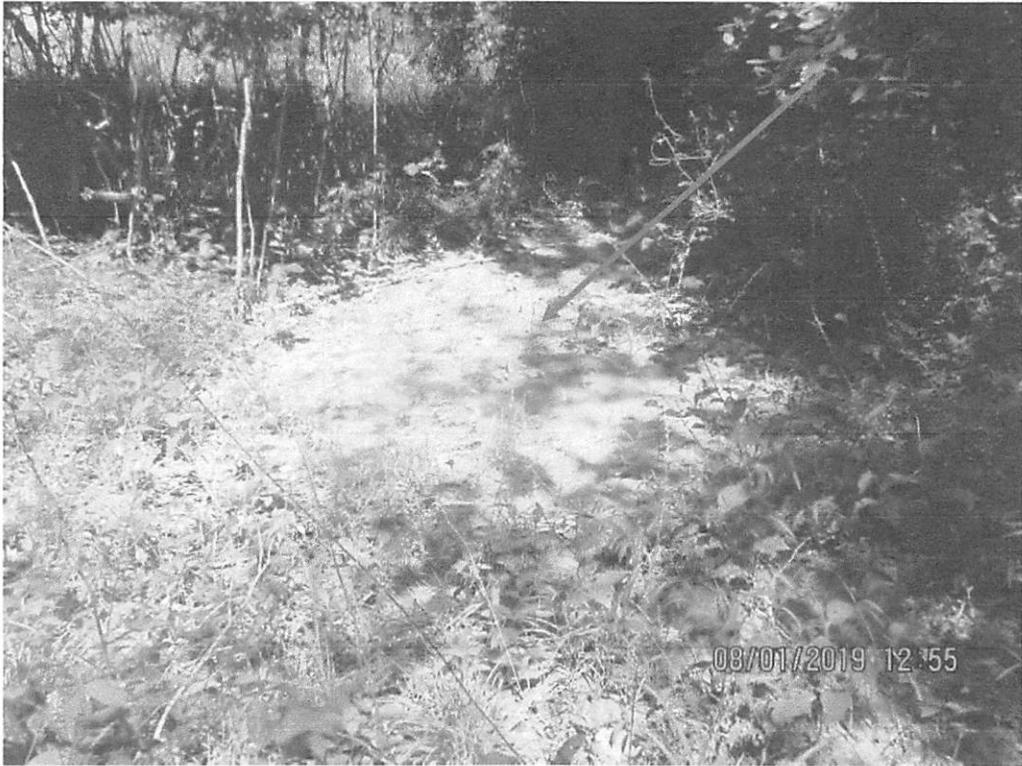
Sediment deposits present below MVP-BR-097 past the LOD and controls

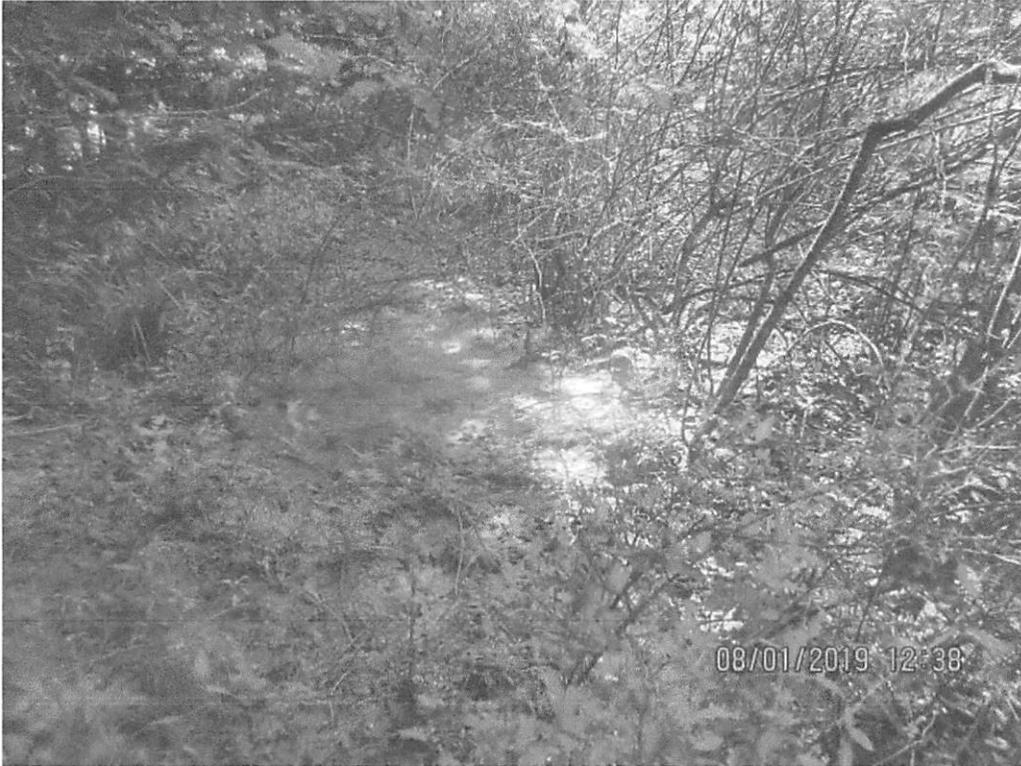
Sediment deposits past the LOD and controls below MVP-BR-097.

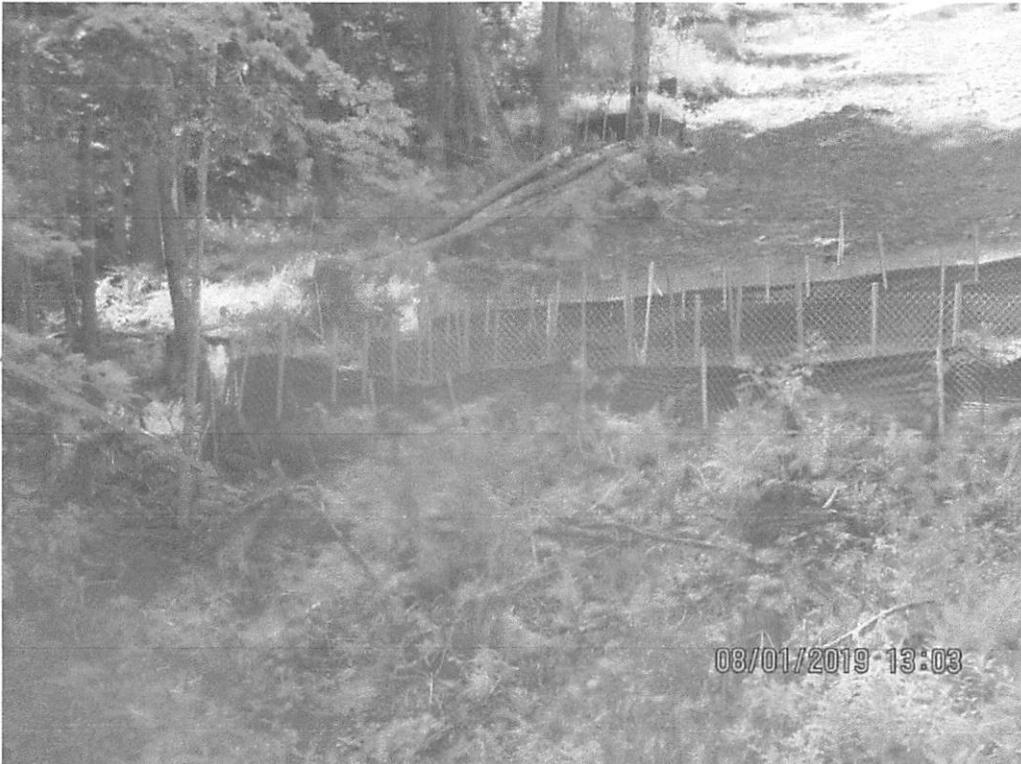
Controls above the South side of Falls Run (Stream S-J70) and US 19/Hwy 4 ROW crossing. Scouring present below controls.

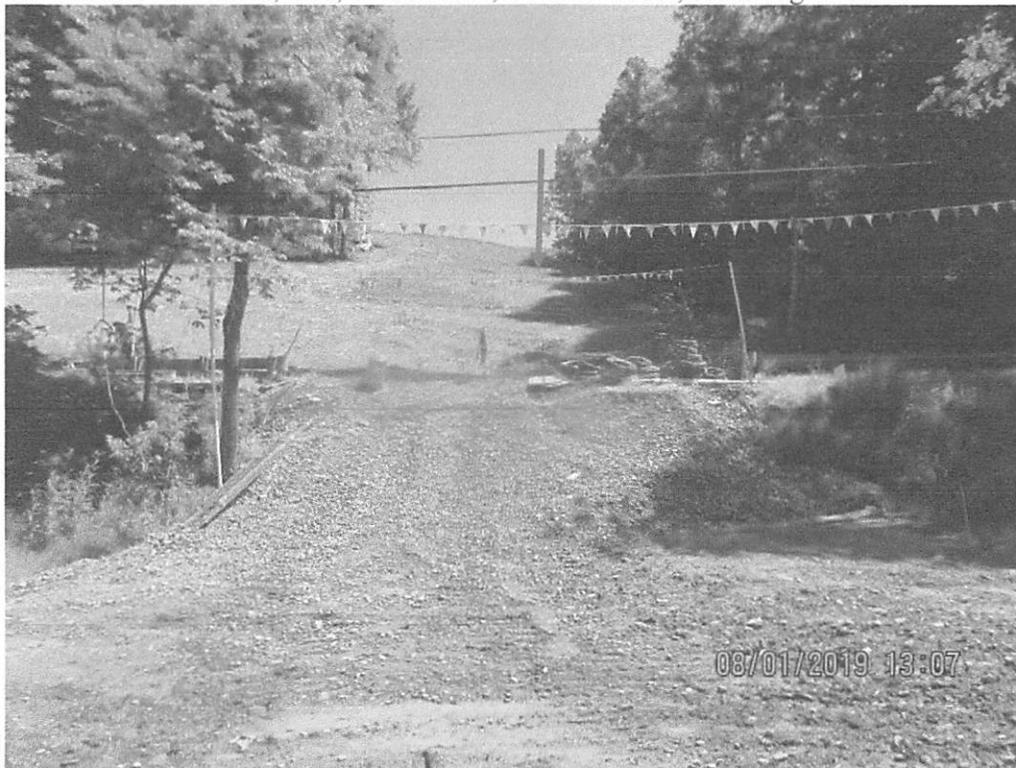
Above stream S-J70 and below US 19/Hwy 4 crossing near station 3829+00. Arrow depicts slope with lack of temporary stabilization.

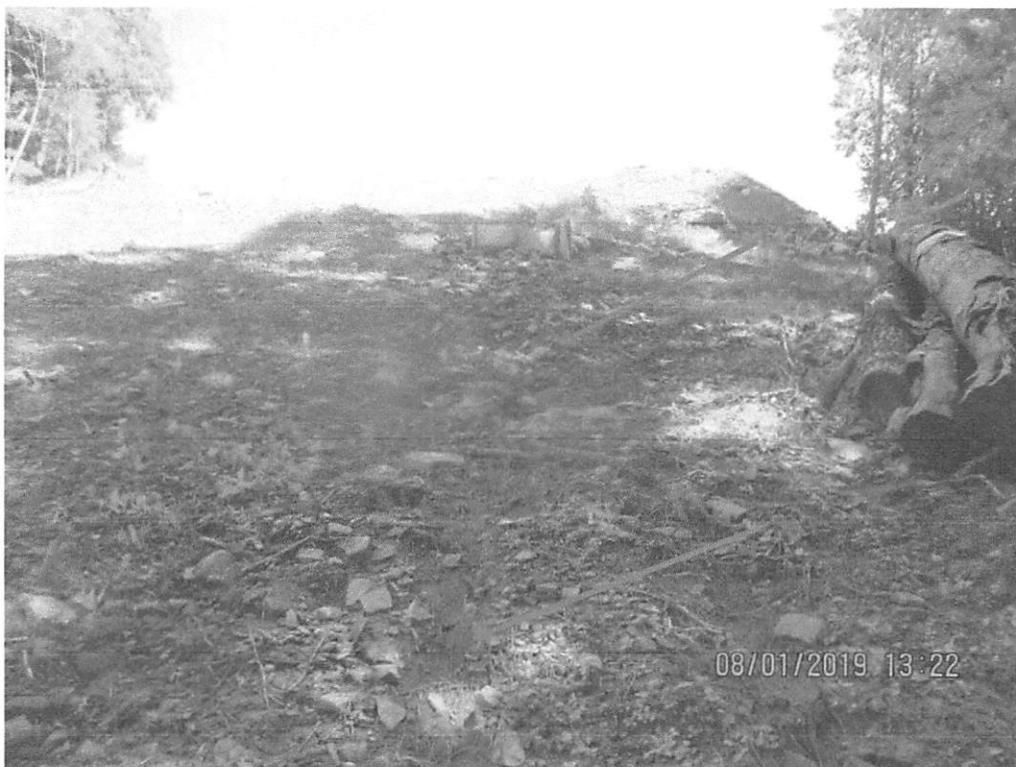
Slope above US 19/Hwy 4 and station 3831+00 not stabilized. Waterbars terminating onto ROW and not at edge of LOD. Arrow depicts erosion occurring below waterbar on slope.

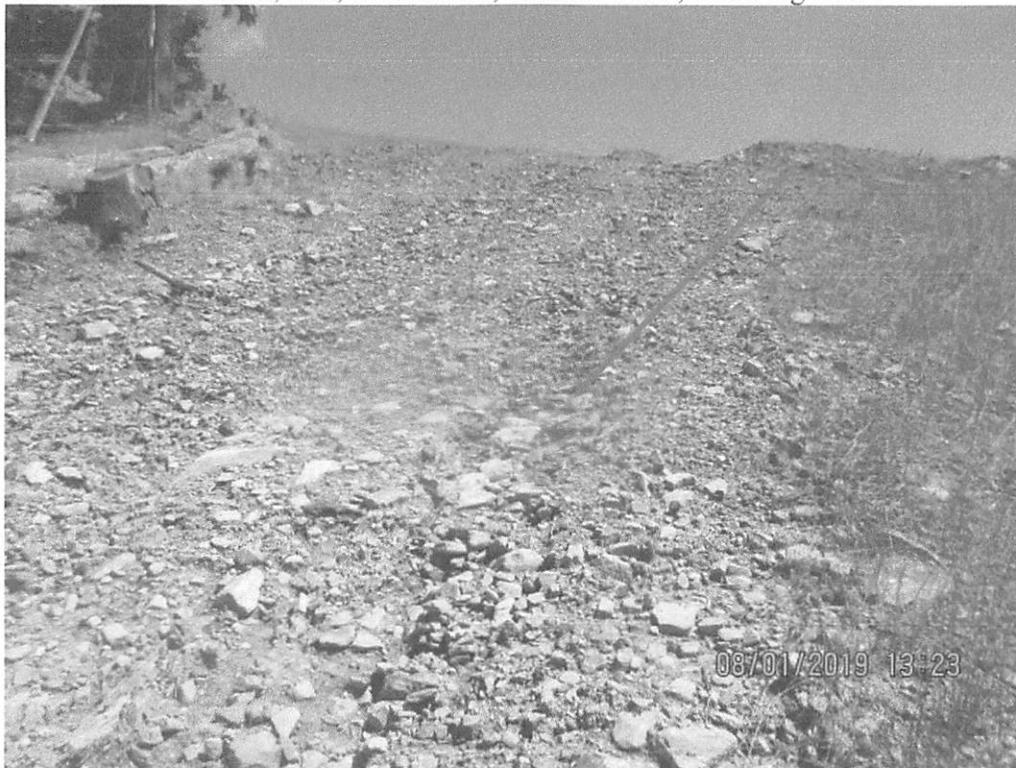
Travel lane on slope near station 3831+00. Erosion present in travel lane, resulting in waterbar being overwhelmed with sediment and not functioning as designed.

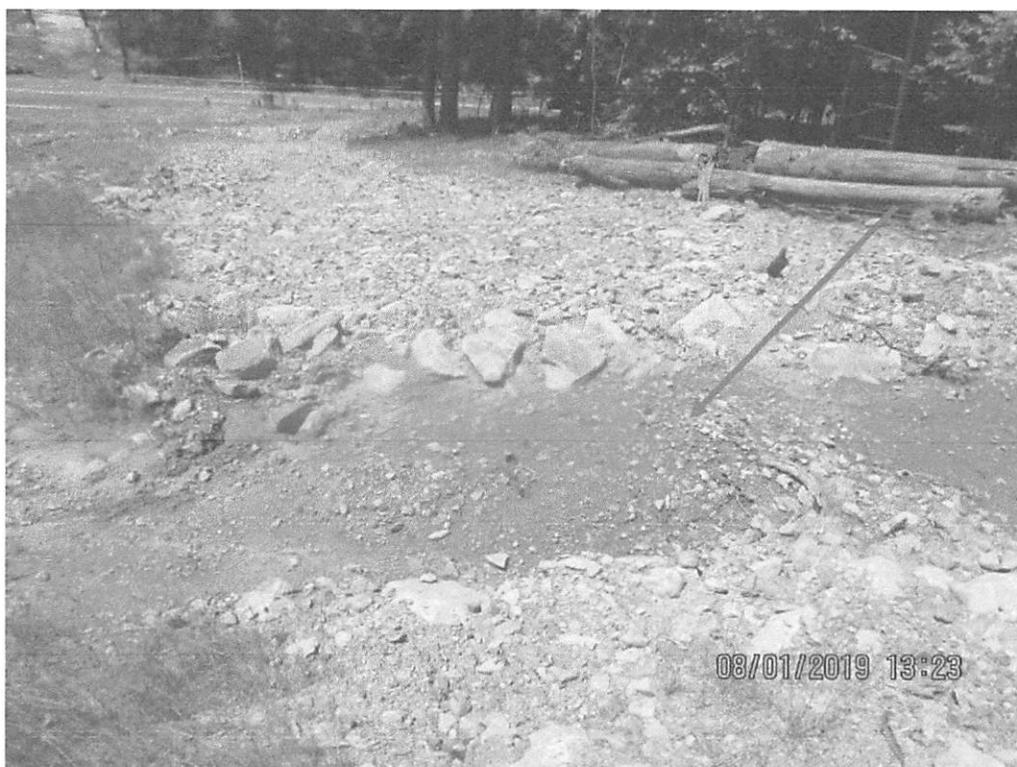
Near station 3831+00. Erosion present in travel lane resulting in waterbar being overwhelmed with sediment and not functioning as designed. Arrow depicts sediment deposited behind Waterbar.

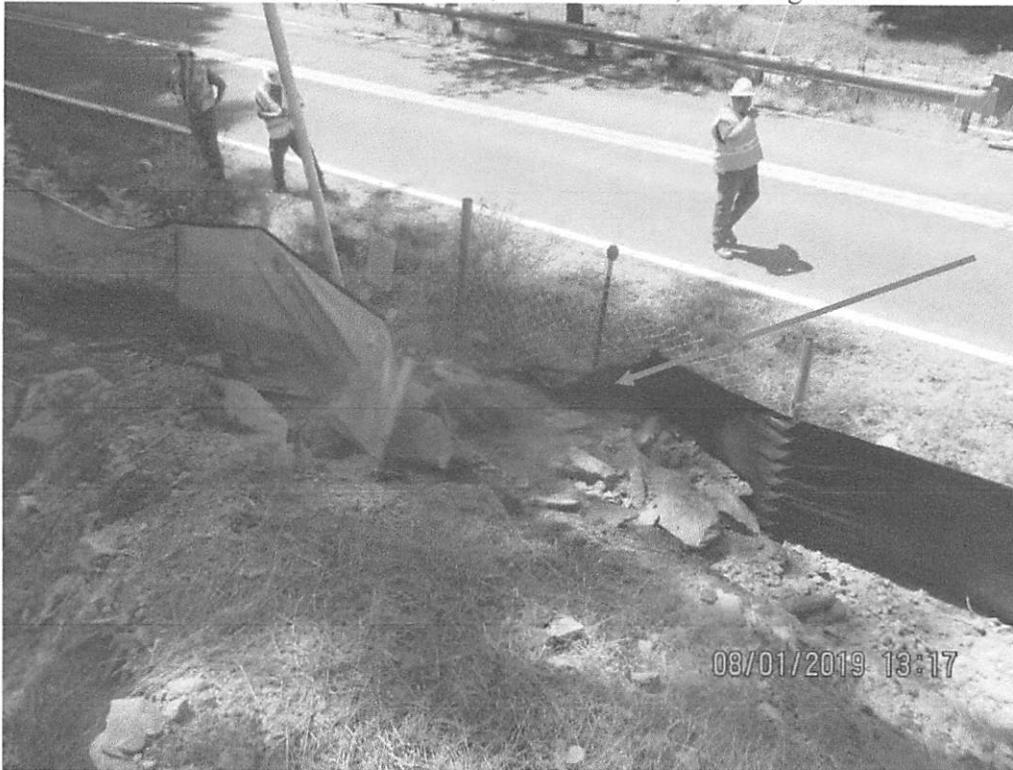
Perimeter controls at base of slope above US 19/Hwy 4 crossing. Controls overwhelmed with sediment, causing control failure above roadside ditch.

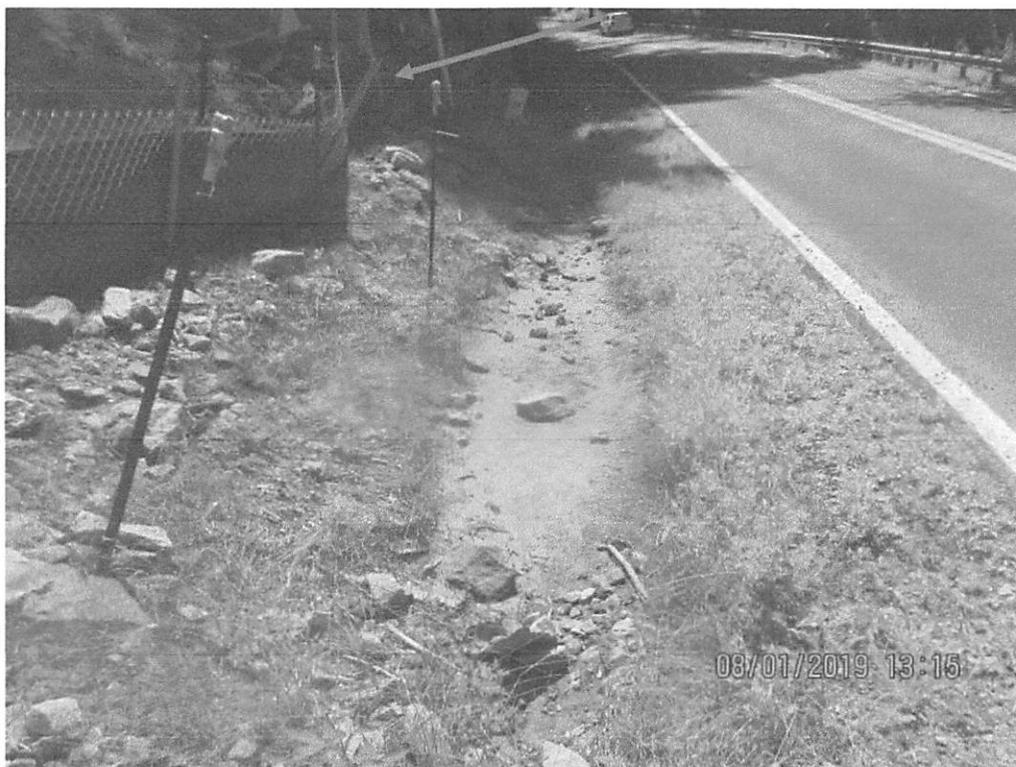
Sediment present in ditch that parallels US 19/Hwy 4 due to control failure. Arrow depicts control failure at base of slope.
