**CONSENT ORDER
ISSUED UNDER THE
WATER POLLUTION CONTROL ACT
WEST VIRGINIA CODE, CHAPTER 22, ARTICLE 11**

TO: Mountain Valley Pipeline, LLC
Robert J. Cooper
2200 Energy Drive
Canonsburg, PA 15317

DATE: December 17, 2020

ORDER NO.: 9925

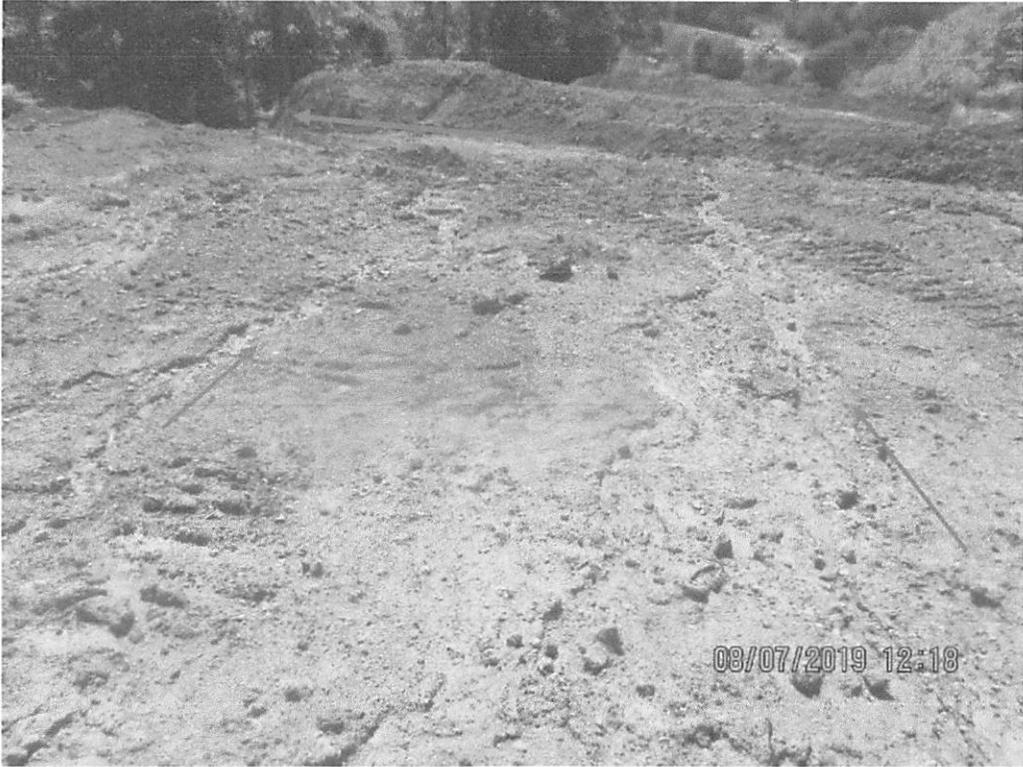
At top of steep slope facing South toward Boom Hollow Road at station 8951+00. Arrow depicts erosion on slope and waterbar with no outlet control.

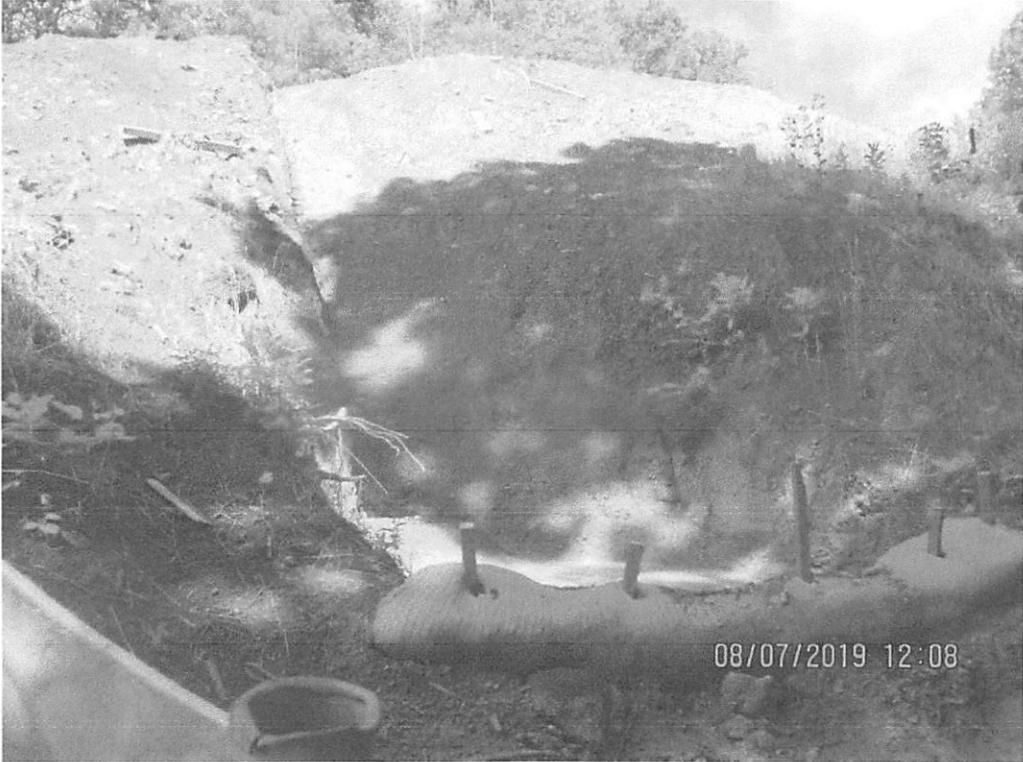
Controls below waterbar termini with no outlet control, terminating onto fill slope and above LOD near station 8951+00.

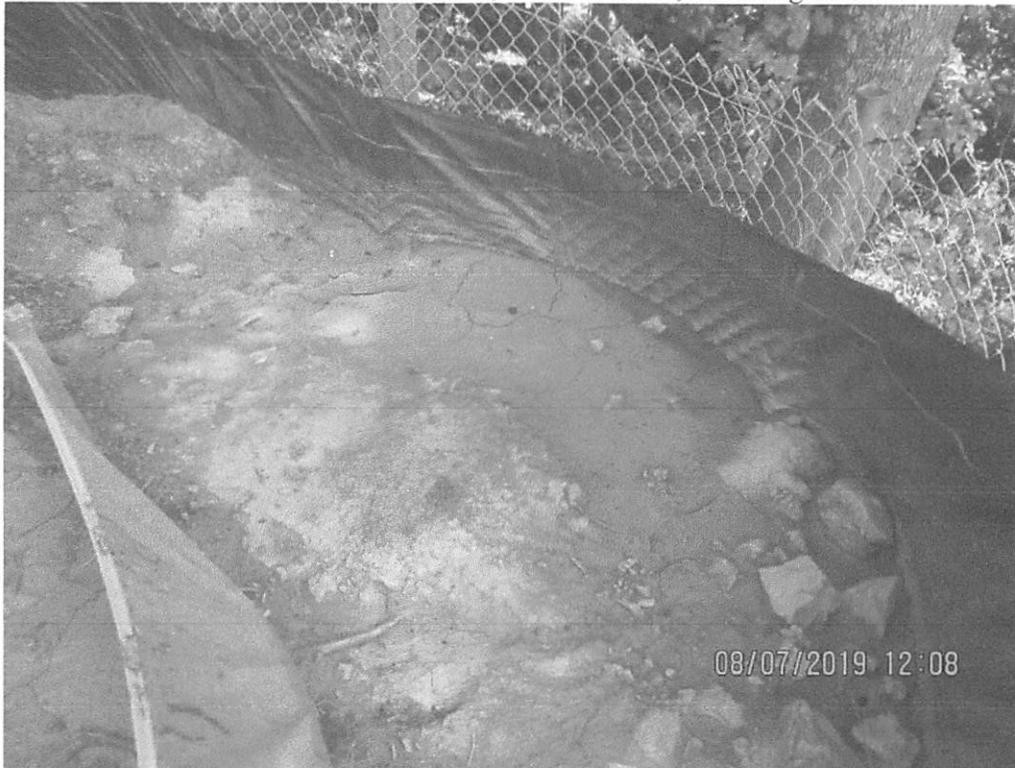
Further downslope near station 8951+00. Controls below waterbar termini with no outlet control terminating onto fill slope and above LOD. Controls needed maintained.

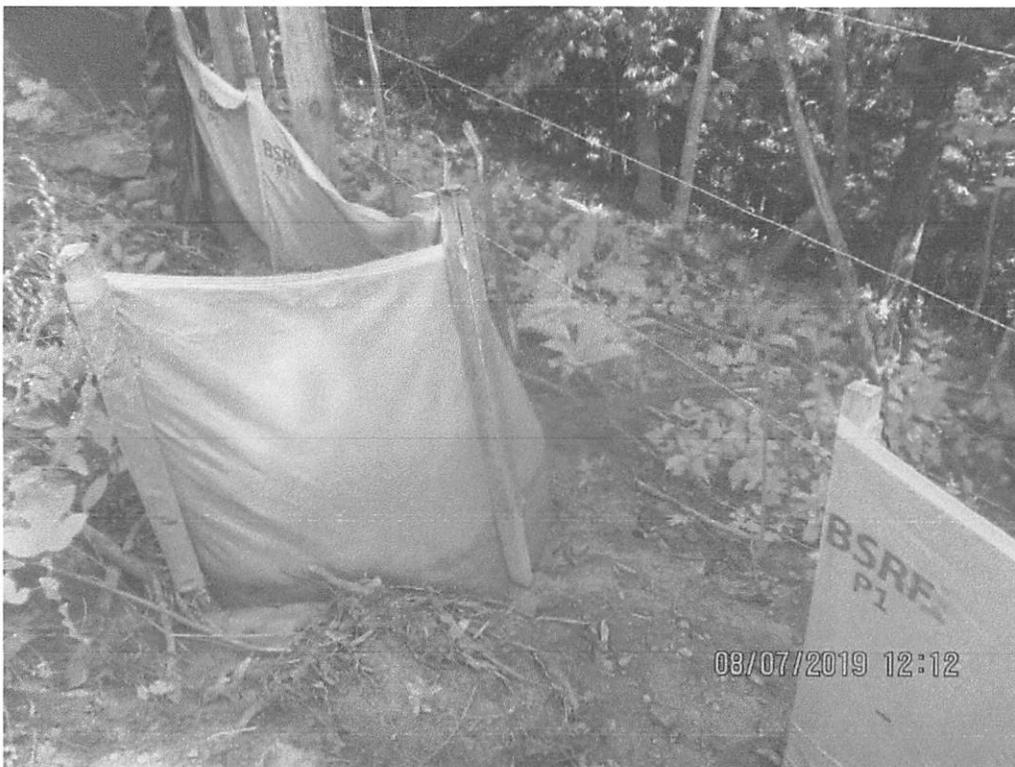
Further downslope near station 8951+00. Perimeter Controls below waterbar termini with no outlet control terminating onto fill slope and above LOD. Sediment deposits observed past the LOD.

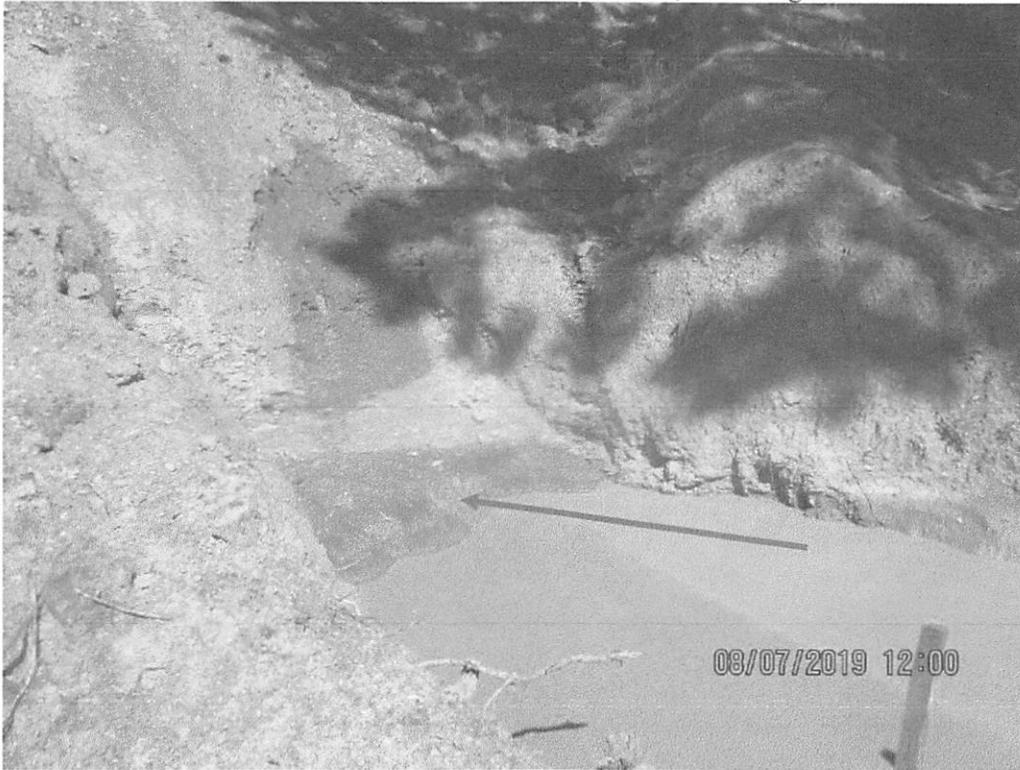
Near station 8955+00. Sump below waterbar terminating onto fill slope. Sump overwhelmed with sediment.

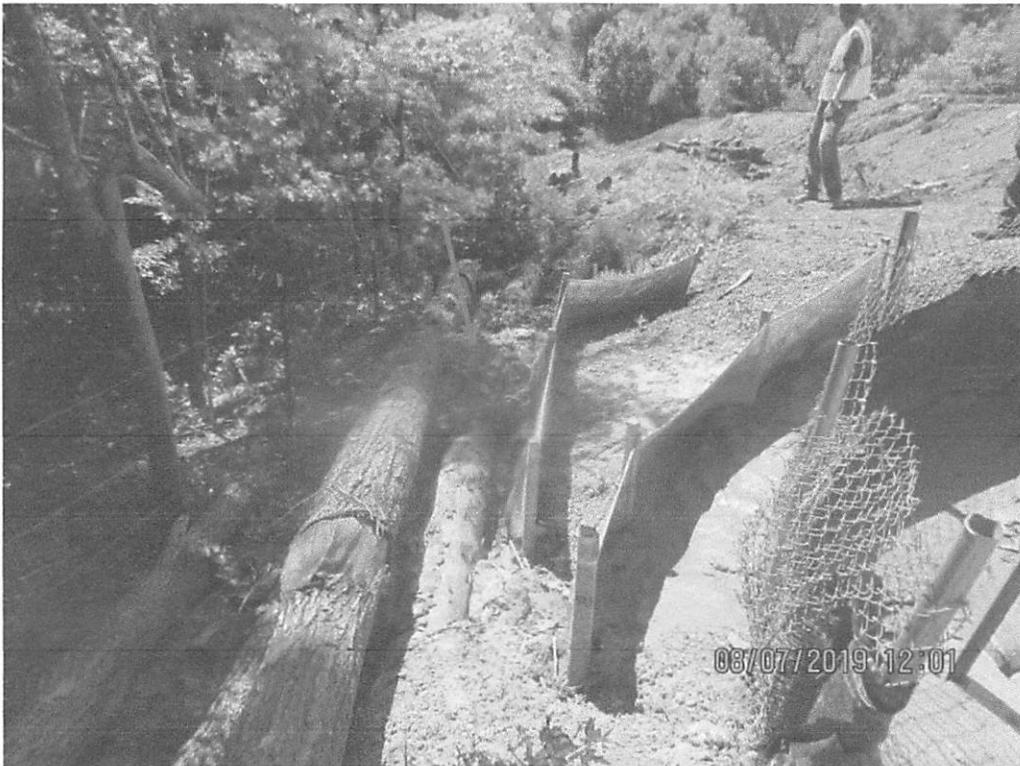
Near station 8955+00. Perimeter controls below waterbar terminating onto fill slope and sump that was full of sediment. Perimeter controls overwhelmed and sediment deposits present past log pile.

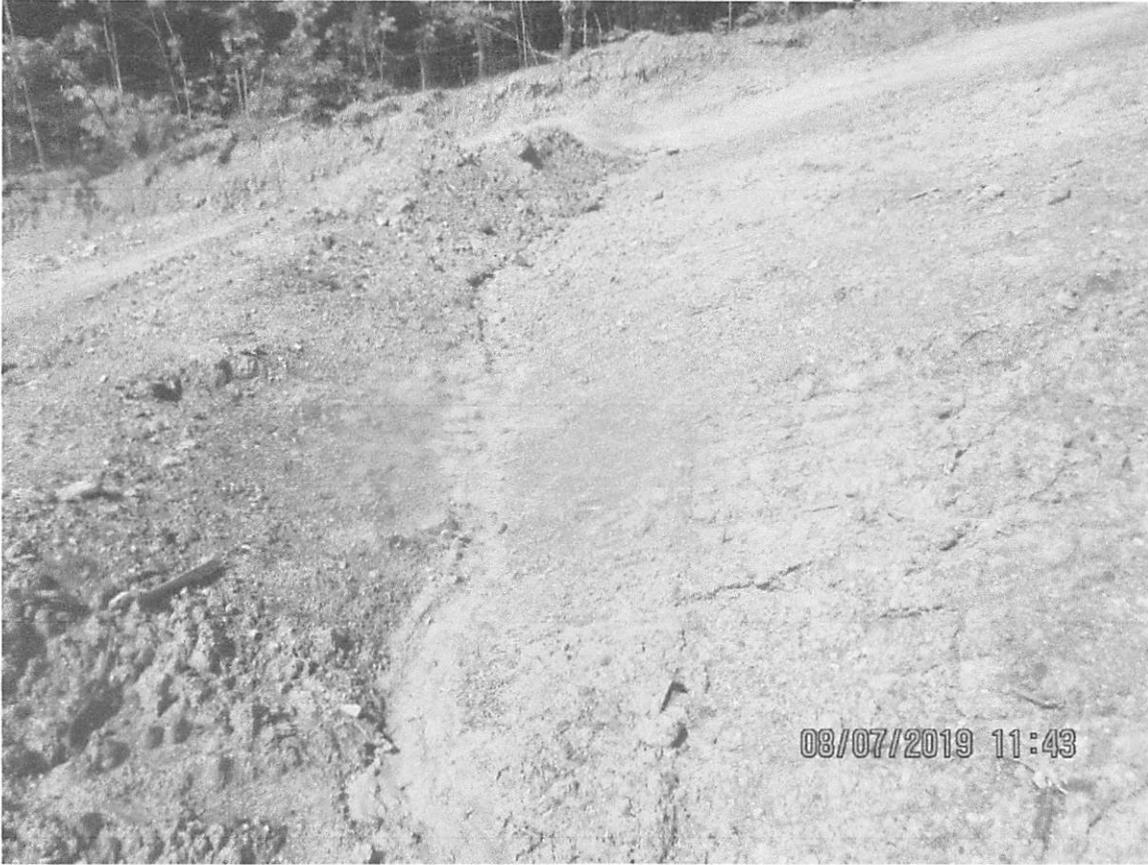
Erosion present in waterbar near station 8955+00 facing upslope.

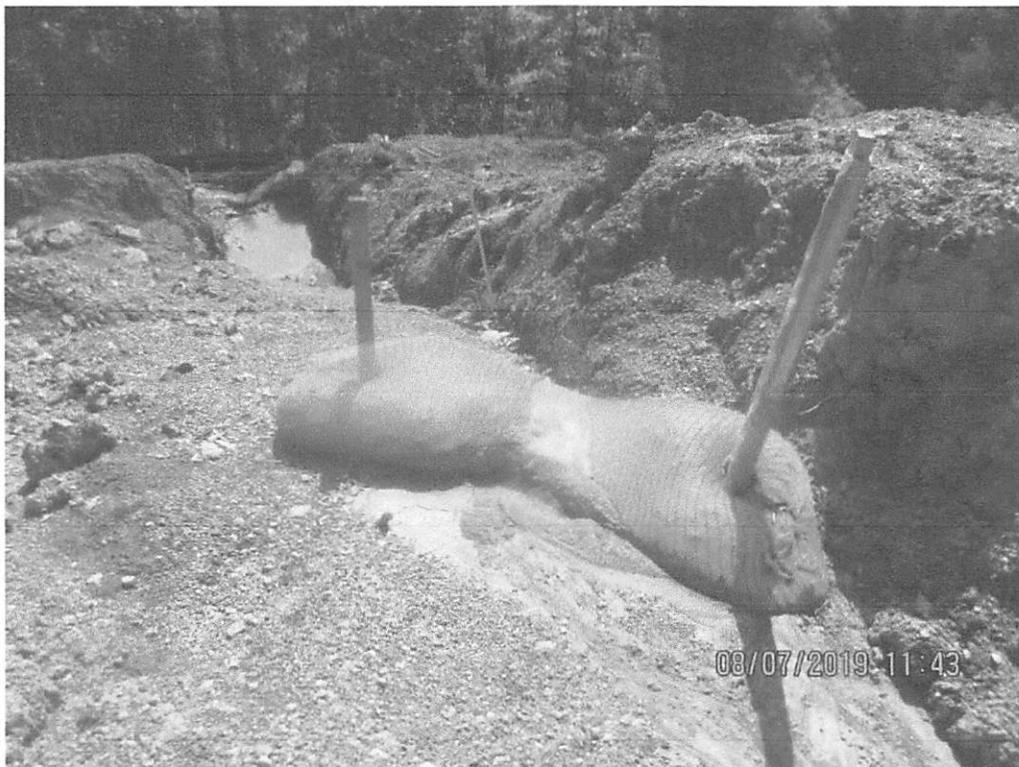
Waterbar terminus near station 8955+00. Erosion present on slope below waterbar terminus.

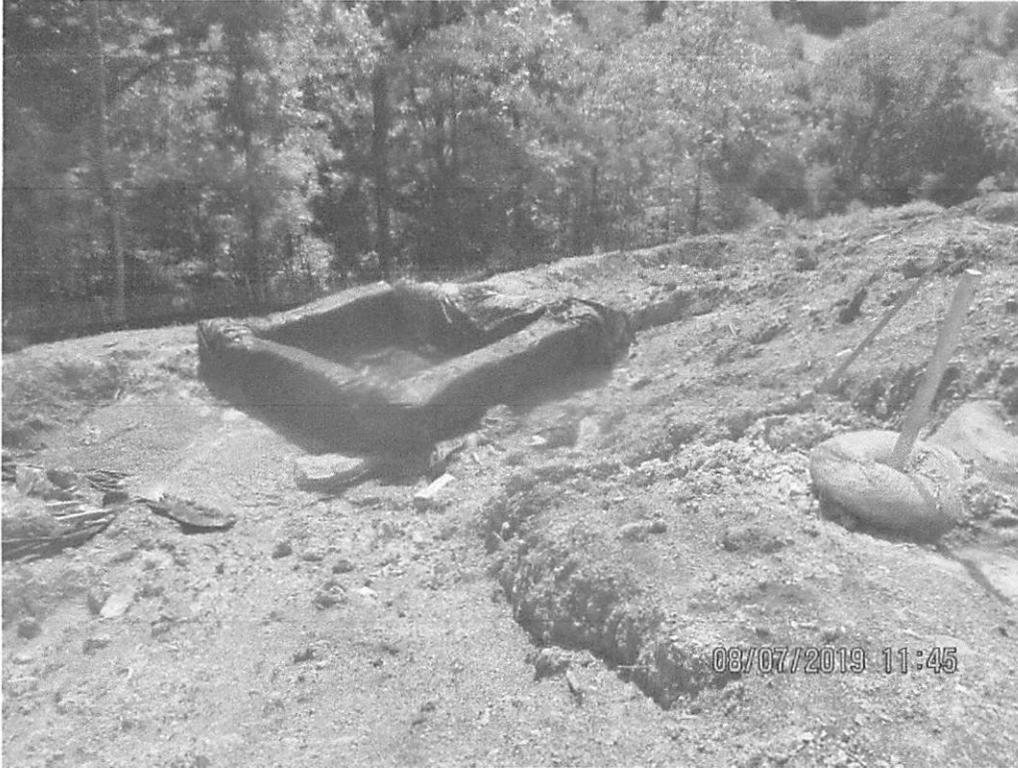
Dewatering structure present on slope and below waterbar terminus near station 8955+00. Erosion present on slope.

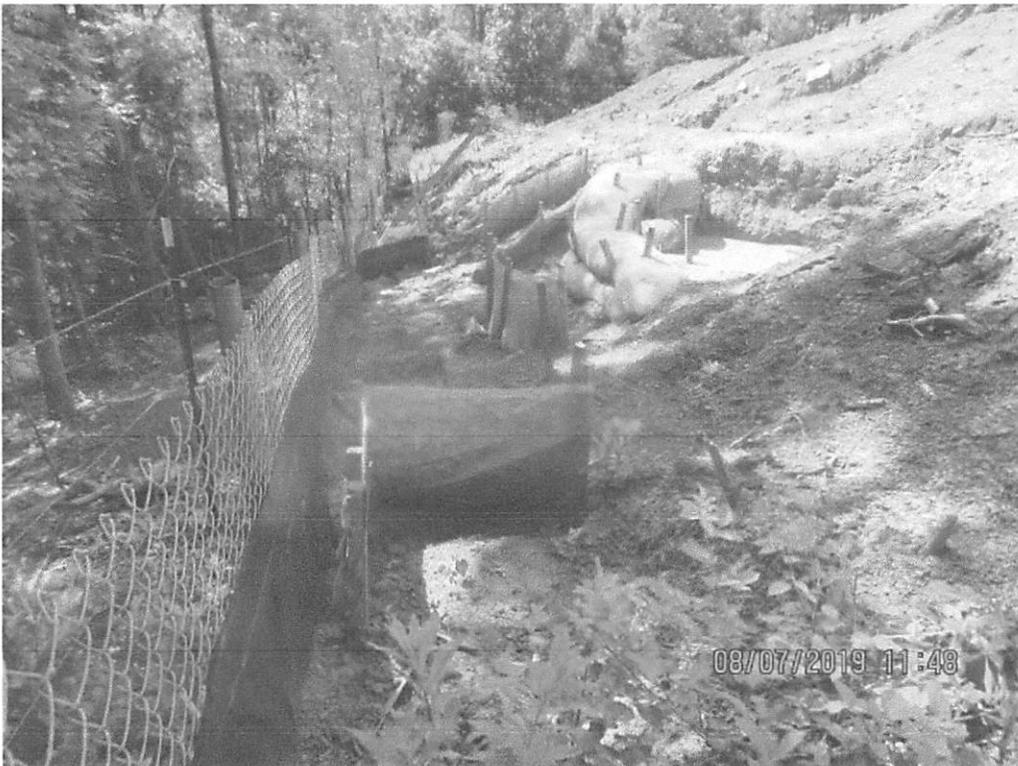
Perimeter controls below dewatering structure at station 8955+00. Arrow depicts where controls were overwhelmed with sediment.

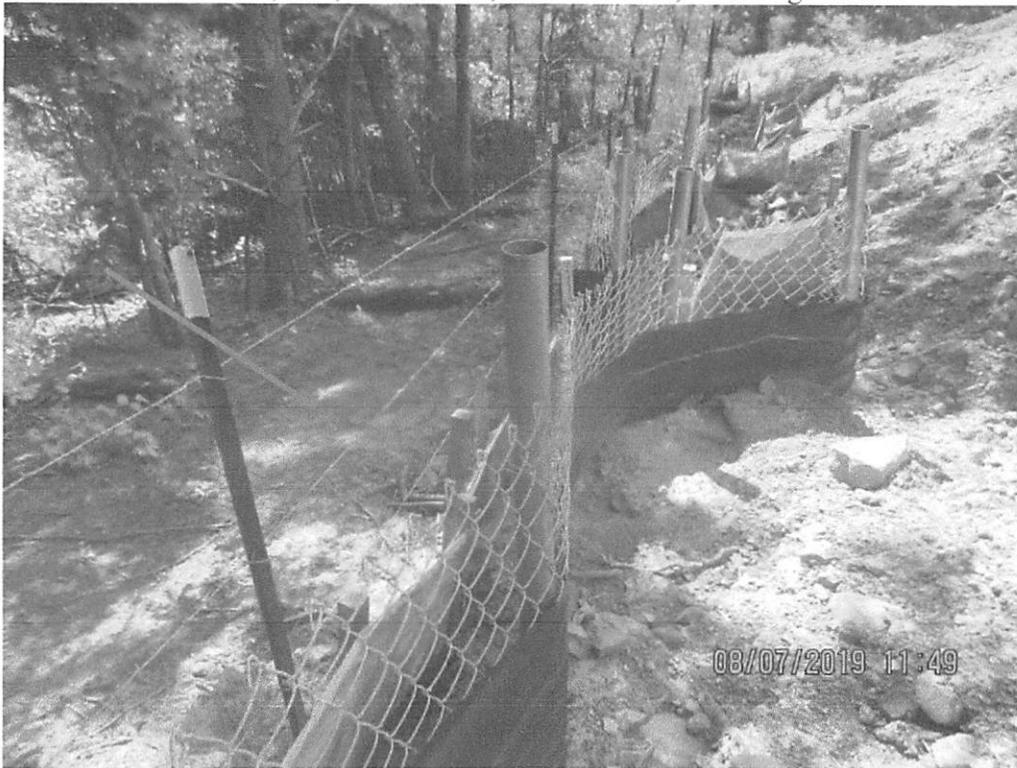
Perimeter controls below dewatering structure at station 8955+00. Arrow depicts where sediment deposits were observed.

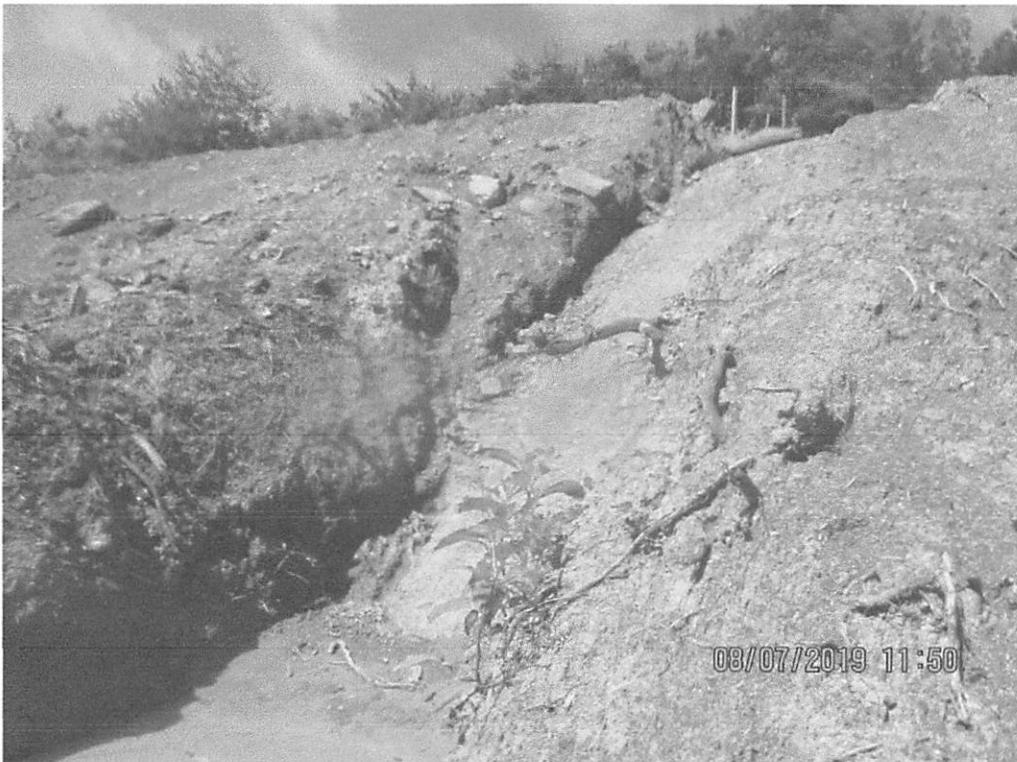
Waterbar terminating onto slope near station 8955+00. Erosion present on slope. Sump overwhelmed with sediment.

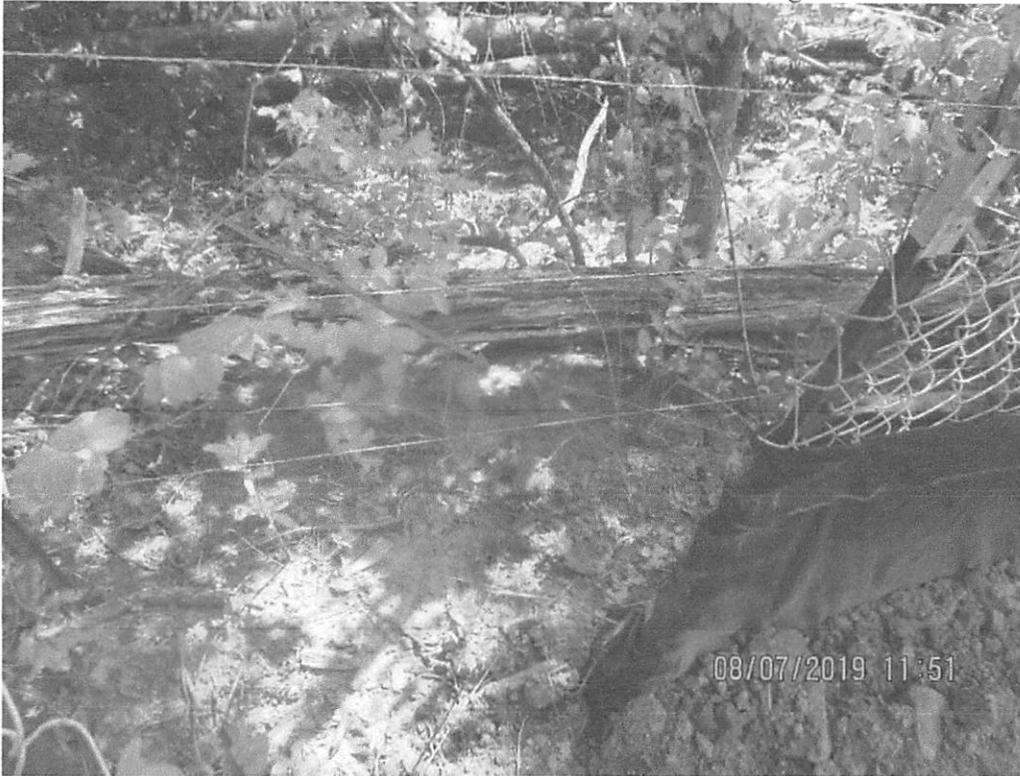
Sediment deposits past the LOD near station 8955+00, downslope of waterbar terminating onto ROW.

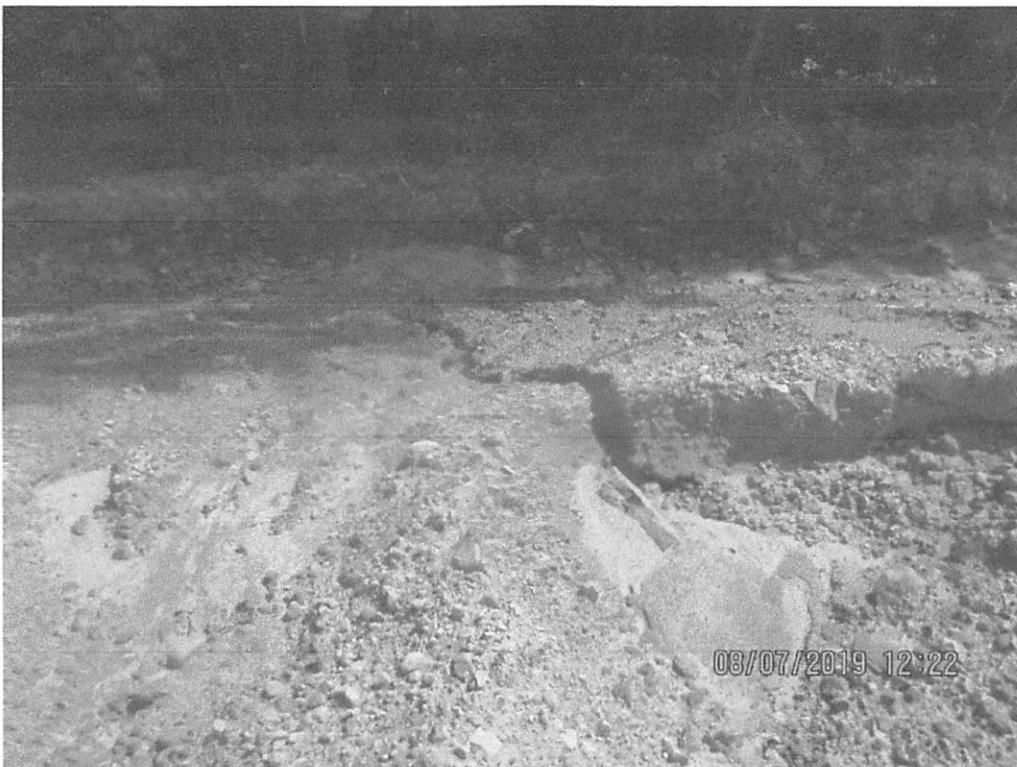
Fill slope near station 8946+00. Erosion present on fill slope resulting in sediment overwhelming perimeter controls.

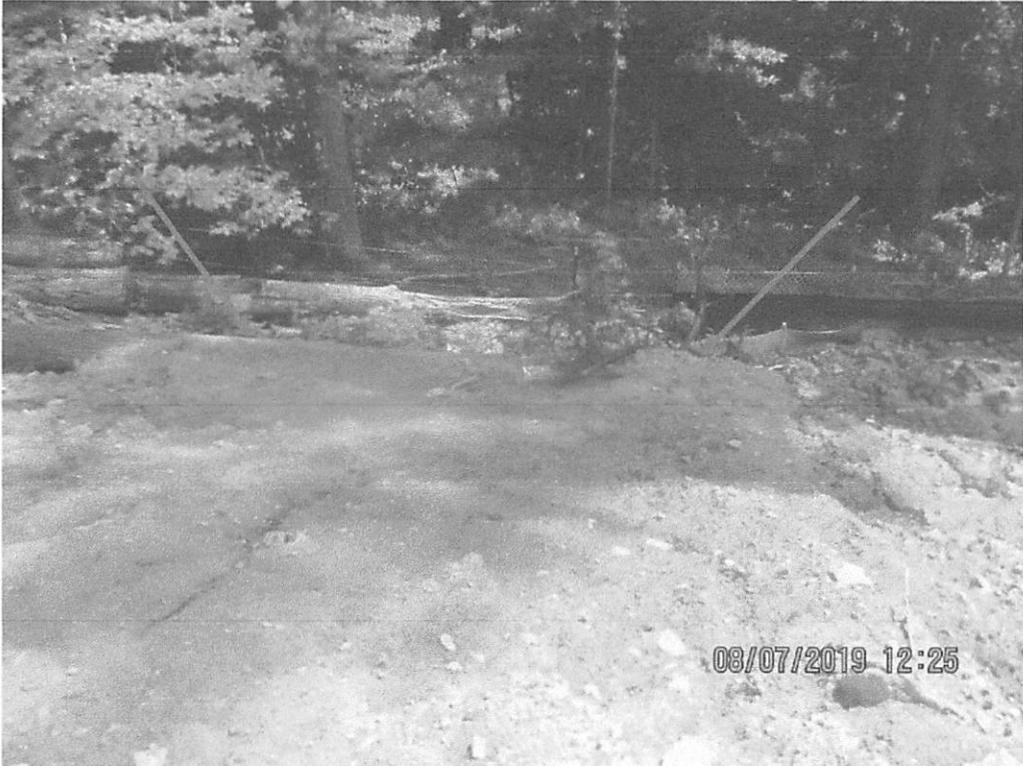
Fill slope near station 8946+00. Erosion present on fill slope resulting in sediment overwhelming perimeter controls.

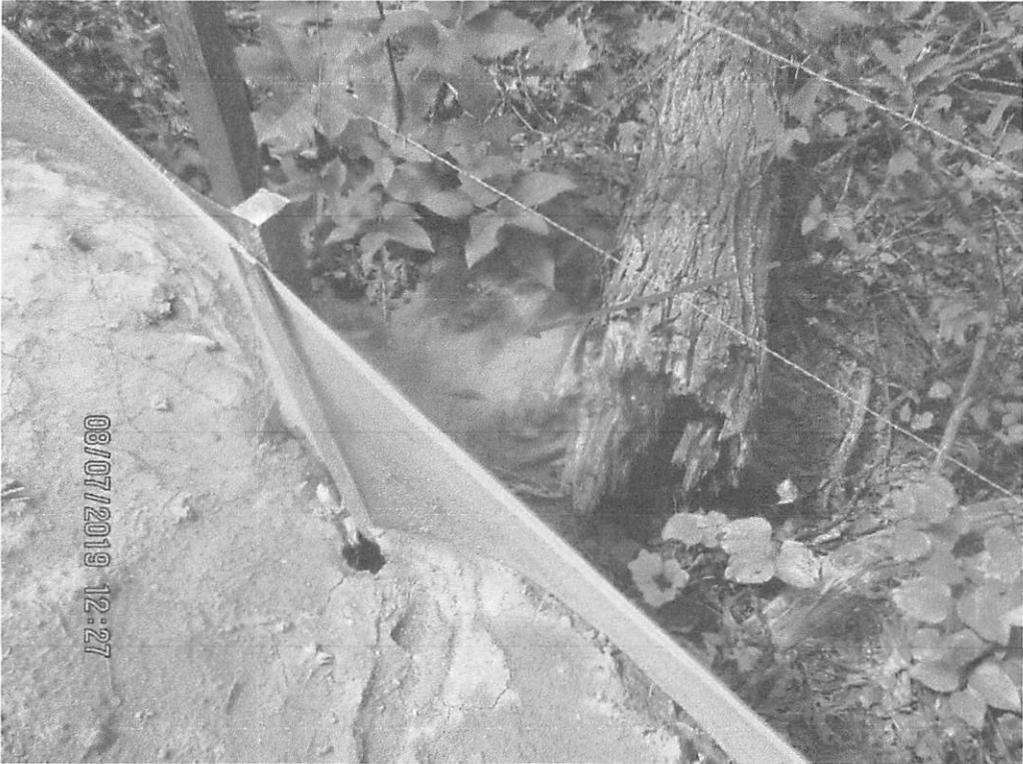
Fill slope near station 8946+00. Erosion present on fill slope resulting in sediment overwhelming perimeter controls. Arrows depict overwhelmed controls.

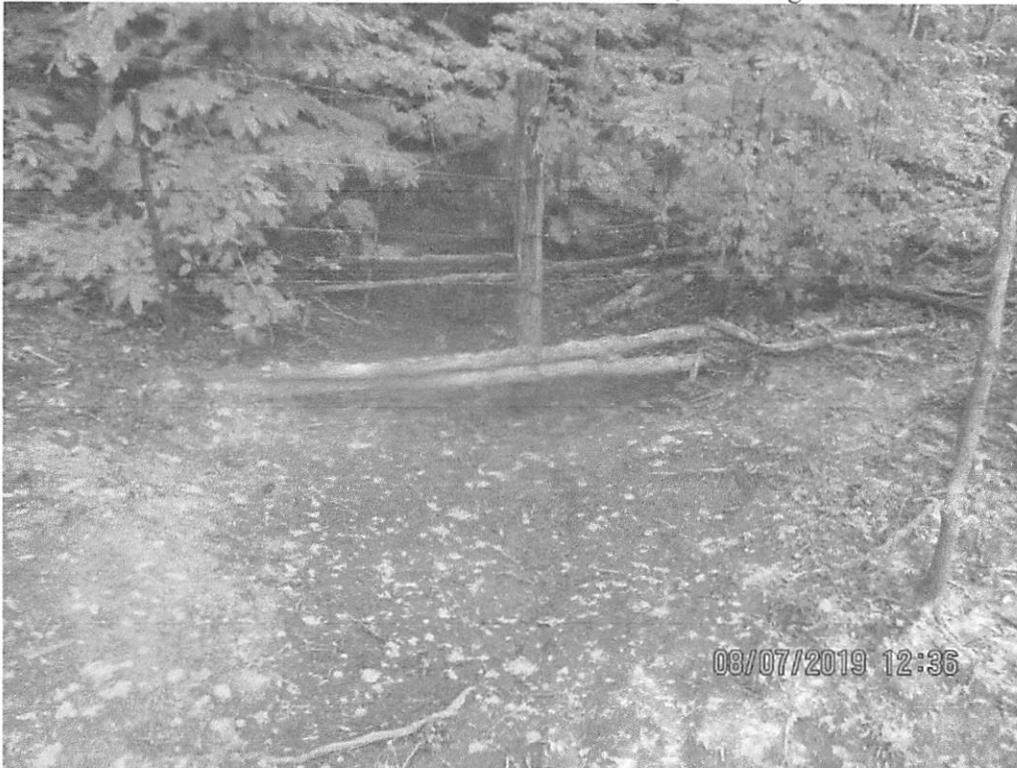
Sediment deposits past controls at station 8944+00.

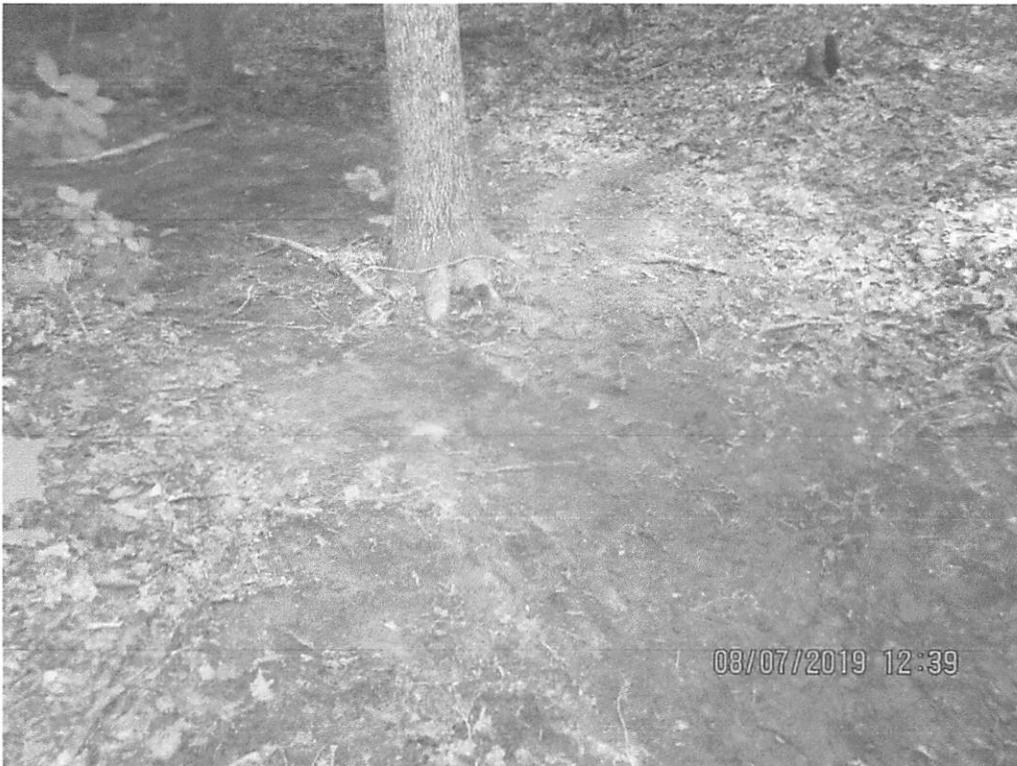
Beginning of Stream S-K16 at edge of LOD near station 8929+00.

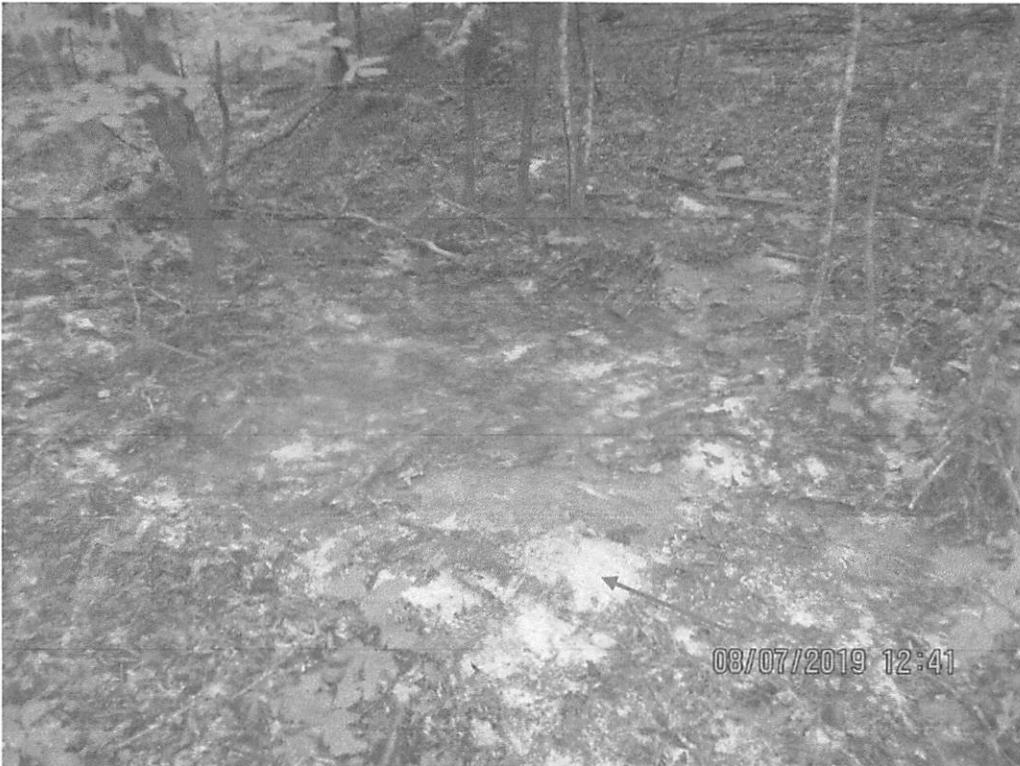
Approximately 150 ft past LOD near station 8929+00. Sediment deposits observed in Stream S-K16.

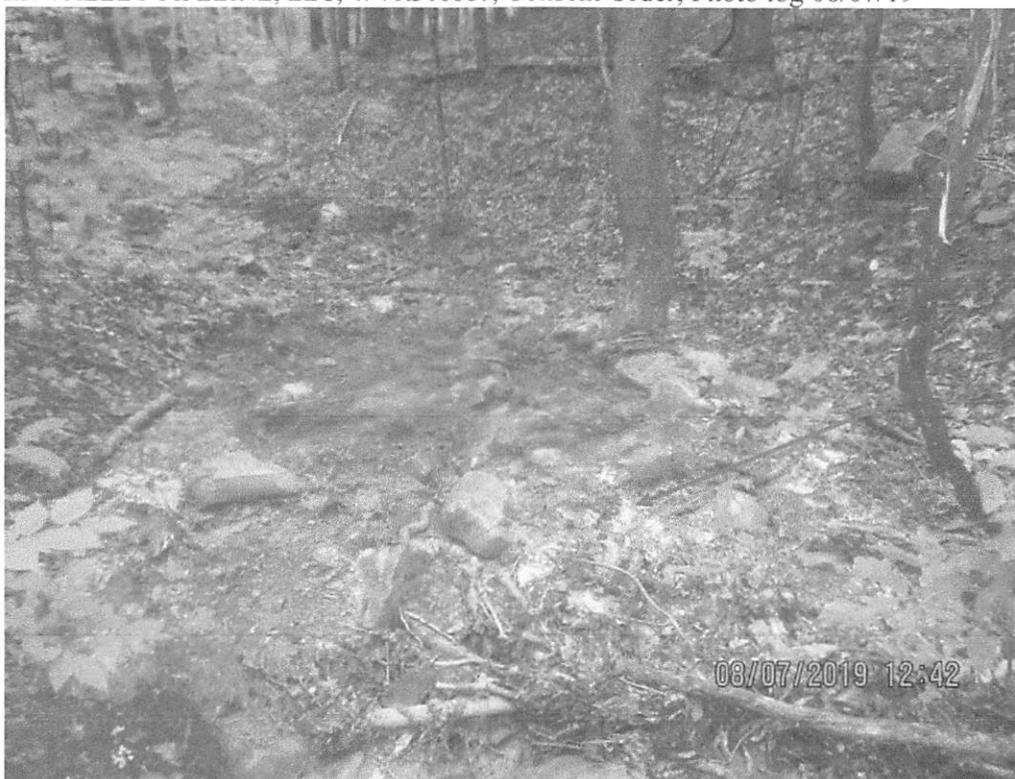
Approximately 200 ft past LOD near station 8929+00. Sediment deposits in Stream S-K16.

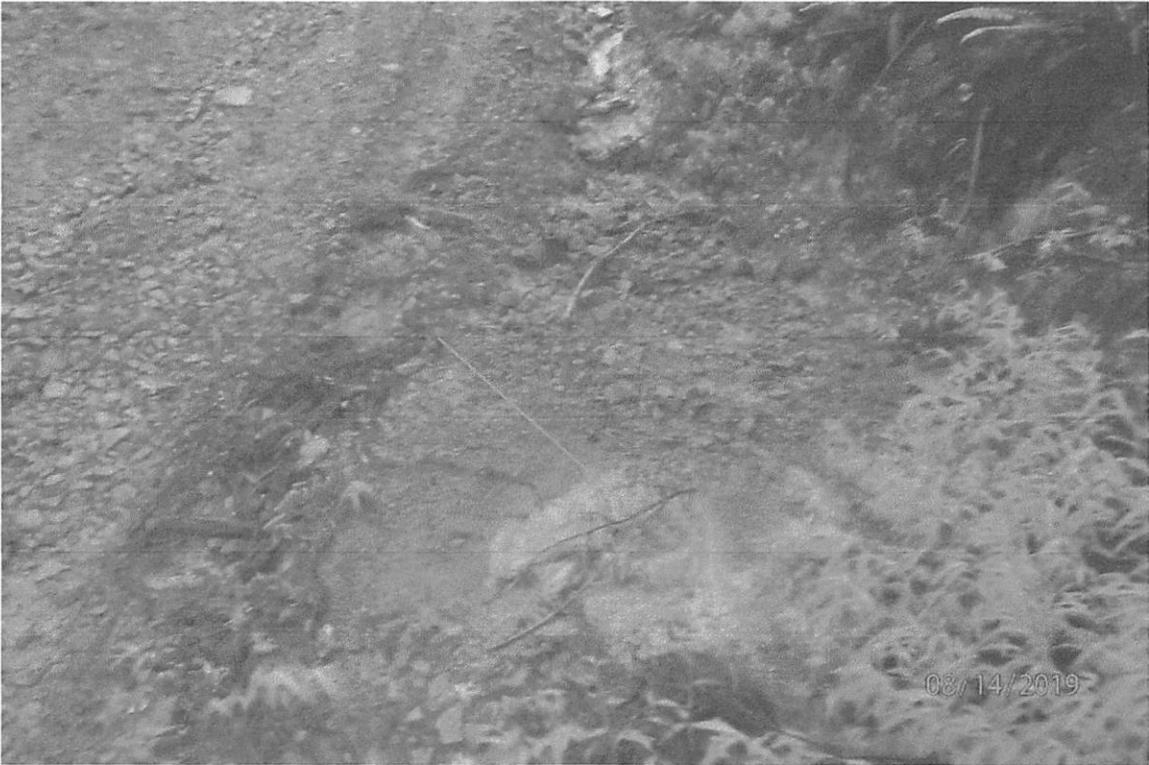
Sediment deposits present approximately 300 ft past LOD in Stream S-K16 near station 8929+00.

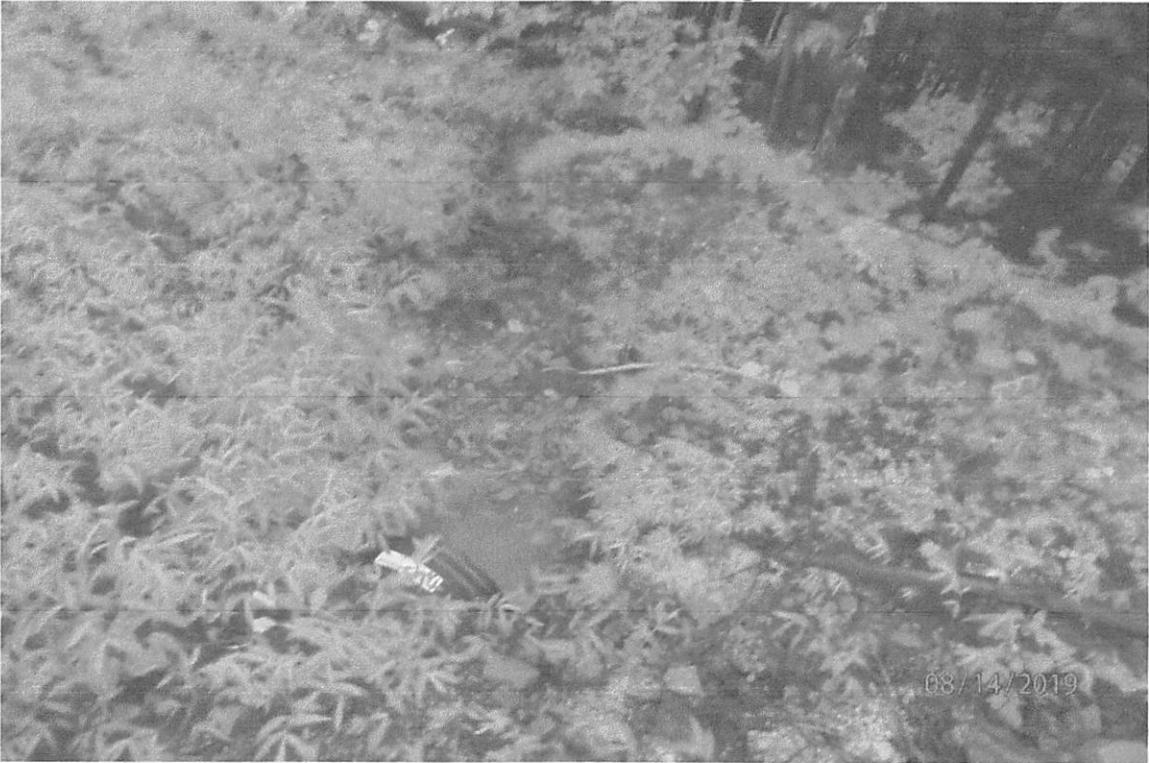
Culvert inlet on access road MVP-BR-092.01 showing the need for maintenance.

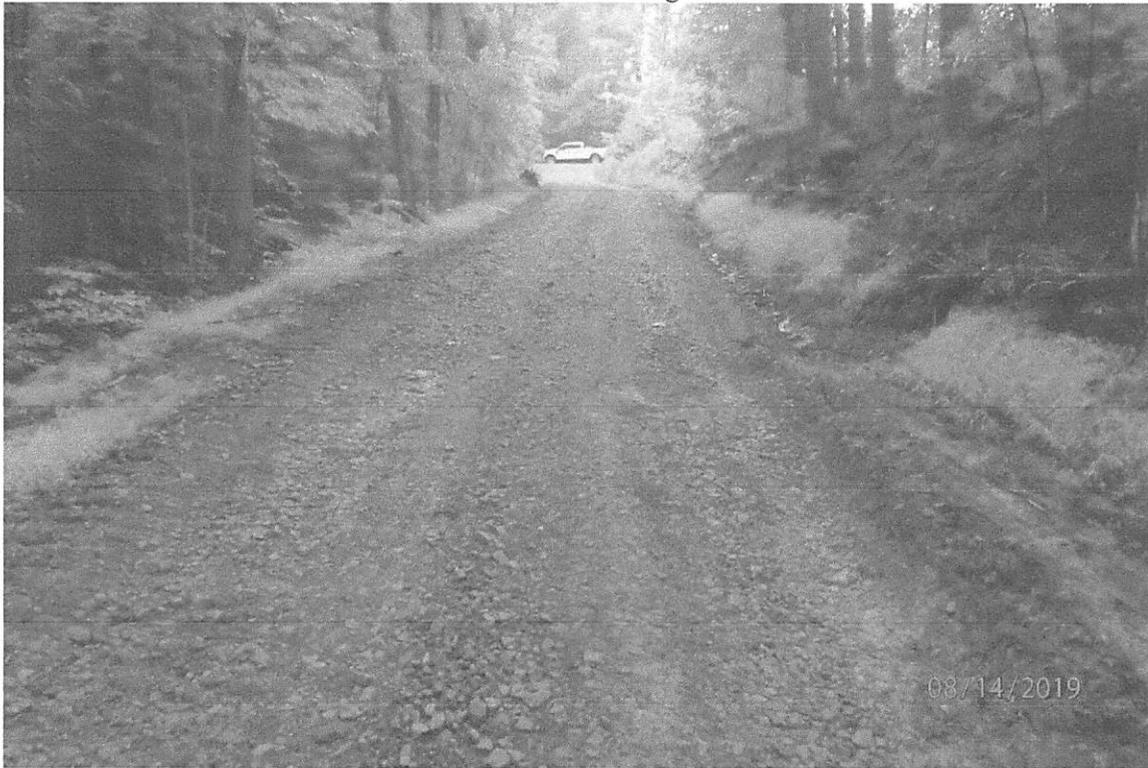
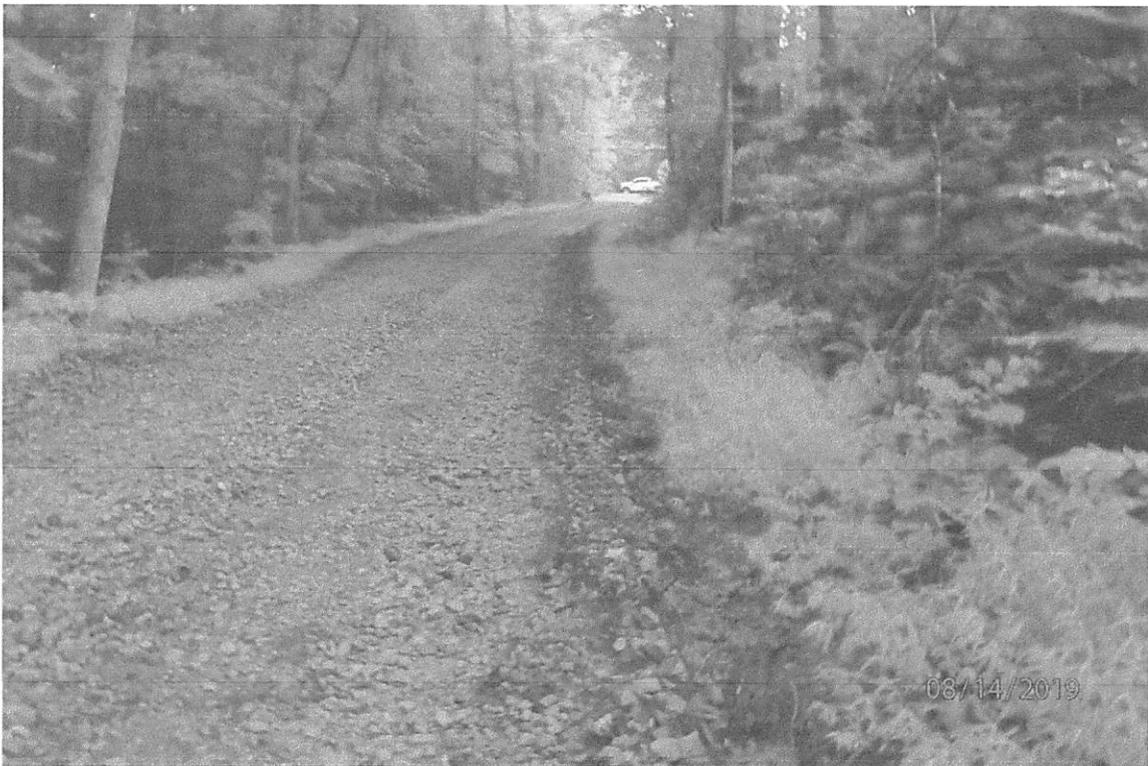
Outlet of the above pictured culvert showing the lack of installed outlet protection and the lack of a BMP.

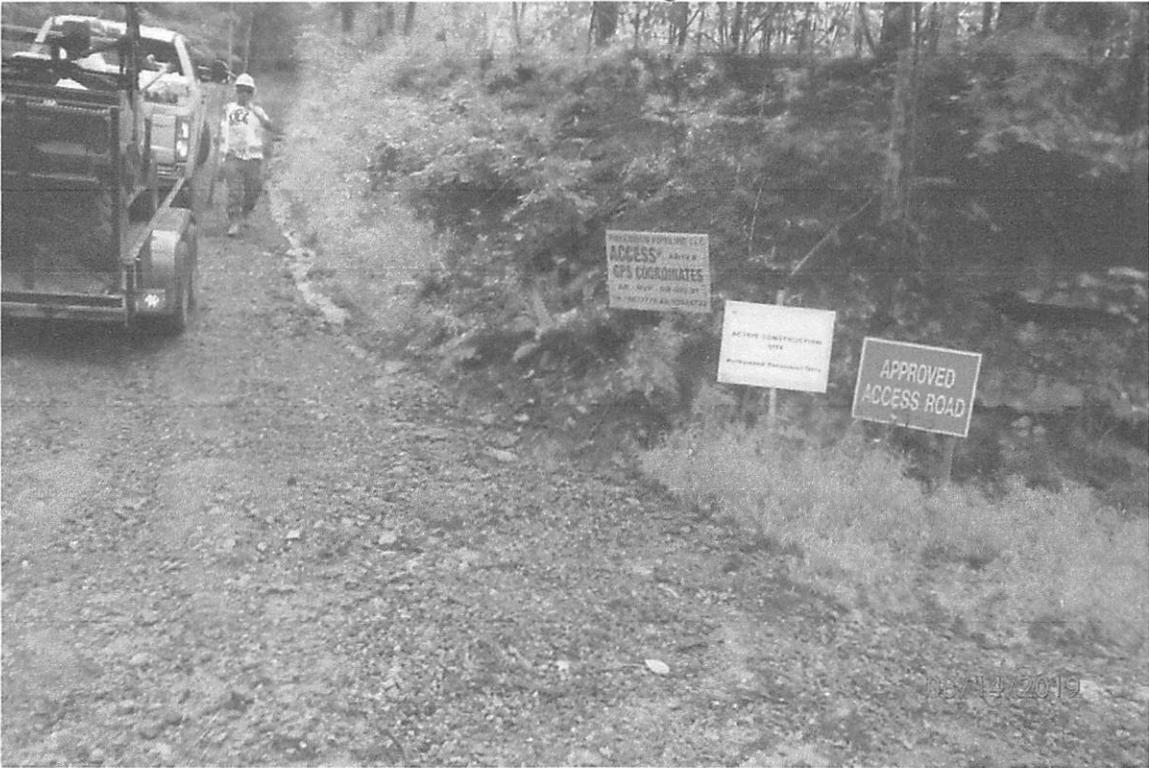
Access road MVP-BR-092.01 showing the area where concentrated flow stormwater is flowing from the top of the slope to the base of the hill due to poor maintenance on the installed culvert. The diversion lacks installed BMPs.

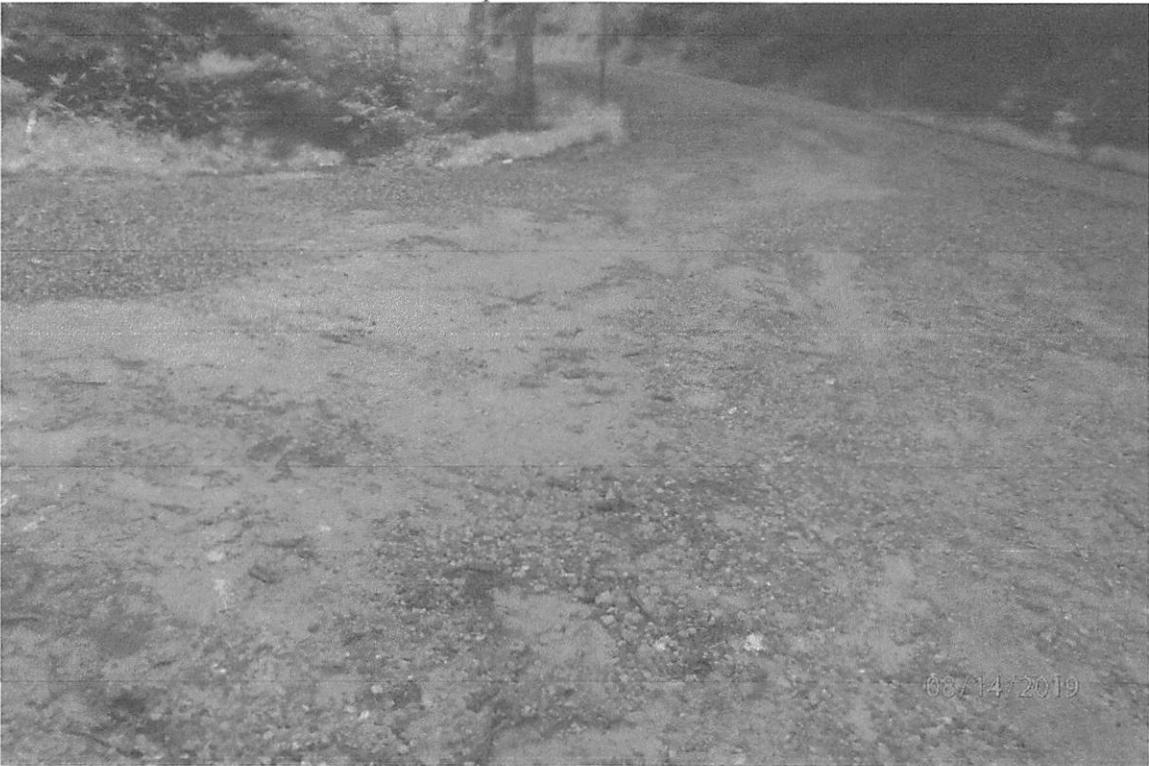
The bottom of the slope on access road MVP-BR-092.01.

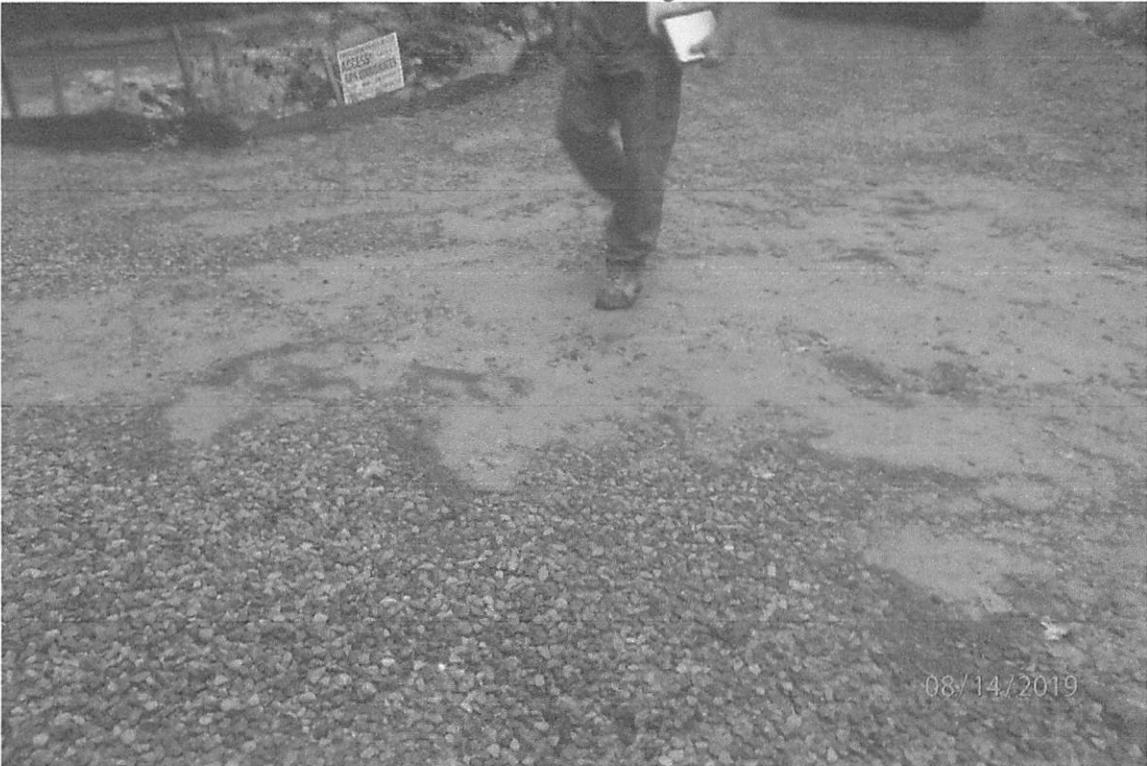
Trail of sediment deposits leading to Keith Run from the above pictured area.
