**CONSENT ORDER
ISSUED UNDER THE
WATER POLLUTION CONTROL ACT
WEST VIRGINIA CODE, CHAPTER 22, ARTICLE 11**

TO: Mountain Valley Pipeline, LLC
Robert J. Cooper
2200 Energy Drive
Canonsburg, PA 15317

DATE: December 17, 2020

ORDER NO.: 9925

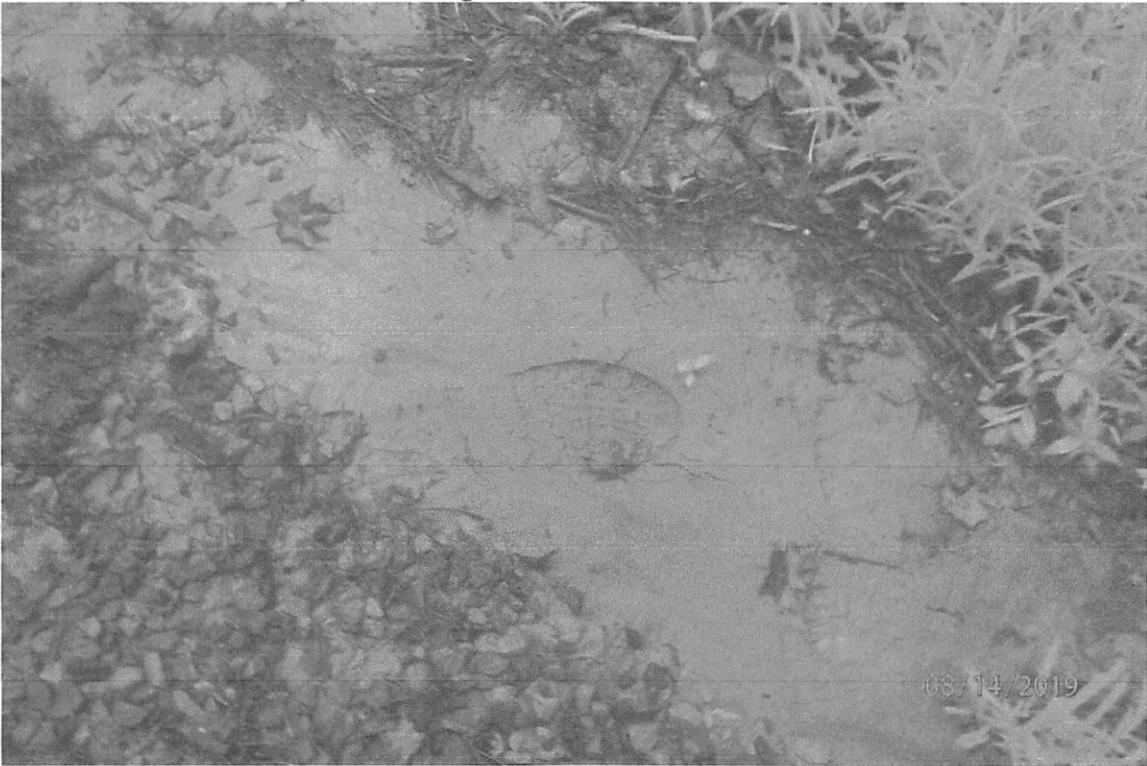
Trail of sediment deposits leading to Keith Run from access road MVP-BR-092.01.

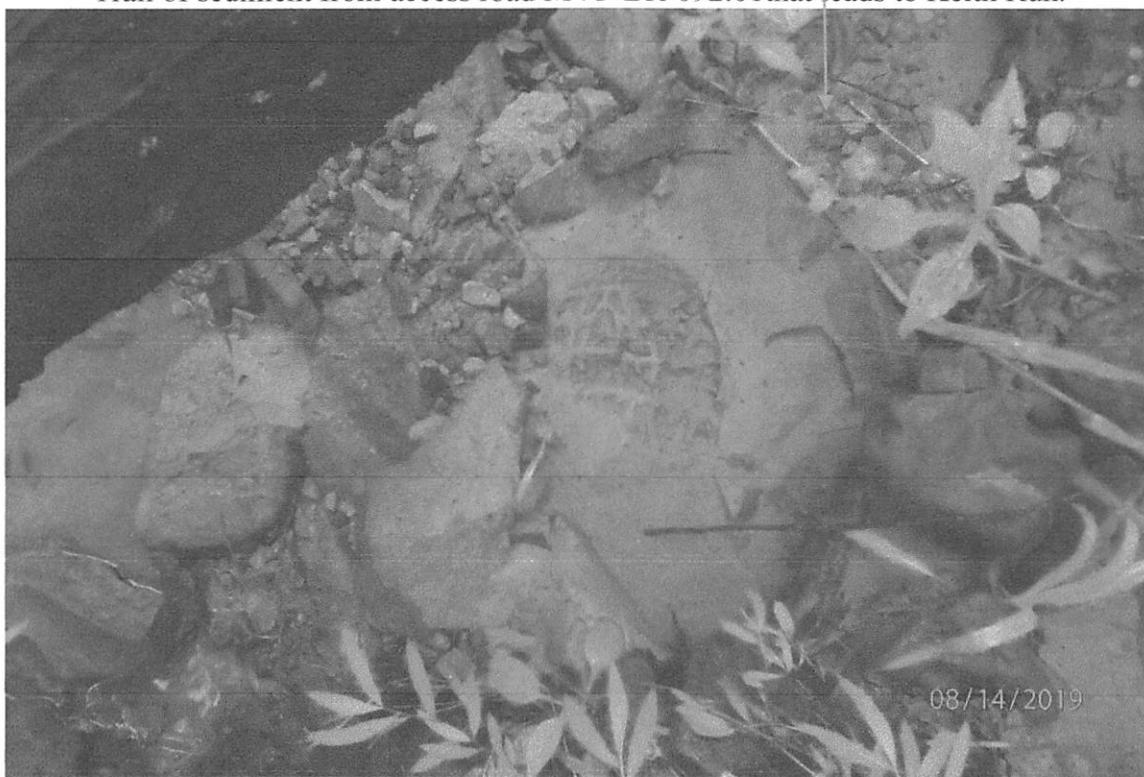
Trail of sediment from access road MVP-BR-092.01 that leads to Keith Run.

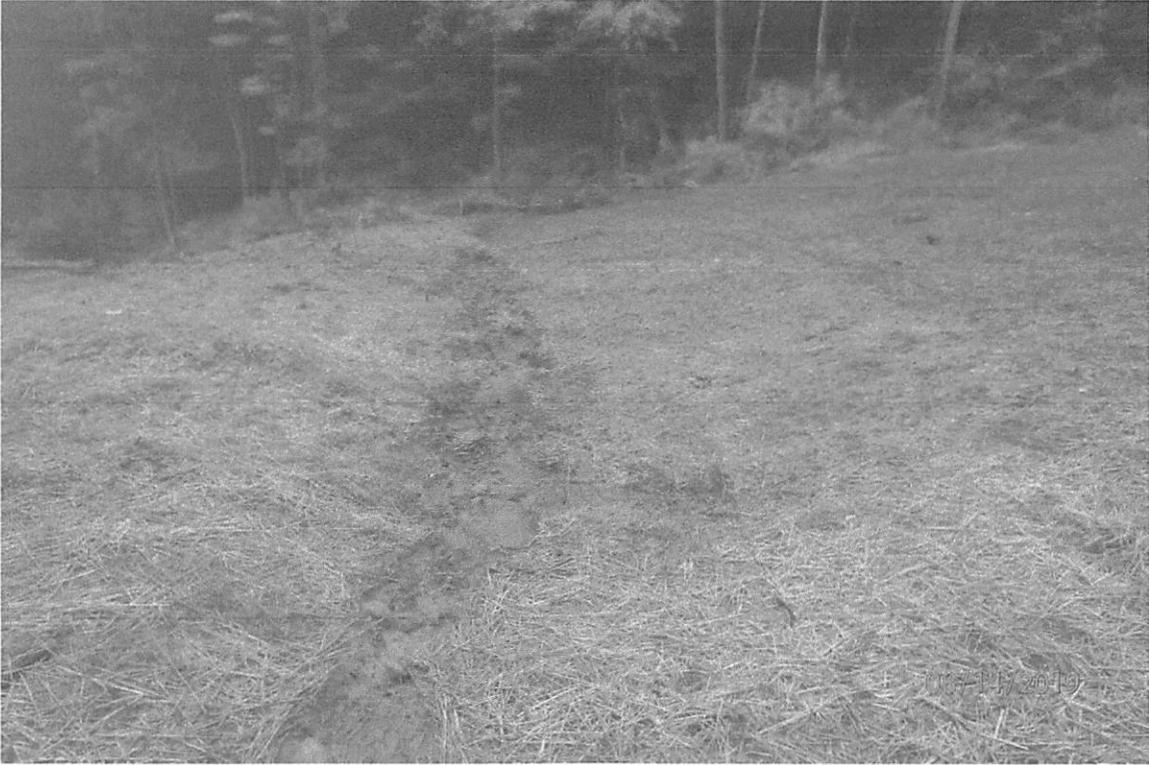
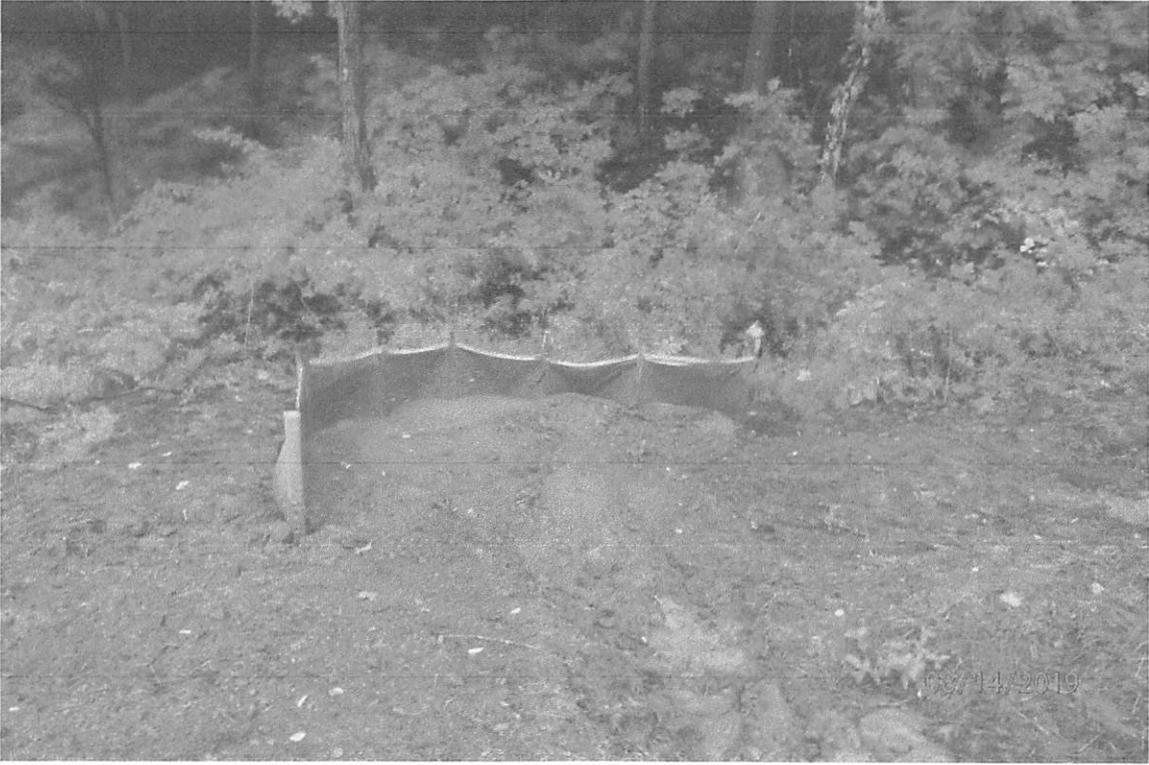
CNA deposits in Keith Run ($38^{\circ} 47.179'$ X $80^{\circ} 31.816'$) at the second location.

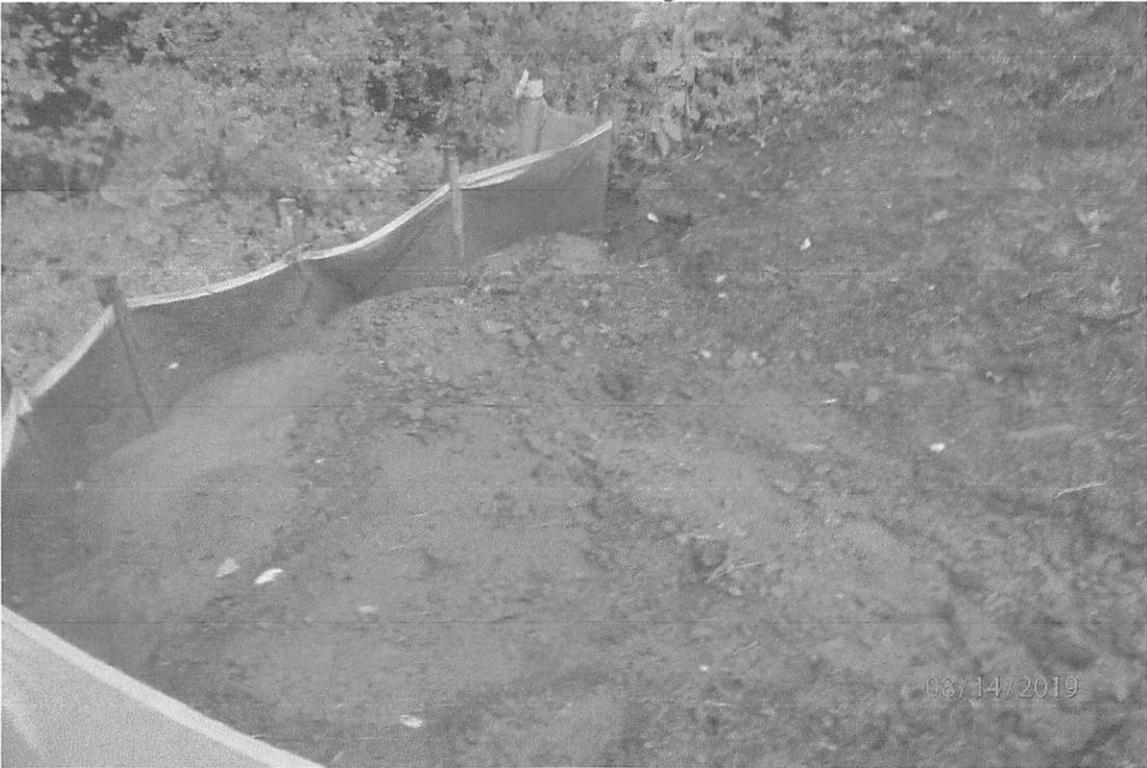
Water bar terminus BMP adjacent to 3760+00 that is in need of maintenance.

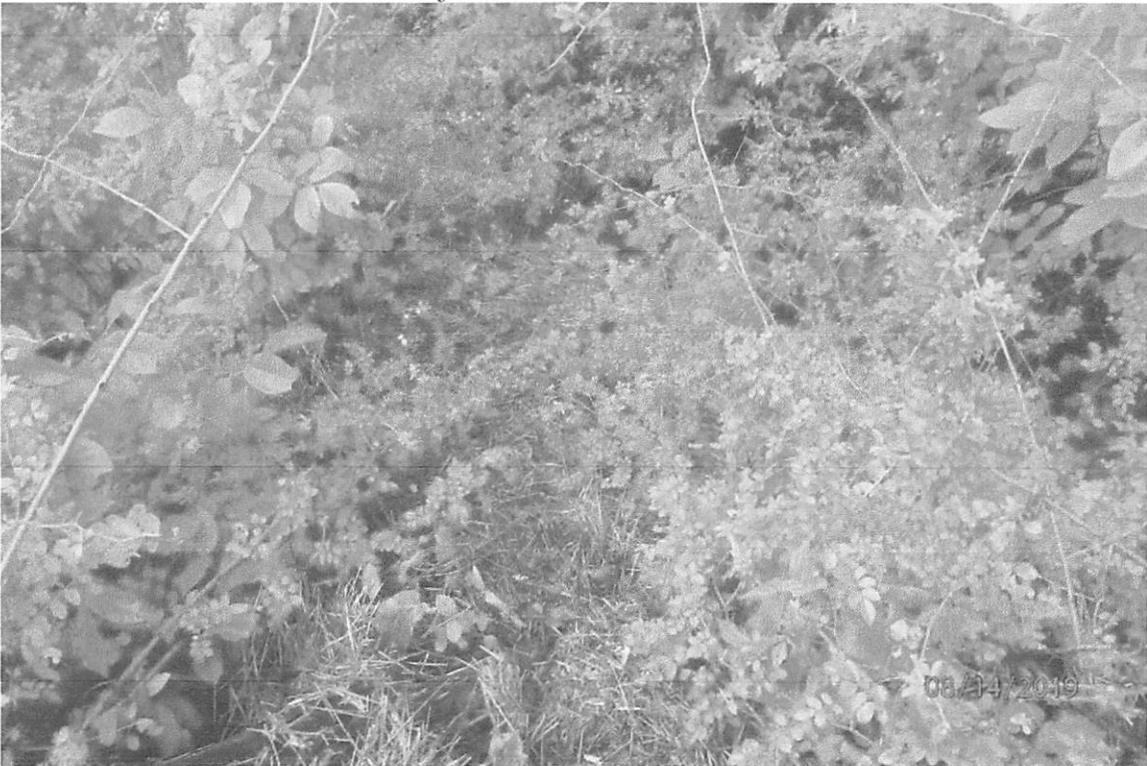
Water bar terminus BMP adjacent to 3760+00 that is in need of maintenance.

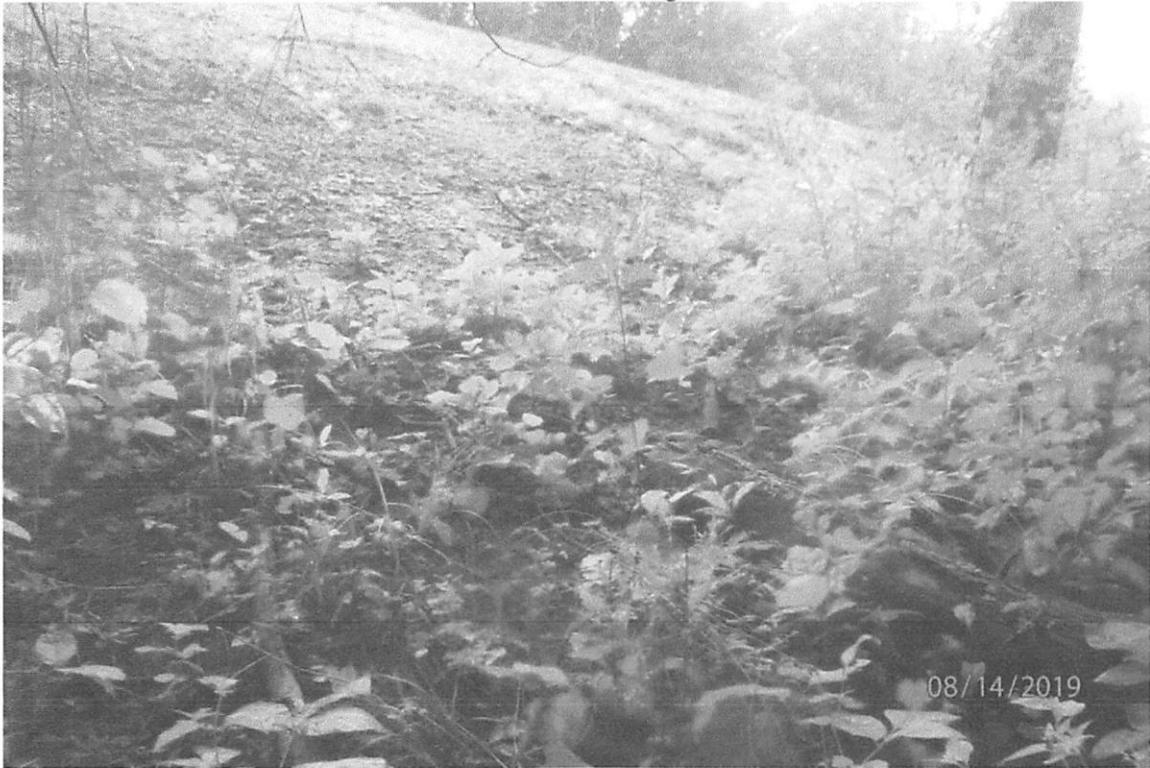
Offsite sediment deposits downslope of the above pictured BMP.

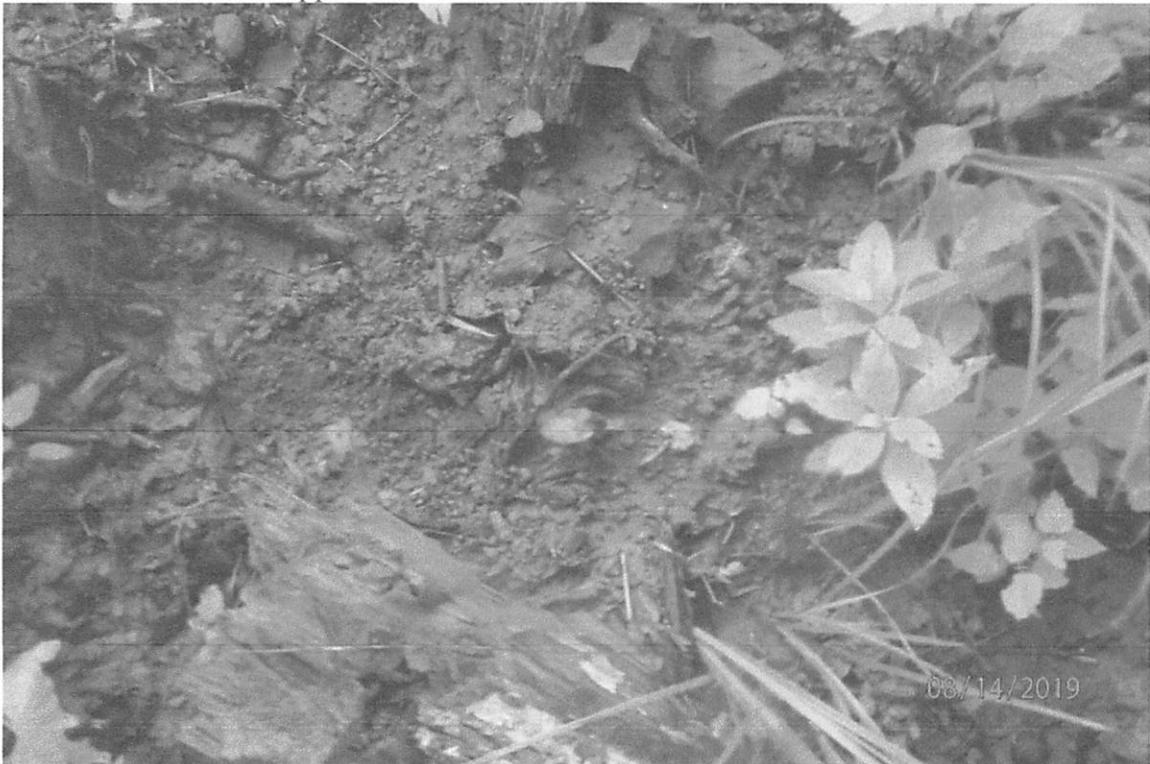
Project area in the Keith Run watershed showing where sediment-laden water is leaving the site in an area where the approved SWPPP does not indicate the need for an installed BMP.

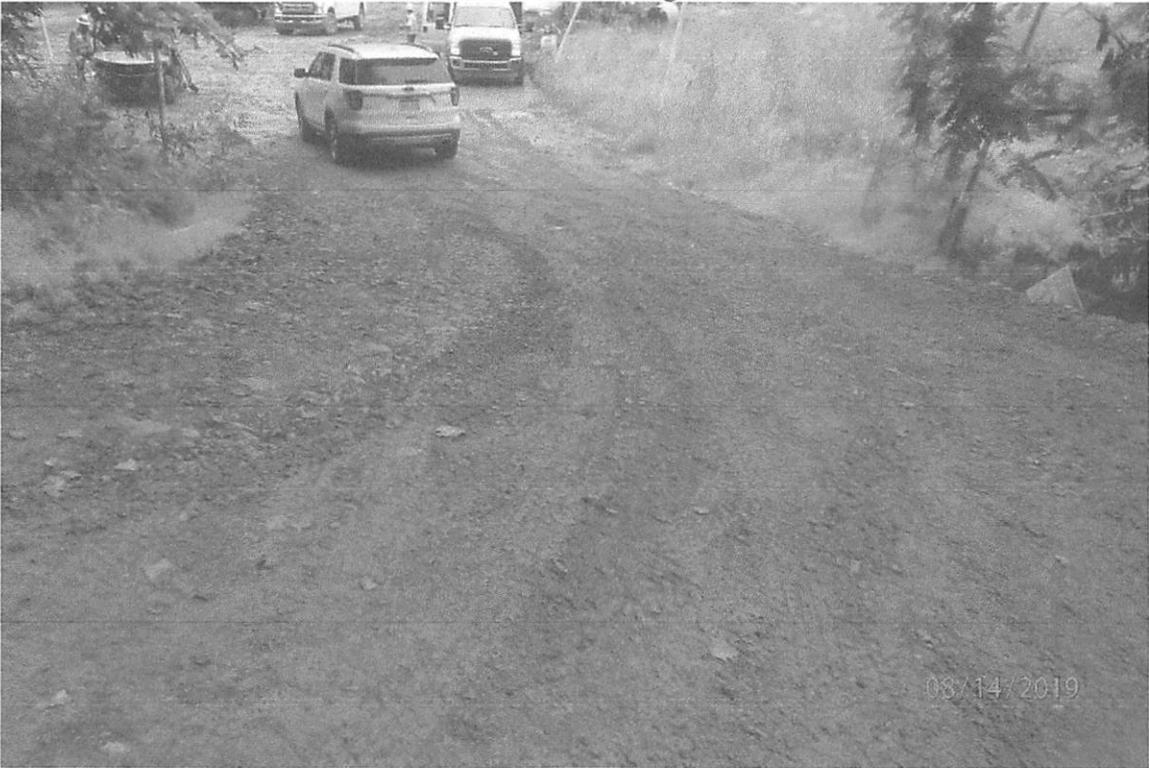
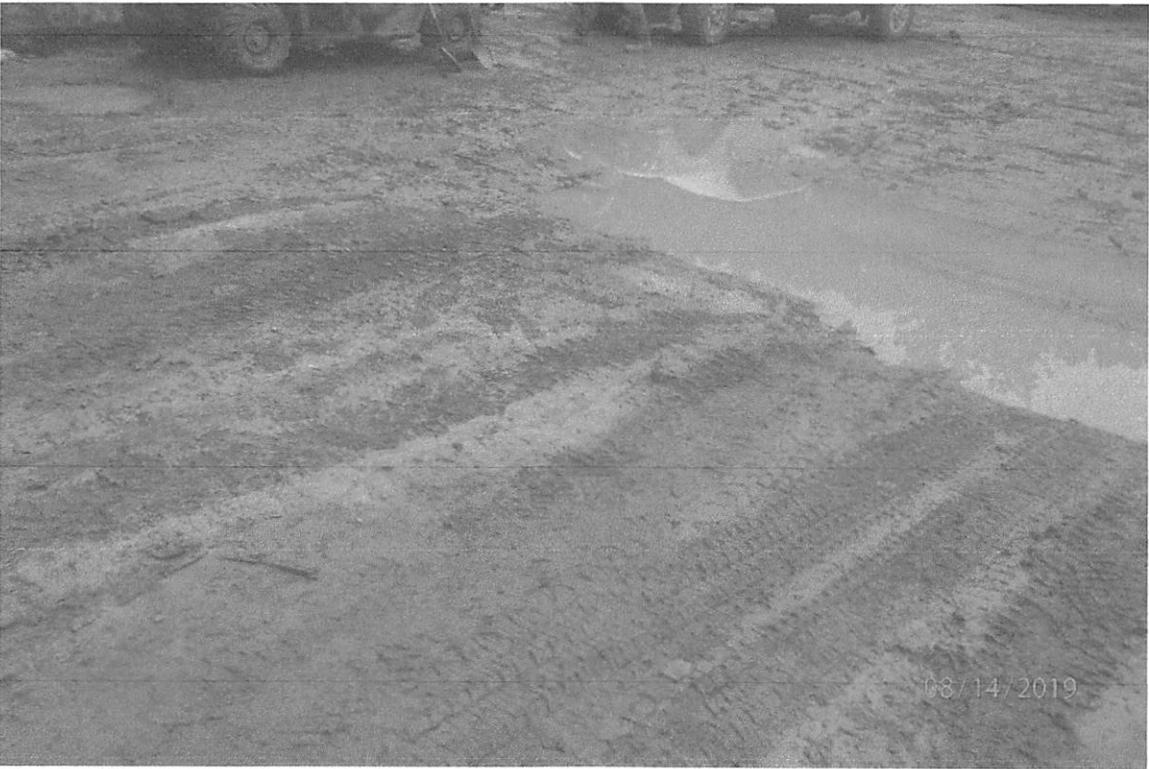
Offsite sediment deposits associated with the above pictured deficiency.

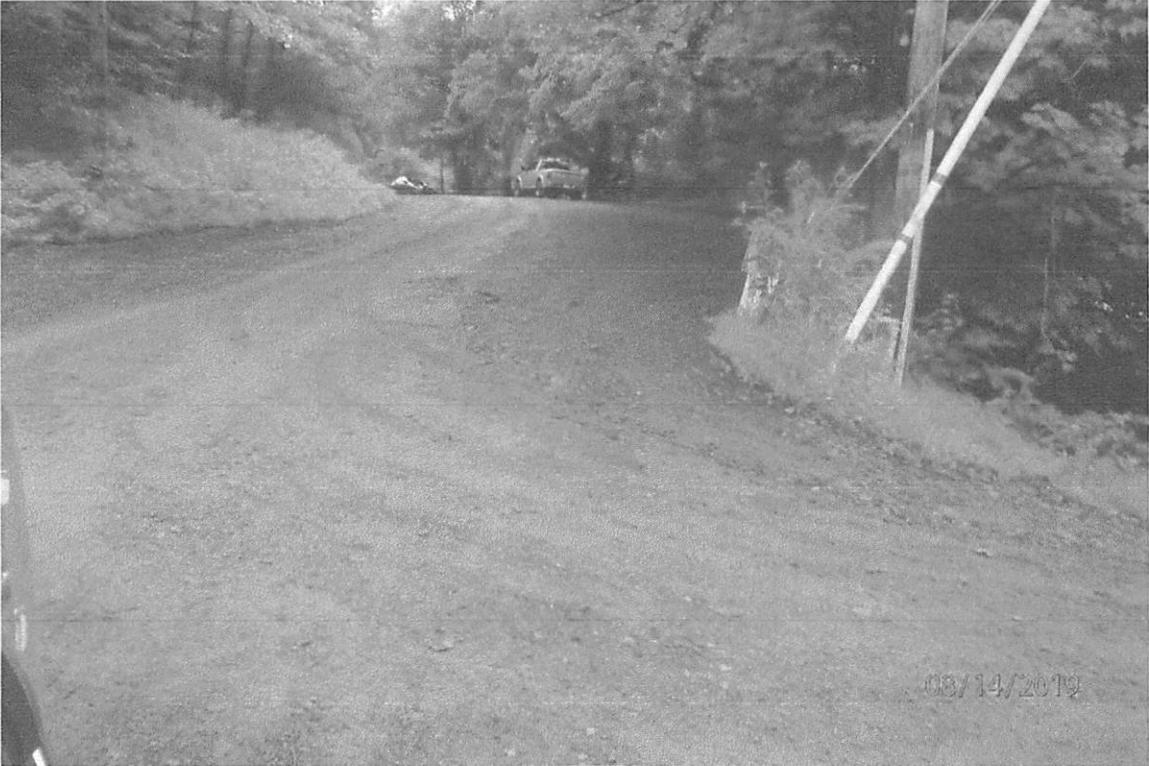
Access road MVP-BR-89.01 showing the need for maintenance to the installed rock construction entrance.

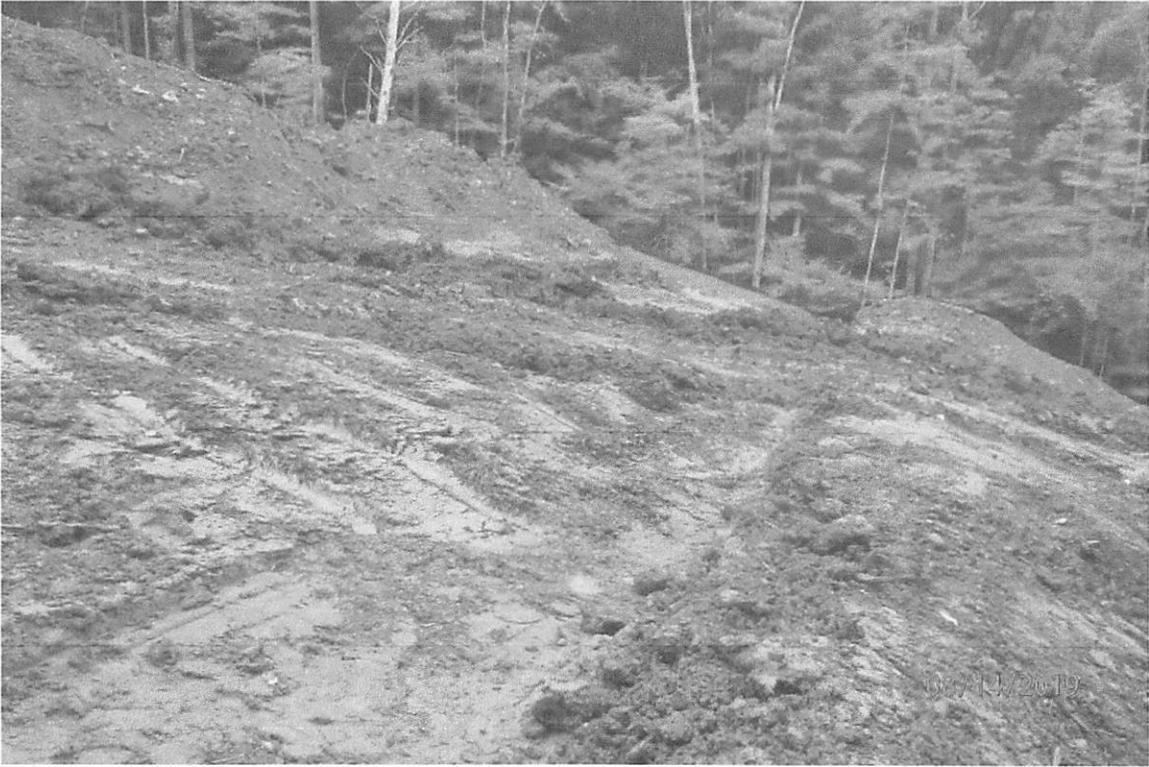
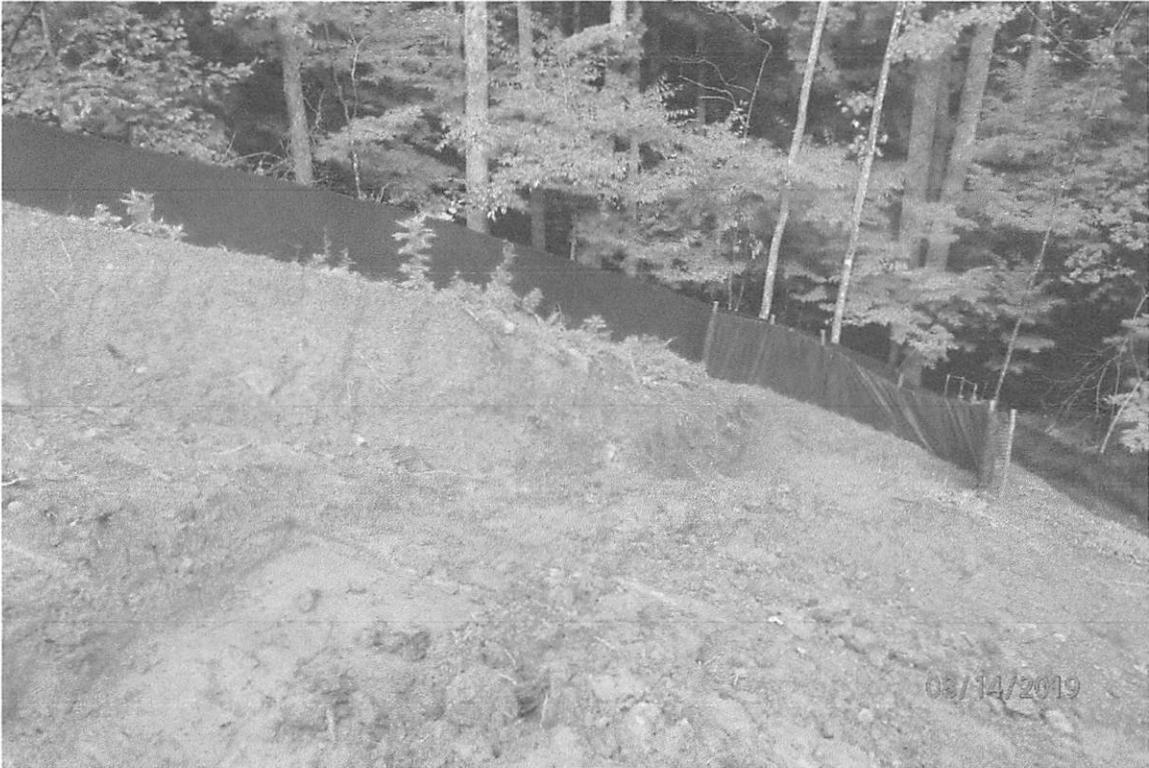
Access road MVP-BR-89.01 showing the track-out onto the public roadway.

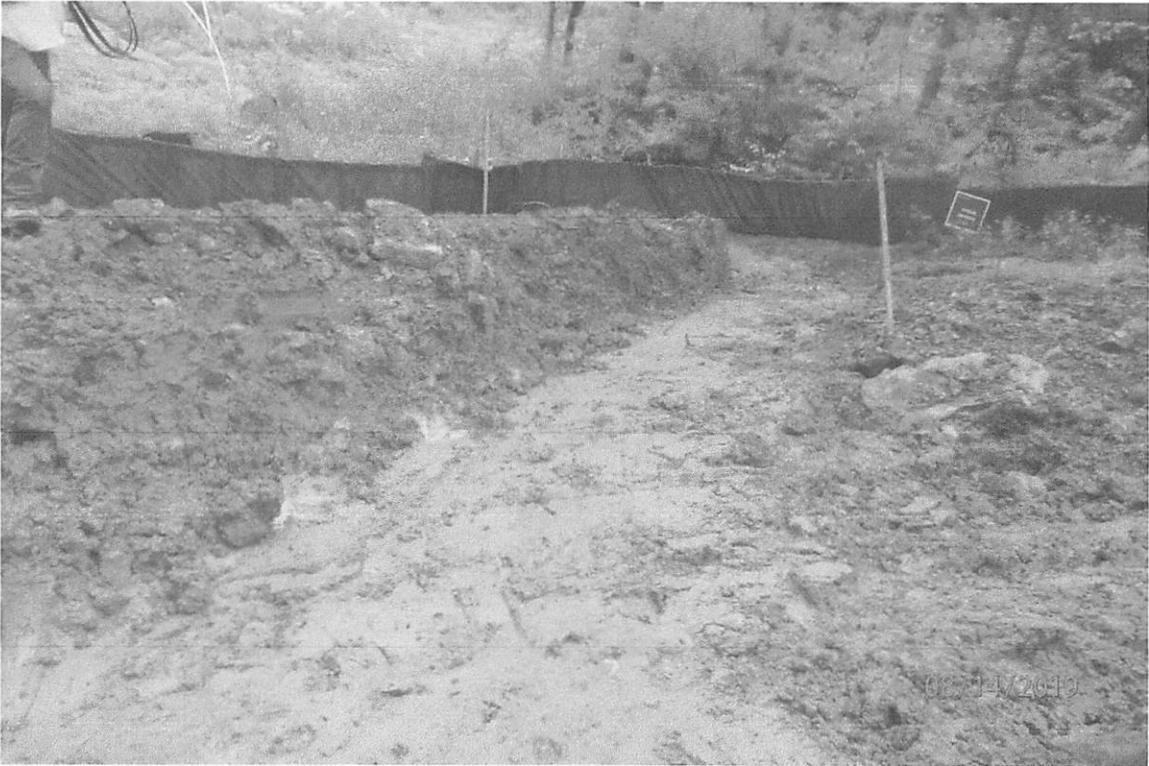
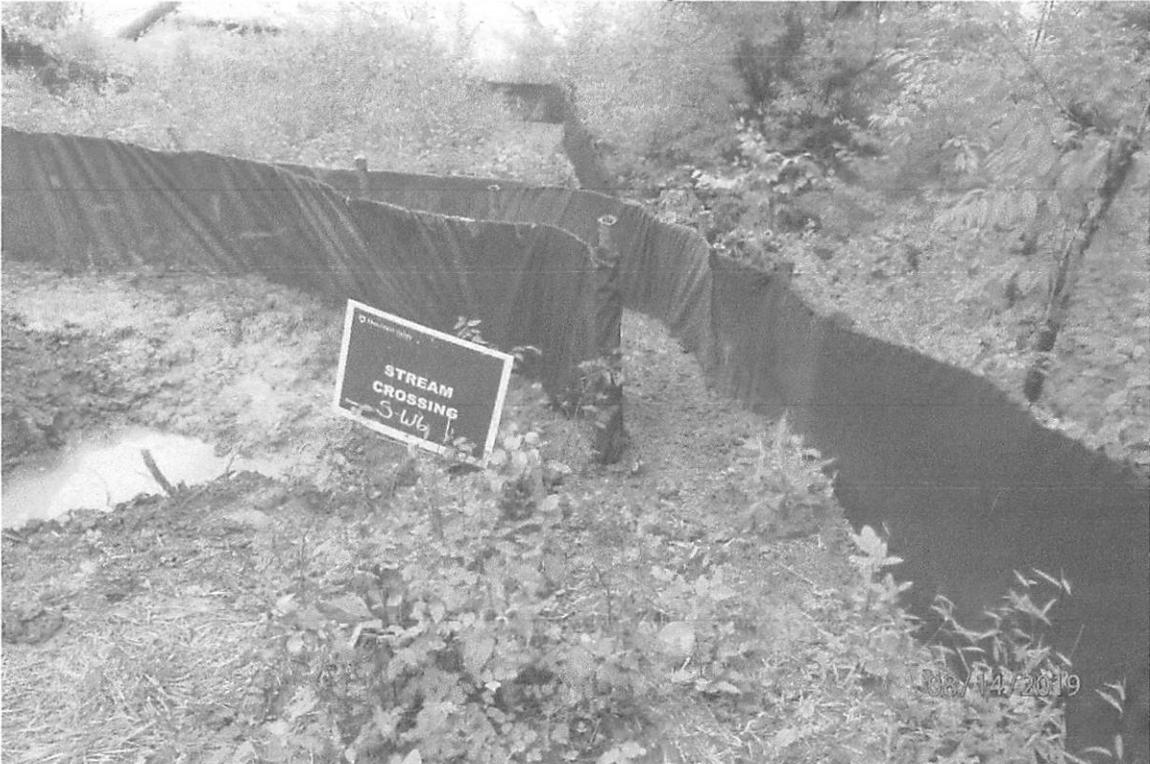
Water bar in inspected area 1 installed at a steep angle and discharging prior to the installed perimeter controls.

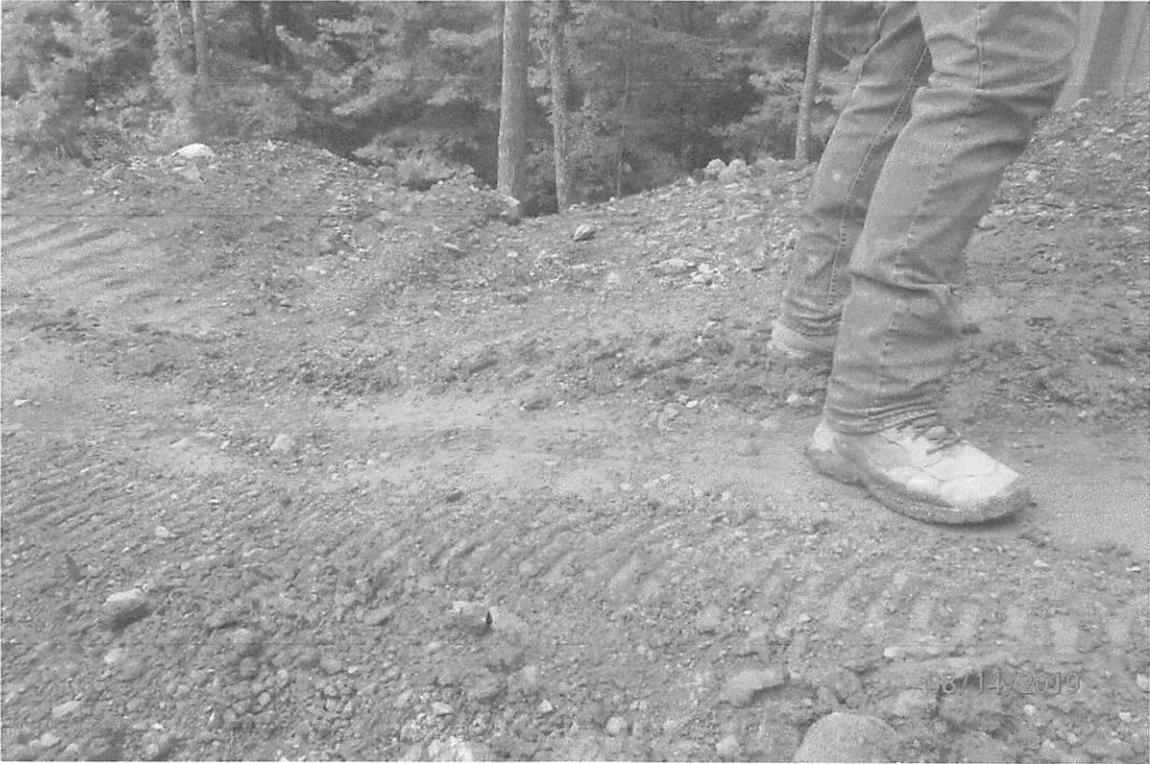
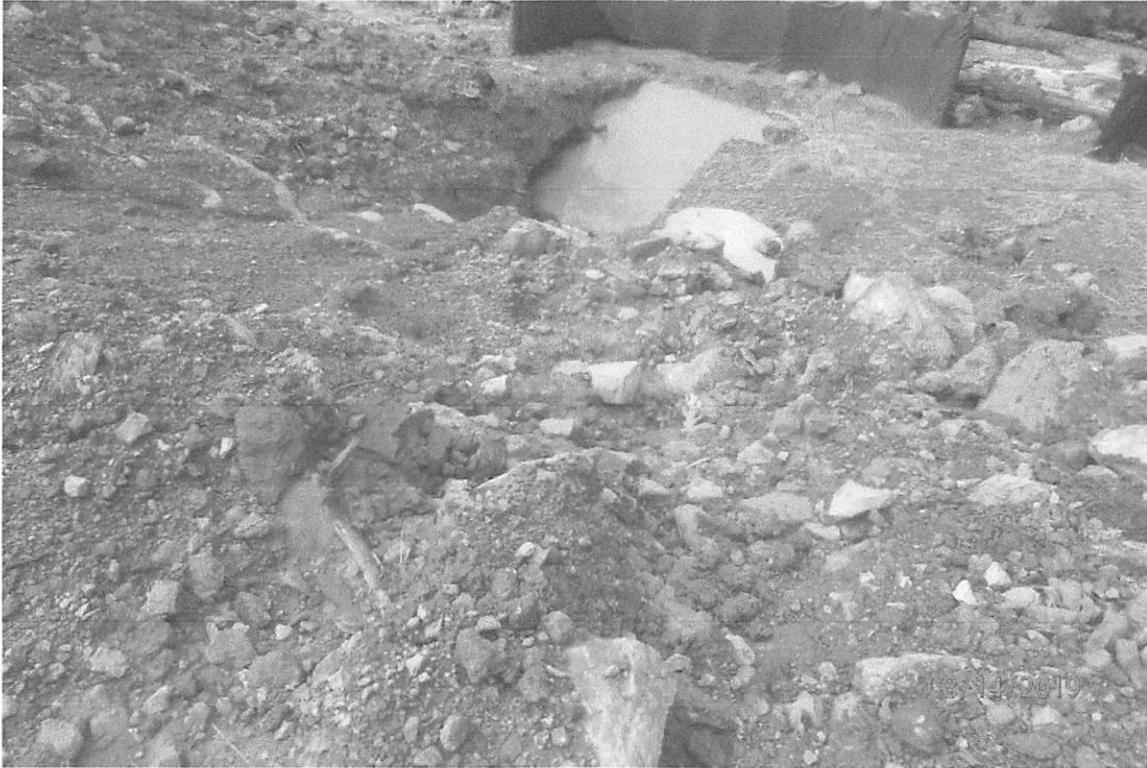
Water bar in inspected area 1 installed at a steep angle and discharging prior to the installed perimeter controls.

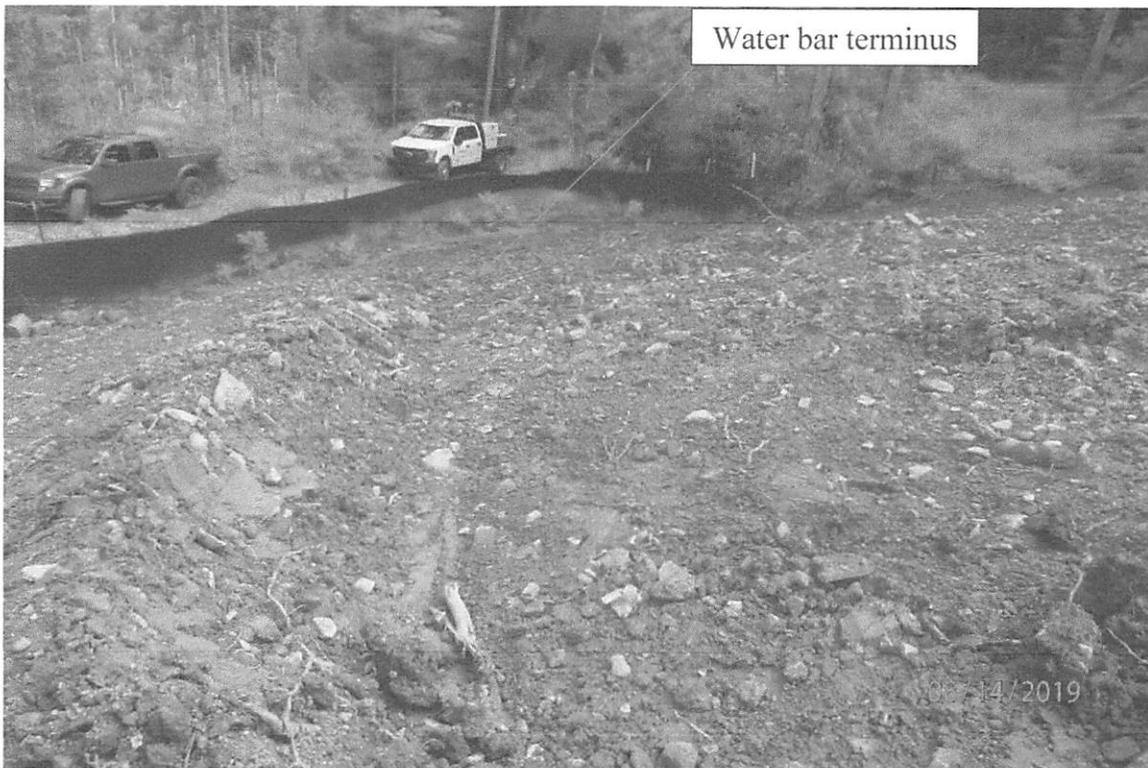
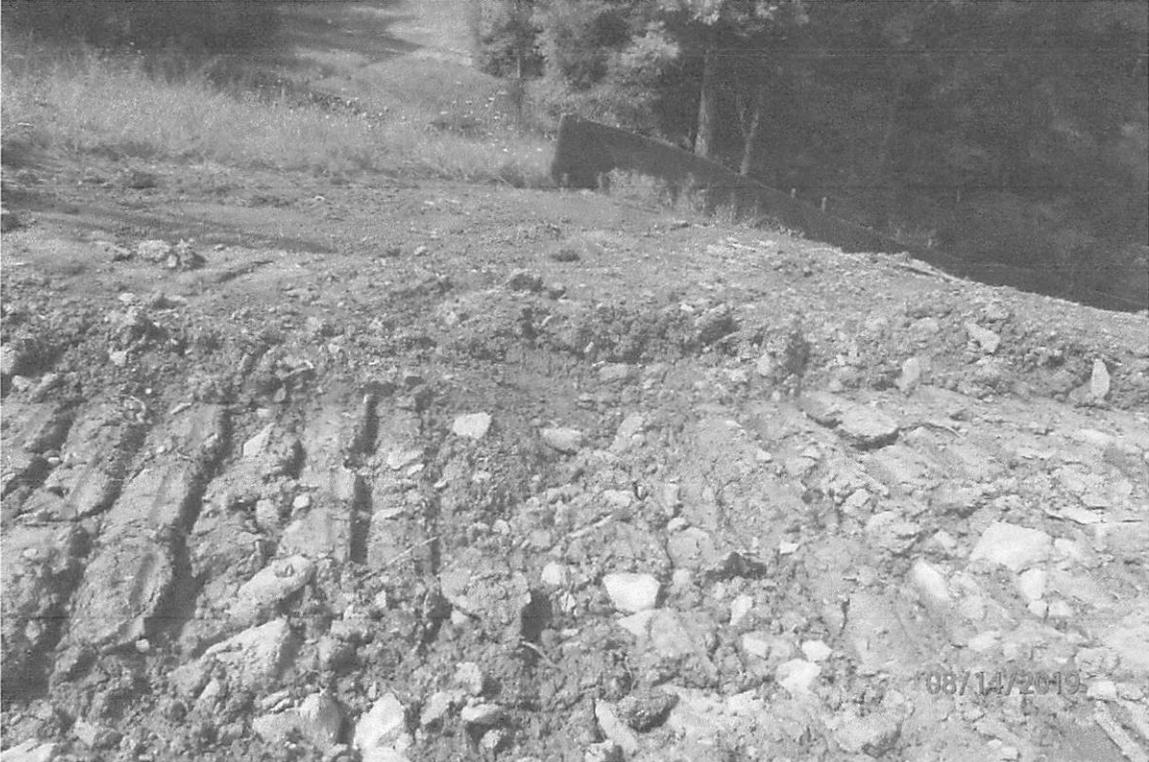
Water bar in inspected area 2 discharging over a steep slope with no fill slope protection in place.

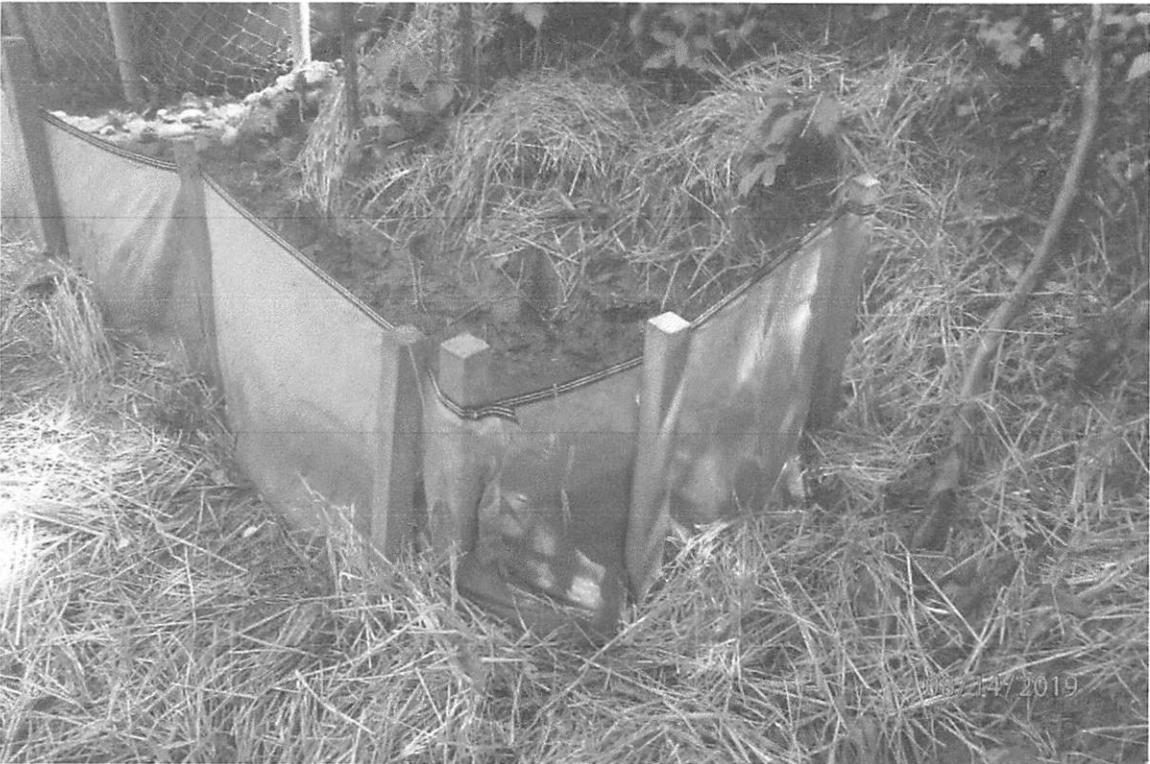
Improperly installed water bars in inspected area 8 that are discharging into a diversion, with stormwater from the diversion being directed at two pieces of installed perimeter controls.

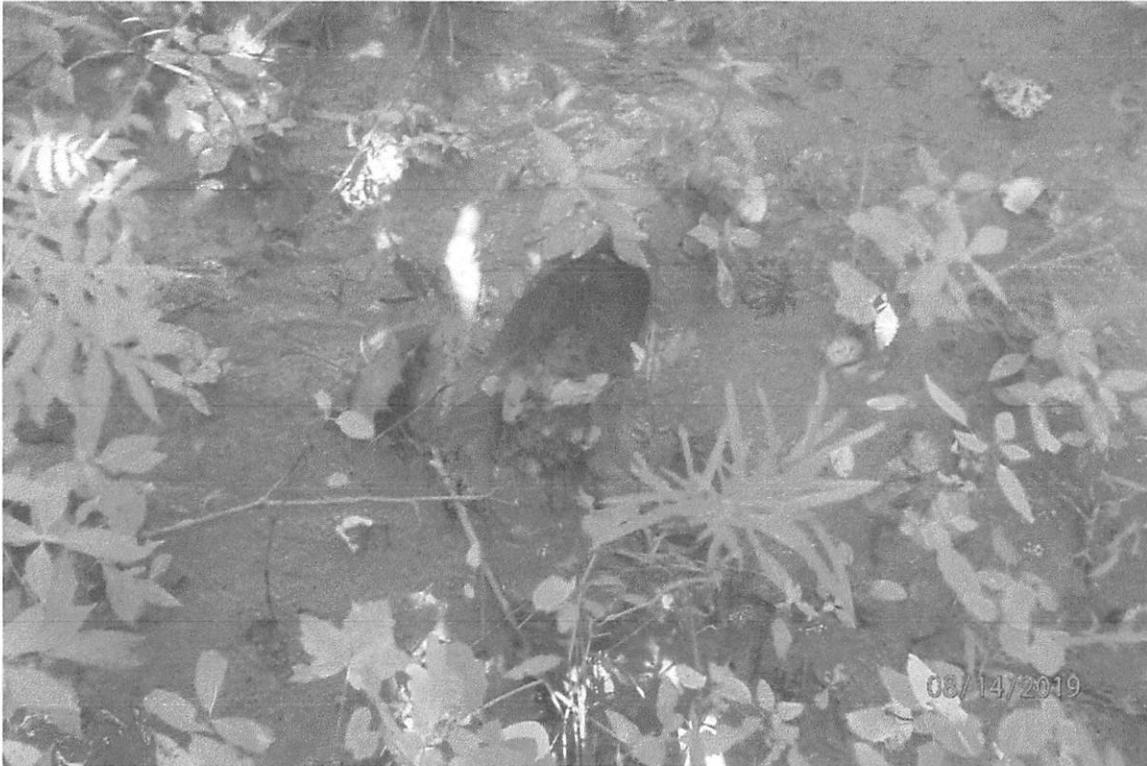
Recently maintained perimeter control utilized to treat stormwater from six water bars upslope of the pictured BMP.

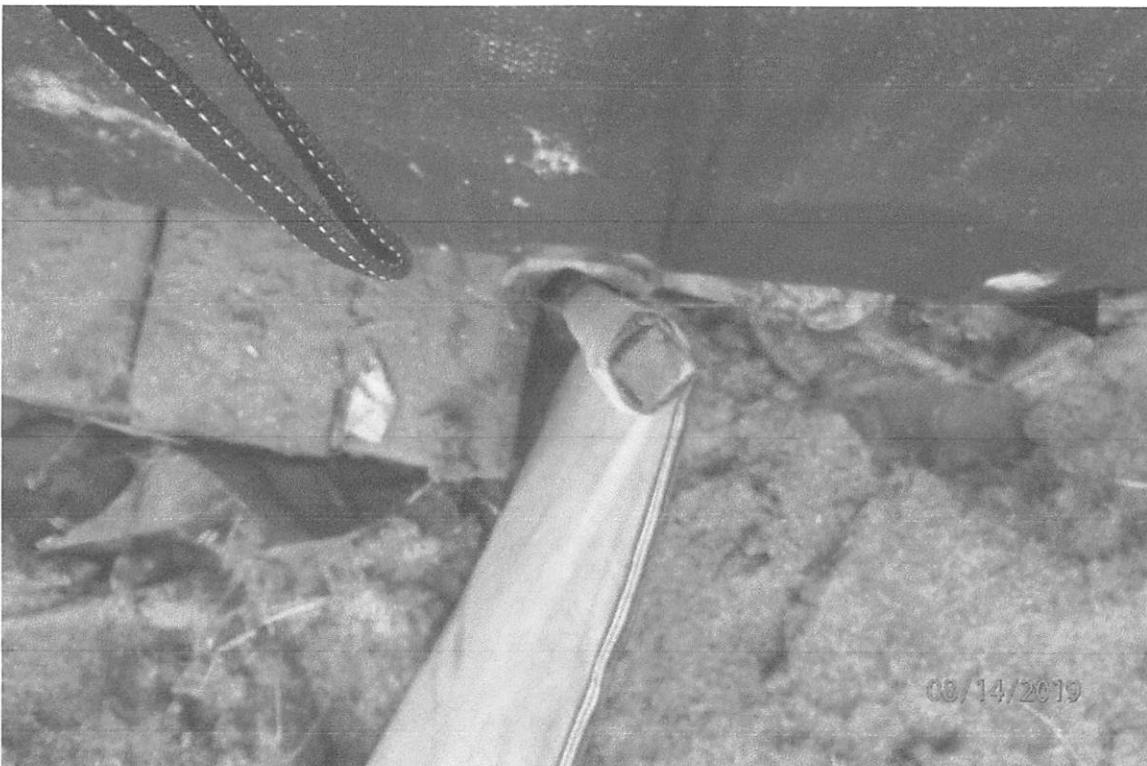
Recent offsite sediment deposits that originate from site downslope of the above pictured BMP.

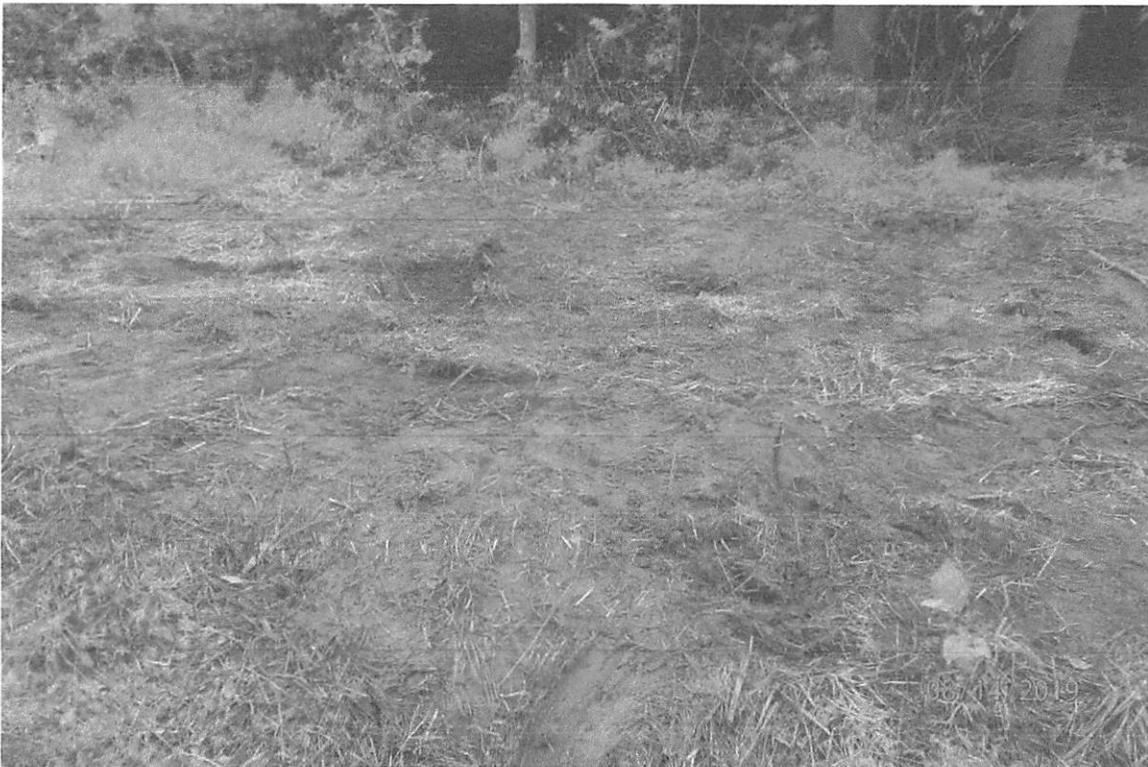
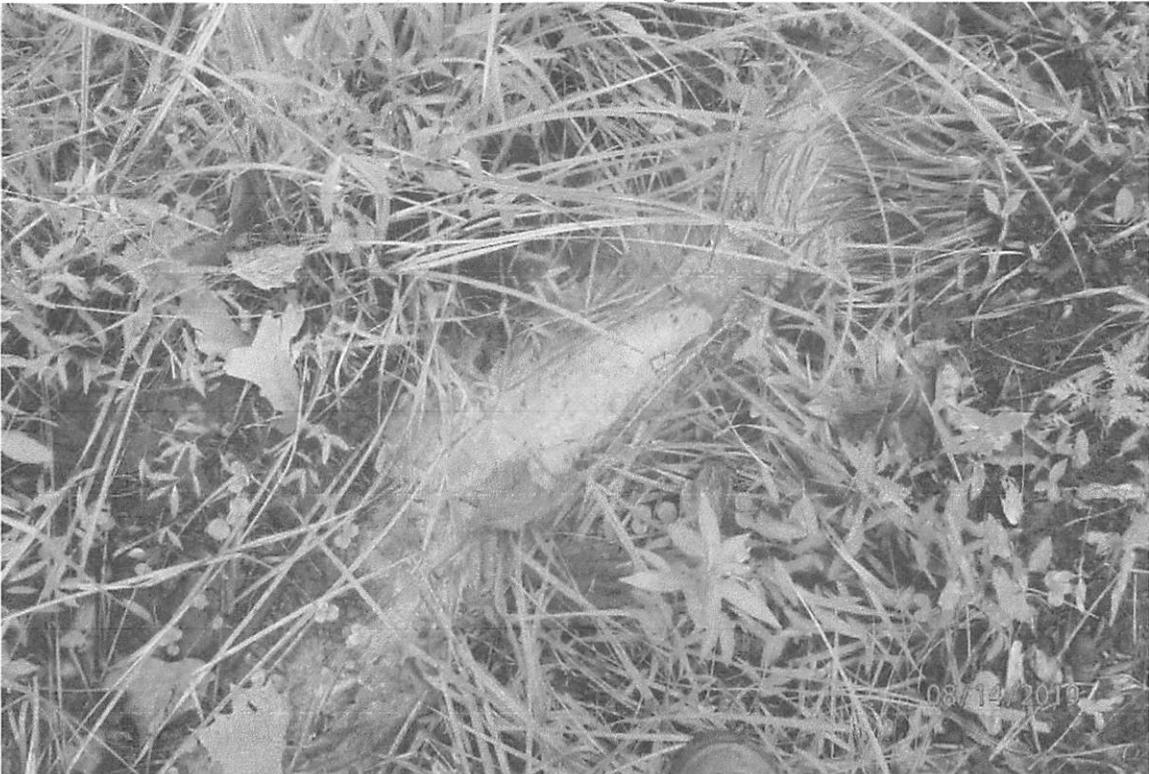
Improperly installed timber mat equipment bridge at the Cove Run (S-K-45) (inspected area 8) crossing, showing an area where sediment-laden water can bypass treatment.

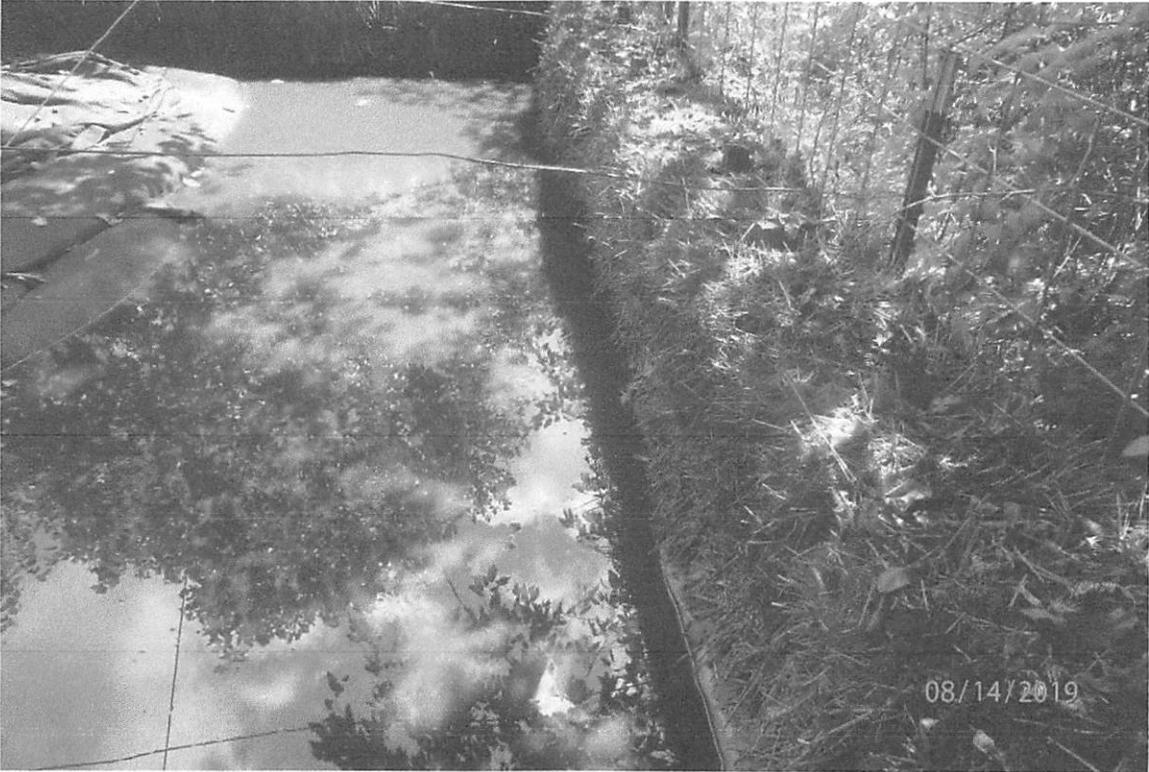
Offsite sediment deposits adjacent to inspected area 3, showing where a dewatering structure was placed offsite and caused offsite deposits.
