**CONSENT ORDER
ISSUED UNDER THE
WATER POLLUTION CONTROL ACT
WEST VIRGINIA CODE, CHAPTER 22, ARTICLE 11**

TO: Mountain Valley Pipeline, LLC
Robert J. Cooper
2200 Energy Drive
Canonsburg, PA 15317

DATE: December 17, 2020

ORDER NO.: 9925

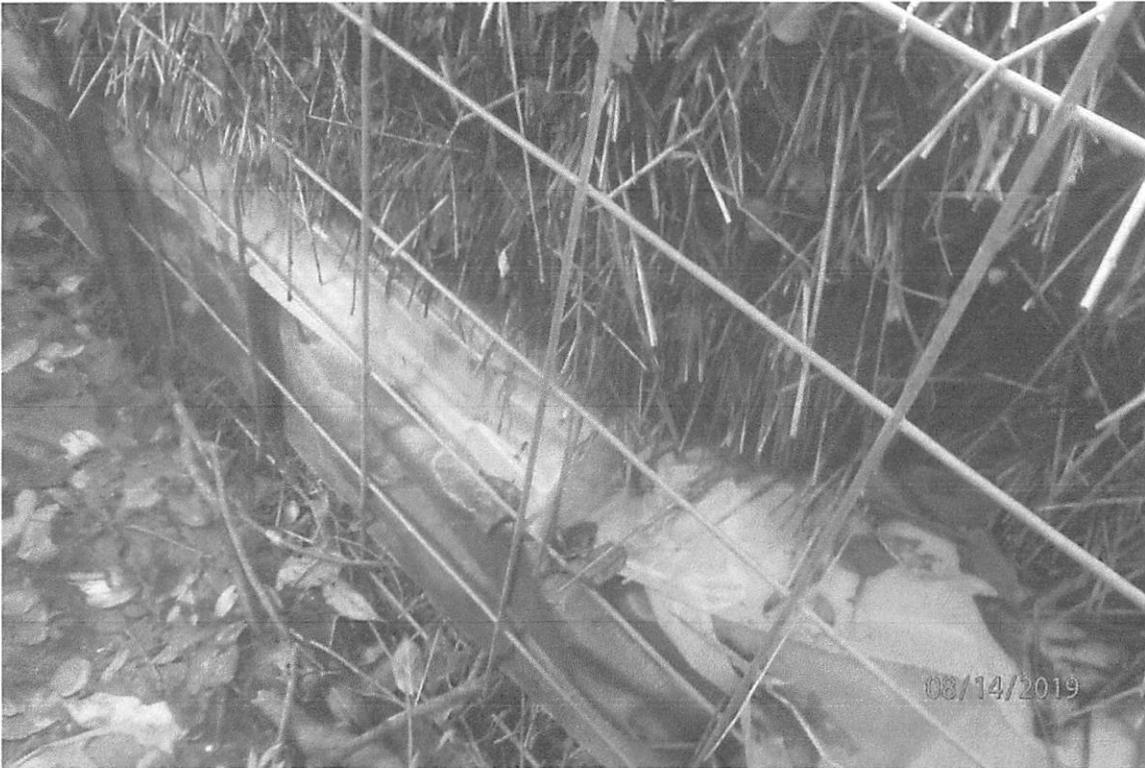
Dewatering structure with impermeable plastic installed, causing it to not function as designed in inspected area 8.

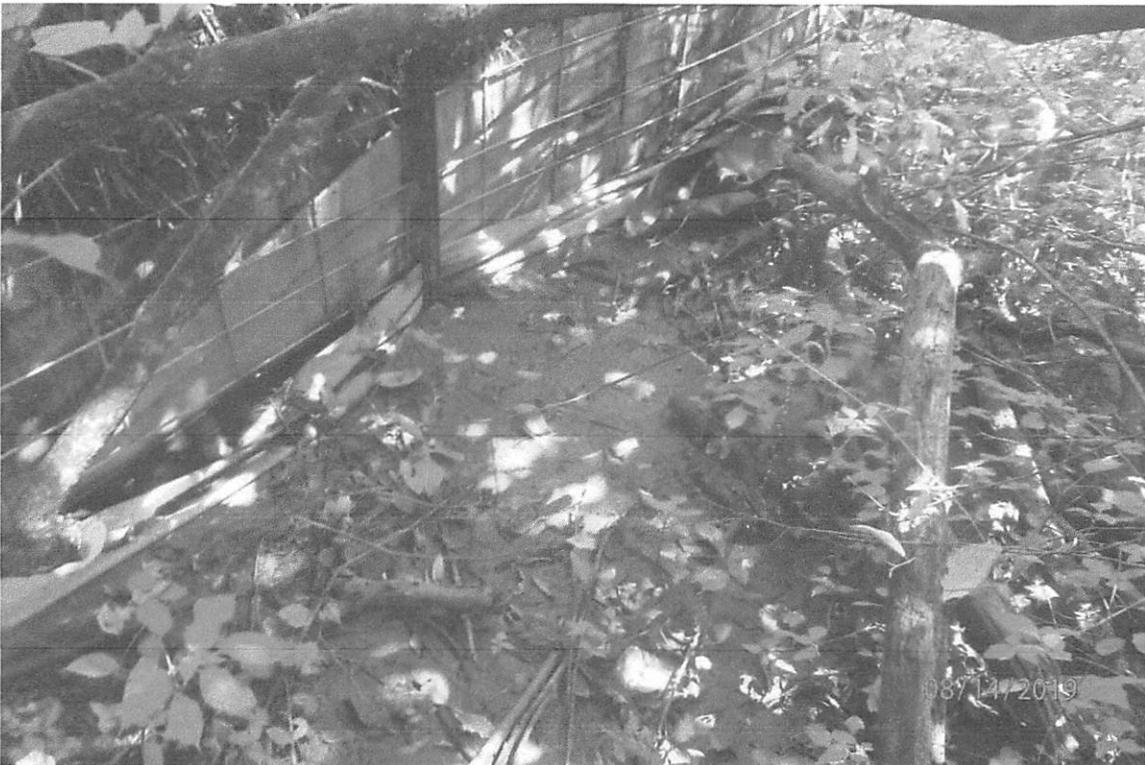
Dewatering structure with impermeable plastic installed causing it to not function as designed in inspected area 8. Offsite sediment deposits pictured.

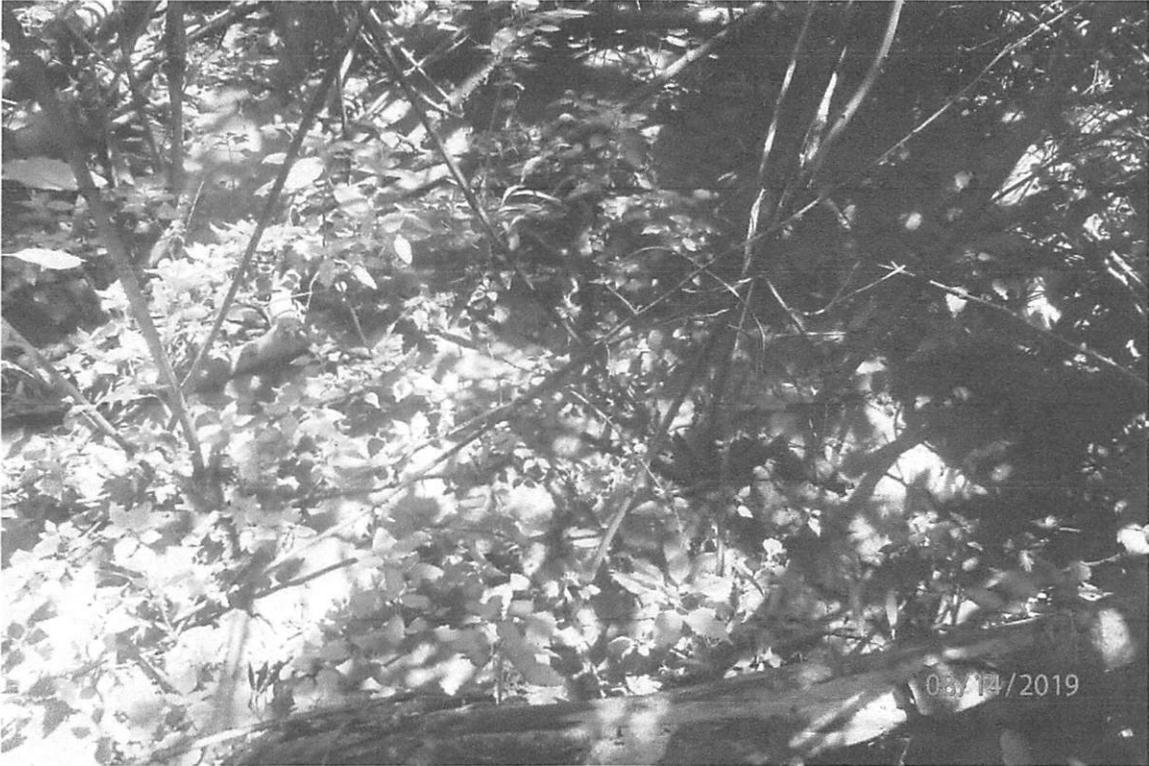
Offsite sediment deposits as a result of the above pictured deficiency.

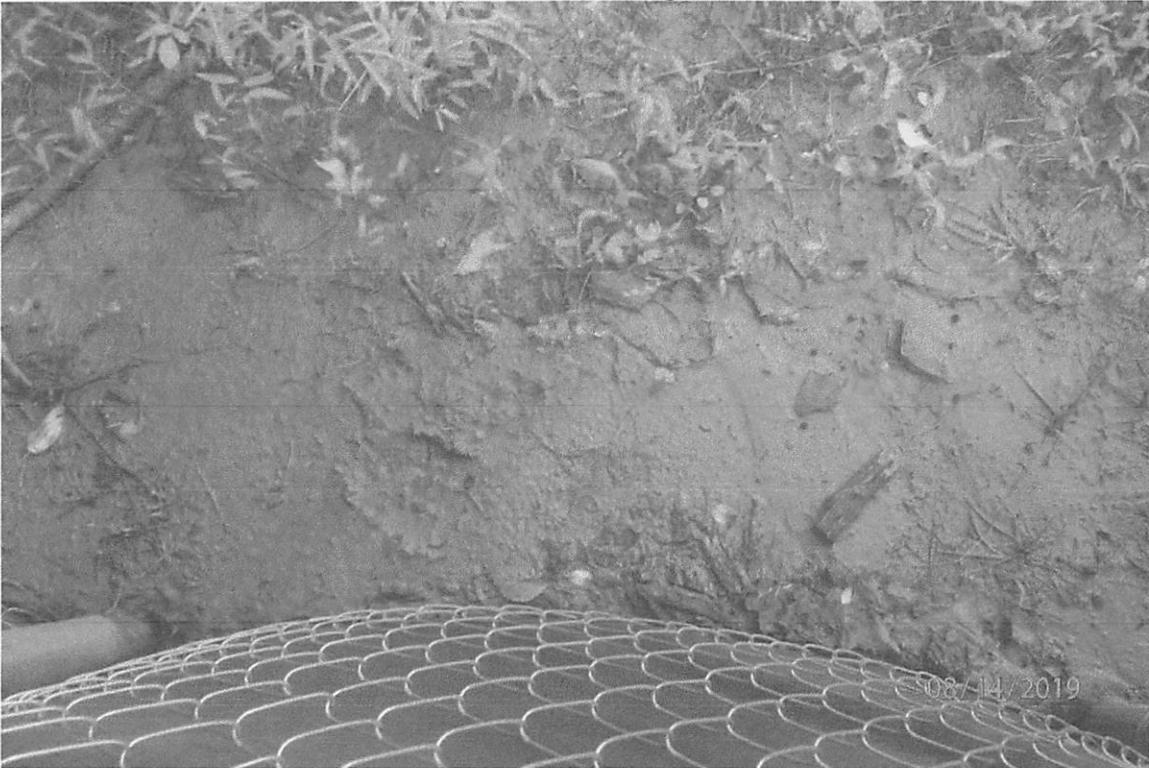
Sediment-laden water that has bypassed under the installed perimeter control in inspected area 3 as a result of failure to properly operate and maintain the installed BMP. Offsite sediment deposits pictured.

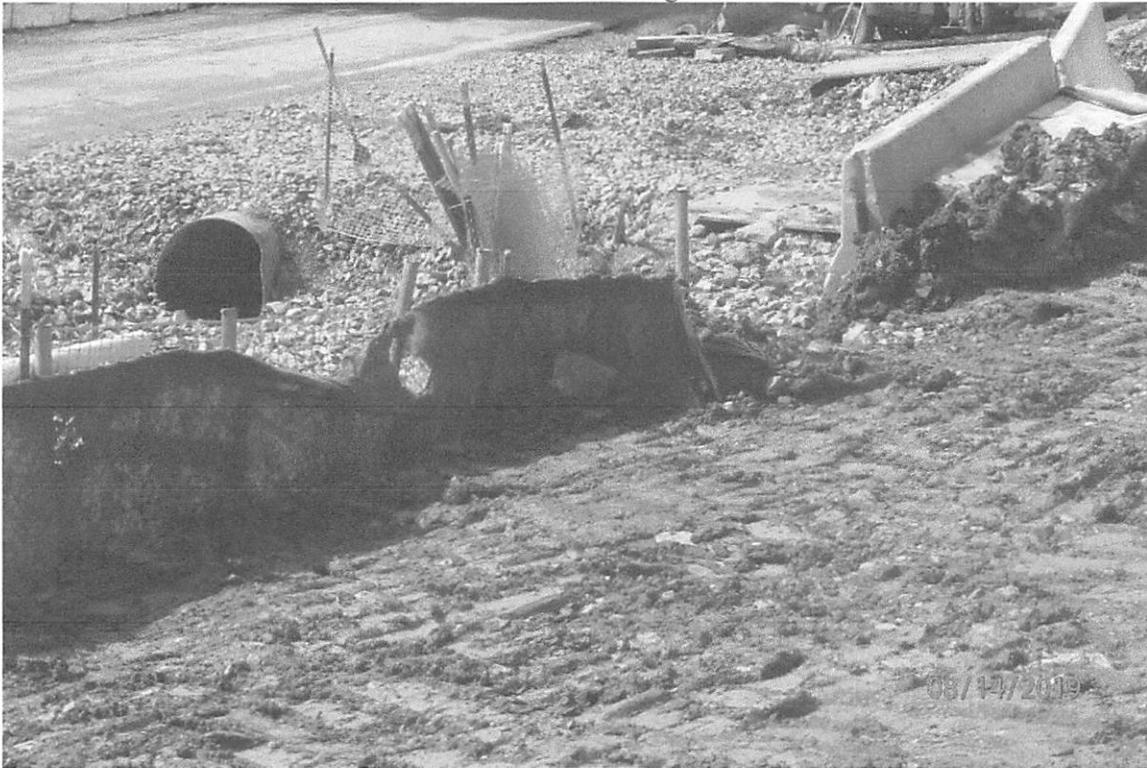
Perimeter controls in need of maintenance in inspected area 3.

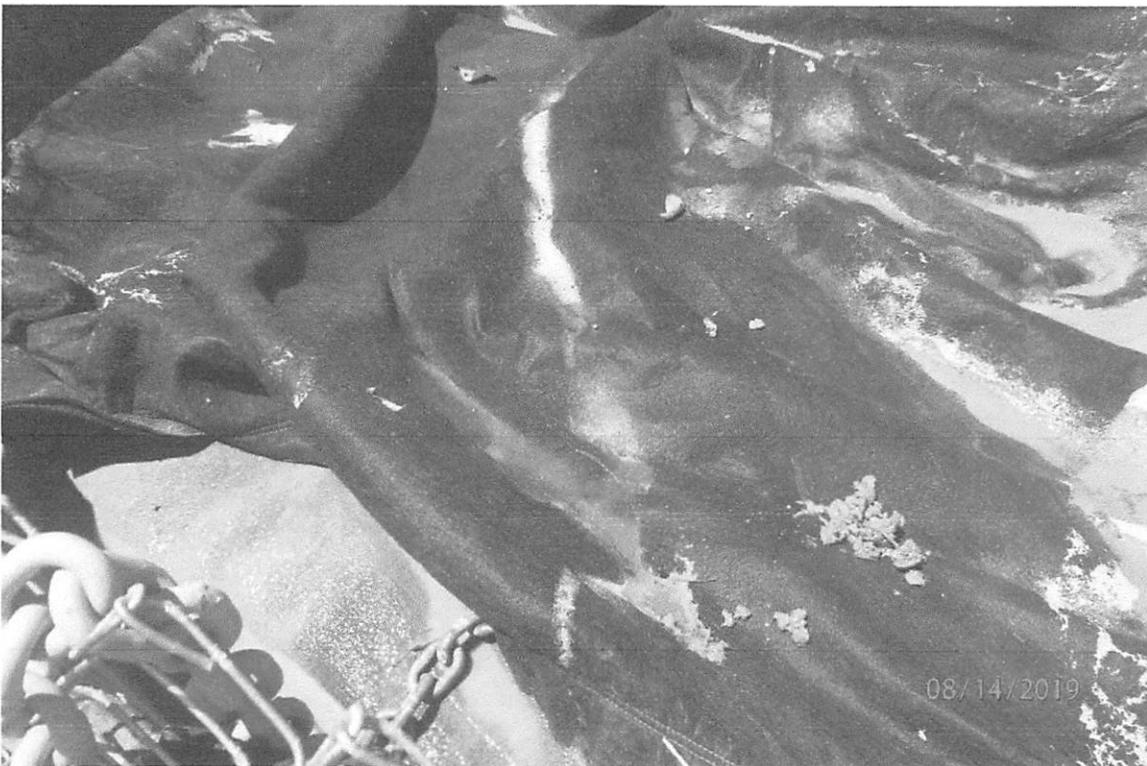
Dewatering bag being utilized in inspected area 6.

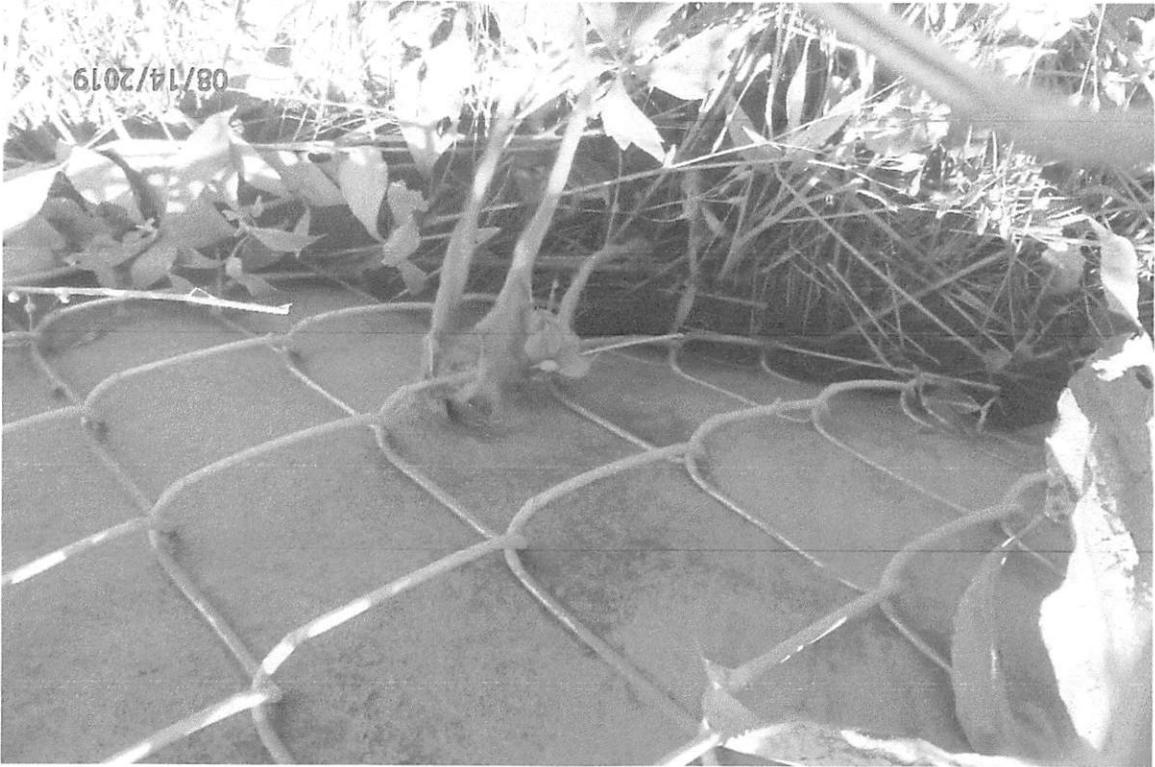
Perimeter control downslope of the above pictured dewatering bag.

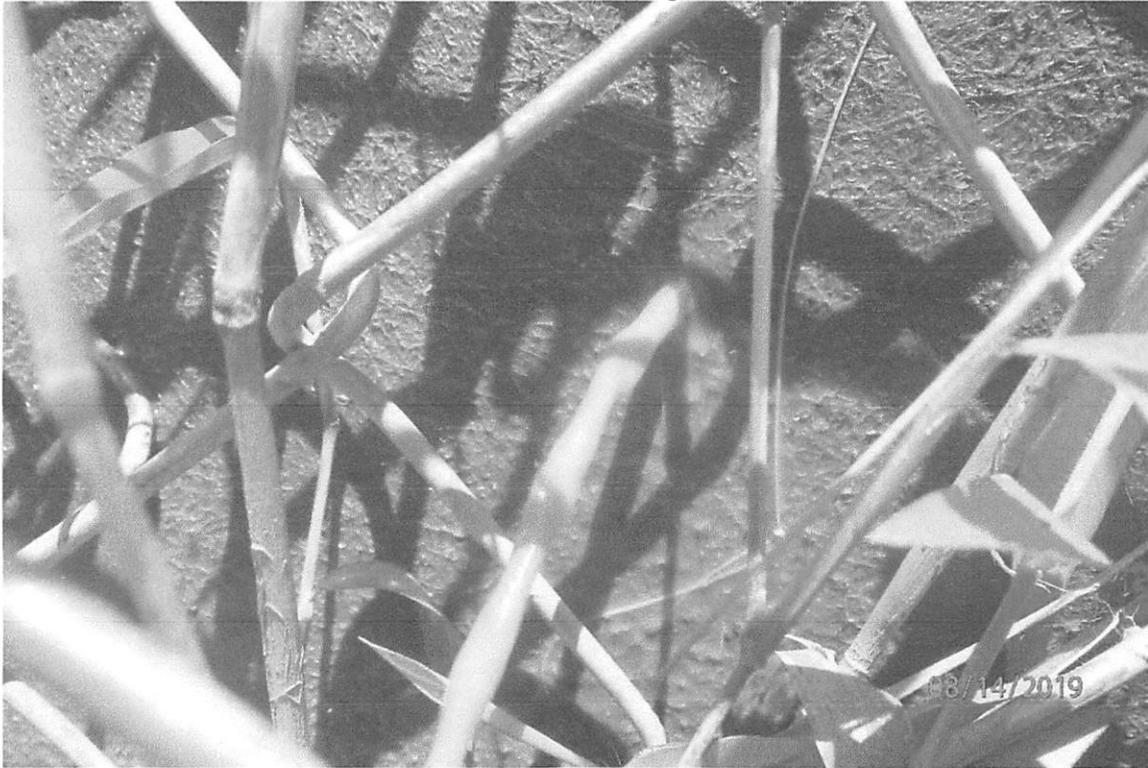
Perimeter control in inspected area 6 downslope of the previously pictured dewatering bag showing the need for maintenance and sediment-laden water bypassing treatment.

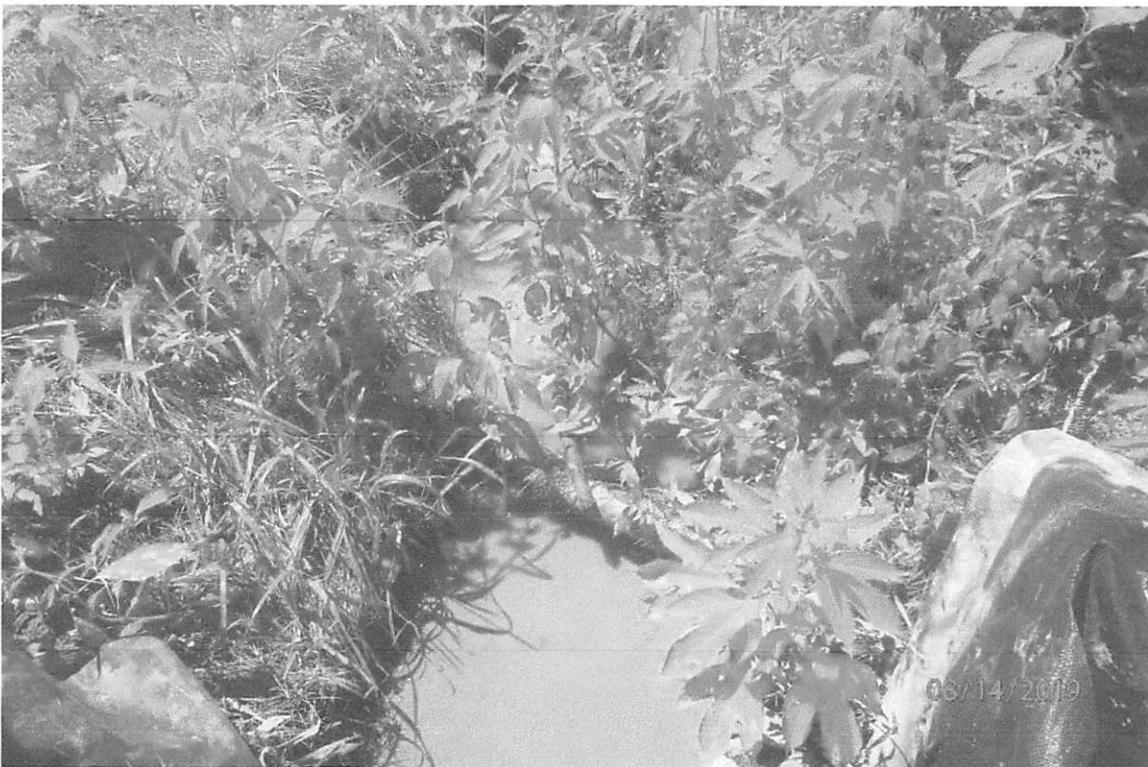
Onsite sediment-laden water in DOH conveyance.

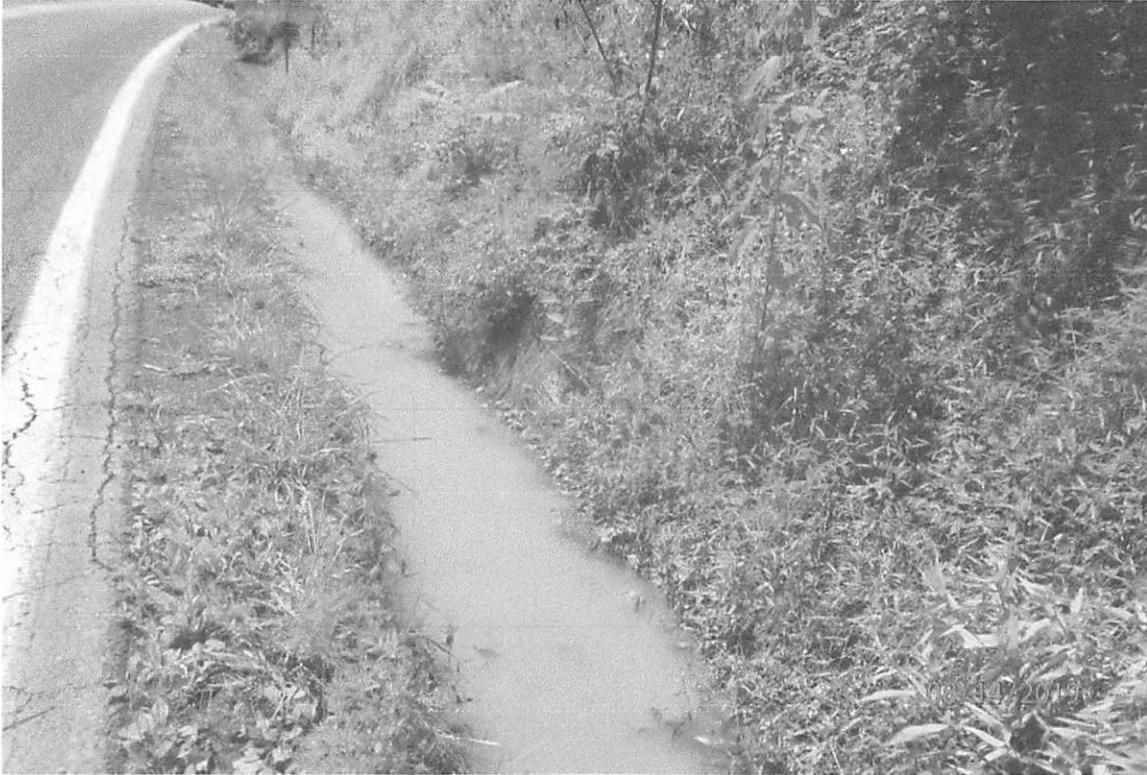
Offsite sediment-laden water in DOH conveyance that leads from the previously pictured dewatering operation with the unmaintained perimeter control.

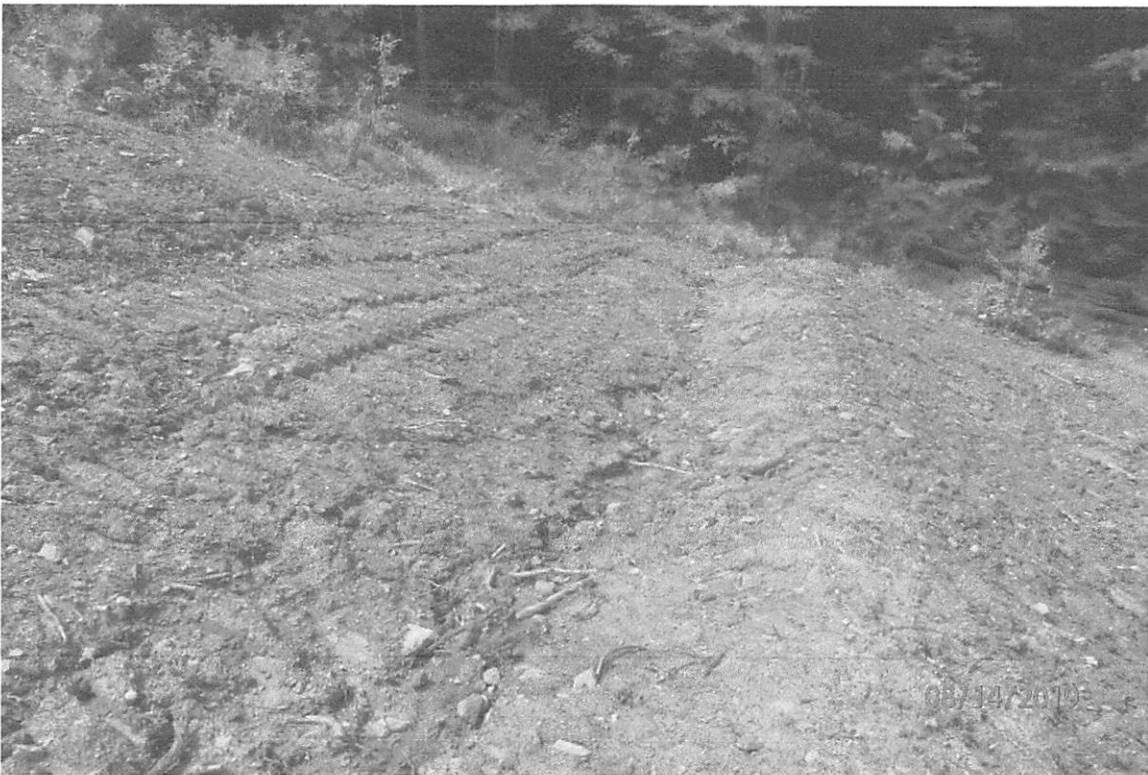
Water bar in inspected area 5 showing the lack of a water bar terminus BMP that is indicated in the approved SWPPP.

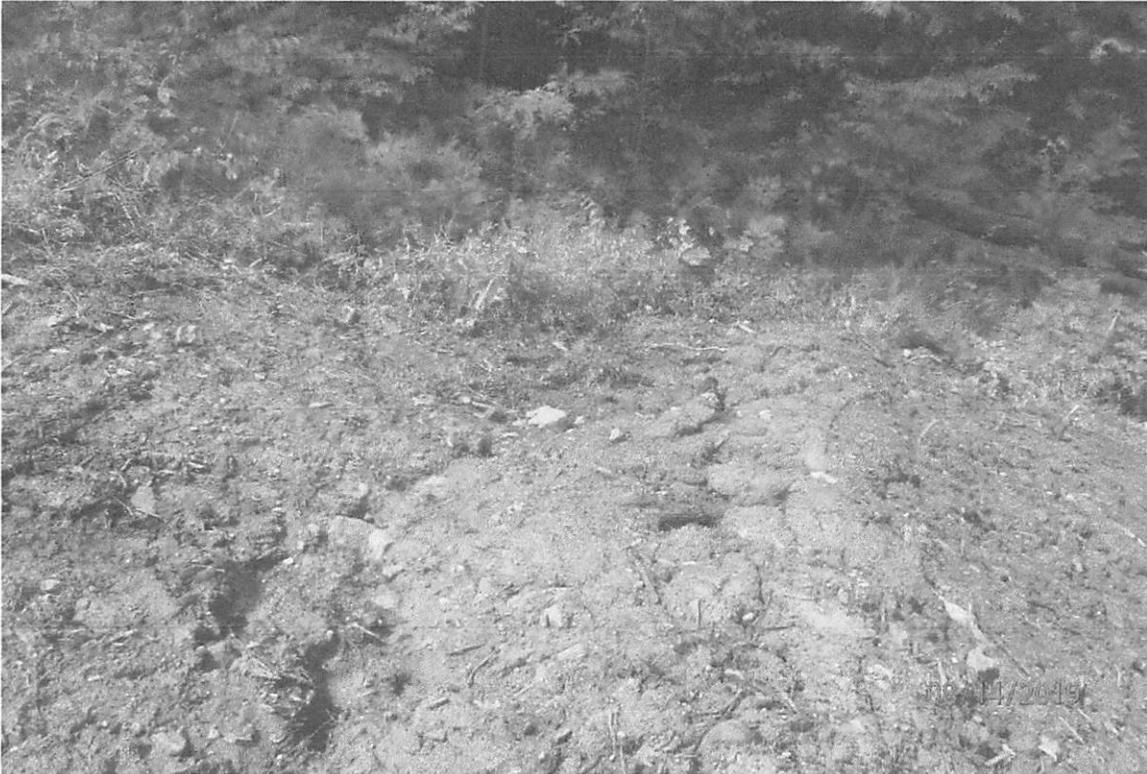
Water bar in inspected area 5 showing the lack of a water bar terminus BMP that is indicated in the approved SWPPP.

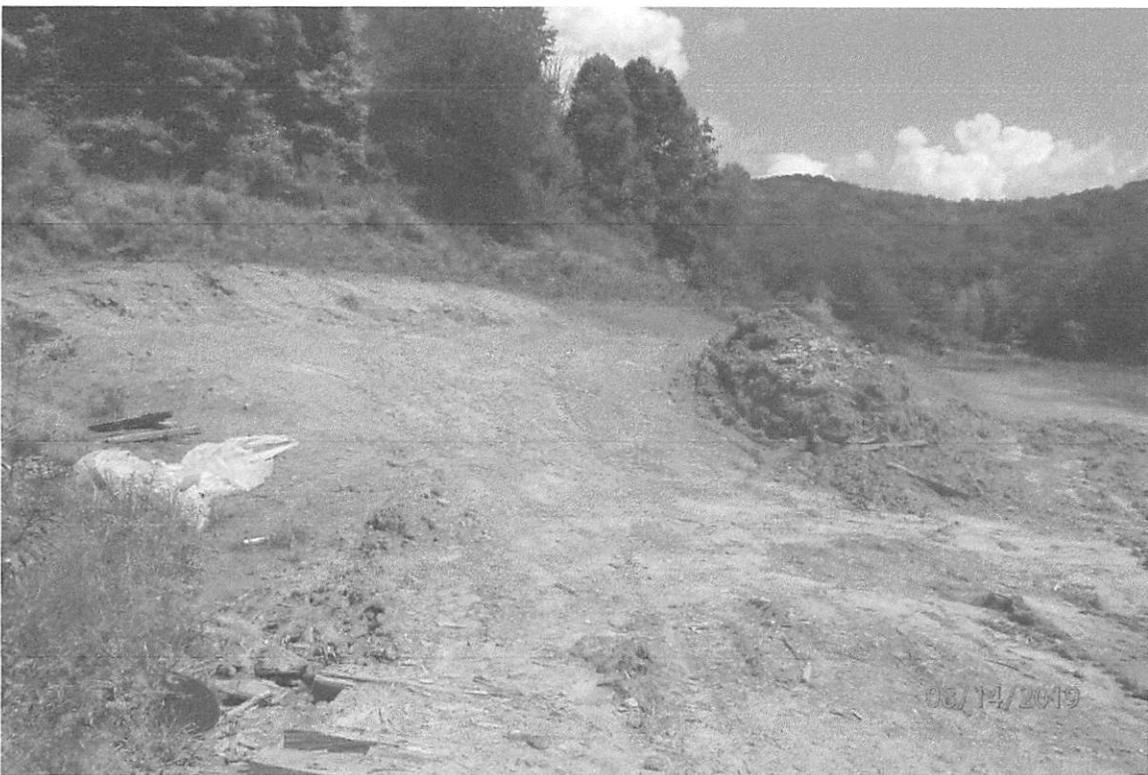
Area of disturbance associated with an extra workspace in inspected area 8 showing the lack of temporary stabilization, even though the site has been idle for a long period of time.

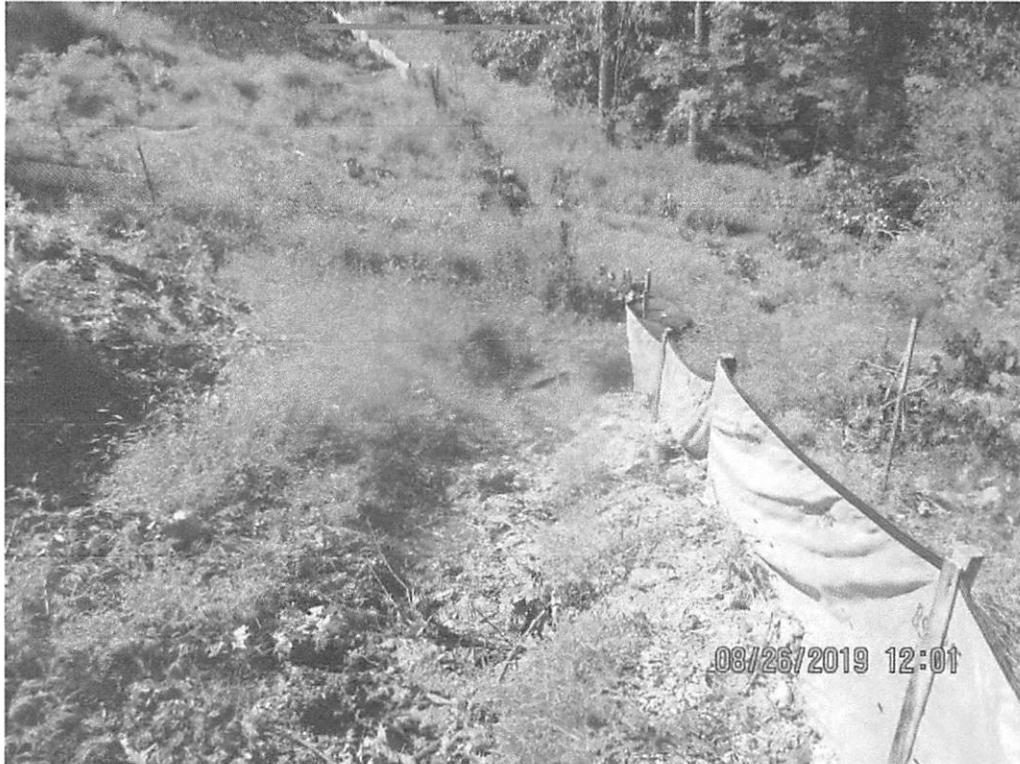
Near Station 1833+00. Perimeter controls overwhelmed due to erosion on slope. Arrow depicts where erosion was occurring.

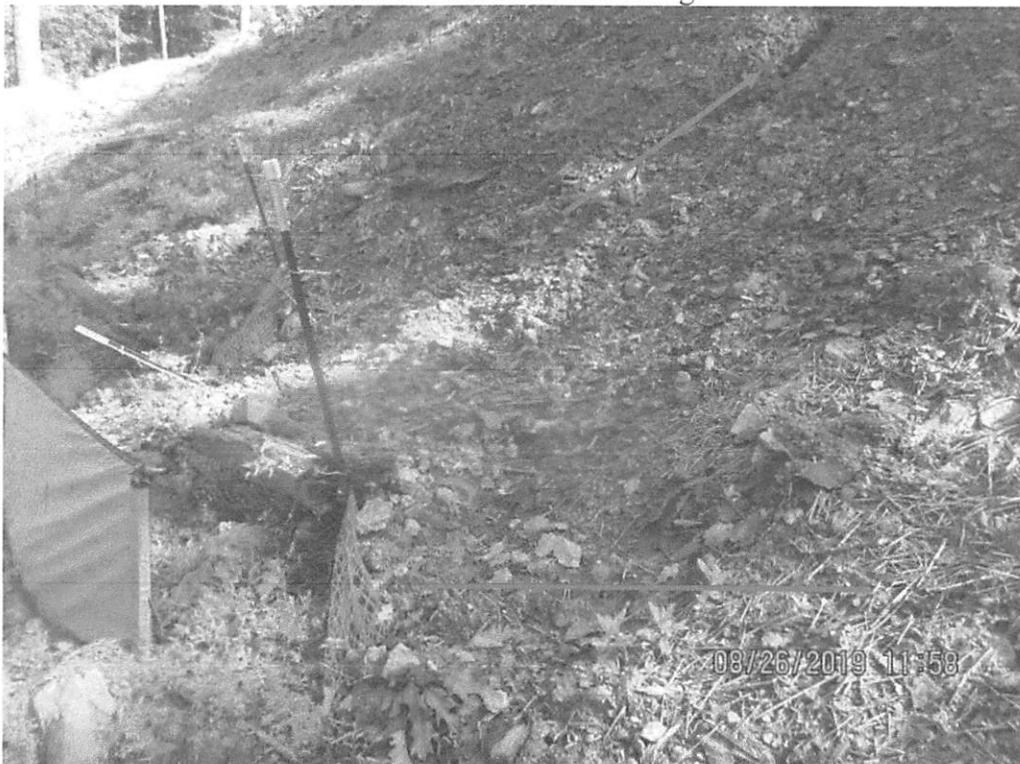
Near Station 1833+00. Erosion occurring on slope leading to sediment deposits being present past the LOD.

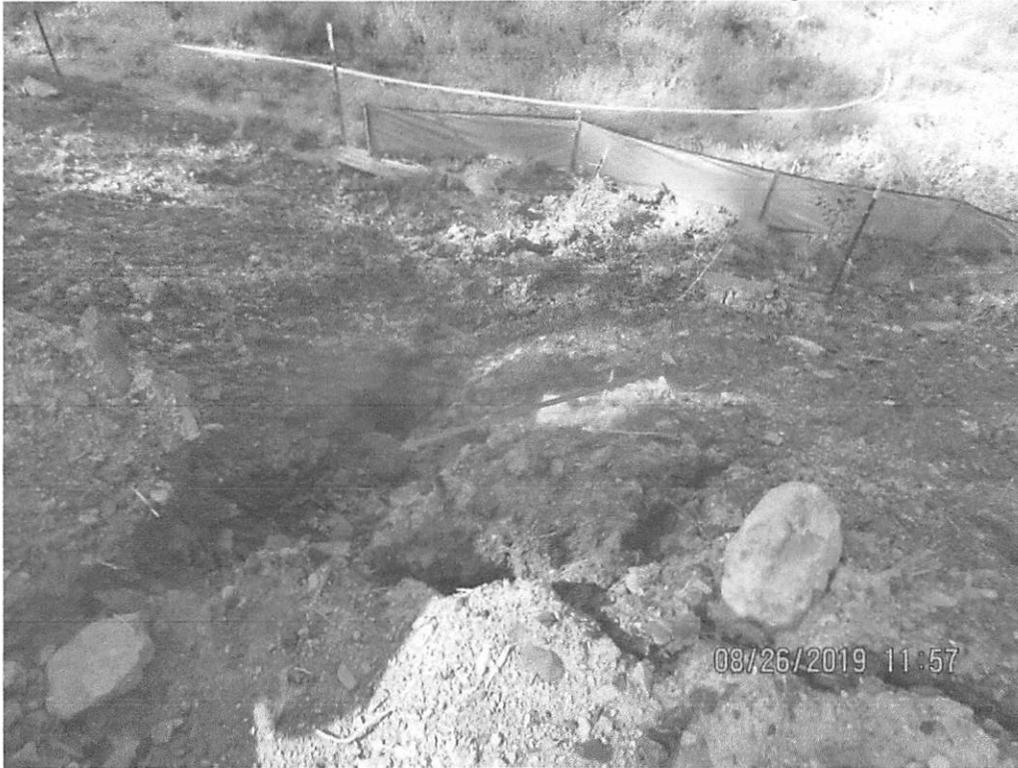
Near station 1833+00. Erosion occurring on slope resulting in sediment deposits being present past the LOD.

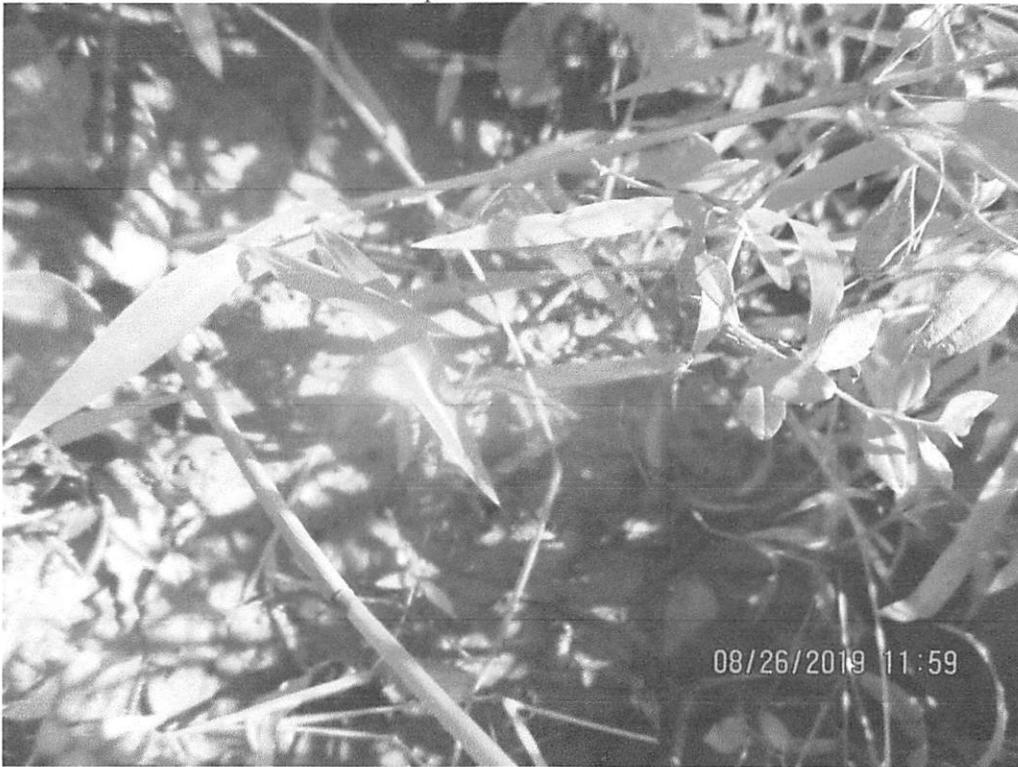
Near Station 1833+00 past controls and LOD. Erosion occurring on slope resulting in sediment deposits being present past the LOD.

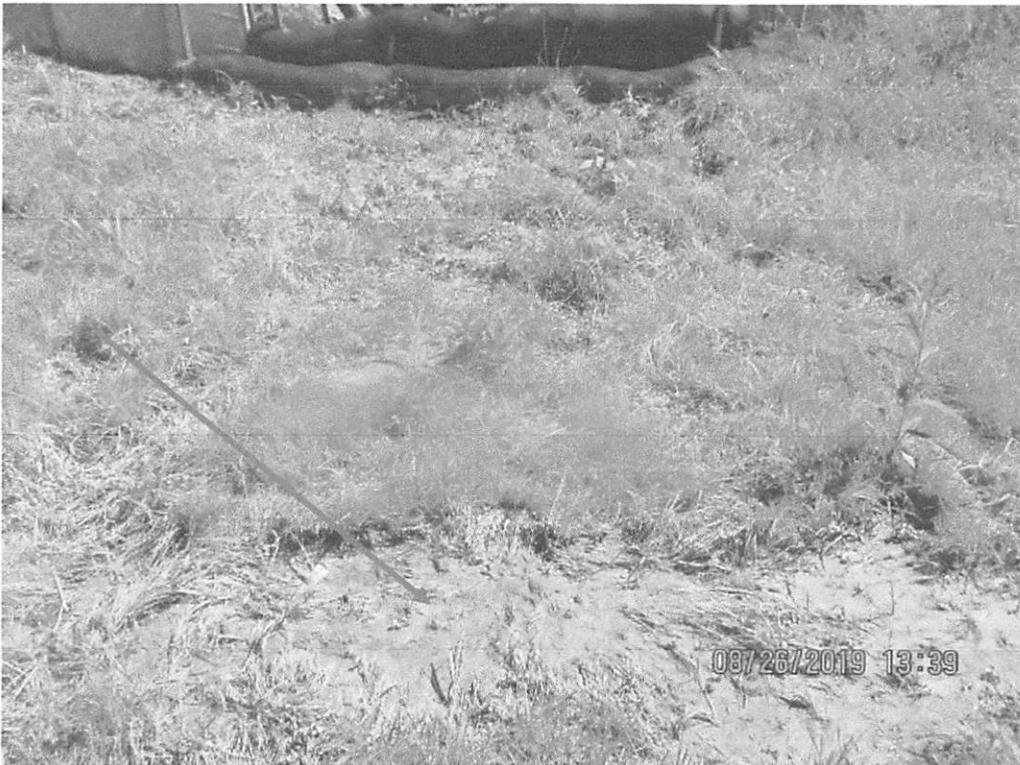
Facing upslope below perimeter controls at station 1730+00. Arrow depicts sediment deposits.

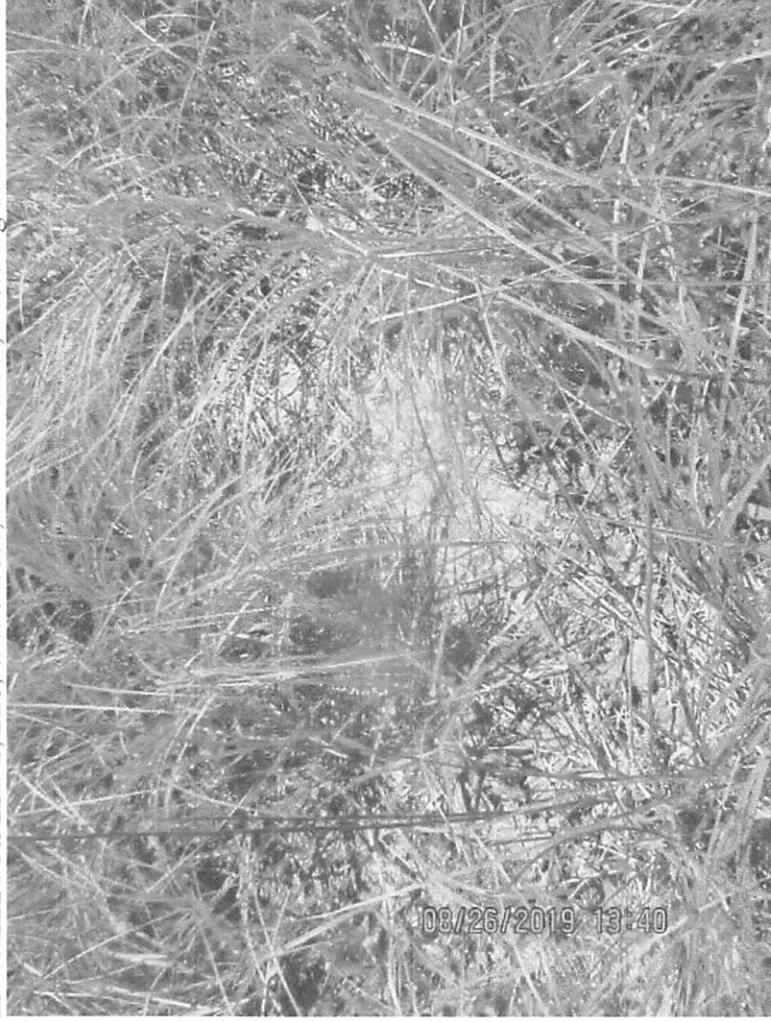
Sediment deposits present past LOD above wetland W-K48 near station 1730+00.

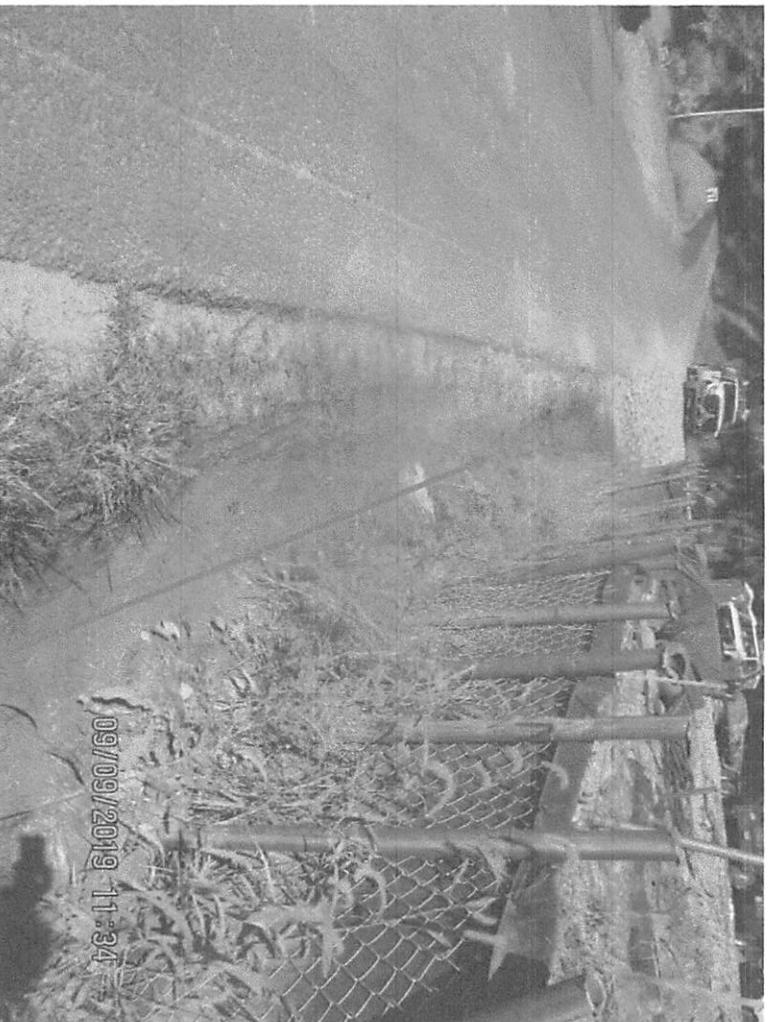
Indian Fork Road (CR21) near station 3089+00 facing toward MVP ROW entrance. Arrow depicts where sediment had been removed during inspection. Complainant photo depicted sediment-laden water impacting this area.

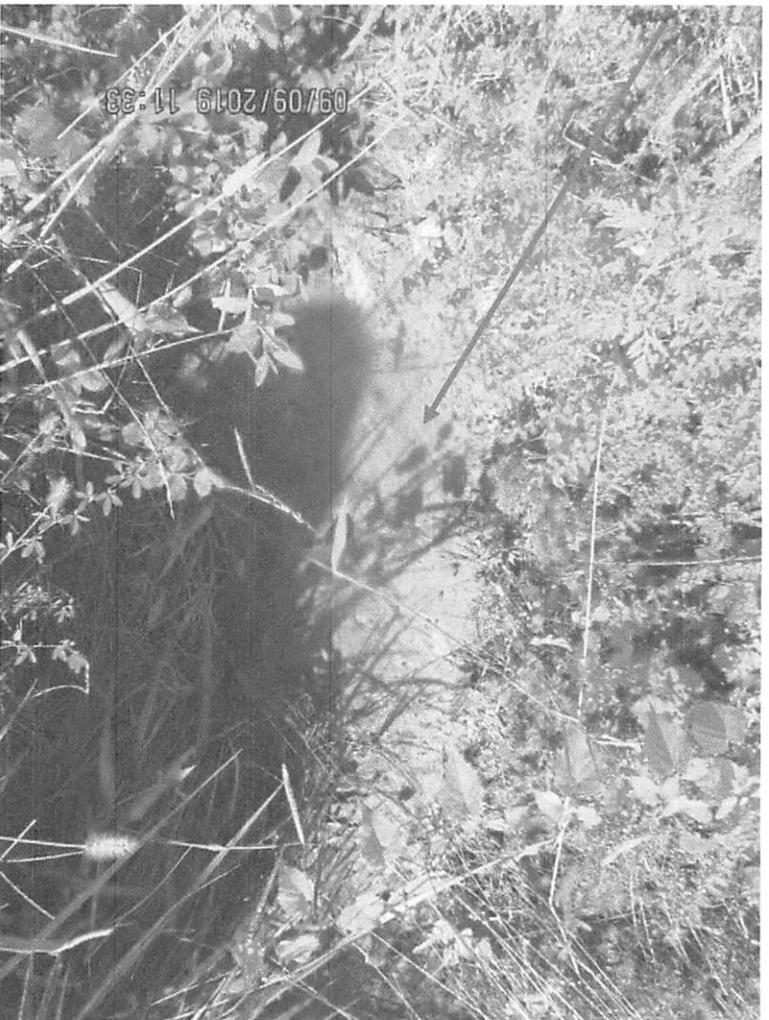
Sediment deposits in ditchline near station 3089+00.

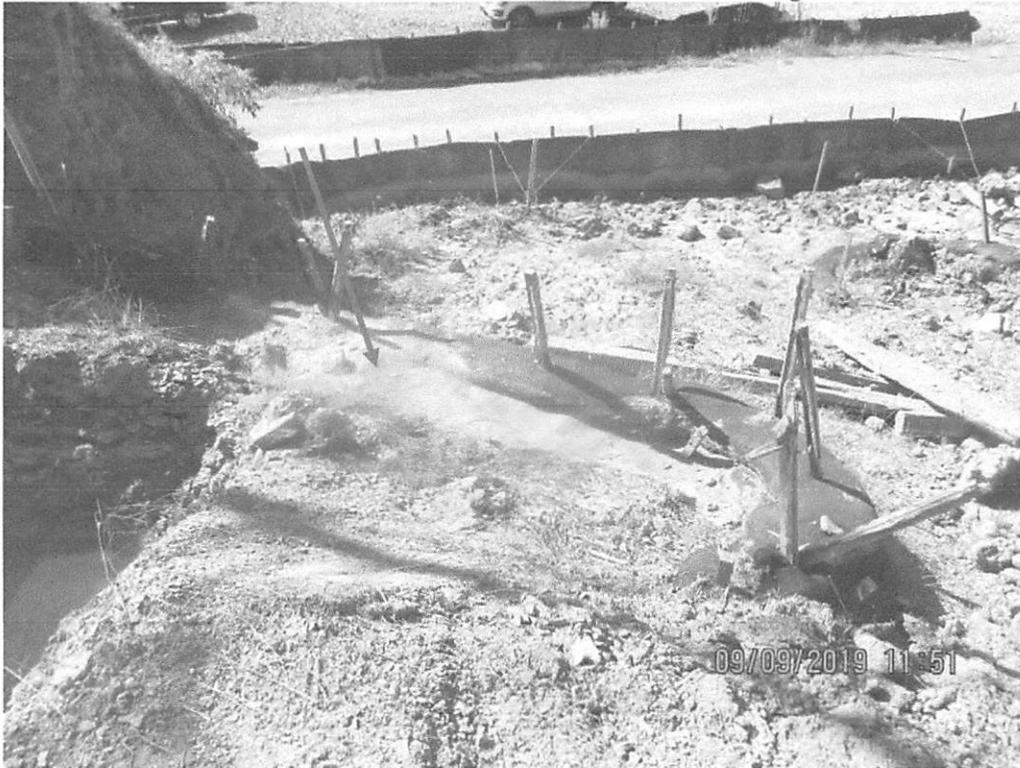
Controls upslope of CR21 and roadside ditch. Arrow depicts where sediment was overwhelming waterbar outlet controls.

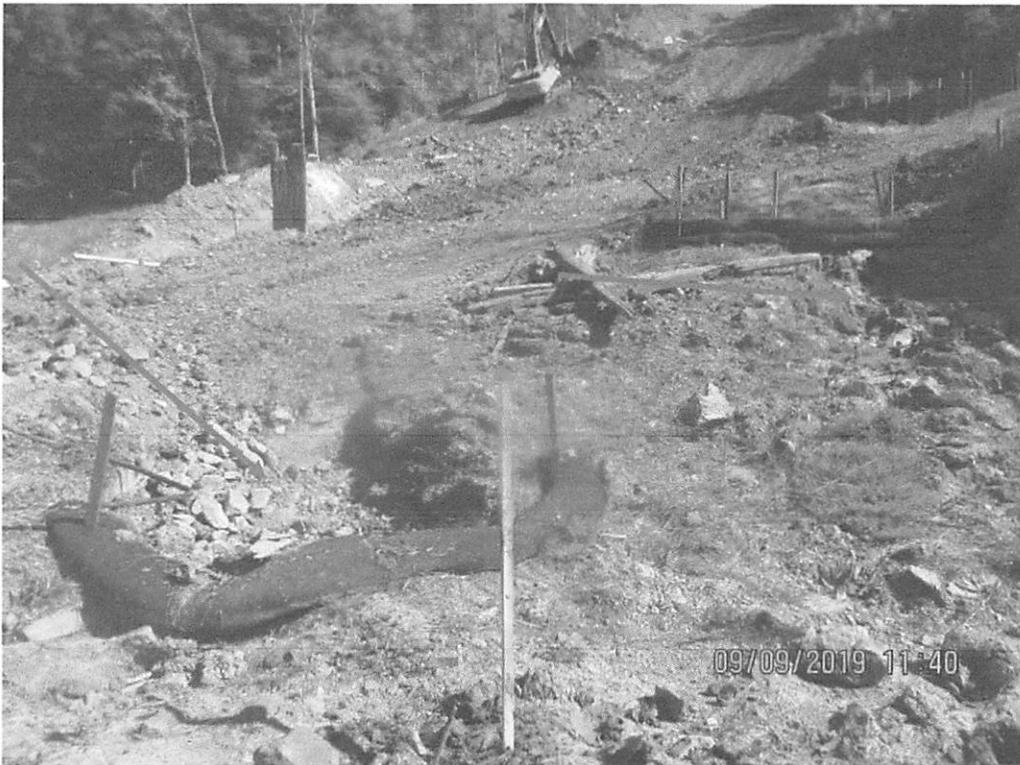
At station 3089+00 facing North. Arrow depicts sump not being maintained and erosion on slope below controls.

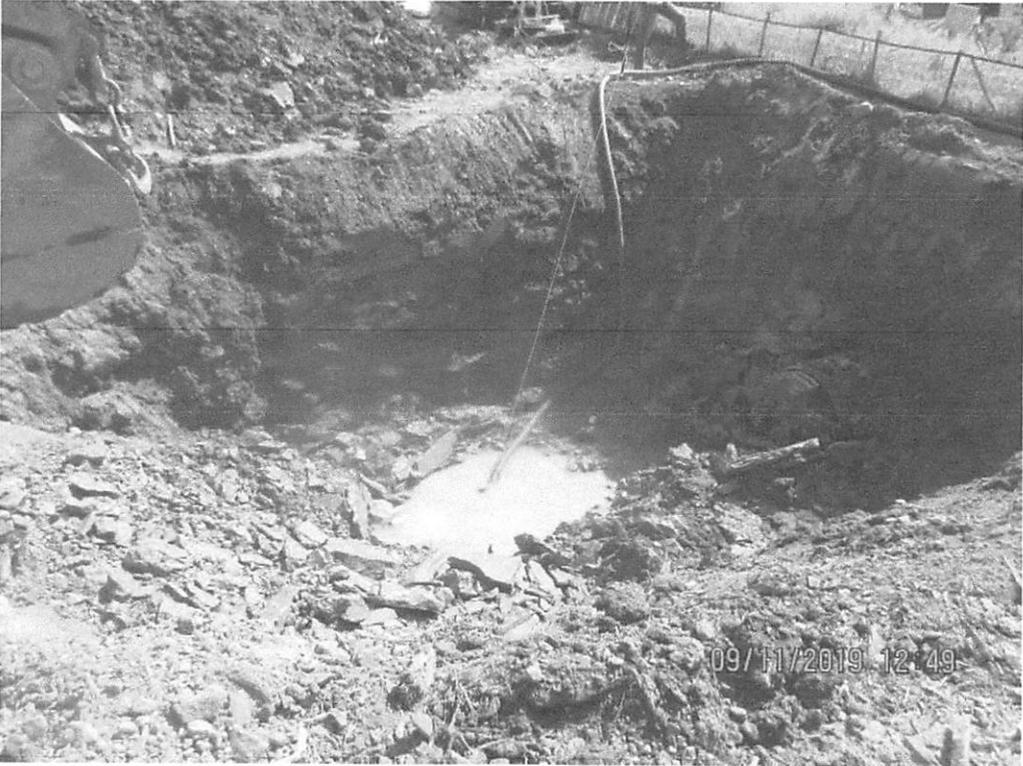
Open bore pit at the Goose Run (Stream S-B75) crossing at station 645+35.

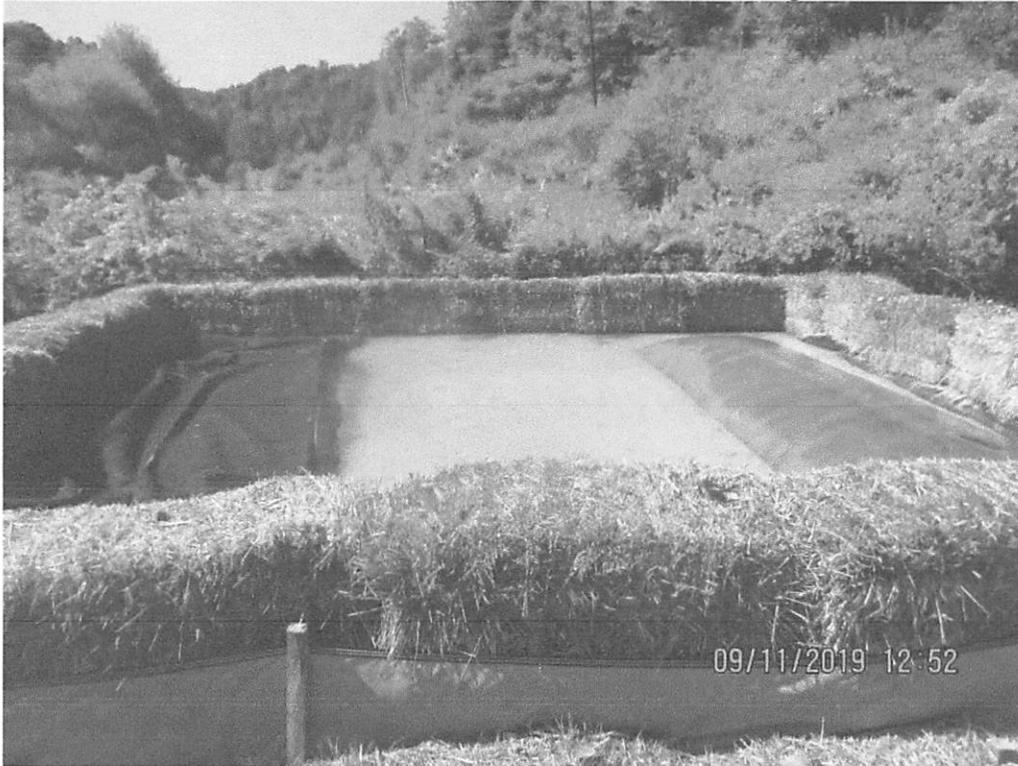
Dewatering structure for Goose Run (Stream S-B75) bore near station 645+35. Dewatering structure full of sediment-laden water.

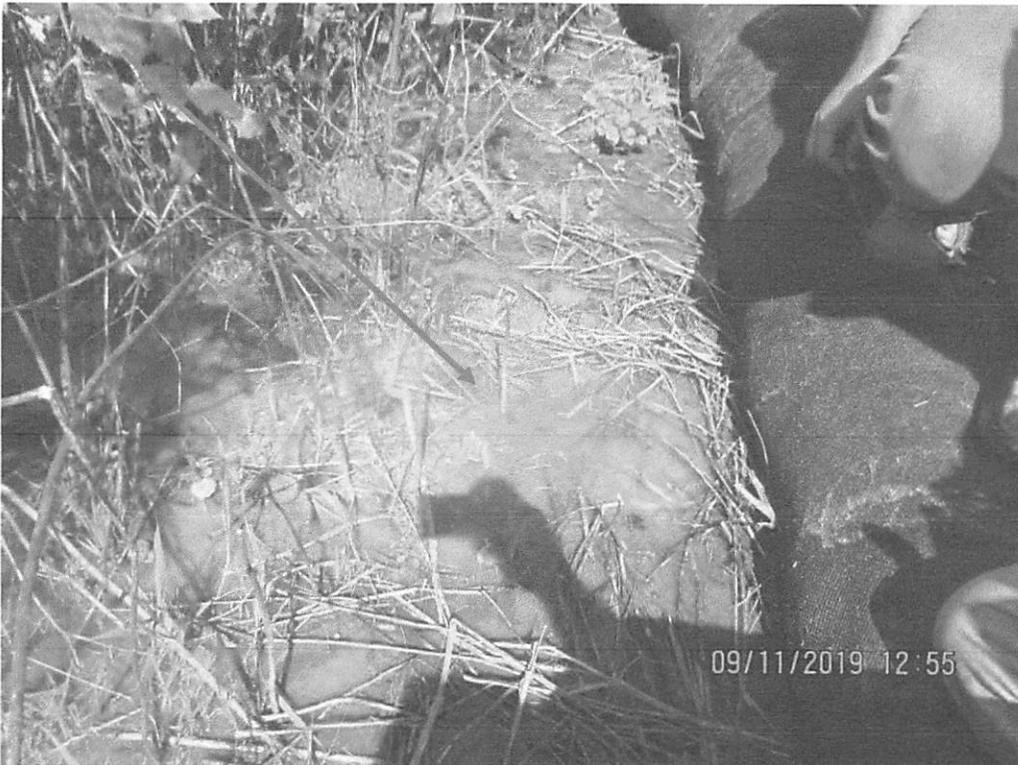
Sediment-laden water flowing under controls and into vegetation above Stream S-B75 (Goose Run) near station 645+35.

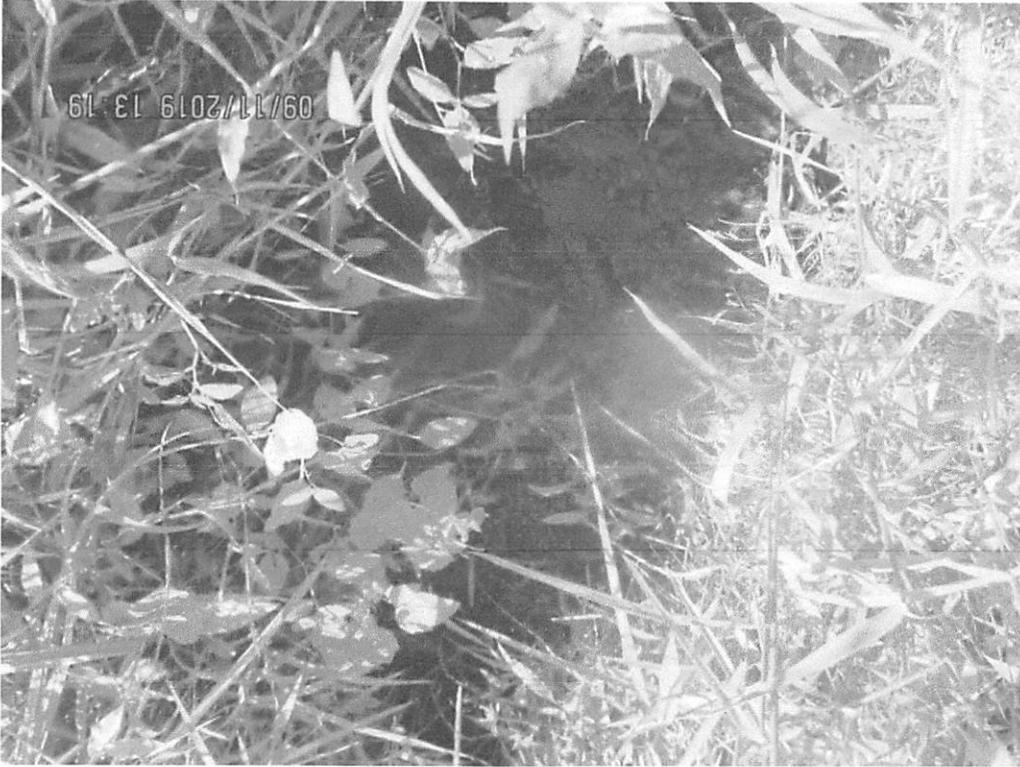
Sediment-laden water flowing into Stream S-B75 (Goose Run) near station 645+35.
