**CONSENT ORDER
ISSUED UNDER THE
WATER POLLUTION CONTROL ACT
WEST VIRGINIA CODE, CHAPTER 22, ARTICLE 11**

TO: Mountain Valley Pipeline, LLC
Robert J. Cooper
2200 Energy Drive
Canonsburg, PA 15317

DATE: December 17, 2020

ORDER NO.: 9925

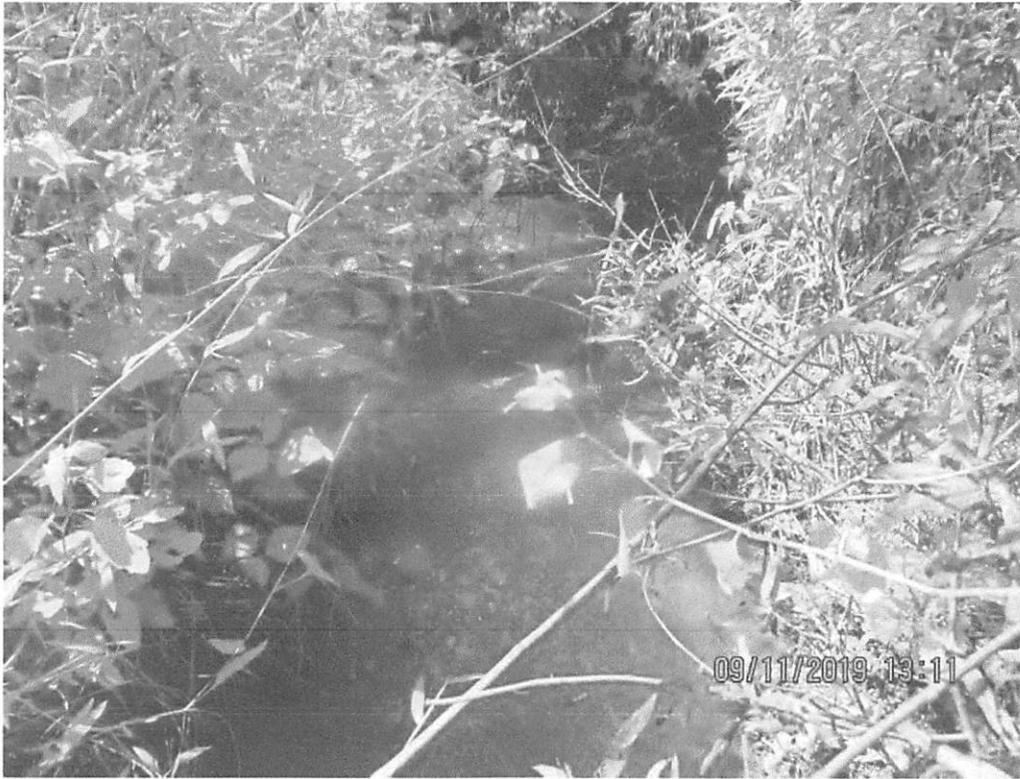
Below where sediment-laden water was entering Goose Run (Stream S-B75) near station 645+35.

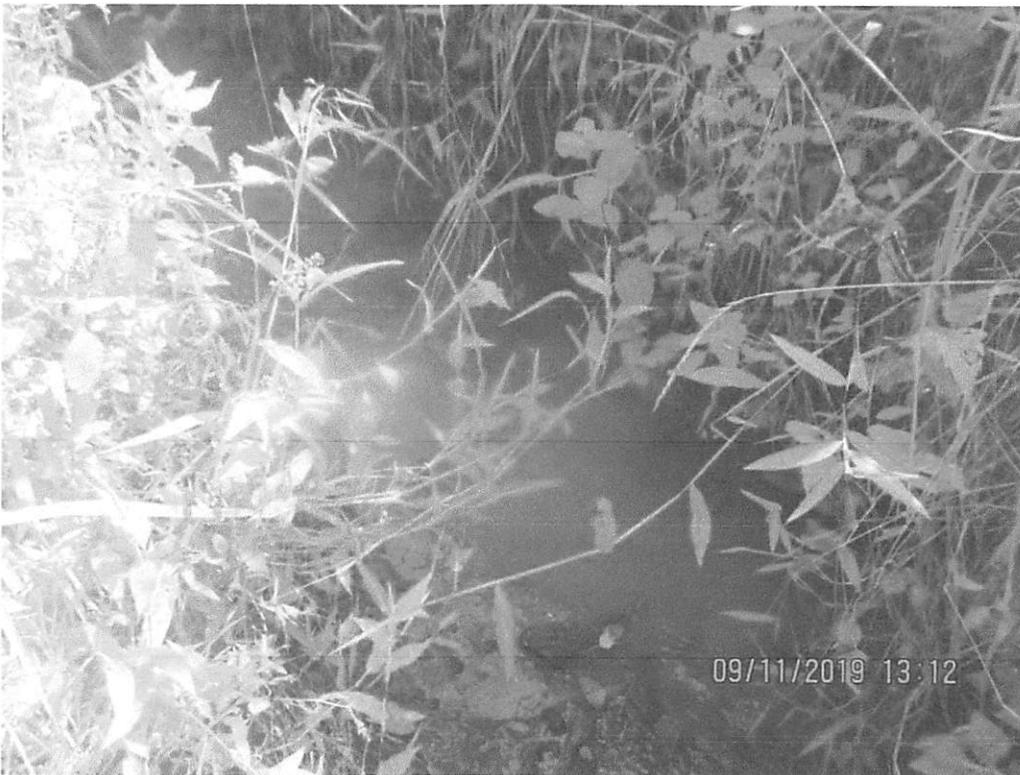
Below where Sediment-laden water was entering Goose Run (Stream S-B75) near station 645+35.

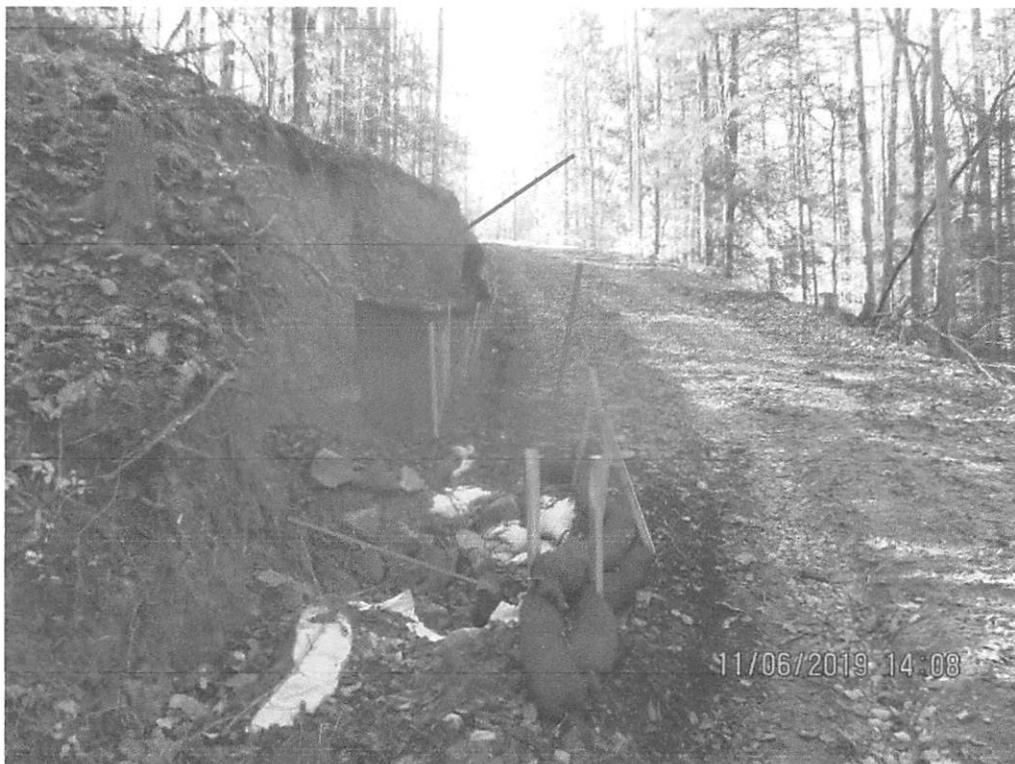
Access Road 114 above Stream S-S2. Red Arrow depicts slip. Orange arrows depict slope drain and small sump with culvert inlet conveying under AR-114.

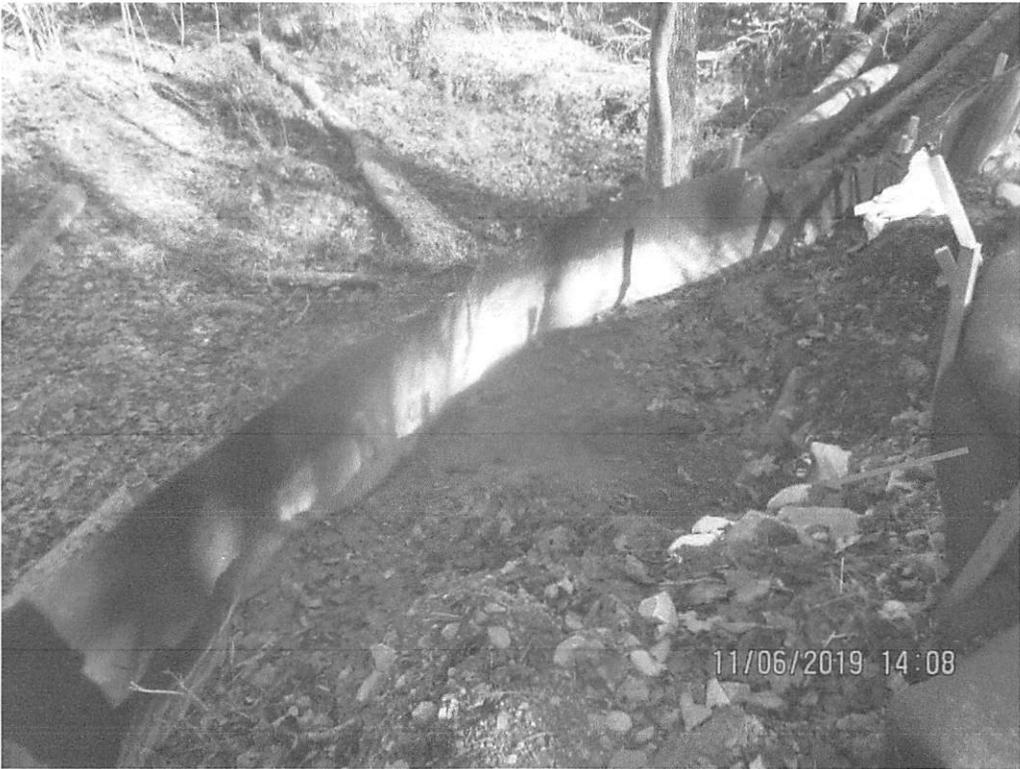
Culvert outlet (red arrow) from slope drain installed at top of slope on AR-114

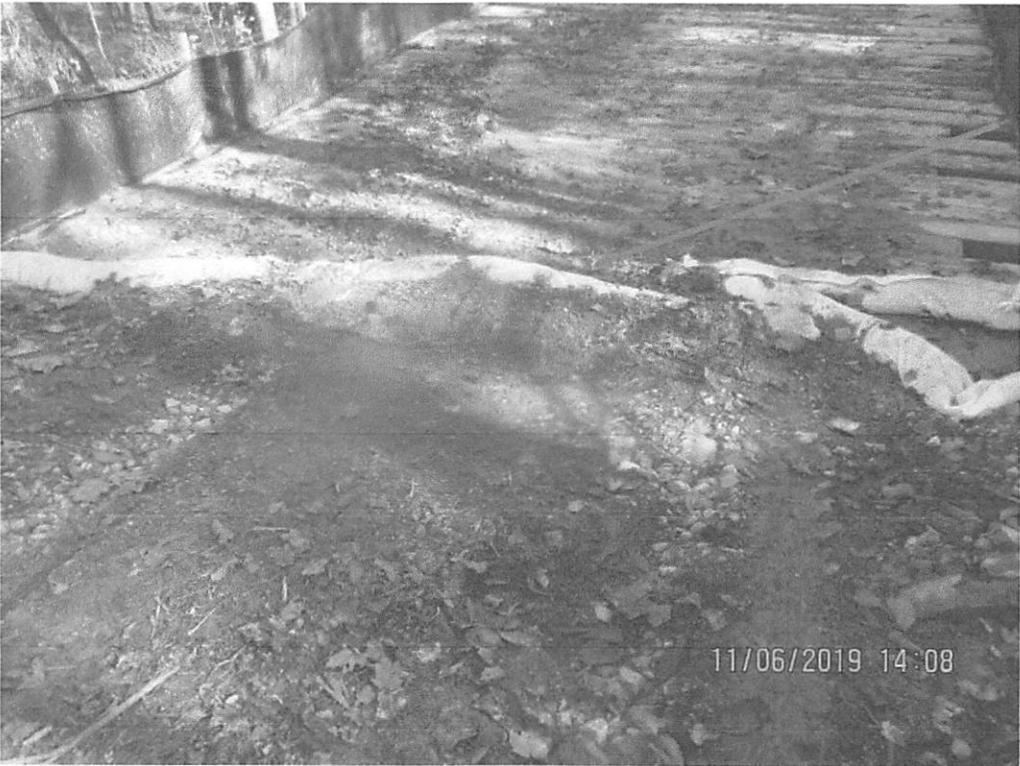
Stream S-S2 near station 4364+00. CFS at edge of bridge crossing flattened with sediment deposits built up behind it.

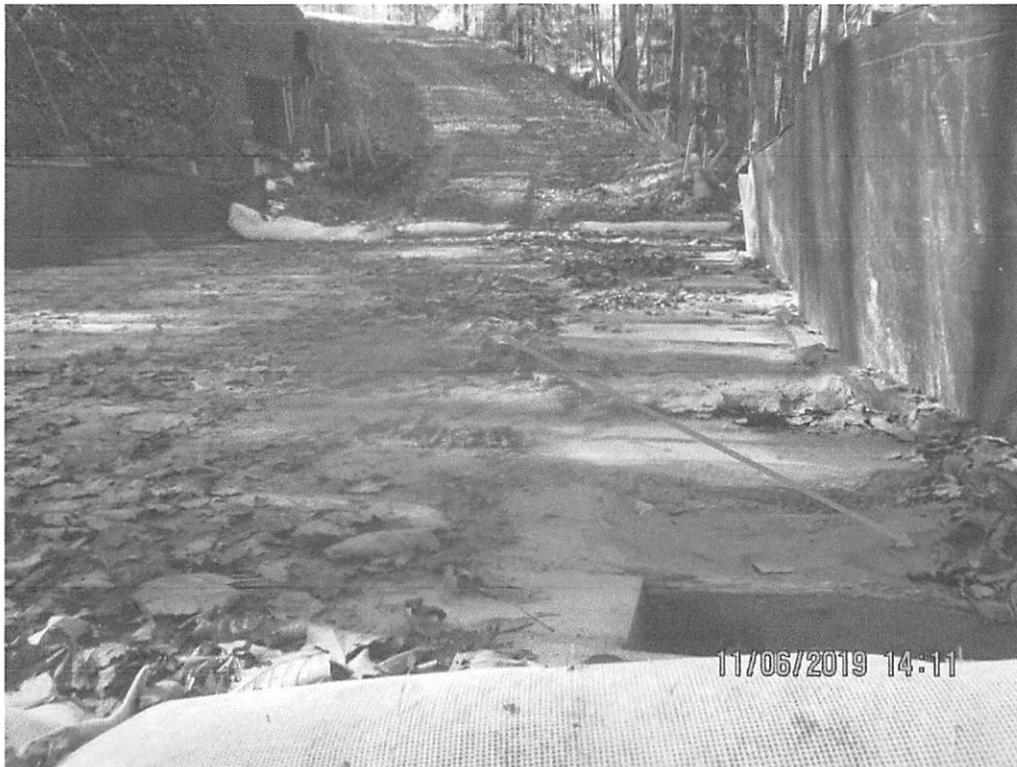
Facing upslope on Stream S-S2 bridge crossing. Arrow depicts where erosion was present on road resulting in controls being overwhelmed and sediment being deposited on bridge and past LOD.

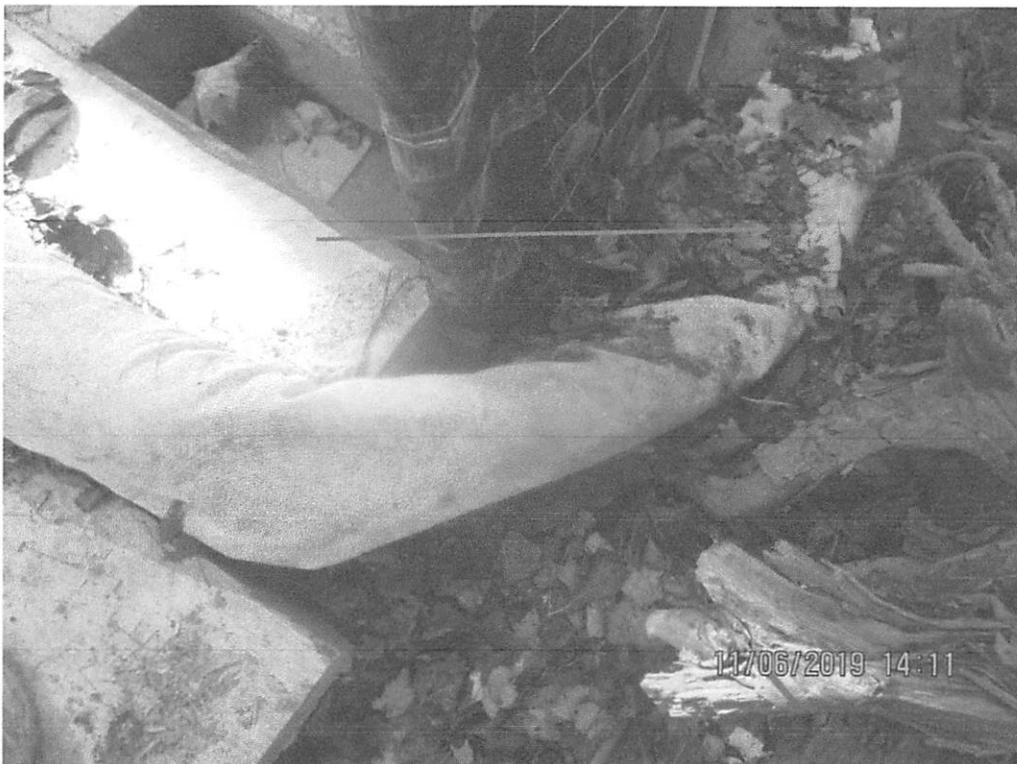
Downslope section of bridge where sediment-laden water was flowing around and past controls near station 4364+00.

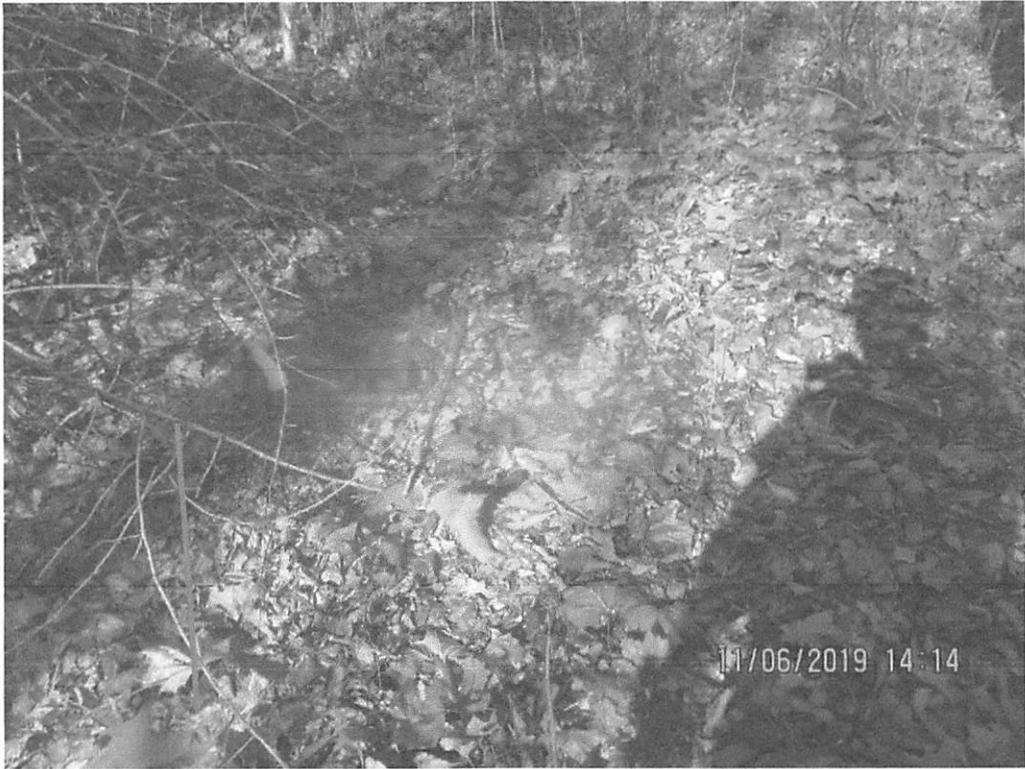
Sediment deposits observed in conveyance to Oddlick Creek past LOD just below bridge near station 4364+00.

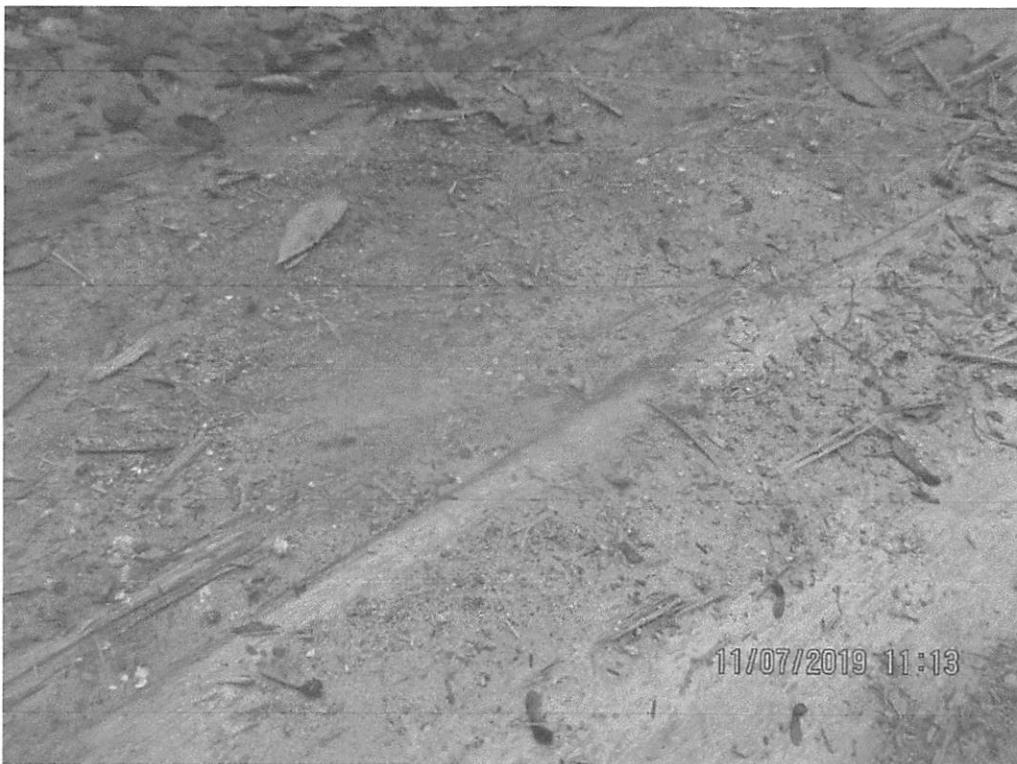
Air bridge located over Stream S-H117. Arrows depicts pellet remnants.

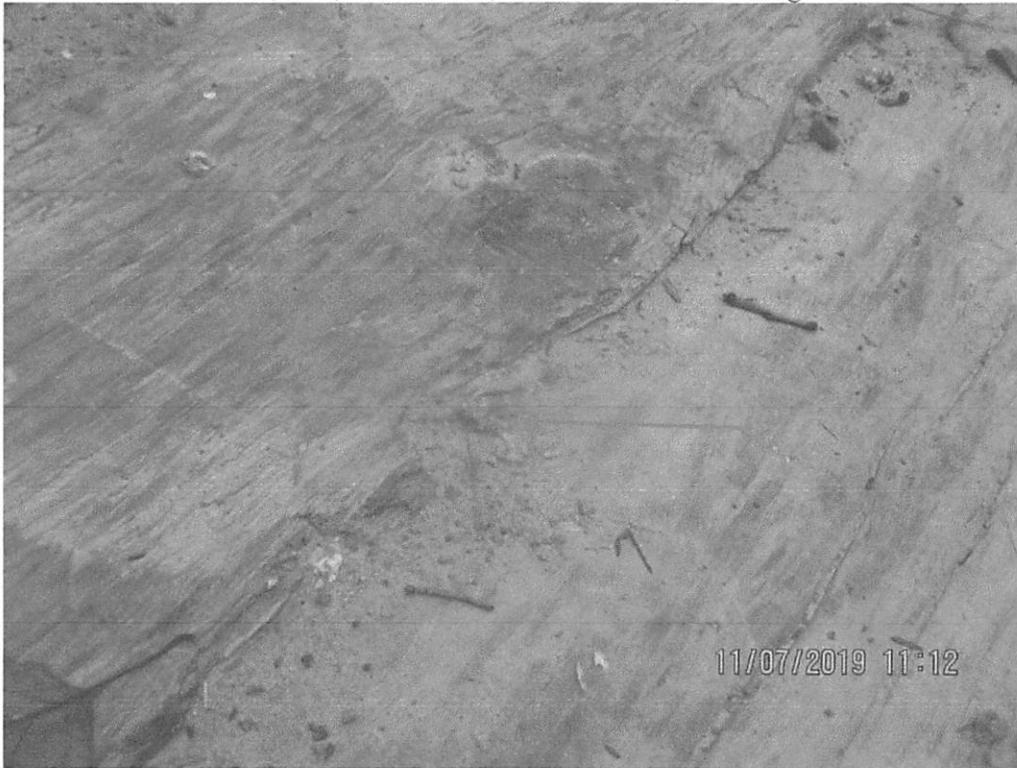
Air bridge located over Stream S-H117. Arrows depicts pellet remnants.

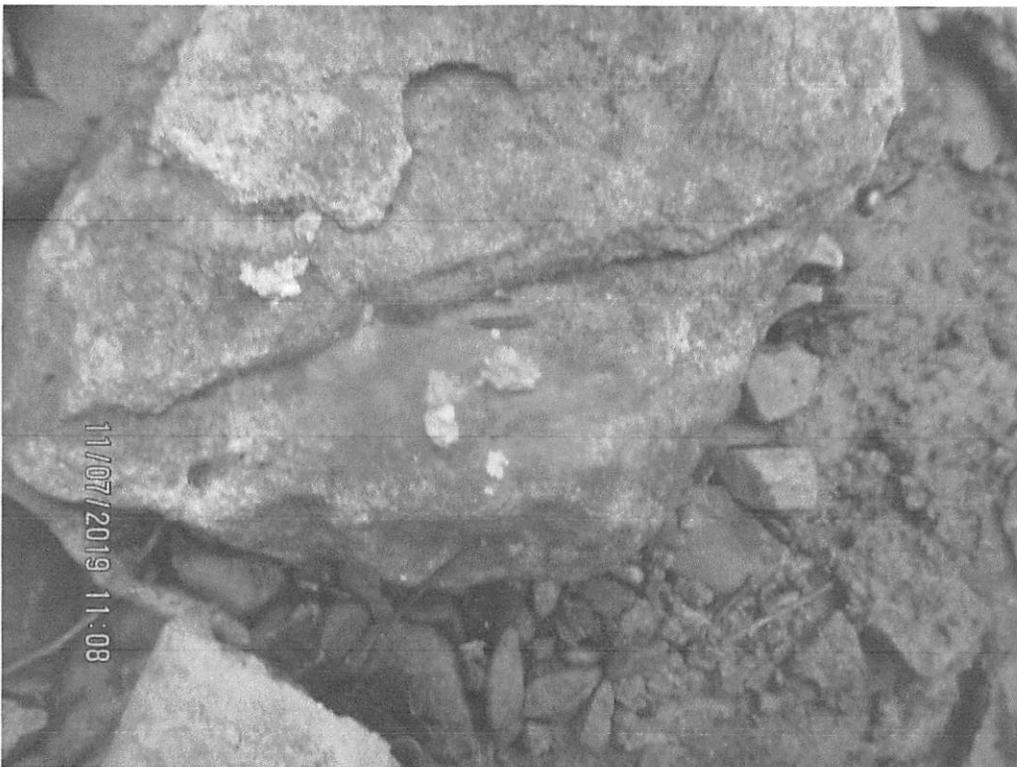
Rock present in Stream S-H117. Pellet remnants present on rocks.

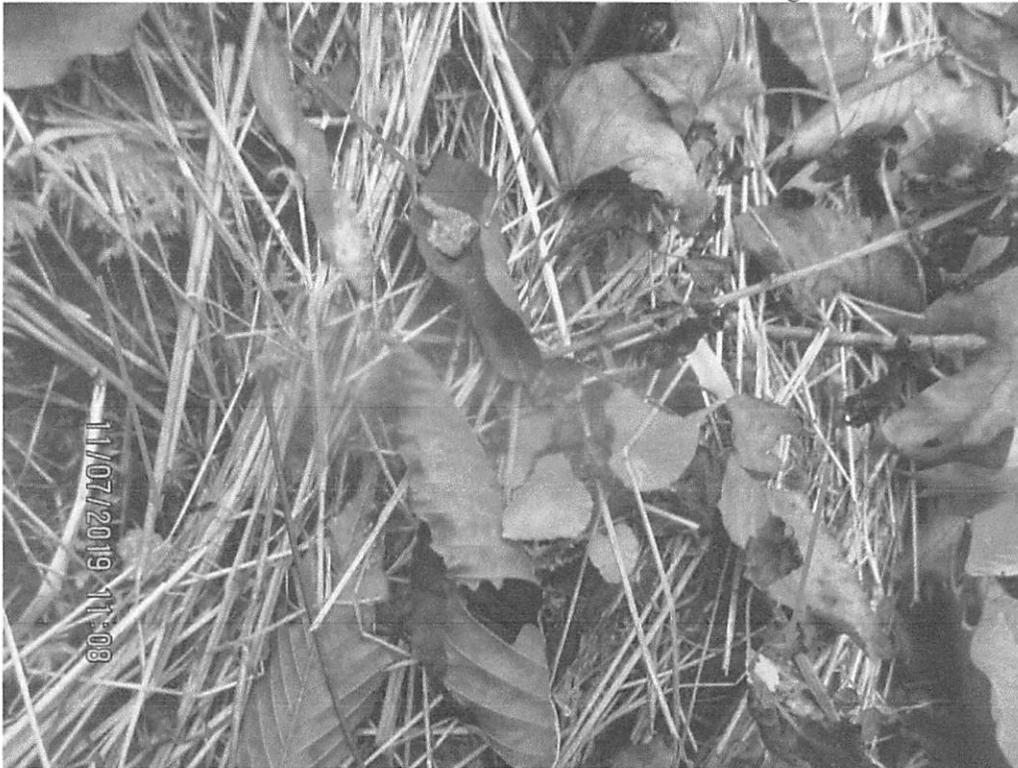
Pellet remnants present along stream bank of Stream S-H117.

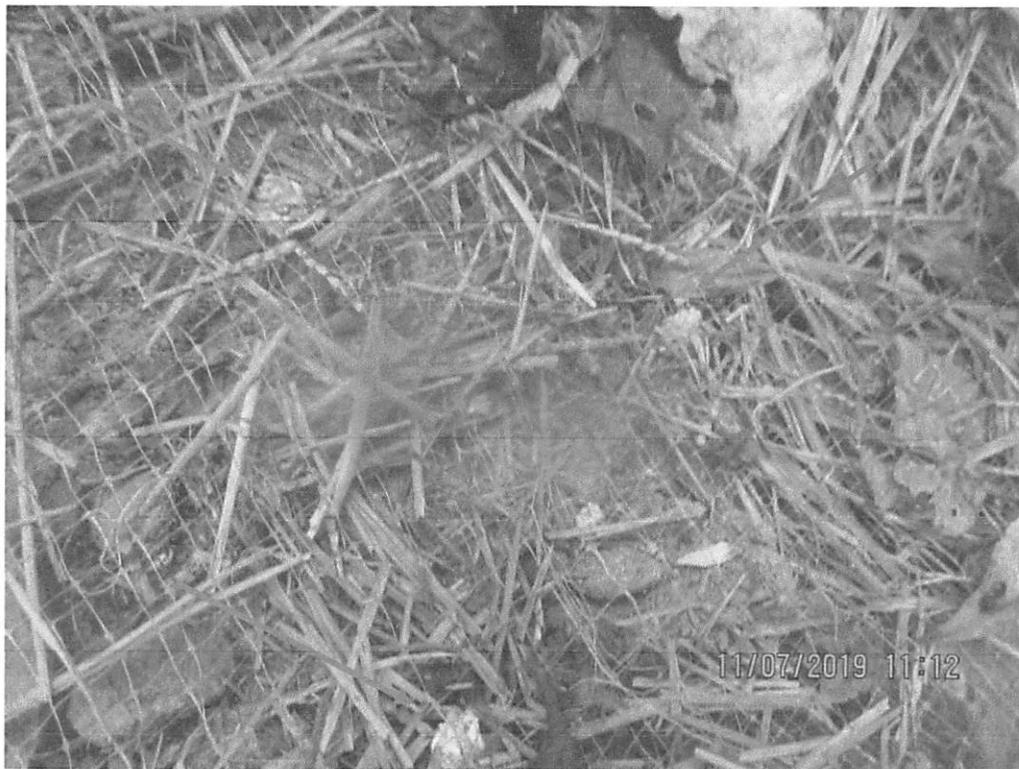
Pellet remnants present along stream bank of Stream S-H117.

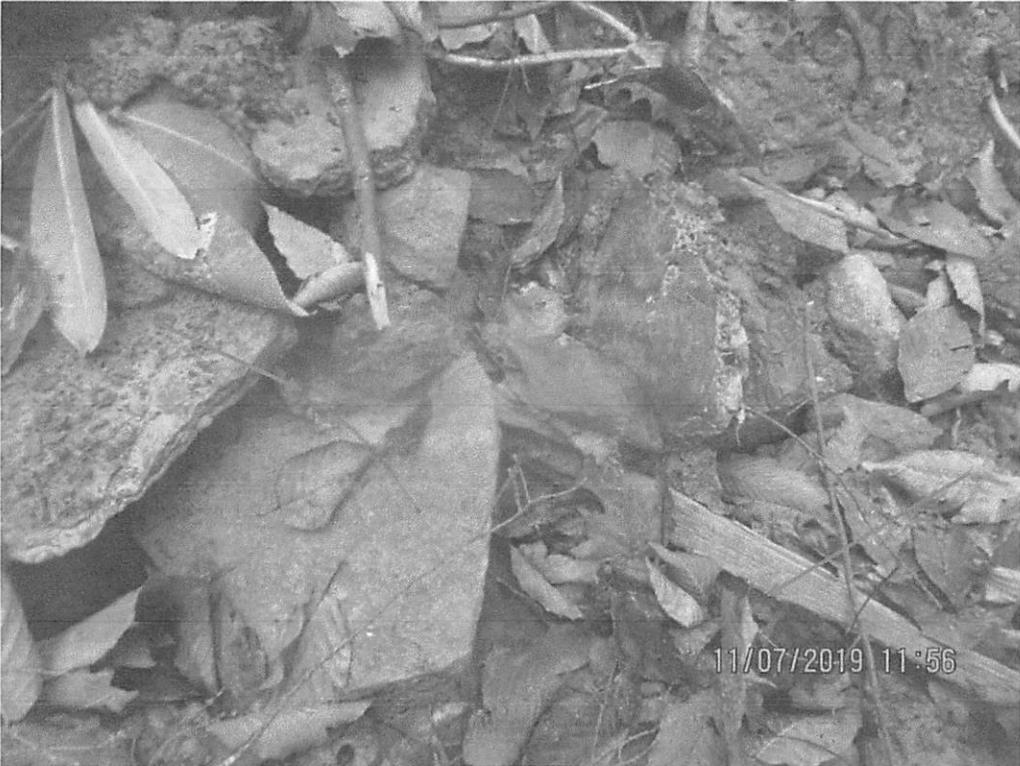
Pellet remnants present in Elliott Run, a tributary of the Little Kanawha River.

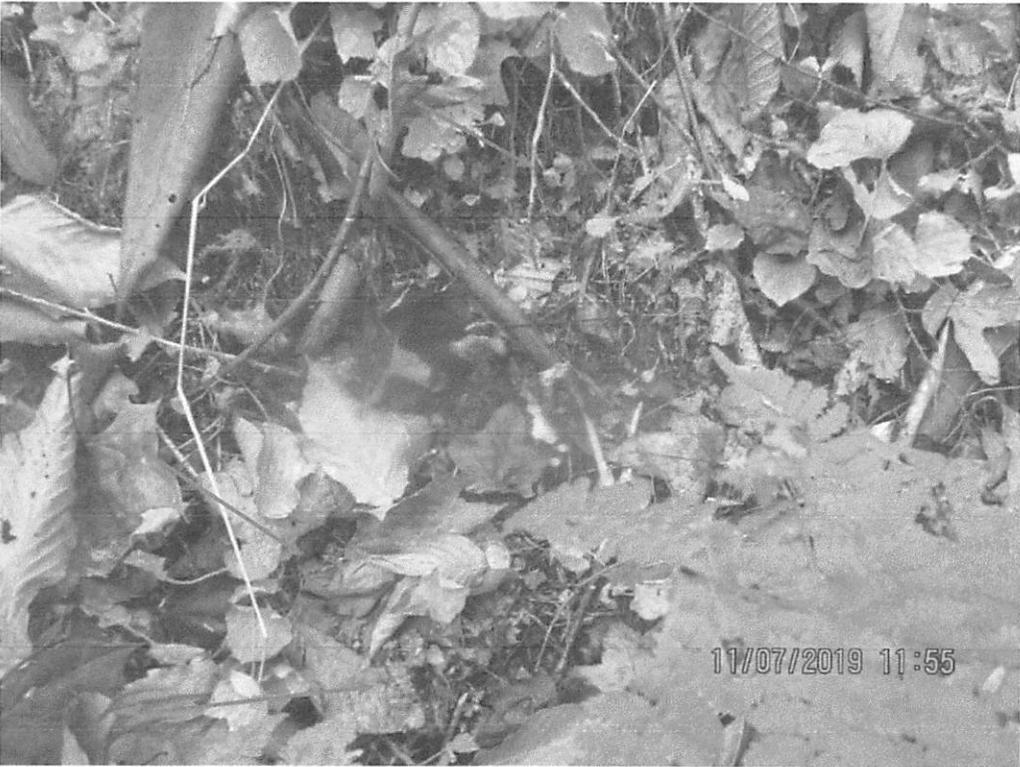
Pellet remnants present on the stream bank on the East bank of Elliott Run past MVP LOD.

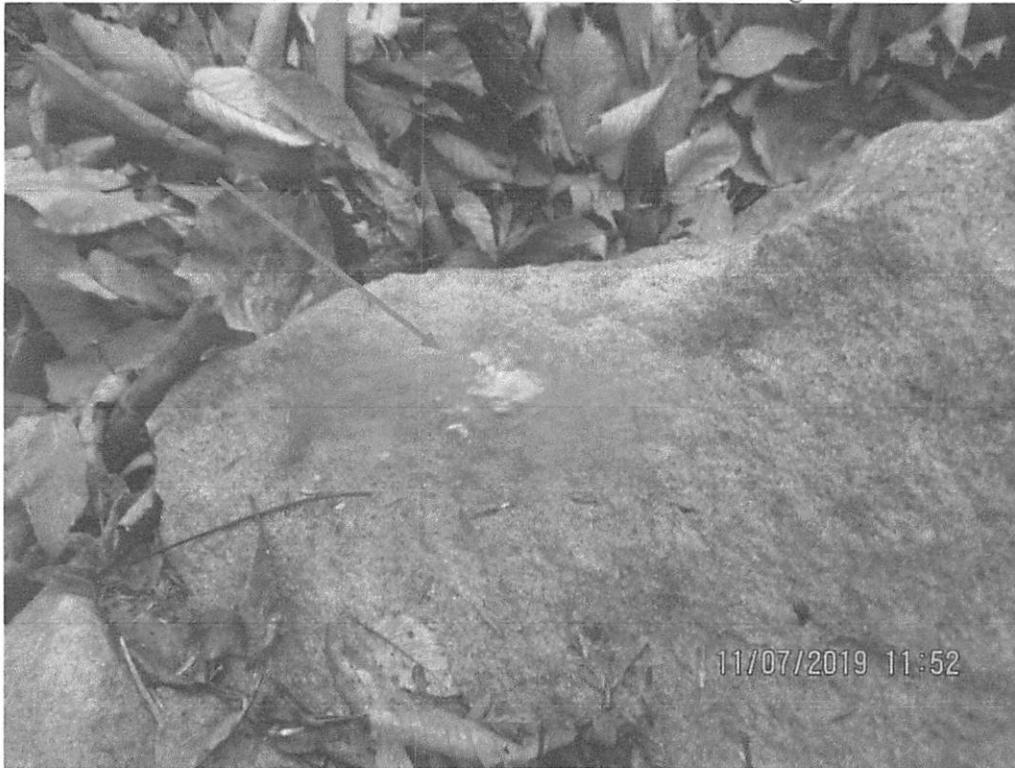
Pellet remnants located on top of rocks in Elliott Run.

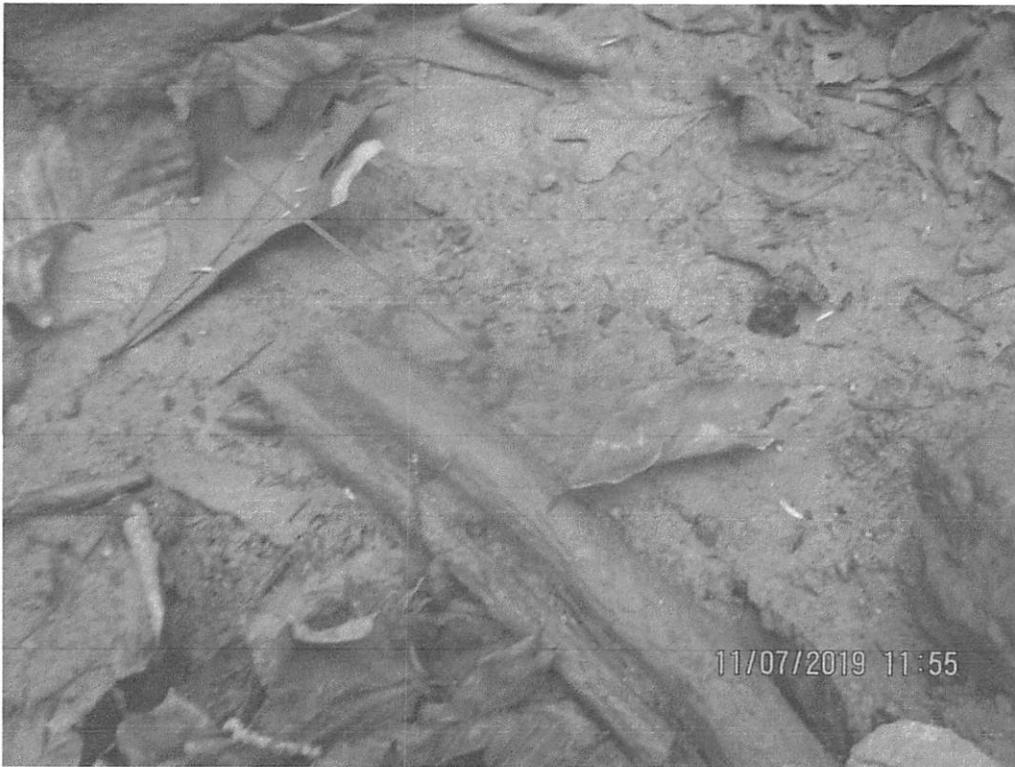
Pellet remnants observed in stream bed of Elliott Run approximately 50-75 ft from confluence with Little Kanawha River.

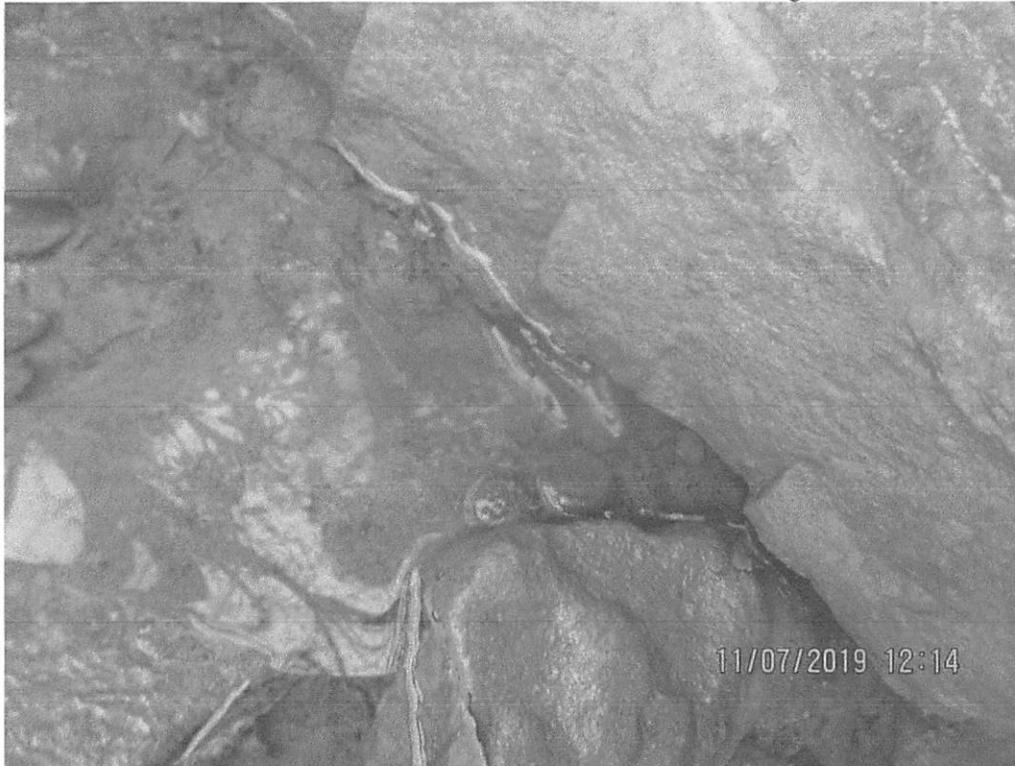
Erosion control pellet remnant observed in Elliott Run near Station 3946+00.

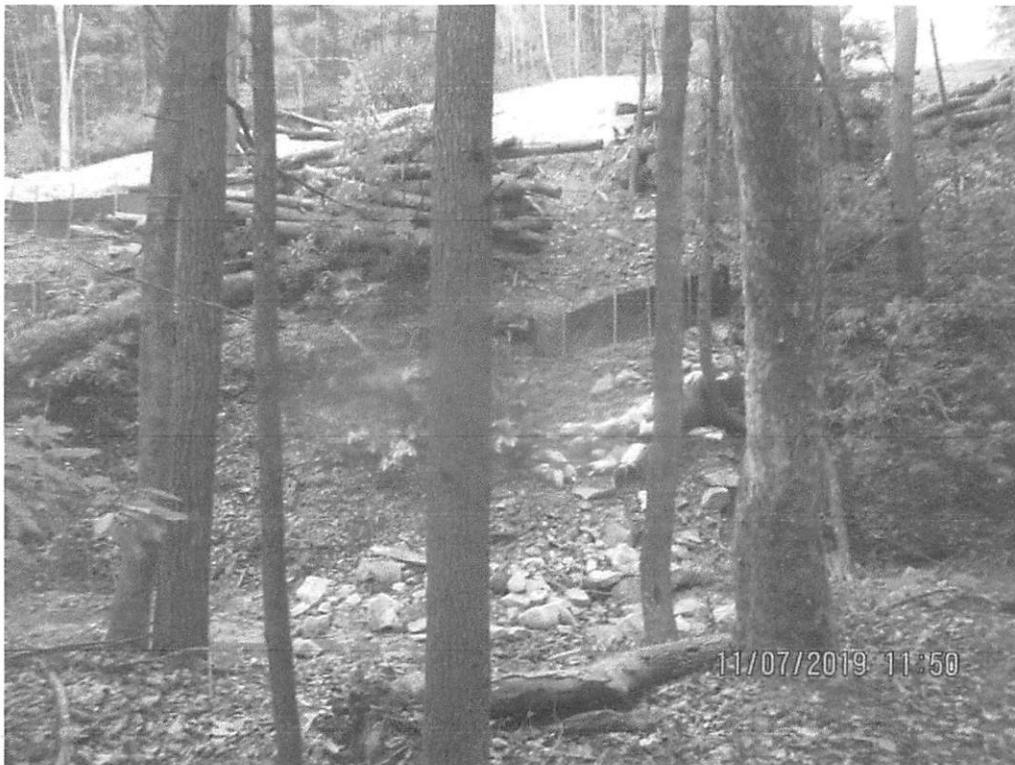
Slip that impacted Elliott Run near Station 3946+00 and was not reported to WVDEP spill reporting hotline.

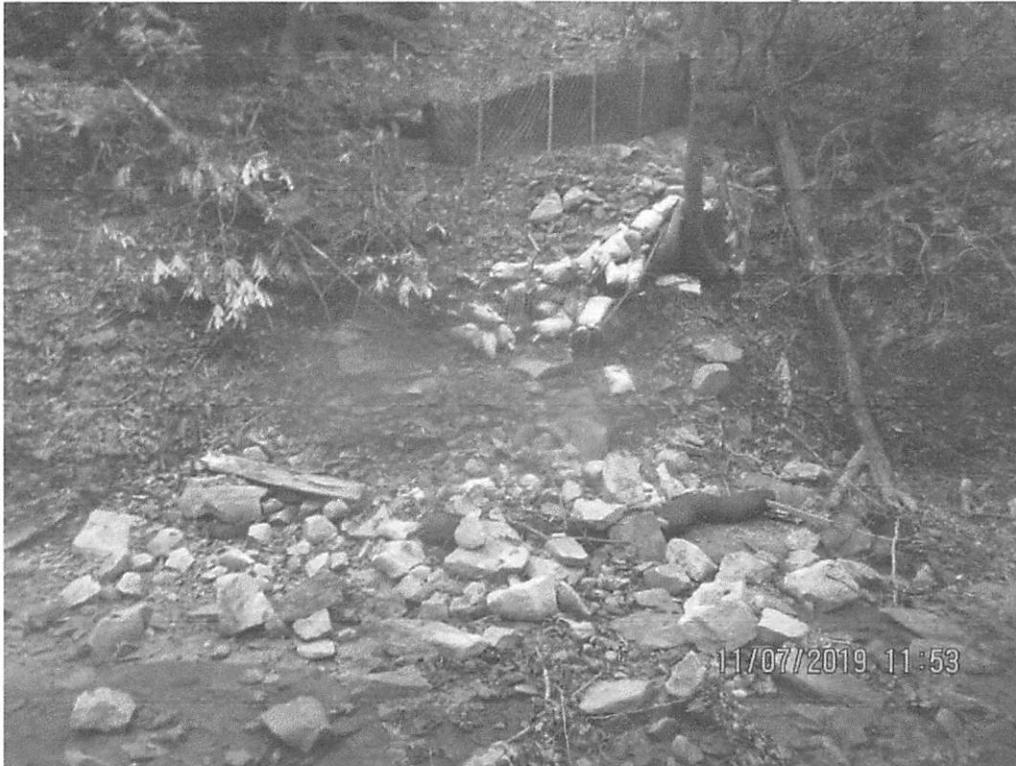
Slip that impacted Elliott Run near Station 3946+00 and was not reported to WVDEP spill reporting hotline.

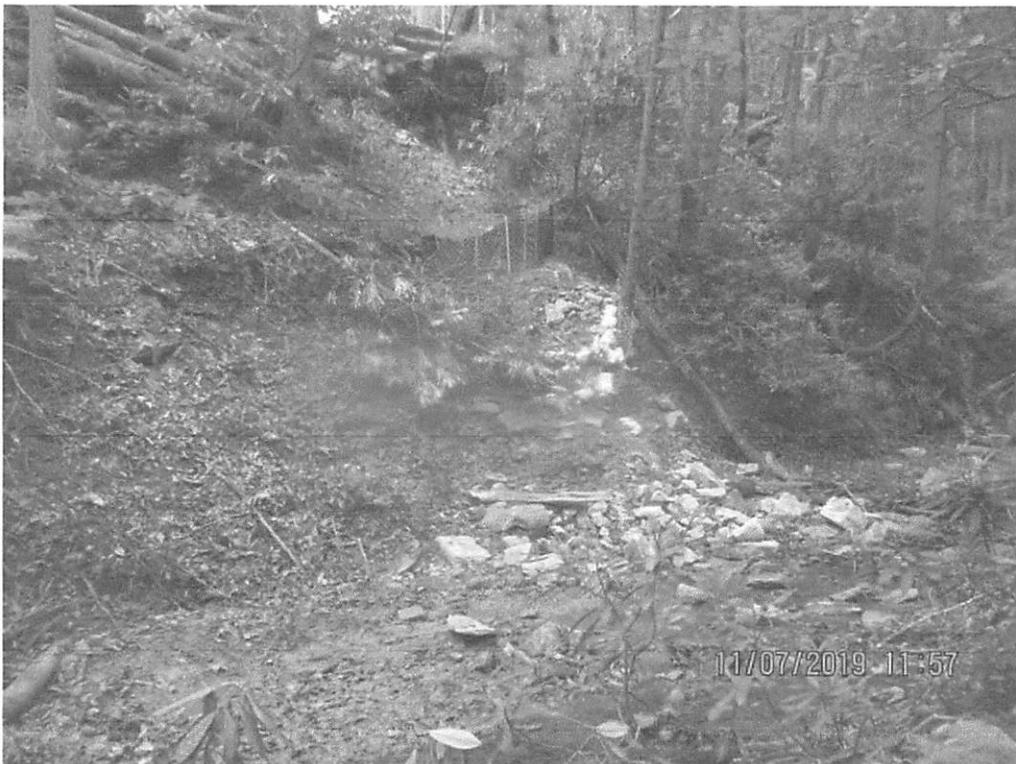
Slip that impacted Elliott Run near Station 3946+00 and was not reported to WVDEP spill reporting hotline. Super silt fence installed near the edge of LOD.

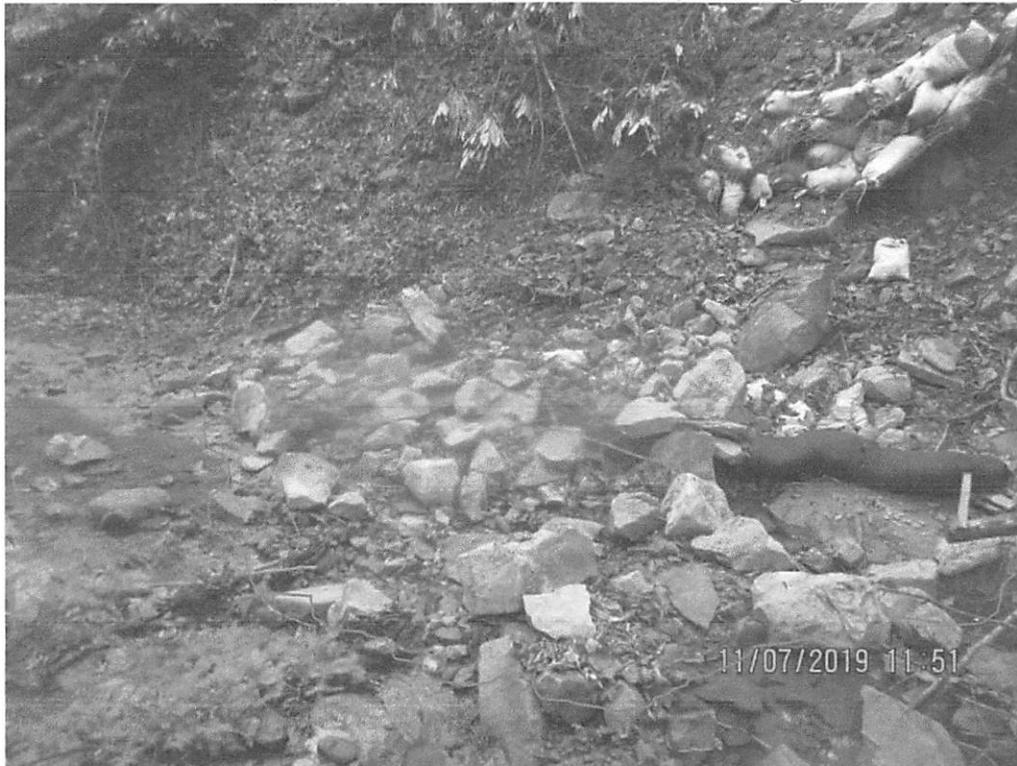
Slip that impacted Elliott Run near Station 3946+00 and was not reported to WVDEP spill reporting hotline. Red line indicates extent of impact.

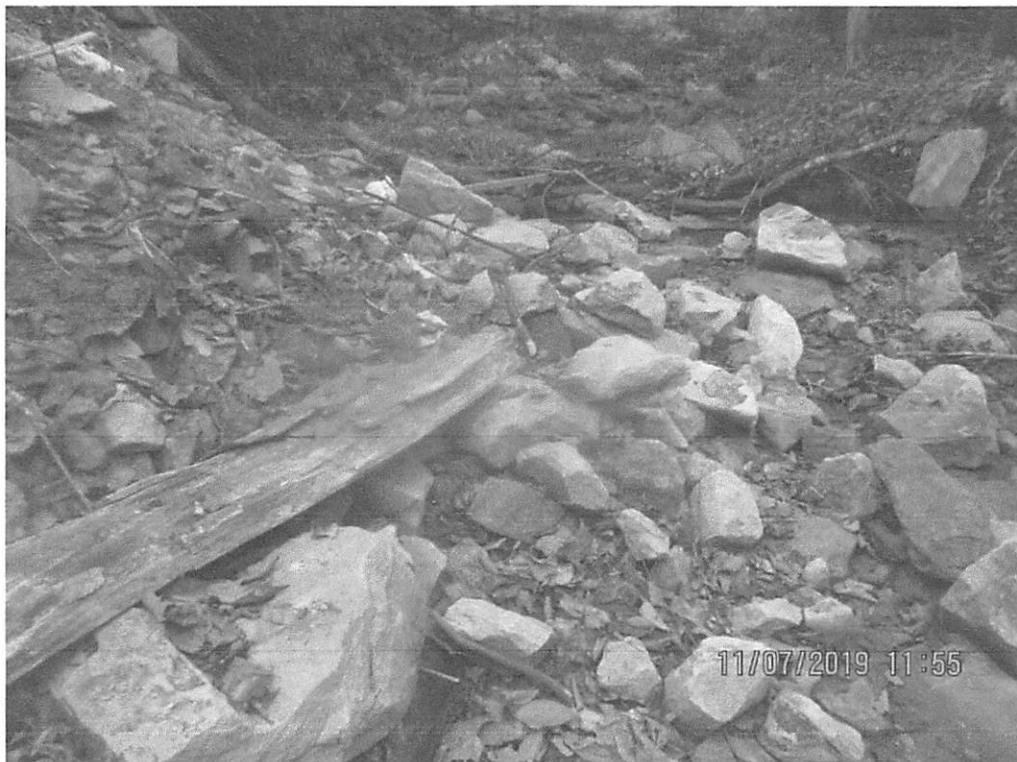
Facing upstream at Elliott Run, slip impacts near station 3946+00.

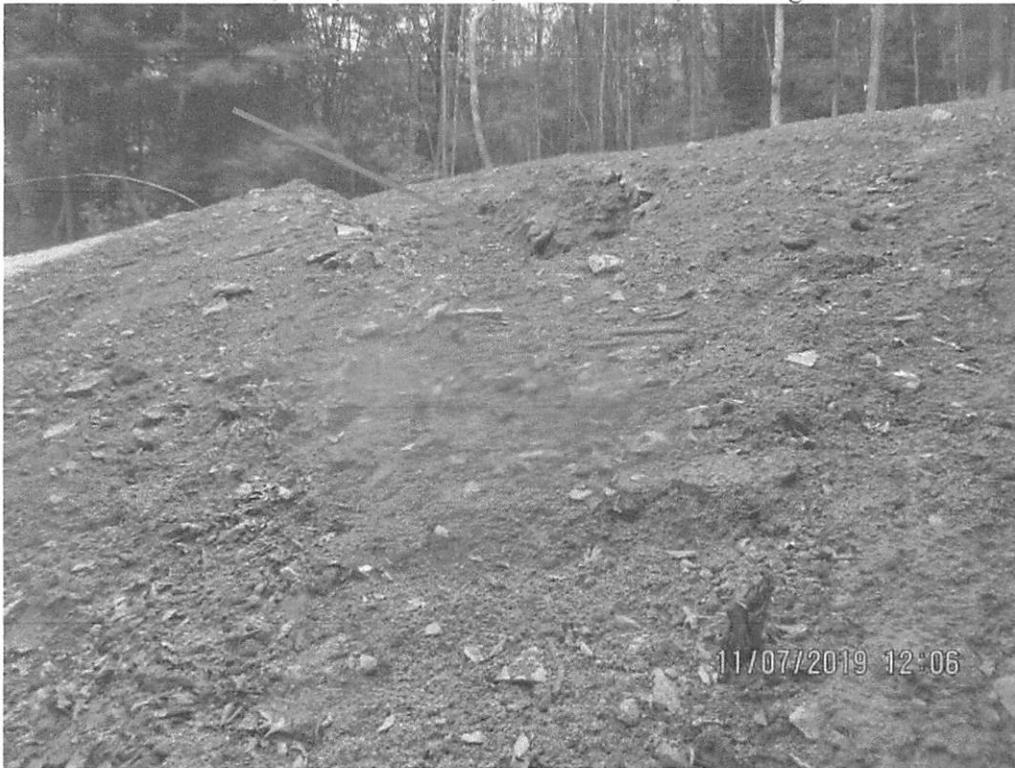
Waterbar terminating onto ROW above slipped section of ROW near Station 3946+00 with no outlet control present. Arrow indicates sump at waterbar terminus.

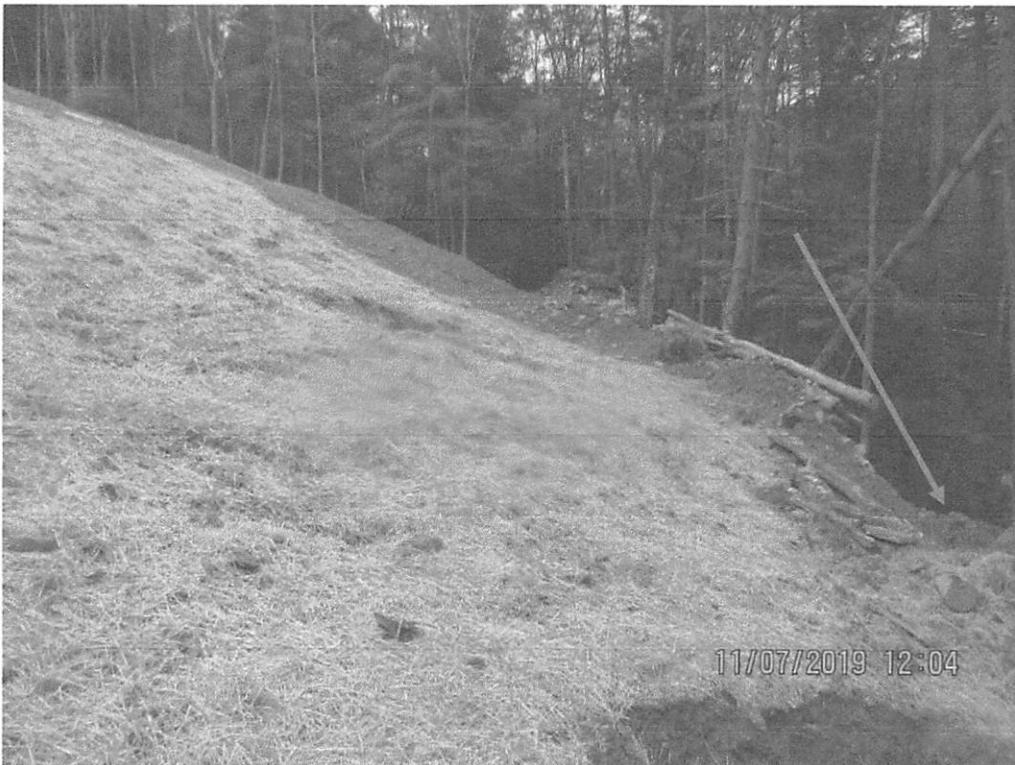
Section of ROW above Elliott Run where slip occurred near station 3946+00.

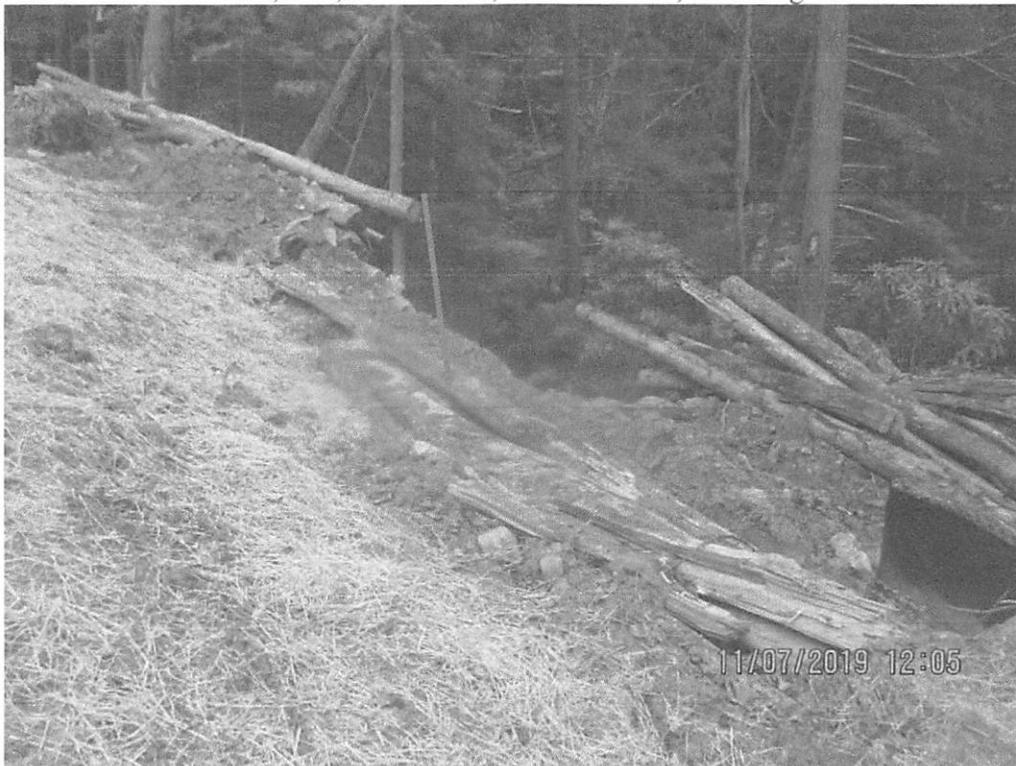
Section of ROW above Elliott Run where slip occurred near station 3946+00. Logs being used as perimeter controls (red arrow).

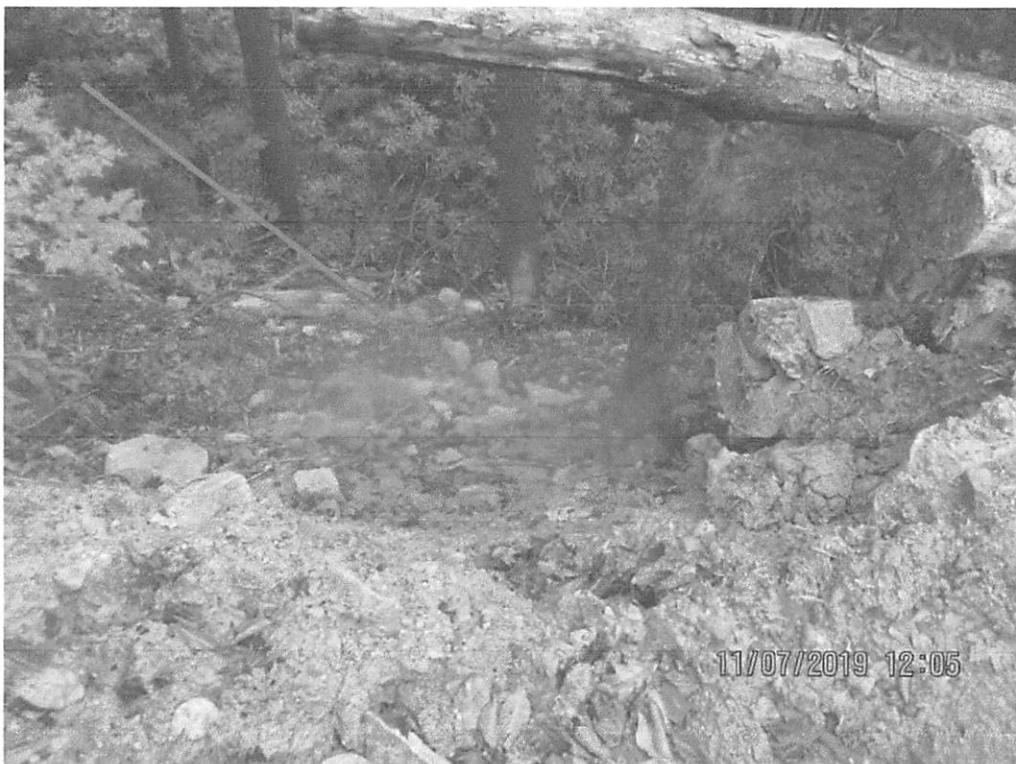
Section of ROW above Elliott Run where material/debris was slipping upstream of larger slip impacting Elliott Run near station 3946+00. No perimeter controls were in place at the time of inspection. Large rocks observed in stream above larger slip.

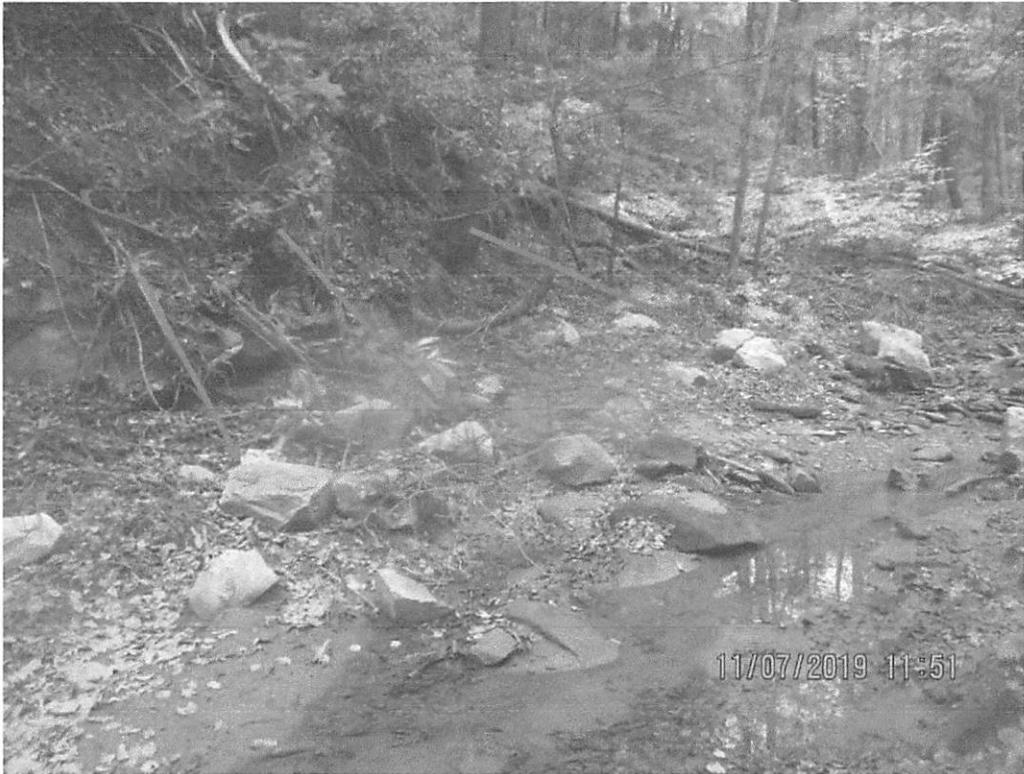
Rocks from ROW present past LOD and in Elliott Run where perimeter controls were not in place upstream from larger impacted section of stream.
