**CONSENT ORDER
ISSUED UNDER THE
WATER POLLUTION CONTROL ACT
WEST VIRGINIA CODE, CHAPTER 22, ARTICLE 11**

TO: Mountain Valley Pipeline, LLC
Robert J. Cooper
2200 Energy Drive
Canonsburg, PA 15317

DATE: December 17, 2020

ORDER NO.: 9925

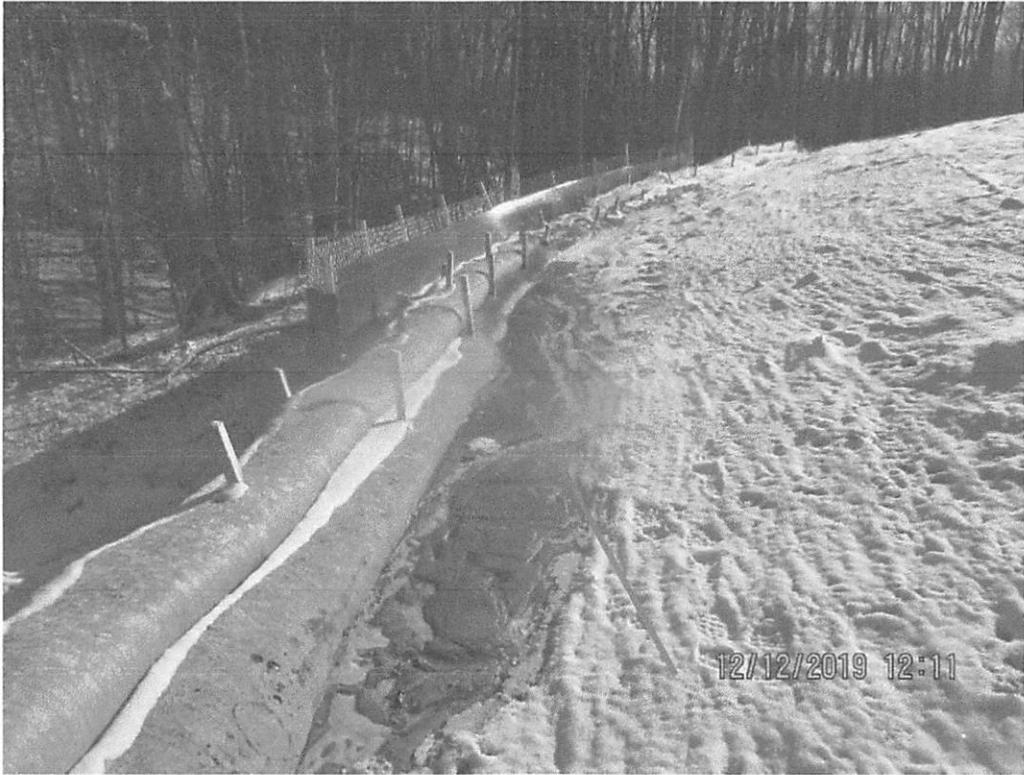
Sediment deposits present behind controls due to upslope erosion at station 8433+50.

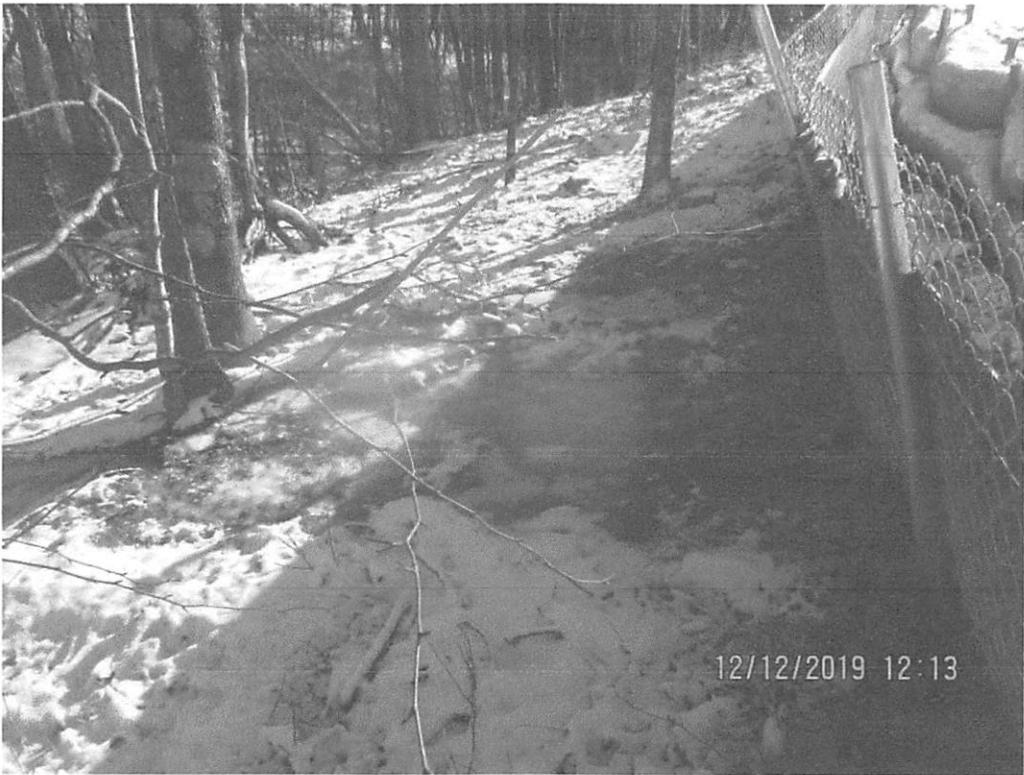
SLW present past controls at station 8433+00

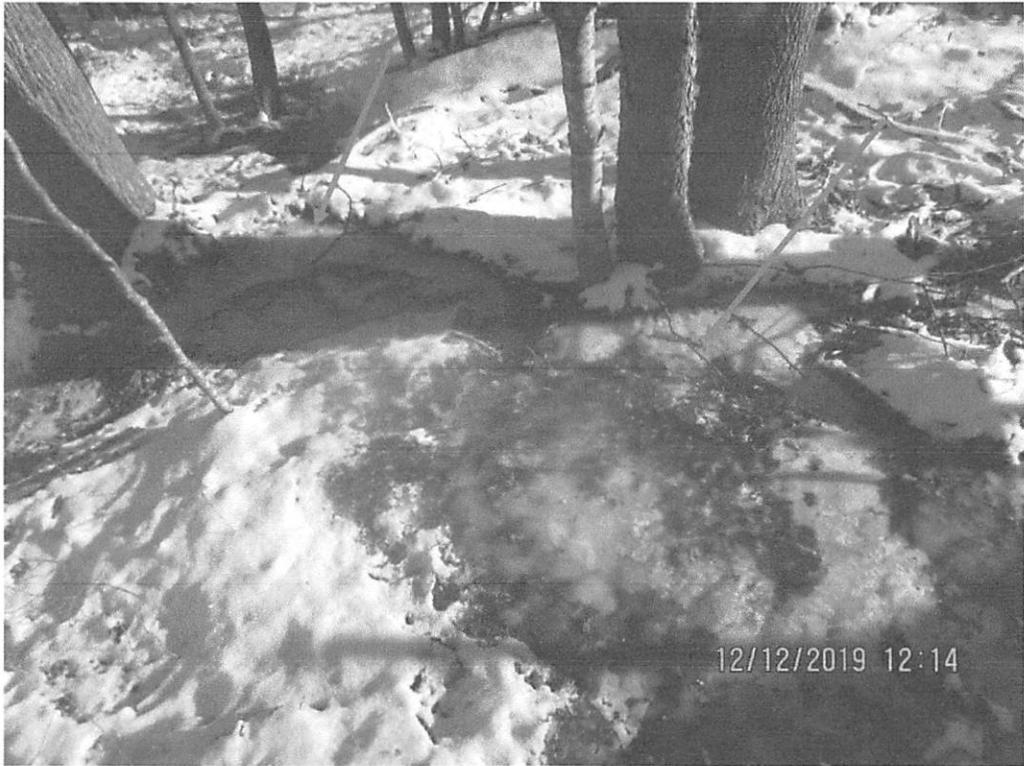
SLW present past controls at station 8433+50.

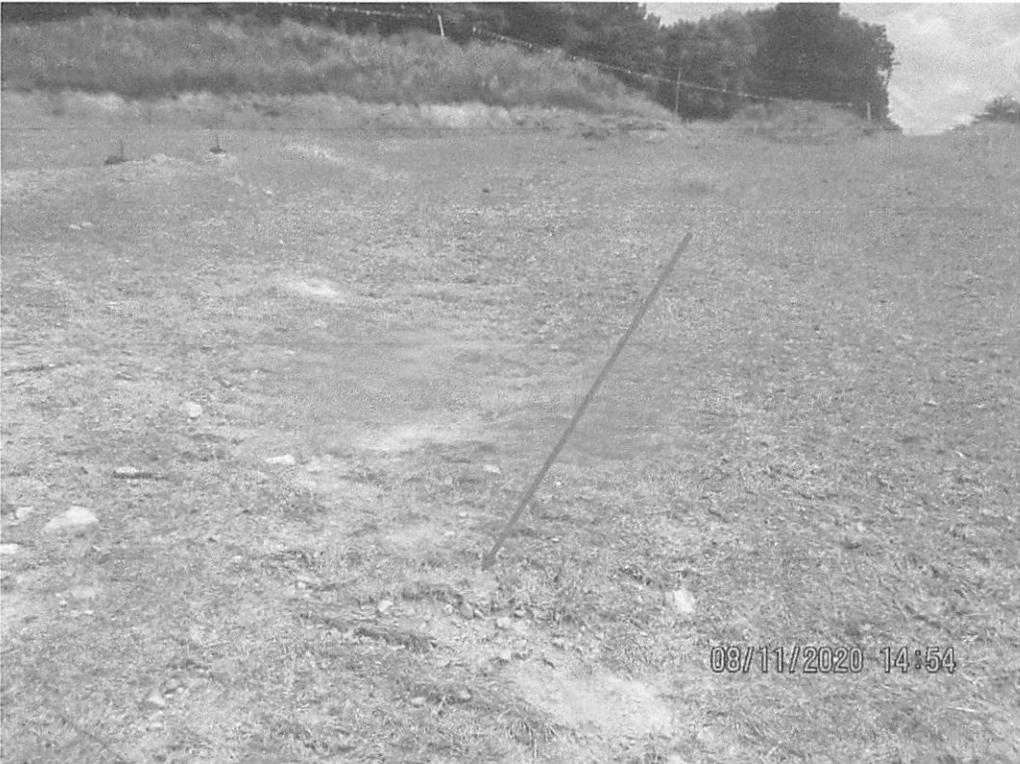
Facing East at the Route 39 crossing. Red arrow depicts where sheet flow was starting to form erosion rills in an area that had less than 70 percent vegetative coverage.

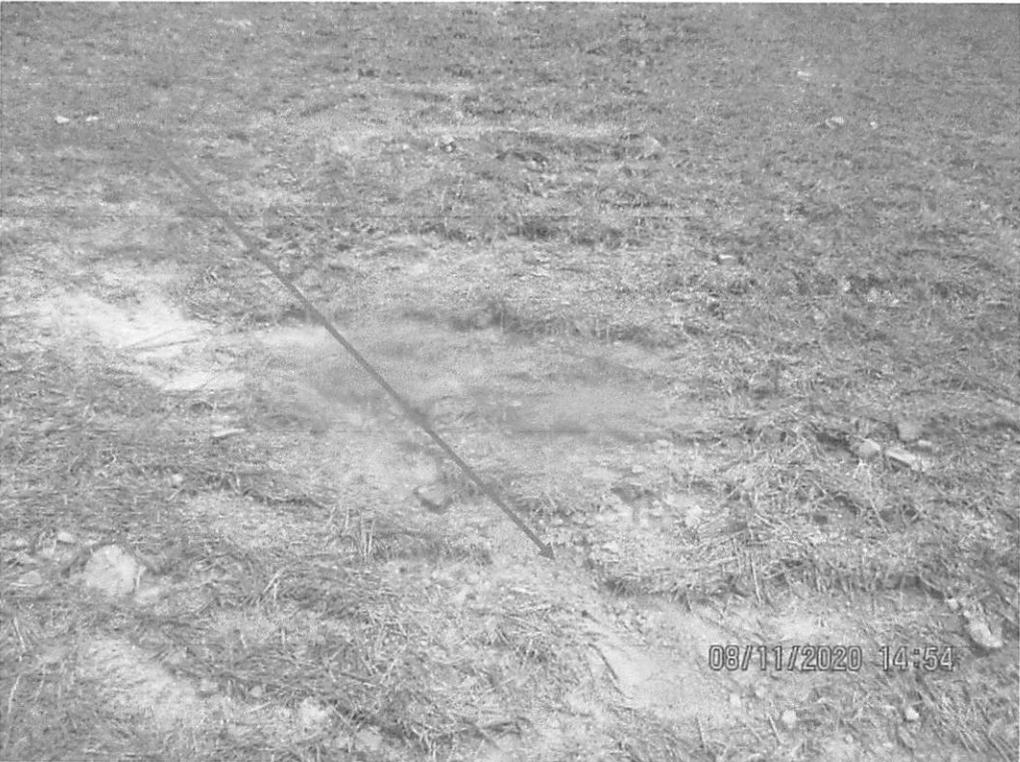
Facing East at the Route 39 crossing. Red arrow depicts where sheet flow was starting to form erosion rills in an area that had less than 70 percent vegetative coverage.

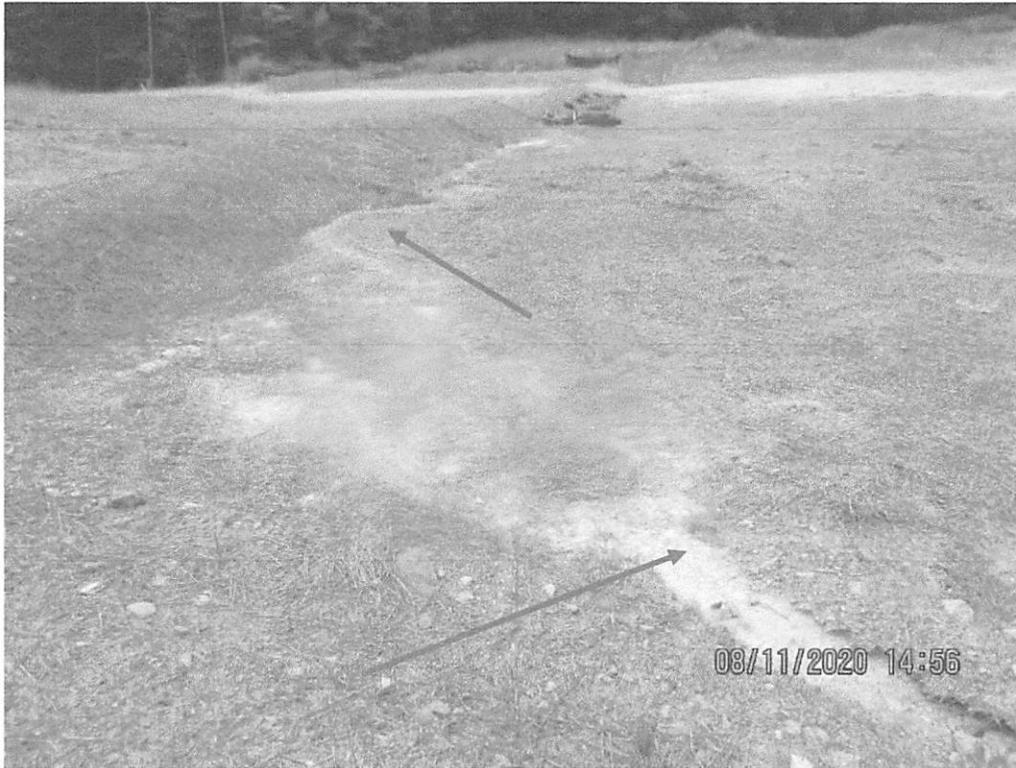
Facing Southwest at the Route 39 crossing. Red arrow depicts where concentrated flow of runoff was forming erosion rills on the slope and in the water bar. Less than 70 percent vegetative cover.

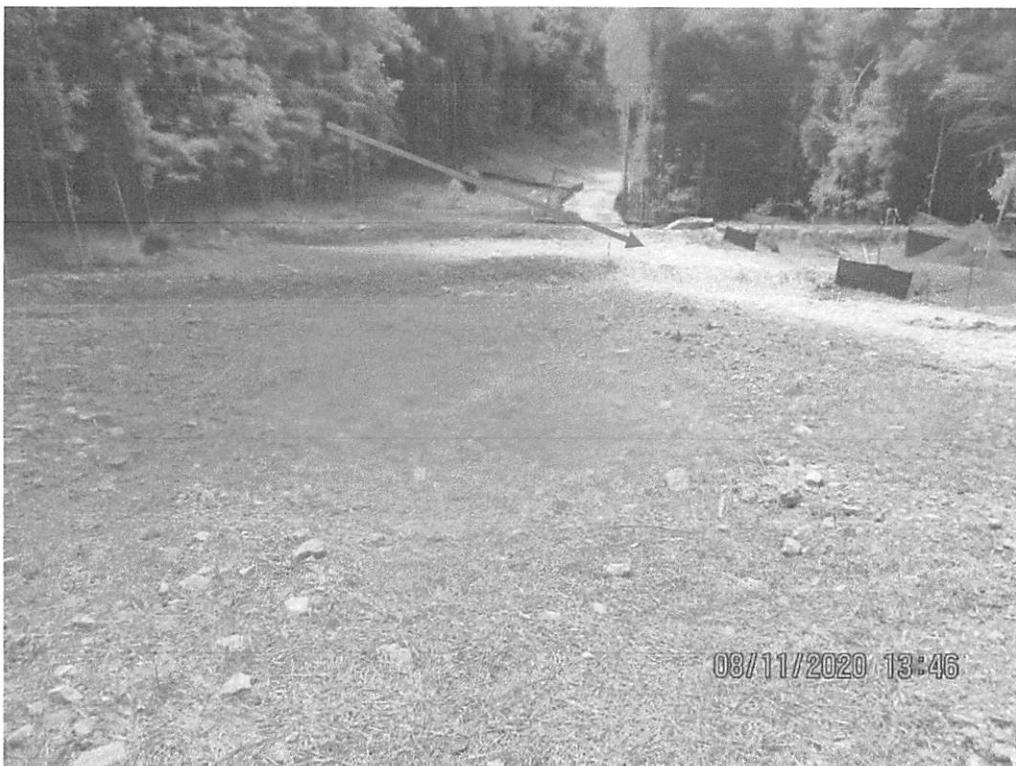
Facing South above Stream S-N10. Red arrow depicts where travel lane was reseeded. To the right and left of the travel lane, vegetative cover was less than 70 percent.

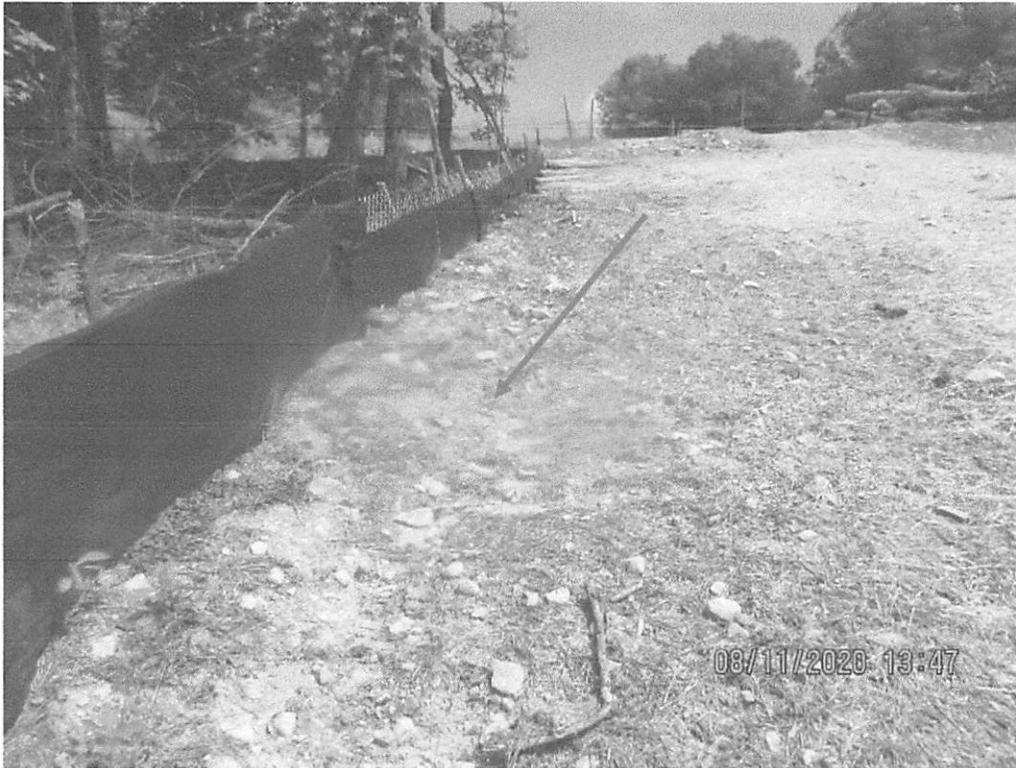
Facing North above Stream S-N10. Perimeter controls were recently replaced. However, erosion was present along controls lacking j-hooks.

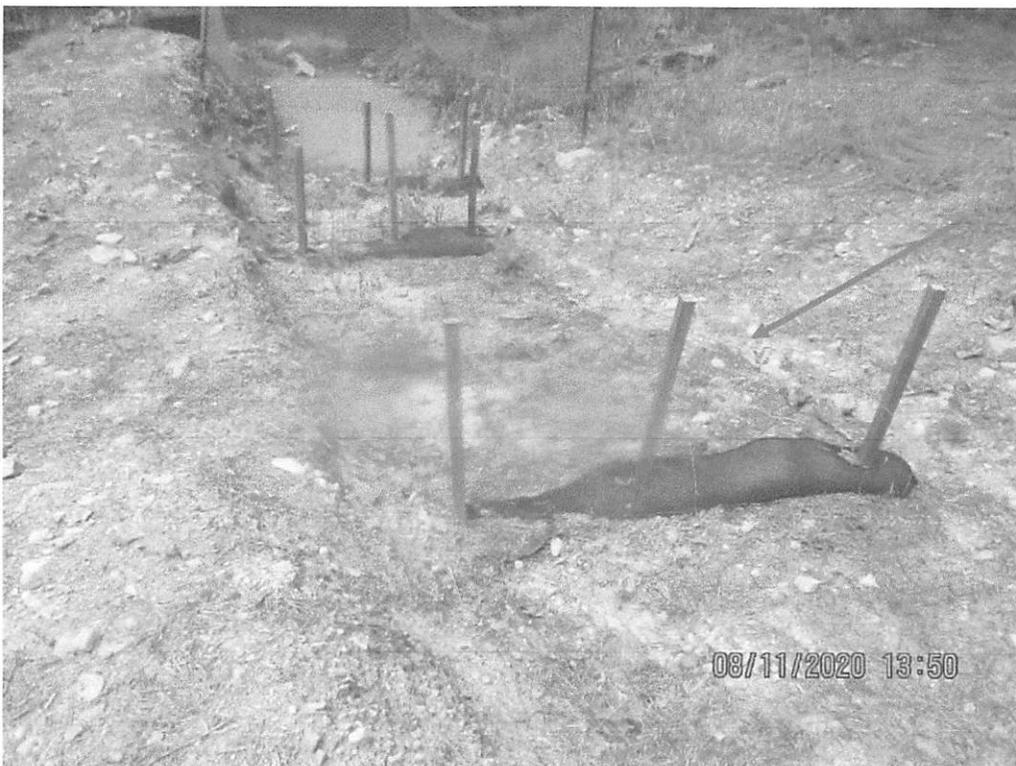
Controls in waterbar on fill slope needed maintenance. Runoff was causing erosion within waterbar and flowing around controls (red arrow).

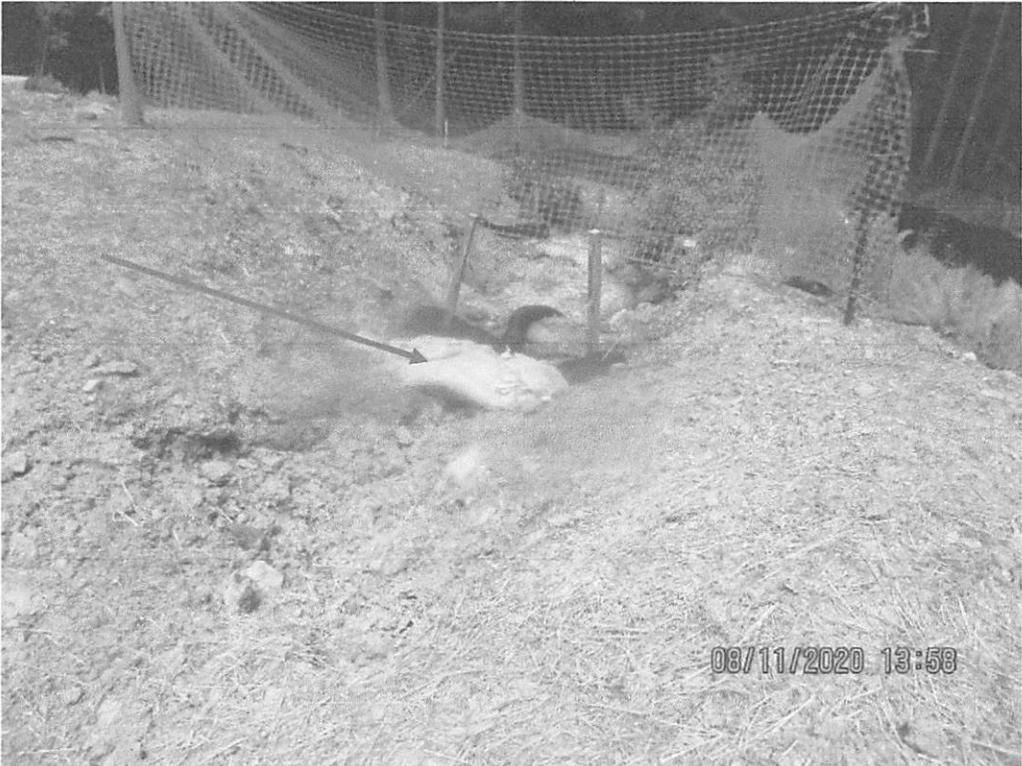
Waterbar outlet terminating onto fill slope. Red arrow depicts recently installed slope drain at top of slope. No sump present at top of slope.

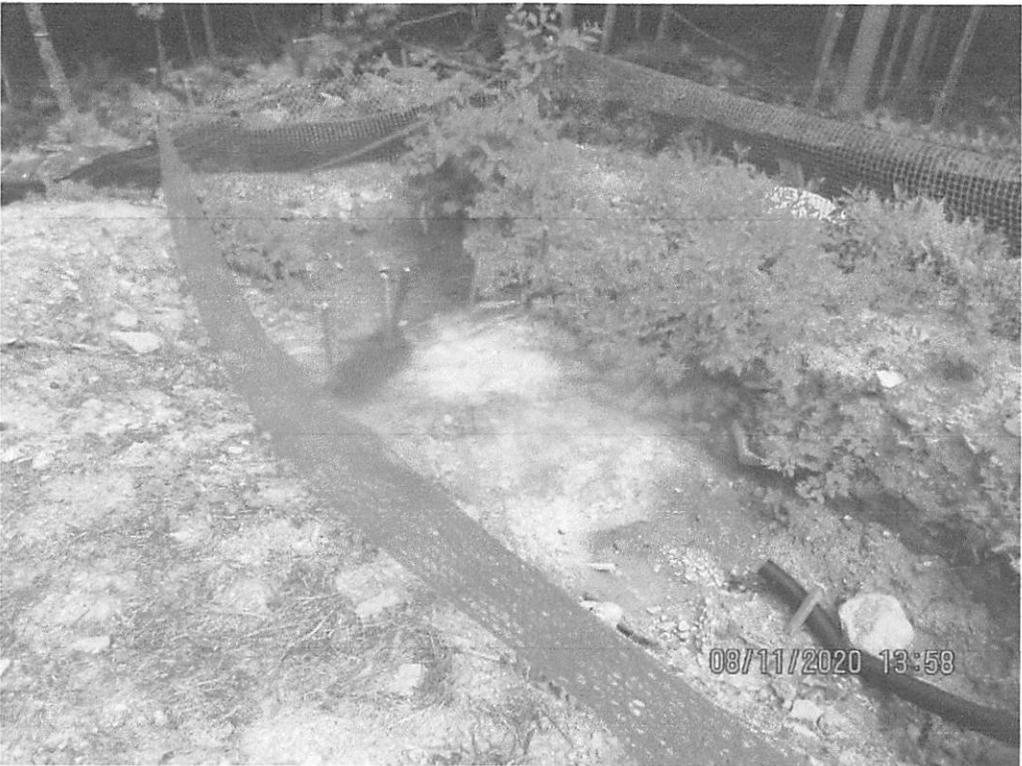
Fill slope below slope drain outlet near Station No. 6485+50.

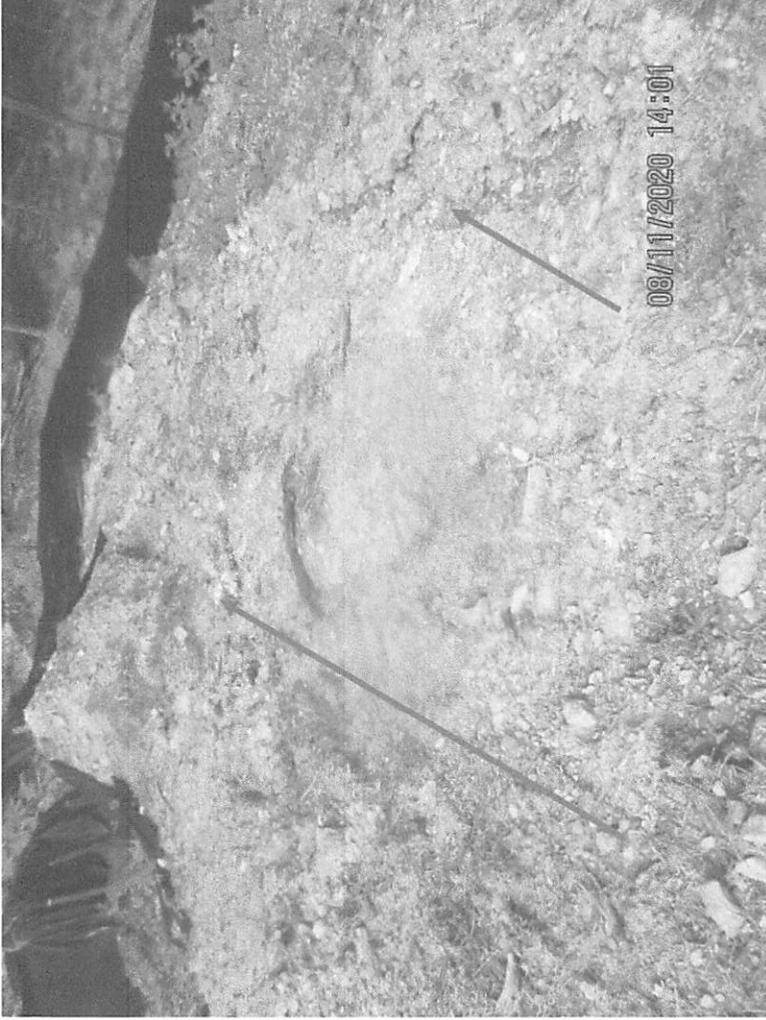
Erosion on fill slope near Station No. 6485+50. Lack of 70 percent vegetative cover and slope was not reseeded.

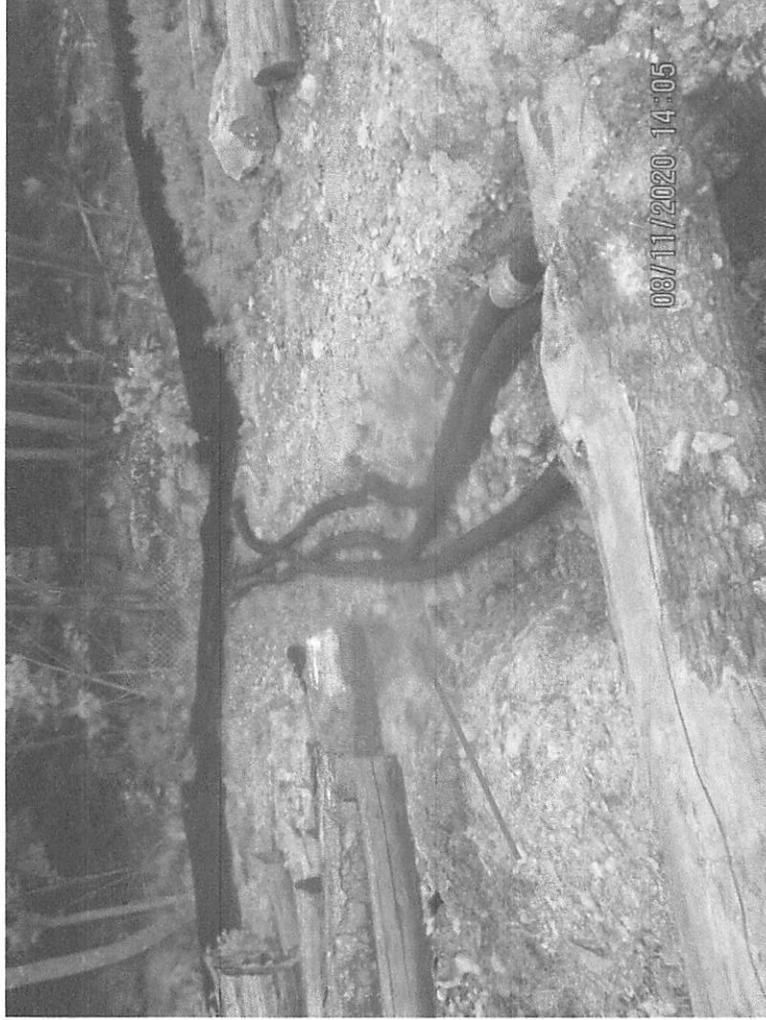
Slope below slope drain install. Erosion present (red arrow) where slope drains were installed and next to the log piles.

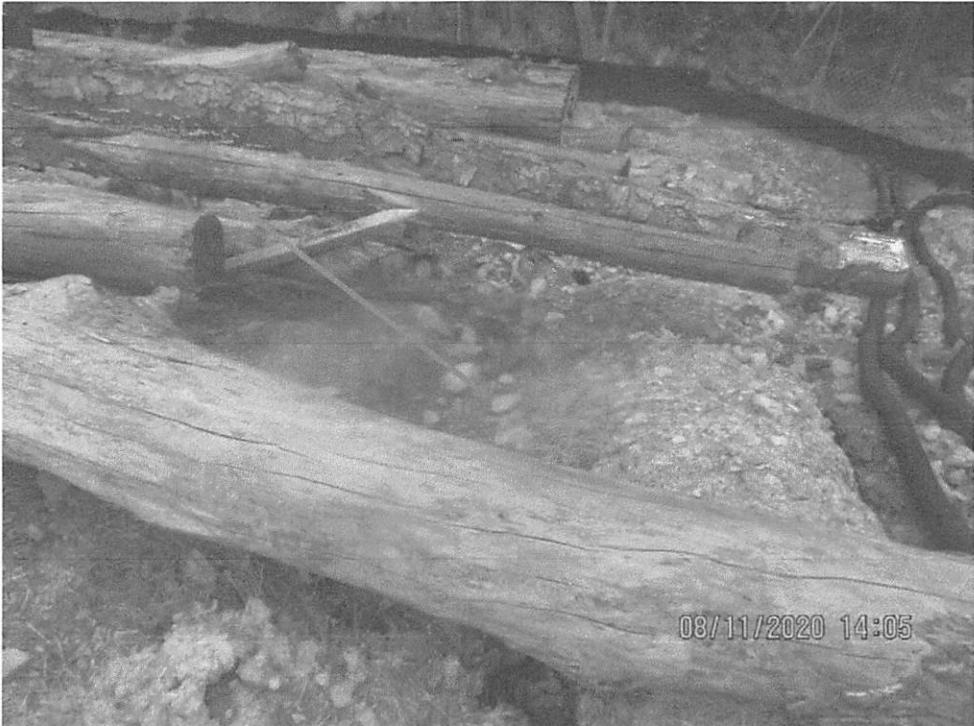
Erosion present (red arrow) next to log pile and slope drains that were recently installed near Station No. 6485+50.

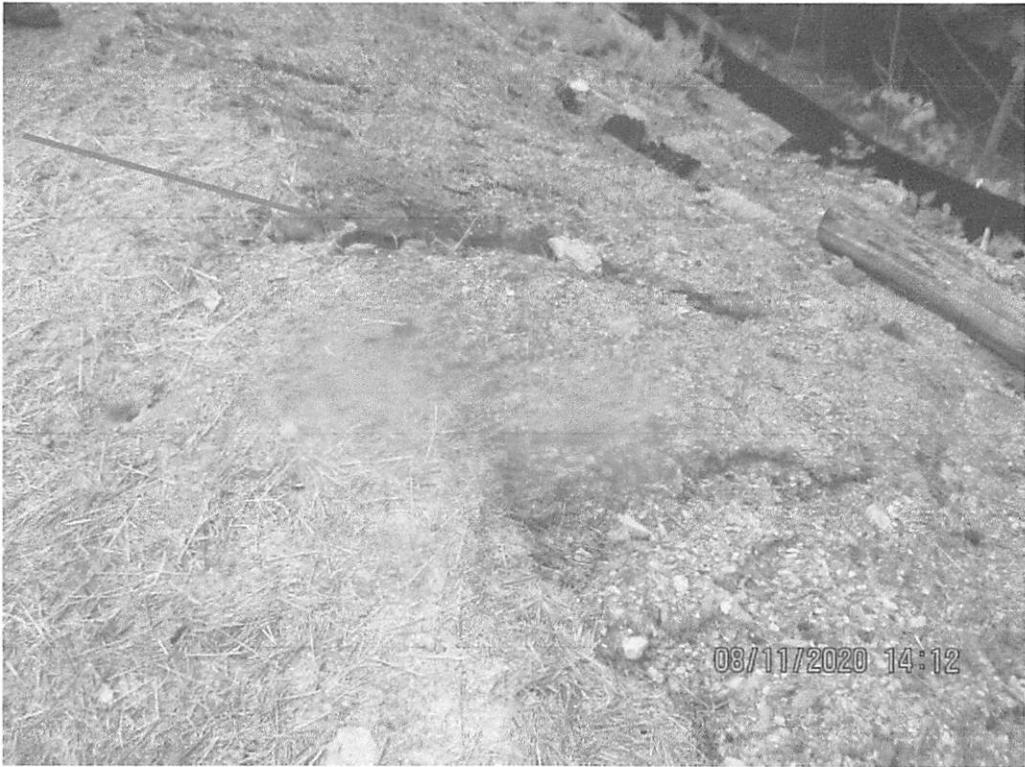
Fill slope erosion above log piles near Station No. 6485+50.

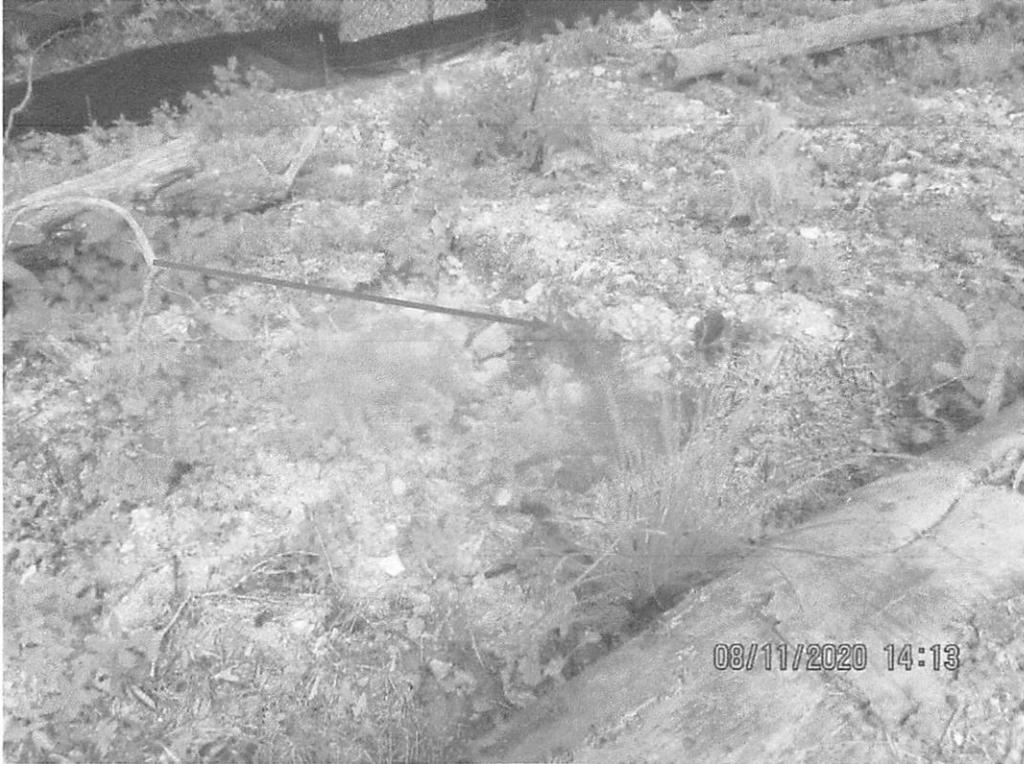
Erosion on fill slope below log pile (red arrow) near Station No. 6485+50.

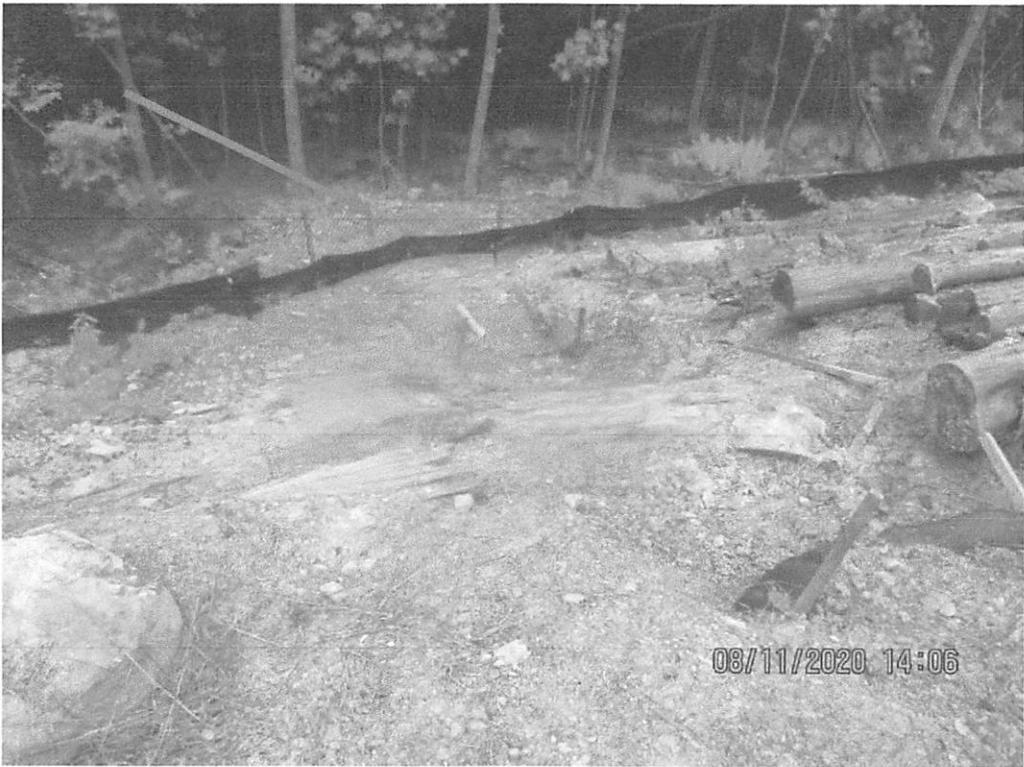
Erosion on fill slope adjacent to log pile near Station No. 6485+50. Sediment deposits were past the LOD (red arrow).

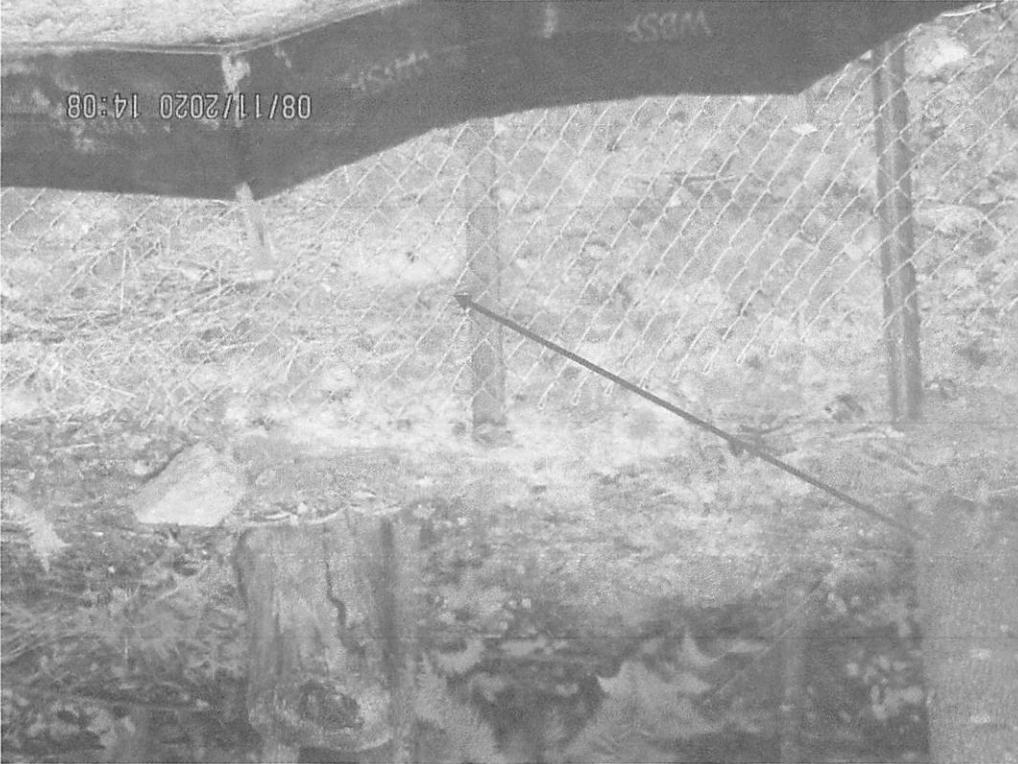
Near Station No. 6485+50. Sediment deposits were past the LOD (red arrow).

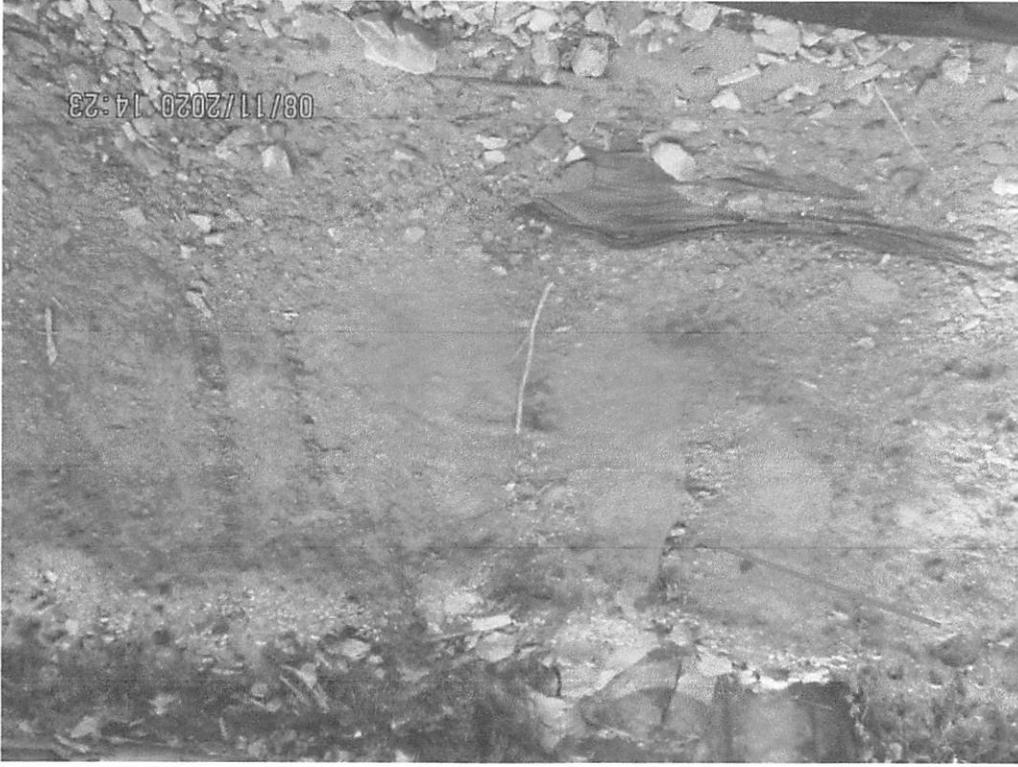
Erosion on cut slope above slope drain inlet at Station No. 6490+00.

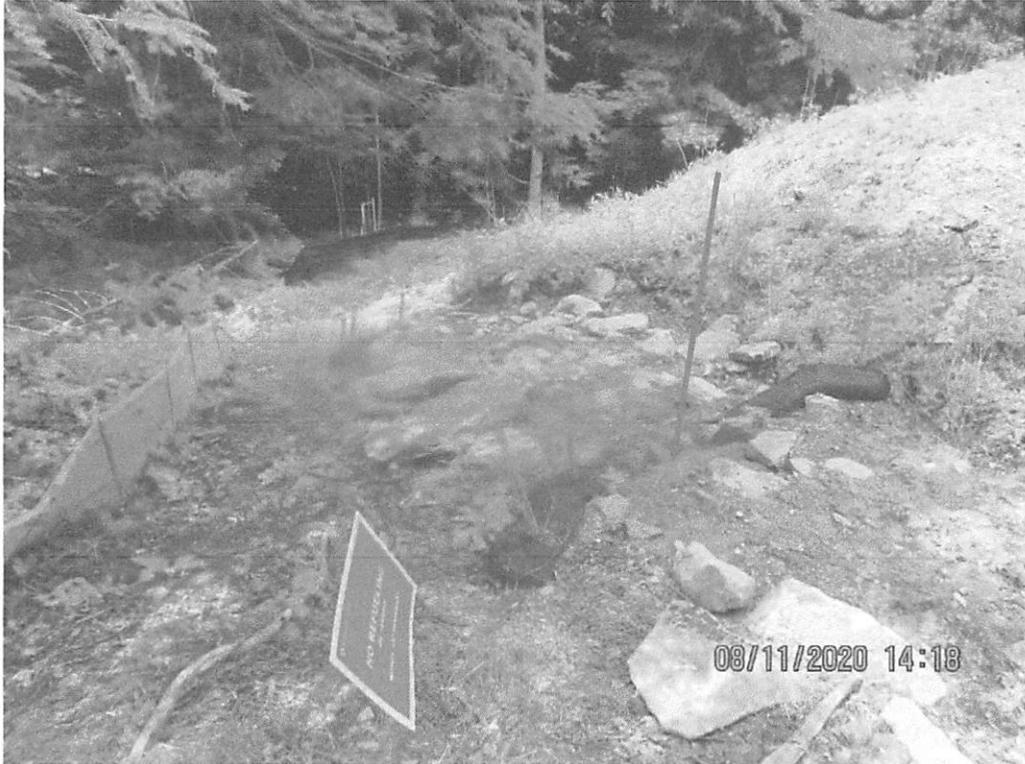
Downslope of slope drain outlet at Station No. 6490+00. Sediment deposits behind controls.

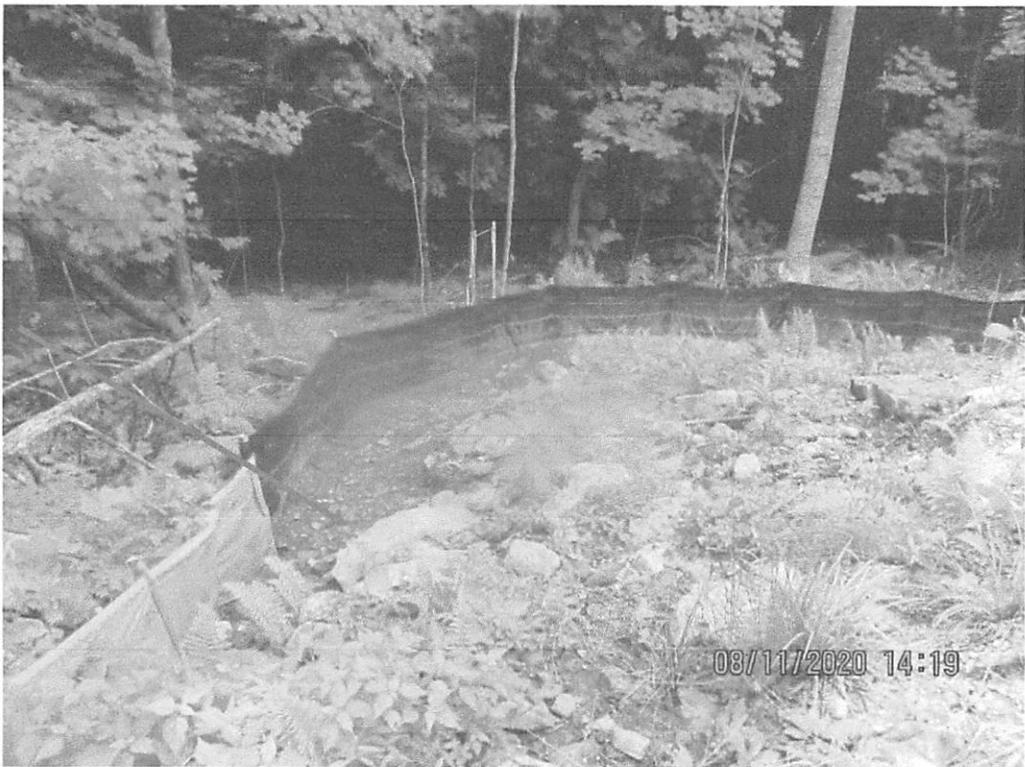
Downslope of the slope drain outlet at Station No. 6490+00. Sediment deposits behind controls due to erosion occurring upslope.

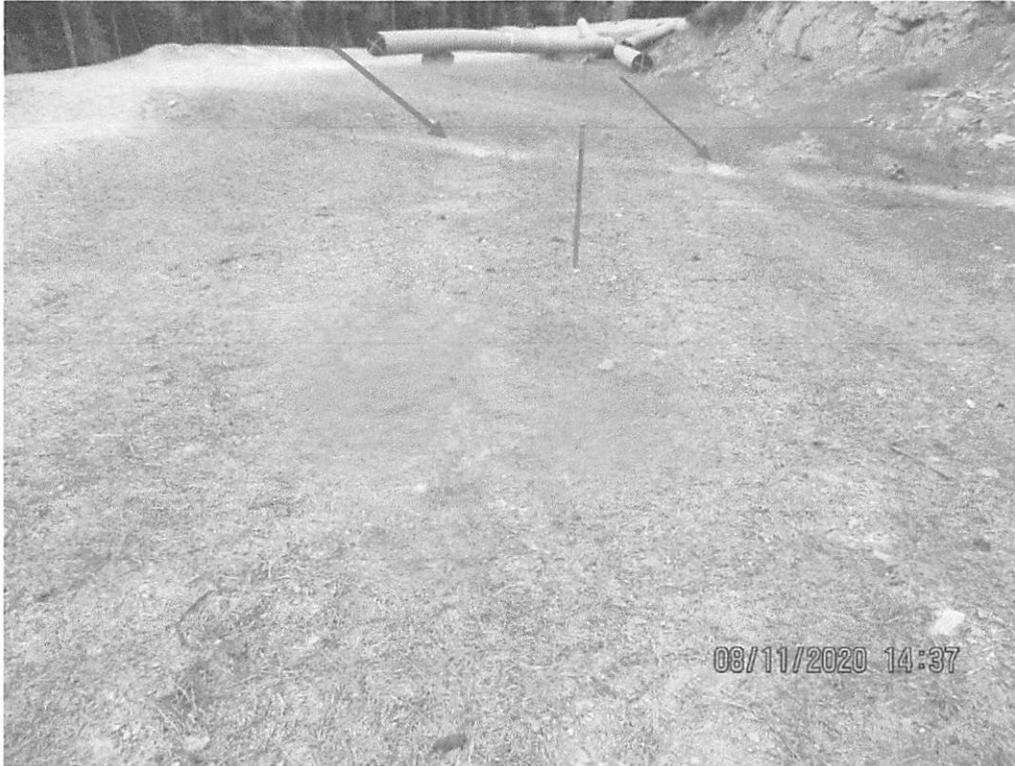
Near Station No. 6485+50 facing North. Sheet flow transporting sediment toward waterbar with sediment deposits (red arrows) in waterbar. Lack of 70 percent vegetative coverage.

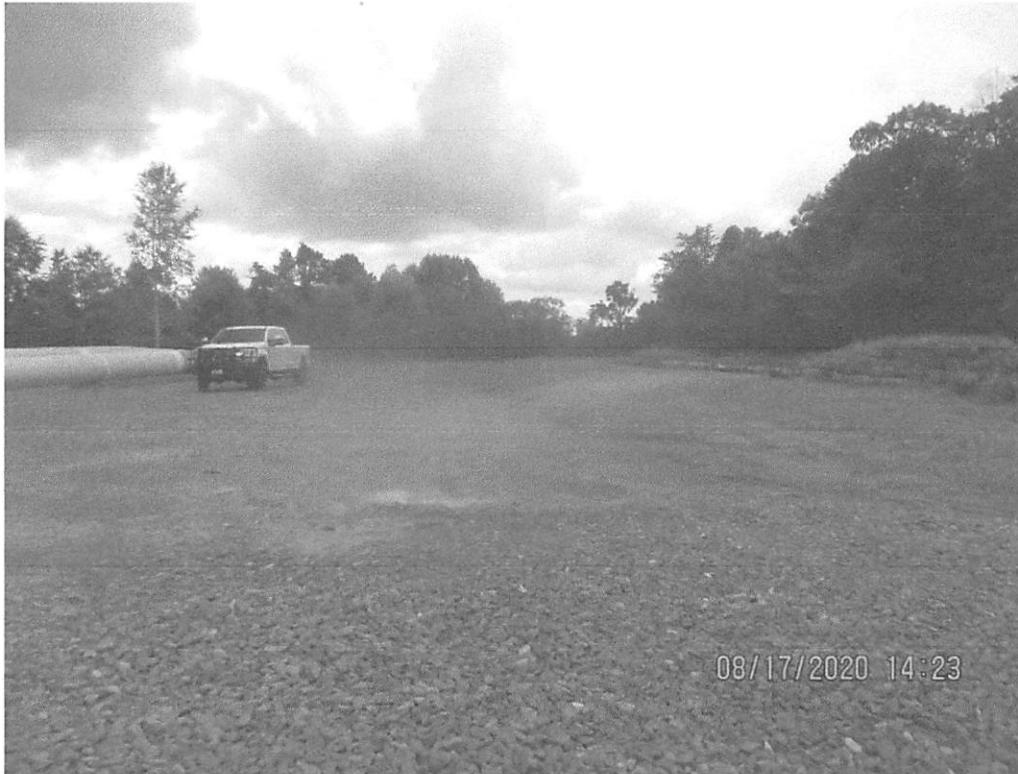
Facing South at Station No. 6613+00. Less than 70 percent vegetative coverage present.

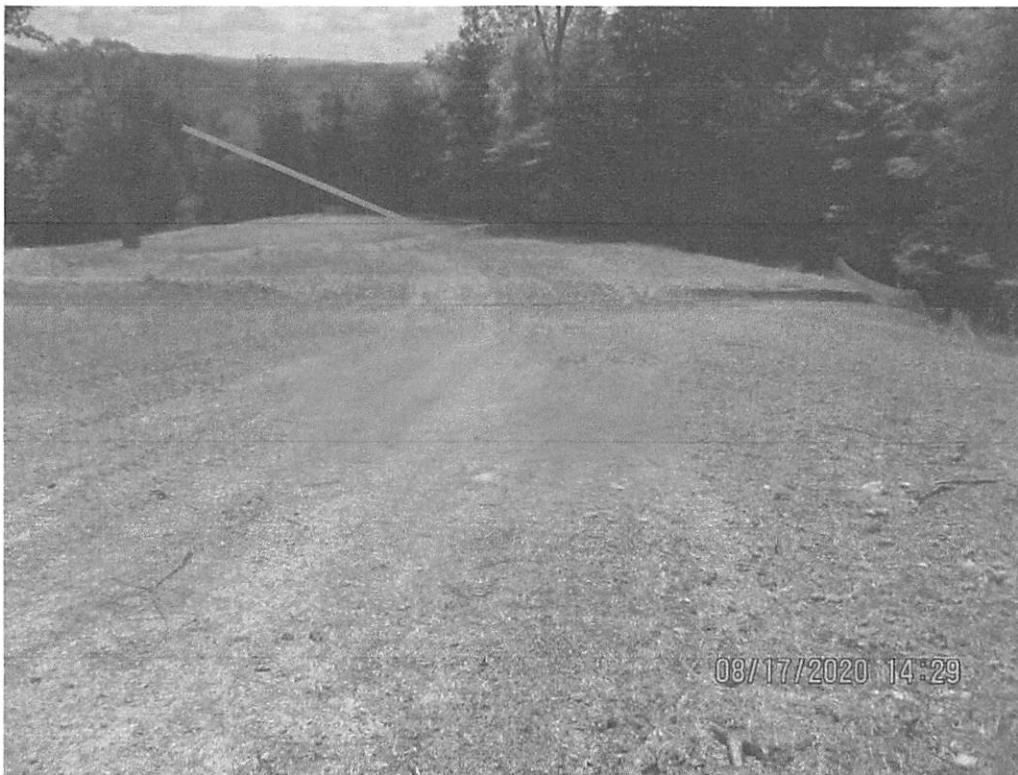
Facing downslope (South) near Station No. 6617+00. Less than 70 percent vegetative coverage. Erosion present in waterbar.

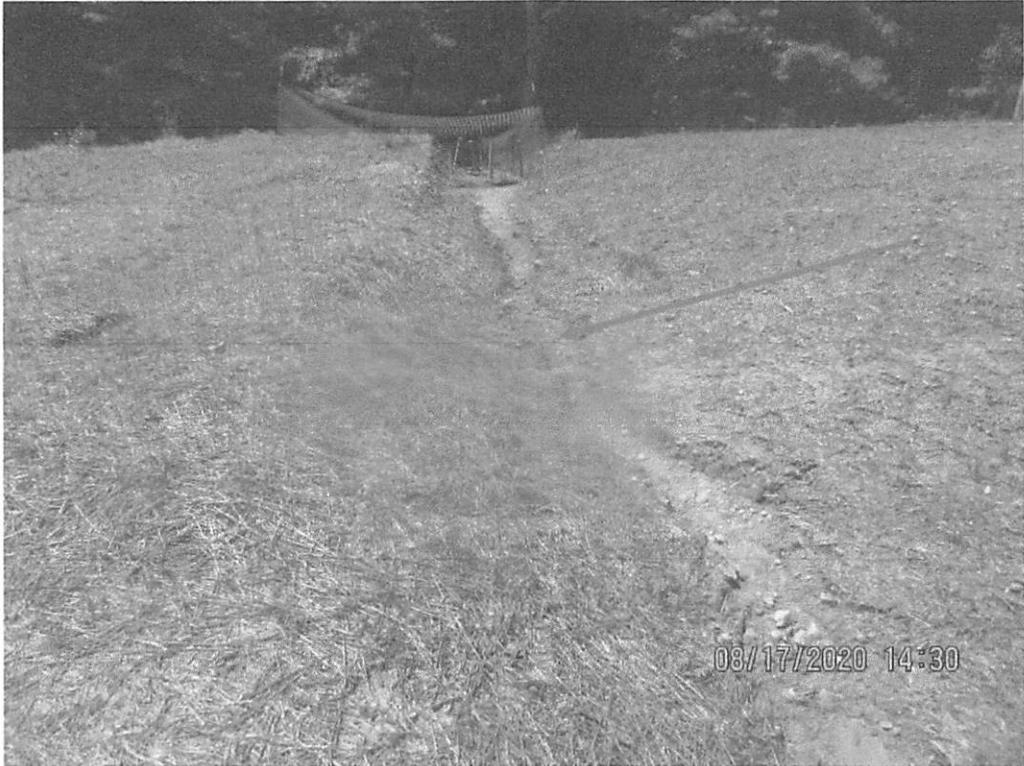
Facing downslope (South) near Station No. 6617+00. Less than 70 percent vegetative coverage. Erosion present in waterbar.

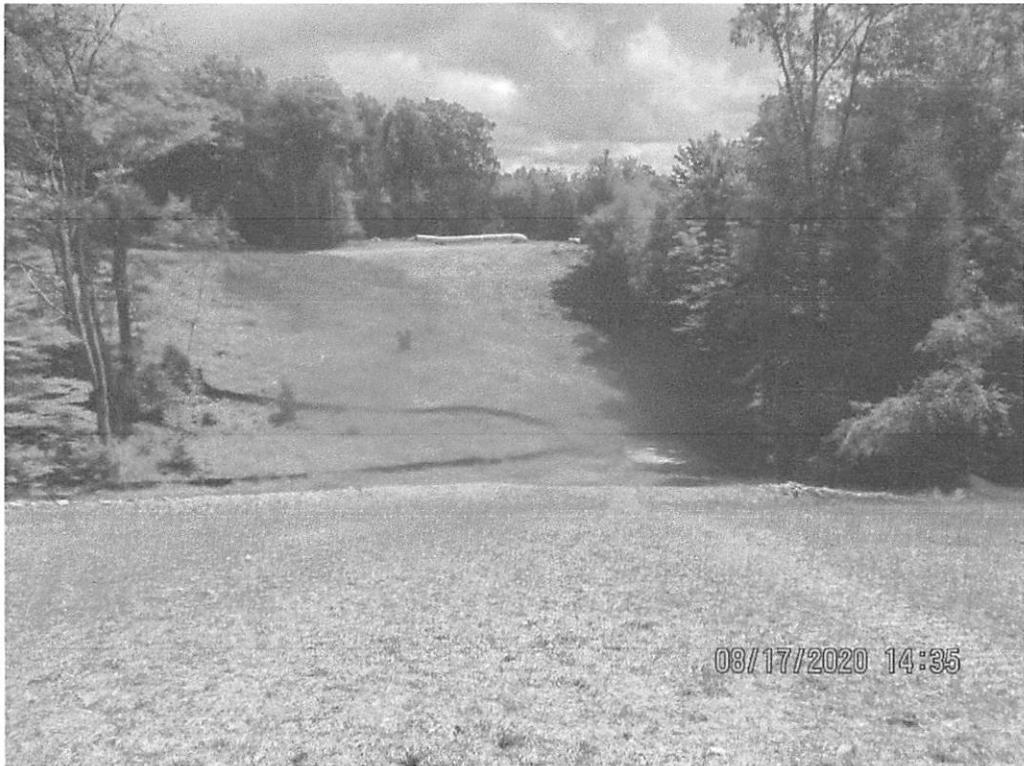
Facing South toward Station No. 6617+00 and Stream S-L37. Less than 70 percent vegetative coverage present.

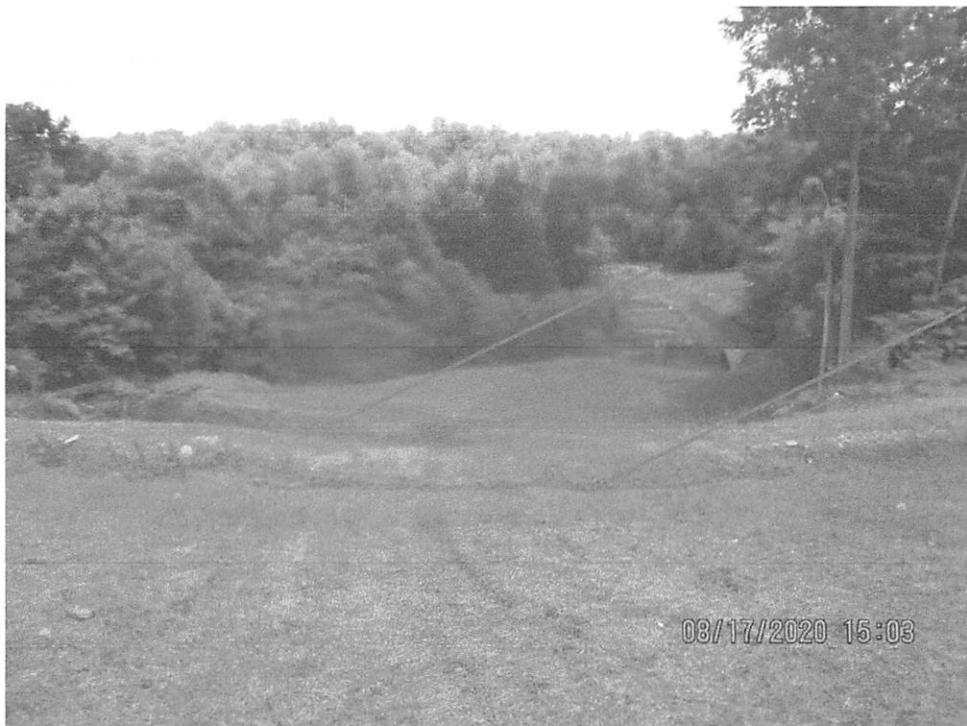
Standing at the Odell town road crossing at Station No. 6613+00 facing North. 70 percent vegetative coverage not present. Erosion present in waterbars (red arrows).

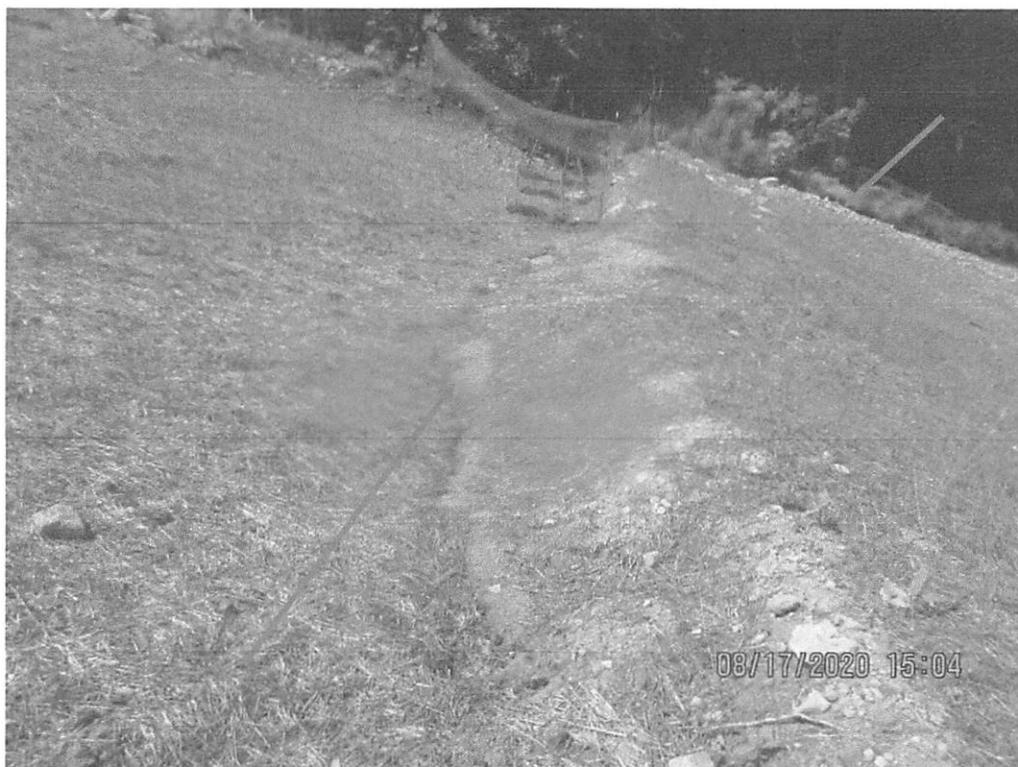
Station No. 6613+00 downslope toward waterbar that failed. 70 percent vegetative coverage not present. Erosion present in waterbar and at outlet (red arrows).
