**CONSENT ORDER
ISSUED UNDER THE
WATER POLLUTION CONTROL ACT
WEST VIRGINIA CODE, CHAPTER 22, ARTICLE 11**

TO: Mountain Valley Pipeline, LLC
Robert J. Cooper
2200 Energy Drive
Canonsburg, PA 15317

DATE: December 17, 2020

ORDER NO.: 9925

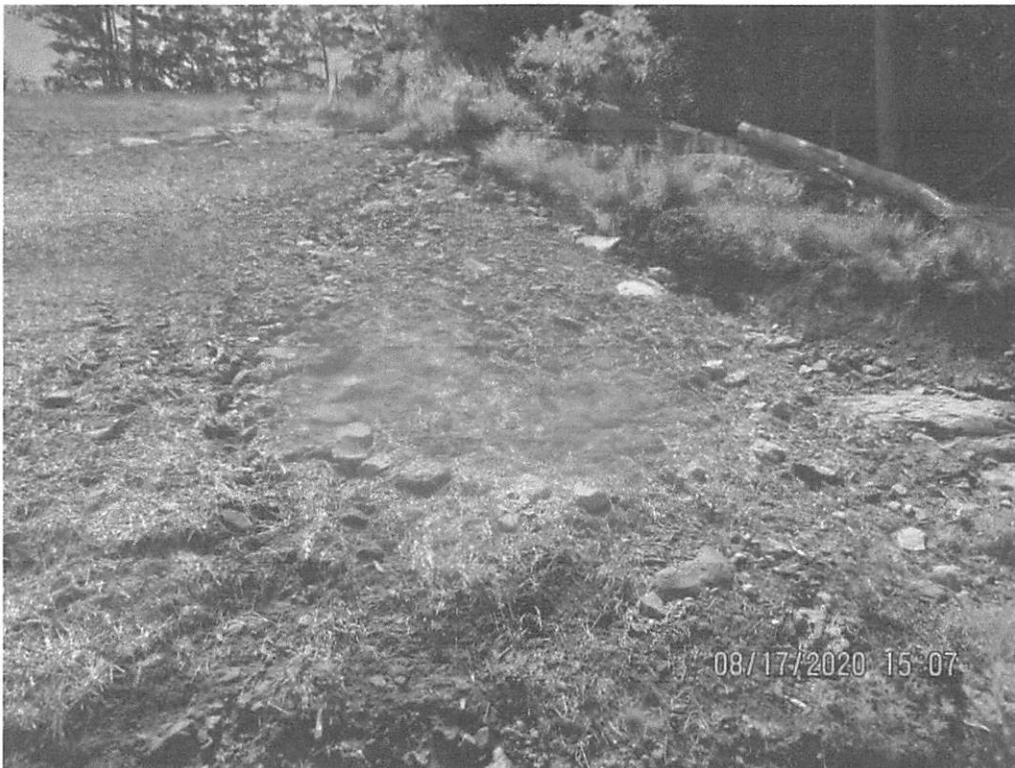
Facing upslope at waterbar that had failed, was terminating onto the fill slope, and was causing erosion at Station No. 6613+00.

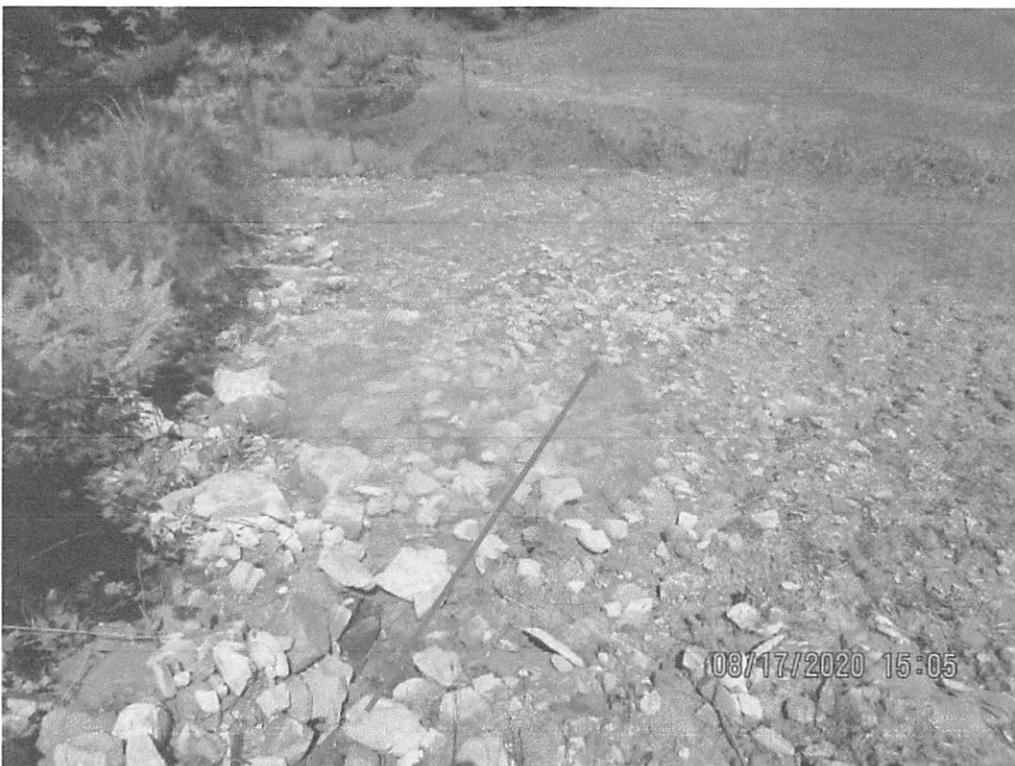
Facing downslope at the fill slope where the waterbar failed and was causing erosion at Station No. 6613+00.

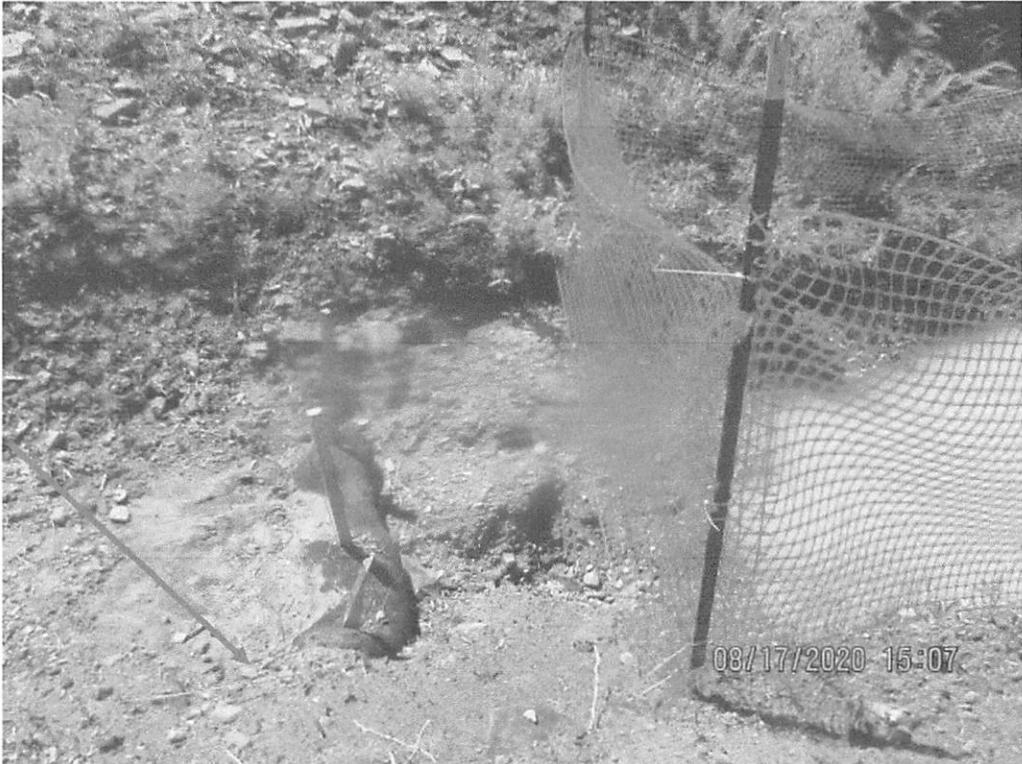
Sediment deposited into waterbar was overwhelming controls below. Waterbar failure and erosion occurring on fill slope at Station No. 6613+00.

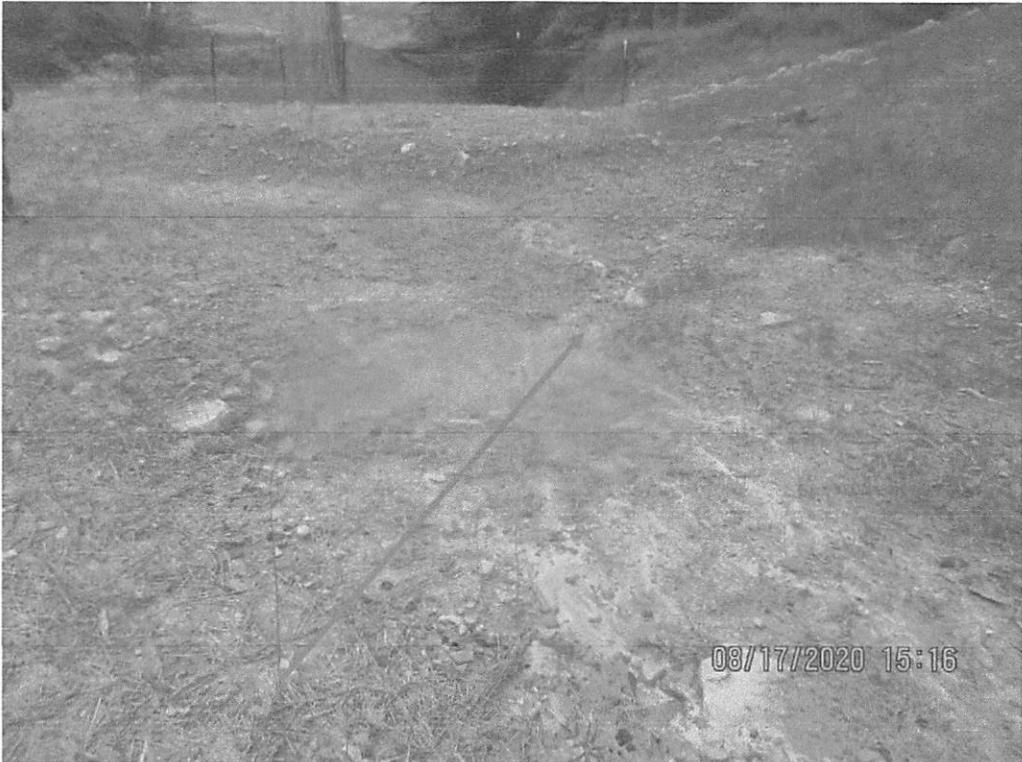
Erosion occurring on fill slope that is downslope from run-on being conveyed onto ROW at Station No. 6613+00.

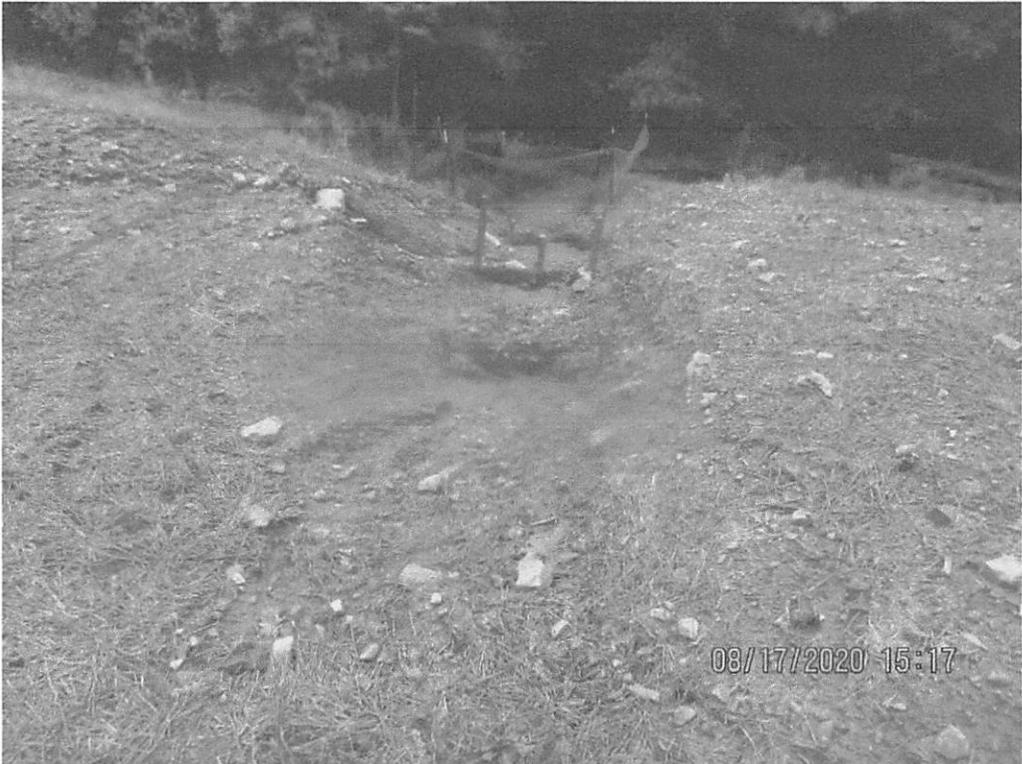
Waterbar downslope of Station No. 6613+00 with erosion present due to concentrated flows. Controls lacking maintenance and/or enhancement. Red arrow depicts erosion on fill slope above waterbar.

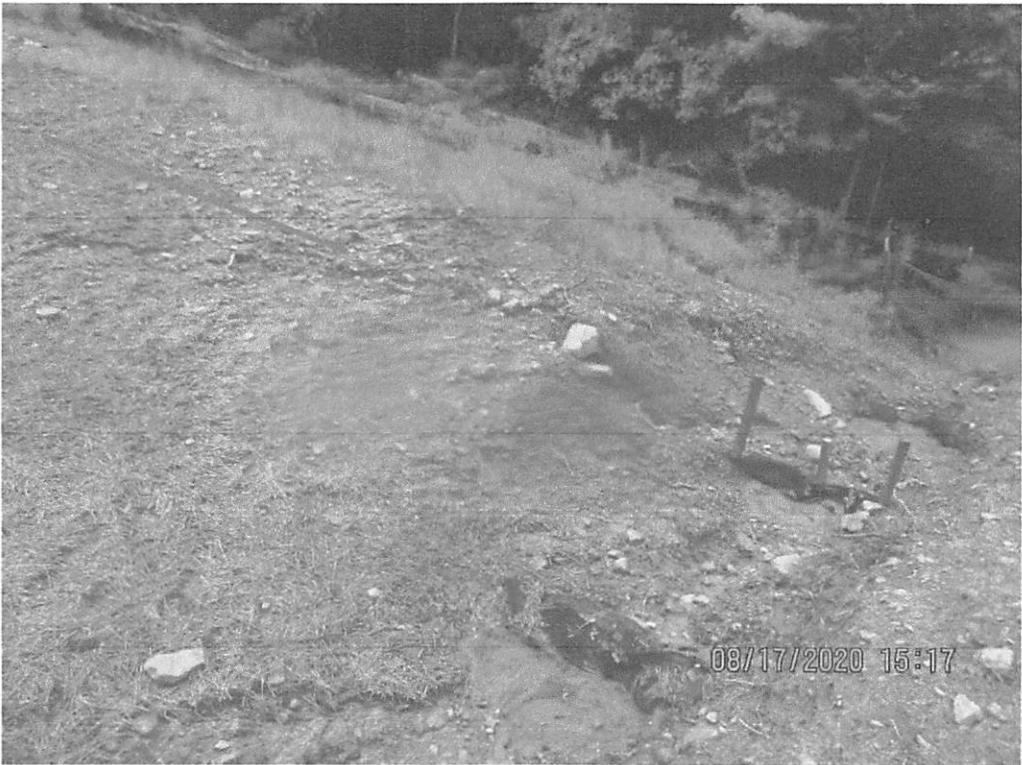
Waterbar downslope of Station No. 6613+00 with erosion present due to concentrated flows. Controls lacking maintenance and/or enhancement. Red arrow depicts erosion on fill slope above waterbar.

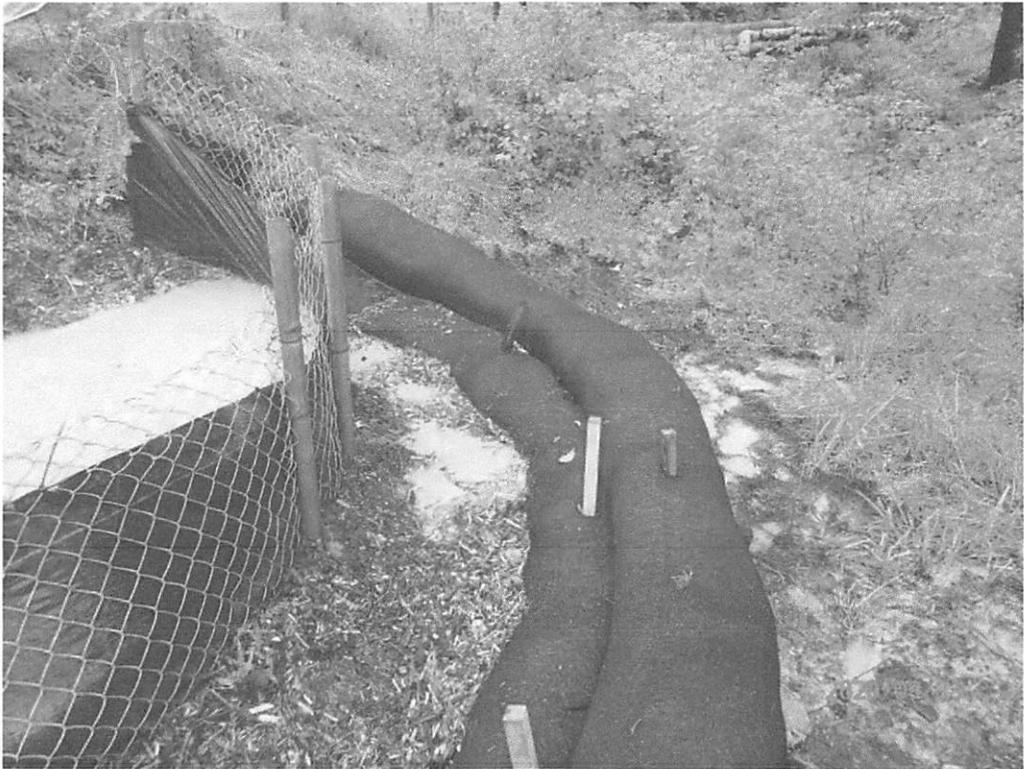
Controls below Stout Run Road were not effective at controlling sediment runoff

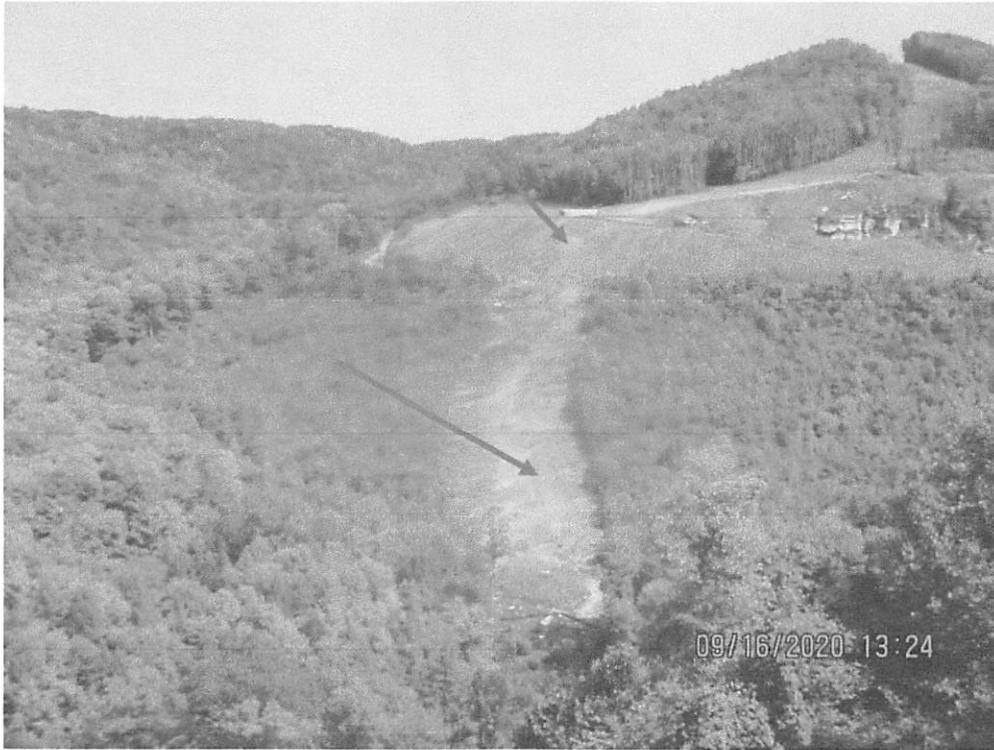
Standing at Station No. 6715+00 toward opposite slope at AR-160.01 (Station No. 6698+00 through 6707+00). Erosion observed on slope (red arrows).

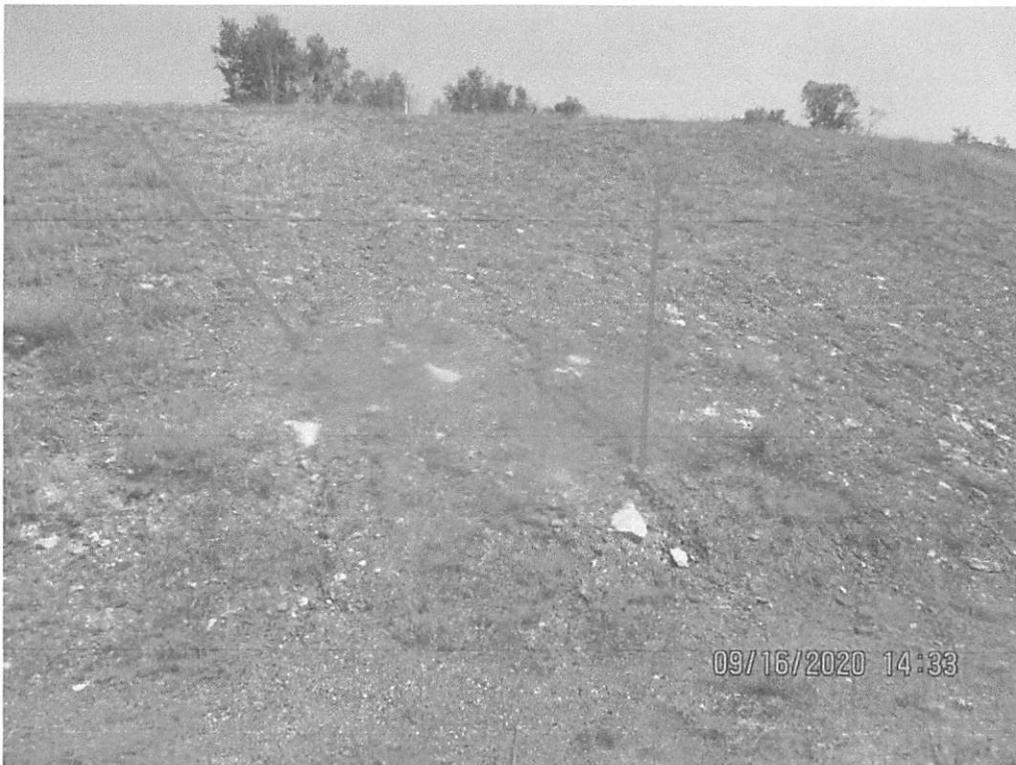
Rill erosion occurring on slope above AR-160.1 at Station No. 6698+00.

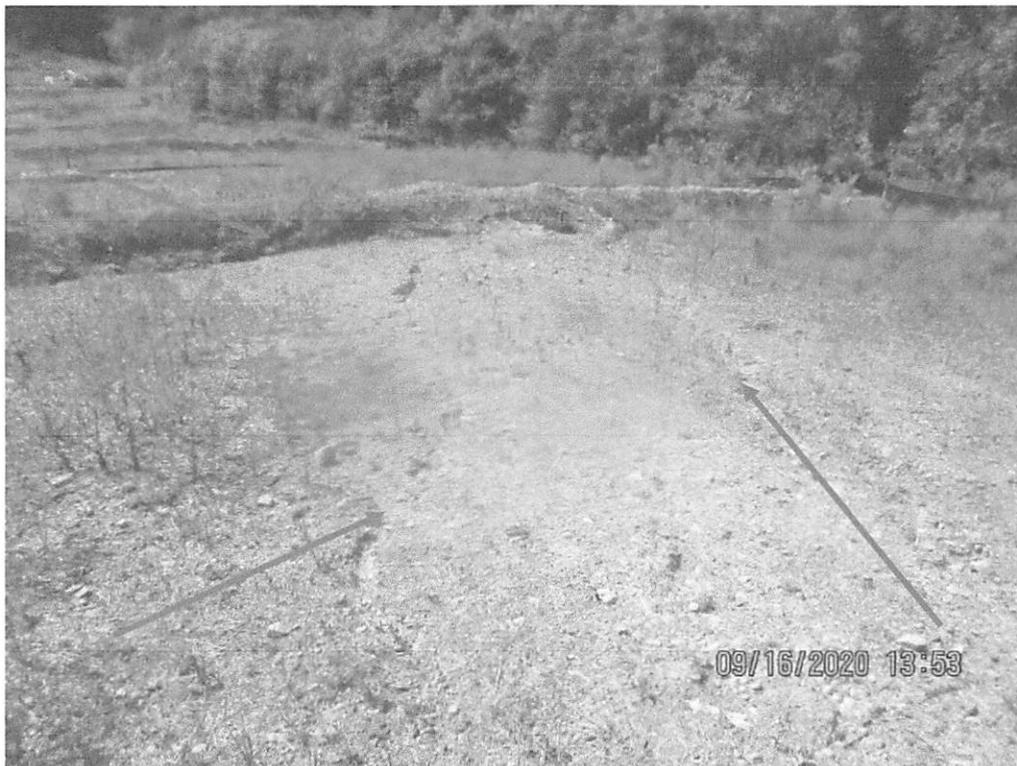
Facing downslope near station No. 6698+00. Erosion occurring between waterbars on slope (red arrow) and in waterbars.

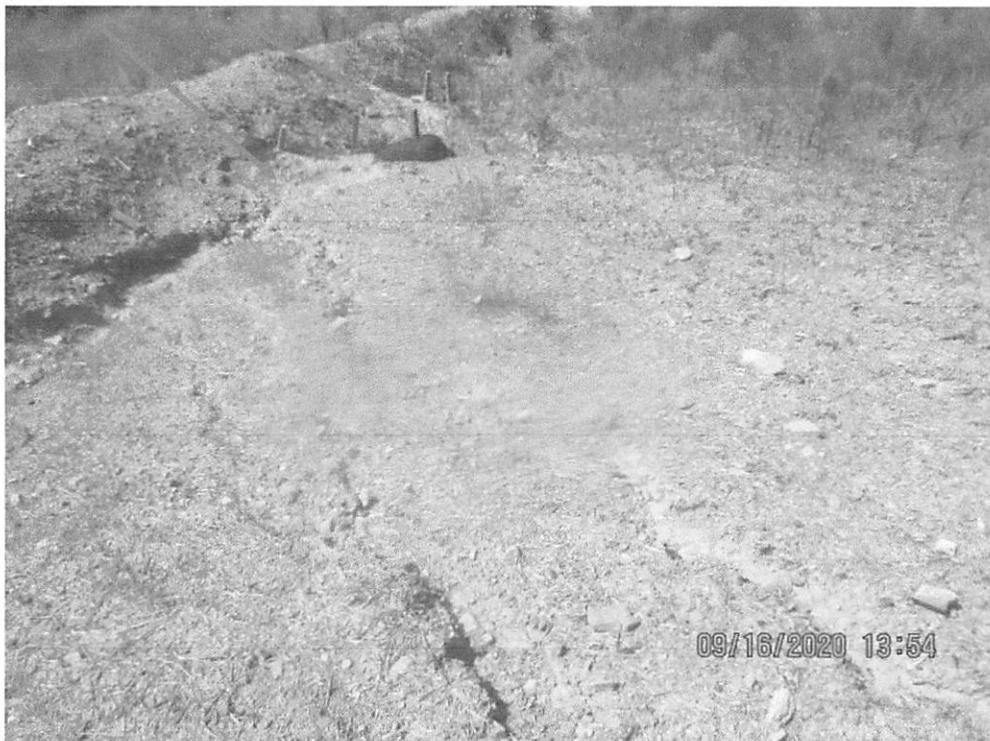
Facing downslope near station No. 6698+00. Erosion occurring between waterbars on slope and in waterbars. Controls lacking maintenance within waterbar (red arrow).

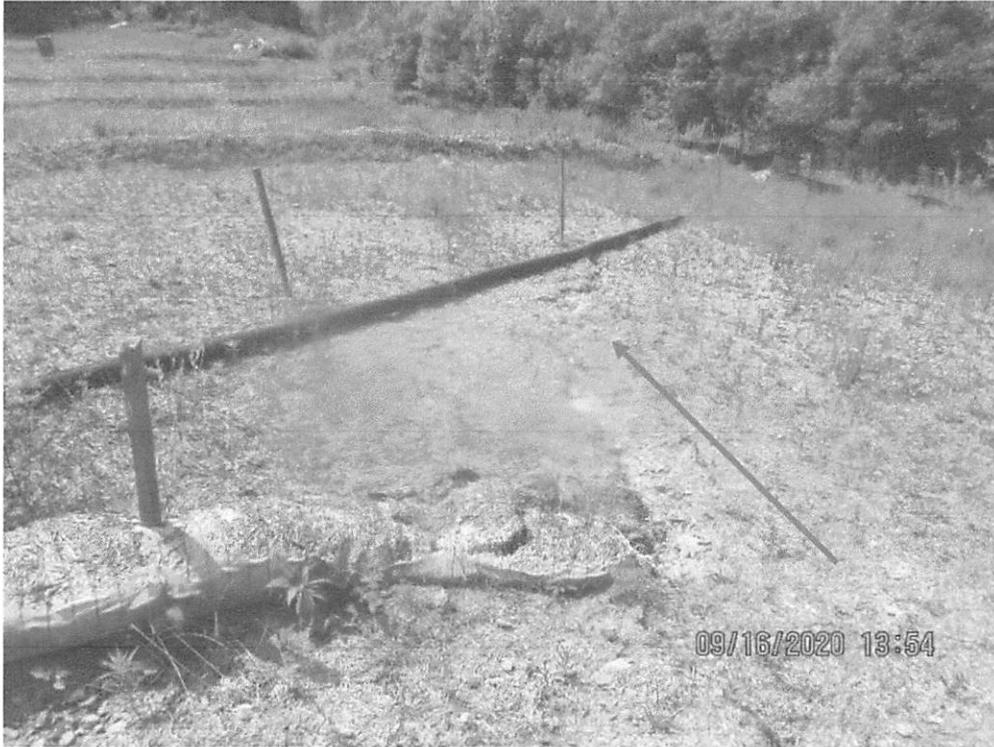
Further downslope from Station No. 6698+00 where trench drain was out-letting onto fill slope and causing erosion (red arrow).

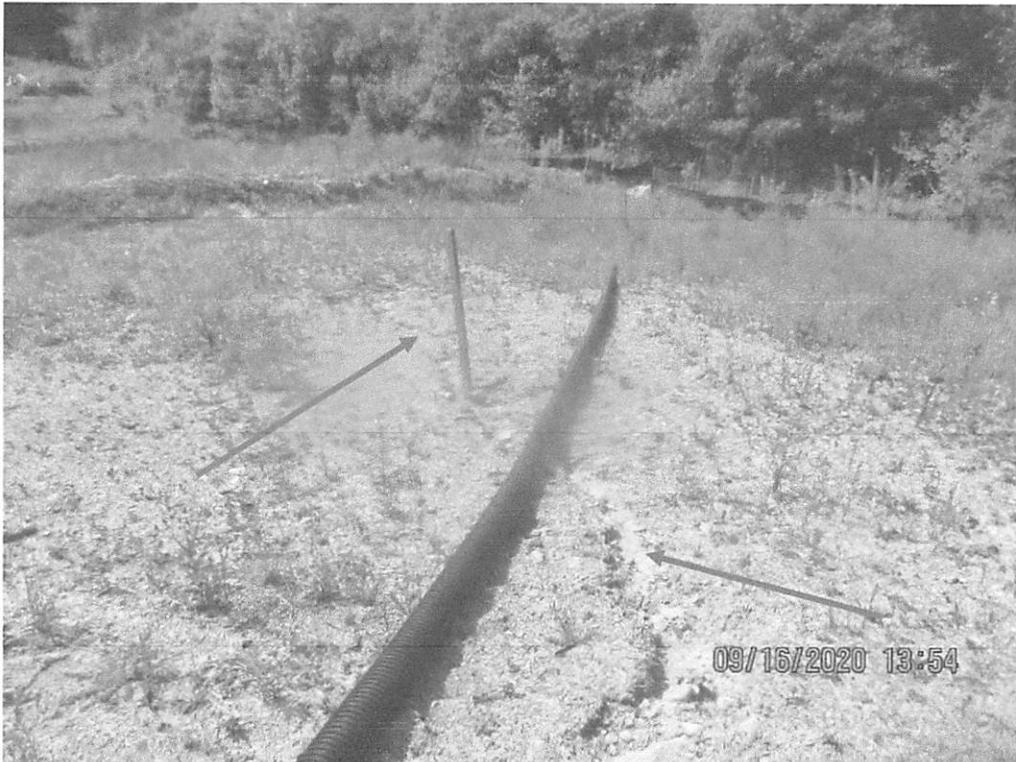
Erosion present on slope below pipe trench drain outlet and slope drain.

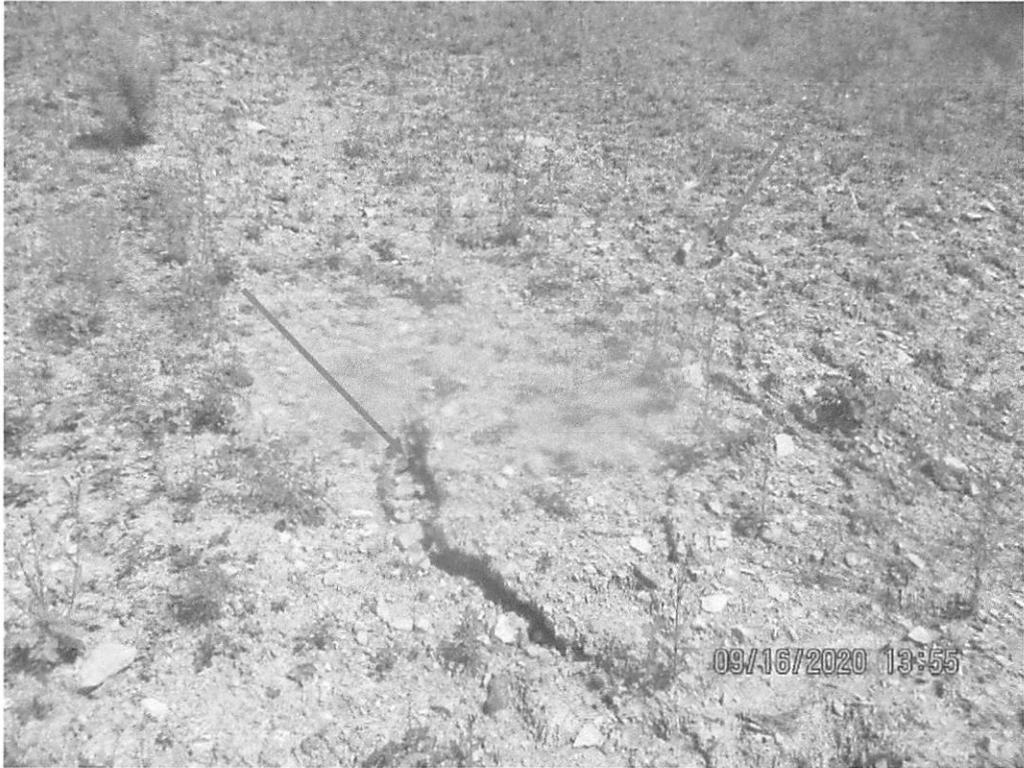
Rill erosion occurring between waterbars downslope near Station No. 6703+00.

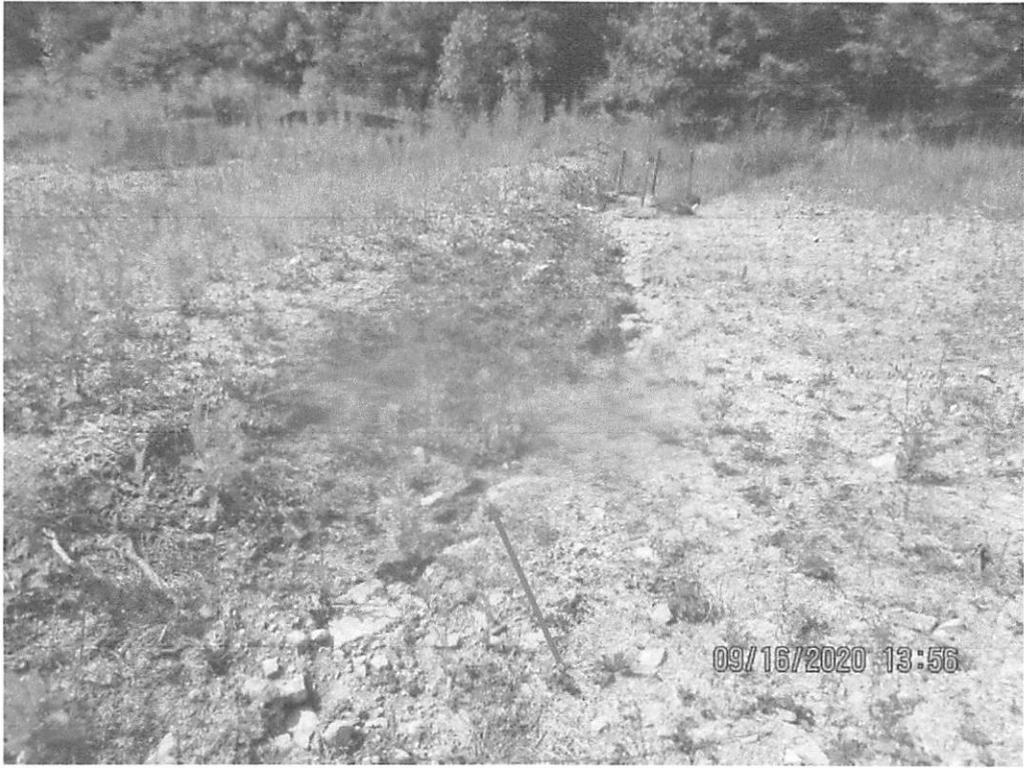
Waterbar with erosion present near Station No. 6703+00, controls in waterbar lacking maintenance.

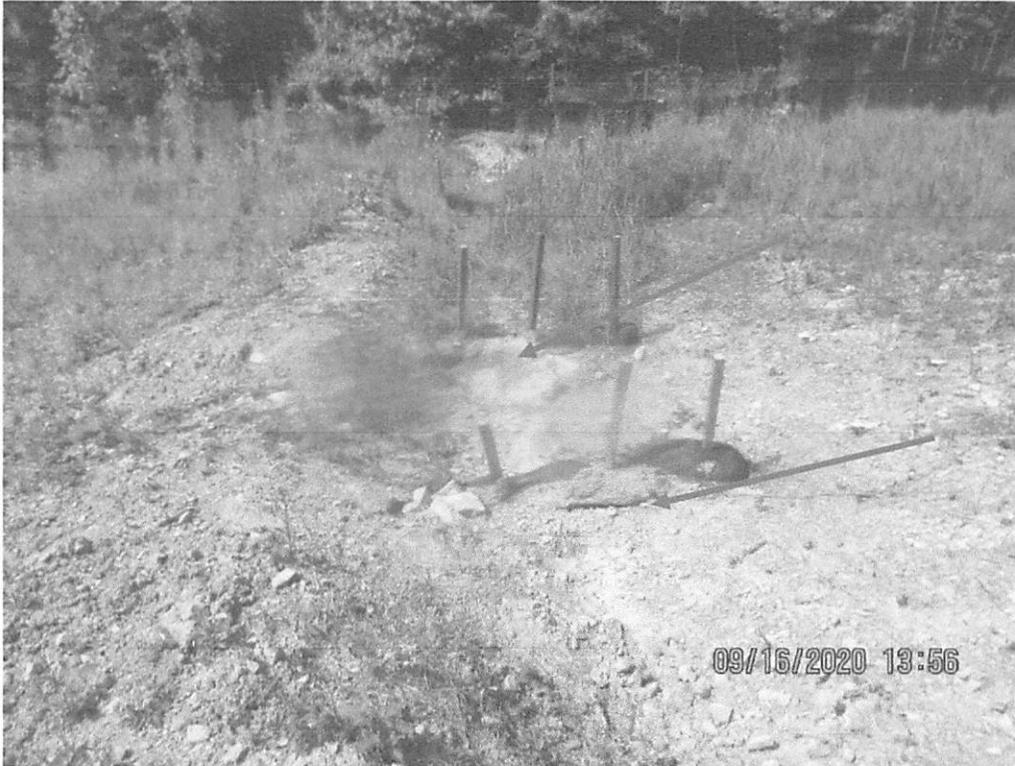
Waterbar with erosion near Station No. 6703+00, controls in waterbar lacking maintenance (red arrow).

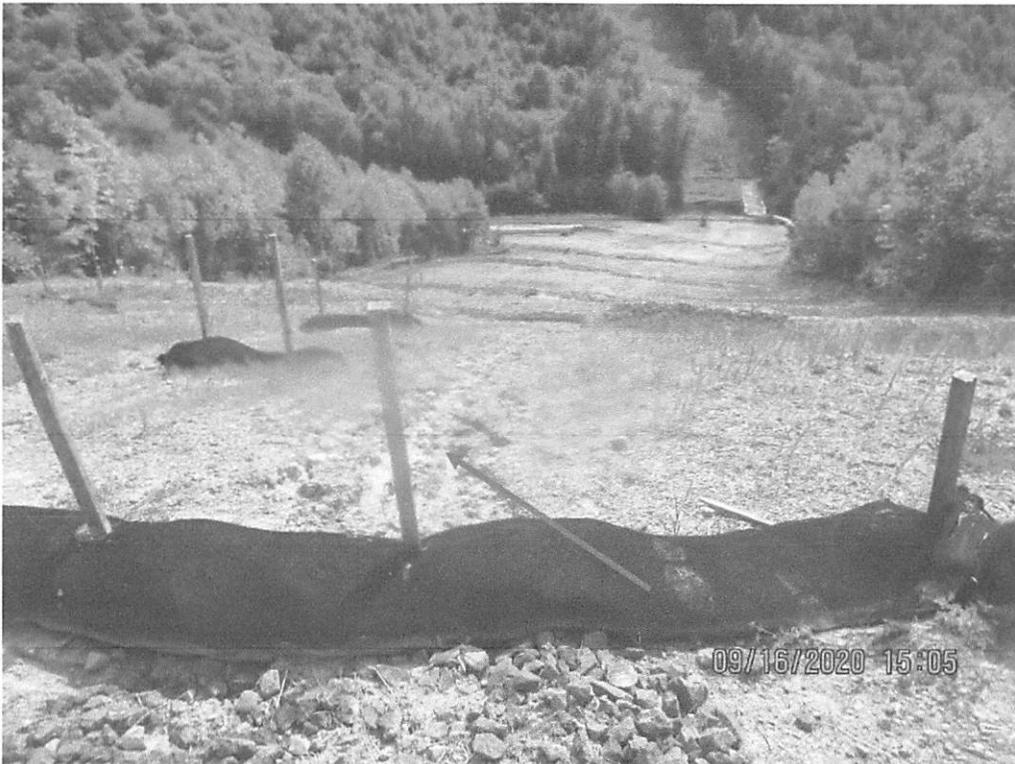
Standing at Access Road 159.01 facing downslope from Station No. 6657+00. Erosion present on slope (red arrow) with deposits in the waterbar channel.

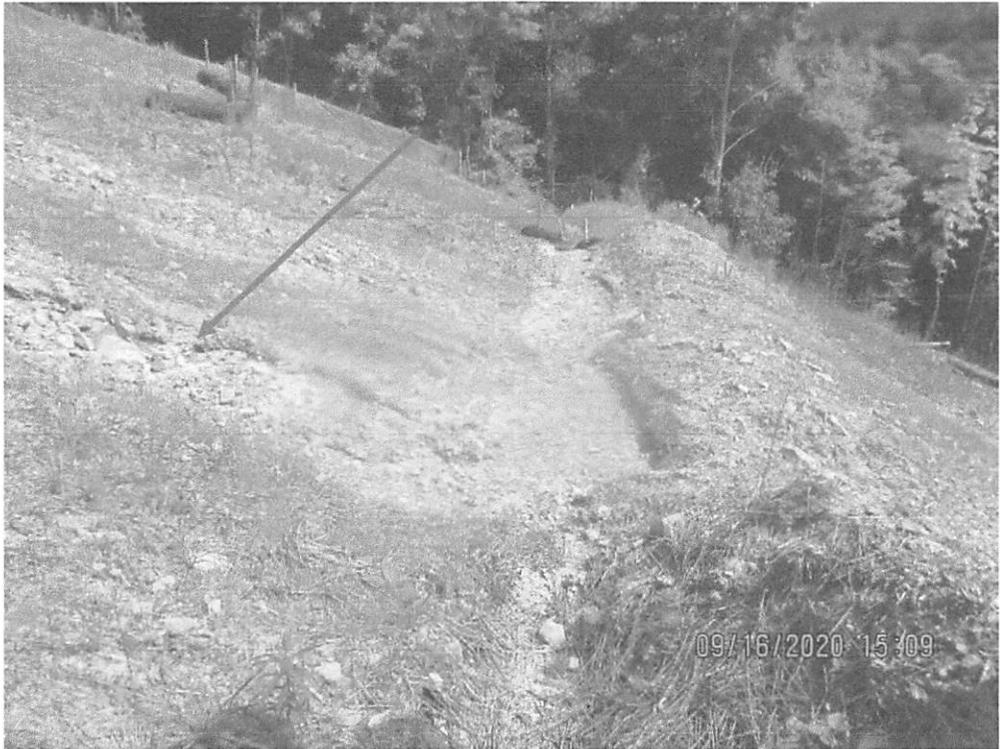
Standing downslope from Access Road 159.01 facing east near station No. 6657+00. Erosion present on slope, depositing sediment into waterbar and controls (red arrow).

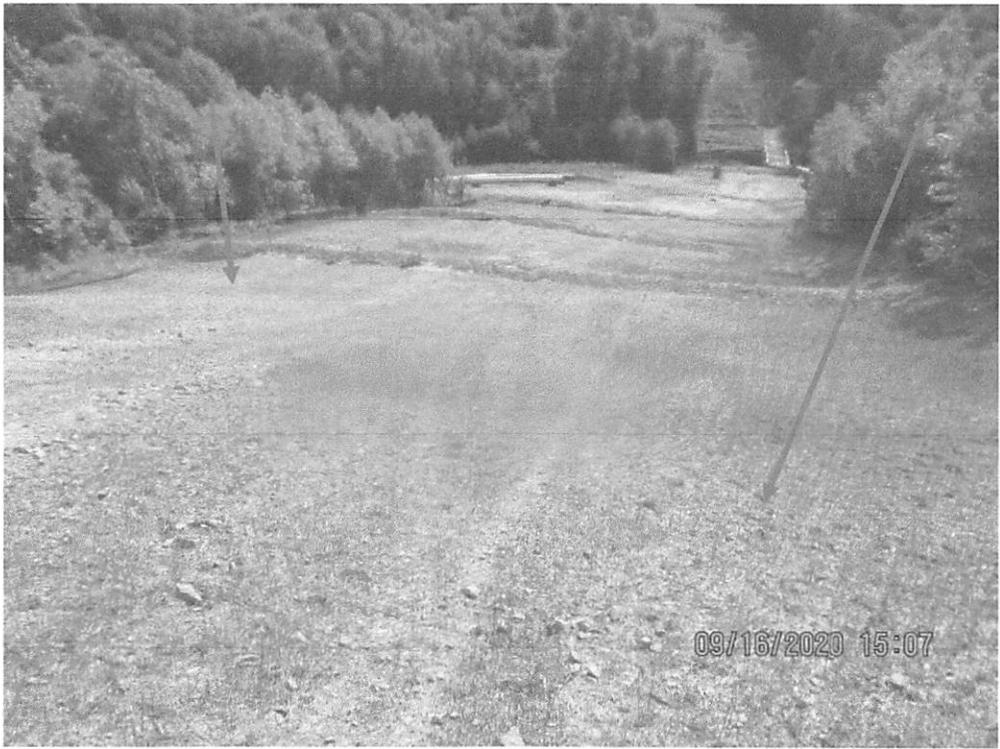
Further downslope of Station No. 6657+00. Travel lane was reseeded, however, ROW adjacent to travel lane was not (red arrows).

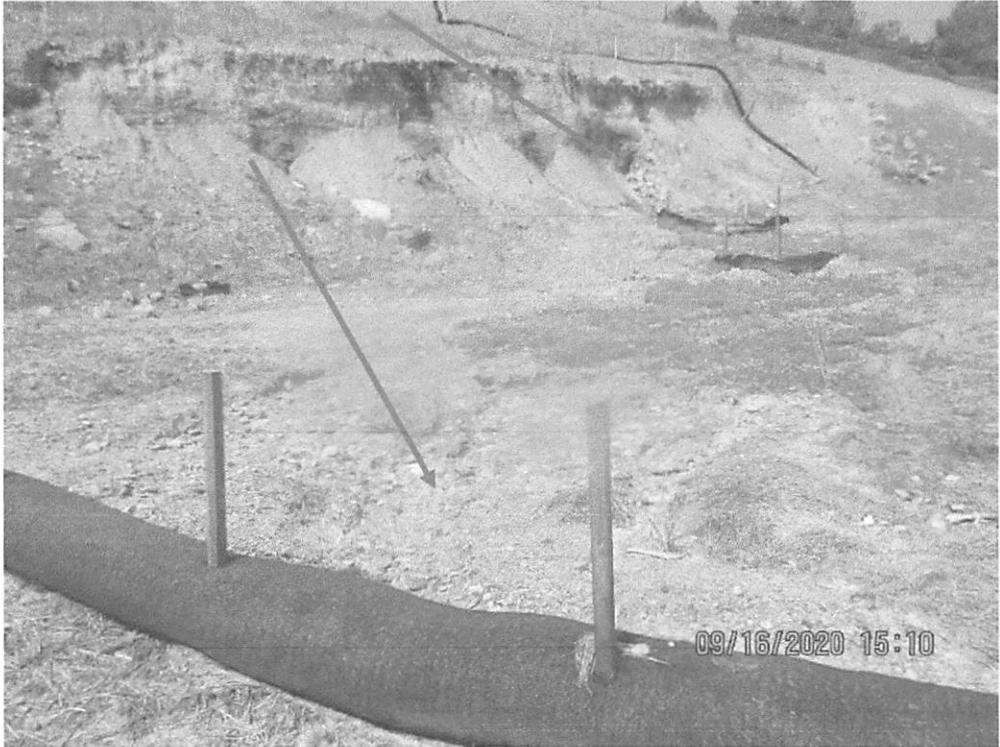
Standing at Access Road 159.01 facing upslope at Station No. 6450+76. Erosion present on cut slope and above controls (red arrow).

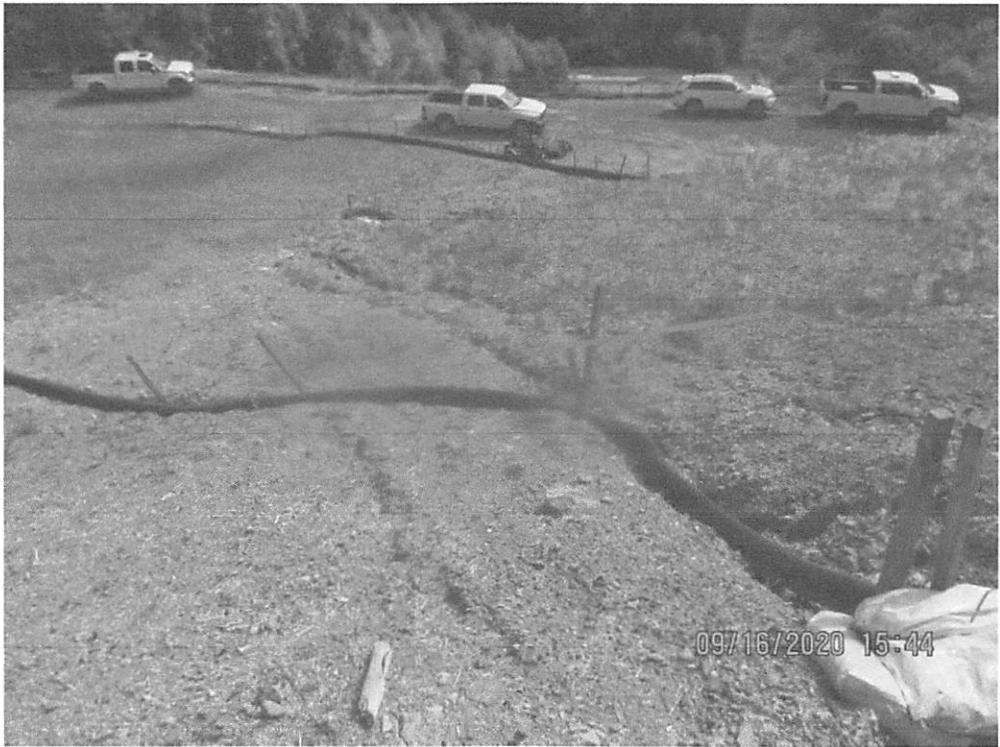
Standing at Station No. 6450+76 at slope drain. Run-off causing erosion on cut slope (red arrow).

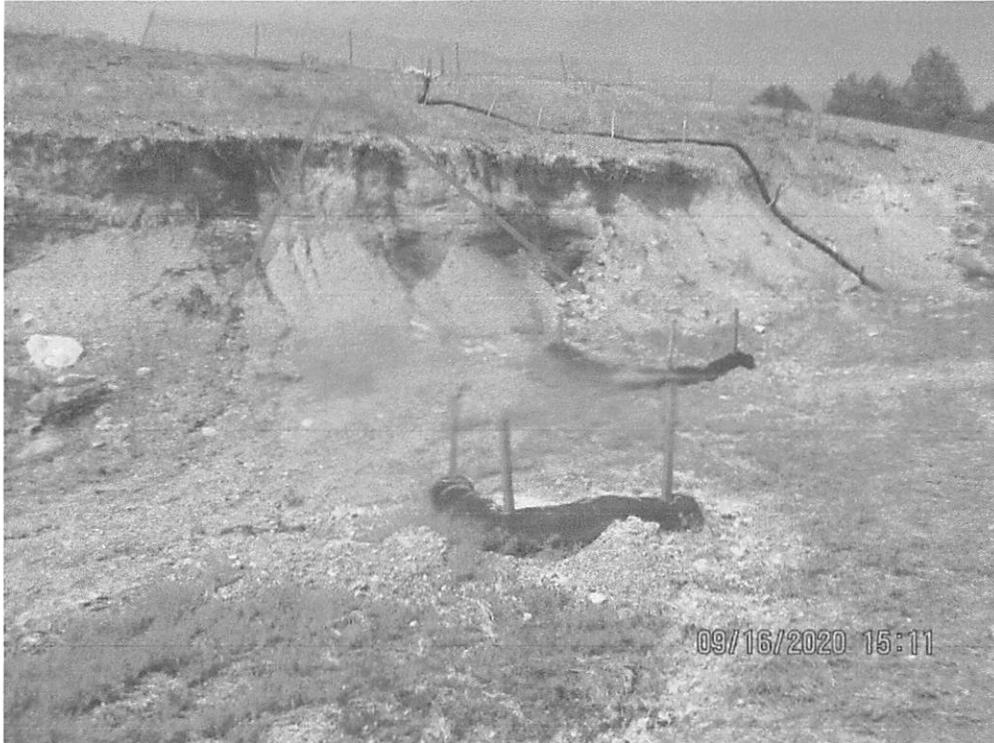
Erosion occurring on cut slope (red arrow) below slope drain outlet at Station No. 6450+76.

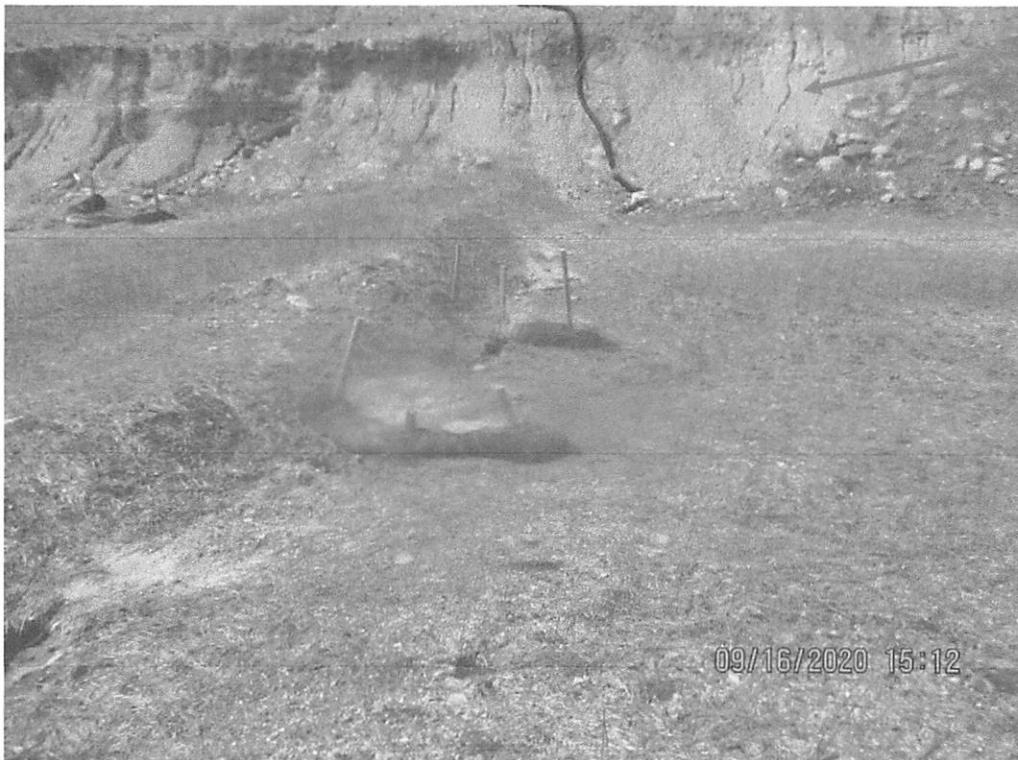
Erosion occurring on cut slope (red arrow) below slope drain outlet at Station No. 6450+76. Erosion present in waterbar. Area not reseeded.

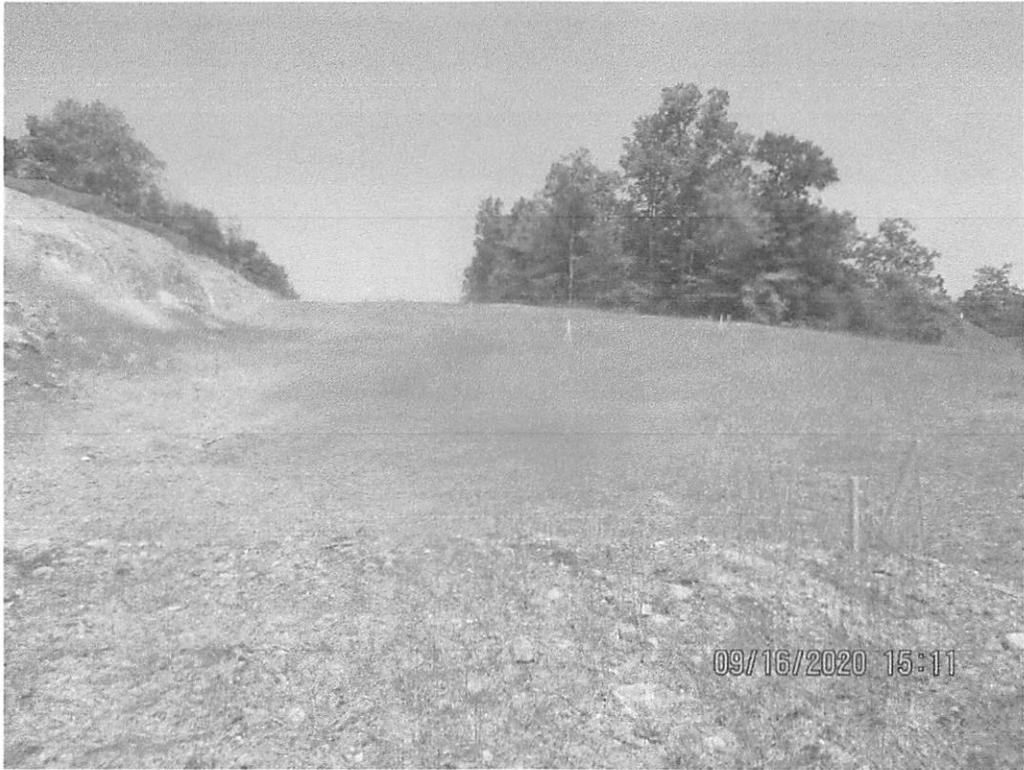
Near Station No. 6450+76 facing North. Area had not been reseeded since last Fall.

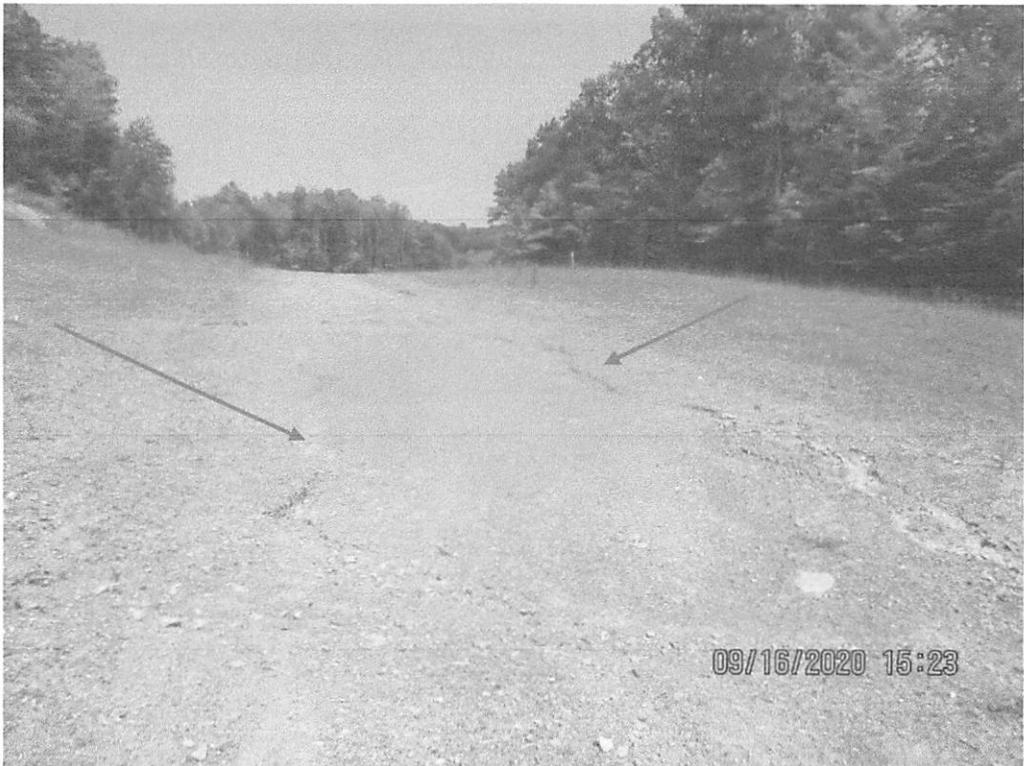
Near Station 6450+76 facing upslope toward erosion on slope (red arrow).

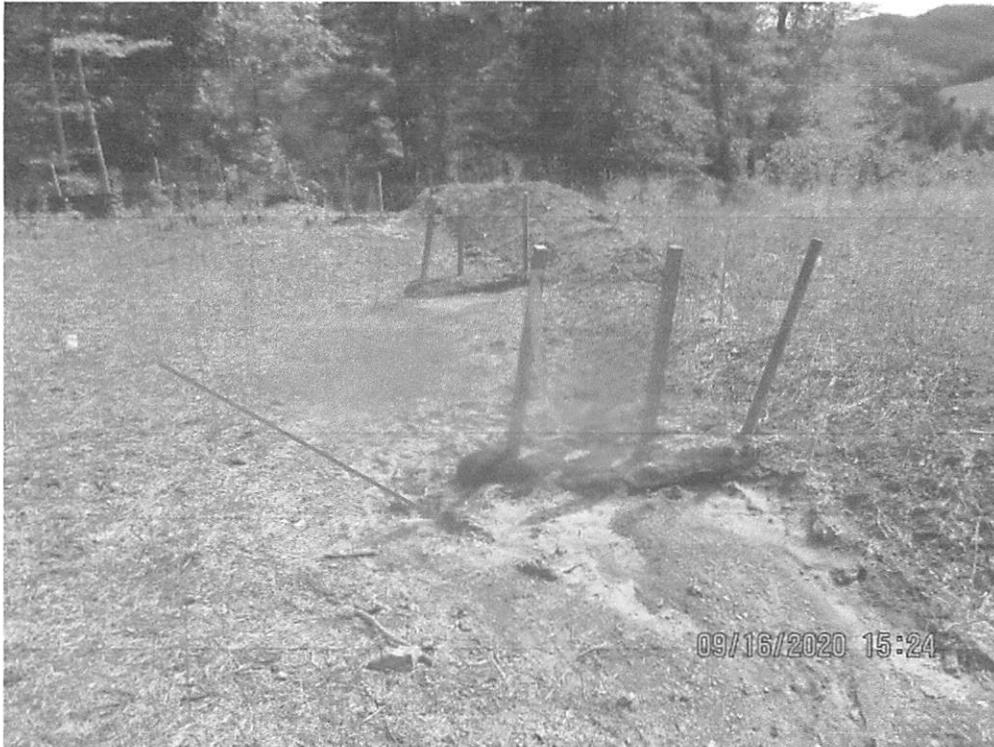
Near Station 6450+76 facing downslope toward erosion in waterbar (red arrow). Sediment was being deposited in waterbar, and runoff was flowing around unmaintained controls.

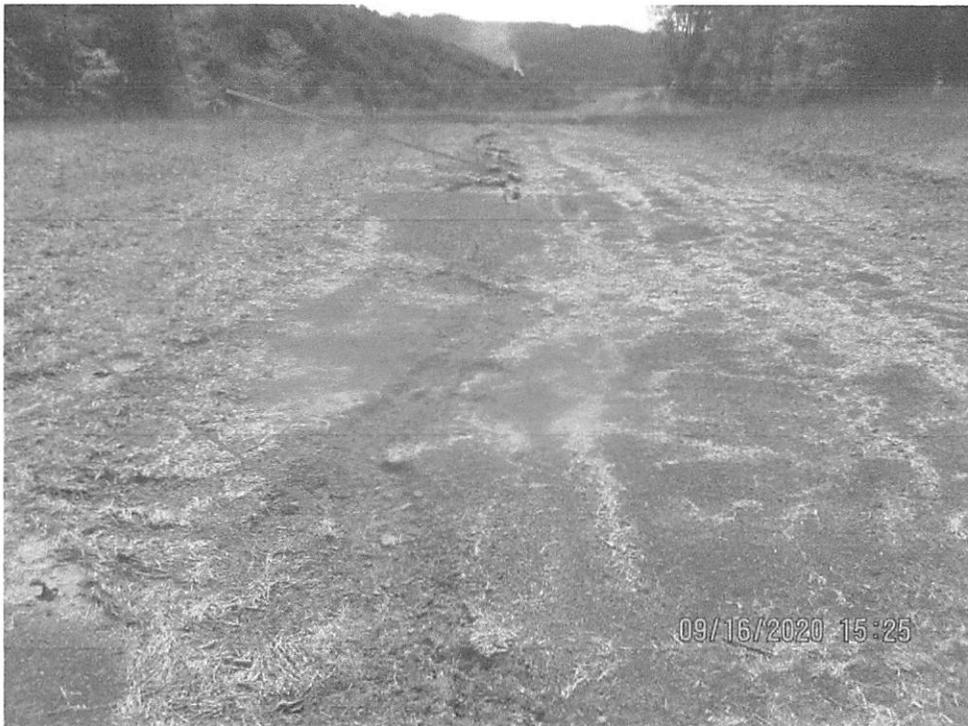
Section of ROW upslope from 6450+76 that was not reseeded since Fall 2019. Red arrow shows erosion occurring due to increased sheet flow.

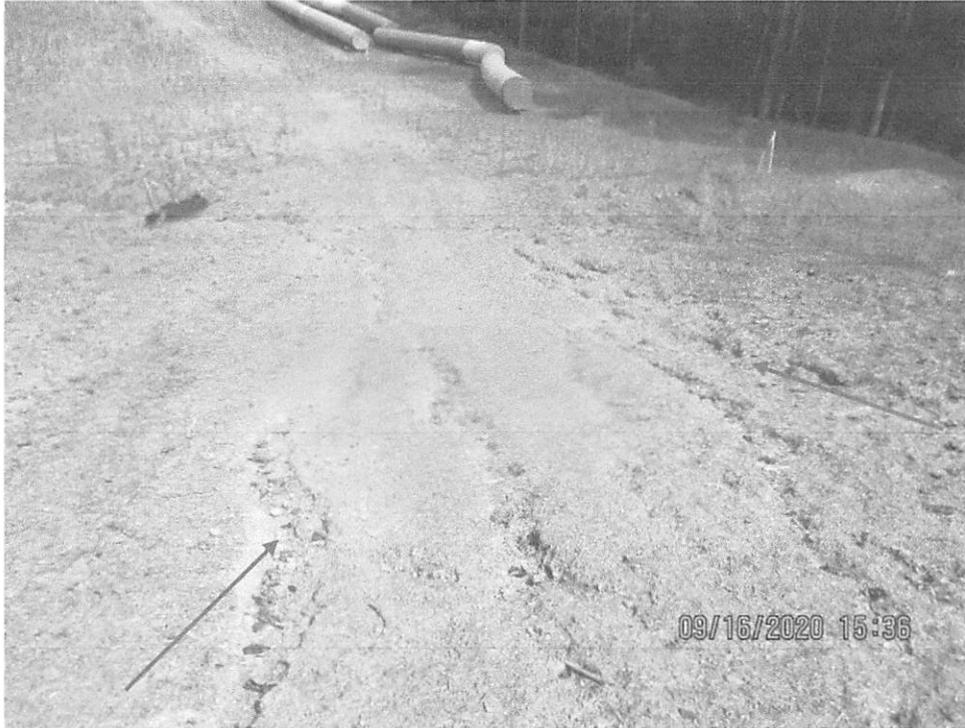
Erosion on slope between waterbars near station No. 6450+76 (red arrows). Area had not been reseeded.
